CPAT Report No. 1812

Tan y Ffridd, Meifod, Powys

Historic Building Survey

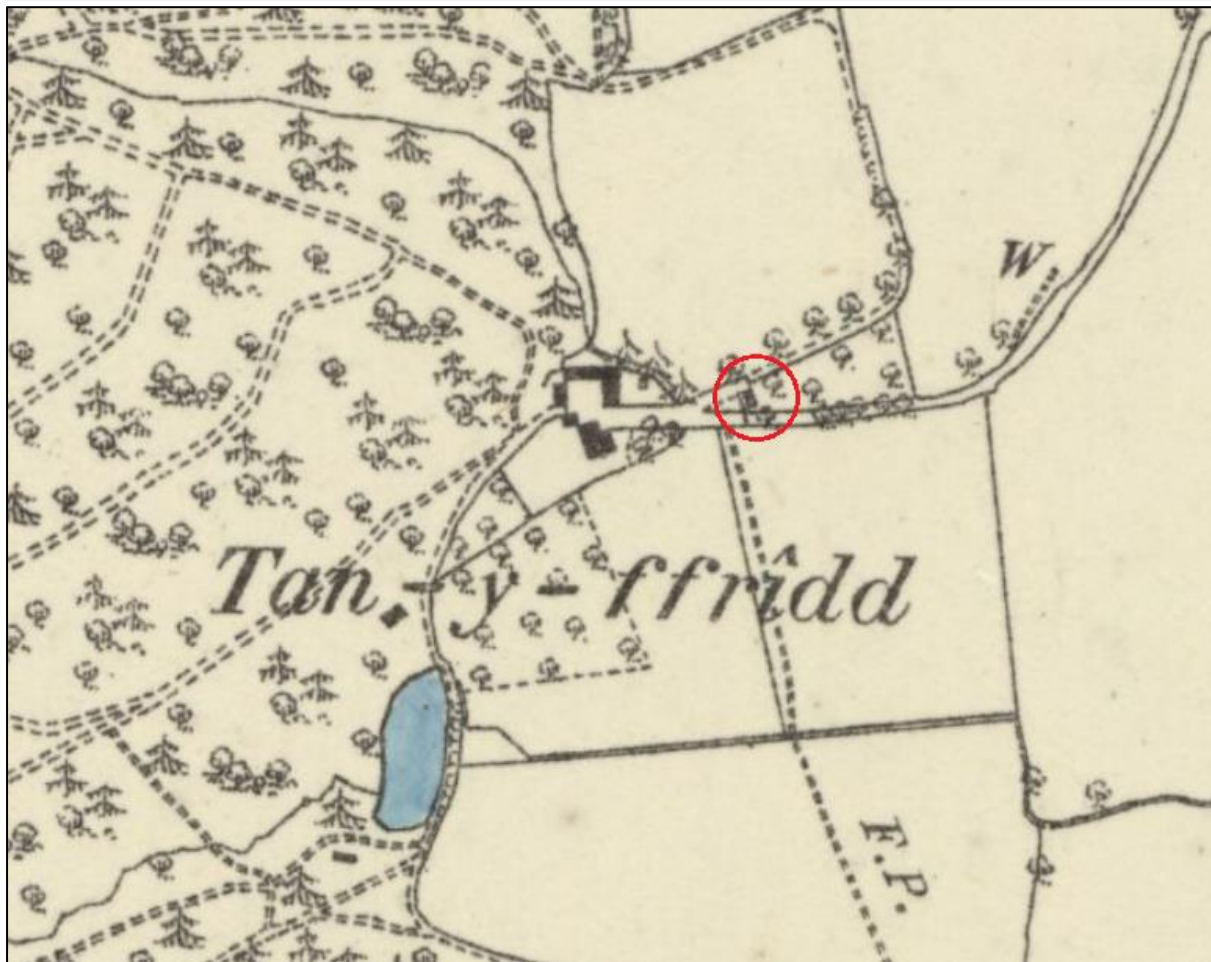
Fig. 2 Extract from the Ordnance Survey 6" map of 1885

- 2.2. The pigsty was first recorded in 1885 and is located well to the east of the farm and house.

- 3.4. Cartographic evidence indicates that the pigsty at Tan y Ffridd was constructed between 1840 and 1885, with the evidence of the construction materials, especially the machine made bricks suggesting perhaps a construction date toward the end of this period. It is possible it was rebuilt following its original build date, which would explain the mixture of brick types utilised, but it is equally possible that it was constructed in a single phase using whatever materials were available to hand at the time. The concrete flooring and rails were a later addition to the construction, the use of concrete flooring in animal sheds being a common design change following the introduction of hygiene regulations during the early 20th century (Historic England, 2013, 14).

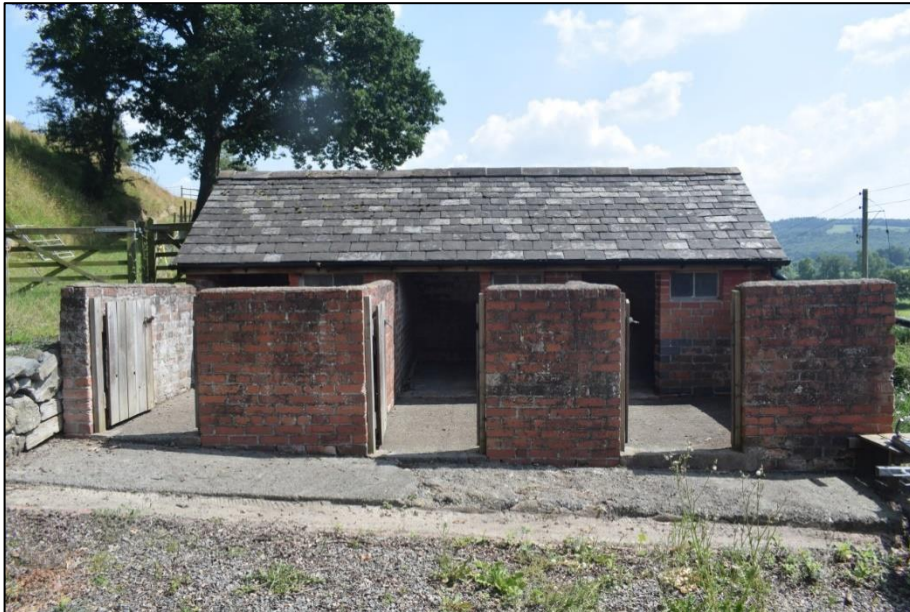
Fig. 3 Pigsty, viewed from the west Photo CPAT 4935-003

- 3.2. The pigsty measured approximately 6m by 4.8m and was constructed in brick, on a plinth constructed from grey uncoursed unworked shale or sandstone which had been terraced into the hillside to the north and built up to the south. The roof was slate. The roof had been rebuilt quite recently and was not of historical significance. The roof slates were largely original but had been relaid when the roof had been rebuilt. The pigsty comprised three identical pens with the covered boxes to the east. Two of the boxes had a rail around the perimeter, to prevent piglets being crushed against the box wall by the sow. The flooring material in all three boxes and pens was concrete throughout.

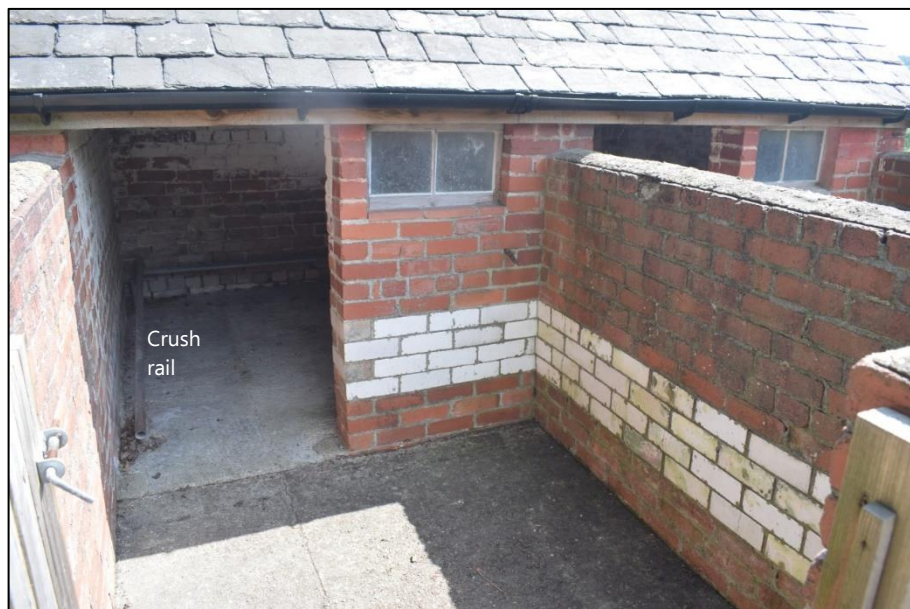
*Fig. 3 Central box of the pigsty showing crush rail and mixture of brick types used in the construction
Photo CPAT 4935-007*

- 3.3. The brickwork on the east, north and south elevations of the boxes was constructed entirely from handmade brick, lime mortared and stretcher bonded with a header course every five

courses. The internal box subdivisions, external pen walls and the west elevation of the boxes were made largely from a mixture of machine made brick including some engineering bricks and some with a white glazed finish. Each box was lit with a window in the west elevation located next to the box entrance. There were small windows with slate sills in the north and south gable ends, probably ventilators.

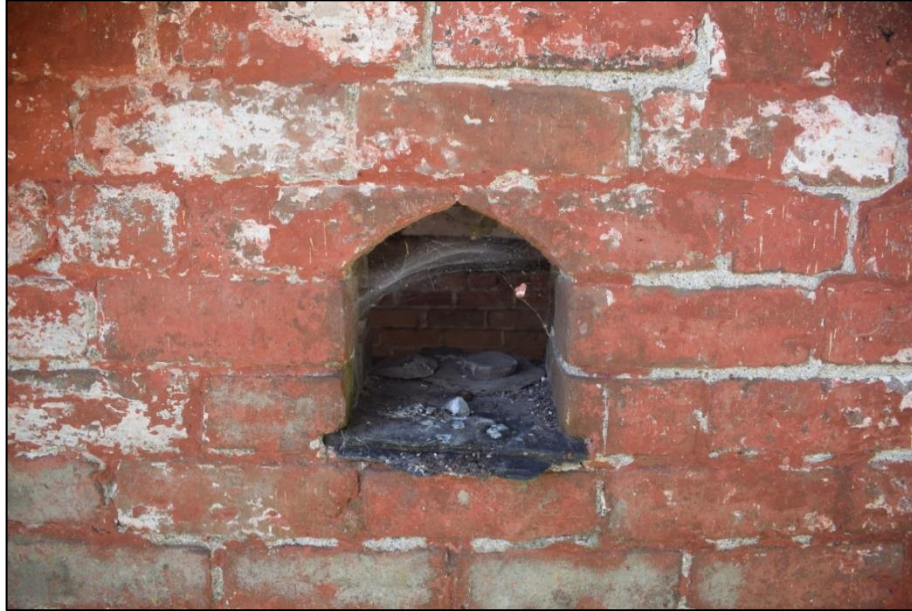
Fig. 3 Ventilator in north gable end Photo CPAT 4935-005

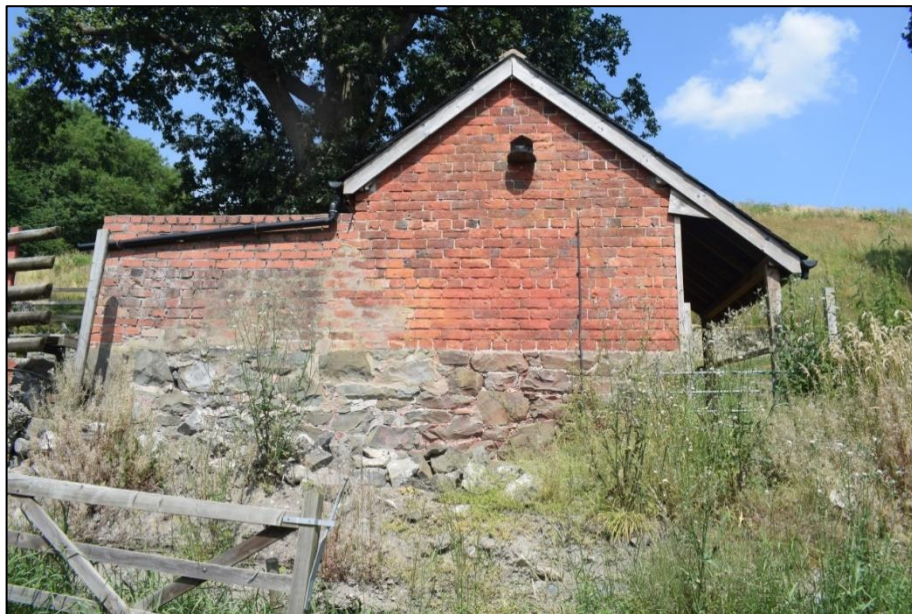
Fig. 4 South elevation of the pigsty Photo CPAT 4935-002

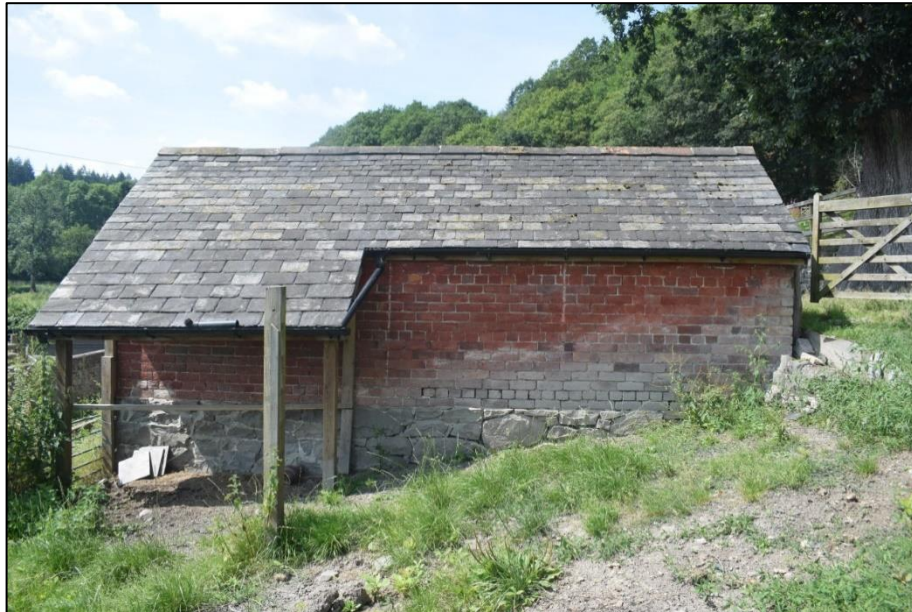
Fig. 4 East elevation of the pigsty Photo CPAT 4935-006
