**CPAT Report No. 2572**

# **Llangollen Lower Weir, Llangollen, Denbighshire**

Level 2 Structural Survey

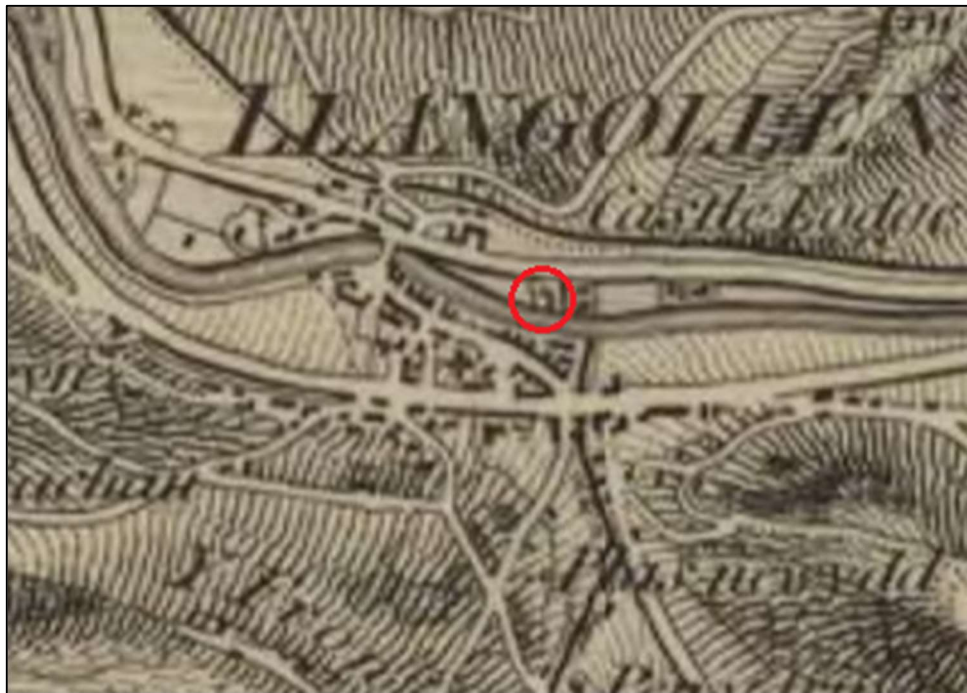
*Fig. 2 Extract from the 1837 Ordnance Survey 1" map showing the mill complex (circled in red)*

- 2.3. The 1" Ordnance Survey Surveyors' Drawing, which was published in 1837 but surveyed in the early 19<sup>th</sup> century doesn't depict the weir or the leat, but does show the mill complex and the canal (Fig. 2). The cotton mill had initially been a success but had suffered a series of misfortunes including a fire in 1814 and then a slump in the cotton trade leaving the owners bankrupt. The complex stood empty for several years until it was taken over by a second Manchester based firm, Gardner, Taylor and Bell, but this revival was short lived and the mills closed again in 1835.

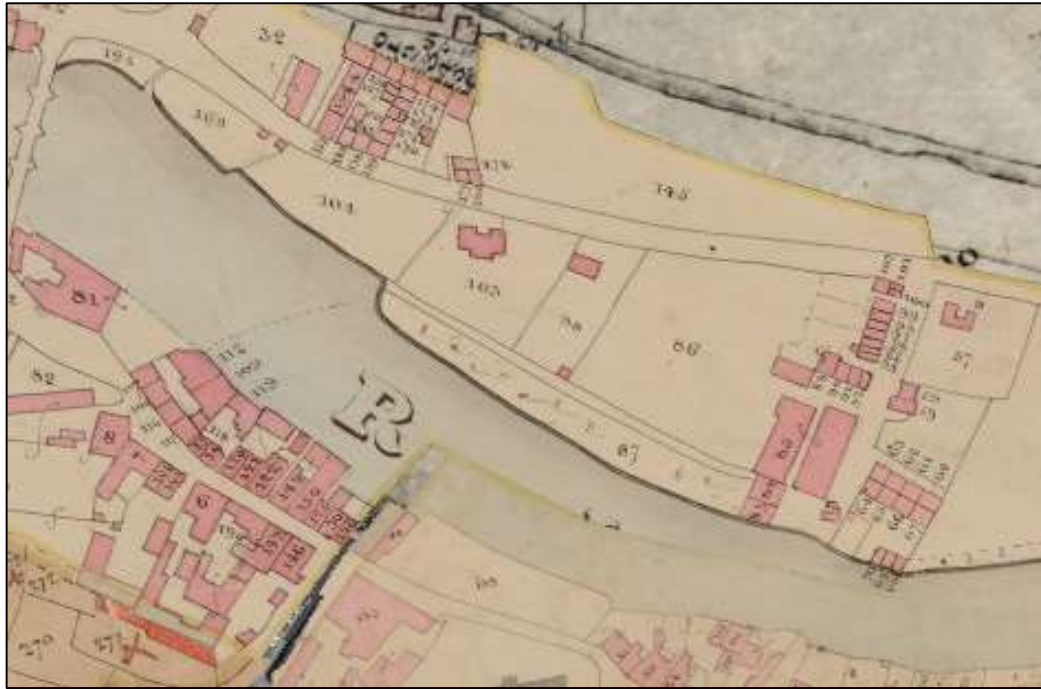
- 2.4. The 1843 Tithe Map (Fig. 3) depicts the details of the site in much more detail, and records the weir, the leat, and possibly the revetment along the northern bank of the river. The factory and the land connecting it to the weir are owned and occupied by John Hughes, who had reopened the site as a woollen mill (Apportionments 83 – 87). He was evidently successful in this venture as he built a second factory, Upper Dee Mill immediately to the west of the Lower Mill site in 1855. Both mill sites were subsequently purchased by the Lloyd Jones family, themselves owners of a mill at Mile End, to the west of Llangollen.

*Fig. 3 Extract from the 1843 Tithe depicting the weir, mill leat and Lower Dee Mill.*

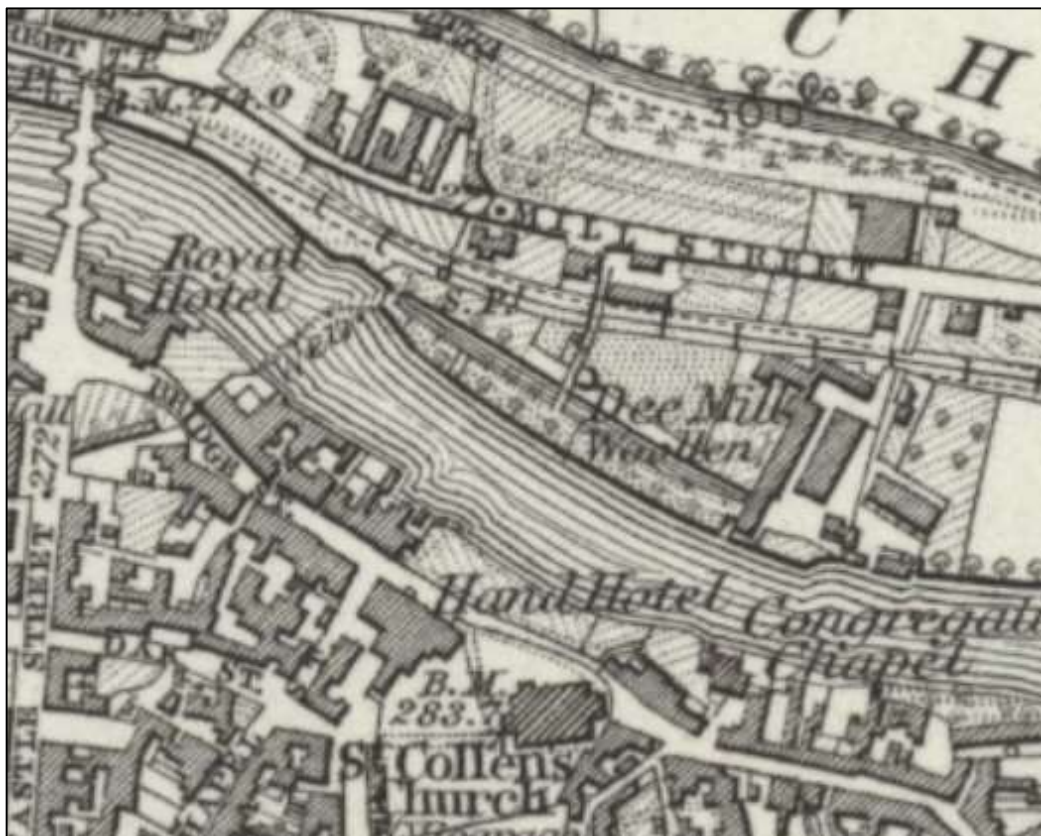
*Fig. 4 Extract from the 1880 Ordnance Survey 6" map depicting the Dee Mills, now expanded by the construction of the Upper Mill site in 1855*

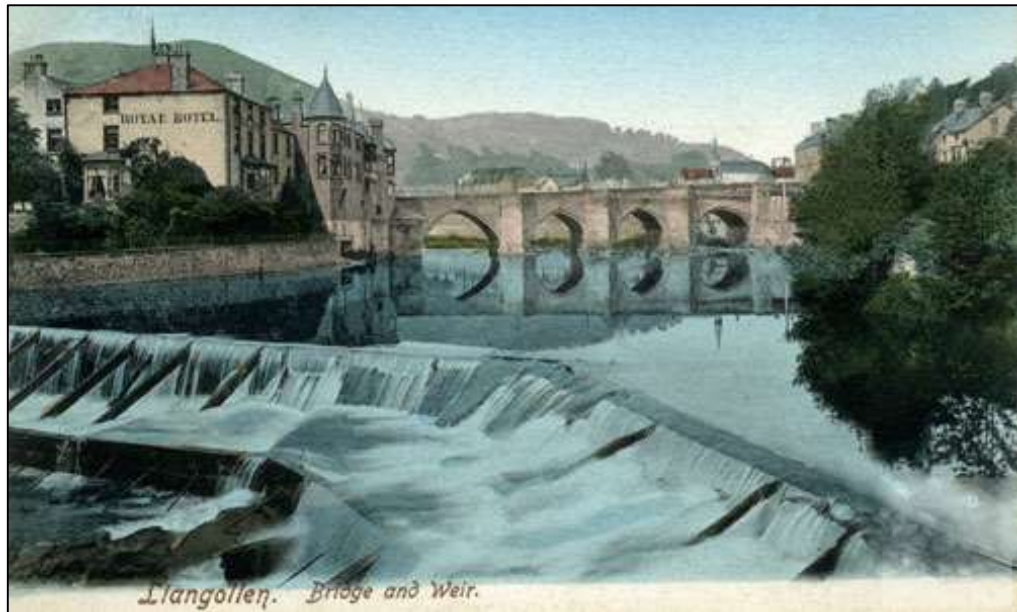
*Fig. 6 A photograph of the weir during the early 20th century*

- 3.2. Photographic evidence from the early 20<sup>th</sup> century (Fig. 6) suggests that the weir was formerly a two tier design and a doglegged structure. An unusual feature is the use of wooden beams to buttress the upper tier, it is unclear whether this was a feature of the design or a later addition to strengthen it.

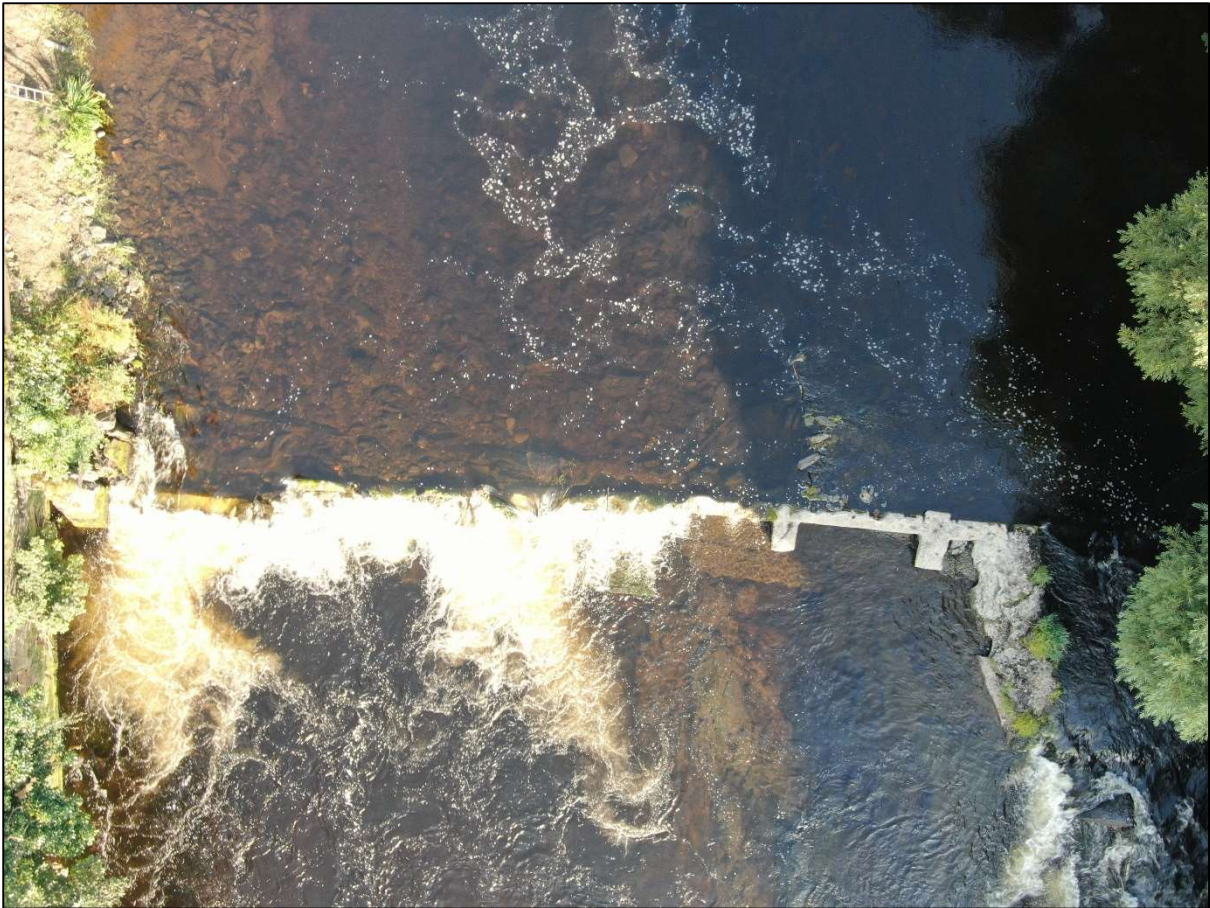
- 3.3. The extant weir dates largely from the later 20<sup>th</sup> century, when the weir was completely rebuilt on a concrete plinth with a stone and concrete superstructure. The rebuilt weir is apparently rather lower than the original design. Some wooden posts are visible within the structure, but these are likely to be remnants of the concrete shuttering used in its construction rather than relating to an earlier form of the weir. The overhead photography does seem to indicate that there is some survival of the earlier weir fabric, visible as a line of stonework running from the south bank of the Dee and truncated by the modern structure (Fig. 7).

- 3.4. The modern weir was in poor condition, with most of the upper structure missing and was largely underwater despite the river levels being very low at the time of the survey. The entrance to the mill leat was well above the current water level and had become overgrown with mature trees.

*Fig. 7 Overhead drone survey photograph of the weir (west is to the top of the photograph). Note the line of a possible earlier structure upstream of the extant weir (left of shot).*

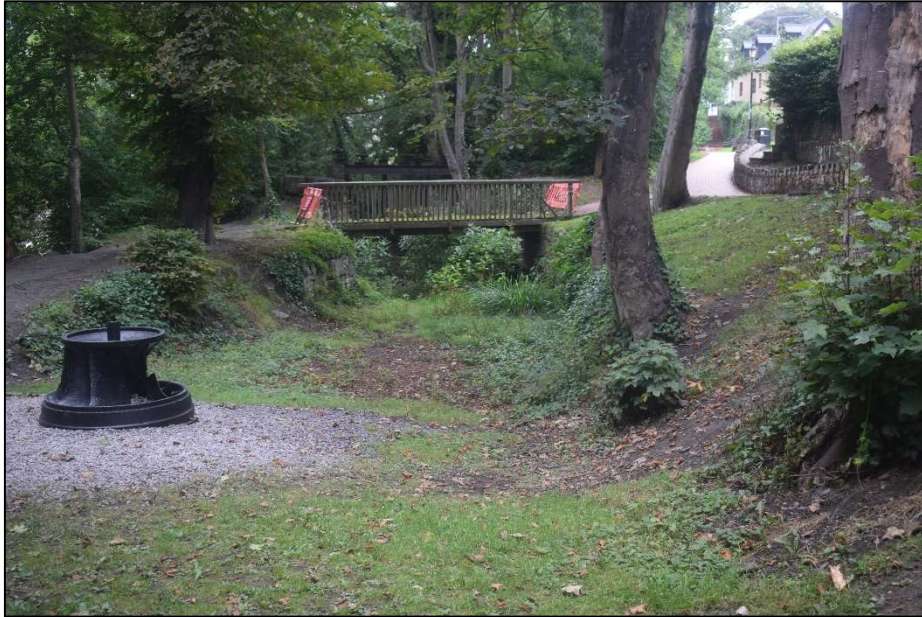
- 3.5. The leat originally extended approximately 110m between the mill pond and the mill complex. The surviving open section of leat measured approximately 30m in length and 7.5m in width, with vertical sides revetted in stone. The base of the leat had become partially infilled and was approximately 1.2m deep (Fig. 8).

*Fig. 8 The mill leat viewed from the east Photo CPAT 4948-001*

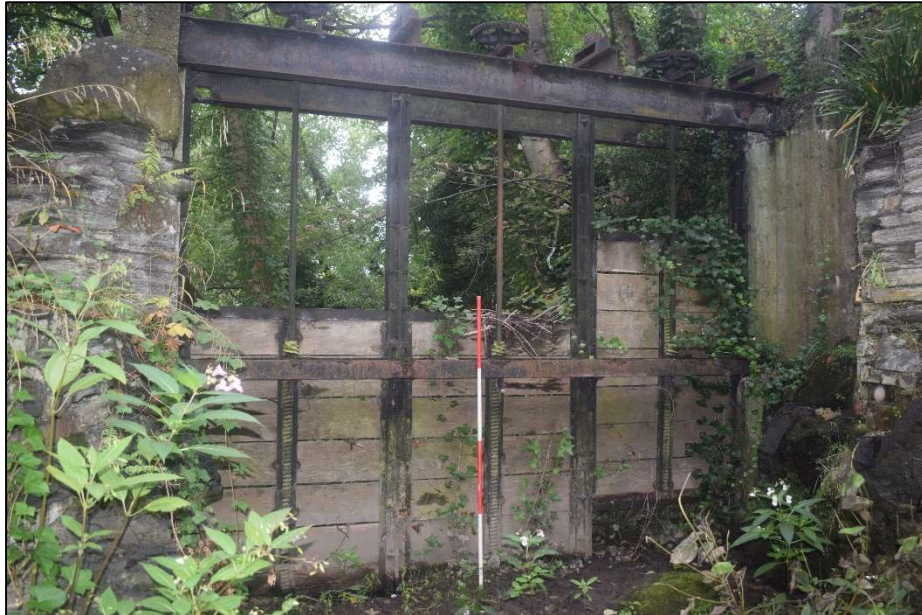
- 3.6. The flow of water into the leat was controlled by a sluice gate located at its west extent (Fig. 9). The sluice gate comprised three gates which could be opened by turning a reduction gear on the south end of the gate. Most of the mechanism, (apart from the geared connecting shaft) was still present and the gates and supporting stonework were in good condition (Fig. 10).

*Fig. 9 The sluice gate, viewed from the east Photo CPAT 4948-013*

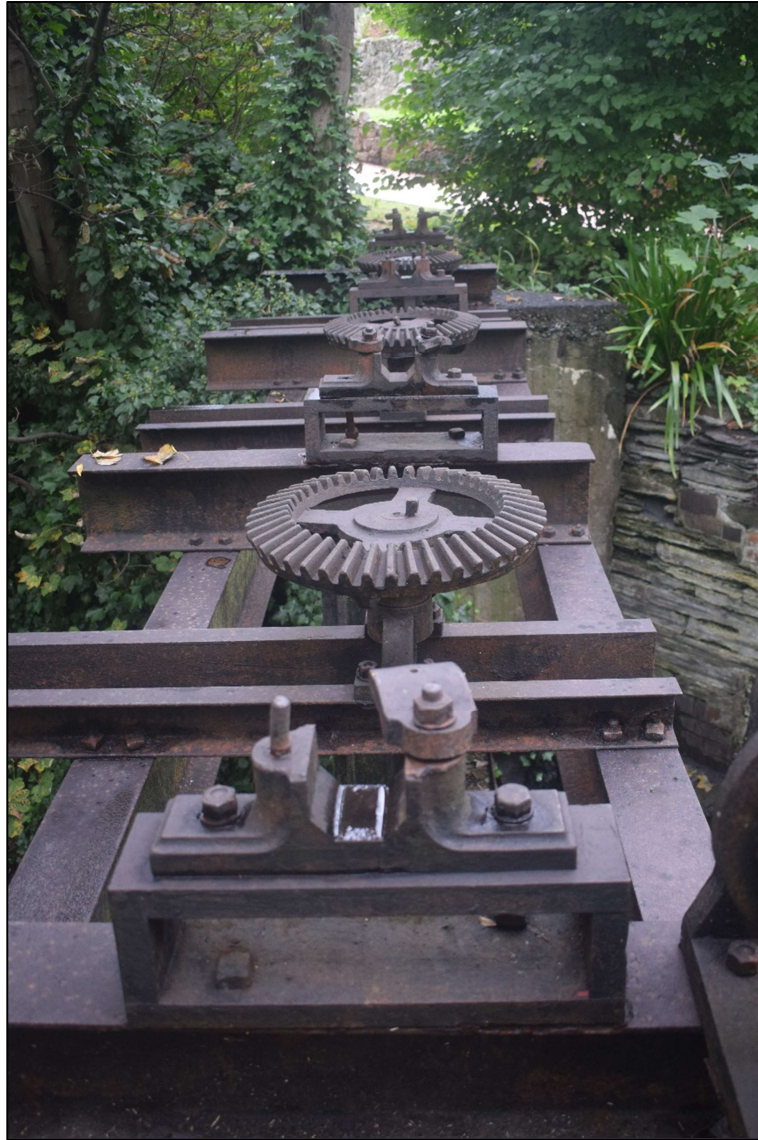
*Fig. 10 Detail of the winding gear for the sluice gate Photo CPAT 4948-010*

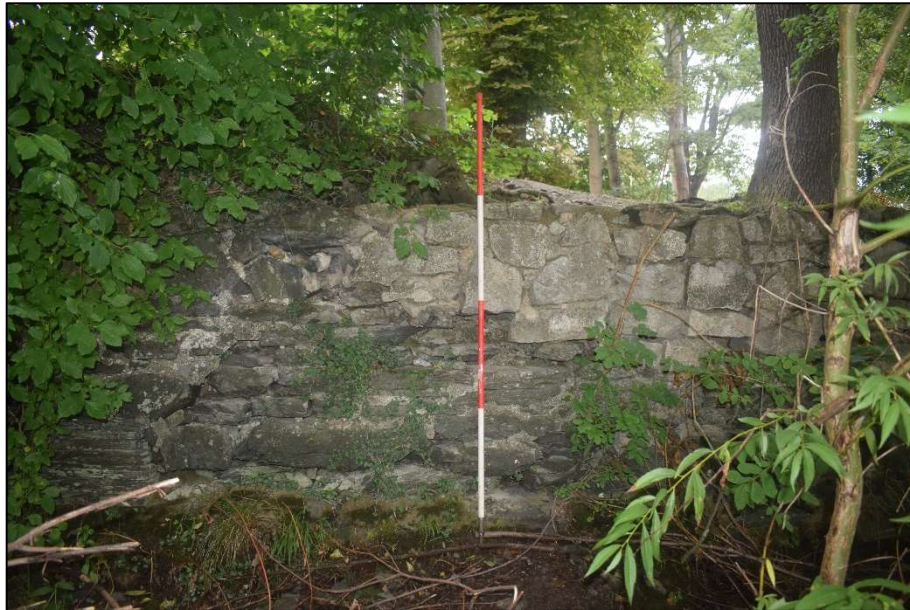
*Fig. 11 Western visible extent of the revetment showing the difference in stonework between the upper and lower structure Photo CPAT 4948-032*

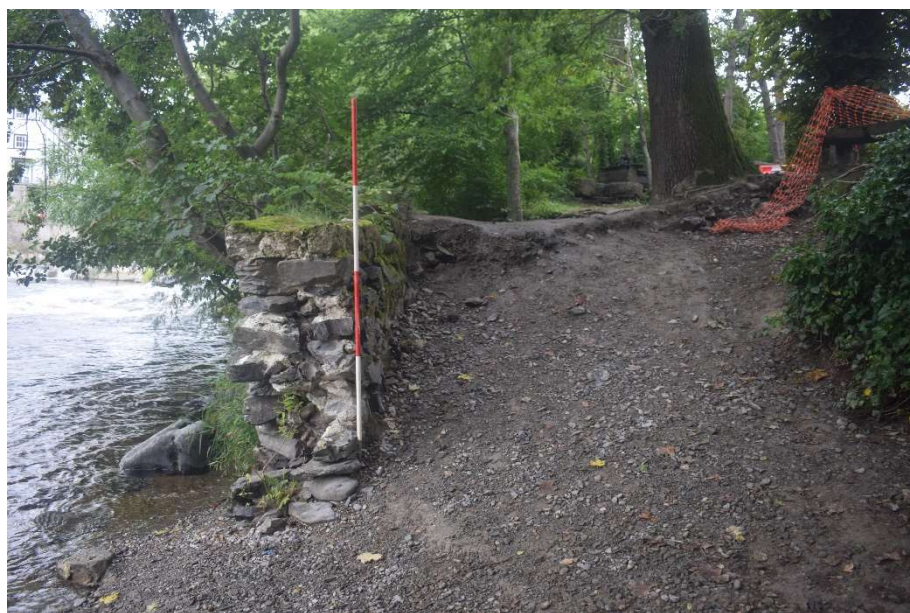
*Fig. 12 Exposed cross section through the revetment viewed from the east Photo CPAT 4948-002*

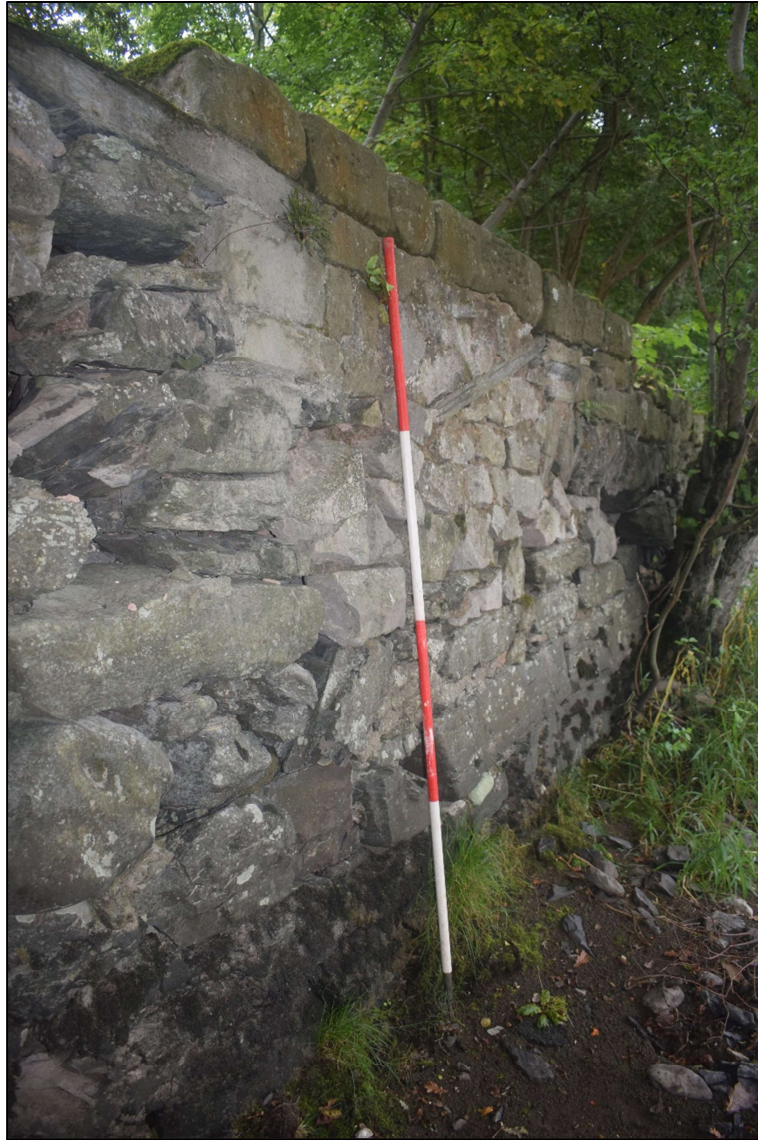
*Fig. 13 View from the west along the revetment showing the batter on the lower structure Photo CPAT 4948-034*

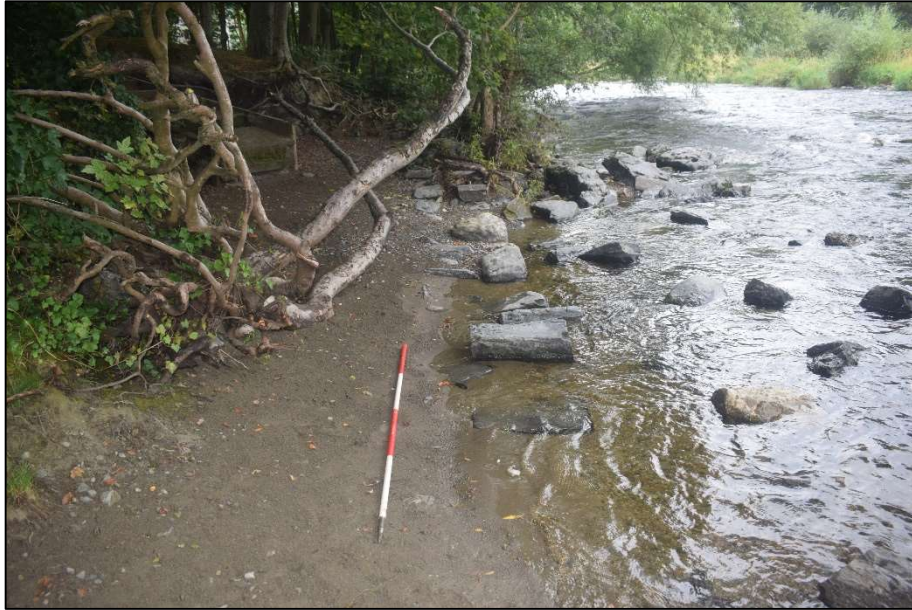
- 3.7. The revetment wall ran east from the south end of the sluice gate along the north bank of the river. The section within the bounds of the development area measured about 23m in length, although the line of the revetment was discernible as a foundation course extending further to the east (Fig. 14). It was constructed from grey random uncoursed sandstone blocks. The lower section of the wall, to a height of 1m was made from dark grey, longer more massive stone blocks than the upper wall, and the wall face was battered. The upper wall section, approximately 1.3m in height was made from smaller, lighter-coloured stone and the wall face was vertical (Figs. 11 - 13). The blockwork was bonded with a whitish gritty mortar, with evidence of repairs and repointing in a reddish cement mortar. Much of the bonding material had washed out of the joints and some of the stone work had become dislodged. The wall was topped with rectangular worked sandstone blockwork coping (Figs. 13). The stonework around the sluice gate comprised massive yellowish sandstone blocks, with blockwork made from a darker finer shale supporting the gate mechanism itself.

*Fig. 14 View east showing the line of the revetment visible as a partially buried foundation Photo CPAT 4948-035*
