# Llyn Bran Reservoir Discontinuance Scheme, Denbighshire

ARCHAEOLOGICAL MITIGATION:  
Watching Brief

Prosiect Rhif / Project No. G2580

Adroddiad Rhif / Report No. 1653

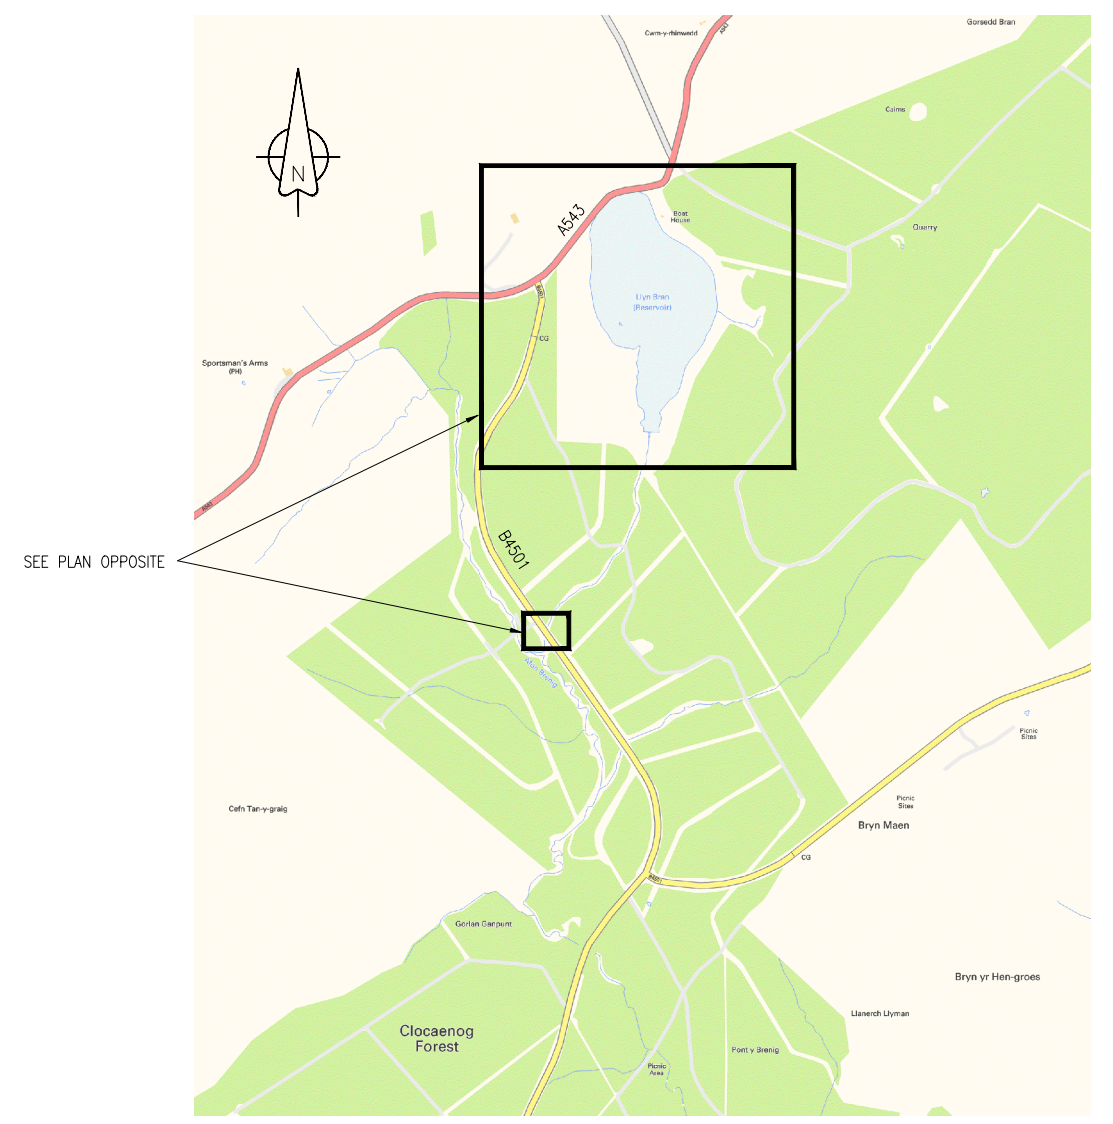
KEY	
	SITE BOUNDARY
	4m WIDE CONSTRUCTION ACCESS ROUTES: WET HEATHLAND TURFS LIFTED FOR TRANSPLANTING TO LAKE MARGINS. ROUTES PROTECTED WITH PROPRIETARY BOG MAT SYSTEM.

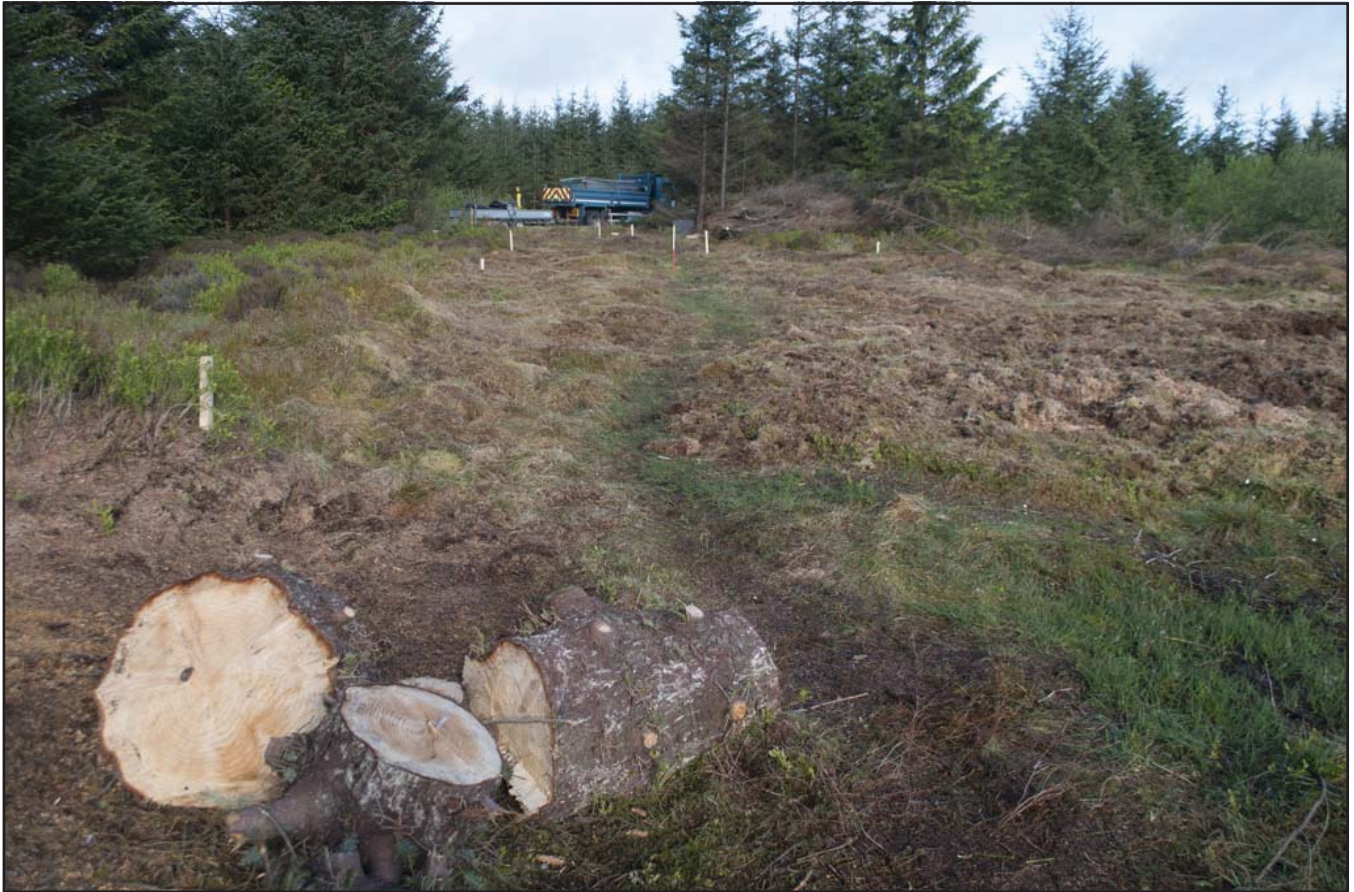
Plate 1: General view of the compound/access track area from the forest before excavation; scale 1x1m; view from E (archive reference: G2580\_062).

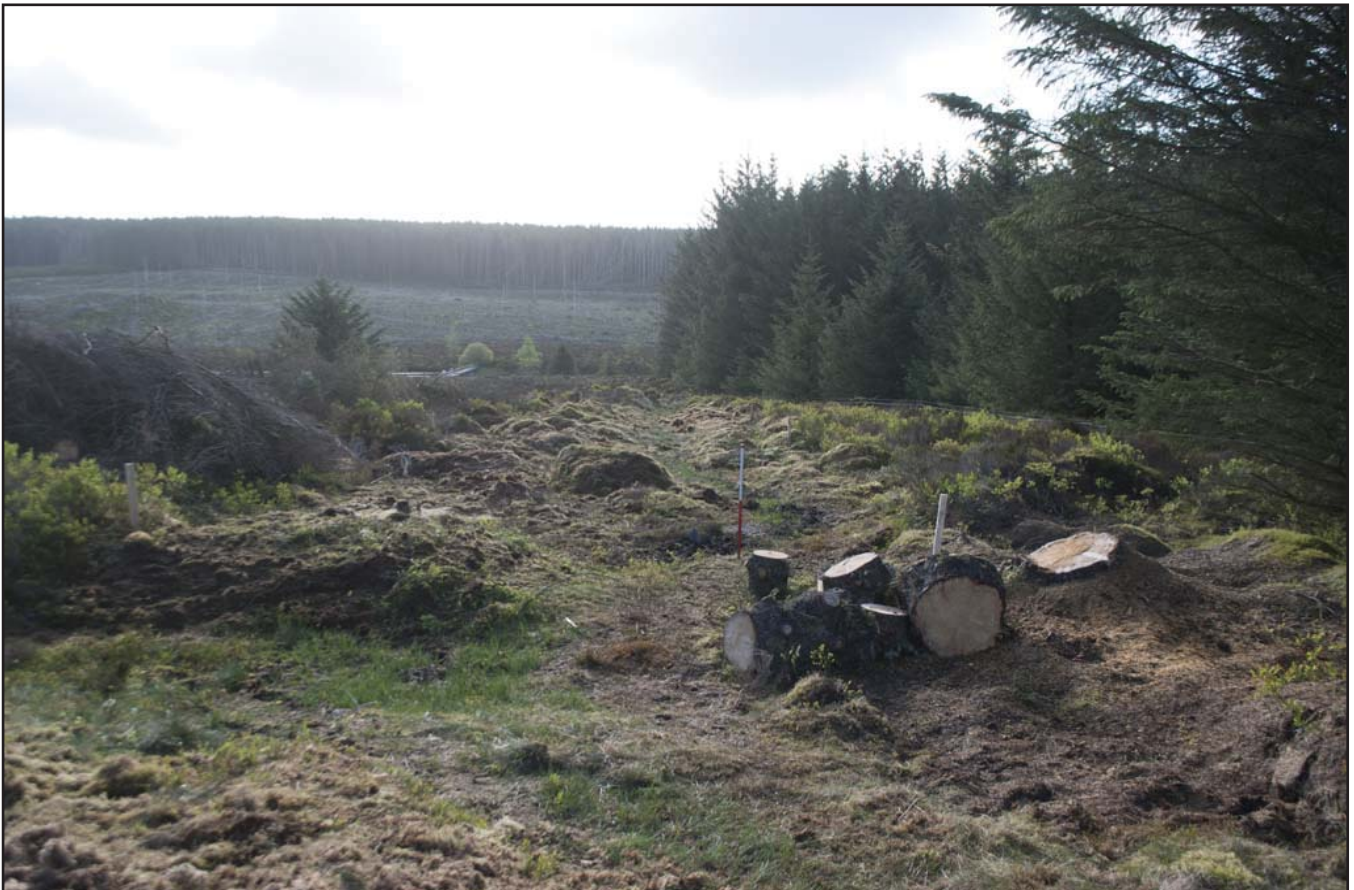
Plate 2: General view looking towards the dam along the access track; scale 1x1m; view from W (archive reference: G2580\_063).

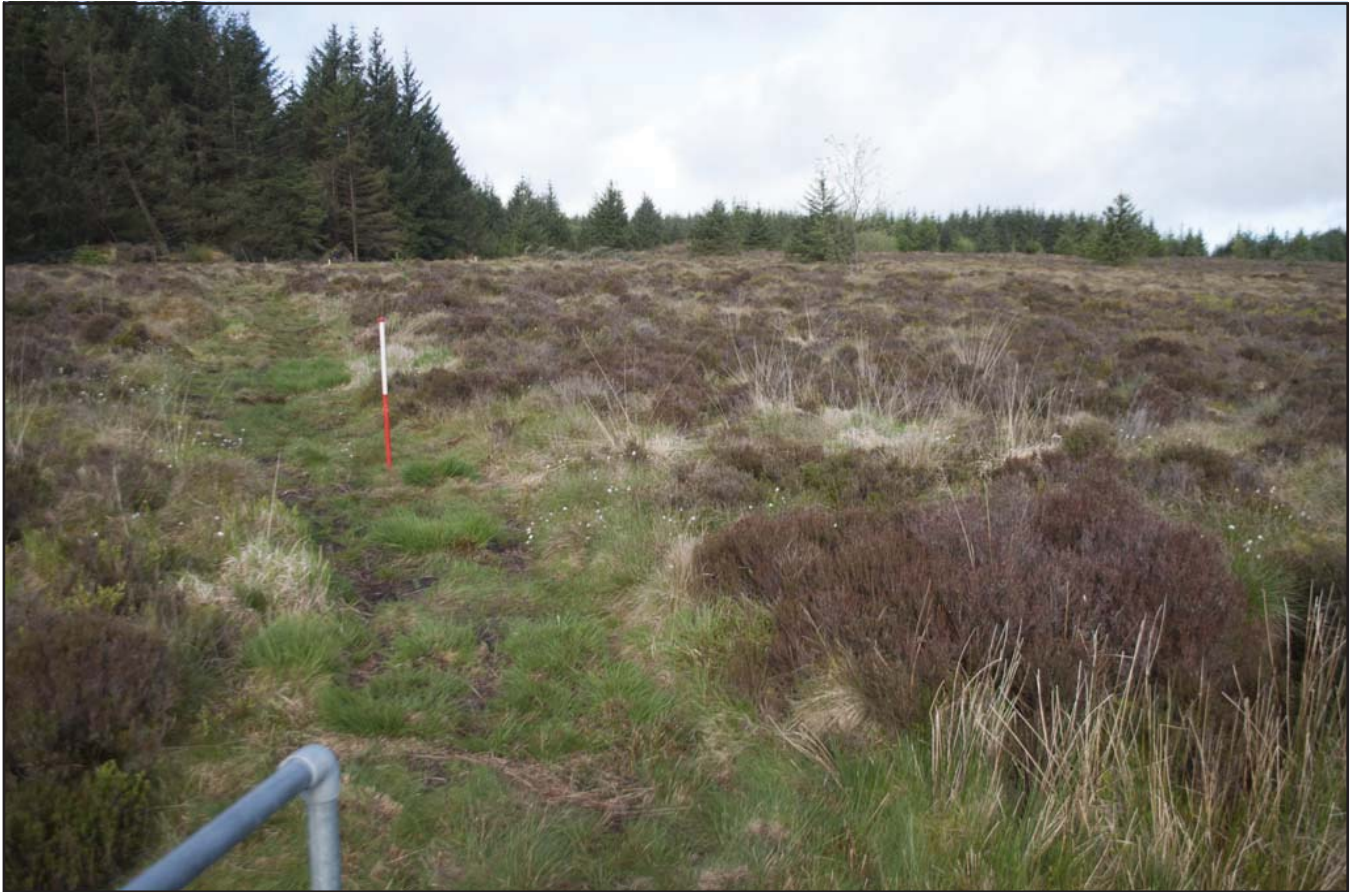
**Plate 3: View of the access trackway from the dam wall; scale 1x1m; view from ENE (archive reference: G2580\_064).**

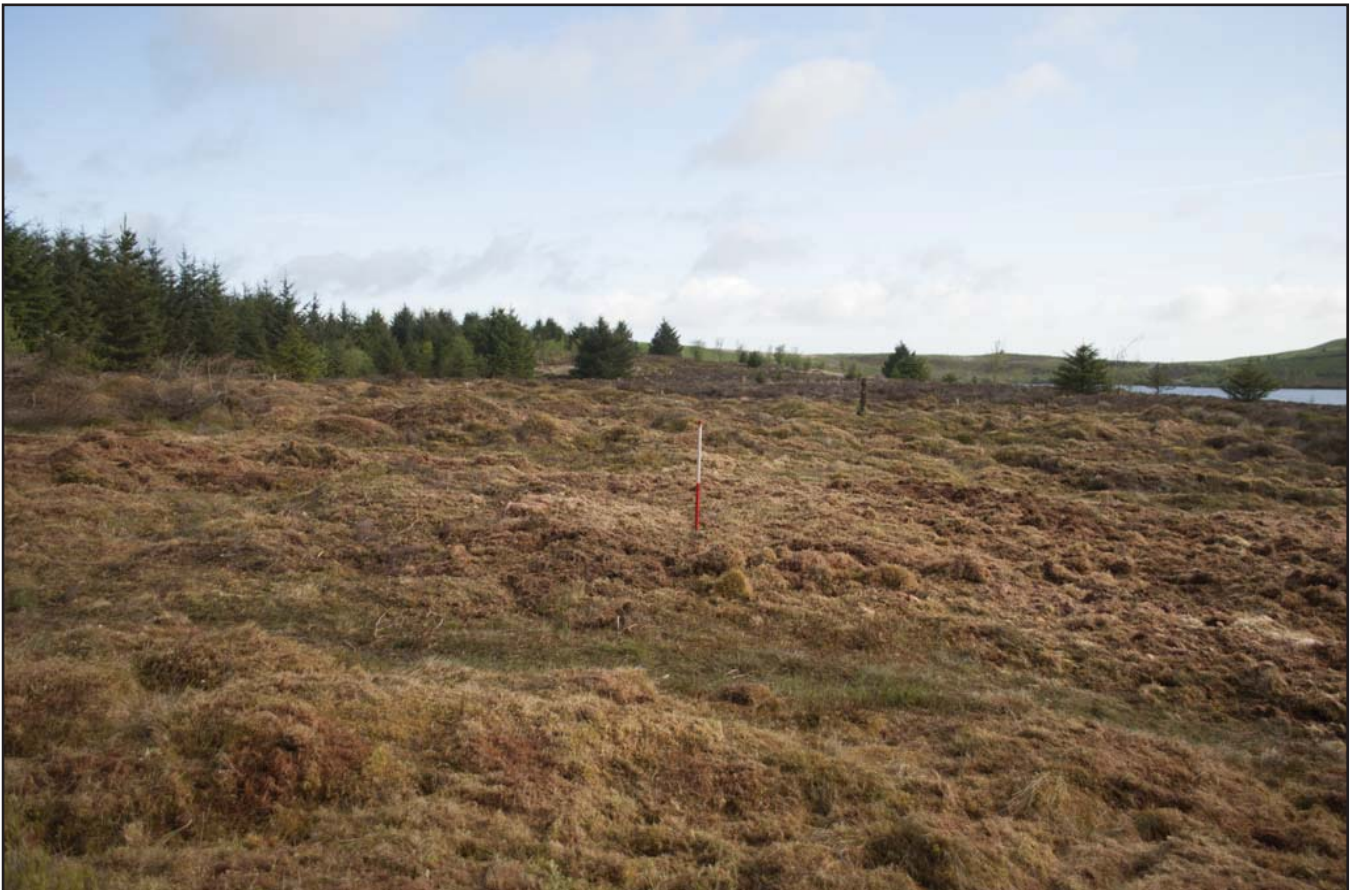
**Plate 4: General view of the compound area; scale 1x1m; view from S (archive reference: G2580\_065).**

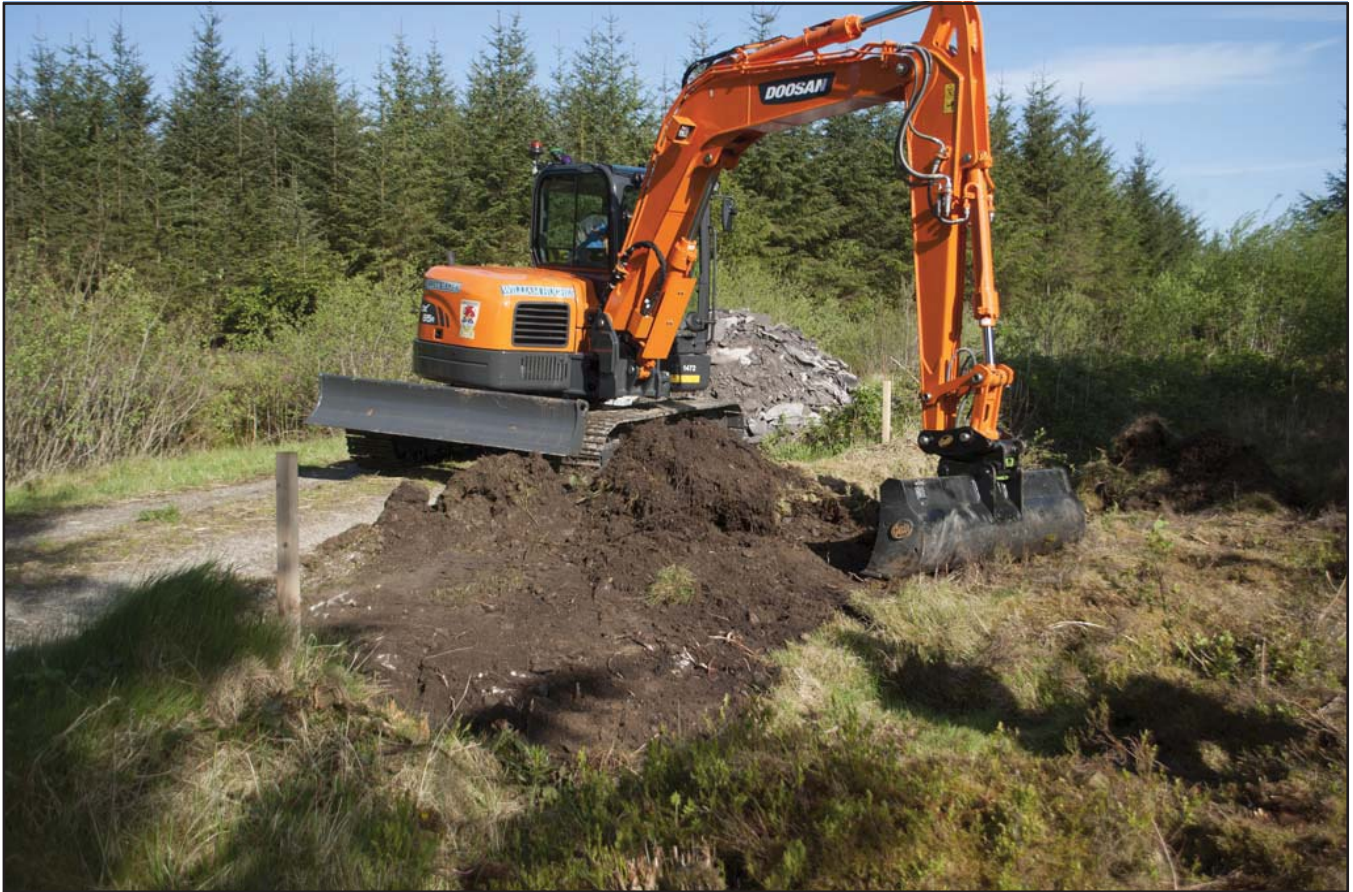
Plate 5: View of the entrance area of the track showing excavation (working shot); scale not used; view from SE (archive reference: G2580\_067).

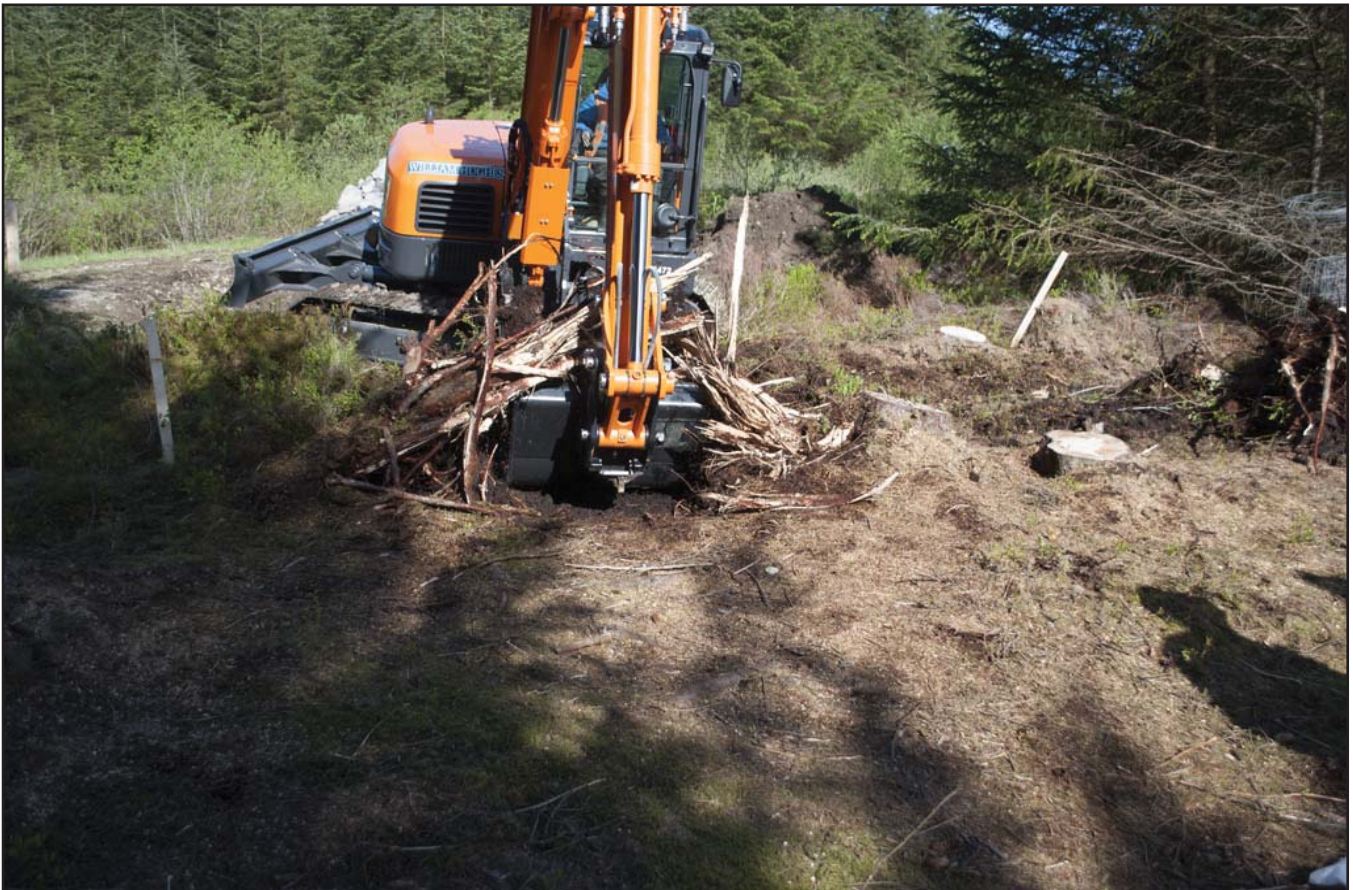
Plate 6: Tree stump removal; scale not used; view from SE (archive reference: G2580\_069).

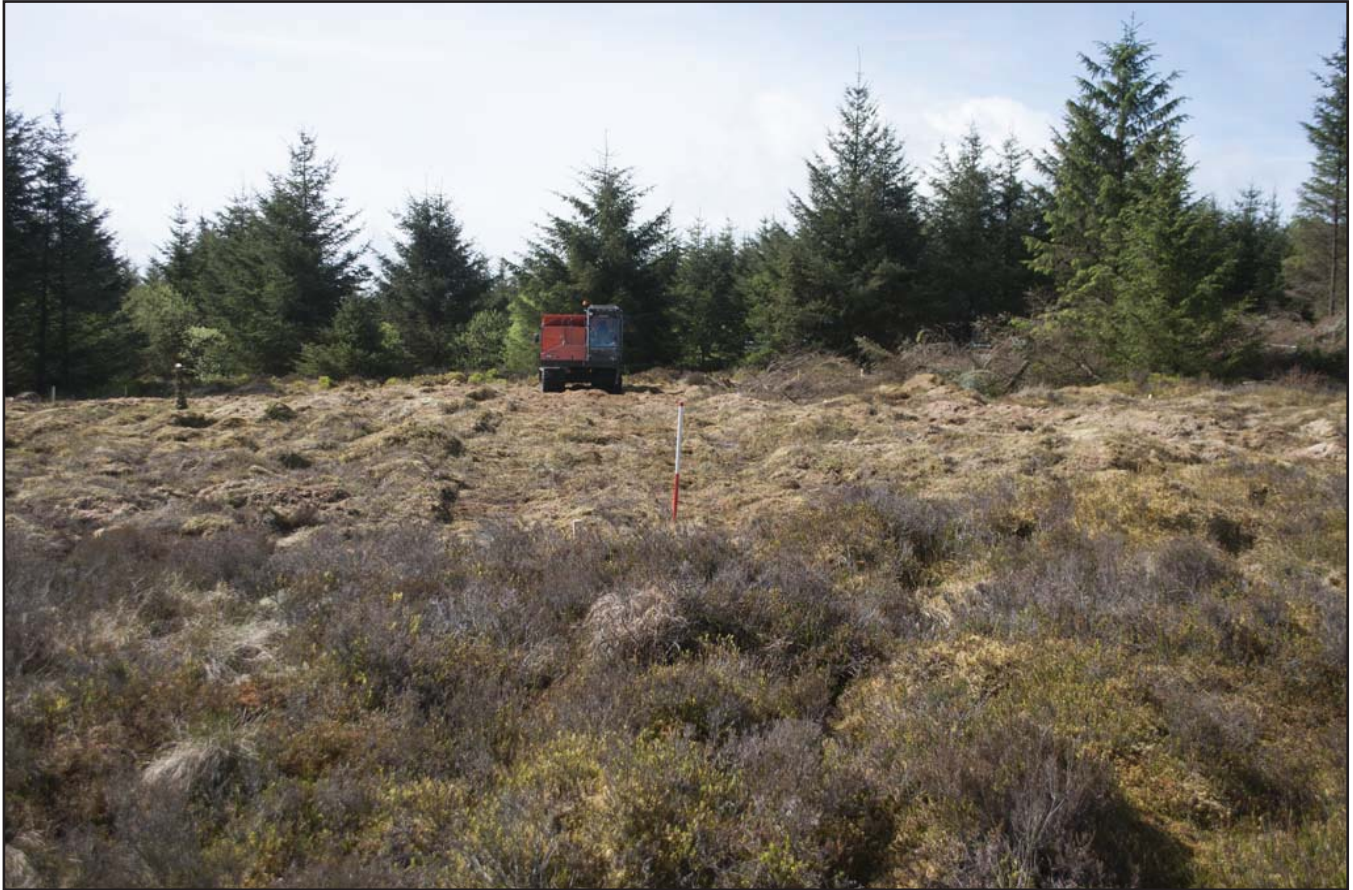
**Plate 7: View of compound area, showing levelling with a tracked dumper; scale 1x1m; view from N (archive reference: G2580\_070).**

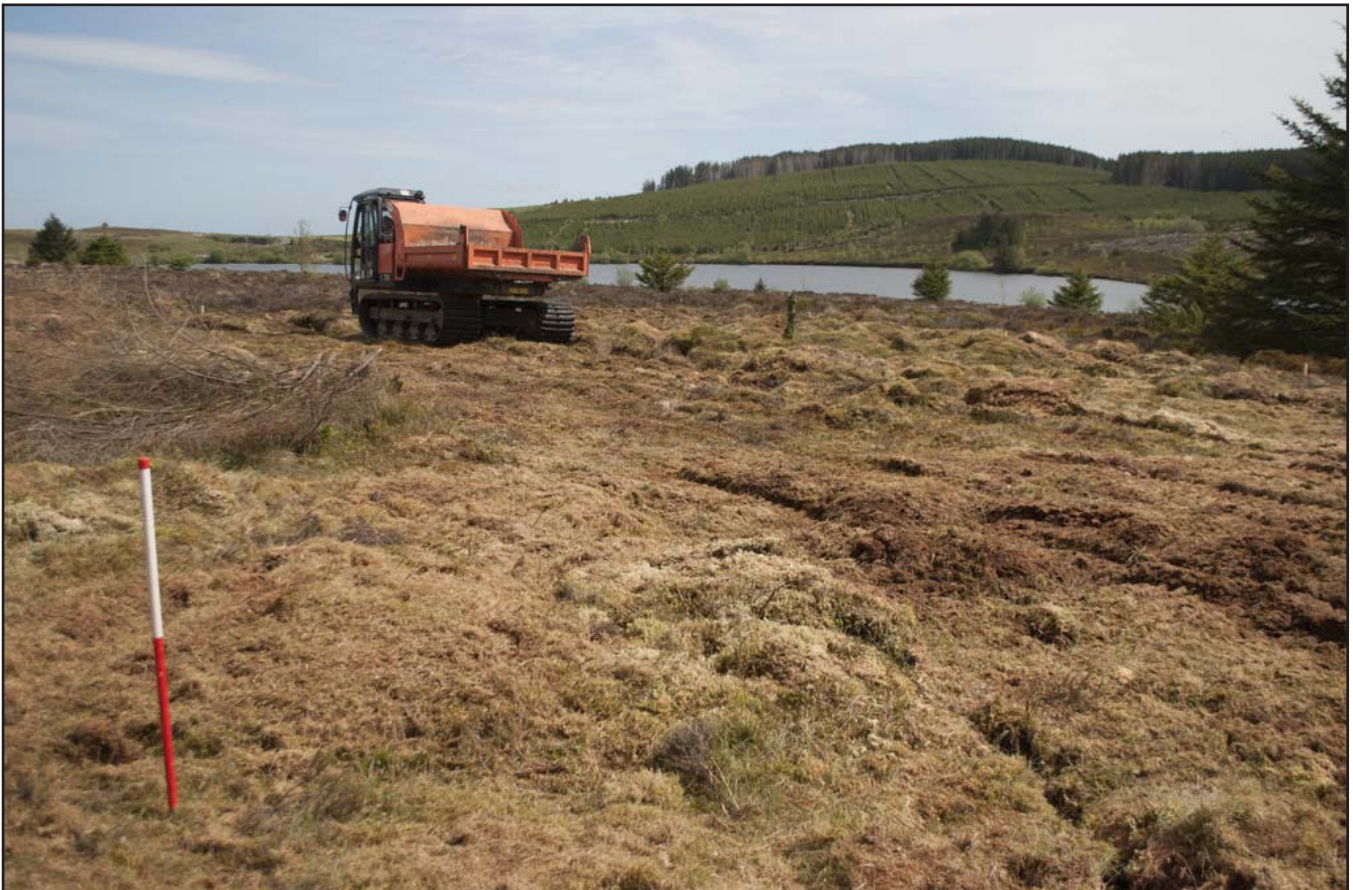
**Plate 8: General view of compound area levelling with a tracked dumper; scale 1x1m; view from NW (archive reference: G2580\_071).**

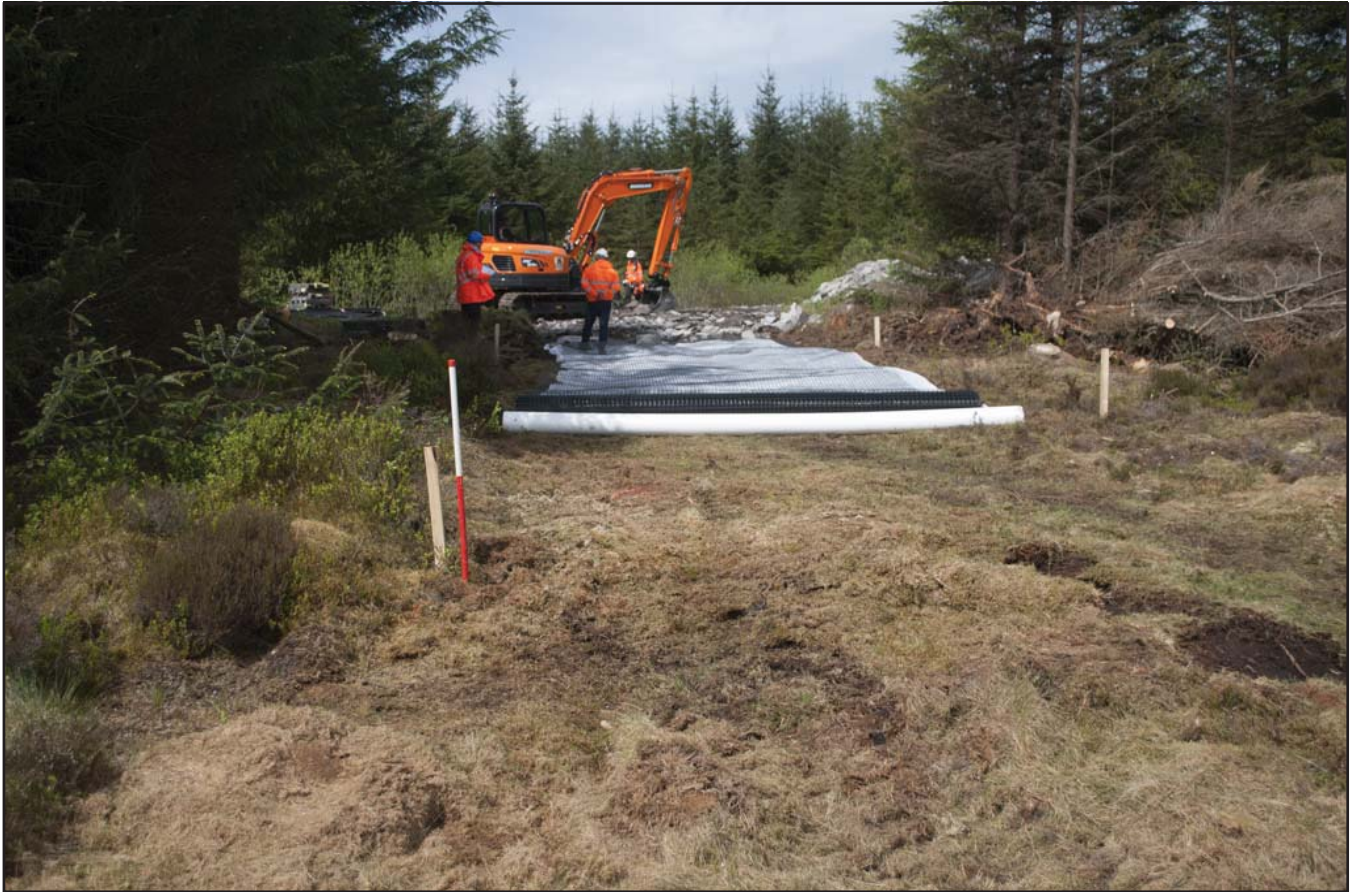
Plate 9: General view of trackway stoning up over log mats; scale 1x1m; view from E (archive reference: G2580\_072).

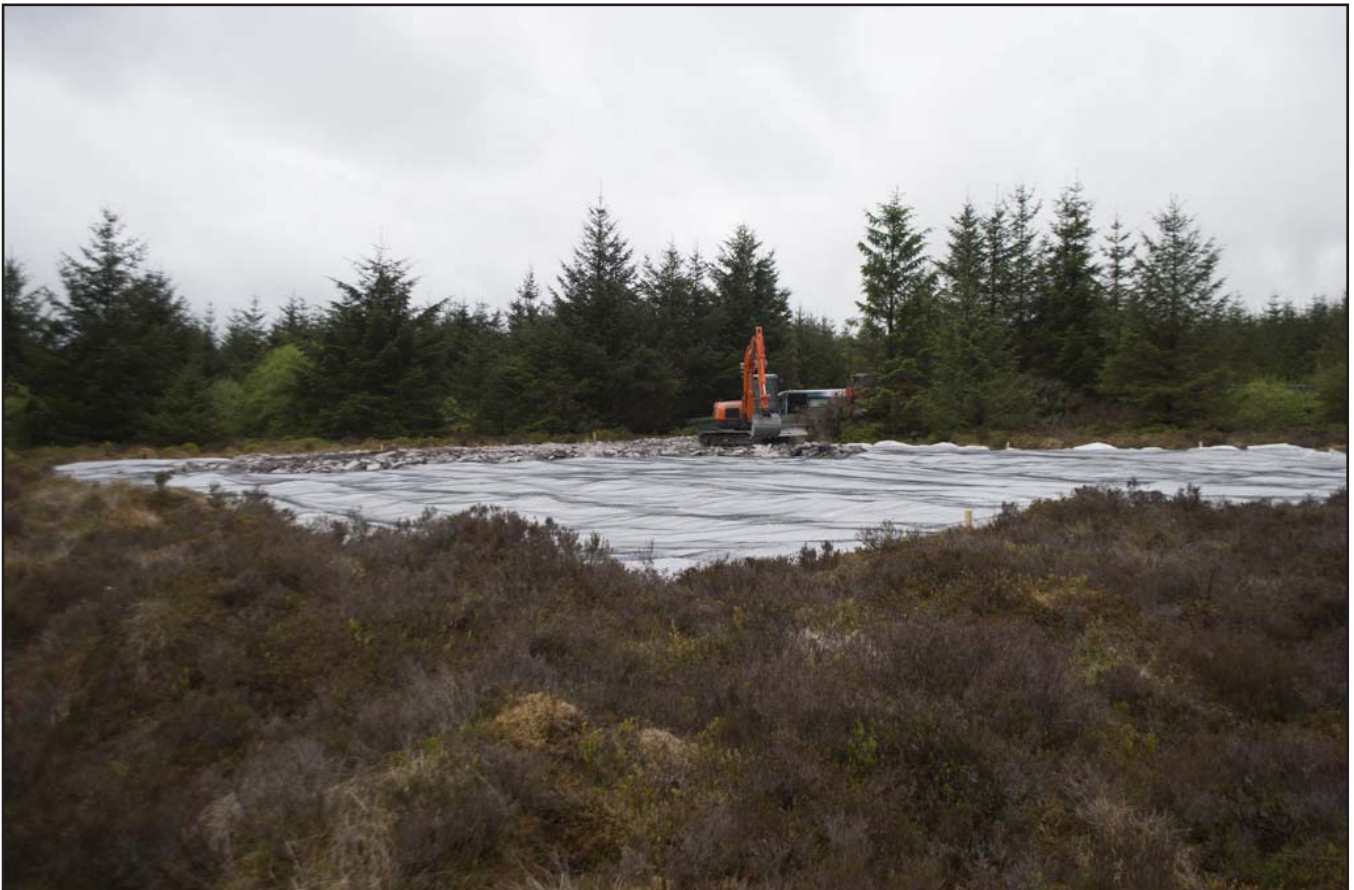
Plate 10: General view of the compound area. Showing terrain, matting down and stoning taking place; scale not used; view from NE (archive reference: G2580\_073).

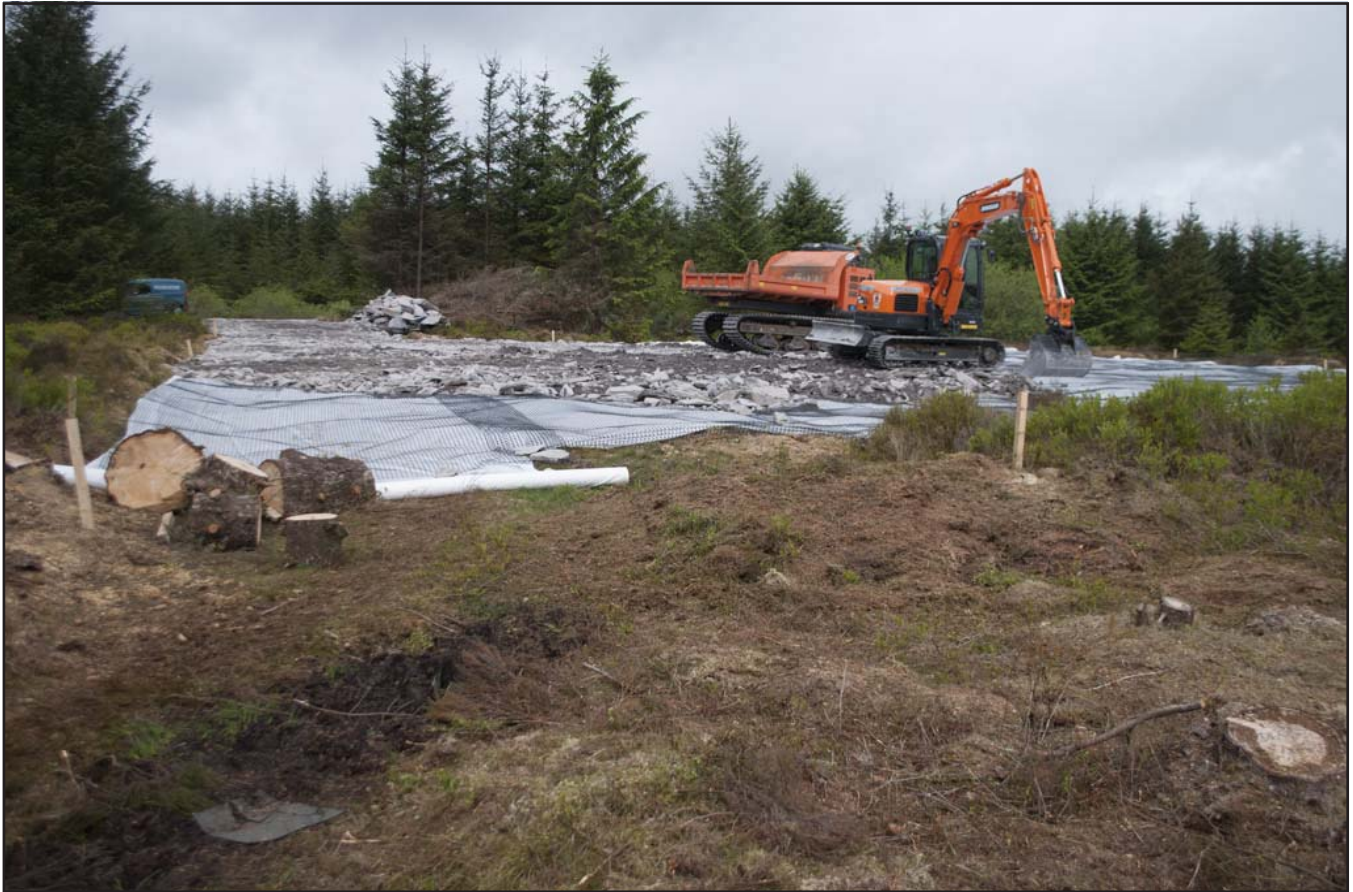
Plate 11: View of shale rubble laying from the west end of the track down to the dam; scale not used; view from E (archive reference: G2580\_074).

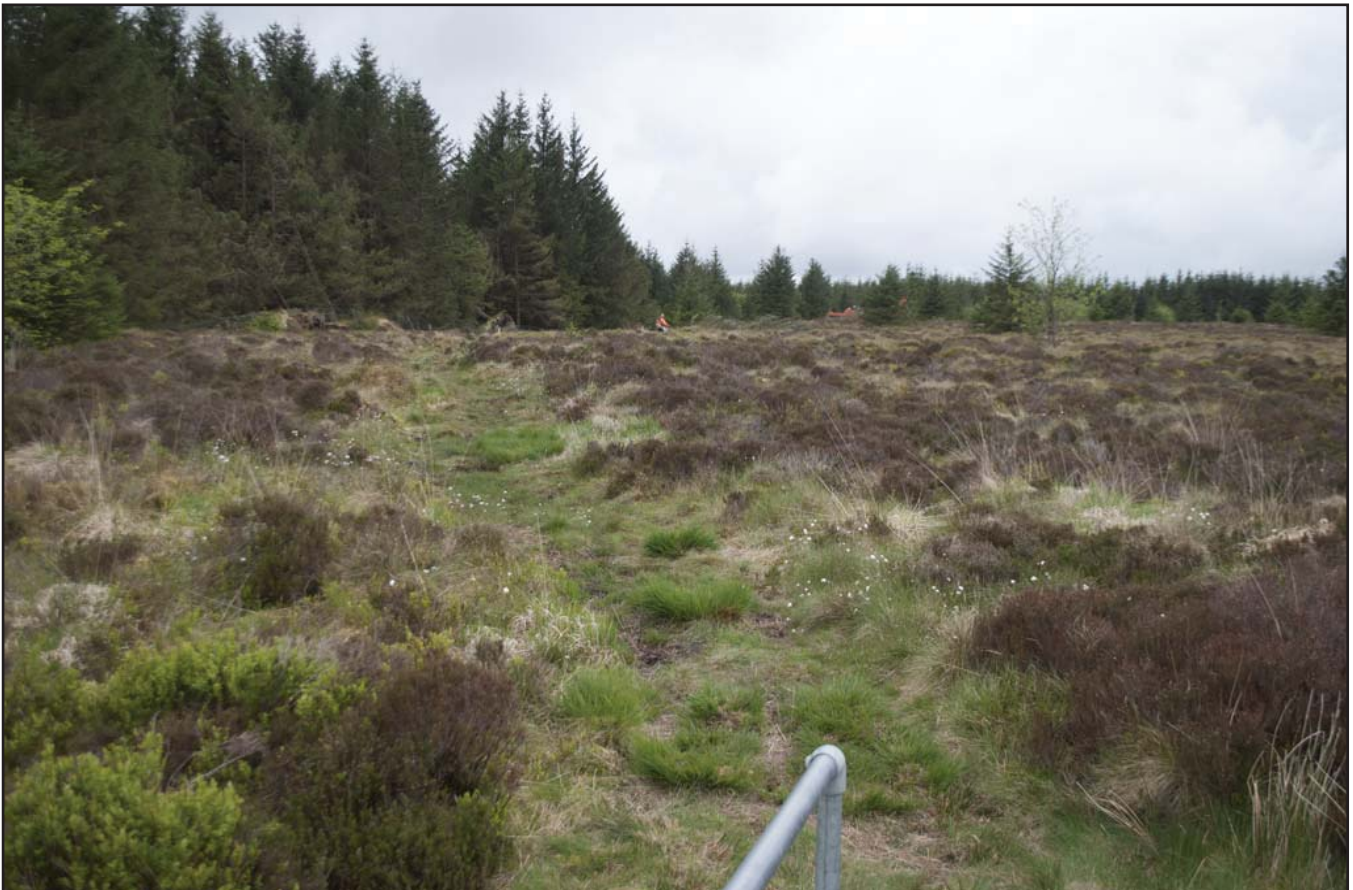
Plate 12: General view of strimming of the pathway from the dam; scale not used; view from ENE (archive reference: G2580\_075).

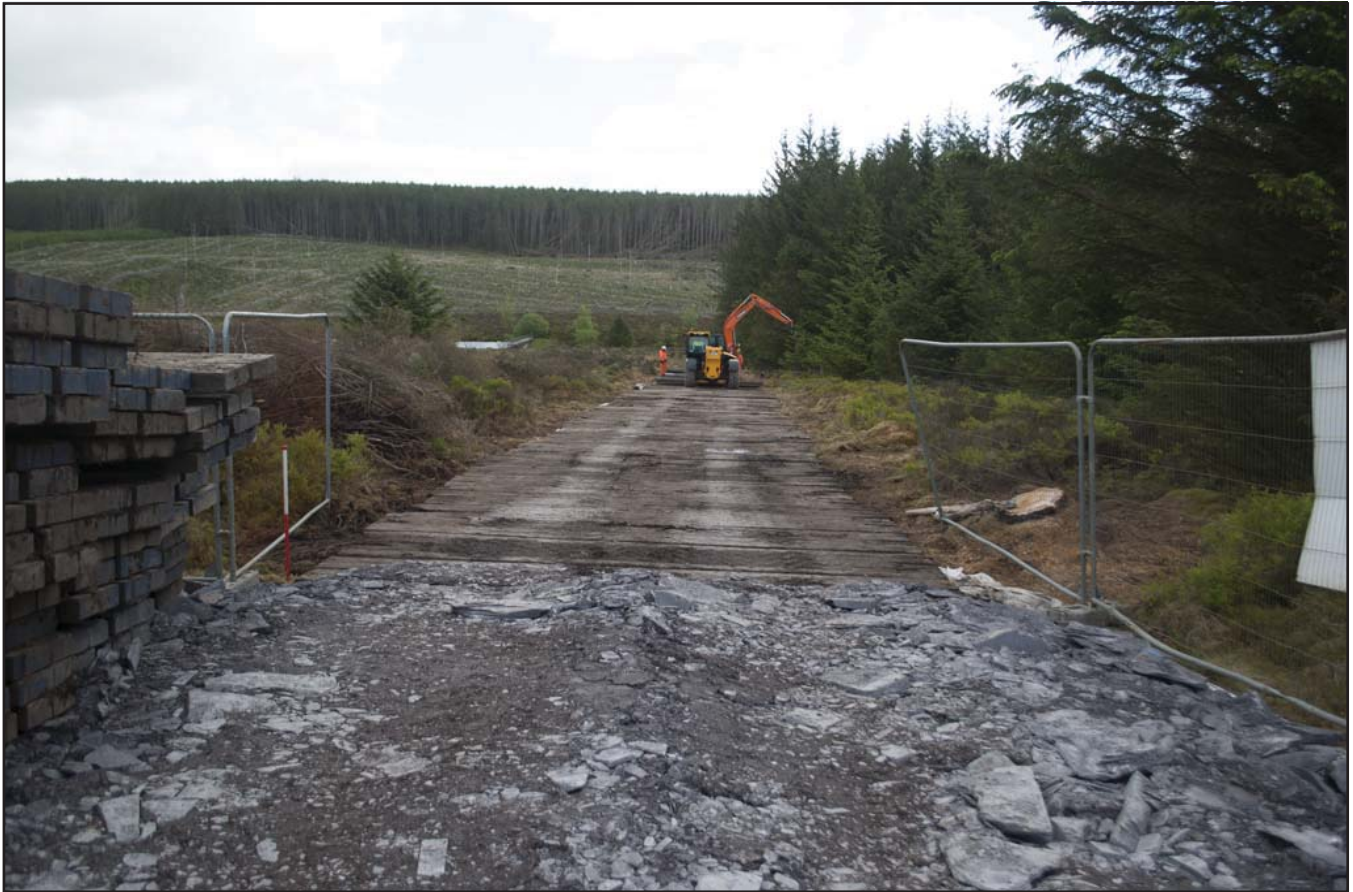
Plate 13: View of bog matting in place at west end of the track; scale not used; view from W (archive reference: G2580\_079).

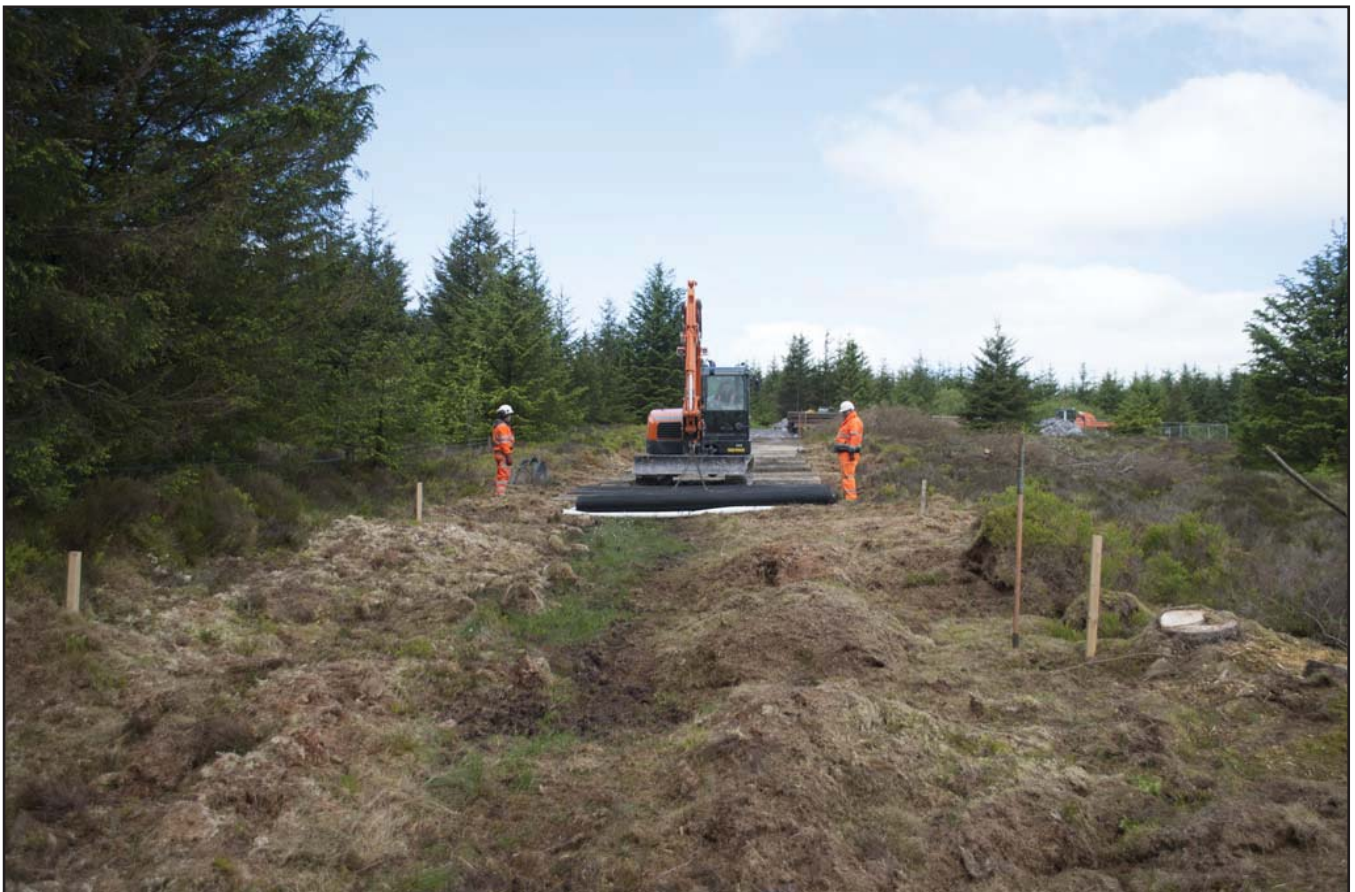
Plate 14: General view showing the laying of log matting; scale not used; view from E (archive reference: G2580\_080).

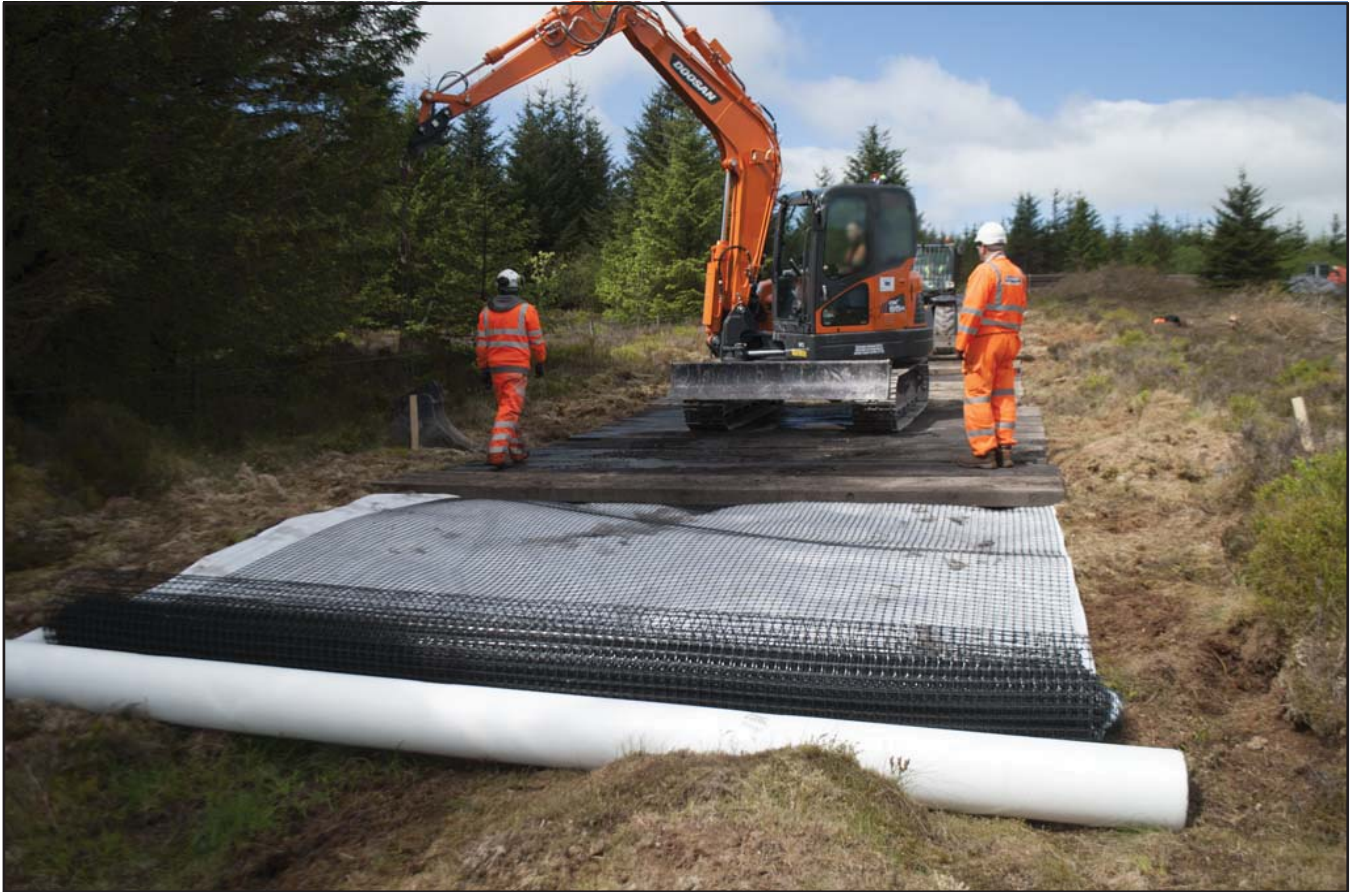
Plate 15: Close up view of bog mat laying; scale not used; view from ENE (archive reference: G2580\_082).

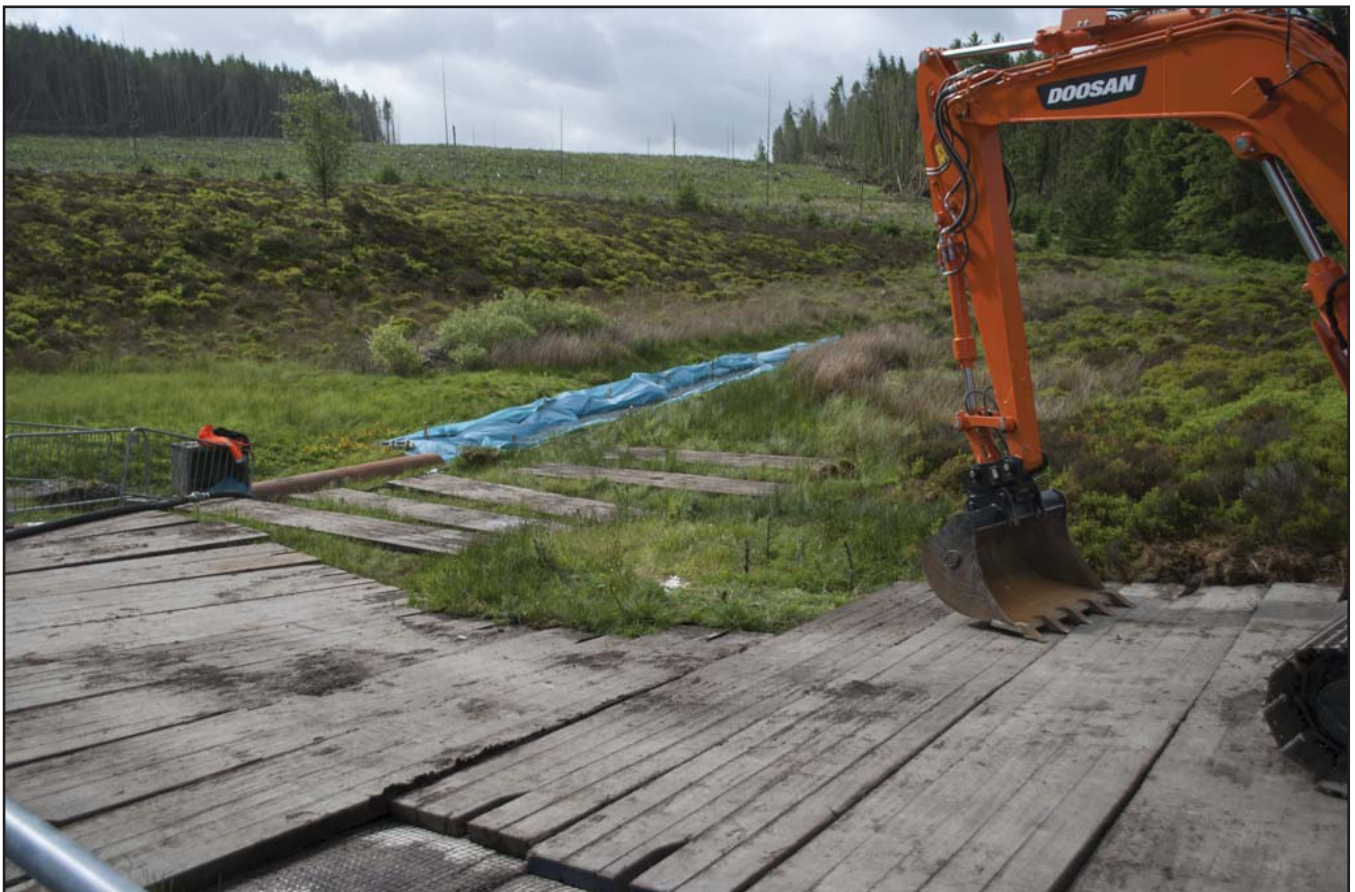
Plate 16: View of ground area immediately south of the dam where a small patch is to be scraped; scale not used; view from NW (archive reference: G2580\_083).

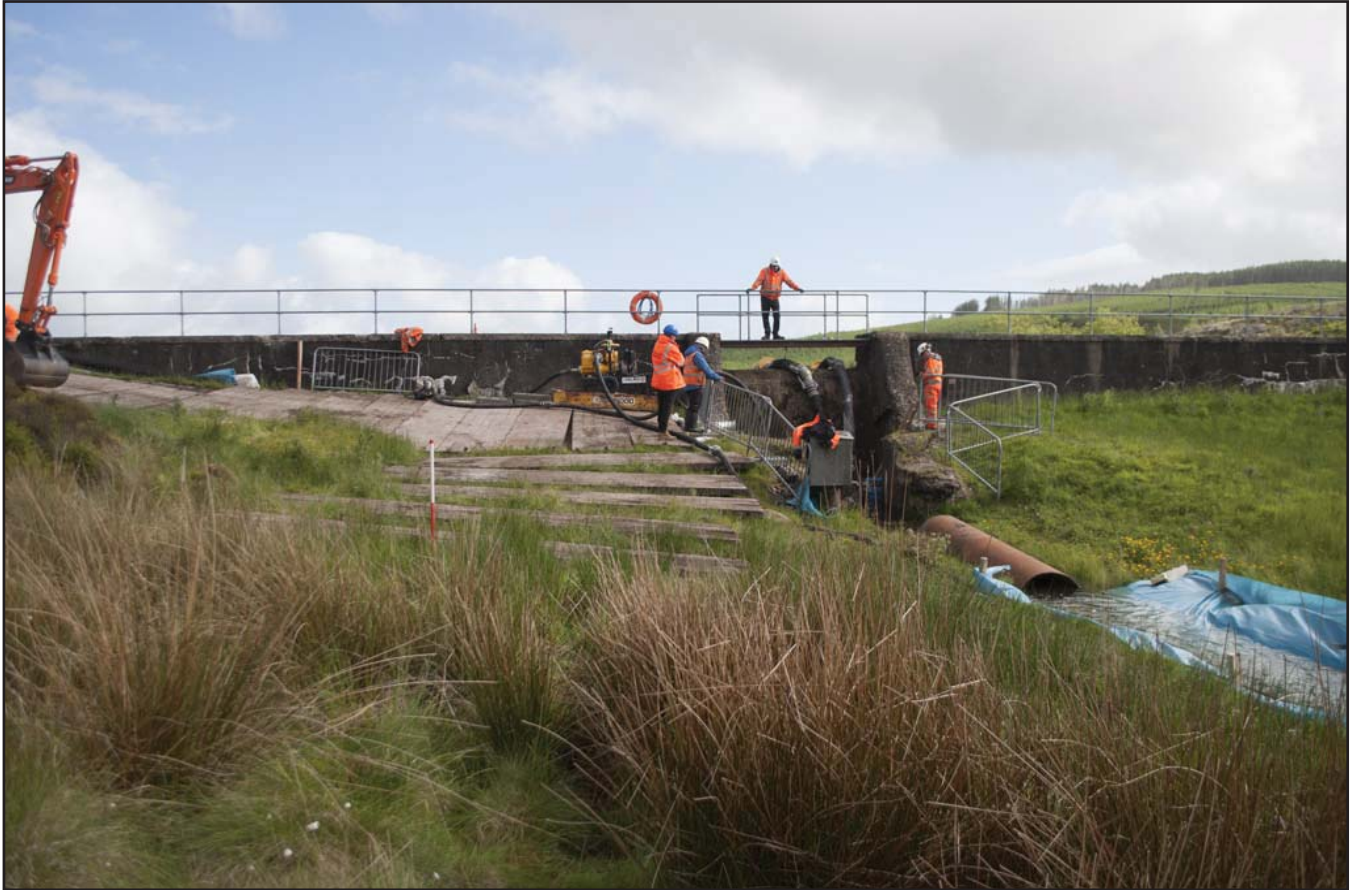
A 5m<sup>2</sup> area located c.7m south of the dam wall and c.5m west of the west bank of the water channel was machine excavated to allow the establishment of pump machinery to drain water from the dam (Plates 17 and 18). The reduced area contained topsoil and fractured stone that may have been deposited from the water channel when it was excavated for the reservoir construction or subsequently dredged. The targeted area also included a grass covered lump that contained slate waste and silt/clay-rich soil that was also interpreted as material associated with reservoir construction or maintenance (Plates 19 and 20).

Plate 17: View of the area to be stripped from the south, looking at the dam face, and showing the water level reduction works; scale 1x1m; view from SSW (archive reference: G2580\_084).
