# Llyn Bran Reservoir Discontinuance Scheme, Denbighshire

ARCHAEOLOGICAL MITIGATION:  
Watching Brief

Prosiect Rhif / Project No. G2580

Adroddiad Rhif / Report No. 1653

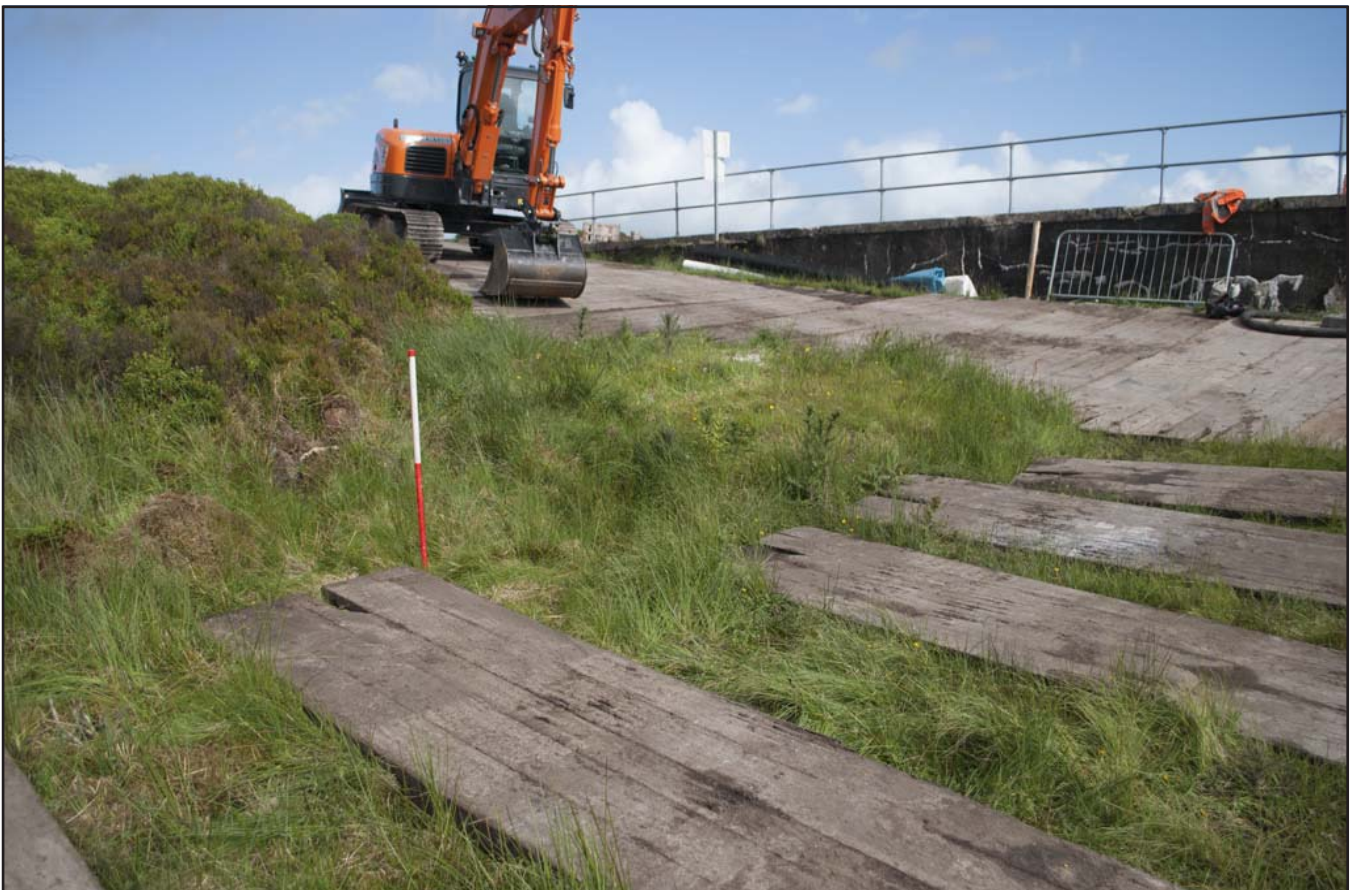
A 5m<sup>2</sup> area located c.7m south of the dam wall and c.5m west of the west bank of the water channel was machine excavated to allow the establishment of pump machinery to drain water from the dam (Plates 17 and 18). The reduced area contained topsoil and fractured stone that may have been deposited from the water channel when it was excavated for the reservoir construction or subsequently dredged. The targeted area also included a grass covered lump that contained slate waste and silt/clay-rich soil that was also interpreted as material associated with reservoir construction or maintenance (Plates 19 and 20).

Plate 18: Detail view showing the small area of ground on SW bank by stream channel near dam to be stripped; scale 1x1m; view from SSE (archive reference: G2580\_085).

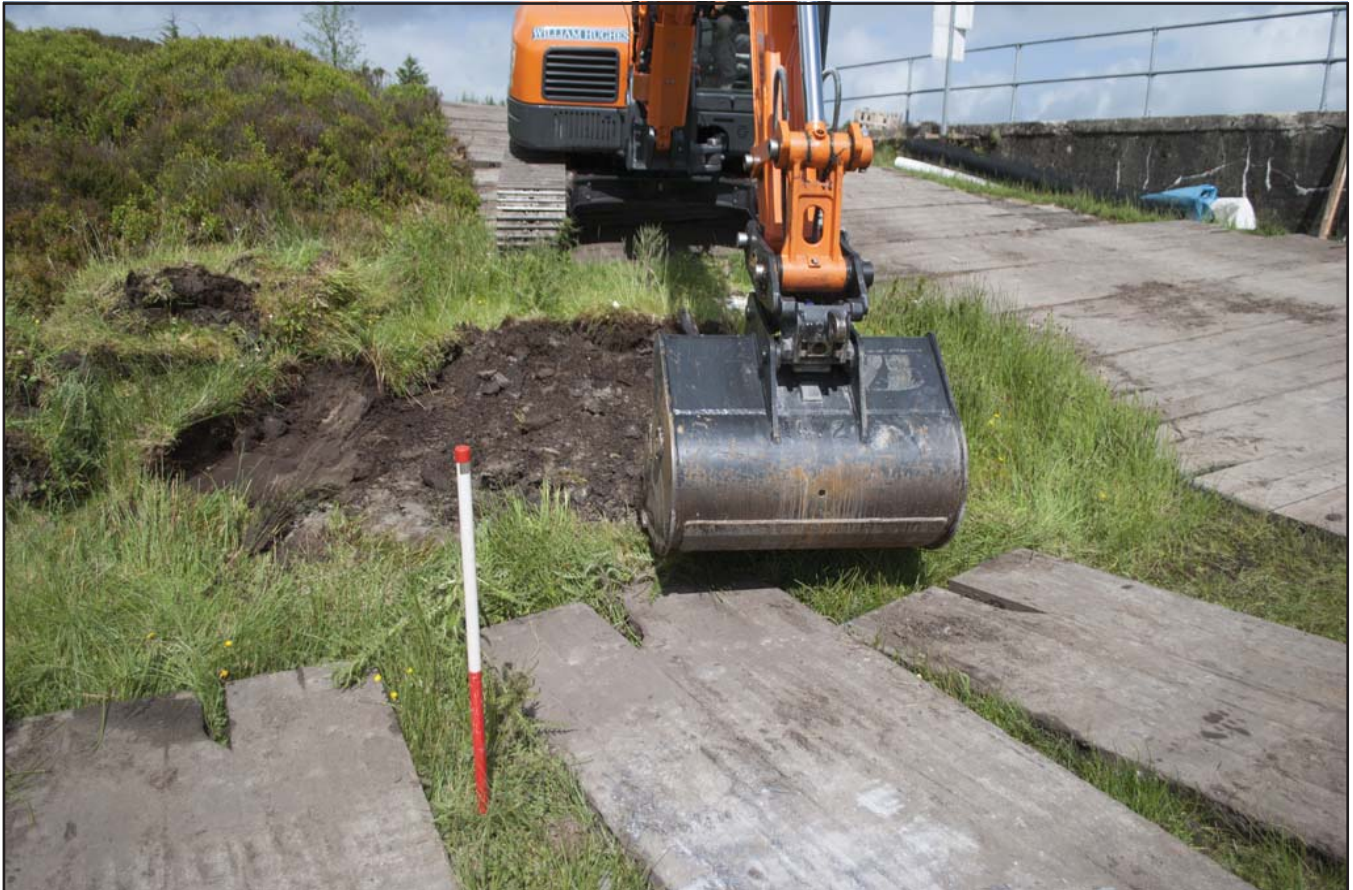
Plate 19: Action shot showing the removal of the grassy mound; scale 1x1m; view from SE (archive reference: G2580\_086).

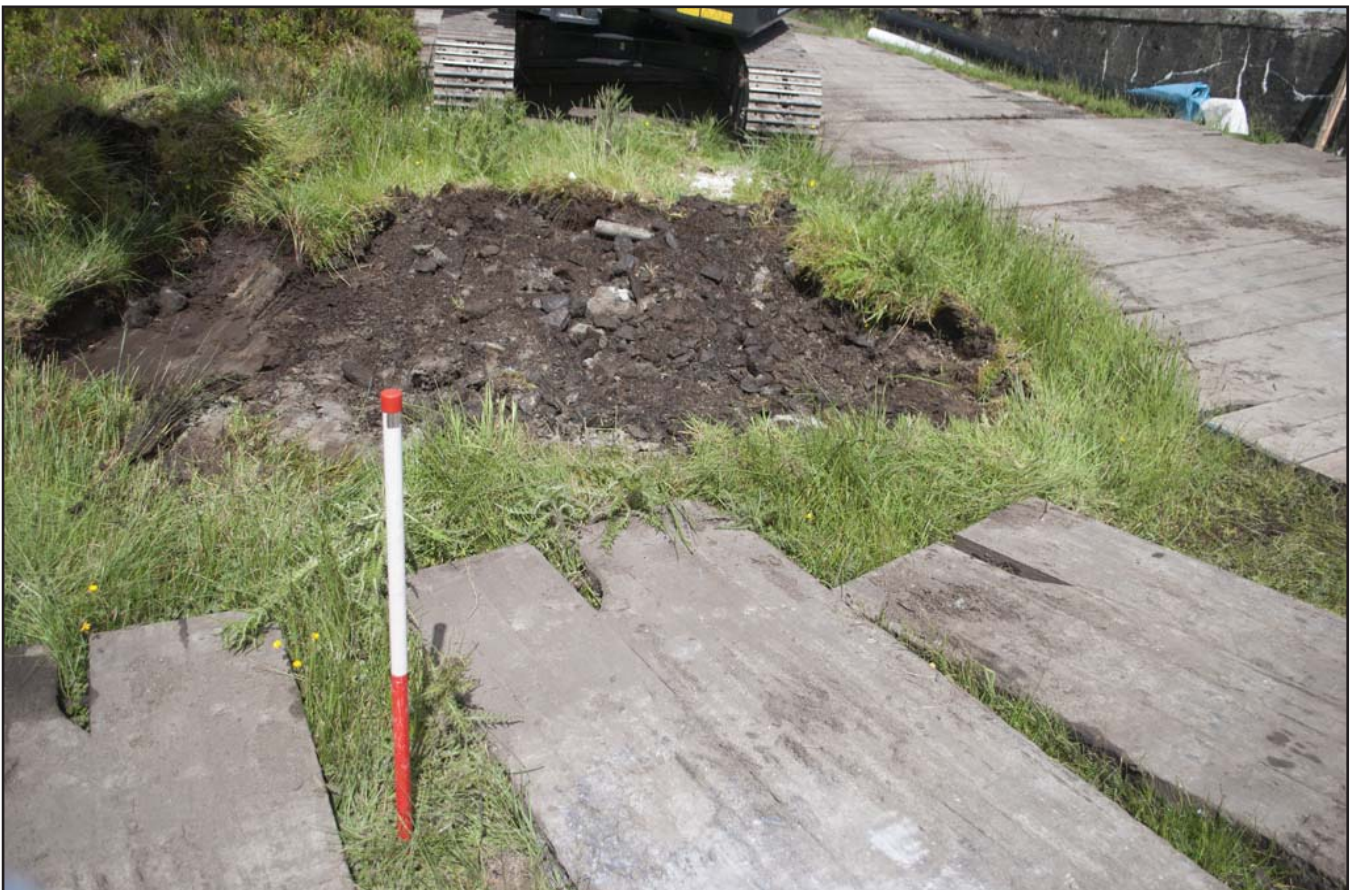
Plate 20: Action shot showing the removal of the grassy mound; scale 1x1m; view from SE (archive reference: G2580\_087).

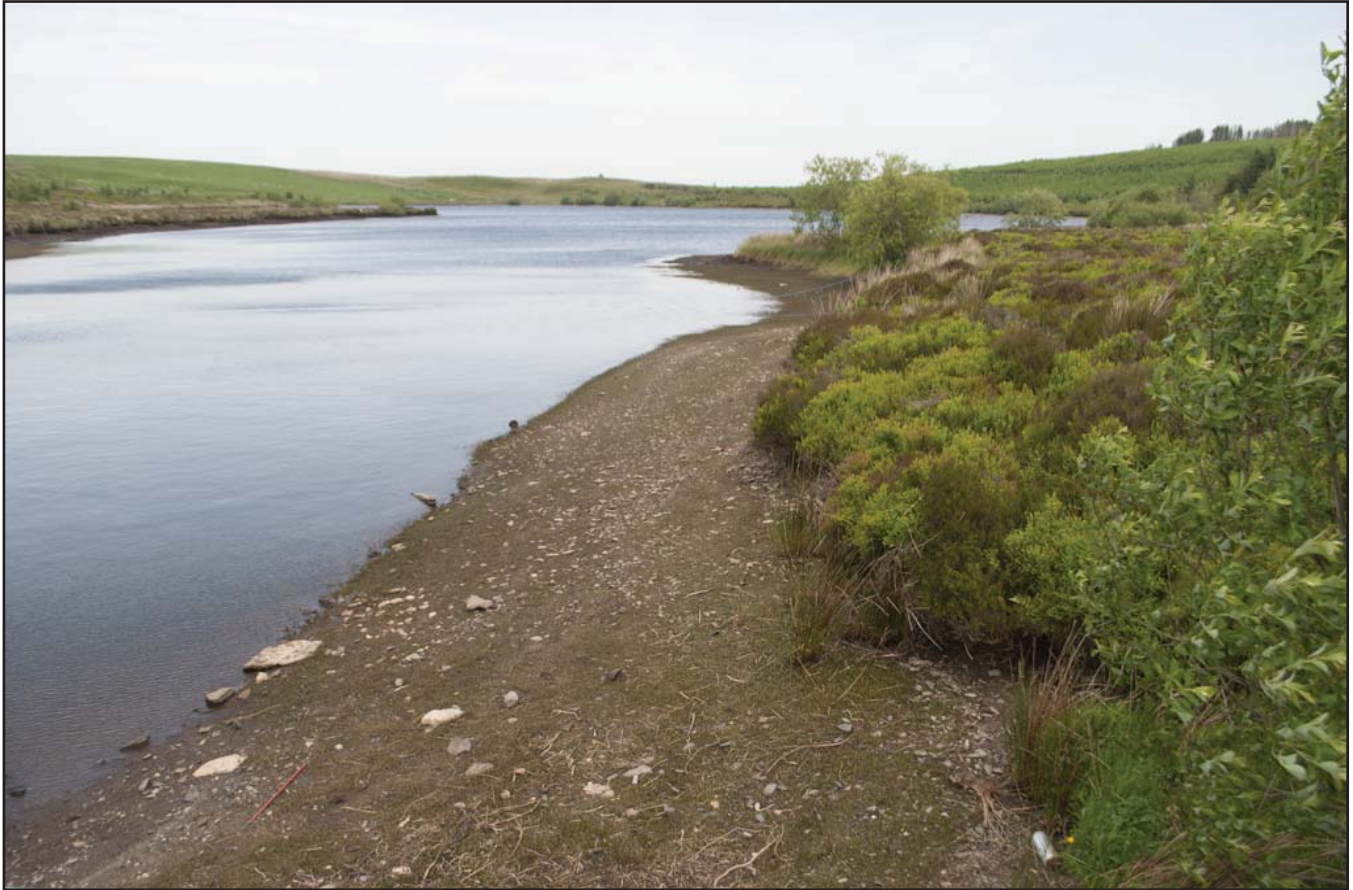
The watching brief also monitored groundworks along the reservoir edge after the water levels had been partly reduced (Plates 21 to 24). The banks of the reservoir were exposed, with the

**Plate 21: View of reduction of water level on the east bank of Llyn Brân; scale not used; view from S (archive reference: G2580\_091).**

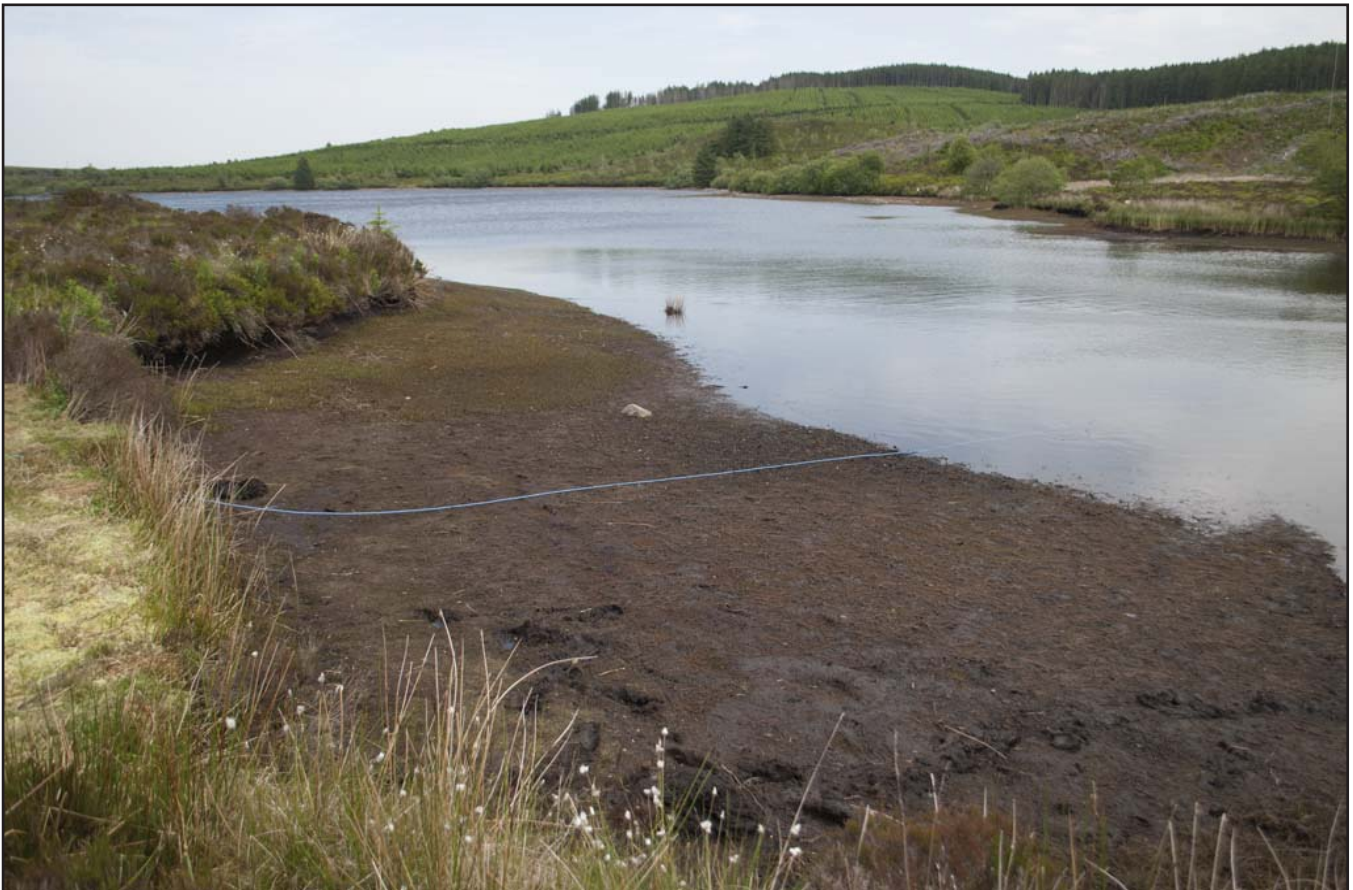
**Plate 22: General view of Llyn Brân showing the exposed western edge of the reservoir; scale not used; view from SW (archive reference: G2580\_093).**

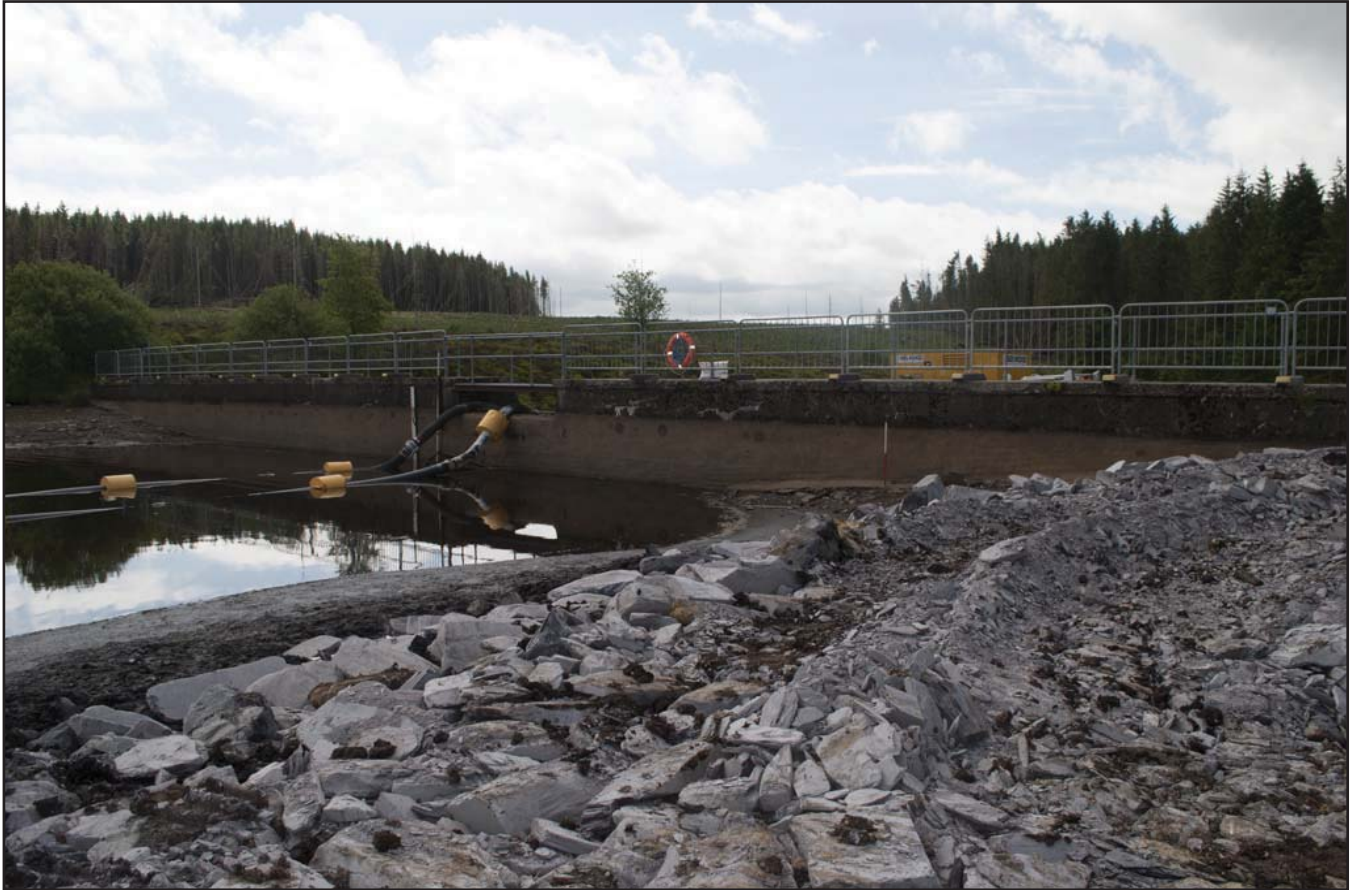
Plate 23: General view of the dam from the north showing the drop in water level; scale 1x1m; view from N (archive reference: G2580\_094).

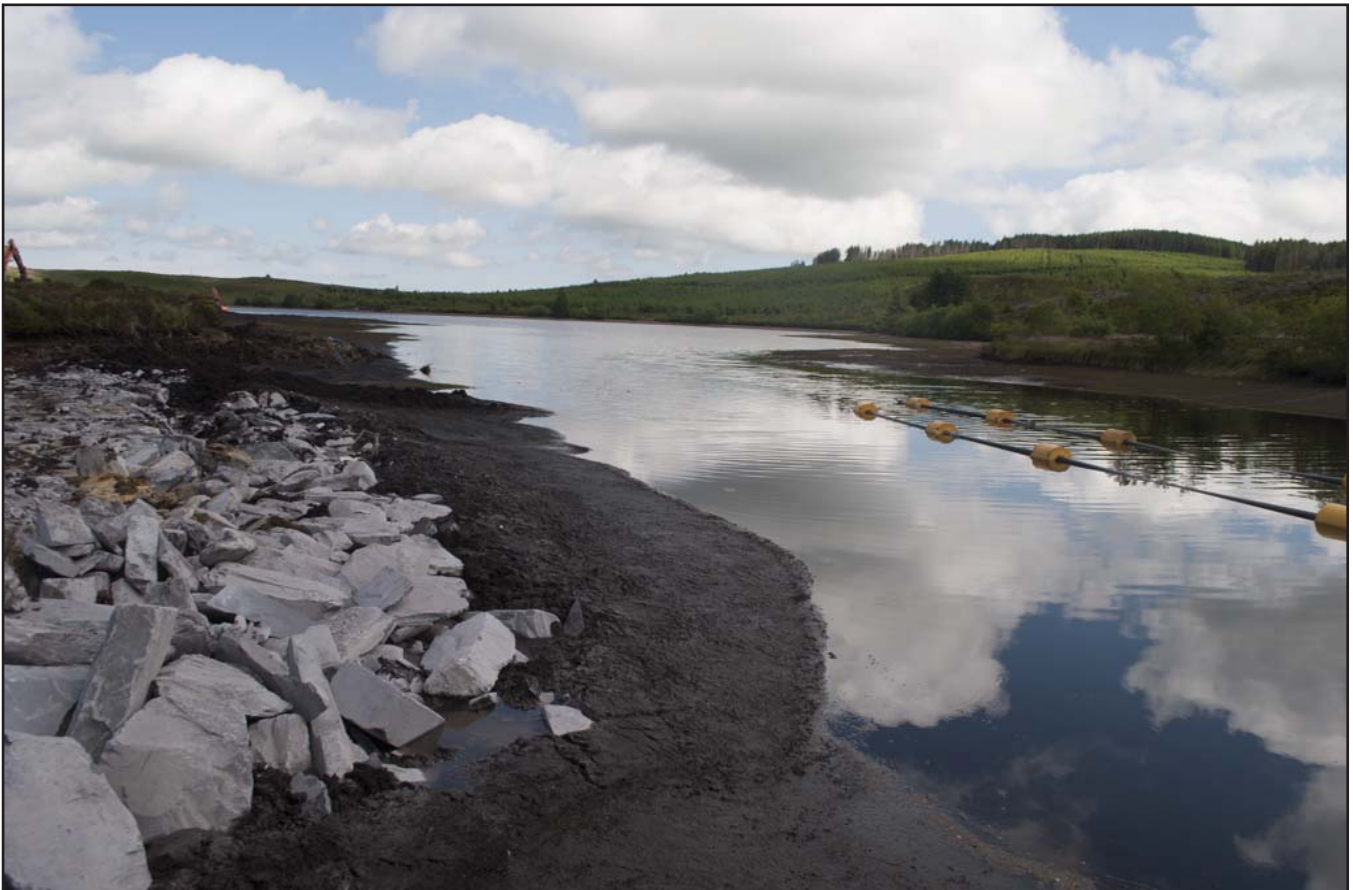
Plate 24: General view of Llyn Brân showing the dropped water level; scale 1x1m; view from S (archive reference: G2580\_095).

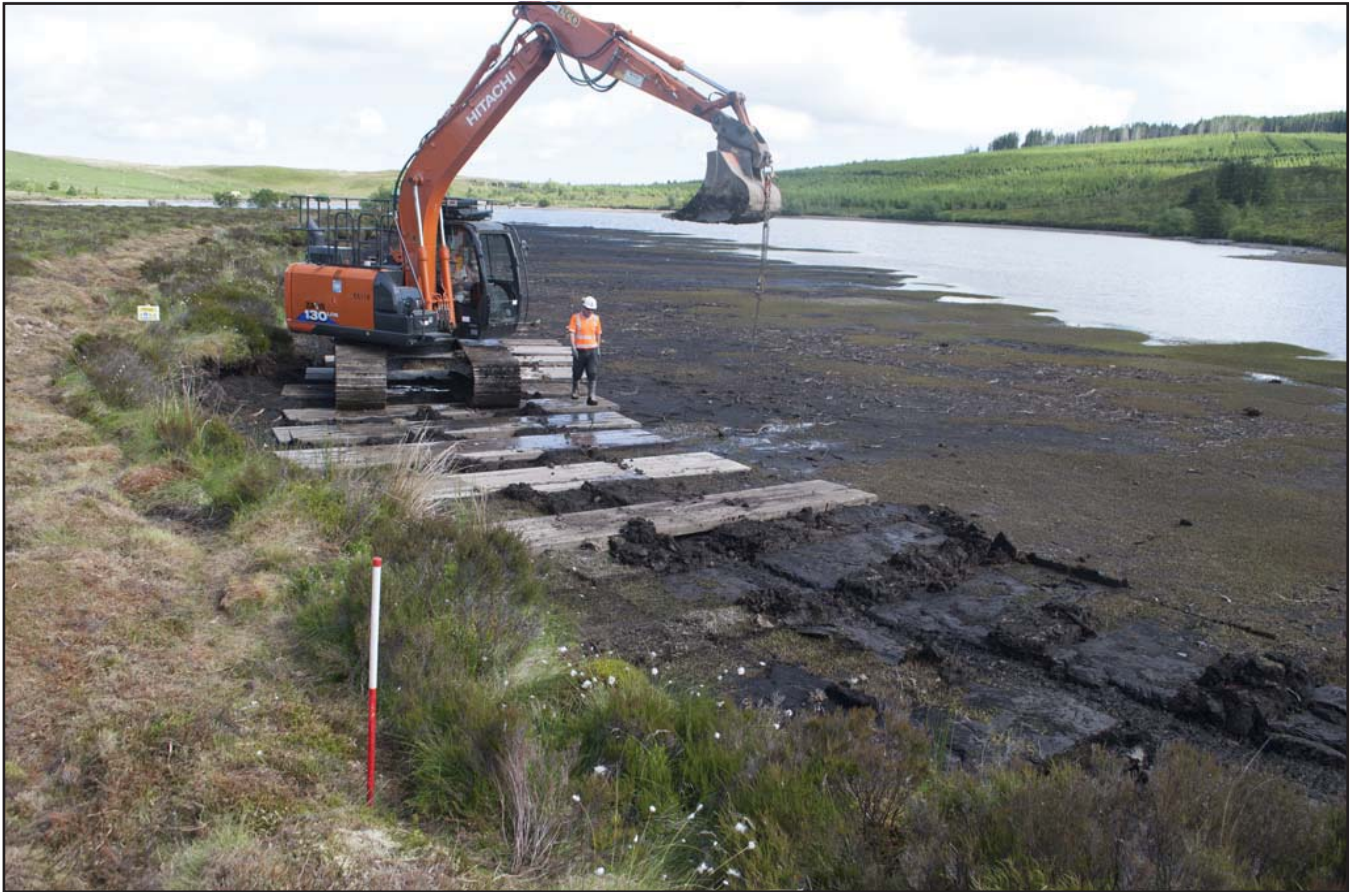
Plate 25: General view from the south showing the reduced level of the west bank of Llyn Brân with bog mats being laid; scale 1x1m; view from S (archive reference: G2580\_096).

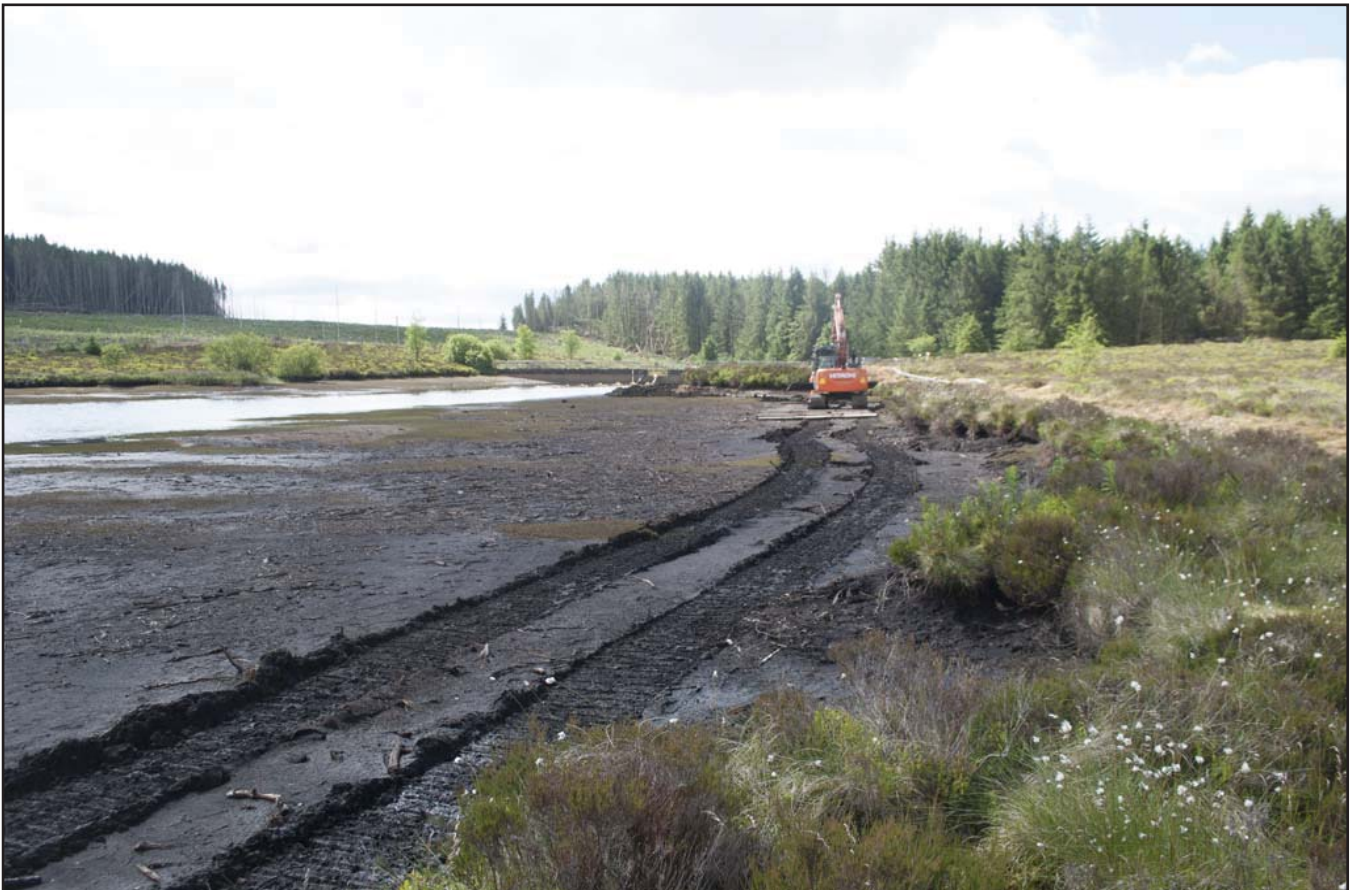
Plate 26: General view along the northern edge of Llyn Brân showing the log mat laying and the reduced water level in dam; scale not used; view from N (archive reference: G2580\_097).

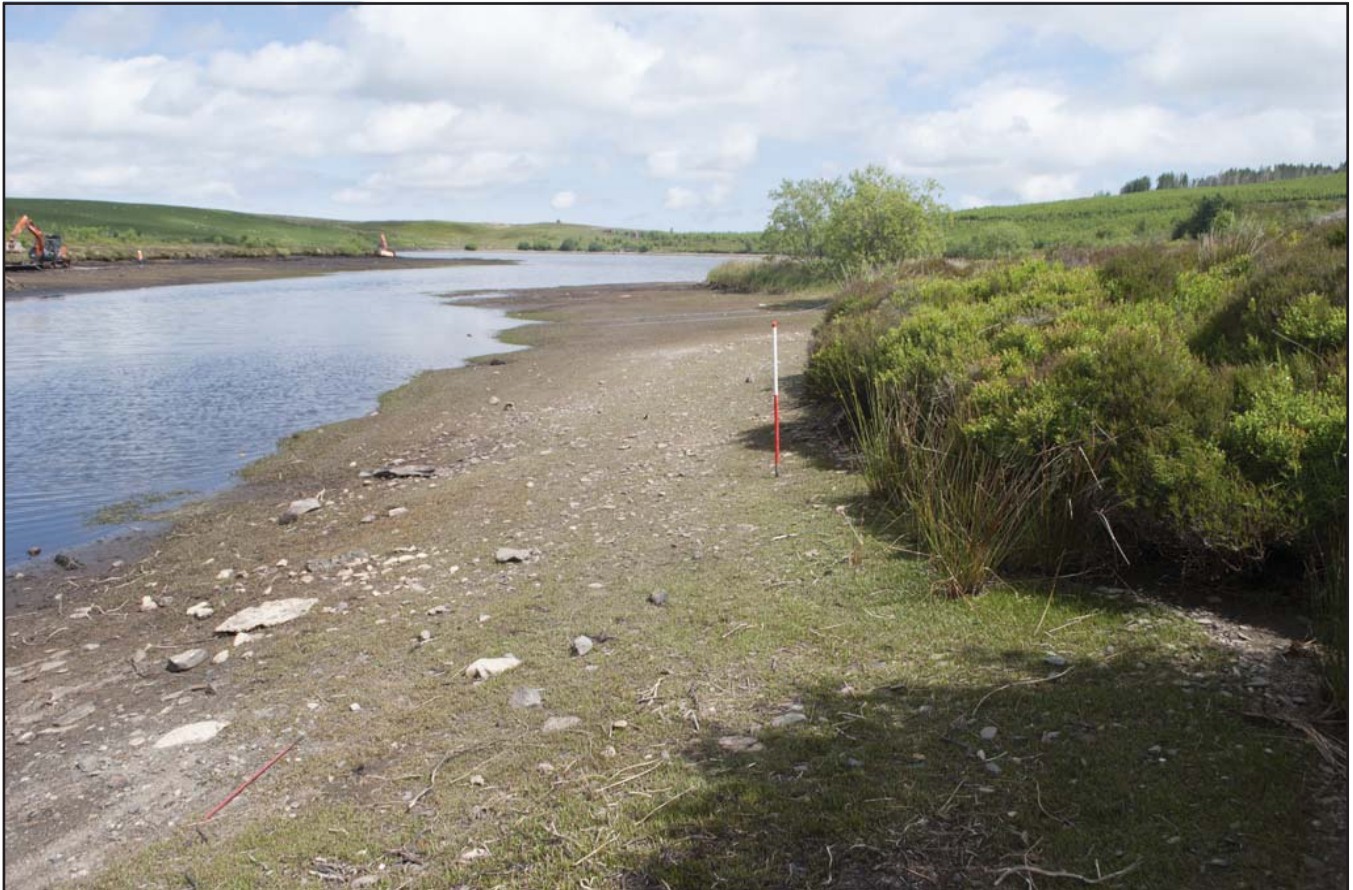
**Plate 27: General view of the eastern bank of Llyn Brân towards the dam, showing the reduced water level; scale 1x1m; view from N (archive reference: G2580\_101).**

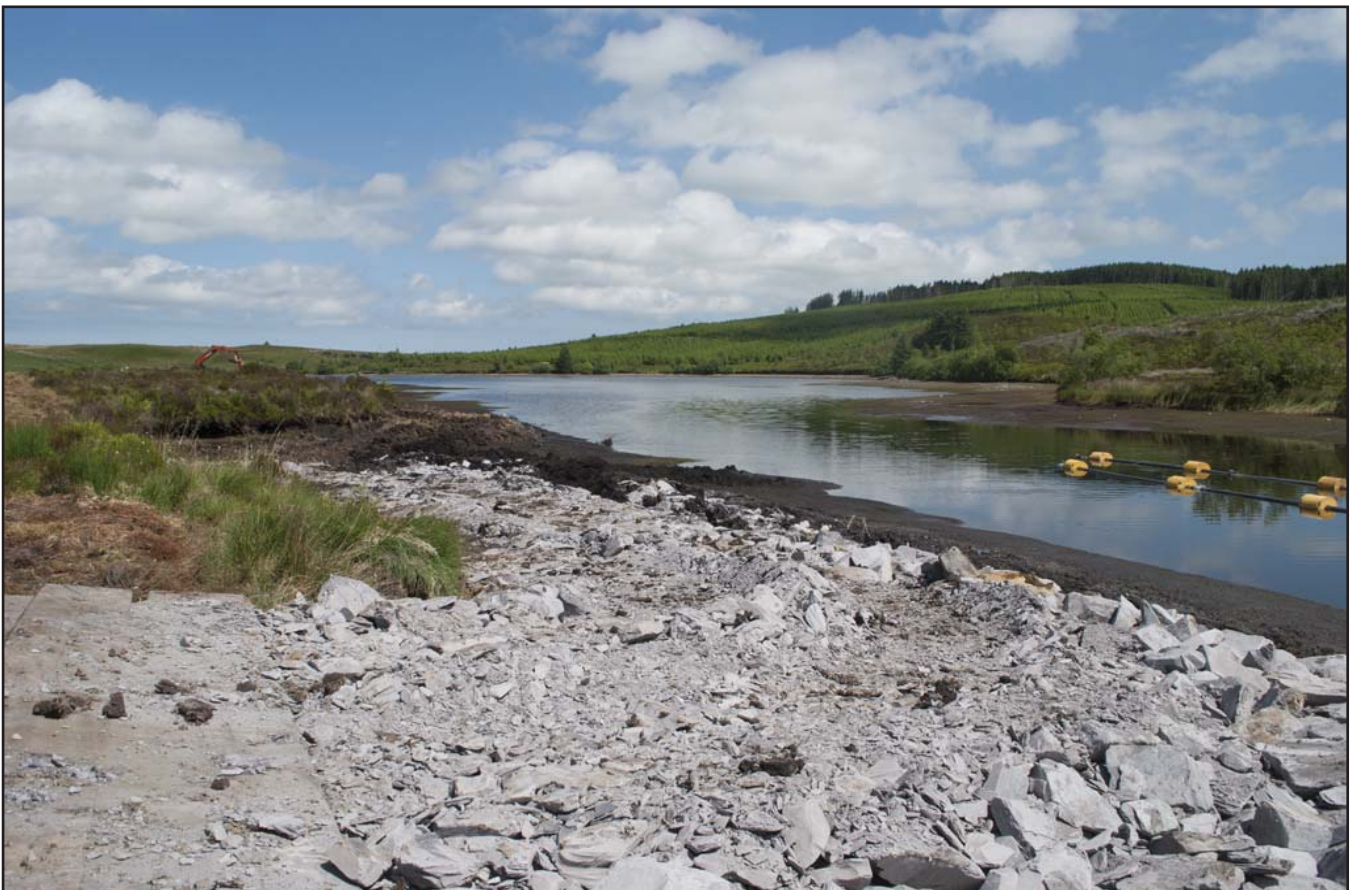
**Plate 28: View of rough section through peat (east facing), on the west side of Llyn Brân; scale 1x1m; view from ESE (archive reference: G2580\_104).**

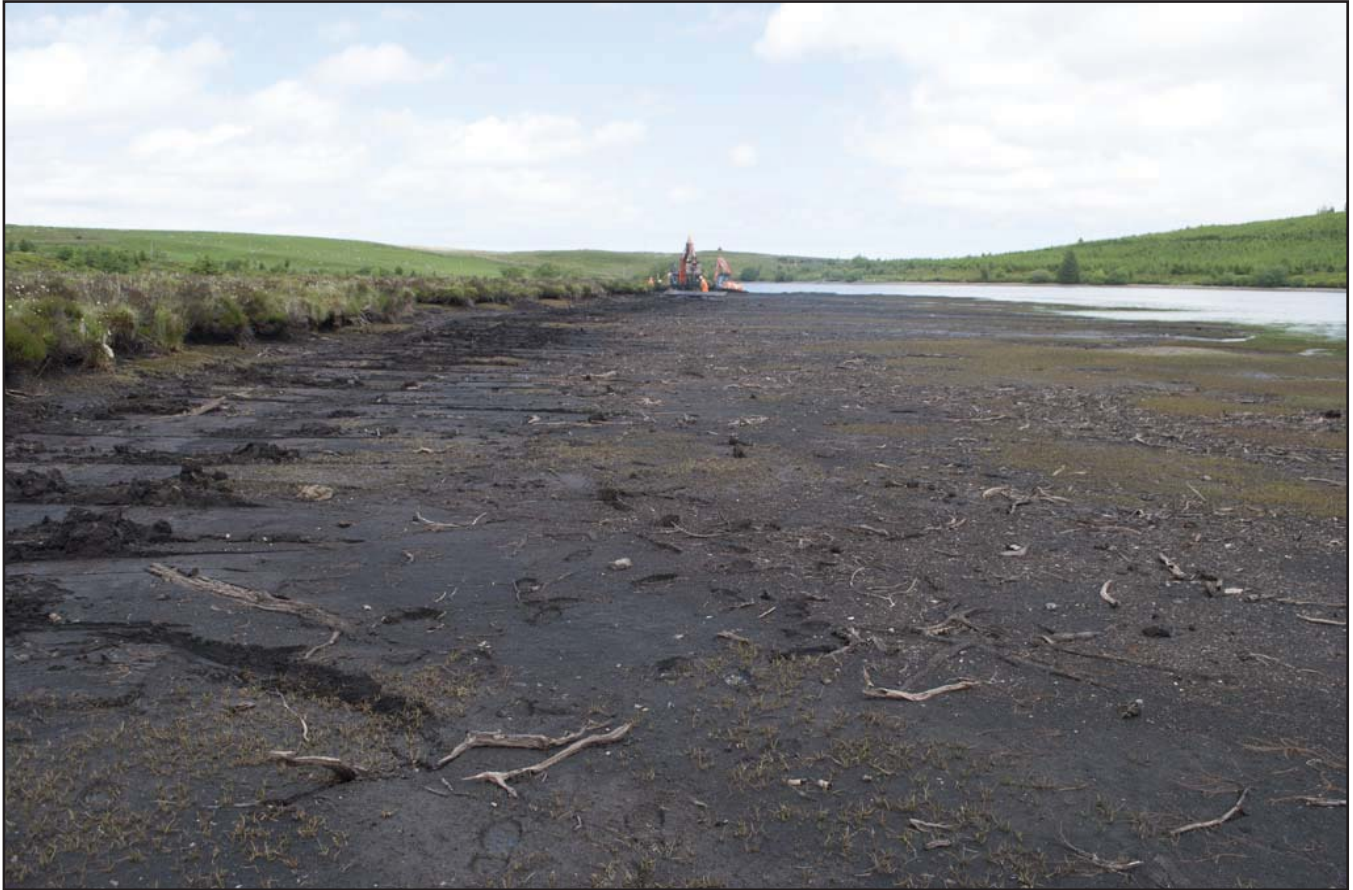
Plate 29: General view showing the east bank of the reservoir; scale 1x1m; view from N (archive reference: G2580\_107).

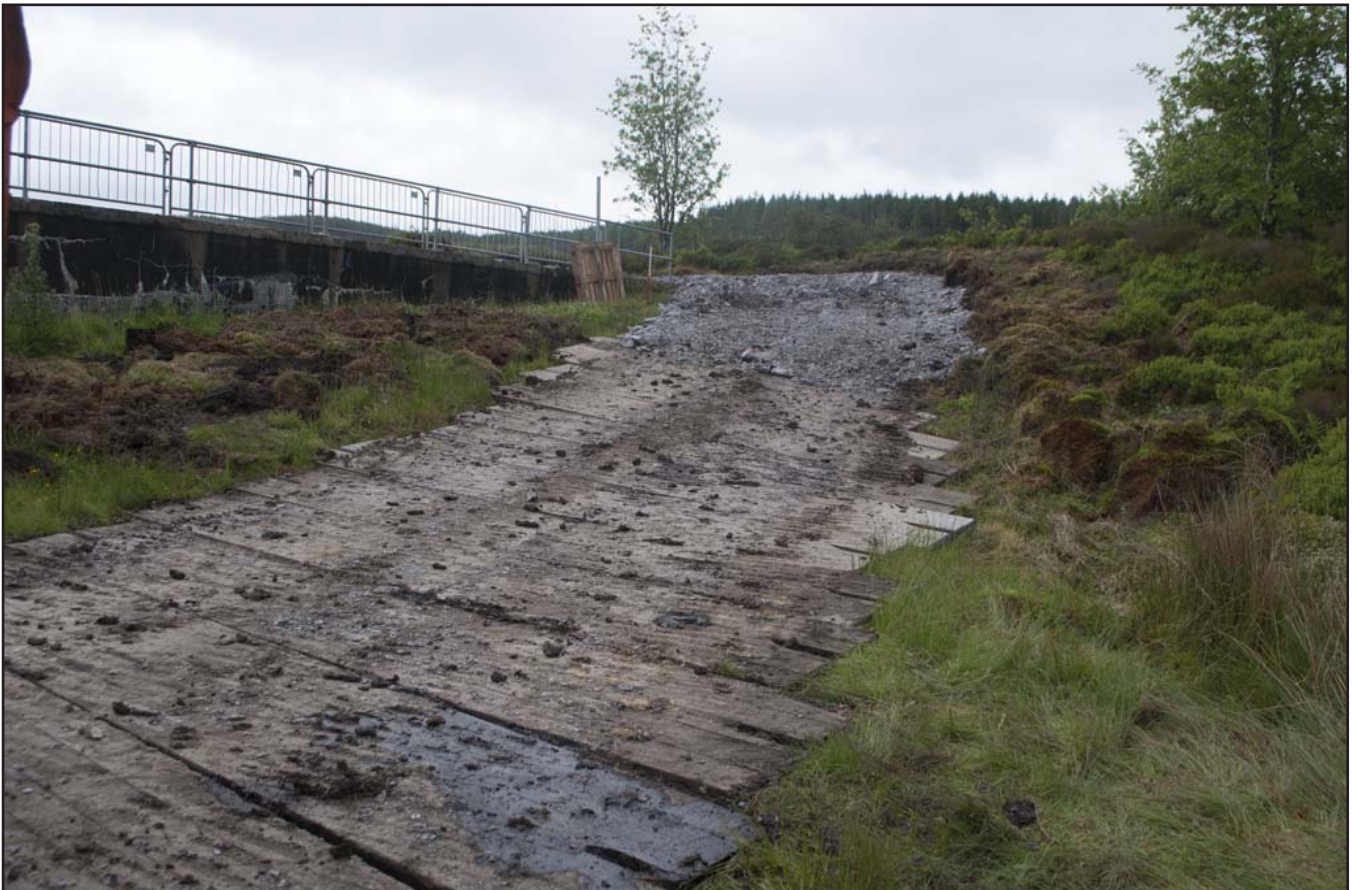
Plate 30: General view of log matting on the east bank of Llyn Brân dam; scale 1x1m; view from N (archive reference: G2580\_108).

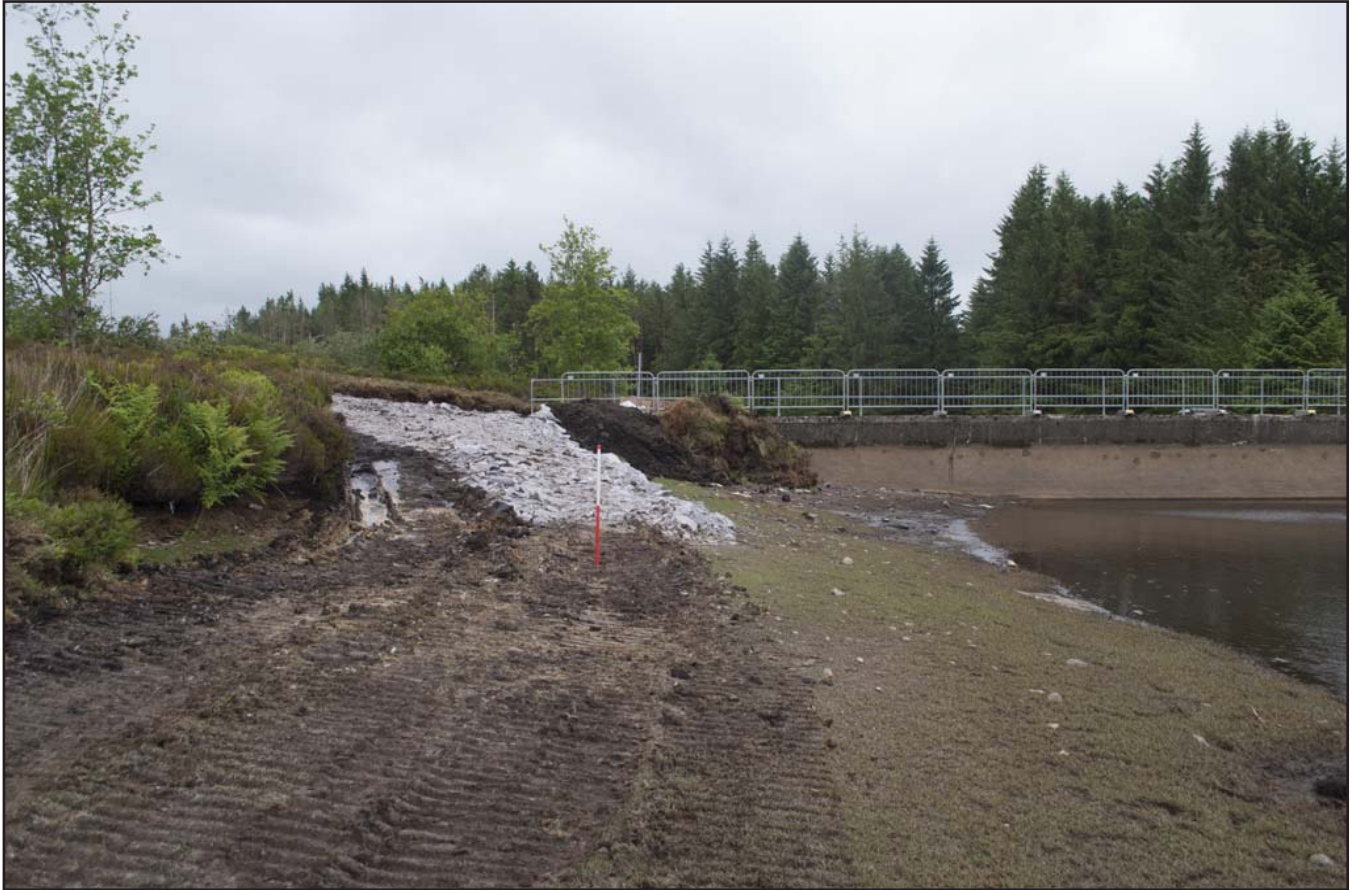
**Plate 31: General view along the east bank showing the retreating waterline and bank works during peat removal; scale 1x1m; view from N (archive reference: G2580\_109).**

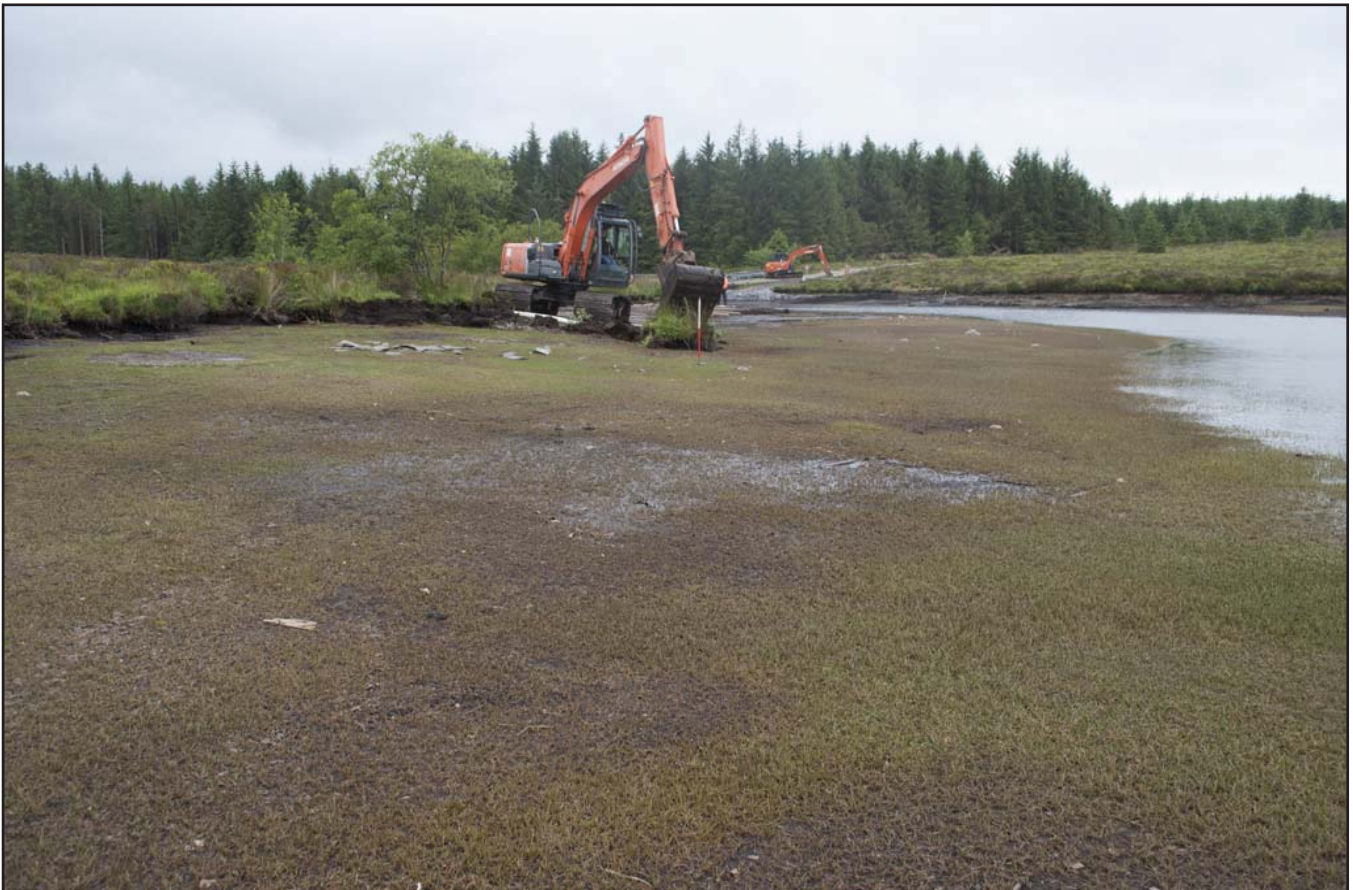
**Plate 32: View from the north showing machine working on the exposed east bank of the reservoir; scale 1x1m; view from N (archive reference: G2580\_110).**

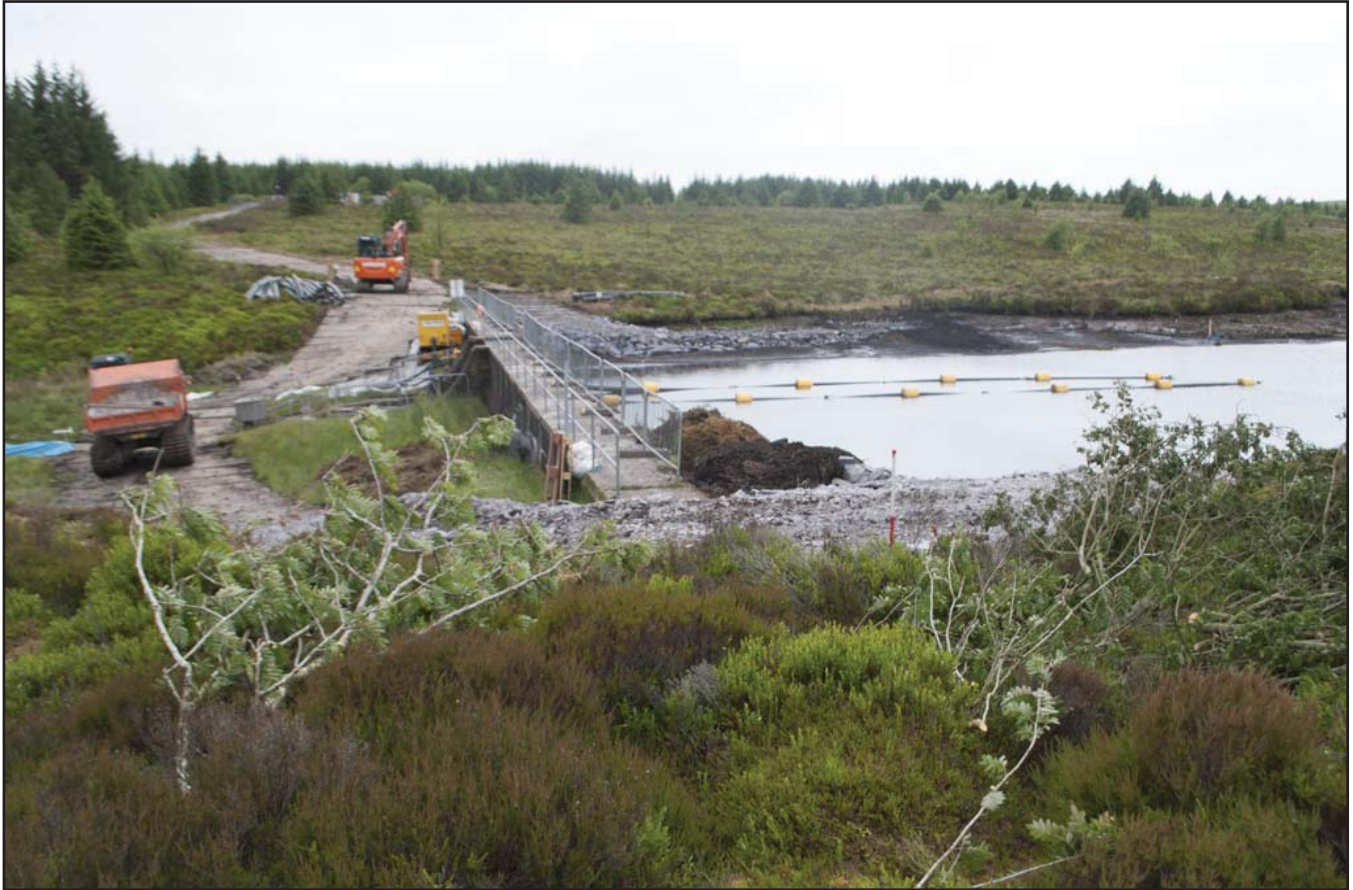
Plate 33: General view showing the chipped east bank of the dam; scale not used; view from E (archive reference: G2580\_111).

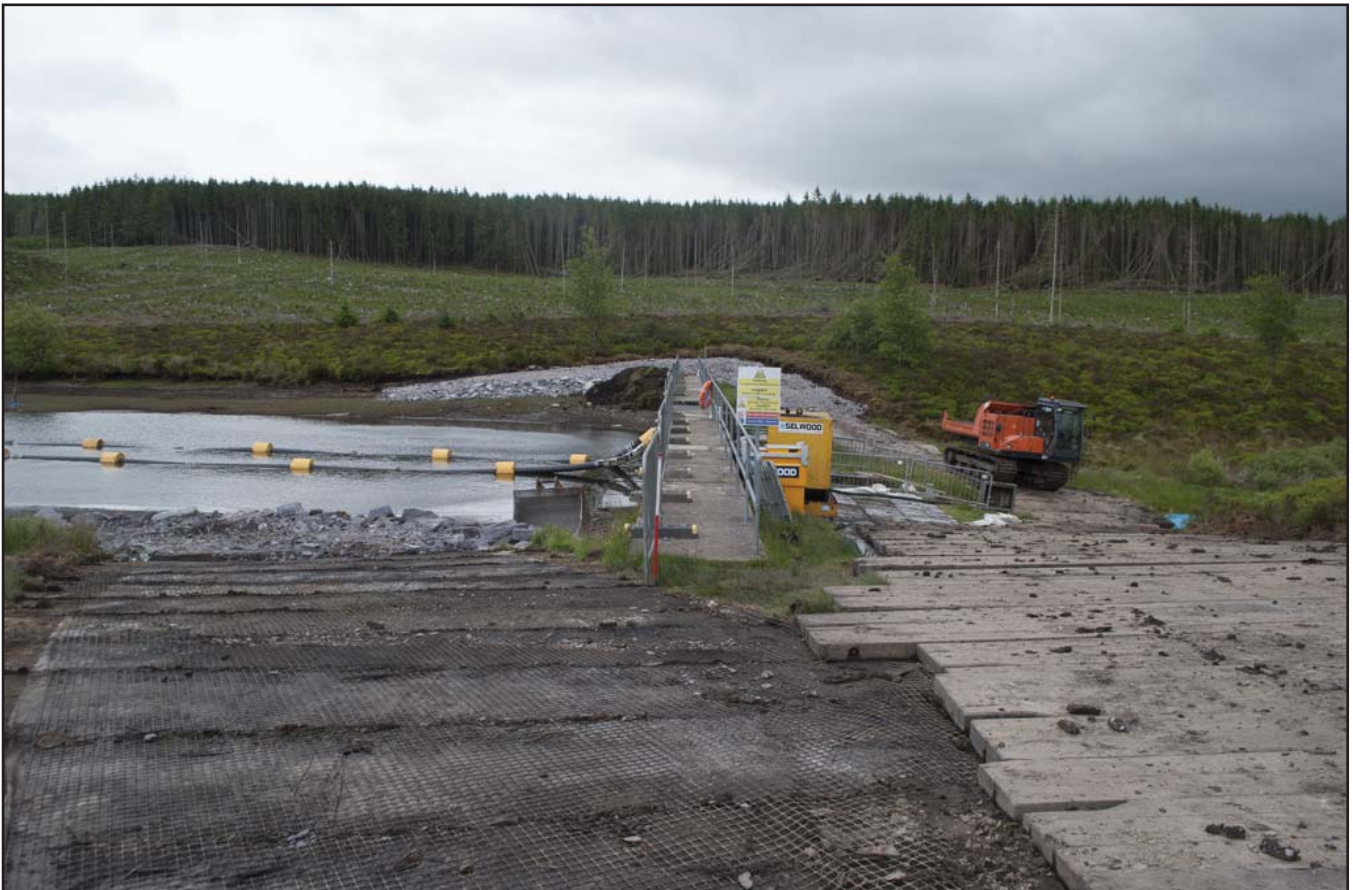
Plate 34: General view of the dam showing areas of chippings and log mats; scale 1x1m; view from W (archive reference: G2580\_113).
