**Cefnamwch, Tudweiliog, Gwynedd,
LL53 8AX
Archaeological Evaluation**

EAS Client report 2020/03

An archaeological evaluation, at Cefnamwlch, took place between 21st and 27th July 2020. Two trenches were excavated, that over the proposed position of the swimming pool and pool house had only two modern features within it. The second trench, nearer to the house, had a large area of disturbance at its northern end which was related to a library range demolished in the late twentieth century and the drains around that structure.

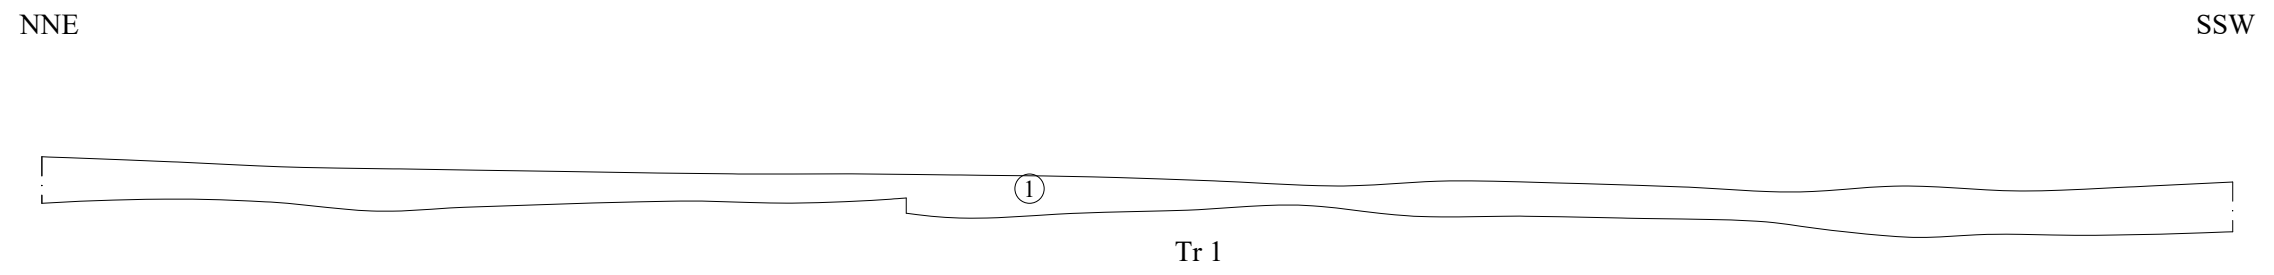
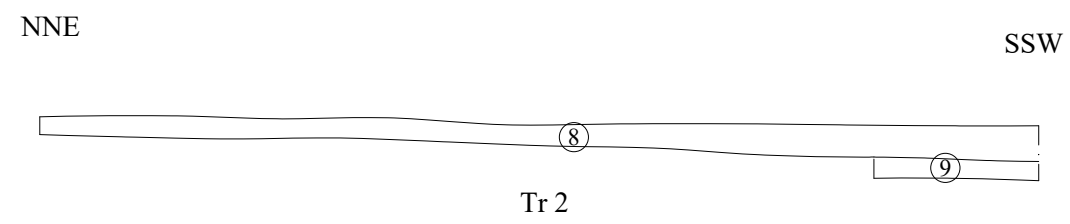
Figure 6: Trench Sections
Scale 1:75

Trench 1 was positioned to sample the area of the proposed pool house and pool (Plate 3). It was 22 m long and 3 m wide. The topsoil (Context 1) depth varied along the trench (Figure 6), but tended to become deeper to the south. It would seem likely that this reflects a levelling of the lawn along the southern boundary of the garden.

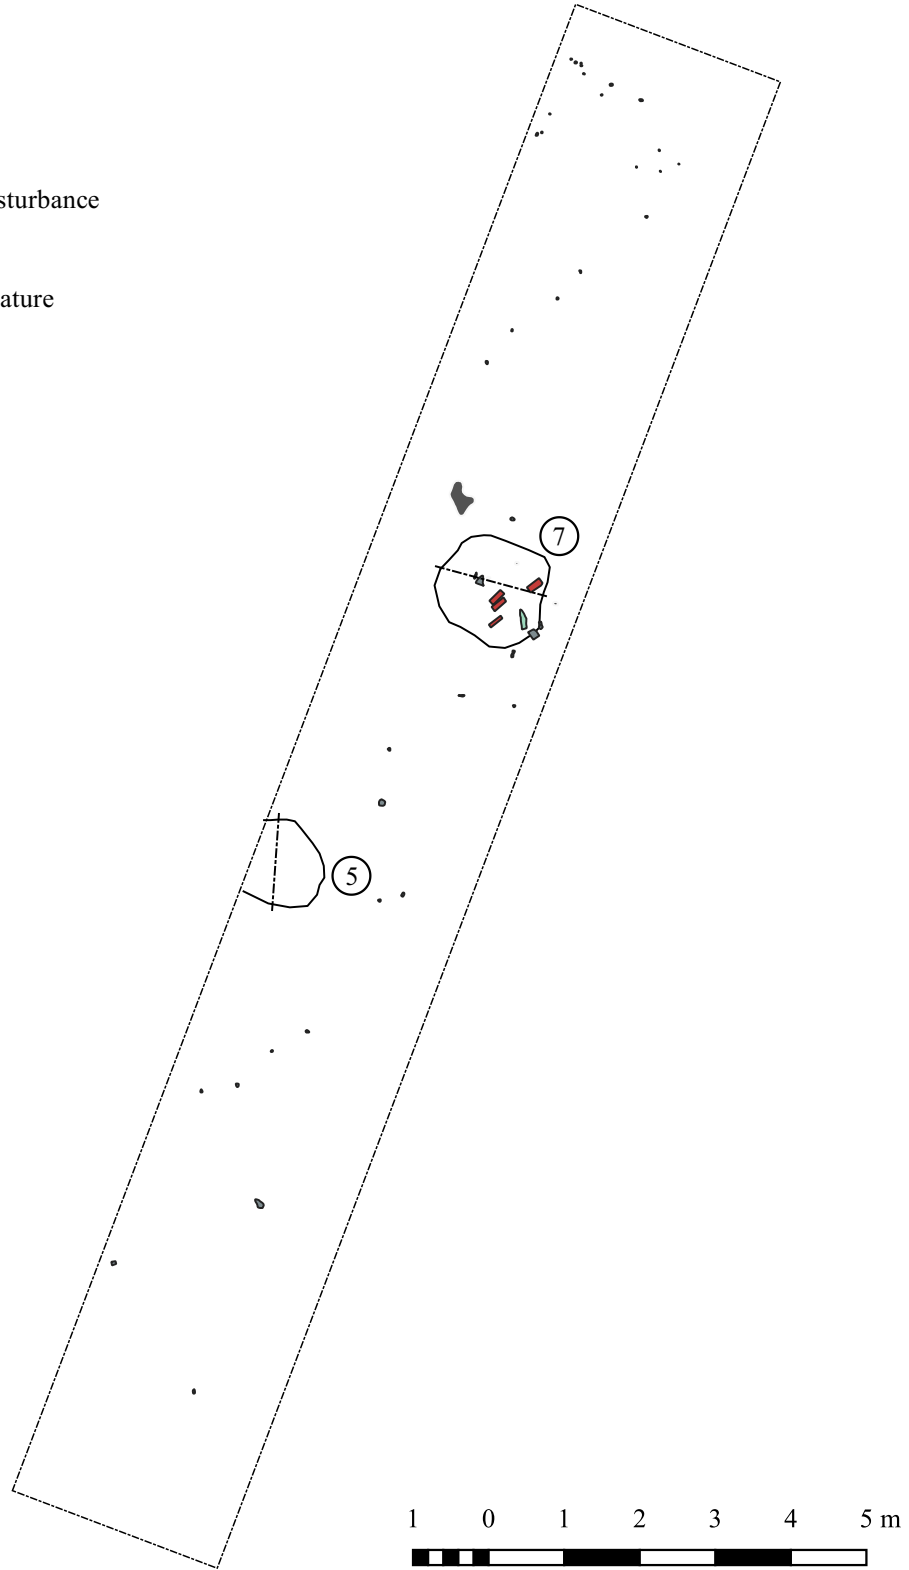
Figure 7: Plan of Trench 1
Scale 1:100

Below the topsoil only two features were located (Figure 7), both of which are considered to be relatively recent in origins. Context 5 (Plates 4 and 5, Figure 9.1) was either a shallow pit or the end of a linear feature which extended beyond the western edge of the trench. It had relatively steep sides and a flat base. It was filled by two layers (Contexts 3 and 4) of relatively clean sand, but was sealed by a thin layer of dark grey brown, sandy soil (Context 2) with a moderate density of small (less than 10 mm), angular stones, a few flecks of charcoal, and fragments of split slate. This layer is thought to be relatively recent in origins and the only artefact found within this feature was a single, handle sherd of a black glazed ceramic of 19th or 20th century date from Context 8.

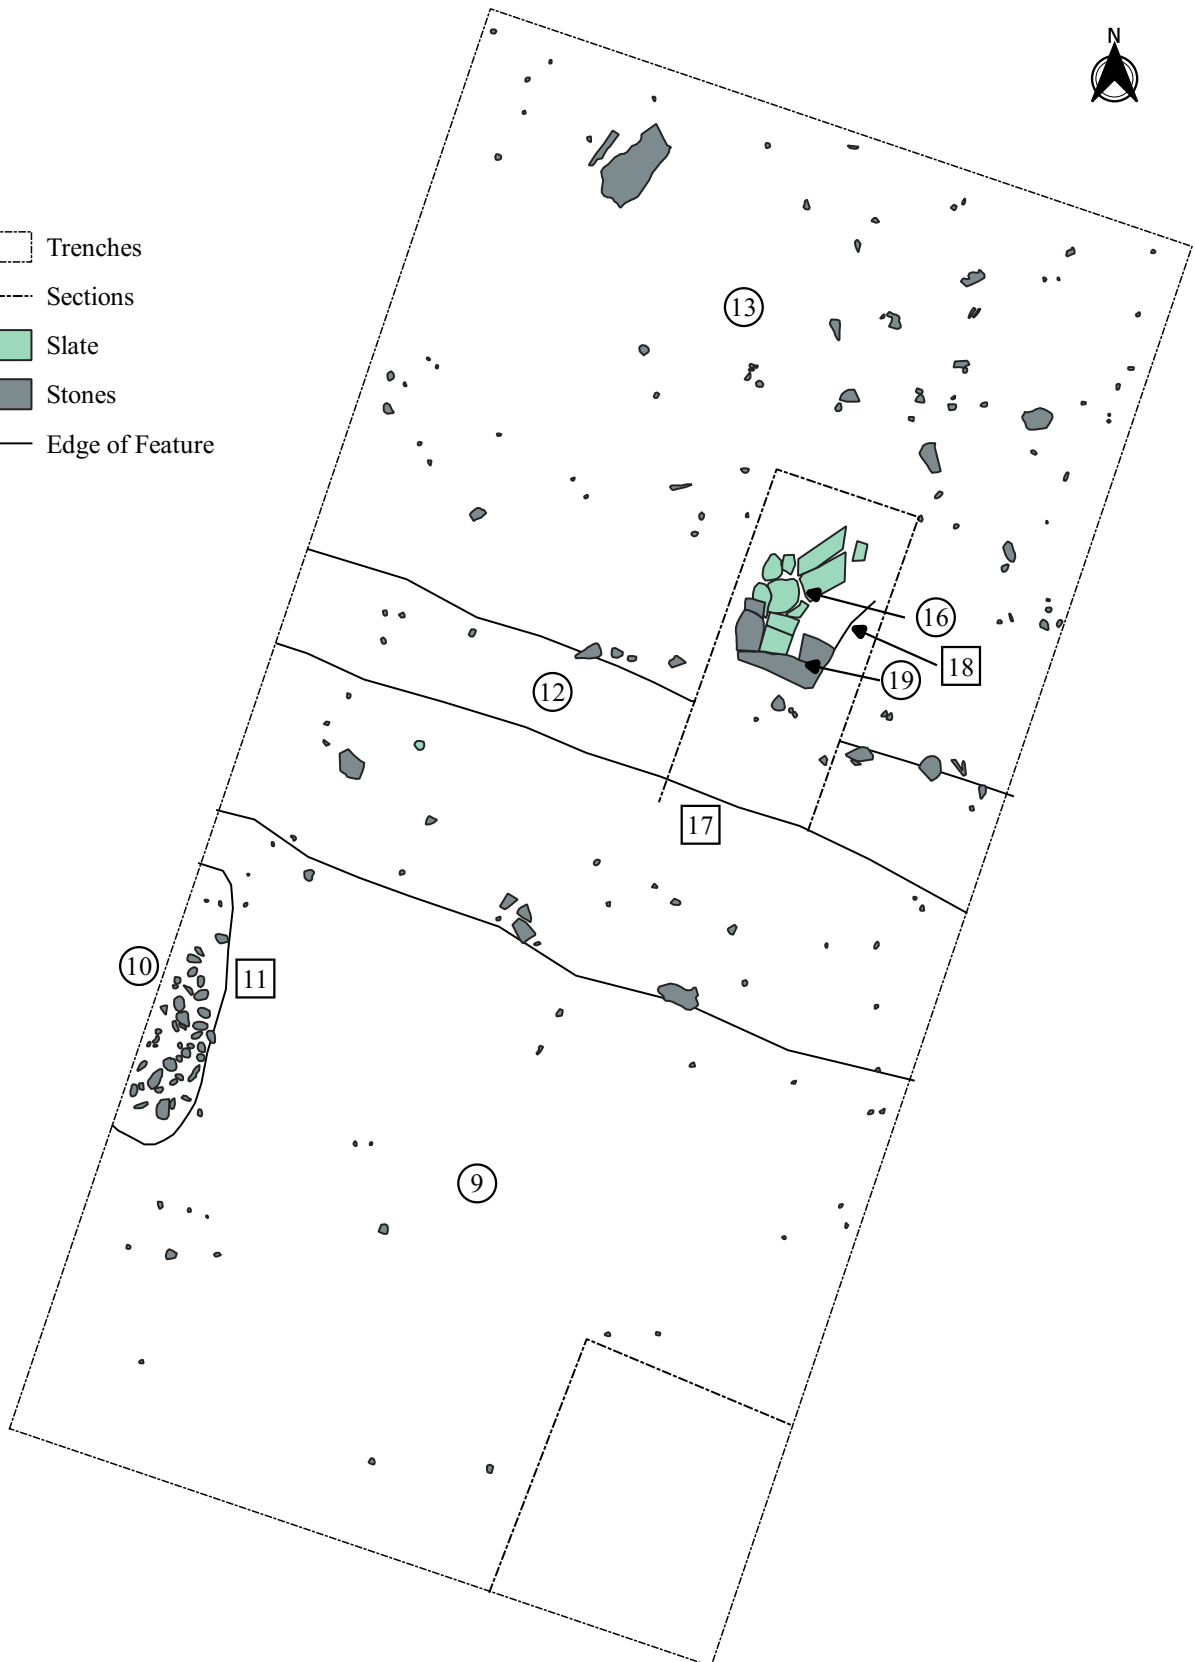
Figure 8: Trench 2 Plan
Scale 1:50

Trench 2 (Figure 8, Plate 2) was located nearer to the house and was positioned to cover the area of a proposed soak-away (Drawing SK-C-02) for the roof run-off and backwash from the pool complex. The topsoil (Context 8) varied in depth between 180 and 400 mm with a tendency to become deeper towards the south (Figure 6). At this end of the trench the topsoil was over a layer of yellowish-brown sandy silt with the occasional fleck of charcoal (Context 9) which was up to 200 mm deep. Context 9 merges with Context 8 above and these two layers suggest that the level of the lawn was increased along the southern boundary in order to produce a flatter lawn.

Cut into the top of Context 9 is the end of a cobble path or surface (Context 10 and 11) which extends out of the trench to the east. The cobble surface (Context 10, Plates 9 and 10) occupies a shallow feature 210 mm deep. There appears to be three layers of cobbles, up to 160 x 120 x 50 mm in size, the lowest level of which was partly held in place with lime mortar. The upper layers of cobbles were bedded in a fine gravel. It would seem likely that this path/surface has been re-surfaced at least once given the layering within the cobbles. One possibility is that this path is that shown on the 1840 Tithe Map of Penllech (Figure 12).

1. The soak-away for the roof run-off and backwash from the pool complex be moved at least 2 m to the south to avoid the disturbance related to the destruction of the library range
2. An archaeological watching brief be commissioned during the construction phase to record any archaeological features not located in the evaluation.

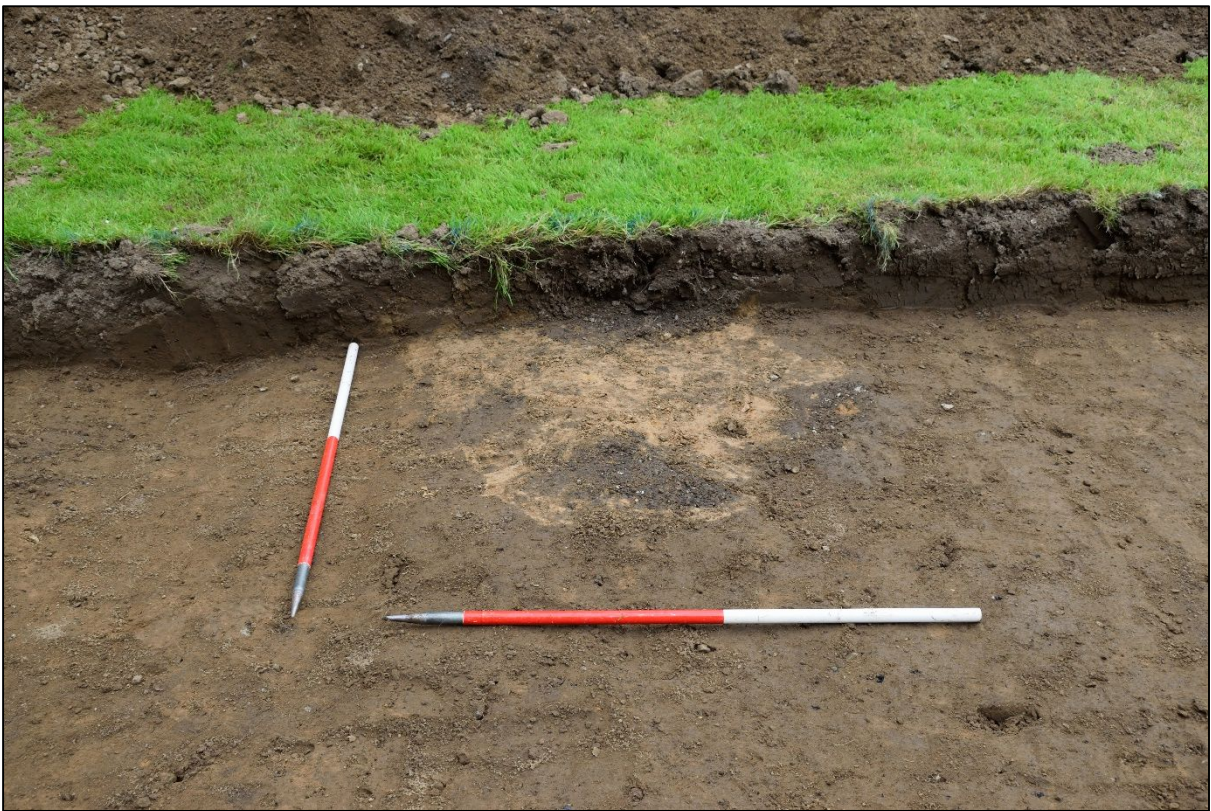
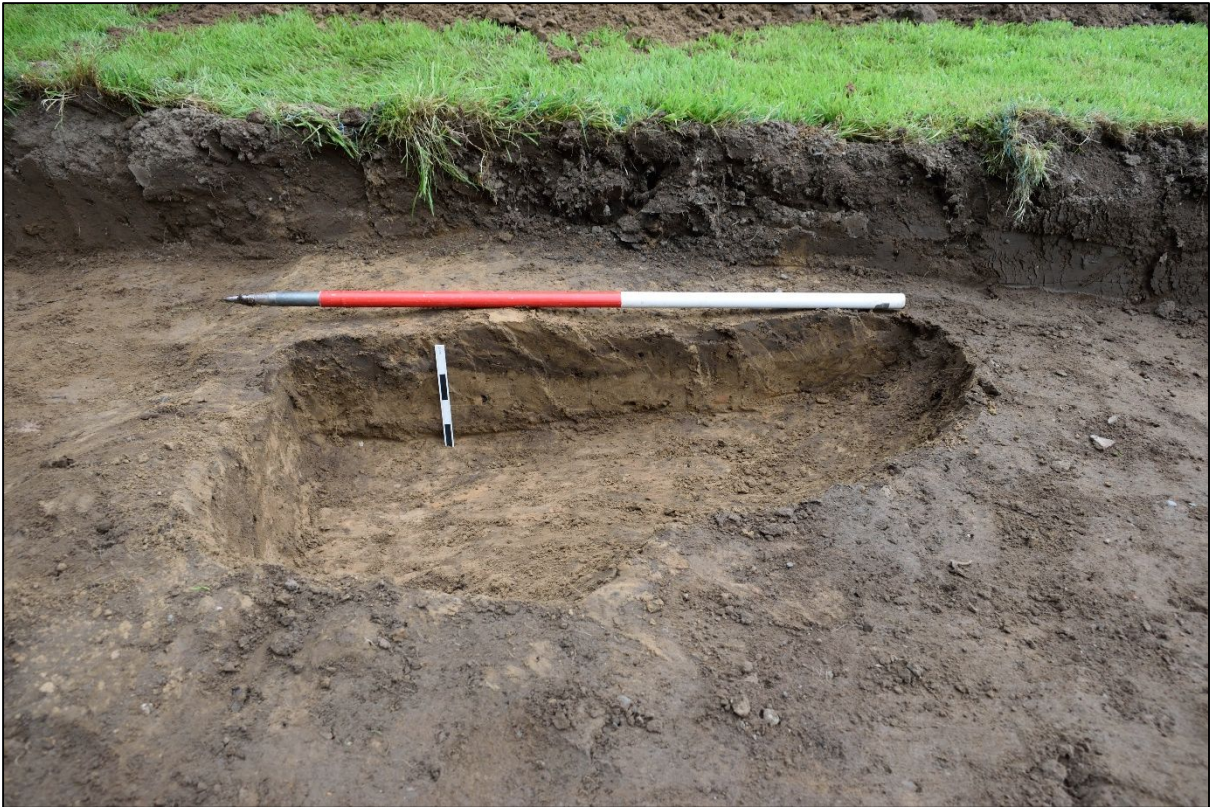
Plate 4: Context 5, before excavation

Plate 5: Context 5, after excavation

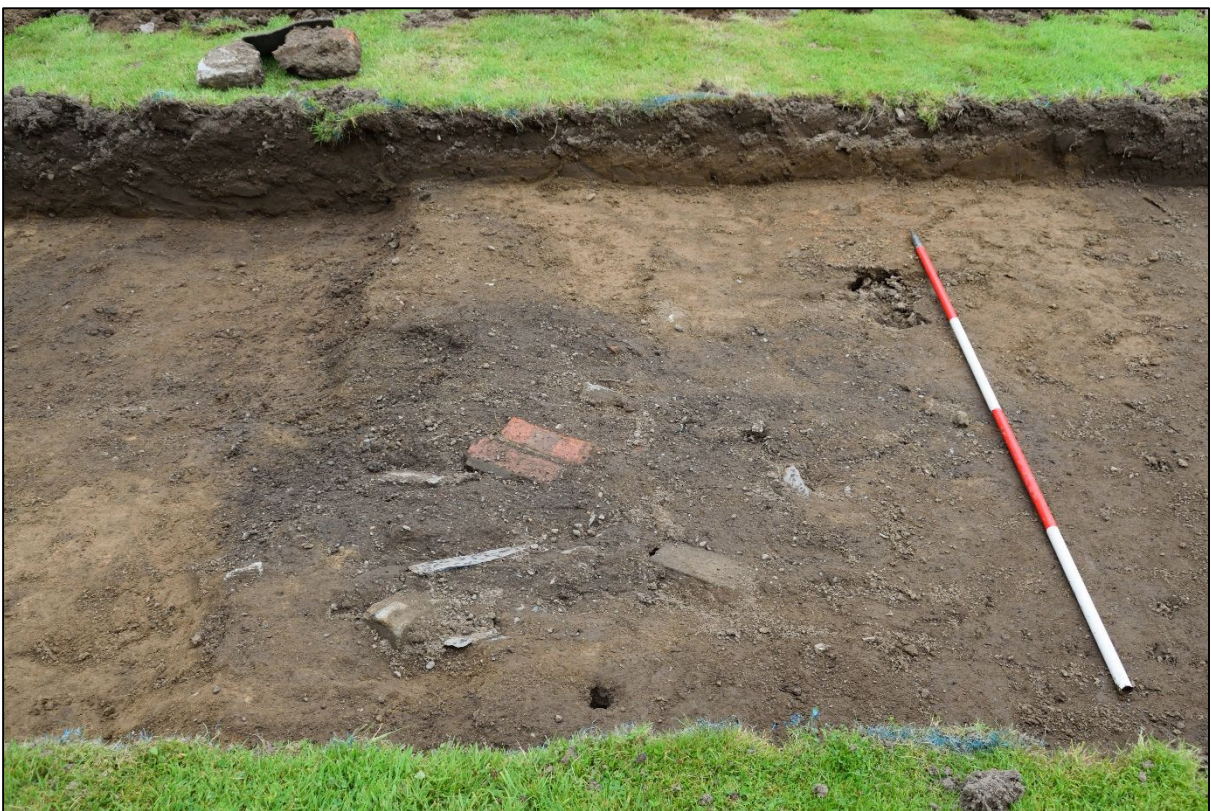
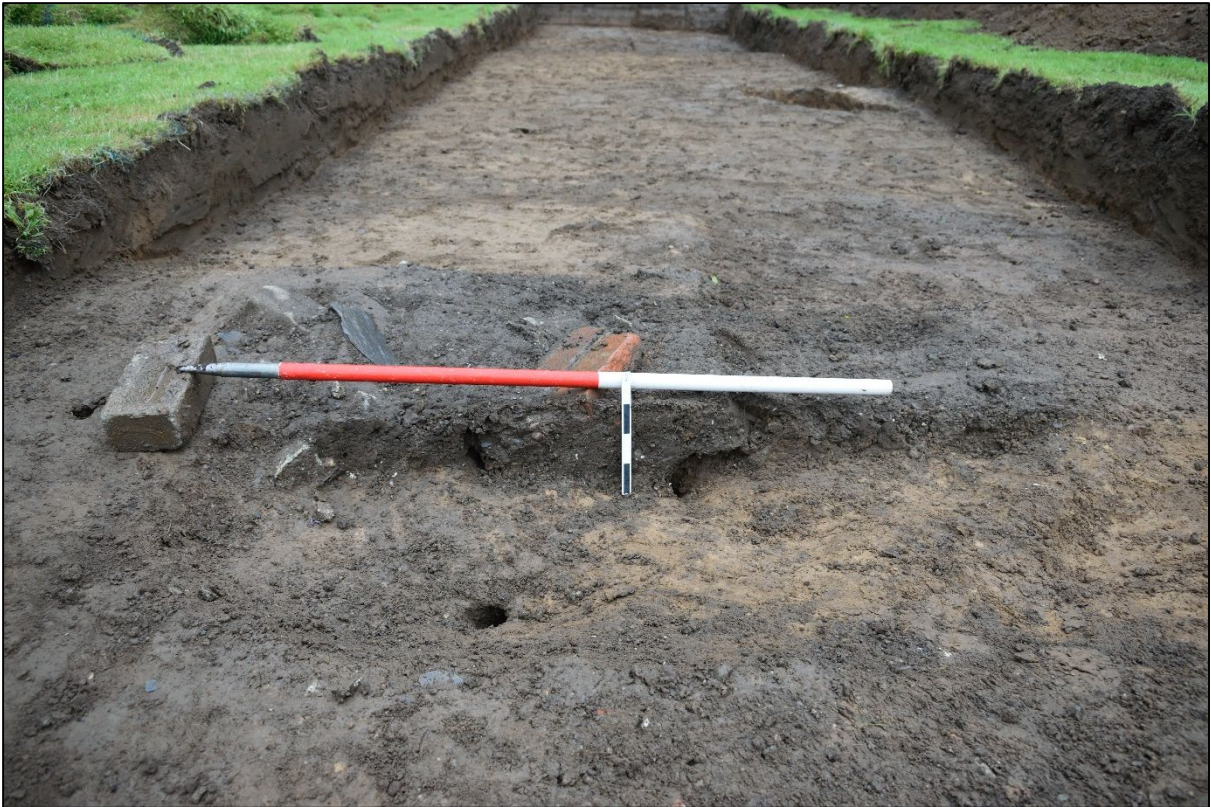
The second feature, Context 2, (Plates 6 and 7, Figure 9.2) was filled with a single context (Context 6). It was a shallow hollow, 1.4 x 1.3 m in size and up to 140 mm deep with a slightly irregular shape. Context 6 included a number of modern, machine made bricks, some of which were still mortared together, suggesting a relatively modern date for this feature. The fill also included a fragment of a plastic label moulded with the inscription “...S SEEDS”. The feature sits within an area with a series of open and collapsing animal burrows and it would seem likely that this feature was an attempt to level the lawn after a series of animal burrows had collapsed.

Plate 6: Context 7, before excavation

Plate 7: Context 7, after excavation.

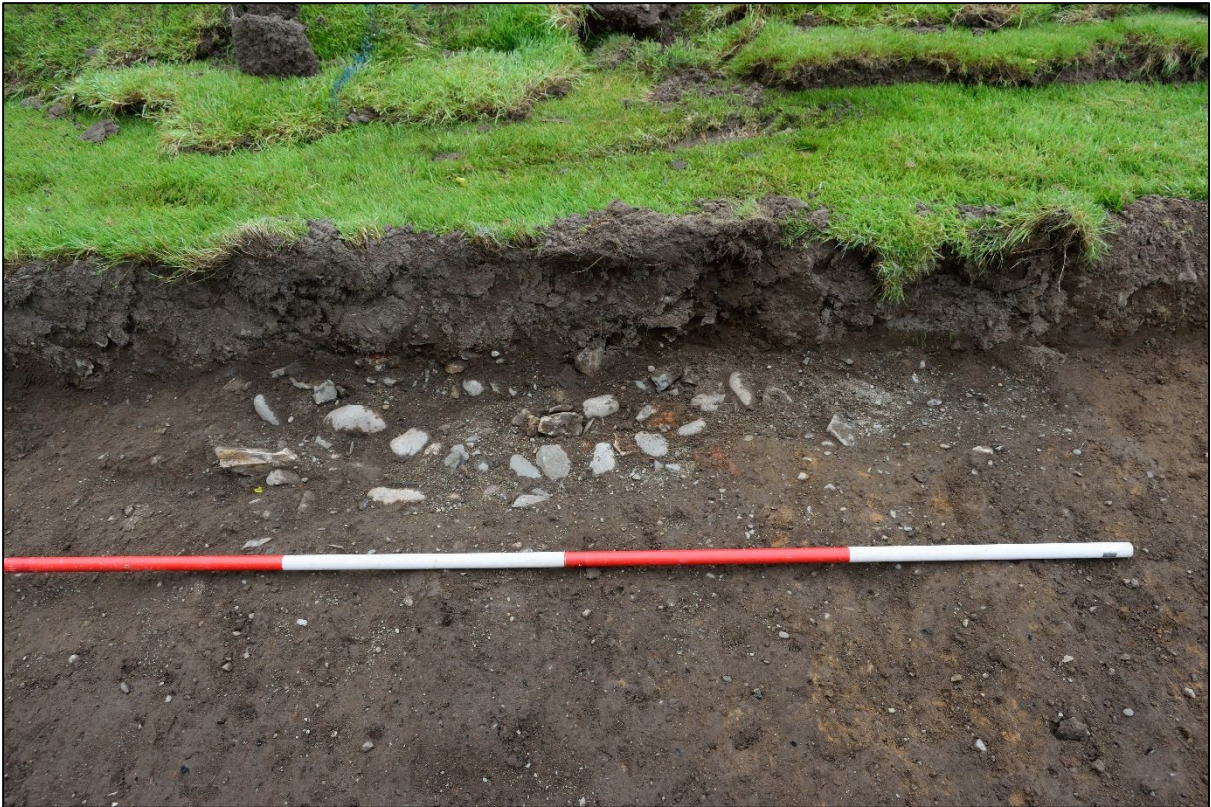
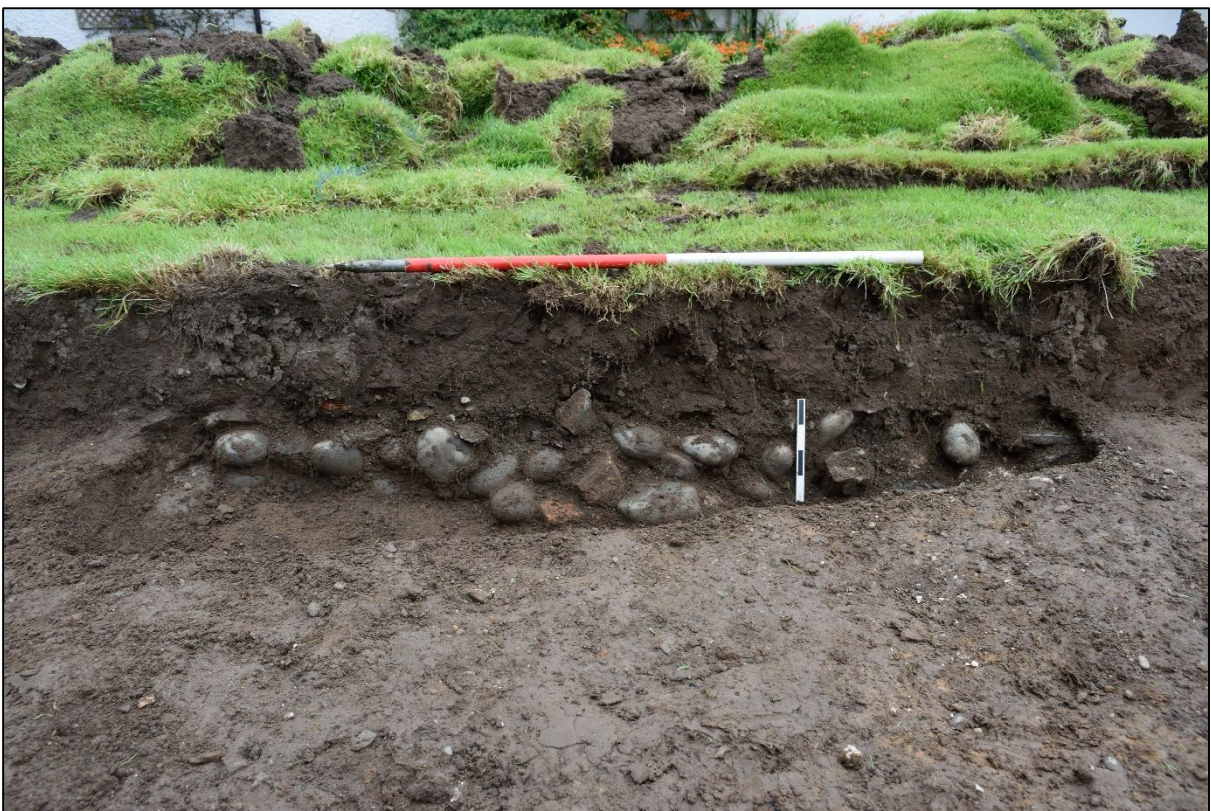
Plate 9: Contexts 10 and 11

Plate 10: Context 10 section

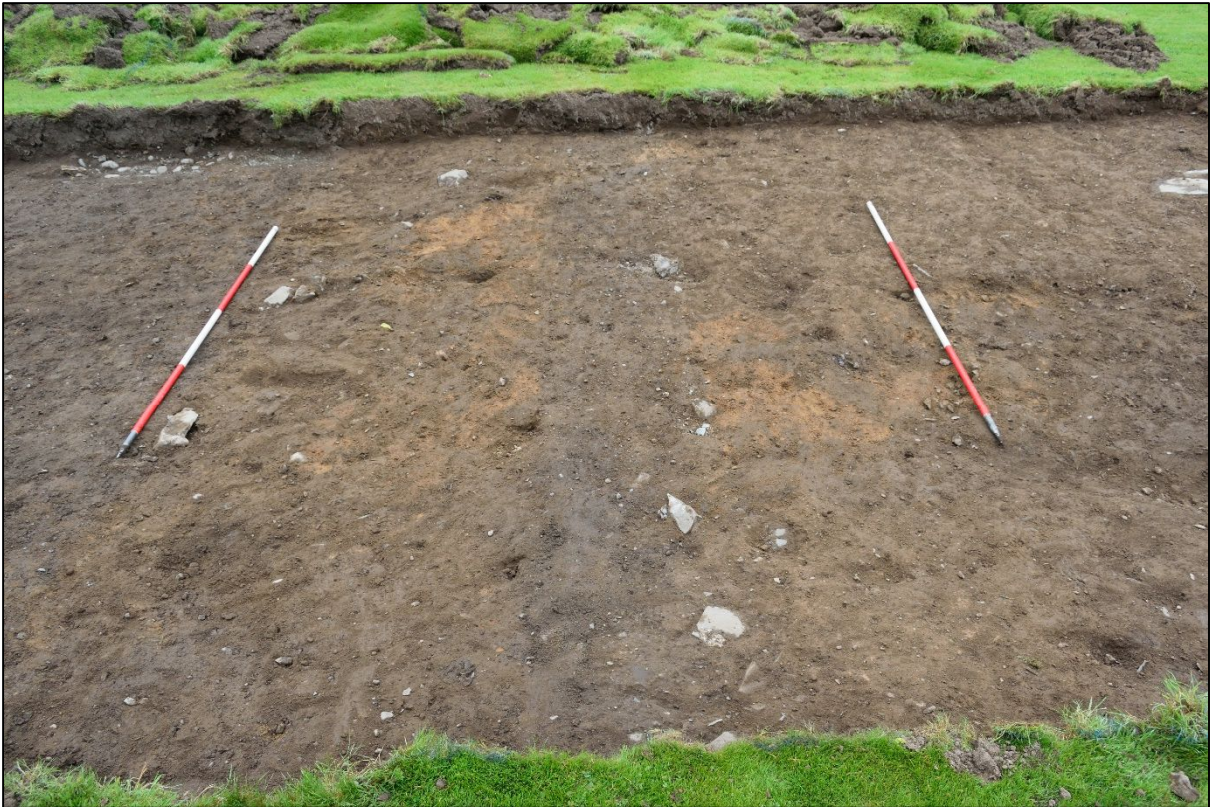
After the removal of the topsoil (Context 8) there was a dark strip crossing the trench (Context 12, Plate 11) which was assumed to be a linear feature such as a gully. However, on excavation this proved to be one of a series of layers within a large feature (Context 17) covering the northern 4.65 m of the trench. A one metre wide trench was dug into Context 17 which showed that the feature has a shelf approximately 250 mm deep running for a distance of approximately 650 mm. At this point the feature becomes deeper reaching depths of up to 570 mm (Figure 9.4 and 9.5, Plate 12). At the break of slope between the two levels there is a stone drain (Context 19). This consists of two upright, dry stone walls capped with a slab of slate. The internal drain measures 280 mm wide and 280 mm high and has a split slate floor (Context 16, Figure 9.6, Plate 14). The split slate floor (Context 16) extended beyond the surviving drain structure forming a curved band 310 mm wide running across the bottom of the sampled area (Figure 10, Plate 13). This would appear to have been the floor of a drain from which the large stonework has been removed. It is likely that the surviving structure (Context 19) is a spur off the main drain which originally ran around the eastern end of the library range. The eastern section of the cut has natural sandy at its base suggesting this may be close to the eastern edge of the drain around the library range.

Plate 11: Context 12, before excavation

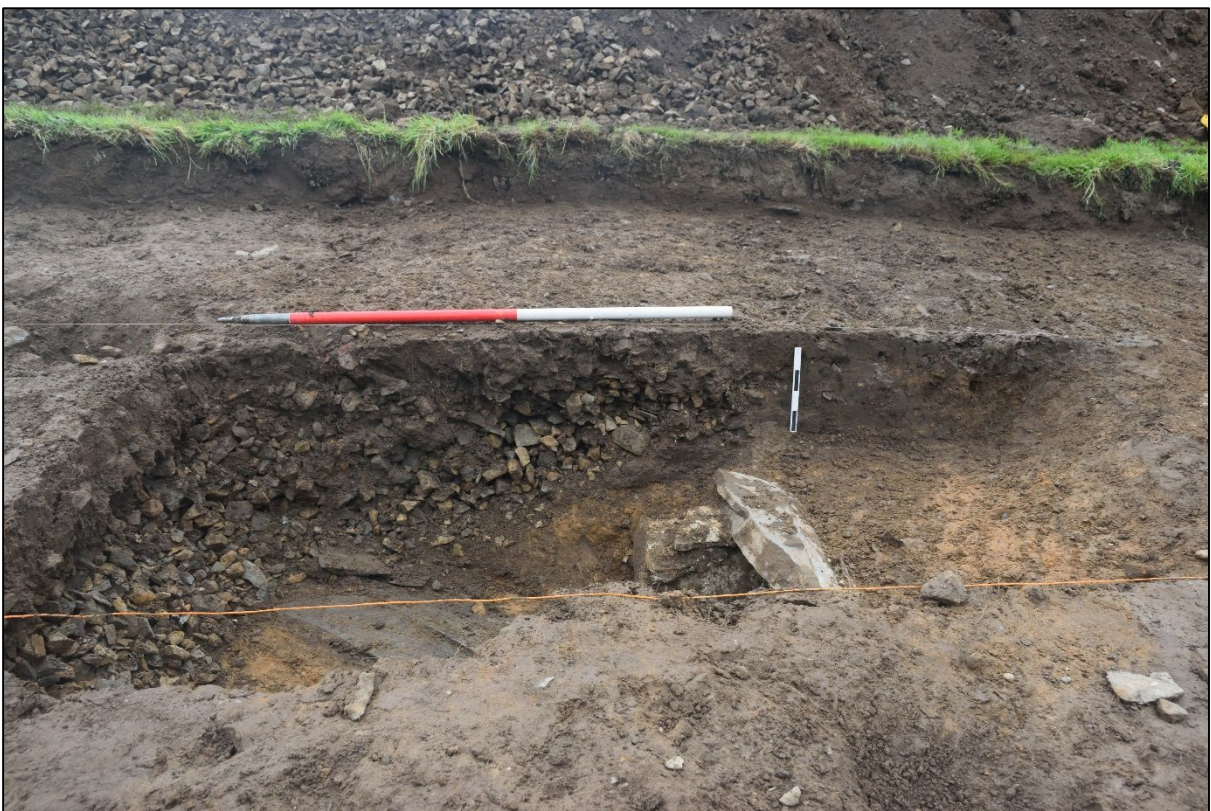
The areas above the assumed robbed out drain was a fill of loosely packed gravel (Context 14) which is assumed to be associated with the drain. This layer extends to partly fill the side drain (Context 19).

Plate 12: Contexts 12, 13, 17, 18 and 19 looking east

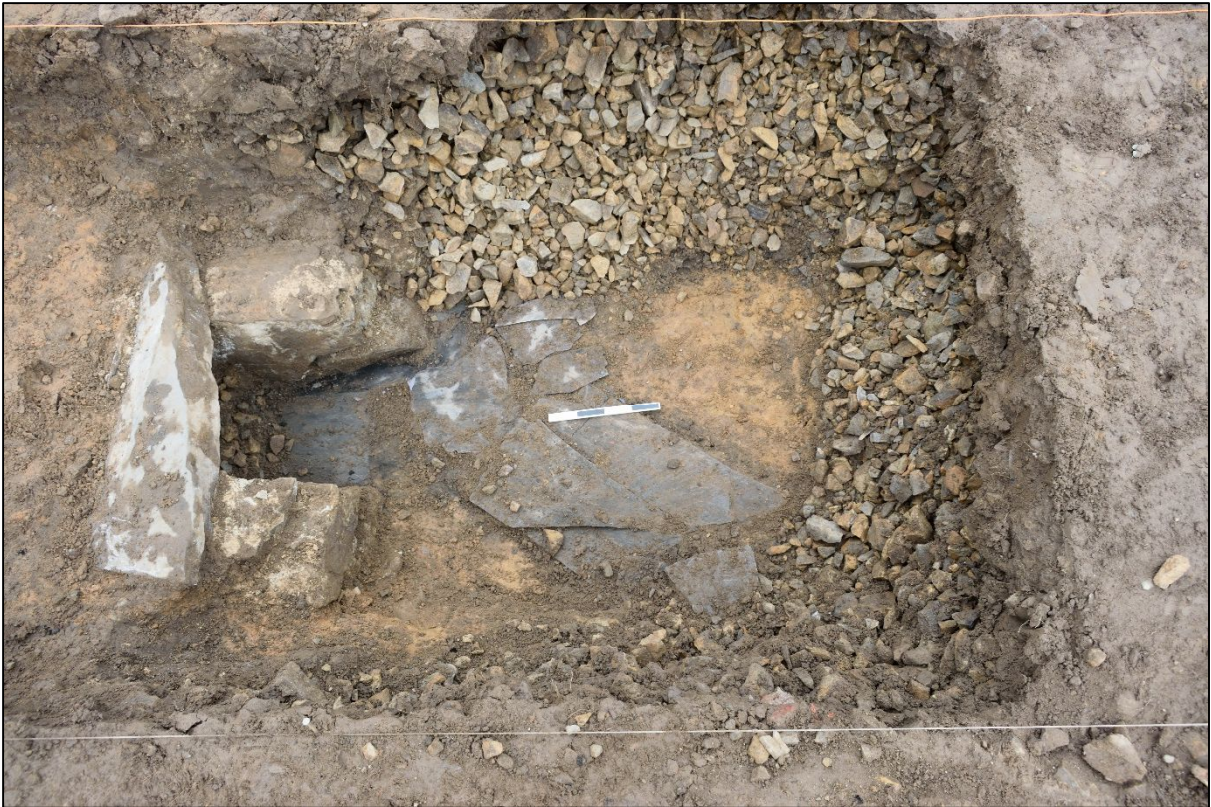
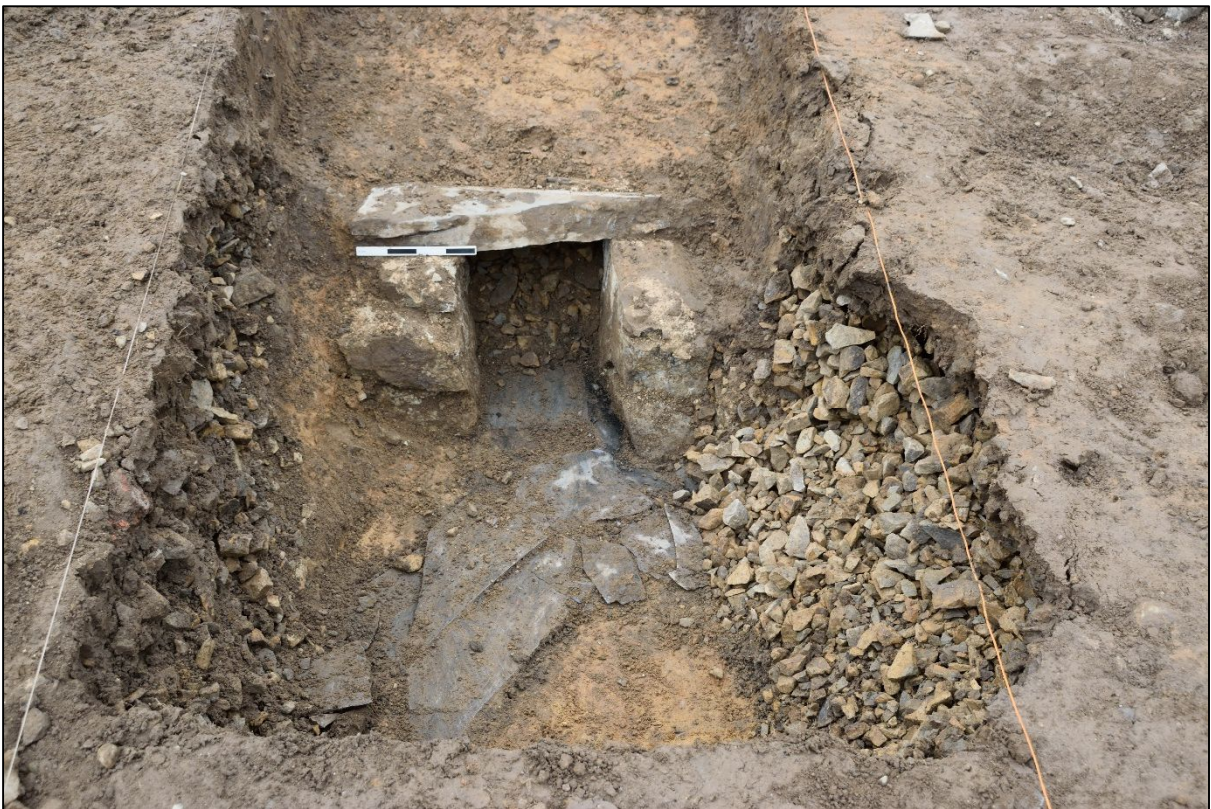
Plate 13: Drains, Contexts 18 and 20 from above

Plate 14: Drain, Context 20, looking south
