Westgate Hotel Columns Survey Record

Newport Museums & Heritage Service
Newport

Date: 26.04.2022
Project No.: AD131

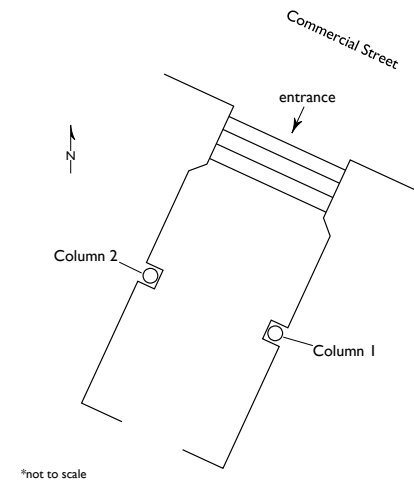
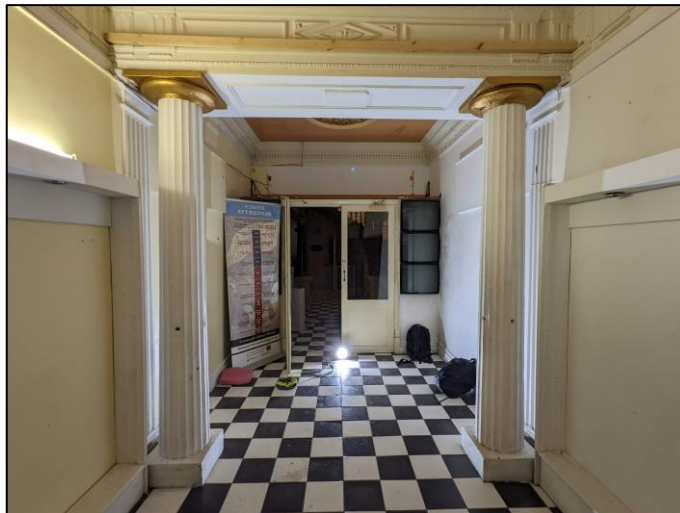
Fig. 1 – Columns viewed on entry: Column 1 (left) – Column 2 (right).

Three pairs of holes are present, one set in Column 1 (A series) and two in Column 2 (B and C series). Each set of holes are at roughly the same level and presumed to be formed of entry and exit of possible musket balls.

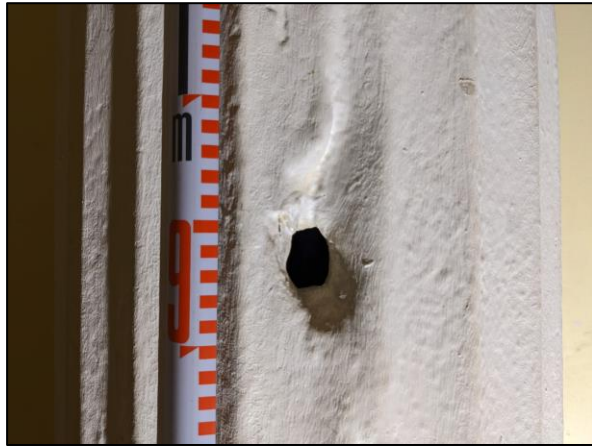
A2

Column 1 sits to the east side of the porch (left on entrance). There are two holes at roughly the same height and are presumed to be entrance and exit. A 3D model can be viewed here - <https://p3d.in/JN53Y>

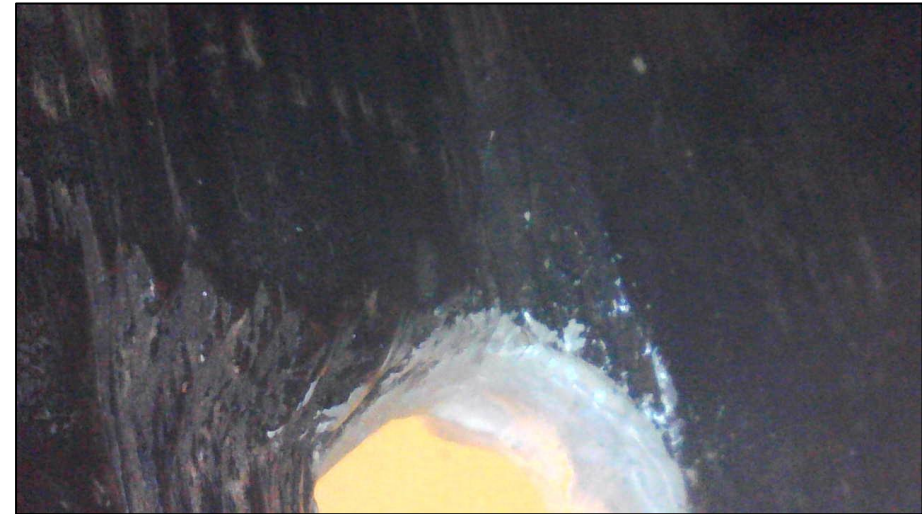
Fig. 3 – Finger polish and paint to hole A1.

Endoscope investigation revealed the holes to be highly finger-polished on their inner faces, and that paint has run in and around the holes, including leaving splatter on the internal faces.

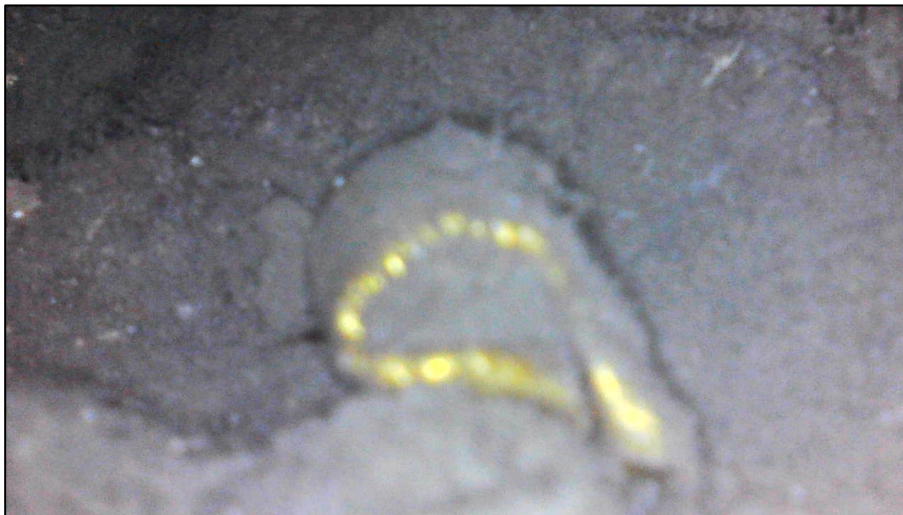
Fig. 5 – Cloth with gold trim.

On a timber former, a piece of cloth with golden trim was observed.

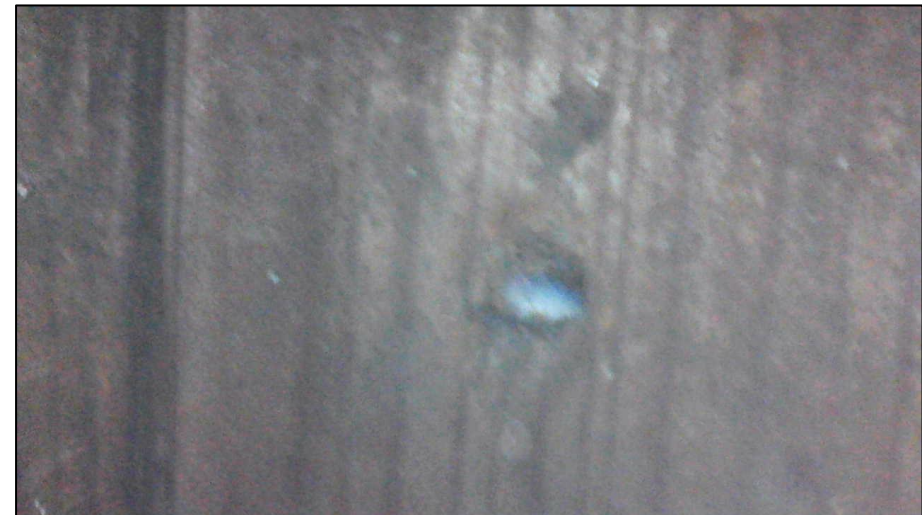
Fig. 4 – Punch hole.

A small punch hole was also observed, but may be related to their fabrication.

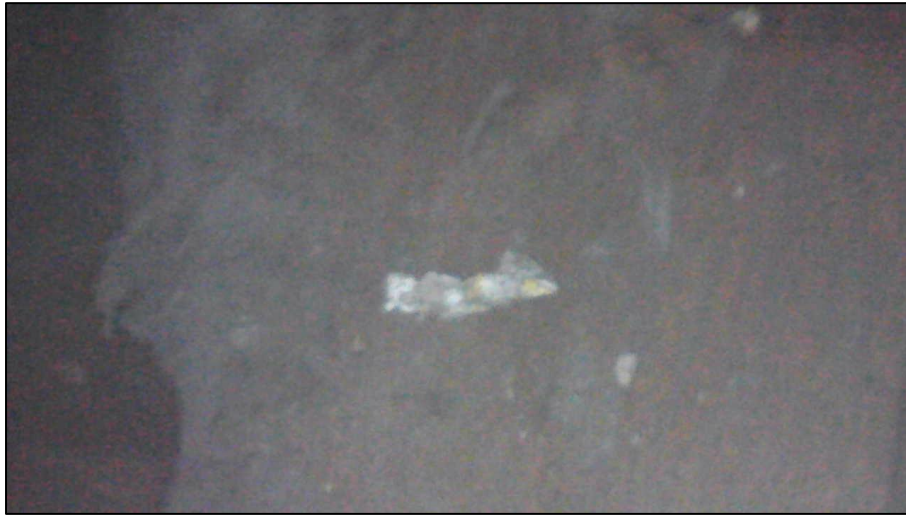
Fig. 6 – Amorphous white object.

Pieces of unusually shaped material of a white colour were identified inside each column, which were photographed and identified as requiring further investigation for the possibility of being lead.

A piece of amorphous material of a white colour was observed attached to the internal face of the column.

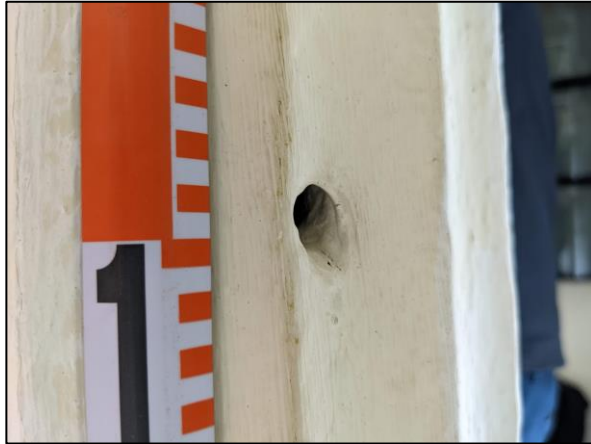
B2

Column 2 sits to the west side of the porch (right on entrance). There are two sets of holes, each set at roughly the same height and are presumed to be entrance and exit. A 3D model can be viewed here - <https://p3d.in/CJWPI>

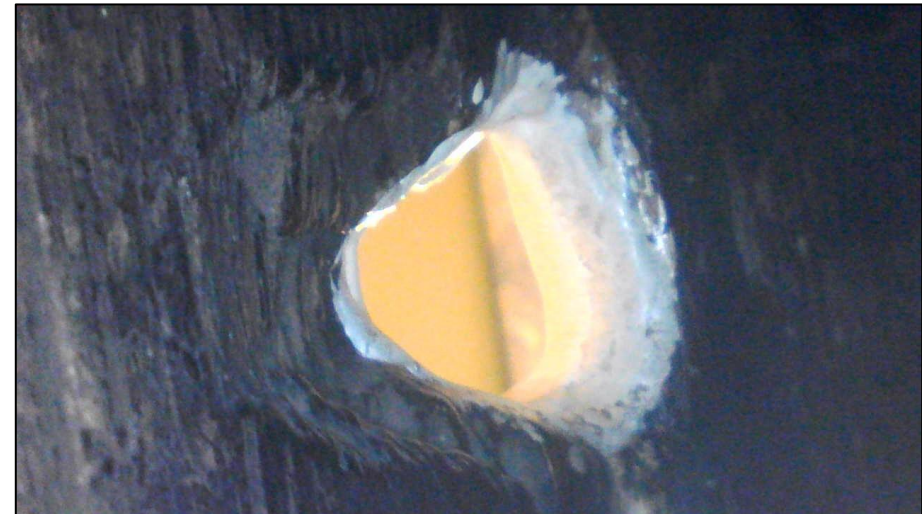
Fig. 7 – Finger polish and paint to hole C1.

Endoscope investigation revealed the holes to be highly finger-polished on their inner faces, and that paint has run in and around the holes, including leaving splatter on the internal faces.

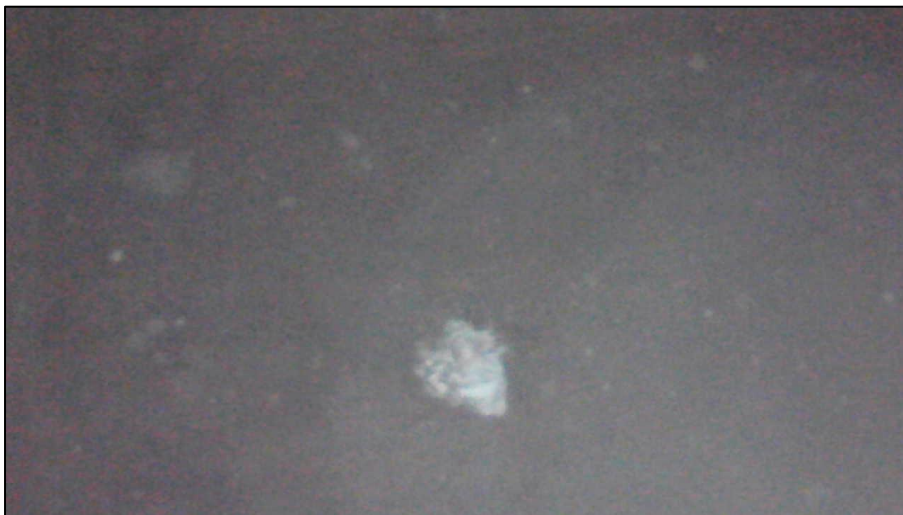
Fig. 9 – Amorphous white material.

A piece of amorphous material of a white colour was observed attached to the internal face of the column.
