PE298 FOEL ERYR ROUND CAIRN SCHEDULED MONUMENT:
RECONSOLIDATION OF CAIRN SHAPE

Prepared on behalf of the Pembrokeshire Coast National Authority by Tomos Jones, Community Archaeologist.

03 October 2022

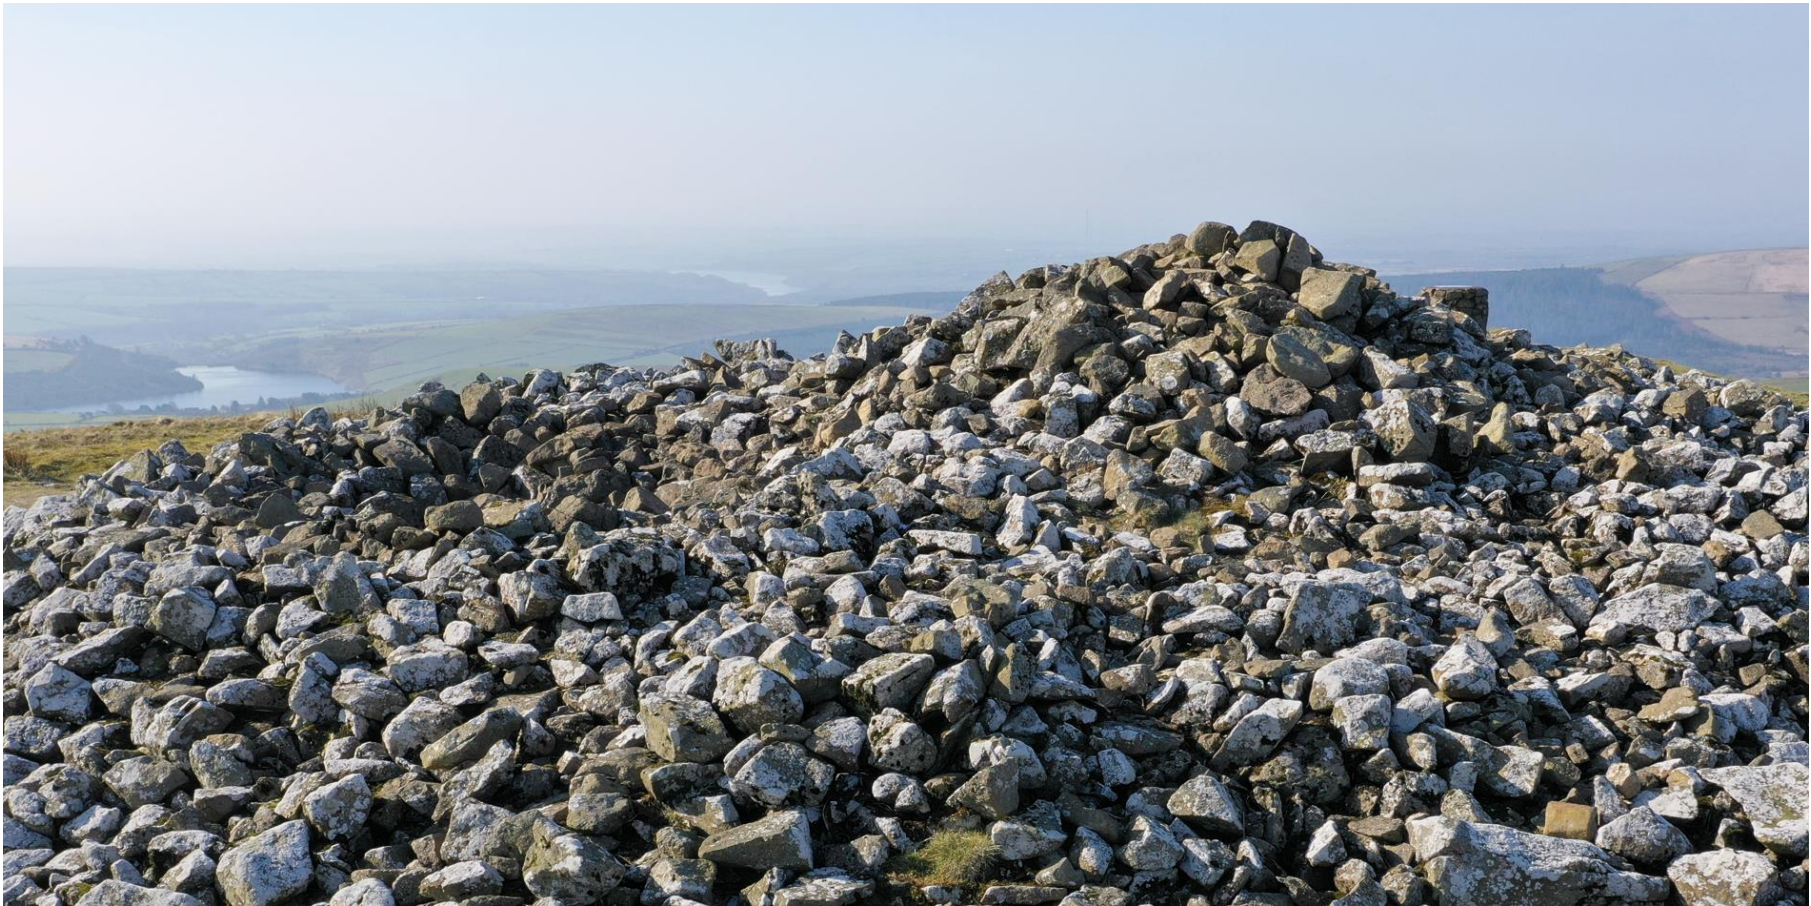
Figure 2. Photo showing disturbance prior to reconsolidation work (looking south).

- Stones were carefully removed to reduce the height of the peak. It is likely that disturbance had been ongoing for a significant amount of time, as such only a degree of reduction took place. Once the height had been reduced, stones with lichen were placed at the surface facing upwards. Stones removed from the peak were used to infill the depression created by visitors redistributing stones to place on the peak.
- A general walk over the cairn surface took place to identify stones that had been disturbed, indicated by the absence of lichen on the surface of stones. Any identified disturbed stones were turned over, so that lichen was facing towards the sky (see example in figures 4 and 5).
- Photographs showing before and after are provided below (section 3).

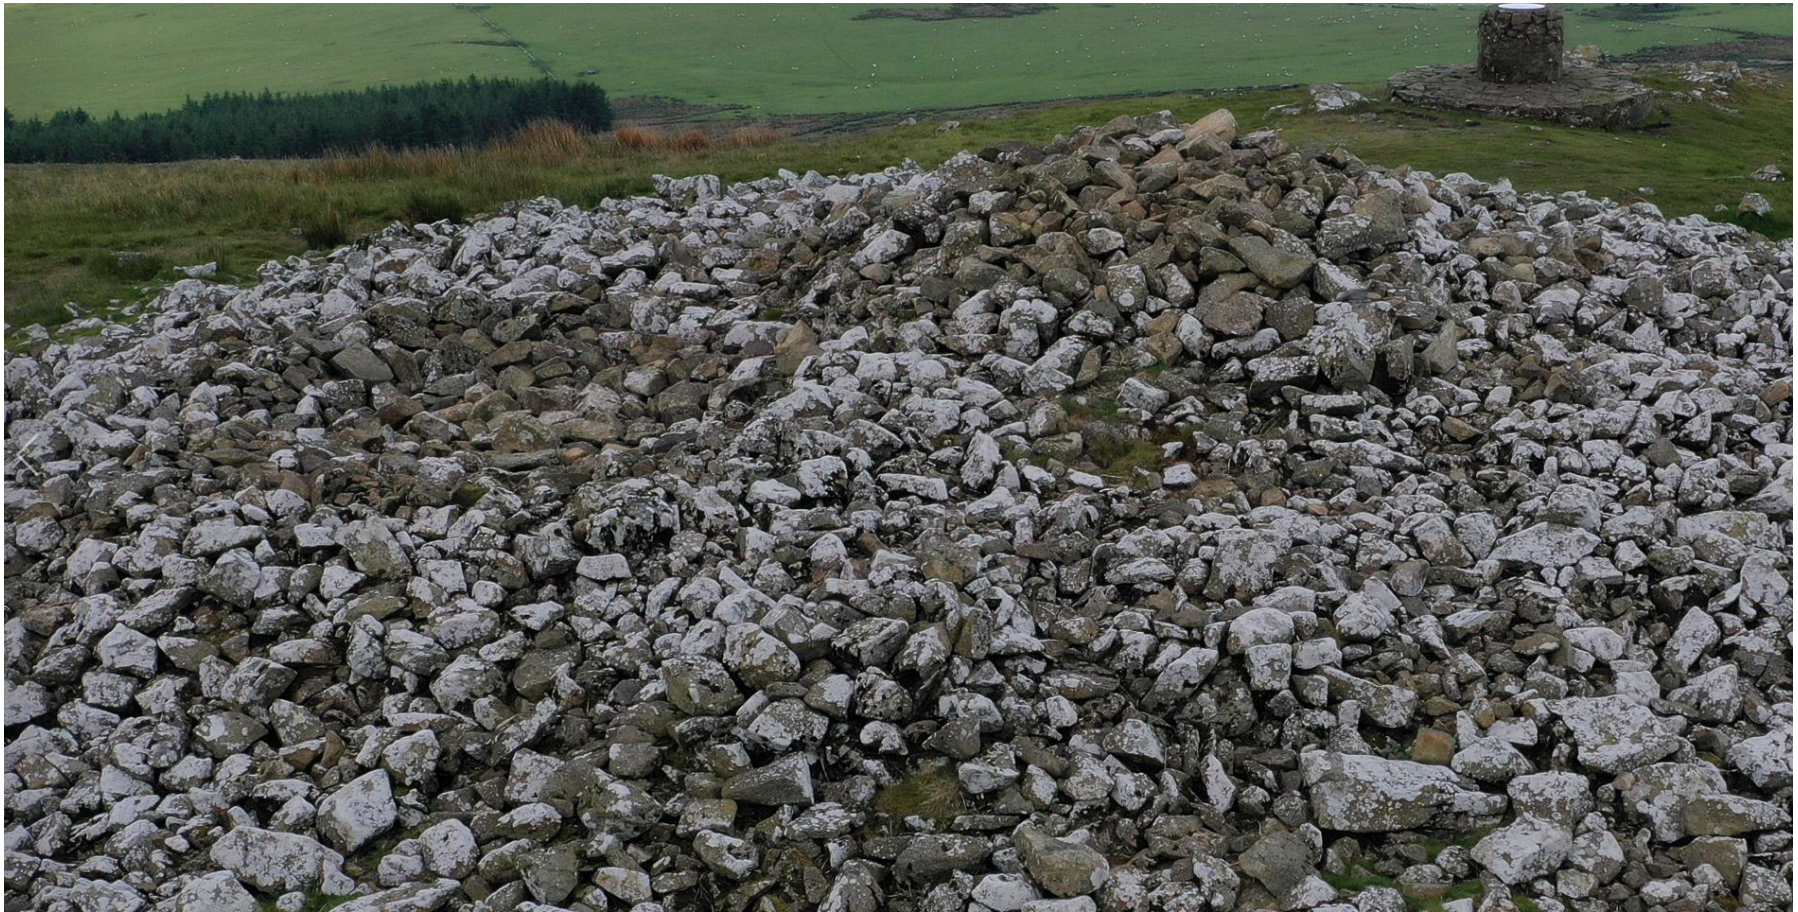
Figure 3. Photo showing disturbance after reconsolidation work (looking south).

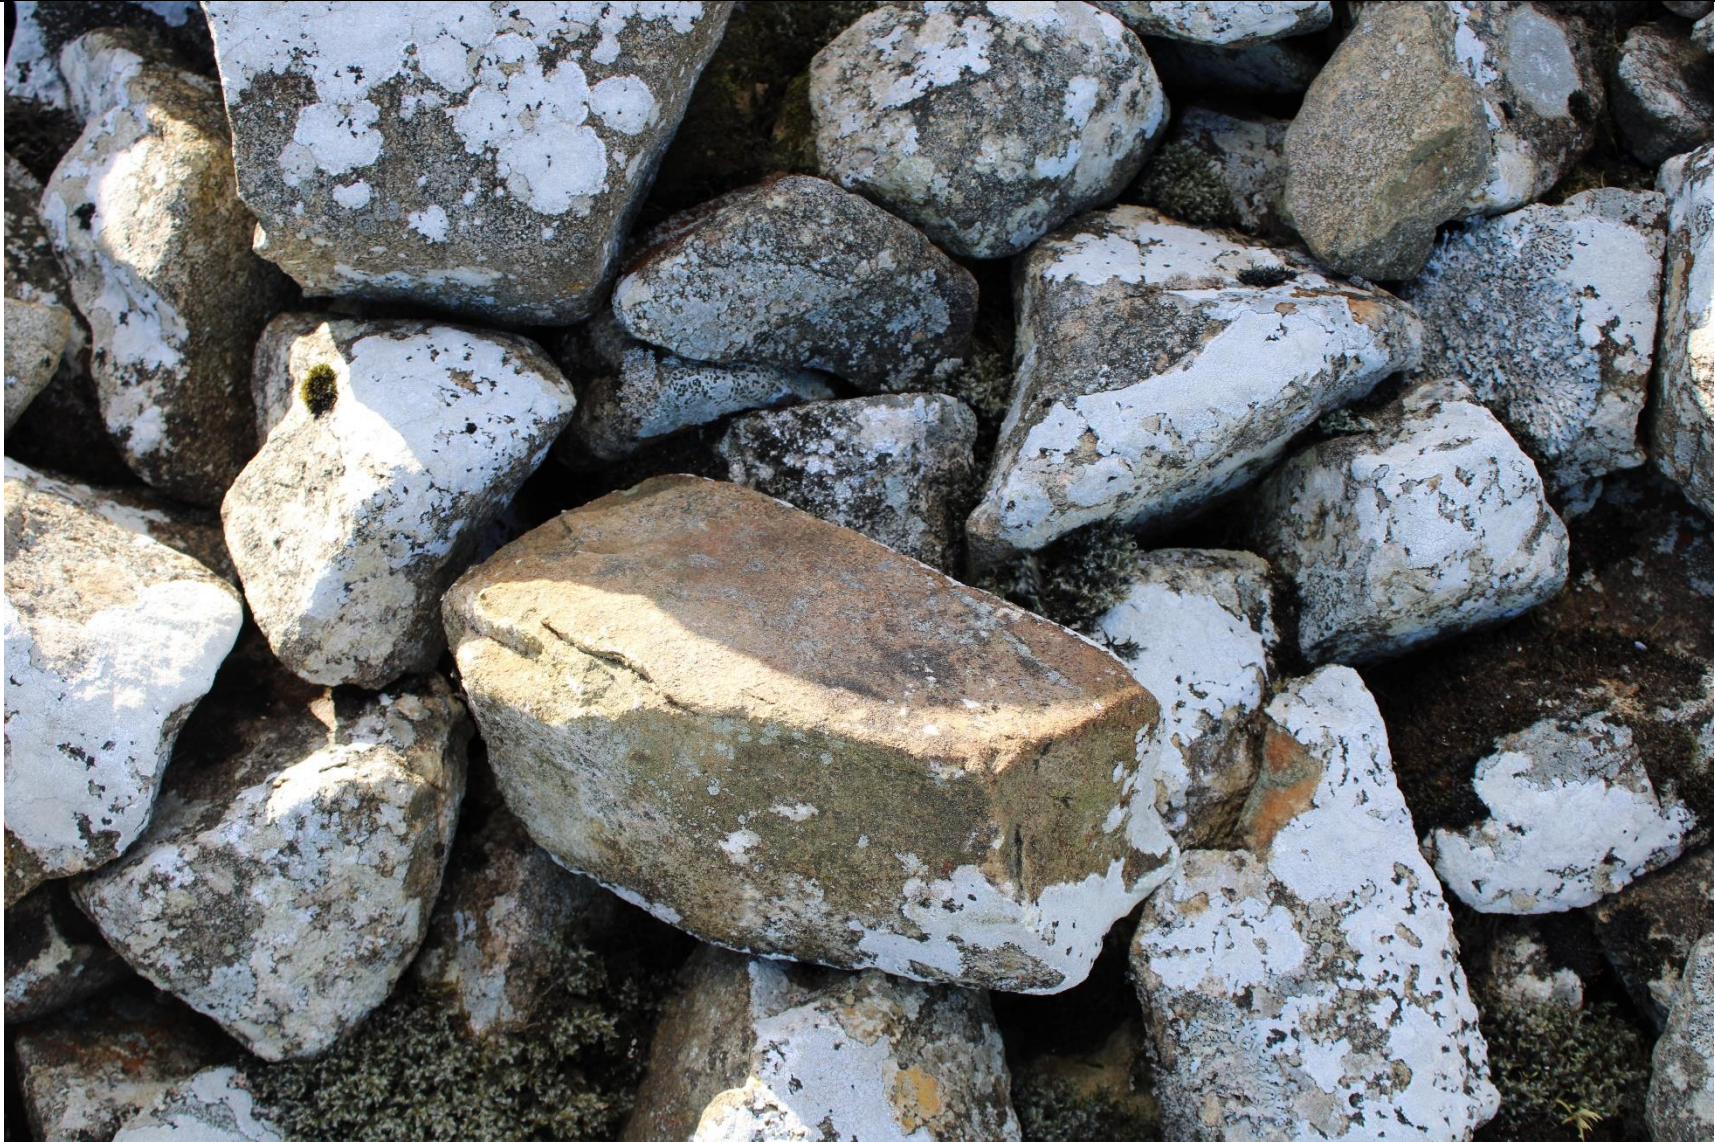
Figure 4. Photo showing example of disturbed stone with lichen facing downwards.

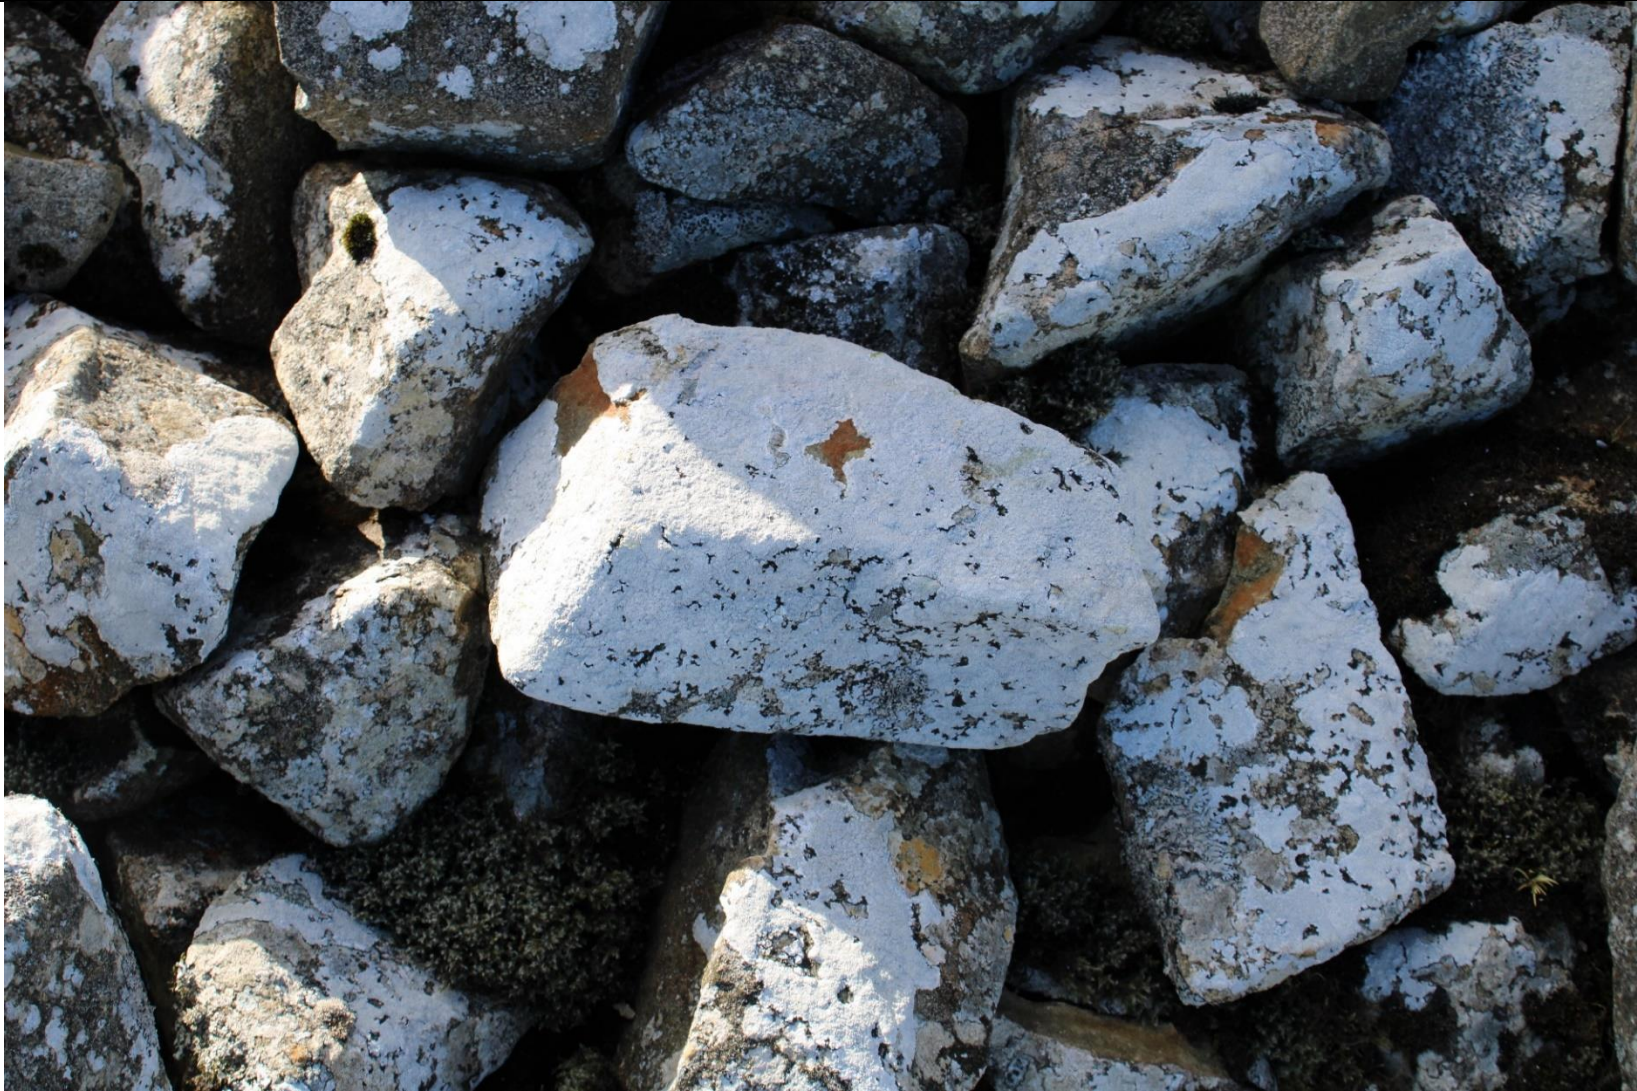
Figure 5. Photo of same disturbed stone in figure 4 turned over so that lichen is correctly facing the sky.
