# **New House, Church Row, Redwick, Newport, NP26 3DE, 17/0610**

## **Archaeological Watching Brief**

Prepared for  
**Mr Christian Rogers**  
of  
**New House, Church Row,  
Redwick, Newport NP26 3DE**

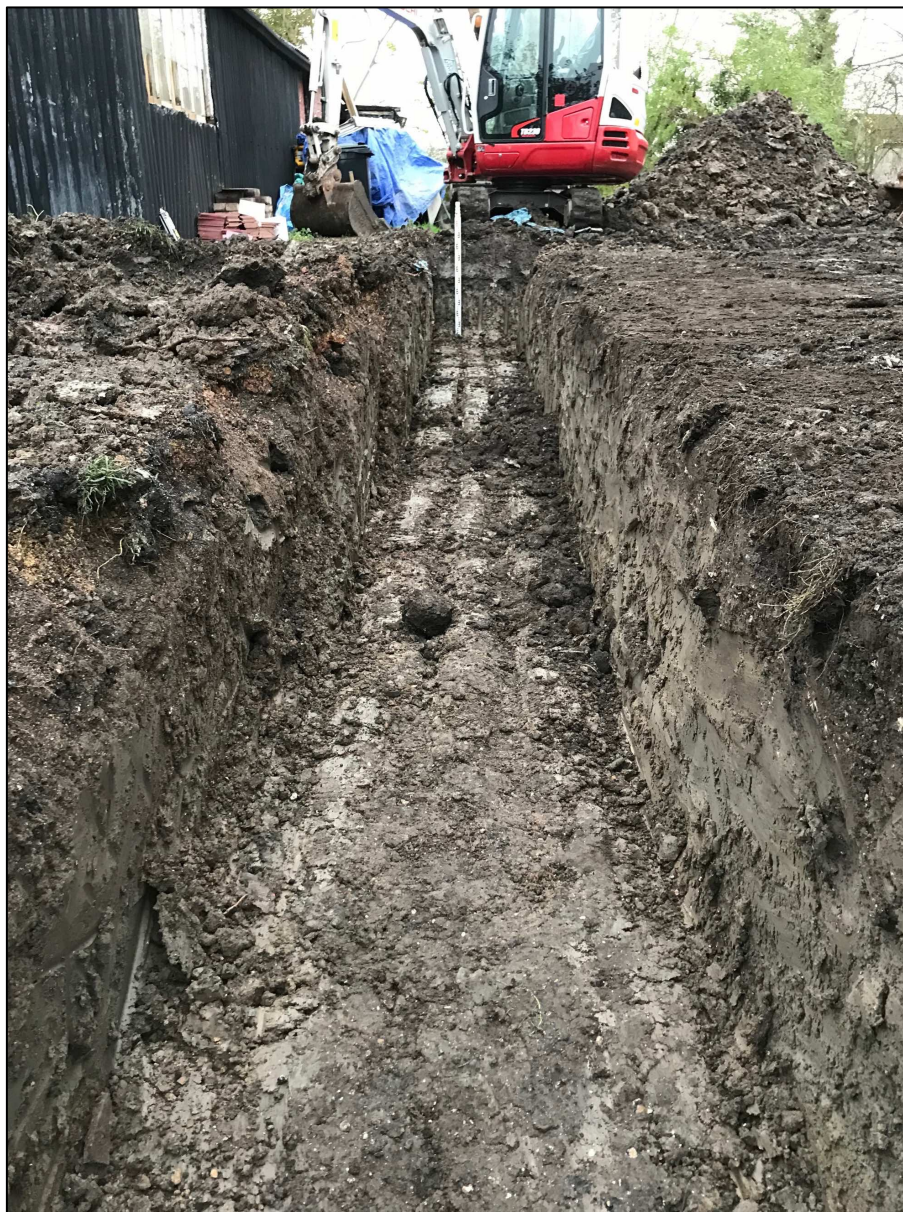
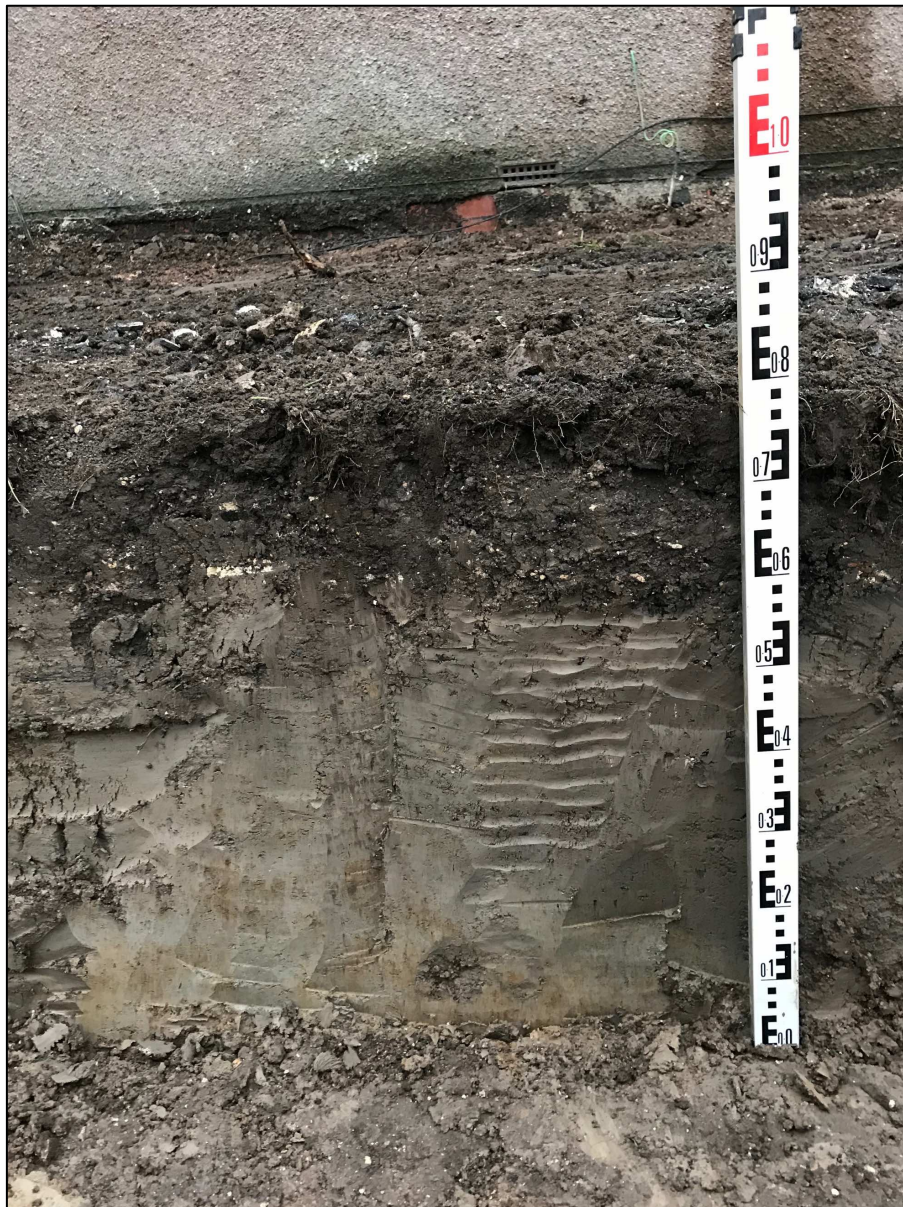
- 3.1.5 Section A (Plates 1 and 2) was 1m in width and 0.85m in depth. The basal layer (A02) was a mid-brown clay with orange mottling, with infrequent charcoal flecks from bioturbation, forming part of the Upper Wentlooge formation. The overlying topsoil (A01) was a very mixed dark-brown sandy clay loam topsoil containing frequent fragments of mortar, brick, coal and modern ceramics.

Plate 1. Side (NE) footings, view SE. Scale 1m in 0.05m sections.

Plate 2. Side (NE) footings, view SW of Section A. Scale 1m in 0.05m sections.

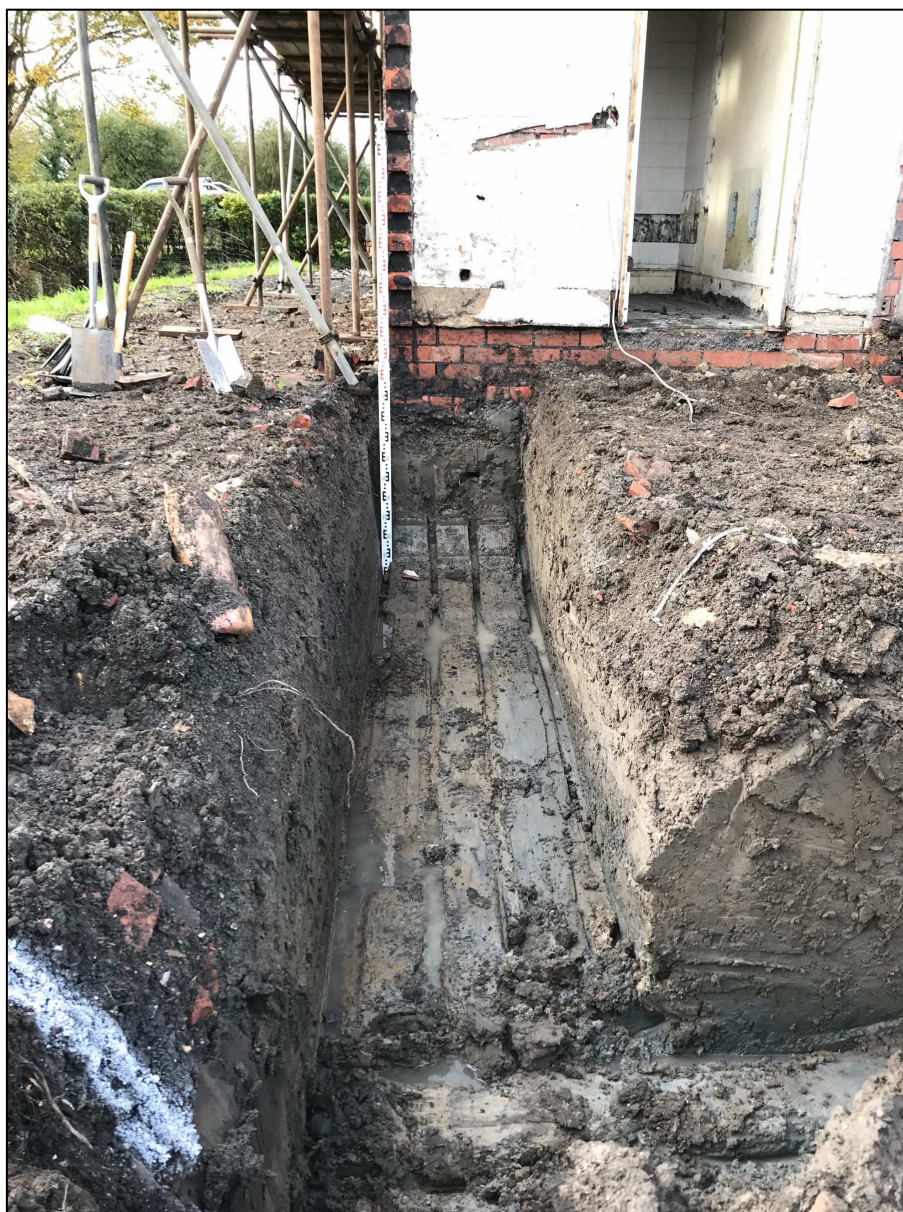
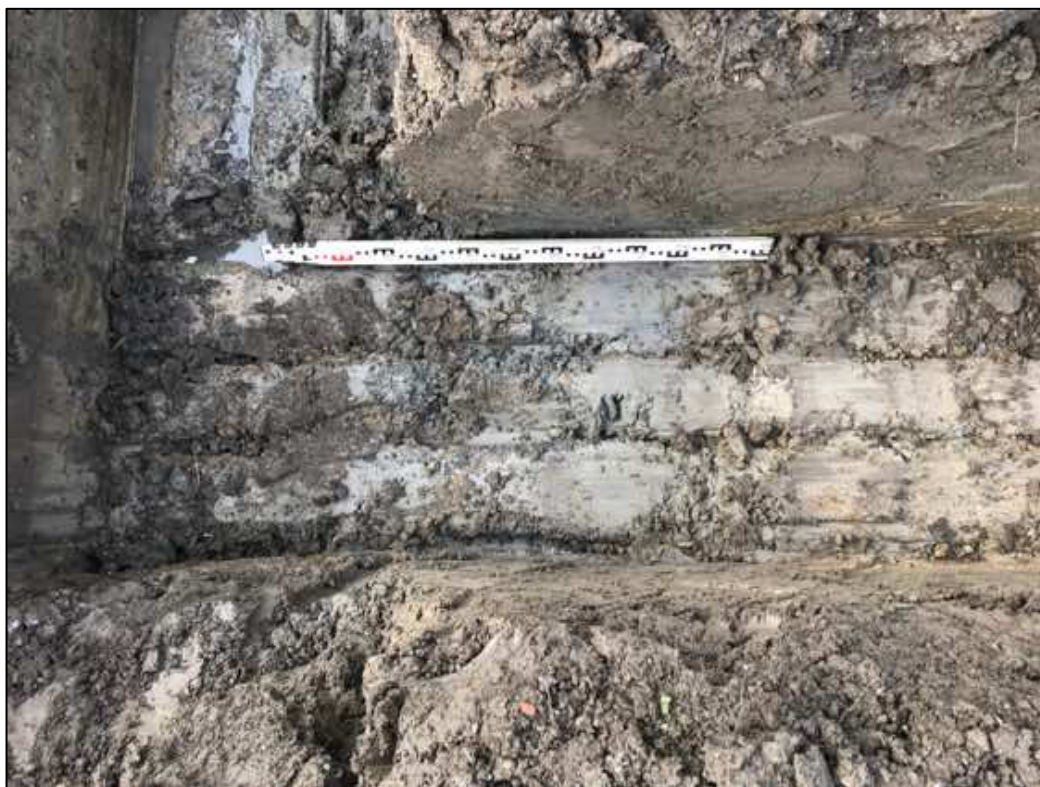
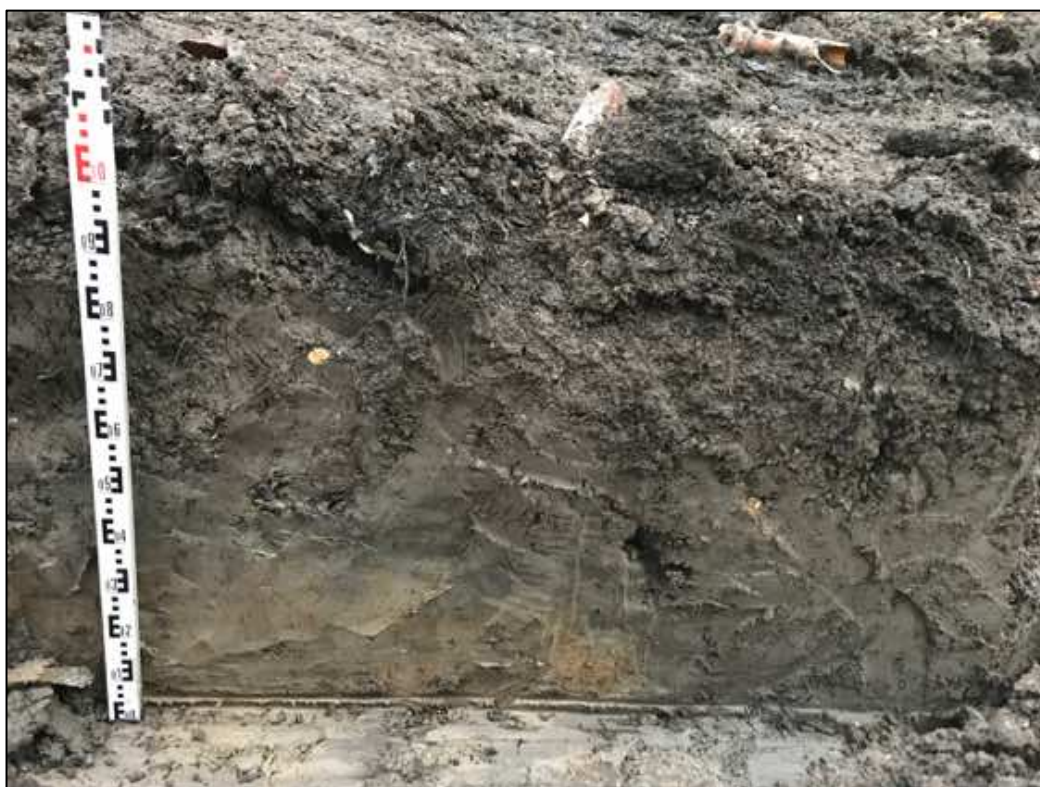
- 3.1.7 Section B (Plates 3-5) was 1.8m wide and partly positioned over palaeochannel B03 and natural clays (Upper Wentlooge Formation). The basal layer in the eastern half of the section was a mid-brown clay of the Upper Wentlooge Formation, with orange mottling and infrequent charcoal flecks from bioturbation (B04). The basal layer in the western half of the section was the upper surface of palaeochannel B03, which overlay or was contained within B04. A fairly mixed grey-brown clay, with frequent quantities of construction/demolition material, overlay both the palaeochannel (B03) and natural clays (B04). The topsoil (B01) was a very disturbed dark-brown sandy clay loam, with frequent fragments of mortar, brick, coal and modern ceramics derived from the recently demolished rear extension.

Plate 3. Rear (SE) footings, view NW of Palaeochannel B03. Scale 2m in 0.05m sections.

Plate 4. Rear (SE) footings, plan view NW of Palaeochannel B03. Scale 1m in 0.05m sections.

Plate 5. Rear (SE) footings, view SE of Section B. Scale 1m in 0.05m sections.

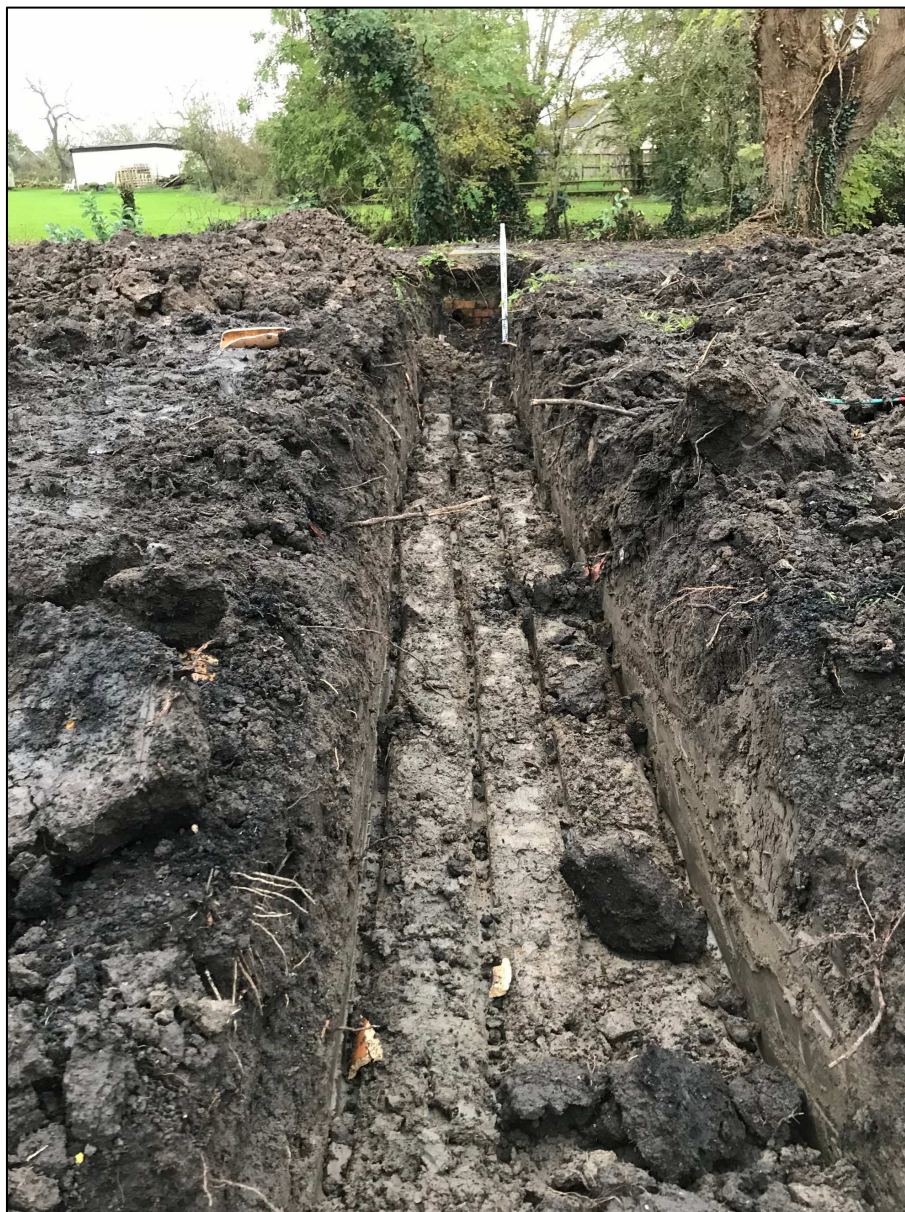
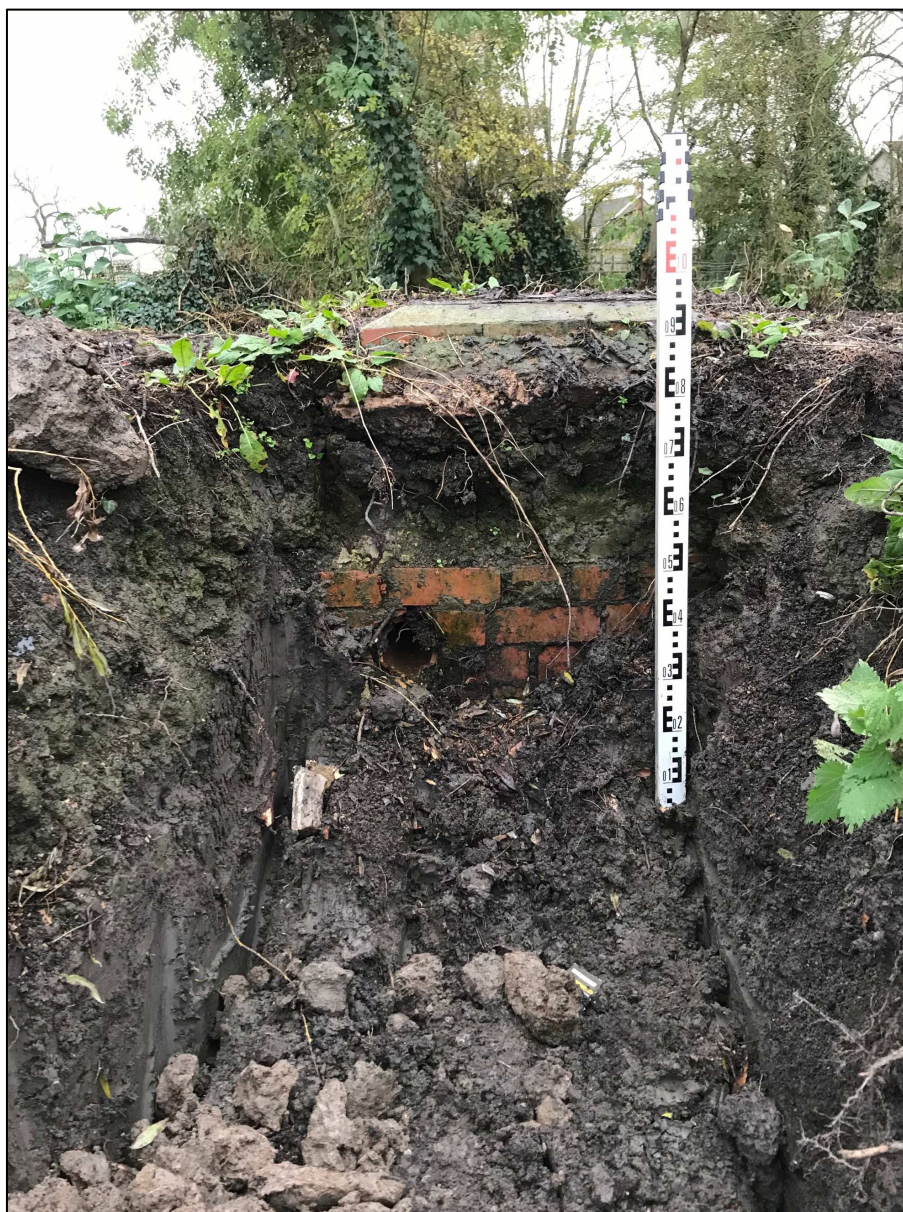
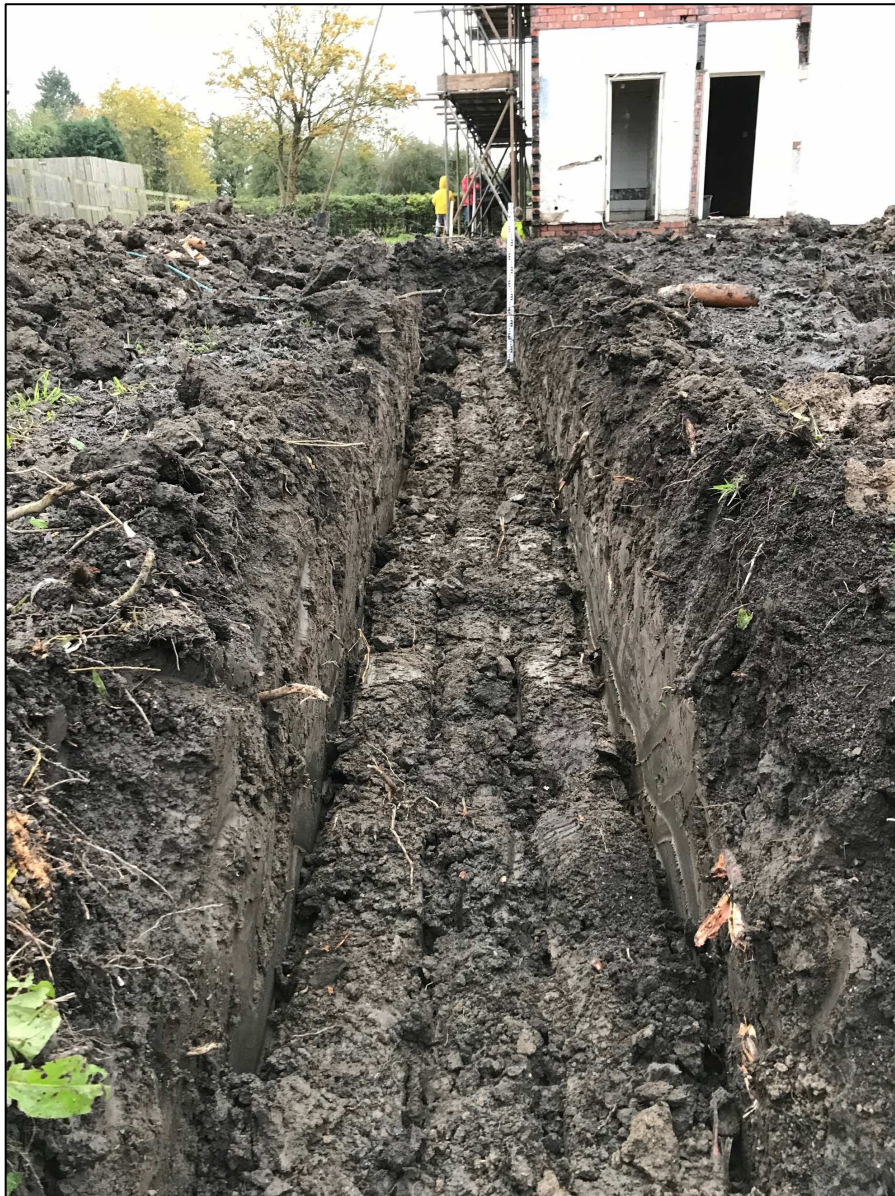
- 3.1.8 An existing foul drainage (Plates 6-8) pipe was re-excavated around 10m SE from the house to a brick-built manhole (D04). The trench was 0.9m wide and averaged 1m in depth. The basal layer encountered was a mid-brown clay with orange mottling, part of the Upper Wentlooge Formation (D03). This was overlain by a grey-brown clay (D02) subsoil and sandy clay-loam topsoil (D01). The manhole (D04) was almost entirely buried but the excavation revealed at least four courses of Flemish-style brickwork and a 150mm foul pile.

Plate 6. Foul drainage re excavation, rear garden, view SE. Scale 1m in 0.05m sections.

Plate 7. Foul drainage re excavation to brick manhole D04, rear garden, view SE. Scale 1m in 0.05m sections.

Plate 8. Foul drainage re excavation, rear garden, view NW. Scale 1m in 0.05m sections.

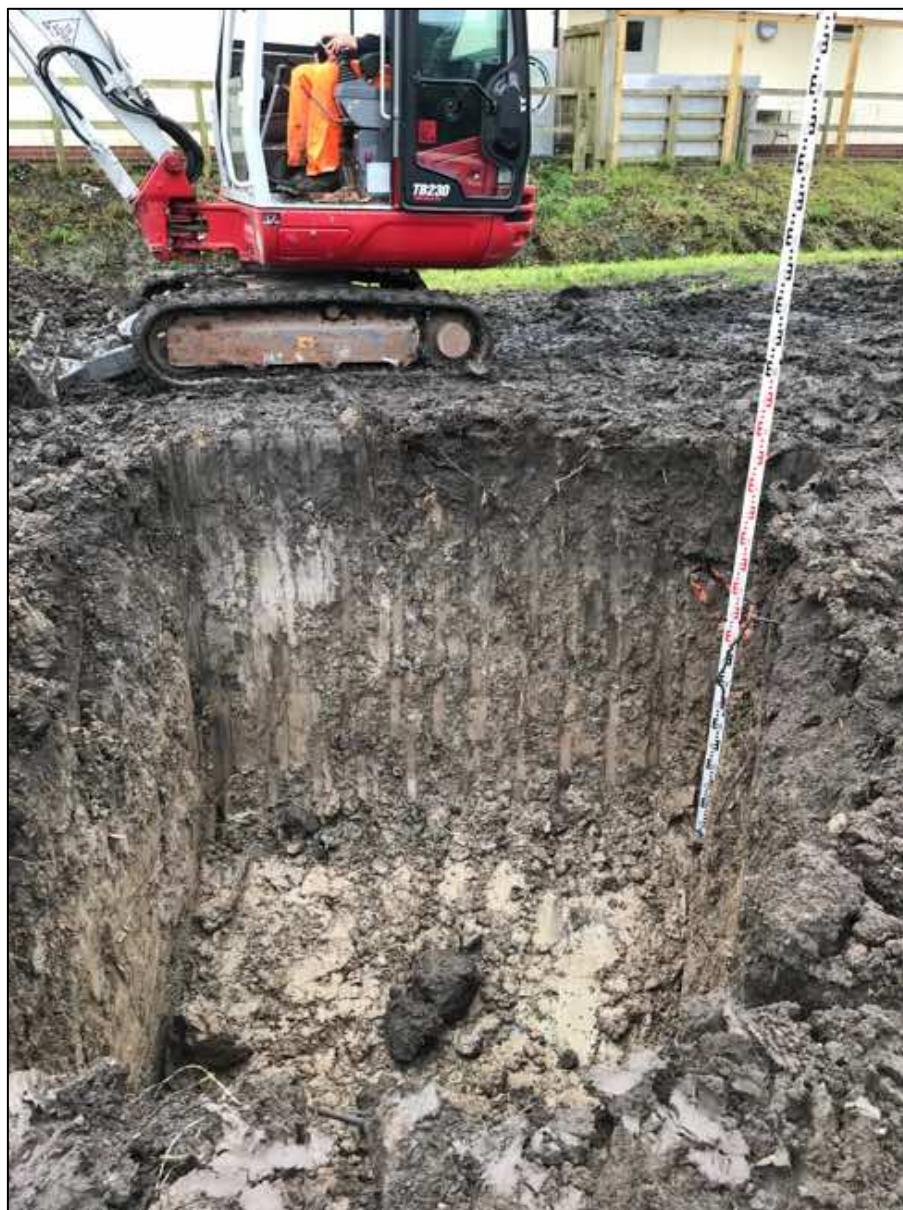
- 3.1.9 **Sump 1** (Figures 2)
- 3.1.10 Soakaway drainage Sump 1 (Plate 9) was located in the rear garden, adjacent to the foul drainage trench noted above. Trapezoidal in shape, the excavation was 3.3m x 3m x 1.8m in area and 1.6m in depth. The topsoil was very disturbed by the tracking/driving back and fourth of the excavator and dumper.

- 3.1.11 The basal deposit encountered was a grey-brown alluvial clay of the Upper Wentlooge Formation (S102). Overlying this was a substantial, up to 0.5m in places, depth of dark-brown clay-loam (S101), probably the remains of flower or vegetable beds. It is curious to note that no great depth of topsoil was observed in the adjacent foul drainage trench.

Plate 9. Sump 1, rear garden, view SW. Scale 3m in 0.05m sections.

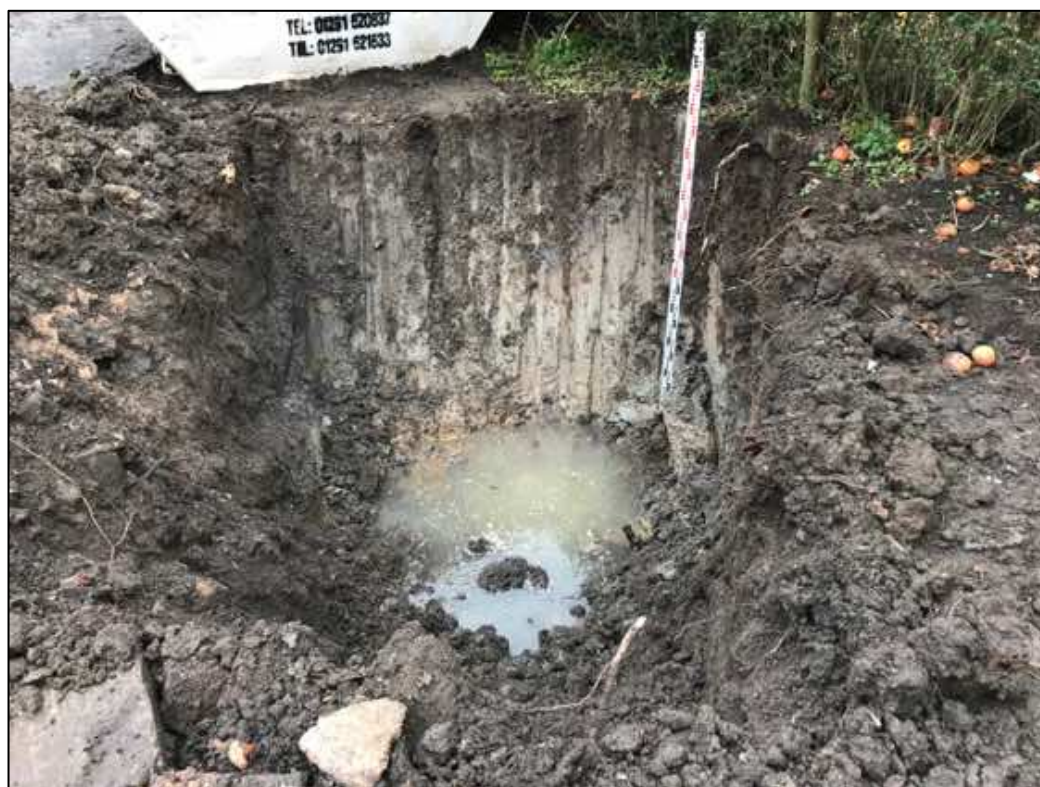
- 3.1.12 **Sump 2** (Figure 2)
- 3.1.13 Soakaway drainage Sump 2 (Plate 10) was located in the front garden between the driveway and northern hedgerow boundary, around 5.6m east off main road. The was trapezoidal in shape, 4.3m x 3.1m x 2.3m in area and 1.6m in depth.

- 3.1.14 The soakaway revealed successive layers of the Upper Wentlooge Formation (S205, S204 and S203) at its lowest extents. These deposits tended to be grey-brown clays with graduating orange (S205) to blue (S203) colouring, typical of the formation. The subsoil was a dark-brown friable clay-loam, which sat directly underneath a modern concrete surface (driveway and pathway).

Plate 10. Sump 2, front garden, view NW. Scale 2m in 0.05m sections.

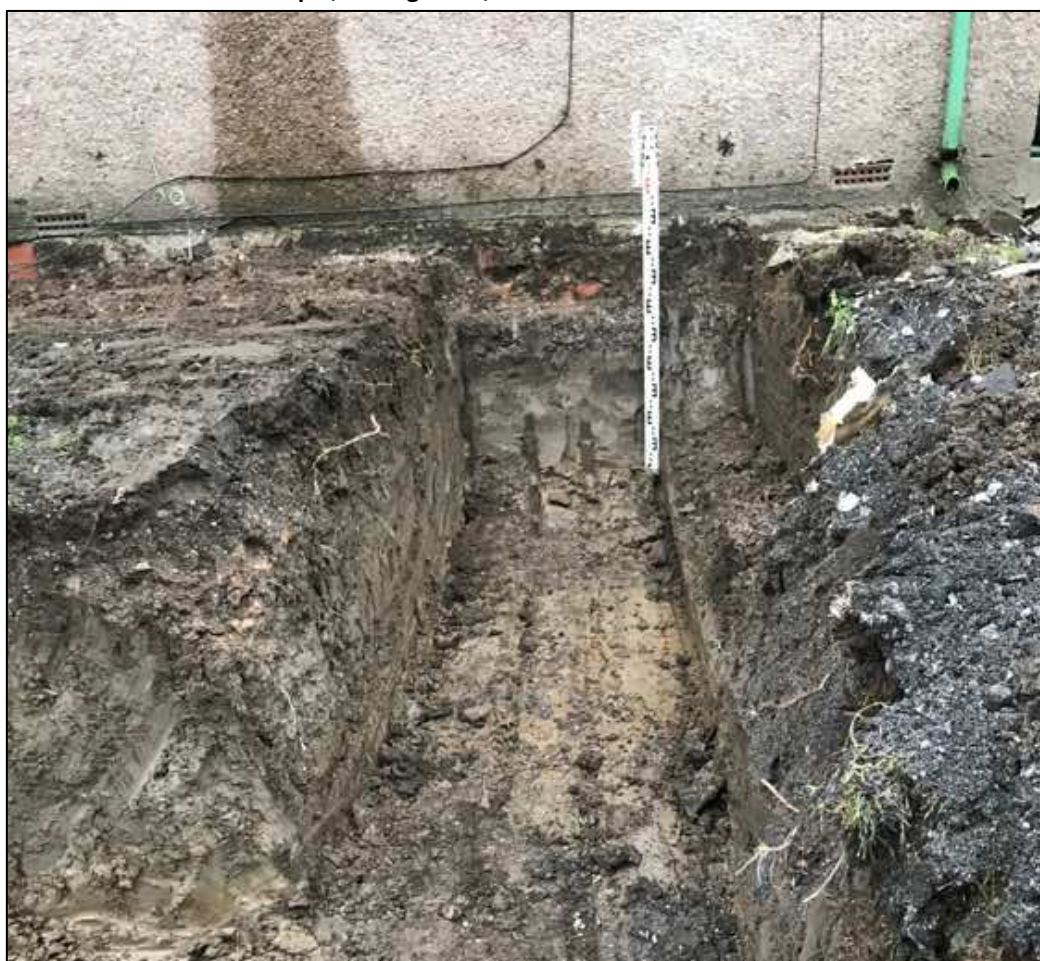
Plate 11. Side (NE) footings excavation, view to SW. Scale 1m in 0.05m sections.

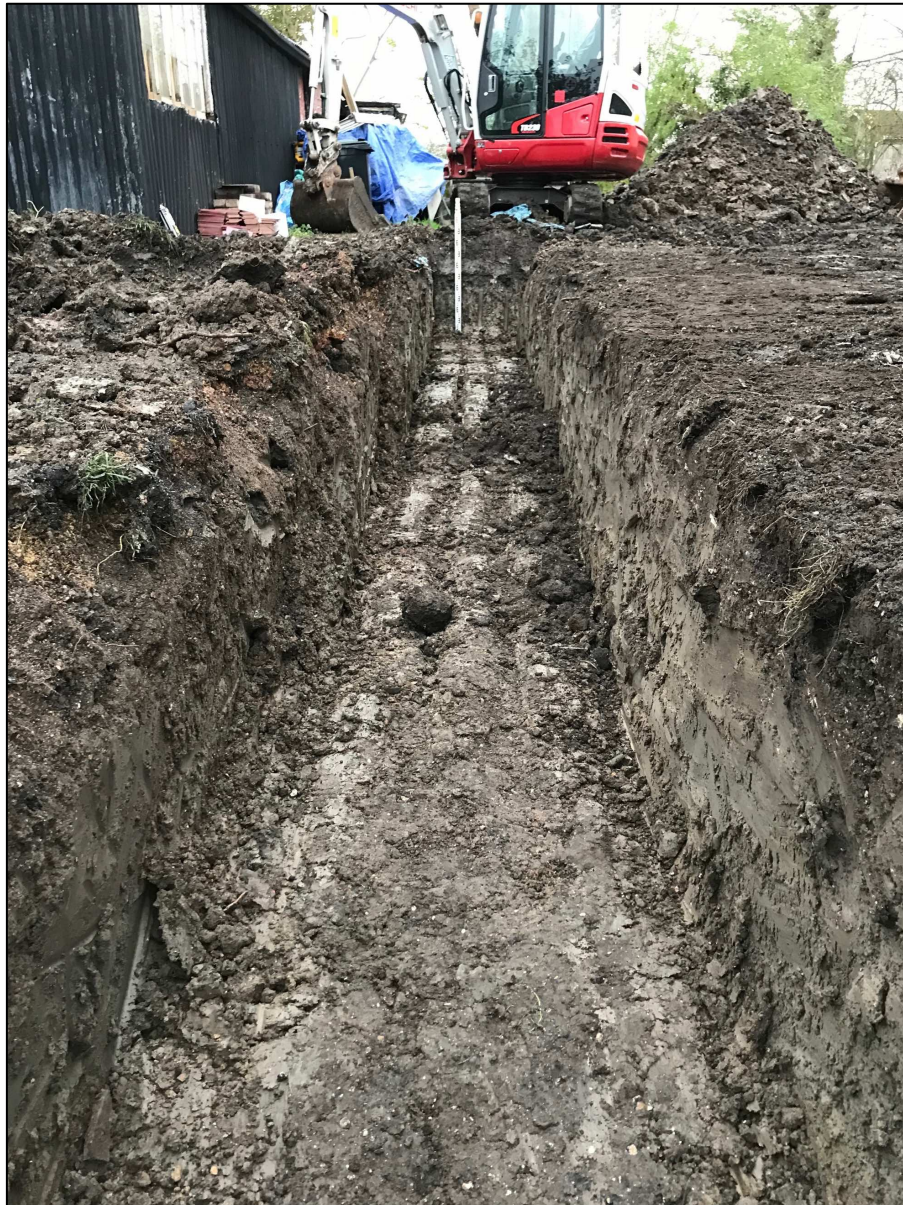
Plate 12. Side (NE) footings excavation, view to SE. Scale 1m in 0.05m sections.

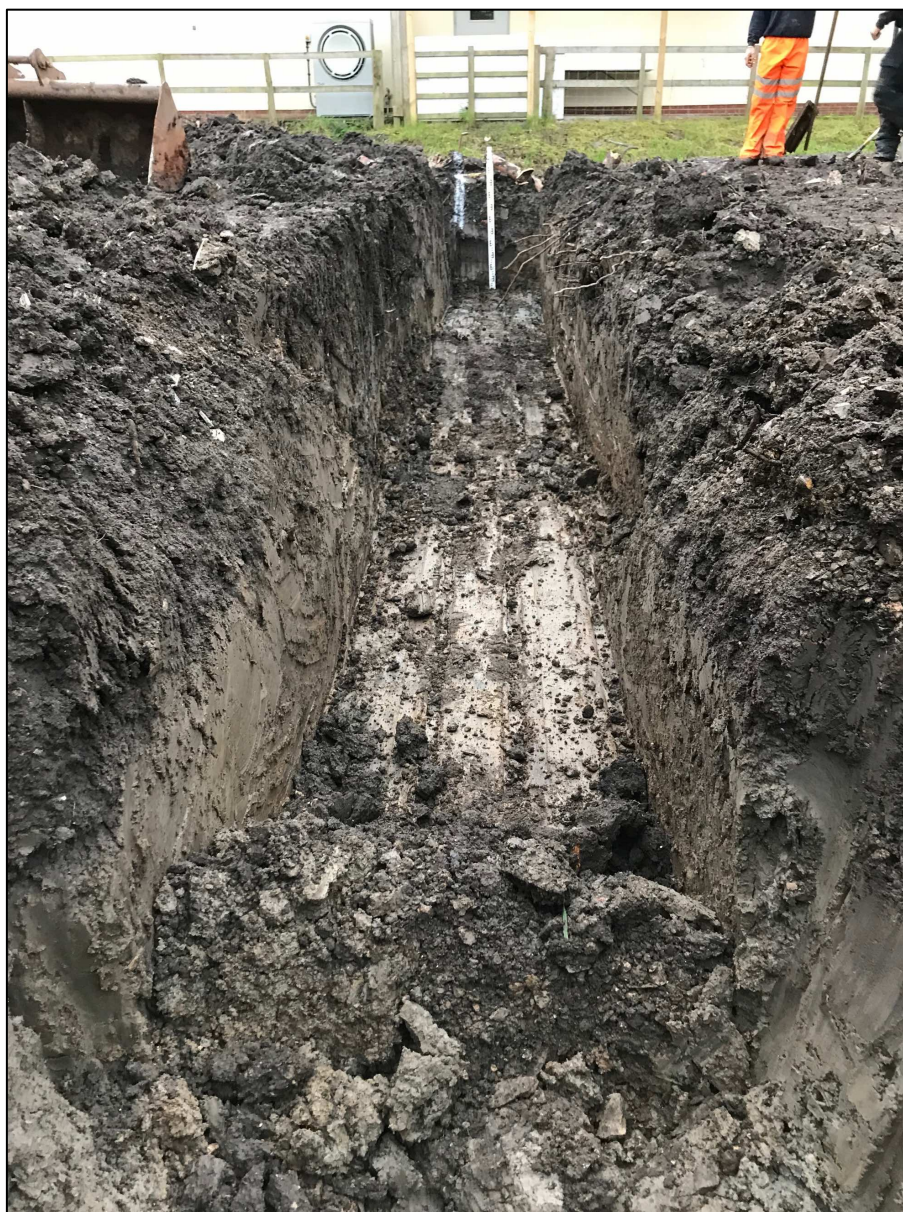
Plate 13. Rear (SW) footings excavation, view to SW. Scale 1m in 0.05m sections.
