**DEMOLITION OF BRADLEY COURT RETAINING 11 PARK PLACE, REDEVELOPMENT AND CHANGE OF USE TO STUDENT ACCOMMODATION, STUDIOS AND COMMUNAL SPACES TOGETHER WITH GROUND FLOOR RESTAURANT AT BRADLEY COURT, 11 PARK PLACE, CARDIFF, CF10 3DR
PL/AP 18/02527/MJR**

Archaeological Watching Brief Report

AECOM on behalf of Vita (Cardiff) 1 Limited

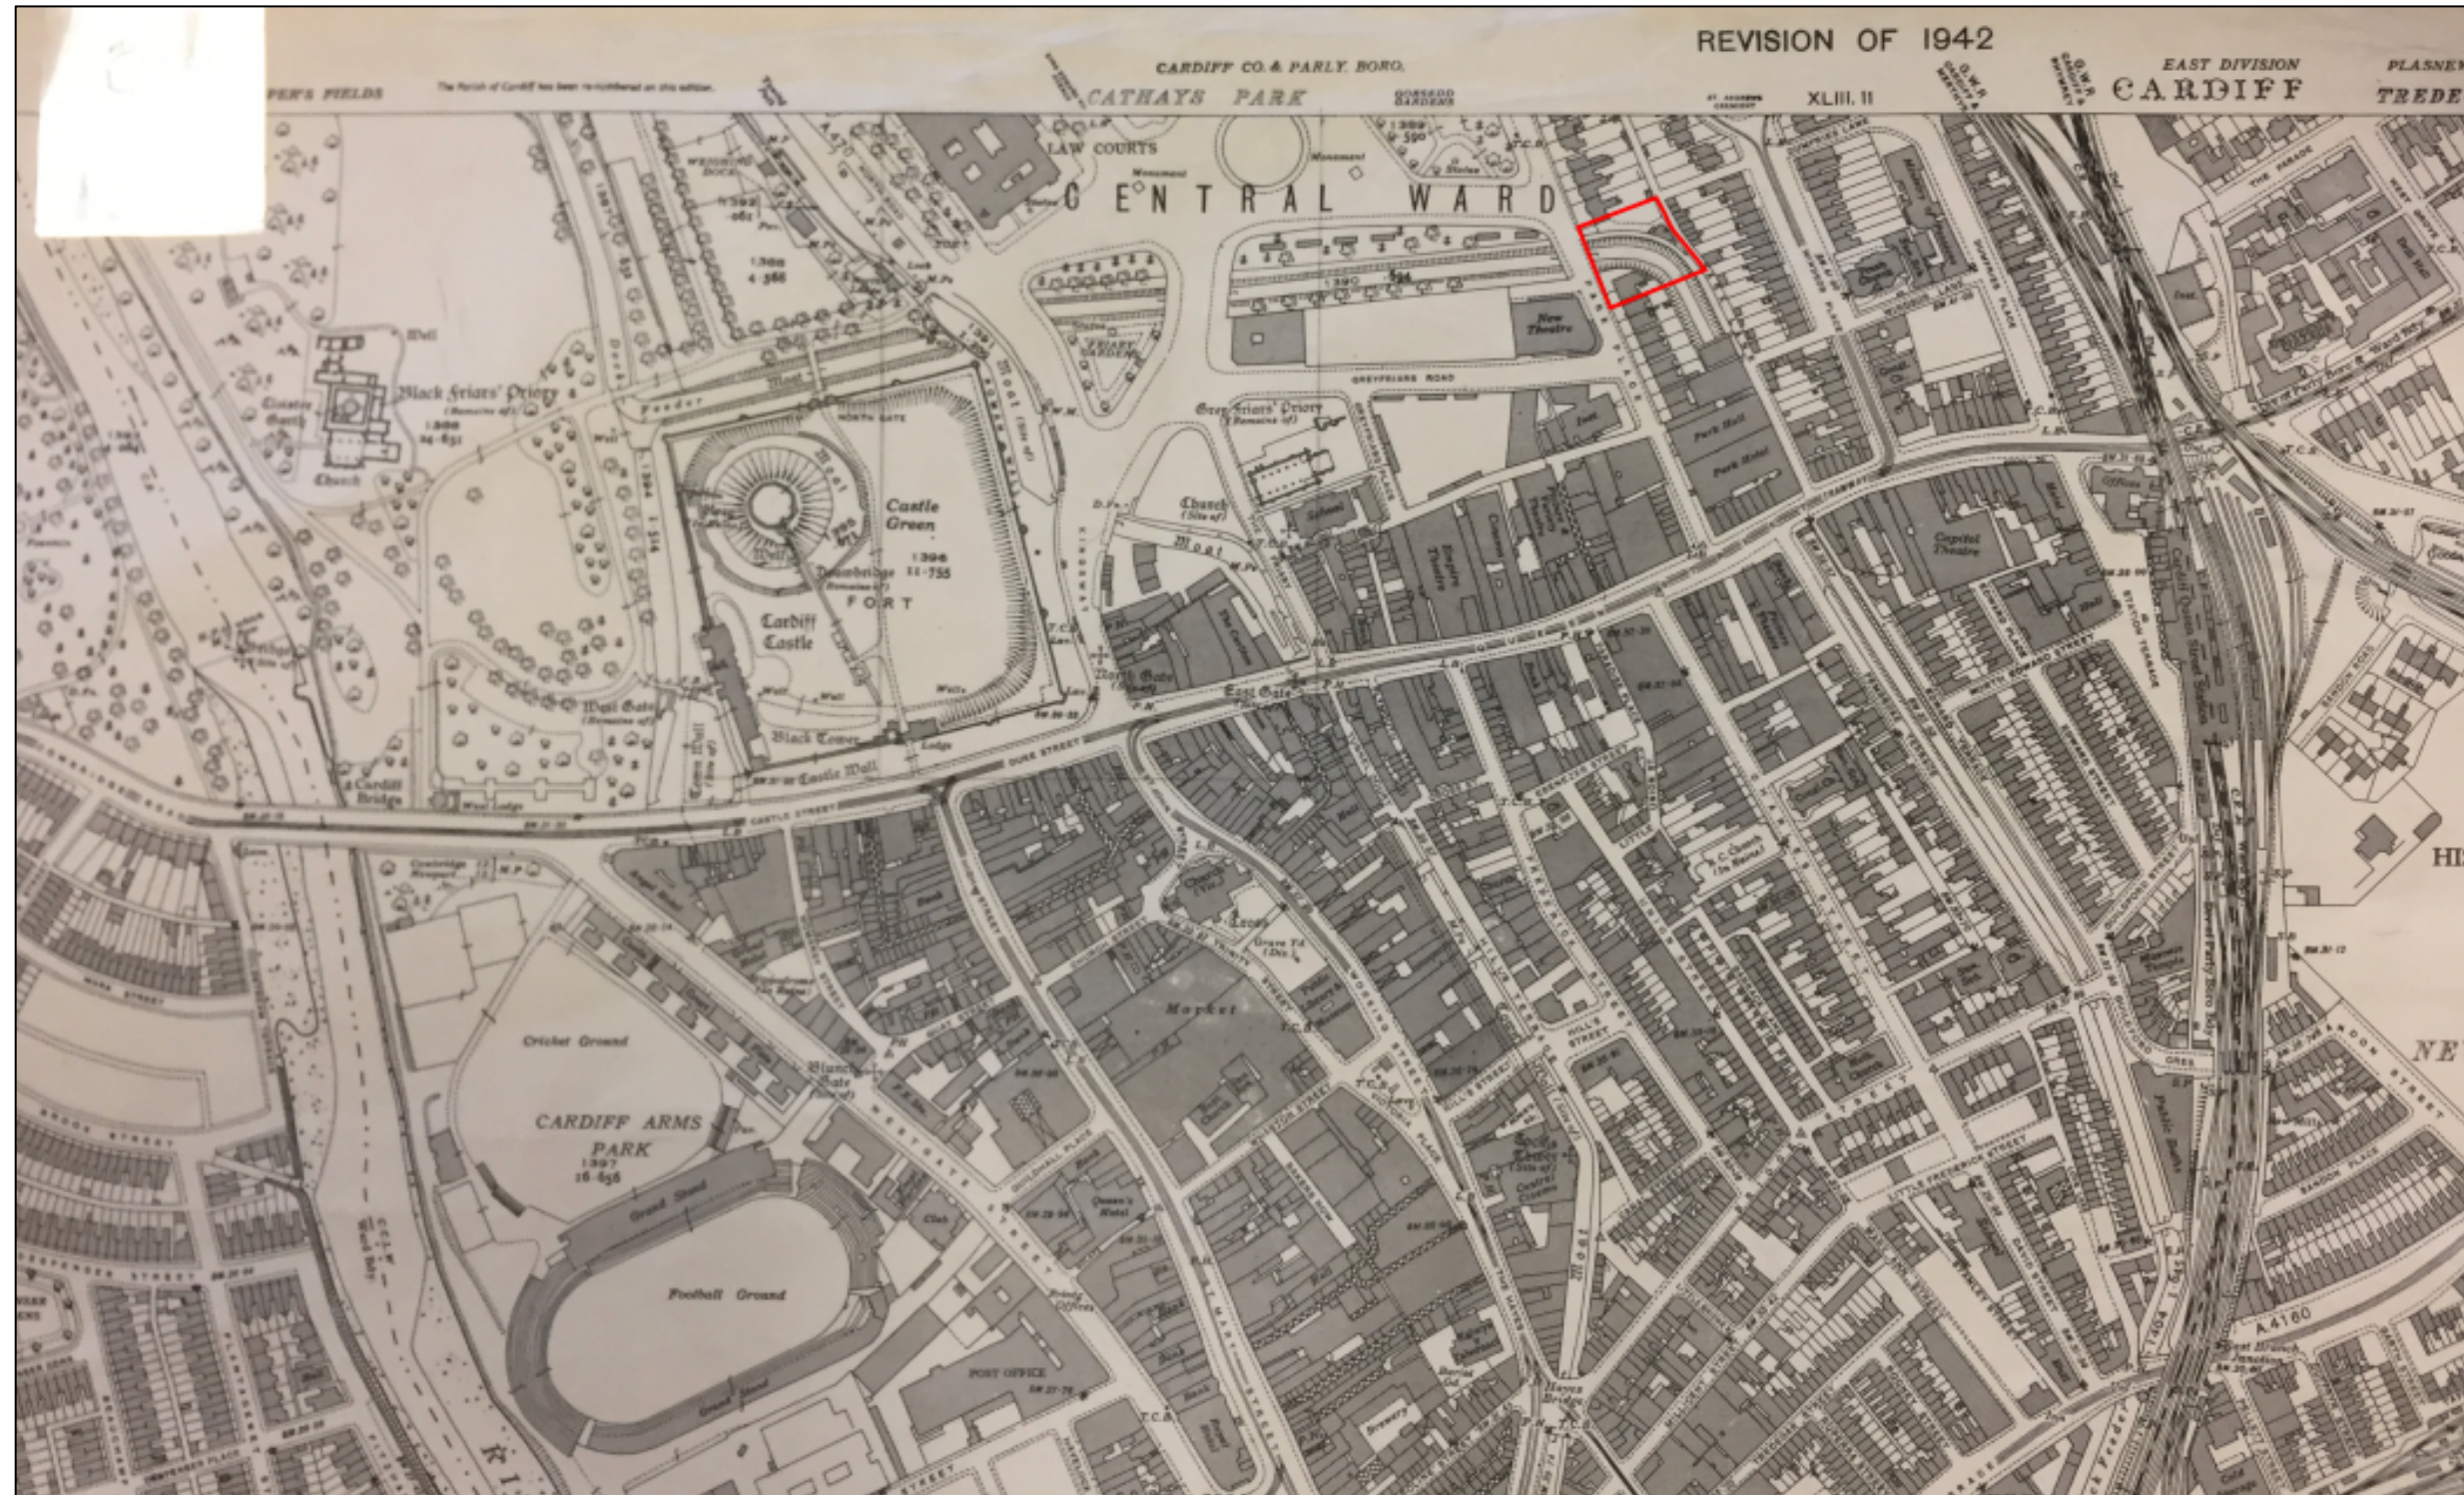
Figure 3. Ordnance Survey (1942) plan showing development area (red) and open Dock Feeder Canal.

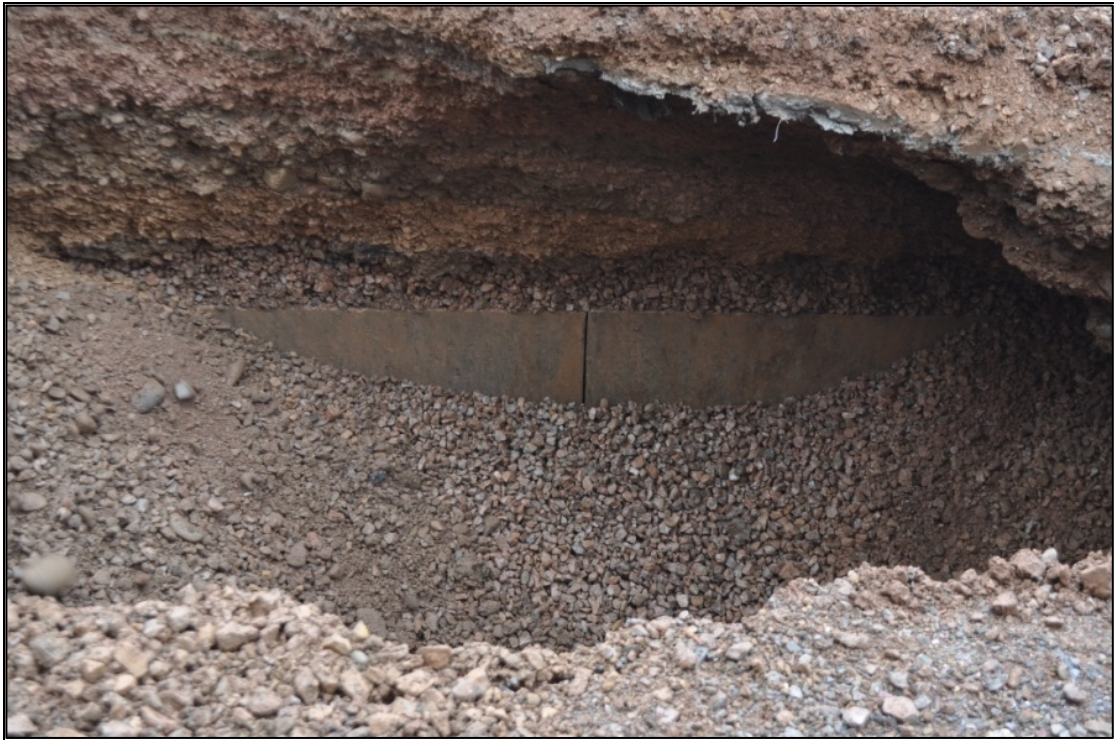
7.2.1 Trench 1 was aligned east-west and excavated adjacent and parallel to the eastern end of the northern elevation of No. 11, Park Place. The trench (Plate 1) was approximately 4m long by 2m wide and excavated to a depth of 1.8m. Underlying the compressed and levelled rubble surface (101), at a depth of c.0.2m, was a remnant concrete surface (102) with remains of a damp course from the demolished building. Below this was various layers of made-up ground that comprised reddish-brown and grey, sandy, angular limestone gravel mix of levelling material (103) and small, grey, angular limestone gravels (104) which appeared uniform across the northern side of the trench and overlaid the top and southern side of the concrete-encased buried Bute Dock Feeder Canal [105] at a depth of c.1.10m (Plate 1). A tip line or possible cut [106] for the concrete-encased Bute Dock Feeder Canal was observed in the east terminal the trench, within made-up ground. The natural (107) was encountered at a depth of approximately 1.5m and comprised brown, sandy gravel with rounded sandstone cobbles and occasional boulders with occasional red clay pockets. No archaeological features were observed with this trench.

Plate 1 - Trench 1 revealing the southern wall of the encased Bute Feeder Canal [105] (looking north).

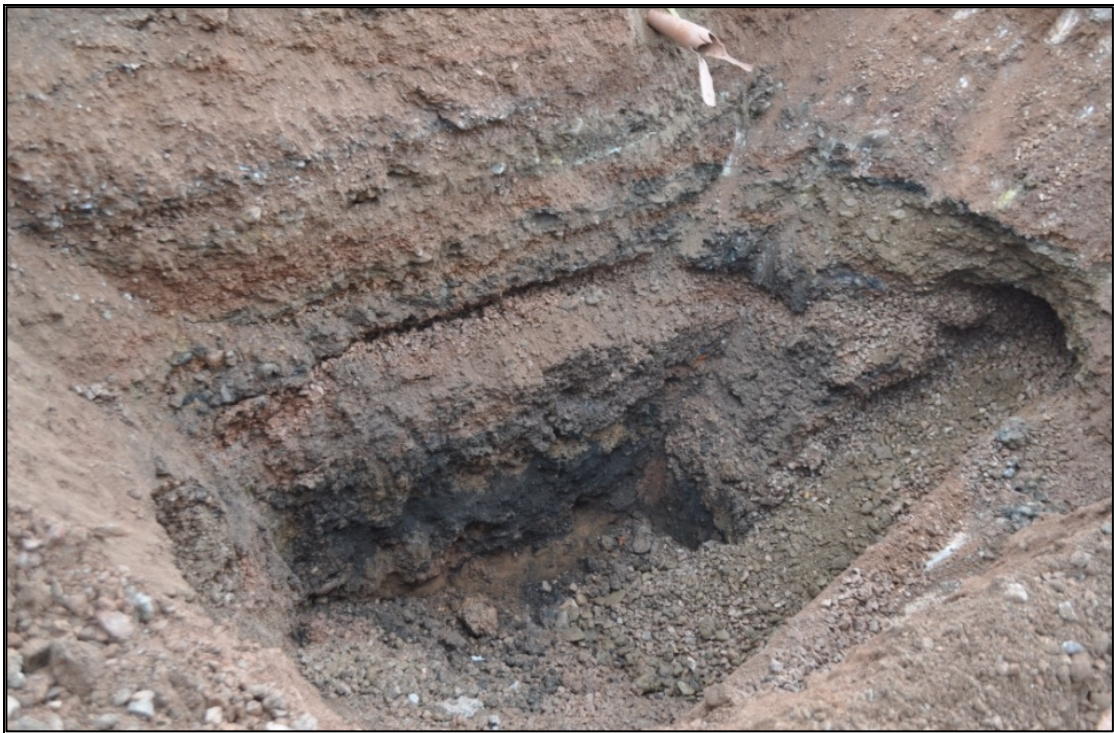
7.3.1 Trench 2 was located to the north of Trench 1 and aligned east-west in order to find the north side of the concrete-encased buried Bute Dock Feeder Canal and its accurate direction across the site. Trench 2 was approximately 7m long by 2m wide and excavated to maximum depth of 2.2m. The upper surface (201) was a 0.3m deep levelled-rubble layer that comprised a grey, slightly clayey sandy gravel with an abundance of fragmented brick, concrete and sandstone (crushed building rubble). Underlying this surface layer was a further 1.5m of made-up ground (202) which comprised a reddish-brown, sandy limestone gravel with bands of small, grey angular limestone gravels (levelling material). In the north section, at the eastern end of the trench and below the levelling material at a depth of c.1.8m was a 0.4m deep by c.3m long spread of dark grey soot/ash and clay mix (203) (Plate 2). This sooty mixture revealed a late 19th century bottle along with occasional sherds of late 19th to early 20th century pottery and a single late 19th to early 20th century brick. A sondage was excavated to ensure that any underlying archaeological potential would not be missed, however, the soot clay layer overlaid a red-clay natural (206). The south section of the trench (Plate 3) revealed the concrete-encased buried Bute Dock Feeder Canal [204] covered with grey, small angular limestone gravels (205) at approximately 1m below the surface and the trench was extended to its 7m length in order to accurately establish its alignment. No archaeological features were observed within this trial trench.

Plate 2 - Trench 2 revealing soot/ash layer (203). (looking north)

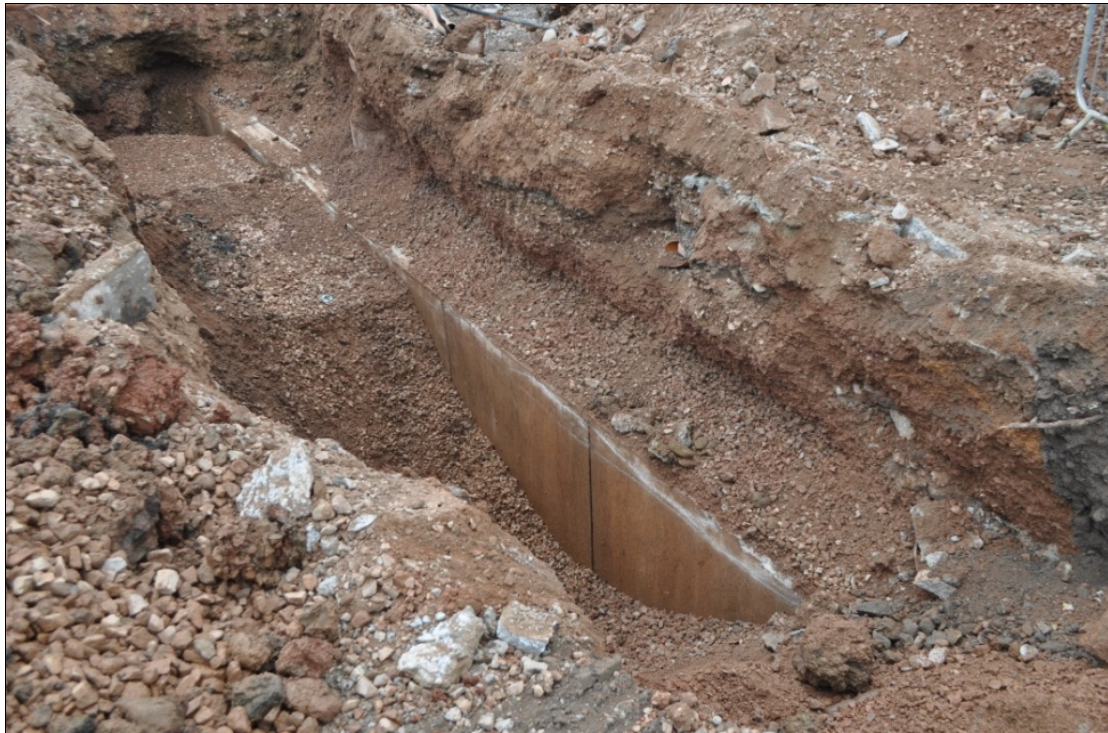
Plate 3 - Trench 2 revealing north wall of the encased Bute Feeder Canal [204]. (looking southeast)

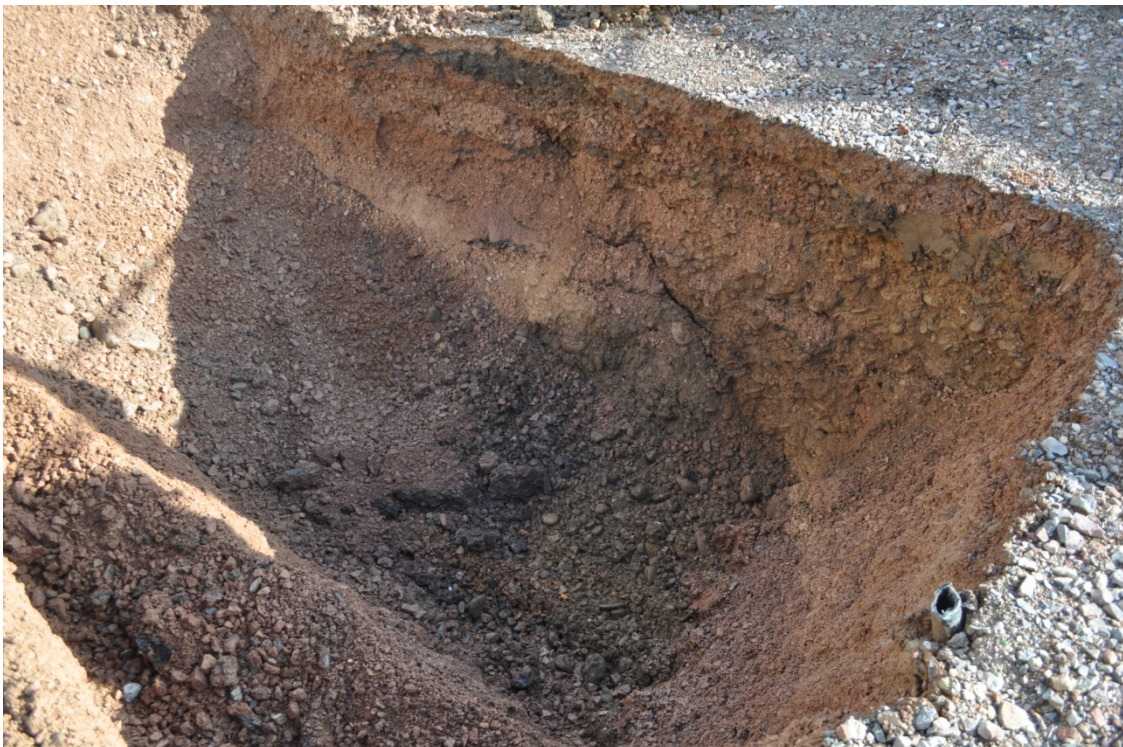
7.4.1 Trench 3 was excavated across the central area of the site and measured approximately 4m by 2m. It was excavated to a depth of 2.2m and aligned east-west. The upper surface layer (301) comprised grey, slightly clayey, sandy gravel with an abundance of fragmented brick, concrete and sandstone (crushed building rubble). This overlaid (302) a further 1.5m of made-up ground that comprised a red-brown, sandy gravel. This overlaid the natural (303) which was encountered at 1.8m and

comprised brown, slightly silty, gravelly sand with rounded sandstones and occasional medium to large cobbles. The trench was bottomed at 2.2m in the natural. No archaeological features were observed within this trial trench.

Plate 4 – Trench 3 showing made ground (302). (looking northwest)

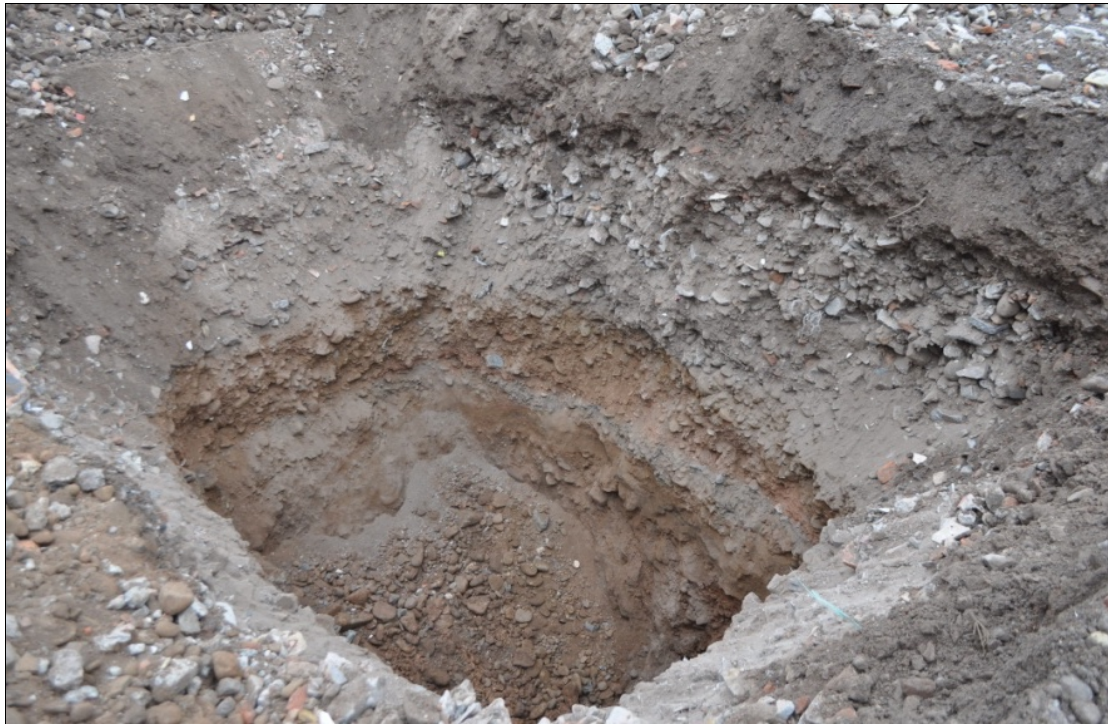
7.5.1 Trench 4 (plate 5) was excavated in the north-eastern of the site and aligned north-south; it measured approximately 3.5m by 2m by 3.5m deep. Two distinct layers of made-up ground were observed: from the surface to a depth of 1.20m was a mixed grey sandy, gravel of crushed concrete and brick building rubble (401). This overlaid another 1.4m of made-up ground (402) that comprised brown, slightly silty, sandy gravel with rounded sandstone and occasional medium to large cobbles. The natural (403) was encountered at 2.30m and excavated to a depth of 2.6m. No archaeological features were observed within this trial trench.

Plate 5 – Trench 4 showing made ground 402 and natural gravels (404). (looking southwest)

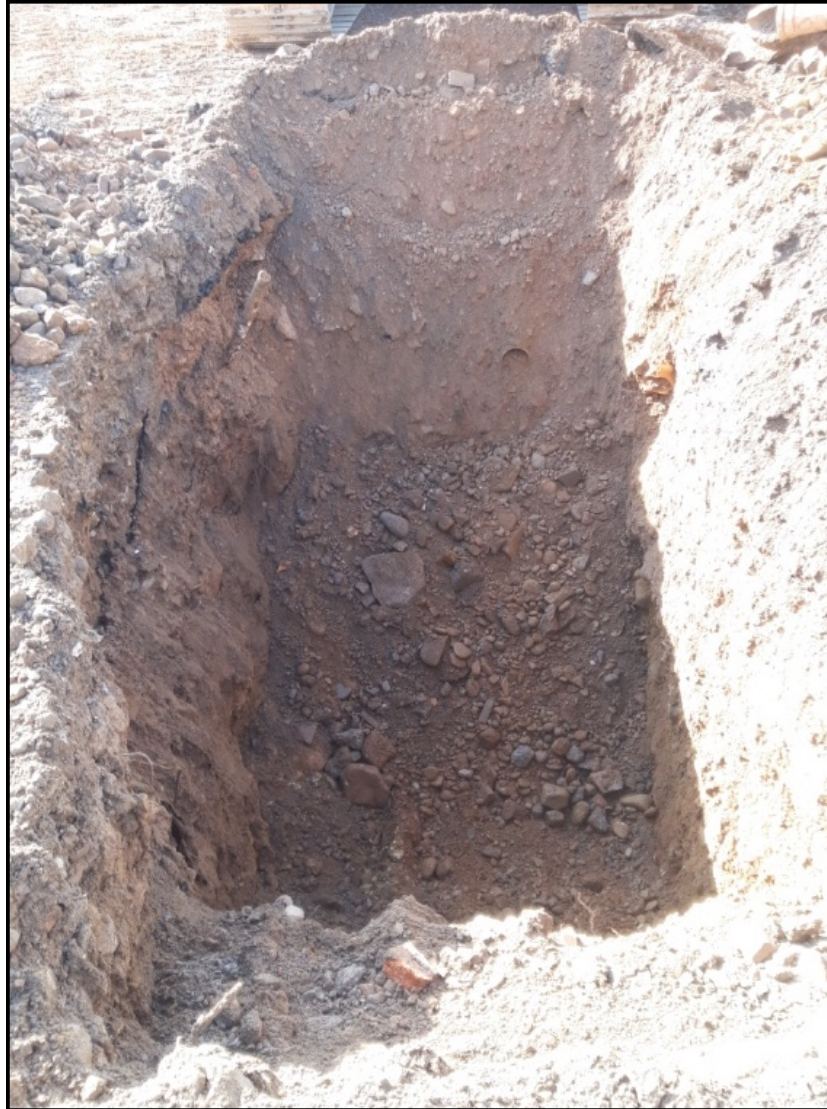
7.6.1 Trench 5 (Plate 6) was excavated to the north of Trench 4 in the northeast corner of the site and aligned north-south. The trench was 3.5m long by 2m wide by 3.5m deep. From the surface there was observed a consistent mix of made-up ground (501) consisting of grey to brown sandy gravel, crushed concrete and sandstone fragments with an abundance of building rubble to depth of 1.10m. Underlying layer (501) was a brown, silty sandy mix with rounded sandstones and occasional cobbles (502). Occasional/rare pieces of plastic were observed throughout this layer. The natural (503) was revealed at 2.10m, comprising a reddish-brown, slightly silty, sandy gravel and cobbles of rounded sandstone with occasional boulders. No archaeological features were observed within this trial trench.

Plate 6 –Trench 5 showing made ground 502. (looking south)

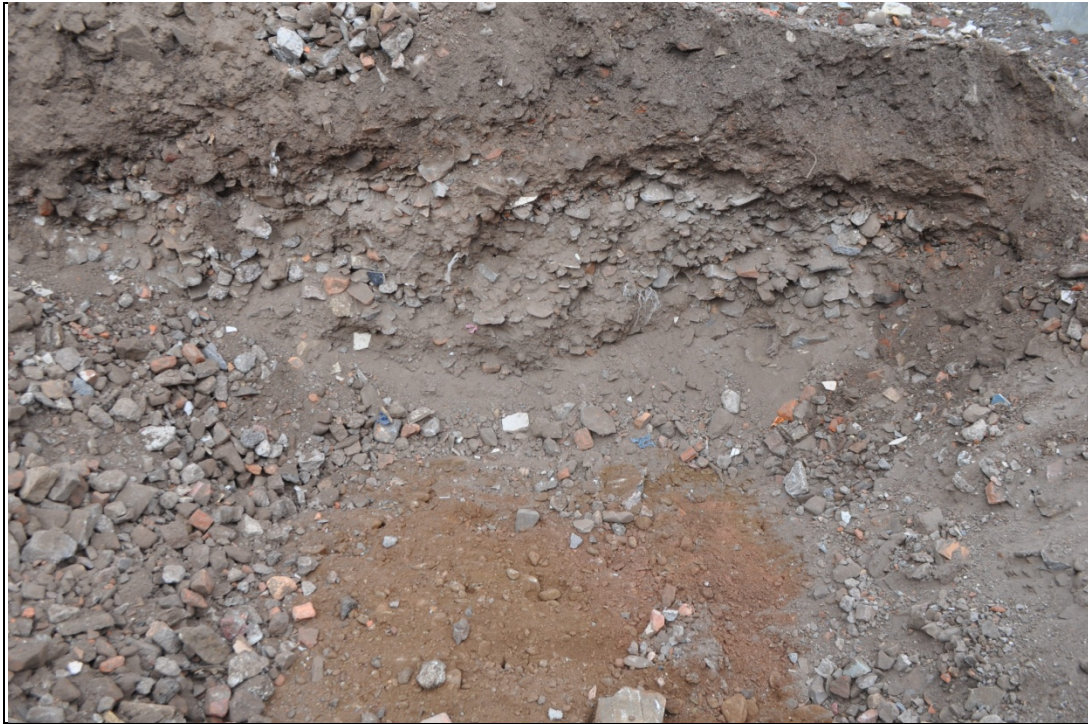
7.6.2 Trench 6 (Plate 7) was excavated to the west of Trench 5 and aligned north-south. The trench was 3.5m long by 2m wide by 3.3m deep. From the remnant tarmac surface (601), there was observed a consistent mix of made-up ground (602) consisting of grey to brown sandy gravel and sandstone fragments, cobbles and an abundance of building rubble (brick, concrete, metal conduit, plastic piping and cables) to depth of 2.4m. Underlying layer (602) was the natural (603), comprising a reddish-brown, slightly silty, sandy gravel and cobbles of rounded sandstone with occasional boulders. No archaeological features were observed within this trial trench.

Plate 7 –Trench 6 showing made ground 602. (looking south)
