Proposed Caravan Park, Glanusk Park, Crickhowell, NP8 1LP

Archaeological Watching Brief

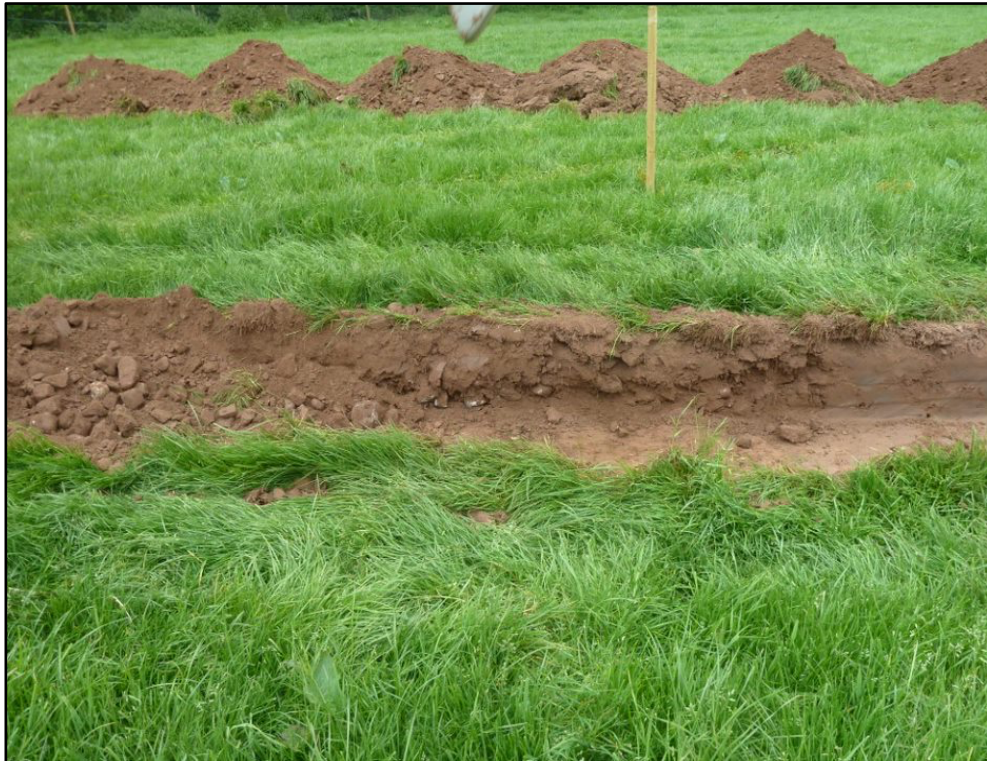
Plate 3. Cut for new trackway revealing the location of a former field boundary (view N)

- 3.1.4 During the excavation of the vehicular access track, a 19th century field boundary (107) (that had fallen out of use and been removed) was uncovered (Plates 3 and 4). The former 19th century field boundary (107) was aligned north/south and is revealed on the 1847 Llangattock Tithe Map. The feature was defined by two shallow linear spreads of small rounded stones (c0.7m between each spread) combined with some relatively modern brick fragments and one complete brick. No further archaeological features or artifacts were revealed.

- 3.1.5 The stratigraphy revealed in the trackway trenches (Plate 3) appeared uniform along the full length of each trench, with occasional concentrations of gravel noticeable in plan. The natural basal layer (103) was a mid-brown silty clay matrix with abundant small to medium rounded cobbles this. It was overlaid by a 0.2m deep modern light-brown silt loam plough soil (102) with frequent small rounded stone inclusions (same as 105). The topsoil (101) was 0.1m deep mid-brown silt loam topsoil with heavy bioturbation. The only artifacts observed during the excavation of these trenches were occasional/rare fragments of modern ceramics and ferrous objects (mainly modern bullet and shotgun cartridges).

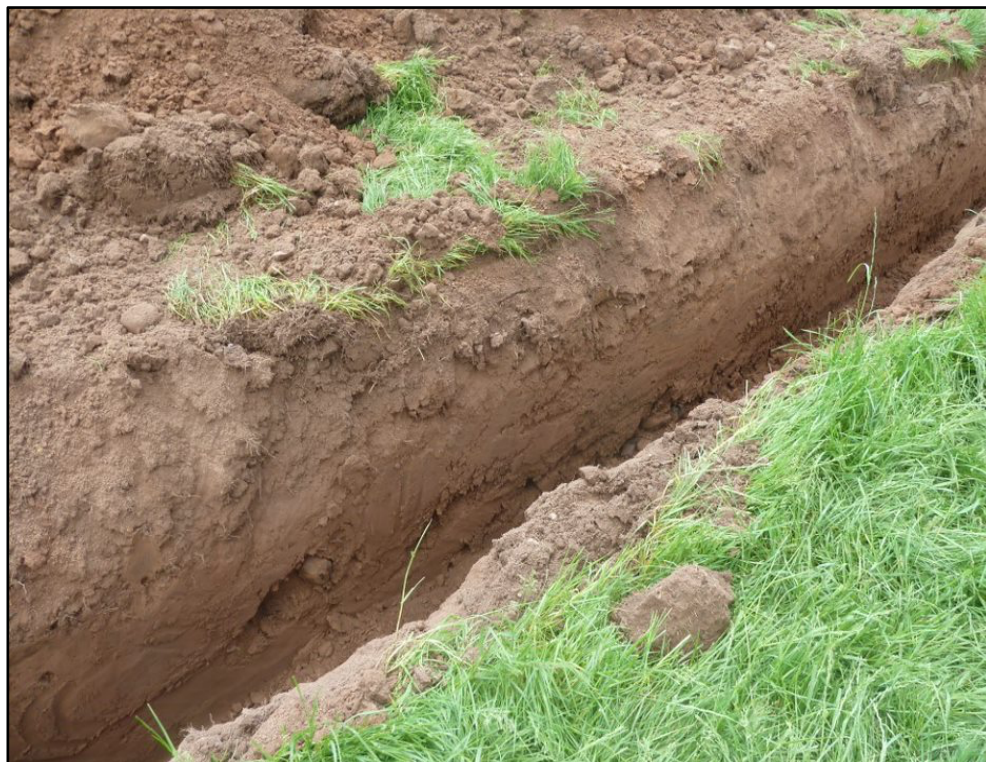
Plate 5. Section of the service trench (view SW)

- 3.1.6 The service trench was excavated using a 0.5m ditching bucket cutting to a uniform depth of 1m (Plates 5 and 6). The natural basal layer (106) was a mid-brown silty clay matrix with abundant small to medium rounded cobbles. Between this and the 0.1m deep mid-brown silt loam topsoil with heavy bioturbation (104) was a 0.2-0.3m layer of dark brown silty loam (105) with frequent small rounded stone inclusions.

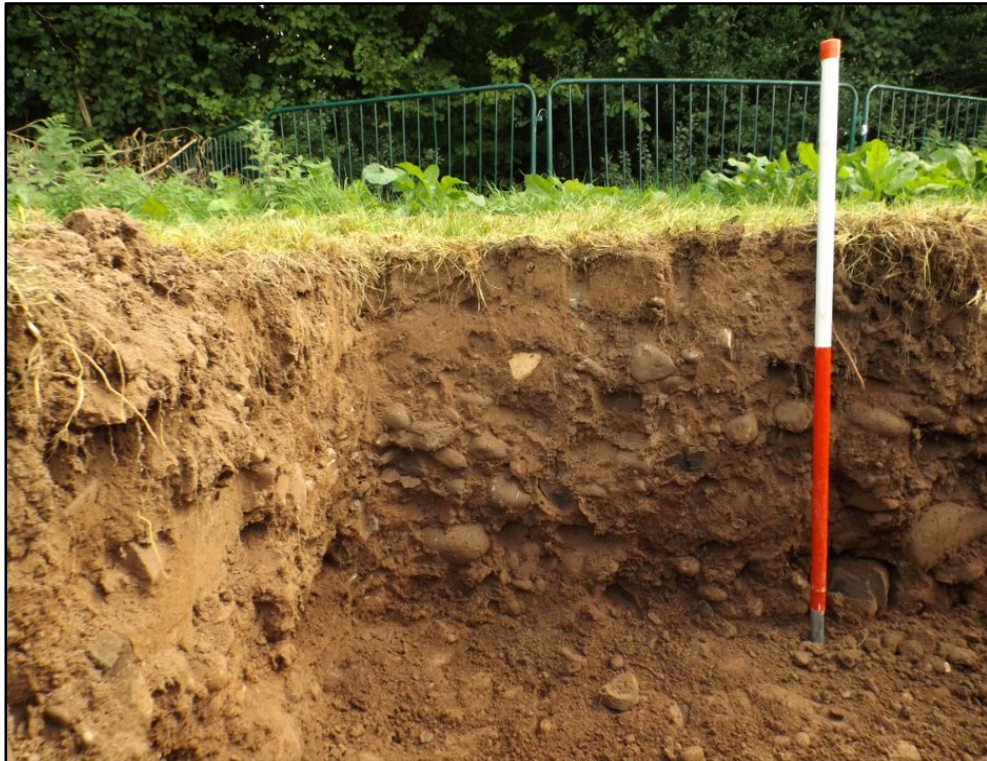
Plate 7. NE corner of amenity block (W facing section)

- 3.2.4 The NE corner west facing section (Plates 7, 8 and 9) revealed a 0.1m deep mid-brown silt loam topsoil with heavy bioturbation (201), this was observed overlying a 0.18m deep mid-brown sit loam (202) identified as a plough soil containing the following inclusions infrequent/ occasional pieces of coal clinker, frequent rounded small cobbles and a single sherd of 19th century salt glazed pottery. Underlying layer (202) was the natural base soil (203) a mid-brown silty clay matrix with abundant small to medium rounded cobbles.

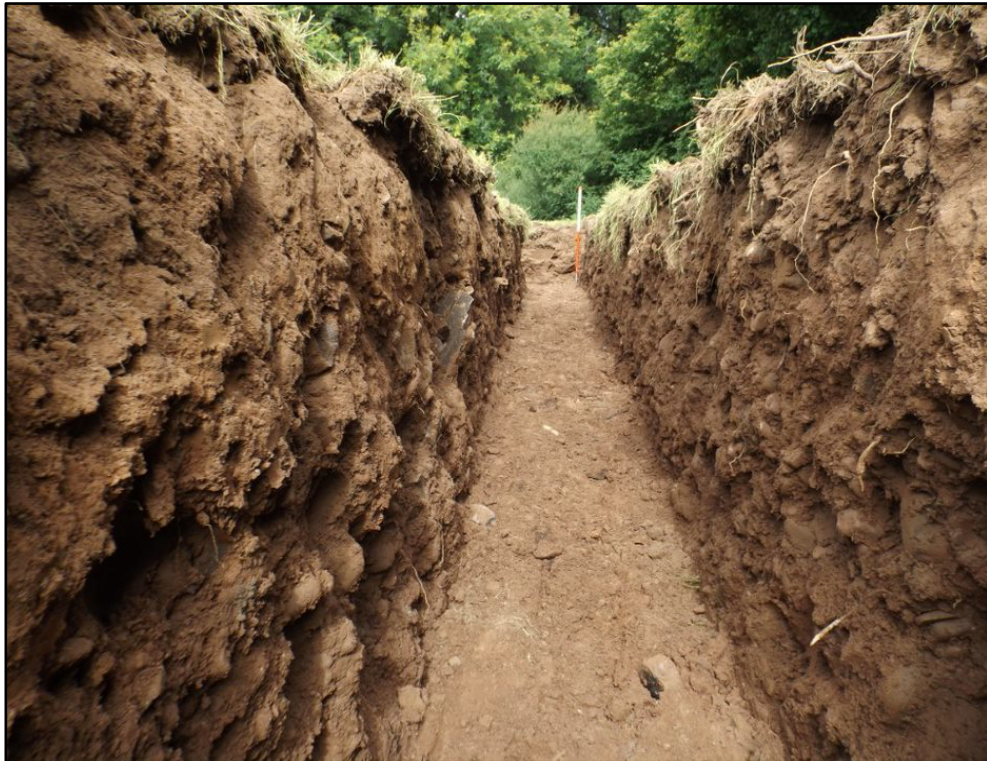
Plate 9. SE corner to NE corner of amenity block (view N)

- 3.2.7 The NW corner of the east facing section (Plate 9) revealed 0.12m deep topsoil (210) that comprised a mid-brown silt loam displaying heavy bioturbation. Underlying the topsoil was a 0.07m deep layer of mid-brown silty loam (211) abundant with small rounded and angular stones, this layer sat directly above (212) the mid-brown silty clay natural with abundant rounded small to medium cobbles (same as 203, 207 and 209).

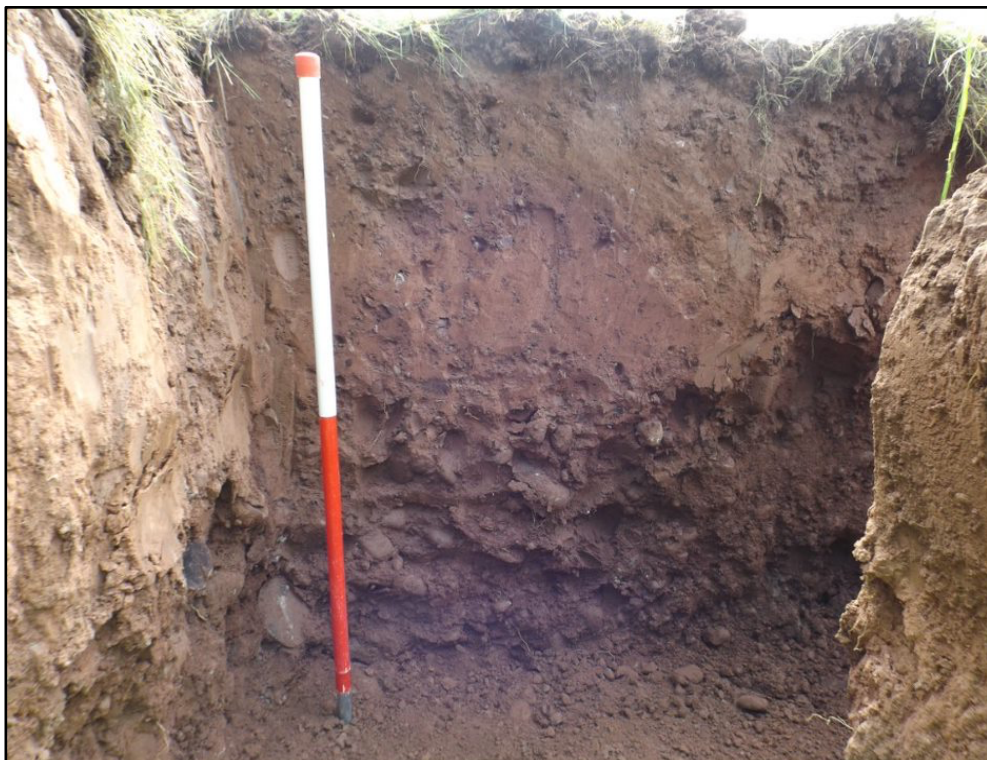
Plate 10. N facing section in the SE corner of amenity block

- 3.2.5 The SE corner north facing section (Plates 10 and 11) revealed a 0.05m deep dark-brown humic silt loam topsoil (204) with heavy bioturbation, this overlaid a 0.25m deep mid-brown silt loam (205) with a moderate amount of small angular stones and a moderate amount coal clinker inclusion. Underlying layer (205) was a c.0.3m deep mid-brown silt loam subsoil (206) that undulated with the underlying natural (207) a mid-brown silty clay matrix with abundant small- to medium-sized rounded cobbles (same as 203).

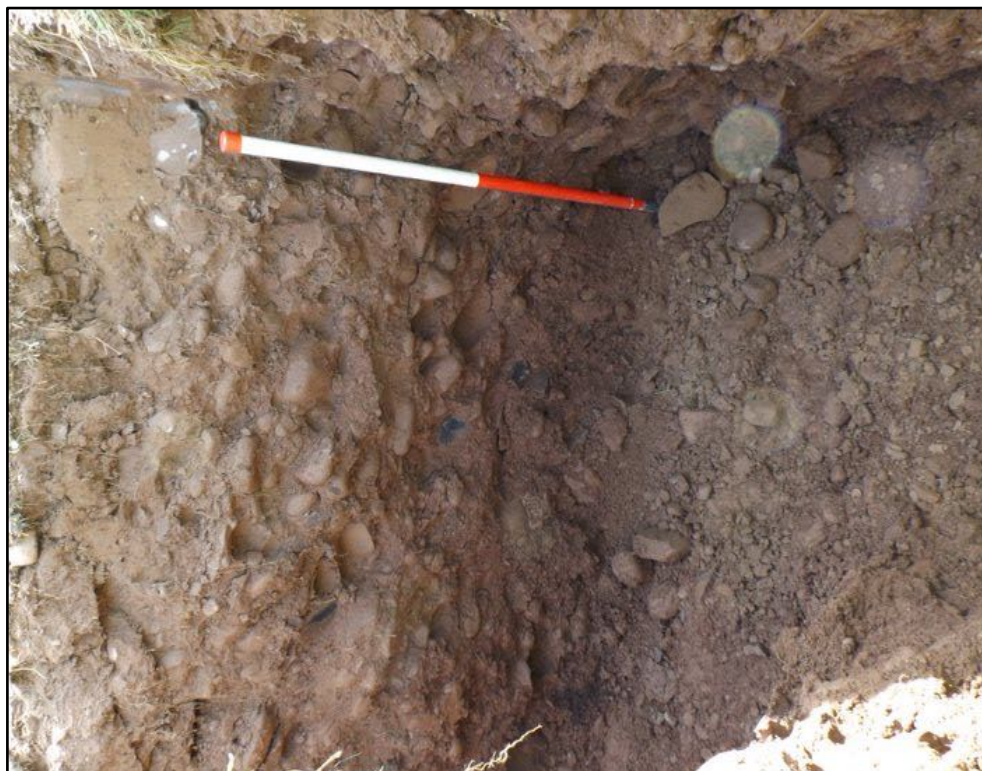
Plate 12. N facing section of SW corner of amenity block

- 3.2.6 The SW corner of the north facing section (Plate 12) revealed a 0.28m deep mid-brown silt loam (208) with frequent small rounded pebbles and angular small stones. The underlying layer (208) was a mid-brown silty clay matrix (209) identified as natural with an abundance of small to medium rounded cobbles (same as 203 and 207).

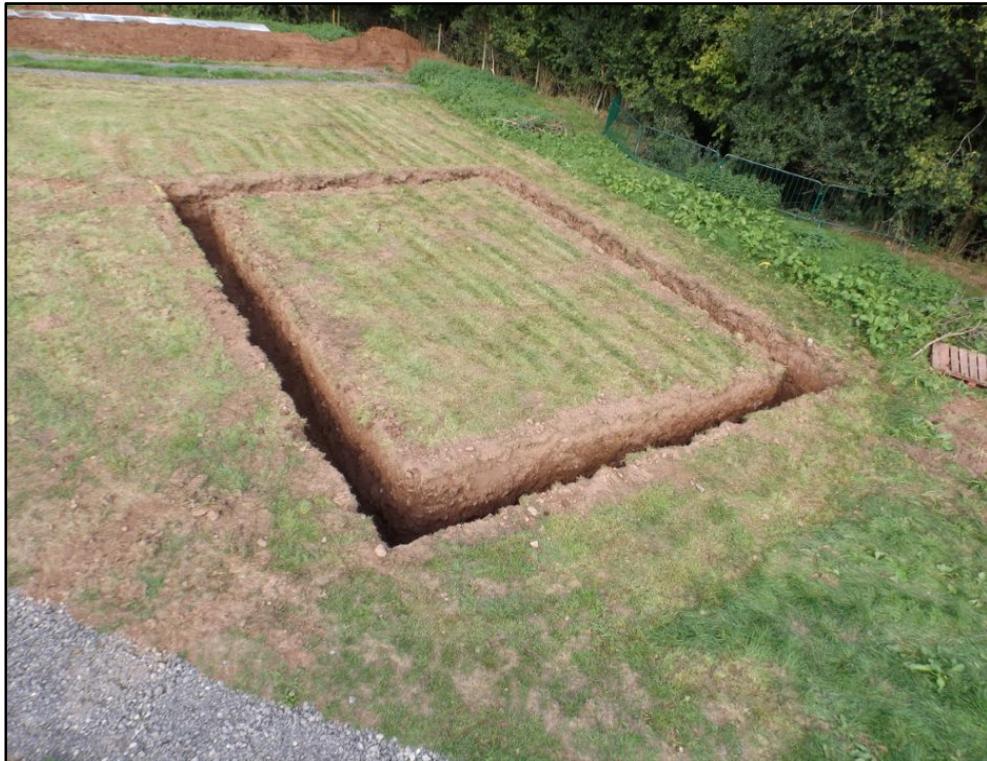
Plate 13. Excavated foundations for the amenity block (view NE)

- 3.2.3 The amenity block footprint was aligned north-south, measuring approximately 7m wide by 9m long (Plate 13). All trenches were watched during the excavation and each of the foundation trenches were recorded in section.

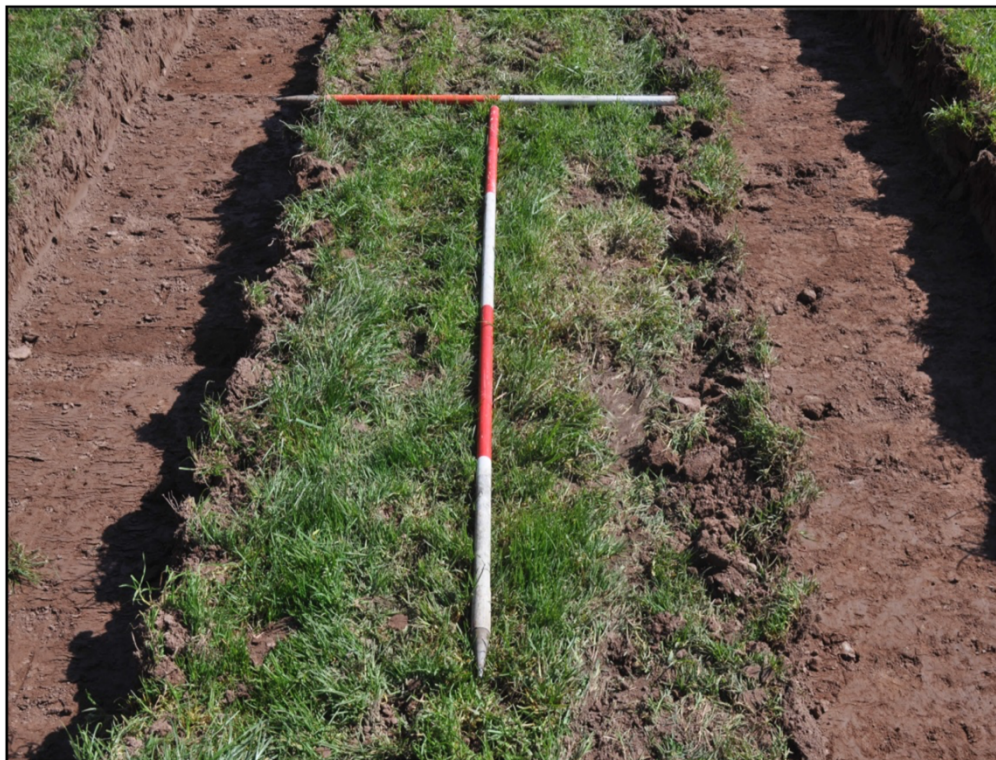
Plate 14. Access track cut for caravan site (view W)

- 3.3.3 Two shallow parallel lanes were trenched by a 13-ton mechanical excavator using a toothless ditching bucket each 0.75m wide by 0.22m deep (Plates 14, 15 and 16). The excavation was so shallow that only the c.0.2-0.25m deep mid-brown silt loam topsoil (301) with heavy bioturbation and the upper level of a mid-brown silt loam plough soil (302) (total depth not defined) were encountered. The plough soil (302) included occasional flecks of coal clinker/coke and charcoal, occasional small and medium cobbles, a few shot gun cartridges, a single sherd of white glazed pottery, and a single piece of twisted barbed wire.

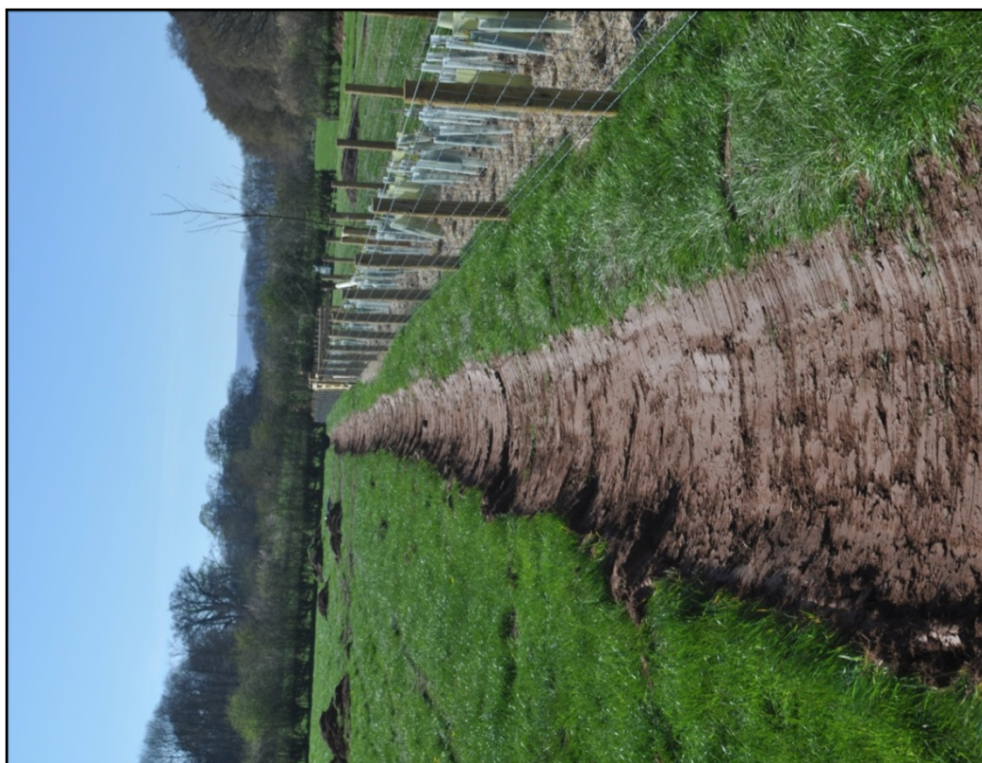
Plate 17. Flood prevention ditch (view W)

- 3.3.5 Following the setting out of the caravan platforms and access trackway a ditch was excavated at the bottom of the sloping field beyond the site perimeter on the southern side of the site as a flood prevention measure (Plates 16 and 17). The excavated ditch was c.70m long by 1m wide narrowing to 0.9m at its eastern end and excavated to a maximum a depth of 0.2m. The 0.1m–0.15m deep topsoil (305) was mid-brown silt loam with heavy bioturbation (same as 301 and 303) underlying the topsoil was (306) a mid-brown silt loam plough soil the same as 302, but with less coal clinker/coke and charcoal flecking.

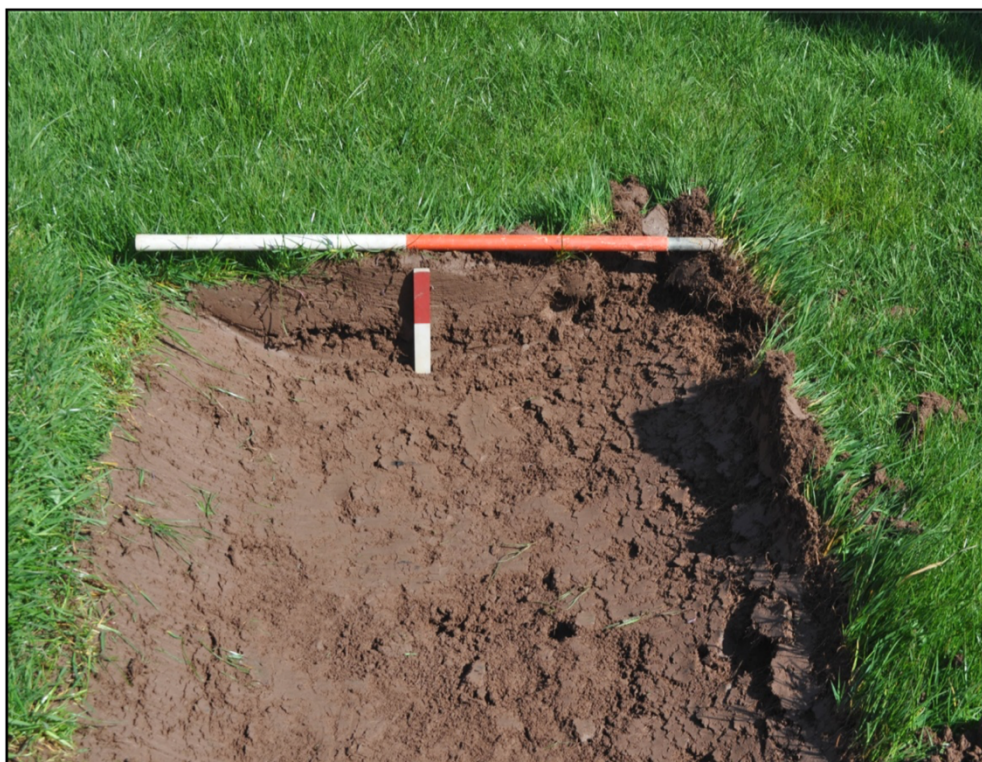
Plate 18. Section of flood protection ditch during cutting (view E)

- 3.3.4 The platforms for the caravan placements were also shallow excavations (Plate 18), cut to maximum of 0.1m, consisting of only grassed topsoil (303) with heavy bioturbation removal (same as 301). Underlying the topsoil was the upper level of a mid-brown silt loam (304) considered as a previous plough soil (same as 302).

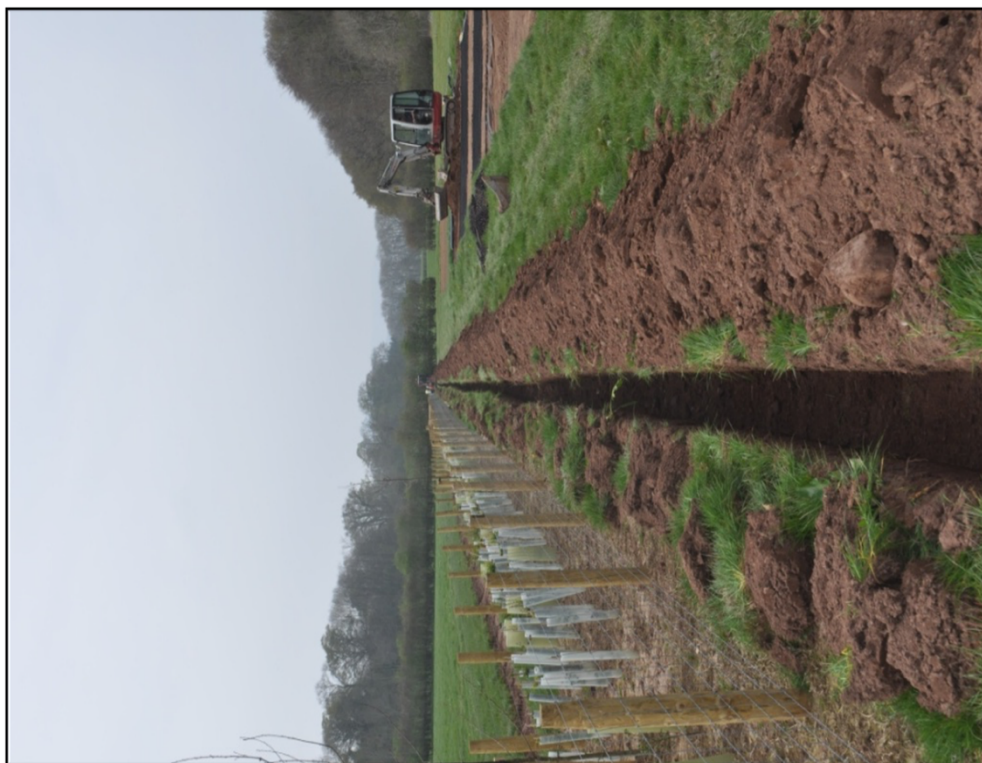
Plate 19. Excavation of service trench and caravan platforms (view W)

- 3.3.6 The final element of this phase of the watching brief was observing the excavation of the service trenches for the new amenity block and the caravan hook-up supply. The hook-up supply service trench was excavated along the southern edge of the caravan park within the perimeter and parallel to the fence and exterior flood protection ditch (Plates 18, 19 and 20). The hook-up supply ditch was 0.3m wide by 0.5m deep. The excavation of this trench revealed (307) a 0.15m deep dark-brown humic silt loam topsoil (same as 305) with heavy bioturbation, this overlaid (308) a 0.25-0.3m deep mid-brown silt loam plough soil (same as 306) with a moderate amount of small angular stones and a moderate amount coal clinker inclusion. Underlying layer (308) was amid-brown silty clay natural.

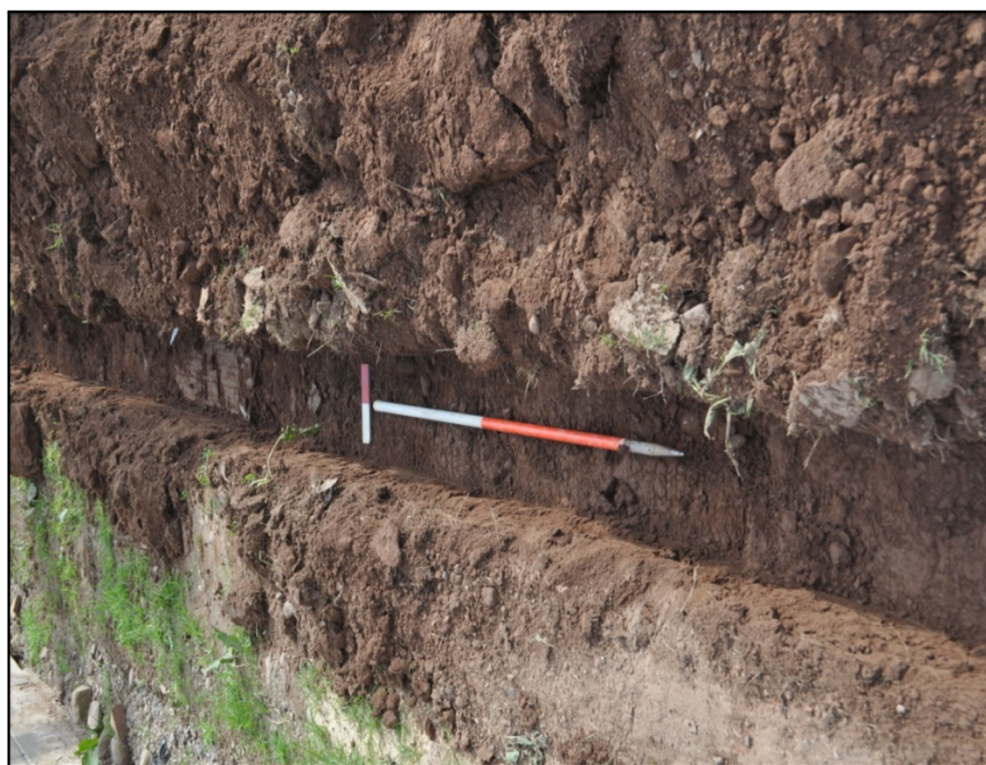
Plate 22. Excavation of service trench T2 to the W of the amenity block (view S)

- 3.3.7 A series of short trenches were excavated into both the east and west sides of the amenity block. Each hand dug trench was 0.2m deep by 0.3m wide (Plate 27 and 28), those on the east side were cut through made-up ground. Both series of short trenches linked into the two main drainage trenches that ran north along east and west sides of the amenity block. These two trenches connected into a single trench that led to a manhole to the north of the amenity block on both its east side. The first trench (T1) was 14m long by 0.5m wide by 0.3m deep (Plate 21 and 25). The second trench (T2) was 16m long by 0.5m wide by 0.3m deep (Plate 22 and 24) which intersected with the eastern trench (Plate 23) before entering the manhole (Plate 26).

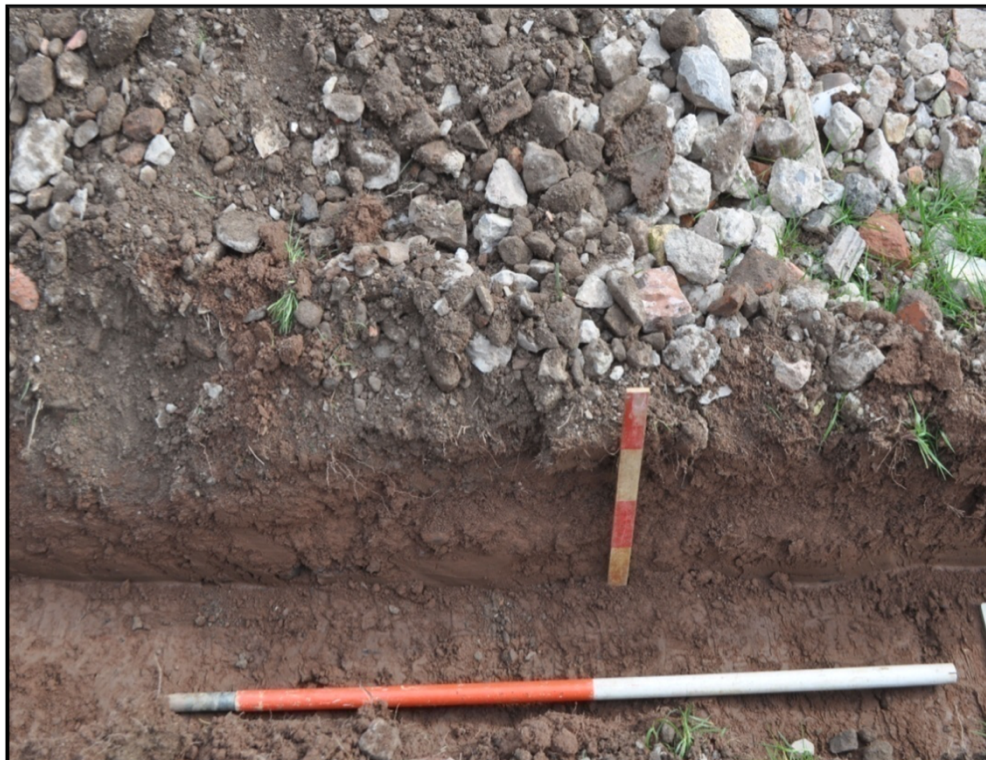
Plate 24. N facing section of trench T2

- 3.3.9 Both trenches that connected north of the amenity block were recorded and were consistent with the other excavations within the field. Trench T1 was cut 0.1m deep into mid-brown silt loam topsoil (309) with heavy bioturbation (same as 301, 303, 305 and 307) which overlaid the upper level of a mid-brown silt loam plough soil (310) whose total depth was not defined (same as 302, 304, 306 and 308). Layer (309) revealed occasional small to medium rounded cobbles, occasional charcoal flecks and occasional pieces of coke. Trench T2 basically mirrored the findings in T1, with context numbers (311) and (312) being attributed to the topsoil and underlying plough soil.
