**Bryn Oer Tramroad,  
Talybont-on-Usk,  
Brecon Beacons National Park**

**Archaeological Watching Brief and Walkover Survey  
(An Interim Report)**

Morgan, R. 2022. *Bryn Oer Tramroad, Talybont-on-Usk, Brecon Beacons National Park: Archaeological Watching Brief and Survey (An Interim Report)*. Black Mountains Archaeology Report No 257.

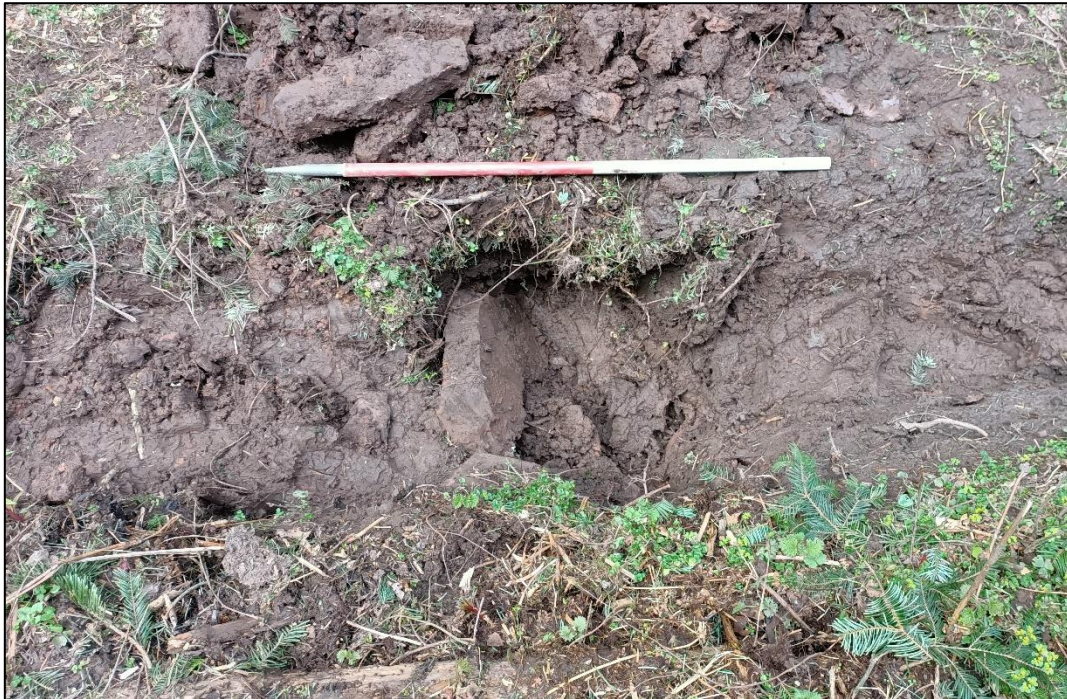
3.1.5 The outfall head of the culvert, situated on the western edge of the tramroad, again included a horizontally laid, sandstone lintel slab [005], which in section measured 0.4m in width x 0.7m in depth. Above this lintel was again 0.4m of tramroad substrate (002). No remnants of side walling were observed within the outfall head itself, yet to the exterior of the head a pair of revetment walls were observed. These walls were parallel with the edges of the culvert and extended 0.6m beyond the mouth of the outfall. In height, these walls measured a maximum of 0.25m. Structurally, these walls comprised single faces of irregularly coursed sandstone masonry and served to retain substrate (002) to either side of the outfall. The southern revetment wall has been numbered [006], while the northern has been numbered [007]. The entire outflow head has been numbered [008]. In profile, the opening of the inflow head measured 0.3m high x 0.28m wide.

Plate 1. Outfall head [008] of Historic Culvert II (ID26 in Appendix IV)

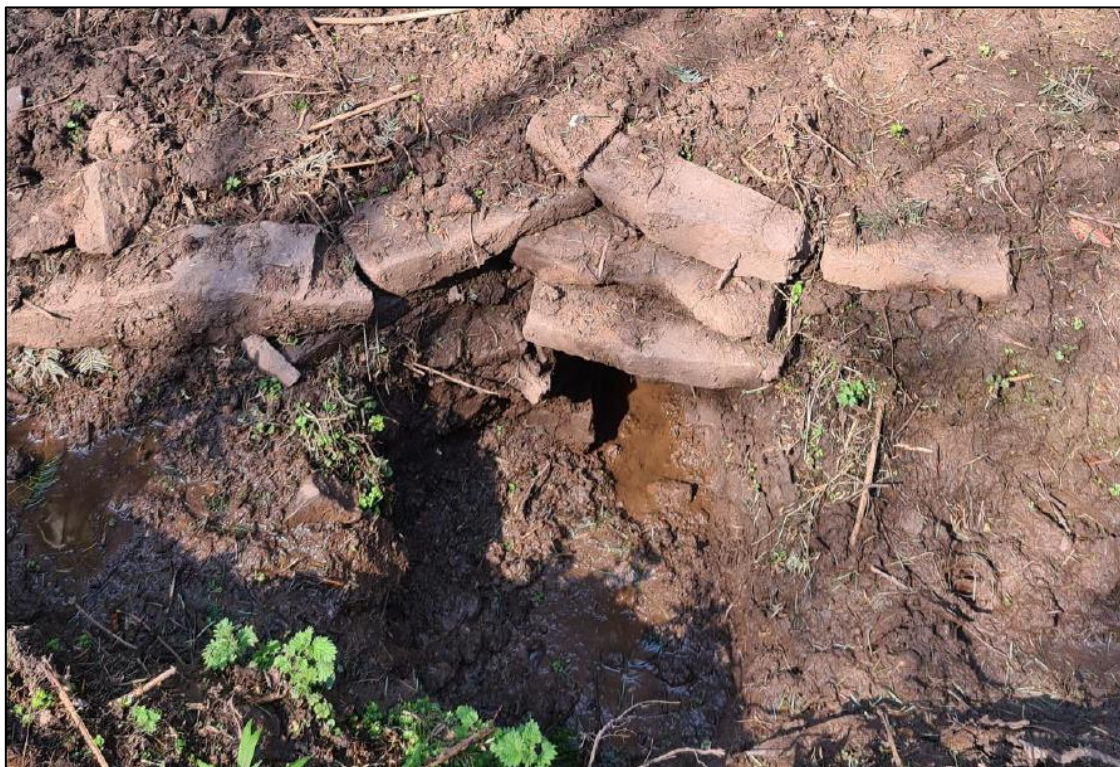
Plate 2. Inflow head [004] of Historic Culvert II (ID26 in Appendix IV)

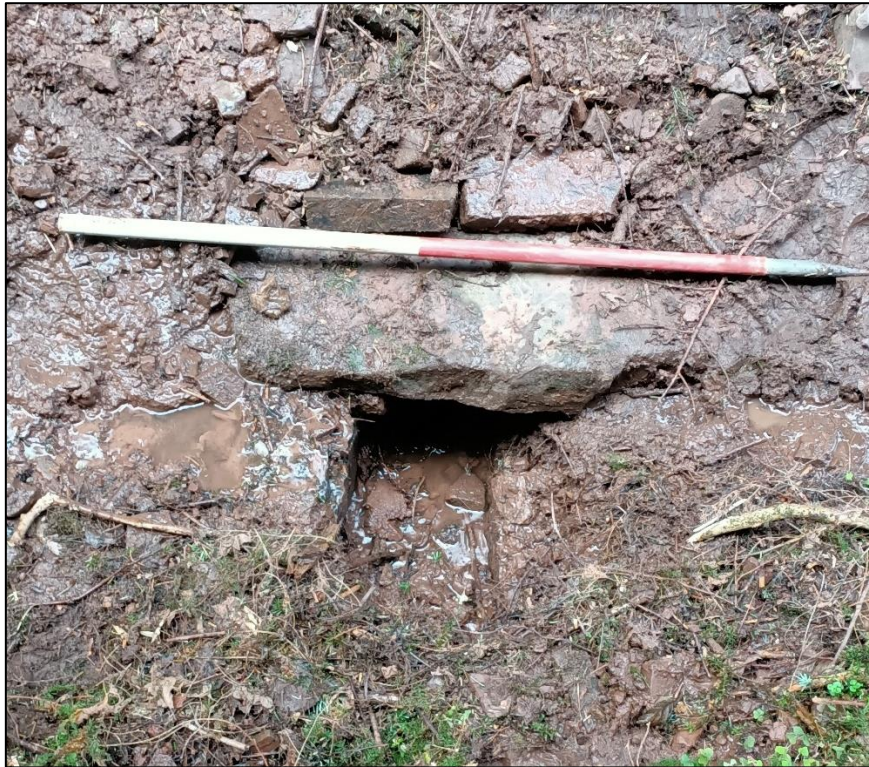
Plate 3. Inflow head [014] of Historic Culvert III (ID27 in Appendix IV)

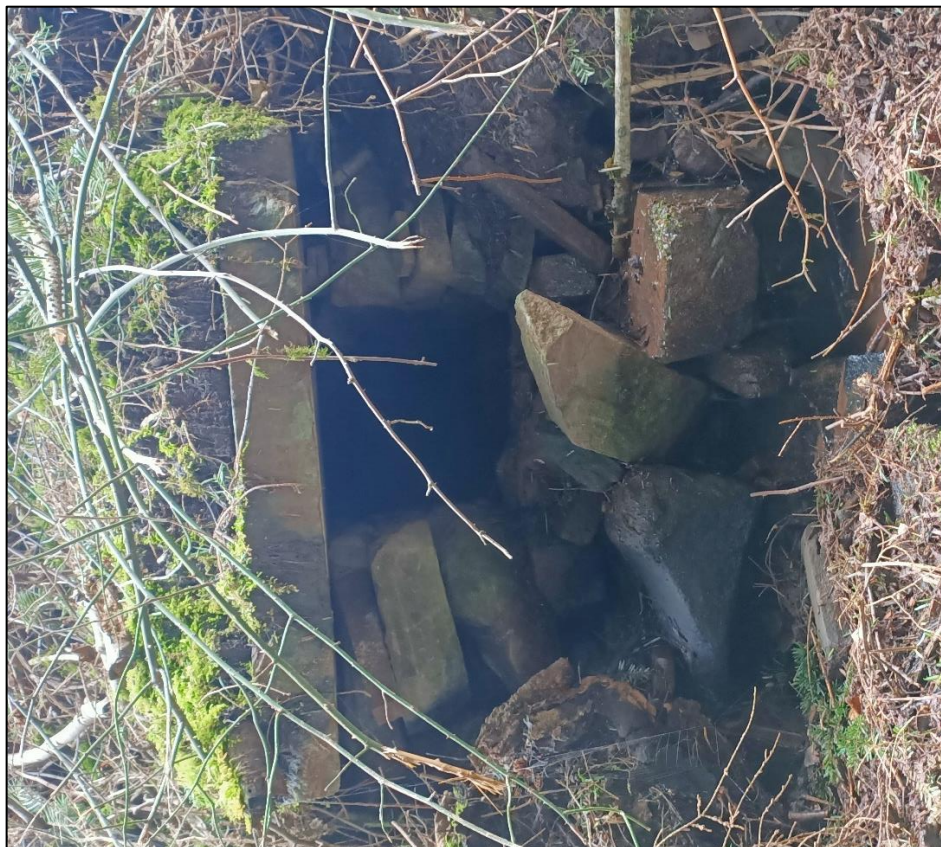
- 3.1.10 The outfall head of the culvert, situated on the western edge of the tramroad, again included a horizontally laid, sandstone lintel slab [015], which in section measured 0.6m in width x 0.1m in depth. Above this lintel was approximately 0.3m of substrate (011). The lintel was suspended above a pair of side walls, which survived in a comparatively good condition. Both walls were formed of four courses of stacked sandstone masonry, each measuring 0.45m high x 0.2m wide. The southern wall has been numbered [016] and the northern has been numbered [017]. To the front of the outfall head was a mess of displaced masonry, the origin of which is unknown. However, it is possible that some of this masonry originally formed the floor of the outfall head. Other than this, no evidence existed indicating a floor. The entire inflow head has been numbered [018]. In profile, the opening of the inflow head measured 0.45m high x 0.6m wide.

Plate 4. Outfall head [018] of Historic Culvert III (ID27 in Appendix IV)

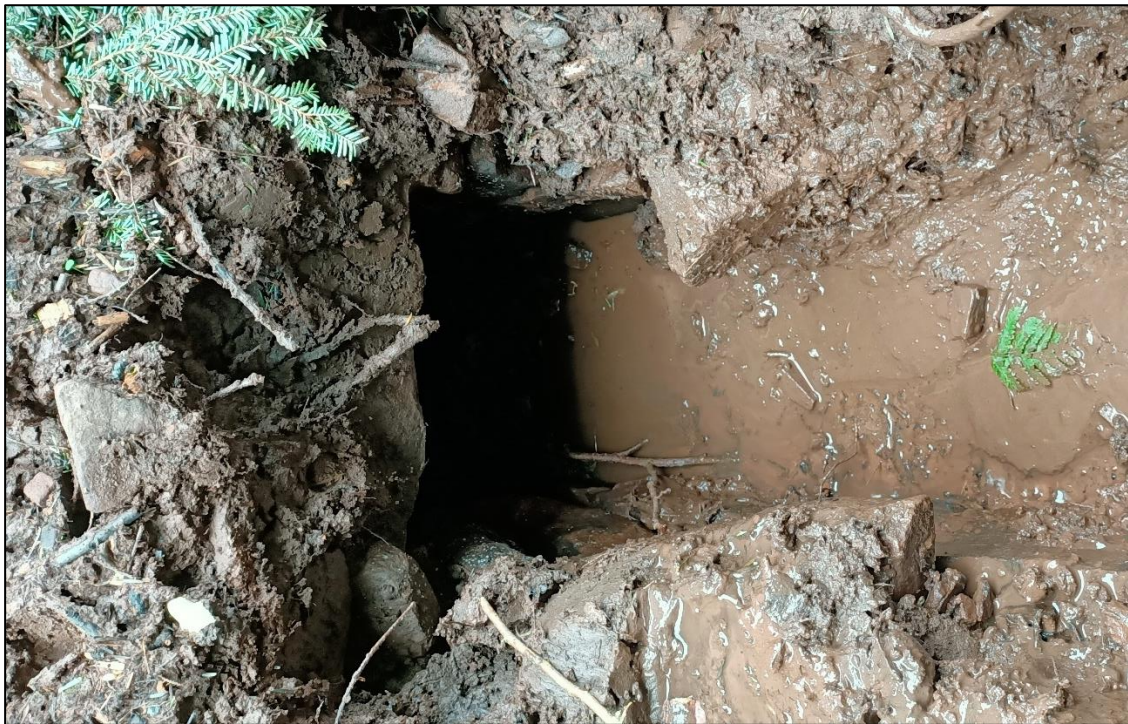
- 3.1.14 The inflow head of the culvert, situated on the eastern edge of the tramroad, included a horizontally laid, sandstone lintel slab [020], which in section measured 0.25m in width x 0.07m in depth. Above this lintel was 0.08m of tramroad substrate. This substrate has been numbered (021) and was identical in composition to deposit (002). The side walls of the inflow head survived in good condition, which comprised single faces of irregularly coursed sandstone masonry 0.25m in height. The northern wall has been numbered [022] while the southern has been numbered [023]. The latter wall was seen to extend beyond the mouth of the inflow head to form a small revetment on its southern edge. No basal slabs were recorded. The entire inflow head has been numbered [024]. In profile, the opening of the inflow head measured 0.25m high x 0.3m wide.

Plate 5. Inflow head [024] of Historic Culvert IV (ID28 in Appendix IV)

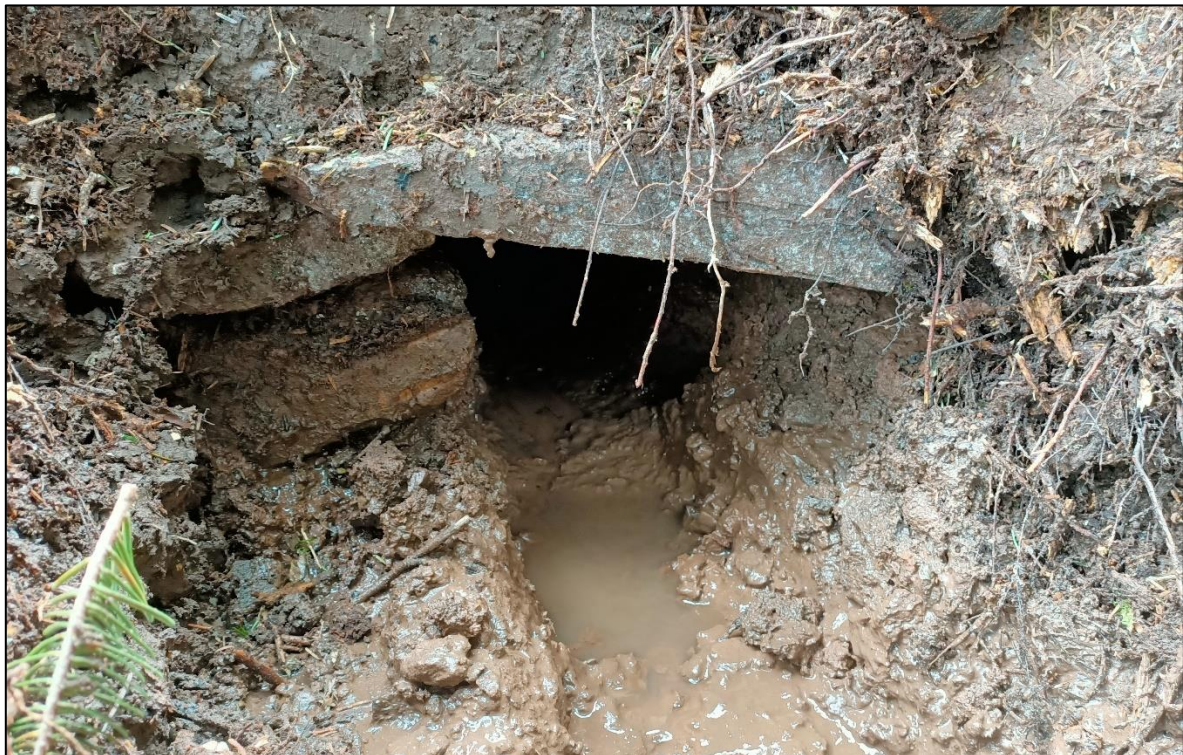
- 3.1.15 The outfall head of the culvert, situated on the western edge of the tramroad, again included a horizontally laid, sandstone lintel slab [025], which in section measured 0.3m in width x 0.1m in depth. Although *in situ*, this lintel was discovered in relatively poor condition and was fractured in two. Above this lintel was 0.4m of substrate (021). Remnants of neither side walls nor basal slabs were recorded. However, the presence of fallen and broken stones on the northern edge of the outfall head may have represented the partial remains of the northern wall, although this is tentative. The entire outfall head has been numbered [026]. In profile, the opening of the inflow head measured 0.25m high x 0.25m wide.

Plate 6. Outfall head [026] of Historic Culvert IV (ID28 in Appendix IV)

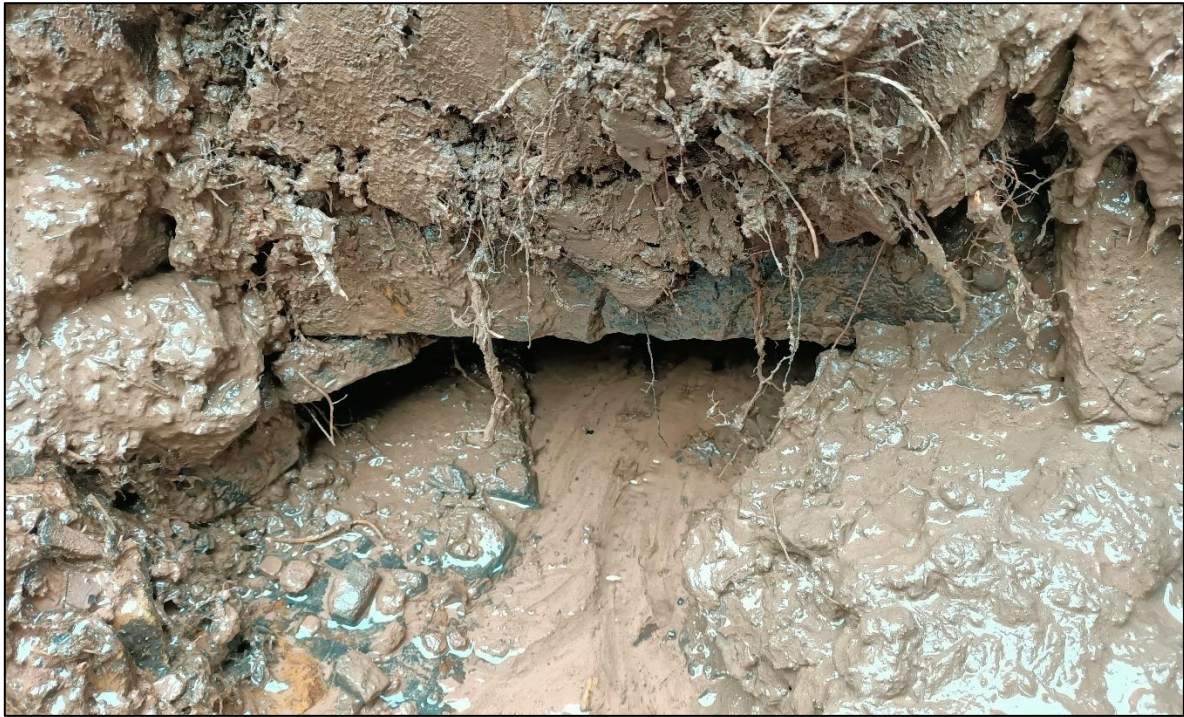
- 3.1.19 The inflow head of the culvert, situated on the eastern edge of the tramroad, included a horizontally laid, sandstone lintel slab [028], which in section measured 0.35m in width x 0.07m in depth. The edges of this lintel extended beyond the width of the inflow head. Above this lintel was 0.26m of tramroad substrate. This substrate has been numbered (029) and was identical in composition to deposit (002). Remnants of collapsed walling were observed on the southern edge of the inflow head, which comprised at least three dislodged stone. This wall has been numbered [030] and appears to have originally stood at only 0.1m high. No comment could be made on the original structure of the wall. Moreover, no corresponding side wall was observed on the opposite, northern side of the inflow head. Remnants of a possible floor were observed in the form of a flag stone projecting from the northern edge of the inflow head, which was likely positioned below wall [030]. This stone, numbered [031], measured 0.1m wide x 0.05m deep. The entire inflow head has been numbered [032]. In profile, the opening of the inflow head measured 0.1m high x 0.25m wide.

Plate 7. Inflow head [032] of Historic Culvert V (ID29 in Appendix IV)

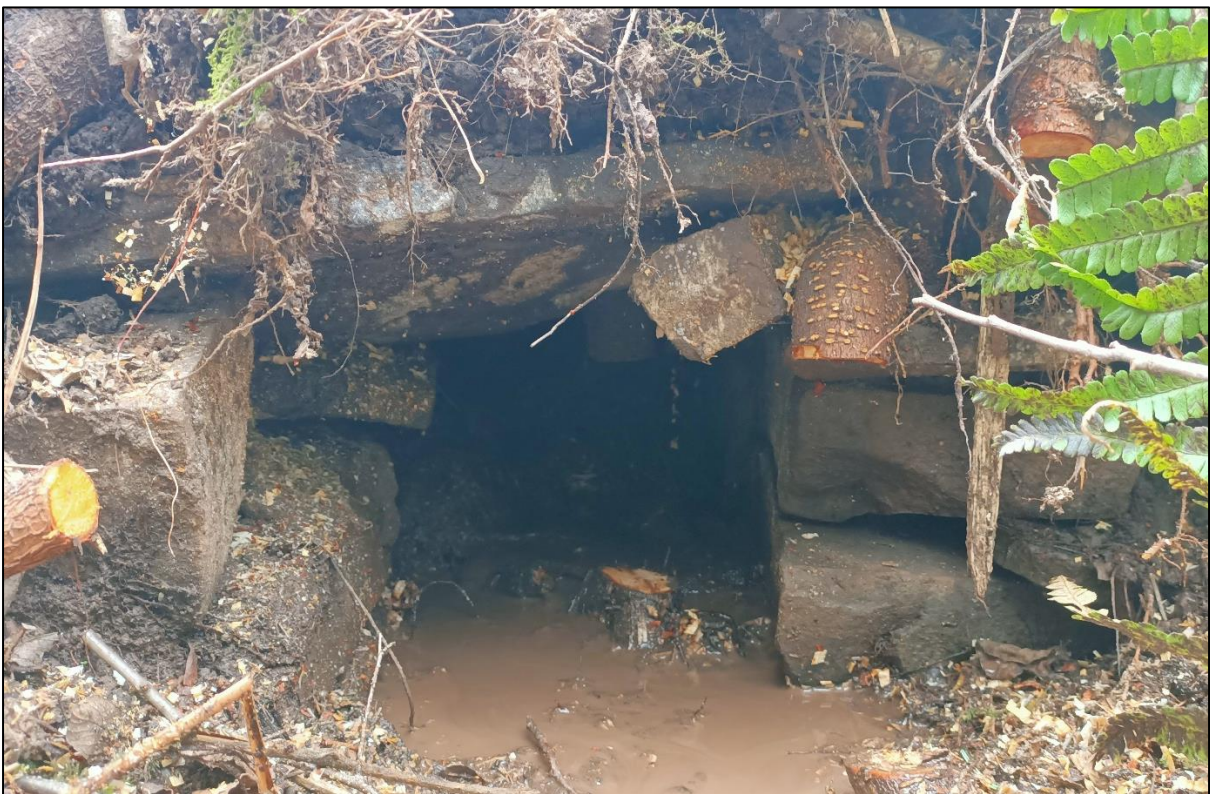
- 3.1.20 The outfall head of the culvert, situated on the western edge of the tramroad, again included a horizontally laid, sandstone lintel slab [033], which in section measured approximately 0.24m in width x 0.1m in depth. This lintel had slipped from its original position and was seen to slope downwards from south to north. Above this lintel was 0.25m of substrate (029). The side walls of the outfall head survived in a notably good condition. Both walls comprised stacks of sandstone masonry blocks, three courses high. The southern wall, numbered [034], measured 0.2m high x 0.13m wide. The northern wall, numbered [035], measured 0.18m high, while its width could not be ascertained. No basal slabs were observed, although the base of the outfall head was heavily disturbed by rooting. The entire outfall head has been numbered [036]. In profile, the opening of the inflow head measured 0.18–0.2m high x 0.28m wide.

Plate 8. Outfall head [036] of Historic Culvert V (ID29 in Appendix IV)

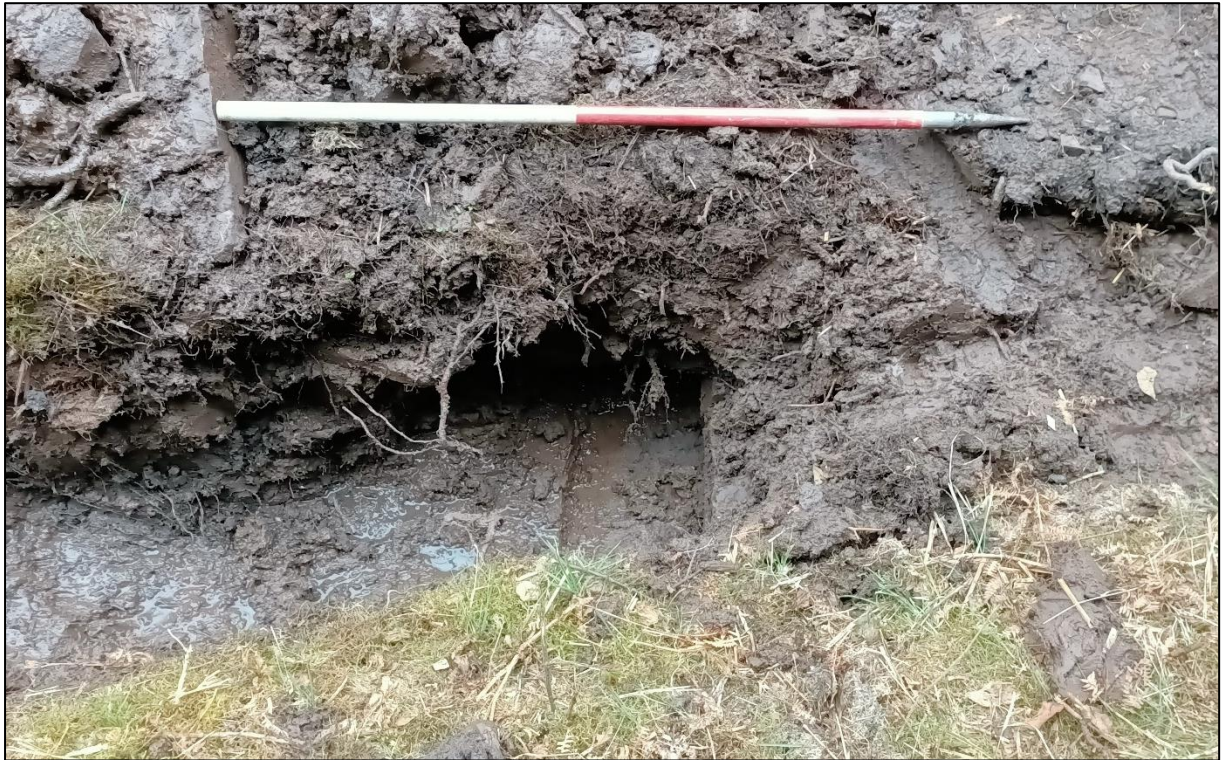
- 3.1.24 The inflow head of the culvert, situated on the eastern edge of the tramroad, included horizontally laid, sandstone lintel slab [038], which in section measured 0.3m in width x 0.08m in depth. This lintel was marginally dislodged and sloped slightly from north to south. Above this lintel was 0.3m of tramroad substrate. This substrate has been numbered (039) and was identical in composition to deposit (002). Neither side walls nor basal slabs were noted, although only a partial view of the interior of the inflow head was possible. The entire inflow head has been numbered [040]. In profile, the opening of the inflow head measured 0.1–0.3m high x 0.31m wide.

Plate 9. Inflow head [040] of Bryn Melyn Culvert I (ID30 in Appendix IV)

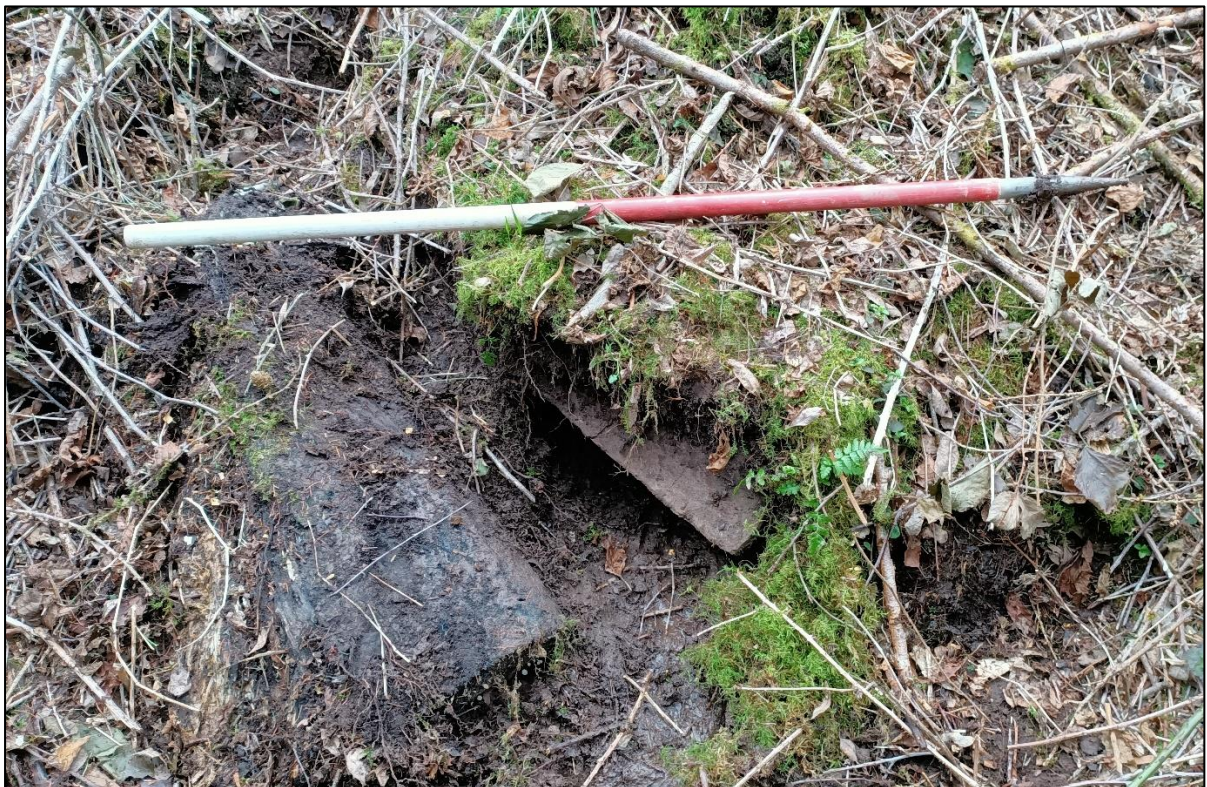
- 3.1.25 The outfall head of the culvert, situated on the western edge of the tramroad, again included a horizontally laid, sandstone lintel slab [041], which in section measured 0.35m in width x 0.08m in depth. Again, this lintel was marginally dislodged and sloped slightly from north to south. Above this lintel was 0.1m of substrate (039). Neither side walls nor basal slabs were noted, although only a partial view of the interior of the inflow head was possible. The entire outfall head has been numbered [042]. In profile, the opening of the outfall head measured 0.1–0.17m high x 0.28m wide.

Plate 10. Outfall head [042] of Bryn Melyn Culvert I (ID30 in Appendix IV)

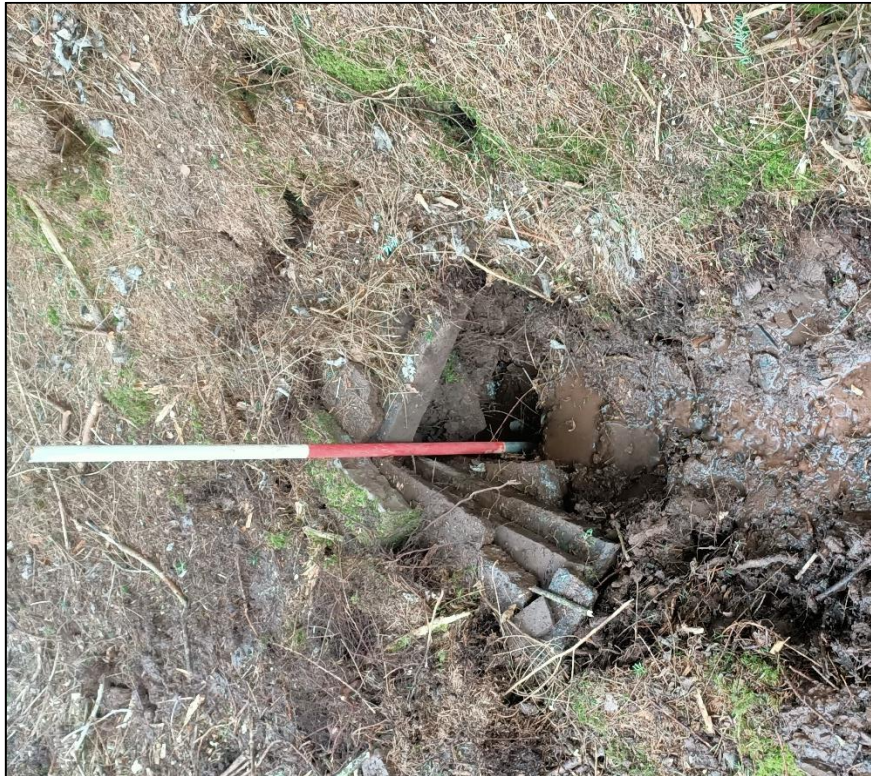
been numbered (045) and was identical in composition to deposit (002). The lintel was seen to be keyed into a revetment wall, which defined the inflow head on its southern edge. This revetment wall, numbered [046], was found in a good state of preservation and was well constructed. In composition, the wall comprised a stack of six sandstone flags, which together measured 0.5m high. The wall was also seen to extend 0.57m beyond the inflow head. Views of the interior of the inflow head were partial and neither side walls nor basal slabs were observed. However, it is possible that revetment wall [046] represented a continuation of a southern side wall. The entire inflow head has been numbered [047]. In profile, the opening of the inflow head measured 0.3m high x 0.38m wide.

Plate 11. Inflow head [047] of Historic Culvert VI (ID33 in Appendix IV)

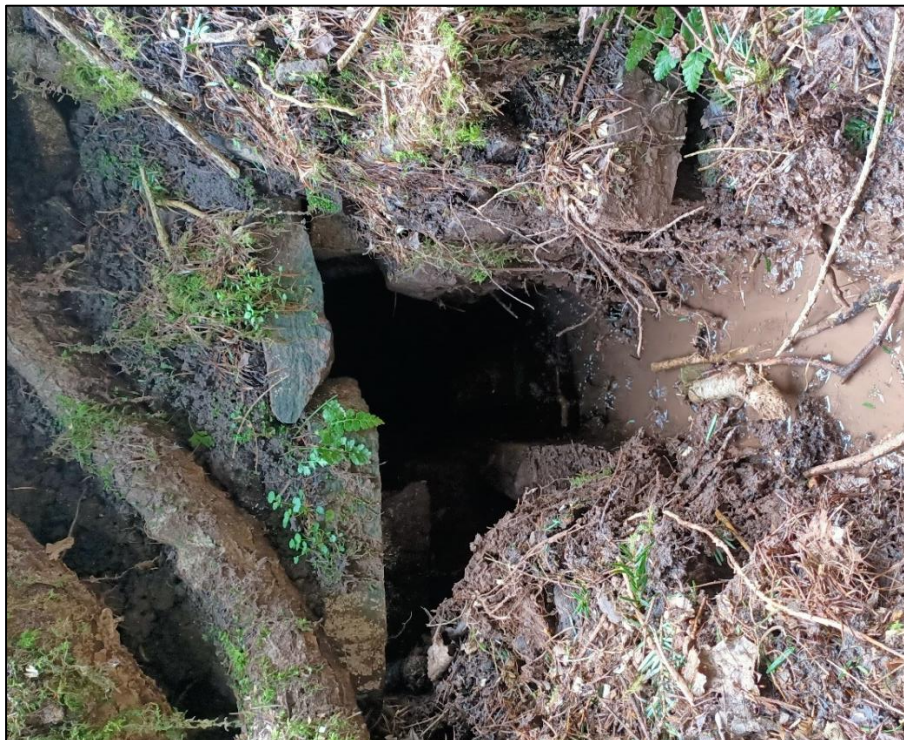
- 3.1.30 The outfall head of the culvert, situated on the western edge of the tramroad, included a horizontally laid, sandstone lintel, which comprised a pair of slabs laid side by side. Together, these slabs, and therefore the lintel of the outfall head, measured 0.34m wide x 0.05m deep. This lintel has been numbered [048]. Above this lintel was 0.65m of substrate (045), which at this end was significantly disturbed by large tree roots. The northern edge of the outfall head was disturbed by rooting and no structural remains were observed. However, on its southern edge were the remains of a well preserved side wall, numbered [049]. This wall measured 0.18m high and comprised a single course of facing stones. This wall was also irregularly coursed. No basal slabs were observed. The entire outfall head has been numbered [050]. In profile, the opening of the outfall head measured 0.2 high x 0.17m wide.

Plate 12. Outfall head [050] of Historic Culvert VI (ID33 in Appendix IV)

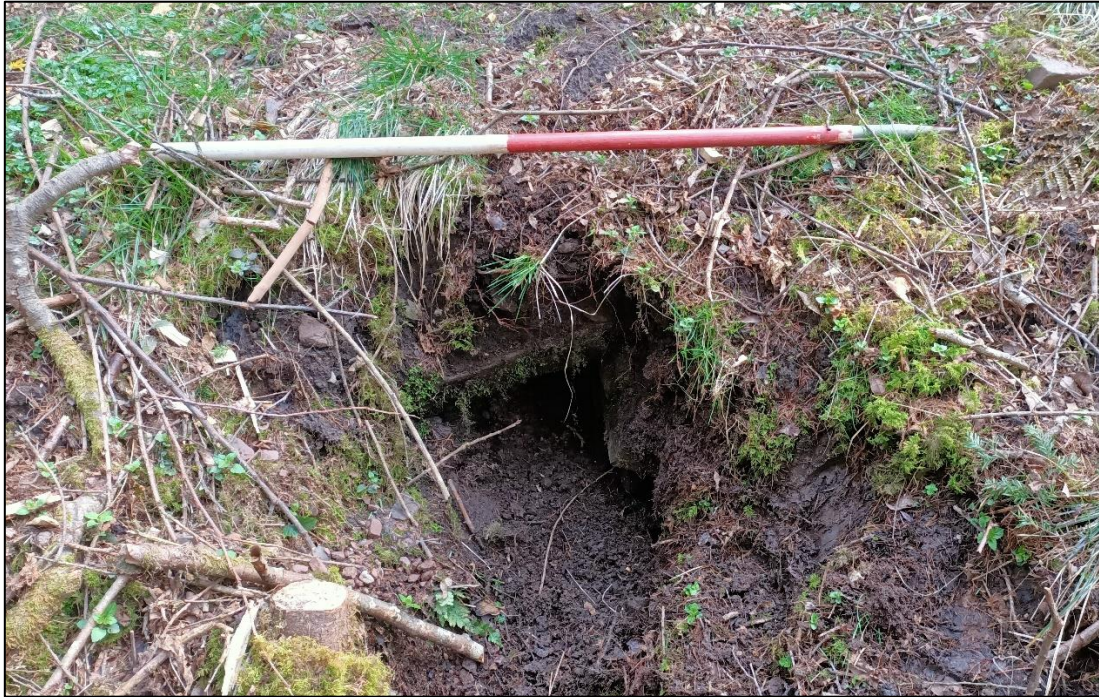
Plate 13. Inflow head [054] of Historic Culvert VII (ID34 in Appendix IV)

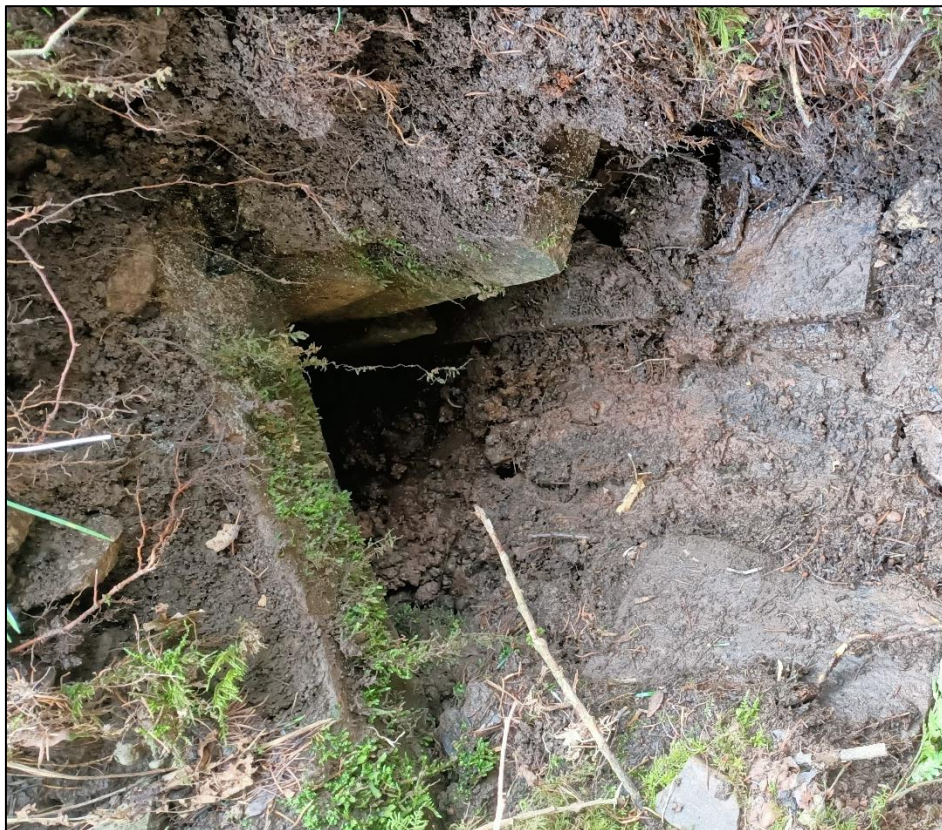
- 3.1.35 The outfall head of the culvert, situated on the western edge of the tramroad, included a horizontally laid, sandstone lintel slab [055], which in section measured approximately 0.24m in width x 0.1m in depth. Above this lintel was 0.29m of substrate (053). The northern edge of the outfall head was in a poor state of preservation. However, a side wall was noted on the opposite, southern edge. This wall, numbered [056], comprised a single face of sandstone masonry, irregularly coursed, measuring 0.2m high. The entire outfall head has been numbered [057]. In profile, the opening of the inflow head measured 0.2m high x 0.37m wide.

Plate 14. Outfall head [057] of Historic Culvert VII (ID34 in Appendix IV)

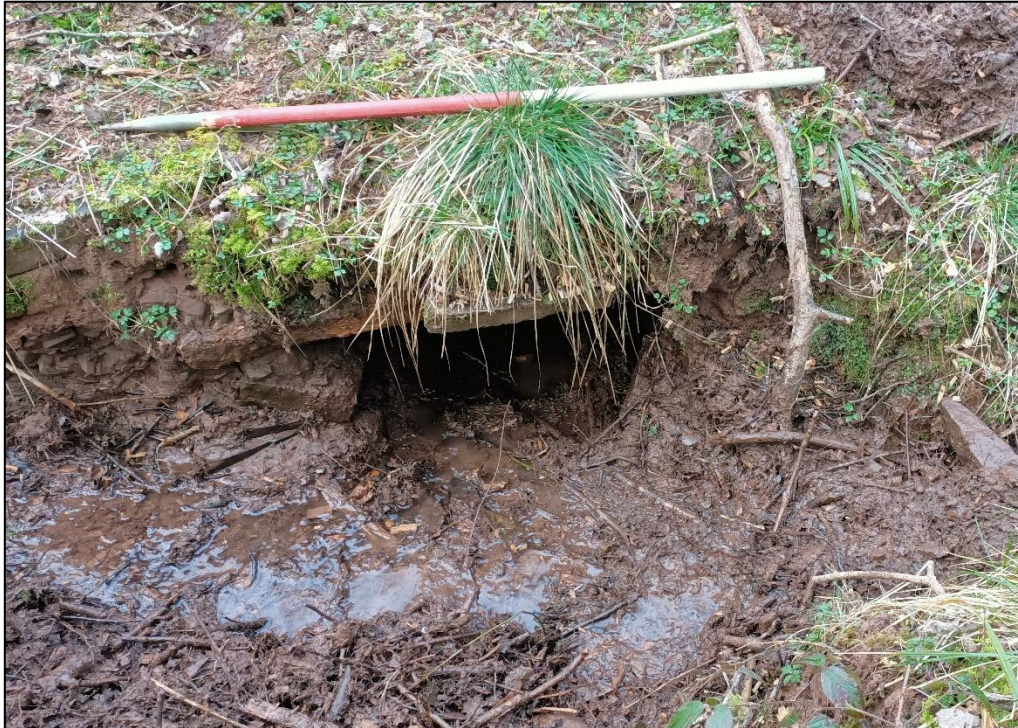
- 3.1.39 The inflow head of the culvert, situated on the eastern edge of the tramroad, included a horizontally laid, sandstone lintel slab [059], which in section measured 0.54m in width x 0.06m in depth. Above this lintel was 0.18m of tramroad substrate. This substrate has been numbered (060) and was identical in composition to deposit (002). No side wall was observed on the northern edge of the inflow head. However, on its southern edge the partial remains of a side wall were observed, which were heavily disturbed. The remains of this side wall, numbered [061], comprised three stone slabs stacked one on top of the other. The uppermost stone had slipped out of place and was resultantly positioned at a broadly 45-degree angle. Moreover, as a result of this disturbance, there was no longer any physical contact between wall [061] and lintel [059], meaning that the latter was suspended rather precariously above the former. The surviving height of wall [061] was 0.15m, while its surviving width was 0.25m. No basal slabs were observed. The entire inflow head has been numbered [062]. In profile, the opening of the inflow head measured 0.3m high x 0.6m wide.

Plate 15. Inflow head [062] of Historic Culvert IX (ID36 in Appendix IV)

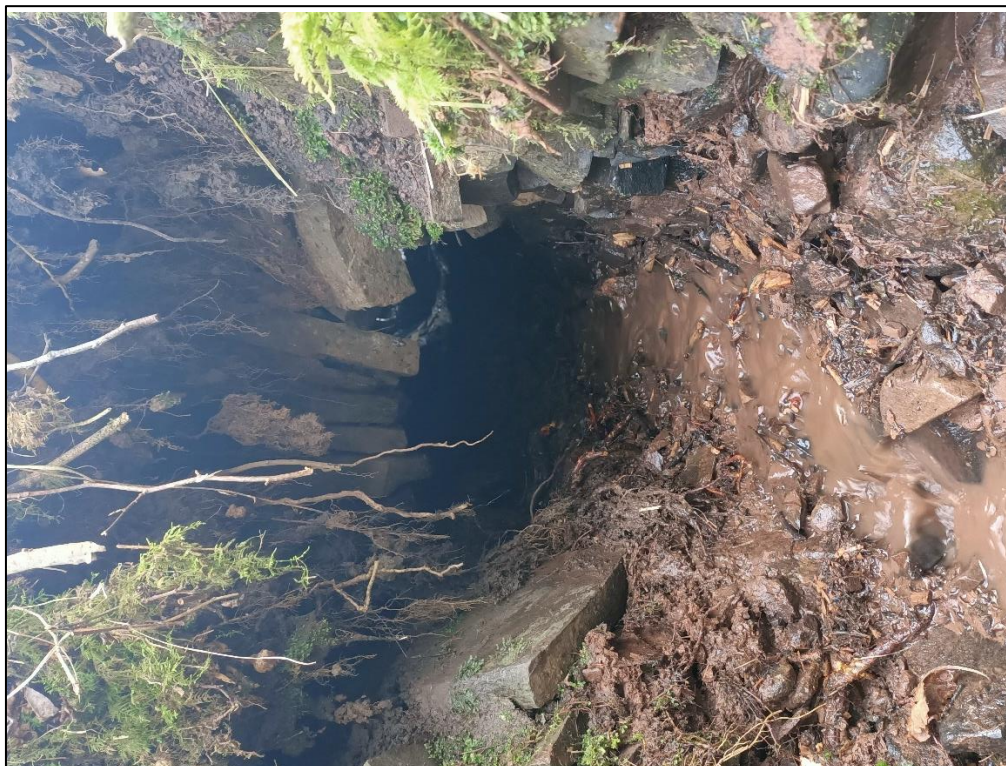
single springer stone was also observed on the southern edge of the arch, which was placed at an approximately 45-degree angle. No corresponding springer was observed on the northern end of the arch, although this end was obscured by soil and vegetation. Above arch [063] was 0.25m of tramroad substrate (060). The side walls of the outfall head comprised single courses of facing stones measuring approximately 0.2m in height. The northern side wall is numbered [064] and the southern is numbered [065], on top of which the southern springer of arch [063] sat. No basal slabs were observed. The entire outfall head has been numbered [066]. In profile, the opening of the outfall head measured 0.2 high x 0.4m wide.

Plate 16. Outfall head [066] of Historic Culvert IX (ID36 in Appendix IV)

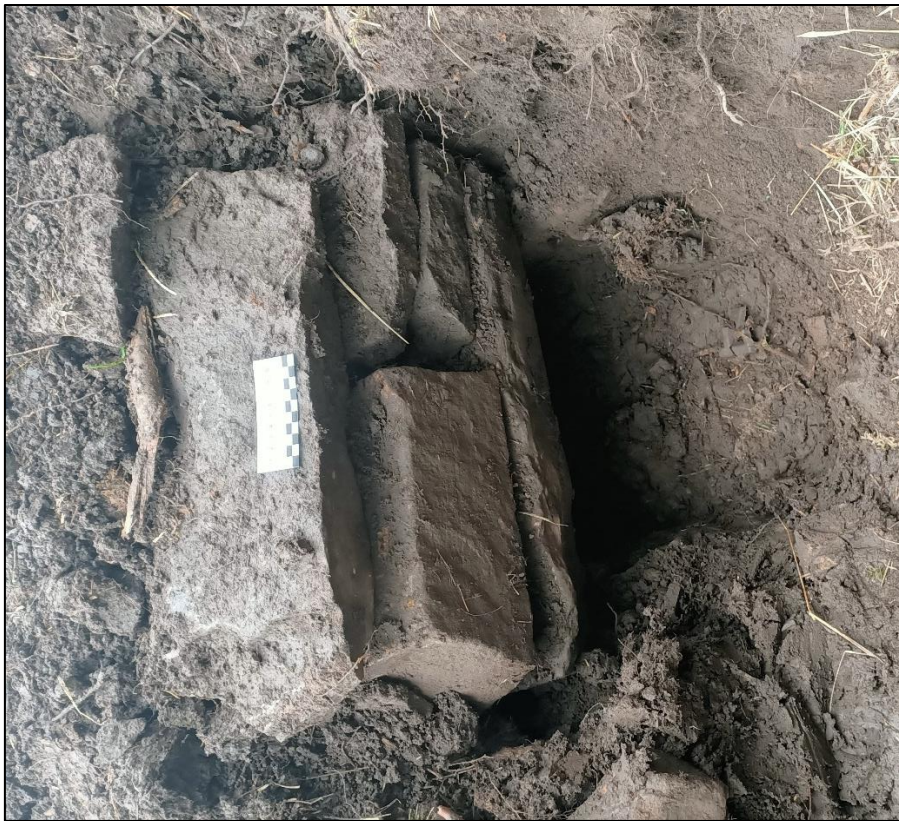
- 3.1.44 The inflow head of the culvert, situated on the eastern edge of the tramroad, included a horizontally laid, sandstone lintel slab [068], which in section measured 0.35m in width x 0.06m in depth. Situated directly above this lintel was a stone support, which comprised three slabs and one block of masonry. This stone support measured 0.2m deep x 0.35m wide and is numbered [069]. Situated directly above support [069] was 0.1m of tramroad substrate. This substrate has been numbered (070) and was identical in composition to deposit (002). Neither side walls nor basal slabs were observed within the inflow head. The entire inflow head has been numbered [071]. In profile, the opening of the inflow head measured 0.15m high x 0.35m wide.

Plate 17. Inflow head [071] of Historic Culvert X (ID43 in Appendix IV)

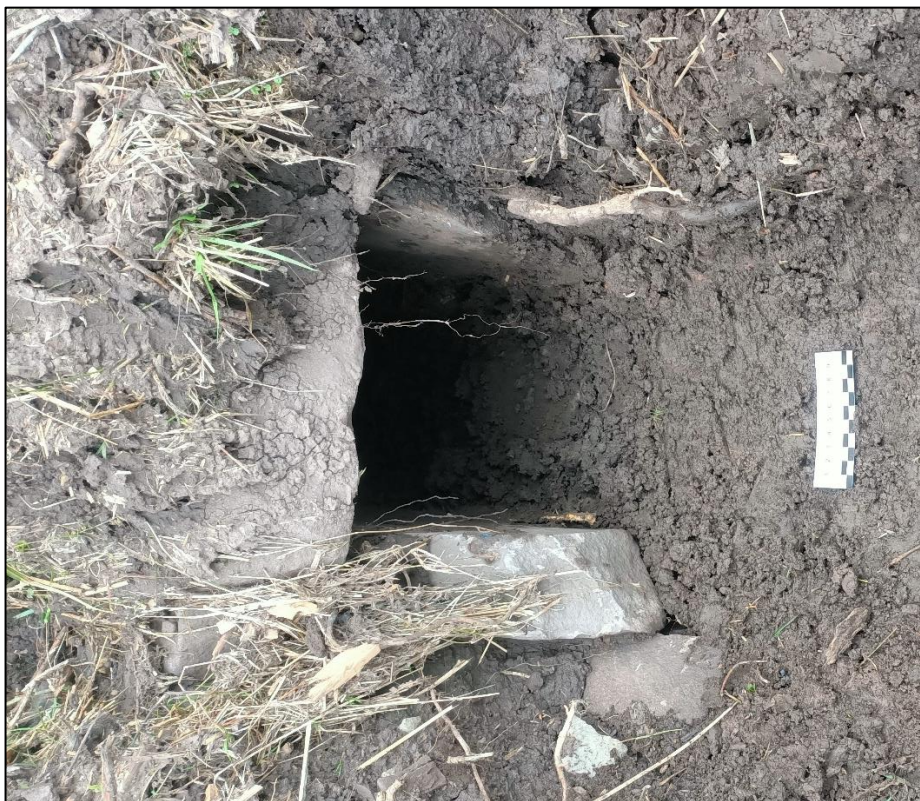
- 3.1.45 The outfall head of the culvert, situated on the western edge of the tramroad, included a horizontally laid, sandstone lintel slab [072], which in section measured approximately 0.28m in width x 0.06m in depth. Situated above this lintel was 0.15m of (070) This lintel was suspended above a pair of side walls, each of which were composed of lines of large slabs placed in single file along the culvert edge. The southern side wall has been numbered [073] while the northern has been numbered [074]. Both side walls measured 0.8m wide x 0.23m high. No basal slabs were observed. The entire outfall head has been numbered [075]. In profile, the opening of the outfall head measured 0.2 high x 0.25m wide.

Plate 18. Outfall head [075] of Historic Culvert X (ID43 in Appendix IV)
