# Marconi's Carnarvon Station 1912-1939

A journey into early commercial  
wireless in north Wales.

**John Rowlands**

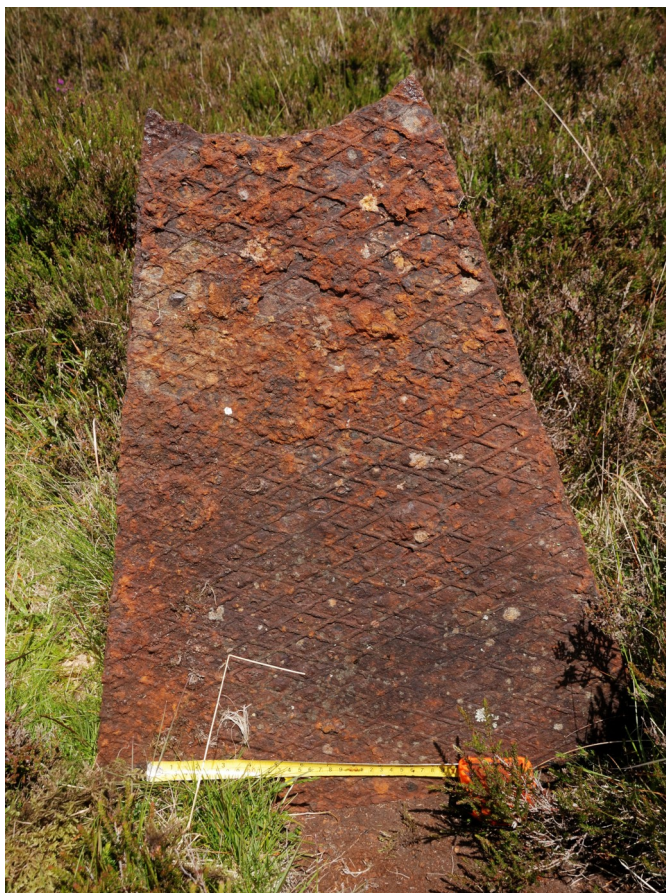
5. Tread steel plate, with inner and outer curved edges, possibly part of the standing area of a mast-top gallery, potentially Mast 8, which is seen in a 1939 British Pathé film reel ('Felling Wireless Masts at Carnarvon', Film ID: 1013.05, issued 1/06/1939) to fold on toppling, which might explain this plate being found 265', and not 400' from the mast base. Yellow part of tape open to 1 foot. 25¾" long, outer edge 21¾" long, inner edge 9½" long, ½" thick.

A gallery was fitted between the last and next-to-last tube unit at the top of the masts. This seems, from photographs, again of inadequate quality to be absolutely sure, to have had only a couple of steel plates either side of the mast top, rather than a continuous walkway all the way around. A section of tread steel plate was discovered in a position reflecting roughly where the top of Mast 9 might have come to rest (269' from its base) when the site was cleared in 1939. This may well be the tower seen falling, folding in the process (hence the 269' from the base, rather than ~400') to the north, recorded in a 1939 British Pathé newsreel about the demolition, work which was undertaken by Thomas William Ward Ltd., Sheffield – famous in earlier times for hiring an elephant and its keeper to haul trailers during WW1, when horses were in very short supply. The base bolts were first cut (see 21), and then the guys on one side blown with gelignite, causing the mast to "sway ominously". The steel plates of the masts were sent to the Rhondda Valley for use as water carriers (*Liverpool Daily Post*, 24/5/1939, p.13).

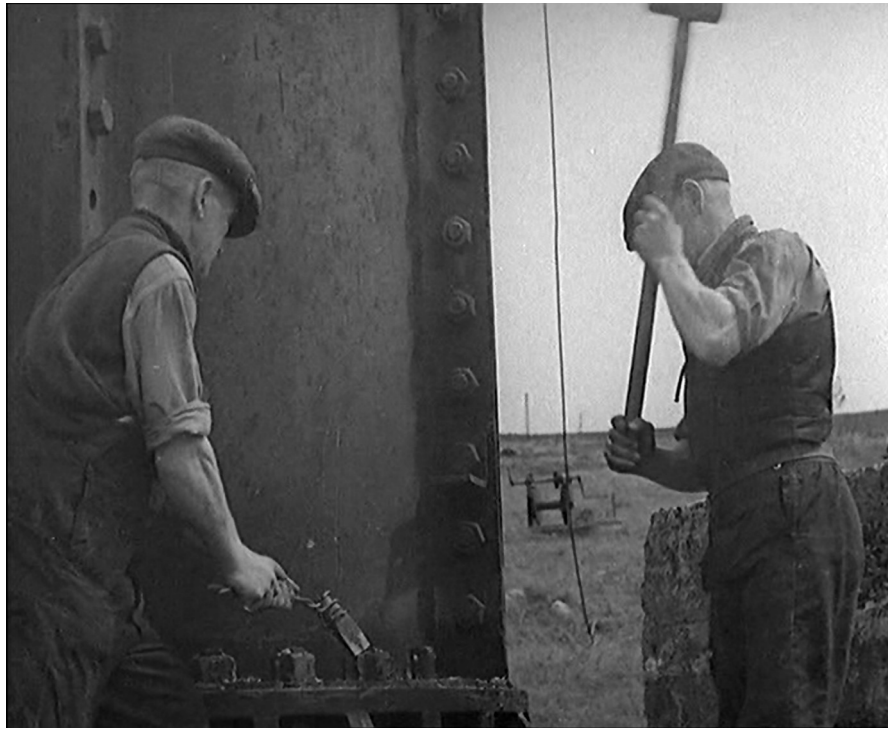
**21.** Hand-operated, empty triatic winch uphill of a mast during demolition in 1939. The scene shows the men splitting mast base-securing nuts with a sharp chisel mounted on a thick twisted-wire handle to eliminate impact shock to the user's hand. This usefully explains the numerous split nuts still to be found across the site. Source: © Reuters via British Pathé, Film ID: 1013.05, issue date: 1/06/1939, under licence.

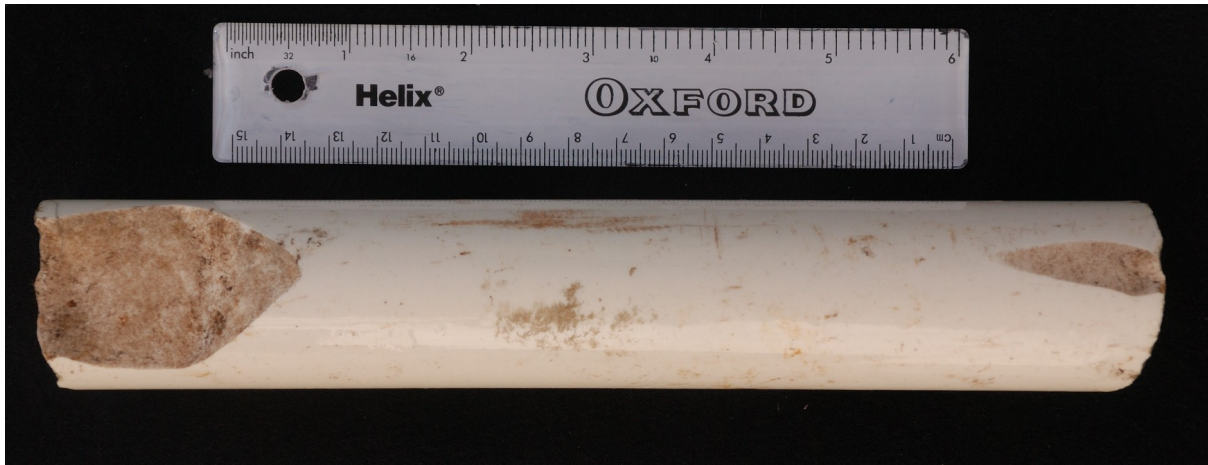
**28.** *Ceramic rod insulator fragment recovered at Carnarvon. These were used extensively around the site, including to hang radiator wires from triatics. Scale = 150mm/6"*

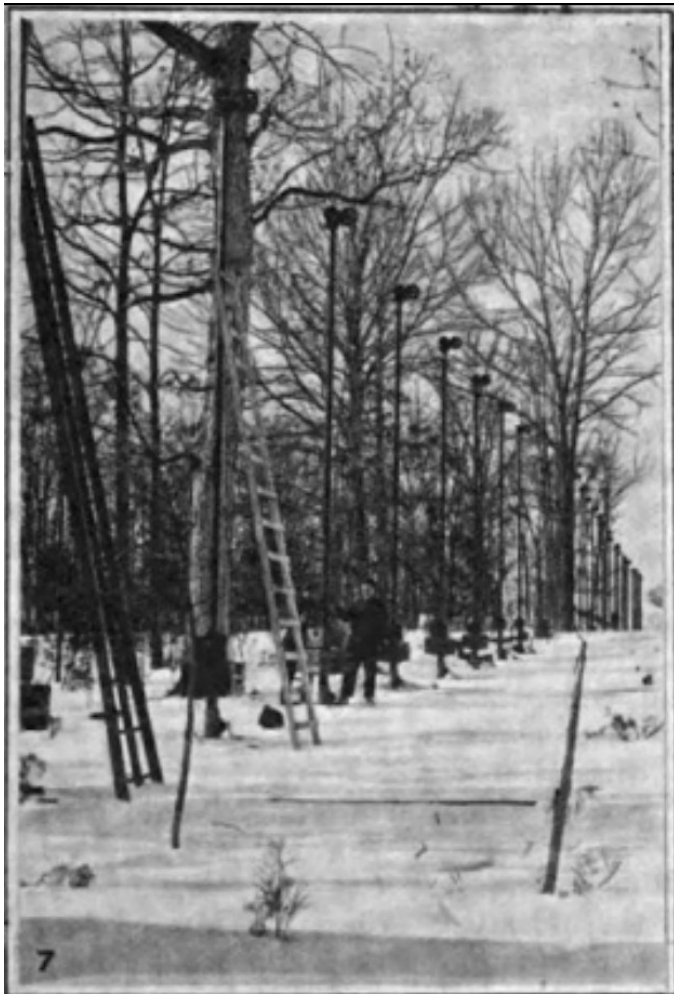
**30.** A poor copy image from *The Wireless World*, May 1914 (p.95, image 7 of a montage of 8), showing a row of wire tensioners at the Marconi, New Brunswick station, USA. Note pulleys at top, facing the antenna (off scene, to right), and coaxial weights near their bases. Height of the bases, taking the man to be an approximate guide, is about 22 feet. Chains attached to the bottom of the poles (just visible to the left of the ladder base, and still to be found at Marion and one base at Carnarvon) are of unknown function at the time of writing, but possibly for limiting the upwards extent of the weights' movement. See also **31-34**.

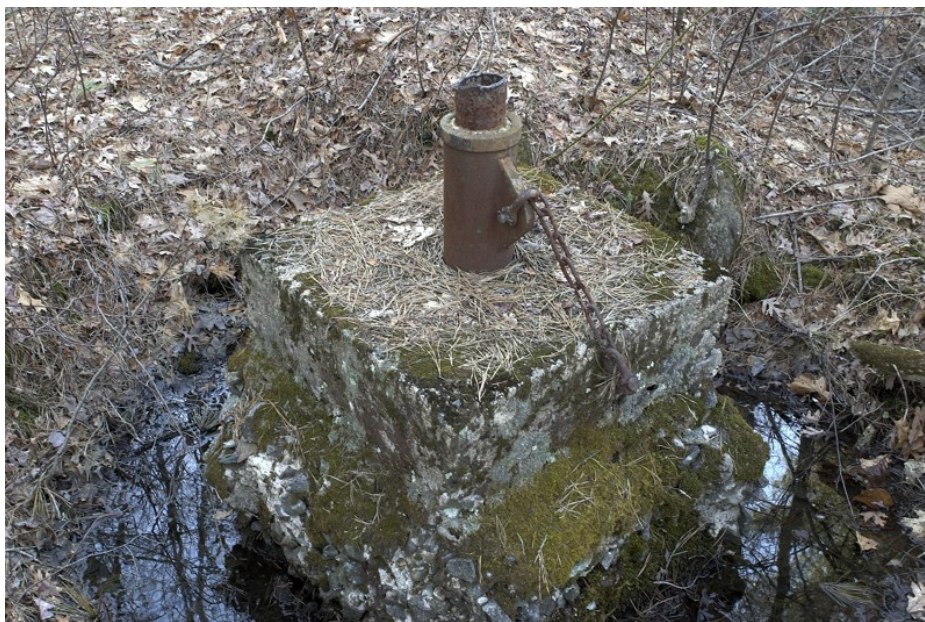
**33.** Wire strainer base at Marion, MA. Image by kind permission and © of Marian Howell via Sippican Lands Trust.

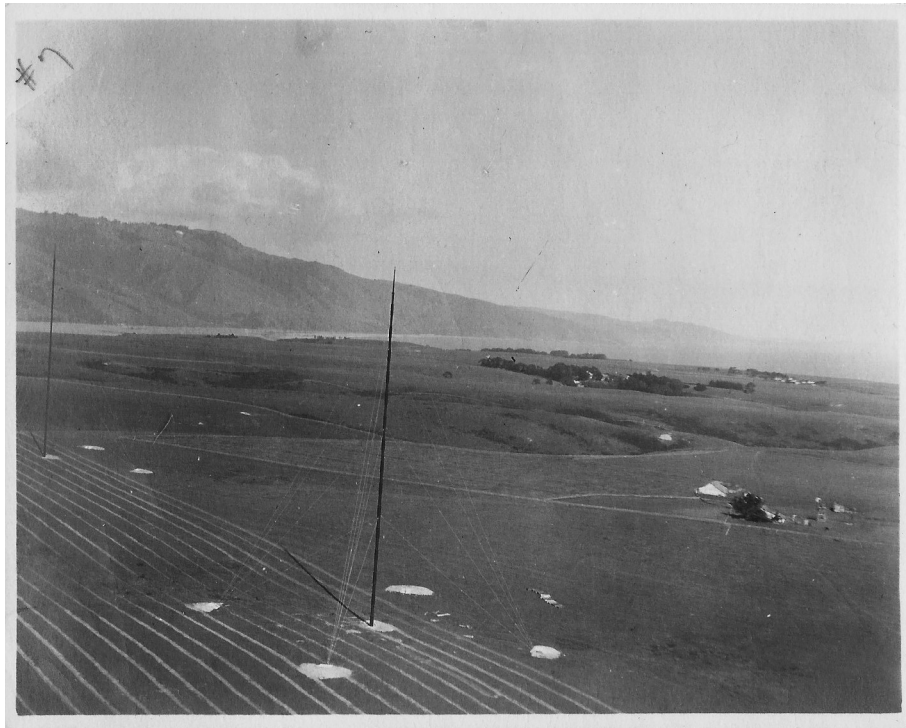
**42.** *The pattern of the earth screen at Bolinas is seen very clearly, running lower centre to centre left, in an aerial photograph of 1913/14 (based on date of construction and opening given by Bolinas Museum, CA), taken shortly after installation where the bright cut ground for the wires contrasts strongly with the surrounding grassy cover. The extent of Carnarvon's buried screen was almost certainly the same – to just inside the outer anchor blocks of each mast. Image courtesy California Historical Radio society*

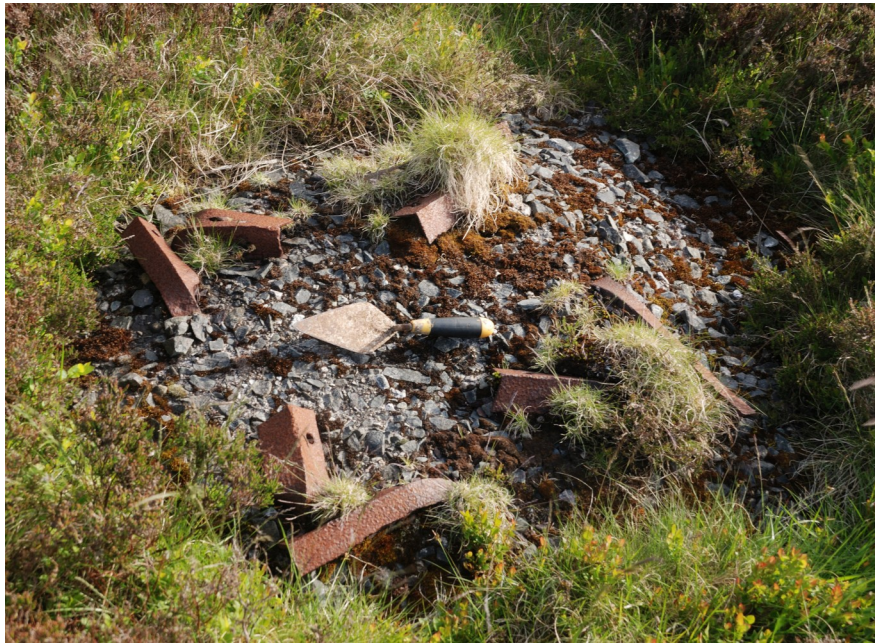
**48.** A typical concrete base for an elevated counterpoise lattice mast of the 1914 antenna, with remains of the mast legs ( $1\frac{3}{4}$ " x  $1\frac{3}{4}$ " L-section steel). Many of the bases can only now be found when the pattern of installation is worked out from those few that are more readily found, and the pattern of shallow trenches, of uncertain purpose, that are still seen to run between them. The bases in many parts of the lower end of the 1914 antenna are now fully buried by bog growth, whilst the bases for the 1923 extension are typically overgrown by dense, tall heather and, at the lower end, by bog growth. Trowel blade = 6"/15cm, bases typically 35"x35", lattice sides  $20\frac{1}{2}$ " x  $20\frac{1}{2}$ ".

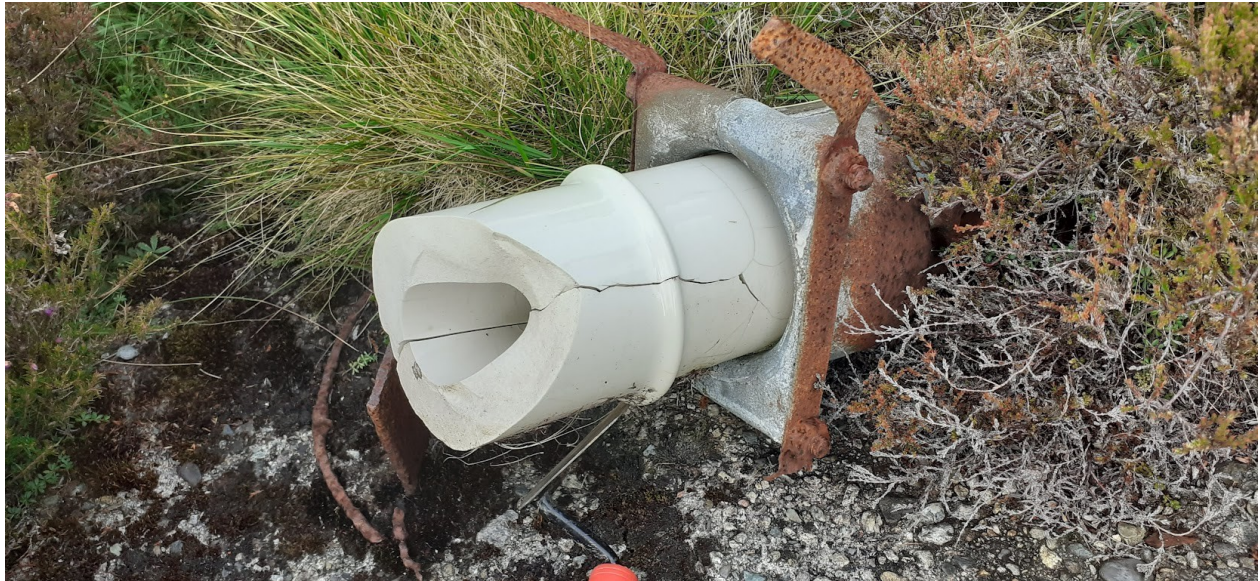
50. Detail of a 1923 counterpoise system insulator fixing (galvanised steel and ceramic).  
53.122355°, -4.171794°

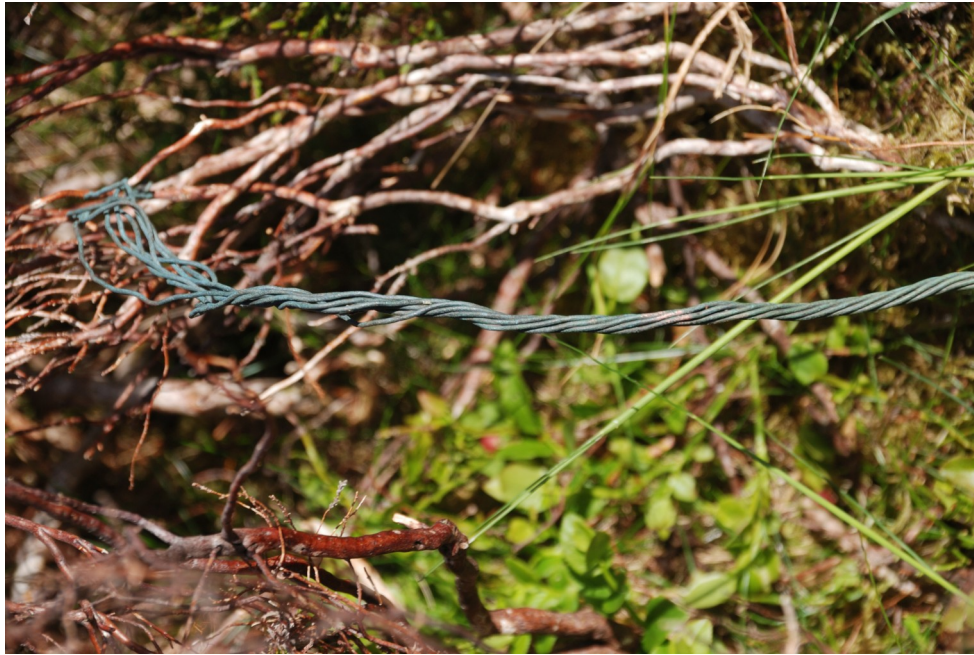
**53.** *Remnant wire found at the upper end of the 1923 extension. This is 7, rather than the 6-stranded wire generally seen around the 1914 site, though 7 strand was originally specified for the 1914 antenna.*

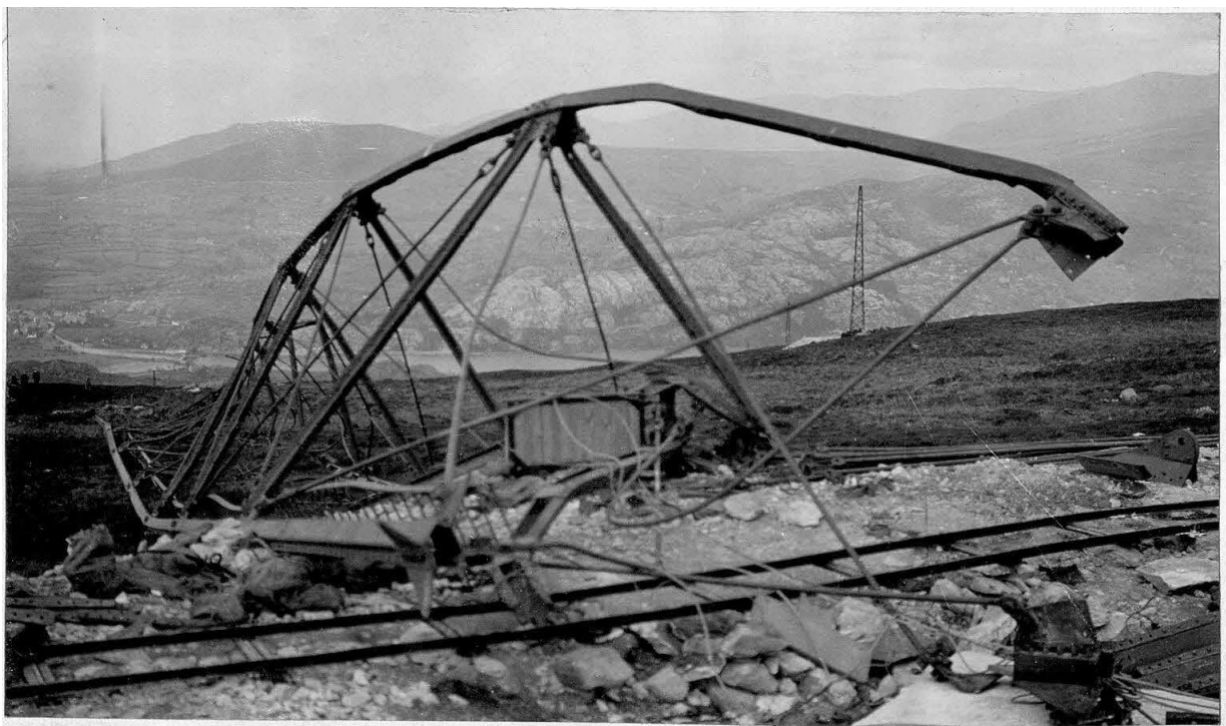
**59.** Total collapse of Mast 13 in a photo dated June 1923. The replacement was built on the same foundation blocks, but reallocated as Mast 17. Bodleian Special Collections MS.Photogr.c.243, photo 730/x.

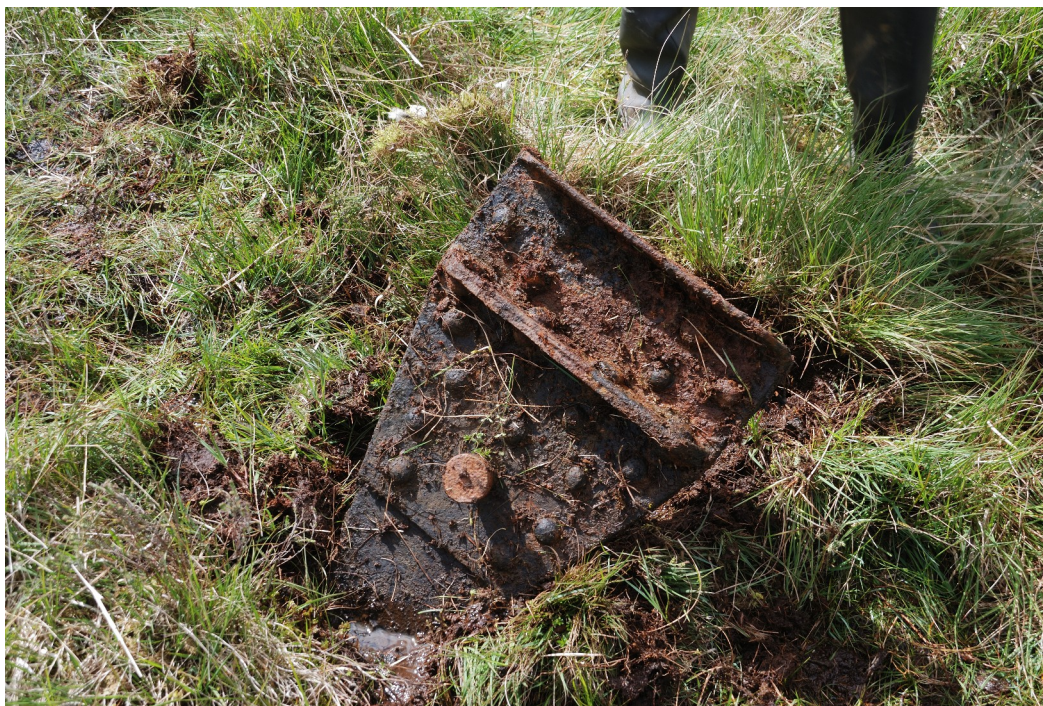
**60.** A chance discovery of a small, projecting piece of iron, made near to the field wall running down the hillside, revealed a large remnant that, on further examination, was seen to almost certainly be an upper part of the ill-fated Mast 13. Approximately 2' by 1½'. It appears to still be connected to a bracing rod, now buried in bog, under the apex at lower centre left. North to centre right. 53.125259°, -4.171007°.

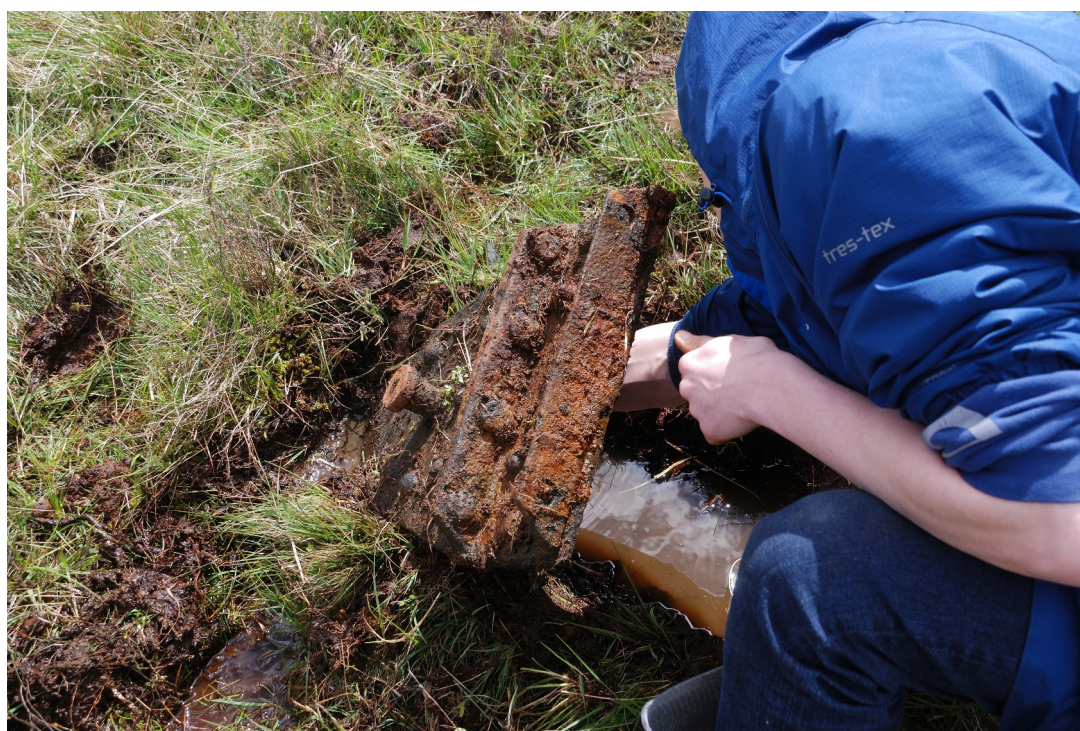
**61.** View of the end to which the fixing attached to Mast 13.

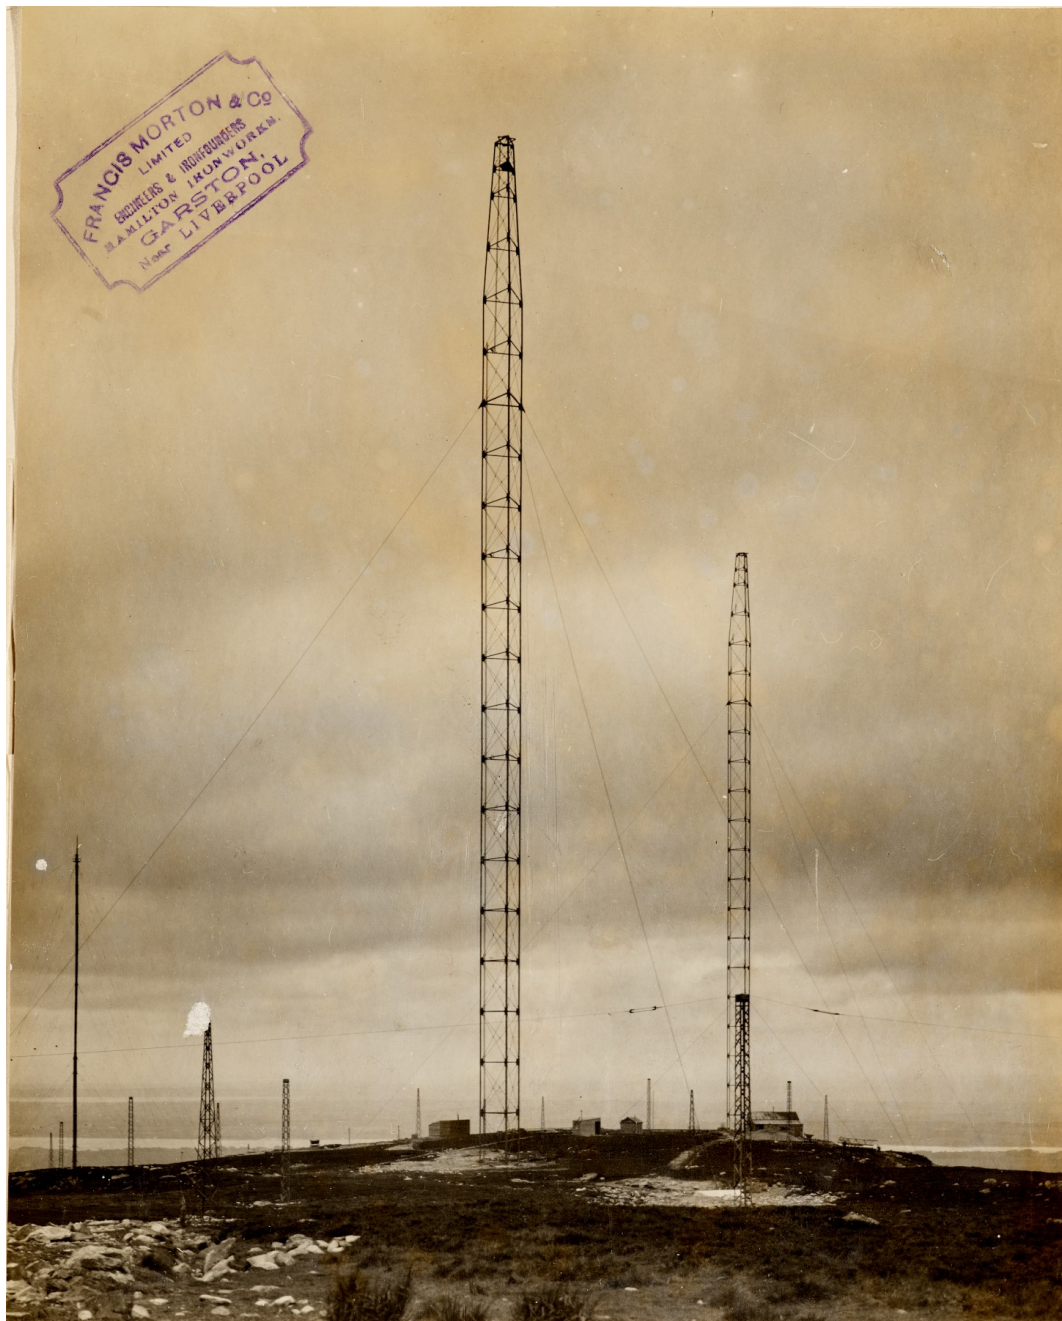
**65.** An extremely informative, chance-find photograph of Carnarvon from June 1923 (MS. Photogr. c. 244, a file dealing with Ongar and Brentwood stations, Essex), which appears to be correct dating and labelled photo 737/x. Mast 11 lies, without triatic and antenna wire as yet, in the background, behind blockhouse 5 which has a mixed stone/brick extension to the original, entirely-brick building, for use during the antenna extension's construction (see Appendix IV); blockhouse 6, out of shot to the rear of this photograph, is seen in photo 705/x of the same folder to already be missing its roof and semi-derelict by 1923, only 9 years after the armistice. Mast 12 lies at centre. Various small lattices, mostly or all for elevated counterpoise ('earth screen') support feature prominently, as does the upper, northernmost tube mast of the 1914 antenna, lower far left. What may be wire strainer poles are just visible above the horizon of the summit, lower left, though they were redundant by this time. The ca. 1921 extension, northern Pylon A, would dominate the view between the 1914 mast and Mast 12, but has clearly been removed by this point; one of its concrete base feet is visible at original scale.

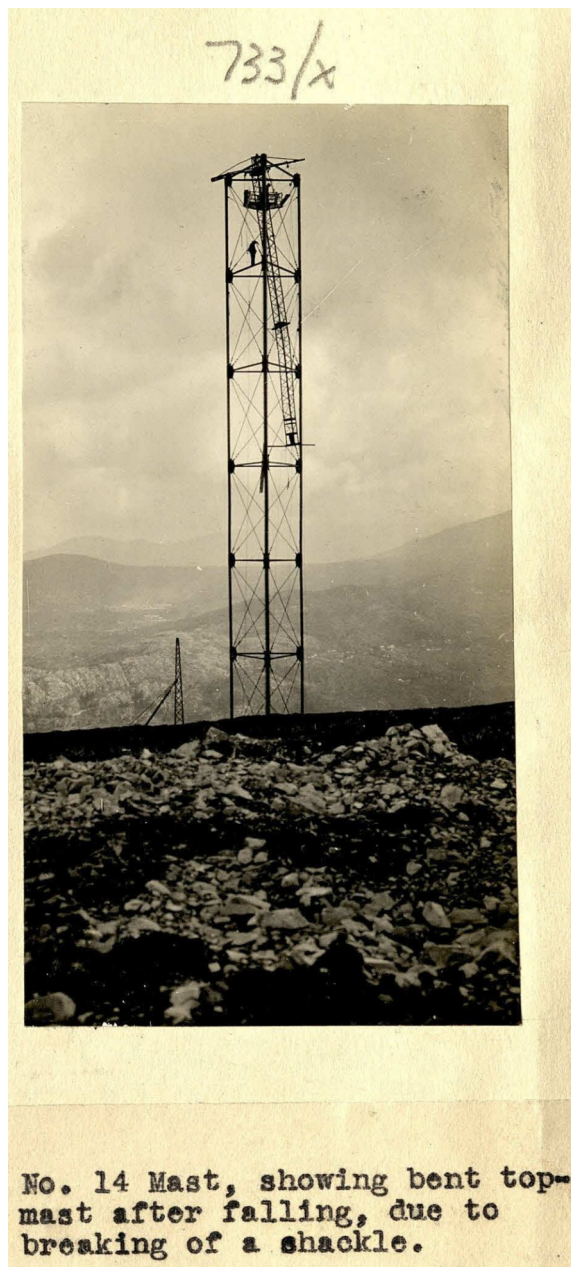
**68.** Bodleian MS. Photogr. c. 243 photo 733/x, showing failure of a shackle caused damage and may have been the event (the estimated height to the top of the main mast is about 90 feet) that caused the death of a worker, John Pierce Jones, in the same month (June, 1923), reported in the press (**69**, below, courtesy The British Newspaper Archive). The *Pall Mall Gazette* (also 5<sup>th</sup> June, 1923), on the same event, noted that Jones had just reached the top of the tower being built when he fell, being “killed instantly”; he left behind a widow and four children.

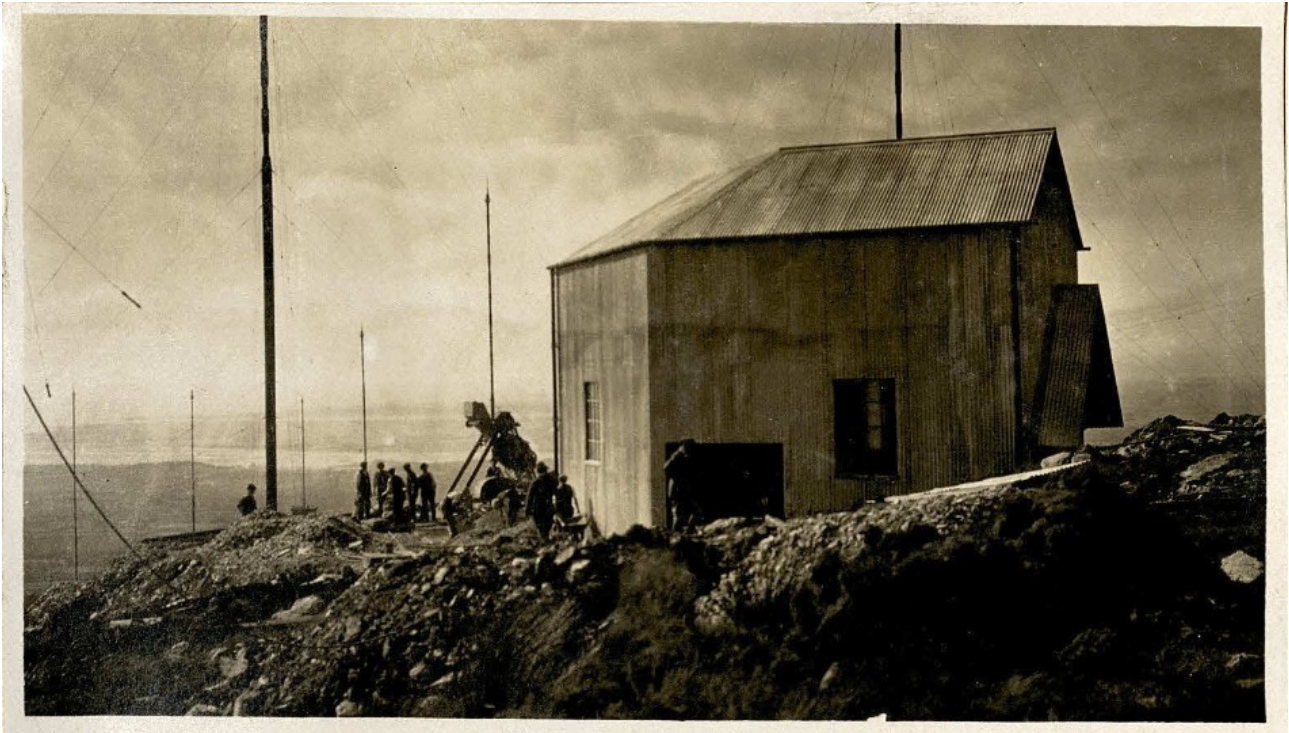
**72.** A very atmospheric photograph of the double inductor ('ATI') house during construction in early 1923. MS.Photogr.c.243, photo 711/x. The dark line across the building appears to be an old water stain on the image. Note the slack wire running steeply from ground at lower right; this may be evidence the 1921 pylons are still in place. A rod-insulated wire is also seen and may have been for tensioning, acting forwards, but removed from its pole.

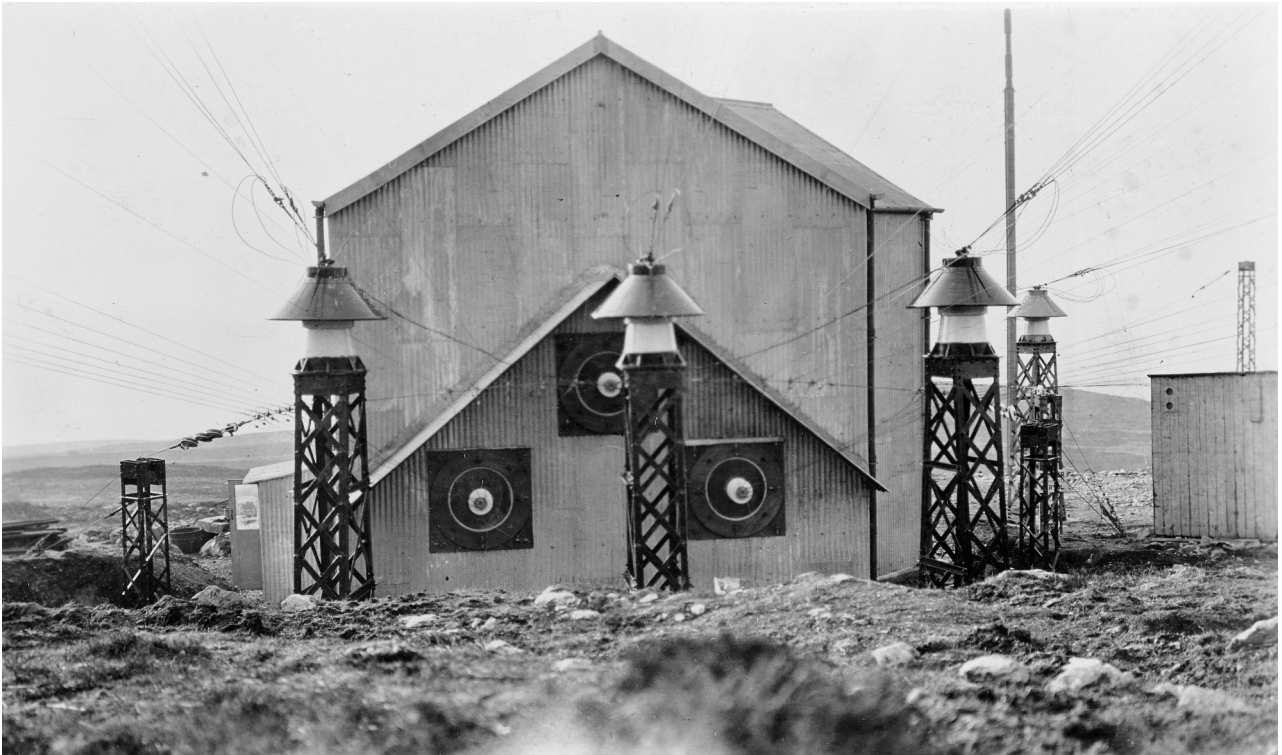
**73.** Double ATI scene (MS. Photogr. c.24, 745/x). The three lattice supports in the foreground were set on concrete bases on an elevated, rocky platform between the foreground and end of the building. The central base was sought and confirmed during fieldwork (see 75). Bodleian Special Collections.

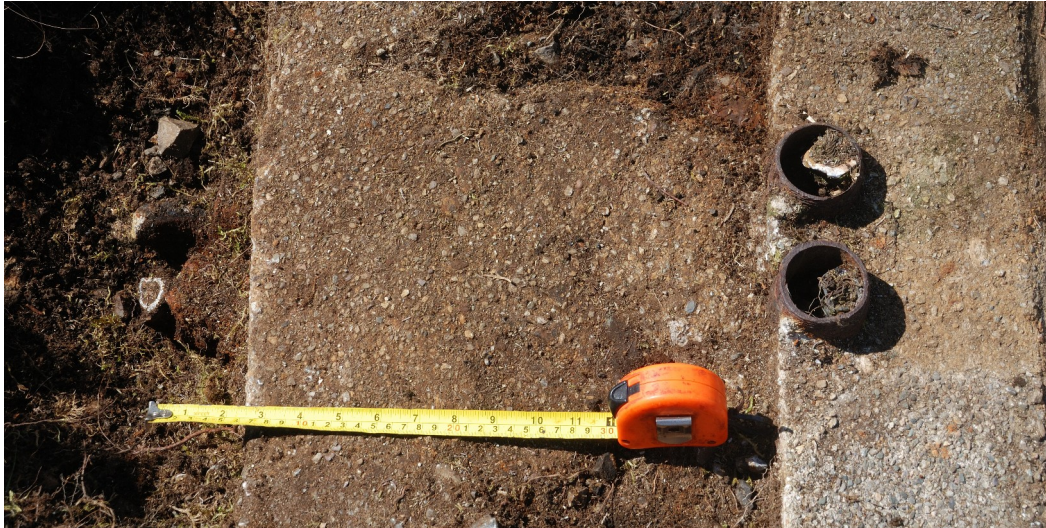
**82.** GLC feedline entering the double ATI base, left, emerging within the building through iron tubes, right and **83**, below:

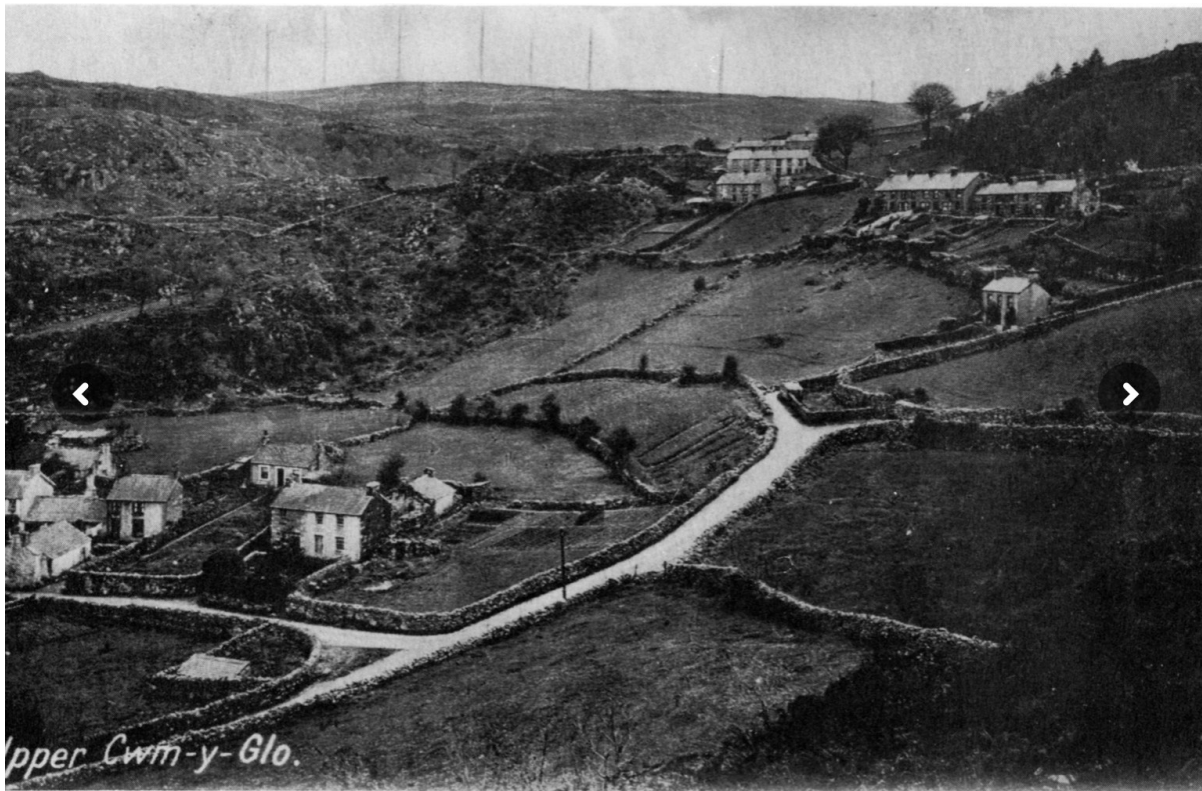
**91.** A photo from Cwm y Glo, date unknown but post-mid-1923 due to the presence of the antenna extension, shows what seems to be a steel lattice tower on the ridge, appearing above and behind the uppermost terraced houses, could be accurately triangulated, but no trace of it, nor of any stay anchors, was found at the site. It remains unexplained, but could conceivably be the rear support for the lengthened GLJ. Photo courtesy of Cyngor Cymuned Llanrug web site.

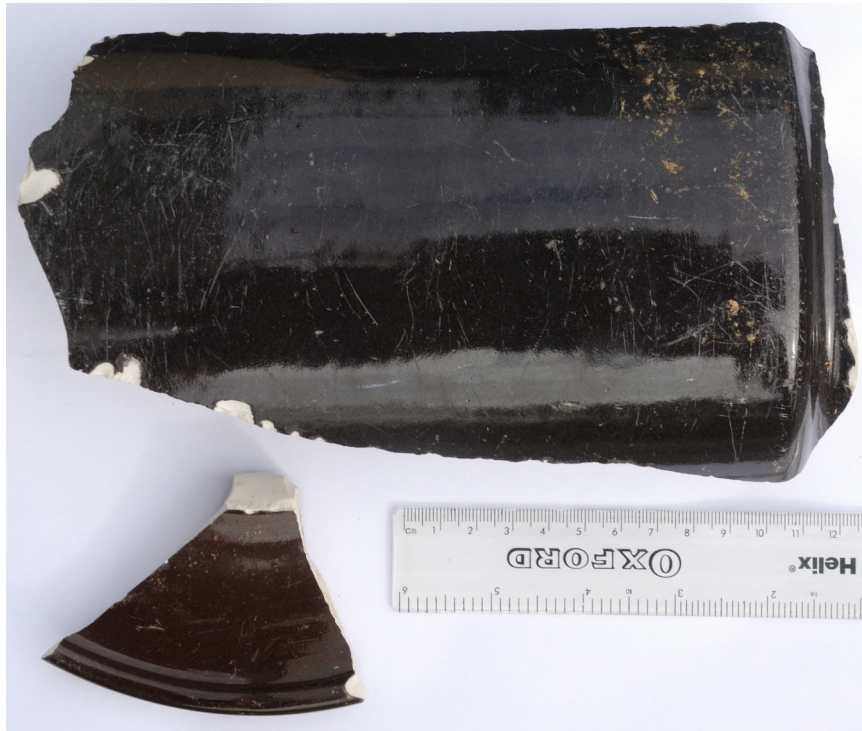
**111.** *Brown-glazed ceramic insulators found lying next to the octagonal concrete base.*

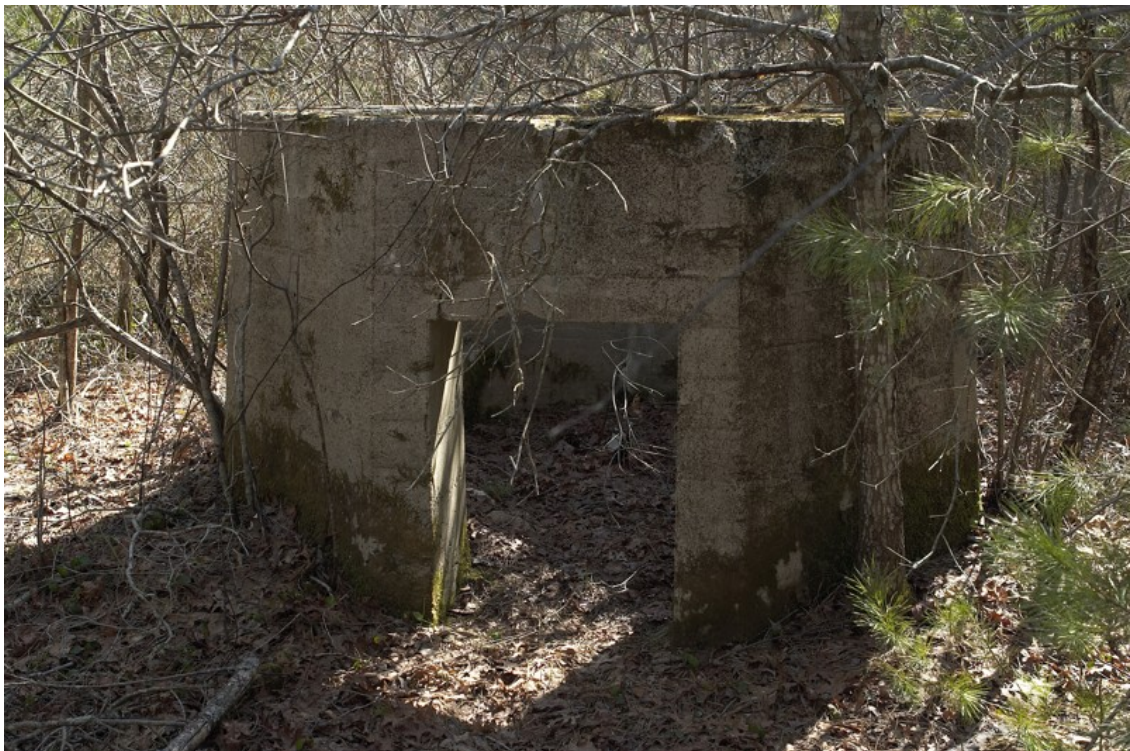
**112.** *Other than the use of horizontal shuttering to construct it, an apparently identical octagonal inductor base at the Marconi station of Marion, MA, USA. Courtesy and © 2008, M. Howells via Sippican Lands Trust.*

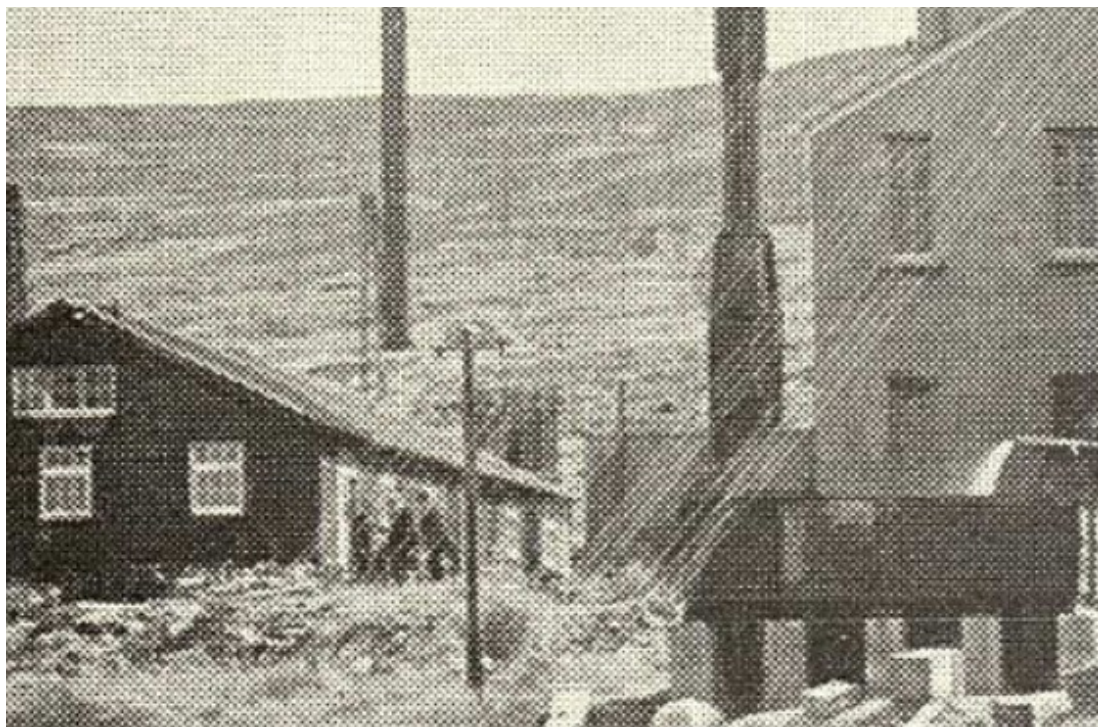
**116.** Detail from a larger, poor quality image that nevertheless distinctly shows (centre, just behind and to right of the telegraph-type pole), an inductor at the position of the octagonal base in foreground in **114**. Bodleian Special Collections MS.Marconi.198. The line of the bases to the side of the transmitter house is that of the elevated counterpoise; it is not clear if they were for feed or counterpoise tuning.

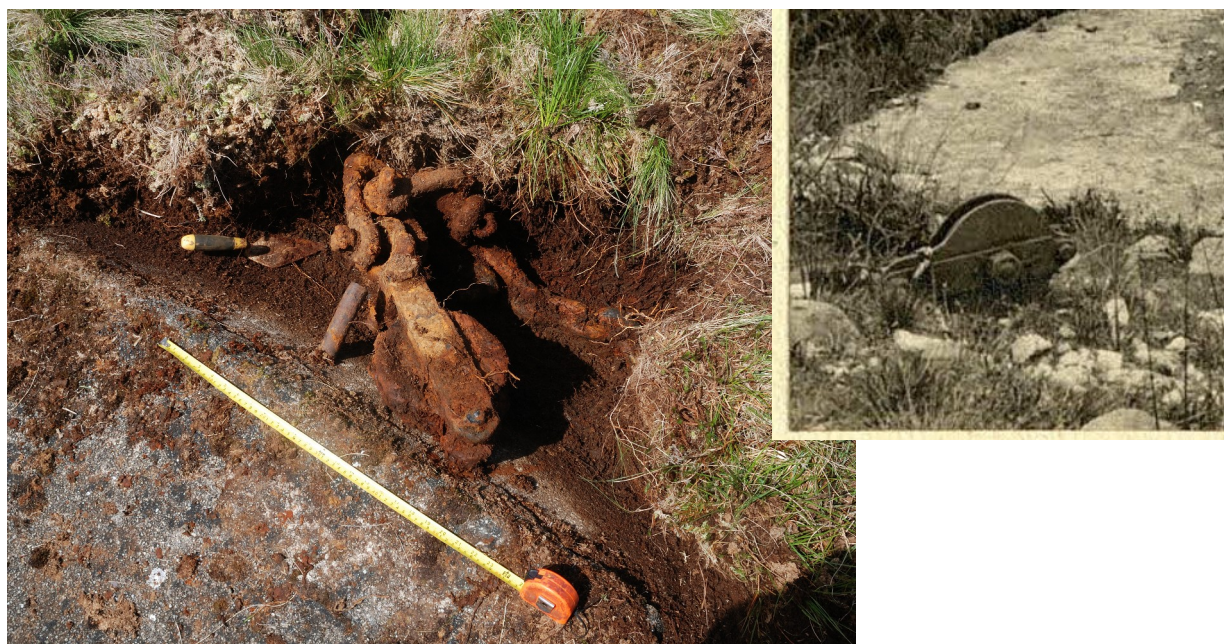
**117.** *Pulley, attached to a series of shackles and a substantial chain still in position next to a base with a cut loop attachment, seemingly forgotten during salvage. A similar, but not identical pulley is seen in Bodleian Archive MS.Photogr.243, photo P.2093 (inset detail, top right). Its purpose in relation to the 1923 antenna is not yet certain, but initially appears to have been related to backstaying of the elevated counterpoise masts. Pulley wheel = 8" diameter, clamp body 1 ¾" thick, top running width 27mm, inner running width 9mm, running groove depth ¾". Shackles 9½ height, 2 ½" inside width, 5" external width, securing pin 2" diameter head, ¾" central hole. 53.120944°, -4.172144°.*

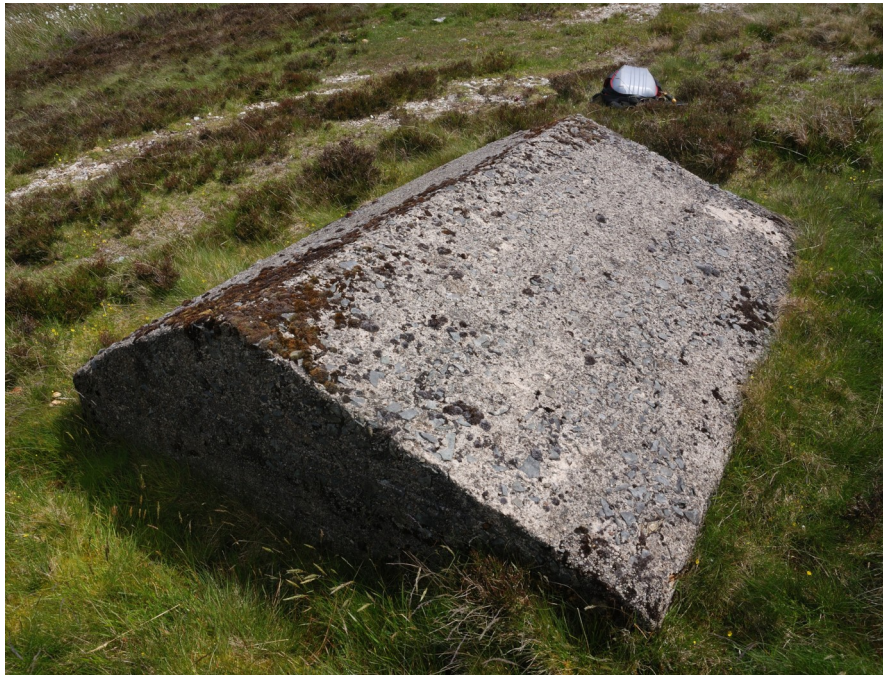
**120.** Anchor blocks are located to the north and south, opposite each pair of support masts for the 1914 antenna. They all have a (now) cut, substantial loop attachment. The purpose is not known with certainty, but would appear to be either additional head-straining stay anchors, or for tensioning triatic steel ropes between the mast heads. 138" wide along rear; 82", 10° sloping rear length, ~2' long 43½° sloping antenna-facing side. Southern boundary, between mast anchors 7A and 7D, at 53.121199°, -4.183082°.

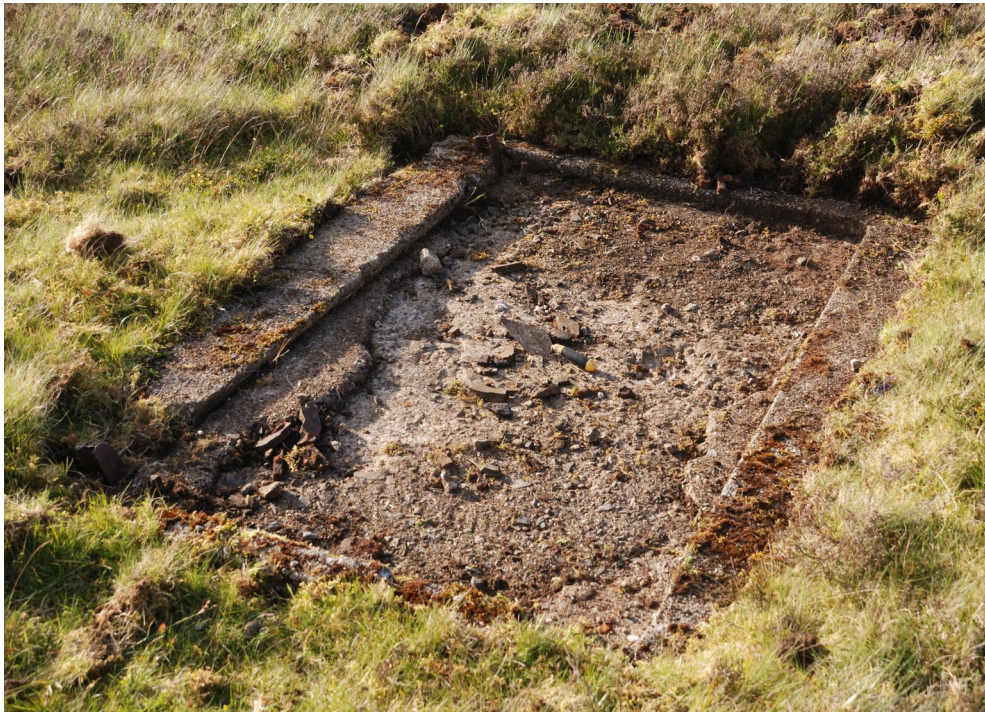
**125.** Entirely grassed-over when discovered, surface clearing revealed a large concrete base with corner bolts, iron spacers and two trackway rails protruding, leaning slightly towards the south-west. Thought to be a trackway winder base serving a trackway running downhill to the west, to a quarrying area behind the 1914 upper masts. Located immediately to the NE of 1921 extension, northern Pylon A. 53.123001°, -4.171694°.

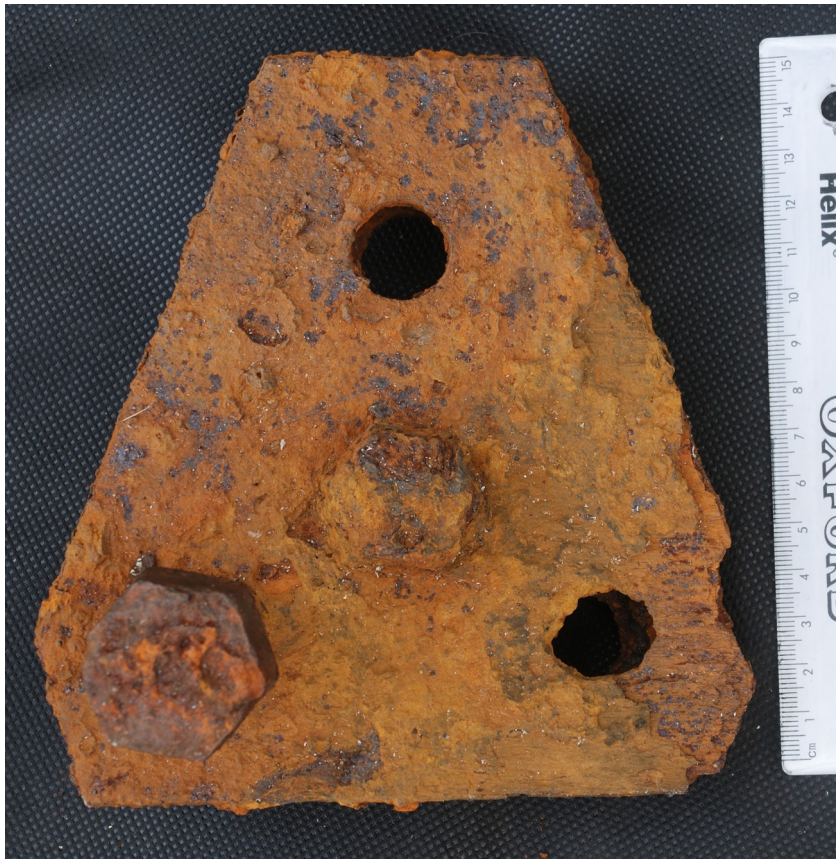
**134.** An anchor-to-two-stay attachment plate. The top hole bolted to the loop on the anchor, the lower holes, one with a bolt still in position, each attached a stay wire. This was found near the wall and below blockhouse 5 on the upper part of the 1923 extension site. It may have been one of the main anchor attachment plates. Found as bolt surface protrusion, at 53.122857°, -4.173596°.

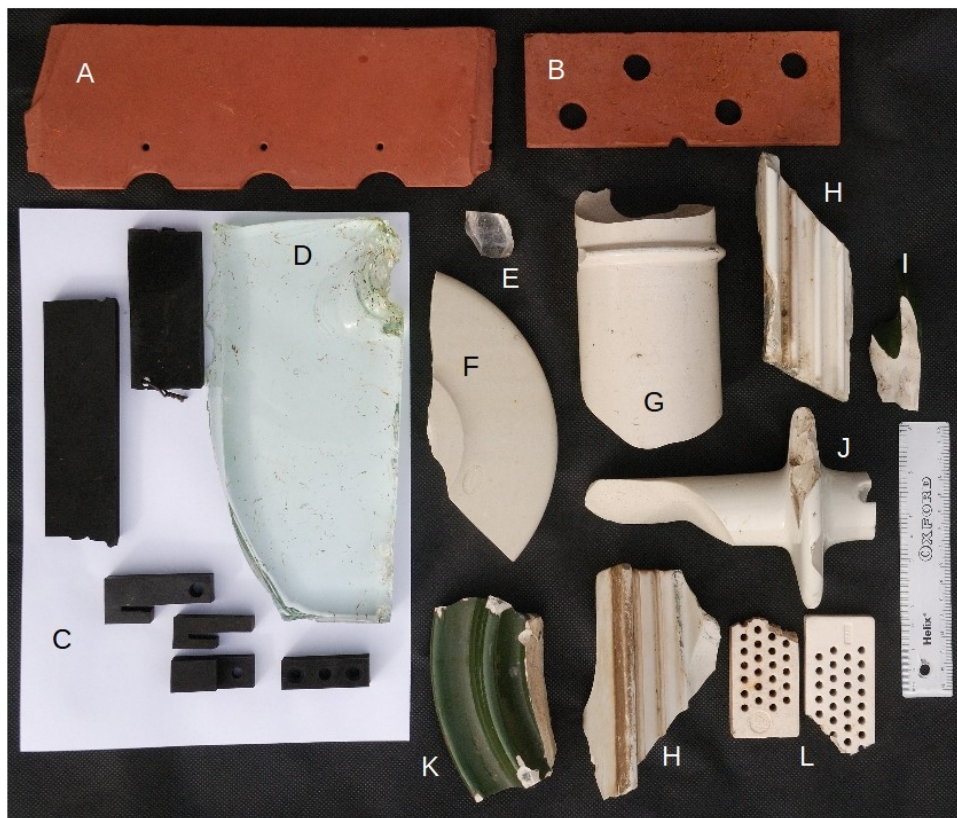
**C1.** A selection of ceramic fragments commonly found, mostly in relation to the ATI house sites. Rule = 15cm/6”.
