# Marconi's Carnarvon Station 1912-1939

A journey into early commercial  
wireless in north Wales.

**John Rowlands**

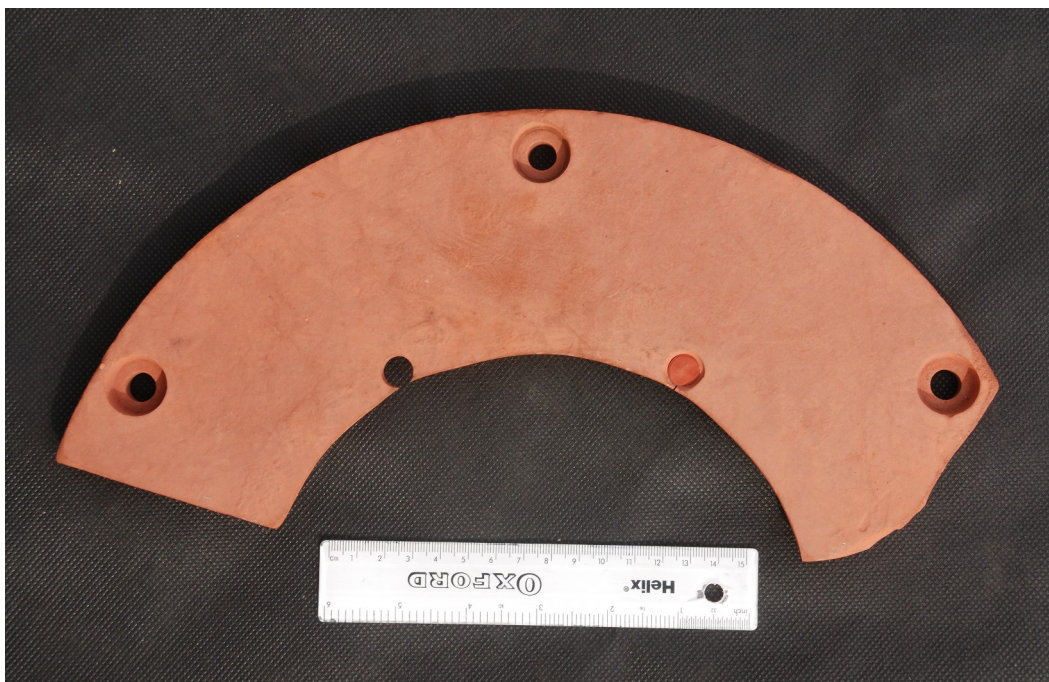
**C11, above.** Toroid disc insulator (rear face) of unglazed ceramic, with bolt holes and ceramic, threaded bolts. Found at double inductor house, almost certainly the base or top mounting insulator for a smaller inductor. The GLC circuit detail allows probable identification as inductor 1'2, indicated as having a diameter of 1'2", with 86 wire turns.

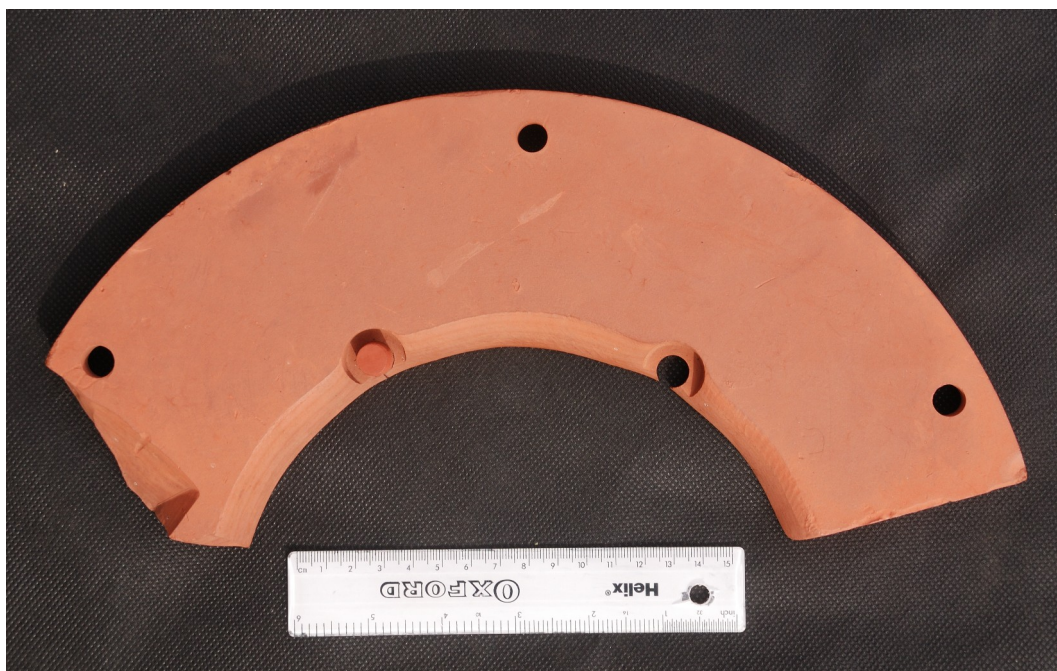
**C12, below.** Upper face. Width variable, 85-88mm; inner diameter =  $7\frac{1}{4}$ "; outer diameter = 14"; thickness = 18mm. Scale = 15cm/6". Inner perimeter apparently hand-chamfered.

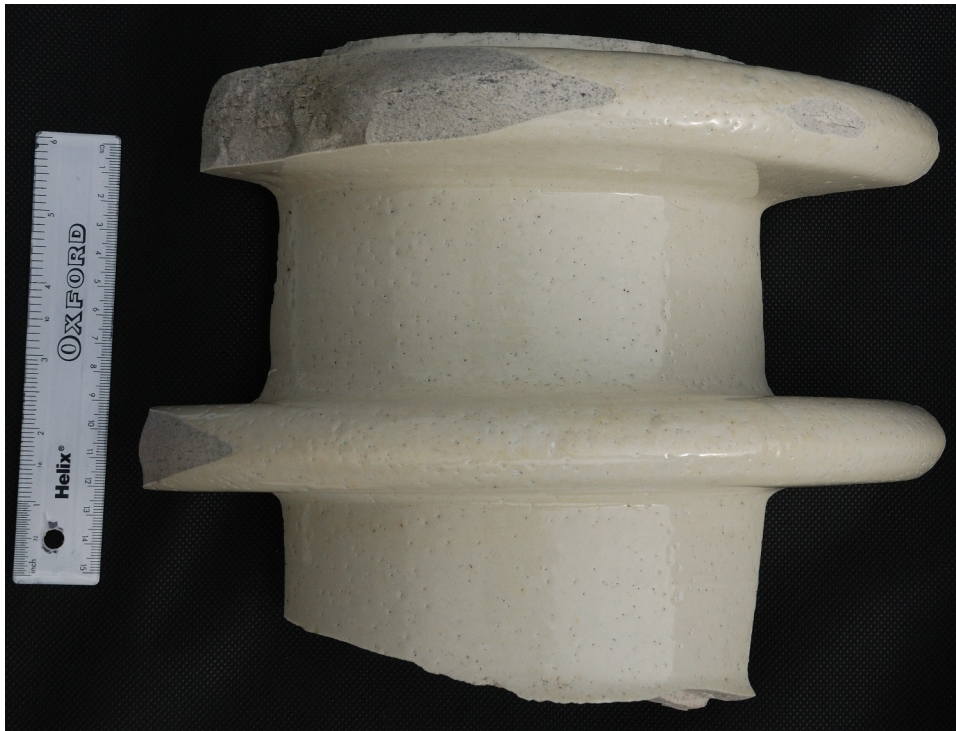
**C15.** A very large, cream-white glazed insulator found at a brake/winding base at the top of the incline for construction of the 1923 extension. This was one of the through-wall insulators seen in several photographs of the inductor ('ATI') houses; intact examples are still seen at the transmitter house. Connections were made to a metal plate with a conductor that ran within the insulator and thus passed through building walls. Its position at the top of the incline suggests it was one of the lower inductor house insulators, probably discarded as of no further use after being transported with scrap metal by rail truck to the summit of Cefn Du. Numerous fragments of the same type of insulator, but with a whiter glaze, were found buried in a nearby boggy pool (marked in context, below, at 53.123069° -4.171382°).

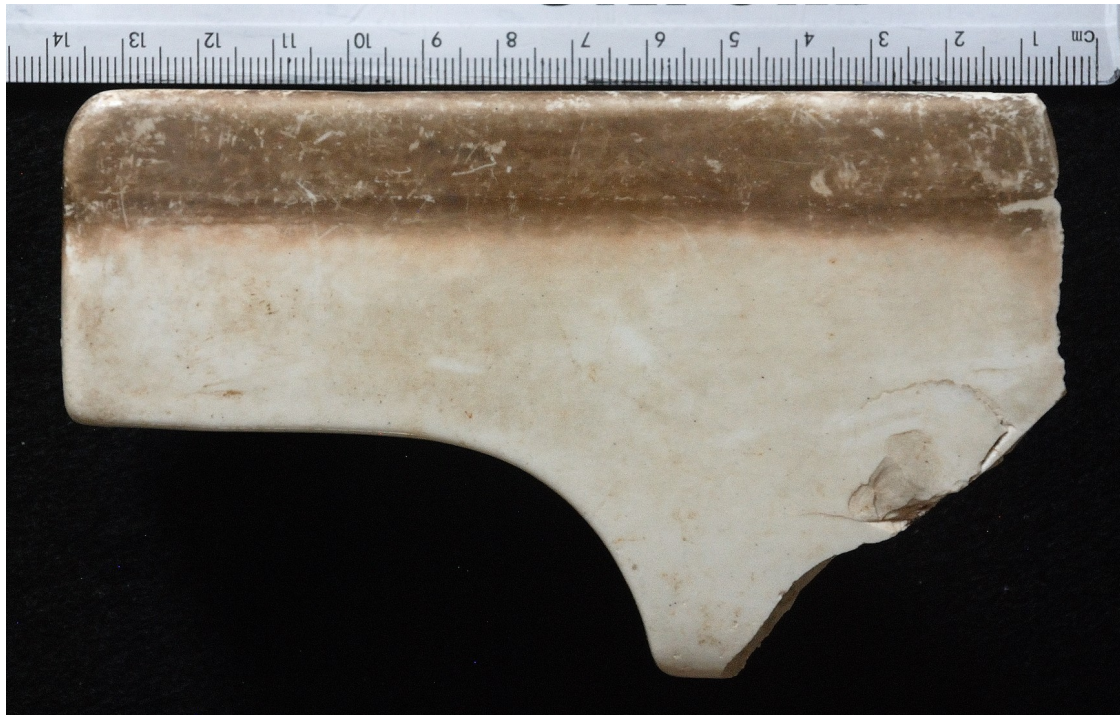
**C19.** Side view of one end of the insulator. No maker's impression has been found on any fragment to date. Scaling from images to fragments allowed the intact length of these insulators to be determined as ~2 feet at the top, ~16" at the bottom.

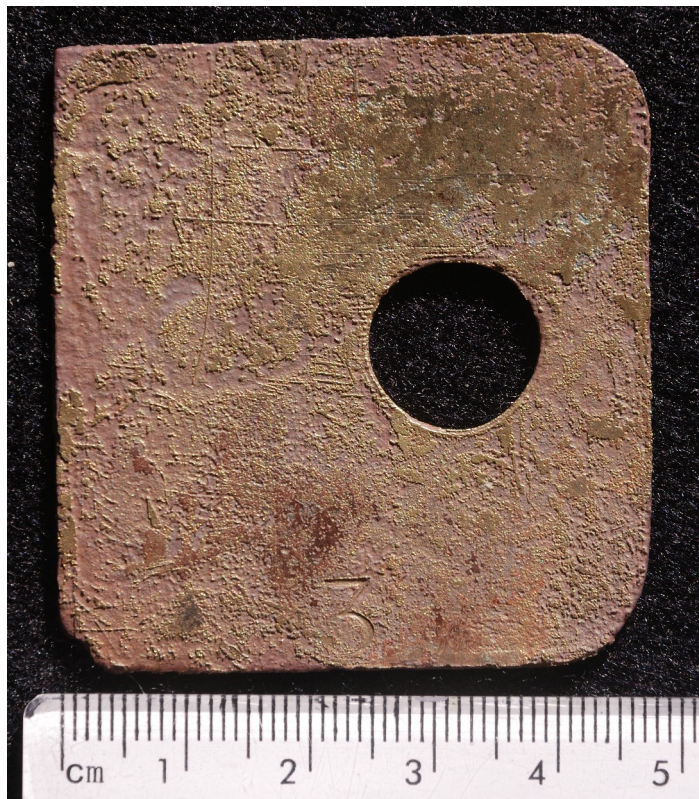
**C22.** Numbered connector tag, probably of an oil-and-glass capacitor from upper ATI house.
