# Marconi's Carnarvon Station 1912-1939

Archaeological Reconstruction  
and History of a Trans-Oceanic  
Wireless Site

**John Rowlands**

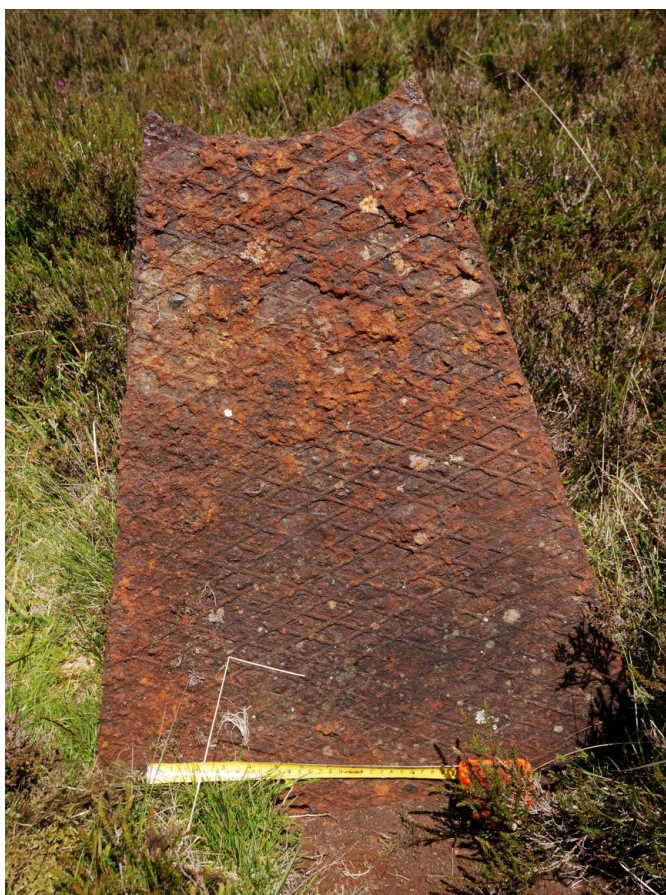
5. Tread steel plate, with inner and outer curved edges, possibly part of the standing area of a mast-top gallery, potentially Mast 8, which is seen in a 1939 British Pathé film reel ('Felling Wireless Masts at Carnarvon', Film ID: 1013.05, issued 1/06/1939) to fold on toppling, which might explain this plate being found 265', and not 400' from the mast base. Yellow part of tape open to 1 foot. 25¾" long, outer edge 21¾" long, inner edge 9½" long, ½" thick.

A gallery was fitted between the last and next-to-last tube unit at the top of the masts. This seems, from photographs, again of inadequate quality to be absolutely sure, to have had only a couple of steel plates either side of the mast top, rather than a continuous walkway all the way around. A section of tread steel plate was discovered in a position reflecting roughly where the top of Mast 9 might have come to rest (269' from its base) when the site was cleared in 1939. This may well be the tower seen falling, folding in the process (hence the 269' from the base, rather than ~400') to the north, recorded in a 1939 British Pathé newsreel about the demolition, work which was undertaken by Thomas William Ward Ltd., Sheffield – famous in earlier times for hiring an elephant and its keeper to haul trailers during WW1, when horses were in very short supply. The base bolts were first cut (see 21), and then the guys on one side blown with gelignite, causing the mast to "sway ominously". The steel plates of the masts were sent to the Rhondda Valley for use as water carriers (*Liverpool Daily Post*, 24/5/1939, p.13).

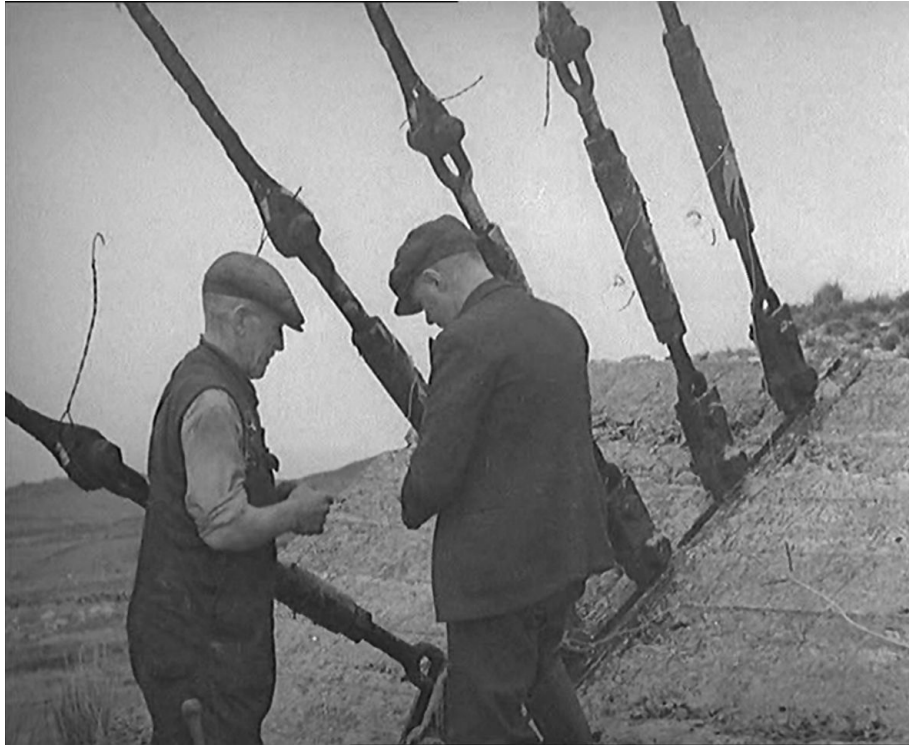
**6.** *Preparations for stay cutting with explosives (method confirmed in Aberdeen Evening Express, 24<sup>th</sup> May, 1939, p.5 and Liverpool Daily Post of the same date, p.13), during May 1939. Five stay attachments are seen. Other photographs show seven stay wires. This is explained by two wires being attached, via a trapezoid plate, to each of the lower two anchor attachment rings (plate just visible lower centre). In this image, and in another of the tower immediately before felling, some of the lower stays have already been detached. The projecting thin wires appear to be copper grounding wires (cut) between stays. Image © Reuters via British Pathé, still N°. 7, Film ID: 1013.05, issue date: 1/06/1939, under licence.*

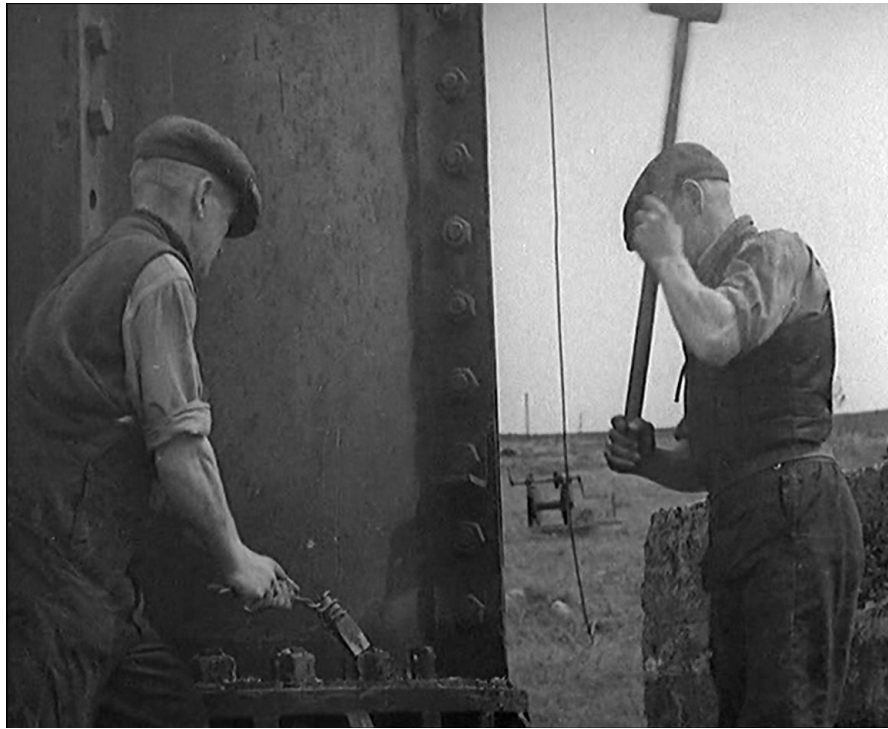
**21.** Hand-operated, empty, possibly triatic winch uphill of a mast, almost certainly Mast 1, given the concrete anchor to the immediate right of the hammer-wielding gentleman, during demolition in 1939. The scene shows the men splitting mast base to tube-securing nuts with a sharp chisel mounted on a thick twisted-wire handle to eliminate impact shock to the user's hand. This usefully explains the numerous split nuts still to be found across the site. Source: © Reuters via British Pathé, Film ID: 1013.05, issue date: 1/06/1939, under licence.

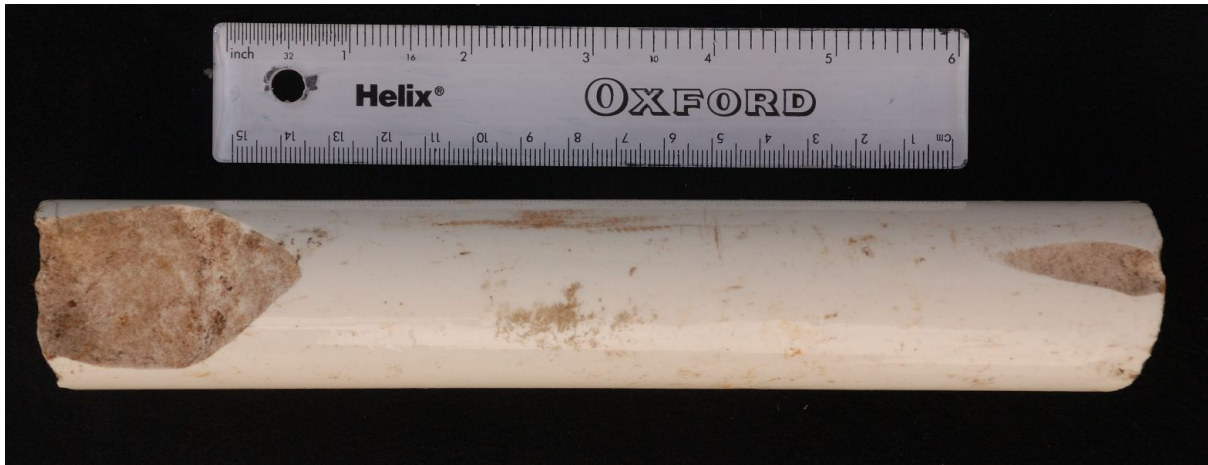
**28.** *Ceramic rod insulator fragment recovered at Carnarvon. These were used extensively for various purposes around the site. Scale = 150mm/6"*

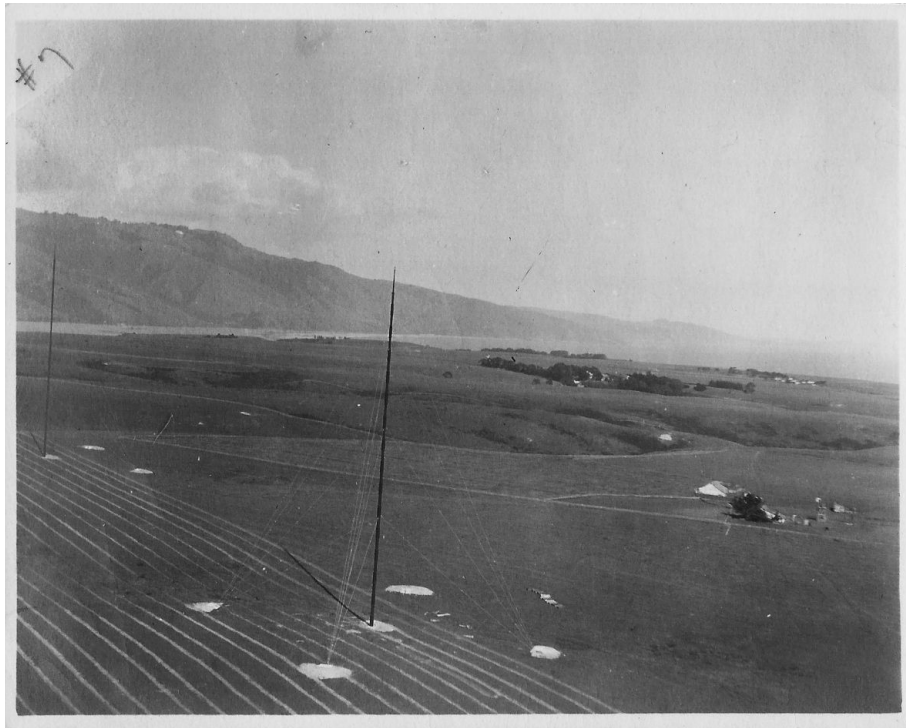
**42.** The pattern of the earth screen at Bolinas is seen very clearly, running lower centre to centre left, in an aerial photograph of 1913/14 (based on date of construction and opening given by Bolinas Museum, CA), taken shortly after installation where the bright cut ground for the wires contrasts strongly with the surrounding grassy cover. Survey at Carnarvon shows the extent of its buried screen was the same – to just inside the outer anchor blocks of each mast. Image courtesy California Historical Radio society

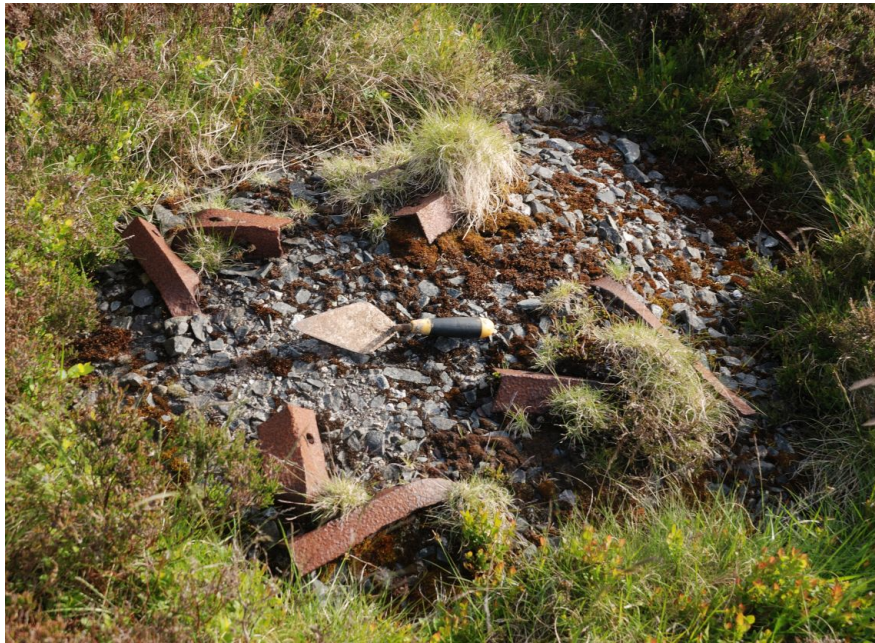
**48.** A typical concrete base for an elevated counterpoise lattice mast of the 1914 antenna, with remains of the mast legs ( $1\frac{3}{4}$ " x  $1\frac{3}{4}$ " L-section steel). Many of the bases can only now be found when the pattern of installation is worked out from those few that are more readily found, and the pattern of shallow trenches for ground wires that are still seen to run between them. The bases in many parts of the lower end of the 1914 antenna are now fully buried by deep bog growth, whilst the bases for the 1923 extension are typically overgrown by dense, tall heather and, at the lower end, by bog growth. Trowel blade = 6"/15cm, bases typically 35"x35", lattice sides  $20\frac{1}{2}$ " x  $20\frac{1}{2}$ ".

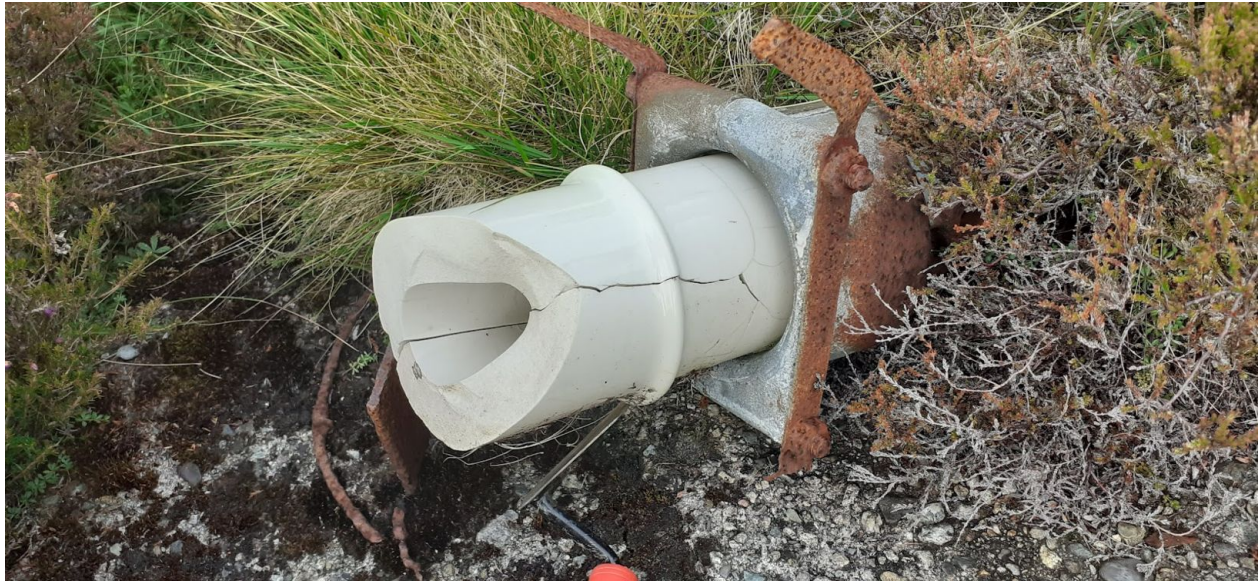
50. Detail of a 1923 counterpoise system insulator fixing (galvanised iron and ceramic).  
53.122355°, -4.171794°

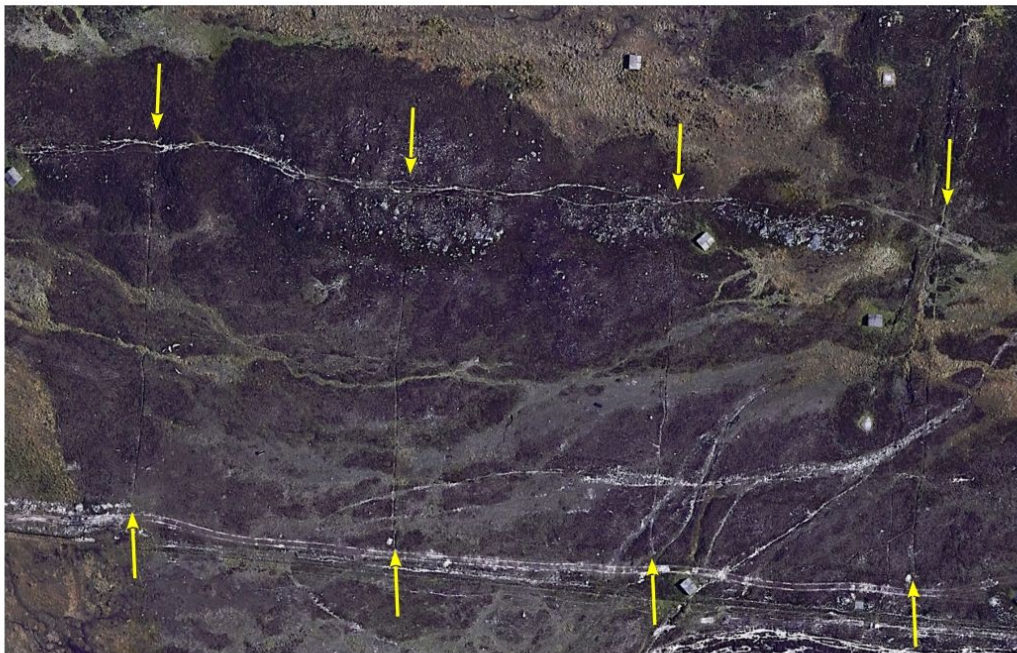
**51.** Arrows indicate obvious cuts in the ground running along a roughly N-S line between counterpoise masts (or existed beforehand). The cuts are also obvious from ground level.

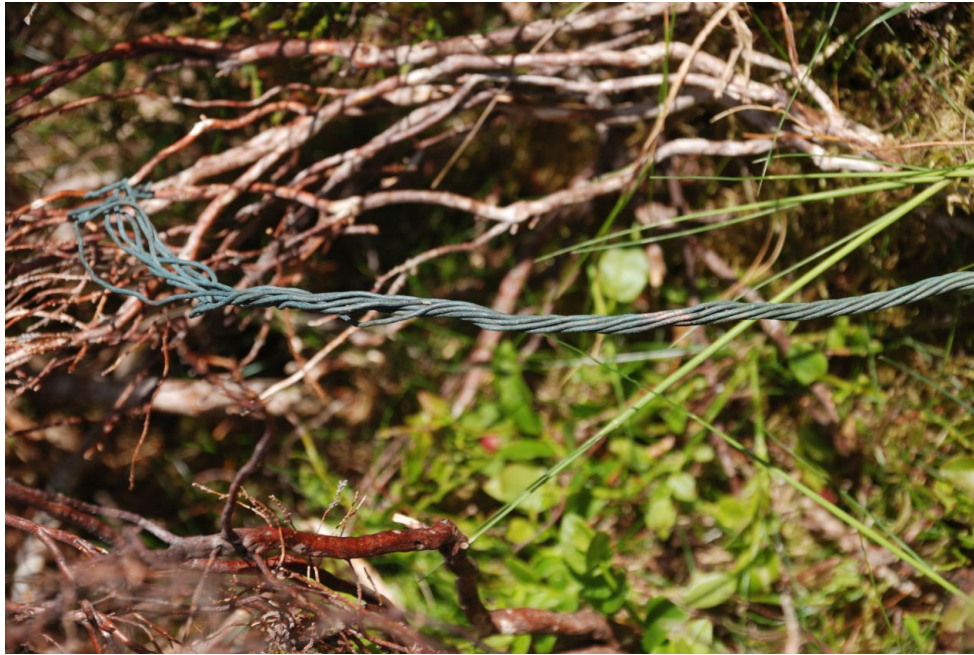
**53.** *Remnant wire found at the upper end of the 1923 extension. This is 7, rather than the 6-stranded wire generally seen around the 1914 site, though 7 strand was originally specified for the 1914 antenna.*

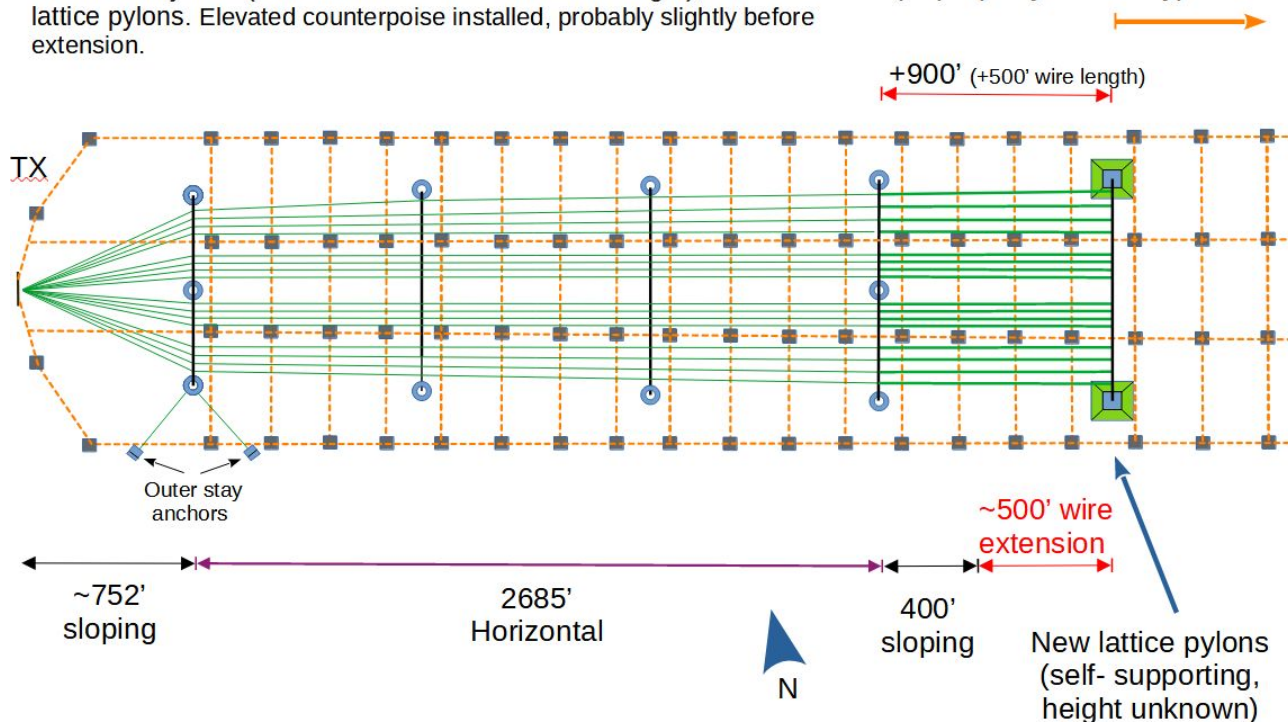
57. The ca. 1921 extension of ~500ft, to end 900ft from the original easternmost masts. The earlier buried ground screen was replaced with an elevated counterpoise system, probably slightly ahead and in anticipation of the extension. Not to scale. Two example outer stay anchors shown to indicate widthwise extent of counterpoise. The radiating wires (green) are indicative only and, for clarity, do not represent the installed number. Elevated counterpoise in orange dash. 'TX' = transmitter.

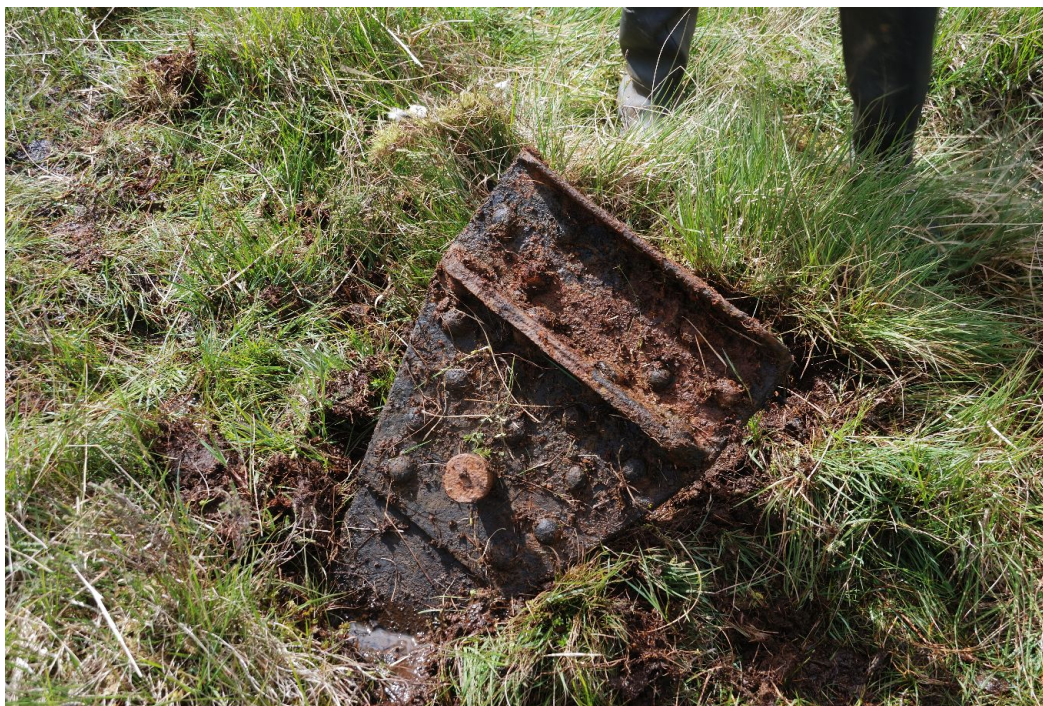
**60.** A chance discovery of a small, projecting piece of iron, made near to the field wall running down the hillside, revealed a large remnant that, on further examination, was seen to almost certainly be an upper part of the ill-fated Mast 13. Approximately 2' by 1½'. It appears to still be connected to a bracing rod, now buried in bog, under the apex at lower centre left. North to centre right. 53.125259°, -4.171007°.

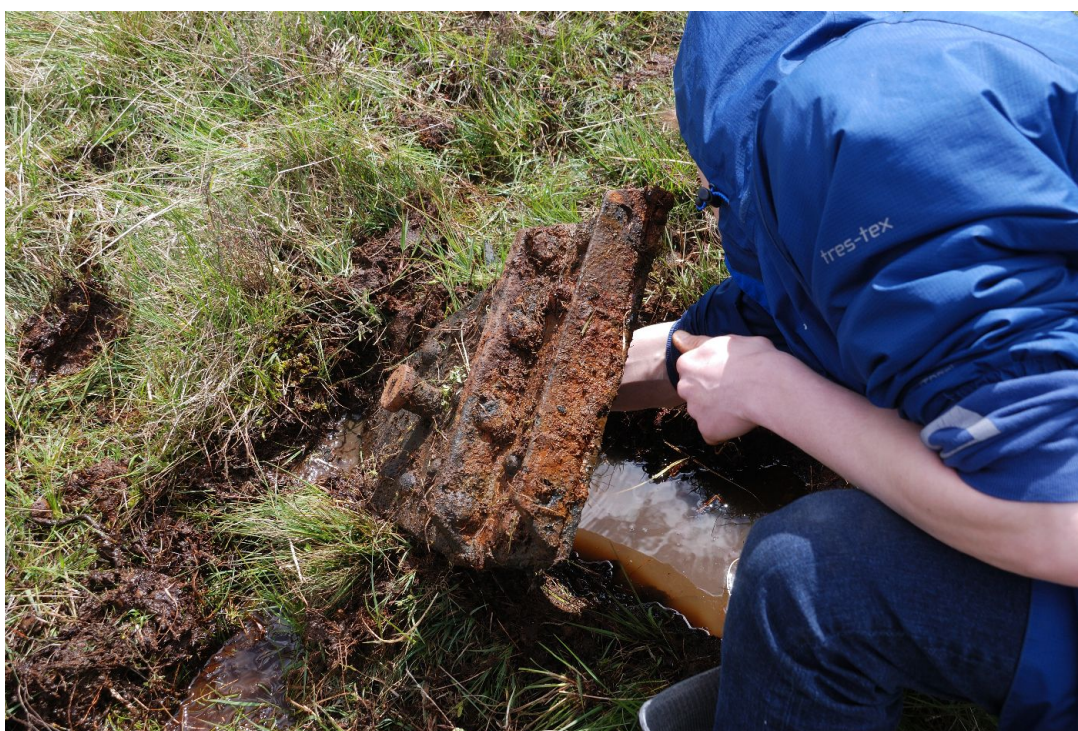
**61.** View of the end to which the fixing attached to Mast 13.

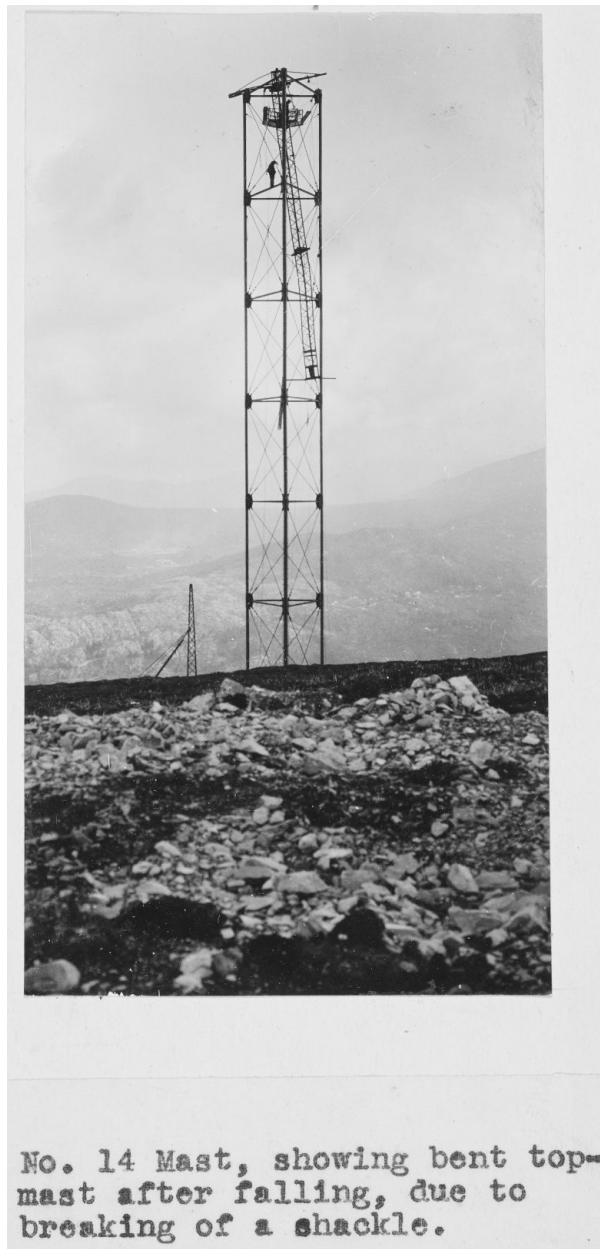
**68.** Bodleian MS. Photogr. c.243 photo 733/x, showing failure of a shackle caused damage and may have been the event (the estimated height to the top of the main mast is about 90 feet) that caused the death of a worker, John Pierce Jones, in the same month (June, 1923), reported in the press (**69**, below, courtesy The British Newspaper Archive). The Pall Mall Gazette (also 5<sup>th</sup> June, 1923), on the same event, noted that Jones had just reached the top of the tower being built when he fell, being “killed instantly”; he left behind a widow and four children.

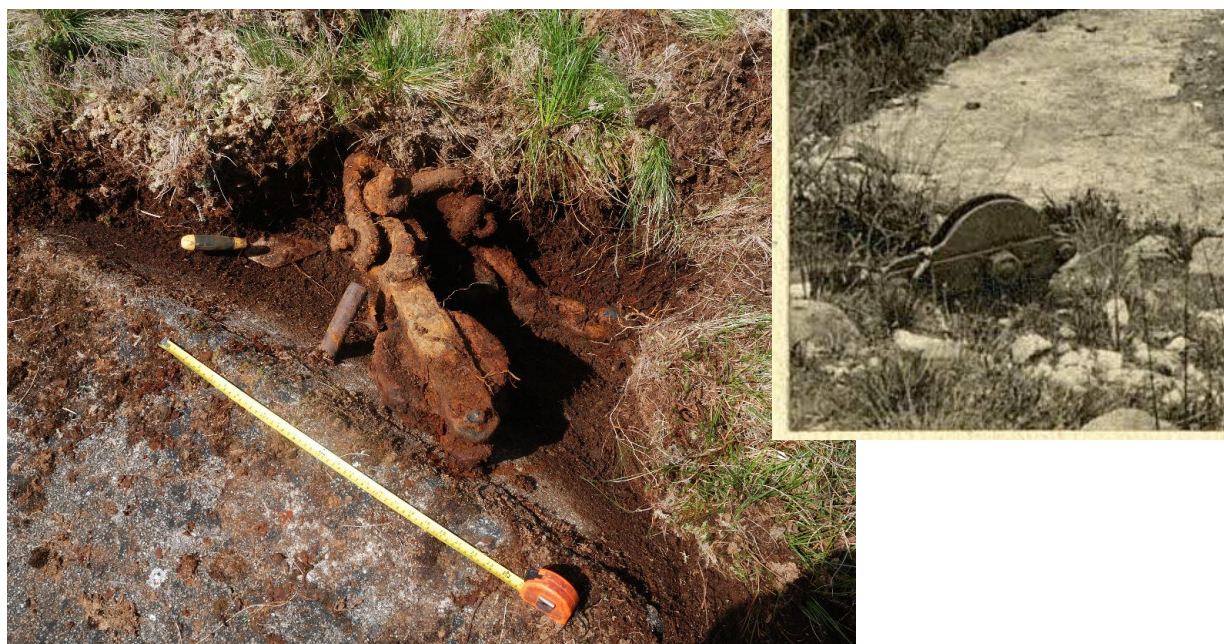
**117.** *Pulley, attached to a series of shackles and a substantial chain still in position next to a base with a cut loop attachment, seemingly forgotten during salvage. A similar, but not identical pulley is seen in Bodleian Archive MS.Photogr.243, photo P.2093 (inset detail, top right). Its purpose in relation to the 1923 antenna is not yet certain, but initially appears to have been related to backstaying of the elevated counterpoise masts. Pulley wheel = 8" diameter, clamp body 1 ¾" thick, top running width 27mm, inner running width 9mm, running groove depth ¾". Shackles 9½ height, 2 ½" inside width, 5" external width, securing pin 2" diameter head, ¾" central hole. 53.120944°, -4.172144°.*

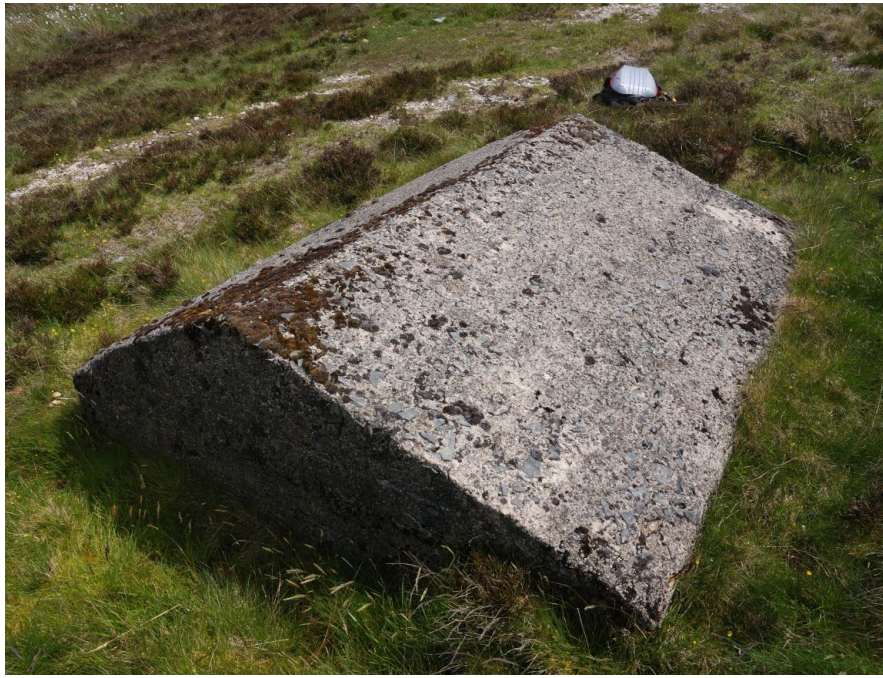
**120.** Anchor blocks are located to the north and south, opposite each pair of support masts for the 1914 antenna. They all have a (now) cut, substantial loop attachment. The purpose is not known with certainty, but would appear to be either additional head-straining stay anchors, or for tensioning triatic steel ropes between the mast heads. 138" wide along rear; 82", 10° sloping rear length, ~2' long 43½° sloping antenna-facing side. Southern boundary, between mast anchors 7A and 7D, at 53.121199°, -4.183082°.

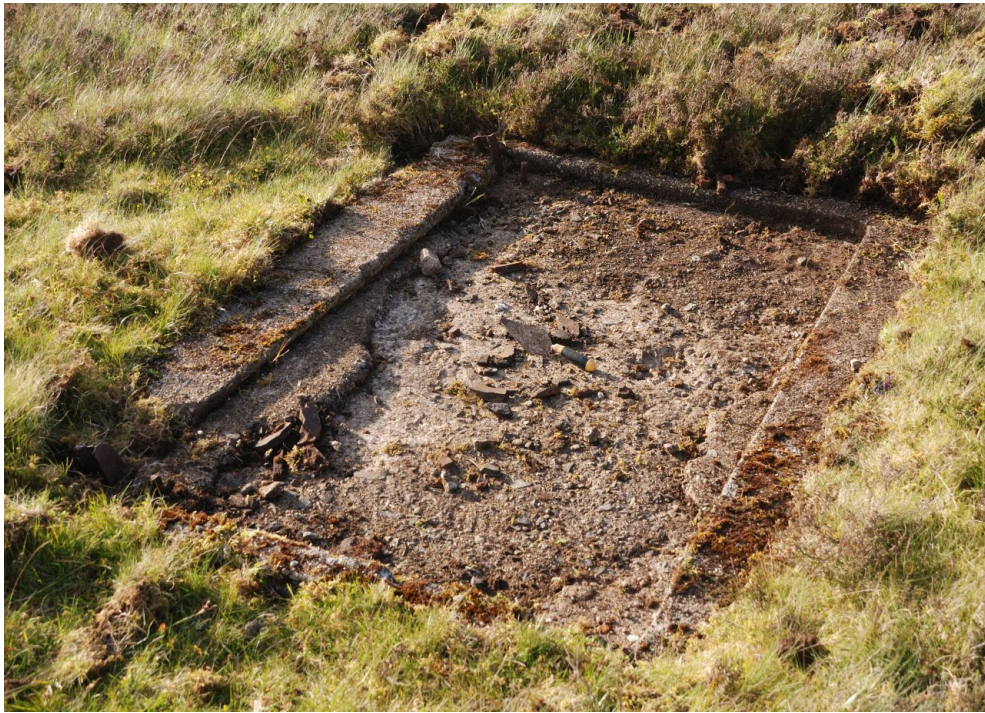
**125.** Entirely grassed-over when discovered, surface clearing revealed a large concrete base with corner bolts, iron spacers and two trackway rails protruding, leaning slightly towards the south-west. Thought to be a trackway winder base serving a trackway running downhill to the west, to a quarrying area behind the 1914 upper masts. Located immediately to the NE of 1921 extension, northern Pylon A. 53.123001°, -4.171694°.

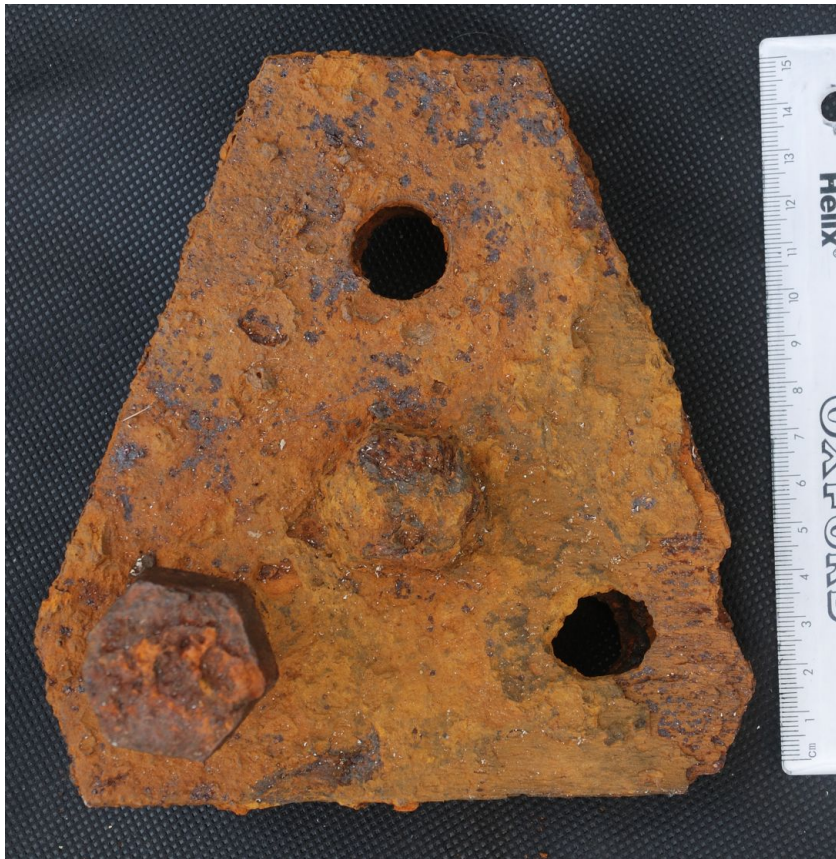
**134.** An anchor-to-two-stay attachment plate. The top hole bolted to the loop on the anchor, the lower holes, one with a bolt still in position, each attached a stay wire. This was found near the wall and below blockhouse 5 on the upper part of the 1923 extension site. It may have been one of the main anchor attachment plates. Found as bolt surface protrusion, at 53.122857°, -4.173596°.

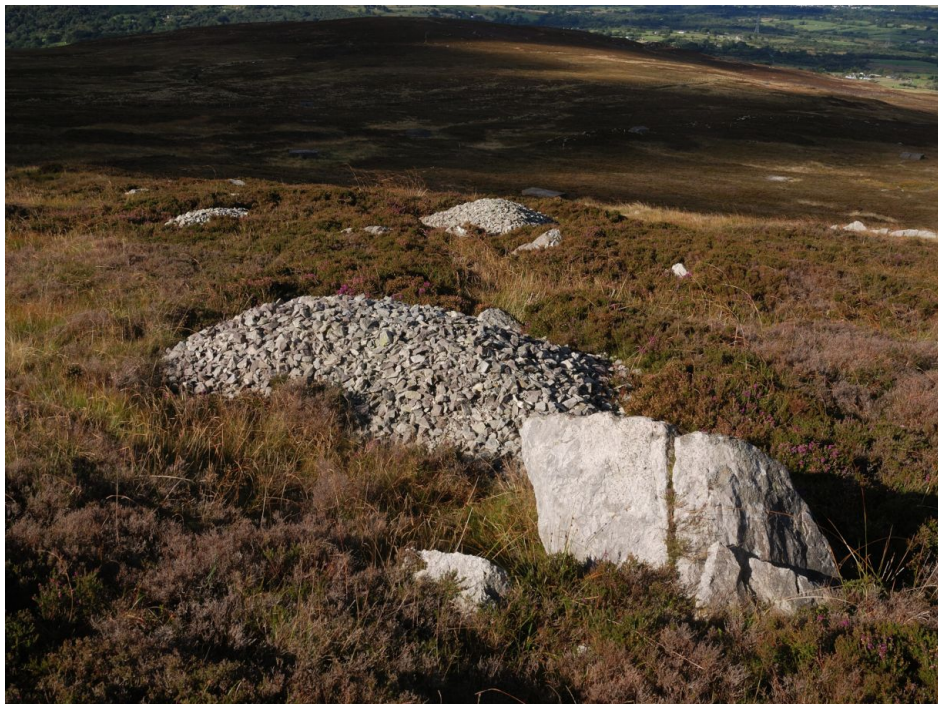
**135.** Glacial boulders reduced to trackway ballast on the spot. 53.121906°, -4.176516° (nearest pile)

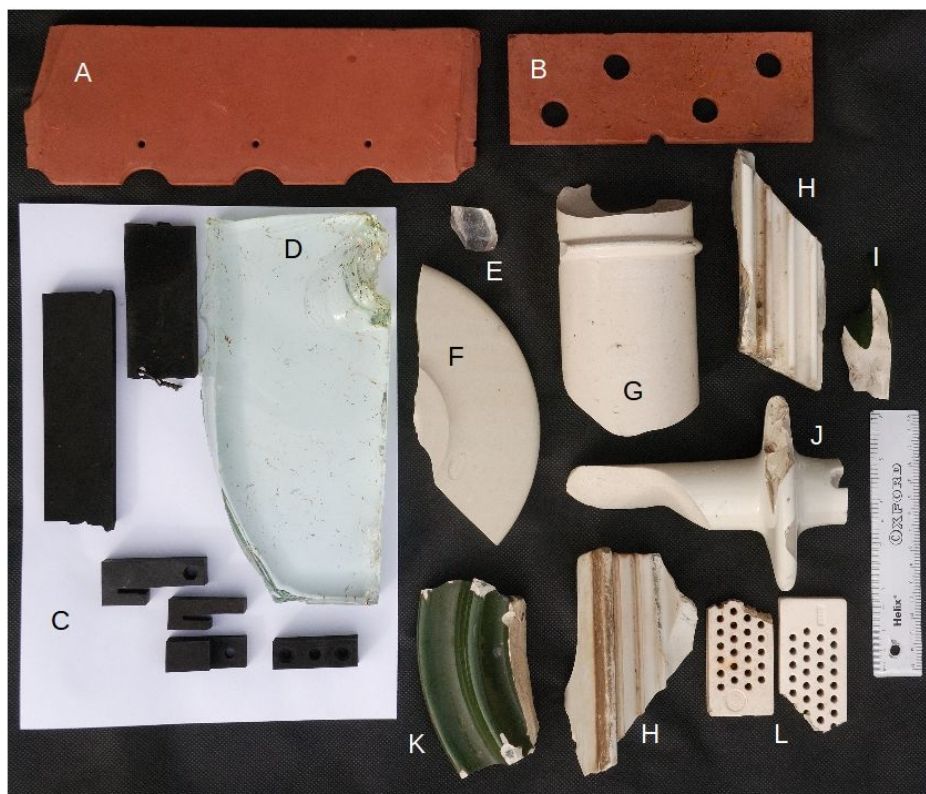
**C1.** A selection of ceramic fragments commonly found, mostly in relation to the ATI house sites. Rule = 15cm/6”.

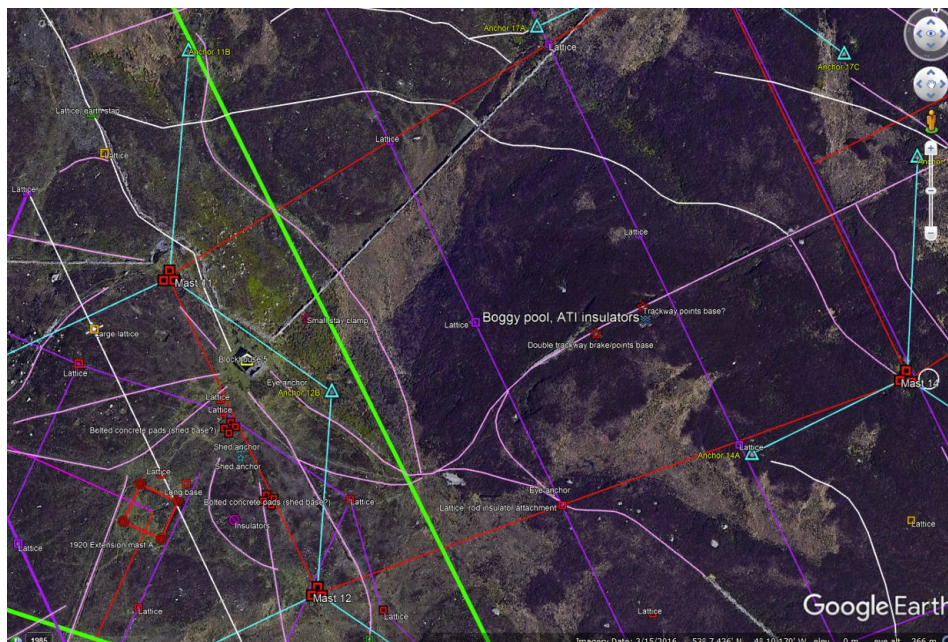
**C16.** Location of boggy pool into which the greater part of a large insulator, of the same type as indicated at C15, had been thrown. Its depth in the peat suggests it was deposited upon dismantling.

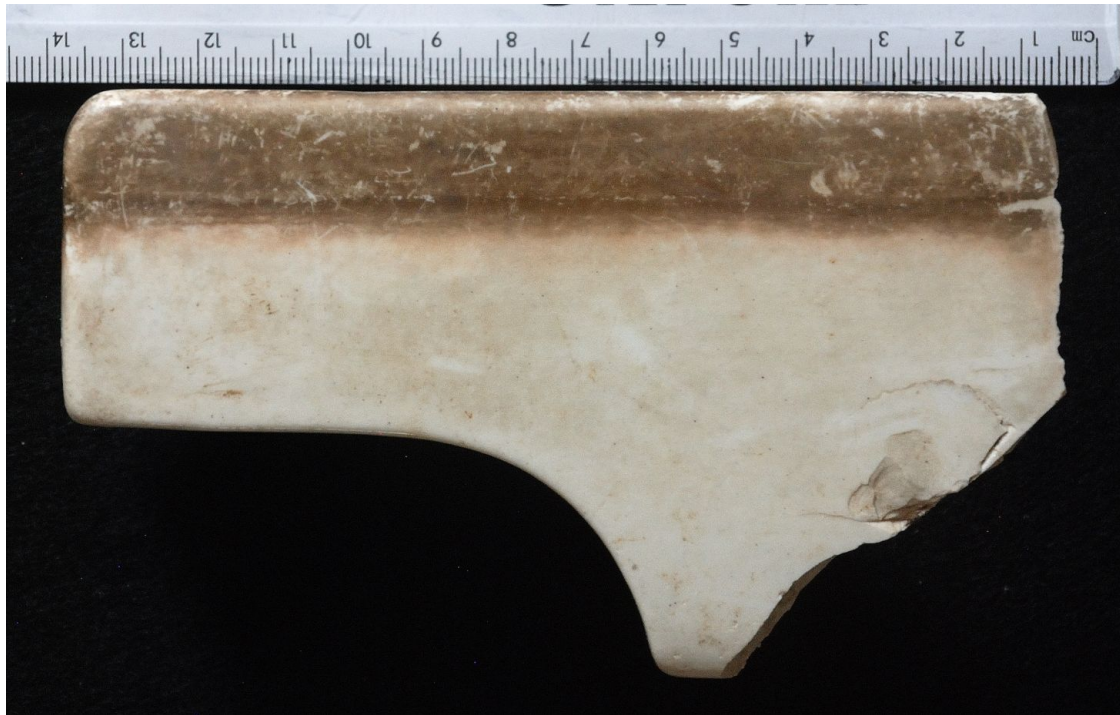
**C19.** Side view of one end of the insulator. No maker's impression has been found on any fragment to date. Scaling from images to fragments allowed the intact length of these insulators to be determined as ~2 feet at the top, ~16" at the bottom.

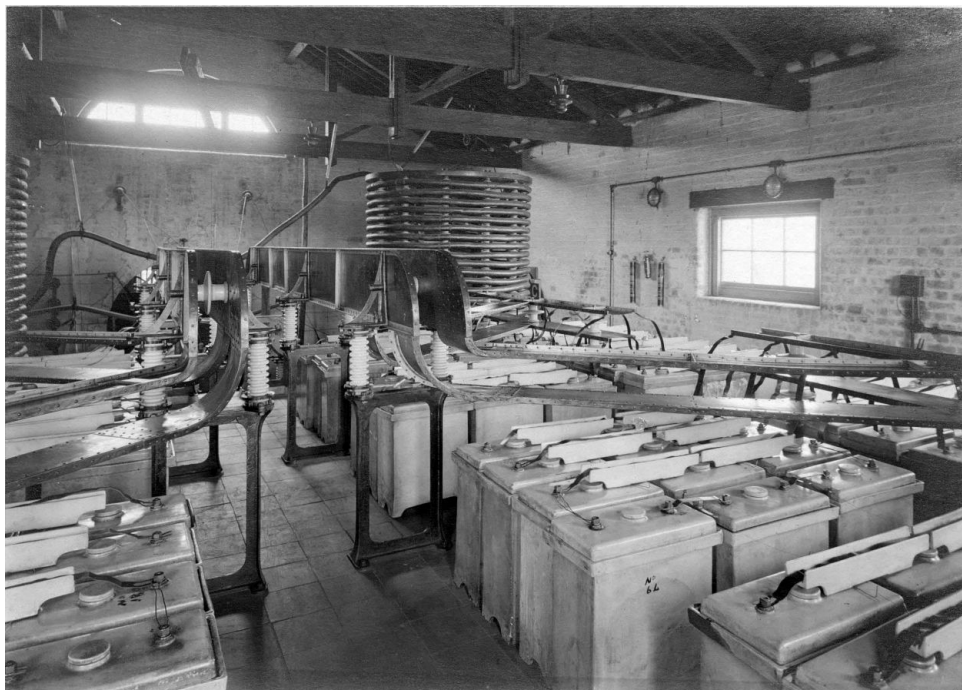
**C20.** The 'bridging' insulators seen at work, bridging glass-and-oil capacitor tanks of porcelain, in this case, in the transmitter building in 1918. The capacitors were a fundamental part of a resonating, so-called 'tank' circuit, acting in concert with the large inductor coils at background. Strips of copper conductor run inside the insulator channel. Image: Bodleian Special Collections, MS. Photogr.c.243, photograph number P.2072.

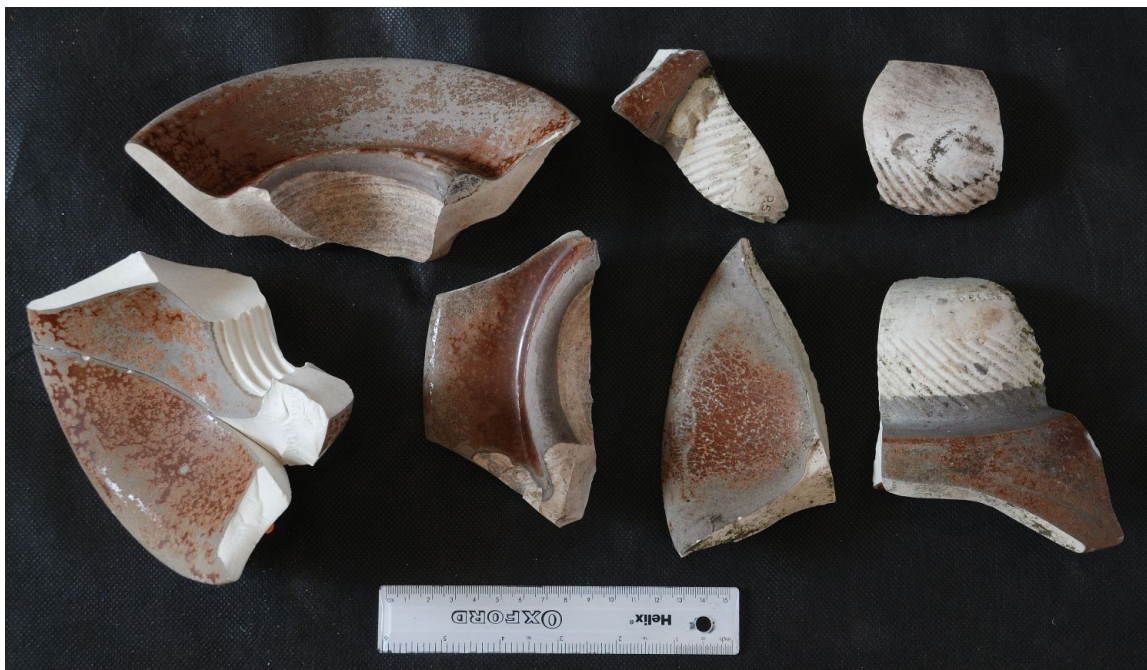
**C24.** *Fragments, at least two pieces from the same insulator, where the outer brown glaze has severely deteriorated. These were parts of a nested insulator, cemented together, and found close to a counterpoise lattice mast, upon which it is thought most likely was mounted. The larger fragment at far right has a maker's number, P.5656 (see detail, below). The top centre fragment has the same, but partial P.56...mark. A single top piece (not shown) bearing the same P.5656, has a groove of ca. 15mm diameter for receiving a wire, which may add to the belief this was a counterpoise masthead insulator, though the groove may not have been used.*
