MOEL DDINAS, RHOSYGWALIA, Y BALA

COFNOD ADEILADAU HANESYDDOL / HISTORIC BUILDING RECORDING

Rhif Prosiect / Project No. G2778

Rhif Adroddiad / Report No. 1705

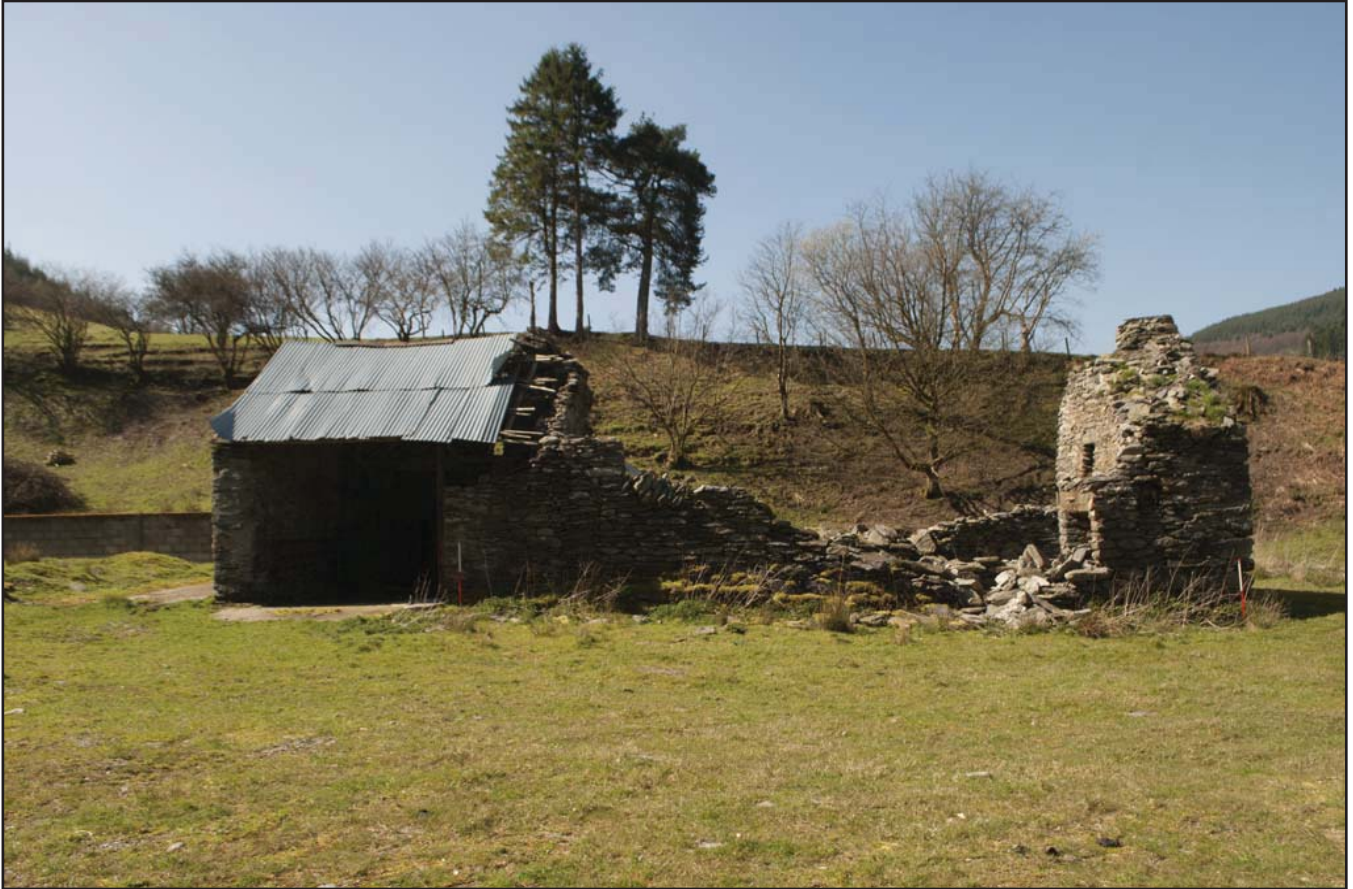
Plate 1: Exterior - View of exterior NE wall of cottage and large entrance to barn; scale 2x1m; view from NE (archive reference: G2778_001).

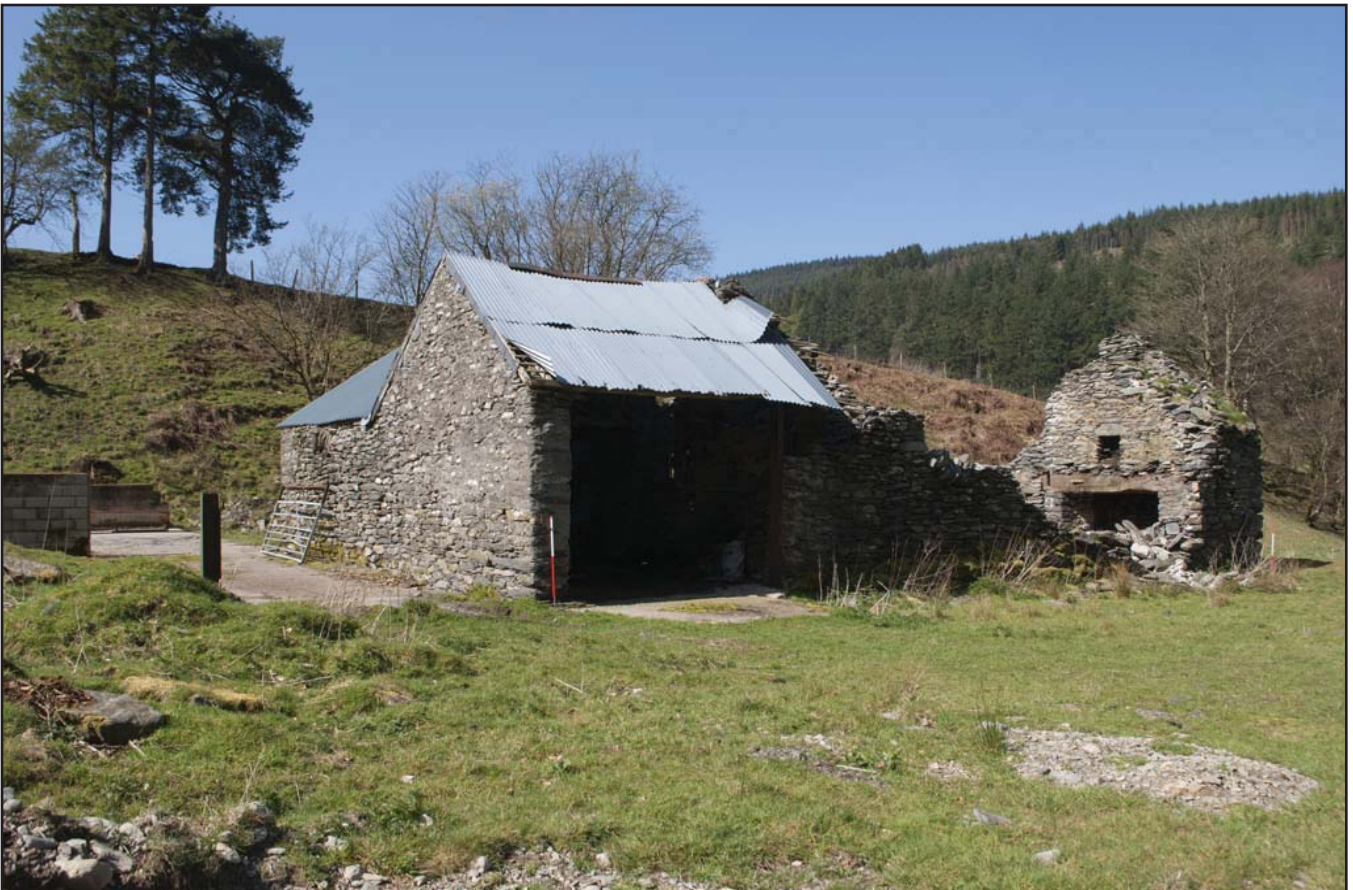
Plate 2: Exterior - Oblique view of barn and cottage from the E corner, exterior; scale 2x1m; view from E (archive reference: G2778_002).

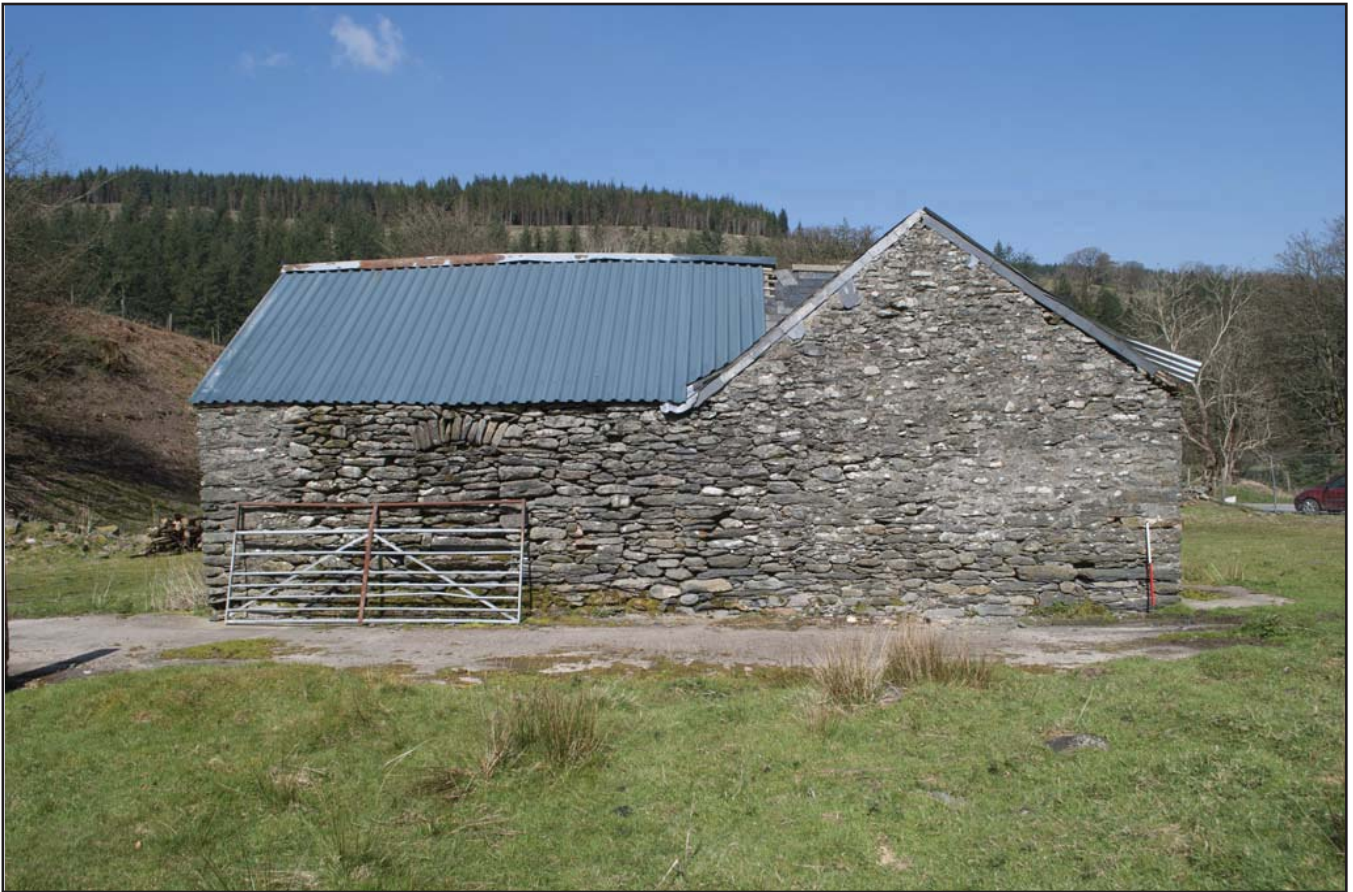
Plate 3: Exterior - View of exterior SE wall of barn, showing window infilled with stone; scale 1x1m; view from SE (archive reference: G2778_003).

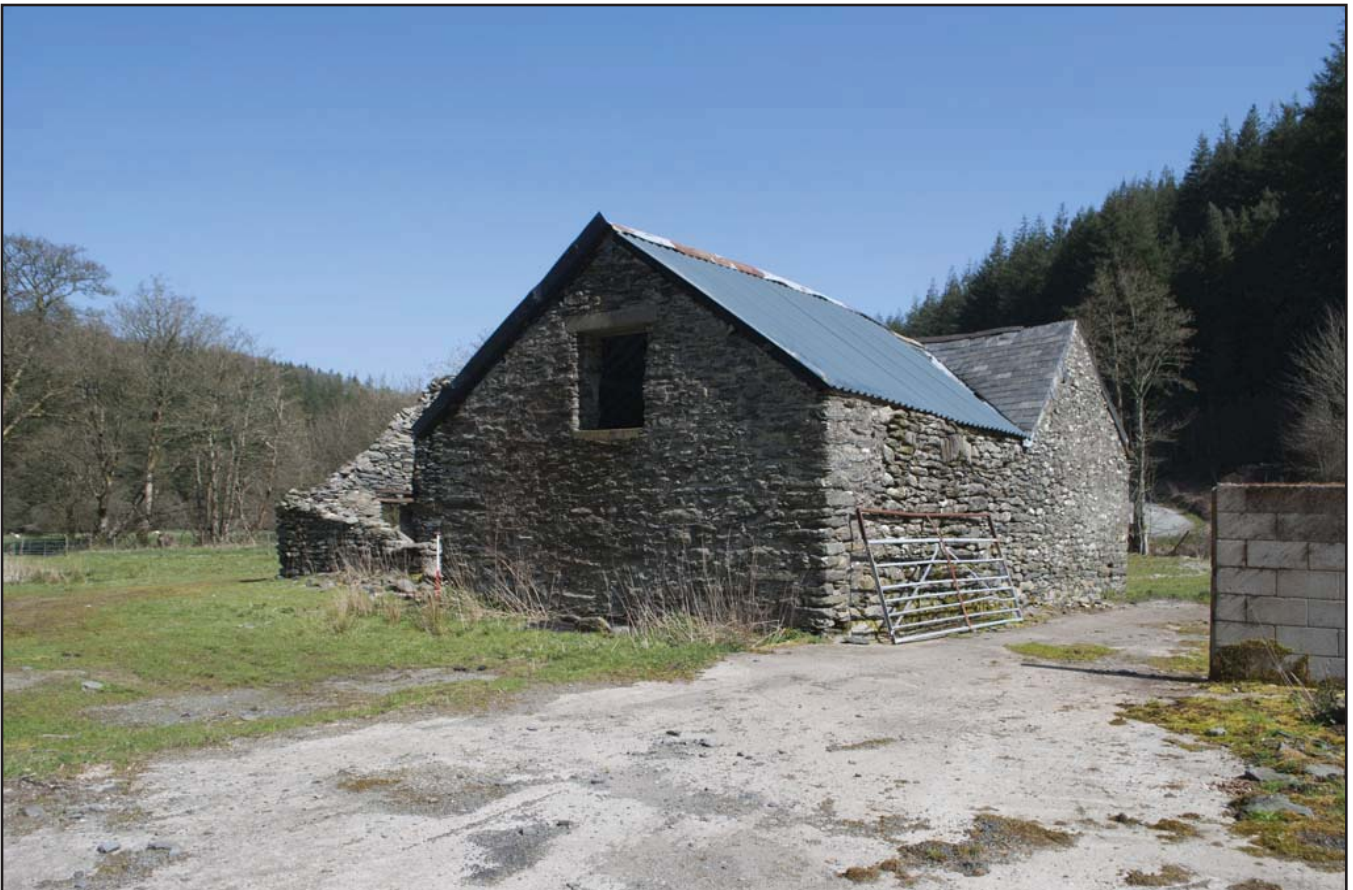
Plate 4: Exterior - Oblique view of S corner of barn with corner of cottage in background; scale 1x1m; view from S (archive reference: G2778_004).

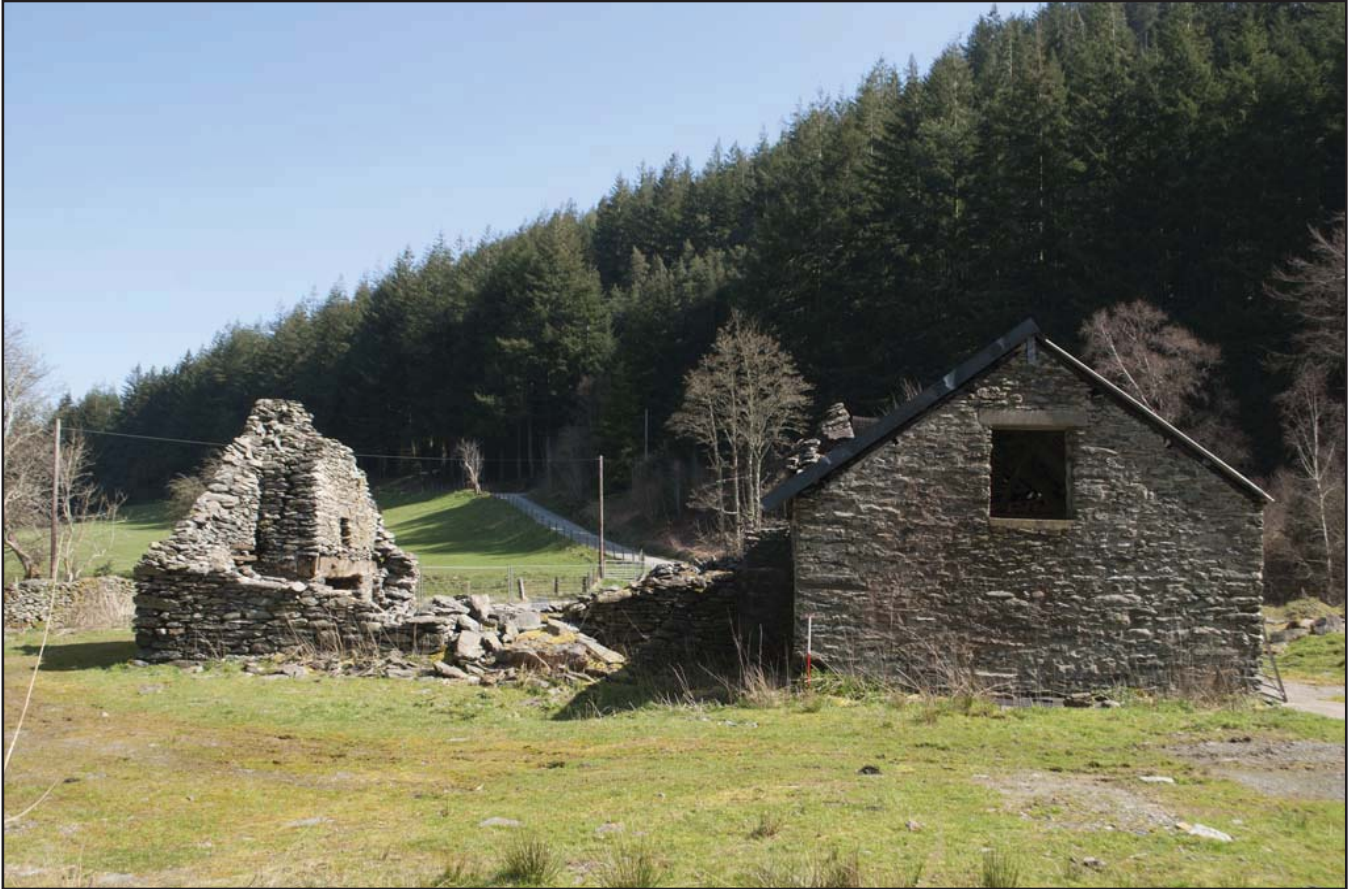
Plate 5: Exterior - View of exterior SW wall of cottage and barn, showing window of barn; scale 1x1m; view from SW (archive reference: G2778_005).

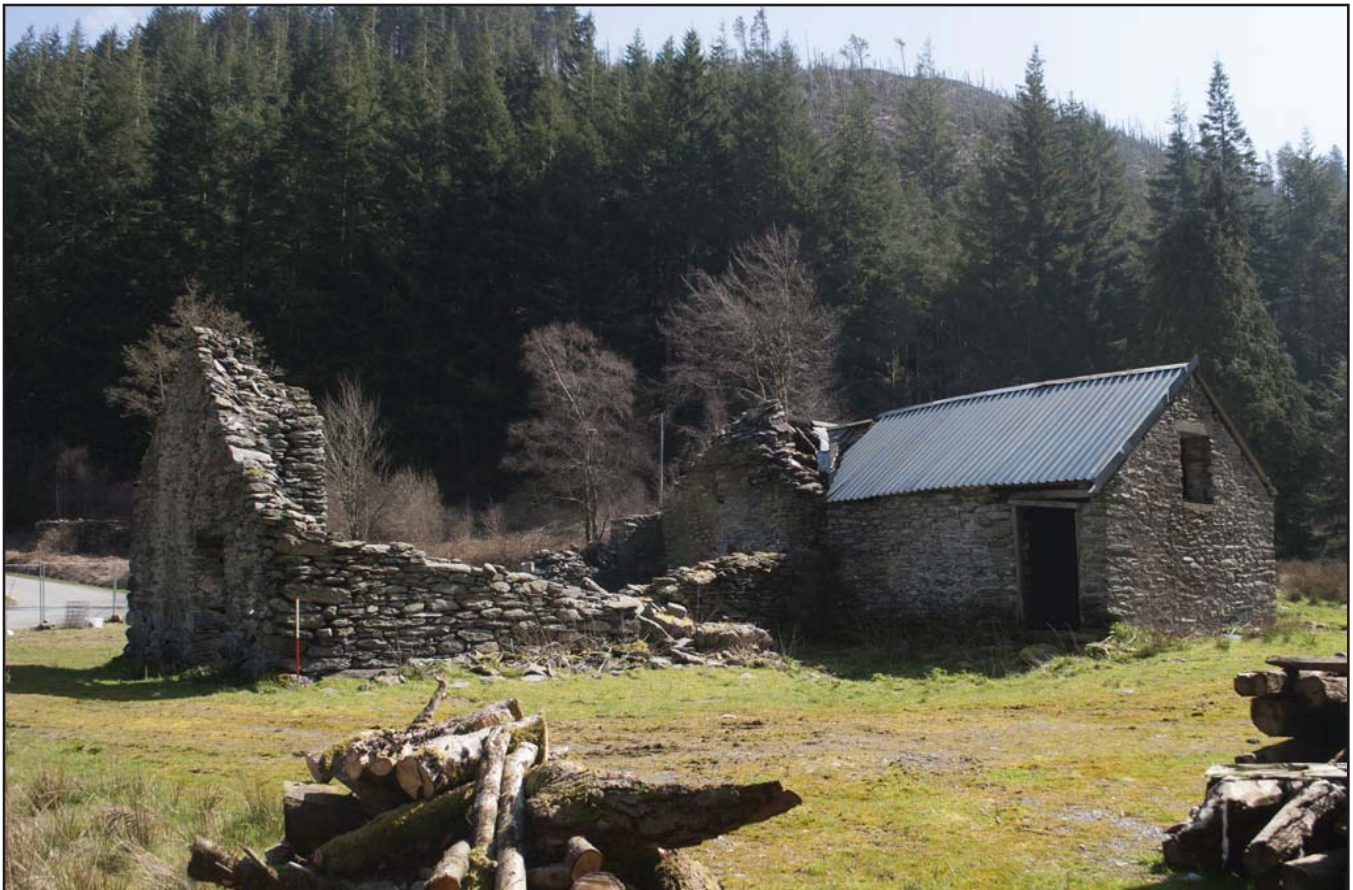
Plate 6: Exterior - Oblique view of NW corner of cottage and barn, showing door into barn; scale 1x1m; view from NW (archive reference: G2778_006).

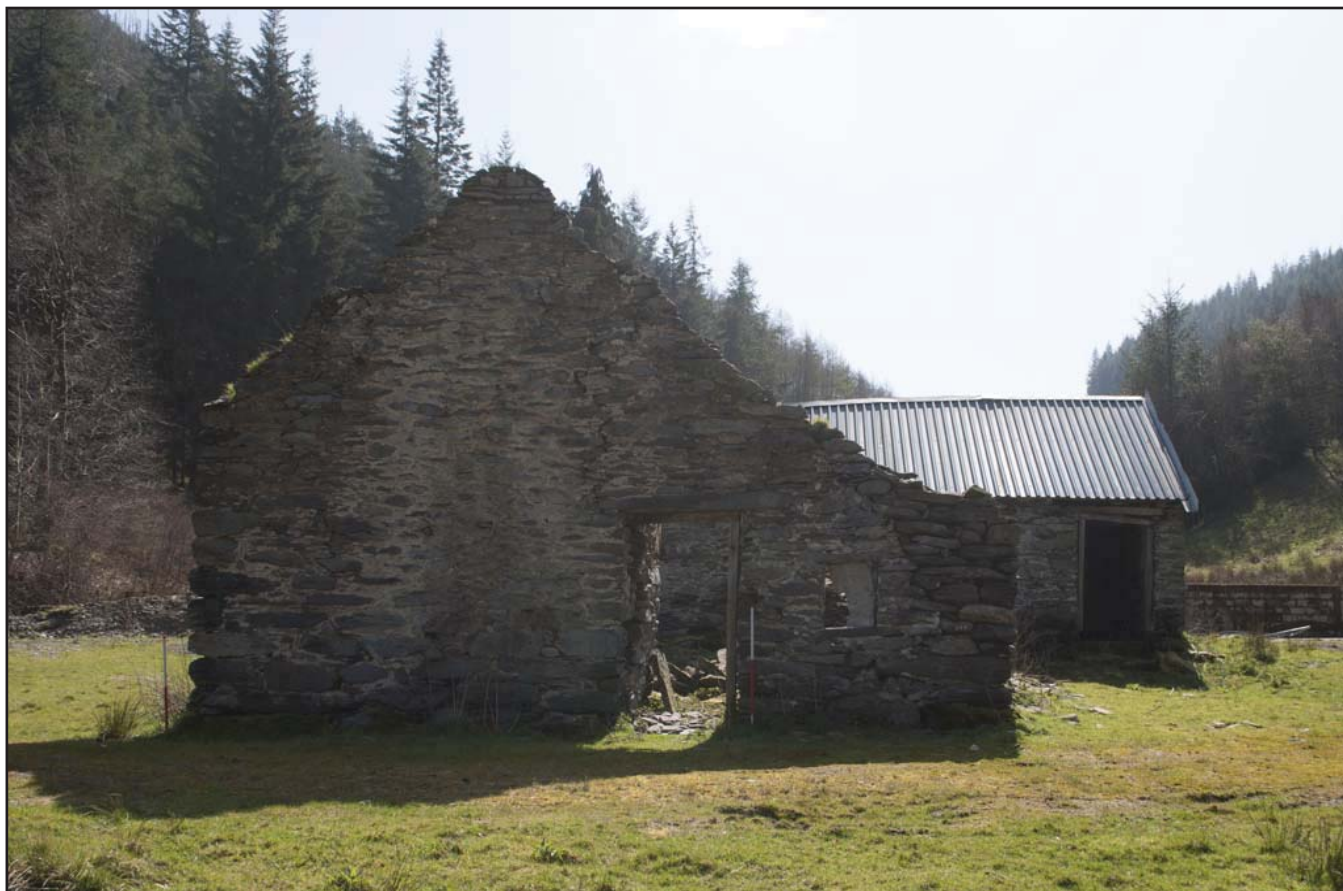
Plate 7: Exterior - View of N wall of cottage showing door into cottage, with barn in background; scale 2x1m; view from N (archive reference: G2778_007).

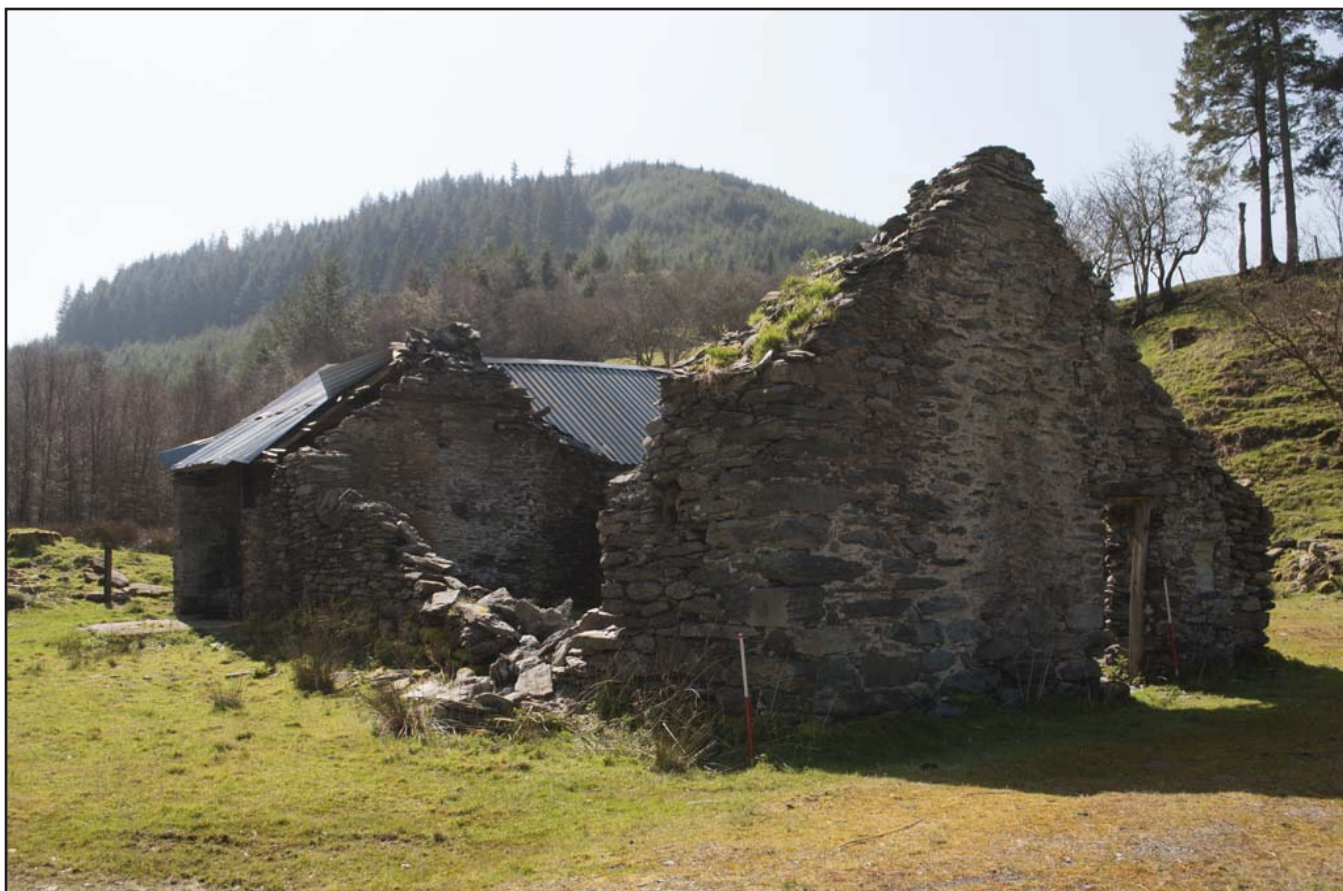
Plate 8: Exterior - Oblique view of N corner of cottage showing collapsed wall; scale 2x1m; view from N (archive reference: G2778_008).

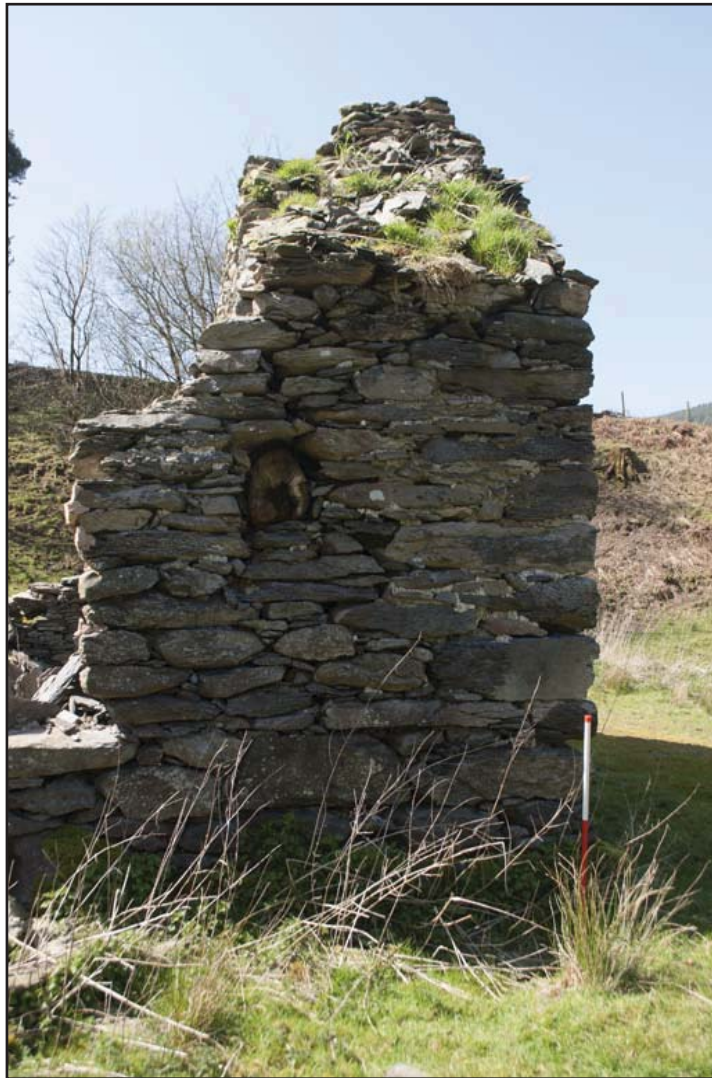
Plate 9: Exterior - View of NE corner of cottage showing fireplace beam; scale 1x1m; view from NE (archive reference: G2778_009).

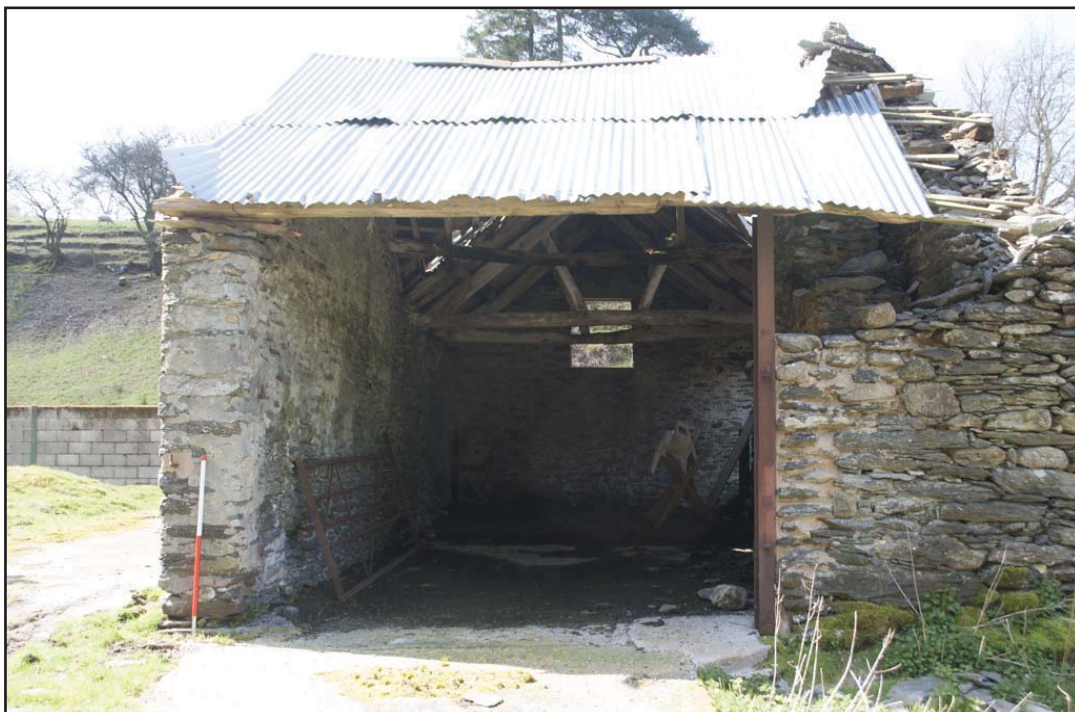
Plate 10: Exterior - View of large entrance into barn; scale 1x1m; view from NE (archive reference: G2778_010).

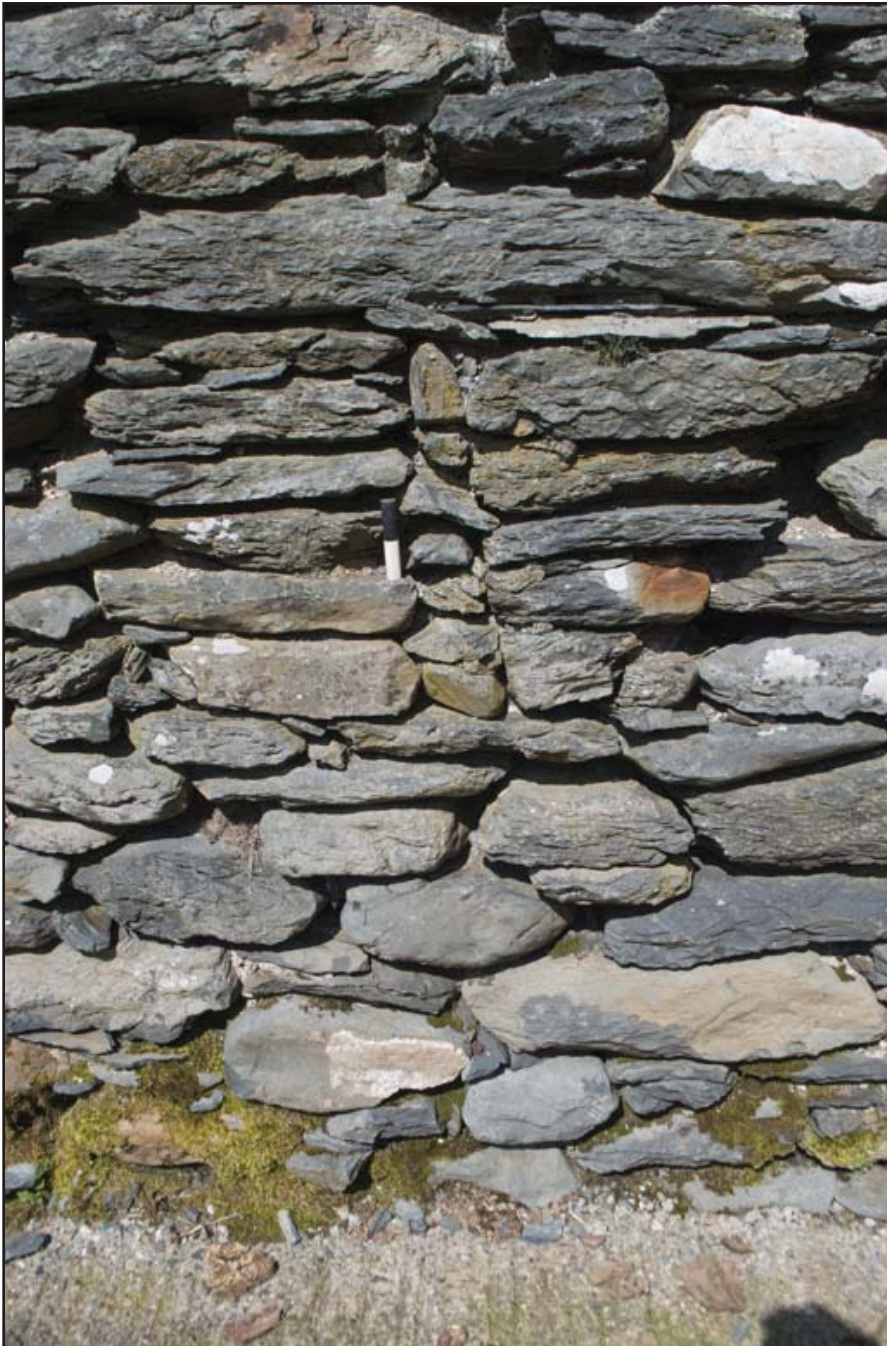
Plate 11: Exterior - Infilled ventilation slit in SE wall of barn; scale 0.10 m; view from SE (archive reference: G2778_011).

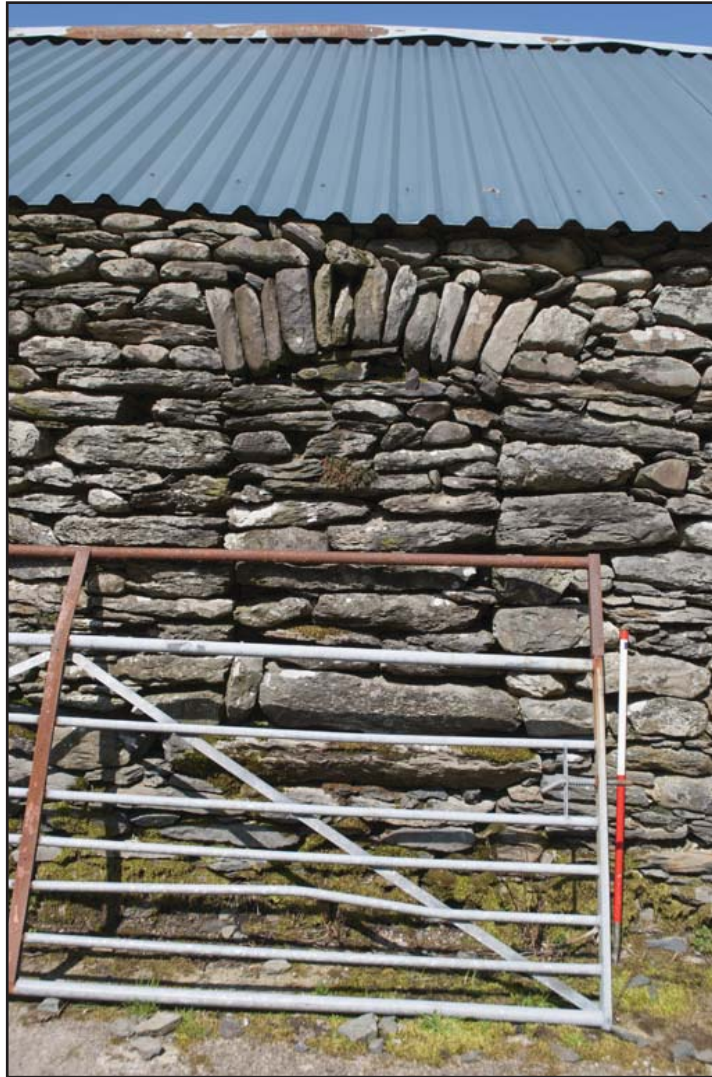
Plate 13: Exterior - Close-up of window infilled with stone in SE wall of barn; scale 1x1m; view from SE (archive reference: G2778_013).

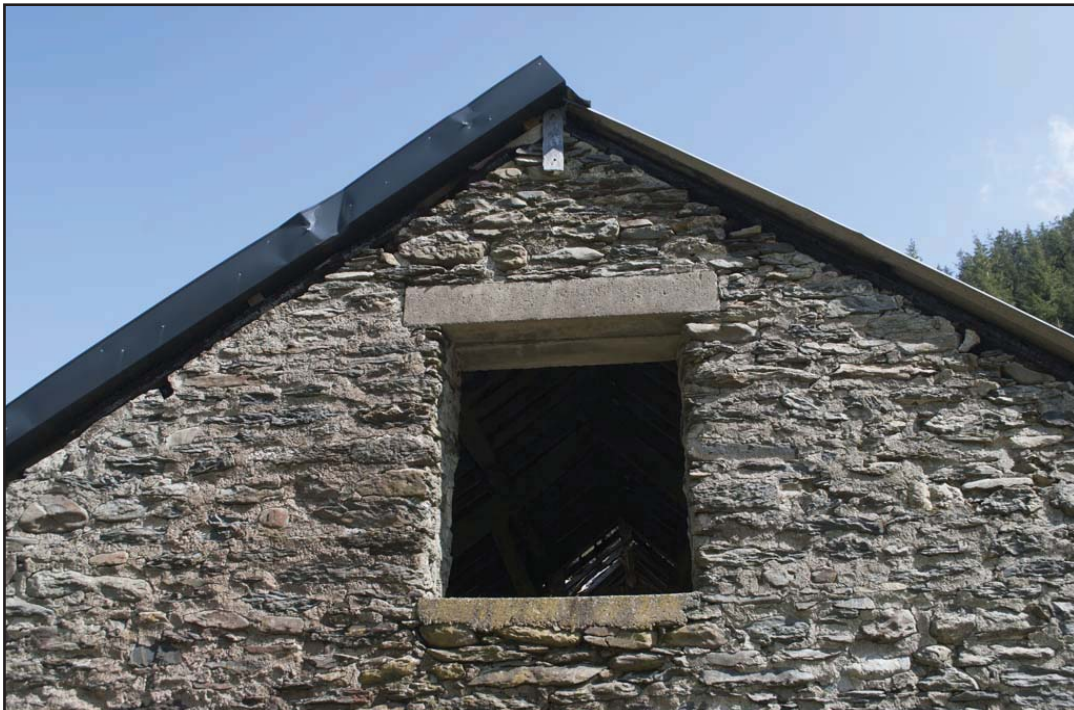
Plate 14: Exterior - Close-up of window with concrete lintels and roof of barn; scale not used; view from S (archive reference: G2778_014).

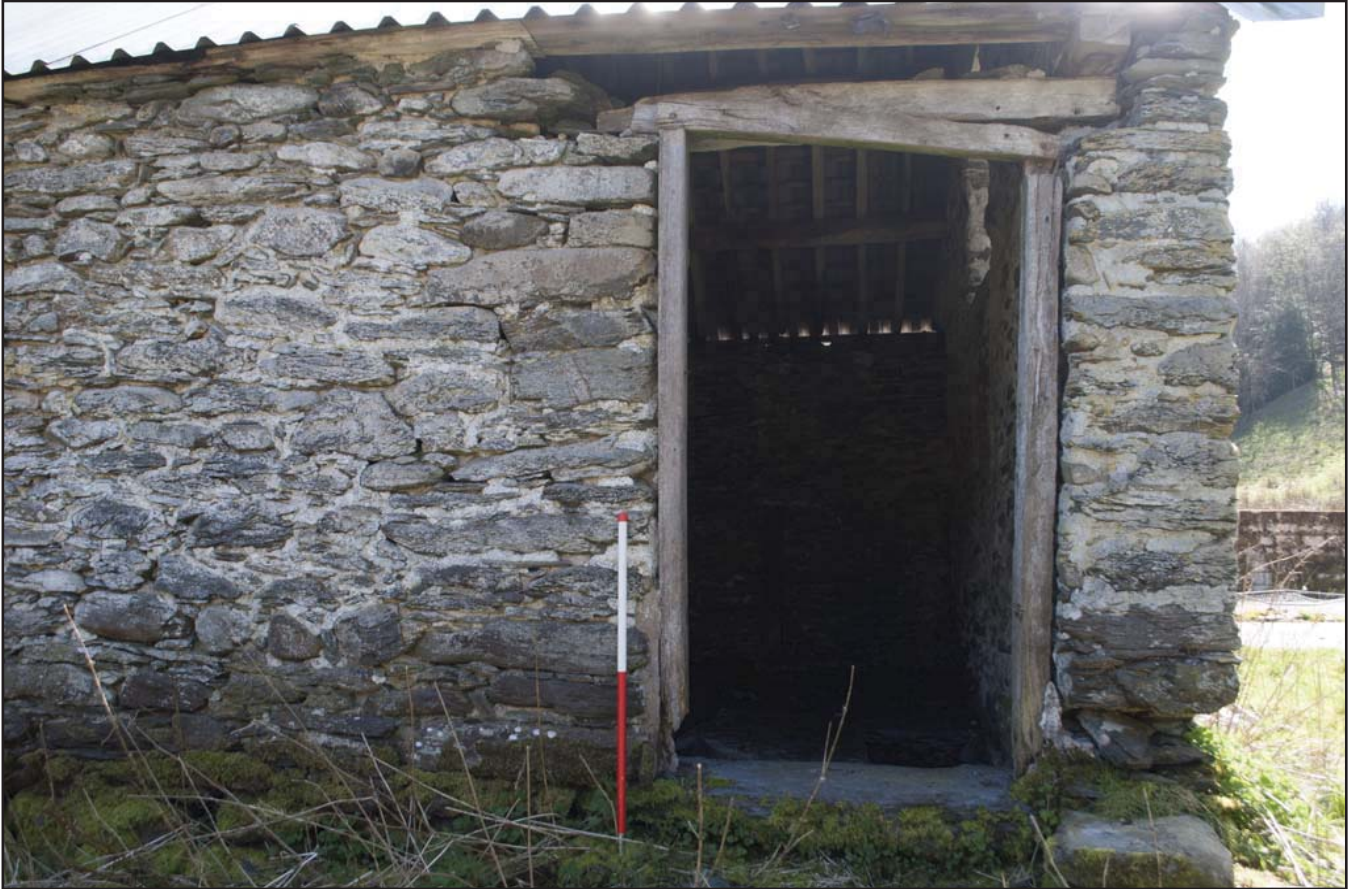
Plate 15: Exterior - View of doorway into barn; scale 1x1m; view from NW
(archive reference: G2778_015).

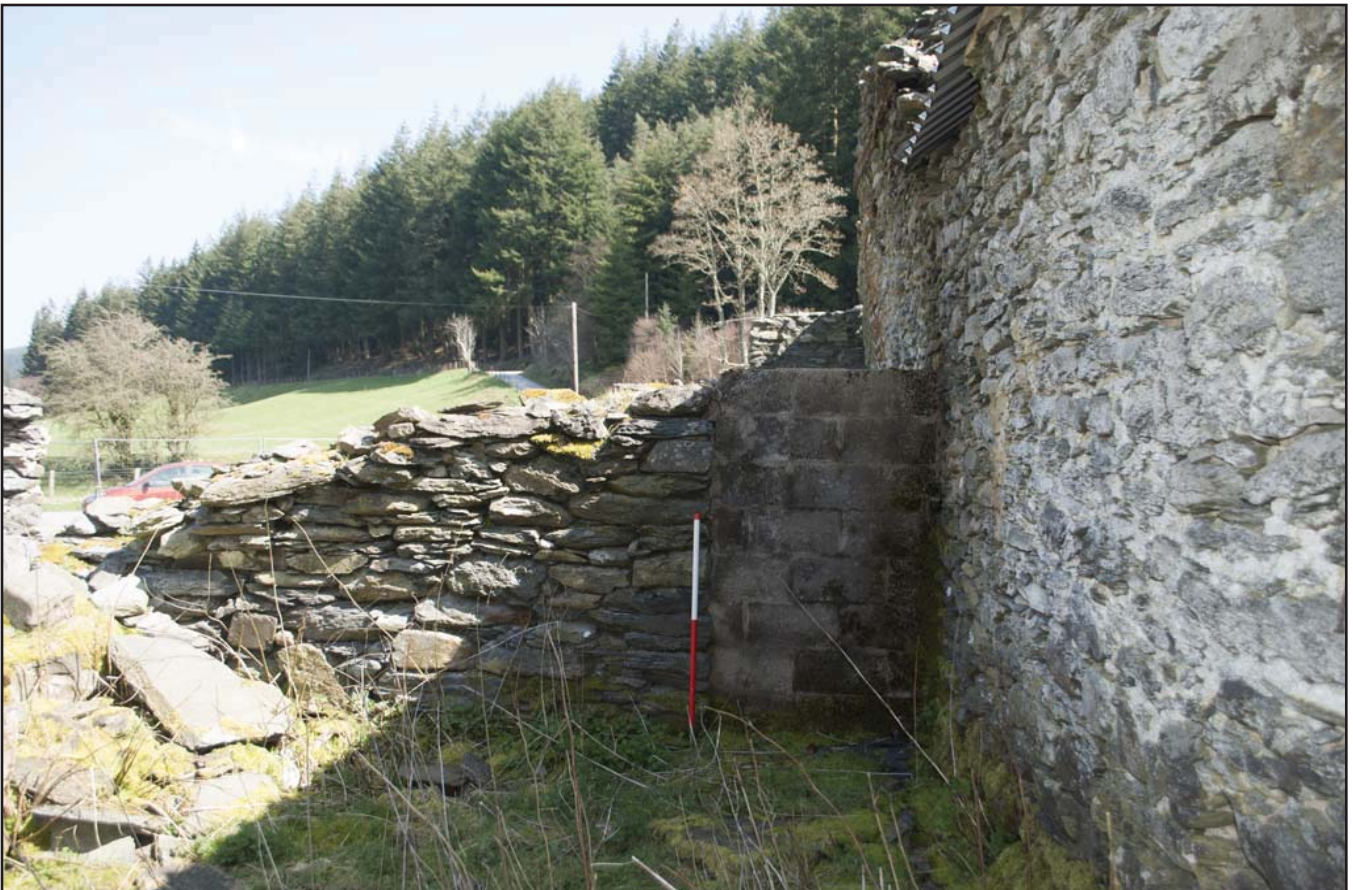
Plate 16: Exterior - View of blocked up doorway into cottage; scale 1x1m; view from SW
(archive reference: G2778_016).

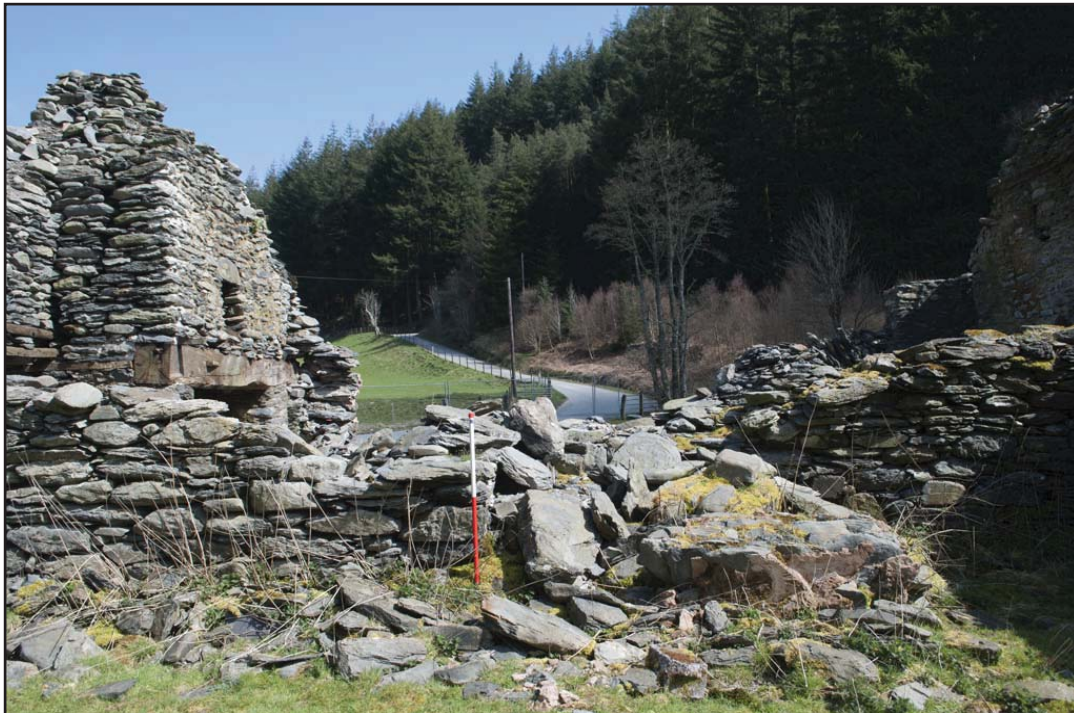
Plate 17: Exterior - View of collapsed SW wall of cottage and fireplace within; scale 1x1m; view from SW (archive reference: G2778_017).

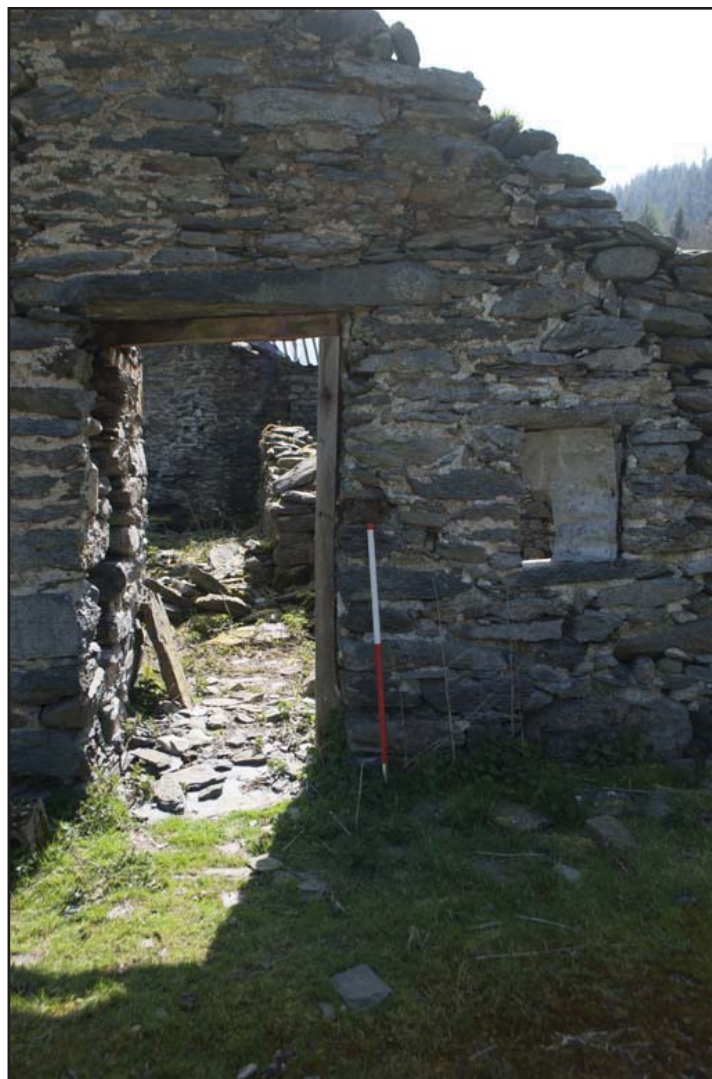
Plate 18: Exterior - View of doorway into cottage and adjacent window; scale 1x1m; view from NW (archive reference: G2778_018).

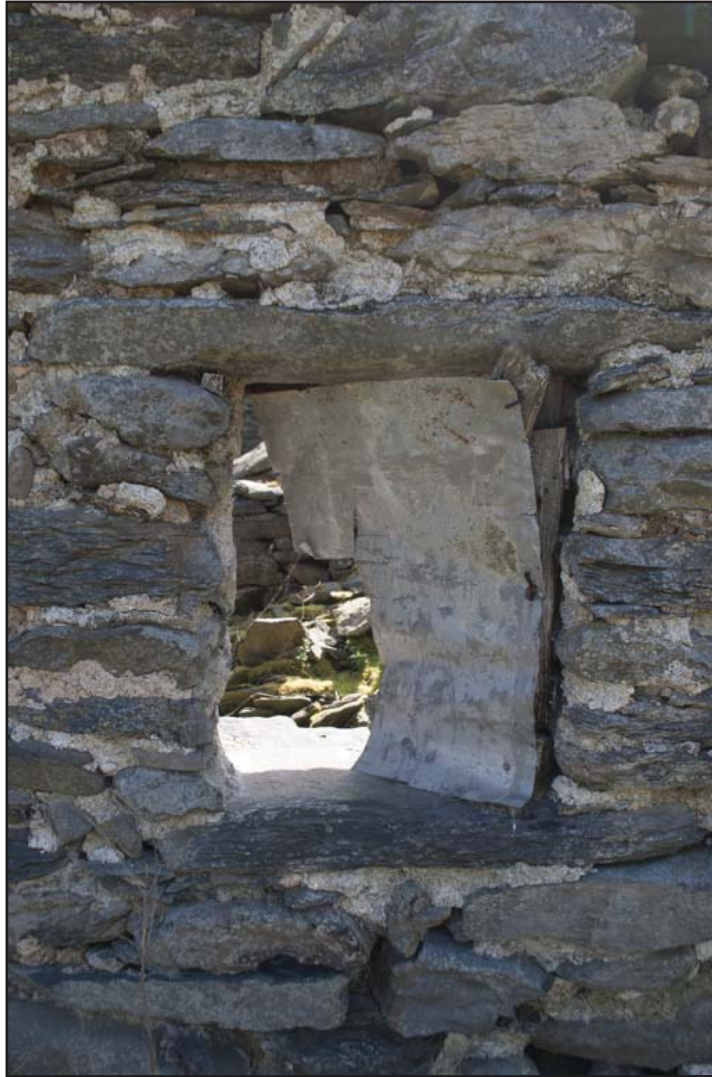
Plate 19: Exterior - Close-up of window with sheet metal; scale not used; view from NW (archive reference: G2778_019).

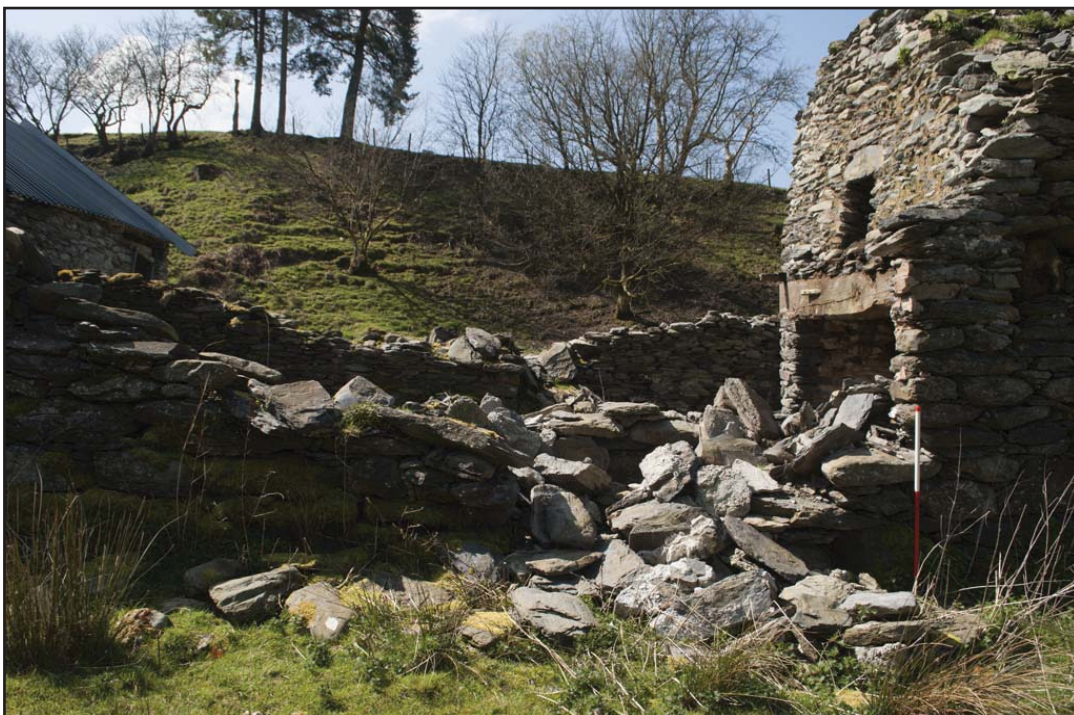
Plate 20: Exterior - View of collapsed NE wall of cottage and fireplace within; scale 1x1m; view from NE (archive reference: G2778_020).

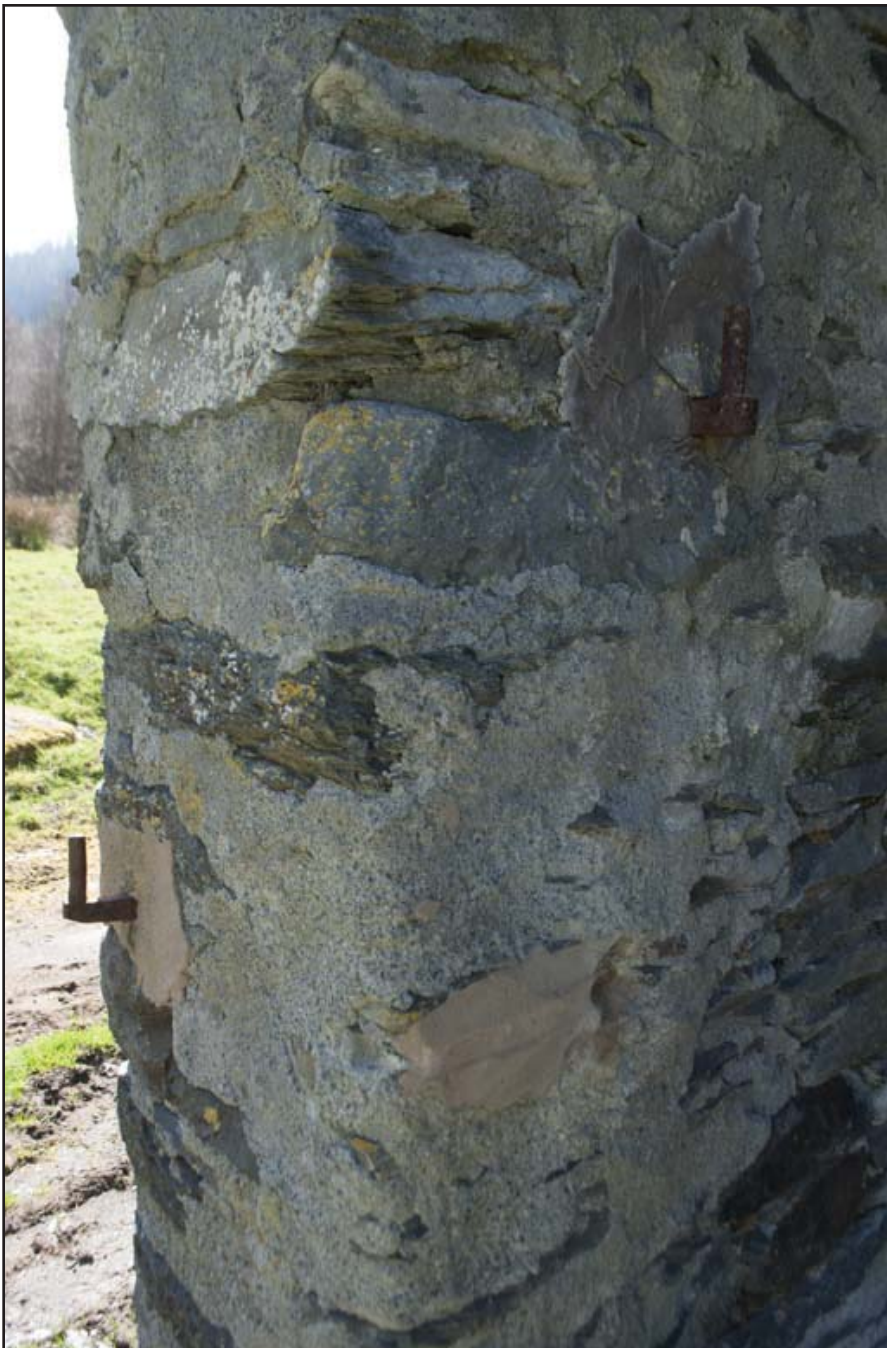
Plate 21: Exterior - Close-up of metal pins for gate in large entrance to barn; scale not used; view from N (archive reference: G2778_021).

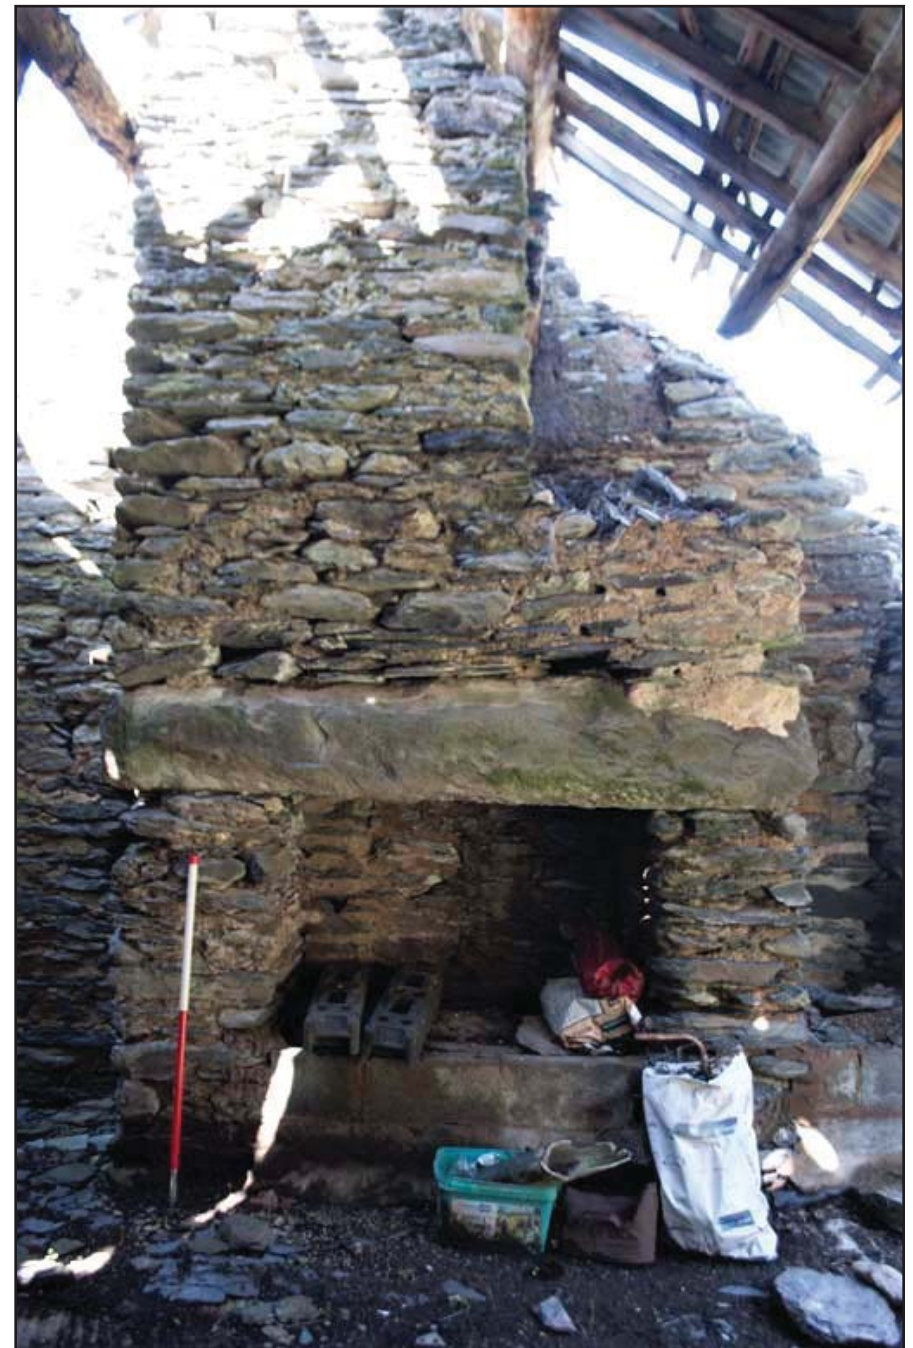
Plate 22: Interior Barn - View of large fireplace inside barn; scale 1x1m; view from S (archive reference: G2778_022).
