MOEL DDINAS, RHOSYGWALIA, Y BALA

COFNOD ADEILADAU HANESYDDOL / HISTORIC BUILDING RECORDING

Rhif Prosiect / Project No. G2778

Rhif Adroddiad / Report No. 1705

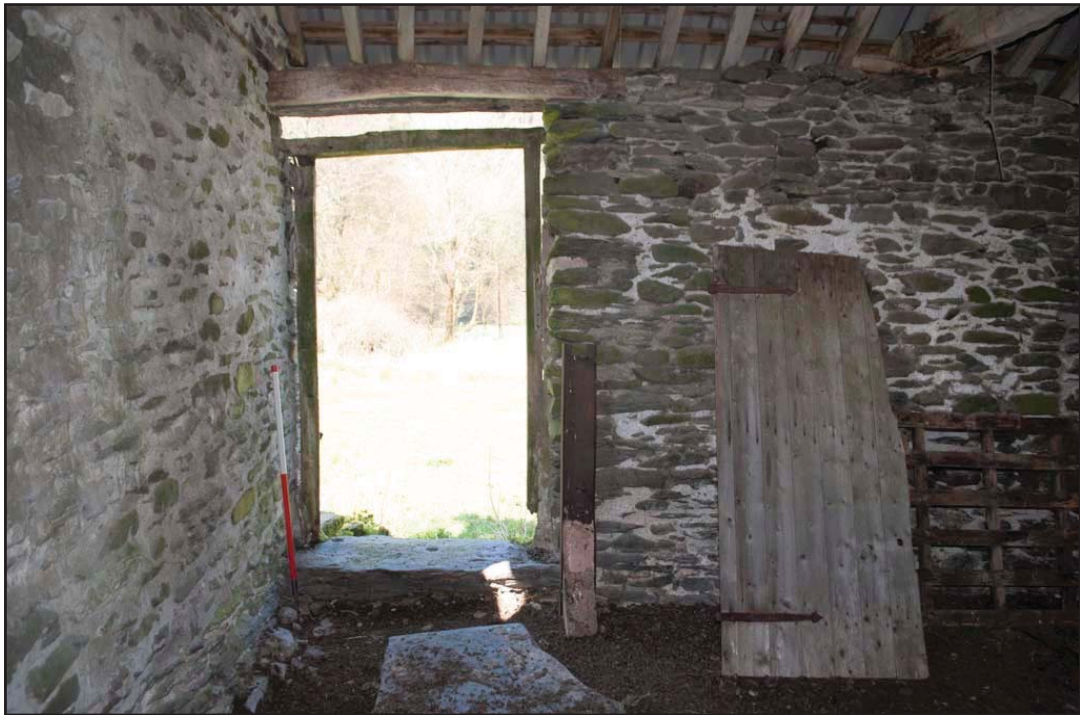
Plate 25: Interior Barn - View out of the barn doorway; scale 1x1m; view from S (archive reference: G2778_025).

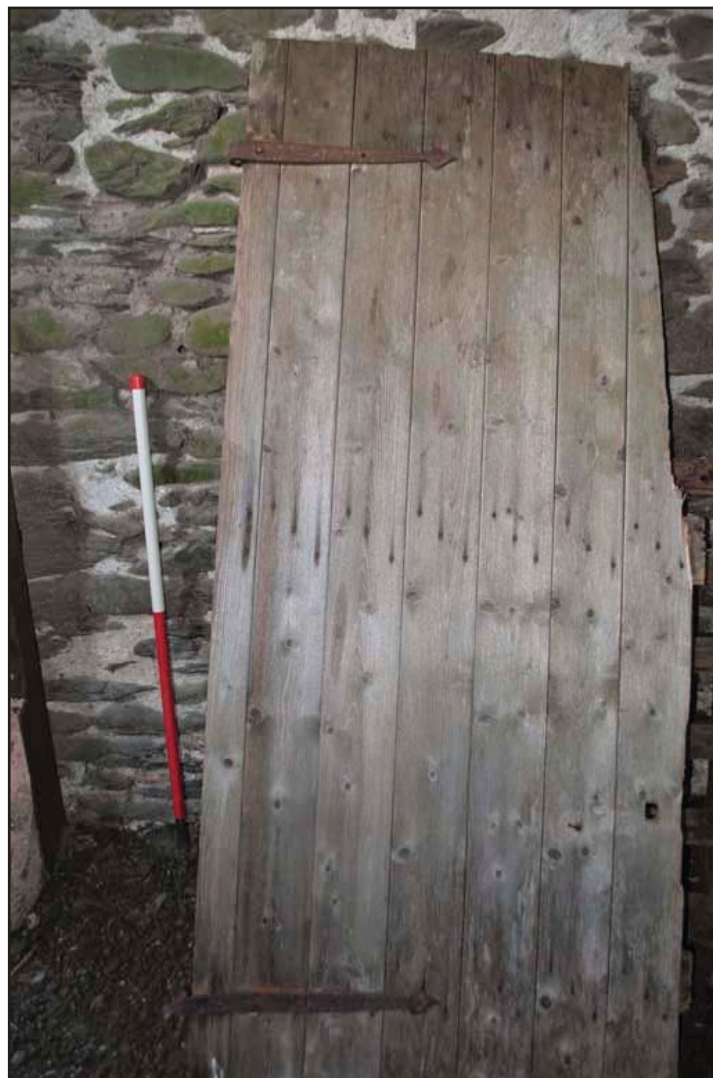
Plate 26: Interior Barn - Close-up of old barn door; scale 1x1m; view from S (archive reference: G2778_026).

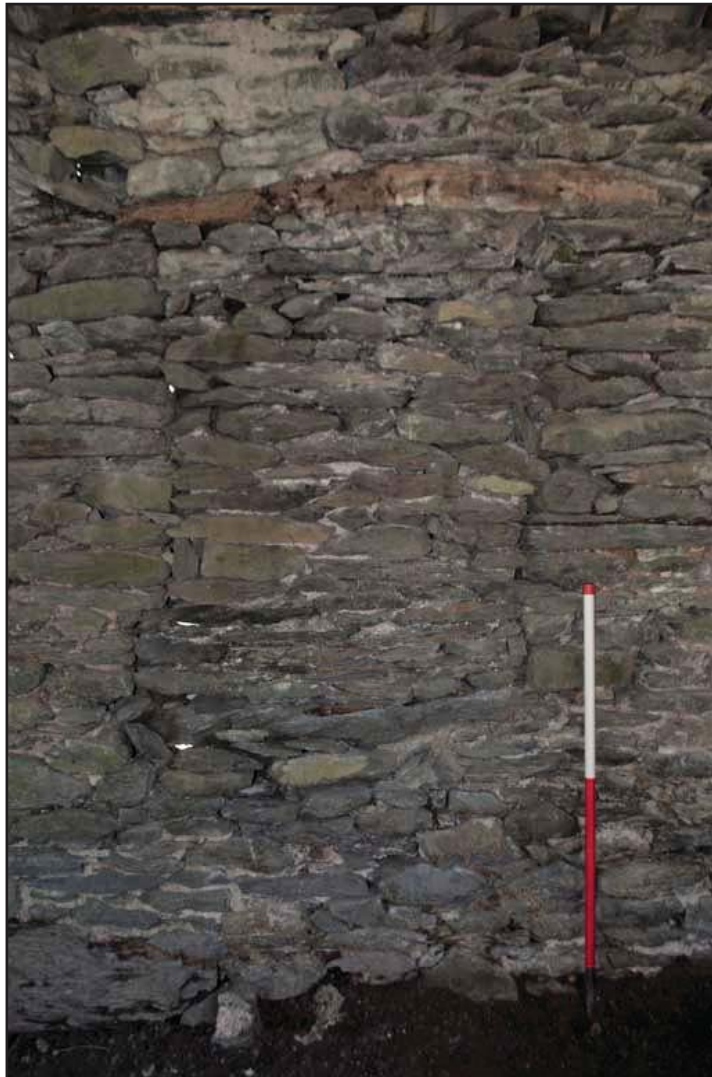
Plate 27: Interior Barn - View of window infilled with stone; scale 1x1m; view from N (archive reference: G2778_027).

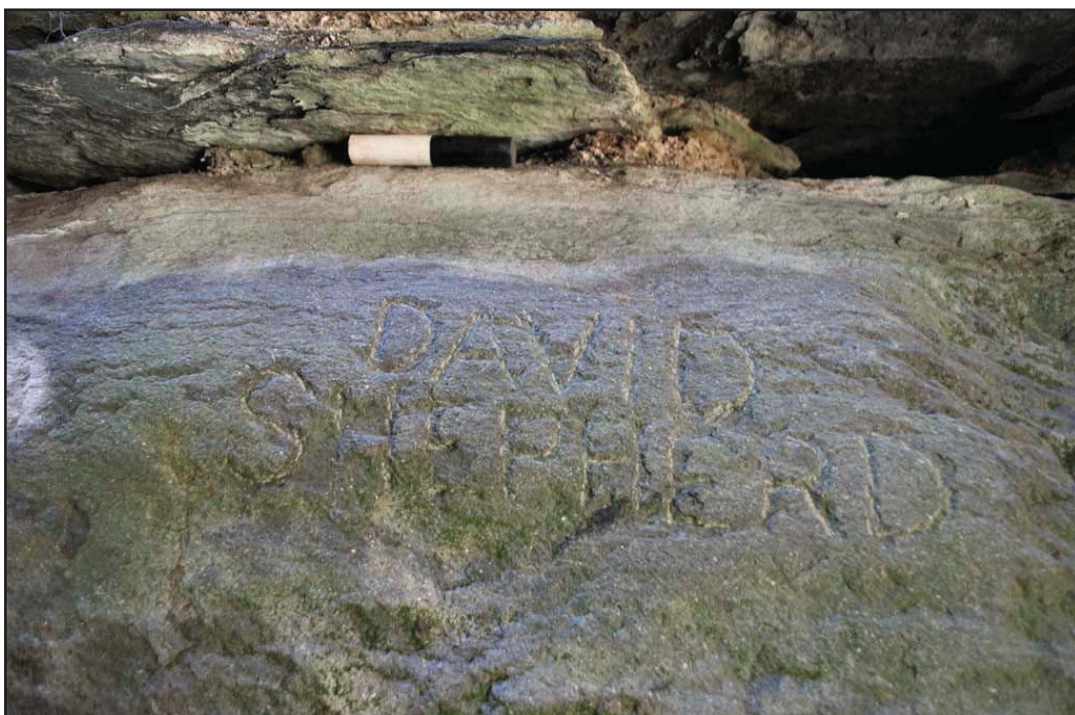
Plate 28: Interior Barn - Close-up view of graffiti in fireplace lintel "David Shepherd"; scale 0.10 m; view from S (archive reference: G2778_028).

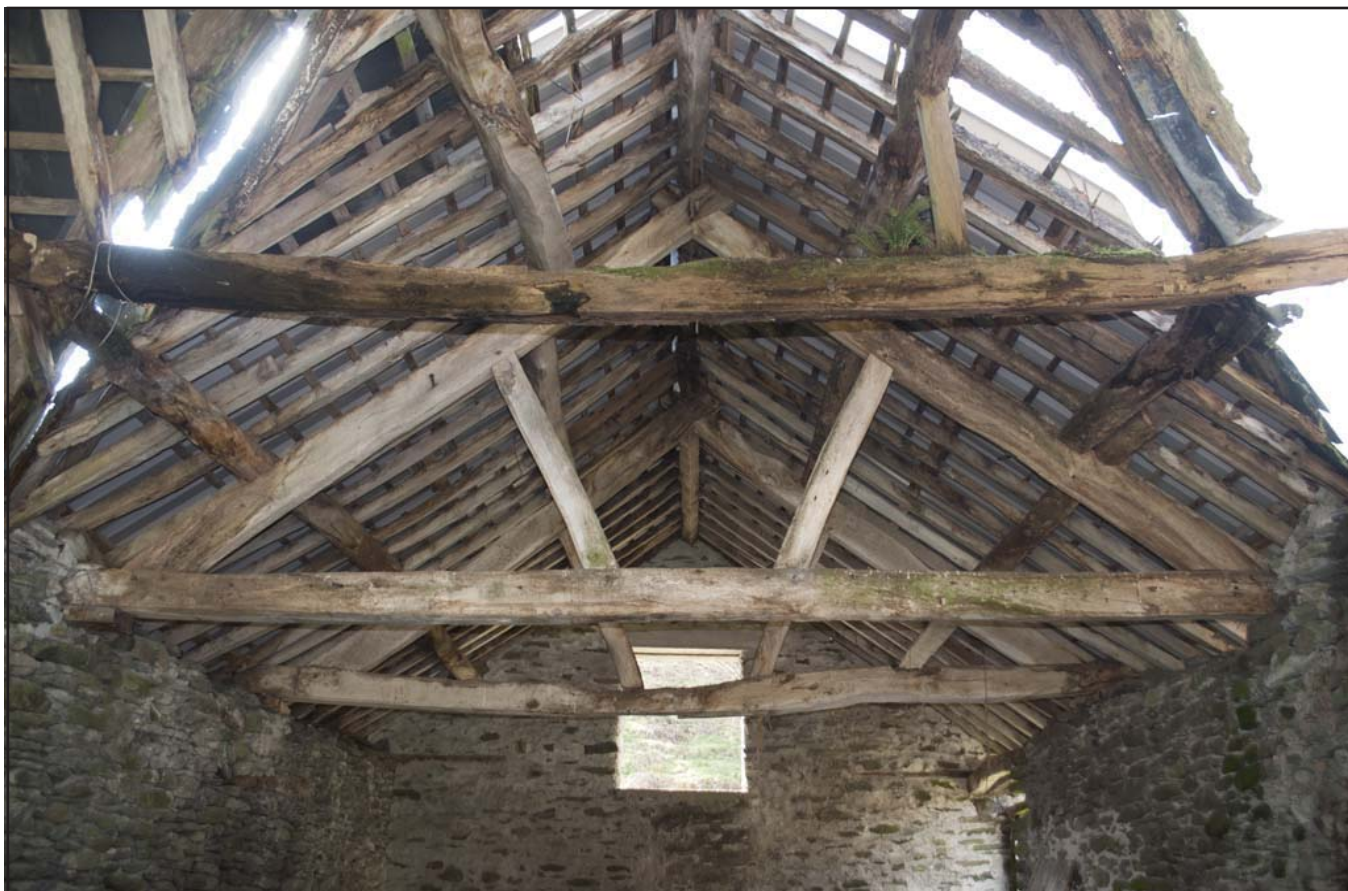
Plate 29: Interior Barn - View of trussed roof inside barn; scale not used; view from E (archive reference: G2778_029).

fields. The cottage (room 1) appears to be of an earlier 18th or 17th century date. The large fireplace lintel in room 1 and the roof trusses in the barn (room 2) seem suitable for dendrochronology in order to better estimate the date of the building, if this was considered appropriate. (cf. Figure 03). The river runs alongside the cottage to the north and east and would have provided essential supplies. To the rear of the building, evidence of a modern yard was noted. In the southwest corner of the western lateral wall was a doorway, 1.28 m wide and 1.8 m high. A large slate threshold slab was noted against the southern gable end wall. The southern gable end wall has a high window opening (unable to measure) that had a concrete sill and lintel, suggestive of modern work being carried out. Damage was noted to the bottom of the southwest corner of the gable.

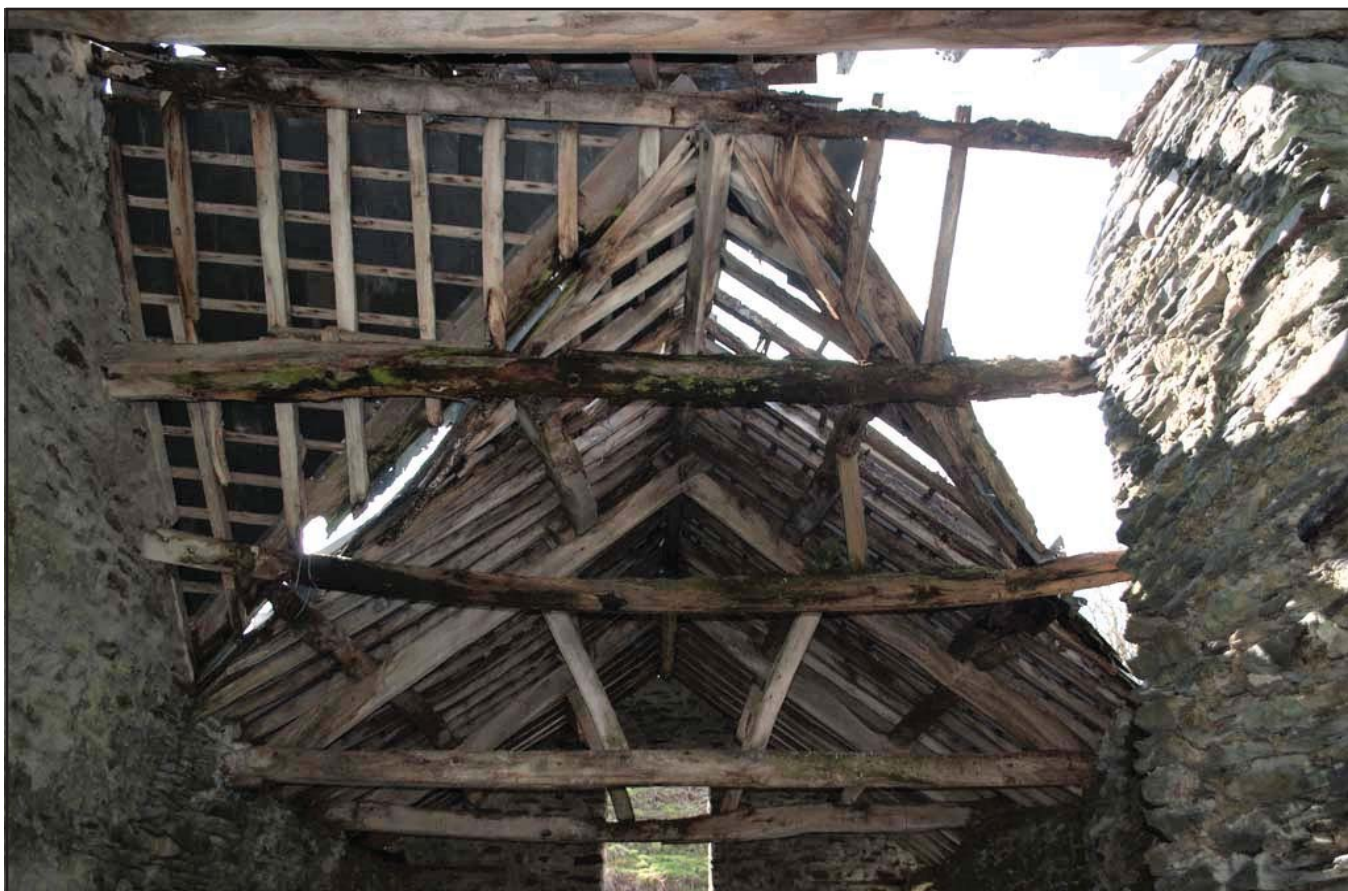
Plate 30: Interior Barn - View of trussed roof inside barn showing collapse; scale not used; view from E (archive reference: G2778_030).

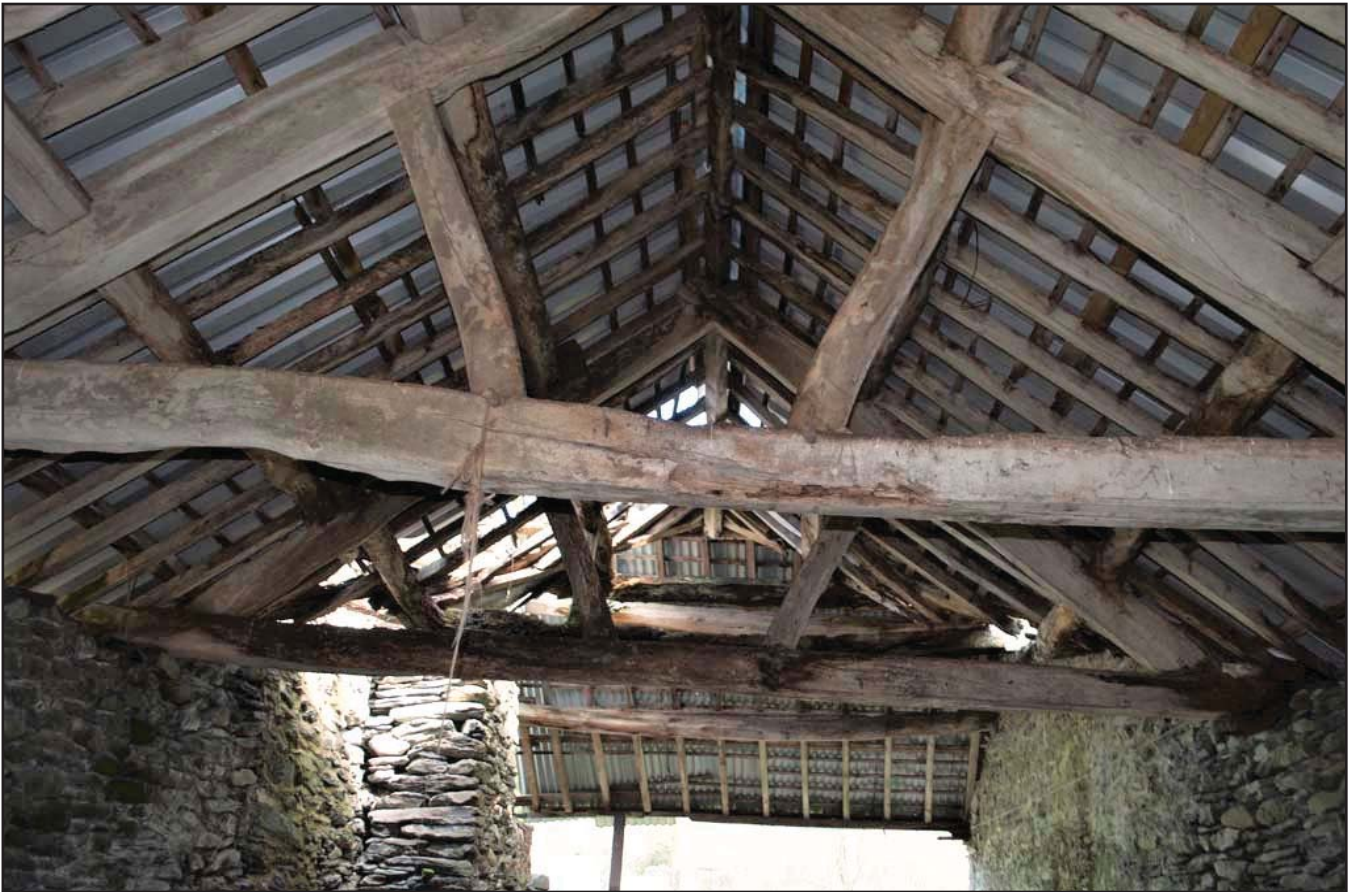
Plate 31: Interior Barn - View of trussed roof inside barn; scale not used; view from SW (archive reference: G2778_031).

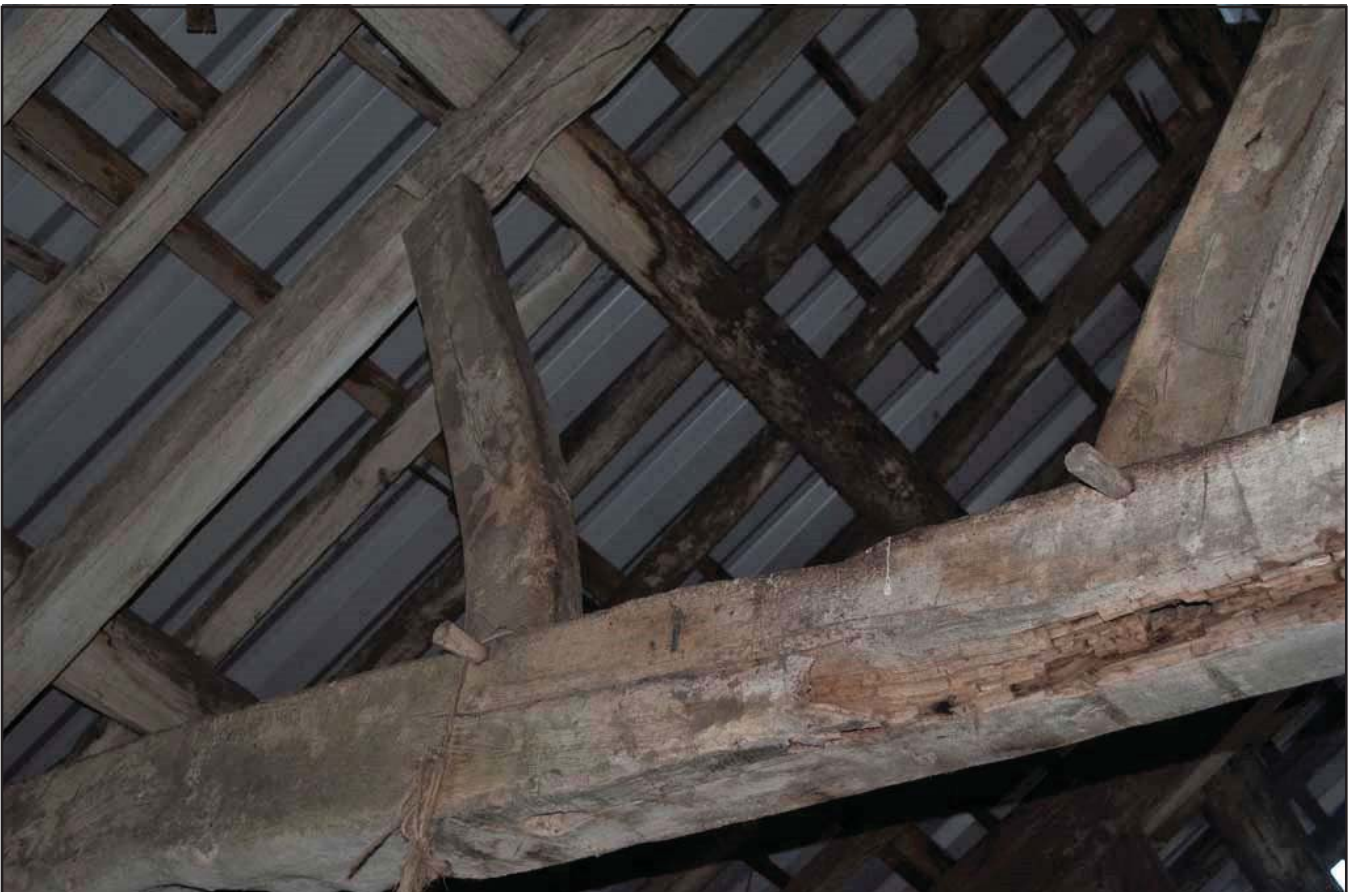
Plate 32: Interior Barn - Close-up of wooden pegs in trussed roof; scale not used; view from SW (archive reference: G2778_032).

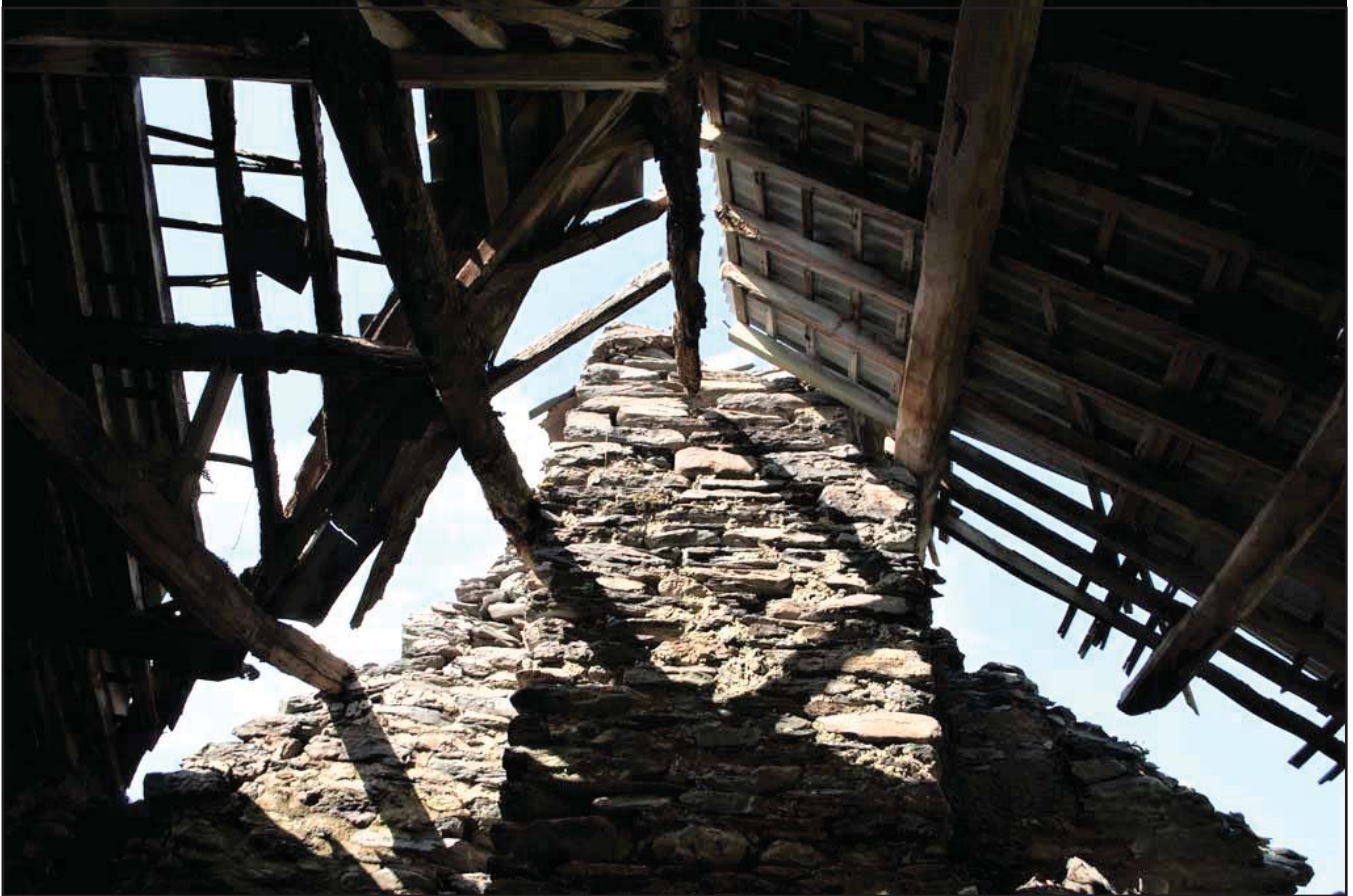
Plate 33: Interior Barn - View of collapsed roof above fireplace in barn; scale not used; view from S (archive reference: G2778_033).

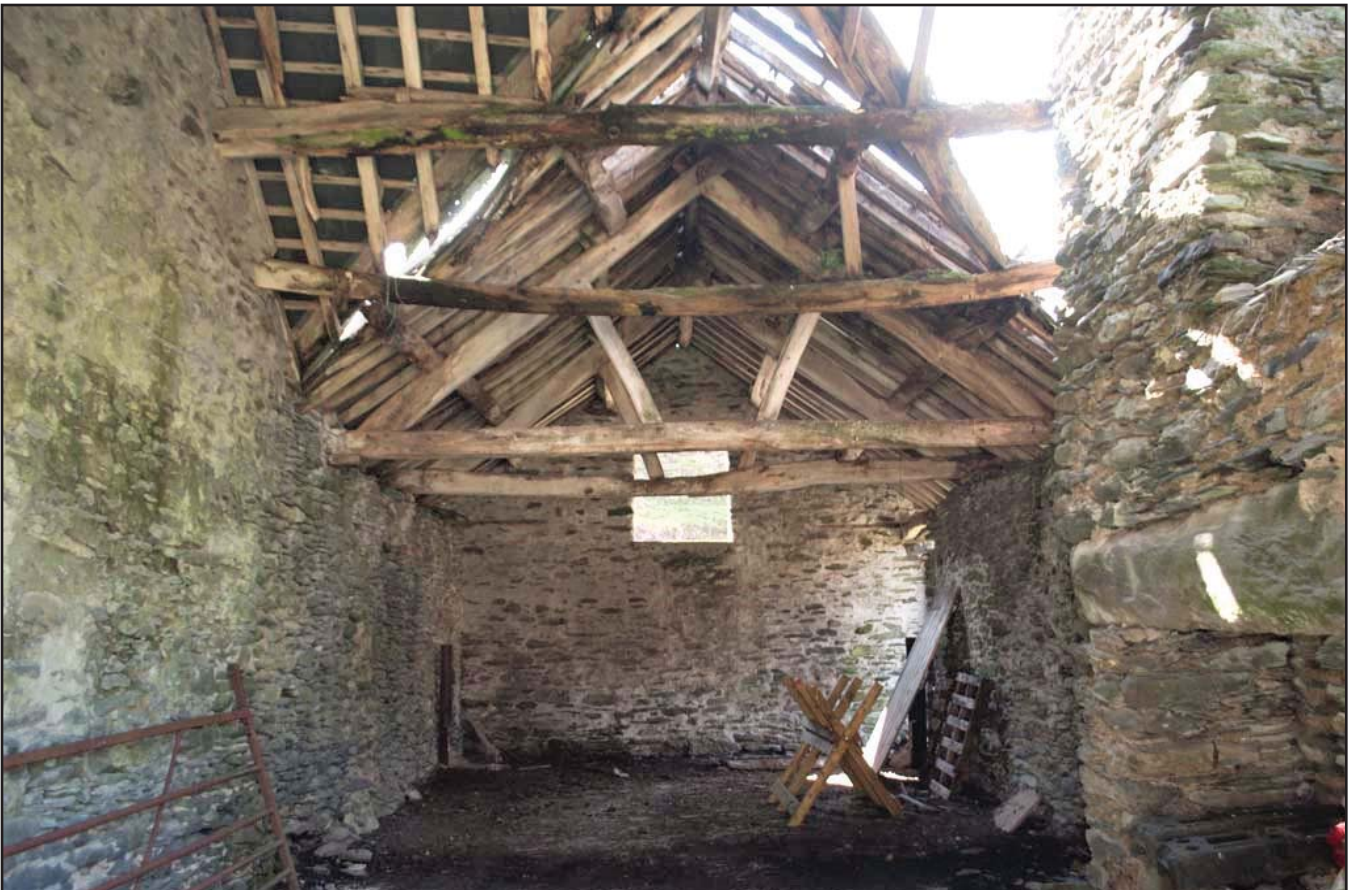
Plate 34: Interior Barn - View into barn from large entrance showing roof trusses; scale not used; view from E (archive reference: G2778_034).

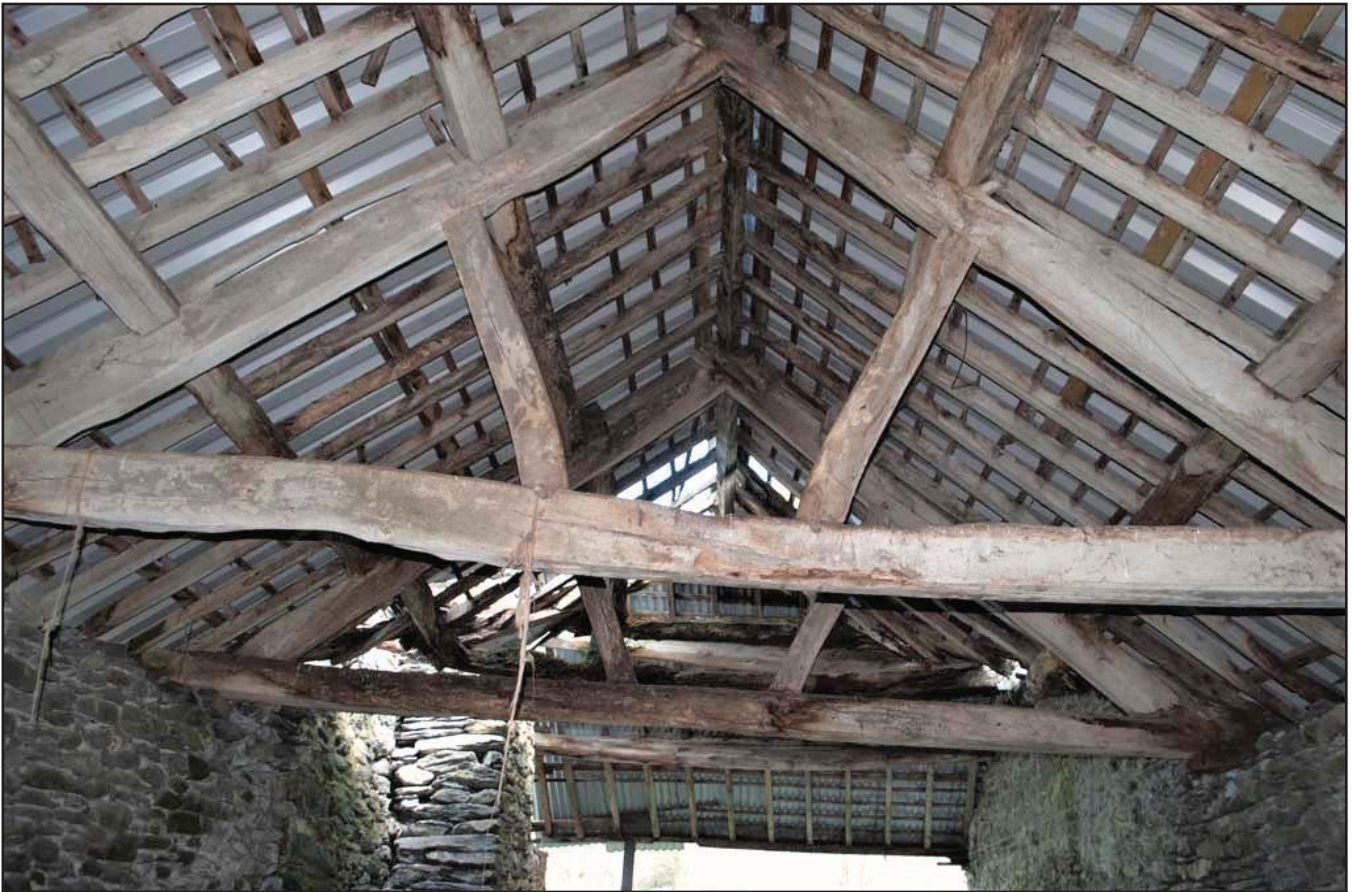
Plate 35: Interior Barn - View of trussed roof in barn; scale not used; view from SW
(archive reference: G2778_035).

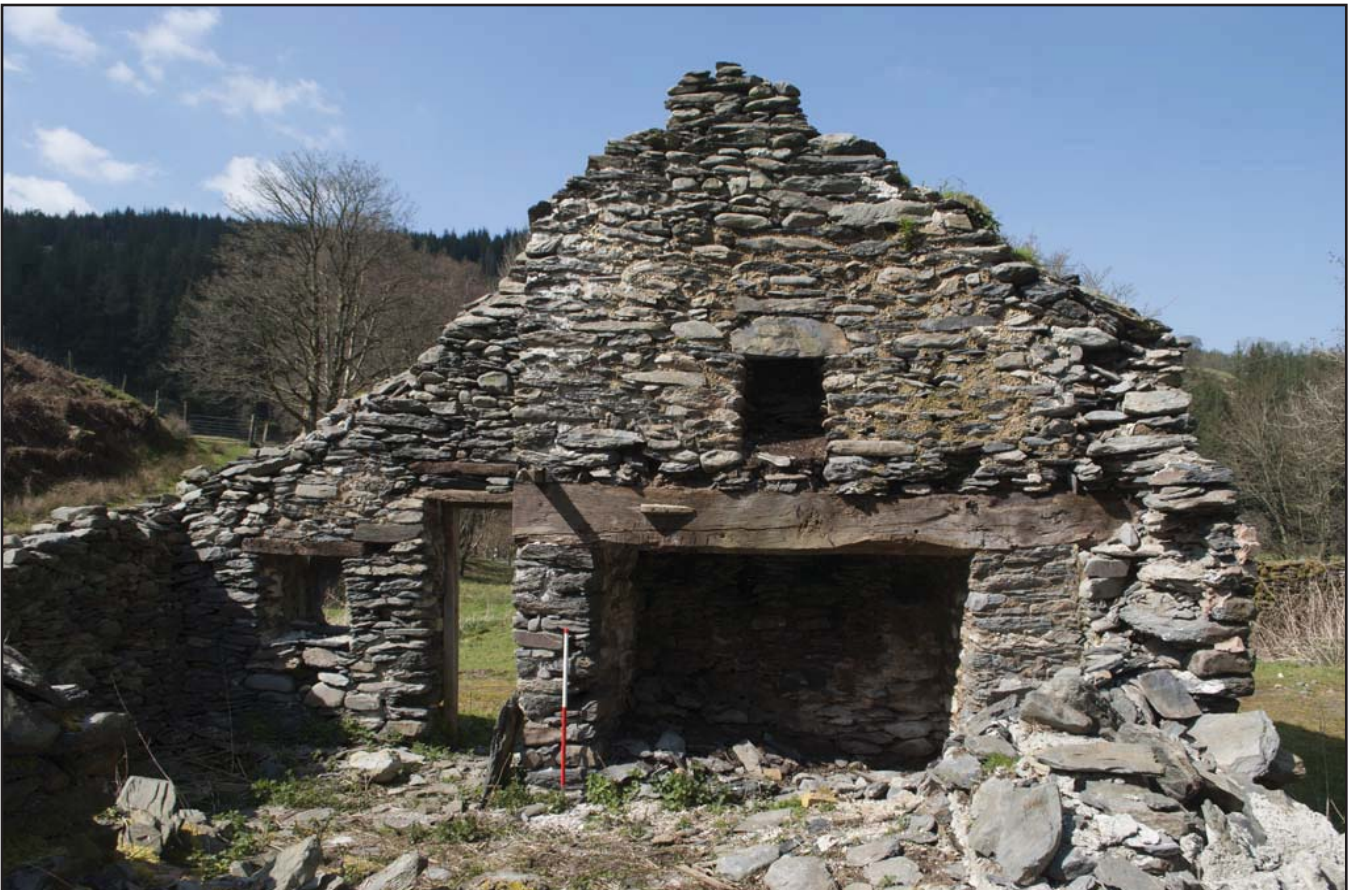
Plate 36: Interior Cottage - View of large fireplace in N wall of cottage; scale 1x1m; view from SE
(archive reference: G2778_036).

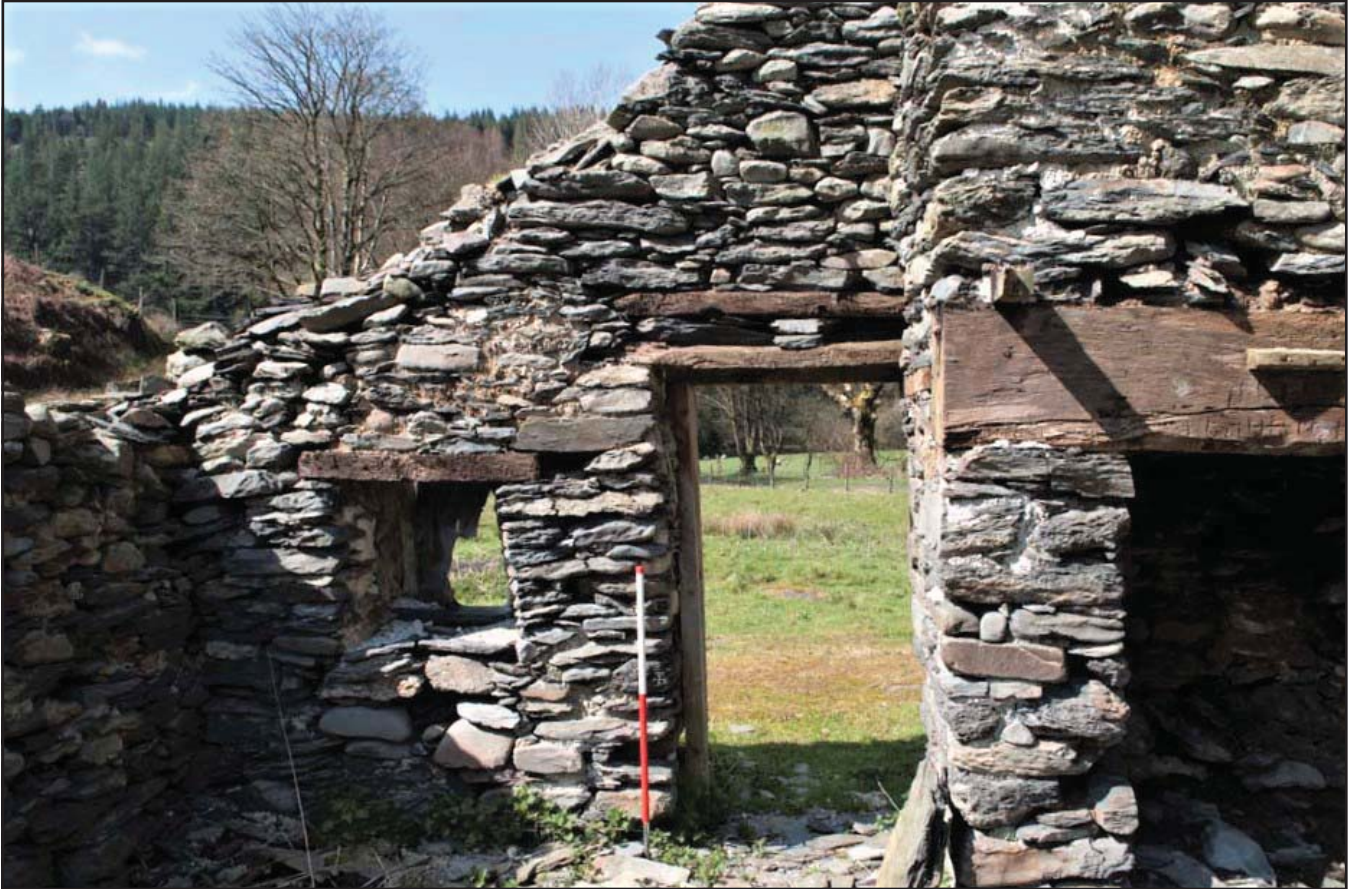
Plate 37: Interior Cottage - View out of the door and window into the cottage; scale 1x1m; view from S (archive reference: G2778_037).

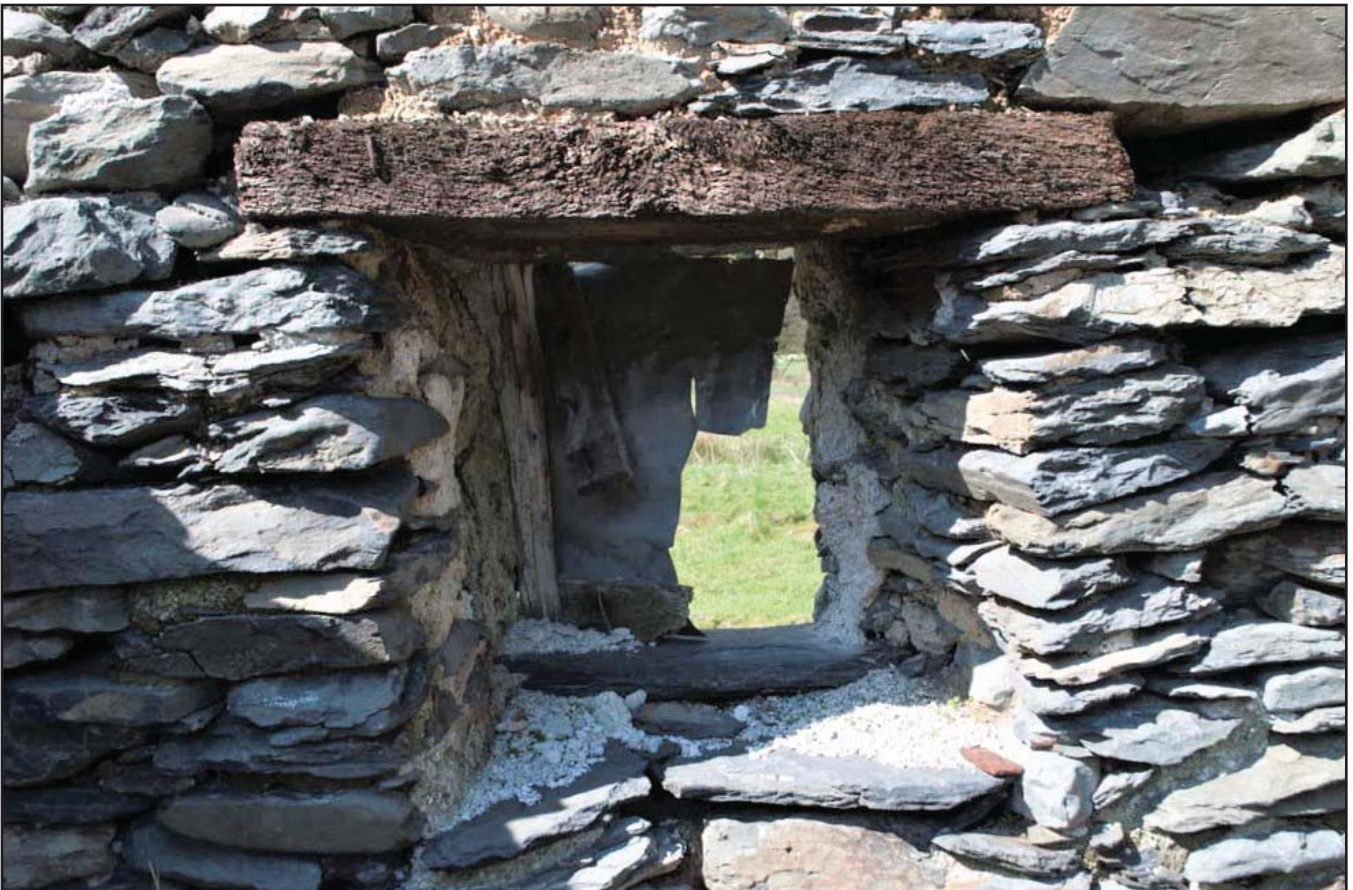
Plate 38: Interior Cottage - Close-up of cottage window; scale not used; view from SE (archive reference: G2778_038).

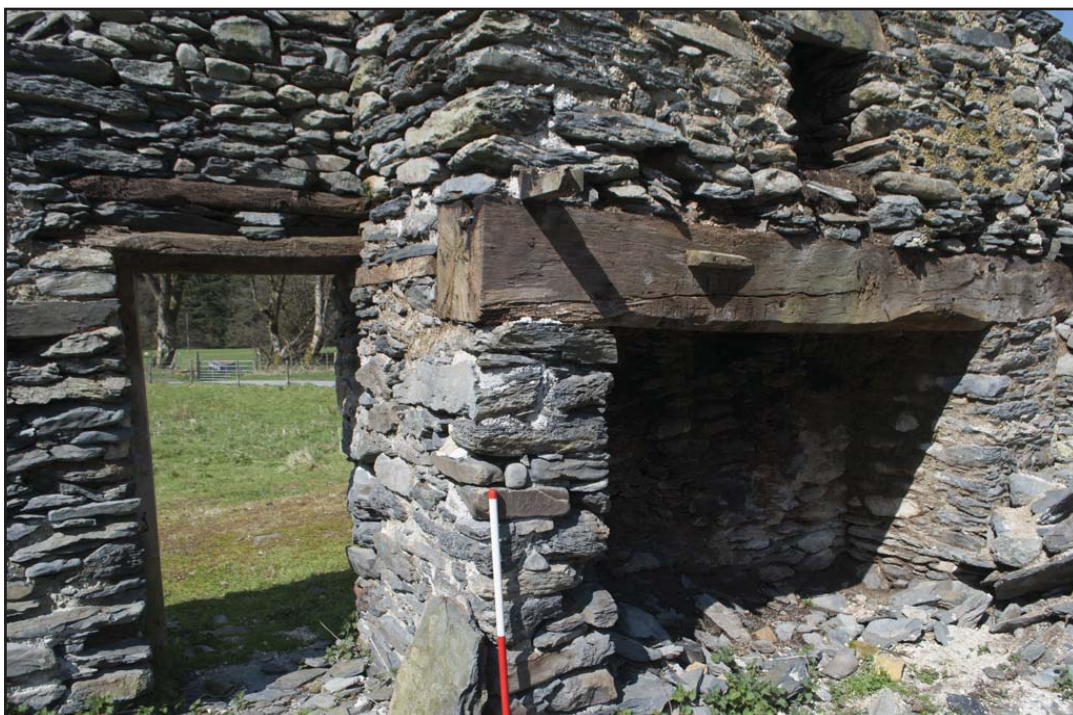
Plate 39: Interior Cottage - Oblique view of fireplace and door leading out of cottage; scale 1x1m; view from SE (archive reference: G2778_039).

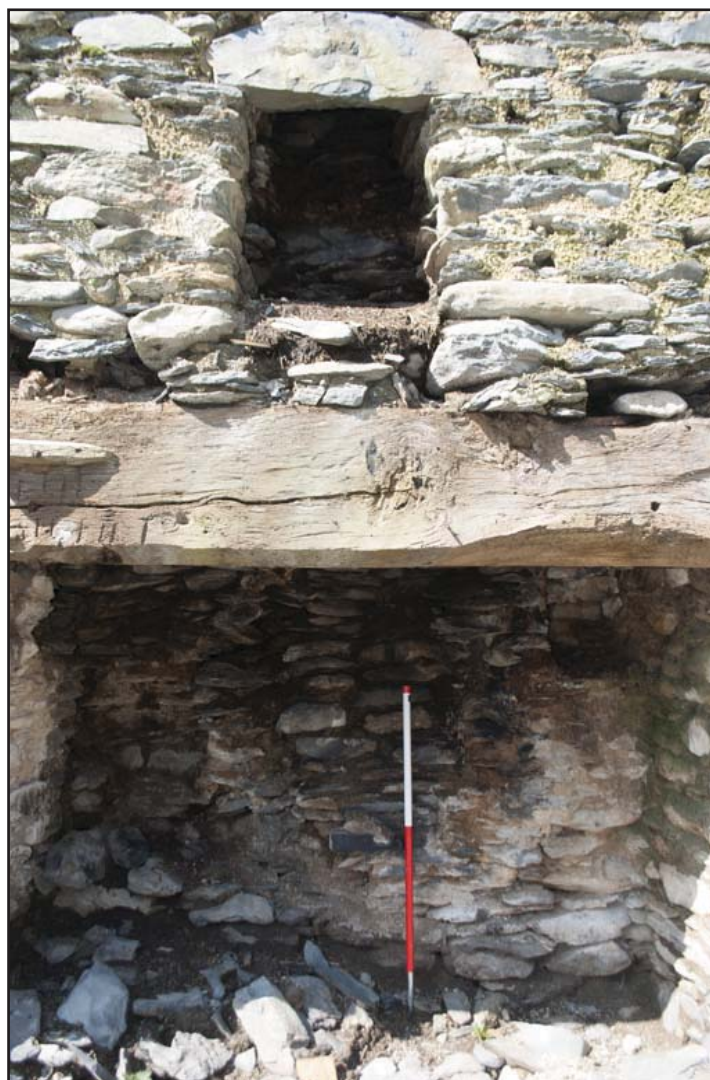
Plate 40: Interior Cottage - Close-up view of fireplace showing first floor fireplace above and small alcove in the right hand corner; scale 1x1m; view from SE (archive reference: G2778_040).

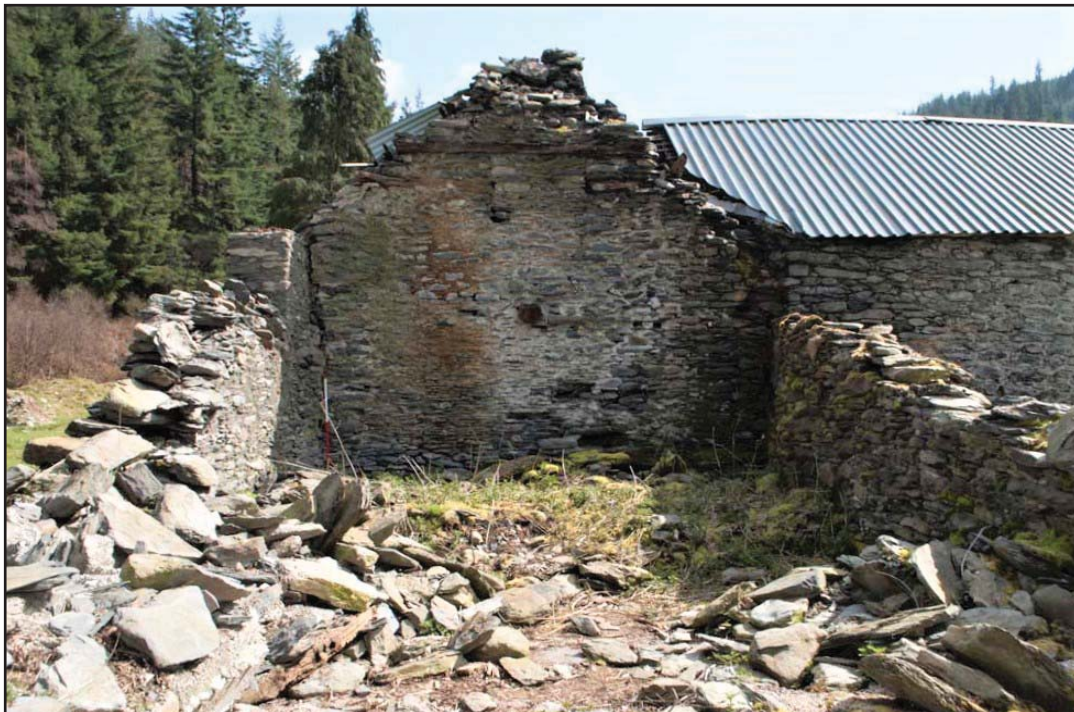
Plate 41: Interior Cottage - View of inside of cottage from the fireplace; scale 1x1m; view from NW (archive reference: G2778_041).

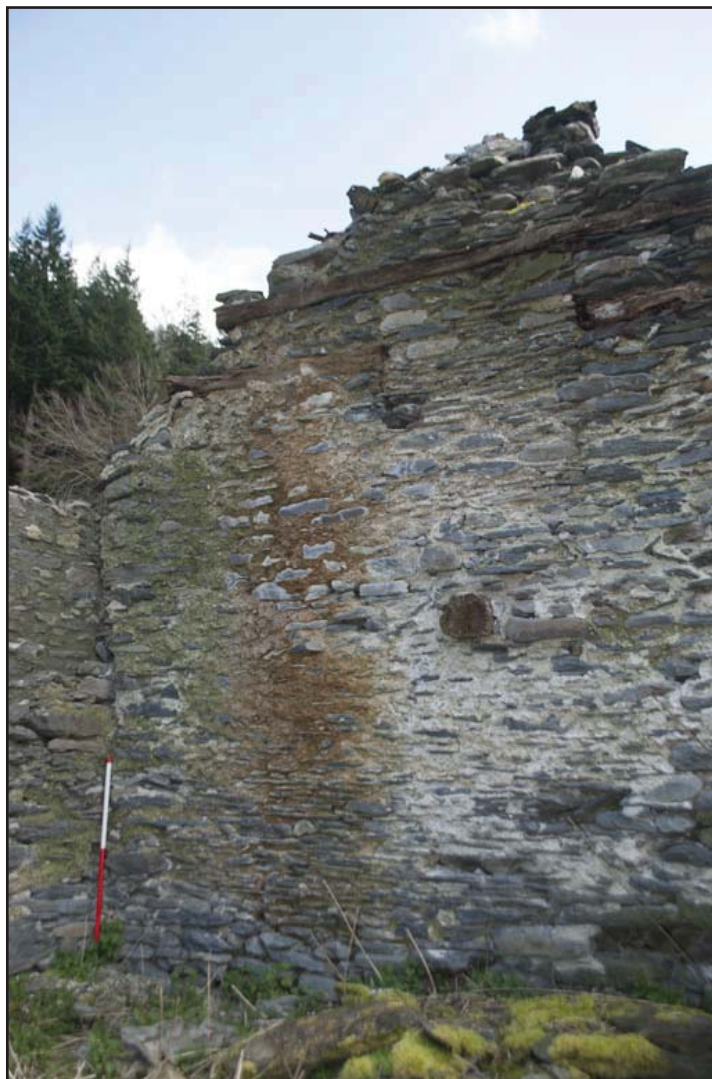
Plate 42: Interior Cottage - View of SE gable end of cottage; scale 1x1m; view from NW (archive reference: G2778_042).

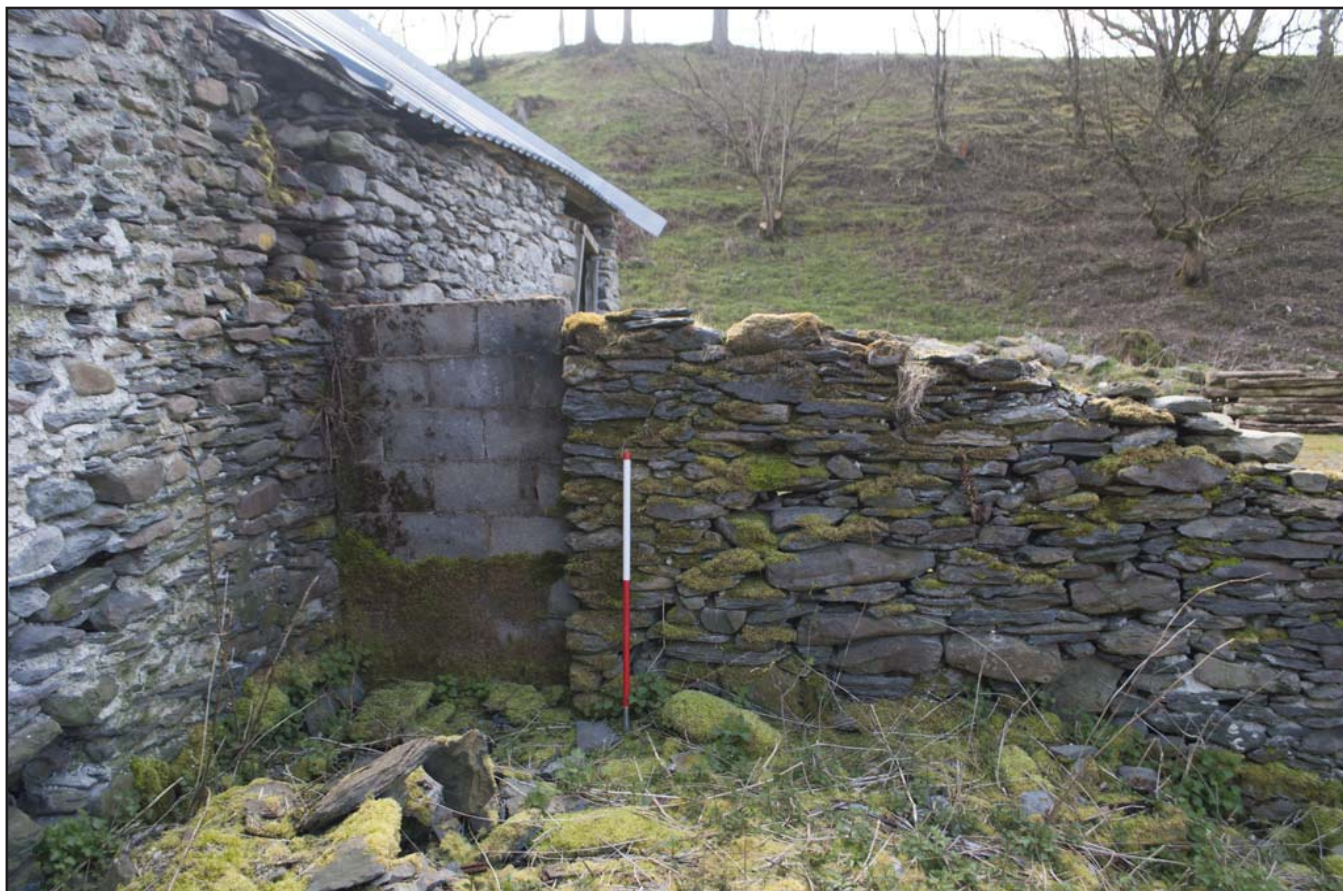
Plate 43: Interior Cottage - View of blocked up doorway into cottage; scale 1x1 m; view from NE (archive reference: G2778_043).

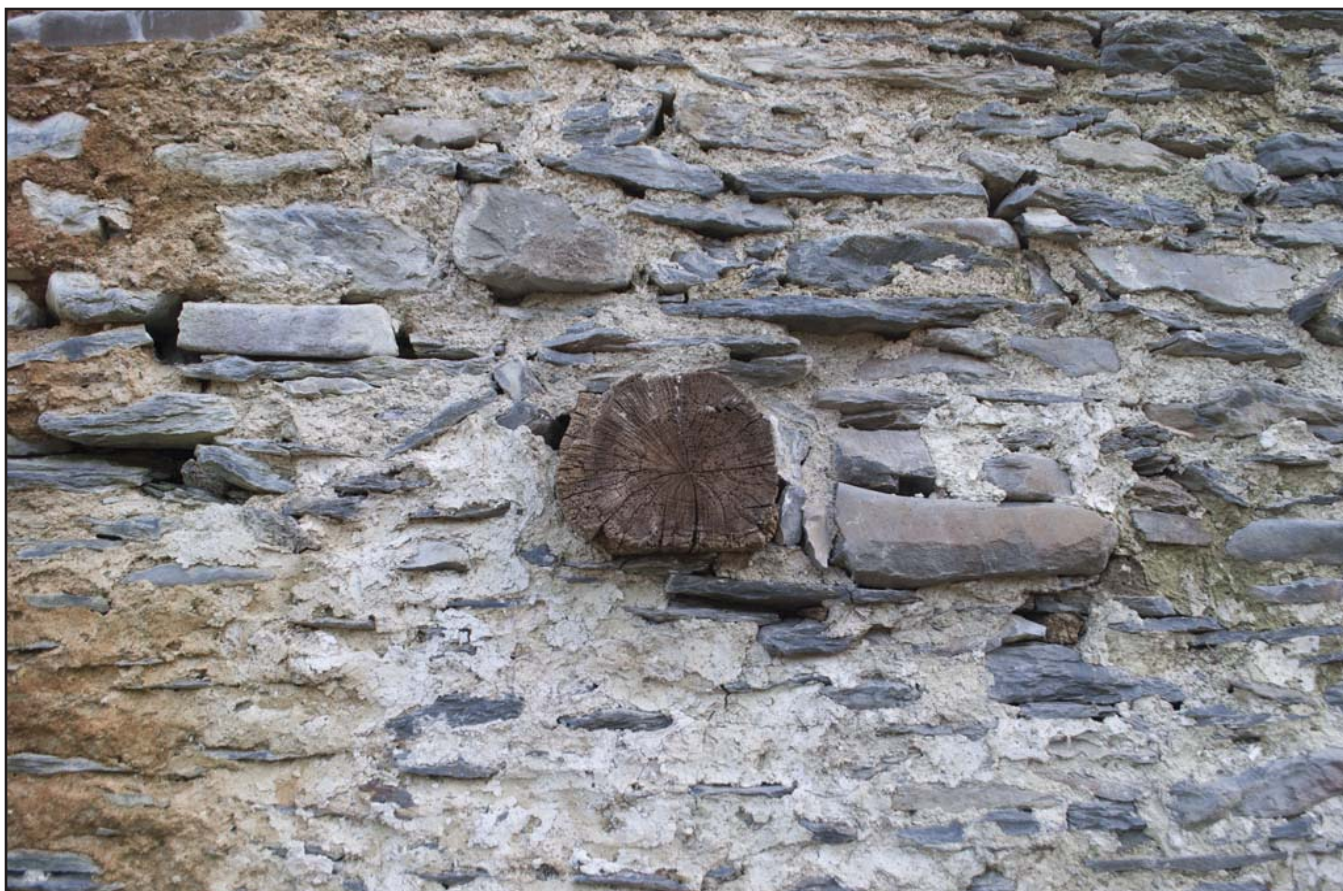
Plate 44: Interior Cottage - Close-up view of wooden beam protruding from SE gable end of the cottage; scale not used; view from N (archive reference: G2778_044).

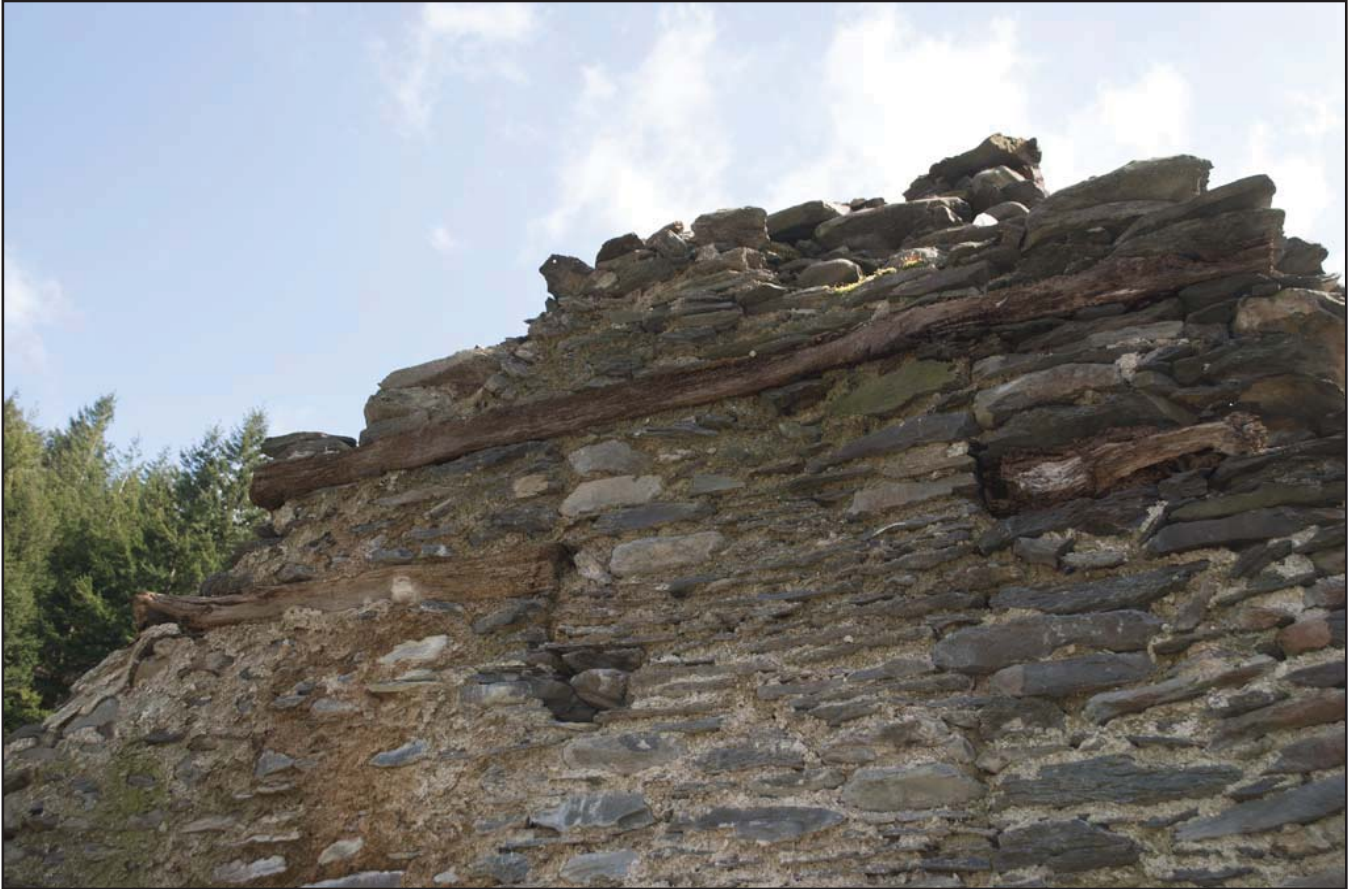
Plate 45: Interior Cottage - View of wooden beams in the top of SE gable end; scale not used; view from NW (archive reference: G2778_045).
