MOEL DDINAS, RHOSYGWALIA, Y BALA

COFNOD ADEILADAU HANESYDDOL / HISTORIC BUILDING RECORDING

Rhif Prosiect / Project No. G2778

Rhif Adroddiad / Report No. 1705

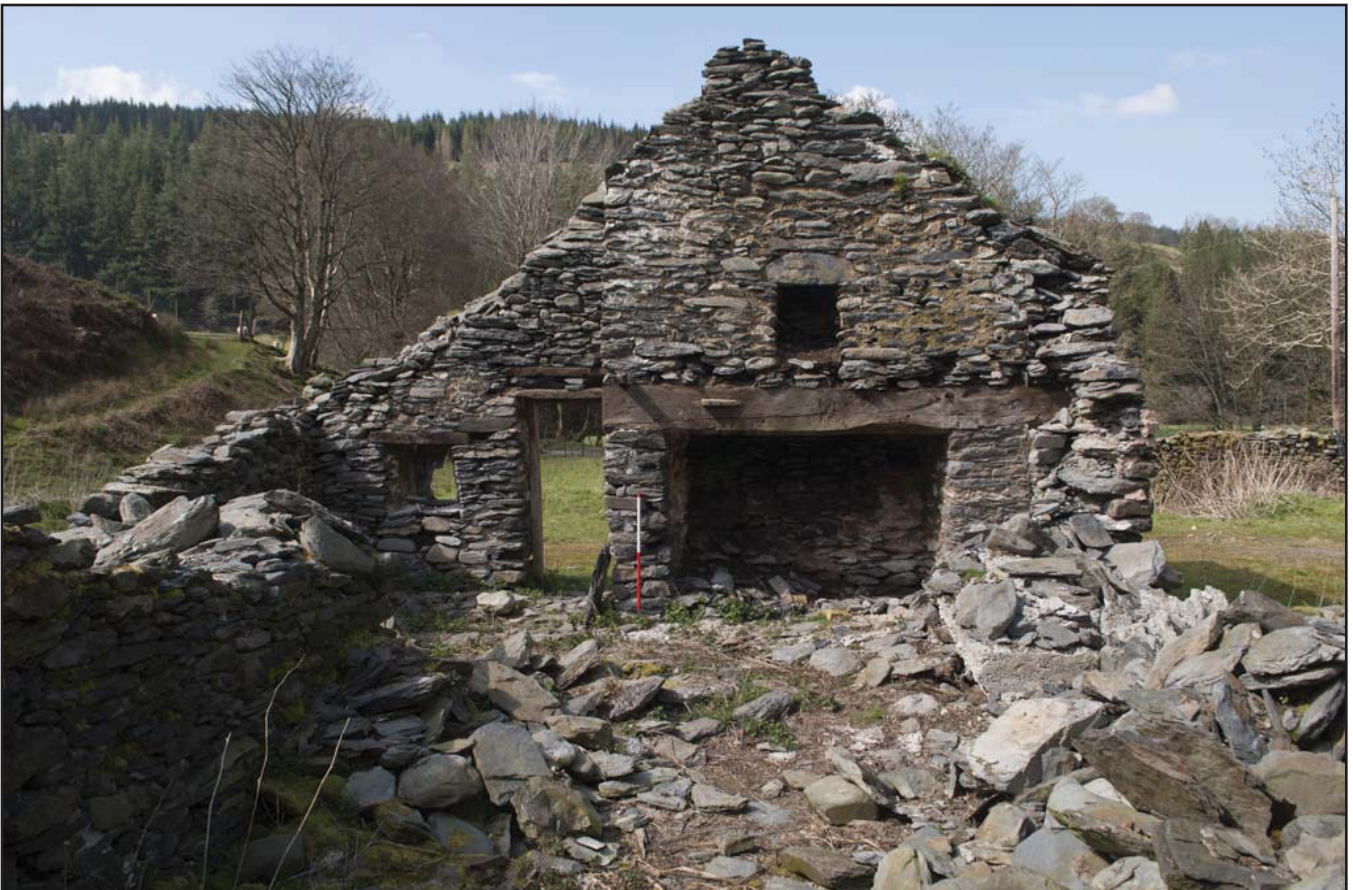
Plate 46: Interior Cottage - View of interior of cottage showing fireplace; scale 1x1m; view from SE (archive reference: G2778_046).

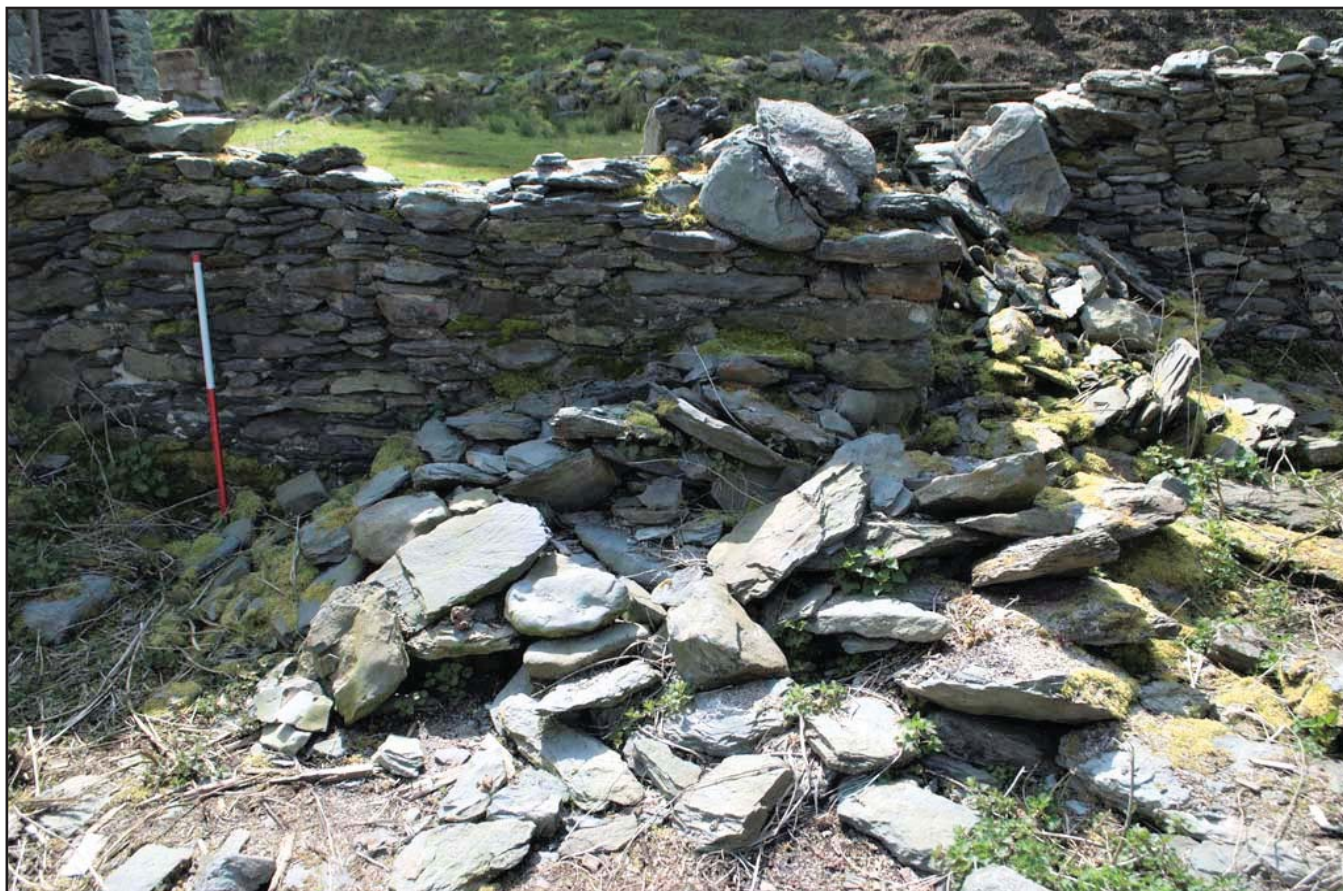
Plate 47: Interior Cottage - View of SW wall of the cottage showing collapse; scale 1x1m; view from NE (archive reference: G2778_047).

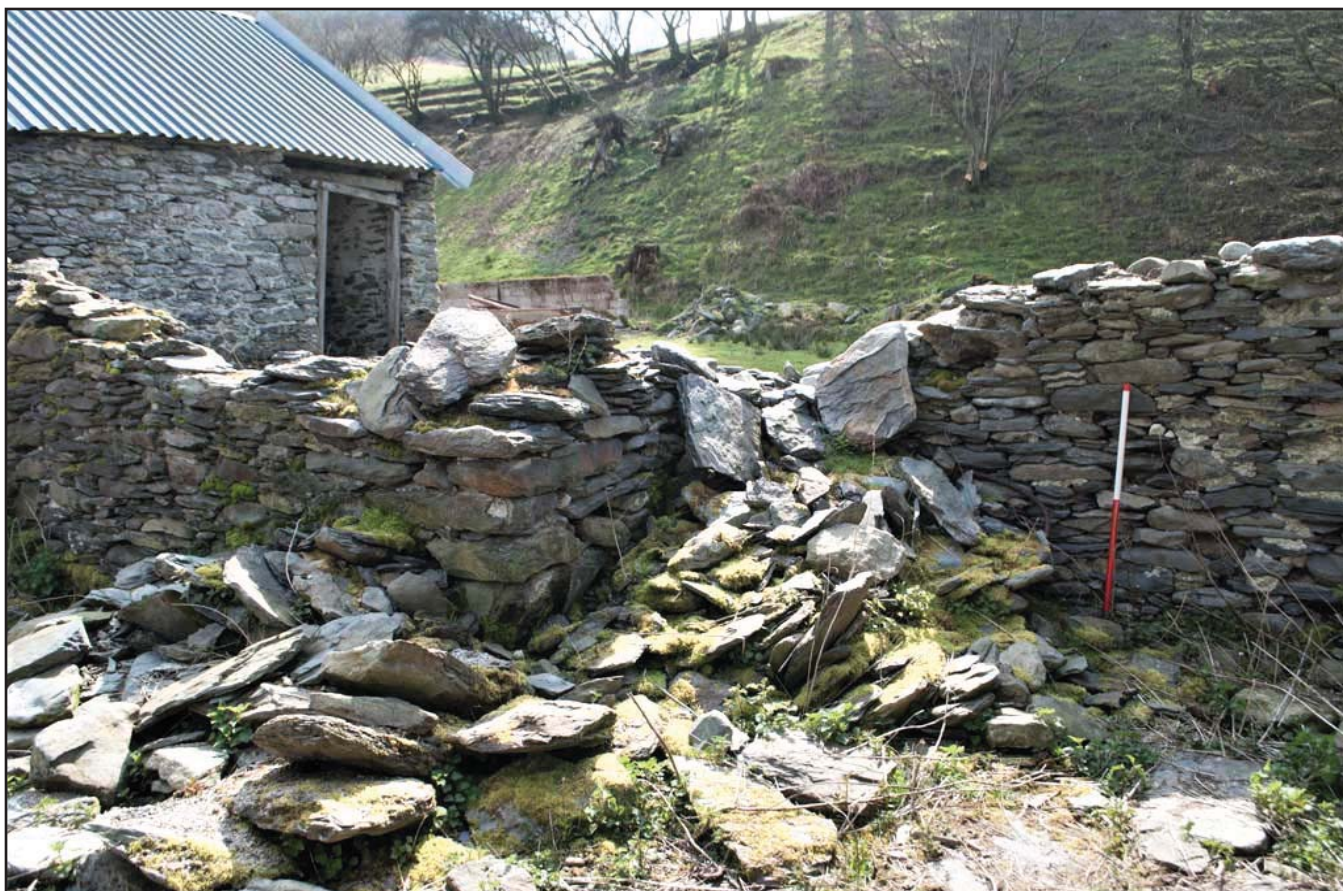
Plate 48: Interior Cottage - View of SW wall of the cottage showing collapse; scale 1x1m; view from N (archive reference: G2778_048).

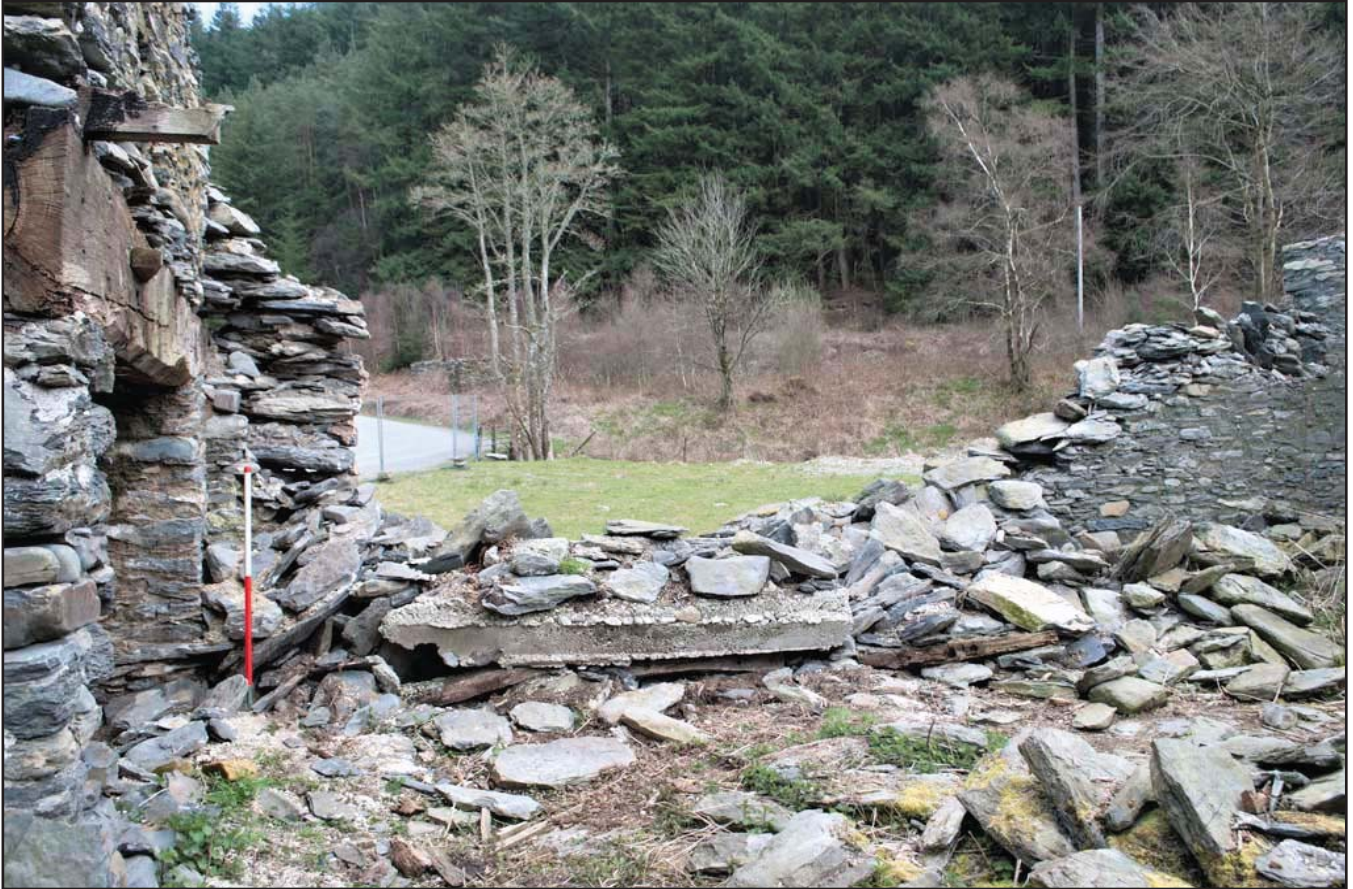
Plate 49: Interior Cottage - View of the NE wall of the cottage showing collapse, large concrete block; scale 1x1m; view from W (archive reference: G2778_049).

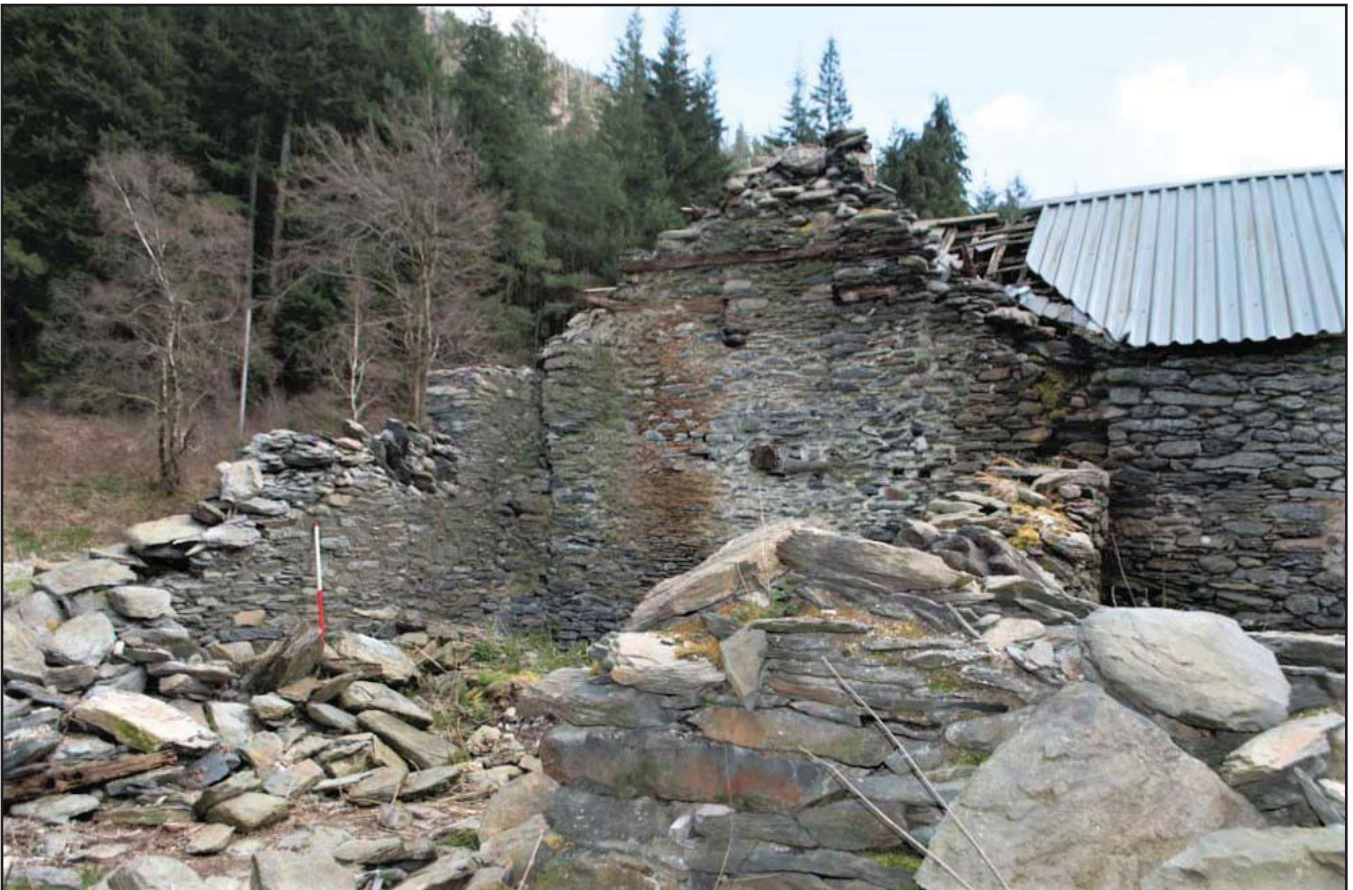
Plate 50: Interior Cottage - View of the NE wall of the cottage showing collapse, large concrete block; scale 1x1m; view from W (archive reference: G2778_050).

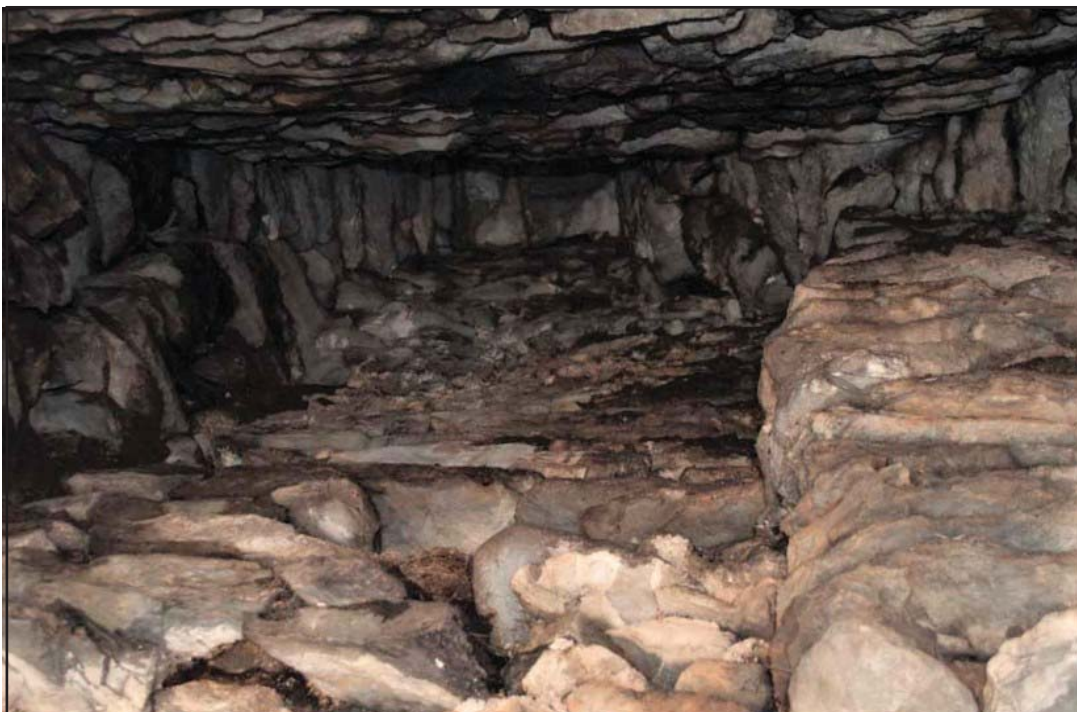
Plate 52: Interior Cottage - View up into fireplace chimney in cottage; scale not used; view from E (archive reference: G2778_052).

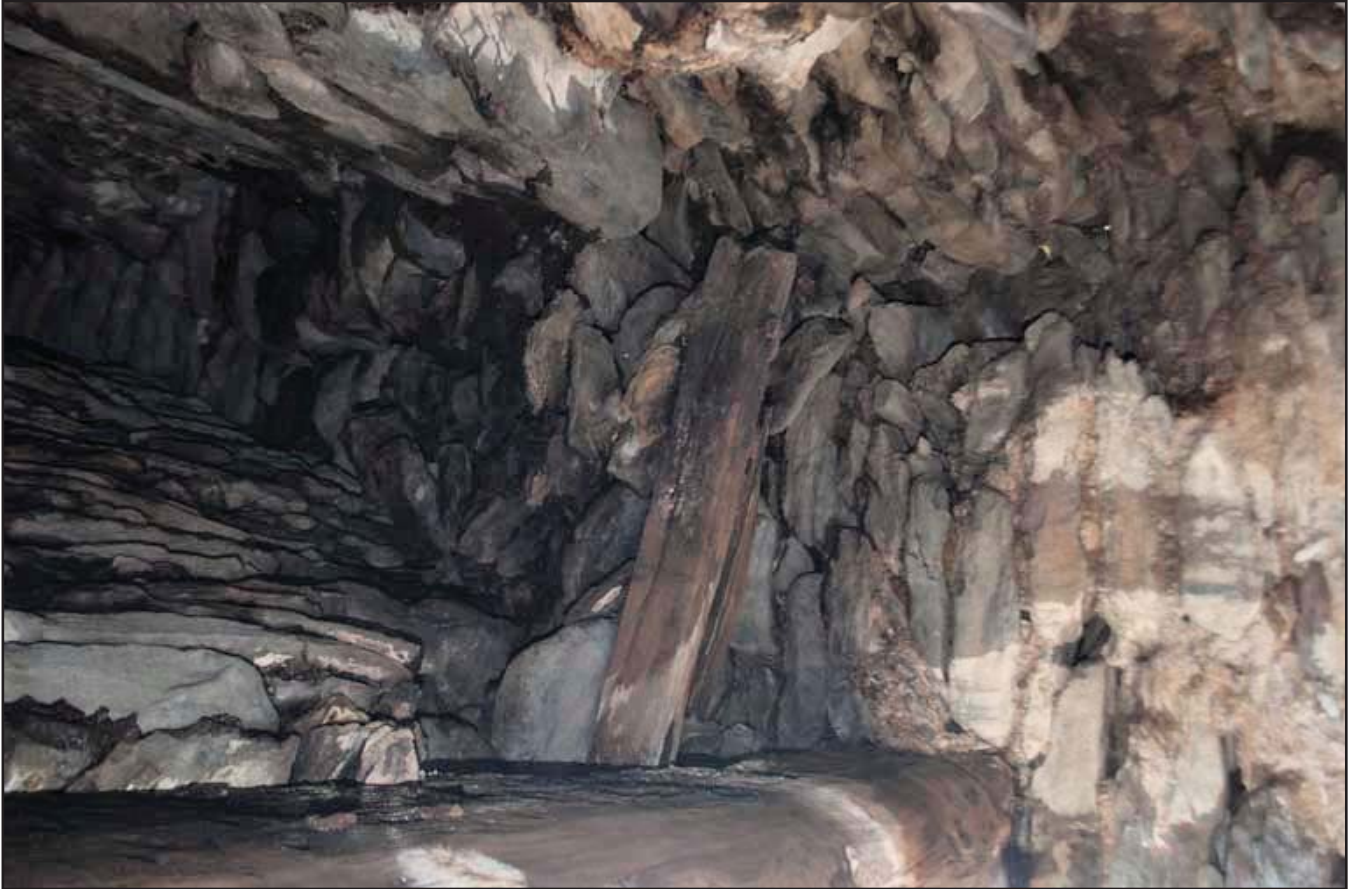
Plate 53: Interior Cottage - View up into fireplace chimney in cottage, showing collapsing beam; scale not used; view from E (archive reference: G2778_053).

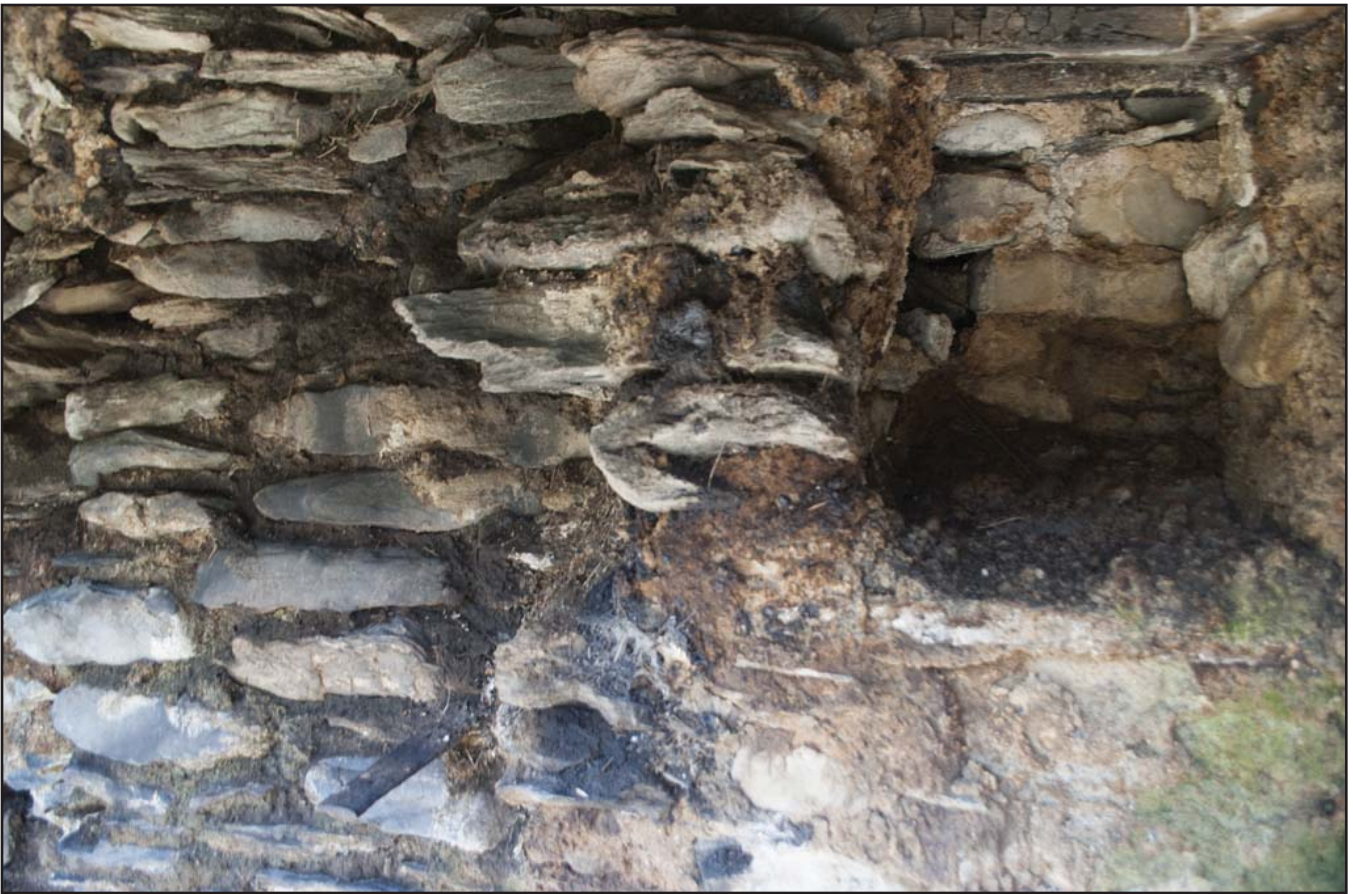
Plate 54: Interior Cottage - Close-up of alcove and metal bar in fireplace; scale not used; view from SE (archive reference: G2778_054).

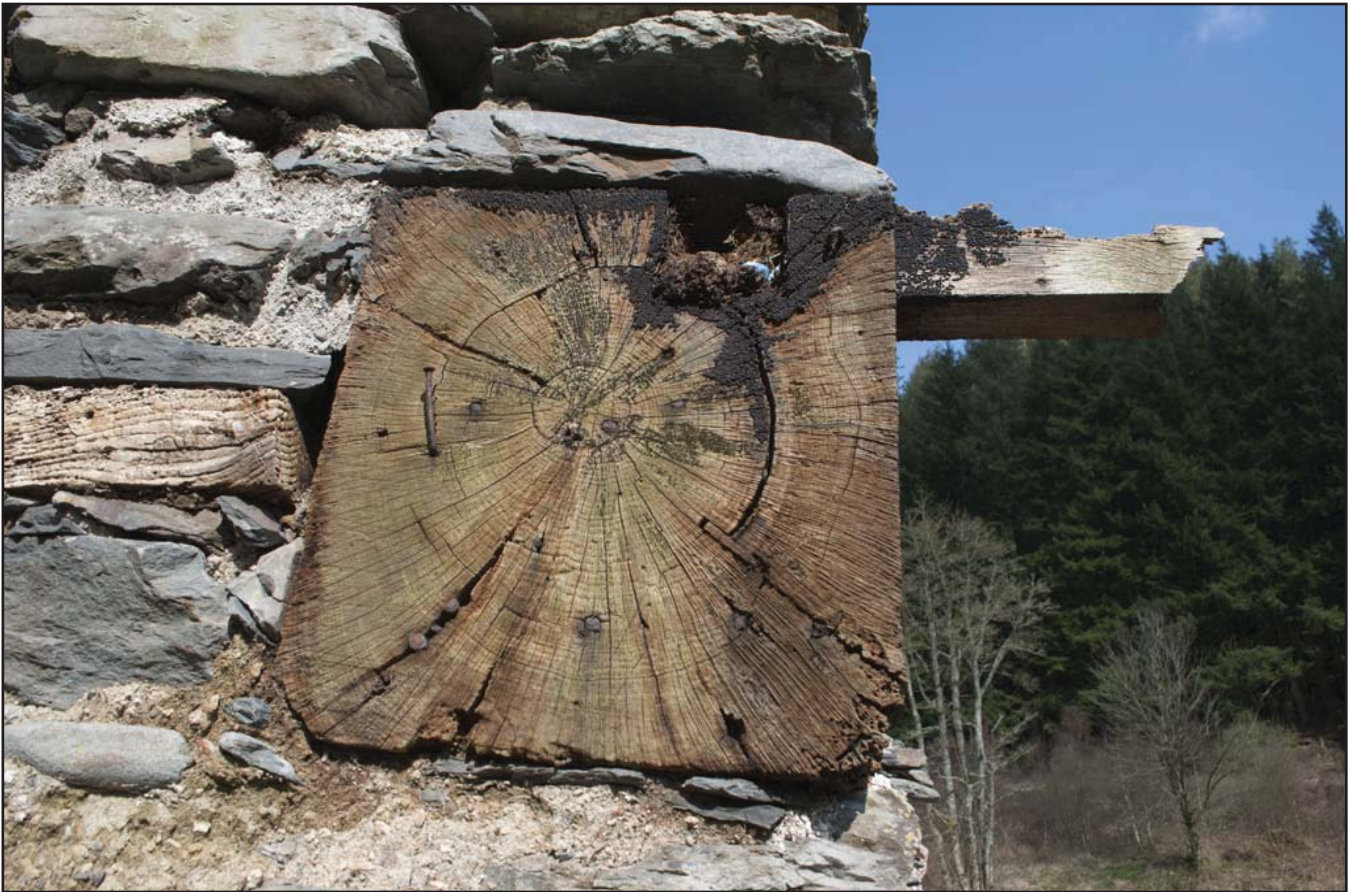
Plate 55: Interior Cottage - Close-up of wooden fireplace lintel; scale not used; view from SW (archive reference: G2778_055).

fields. The cottage (room 1) appears to be of an earlier 18th or 17th century date. The large fireplace lintel in room 1 and the roof trusses in the barn (room 2) seem suitable for dendrochronology in order to better estimate the date of the building, if this was considered appropriate. (cf. Figure 03). The river runs alongside the cottage to the north and east and would have provided essential supplies. To the rear of the building, evidence of a modern yard was noted. In the southwest corner of the western lateral wall was a doorway, 1.28 m wide and 1.8 m high. A large slate threshold slab was noted against the southern gable end wall. The southern gable end wall has a high window opening (unable to measure) that had a concrete sill and lintel, suggestive of modern work being carried out. Damage was noted to the bottom of the southwest corner of the gable.

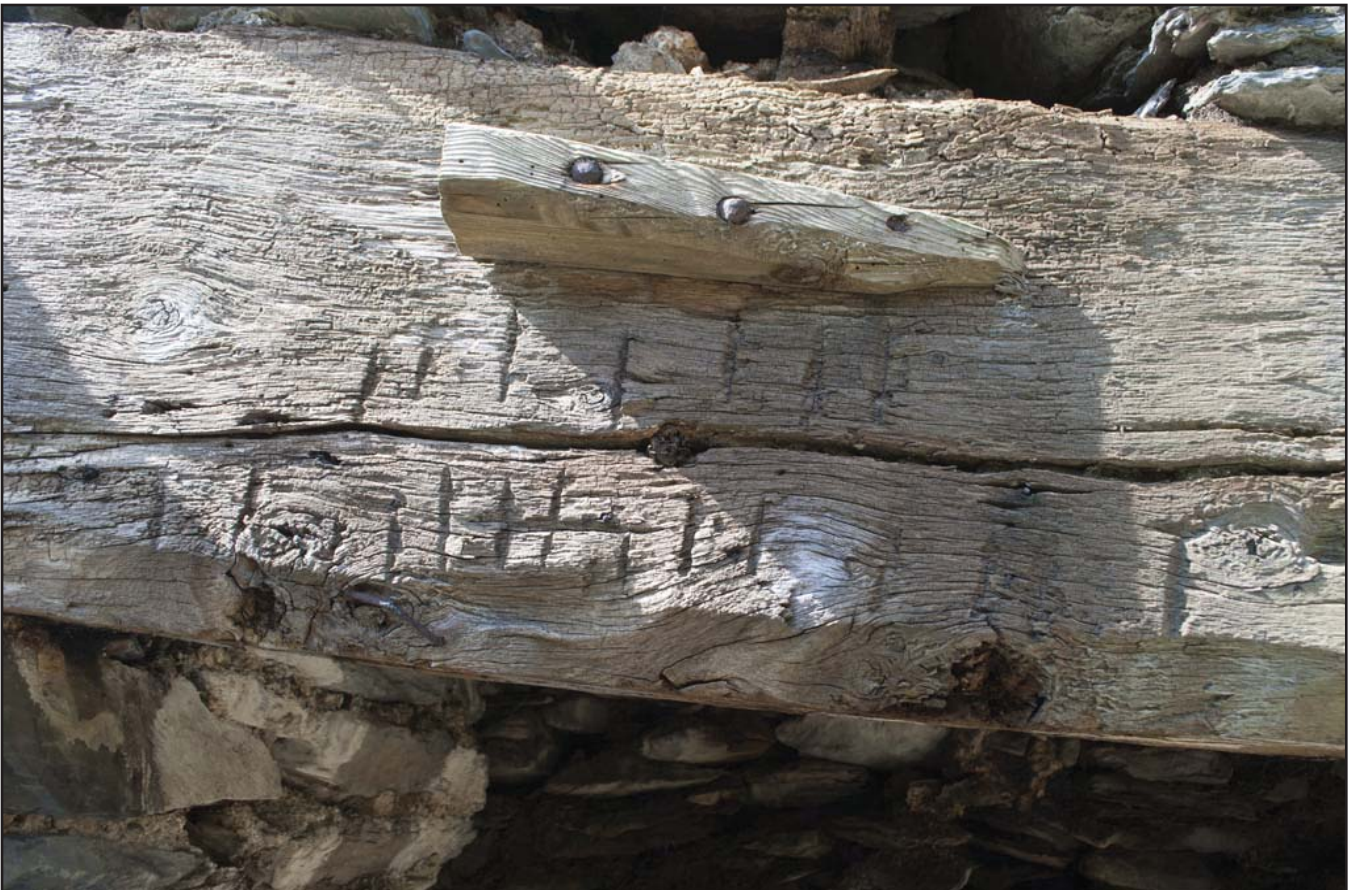
Plate 56: Interior Cottage - Close-up of carving in lintel and wooden addition; scale not used; view from S (archive reference: G2778_056).

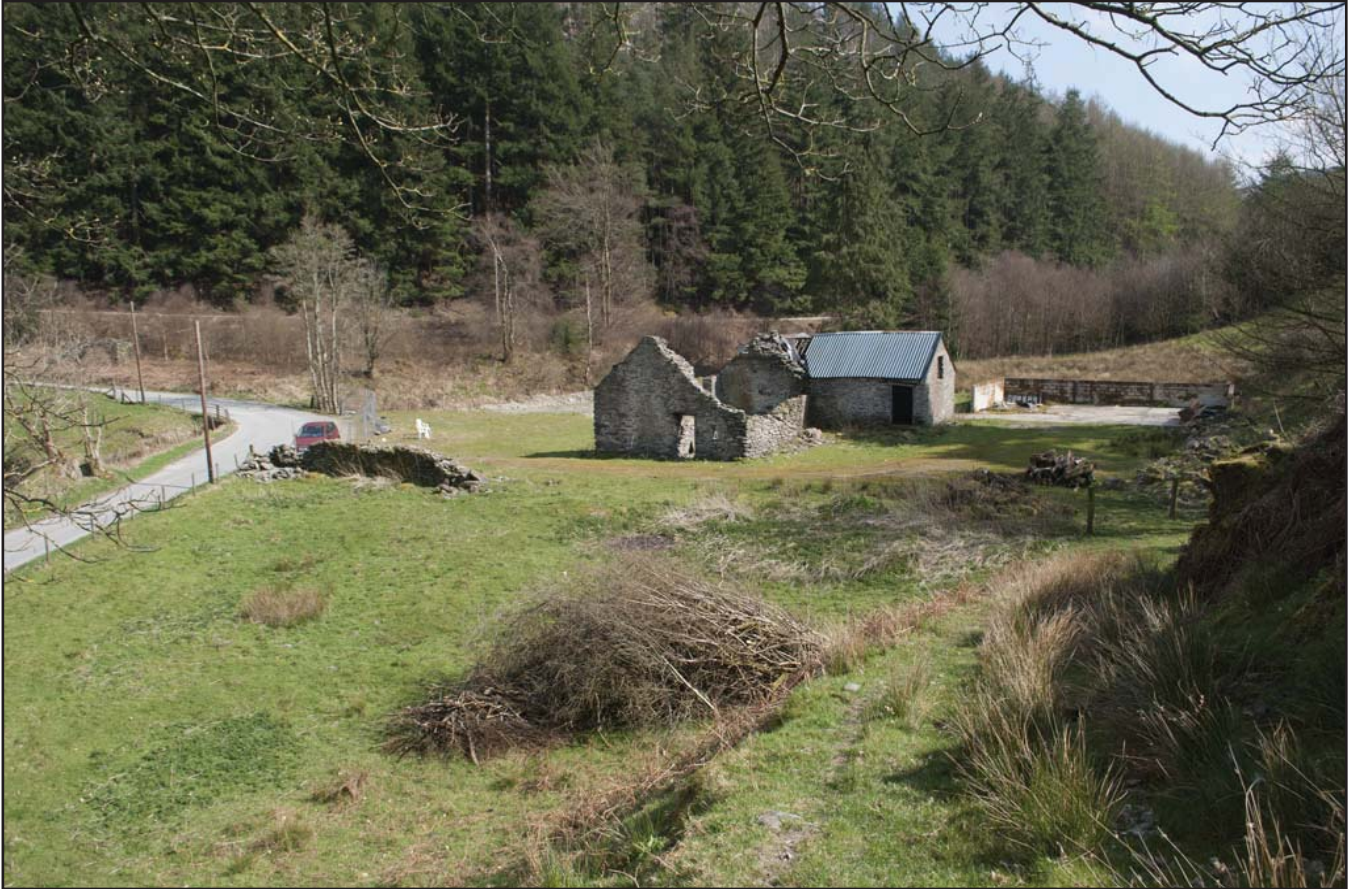
Plate 57: Exterior - View of site in wider landscape context including farm yard; scale not used; view from NW (archive reference: G2778_057).

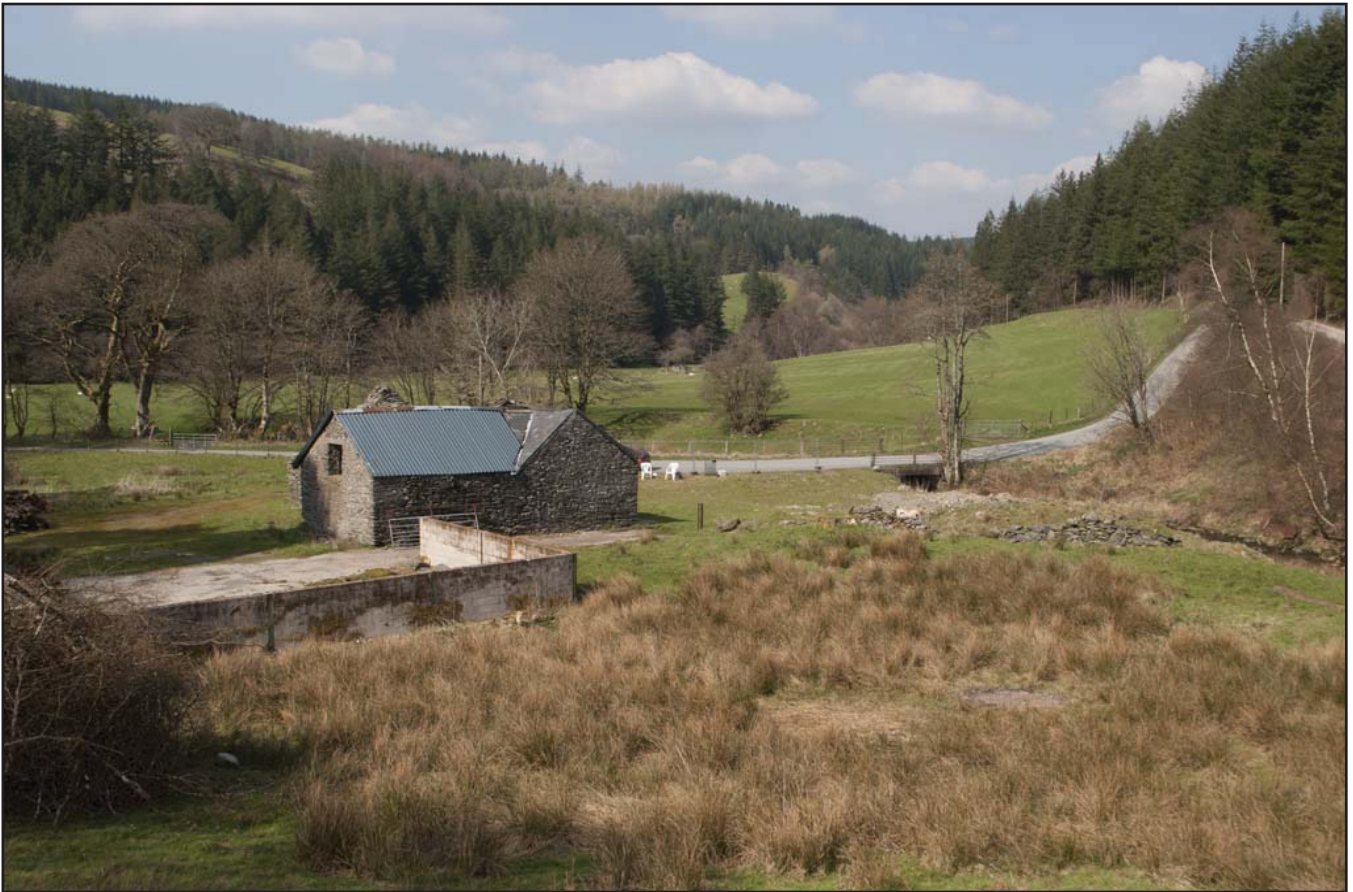
Plate 59: Exterior - View of site in wider landscape context from the S; scale not used; view from S (archive reference: G2778_059).

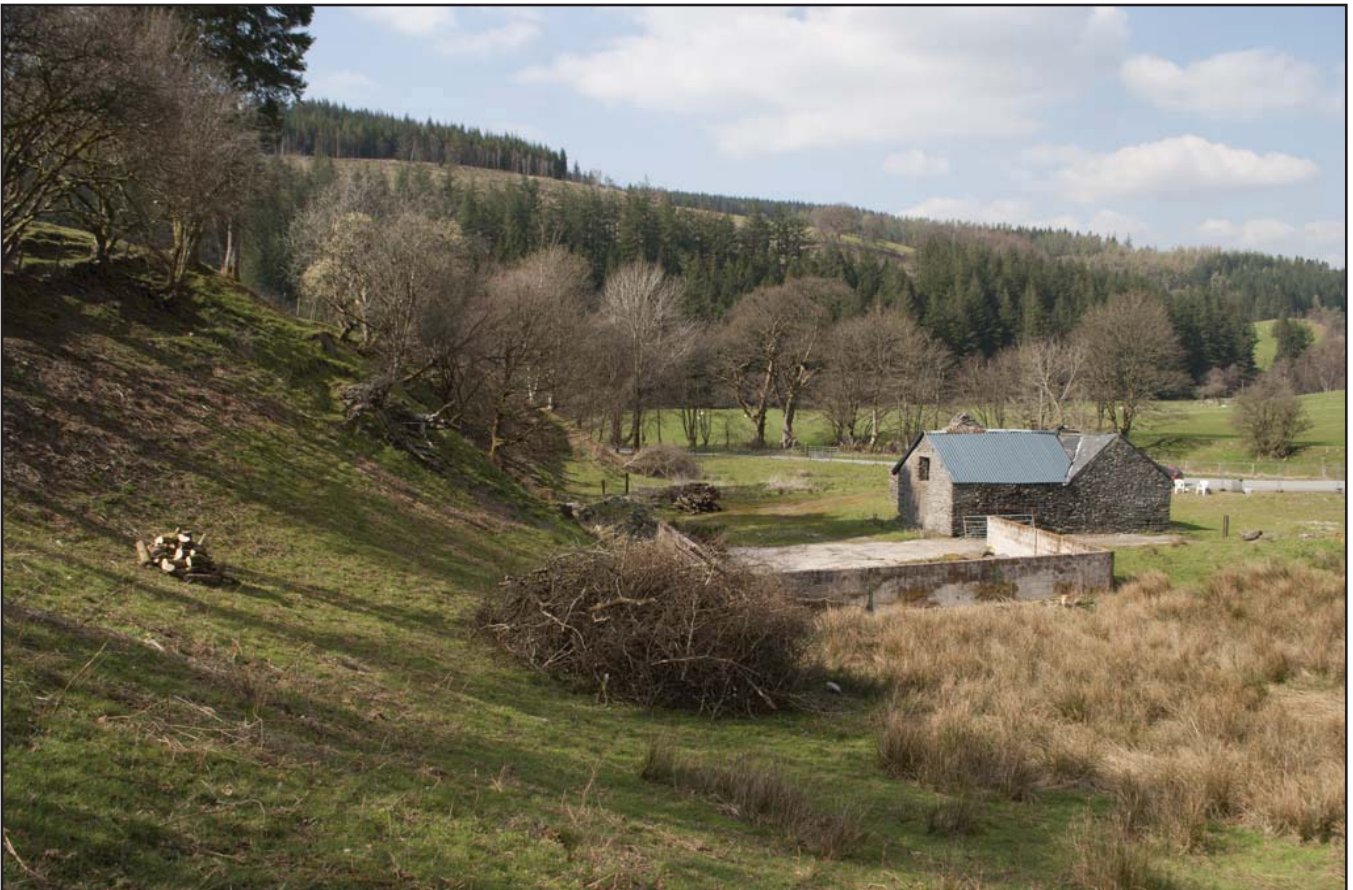
Plate 60: Exterior - View of site in wider landscape context from the S, showing adjacent hill; scale not used; view from S (archive reference: G2778_060).

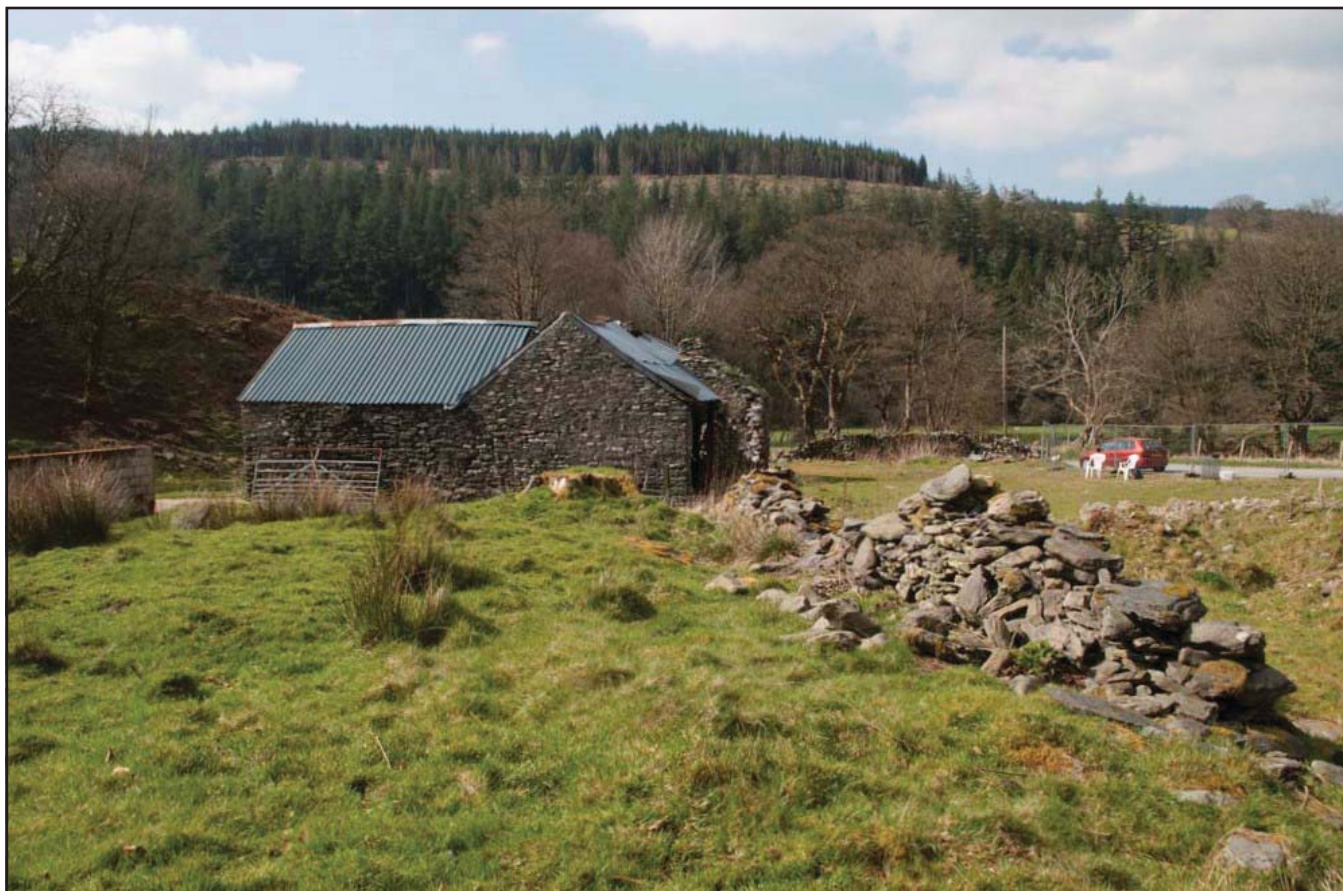
Plate 61: Exterior - View of site in wider landscape context with drystone wall in the foreground; scale not used; view from SE (archive reference: G2778_061).

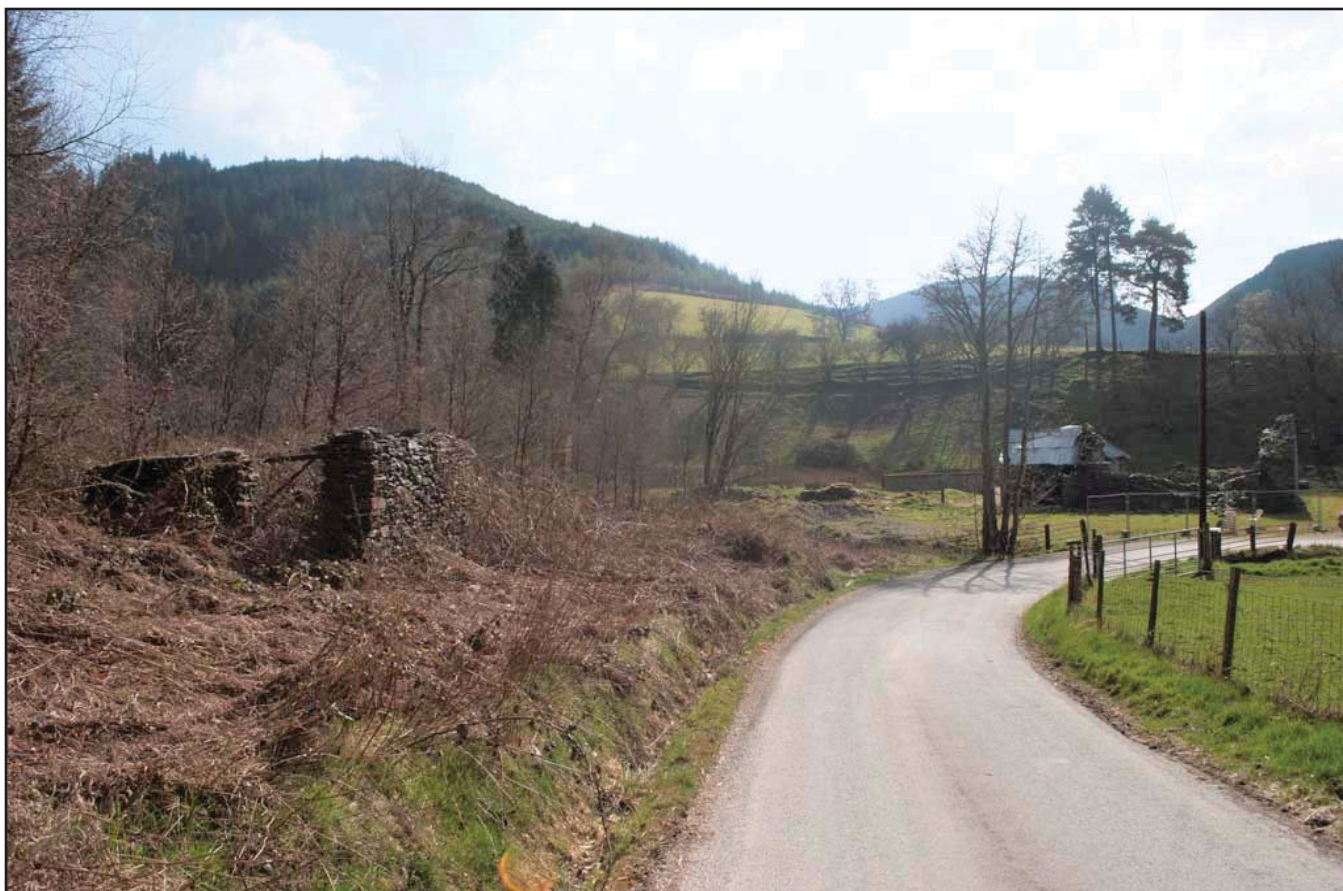
Plate 62: Exterior - View of site in landscape with nearby small ruined building; scale not used; view from NE (archive reference: G2778_062).

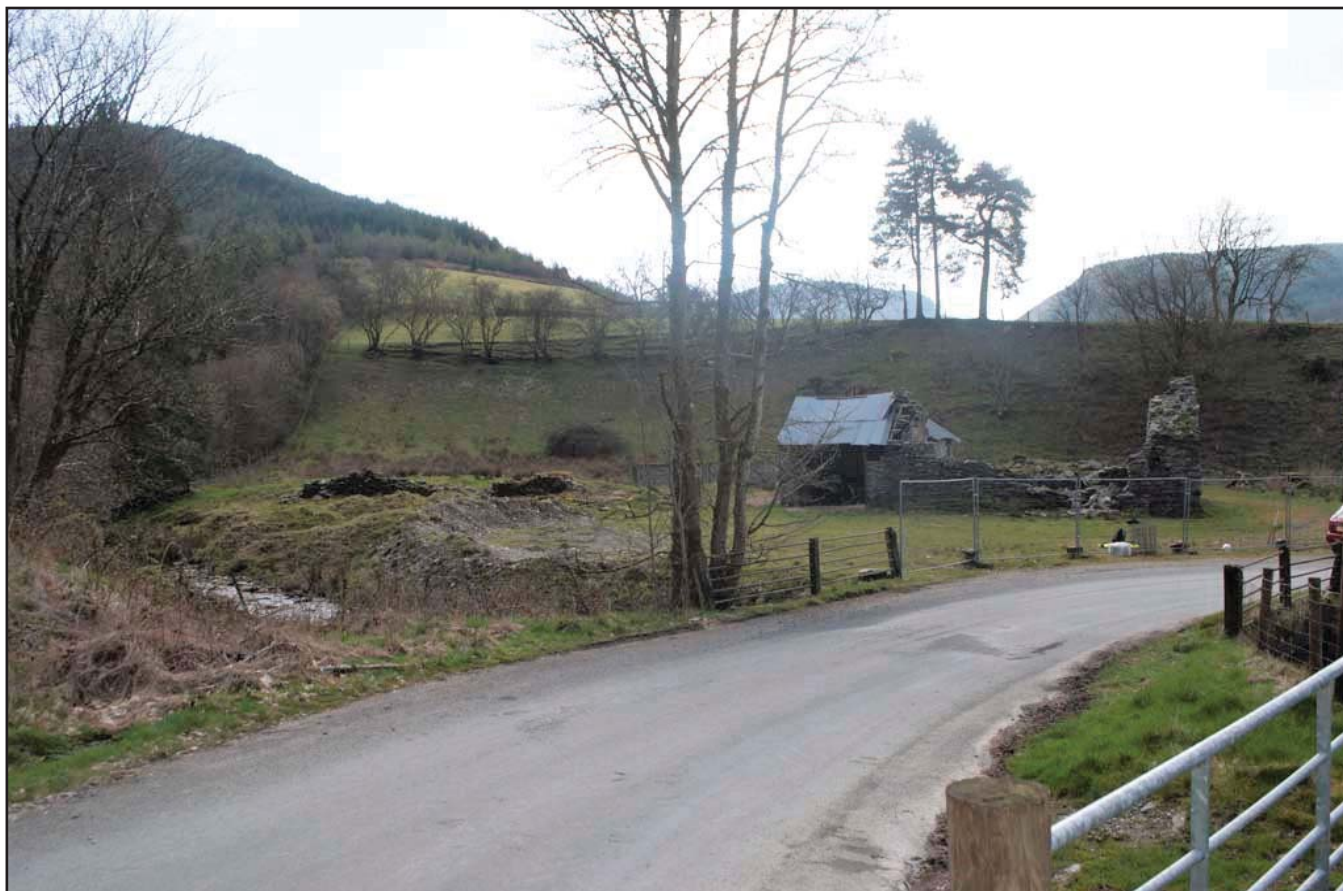
Plate 63: Exterior - View of site from road with river adjacent; scale not used; view from NE (archive reference: G2778_063).

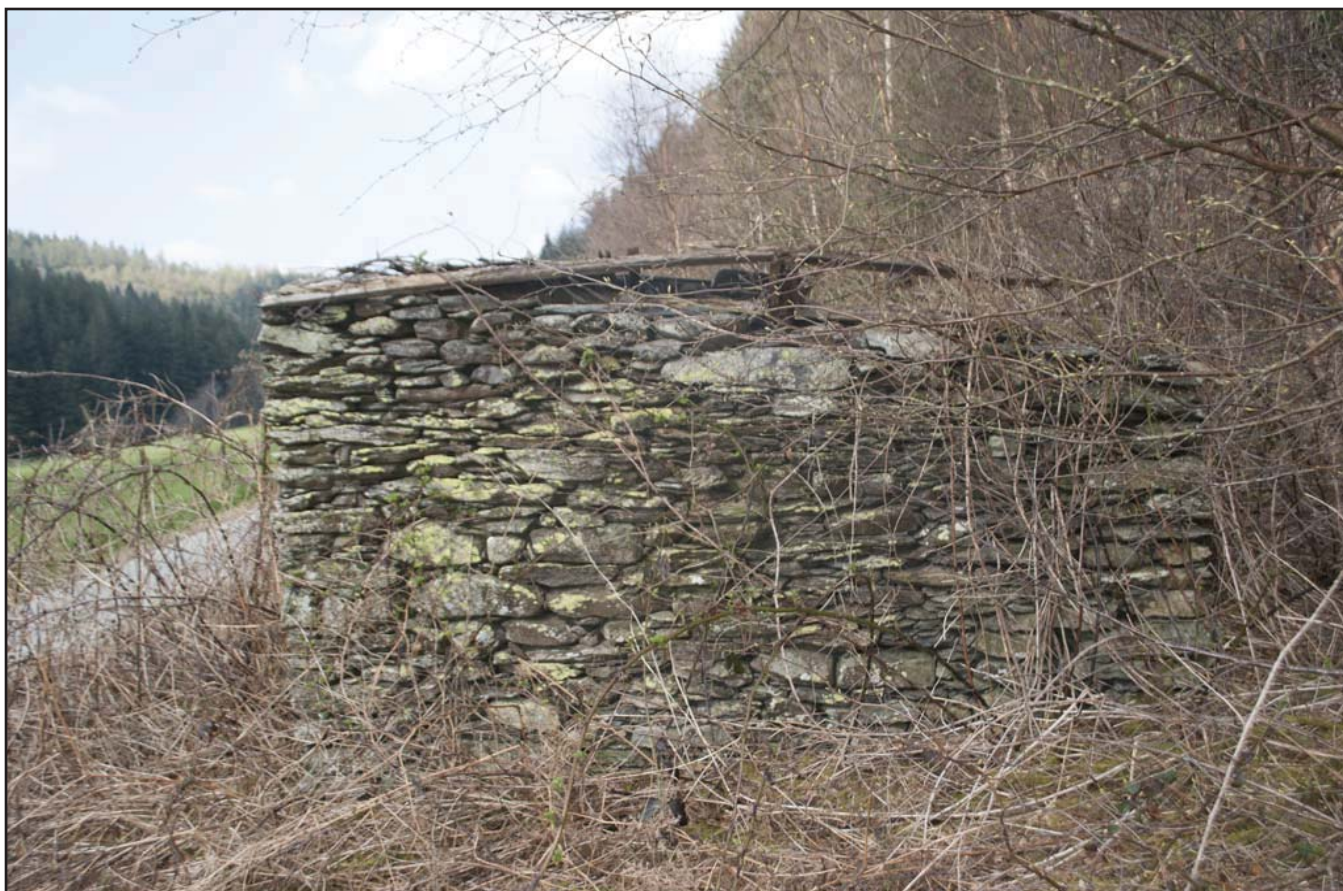
Plate 64: Exterior - View of nearby small ruined building with collapsed roof; scale not used; view from S (archive reference: G2778_064).

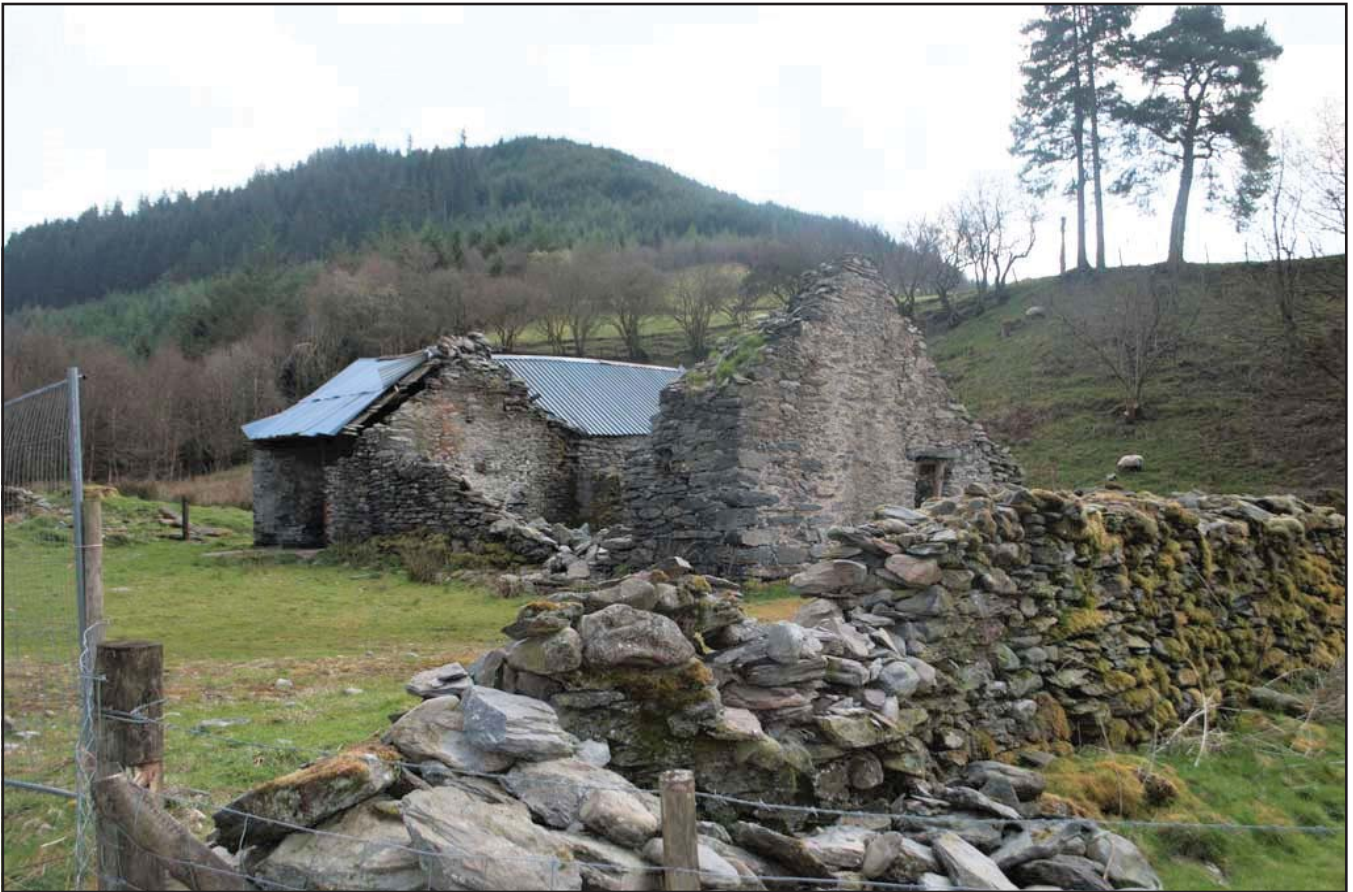
Plate 65: Exterior - View of site from the road showing drystone wall; scale not used; view from N (archive reference: G2778_065).
