Coed Foeldinas, Dinas Mawddwy, Gwynedd

Asesiad Archeolegol / Archaeological Assessment

Prosiect Rhif / Project No. G2754

Adroddiad Rhif / Report No. 1675

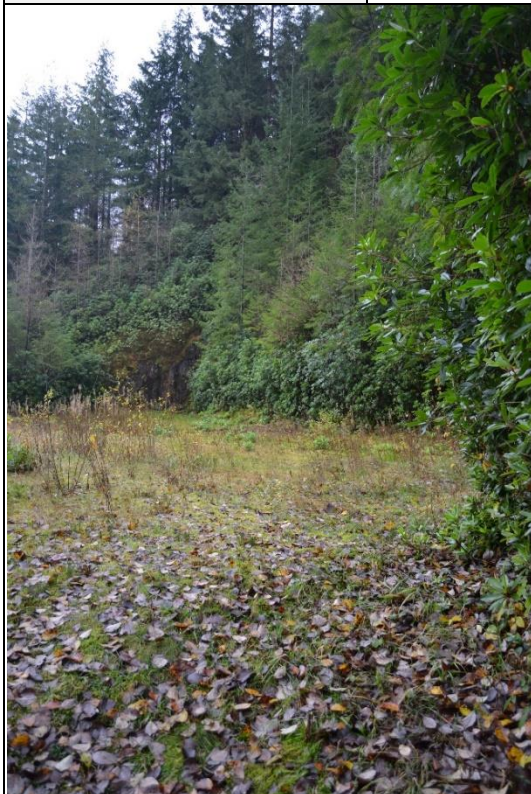
Feature number	01.1
Primary Reference Number	20458 and 93758
Site name	Old Quarry, West of, Dinas Mawddwy (Slate Quarry, Targwrmoel)
National Grid Reference	SH8552214866
Period	Post-Medieval
Site type	Slate Quarry
Assessment category	B
Description	The site is listed in the regional Historic Environment Record as “Trial associated with Minllyn. Remains: In forestry”. The quarry is shown as “Old Quarry” on the 1st and 2nd edition 25-inch OS maps, so it was out of use before 1889. A covered reservoir is now built inside quarry. Visited on 24/11/2022 but no unauthorized access to reservoir area. The quarry face is still visible but heavily over-grown.
Impact	Unlikely
Recommendation	Do not fell trees into the quarry as this risks damaging the reservoir

Old quarry with covered reservoir inside from NW
(archive reference: G2754_0077)

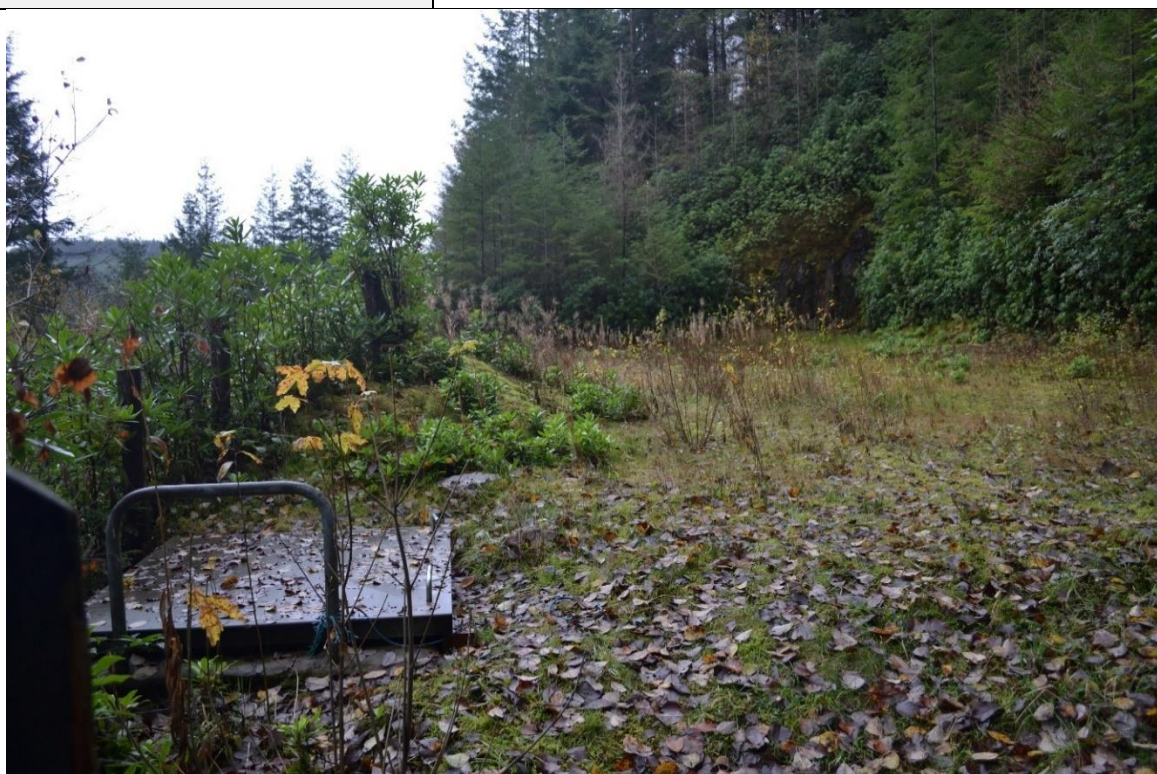
Feature number	01.2
Primary Reference Number	93757
Site name	Reservoir, South of, Dinas Mawddwy
National Grid Reference	SH8553314869
Period	Post medieval
Site type	Reservoir
Assessment category	D
Description	A small rectangular reservoir in the base of the disused quarry is shown on both the 1st and 2nd edition 25-inch OS maps, so it was built by 1889. The reservoir has since been entirely rebuilt is now a covered reservoir that entirely fills the quarry. The reservoir is marked as disused on the OS digital mapping, but it is definitely still in use and supplies water to Dinas Mawddwy. Visited 24/11/2022 but reservoir area not accessed.
Impact	None
Recommendation	Do not fell trees into the quarry as this risks damaging the reservoir

Covered reservoir inside the old quarry from NW (archive reference: G2754_0076)

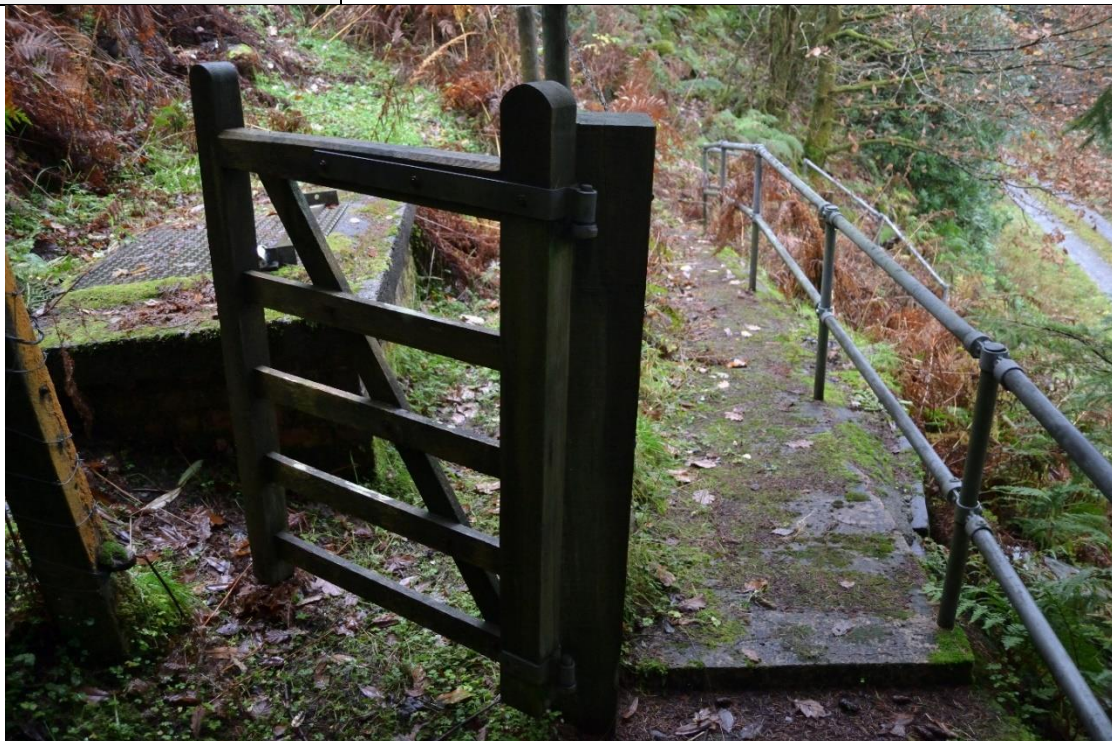
Feature number	03.2
Primary Reference Number	98999
Site name	Spring, Coed Foeldinas
National Grid Reference	SH8525215041
Period	Modern
Site type	Spring
Assessment category	D
Description	The natural spring near this location has been constrained and covered so that it can supply water for Dinas Mawddwy. There is a brick and concrete structure with a locked hatch and a smaller concrete access point nearby. Concrete steps with guard rails lead up from the forest road to the fenced enclosure with the covering structure in the corner. Visited 24/11/2022.
Impact	Likely
Recommendations	Avoid

Structure over water intake and concrete access steps from E (archive reference: G2754_0063)

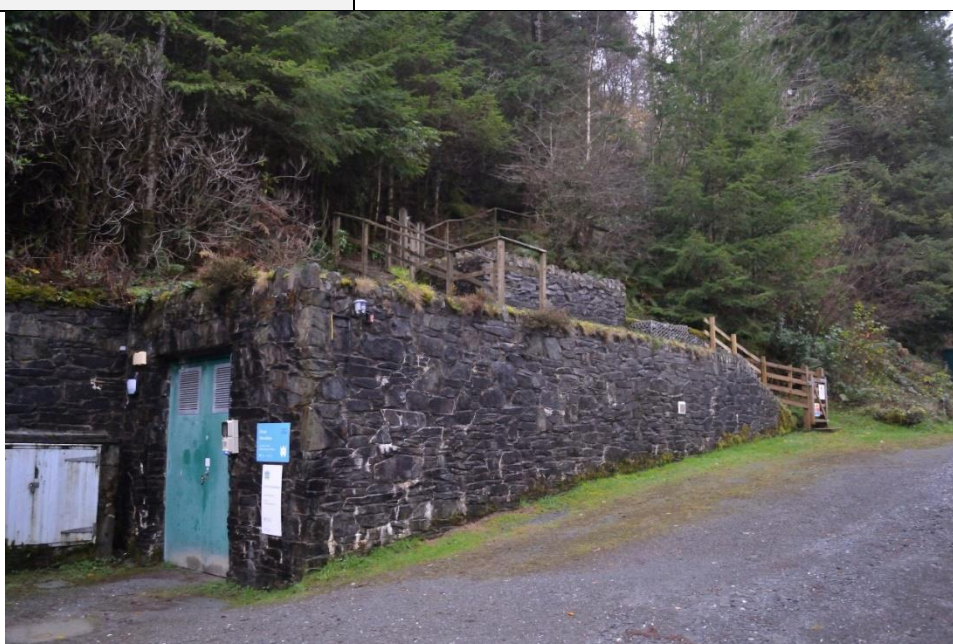
Feature number	04
Primary Reference Number	93754
Site name	Reservoir, South of, Dinas Mawddwy
National Grid Reference	SH8576814511
Period	Modern
Site type	Reservoir
Assessment category	C
Description	A small rectangular reservoir is shown on the 2nd edition 25-inch OS map but not on the 1st edition, so it was probably built just before 1900. It is marked as "reservoir (Mallwyd U.D.C. Water Works)". The reservoir appears slightly larger on the aerial photographs than on the early maps, so it has probably been rebuilt but it is still a small rectangular covered reservoir and is still in use. A water treatment works has been built below the reservoir with steps up from the works to the reservoir. Visited on 24/11/2022 but no access to see the reservoir.
Impact	Likely
Recommendation	Avoid

Water works building with steps up to the reservoir from SE (archive reference: G2754_0082)

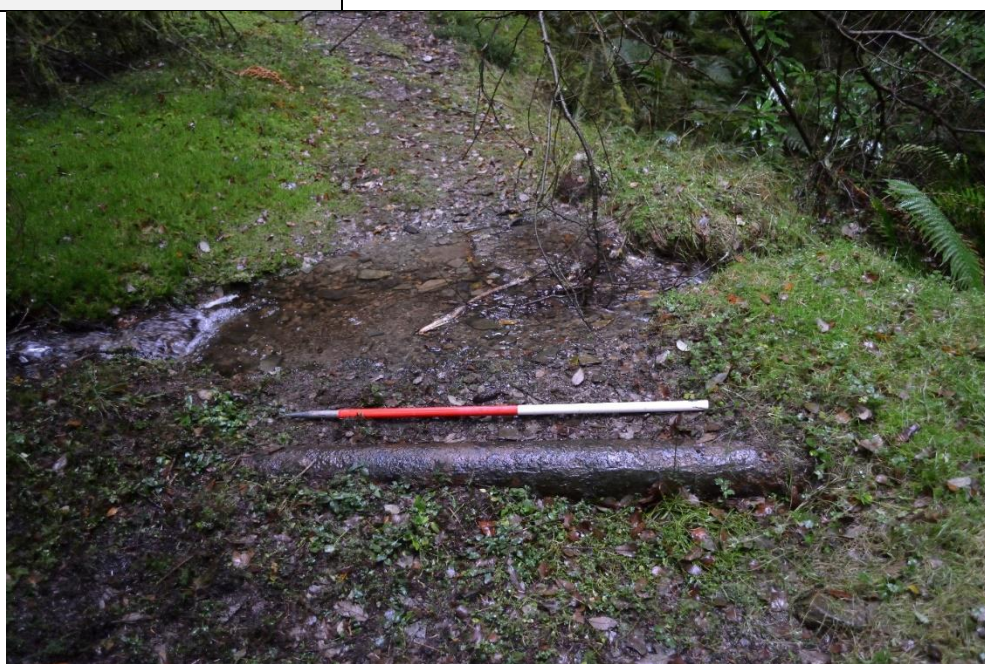
Feature number	08
Primary Reference Number	Not assigned a PRN
Site name	Water pipe, Coed Foeldinas
National Grid Reference	SH85314 14748
Period	Modern/ post medieval
Site type	Pipe
Assessment category	D
Description	Cast iron pipe about 16cm (6 1/4 inches) diameter running across forestry track next to a small stream. The 1st and 2nd edition 25-inch OS maps show the stream doing a sharp diversion here and the pipe may have carried the stream for a short distance. This was before a track was built in this location and it is not obvious from the maps why this diversion occurred. The map evidence and the pipe may be the only trace of some earlier structure here.
Impact	Considerable
Recommendation	Inspect area when improving the track for any evidence of any structure related to the pipe.

Cast iron water pipe crossing the forest track from SE (archive reference: G2754_0004)

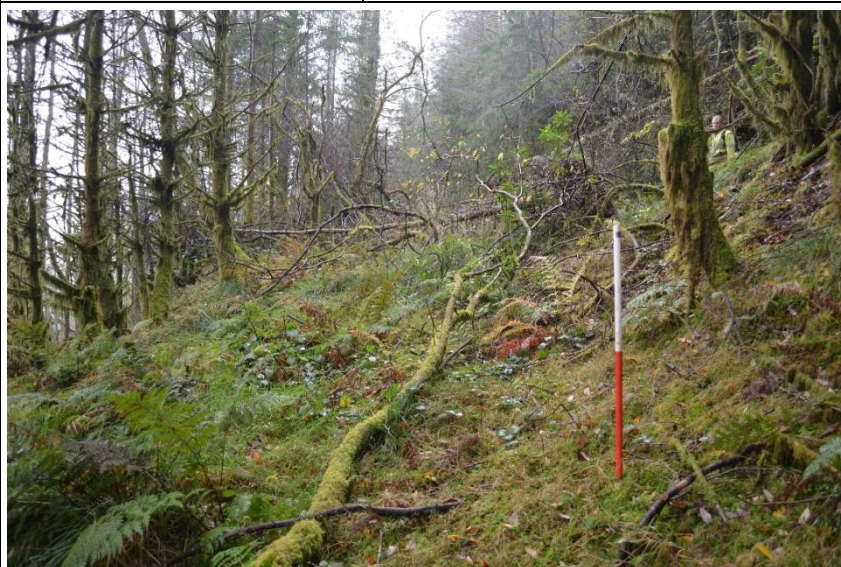
(archive reference: G2754_0006)

Looking up the trackway from N

Impact	Significant
Recommendation	Record track in more detail once vegetation has been cleared. If possible, locate using a survey quality GPS and investigate as far down the track as safely accessible once the trees have been felled.

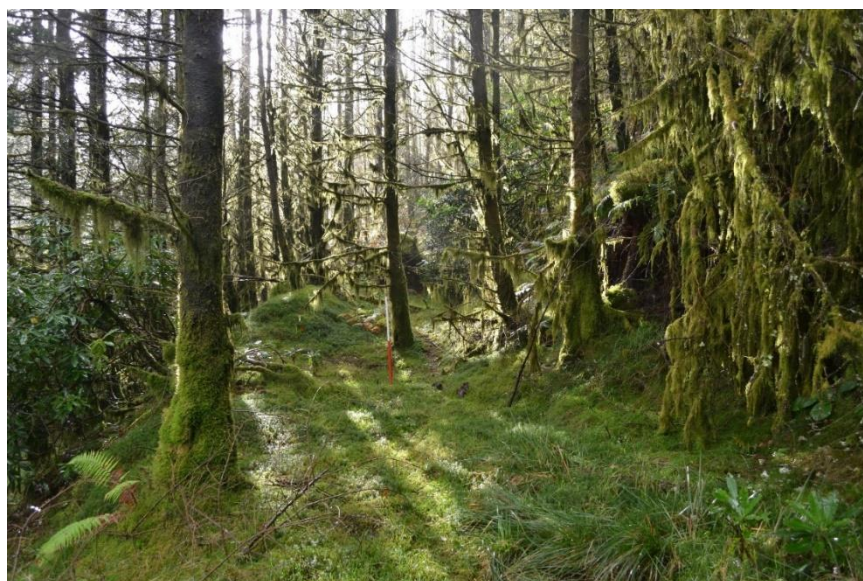
Looking along the trackway from NE
(archive reference: G2754_0011)

Impact	Significant
Recommendation	Record track in more detail once vegetation has been cleared. If possible, locate using a survey quality GPS and investigate as far down the track as safely accessible once the trees have been felled.

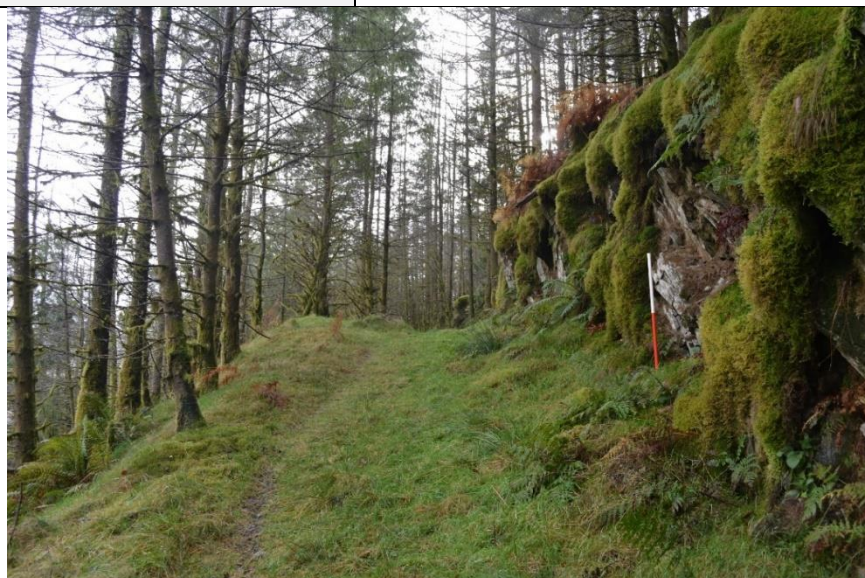
Feature number	10.1
Primary Reference Number	Not assigned a PRN
Site name	Modern forest trackway
National Grid Reference	SH8547714448
Period	Modern
Site type	Trackway
Assessment category	D
Description	Current access to the upper part of the plantation is by a recent forest track which has been benched into the hill slope and is about 3m wide, though in places where it ascends the hill it is about 6m wide. This track reuses part of the Quarry Path (PRN 99004), then ascends the hill with hairpin bends and runs along the upper part of the planation on a newly cut route that cuts across the earlier track (PRN 99002). The track curves at its northern end to finish against the boundary with the open moorland. This end is very wet. This track is shown on an aerial photograph of 1962 as a bright, newly created track, so it seems to have been built in the early 1960s.
Impact	Considerable
Recommendation	Inspection of areas to the sides of the track as vegetation is cleared to identify any features not previously visible.

Modern forest trackway showing where it cuts through a rock outcrop in the upper part of the plantation, from NE (archive reference: G2754_0009)

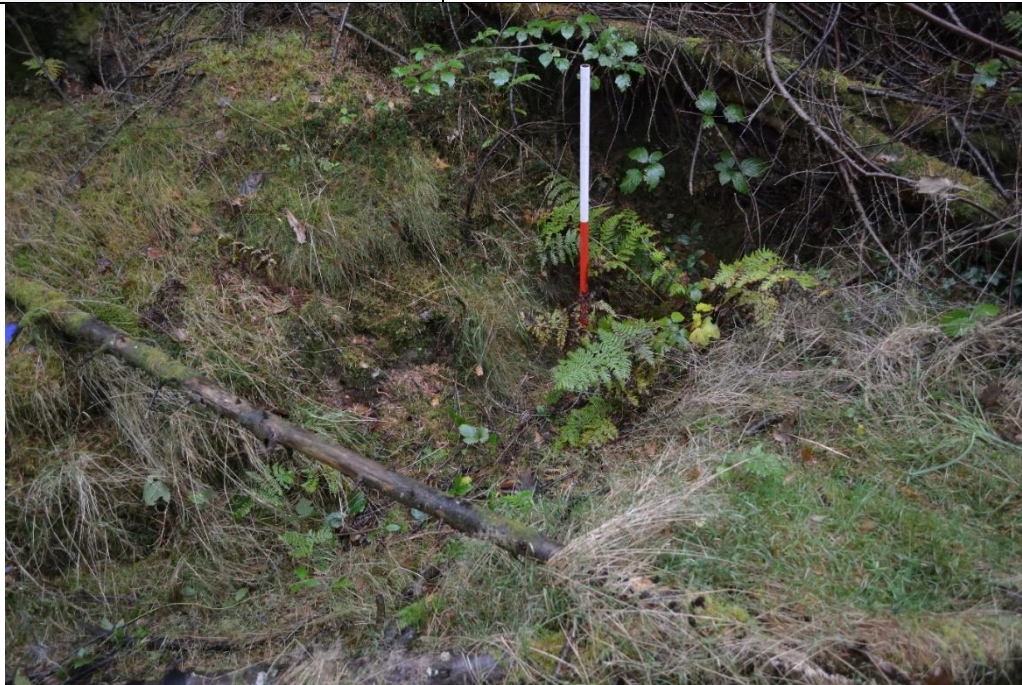
Feature number	10.2
Primary Reference Number	Not assigned a PRN
Site name	Rock cut drainage channel
National Grid Reference	SH85405 14095
Period	Modern
Site type	Drainage channel
Assessment category	D
Description	Rock cut channel about 1m wide and up to 1m deep, running down from NNE to SSW. Heavily over-grown. Next to this on the downhill side is a flat area. The channel carries on the line of the forestry track and the flat area is at the point of the hair-pin bend. The channel is almost certainly to drain the recent track and the flat area was presumably caused by creating machine access to dig the channel.
Impact	Significant
Recommendation	Inspection of area around the channel as vegetation is cleared to identify any features not previously visible.

Rock cut channel to drain modern forestry track, from S (archive reference: G2754_0014)

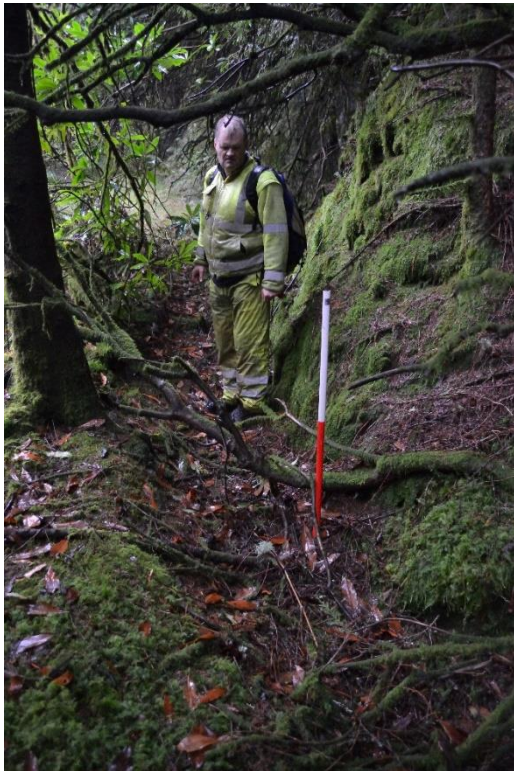
Feature number	10.3
Primary Reference Number	Not assigned a PRN
Site name	Rock cut drainage channel
National Grid Reference	SH8559614162
Period	Modern
Site type	Drainage channel
Assessment category	D
Description	Rock cut channel about 1m wide and up to 1m deep, running down from SW to NE into a small natural ravine. Heavily over-grown. Next to this on the downhill side is a flat area. The channel carries on the line of the forestry track and the flat area is at the point of the hair-pin bend. The channel is almost certainly to drain the recent track and the flat area was presumably caused by creating machine access to dig the channel.
Impact	Significant
Recommendation	Inspection of area around the channel as vegetation is cleared to identify any features not previously visible.

Rock cut channel to drain modern forestry track, from S

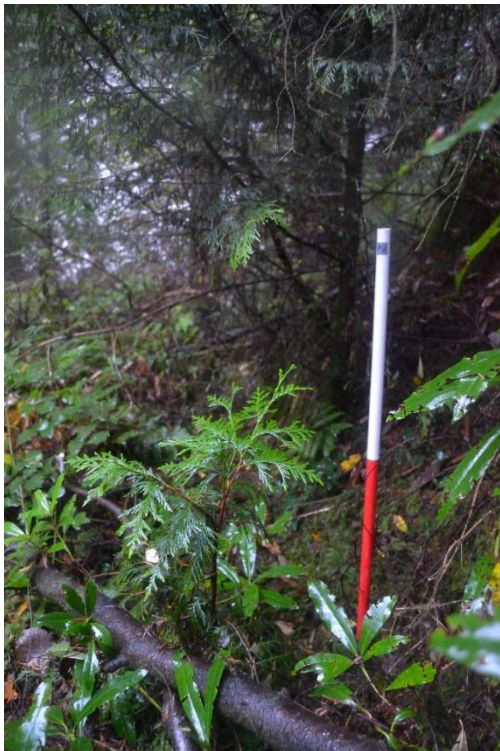
Feature number	10.4
Primary Reference Number	Not assigned a PRN
Site name	Rock cut drainage channel
National Grid Reference	SH8551113982
Period	Modern
Site type	Drainage channel
Assessment category	D
Description	A rock cut channel about 1m wide running downhill from NE to SW and emptying into the stream gorge. This is the same as the other channels draining the forestry track but stops next to the quarry path and does not join through to the forestry track, so in its present state could not drain the track. Presumably it originally continued, and this area has been backfilled, as a footpath now runs up the quarry path and the channel would have blocked that. There is too much undergrowth to confirm this.
Impact	Significant
Recommendation	Inspection of area around the channel as vegetation is cleared to identify any features not previously visible.

Rock cut channel to drain modern forestry track, from NE

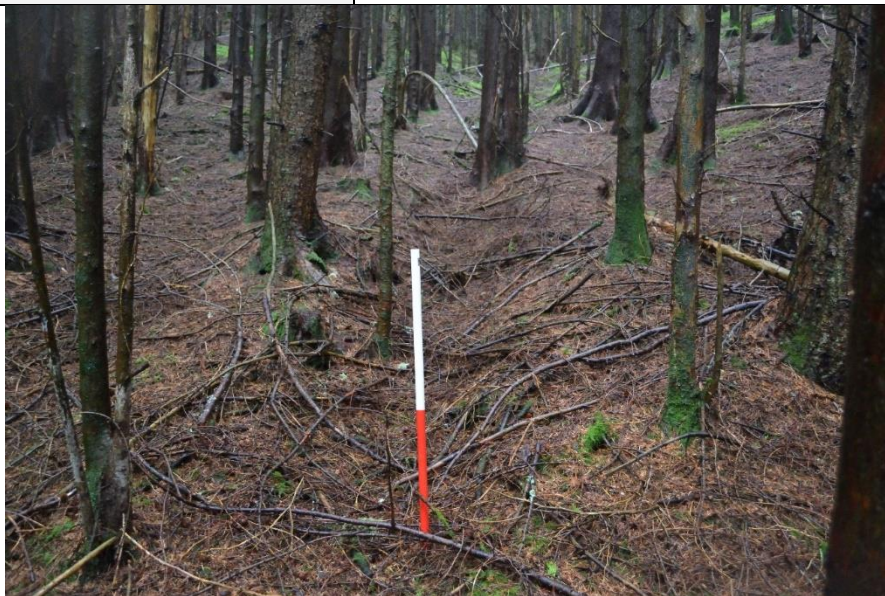
Feature number	11
Primary Reference Number	99003
Site name	Pathway, Coed Foeldinas
National Grid Reference	SH8553314006
Period	Post-medieval
Site type	Pathway
Assessment category	C
Description	A shallow gully runs directly down slope with low banks about 2m wide on each side. Trees grow on the banks and in the gully, but none are very old. This was initially assumed to be remains of drainage ridges from the initial plantation of the area, but it coincides with a track or path shown on the 1st and 2nd edition 25-inch maps. The path runs directly downhill at this point, and it is concluded that the gully and banks are the remains of this track or footpath. The steepness of the route suggests that this was a footpath, but it was clearly a constructed path like many in the wood.
Impact	Significant
Recommendation	Minimise damage from dragging felled trees over this area. Record route after felling.

Pathway in forest, from SE (archive reference: G2754_0017)

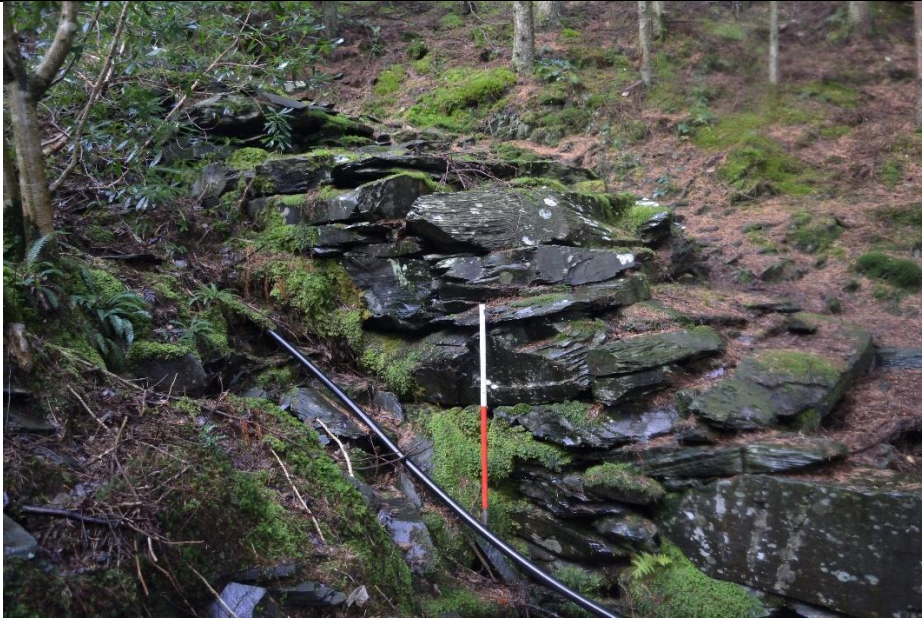
Quarry Path steps from the side, from S (archive reference: G2754_0023)

Impact	Likely
Recommendation	Avoid damage to the structure. Do not fell onto the structure or drag trees across it. Record more fully after felling.

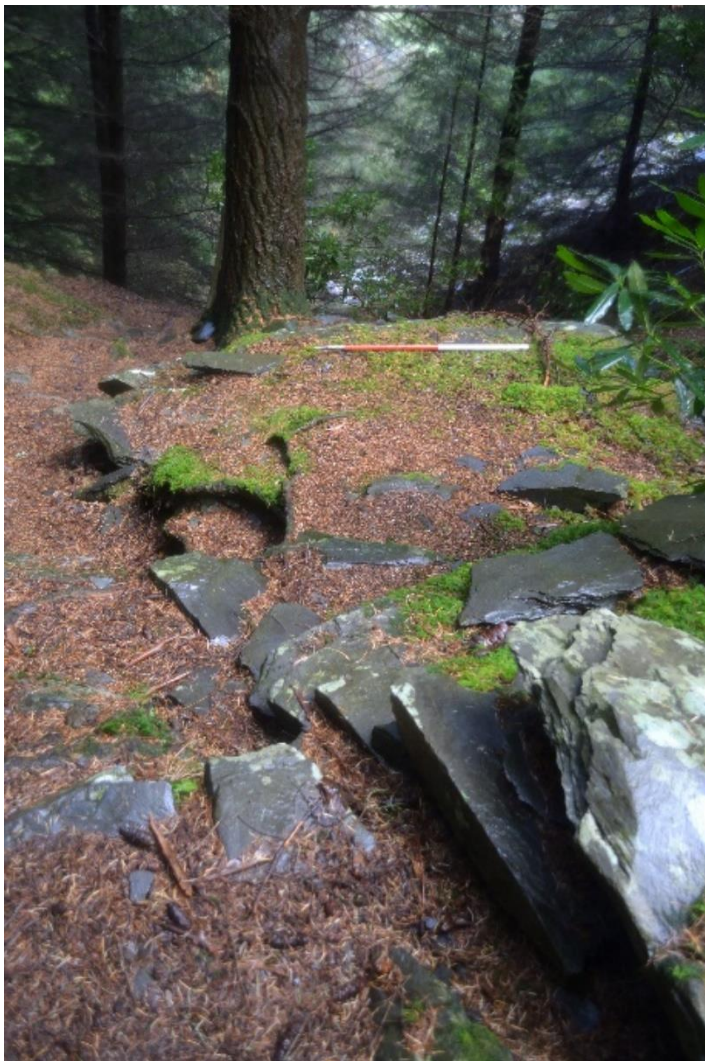
Quarry Path steps from top, from NW
(archive reference: G2754_0021)

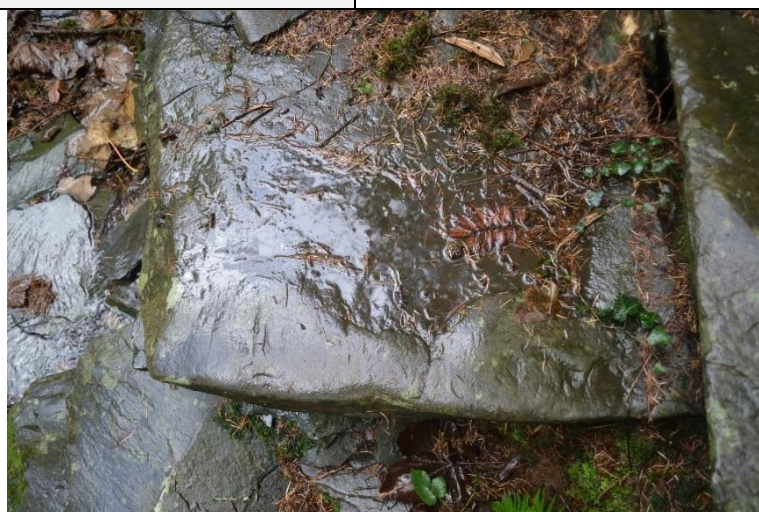
Feature number	12.3
Primary Reference Number	99006
Site name	Foot Bridge, Coed Foeldinas
National Grid Reference	SH8540014002
Period	Post-medieval
Site type	Bridge
Assessment category	B
Description	A narrow bridge formed by a single large slab (c.1.5m by 0.75m and 0.18m thick) placed on drystone piers. The edge of the slab is worn and scratch marks are visible, possibly from hobnails. A long thin slab is placed on the uphill side of the bridge, possibly forming a kerb. A similar kerb may have been present on the downhill side to stop pedestrians slipping off the bridge. The stream that passes under the bridge runs in a narrow ravine which is partially filled with slate waste from an adjacent tip. This runs from the reservoir (PRN 99000). The stream disappears into the slate waste below the bridge, but the maps suggest there was a channel to take the stream, which probably still exists buried under slate waste. The narrowness of the bridge and the lack of any trace of rails suggest that this was a foot bridge. The Quarry Path (PRN 99004) ran to the bridge, but the maps also show a path from the north-east, which could not be seen on the ground.

Wear on the edge of the bridge possibly from hobnail boots, from ENE (archive reference: G2754_0029)

Impact	Likely
Recommendation	Avoid damage to the bridge. Do not fell onto the bridge or drag trees across it. Record more fully after felling.

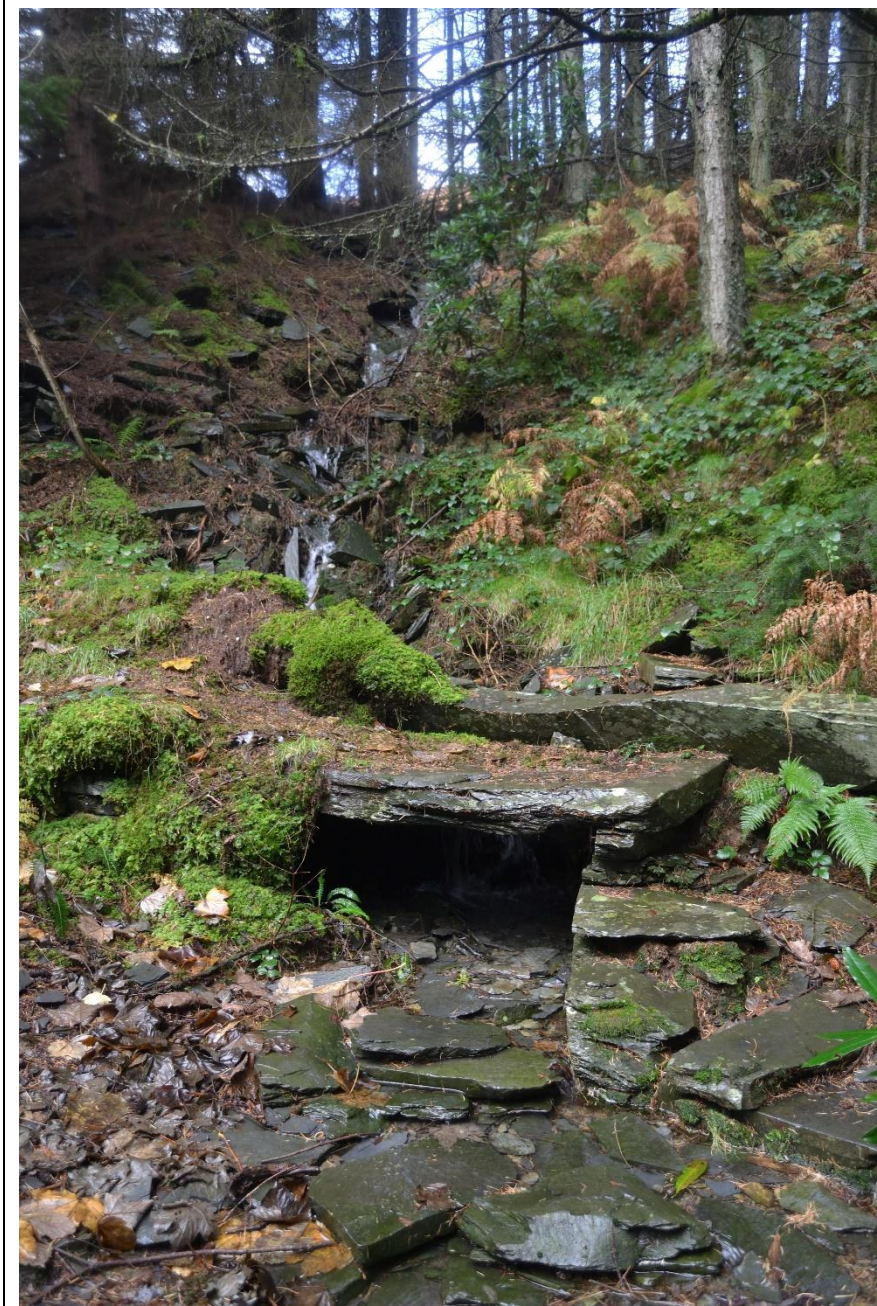
Bridge on the Quarry Path, from SE (archive reference: G2754_0028)

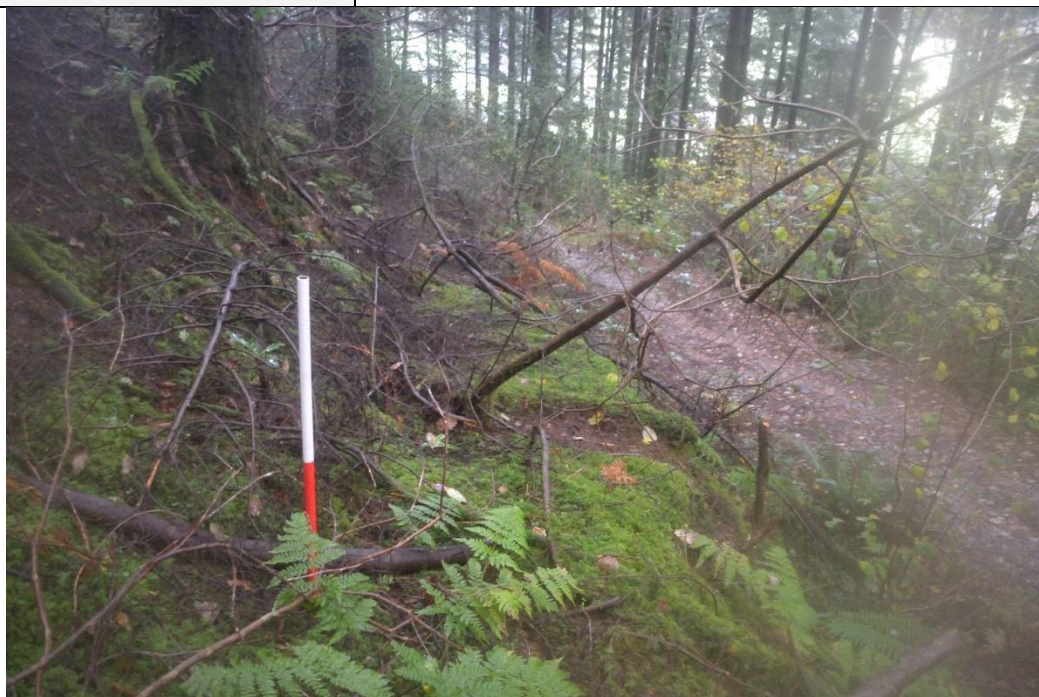
Feature number	12.4
Primary Reference Number	99007
Site name	Part of Quarry Path, Coed Foeldinas
National Grid Reference	SH8560714004
Period	Post-medieval
Site type	Pathway
Assessment category	C
Description	A narrow terrace about 1m wide partly cut away by the forestry track, which is about 3m below the terrace. The terrace appears to be the remains of a benched path and is likely to be part of the original quarry path that led to the upper mill (PRN 99016). However, the 25-inch maps show the quarry path as being deeply cut into the slope at this point, so it is possible that the terrace belongs to an earlier version of the path. The terrace can be seen from at least SH85580 13990 to SH85631 14031, but it is overgrown and less visible at its upper end.
Impact	Significant
Recommendation	Ideally avoid widening the forest track at this point.

Terraced pathway with forest track below, from SW (archive reference: G2754_0046)

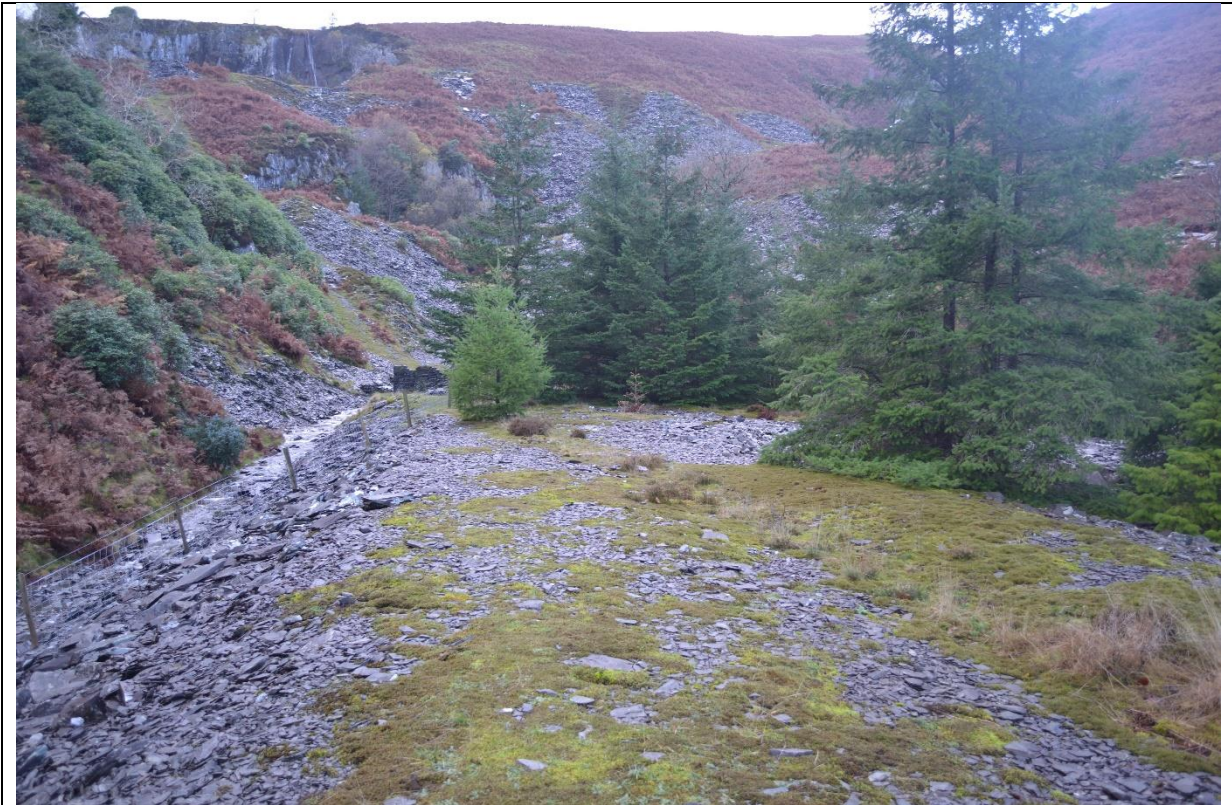
Feature number	13
Primary Reference Number	8215
Site name	Waste tramway, Minllyn Slate and Slab Quarry, Mawddwy
National Grid Reference	SH85381395
Period	Post-medieval
Site type	Railway
Assessment category	B
Description	A linear waste heap on which a tramway would have run. Now forms part of an open plateau on the top of the combined waste heaps but the flat surface where the tramway would have run is still visible. This ends at SH85435 13923, where waste would have been tipped from the end of the tramway. There is a high steep tip face at this point. The route of the tramway is shown on the 1st and 2nd edition 25-inch maps, but it changed between the maps and the earlier route is buried under the tipping from the later route.
Impact	Likely
Recommendation	Minimise damage from dragging felled trees over this area. Record route after felling.

Route of waste tramway, from SW (archive reference: G2754_0039)

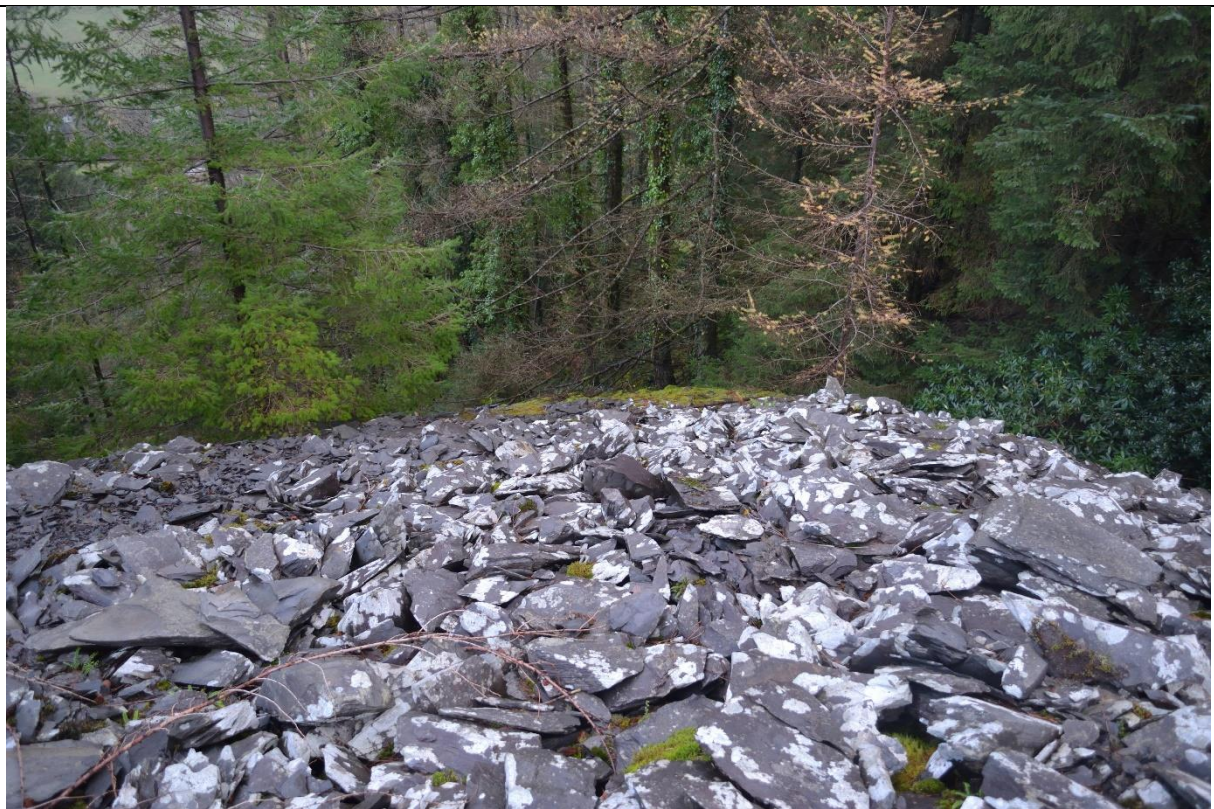
End of waste tip, from NE (archive reference: G2754_0040)

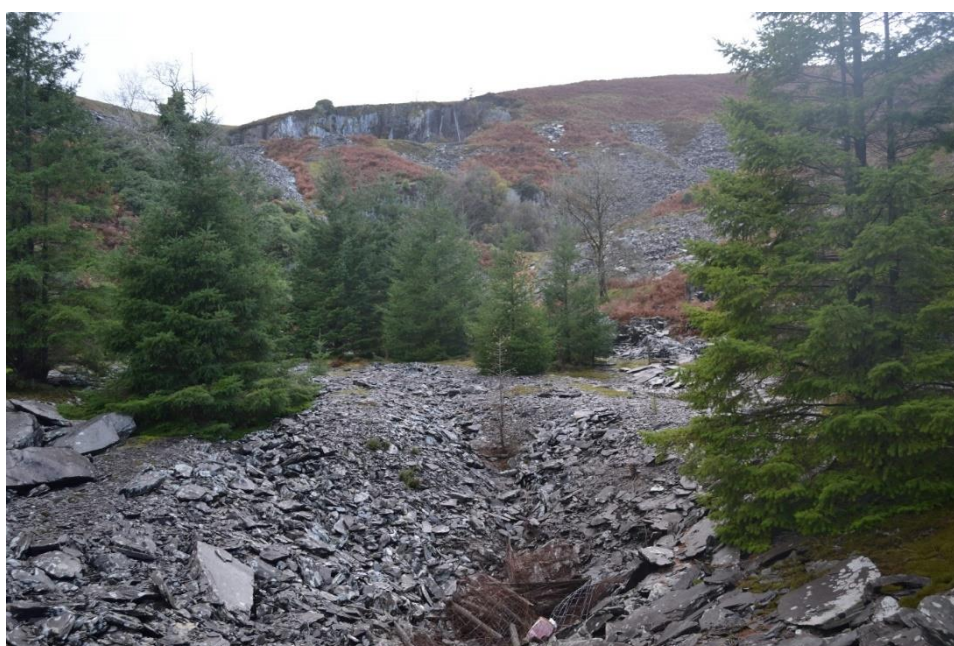
Feature number	14
Primary Reference Number	8216
Site name	Waste tramway, Minllyn Slate and Slab Quarry, Mawddwy
National Grid Reference	SH85401397
Period	Post-medieval
Site type	Railway
Assessment category	B
Description	A linear waste heap on which a tramway would have run. Now forms part of an open plateau on the top of the combined waste heaps but the flat surface where the tramway would have run is still visible. Overgrown with trees and other vegetation. The route of the tramway is shown on the 1st and 2nd edition 25-inch maps, but it changed between the maps and the earlier route is buried under the tipping from the later route.
Impact	Likely
Recommendation	Minimise damage from dragging felled trees over this area. Record route after felling.

The point at which the waste tramways PRN 8215 and 8216 merge, PRN 8216 on the right, from E (archive reference: G2754_0037)

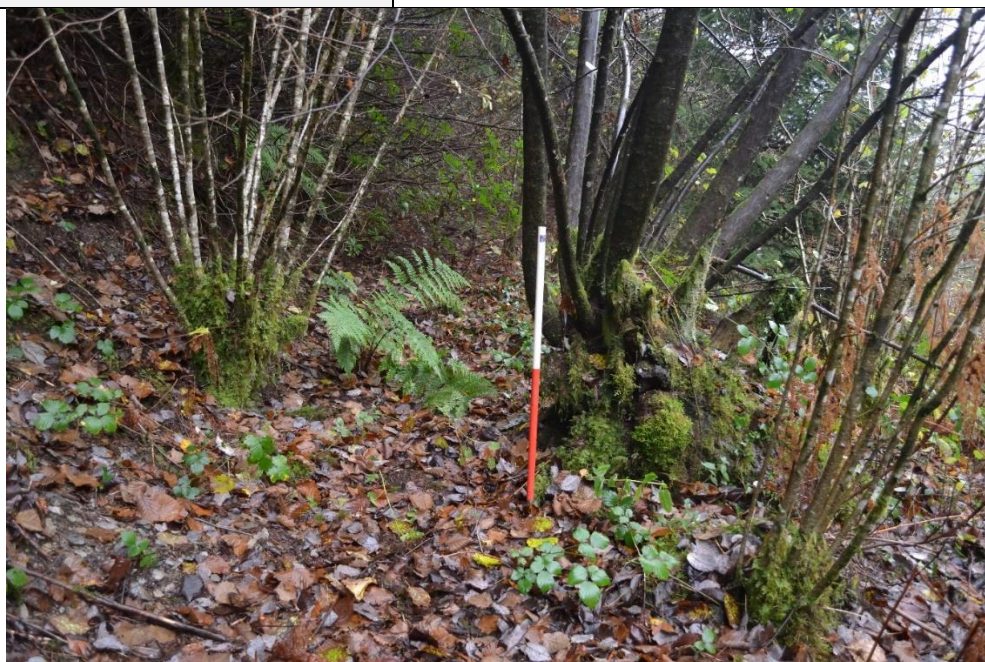
Feature number	16
Primary Reference Number	Not assigned a PRN
Site name	Trackway, Coed Foeldinas
National Grid Reference	SH8570614128
Period	Modern
Site type	Trackway
Assessment category	D
Description	An overgrown benched track, about 3m wide, was seen at this point where it meets the forestry track. This was similar to the other earlier forest tracks that can be seen in the plantation, but an aerial photograph shows that in 1962 a forest track ran above the route of the current lower forest road, before the latter was built. This feature seems to be the early 1960s forest track. It is not shown on 25-inch OS maps but is the only track visible on the available Lidar, suggesting its late date (Figure 8).
Impact	Likely
Recommendation	None

Start of trackway, from S (archive reference: G2754_0053)

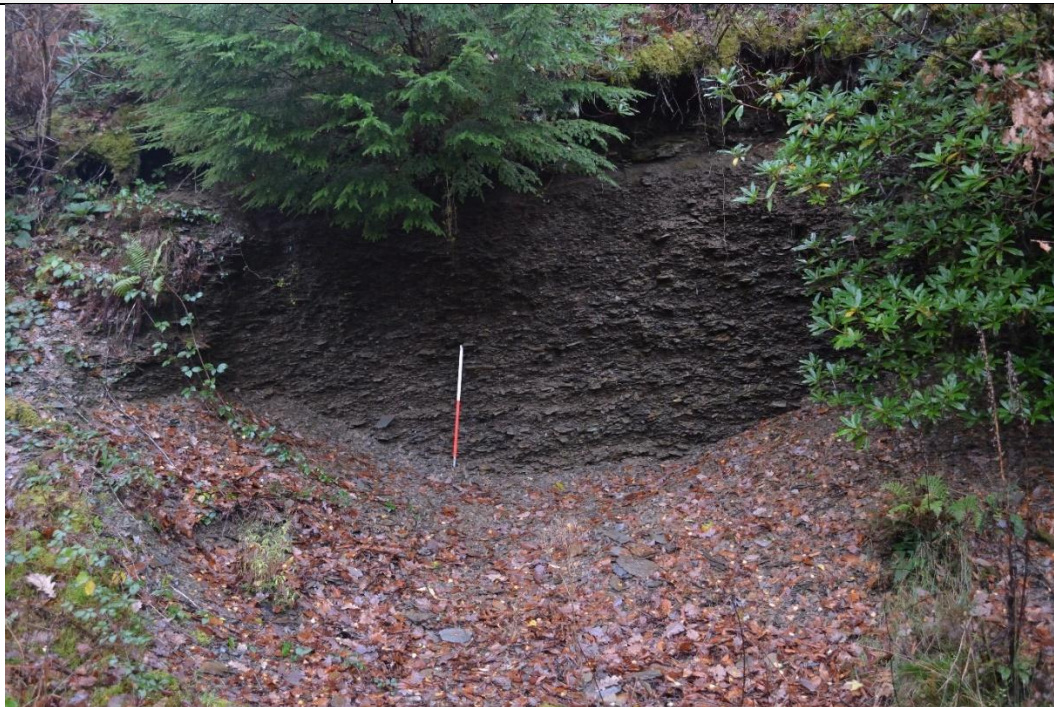
Feature number	17
Primary Reference Number	99009
Site name	Borrow pit, Coed Foeldinas
National Grid Reference	SH8581214292
Period	Modern
Site type	Borrow Pit
Assessment category	D
Description	A borrow pit with a vertical face where slatey material has been dug out probably for the modern forestry track. In the section the material resembles densely packed small pieces of slate waste. It loose and has no matrix and is clearly not shaley bedrock. It is possible that the borrow pit is dug into an old slate waste tip that is otherwise invisible due to the vegetation.
Impact	Unlikely
Recommendation	Investigate area after felling to determine if there is any trace of early quarrying.

Borrow pit, possibly dug through slate waste heap, from E (archive reference: G2754_0055)

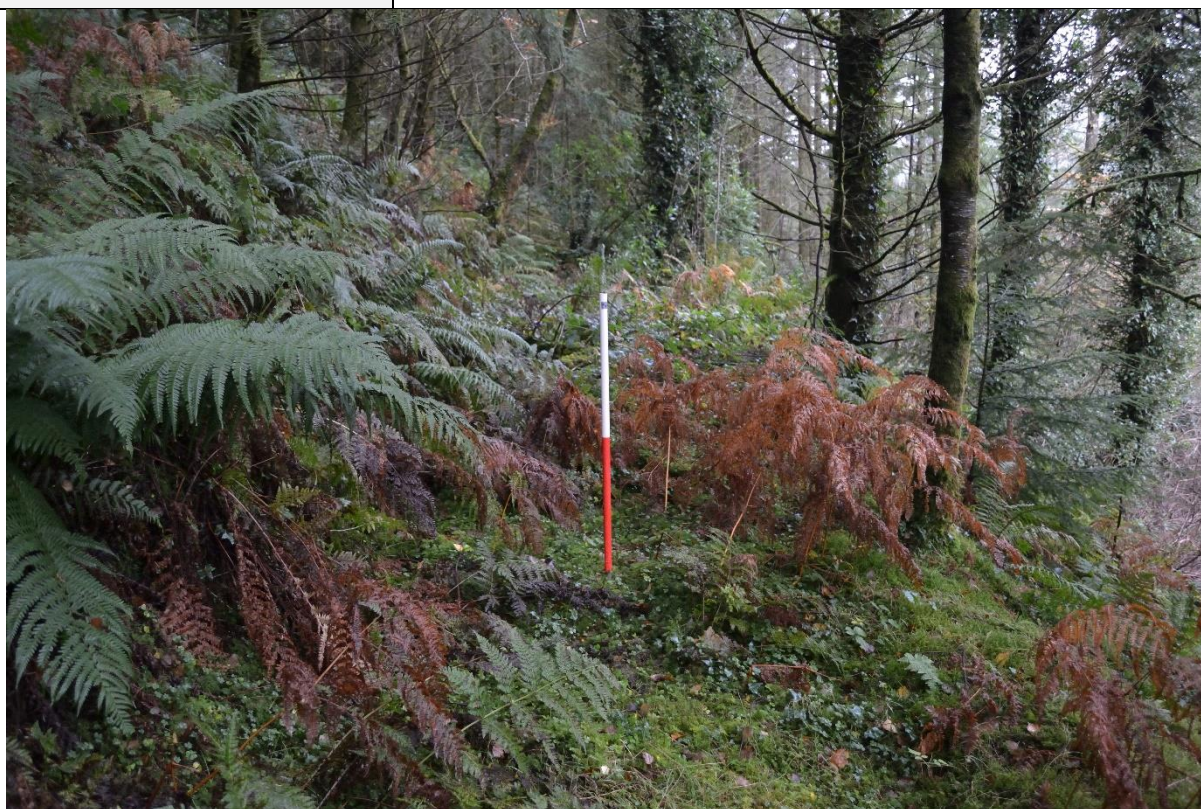
Feature number	18
Primary Reference Number	99010
Site name	Trackway, Coed Foeldinas
National Grid Reference	SH8520815061
Period	Post-medieval
Site type	Trackway
Assessment category	C
Description	Benched track running ESE to WNW, about 3m wide. Now overgrown. One of the early forest tracks shown on the 1st and 2nd edition 25-inch maps.
Impact	Likely
Recommendation	Minimise damage while extracting trees, record after felling.

Start of overgrown trackway, from ESE (archive reference: G2754_0064)

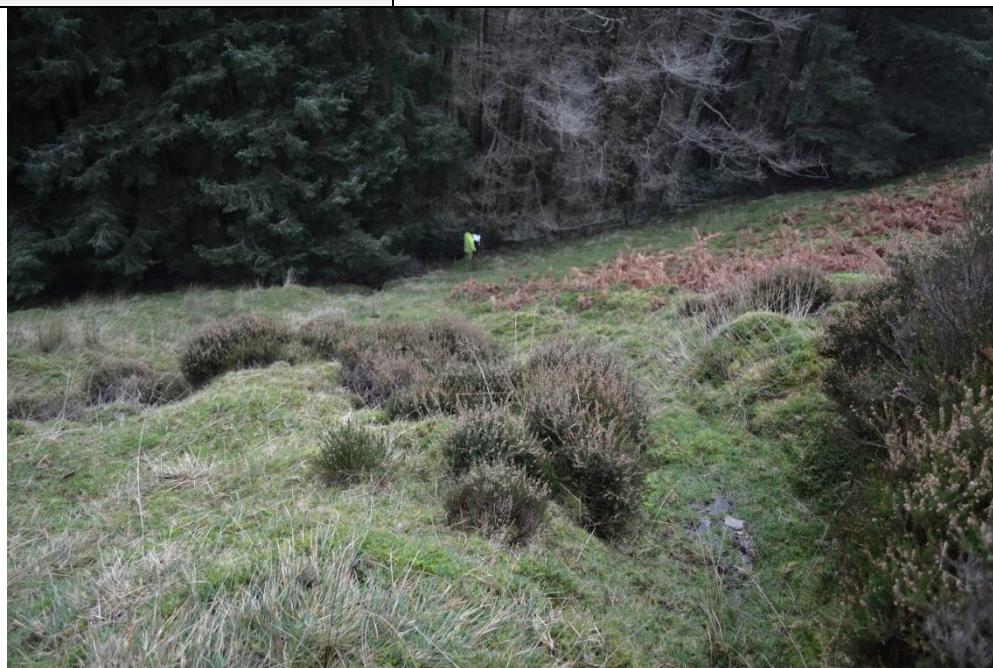
Feature number	20
Primary Reference Number	99012
Site name	Pit (disused), Coed Foeldinas
National Grid Reference	SH8487814975
Period	Post-medieval
Site type	Pit/quarry?
Assessment category	E
Description	The modern 1:10,000 map indicates a "Pit (dis)" in this area. This is not precisely located on the map, but a search of the area failed to reveal any convincing traces that there had ever been any quarrying work here. Some gullies running down the steep hillside appeared to be the result of natural erosion, and this had washed some slate material out on to the path by the forest but there was not enough for this to be from a slate waste tip. The 1st and 2nd edition 25-inch OS maps do not show any quarrying in this location. It is possible that the pit remains undiscovered within the forest, but this seems unlikely.
Impact	Unknown
Recommendation	None

Erosion gullies running down the hill near location of "Pit (dis)", from SW (archive reference: G2754_0073)

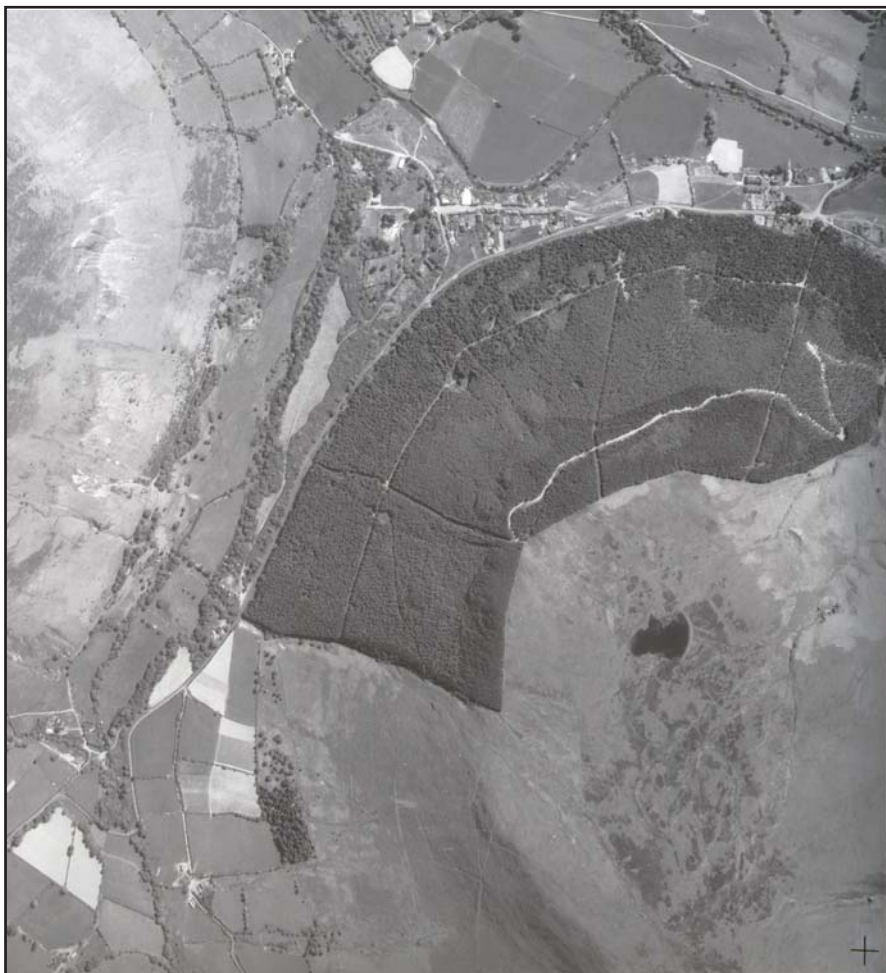
Plate 2. Aerial photograph from 1962 showing Coed Foeldinas, north to left (Welsh Government Library No. 6208, sortie no. 58 RAF 5165, date 06/06/1962)
