Coed Foeldinas, Dinas Mawddwy, Gwynedd

Asesiad Archeolegol / Archaeological Assessment

Prosiect Rhif / Project No. G2754

Adroddiad Rhif / Report No. 1675

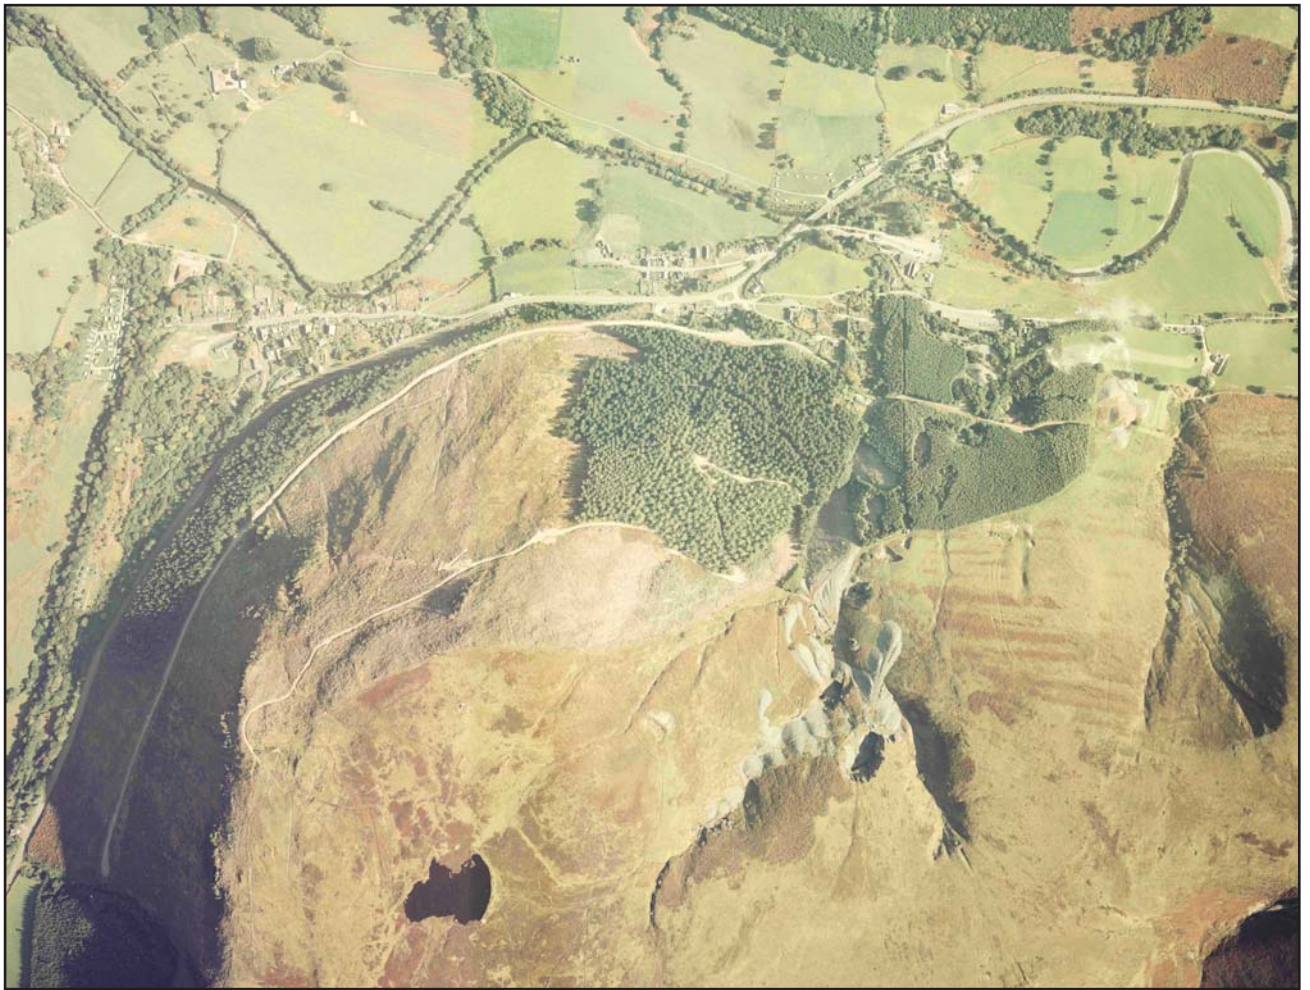
Plate 3. Aerial photograph from 1986 showing Coed Foeldinas, north to left (Welsh Government Library No. 8606, sortie no. J A Story, date 01/10/1986)

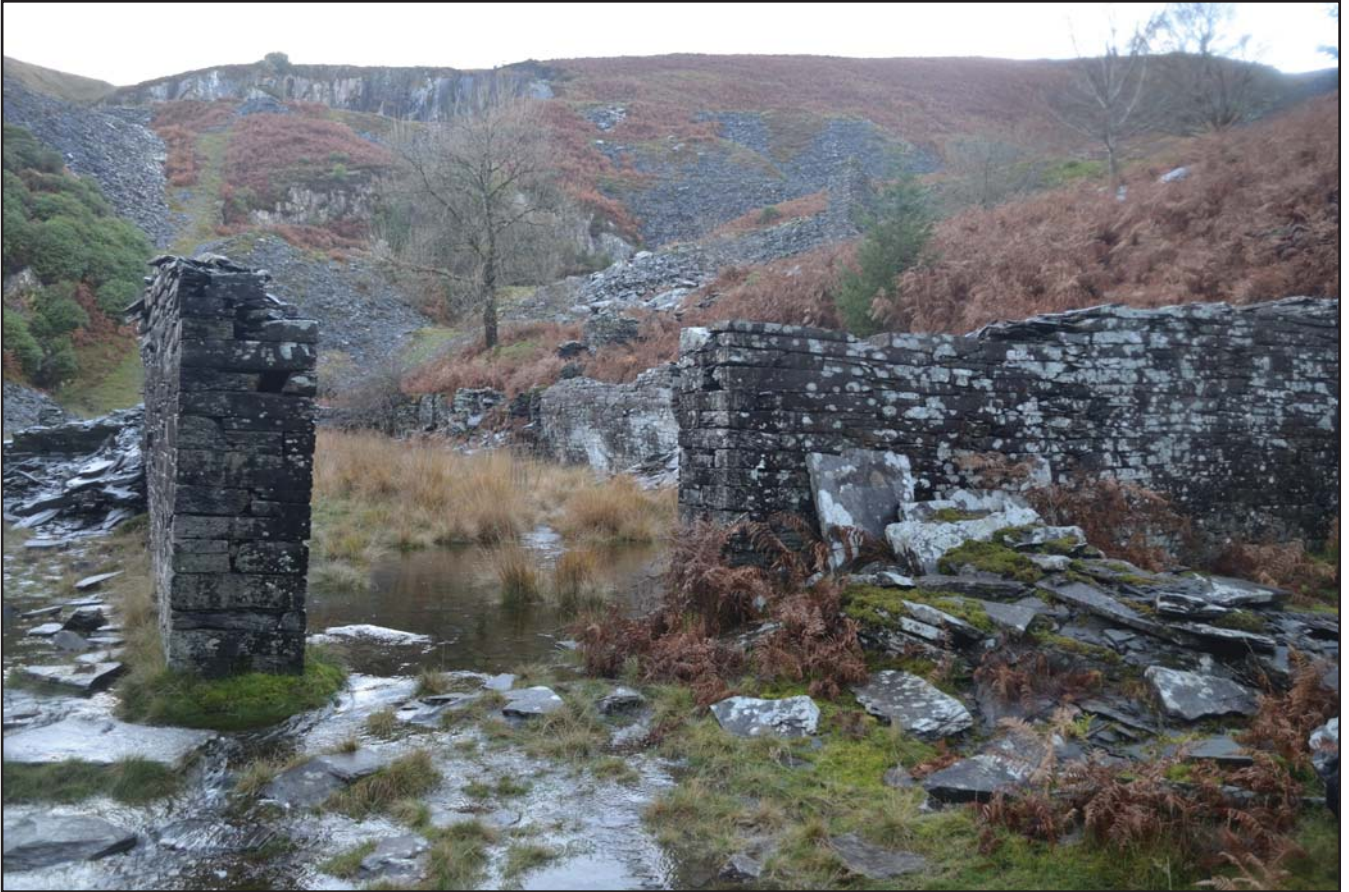
Plate 4. Slate processing mill PRN 99016 from east-north-east (archive reference: G2754_0030)

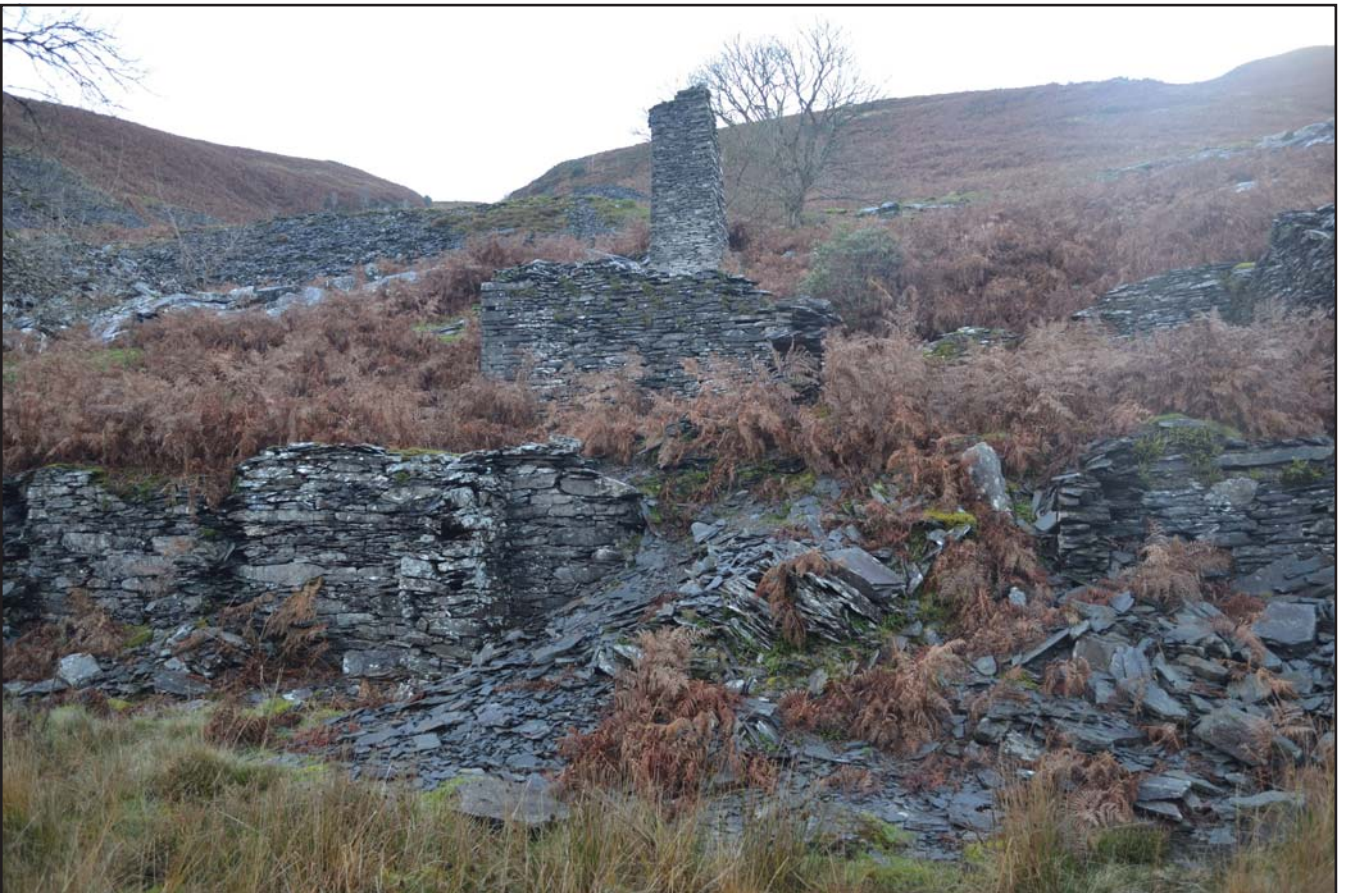
Plate 5. Slate processing mill PRN 99016 with chimney behind from south-south-east (archive reference: G2754_0036).
