CPAT Report No. 1901

# Pengwern Hall, Llangollen

Archaeological Watching Brief

Client name: Mr and Mrs Stephen and Cathryn Johnson  
 CPAT Project No: 2648  
 Project Name: Pengwern Hall, Llangollen  
 Grid Reference: SJ 22455 41107  
 County/LPA: Denbighshire  
 Planning Application: PP/08643095  
 CPAT Report No: 1901  
 Event PRN: 214631  
 Report status: Final  
 Confidential until: N/A

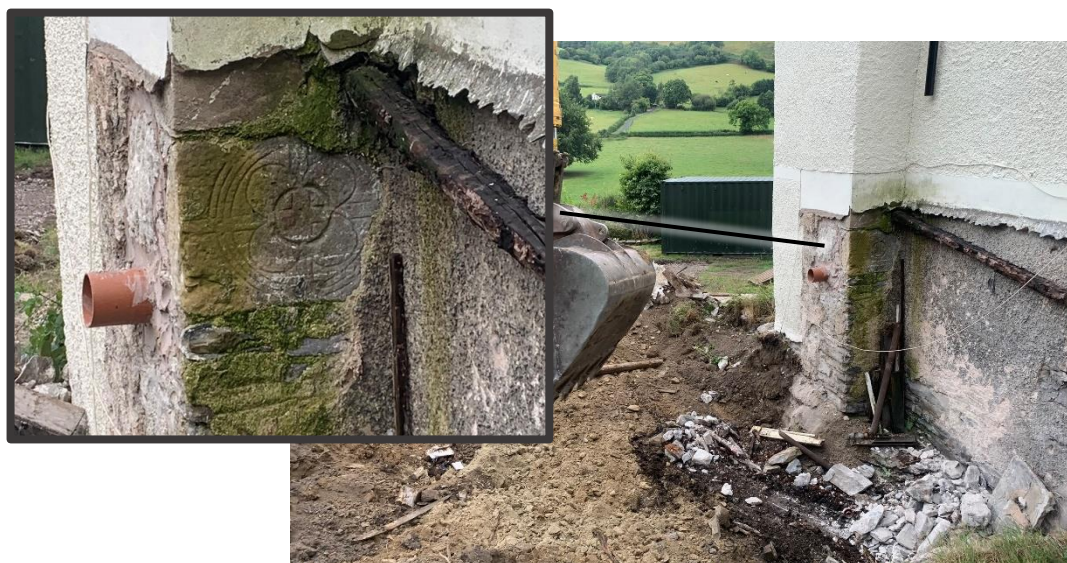
- 3.3. The former wood store shown in Figure 2 (noted as an outbuilding), was comprised of a rubble coursed stone-built structure abutting the main building (Figure 4). The floor and foundations were constructed directly onto a degraded mudstone natural (O4) with a single visible intrusion associated with a drain that ran under the main building. Exposed on the northeast-facing elevation of the chimney stack below the former roof line of the wood store, was an ornately carved stone (Figure 3) that had been sealed by a later rendering. The stone is medieval in origin and is likely to have been reused from the adjacent medieval structure or nearby Valle Crucis. The carving depicts a cross with a central quatrefoil rose surrounded by concentric circles and is possibly part of a reused tombstone.

Fig. 3 Carved medieval stonework built into chimney stack CPAT photo 5018-9 and 28

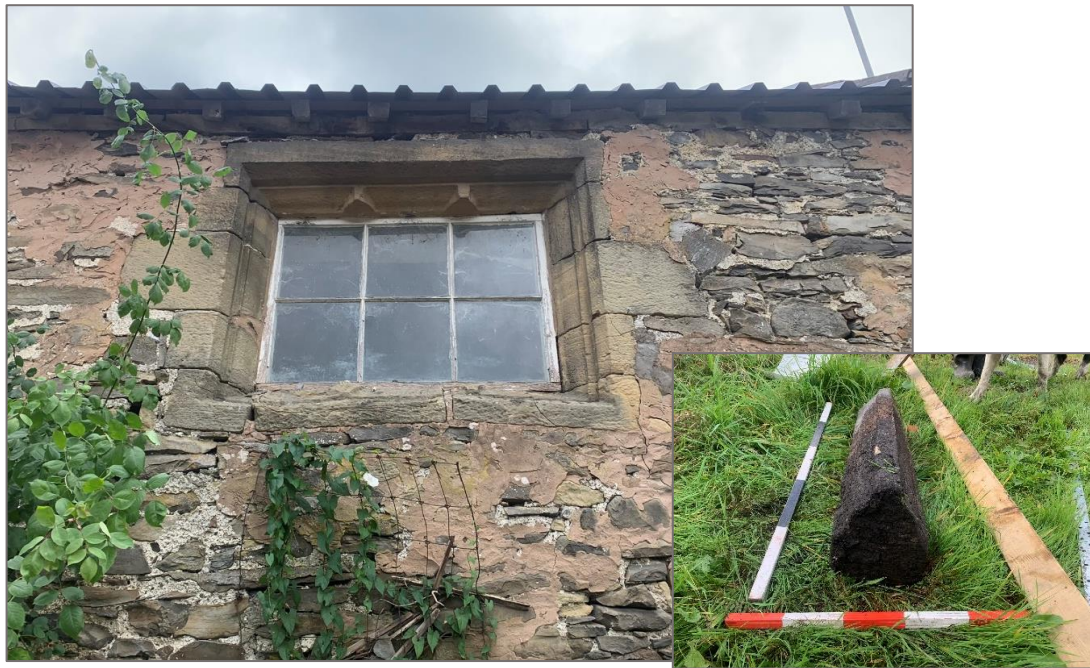
*Fig. 5 Photo showing southwest facing upper window CPAT photo 5018-23 and decorative mullion found in (03) CPAT photo 5018-16*

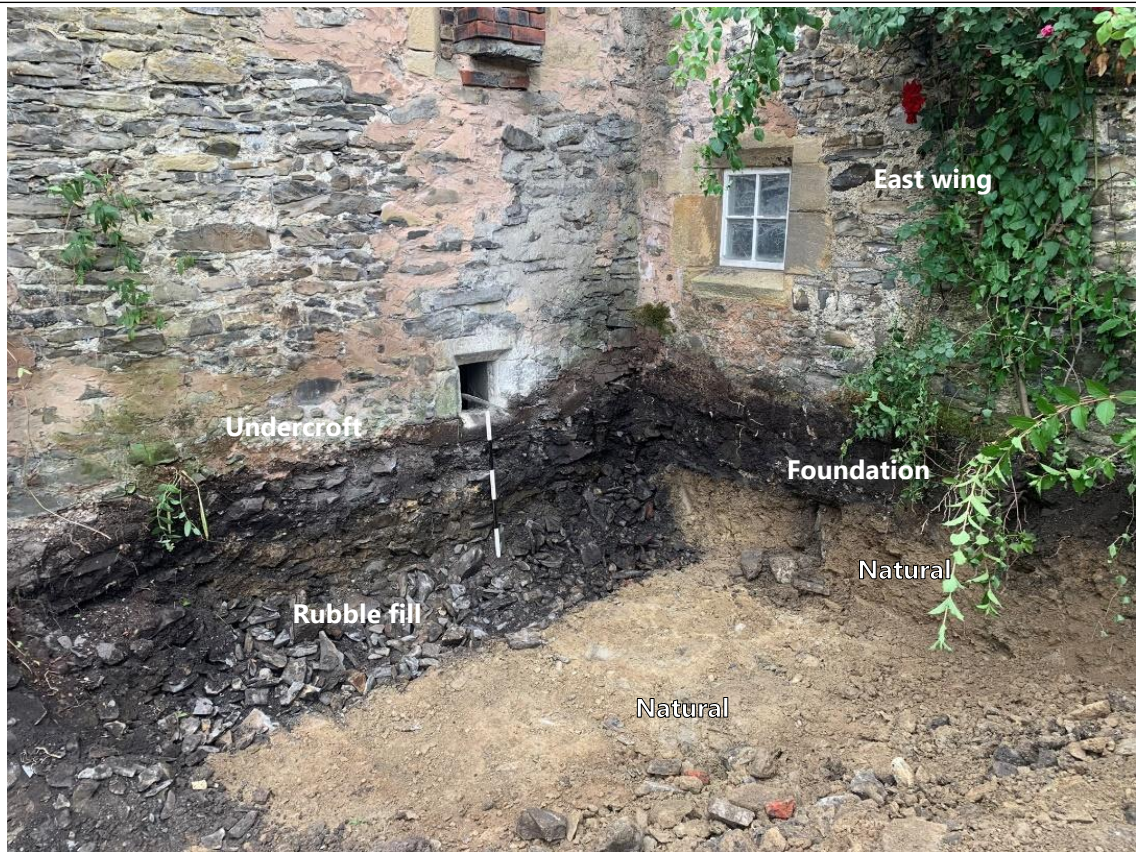
- 3.5. During the excavation, the foundation level of the eastern wing of the medieval building was also exposed. There was no visible construction cut, with the rubble-coursed foundation extending only 0.6m below the modern turf level (Figure 6). Up to 0.4m of natural geology was exposed below the foundation. The fill of the cut feature [02] could be seen in the section below the foundations of the east wing, however, it is unclear to what extent the later cut feature extended below this foundation. Based on the finds within the rubble, it is likely to have been a later undermining associated with the 19<sup>th</sup> century remodelling (Figures 6 and 7).

*Fig. 7 Photo showing rubble-filled cut along undercroft wall CPAT photo 5018-20*

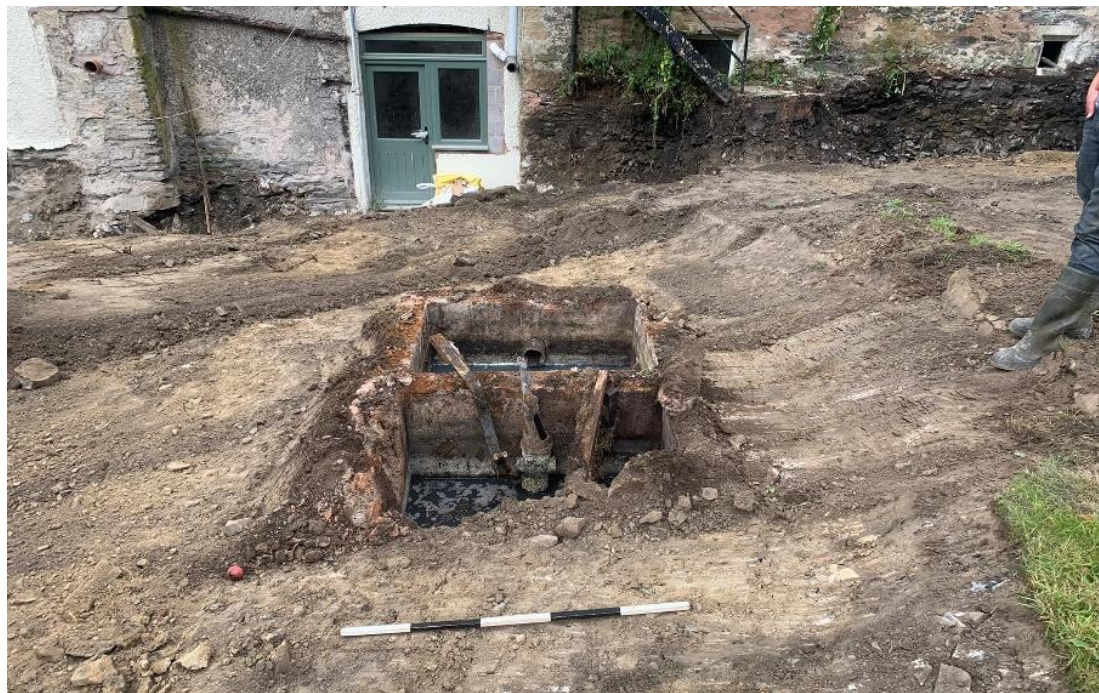
3.7. The disused septic tank located in the centre of the lawned area (Figure 2) was fully removed. Initially, the tank was exposed to the depth of the surrounding natural (Figure 8) and then removed using a toothed bucket. Due to the presence of contaminated water, the resulting hole was instantly backfilled using the extracted natural and rubble. There was no visible construction cut to the tank, however, most of the feature was cut into the natural and therefore is unlikely to have overlaid any earlier features.

*Fig. 8 Photo showing remains of septic tank CPAT photo 5018-29*
