Historic Building Recording of

# TAN Y CAPEL GLYNDYFRDWY

Ethan Ellis MA

Doc Ref: LP4004C-HBR-v1.4

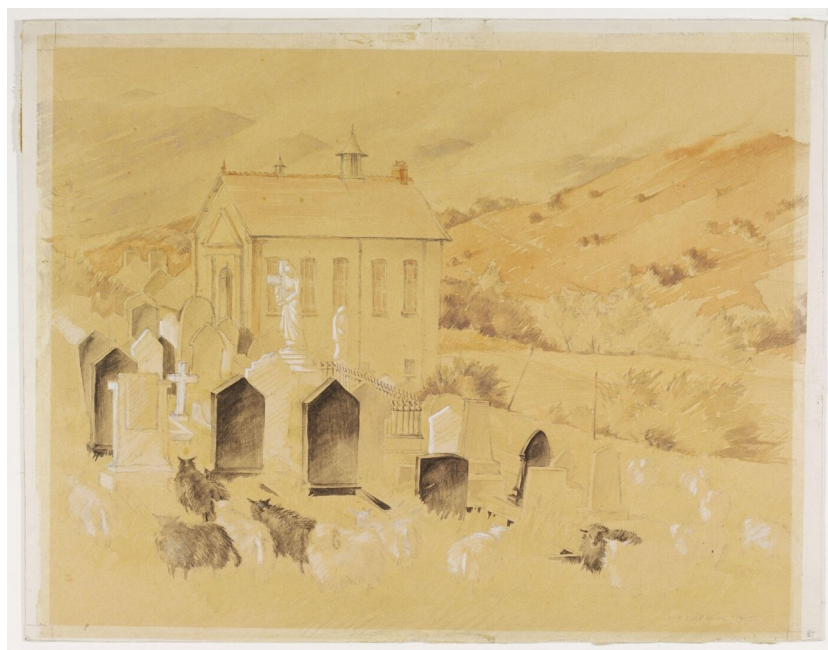
Plate 1 - 1943 Water Colour Drawing by Mildred E. Eldridge

- 3.2.4. A water coloured drawing by artist Mildred E. Eldridge from 1943, commissioned as part of the Committee for the Employment of Artist in Wartime scheme (VA MUSEUM 2021), depicts the east elevation of Tan Y Capel set within the adjacent cemetery to the east and the surrounding mountainous region of Denbighshire in the foreground. In Eldridge's rendition, a classical themed portico of the front facade (south-elevation), in addition to the five narrow rectangular sash windows which run consecutively in a horizontal fashion along the upper floor of the east elevation, two cupola roof vents, roof

finial, and a chimney stack is evident.

final, illustrated in the 1943 rendition, were absent with no trace of their former presence during the time of survey. A photograph held by Coflein, from 2010, illustrates two base foundations where the cupolas once sat, indicating a later phase of restoration to the roof. There is no indication whether the pebble dash surface is original or a latter adaption.

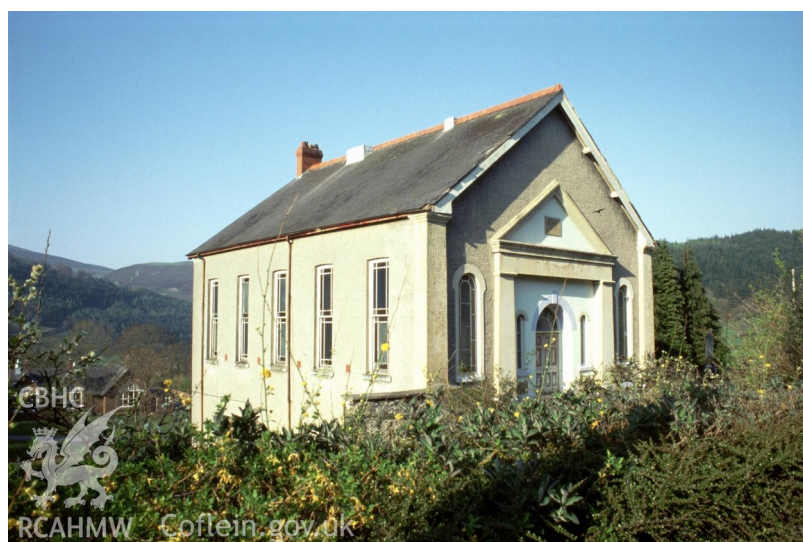
Plate 2 - Coflein Photo 2010

- 3.2.5. Tan Y Capel was still in use as a chapel in 1980 but had fallen into disuse by 2003 (COFLEIN 2021). Restoration works after 2010 incorporated the date plaque on the front facade and likely the restoration of the gable roof, with the removal of two cupola bases that were visible in the Coflein photographs taken in 2010 (COFLEIN 2021).

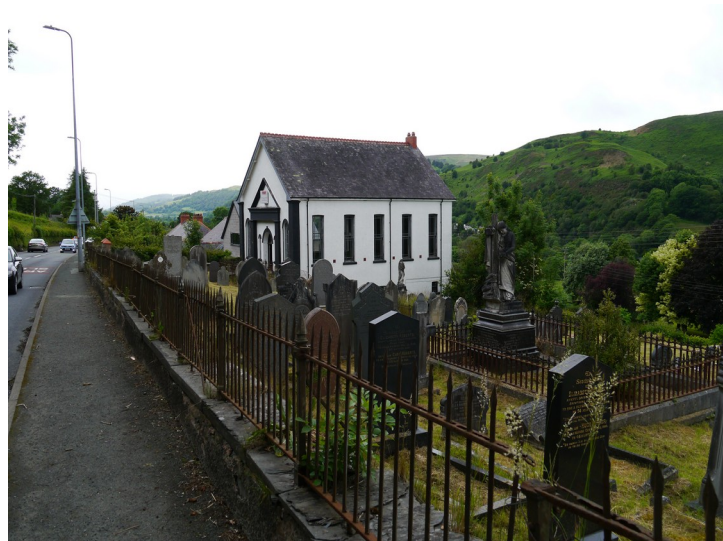
Plate 3 - The setting of the Chapel, looking west

6.4.1. The building is located directly north of the A5 road (PLATE 3), set against the north sloping hillside (FIGURE 2). The complex is assessable via the gated entrance from the A5 road, via the graveyard, to the south elevation, and a country road to the north elevation which interconnects to the A5.

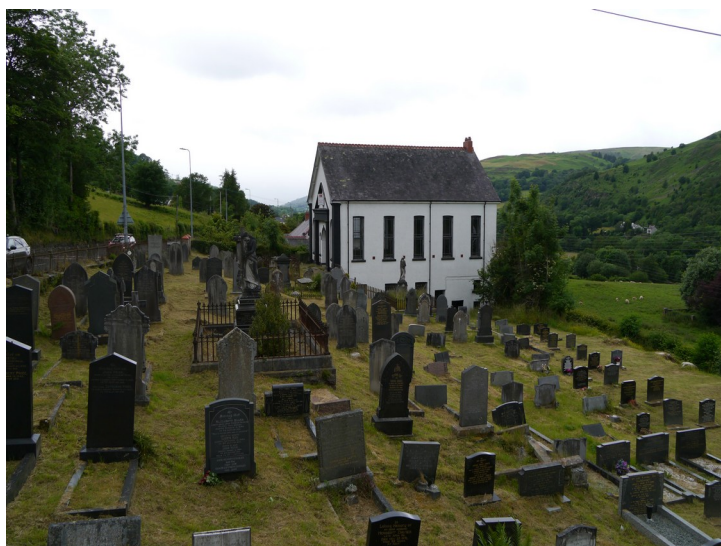
Plate 4 - Chapel and cemetery, looking west

- 6.4.2. There is one single entry point into the main chapel nave on the ground floor made via the south facade. Where access into the lower level via a doorway on the east elevation, and another on the west elevation to the rear.
- 6.4.3. A cemetery lay immediately adjacent to the chapel to the east which slopes gradually with the hillside northward, terminating with the east-west running country road to the rear of the complex (PLATE 4).

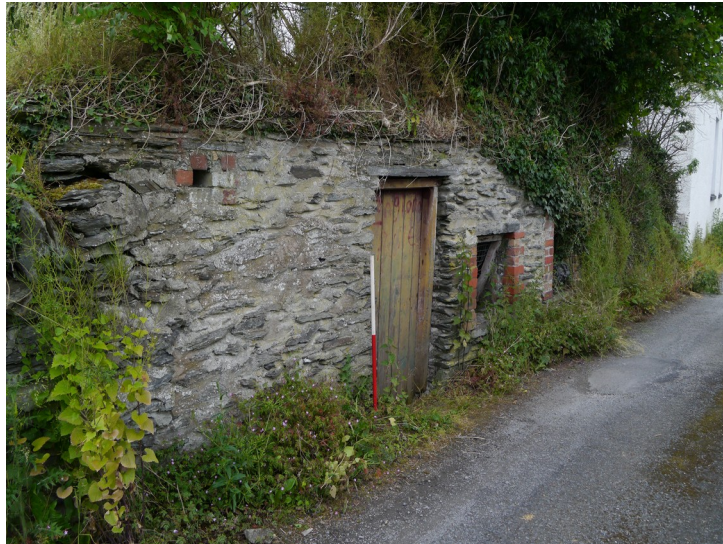
Plate 5 - Outhouse, looking southwest

- 6.4.4. A concrete pathway stems from the main entrance gate to the south and continues to south facade of the Chapel, encompassing the south and east elevation.
- 6.4.5. A small derelict outhouse (PLATE 5), which consists of similar stone and bonding material as the main chapel skeletal fabric, is located at the north most side of the cemetery, adjoining the country road. Accessible via a narrow doorway on the north elevation with a burial stone for a threshold. The build is present on the 1875 OS Map and absent on the 1899 OS Map, which suggest possible disuse by the 20<sup>th</sup> century. A brick lined window has been implemented at a later date, west of the access point on the north facade, in addition to a stone support post within. May have originally been utilised as storage for heating materials such as coal and wood for the Chapel.

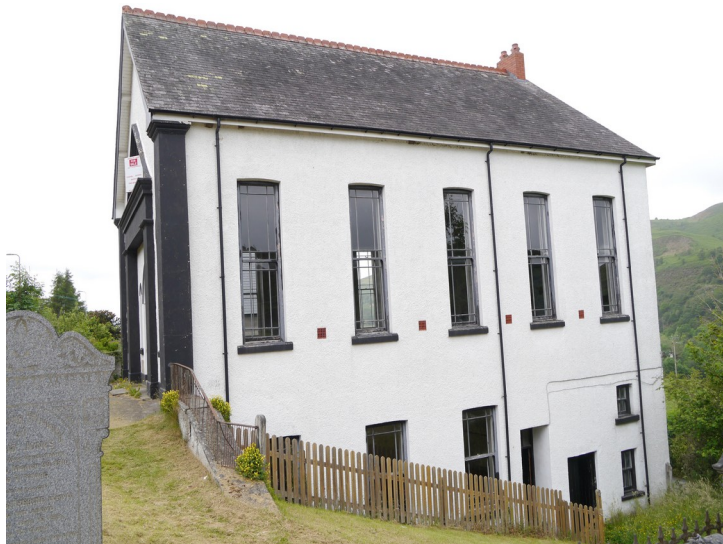
Plate 6 - Eastern elevation of the Chapel

6.4.7. The building form is a two storey, bank construction, of stone, three bays by five bays in plan, with a pitched roof of slate, with ceramic ridge tiles, forming gables at the north and south elevations (PLATE 6).

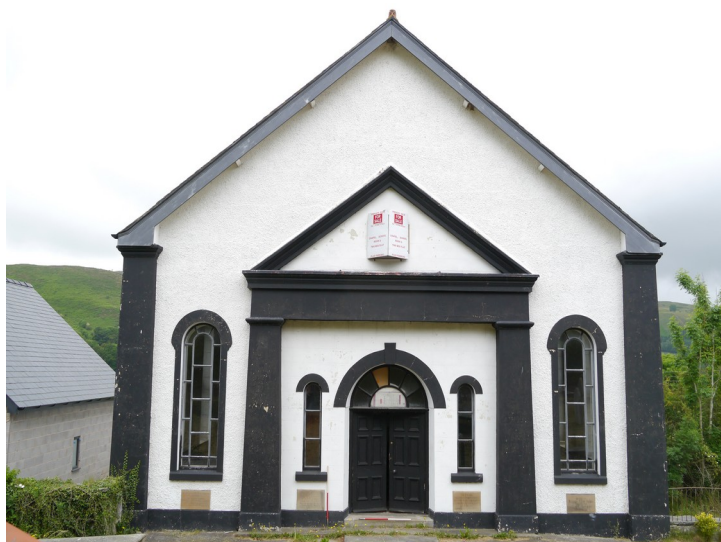
Plate 7 - Southern elevation of the Chapel

ADDOLDY Y BEDYDDWYR 1906, ADEILADWYD CYNTAF YN 1824 AIL-  
ADEILADWYDYN 1841

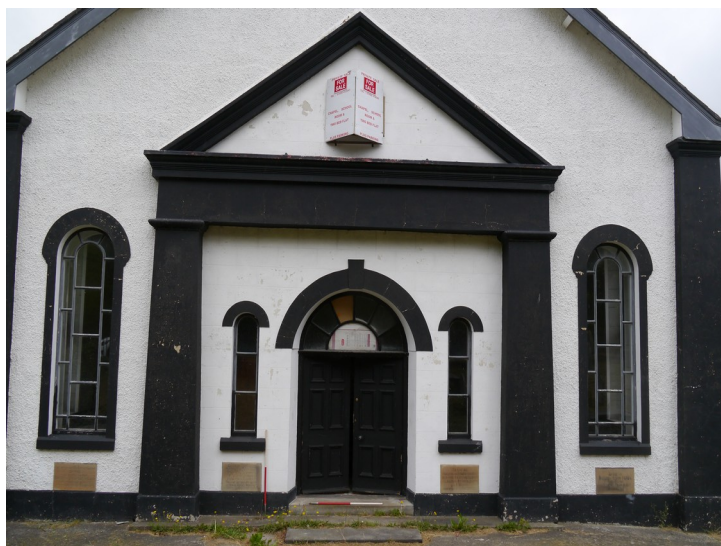
Plate 8 - Portico, looking north

- 6.5.3. Two further small, narrow Romanesque windows were situated within the portico, one either side of the doorway, with much larger scale windows of similar style either side of the portico (PLATE 7).
- 6.5.4. Two protruding square pillars, narrowing towards their apical, and similar in design as the portico pilasters, decorate the corners of the south facade. With a plain wooden gable sat above the pillar.
- 6.5.5. The wall face was pebble dashed, while the surface within the portico was smooth plastered and scored to resemble stretcher bond stone. Coated in white wash, while the protruding pillars, portico, window arches and stone chamfered sills were painted black (PLATE 8).

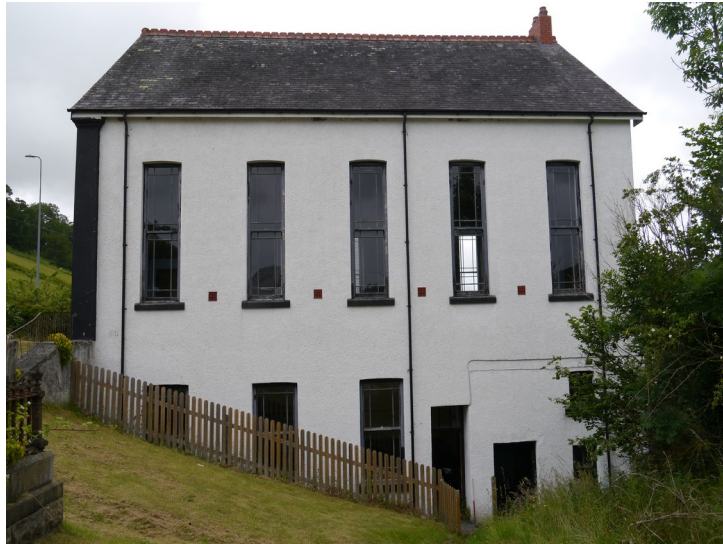
Plate 9 - Eastern elevation of the Chapel

- 6.6.1. The eastern elevation shows the change in ground level from the A5 to the northern road, showing the ground floor access at the south and lower ground floor access from the other elevations. Five narrow rectangular, double height, flat-headed early-twentieth century sash windows with margin panes, run consecutively in a horizontal fashion along the ground floor level, parallel to the west elevation windows (PLATE 9).

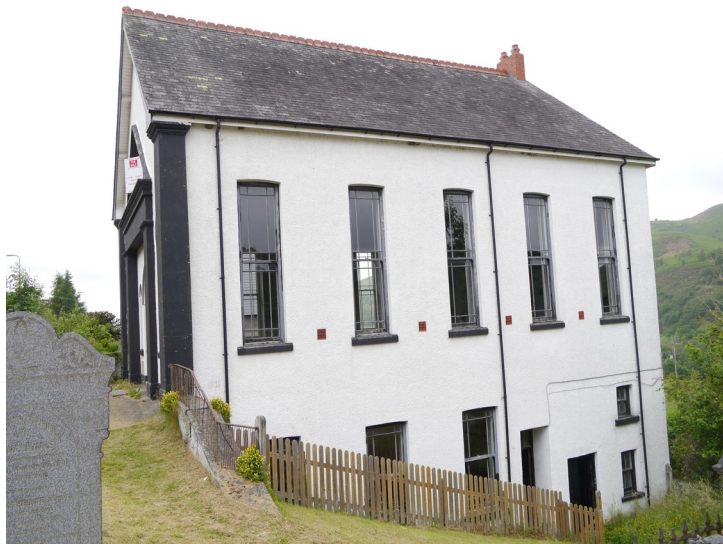
Plate 10 - Eastern elevation, showing lower ground floor fenestration and access

- 6.6.2. Four small square ceramic air ventilation bricks ran in a horizontal fashion between the five sashed windows.
- 6.6.3. Three wider, and shorter flat-headed early twentieth century sash windows were situated along the lower level, parallel to the south three upper ground floor level windows.
- 6.6.4. Situated east of the third lower level window, an original narrow recessed doorway in transom windowed fashion, with a worn sandstone threshold, and parallel to the east elevation doorway in similar in dimension (PLATE 10).

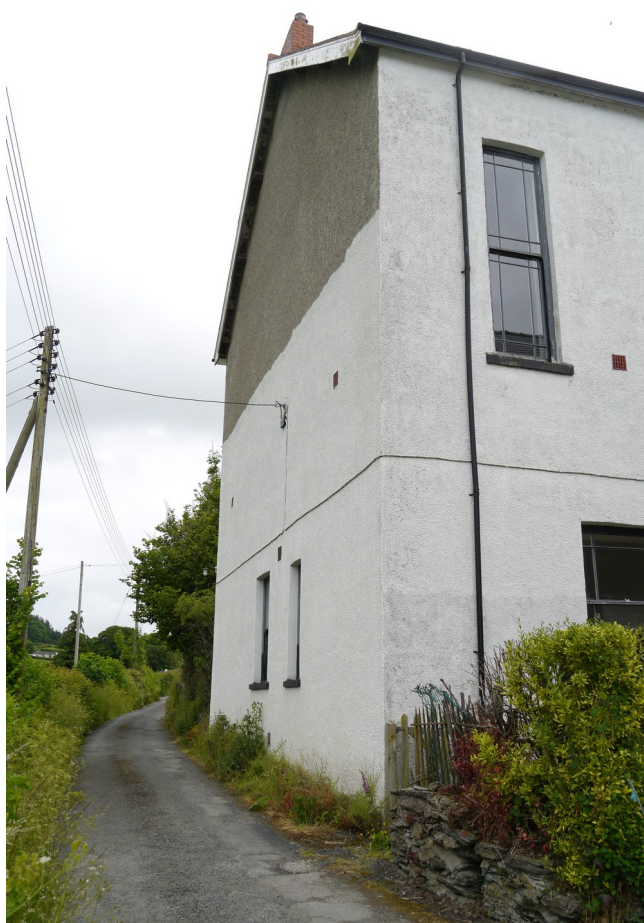
Plate 11 - Northern elevation of the Chapel, looking east

6.7.1. The north elevation (PLATE 11) consists of a plain gable, two rectangular sash windows situated on the lower level, a ceramic air ventilation brick at the base of the building, with another directly above and in the centre of the two windows. A further two ventilation bricks on the ground level lay horizontal to those on the east and west elevation.

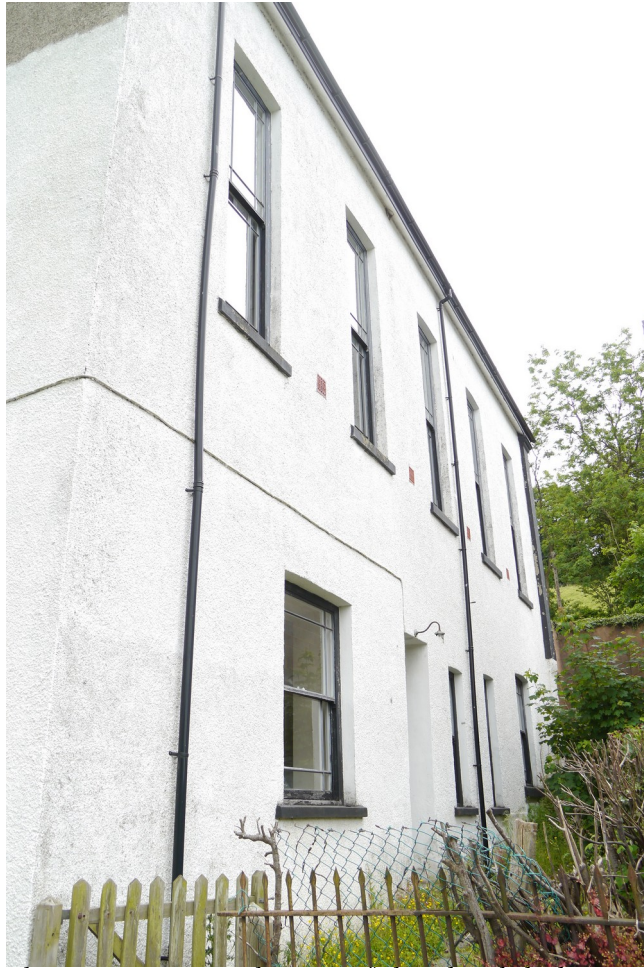
Plate 12 - Western elevation of the Chapel, looking southeast

- 6.8.1. The western elevation was obscured by the neighbouring building and limited access from the northern road. No access to the western elevation was possible from the south.
- 6.8.2. Five narrow rectangular, flat-headed early-twentieth century sash windows with margin panes, run consecutively in a horizontal fashion along the upper, ground floor level, parallel to the east elevation windows (PLATE 12).

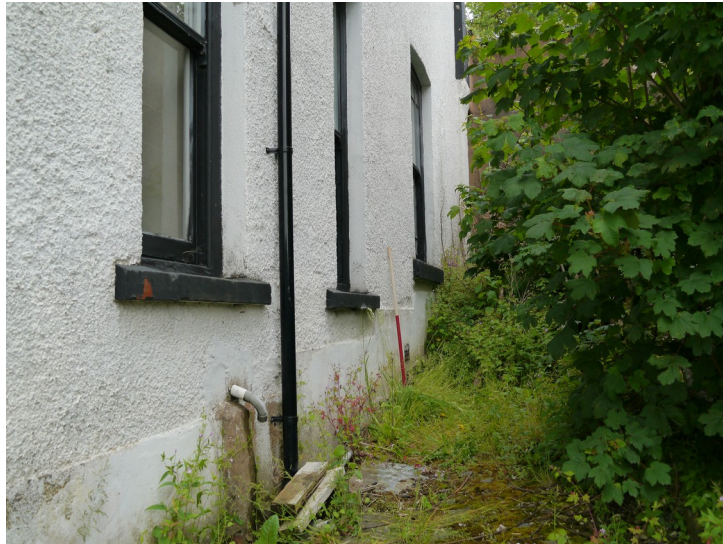
Plate 13 - Lower ground floor windows and plinth

- 6.8.3. Four small square ceramic air ventilation bricks run in a horizontal fashion between the five sashed windows. Another ceramic vent was visible at the base of the structure, below the south most window, along the steeped foundation.
- 6.8.4. Four sashed windows of slight disproportioned dimensions gradually ascend southwardly with the embankment and respecting a plastered plinth (PLATE 13).

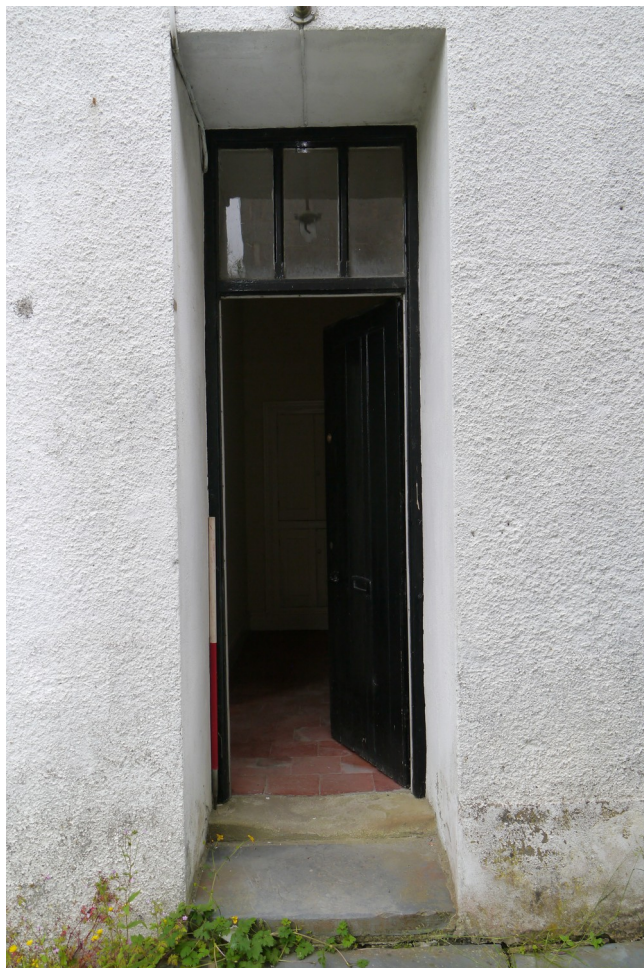
Plate 14 - Western entrance

6.8.5. Situated east of the first lower level window, an original narrow recessed doorway in transom windowed fashion, with a slate and sandstone worn threshold. Parallel to the east elevation doorway and similar in dimension (PLATE 14).

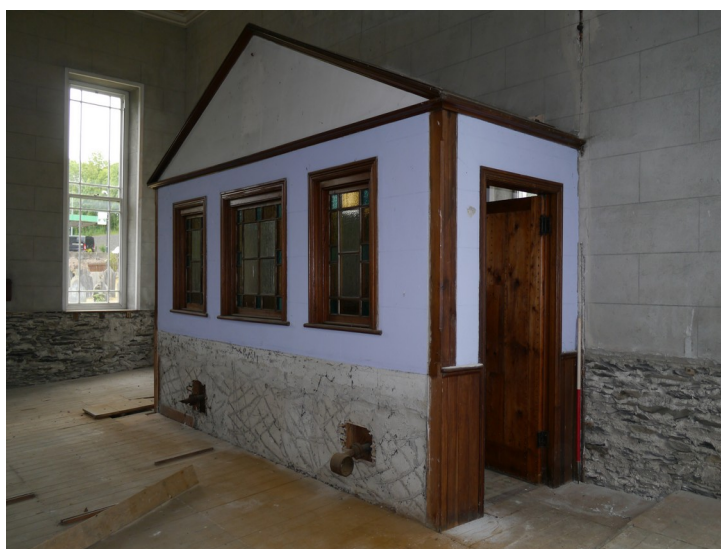
Plate 15 - Vestibule G1, looking southeast from within G2

6.10.2. Room G1 was accessed via the main doorway at the south end of the building, through the front facade, and two doorways located on the narrow east and west wall leading into G2 (PLATE 15).

6.10.3. The walls were constructed from lath and plaster that incorporated the original heating pipes (PLATE 15), which stemmed from the floor and continued into

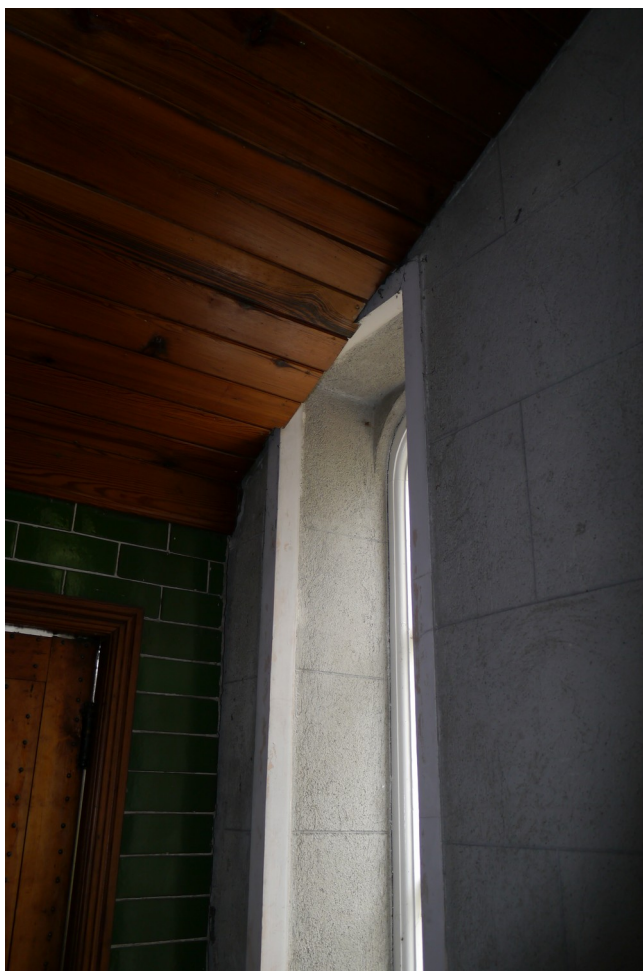
Plate 17 - Room G1 ceiling interaction with front facade windows

**6.10.5.** This is most likely a later adaptation replacing an early entrance area, due to the structure not being fused to the south elevation wall of the Chapel, and considering the gable designed roof truncates the corners of the Romanesque windows of the external front facade (PLATE 17). The heating system and decorative floor tiles were likely original features with G1 built to accommodate.

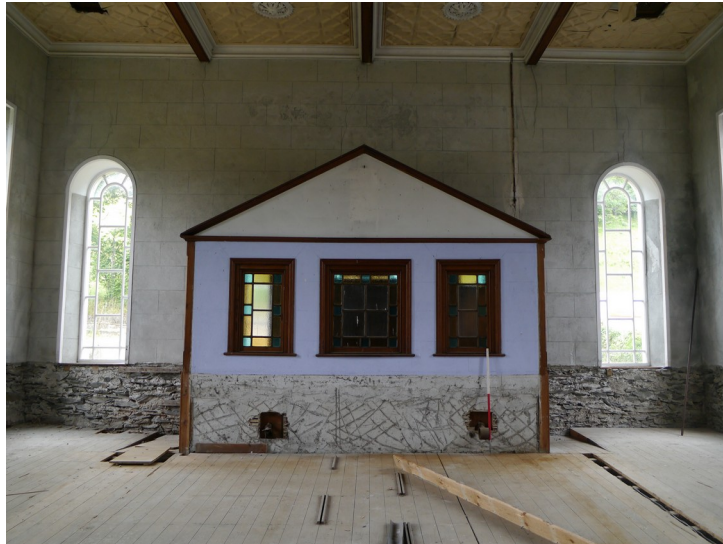
Plate 18 - Vestibule G1, from G2

**6.10.6.** The external plaster of G1 which is visible from G2, had been scored to resemble stretcher bond stone, similar to the external front facade. The lower area had previously had pews attached to it, however the wooden material had been removed prior to survey (PLATE 18). The client kindly supplied some additional images from prior to purchase, which are included in Appendix 2.

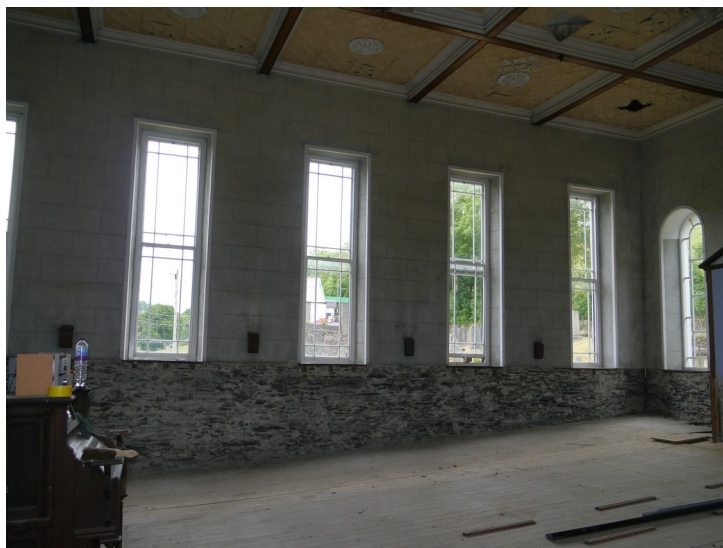
Plate 19 - Room G2, looking east, showing slope of floor

6.10.8. The wooden floor surface sloped gradually from the south wall towards the north, so that the pews formed a rake themed sitting area (PLATE 19), typical of the Victorian Nonconformist architectural style for rural chapel buildings (WAKELING 2016, 9). At the northern end of the room, a raised platform was noted.

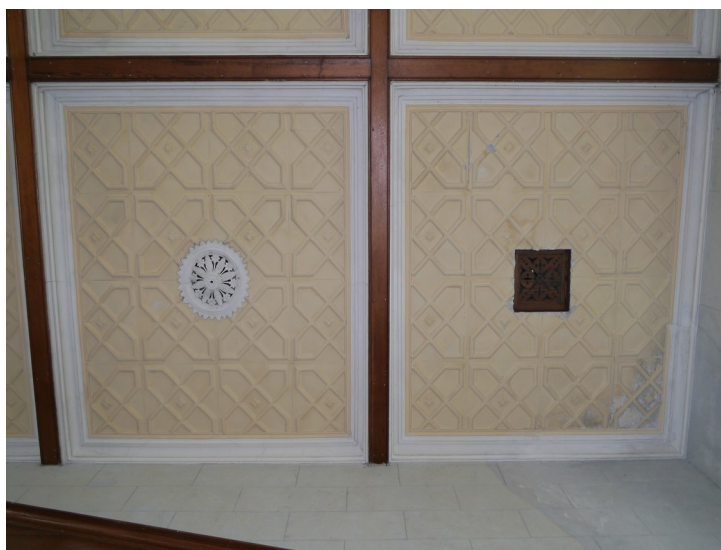
Plate 20 - Comparison of wooden and metal ornamentation within ceiling panels

6.10.9. Ornamental paper adorned the entire ceiling which had been decorated into 4 by 5 quadrates, and sectioned by thick wooden beams. Positioned within the centre of each 20 quadrate, an air ventilation system fashioned with a protruding sculpture. The four decorated intruding wood air ventilation vents located in each corner of the ceiling were likely the early example, while the decorative white protruding metal vents were a later feature contemporary with the ceiling paper (PLATE 20).

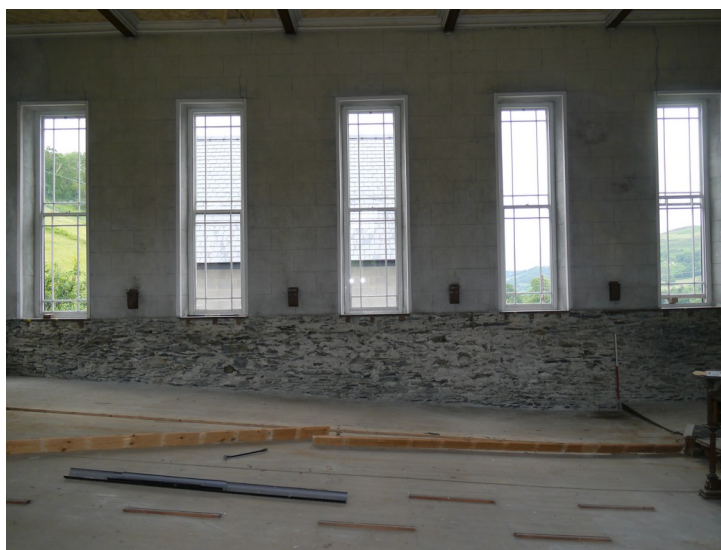
Plate 21 - West wall of G1

6.10.10. The fenestration of the room was mirrored on the east and west walls, with the fish double height sash windows present (PLATE 21).

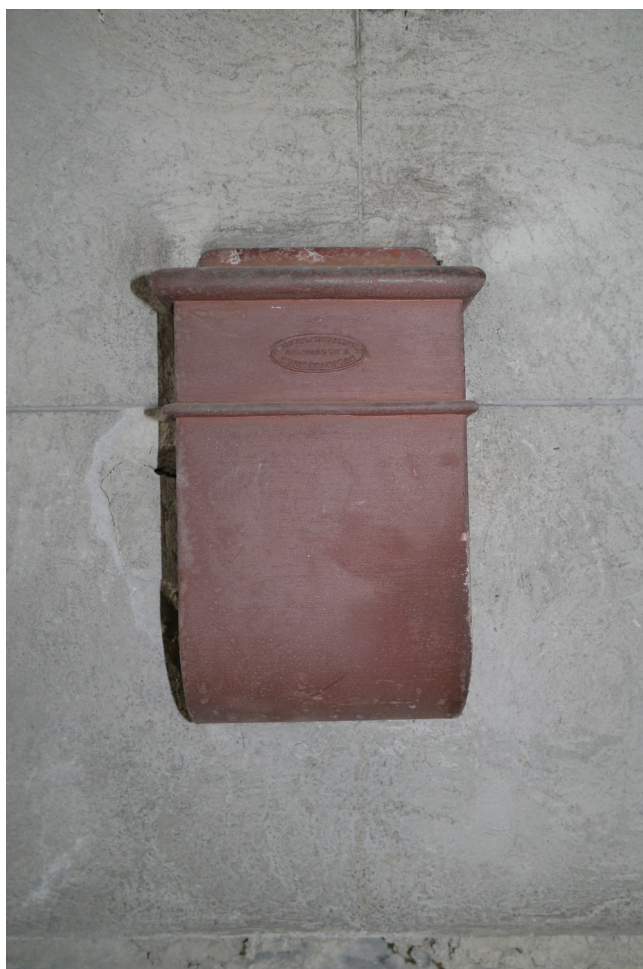
Plate 22 - Room G1 wall vents

6.10.11. The upper section of the walls were plastered and scored to resemble stretcher bond stonework, while the lower elevation below the window line had exposed stonework at the time of survey, however, client photographs show that this had originally been decorated with stained wooden wainscoting.

6.10.12. Situated on the east and west elevations, between the flat-headed early-twentieth century sash windows, were four metal fashioned air ventilation systems that corresponded to the ventilation bricks that can be seen from the external elevation (PLATE 22). The 8 vents are stamped with the inscription '.....  
*LATEST IMPROVED AIR INLET TUBE WOLVERHAMPTON*'

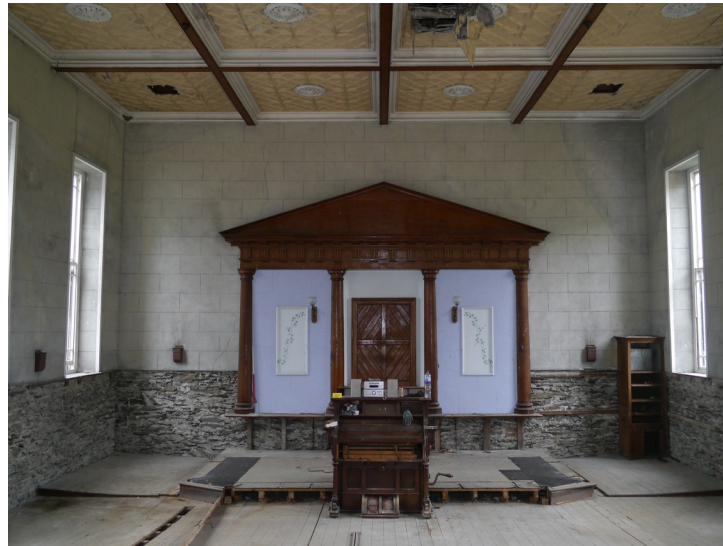
Plate 23 - Reredos and dais at north end of G1

spaces, and Tuscan style pilasters. The central section had contained a decorative wooden panel, however, this was missing at the time of survey. This element is possibly associated to the second phase of renovation, due to its familiarities to the fabric and design of G1.

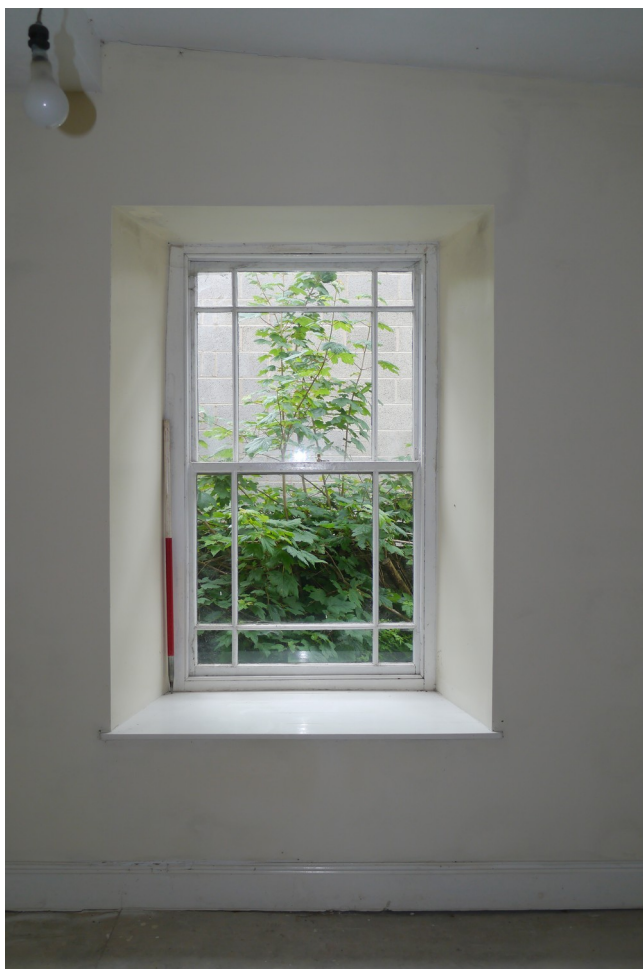
*Plate 24 - Window within L1, looking west*

6.11.3.The room consisted of a plain, plastered ceiling, dry wall finish, and a large splayed reveal sash window (PLATE 24) in the centre of the west elevation wall.

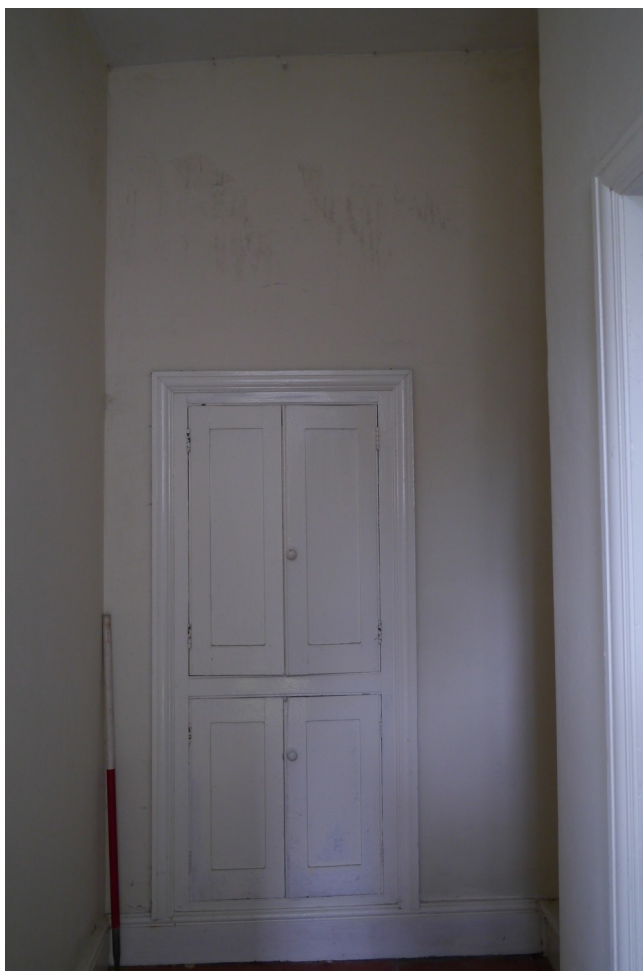
Plate 25 - Cupboard, possibly earlier doorway, in L2,  
looking east

6.11.6. An intruding cupboard located on the east elevation (PLATE 25), where the 90 degree corner began, was originally a doorway connecting to Room L8.

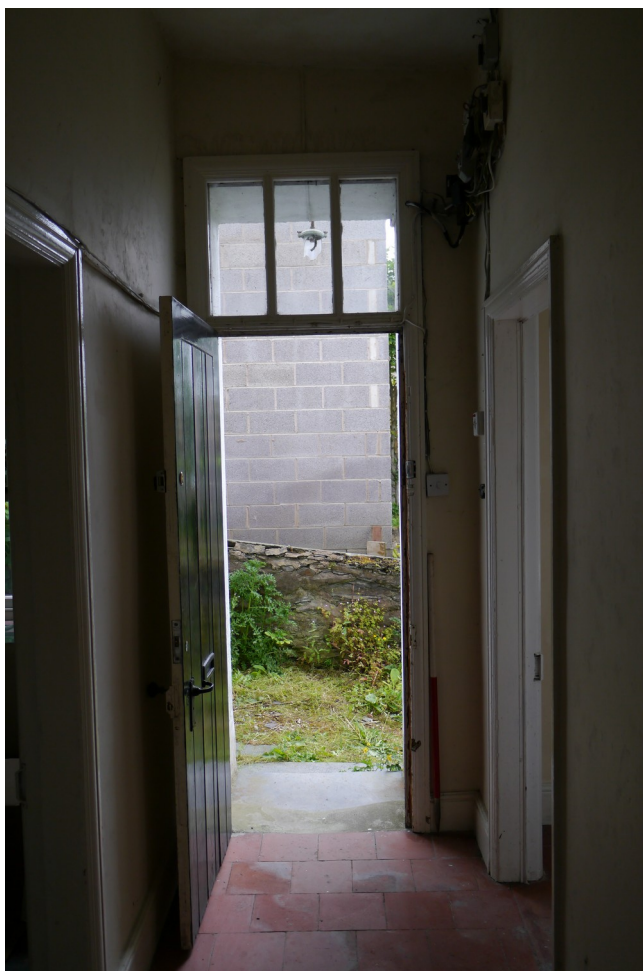
Plate 26 - External doorway into L2

6.11.7. The floor consisted of matt red quarry square tiles that extended from the external doorway (PLATE 26) towards the east division wall where it ceased, beyond which, the north running hallway consisted of a raised wood floor.

6.11.8. Above the external doorway was a simple three pane transom light (PLATE 26).

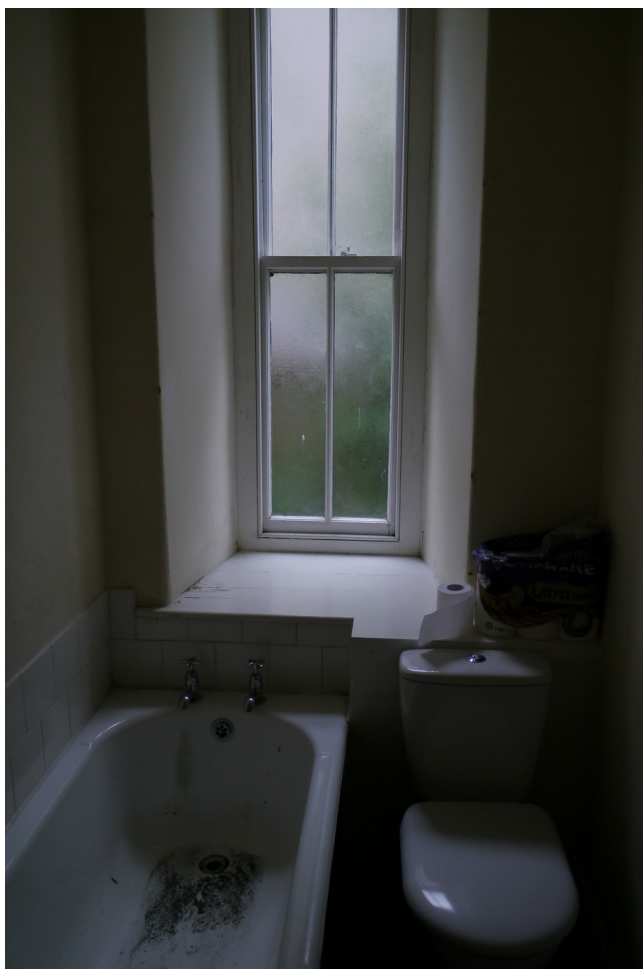
Plate 27 - L3, looking east

6.11.10. The narrow vertical edge reveal window, sat on the west elevation wall. Possibly a later design as all other windows on the lower floor level, except Room 5, were of splayed reveal fashion (PLATE 27). The floor consisted of large stone slabs with a latter channel cut and filled with cement, running westwardly across the room which incorporated piping from the sink situated on the east wall.

6.11.11. The walls were plastered with bathroom tile along the south wall. An air ventilation brick can be seen on the lower east wall.

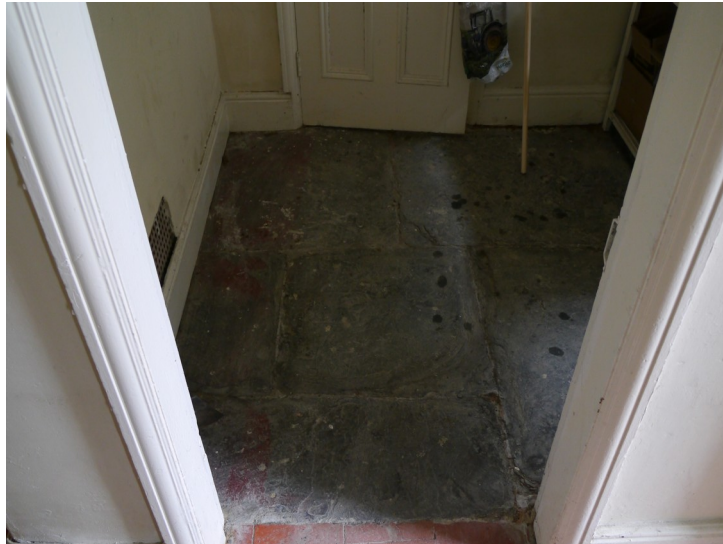
Plate 28 - Stone flag floor in L3 and L4

6.11.13. The floor consisted of large stone slabs which continued into L3, and an air ventilation brick can be seen on the lower east wall (PLATE 28).

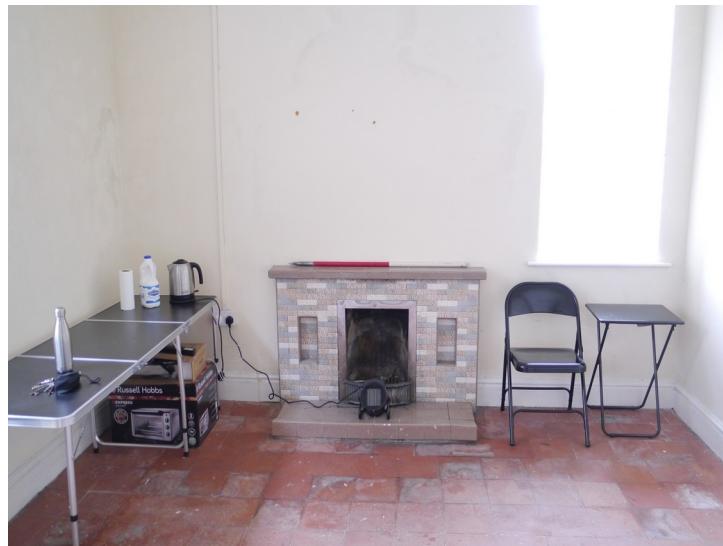
Plate 30 - Room L5, looking north

6.11.15. Room L5 was a much larger square space, accessible via the doorway into L2 and another into L6. The ceiling appeared to have been decorated in polystyrene tiles, the walls plastered, and the floor styled in red quarry matt tiles as in L2 (PLATE 30).

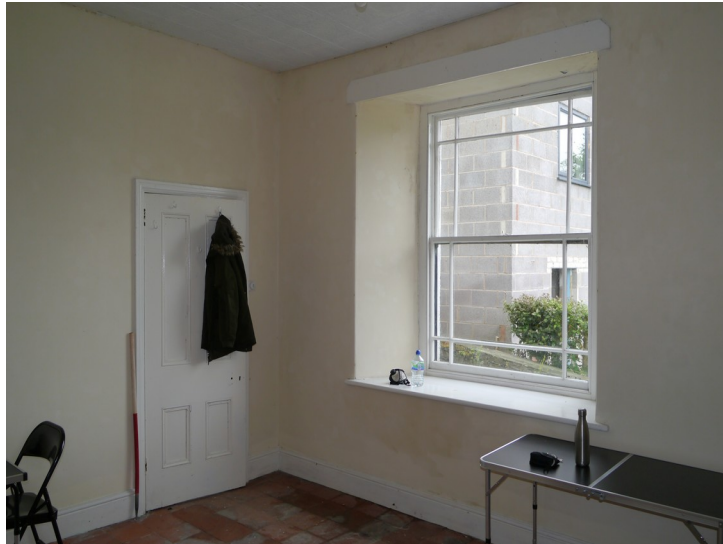
Plate 31 - Room L5, looking southeast

6.11.16. A large splayed reveal sash window sat in the centre of the west elevation wall, in similar dimension to the L1 window (PLATE 31). While another narrow vertical edge reveal window, similar dimension and design as L3, sat on the east most side of the north elevation wall, beside the original fireplace. No chimney breast was visible on the north wall, which indicates a later stage of reconstruction, or an internal wall design to conceal the chimney (FIGURE 9 & PLATE 31).

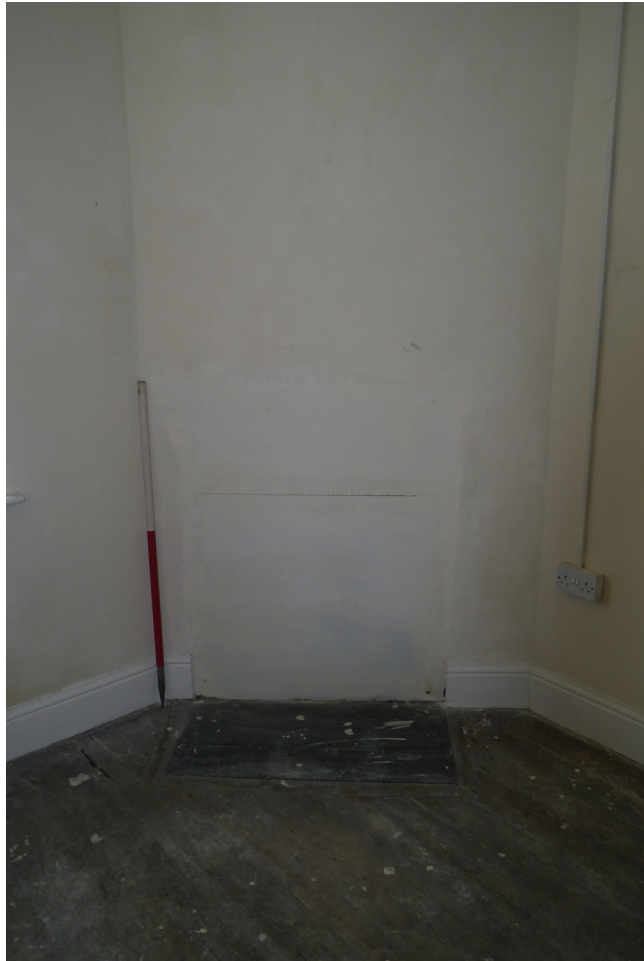
Plate 32 - Fireplace in L6, looking northeast

6.11.18. An original design splayed reveal sash window was located on the north wall, and the floor made up of wooden floor boards. The east wall was made of brick and plaster render and was not original, rather a later build during the second phase of reconstruction, in addition to the closed chimney in the corner where the north and east wall joined (PLATE 32).

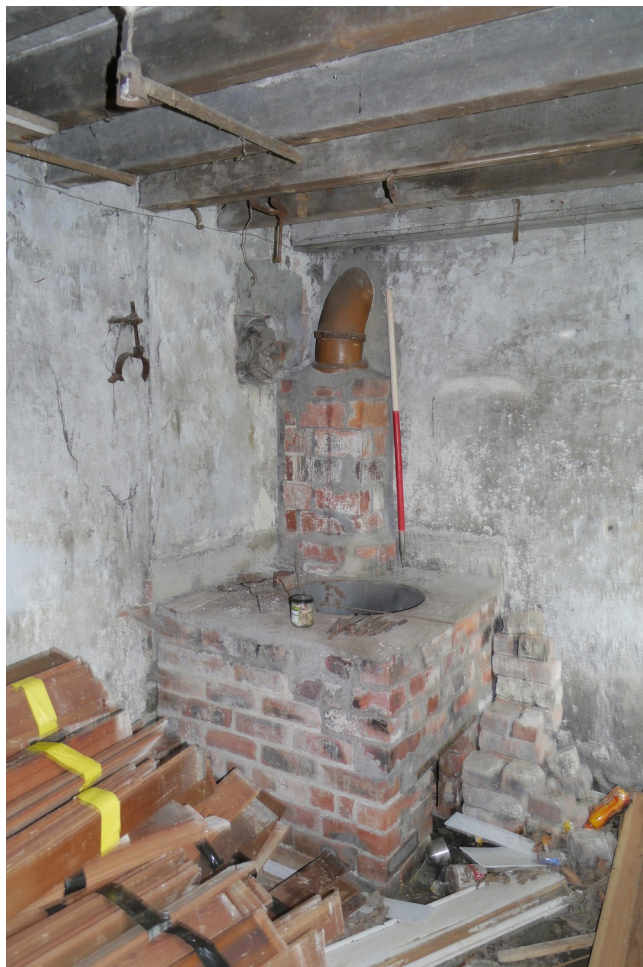
Plate 33 - Heating stove in L7, looking northwest

6.11.19. Room L7, consisted of two shallow floors levels, the lower built to function as a heating room with a chimney built in brick against the north and west wall (PLATE 33).

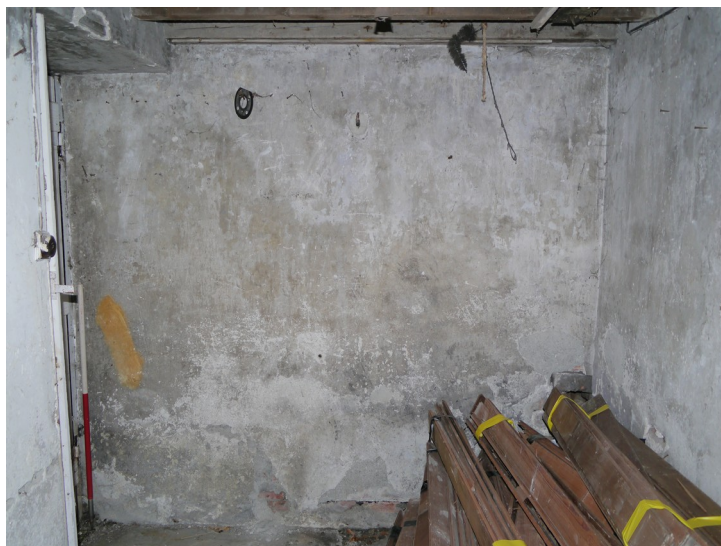
Plate 34 - Dividing wall between L7 and L8, with brickwork exposed at base

6.11.20. The west and south walls made of brick and cement render (PLATE 34). A small square sash window and the broad main entry point doorway, were located on the east main structural wall. The ceiling consisted of wooden beams running east westwardly supporting the storage space above.

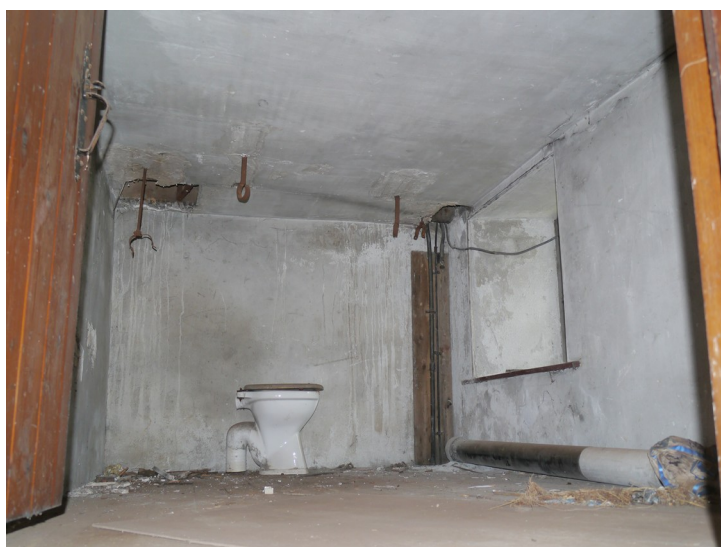
Plate 35 - Storage area above L7, looking north

6.11.21. The upper room was accessed via a hatch on the upper north wall of L8 and was a small storage area. Another small square sash window was located on the east wall parallel to the window below, and the floor surface was made of wood (PLATE 35).

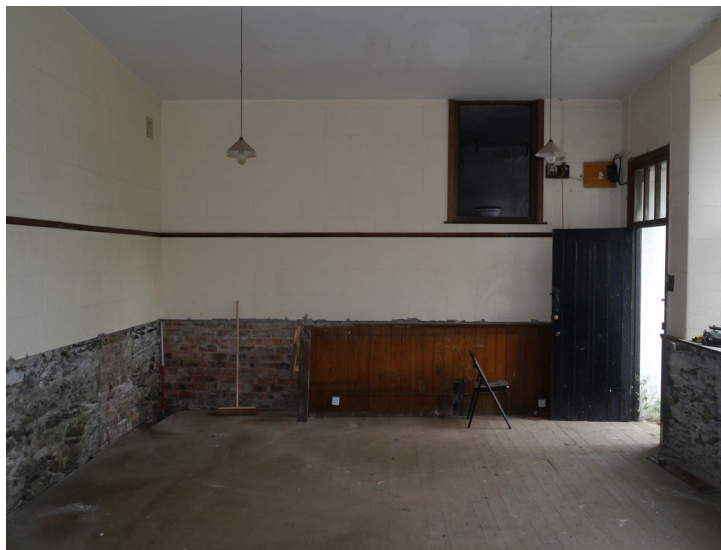
Plate 36 - North wall of L8

6.11.22. Room 8 was a large rectangular shaped space located on the east most side of the building accessible via the original narrow recessed doorway in transom windowed fashion on the north most side of the east wall. The extent of the area indicates an original use as a school or other religious service activity. The layout closely resembles G2 in design. The upper elevation of the walls were plastered and scored to resemble stretcher bond stonework, while the lower elevation below the window line was decorated with stained wooden wainscoting, and a wooden floor surface (PLATE 36).

6.11.23. The entire north wall of Room L8 had been constructed of brick and mortar, unlike the original stone and cement rendering of the main 1906 skeletal structure. A square open hatch was located on the upper section of the north wall accessing L7 storage space (PLATE 36).

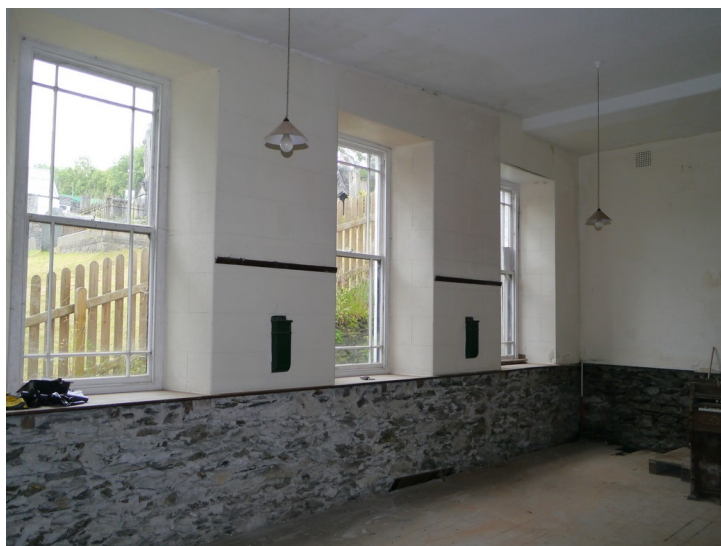
Plate 37 - East wall of L8

6.11.24. Situated on the east elevations, three large splayed reveal flat-headed early-twentieth century sash window, where three metal fashioned air ventilation systems identical to those in G2, although painted green in L8 (PLATE 37).

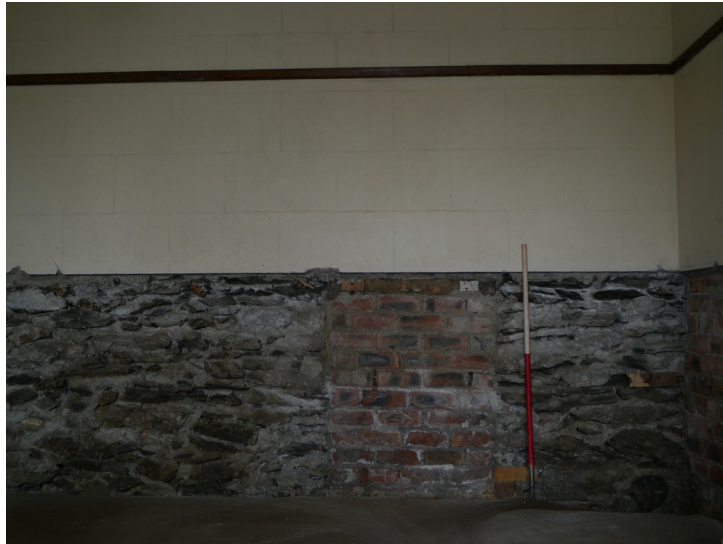
Plate 39 - Blocked doorway on east wall of L8

6.11.26. A doorway situated on the west wall, 1m south of the north wall, had been sealed by brick and plastered over. An intruding cupboard was present on the far south side of the west wall. At the southern end of the room a matching cupboard could be seen (PLATE 38). When tapping the eastern wall of L1 in this area, the hollow sound produced suggests that this may have also been an earlier doorway.
