Historic Building Recording of

**1 - 3 COLLEGE STREET
WREXHAM**

Doc Ref: LP3893C-HBR-v1.4

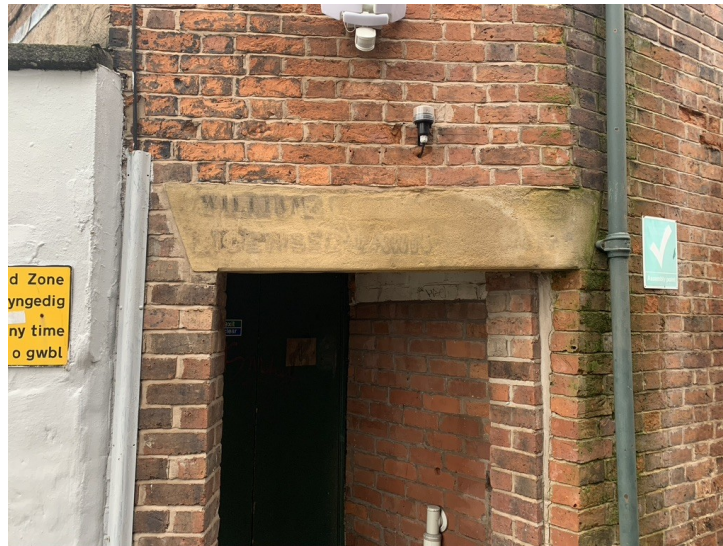
2.4.11. During this timeframe it has been stated that "*College Street housed a bordel (brothel) and a pawn shop used by the needy to get them through the week till pay day*" (WREXHAM COUNTY BOROUGH COUNCIL 2020). During the site survey a lintel was noted on the structure to the northeast of 1-3 College Street, which, although heavily worn, had been inscribed "*William ... Licensed Pawn...*" (PLATE 2).

Plate 2 - Pawnbroker lintel to northeast of the study structure

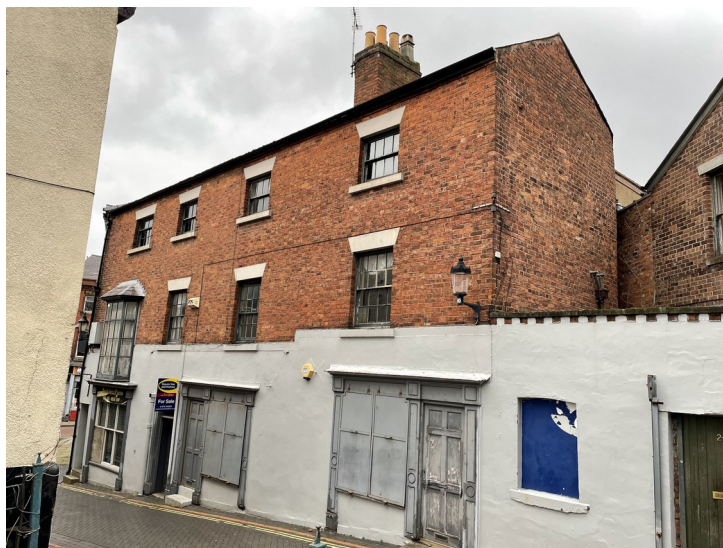
Plate 5 - Southern elevation of 1-3 College Street

4.5.1. The structure is a three storey early 19th century part rendered brick building comprising, what would have been, three terraced shops with first and second floor dwellings (PLATE 5). Only the southern end eastern elevations are visible from College Street, with the northern elevation obscured by neighbouring structures.

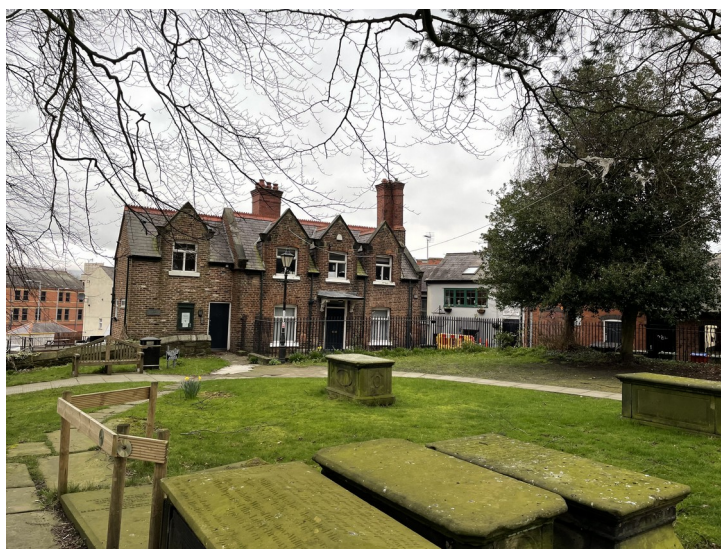
Plate 6 - College House showing the gabled dormer windows also present on the 1748 illustration.

- 4.5.4. The roofline is formed of an unbroken apex, with even pitches on northern and eastern elevations, and a chimney stack sited between numbers 2 and 3. This even roofline stands in contrast to the stepped roofline shown on the 1748 illustration (PLATE 1). The detail of college house on the illustration, which matches the standing building (PLATE 1 & PLATE 6) shows a high level of accuracy.

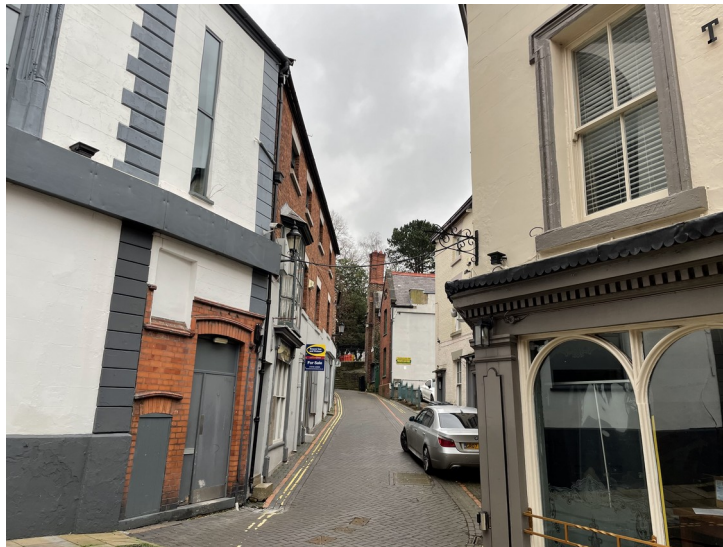
Plate 7 - Junction of 1 College Street with the neighbouring property to the west.

4.5.7. The western elevation is the boundary wall between Senso, on the corner of Town Hill and College Street, and 1 College Street (PLATE 7). This junction is at the corner of the street, where the road widens, which allows for a change in the angle of the frontage.

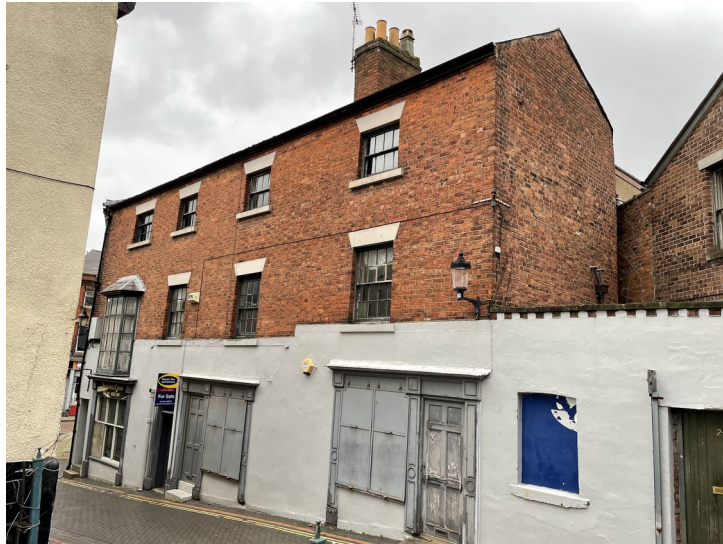
Plate 8 - Southern elevation

4.5.8. The southern elevation is the main facade of the properties and the most decorative elevation constructed of dark orange brick in Flemish Bond, popular from the mid 1830s, visible at first and second floor level (FIGURE 8 & PLATE 8). The ground floor is rendered and painted grey, although this is likely a later modification.

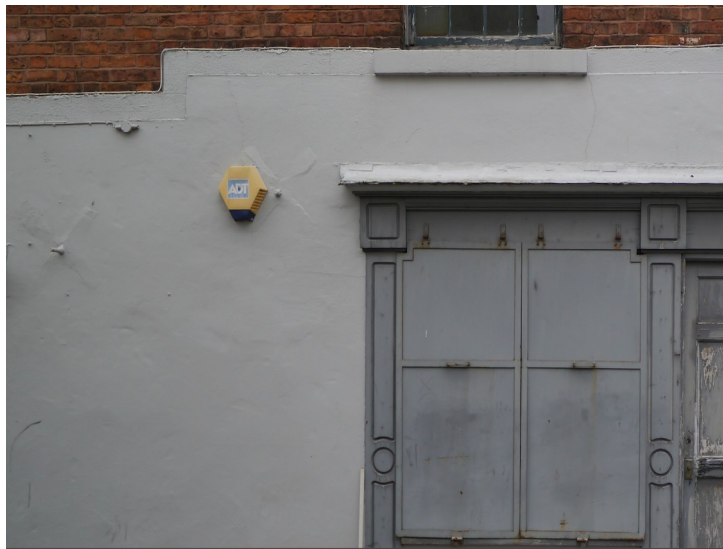
Plate 9 - Wall ties to the west of number 3 shopfront

4.5.9. Between the shop windows of numbers 2 and 3 two offset wall ties can be seen beneath the render (PLATE 9). This shows that the current render, at least, post dates a repair to strengthen the frontage.

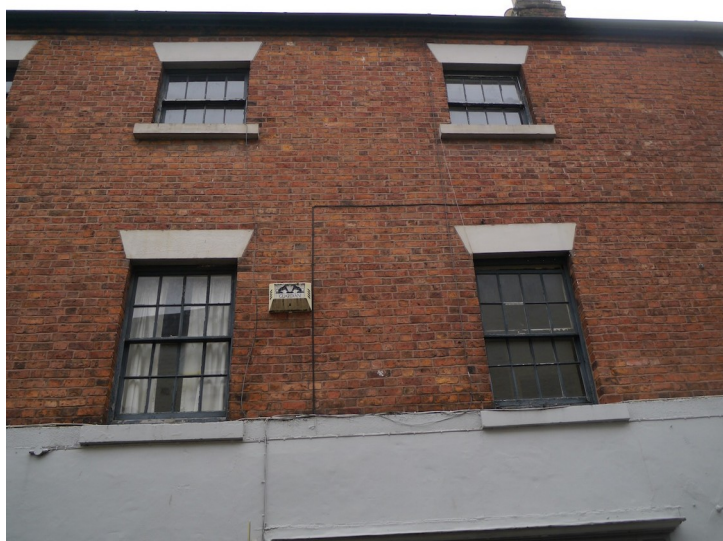
Plate 10 - Representative fenestration

4.5.10. The fenestration at first and second floor levels are consistent with a single phase of construction, excluding the bay window at the western end. The windows comprise wooden framed sash windows of 16 panes at first floor and 8 panes at second floor level (PLATE 10). Both floors show rectangular stone sills and trapezoidal stone lintels.

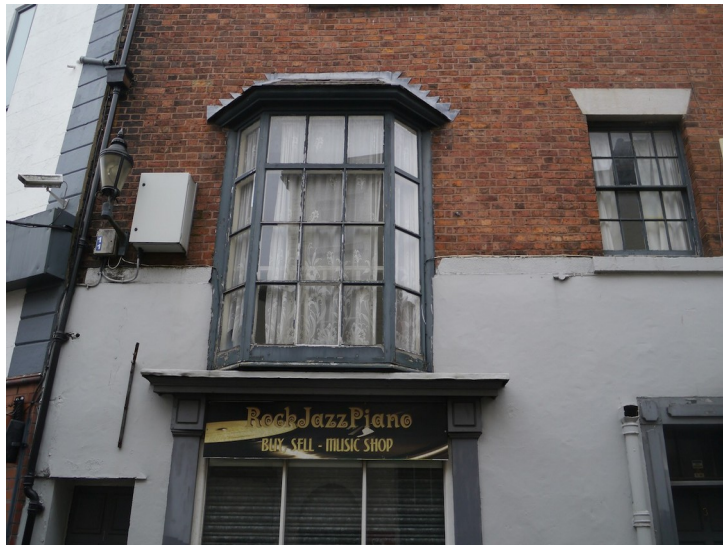
Plate 11 - Western bay window

4.5.11. The canted bay window at first floor level at the western end is clearly inserted (PLATE 11), with disturbance to the surrounding brickwork evident in the upper section, where lead flashing has been added, and in areas where the render is disturbed. The styling of the bay window matches that of the other frames on this elevation and was a sympathetic addition.

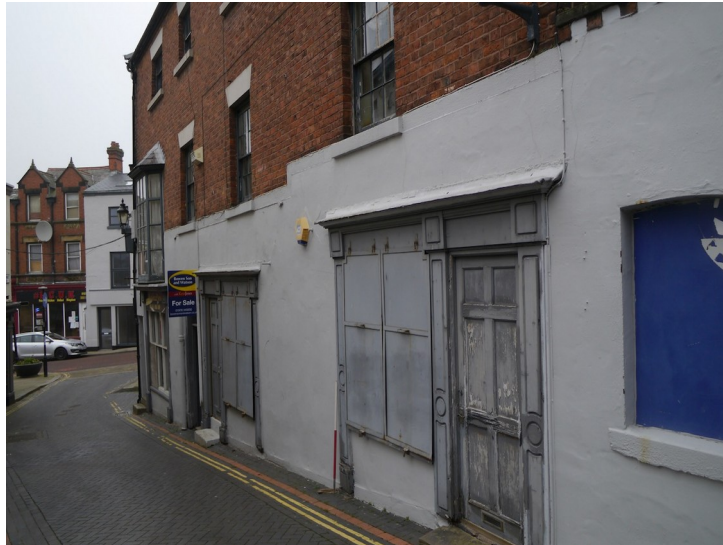
4.5.12. The shop frontages are thought to have initially been matching in style, with numbers 2 and 3 retaining their original elements (PLATE 12). The frontage of number 1 appears to have undergone modifications during the 20th century when the properties were linked and internal modifications were made. These changes separated off the shop area of number 1 from the rest of the

Plate 12 - Shop frontages

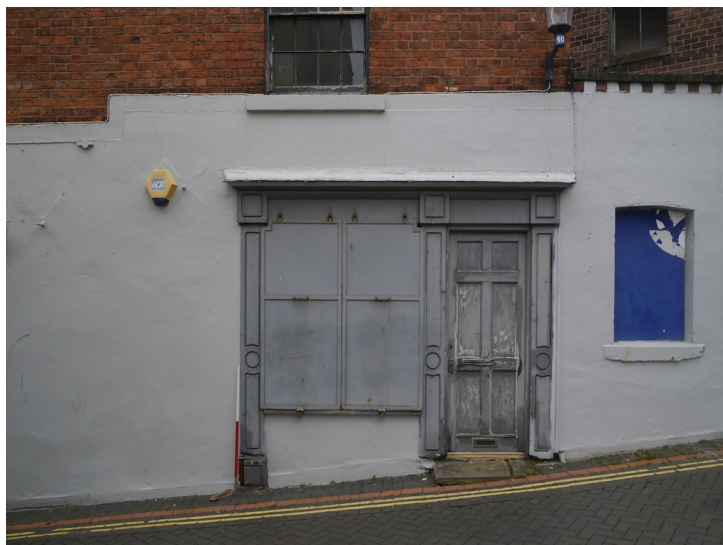
Plate 13 - Number 3 shop front

4.5.13. The original shop frontages were integrated display windows and doors (PLATE 13). The surrounding architrave for both door and window had a simple panel motif, almost neoclassical in style, with square panels at the tops and bottom, elongated panels along the sides, with central circular element at lock rail level. Above the door and window were simple undecorated overpanels below a thin integrated canopy. The windows were covered by modern metal shutters.

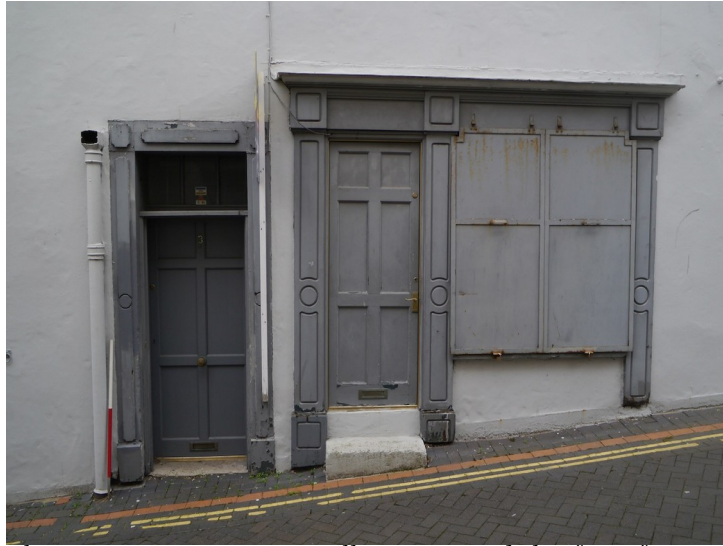
Plate 14 - Doorway to 1 College Street and shopfront for 2 College Street

the eastern end of number 1 (PLATE 14). The doorway to 1 College Street is slightly different from 2 and 3, with a thinner architrave and plain fanlight above the wooden transom.

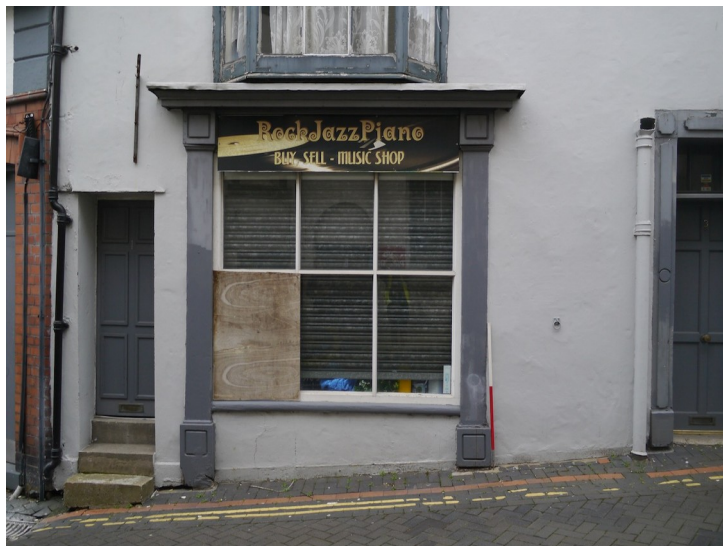
Plate 15 - Shopfront of 1 College Street

4.5.15. The modified shopfront at 1 College Street is larger in scale and more simple in decoration (PLATE 15). The square panels at top and bottom of the architrave are still present, however, the elongated panels interspersed with circular motif are not present.

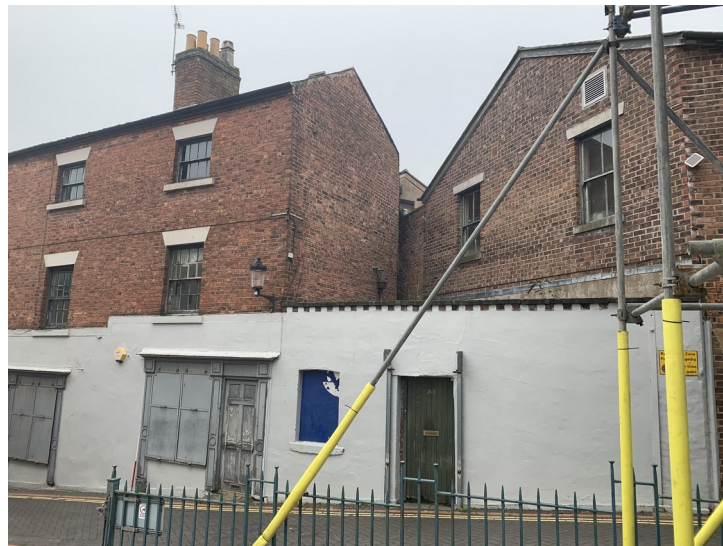
Plate 16 - Eastern extent of southern elevation

4.5.17. At the eastern end of the property is a single storey wall, now rendered except for the brick denticulation below the stone coping course (PLATE 16). This wall would have enclosed the yard to the east of the building, and would have been accessed by the central doorway, a simple wooden door with no decorative framework.

- 6.9. At the eastern end of the southern elevation the yard wall, with decorative brick course and coping stones at the top, is thought to be slightly later than the original construction, and was erected to form a small yard to the east of the properties. This now forms part of a later 20th century single storey extension added to the eastern elevation of the properties. The extension forms a new entrance and toilet block. Above this extension repair to the brickwork of the eastern elevation can be seen at both first and second floor levels. There is no evidence of ghosting for removed structures, however there may have been a further terrace between 1-3 and the pawn shop to the east when first constructed. The erection of the yard wall and repair to the eastern elevation may date to this phase, thought to be later 19th century in date.

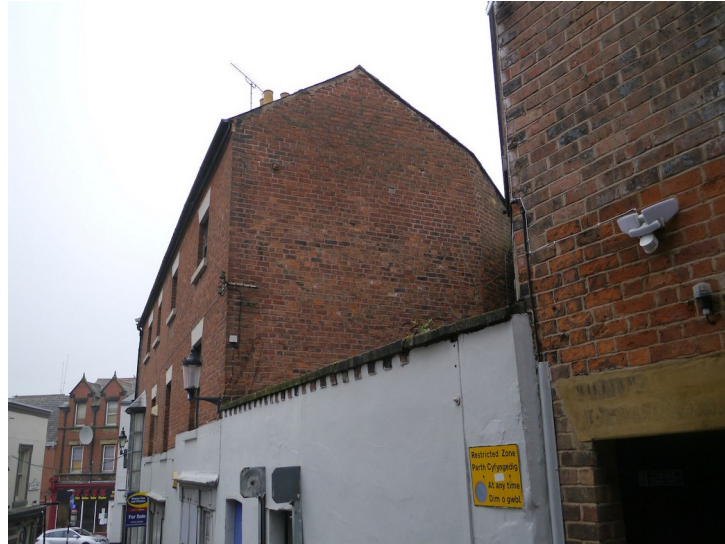
Plate 17 - Eastern elevation

southern elevation, however, this elevation is in English garden Wall bond. A large area of the elevation appears to show significant repair to the brickwork (FIGURE 8).

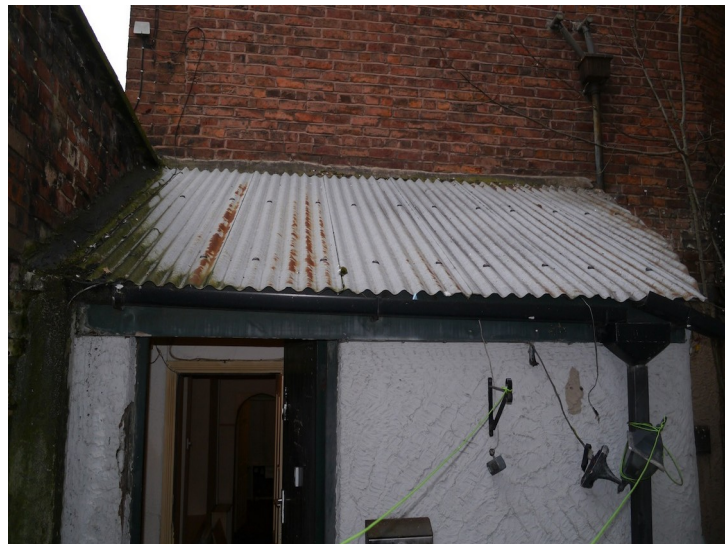
Plate 18 - 20th century extension

4.5.20. At ground floor level the elevation contains the small 20th century single storey extension (PLATE 18). This is a small entrance area, containing a toilet and washing area. It has textures white render and corrugated metal sloping roof.

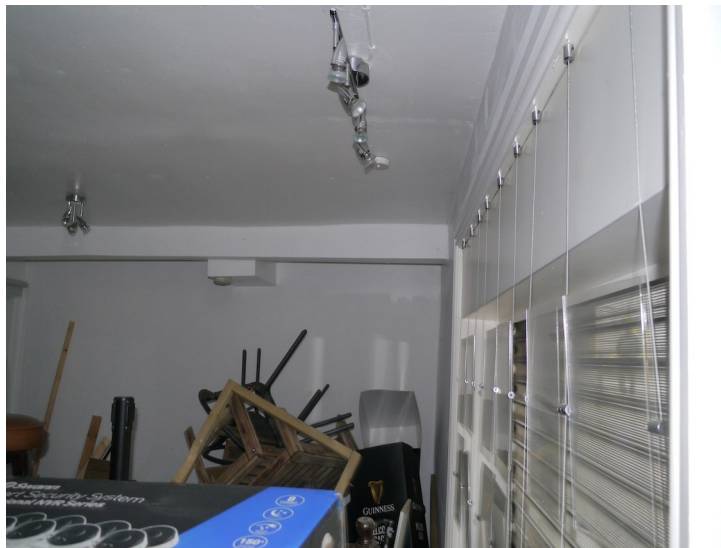
Plate 19 - Room G1 looking east

- 4.6.4. Room G1 was accessed only via the doorway at the western end of the building off College Street, and formed the single shop at the western end. This had been fully refitted and was a wholly modern entity, with plastered walls to the east, north and west, and the inserted modern window frontage to the south (PLATE 19).

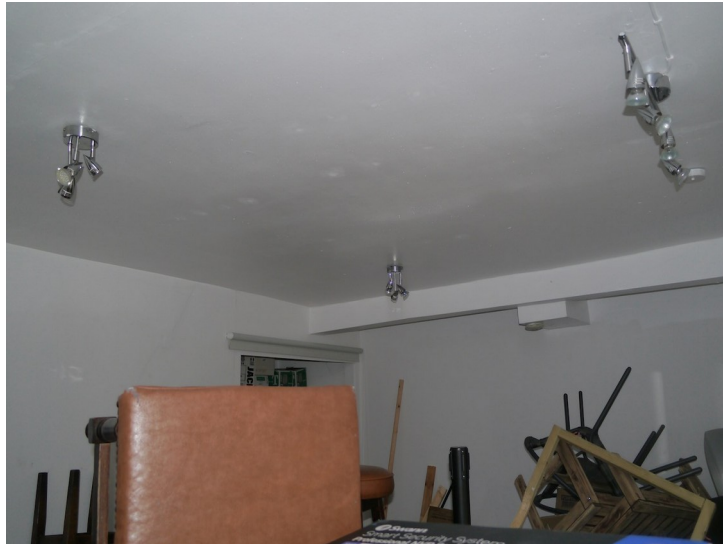
Plate 20 - G1 looking northeast

- 4.6.5. At the time of survey the room was being used for storage and access was difficult. However, some photographic record could be made. The walls had smooth plasterwork with light grey/white paint, which continued around all four walls. The ceiling had been re-boarded and plastered smooth with white paint.

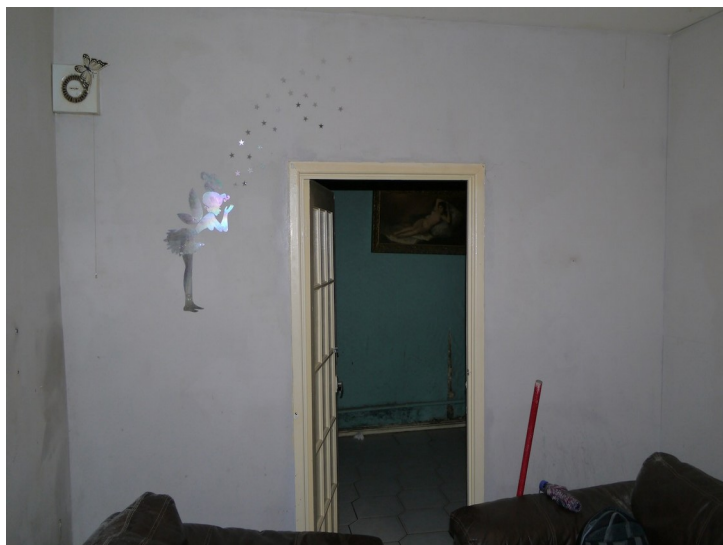
Plate 21 - North wall of G2

main structural dividing wall between 1 and 2, with the western and northern walls being modern inserted partition walls (FIGURE 9 & PLATE 21). To the north was room G6, labelled as Massage Room 1, and the eastern wall formed a narrow corridor with the main dividing wall between 2 and 3, leading from G6 to G3.

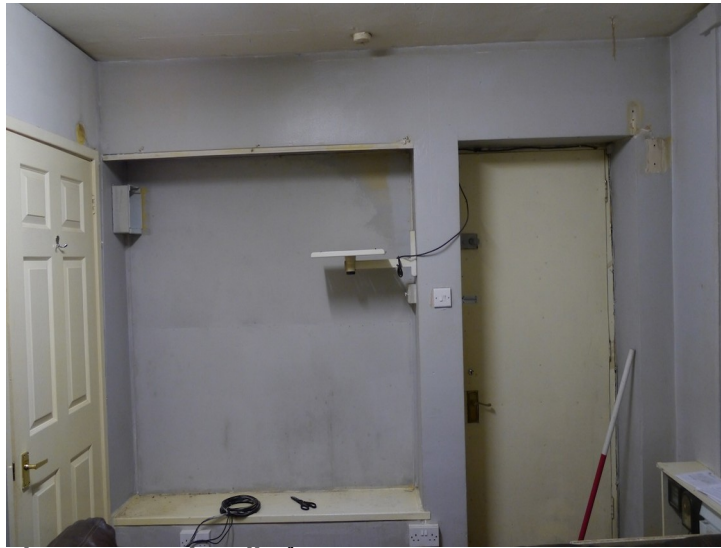
Plate 22 - South wall of G2

4.6.9. The southern wall contained the external door and blocked main frontage window (PLATE 22). Modern plasterwork obscured any potential historic fabric.

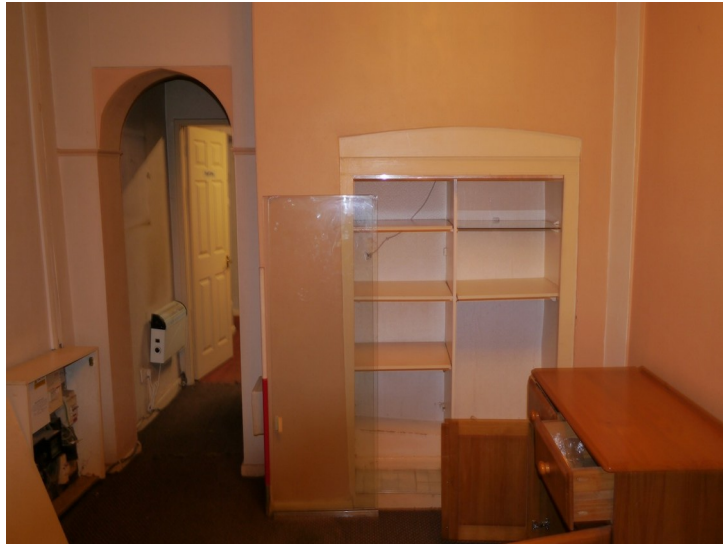
Plate 23 - West wall of G3

4.6.11. As with G2, G3 had been plastered and painted, obscuring any historic fabric. Although the fireplace and chimney breast were still intact, the modern decoration meant that any original features could not be recorded, although it is thought unlikely they would survive at this location.

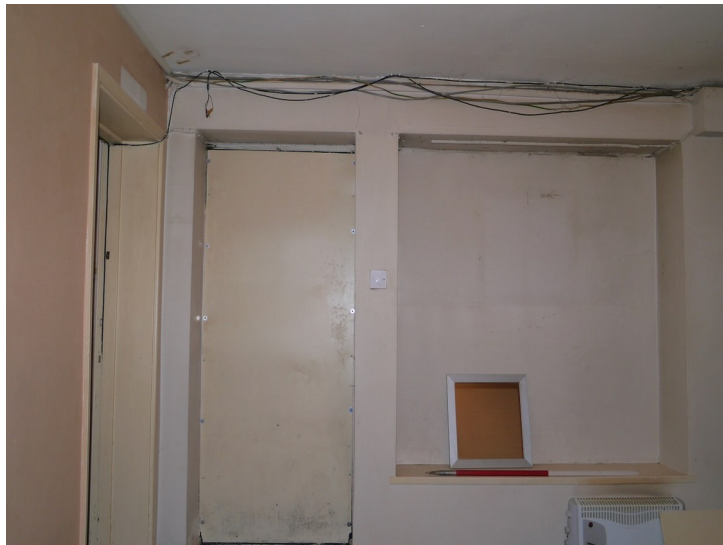
Plate 24 - Southern wall of G3

4.6.12. The southern wall of G3 followed the same layout as G2, with the external doorway to College Street and the main frontage window still evident, albeit covered with boarding and modern plasterboard and paint (PLATE 24). A series of steps led from the floor level to the doorways to College Street and E2 at the southwestern corner of the room.

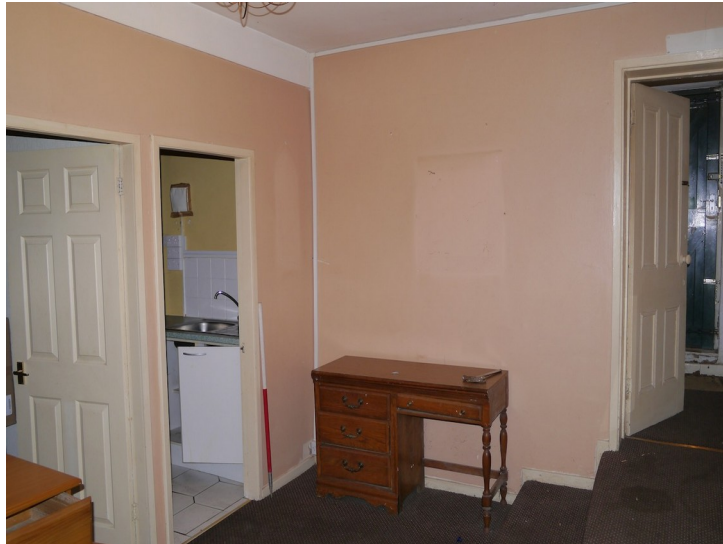
Plate 25 - North and east walls of G3

4.6.13. The eastern wall of G3 was the original external wall of the property, however the northern wall was an inserted partition wall from the 20th century to divide off a small kitchen area at the northeast (G4) and a small bedroom, labelled Massage Room 2 (G5) at the northwest (PLATE 25).

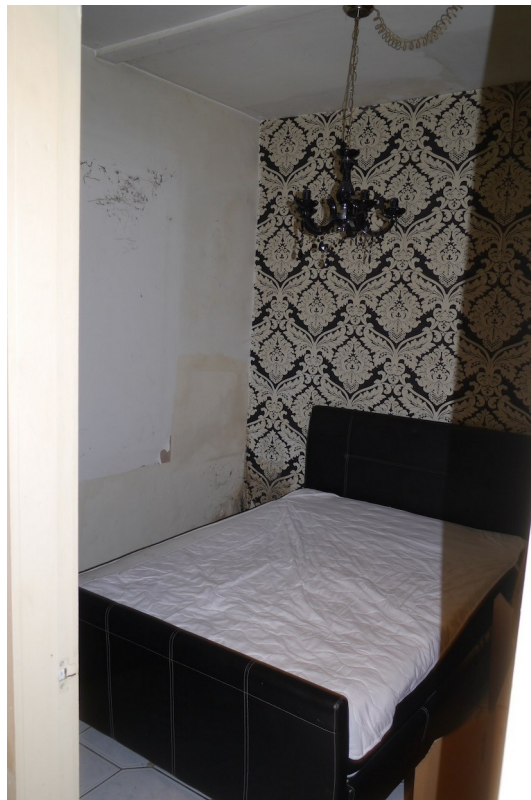
Plate 26 - Room G5, looking northwest

4.6.14. Within G4 and G5 a beam can be seen along the ceiling running east to west, which may suggest the location of an earlier room division (PLATE 26). No other historic fabric was visible in G4 and G5.

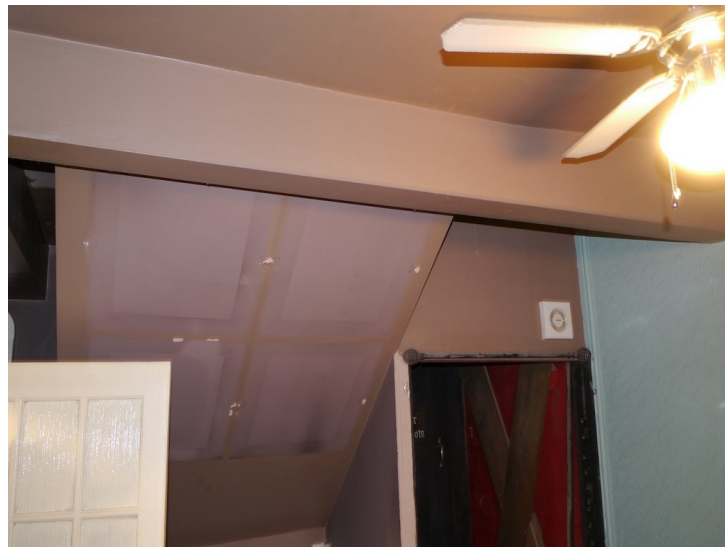
Plate 28 - Ceiling line of G6 showing inserted staircase and boxed in beam

4.6.16. Along the ceiling at the western side of G6 the inserted staircase leading from G7 to F5 can be seen. The low start of this sloped area in the centre of the room is contrary to the rest of the design of the building and is clearly a later modification (PLATE 28). A north-south RSJ has been inserted in G6 to support the inserted staircase.

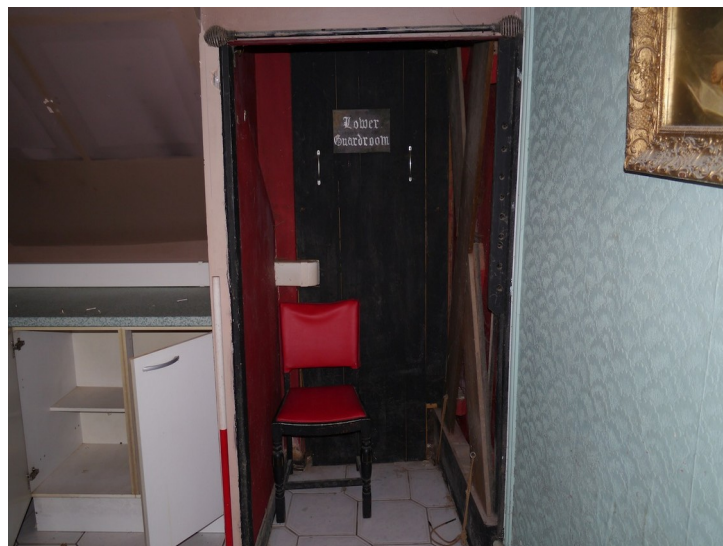
Plate 29 - Alcove in G6 with external door

the room, which led to a small doorway on the western wall. This leads out of the building and historically may have led to another yard shared with the neighbouring property (PLATE 29). No historic fabric was evident within the alcove.

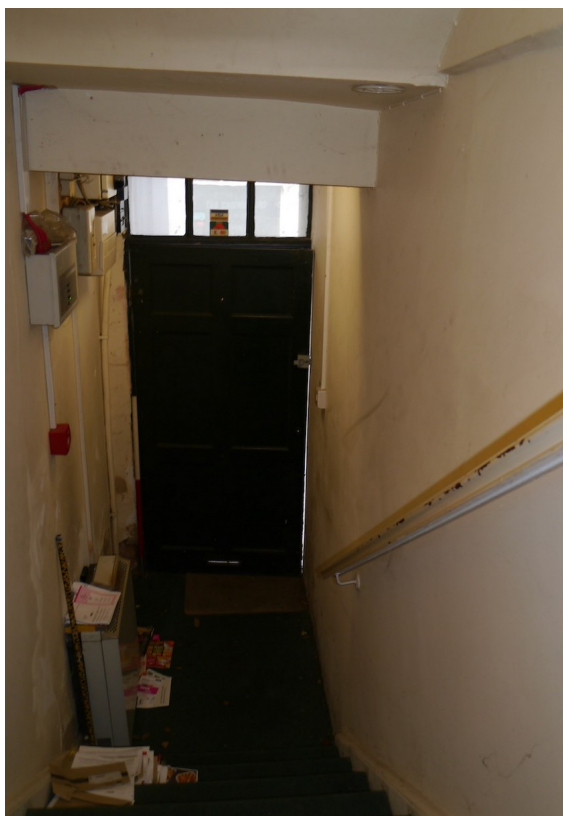
Plate 30 - Room G7, looking south

4.6.18. Room G7 was accessed via College Street and contained the staircase leading to the first floor (PLATE 30). The staircase is thought to be an original fixture, which would have given access to the first floor of 1 College Street. However, modern alterations have turned the stairs to the east and the western wall is a later inserted partition wall. The western wall of G7 is the main structural dividing wall between 1 and 2 College Street.

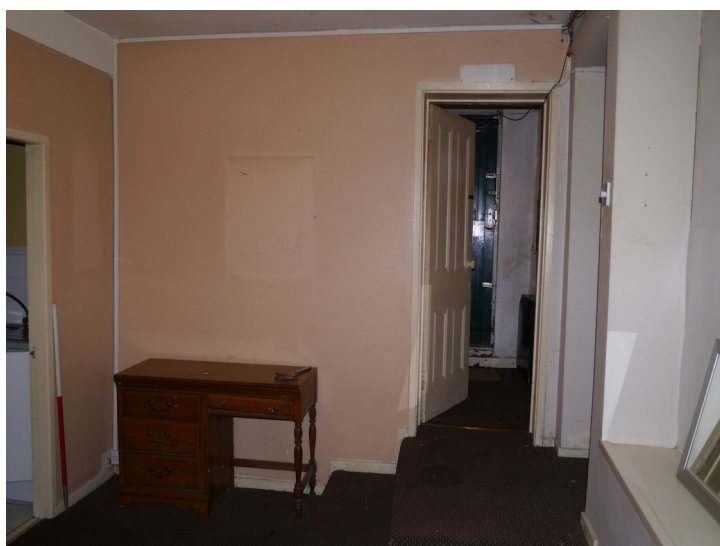
4.6.19. At the eastern end of the ground floor was the 20th century extension, comprising rooms E1 and E2. These were accessed via a doorway up a series of steps at the southeastern corner of G3 (PLATE 31) which would have originality given access to the eastern yard area.

Plate 31 - Access to E2 on east wall of G3

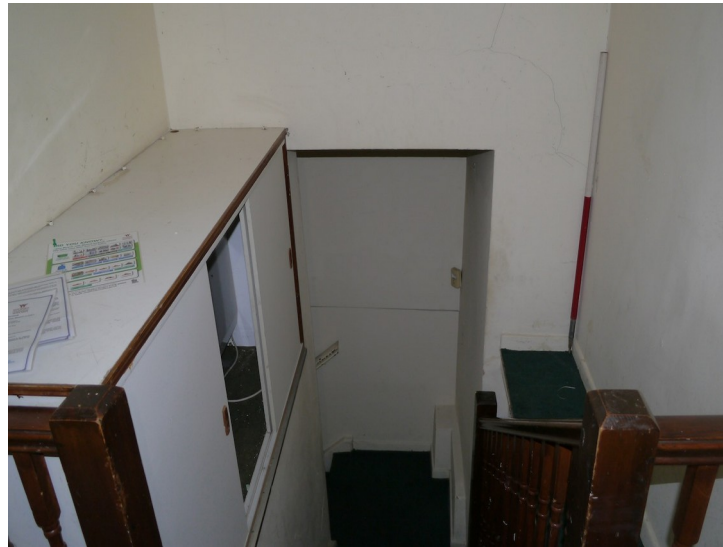
4.6.21. The first and second floors had been significantly modified in the 20th century and combined all three properties into a single unit. Access to the first and second floors was via G7 on the ground floor. At the top of G7 the stairs turn to the east and open up into F5 (FIGURE 10).

Plate 32 - F5 looking west to G7

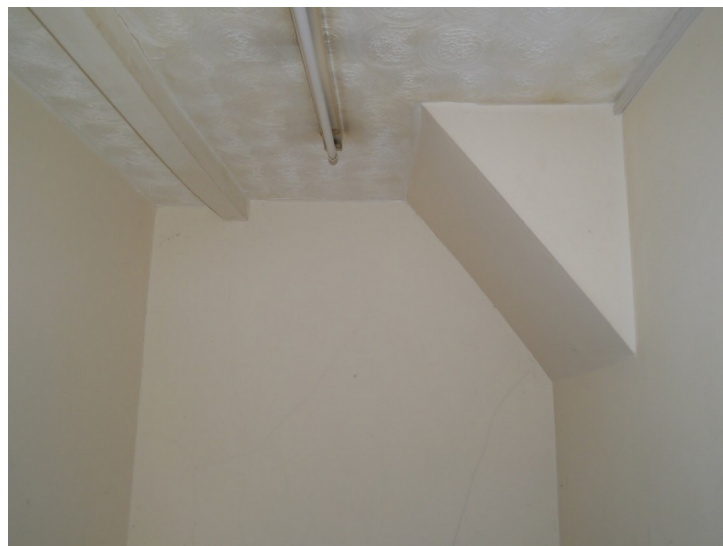
Plate 33 - Ceiling of F5, looking west

leading to a small toilet (F6), front room (F2) and the stairs to the second floor (S/F1). The ceiling of F5 (PLATE 33) has a 20th century textured plaster finish. However, a narrow beam can be seen towards the southern wall, which may indicate an earlier subdivision of the room.

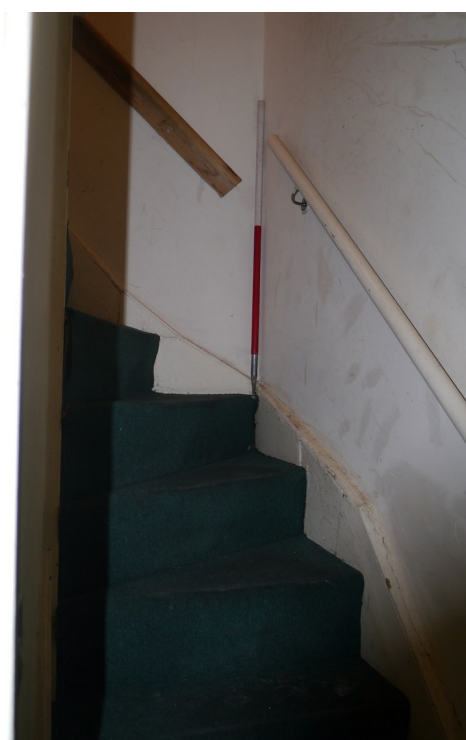
Plate 34 - S/F1 looking west

4.6.23.S/F1, the stairs to the second floor appear to be the original stair access within 2 College Street from the first floor to the second floor. The stairs head west and turn to the south along the dividing wall between 1 and 2. The skirting board along the steps appears to be early furniture, however the rails are modern additions (PLATE 34).

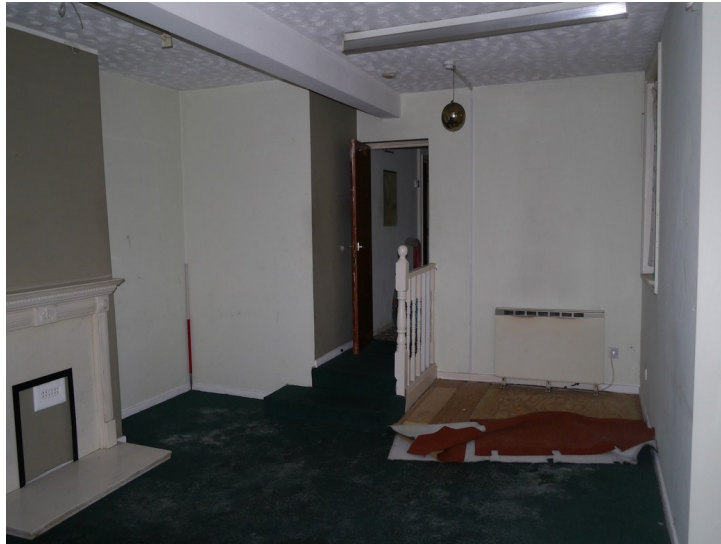
Plate 35 - Room F1, looking east

4.6.25. Room F1 is the largest room at first floor level and takes up the entire first floor footprint of 1 College Street (FIGURE 10). The room sits at a lower level than F2, and is accessed via a set of steps and a doorway punched through the dividing wall between 1 and 2 (PLATE 35).

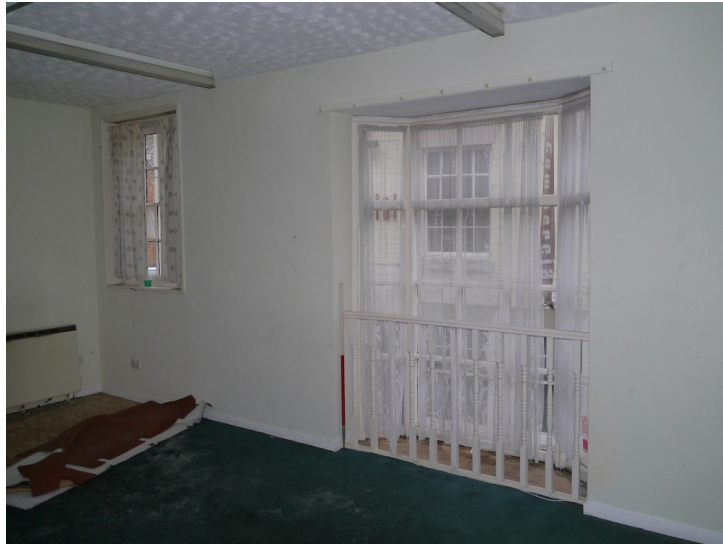
Plate 36 - Southern wall of F1

4.6.26. The northeastern corner of the room is boxed off by partitioning to account for the headroom needed for the inserted stairway of F5. It is likely this was the original area where the stairs from G7 entered the first floor. A significant beam crosses the ceiling along an east-west axis (PLATE 35). The beam does not appear to represent any form of division, and is a structural element to support the upper floor.

4.6.28. In the area near the small window the flooring has been exposed below the modern carpet. These are clearly 20th century replacement floorboards and not original fabric (PLATE 36).

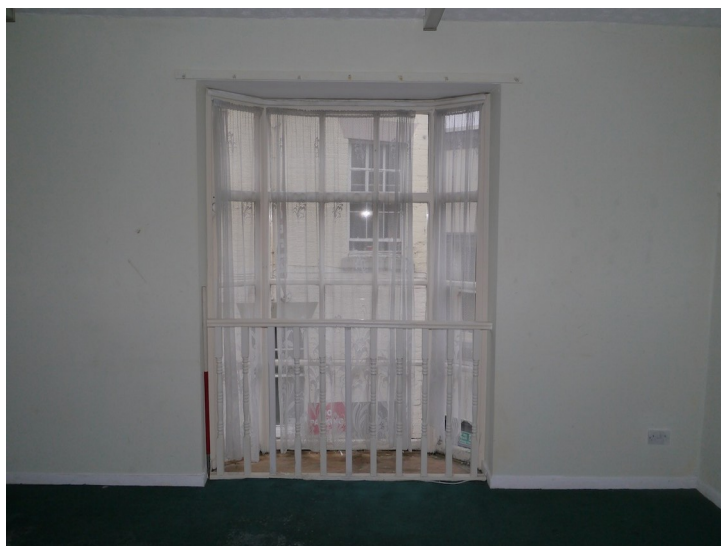
Plate 37 - Bay window in F1

4.6.29. The bay window extends from the frontage, however the exposed floorboards around it are 20th century in date and appear not to be structural. The small wooden railing in front of the window supports this assertion. As an inserted feature, it is unlikely that any cantilevered elements were in place and it is merely a decorative addition (PLATE 37).

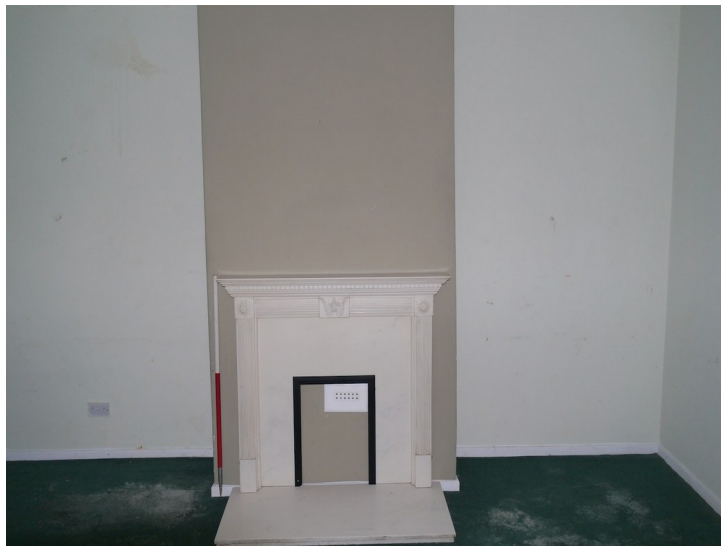
Plate 38 - Fireplace in F1

4.6.30. The western wall was plain with no decorative elements in place. The northern wall contained the fireplace and chimney breast (PLATE 38). Although the chimney breast is an original *in situ* element, the current fireplace and hearth are late 20th century composite materials blocking the opening. It is possible that an earlier metal grated fireplace exists behind this facade, which would have been flush with the chimney breast.

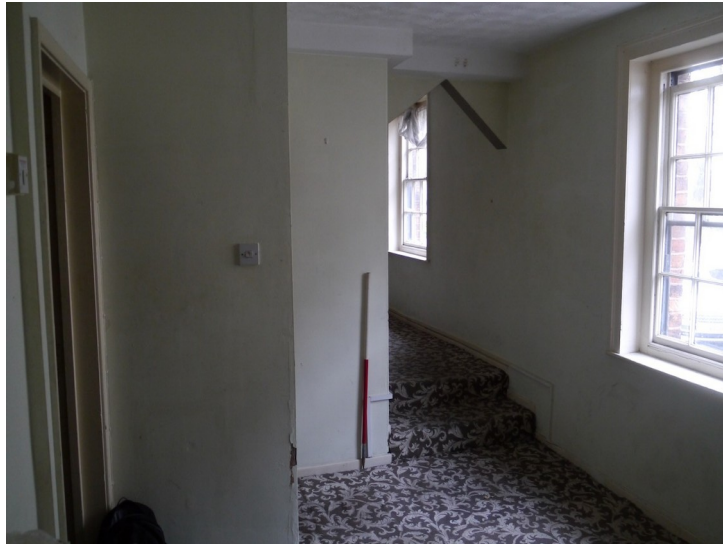
Plate 39 - Room F2, looking southeast

4.6.31. Room F2 (PLATE 39) is noted as a living area and forms a small lounge area between what is noted as a bedroom (F1) to the west and the dining/kitchen area (F3 and F4) to the east.

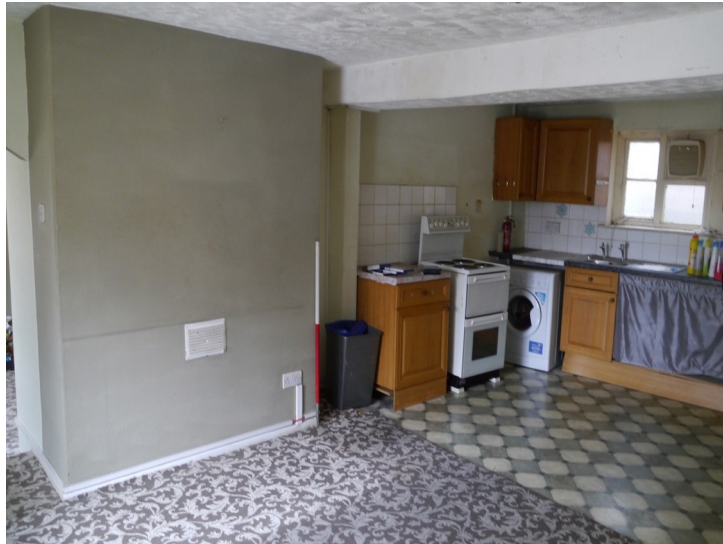
Plate 40 - Rooms F3/F4, looking northwest

4.6.34. Rooms F3 and F4 had been combined into an open plan dining/kitchen area (FIGURE 10). As with F2, the chimney breast along the west wall, mirroring the one in F2, had been boxed in with plasterboard. However, on this face a vent had been added at the location of the fireplace (PLATE 40).

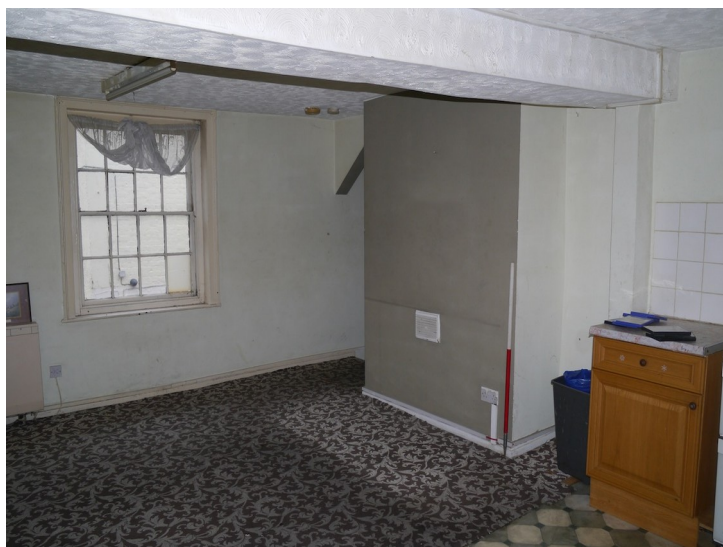
Plate 41 - Room F3, looking south

4.6.35. Rooms F3 and F4 form the footprint of 3 College Street and the 20th century modifications to these rooms have left no visible evidence of previous layouts. The only historic fabric visible beyond the location of the fireplace are the windows on the north (PLATE 40) and south walls (PLATE 41). The southern window matched that of the southern window in F2 in terms of fabric and appearance, including the moulded surround. This would have been the sole window for the main room for the first floor prior to creating the modern layout. The northern window is likely to be in the location of an early window, however the current wooden window is a 20th century element.

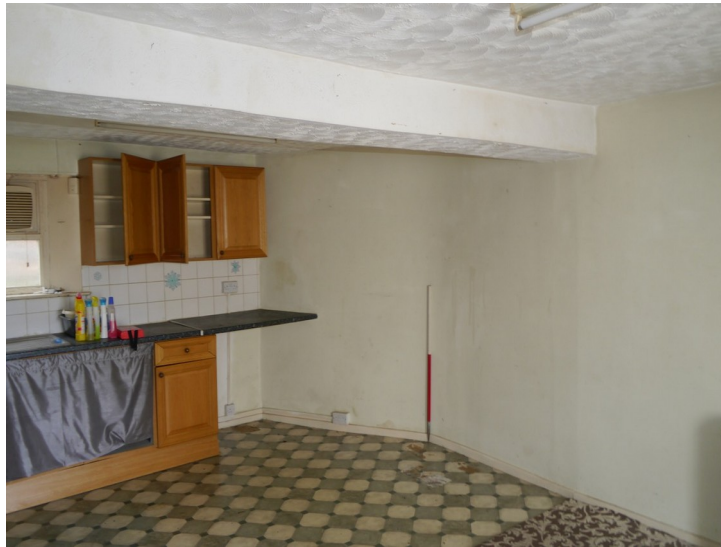
Plate 42 - Northeast corner of F4

4.6.37. The pilaster was absent from the eastern wall, however, ghosting on the plasterwork suggests the removal of a wall at the location of the beam (PLATE 42).

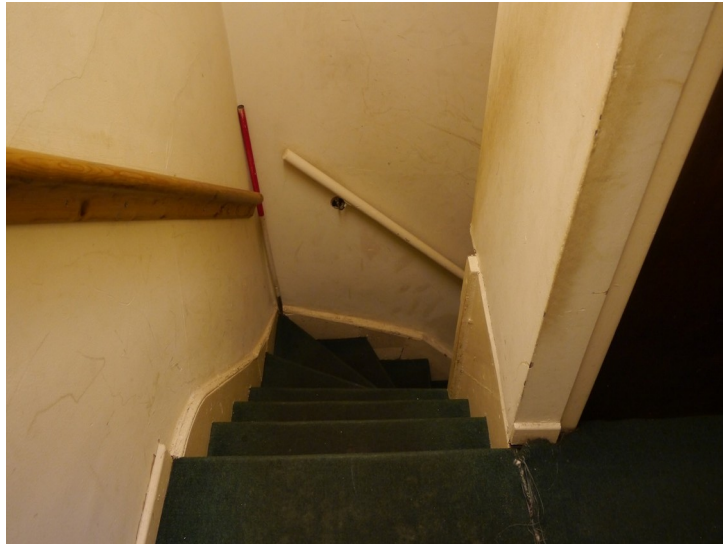
Plate 43 - S/F1, looking north

4.6.39. The second floor comprised a series of four bedrooms and a bathroom. The staircase to the second floor S/F1 led to a small landing, from which access could be made to all rooms (FIGURE 11). As noted above the skirting board along the stairs is thought to be *in situ* historic fabric (PLATE 43).

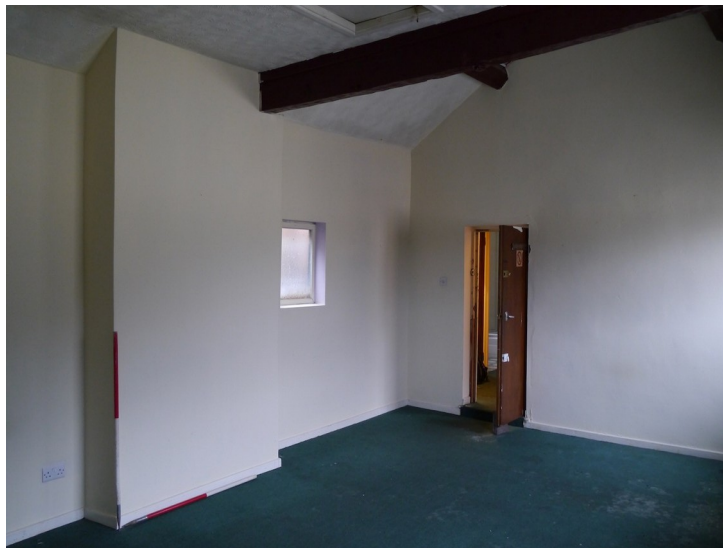
Plate 44 - East wall of S1

4.6.40. Room S1 was accessed via a doorway on its east wall. This wall is the dividing wall between 1 and 2 College Street and the doorway is clearly a later modification cutting through the thick wall (PLATE 44). A small step at the doorway allows for the change of floor level between 1 and 2 College Street.

4.6.41. Room S1 contains three windows. A late 20th century inserted window of plain wood frame and frosted glass at the northeast end of the room (PLATE 44), and two historic windows along the southern wall (PLATE 45). These windows matched the fabric of those seen on the first floor, however they lacked the moulded surround.

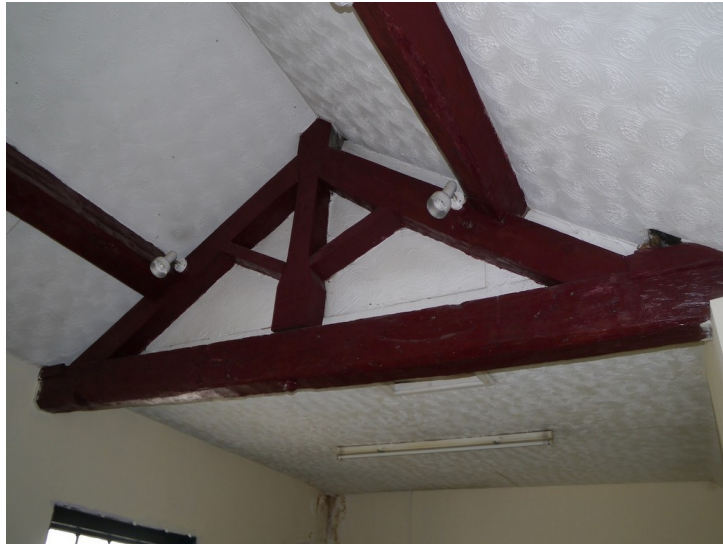
Plate 46 - Ceiling truss in S1, looking southwest

4.6.44. The ceiling of S1 is a modern feature, and it is likely the original ceiling has been removed to create a higher ceiling line. By modifying the room this way the roof truss has been exposed (PLATE 46). The king post truss had a significant tie beam with upright king post and braces against the principal rafters, with squared purlins also visible. However, it was clear that elements of this truss had been replaced in the later 20th century, including the king post, braces and principal rafters.

6.16. Examination of the exposed king post roof truss and roof structure within the small loft space shows that the roof had been replaced in the later 20th century.

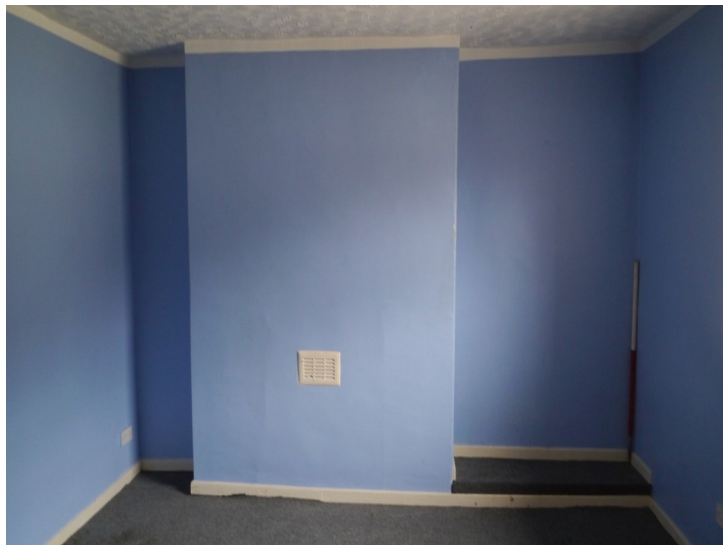
4.6.46. Room S2 was located to the south of the corridor landing S5 and was a small bedroom (FIGURE 11). The eastern wall of S2 contained the chimney breast, with a small vent and ghosting around the location of the fireplace (PLATE 47).

Plate 47 - East wall of S2

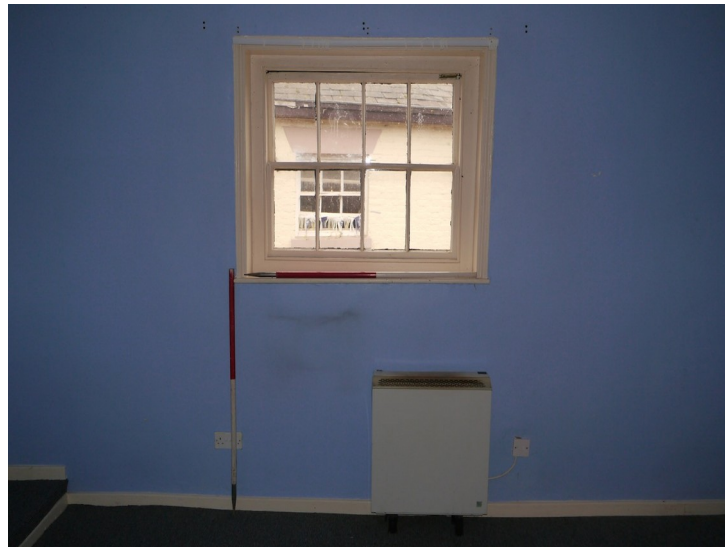
Plate 48 - Window on southern wall of S2

windows on the first floor, albeit of a smaller scale (PLATE 48).

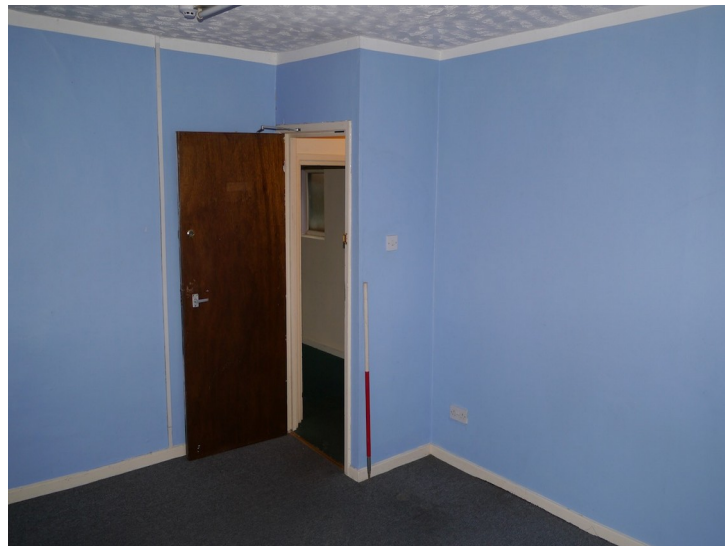
Plate 49 - North wall of S2

4.6.49. The north wall was a modern partition wall (PLATE 49), however, it is thought that it is a replacement for an earlier wall which would have been along this alignment. It appears that during the 20th century renovations the original wall was removed for some reason, then replaced with a partition wall in a similar location.

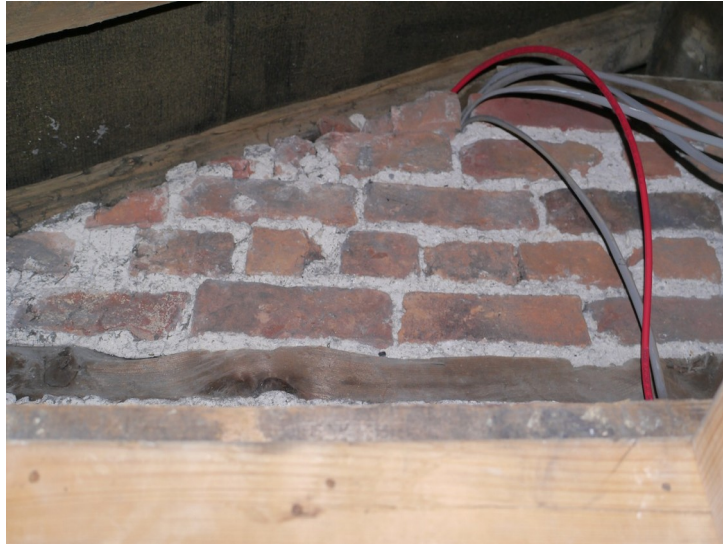
Plate 50 - Dividing wall between 2 and 3 College Street, looking east

the very small loft space, and allowed for a view of the brick construction of the dividing wall (PLATE 50). This access also allowed for a view of the roof construction, which was clearly a 20th century replacement.
