Historic Building Recording of

**1 - 3 COLLEGE STREET
WREXHAM**

Doc Ref: LP3893C-HBR-v1.4

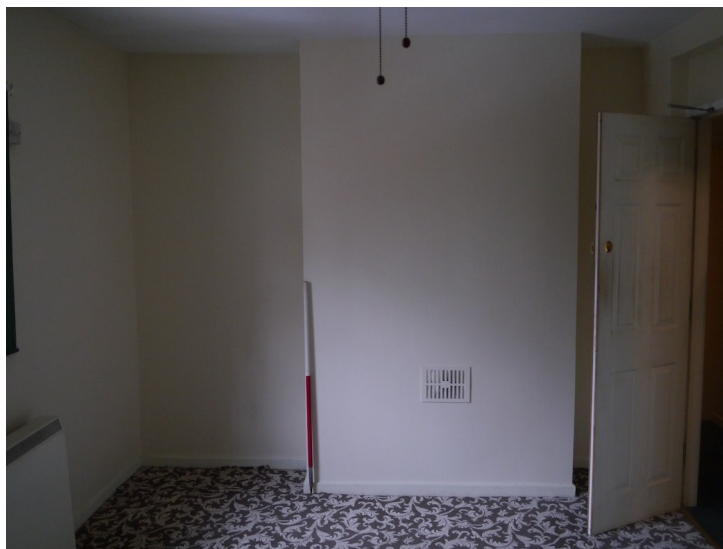
4.6.51. Room S3 was a mirror of S2, with the chimney breast on the west wall and window on the south wall (FIGURE 11 & PLATE 51). As with S2 the fireplace had been blocked up and boarded over.

Plate 51 - West wall of S3

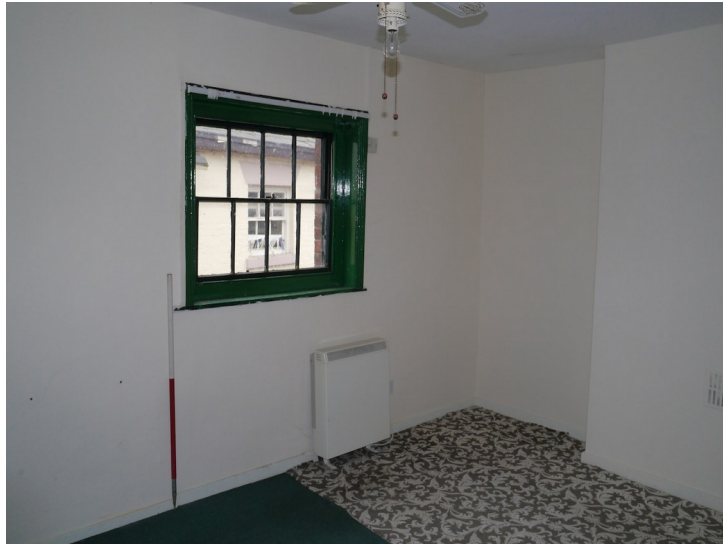
4.6.52. The window on the southern wall matched that of S2 (PLATE 52) with wooden frame and eight pane sash window.

Plate 52 - South wall of S3

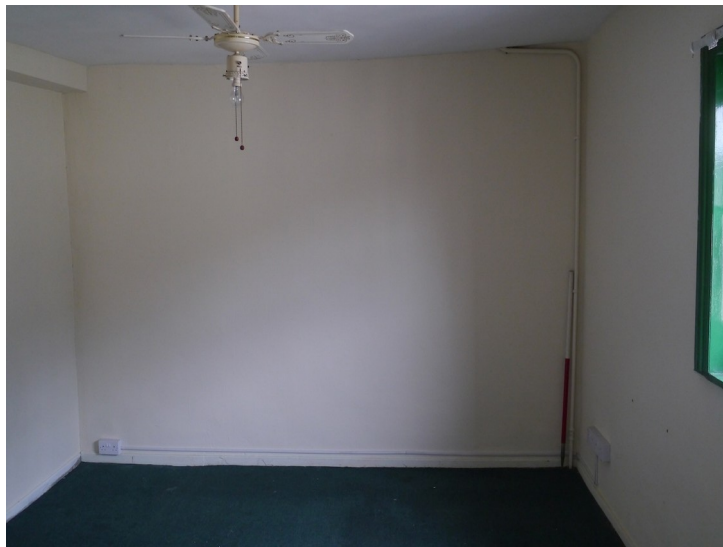
4.6.53. The eastern wall was the external wall of the property and the north wall was a 20th century partition wall. The presence of a beam along the wall line suggests the location of an earlier wall.

Plate 53 - East wall of S3

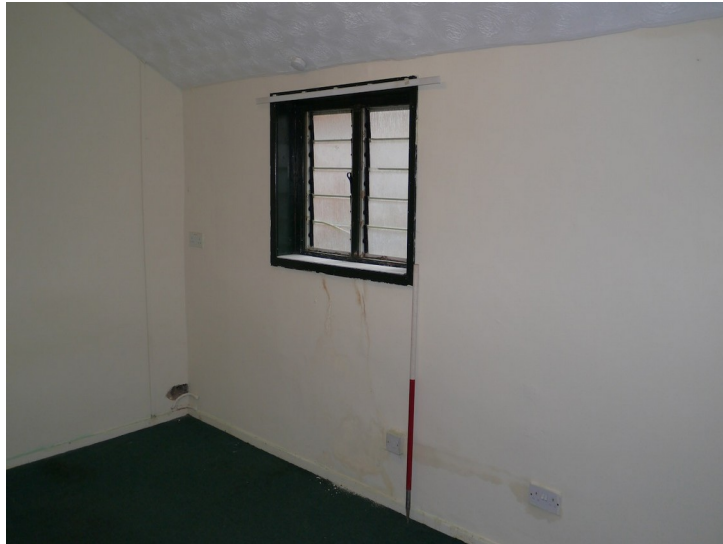
Plate 54 - North wall of S4

4.6.54. Room S4 was the final bedroom at second floor level and occupied the northeastern corner of the property. It is possible that this is the location of the original stairway for 3 College street and the northern window is a landing window (PLATE 54) now replaced with louvre panes.

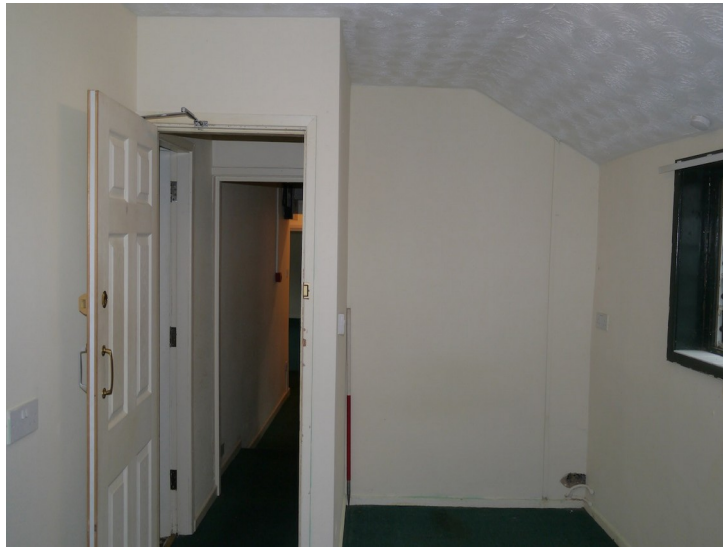
4.6.55. The east and west walls of S4 represent the external wall and dividing wall between 2 and 3, although a 20th century partition wall has been erected at the southwest end to allow for a small access area for room S3 from S5 (PLATE 55).

Plate 55 - Room S4, looking west

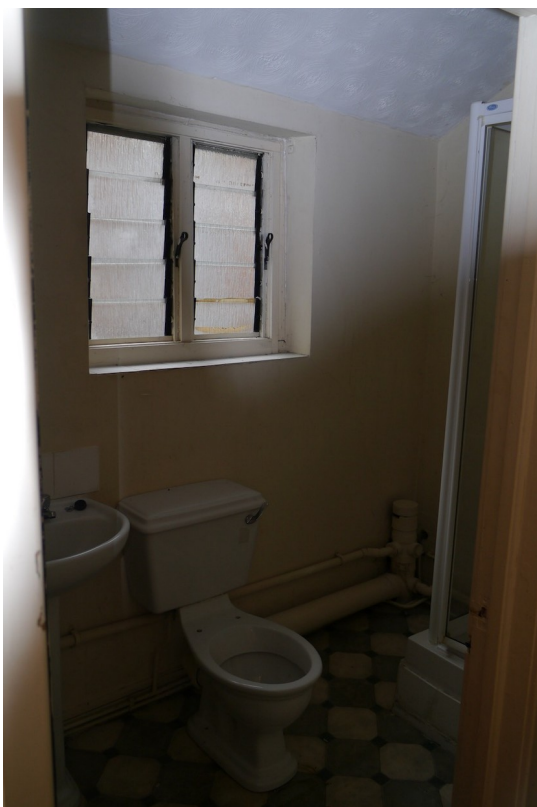
Plate 56 - Room S6, looking north

4.6.56. Room S6 was a small shower/toilet area divided from S5 by a modern partition wall (FIGURE 11 & PLATE 56). The only *in situ* feature was a window on the north wall, which matched the style of frame for the rest of the floor, however the sash had been replaced with louvre panes.

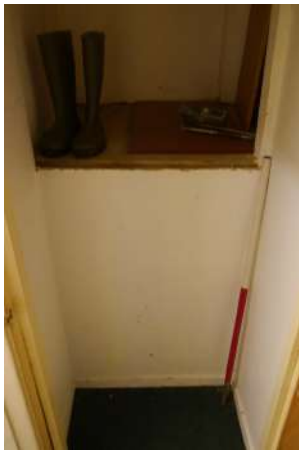
49.jpeg

4.6.49. The north wall was a modern partition wall (PLATE 49), however, it is thought that it is a replacement for an earlier wall which would have been along this alignment. It appears that during the 20th century renovations the original wall was removed for some reason, then replaced with a partition wall in a similar location.
