## **Dinas Dinlle Coastal Hillfort**

**Interim Report. Assessment of exposed cliff-face features and core transect, 3-7 June 2019.**

<b>County:</b>	Gwynedd
<b>Community:</b>	Llandwrog
<b>NGR:</b>	SH43705635
<b>NPRN:</b>	95309
<b>Scheduled Monument No:</b>	CN048
<b>Report No.</b>	CH/RCAHMW-AU 01
<b>Report Authors:</b>	Daniel Hunt (RCAHMW), Louise Barker (RCAHMW), Patrick Robson (AU) and Helen Roberts (AU)
<b>Illustrations:</b>	Daniel Hunt (RCAHMW), Louise Barker (RCAHMW), Patrick Robson (AU) and Helen Roberts (AU)
<b>Date of Investigation:</b>	3-7 June 2019
<b>Date of Report:</b>	10 <sup>th</sup> February 2020

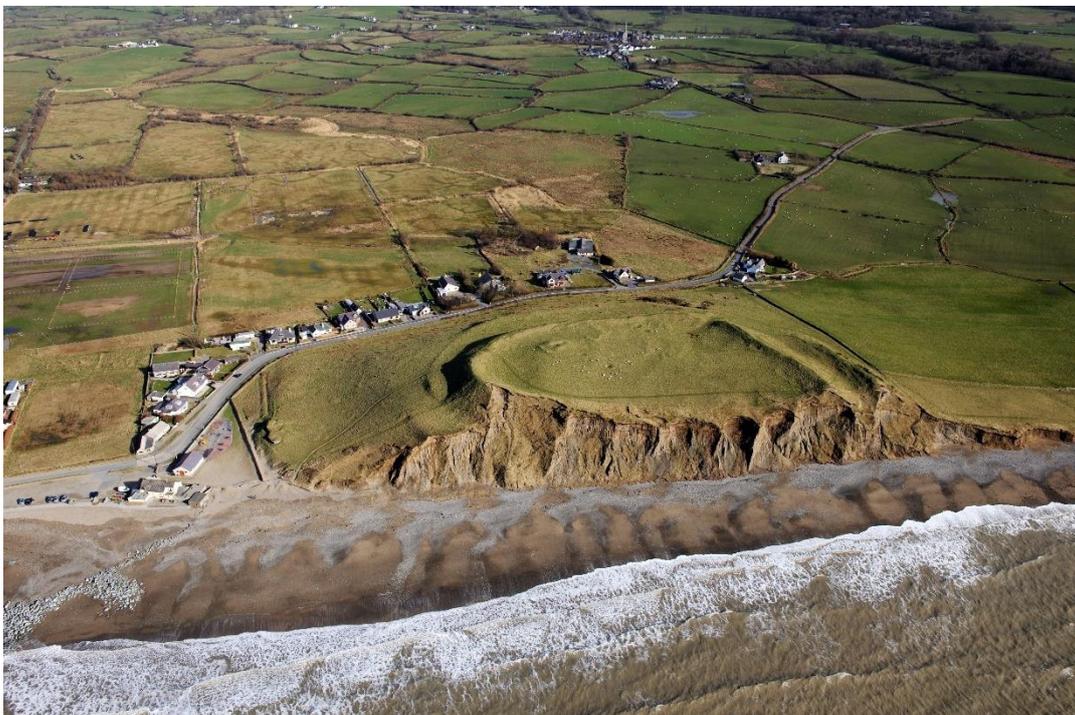
Figure 3: Dinas Dinlle Hillfort, clearly showing the erosion to the western side of the monument. Crown Copyright: RCAHMW AP\_2014\_0877.

Due to large-scale terrestrial and coastal erosion only the northern, eastern and southern sides of the fortifications remain today (Figure 3).

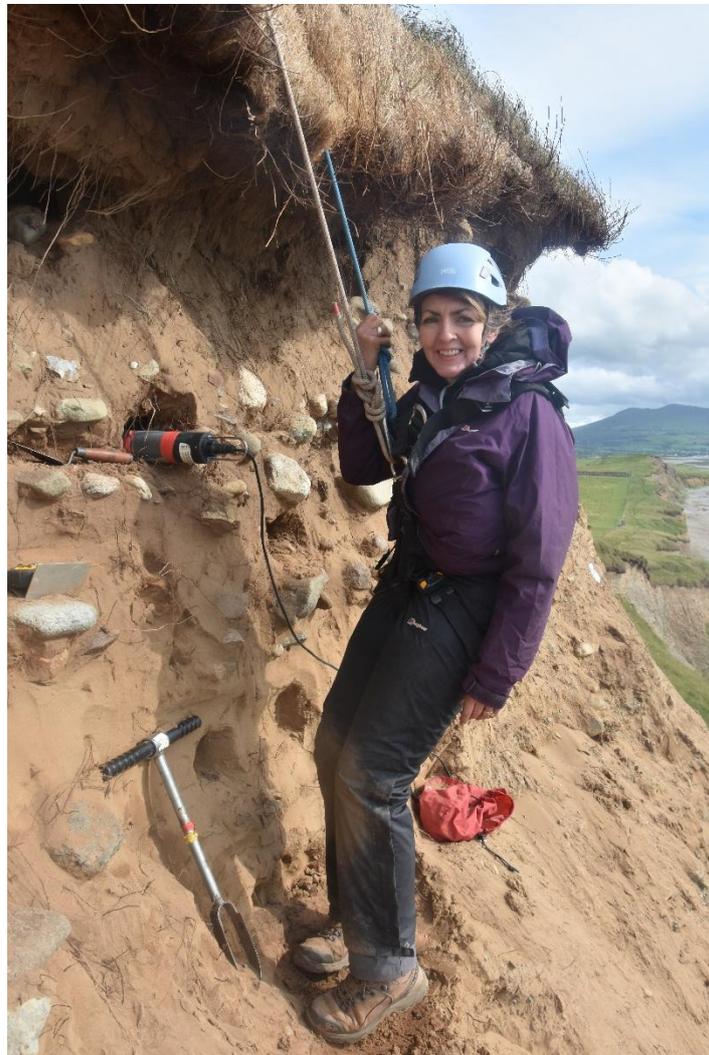
Figure 4: Professor Helen Roberts taking OSL samples from the southern ditch section (Area B). Crown Copyright: CHERISH Project.

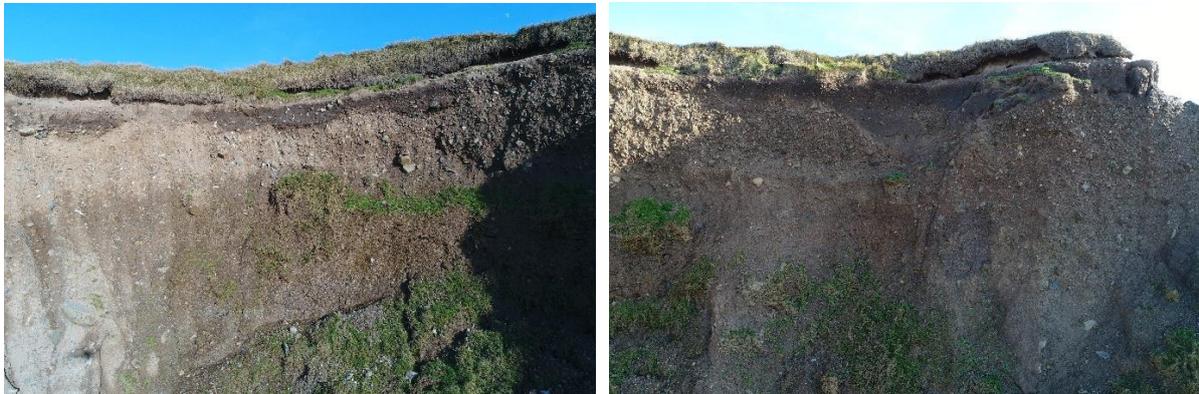
Figure 6: Potential archaeological features- pits and/or ditch features - identified during a CHERISH UAV monitoring survey in February 2019. The left-hand image shows the features standing out as darker (wetter) deposits with feature SH 43642 56329 on the left and SH 43646 56325 in the middle. The right-hand image shows feature SH 43643 56316. Crown Copyright: CHERISH Project.

This area was centred on NGR SH 436 563, within one of the concave inlets along the cliff-face that represents an increased zone of weakness. Three individual features were investigated within this area at SH 43642 56329, SH 43646 56325 and SH 43643 56316. These had provisionally been identified as archaeological features and thought to represent pits and/or ditch features within the interior of the hillfort (Figure 6)

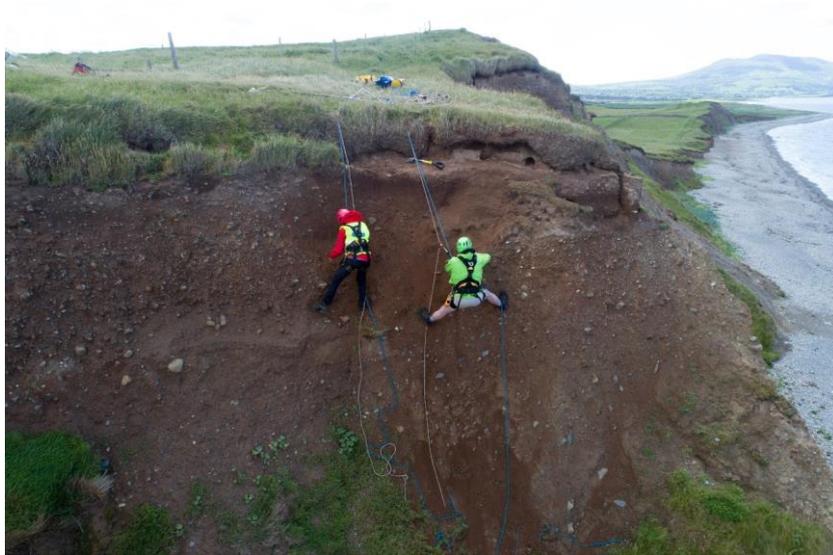
Figure 7: UAV image showing Louise Barker and Patrick Robson investigating a possible archaeological feature at SH 43643 56316 within the interior of the fort (see Figure 7 below). Crown Copyright: CHERISH Project.

The three individual features investigated were lightly cleaned by hand (Figure 7) and photographed using a UAV (Figures 8 and 9). No further recording was undertaken due to the features being identified as natural in origin, formed through sedimentary changes in the geological substrate. This substrate was topped by a heavily eroded loose, pale brown wind-blown sand, around 0.3m in depth that supports the c. 0.2m thick turf layer vegetating the site.

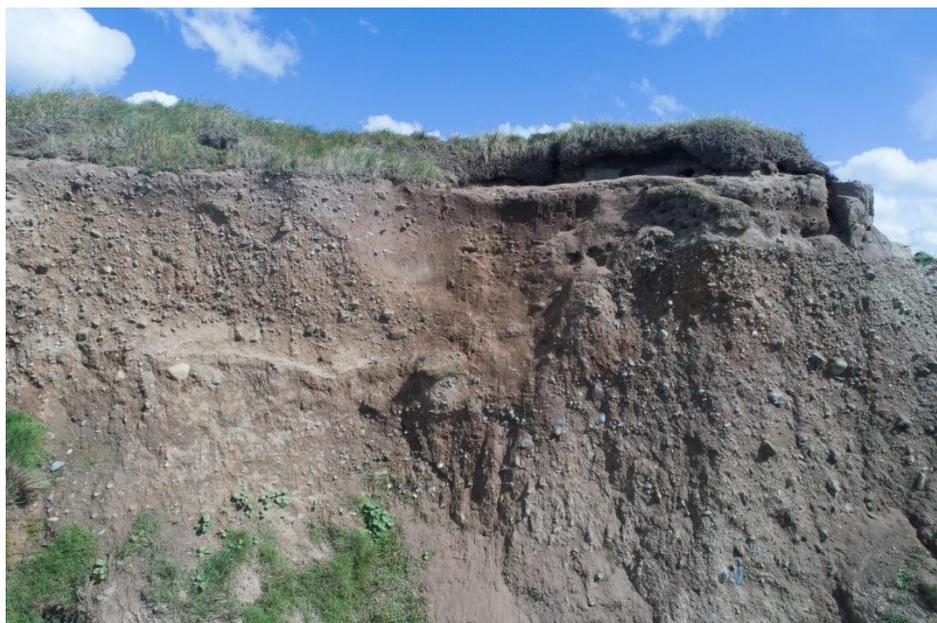
Figure 8: UAV image of feature SH 43643 56316 following cleaning. Excavation found this to be a natural formation within the upper geological substrate. Crown Copyright: CHERISH Project.

1. The upper sand unit is being predominantly eroded by exposure to the wind and rain, undercutting the upper turf layer, and leaving behind a scoured 'shelf' or surface at the junction with the harder sediments. The weight of the overburdening turf is also causing slumping and degradation, clearly seen on the surface. These two processes are exacerbated by avian and mammalian activity exploiting the softer sand units for burrows and nest sites (Figures 8 and 9)

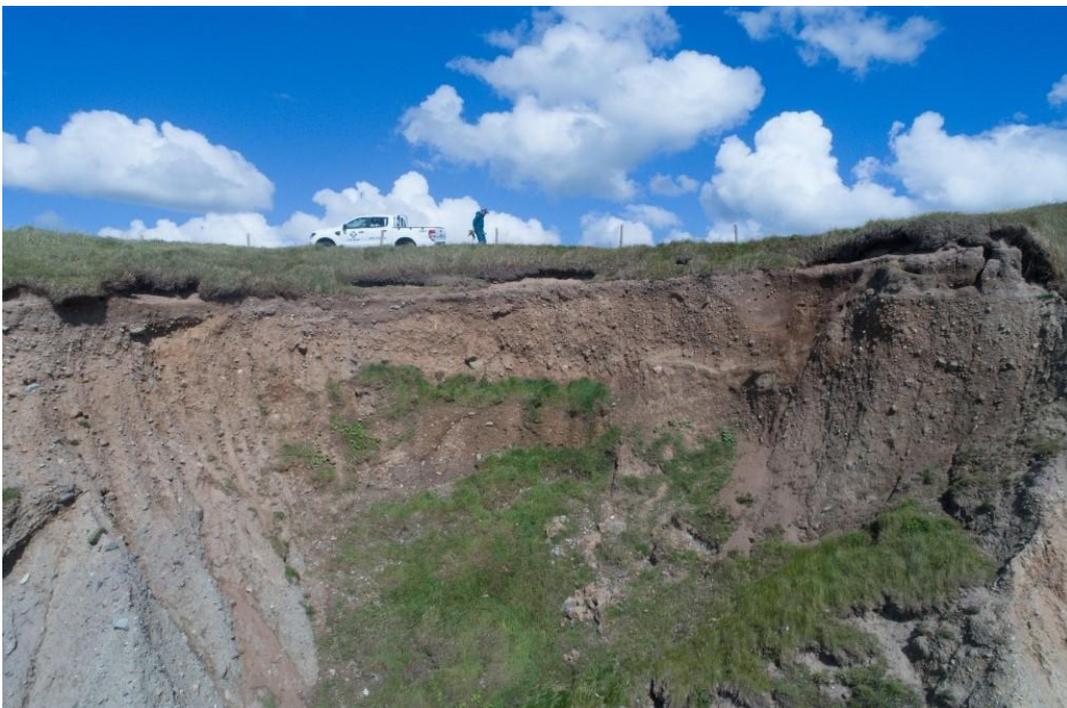
Figure 9: UAV image of showing the entirety of Area A post investigation. Clearly visible is the heavy erosion caused by prevailing winds. This erosion has undercut the upper turf layer and left behind a scoured 'shelf' of more resilient sediments. Crown Copyright: CHERISH Project.

2. Rain water infiltrating the surface of the fort interior passes easily through the sand units but is restricted by the dense nature of the underlying glacial sediments. When saturated, the water emerges from the cliff-face at the interface between the soft and hard sediments which promotes gravitational slumping and degradation of the softer sediments. Surface run-off during intense rainfall events also incise and erode the sediments, this is exacerbated locally by topographic features and faunal activity. If the predictions of increased rainfall intensity associated with near future impacts of climatic change are realised, it is likely that erosional pressures at Dinas Dinlle will increase. It is apparent from CHERISH observations over the past 3 years that the intensity of rainfall is having a significant direct impact on the erosion of the hillfort, effectively 'pushing off' the soft sediments from the cliff face.

Investigations in Areas A and B enabled more detailed analysis of the erosional pressures affecting the site. By assessing two separate areas it was clear that there are various forms of erosion taking place. Exposed sand layers are being eroded through exposure to strong winds from the sea, whilst rain water infiltrating the surface of the fort interior passes easily through the sand units but is restricted by the dense nature of the underlying glacial sediments. When saturated, the water emerges from the cliff-face at the interface between the soft and hard sediments which promotes gravitational slumping and degradation of the softer sediments. This was the clear factor in the collapse of the inner ditch section of Area B in early 2019 and along with wind erosion of the now exposed ditch fills will continue to be a weak point for future erosion.

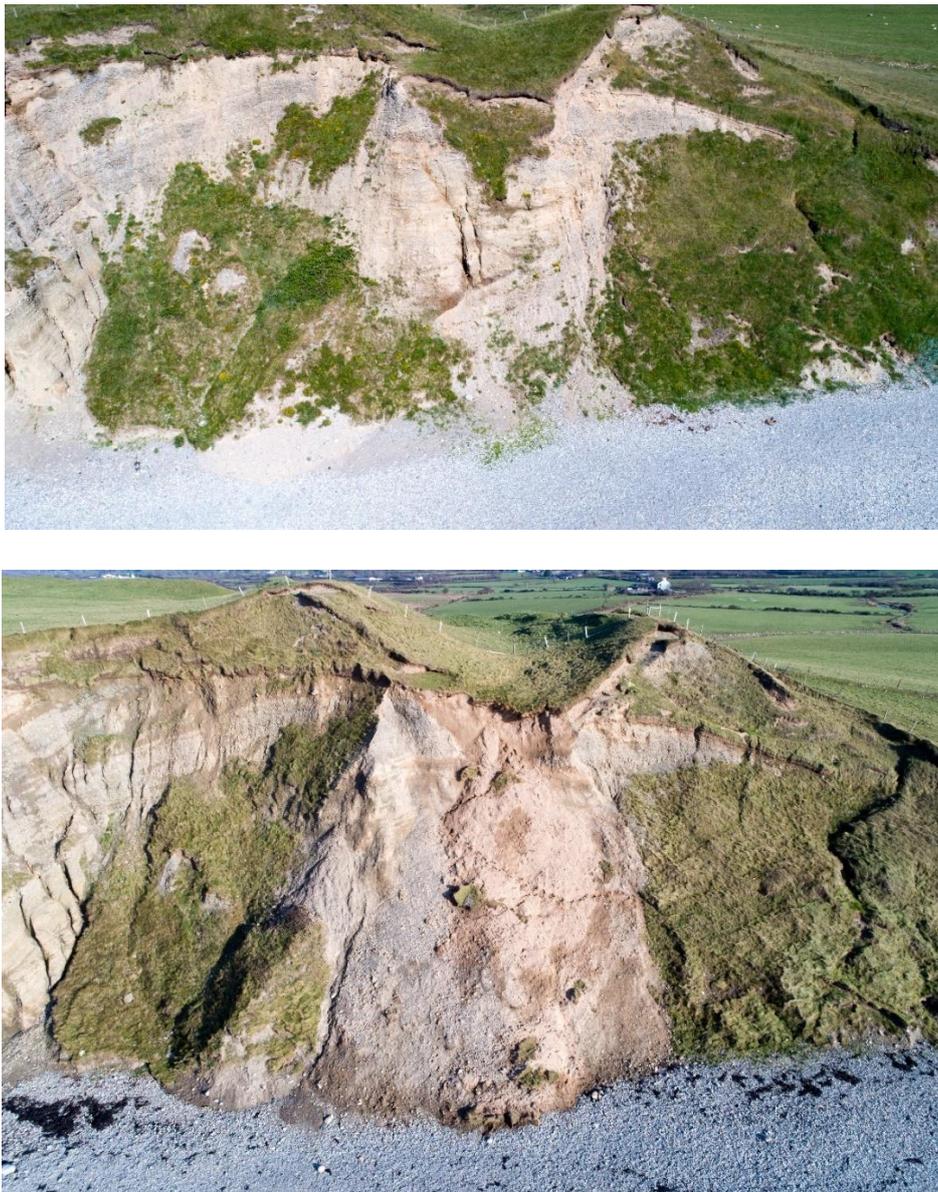
Figure 10: UAV images showing the cliff-face before (upper image, dated 11 June 2018) and after the collapse in early 2019 (lower image, dated 14 February 2019). The collapse revealed what appeared to be the clear edge / cut of the inner ditch and a previously unreported fill of sand. Crown Copyright: CHERISH Project

This area was centred on NGR SH 436 562 and involved the investigation of the heavily eroding southern defences, specifically the inner southern ditch. During a CHERISH monitoring visit on the 14<sup>th</sup> February 2019, a significant collapse of the upper sediments of the ditch section was observed to have very recently occurred (Figure 10). Surface fissures and cracks had been observed in the area on previous visits and the collapse occurred during or immediately after period of intense rainfall. This area therefore had significant archaeological and geological study potential.

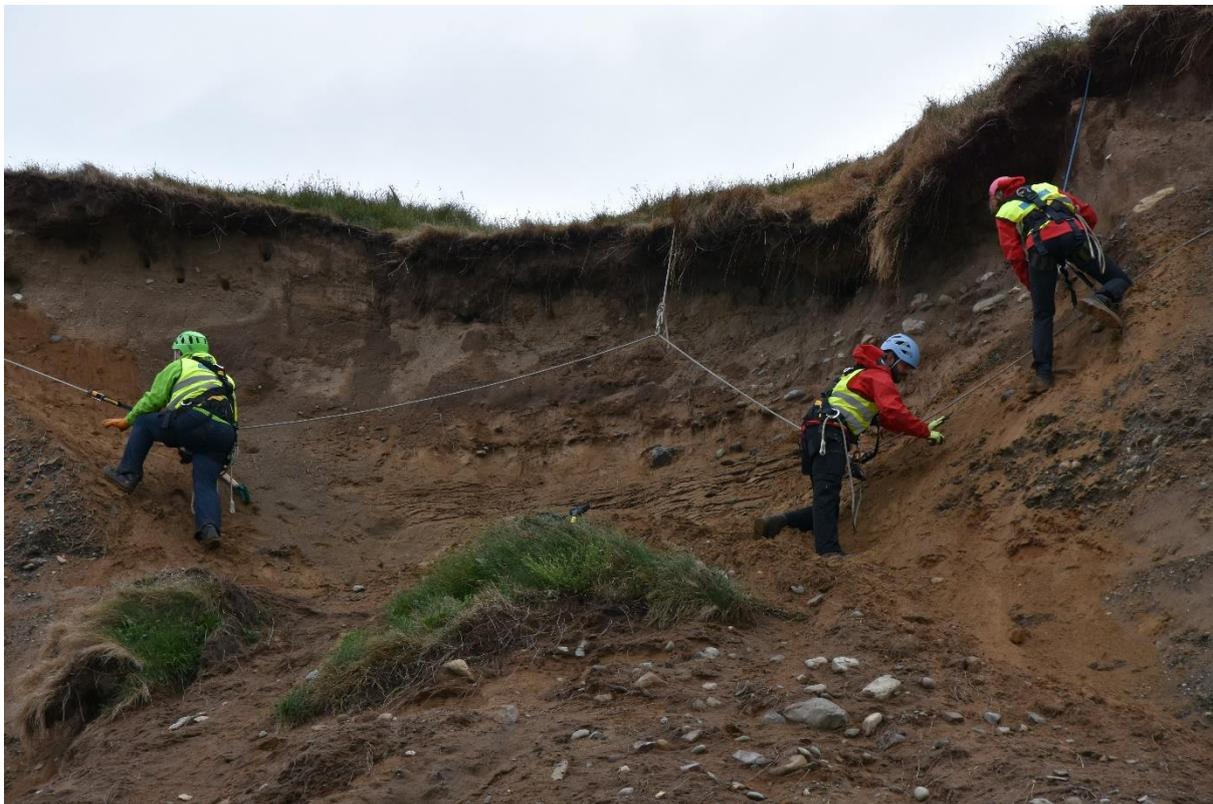
Figure 11: Investigation of the inner ditch showing Patrick Robson, Dan Hunt and Louise Barker cleaning the exposed section. Crown Copyright: CHERISH Project.

The investigation area was located towards the top of the cliff and comprised a 13m wide and maximum 4m deep section of vertical cliff-face (approximately 40m<sup>sq</sup>). The section was cleaned by hand and prepared for recording and interpretation by both archaeologists and geographers (Figure 11). Only a portion of the working area could be sufficiently examined due to issues with accessibility, the presence of slumped material and the inability to use certain tools safely at height while supported by ropes. The upper contexts 001 and 002, which had been exposed prior to the 2019 collapse were also heavily eroded and unstable, the sand of context 002 has been eroded by exposure to wind and rain as well as avian and mammalian activity, all leading to the overhanging turf of context 001. For these reasons only limited work was undertaken at the uppermost level.

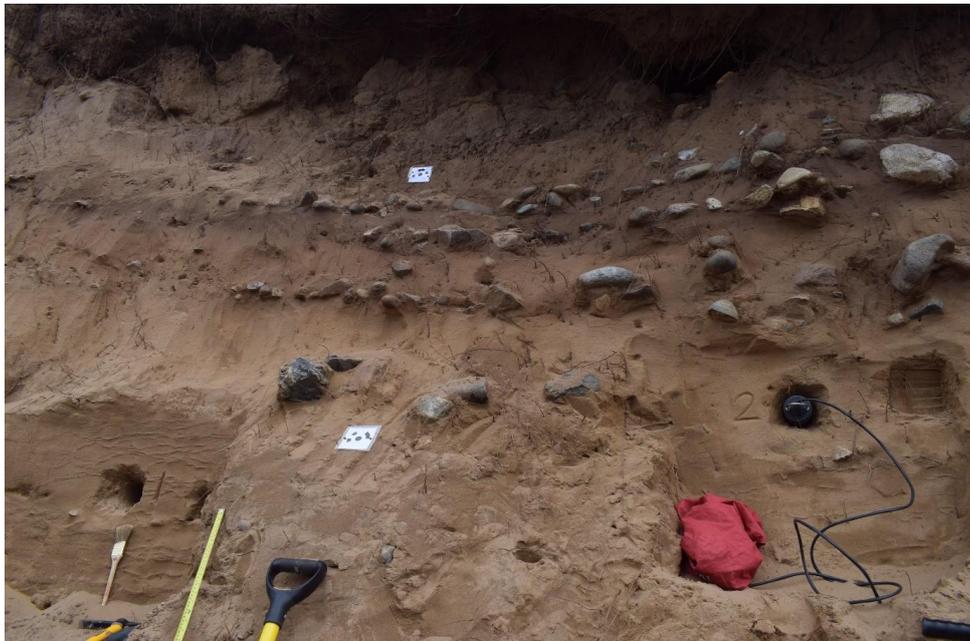
Figure 12: OSL sample location 1 (left-side of image, above paintbrush for scale) and 2 (right-side of image, with gamma spectrometer deployed in the sample hole created by taking the OSL tube-sample). Crown Copyright: CHERISH Project.

Five samples were taken through the profile of the ditch from contexts 011, 010, 007, 005 and 003 for Optically Stimulated Luminescence (OSL) dating (Figures 4 and 12). These were taken by Professor Helen Roberts from the freshly-cleaned cliff-face using opaque black plastic pipe approximately 5cm in diameter and 25cm in length driven horizontally into the exposure using a hammer. Each sample was well-packed with non-absorbent materials to prevent sediments from being mixed within the sample tube and sealed for transport to the Aberystwyth Luminescence Research Laboratory. Once each sample had been removed from the section, an additional small sample of material was taken from the deepest part of the sample hole and carefully wrapped to preserve the moisture content at the time of sampling; this, along with other assessments, will help to inform the final value of water content used for age calculation. Each sample hole was slightly enlarged and deepened using a specially modified short-auger designed for use in cramped conditions, to facilitate *in situ* field measurements of the gamma dose rate at the point where the OSL sample was taken. Assessments of the gamma dose rate were made using a digiDART™ portable gamma spectrometer equipped with a sodium iodide crystal. The locations of samples are indicated in the section drawing (Figure 14), and the sample holes are also visible in the orthomosaic of the ditch section created from the SfM imagery (Figure 13).

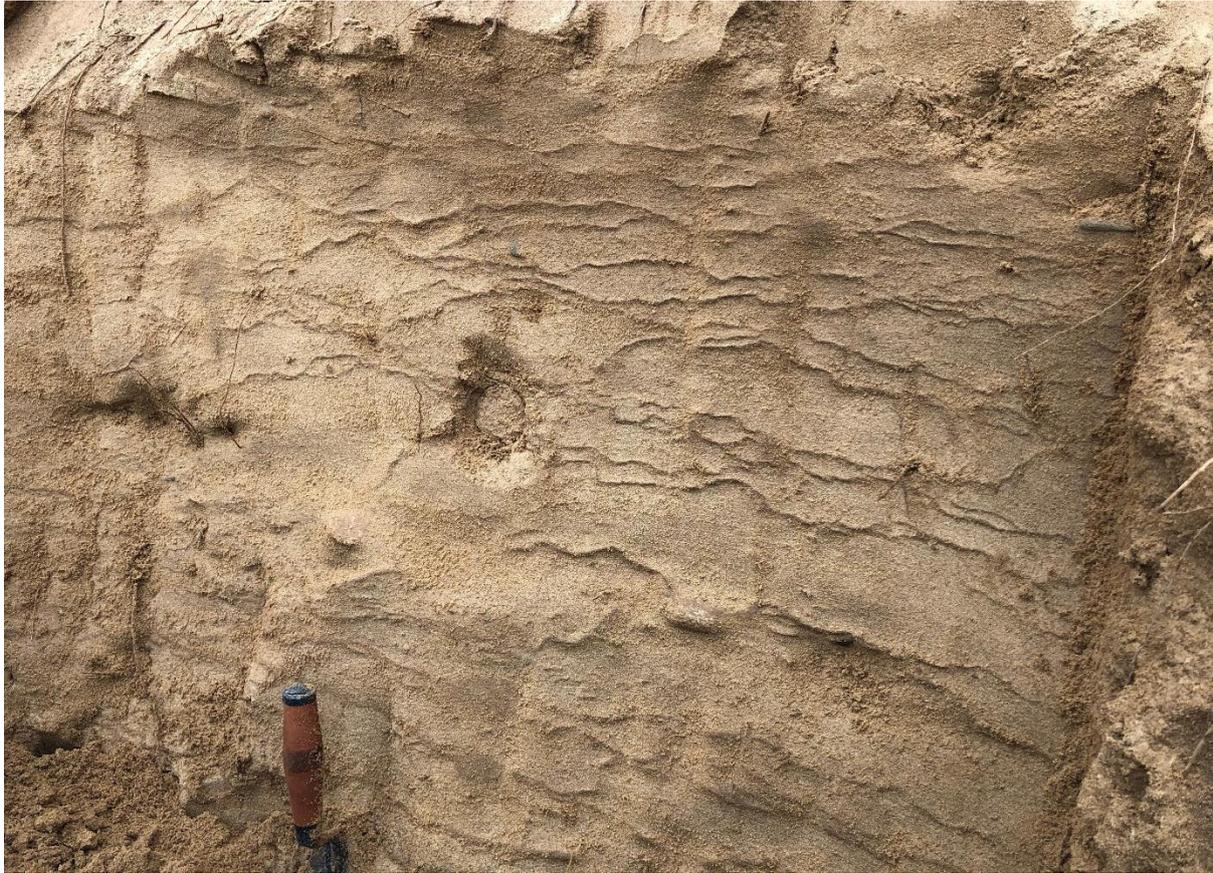
Figure 15: A close-up of the fluvial ripples revealed with a soft brush within context 011. The unit comprises medium sand, rippled with silts and clays and occasional horizontally-bedded pebbles. OSL sample 1 taken from the middle of this unit is indicated by the circular depression in the centre of the image. Crown Copyright: CHERISH Project.

Within the ditch, the lowest fill excavated was context 011, cleaned to a maximum depth of 1.6m, though not fully excavated. This comprised a medium sand with clear lenses (ripples) of silts and clays throughout and very occasional horizontally-bedded pebbles between 1cm and 5cm in width (Figure 15). This type of sediment structure is strongly indicative of fluvial deposition with a variable flow regime. The presence of water-lain sediments therefore suggests that the glacio-fluvial gravels of context 012 was cut by fluvial activity and thus the ditch is natural in origin and represents a palaeo-channel, rather than entirely human in origin and dug during the construction of the hillfort.

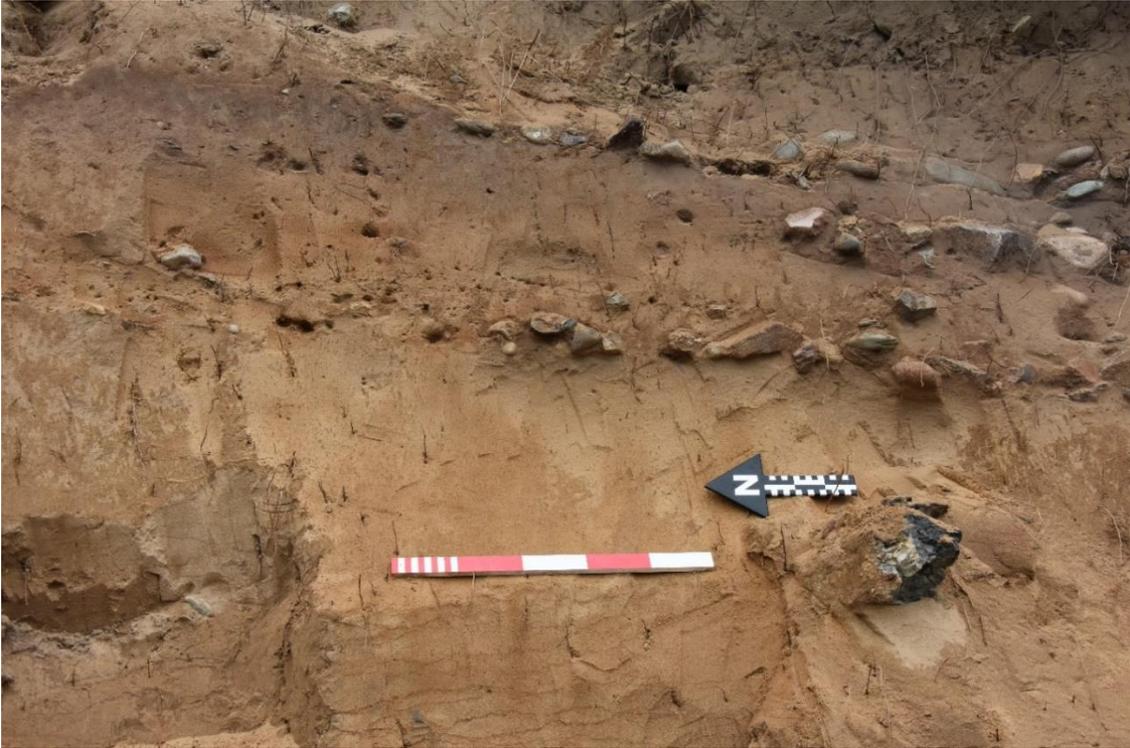
Figure 16: Image showing the central section of the ditch, the fills of sand and stone spreads. The fluvial ripples of context 011 can be seen below the scale whilst the darker brown sand of context 005 is near the top. Crown Copyright: CHERISH Project.

- Contexts 010, 007, 005 and 003 were all well sorted loose sand units running across the full width of the ditch/section, from which samples were taken for OSL dating (Figure 16).
- context 008 was an isolated 14cm thick silty clay lens at the northern end of the section between sand units 010 and 007.
- contexts 009, 006 and 004 were spreads of stones (cobbles and gravels) concentrated towards the southern side of the ditch (Figure 17).

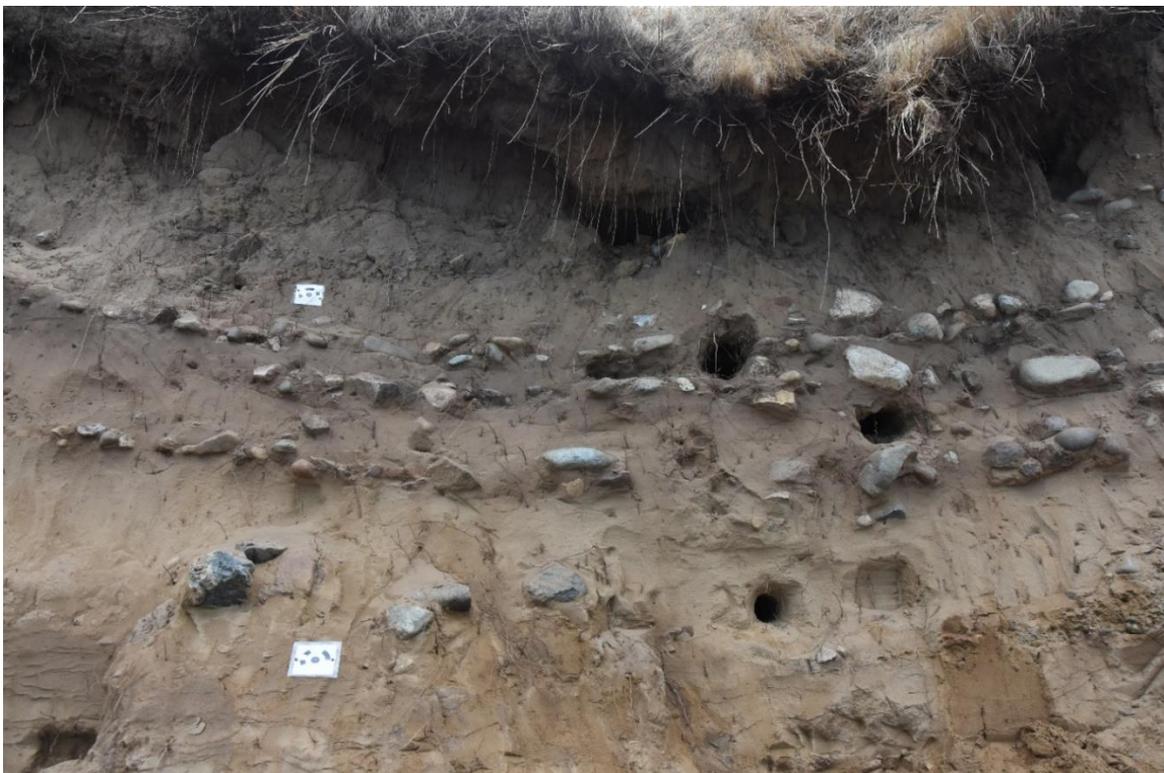
Figure 17: Image of the stone spreads (contexts 009, 006 and 004) within the ditch fill. The circular holes in the section relate to OSL sample locations 2, 3 and 4. Crown Copyright: CHERISH Project.

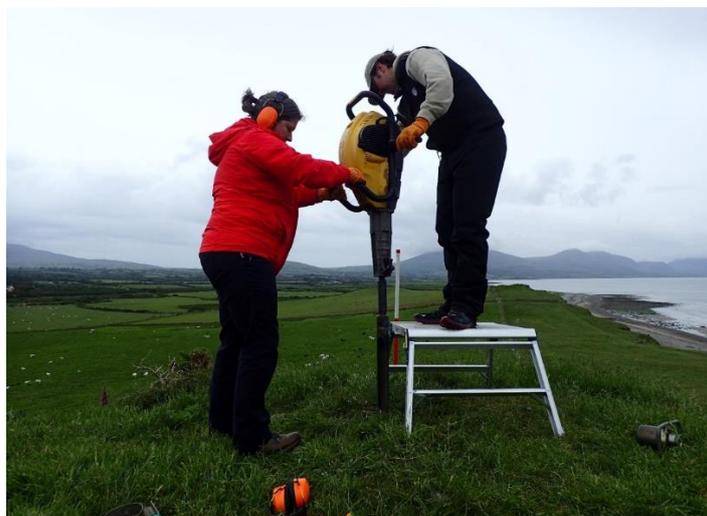
Figure 18: Hywel Griffiths and Sarah Davies coring through the southern outer rampart. Crown Copyright: CHERISH Project.

The firm dry sediments of Dinas Dinlle are too compacted to be sampled with a hand-driven Russian or Livingstone corer, therefore an Atlas Copco Cobra percussion corer was employed. The Cobra uses a petrol driven engine to produce compressed air to hammer a 1m core barrel with 4cm internal diameter into the ground (Figure 18). The core is retrieved using a manual jacking system.

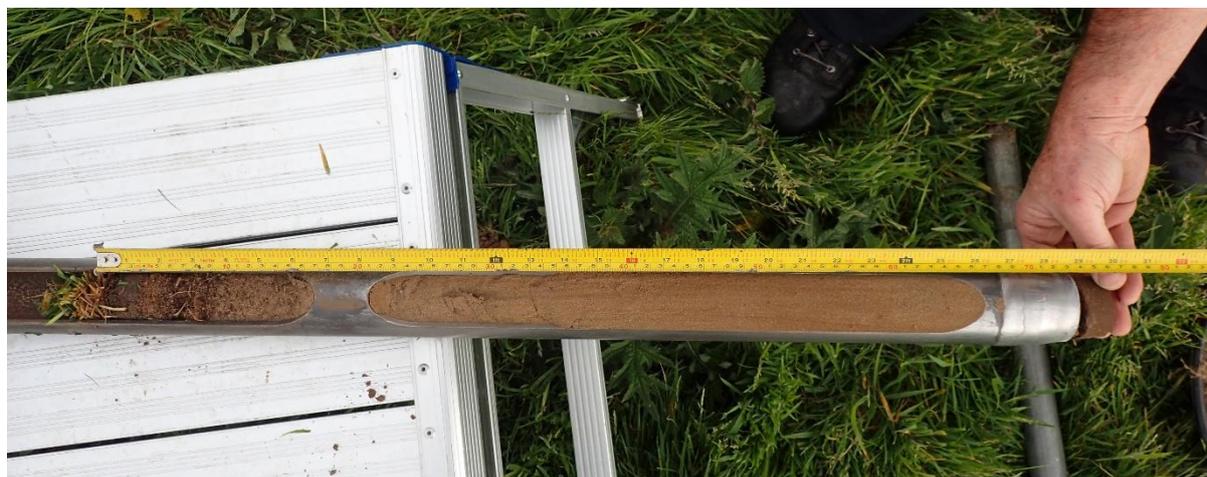
Figure 20: Examining the stratigraphy of test core DDDF 1 in the interior of the hillfort, comprising 10cm of soil with roots over 70cm of uniform sand. Crown Copyright: CHERISH Project.

The cores will be opened, logged and analysed in early 2020, and the results discussed in the final report. Our initial impression is that the stratigraphy broadly reflected that observed in the cliff-face section, principally layers of sand deposits. The depth of sections DDF19- 1, 5 and 6 down to what appears to be natural suggests we are likely to have hit archaeological horizons and this will be particularly interesting for cores DDF19-1 in the interior (Figure 20) and DDF19-8 which provides a section all the way through the outer bank. With the other cores large stones prevented complete retrieval of the stratigraphy, which in the case of cores DDF19-2, 3 and 4 suggest the presence of rampart walling.

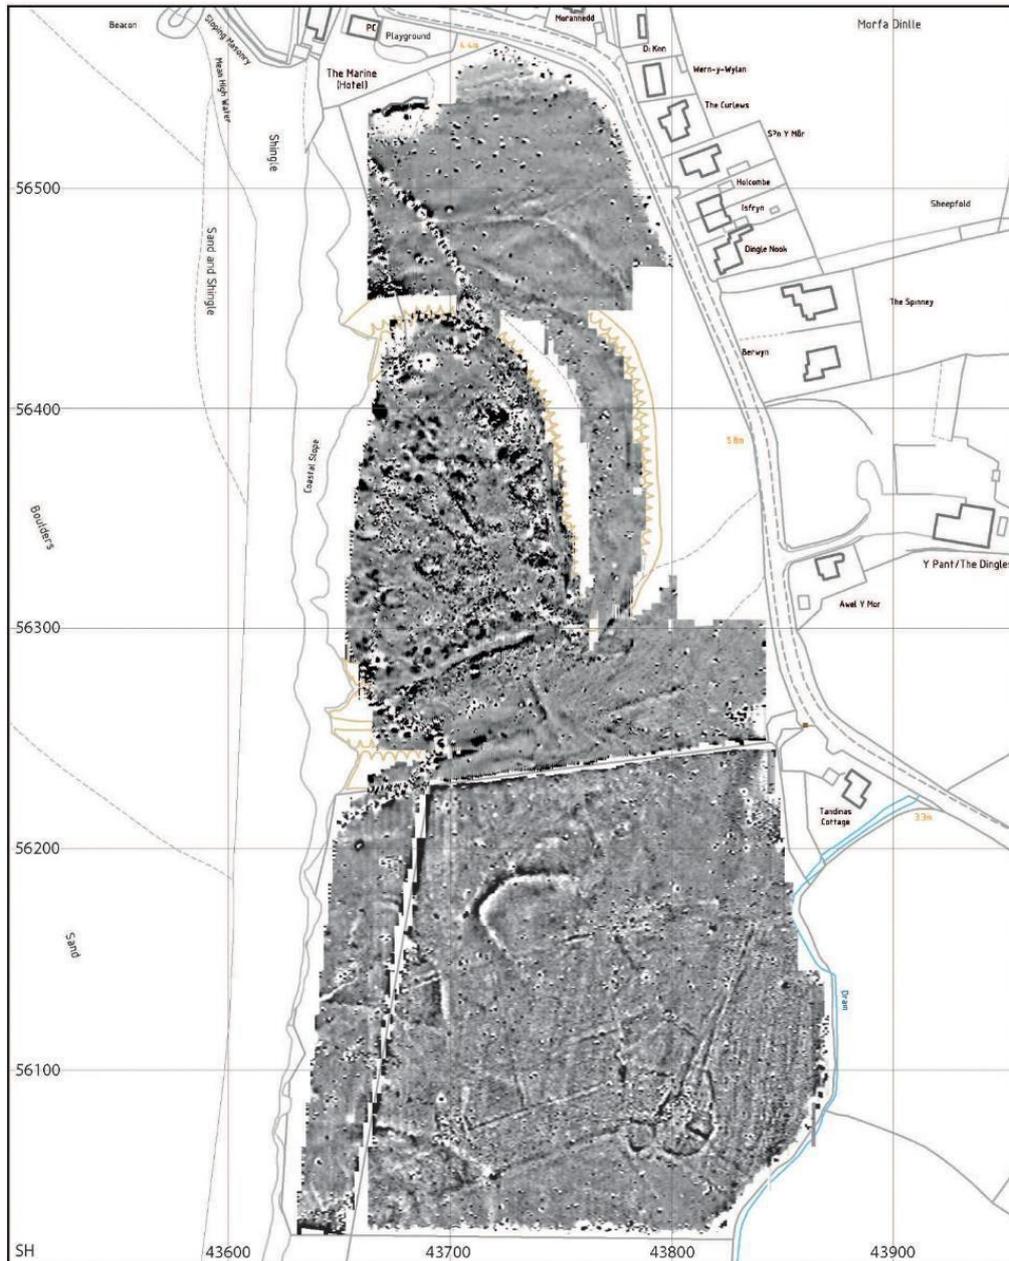
Figure 3: Result of GAT's 2017 & 2018 geophysical surveys of Dinas Dinlle coastal fort and environs (after Hopewell 2018: 8).

Numerous possible roundhouses and other anomalies were identified within the interior of the fort, several of which are situated very close to the eroding clifftop. Further possible prehistoric features, along with post medieval field boundaries, were identified in the southern field. This work has been completed through to final report where all findings and interpretations are delineated.

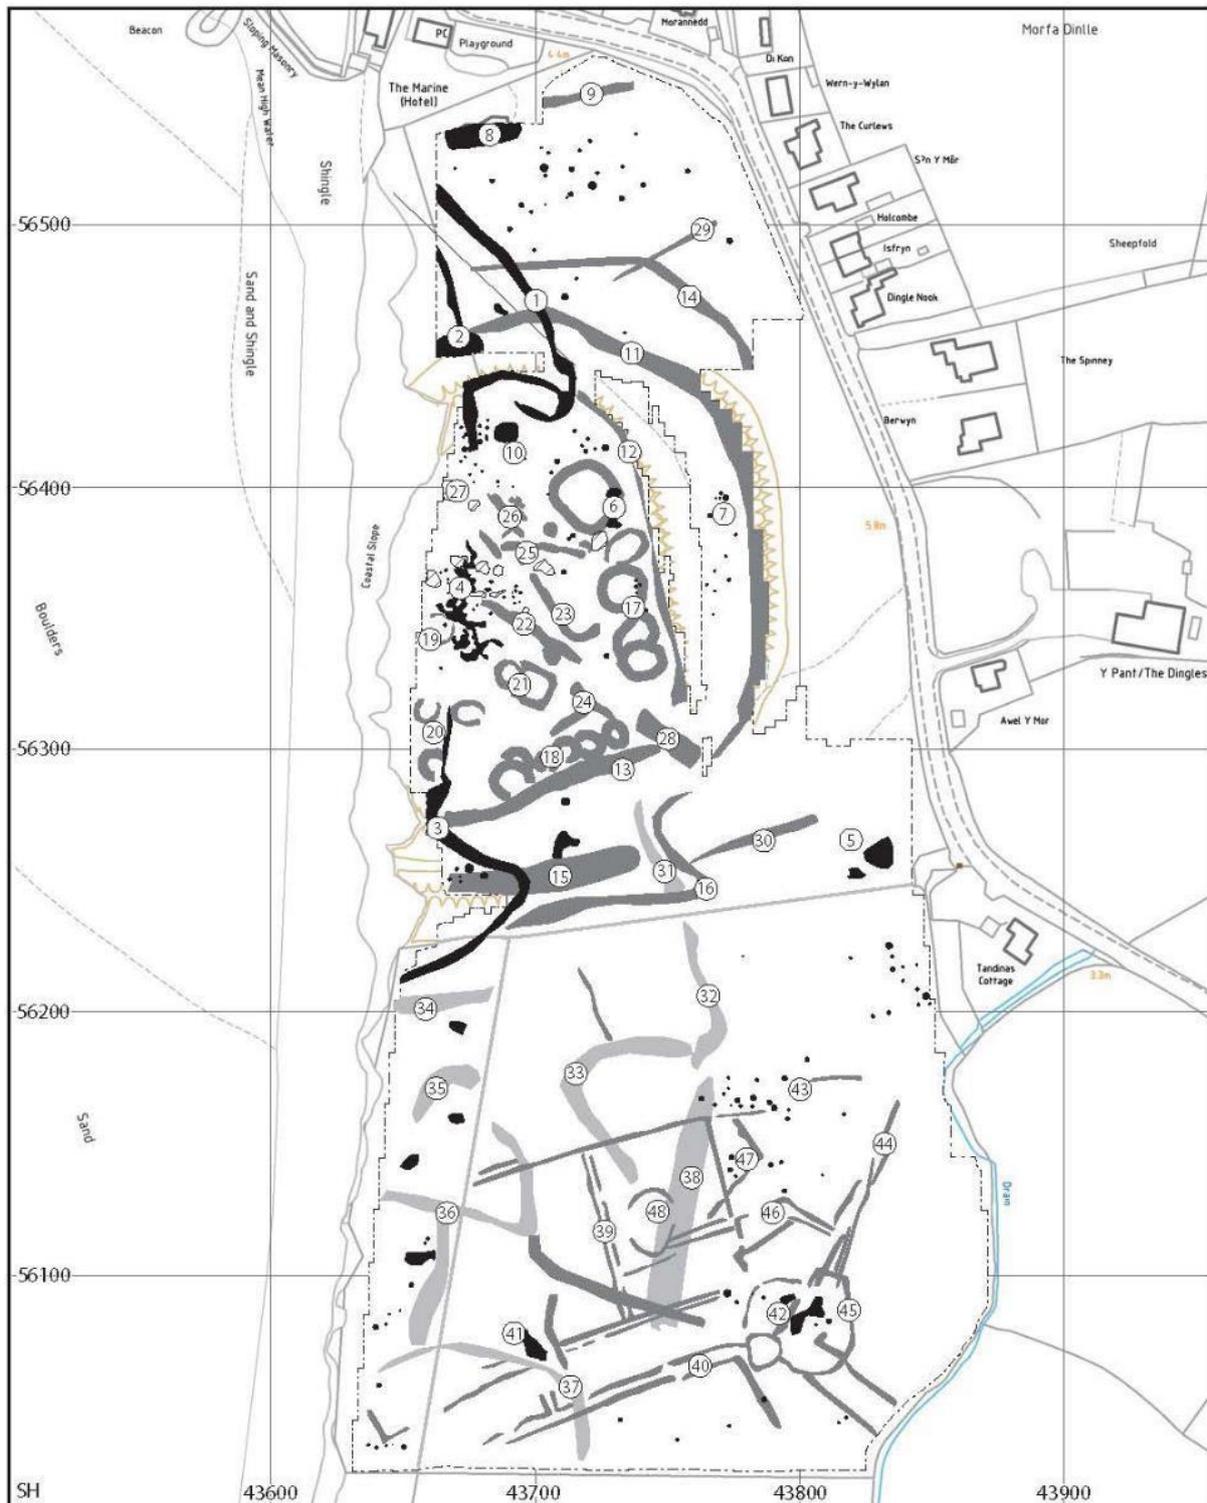
Figure 4: Interpretation plot of anomalies identified during the 2017 & 2018 geophysical surveys of Dinas Dinlle coastal fort (after Hopewell 2018: 9).

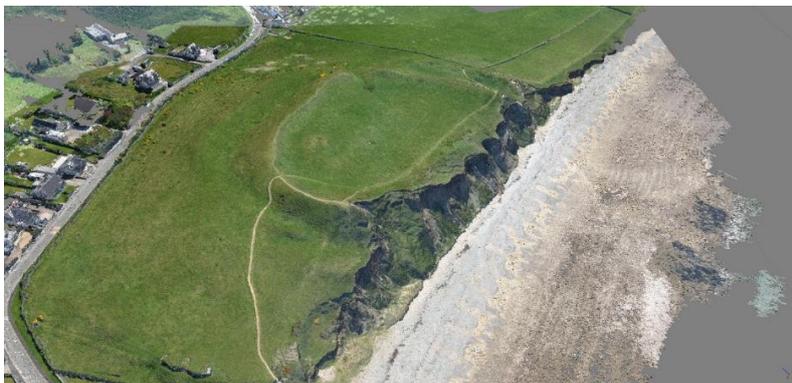
Figure 5: Meshed 3d model of Dinas Dinlle created by photogrammetry (© Crown copyright: CHERISH project 2018).

An aerial photogrammetric survey was carried out to provide a complete metric dataset of the whole monument, including the eroding cliff face. Photographic data was captured using a Phantom 4 Advanced UAV fitted with an integrated gimbal and camera with 1-inch 20-megapixel sensor. Ground control was derived from intersections in field boundaries resulting in a maximum absolute error of 30cm in the geographical positioning of model. Photographs were processed using Agisoft Photoscan Professional up to dense point-cloud level and several products have been produced, including: A new Digital Elevation Model (DEM); scaled 3D model and orthophoto (Figure 5). The resolution of the DEM is approximately 17cm, superseding previously collected 50cm resolution LiDAR data held by Welsh Government.

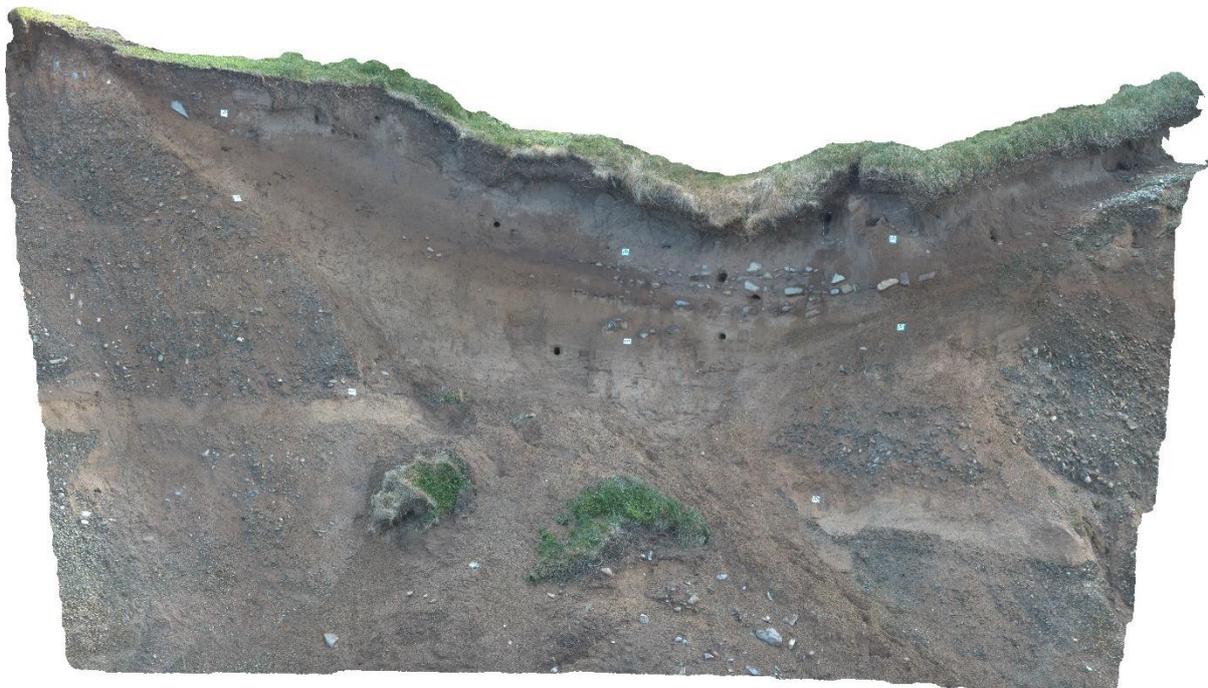
Figure7: Orthomosaic of the southern ditch section created from overlapping SfM UAV imagery in Agisoft Metashape. Ground Control Points (white targets) were used to georectify and scale the image. The series

of layers within the ditch can be seen along with the circular holes where OSL samples were taken. Crown Copyright: CHERISH Project

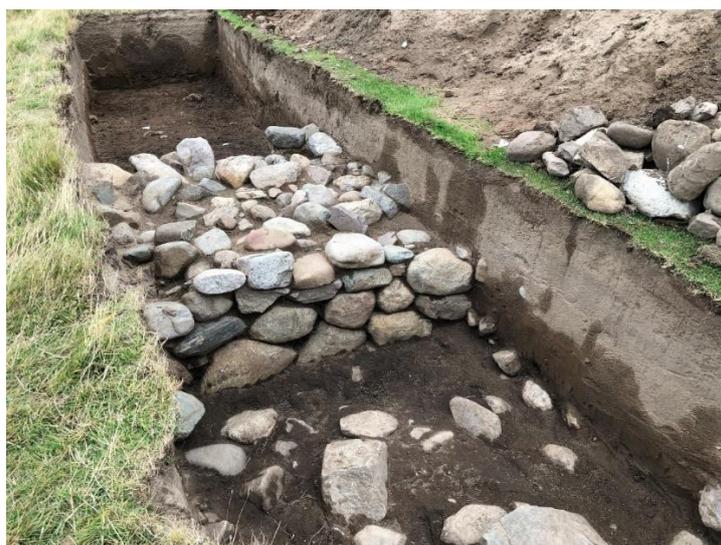
Figure 8: The northern wall of the roundhouse uncovered in trench 1. The walls appear to have been constructed from large stones to a width of 2.4m, and indicate a diameter of some 13.2m. Crown copyright: CHERISH project.

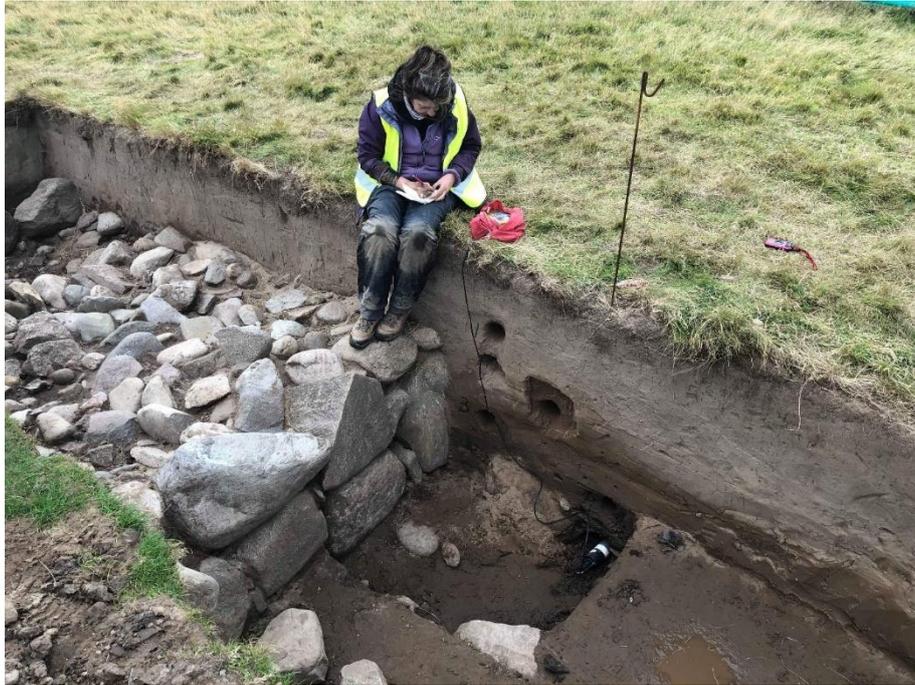
Figure 9: Professor Helen Roberts from Aberystwyth University taking Luminescence samples through wind-blown sand deposits from the section adjacent to the southern wall of the roundhouse in trench 1. Crown copyright: CHERISH project

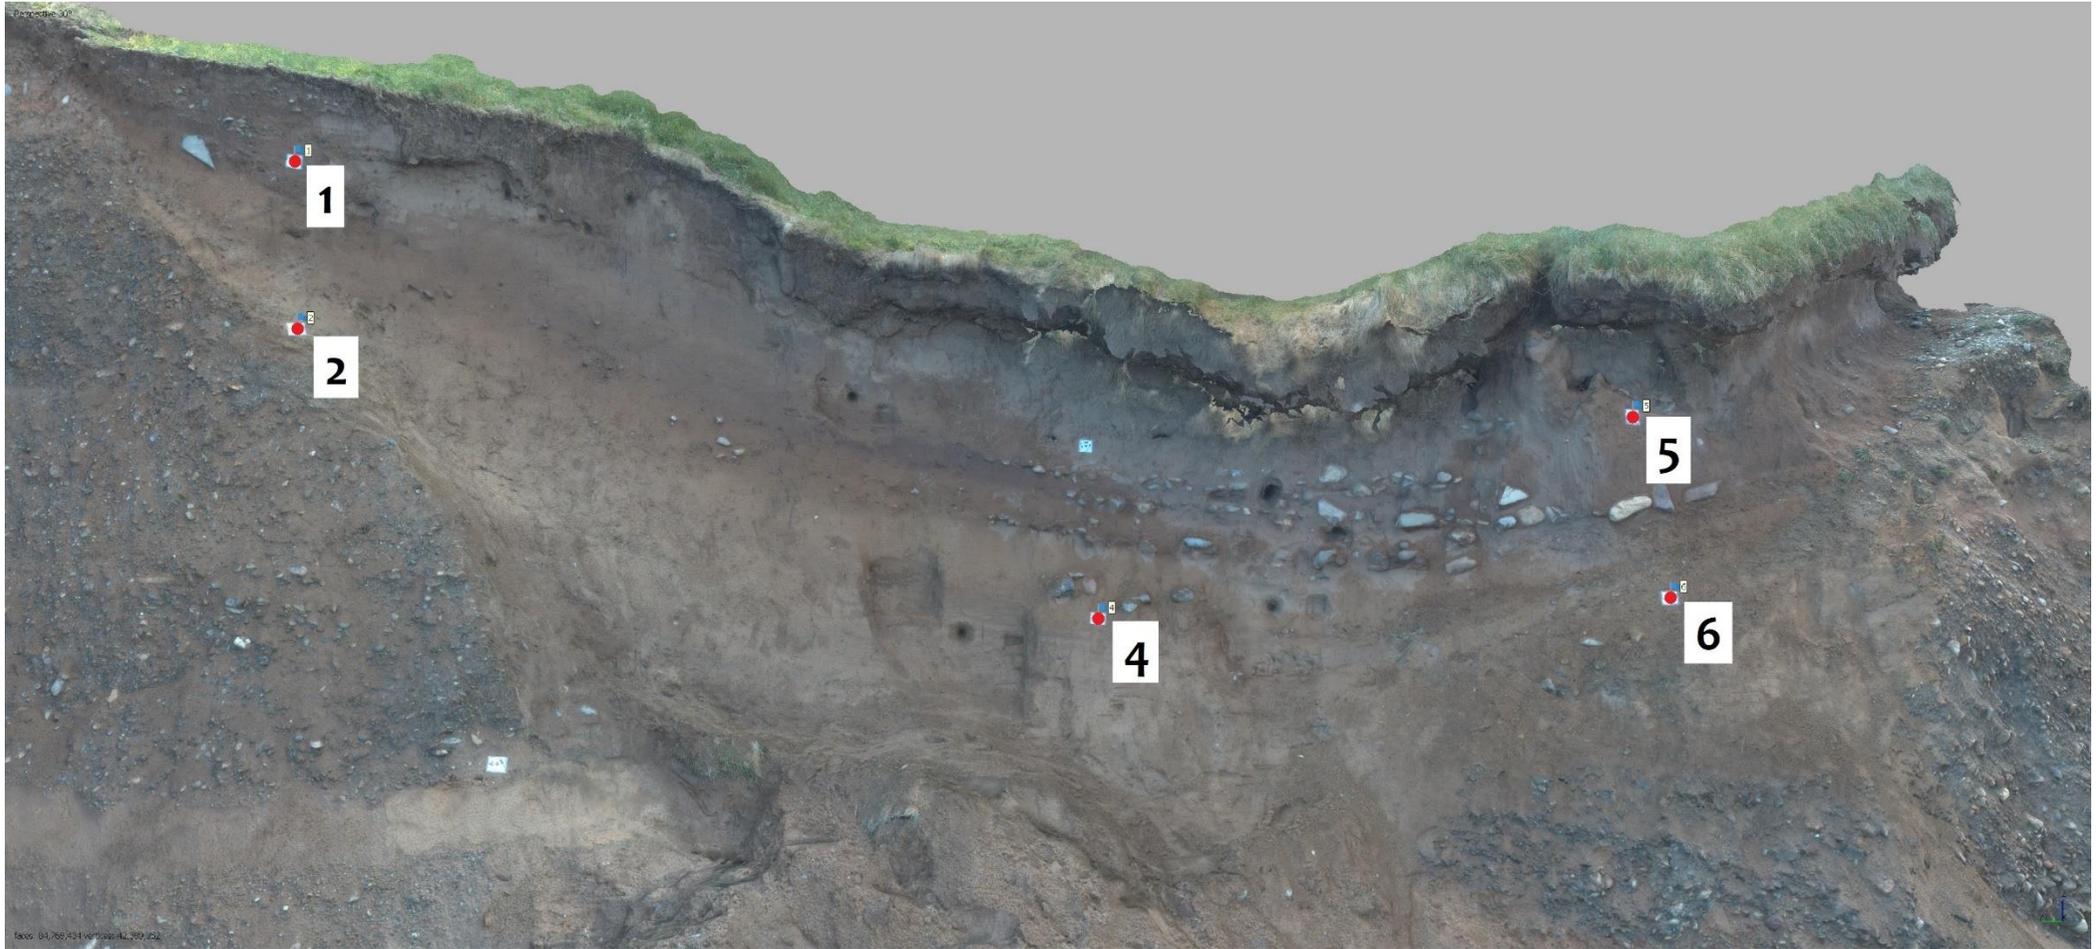
Figure 1 Location of GCPs

Notes on GCPs	<b>GCP 3 was not used for the georeferencing of the orthophoto due to a large error with the GCP position.</b> GCPs were surveyed using a TST set up over a point established by GNSS.
---------------	--
