CPAT Report No. 1874

# Havard House, Brecon, Powys

Building Survey and Heritage Impact Statement

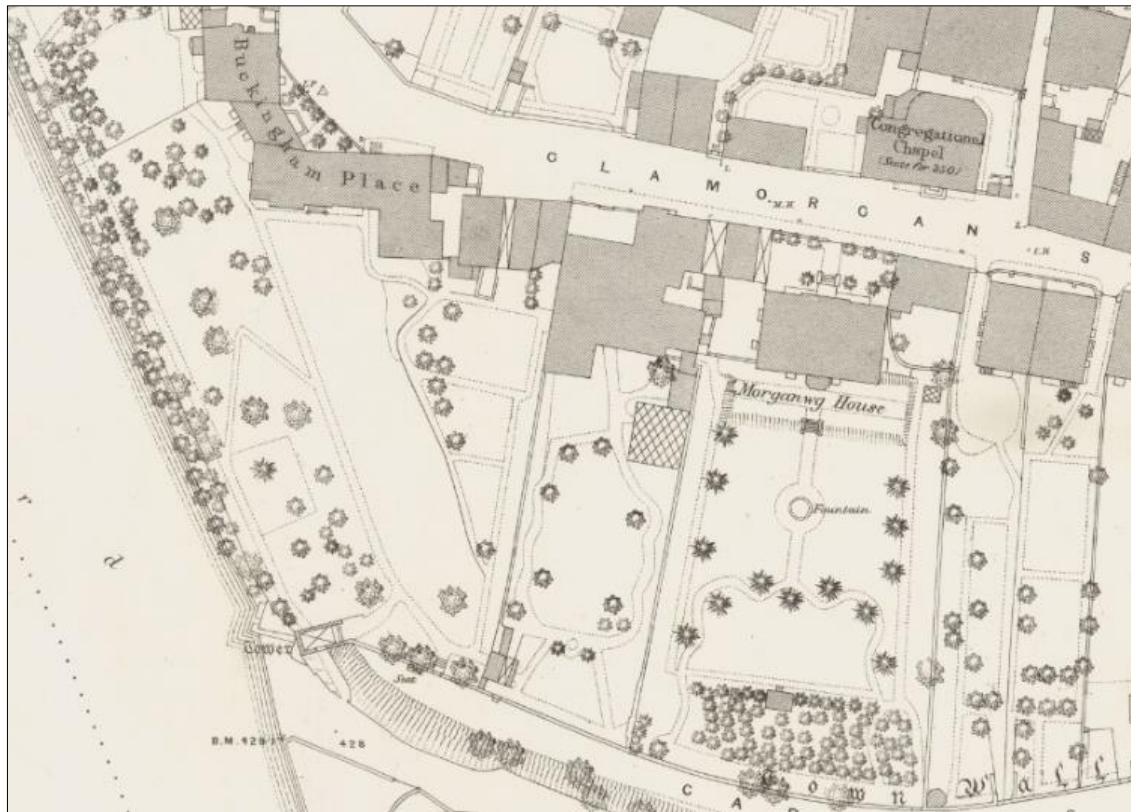
*Fig. 4 Extract from the Ordnance Survey Town Plan of 1888 showing the layout of the house and details of the grounds to the rear*

- 2.7. The 1:500 Ordnance Survey Town Plan of 1888 shows Havard House in a fairly recognisable modern form (Fig. 4). There were two access ways from the street frontage to the courtyard to the east of the house. A small building is located within this yard, possibly a coach house. There are a number of buildings within the grounds, including a set of buildings adjacent to the town wall/Captain's Walk and two buildings and a greenhouse attached to the south-east range of the house. The garden itself is informal in design with meandering pathways lined with trees and a circular pond at the south end.
- 2.8. By the early 20th century, the house was occupied by Les Filles de Saint Esprit of St Brieuc, Brittany, a French religious order and then subsequently it formed part of an Ursuline Convent, which remained until the late 20th century.

- 3.9. A stable and coachhouse block were constructed to the east of the house and somewhat further forwards on the frontage. The two constituent buildings were broadly contemporary with each other, but evidently not constructed at the same time. Both buildings have been considerably rebuilt and reordered internally and externally so that much of their original purpose is no longer discernible. It is likely that the upper floors of these two buildings were either occupied by staff or servants or served as storage for feed or bedding materials. Entranceways for carriage and foot traffic ran through the block to the area to the rear of the property, although these are now only discernible via historic mapping (Fig. 4).

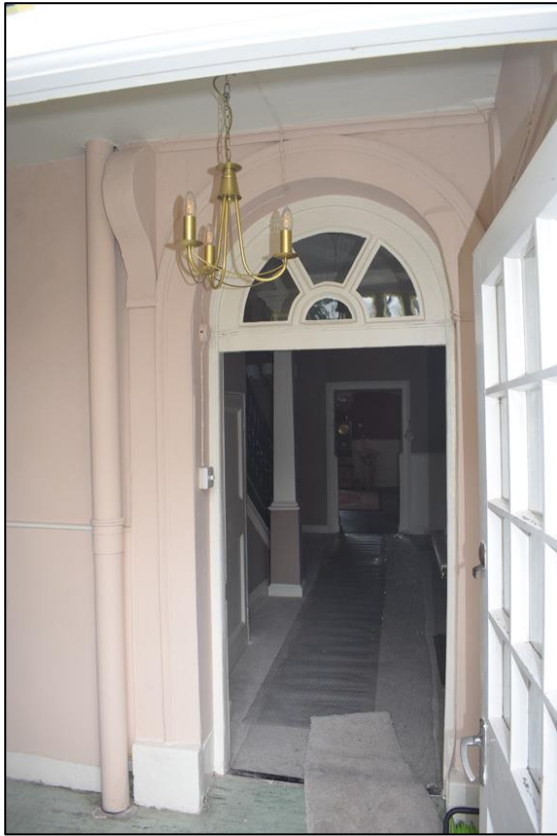
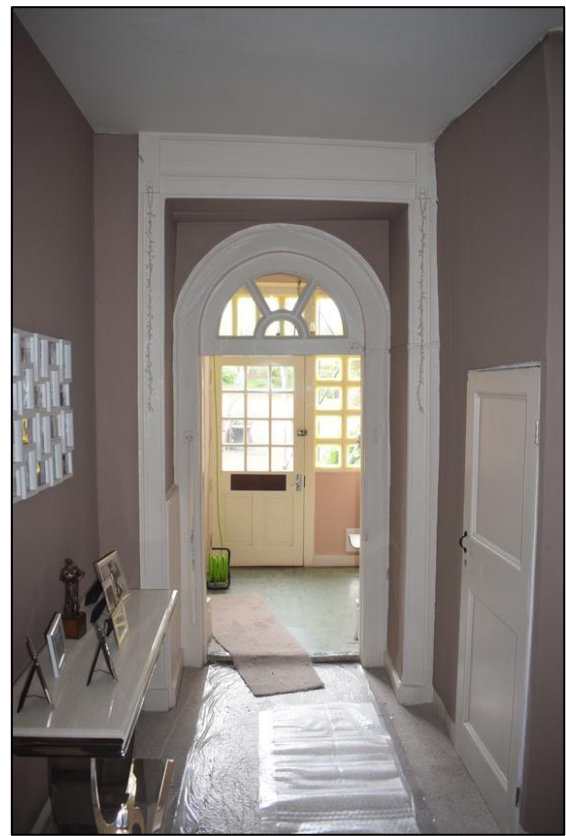
*Fig. 5-6 External doorway on south-elevation Photo CPAT 4992-031 and Photo CPAT 4992-029*

- 3.6. The entrance block was accessed via a round arched doorway with a decorative surrounding (Fig. 5-6). An interesting architectural feature was a small star shaped lookout window to the west of it (Fig. 7). The hallway contained a staircase to the upper floor, which had been subsequently altered, although the shape of the ceiling above it had not been altered (Fig. 9). The stairs to the cellar were also probably located within this area, although the cellar had also been extended during a subsequent phase of development.

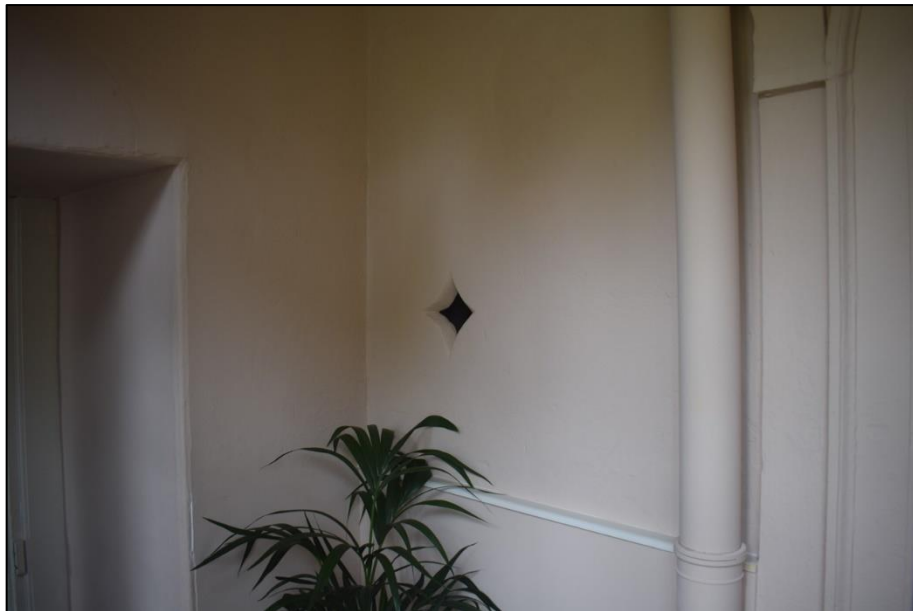
*Fig. 7 Look out window adjacent to doorway Photo CPAT 4992-030*

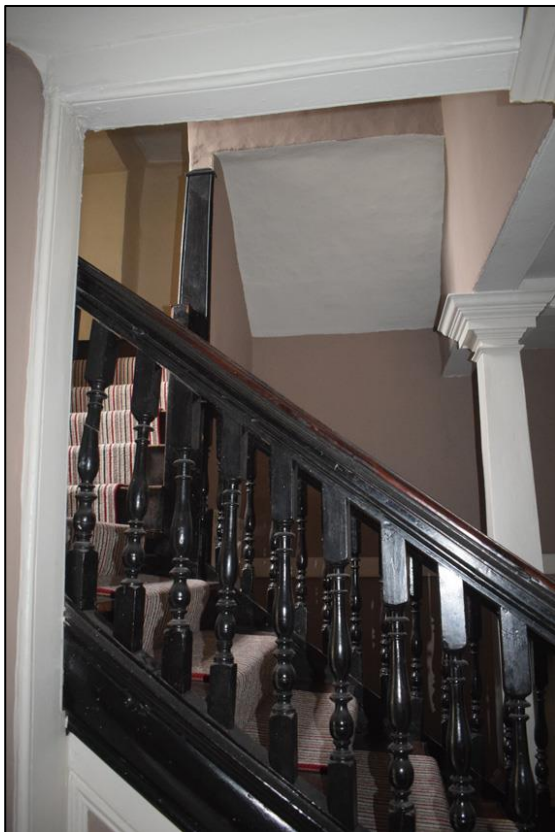
*Fig. 9 Detail of staircase ceiling indicating earlier arrangement Photo CPAT 4992-011*

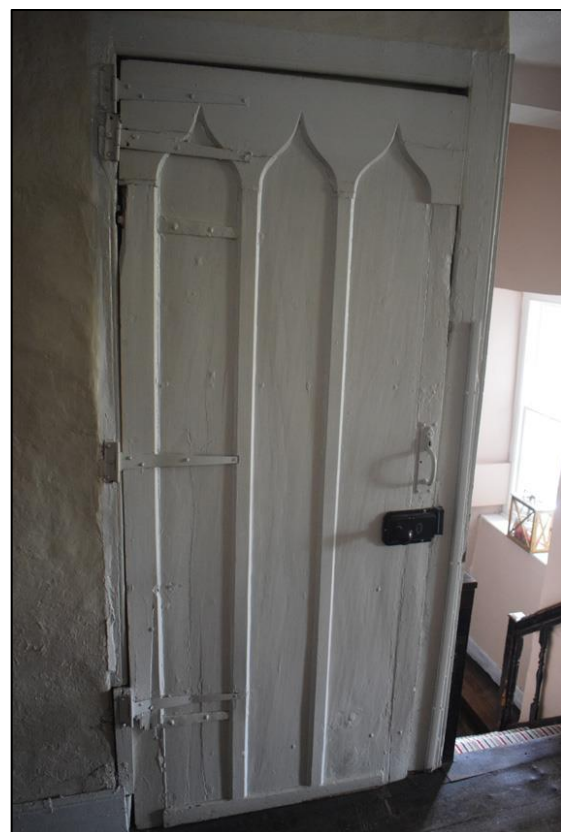
*Fig. 10 17<sup>th</sup> century door to attic Photo CPAT 4992-076*

- 3.5. The southern wing comprised two family rooms, one on each floor, and another attic room above. A large chimney stack formed part of the structure of the southern gable end. A staircase leading to the attic floor was located within this wing (Fig. 10).

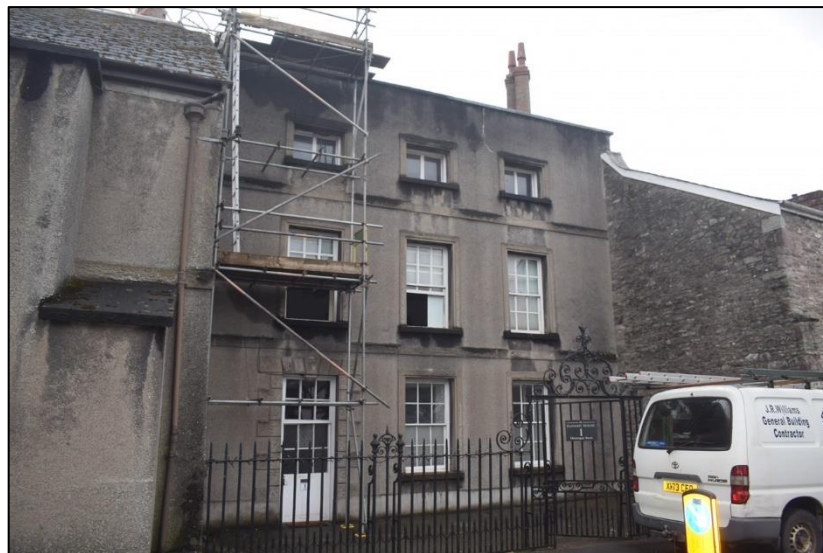
*Fig. 11 North elevation of the house Photo CPAT 4992-052*

- 3.8. The house was subsequently altered and partially rebuilt in the Classical Style during the 18<sup>th</sup> century (Fig 11). The layout was altered so that the main entrance and principal elevation now faced on to Glamorgan Street. A parapet roof was constructed with an additional set of windows for the attic floor, and the roof was rebuilt to accommodate the change in pitch. The internal spaces were reorganised with an entrance hallway on the Glamorgan Street frontage, with a reception room to the side of it. The staircase was redesigned with a wider foot projecting out into the rear hallway and pillars either side of it. The large room on the first floor was subdivided into two rooms. It is likely an access doorway to the adjacent stable block was also let in at this stage. Most of the interior finishes and architectural details appear to date from this phase of the building's construction including the panelled ground floor interiors in the two rooms (Fig. 14-15) and hallways, the redesigned staircase (Fig. 12) and the upper floor. The treatments on the upper floor were rather interesting and included decorative plasterwork either side of a room subdivision that had subsequently been removed (Fig.13) in the northern first floor main room (Fig. 8). Externally the larger windows on the north elevation dated from this phase of the building's development.

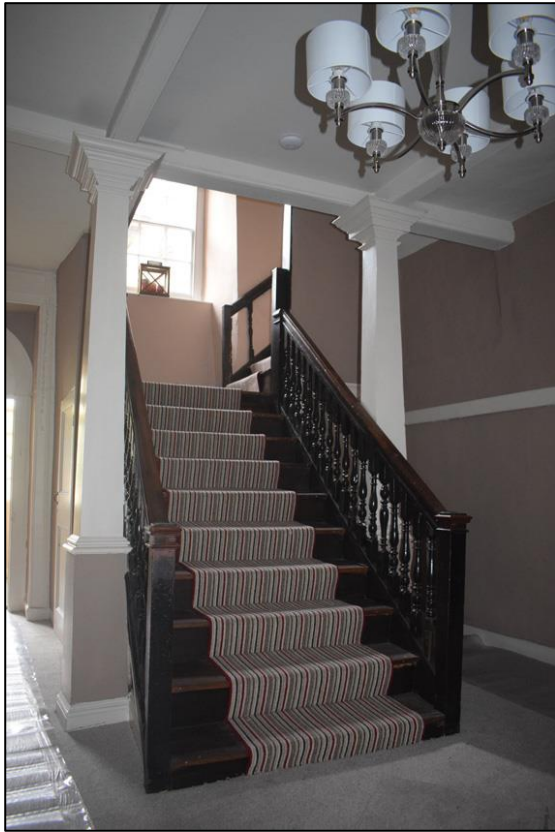
*Fig. 12 Redesigned staircase Photo CPAT 4992-010*

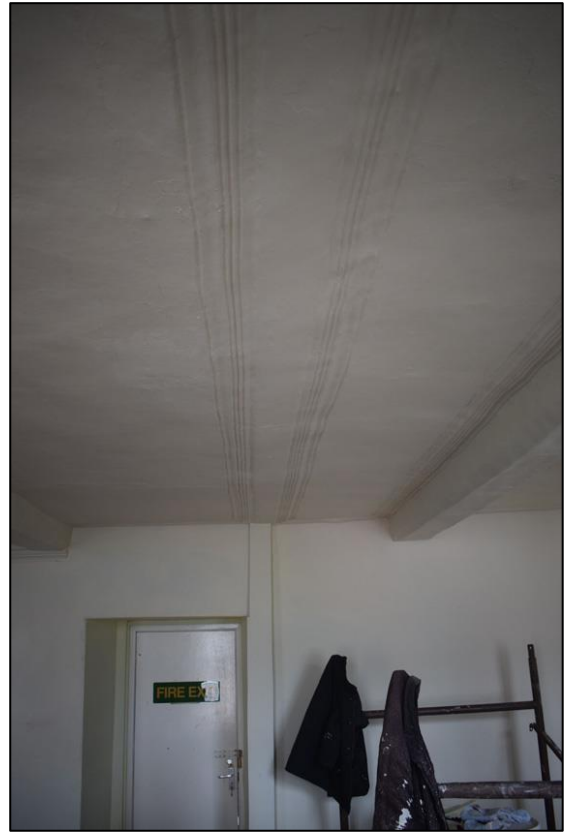
*Fig. 13 Decorative plasterwork on first floor ceiling  
Photo CPAT 4992-087*

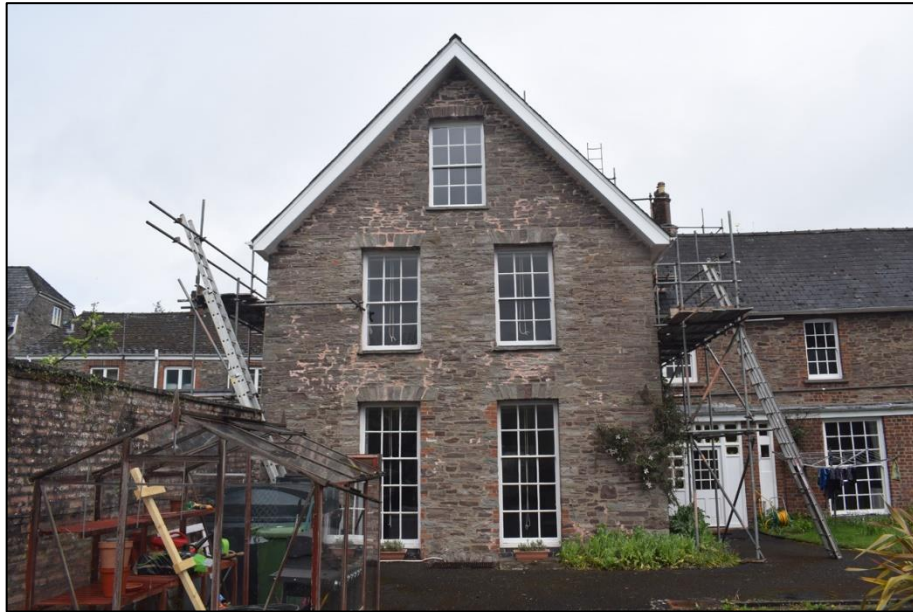
*Fig. 16 Wing to rear of property Photo CPAT 4992-040*

- 3.10. Phase 3 comprised the construction of an extension to the wing on the south elevation of the house (Figs. 16 and 17) and a range running east from the former entrance block (Figs. 18 and 19). Both essentially formed continuations of the existing building and were built in similar materials. It is likely the roof structure was completely renovated at this time as well, as there is no visible difference in the roof structure or materials between the earlier and later sections. It is likely that the 17<sup>th</sup> century chimney tops were rebuilt at this time as the brickwork used appears to be machine made brick. The cellar was also extended beneath the new wing at this time. The windows on the south elevation were evidently renewed or replaced and a window in the east elevation of the wing infilled although this appears to have been a later change. The date of these changes is unclear but appears to have been between 1832 and 1887.

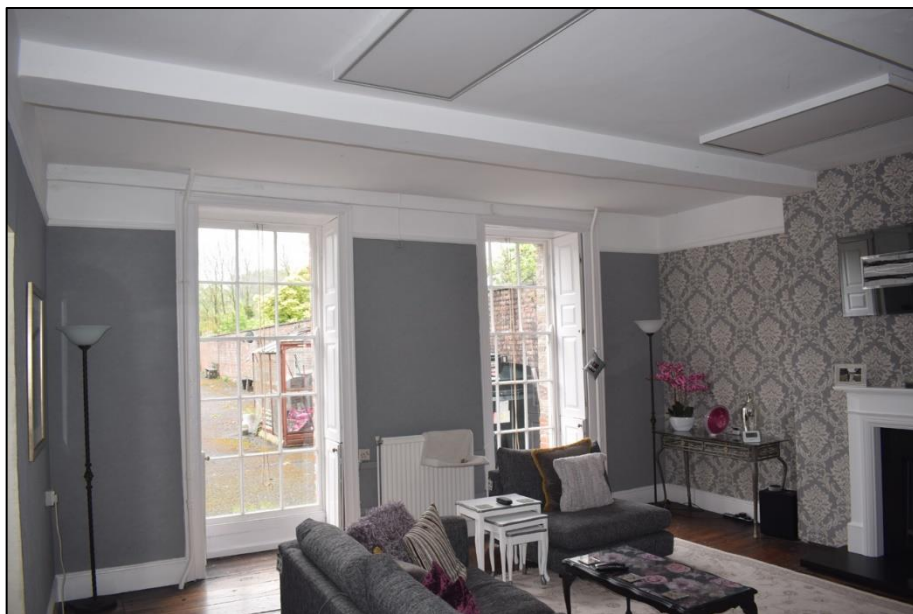
*Fig. 17 Ground floor room of rear wing Photo CPAT 4992-034*

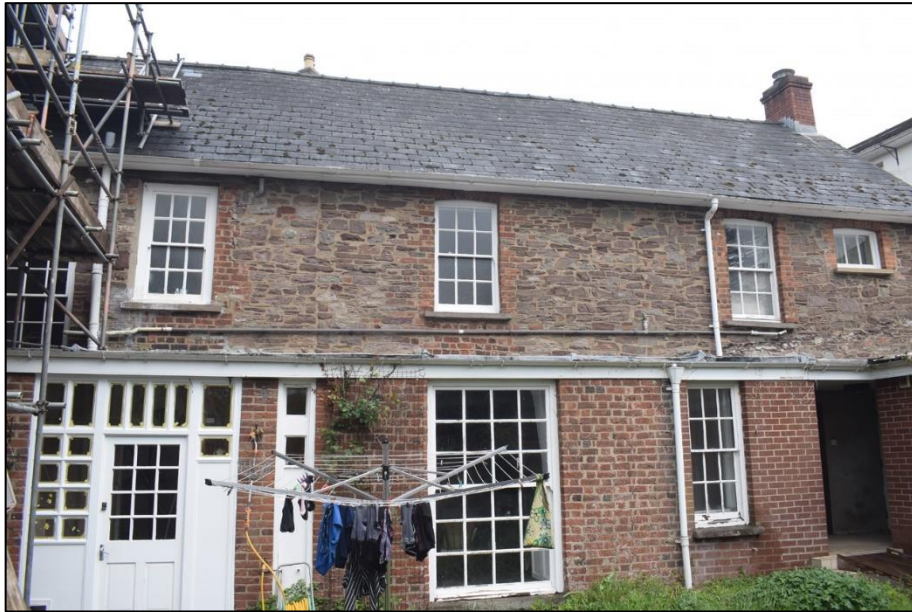
*Fig. 18 Extension to former entrance block to the south-east Photo CPAT 4992-041*

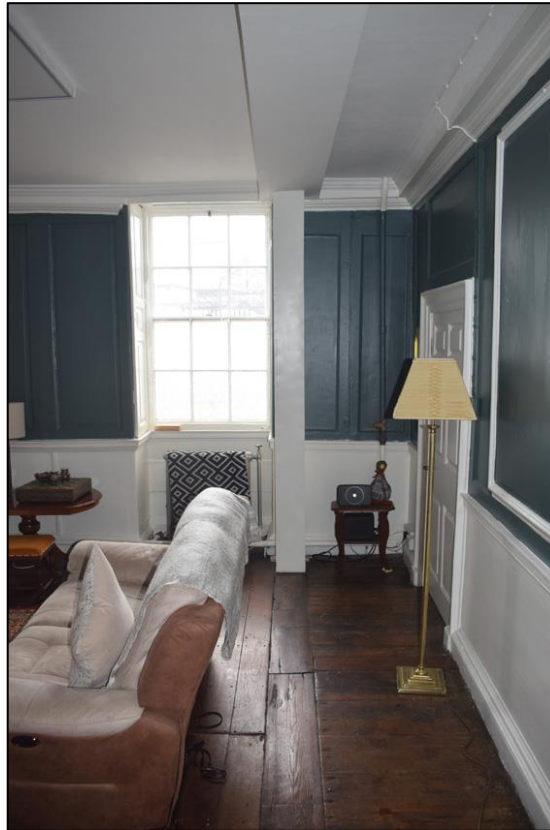
*Fig. 20 Former line of partition between parlour and hallway Photo CPAT 4992-007*

- 3.11. A further change in layout to the interior of the house comprised the movement of the internal partition wall between the hallway and the parlour on the north elevation, presumably to increase the size of the latter (Fig. 20).

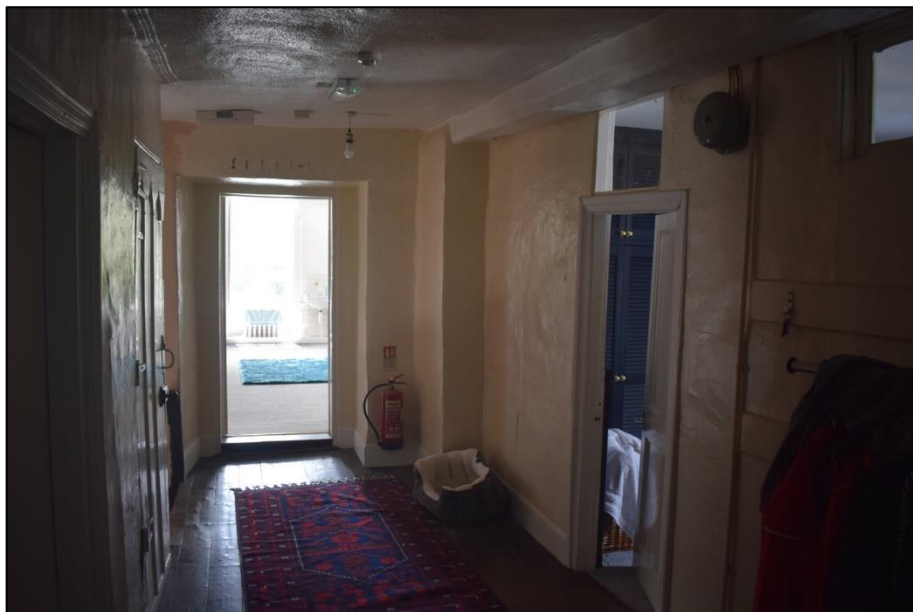
- 5.2. The proposed interior changes to the house are generally fairly minor, with no changes to the layout of the ground floor, and some minor alterations such as the use of fire retardant paint and installation of insulation in some other areas such as the kitchen. Alterations on the first floor include the removal of a 20<sup>th</sup> century shower room and small kitchen adjacent to the staircase, and the construction of a bathroom against the adjacent wall. Apart for the need for careful removal of the modern fabric so as not to damage the 17<sup>th</sup> century staircase, it would also be desirable to preserve the hand-formed decorative finish on the ceiling in this area (Fig. 21).

*Fig. 21 First floor landing with decorative plasterwork on the ceiling Photo CPAT 4992-101*

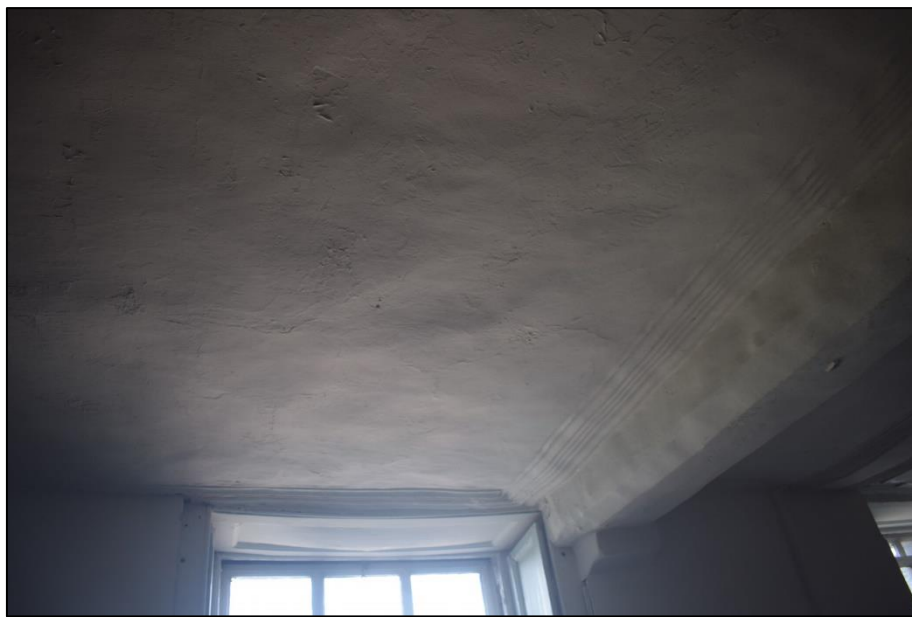
- 5.3. The proposed subdivision of the room on the north elevation first floor has the potential to damage old ceiling treatments or cornicing (Fig. 22). The proposed scheme does mitigate against this by allowing for the use of an exposed joist to locate one of the main wall subdivisions and the location of a former 18<sup>th</sup> century partition (Fig. 13) for another. It should also be noted that some of the cornicing in this room has been historically removed, possibly to allow large ceiling height furniture pieces to be positioned flush against the wall (Fig. 23).

*Fig. 22 Hand formed plaster detail in the first floor room on the north elevation Photo CPAT 4992-140*

- 5.4. The assessment concludes that, although the north elevation first floor room was originally an open area used for entertaining, the evidence is that the room was subsequently subdivided during the Georgian remodelling, therefore such a change would not necessarily be at odds with the dominant style of the house. It is likely the main reception room was relocated to the ground floor during the Georgian redesign, with the bedrooms now relocated to the first floor, therefore this change would constitute a reversion to the layout of the house as it appeared during the 18<sup>th</sup> century.

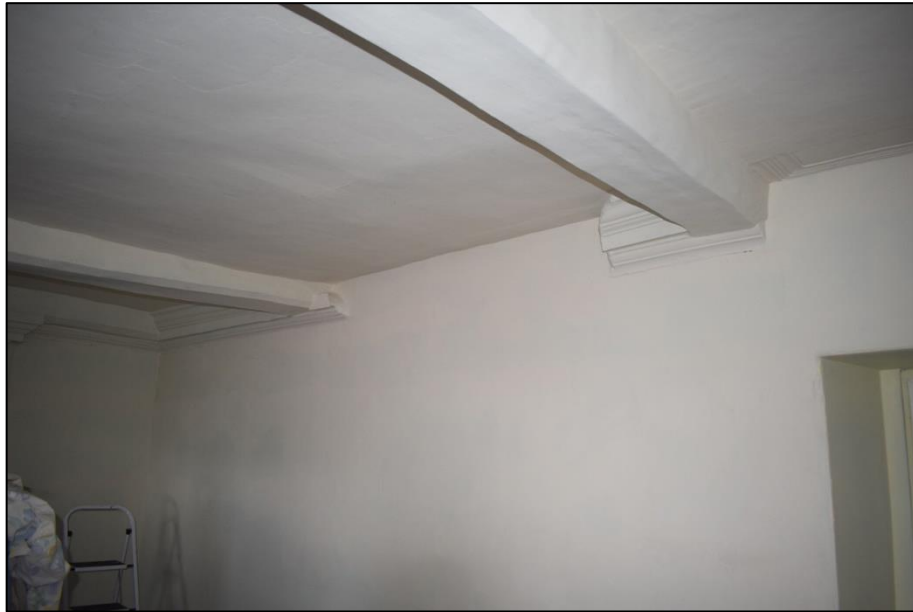
*Fig. 23 Cutout in the cornicing in the first floor room on the north elevation Photo CPAT 4992-141*

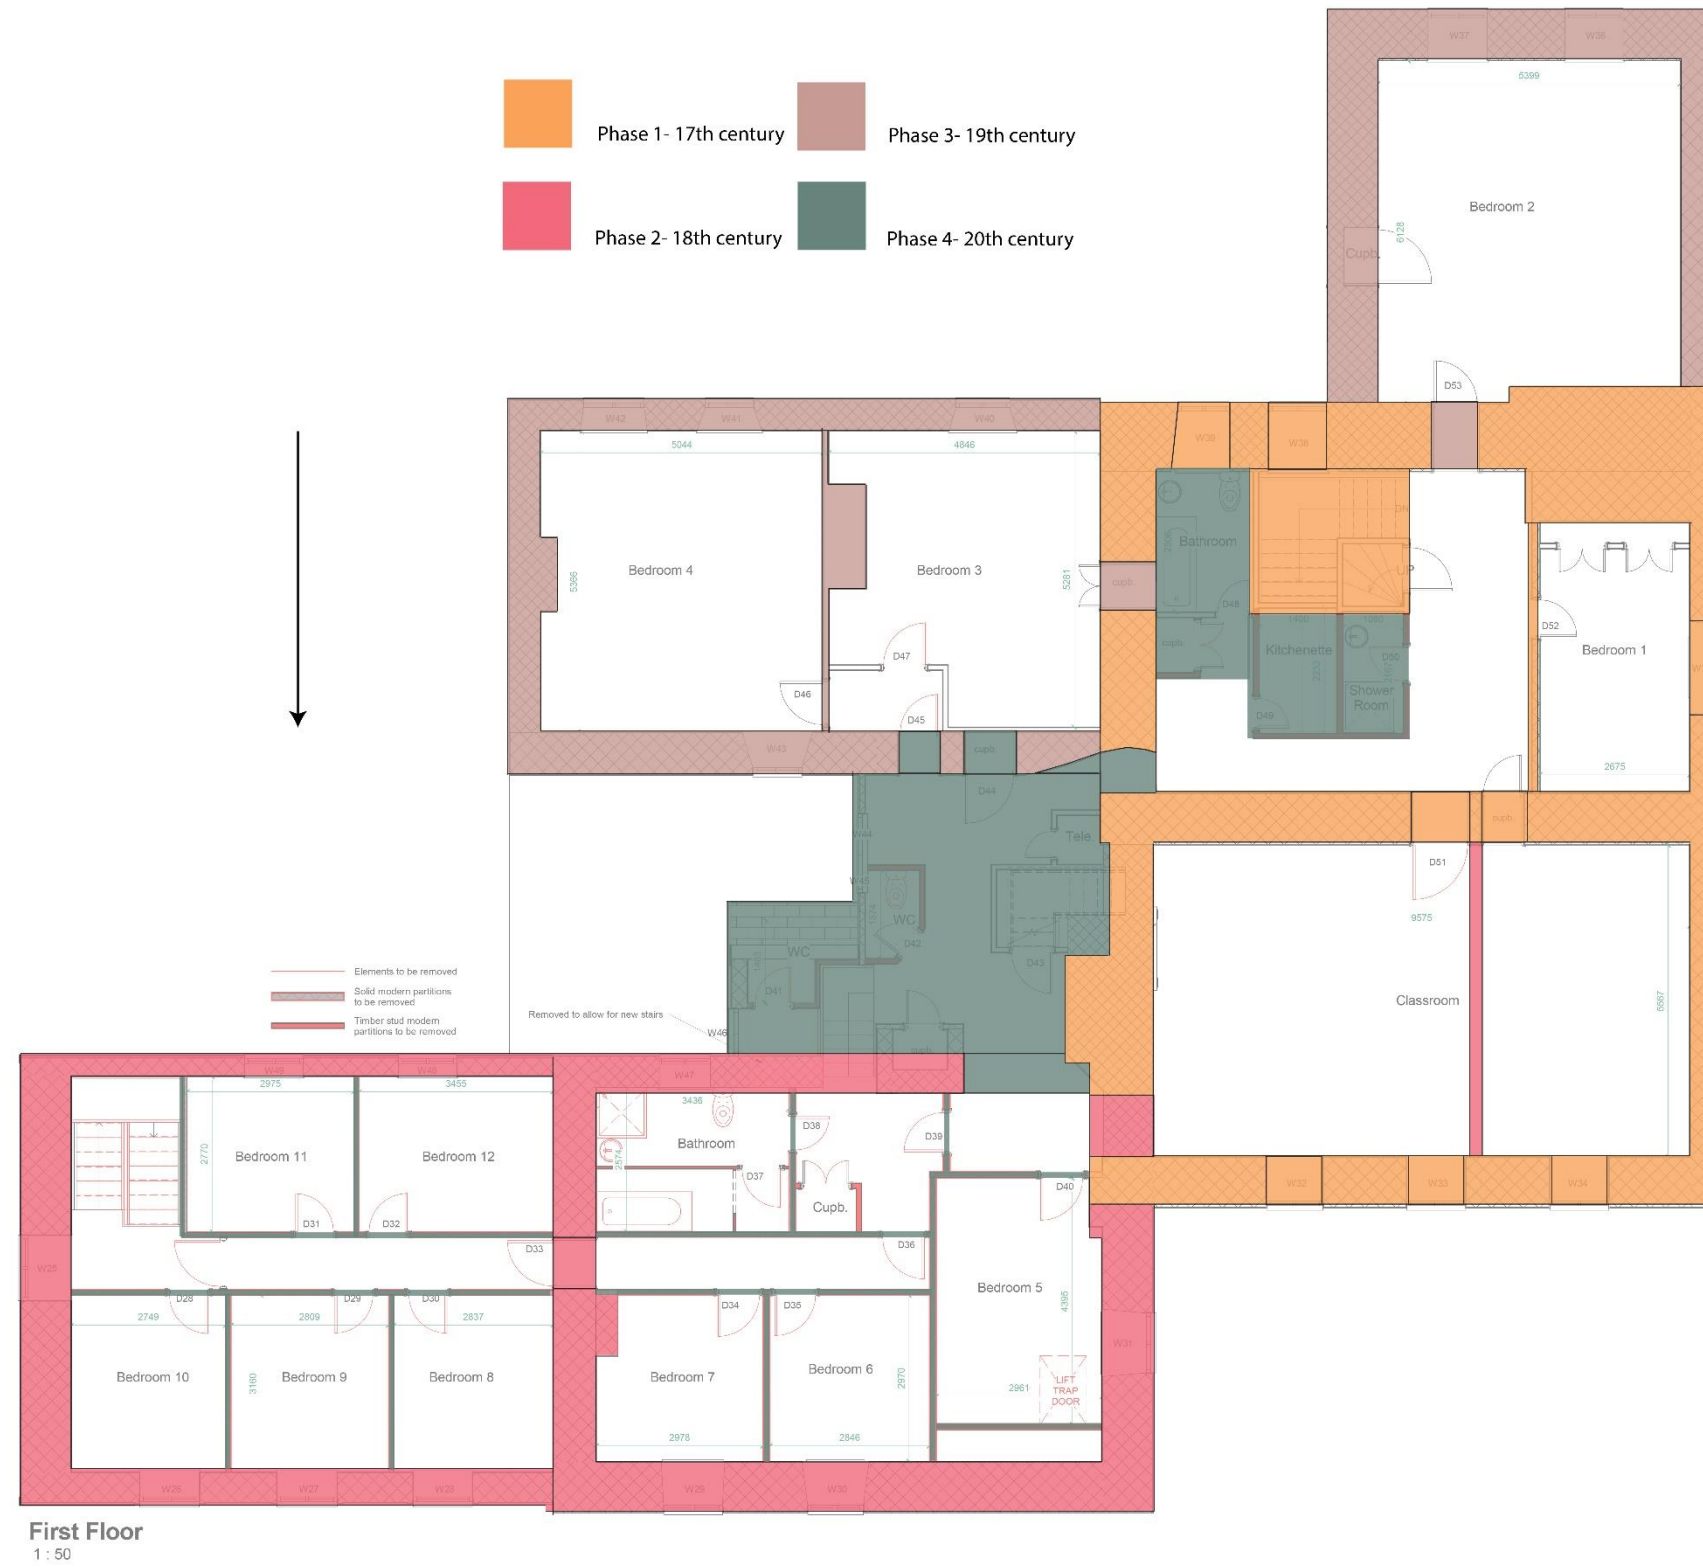
Fig. 29 First floor plan showing construction phases

- 3.1. The survey was conducted according to the Chartered Institute for Archaeologists' (CIfA) *Standard and Guidance for the archaeological investigation and recording of standing buildings or structures* (2020), and took the form of a Level 3 building survey as defined by Historic England (2016) *Understanding Historic Buildings: a guide to good recording practice*. Viewpoint locations and their directions are shown in Figs. 25 – 27 and a full set of contact prints are provided in Figs. 34 – 38.
- 3.2. The complex comprised five broad structural elements, the early 17<sup>th</sup> century townhouse, the adjacent stable block, the south eastern range, the extension to the south and a modern connecting wing located between the stables and the south eastern range. These have been broadly grouped into four phases of development (Figs. 28 – 30).

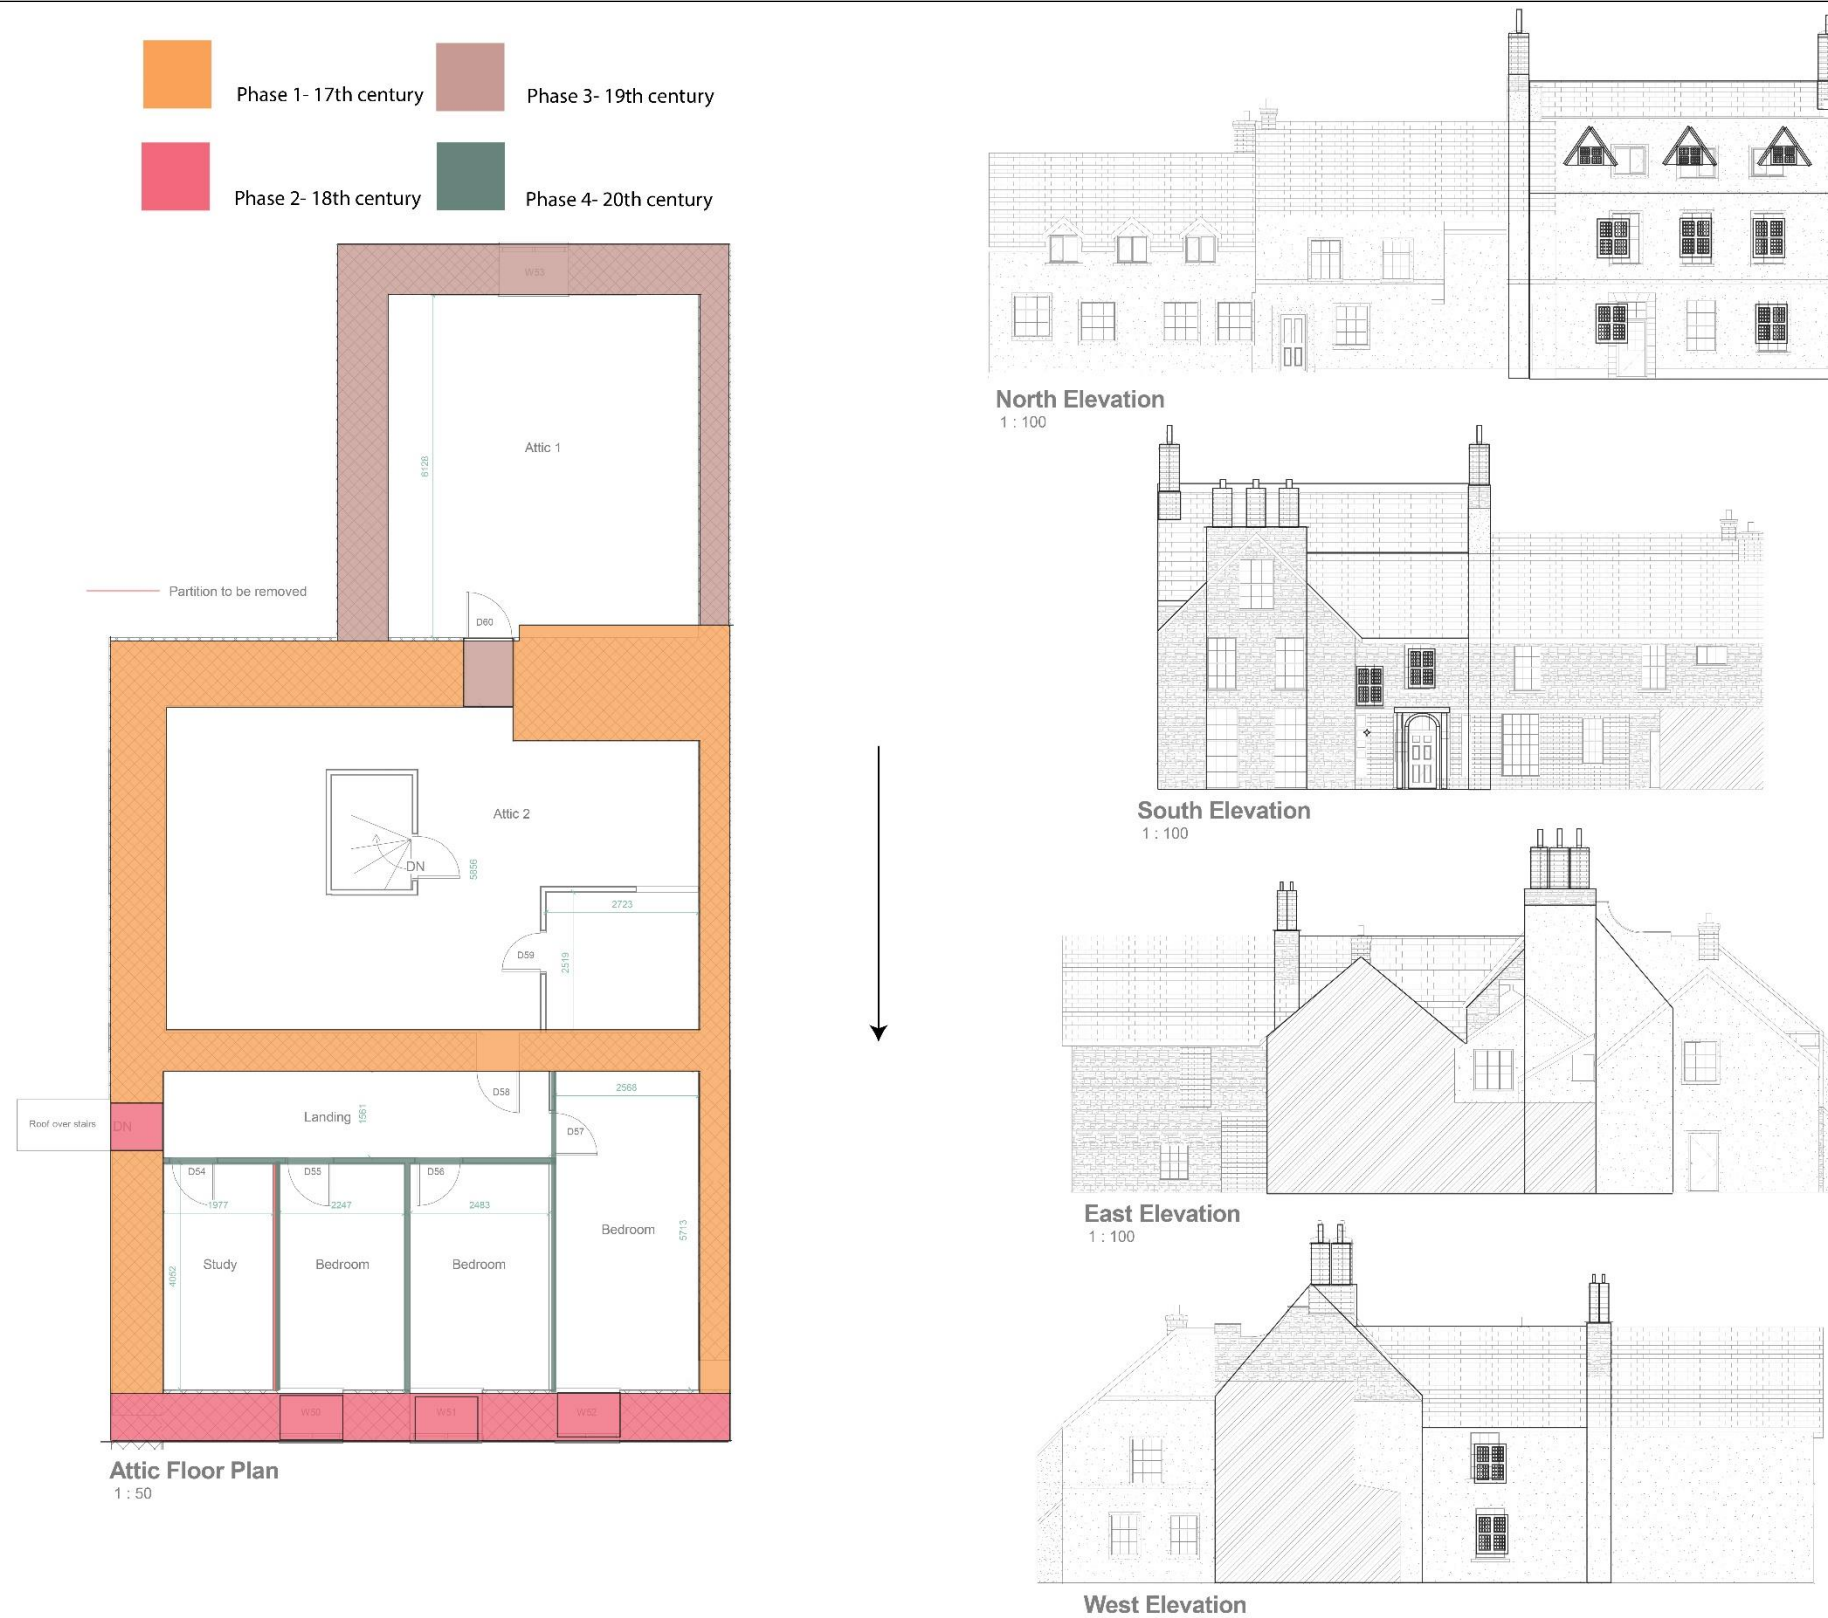
Fig. 30 Second floor plan showing construction phases (left) and position of original house in relation to existing structure (right)
