CPAT Report No. 1860

Old Farm, Isycoed, Wrexham

Heritage Impact Assessment

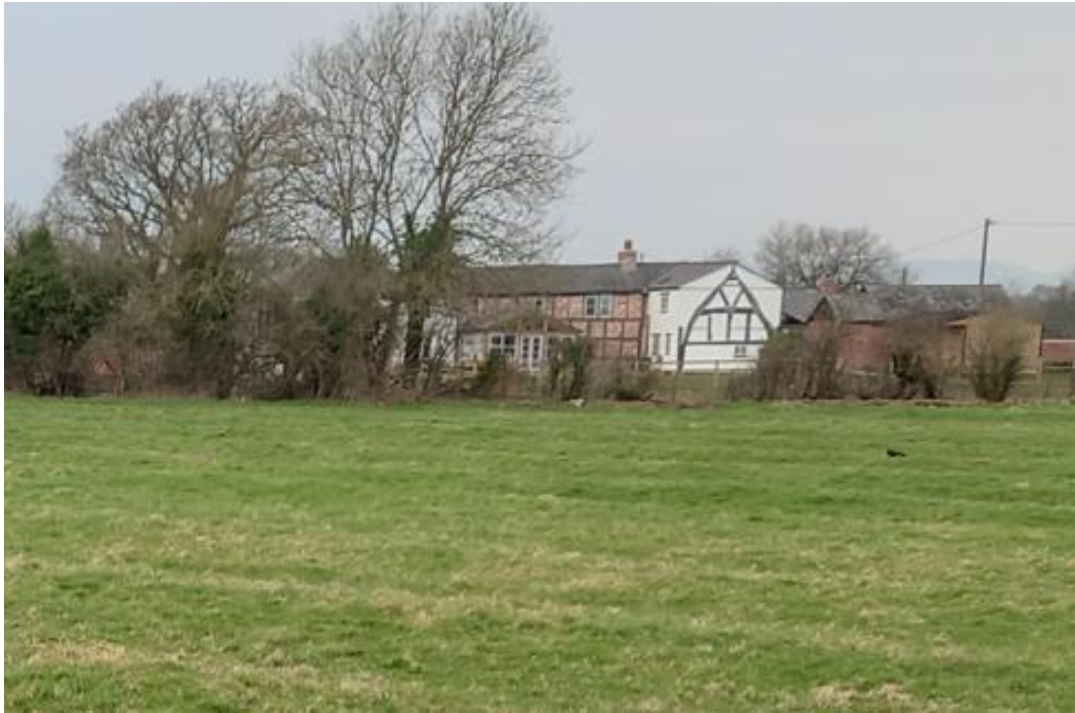
The closest listed building is Chapel House Farm House (LB number 1597) which the northern boundary of the proposed development site wraps around. Built as a medieval cruck house in the 15th or 16th centuries (Figure 2), the roof and walls have been raised and a range added in the 18th or 19th centuries. The timber-framing is infilled with bricks and a light scantling extends from the outer faces of the cruck blades.

Fig. 2 The cruck- and timber-frame house at Chapel House Farm with ridge and furrow in field to east of it

Ridge and furrow cultivation was not seen as earthworks within the proposed solar farm fields, but it was evident in the north-western field within the red line boundary (Figure 14). It was also evident to the west of the church, in the field between this and Chapel House Farm (Front Cover photograph and Figure 2).

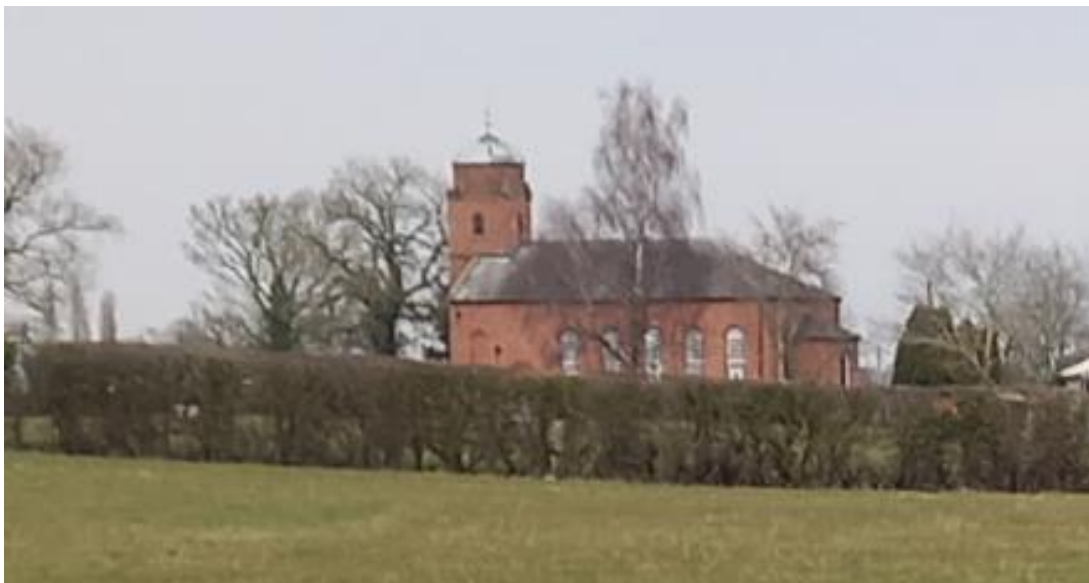
The church of St Paul (LB number 17815) is located c100m north-east of the site boundary (Figure 3). It was constructed in red brick in 1829, but on the site of an earlier one from the 18th century. Formerly the community had been included in the parish of Holt, but in 1827 it became a separate parish. The listing description refers to it as a simple late Georgian style, constructed in flemish bond with light headers to give a chequered effect. It has a rectangular plan with a projecting sanctuary at the east end, and a slightly projecting tower at the west end. The east end is hipped and the roof is in slate.

Fig. 3 The Church of St Paul seen from the site looking north

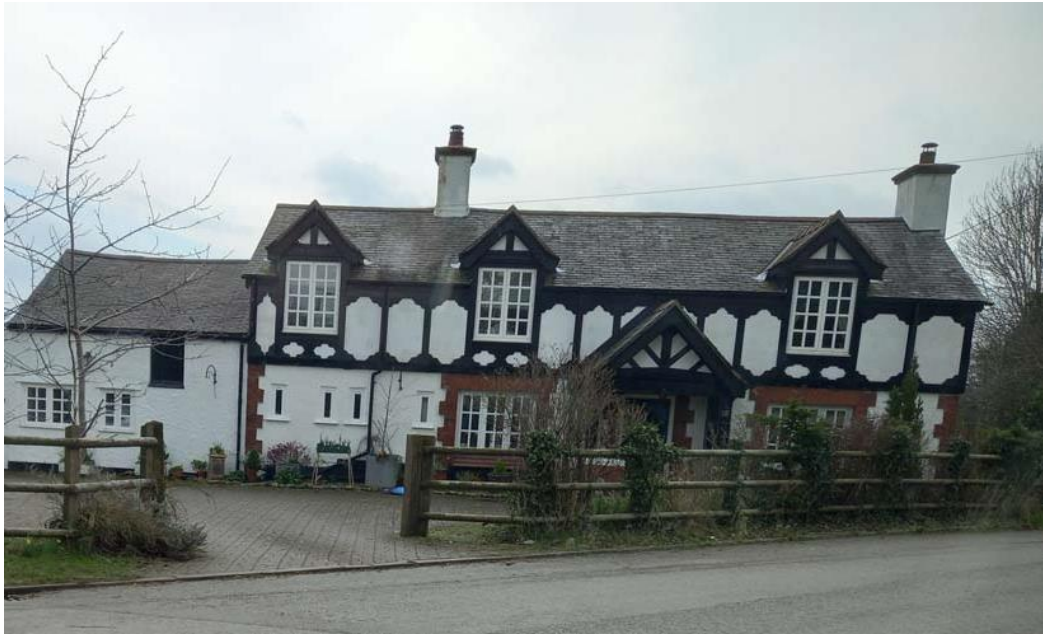
The Plough Inn (LB number 1598) is located just to the east of the church, but its 19th century appearance (Figure 4) hides origins as a cruck-framed house in the 15th or 16th centuries, with roof and walls raised in the 17th century, and then further changes in the 19th and 20th centuries. It is described as a single storey with attic dormers.

Fig. 4 The former Plough Inn looking east

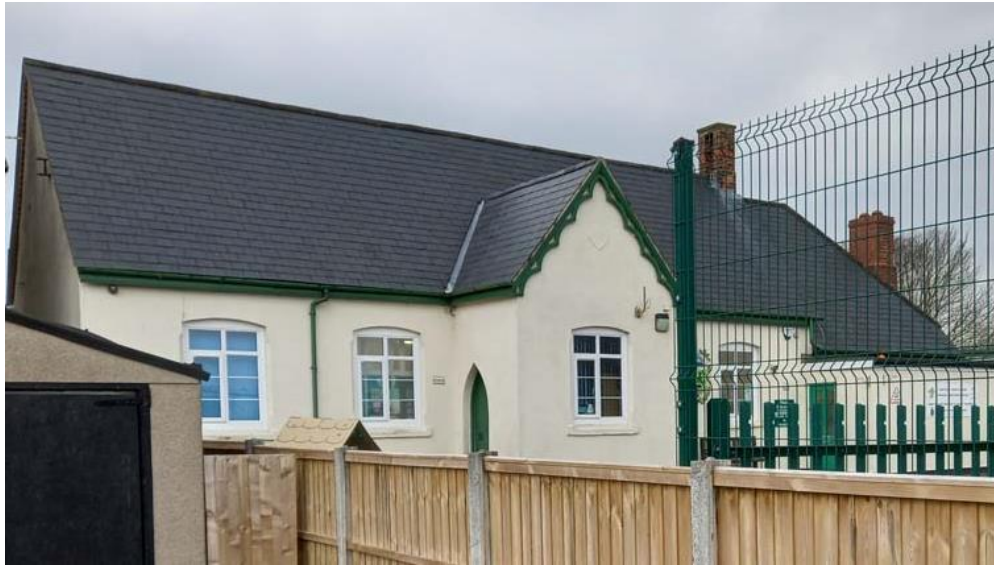
Fig. 5 The former independent meeting house now a school

Also in close proximity across the road at the north-western edge to the site, lies the school, which was formerly an independent meeting house (Figure 5) erected in 1817 (NPRN 7637). The HER includes an entry for the historic settlement of Isycoed (15678) noted to have been situated on a slight terrace above the Dee flood plain, and also for a WW2 airplane crash site in the vicinity (130230).

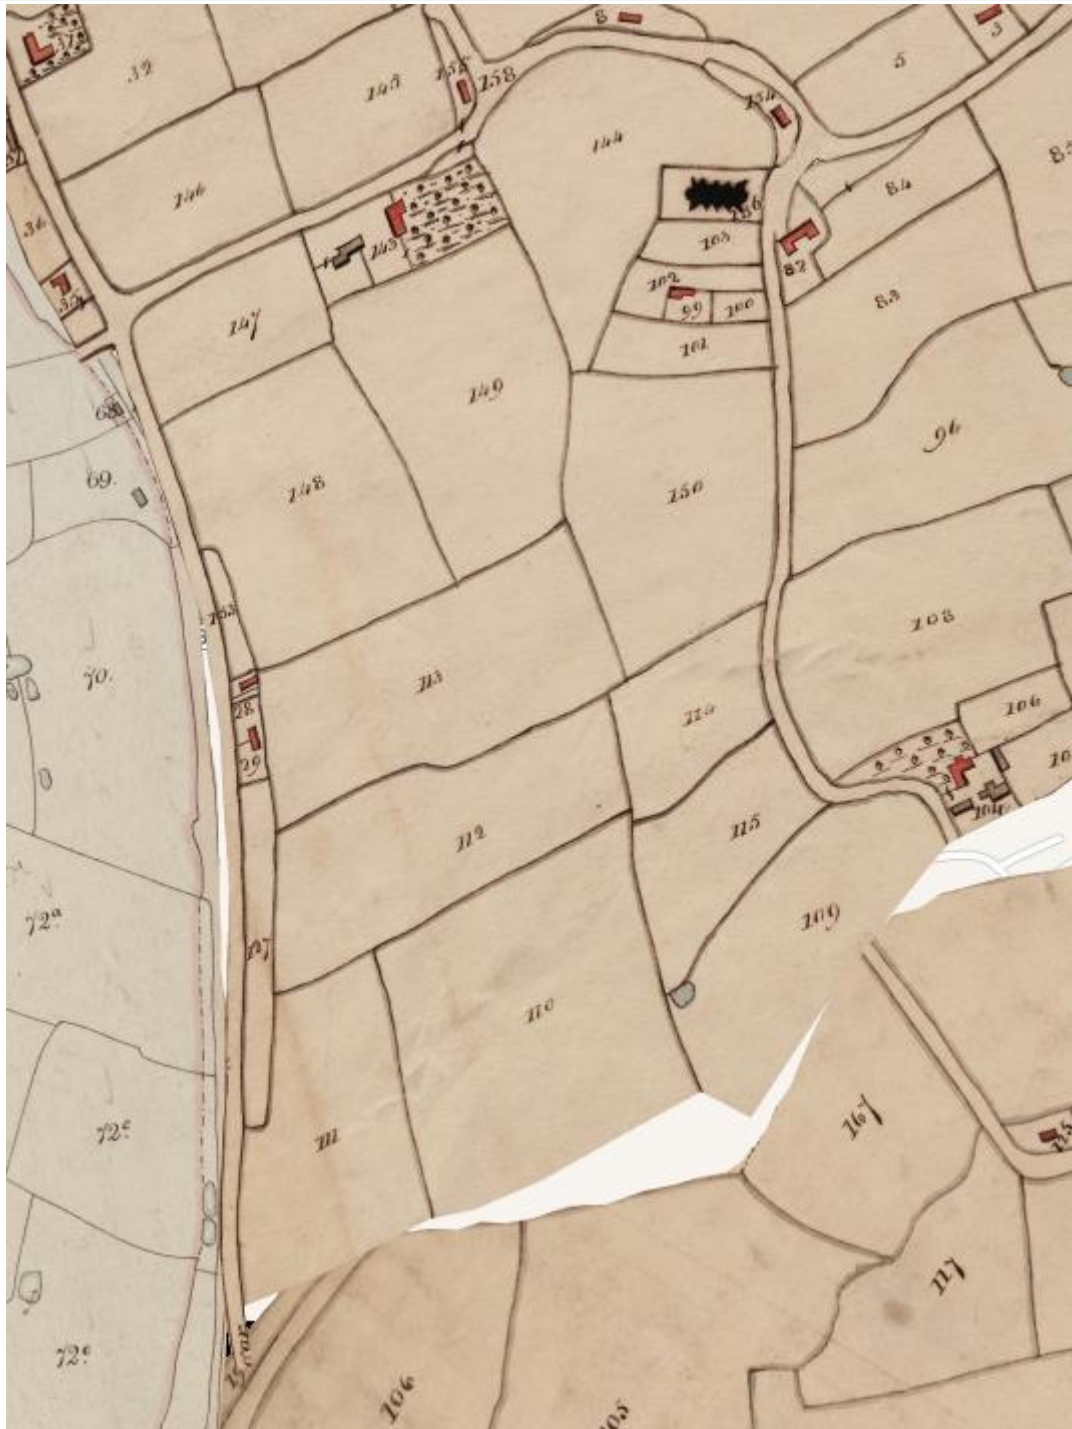
The Tithe map for Dutton Diffeth dated 1845 shows the site with a pattern of fields almost identical to what survives today (Figure 6). The apportionments show that the southern fields within the site were owned by the "Poor of Anglesea" and farmed by Robert Parker, whereas the northern fields and Chapel House Farm were owned by Brownlow Wynne Esq. and farmed by Phillip James (Table 1). Generally the eastern and north-western sides were in pasture and the south-western side arable. The first edition Ordnance Survey map at 1:10560 scale surveyed in 1872 (published 1879 (Figure 7)) shows a very similar field pattern.

Fig. 6 1845 Tithe map of the Site (Map of the township of Dutton Diffeth)

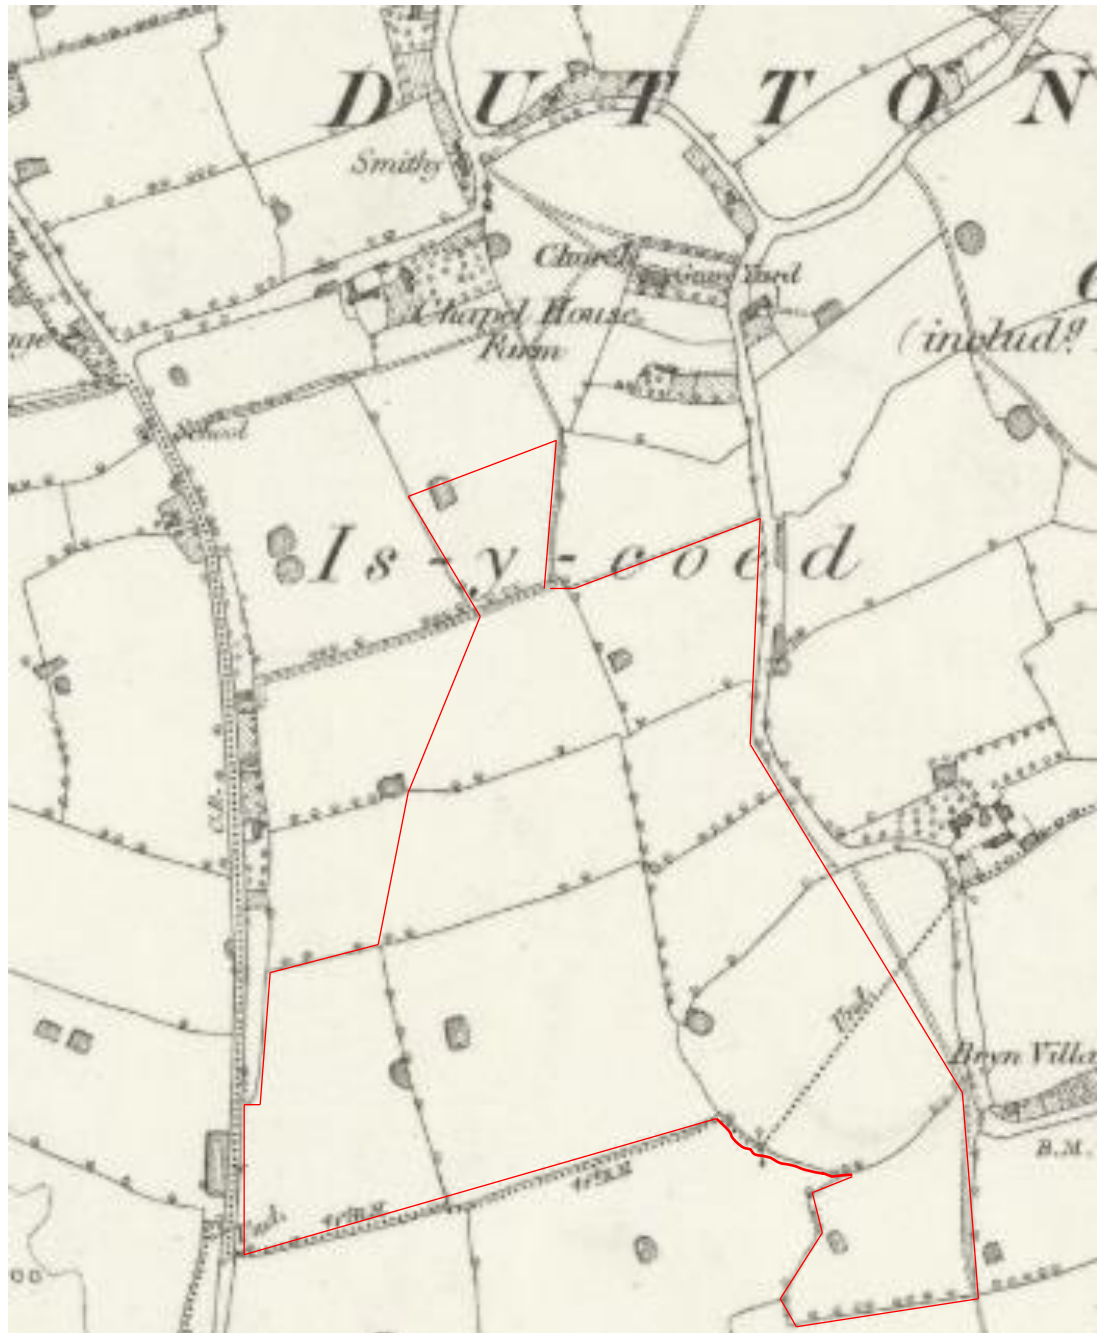
Fig. 7 1879 Ordnance Survey map at 1:10560 scale Denbigshire Sheet XXIX with proposed development area outlined in red

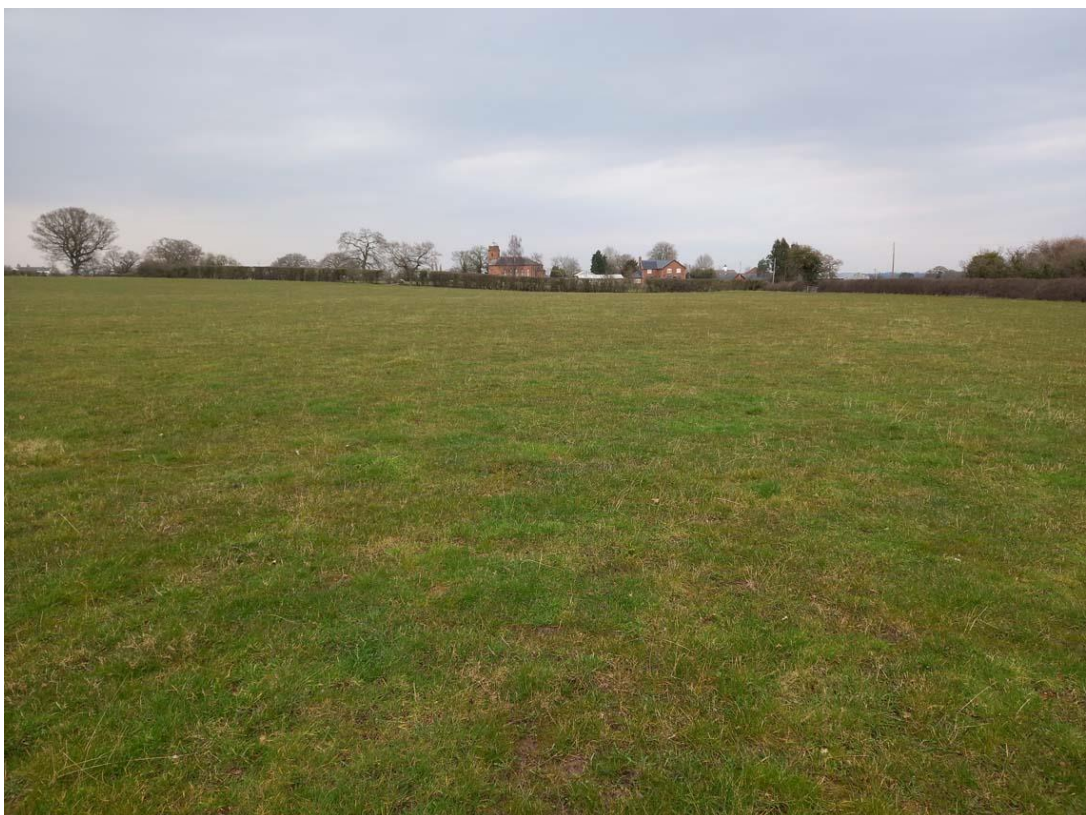
Views of the development site to and from the church were only possible at the north-eastern limits of the proposed development, and intervening hedges and trees reduce the intervisibility (Figures 12 and 13). The same minimal lack of intervisibility is even more pronounced for Chapel House Farm, and there is no intervisibility with the other listed buildings.

Fig. 12 View north across north-eastern part of site with St Paul's church in background

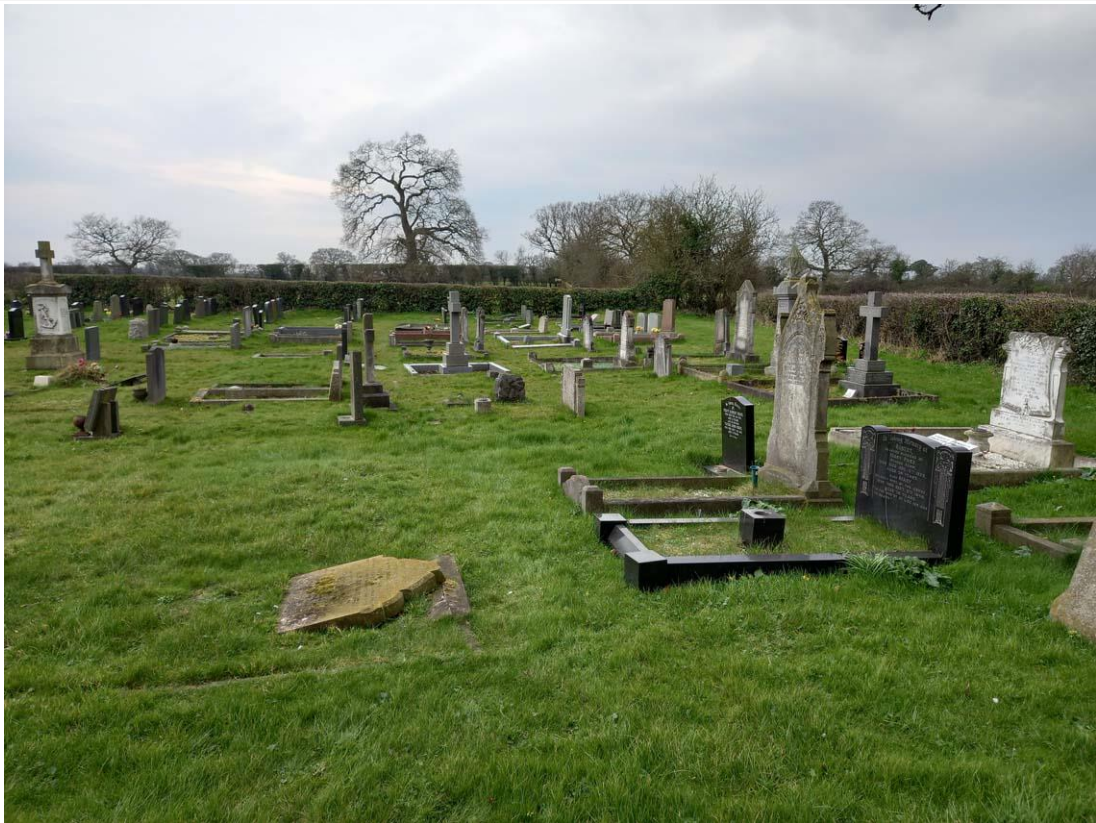
Fig. 13 View south towards north-western part of site from the church

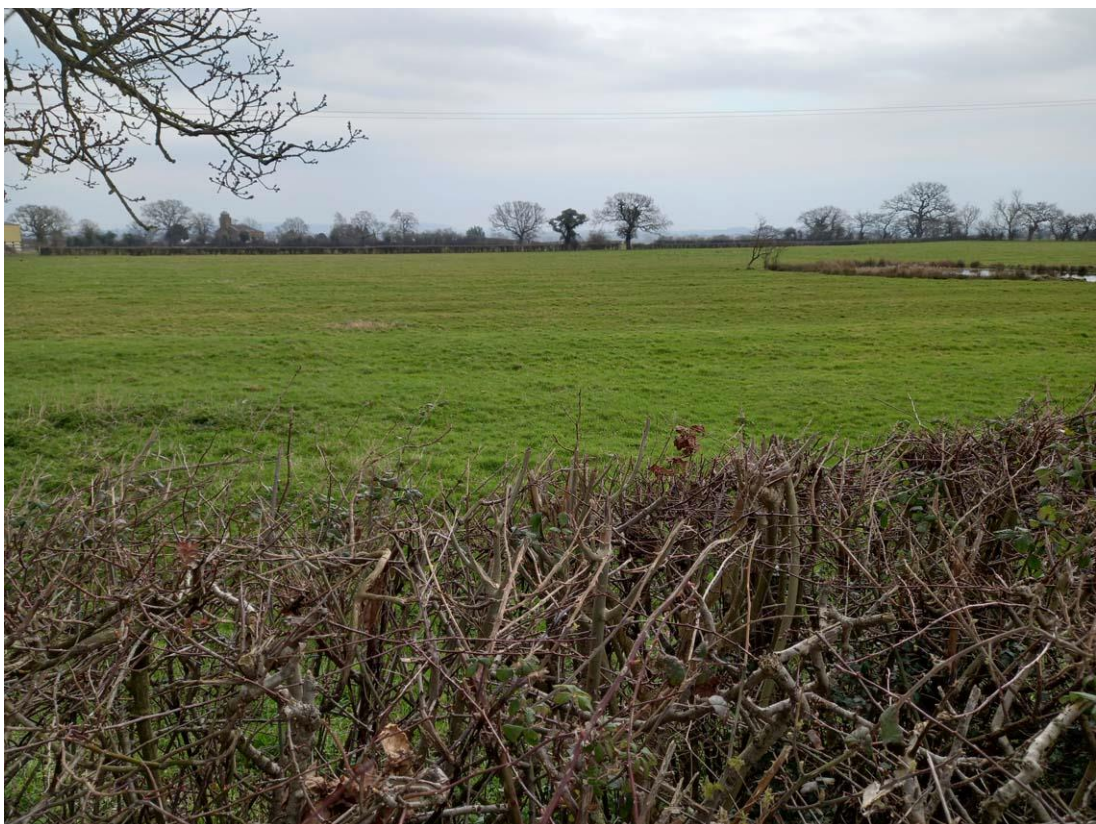
Fig. 14 View south-east towards north-western part of site with ridge & furrow in near field
