Diamond, Cardigan Bay

Designated Site Assessment:

Full Report

DIAMOND, SARN BADRIG, CARDIGAN BAY

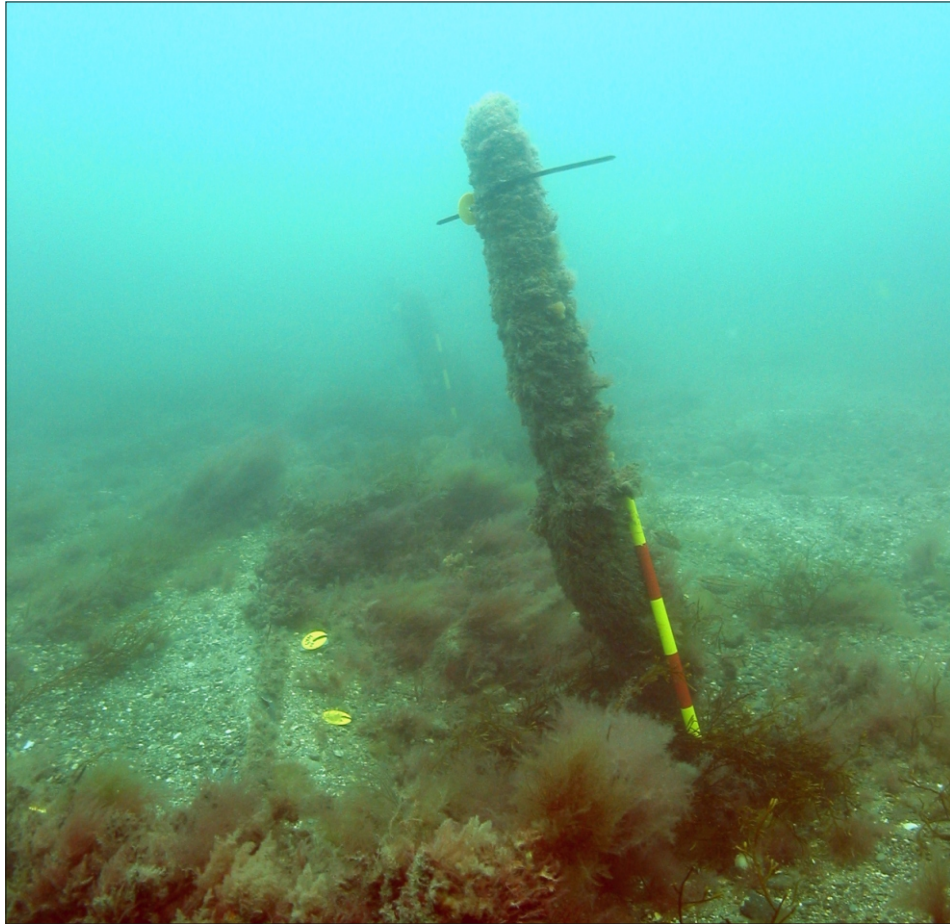
Plate 1: General view of southern edge of site, looking west-north-west

- 5.4.2. All of the surveyed features are contained within an area that measures approximately 52 metres east-west and 20 metres north-south (i.e. an area of 1040 square metres). Within that the main area of the site consists of a slightly irregular flattened oval that is very approximately 44 metres long by 10 metres wide (**Figure 2**). The long axis of this oval is orientated approximately east - west. Most of the iron features and cuprous sheathing lie around the edges of this oval. Most of the remaining archaeological features, including the ballast mound and iron boxes lie within the oval. Isolated areas of features were observed outside of this area. A general view of features located on the southern periphery of the site is shown in **Plate 1**.

- **MP3** – (**Plate 1**) is a view of the exposed run of sheathing (**WA52**) and knee-riders **WA54** and **WA55** on the southern edge of the site, taken from the east. Repeats of this photograph at yearly intervals will allow gross changes in the level of the seabed around the south side of the surviving hull to be monitored.

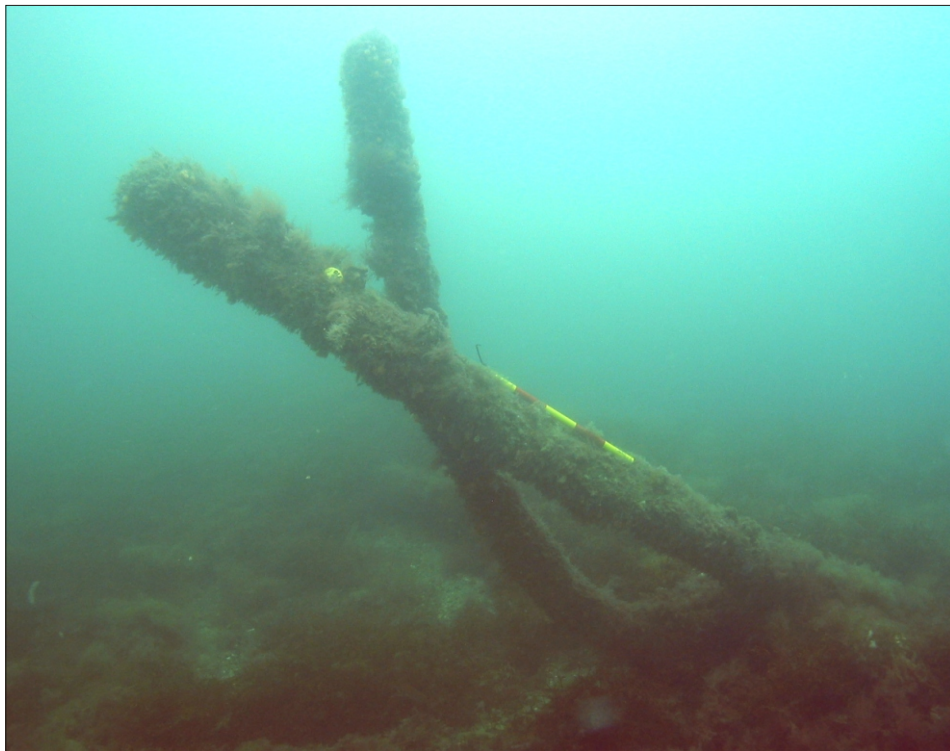
Plate 2: Knee-riders WA18 and WA19

suggestive of this. **Plate 2** shows two examples of *in situ* features of this type from the northern alignment. Although the short arms are now missing, these *in situ* features demonstrate that they were vertically aligned and that the curved arm is the lower arm and the straight arm is the upper arm. The curve faces south and the straight arm would have pointed across the site towards the southern alignment. It is not known whether these features are made of wrought or cast iron. Selective examples of these features are described in the following paragraphs.

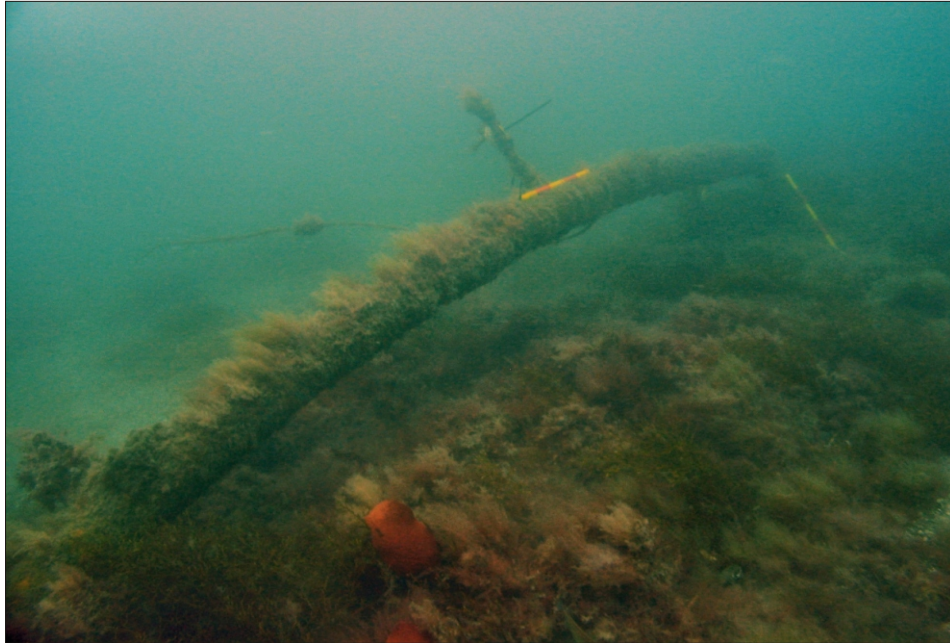
Plate 3: Knee-rider WA13

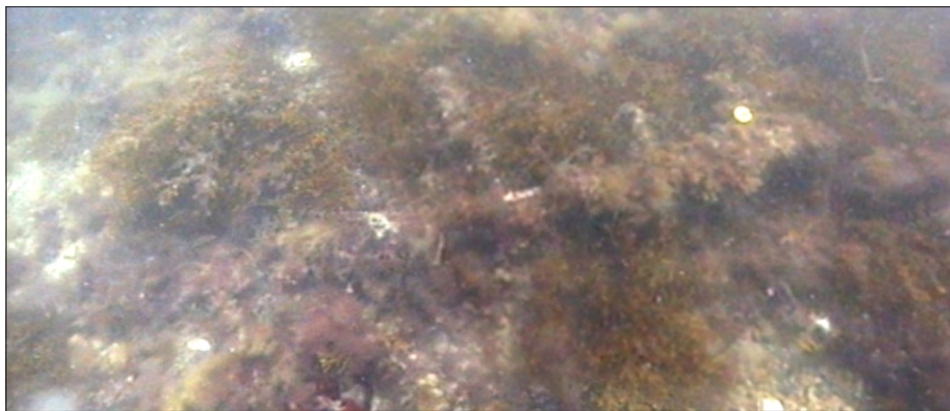
Plate 4: Iron reinforcement WA35

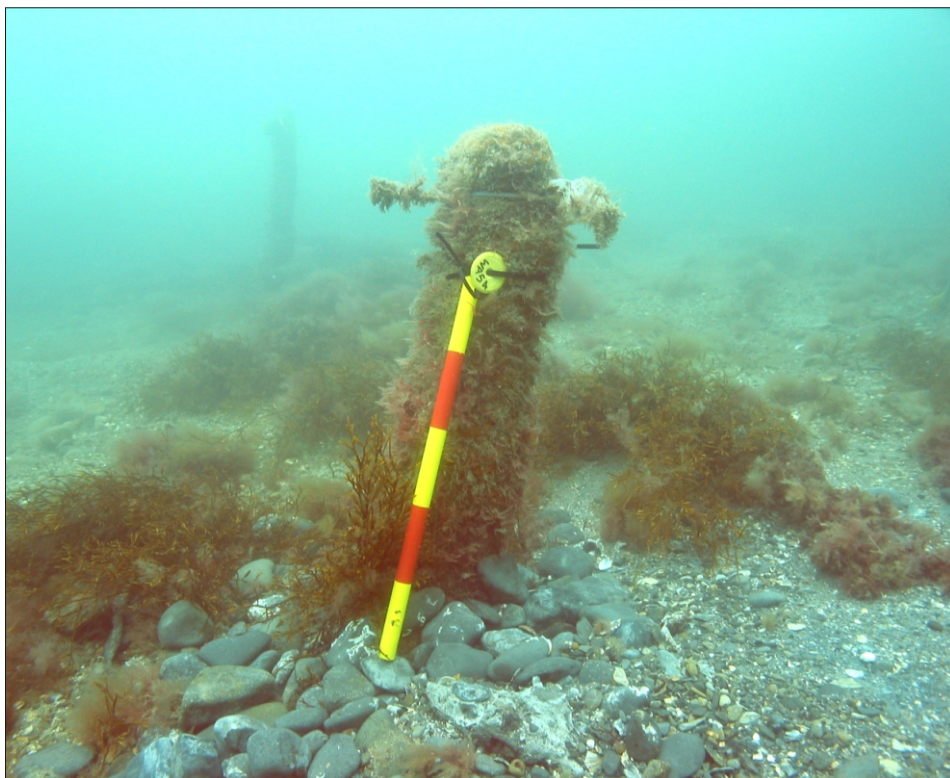
Plate 5: Knee-rider WA54

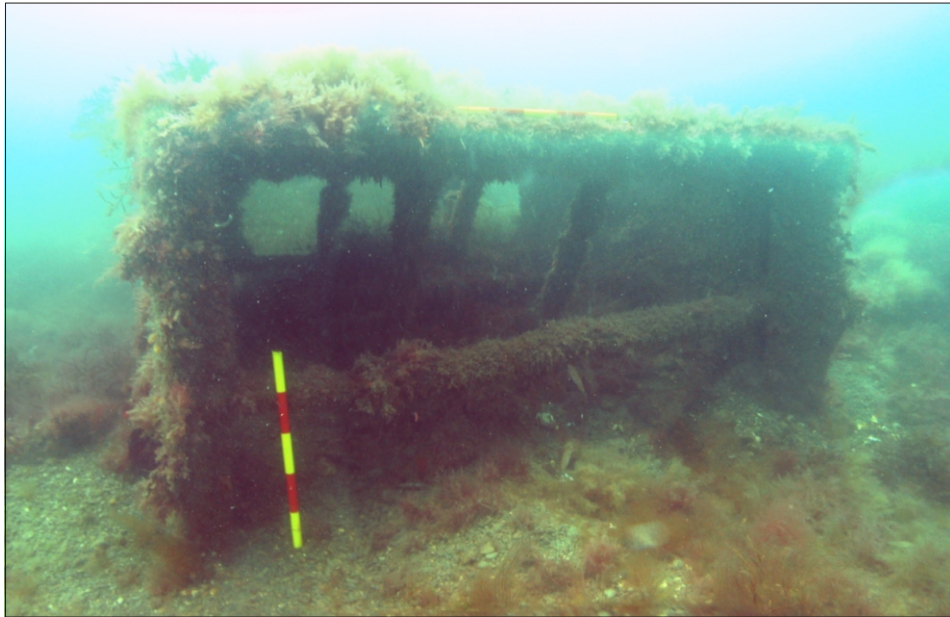
5.4.23. **WA27** is a large iron box on the northern edge of the site (**Figure 2**). It is partly buried, but is exposed to a height of approximately 1.04 metres. It is rectangular in form, with flat iron plate sides and upper surface, except for the south west facing side, which is open. The plates are generally fragmentary with significant holes in places caused by the decay of the metal (**Plate 10**). The box is internally braced by iron bars (**Plate 10**). Measurements of the sides produced a slightly irregular result but this is likely to have been affected by concretion and marine growth and the box is at least 1.90-1.98 by 2.95-3.00 metres in size (measurements to the top edges of the side plates).

- 5.4.26. The purpose of these iron boxes is uncertain. It has been suggested by previous investigators of this site that the boxes are tanks and that the most probable explanation is that they are the remains of water tanks. MacGregor (1984(b); 147) cites the naval architect J.Bennett, commenting on progress in the use of iron in ship design in the 1820s, as saying that wooden casks (of water) were being replaced by iron tanks. By the mid-19th Century it was not uncommon to see water tanks being shown in the plans of naval architects.

Plate 10: Iron box WA27

- 5.10.2. The photographs are listed as follows:
 - **MP1** – (**Plate 10**) is a view of **WA27** taken from the north. This feature has been interpreted as a possible iron water tank and may therefore be an early and important survival of this type of ship fitting. It is corroding and is currently unprotected, and is likely to be subject to further corrosion and eventual collapse. It is also vulnerable to any fishing or anchoring operations that take place on the site. Repeats of this photograph at intervals will allow gross damage to or gross changes in the condition of the structure of this feature, together with changes in seabed level relative to the feature to be monitored.

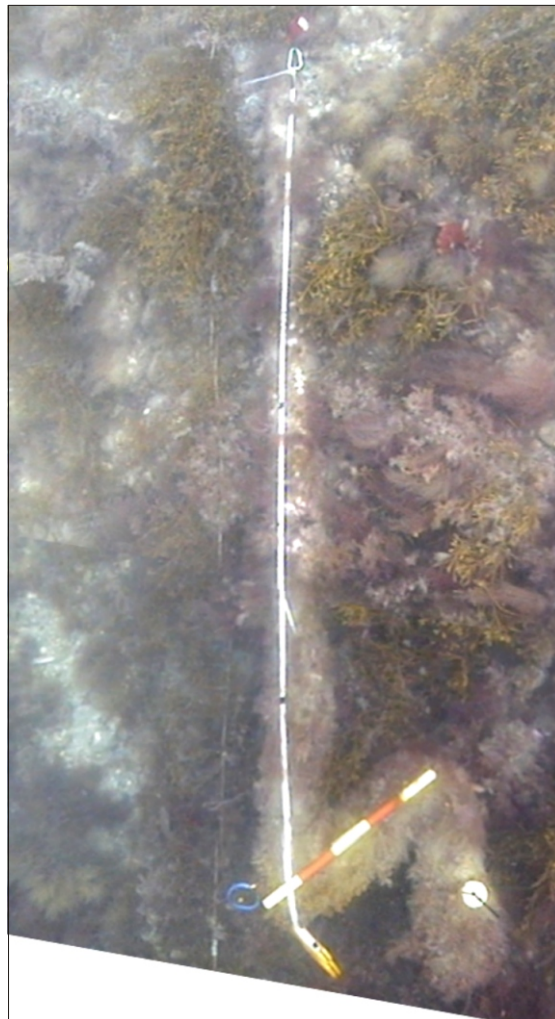
Plate 11: Iron reinforcement WA33

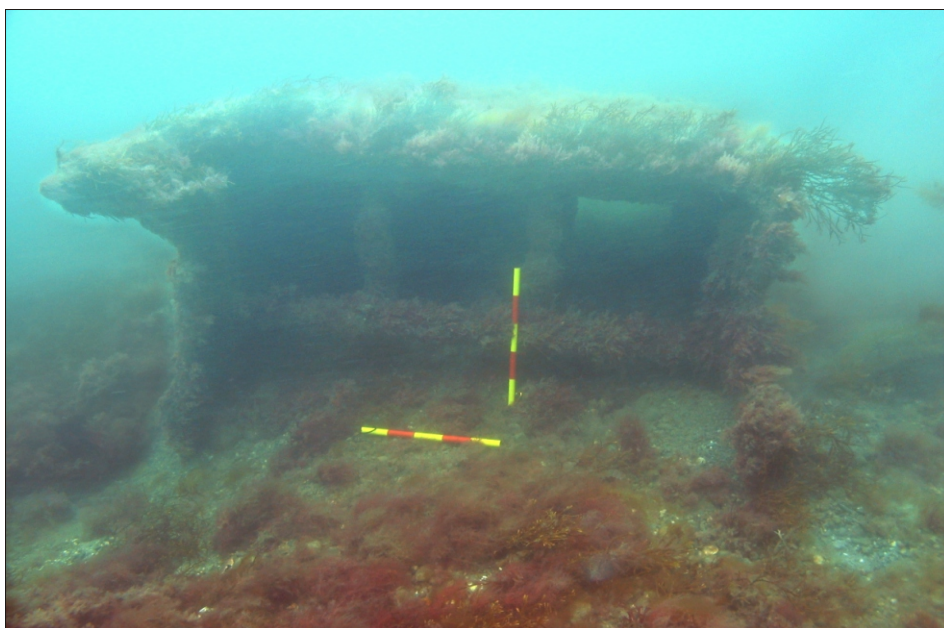
- 5.4.28. The starboard tank of the *Jhelum* was rebated along its forward edge to enable it to fit under a hold beam. This rebate is very similar to that noted on **WA46**. Like **WA46** it was internally braced and had lead piping (as observed on the *Diamond* site by Mr Iles). A characteristic of water tanks of this period was a thin internal coating of cement to stop contamination with rust (Stammers and Keaton, 1992) but no detailed examination of the interior of the *Diamond's* tanks was carried out due to time constraints.

Plate 12: Iron boxWA46/09

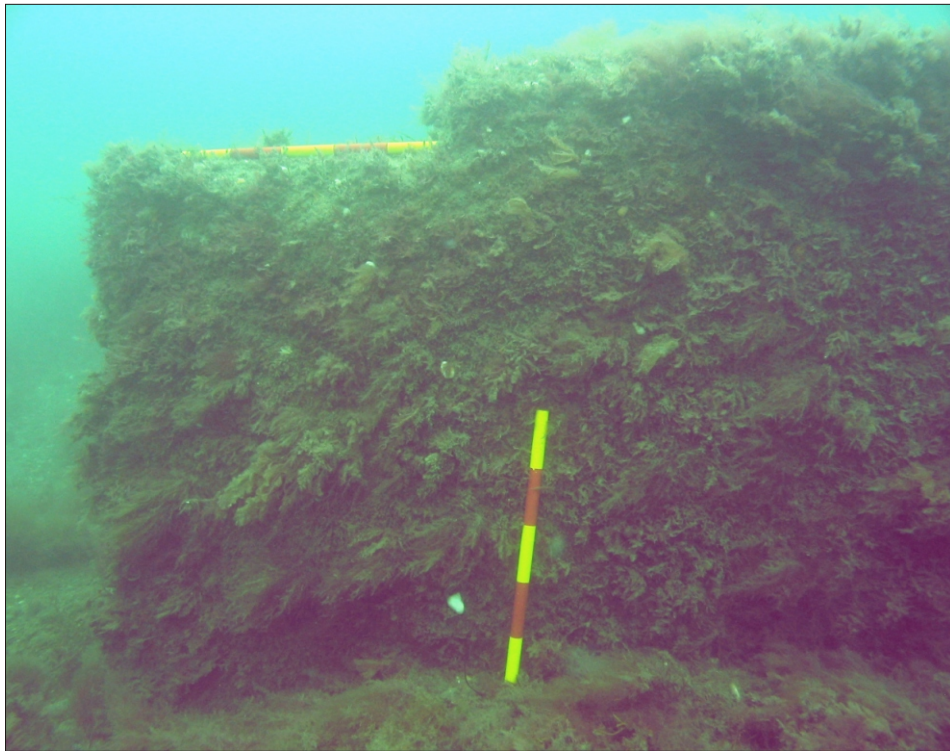
Plate 14: WA46 - detail (constructional feature)

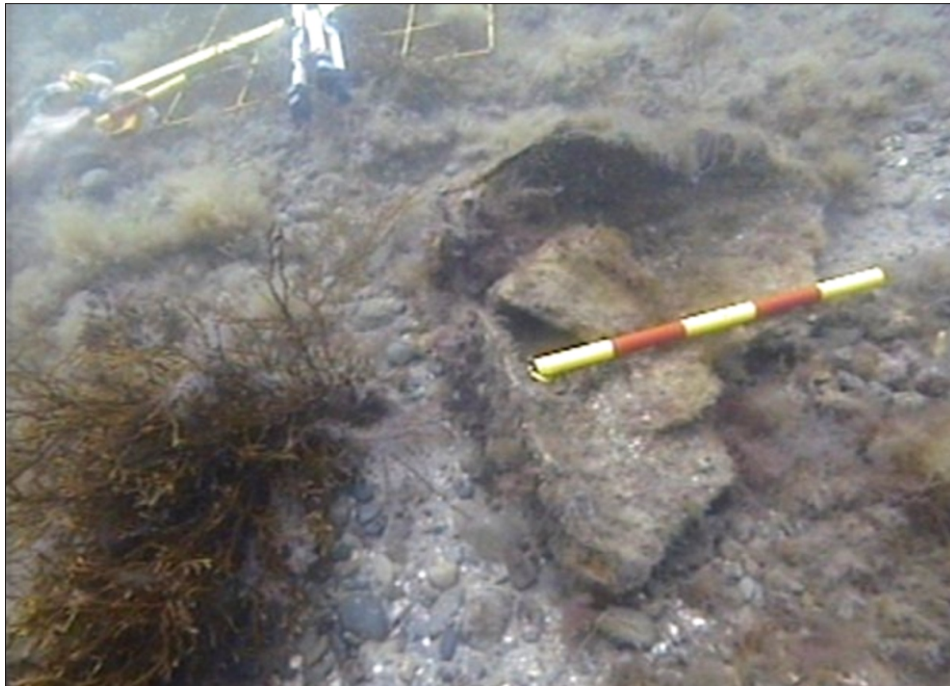
Plate 16: Iron plate fragment WA93
