UNMANNED SITES INTERPRETATION INSTALLATIONS - WATCHING BRIEF REPORT

CN006 SEGONTIUM ROMAN SITE AN011 TREFIGNATH BURIAL CHAMBER AN016 HOLYHEAD MOUNTAIN HUT CIRCLES

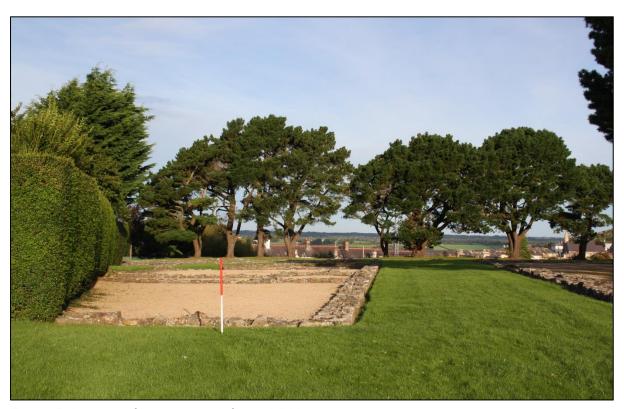
Figure 5: Location for new panel, facing NW

The panel was to be placed in a position identified previously by Adele Thackray (Cadw) to the contractor, at SH 48579 62395. After discussion the panel was rotated to reflect the view shown on the panel with the actual view. A Im x 0.6m x 0.2m deep hole, aligned NE-SW, was hand dug for the insertion of a steel box frame to hold the feet of the panel, which were then set into concrete contained within the box. All material was excavated onto a plastic sheet to minimise impact on the grass. The entire excavated material comprised a dark greyish-black loamy-silt topsoil (01) with c.5% slate chips and pebbles. Four sherds of 18th and 19th century ceramic and a fragment of bottle glass, and a single sherd of residual Roman ceramic were retrieved (see Appendix 1). After installation of the panel, the turf was relaid over the excavated area.

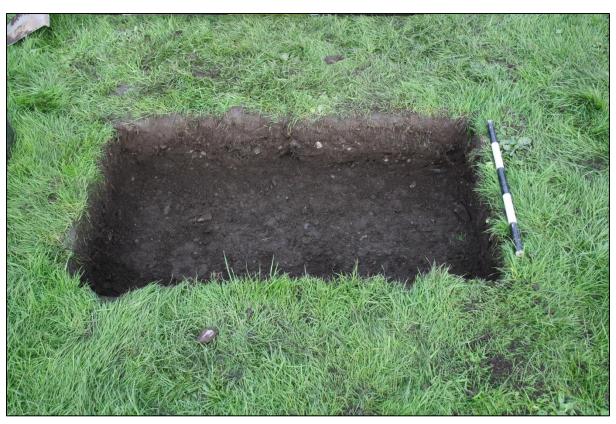
Figure 6: Trench for new panel, after excavation, facing NW

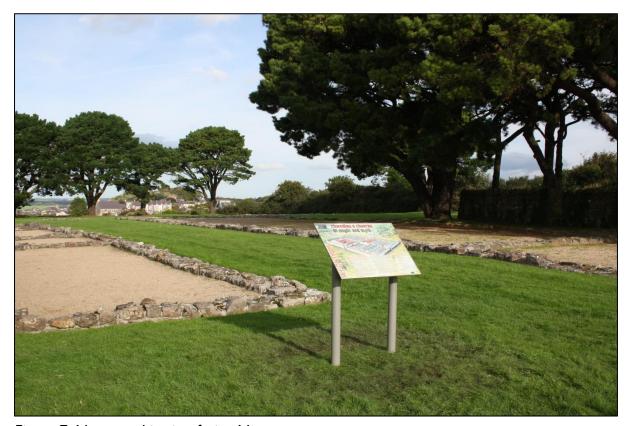
Figure 7: New panel in situ, facing N

No deposits of archaeological significance were disturbed by the installation of the new interpretation panel. The material excavated probably reflects late post-Medieval levelling and disturbance material, derived from earlier excavations of the main site, and local development of modern housing. This is reflected in the ceramic and glass evidence.

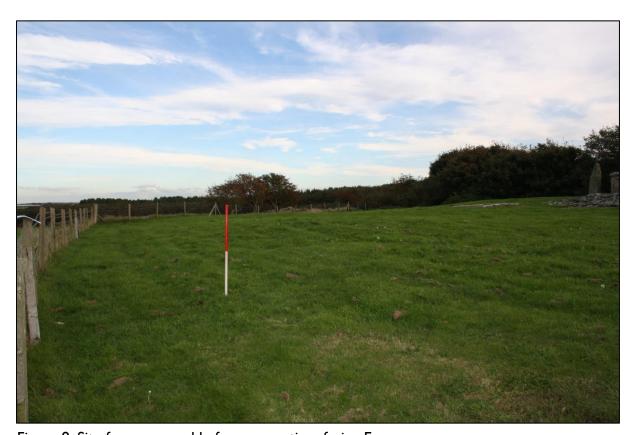
Figure 8: Site for new panel before excavation, facing E

The panel was to be placed in a position identified previously by Adele Thackray and Erin Lloyd-Jones (Cadw) to the contractor at SH25853 80572. A Im x Im hole was hand dug for the insertion of a steel box frame to hold the feet of the panel, which were then set into concrete contained within the box. The excavation revealed a dark blackish-brown clay-silt (01) with occasional schist pebbles (<10%), overlying the natural schist bed-rock (02) which falls away sharply to the north. All material was excavated onto a plastic sheet to minimise impact on the grass. The turf was then relaid over the excavated area. Six sherds of 19th and early 20th century ceramic were retrieved (see Appendix 1).

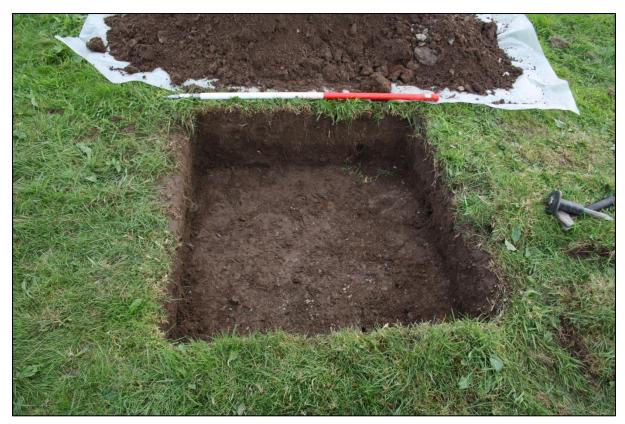
Figure 9: Site for new panel after excavation, facing S

No deposits of archaeological significance were disturbed by the installation of the new interpretation panel. The material excavated probably reflects late post-Medieval levelling and disturbance material, derived from earlier excavations of the main site, and local agricultural activity. This is reflected in the ceramic evidence.

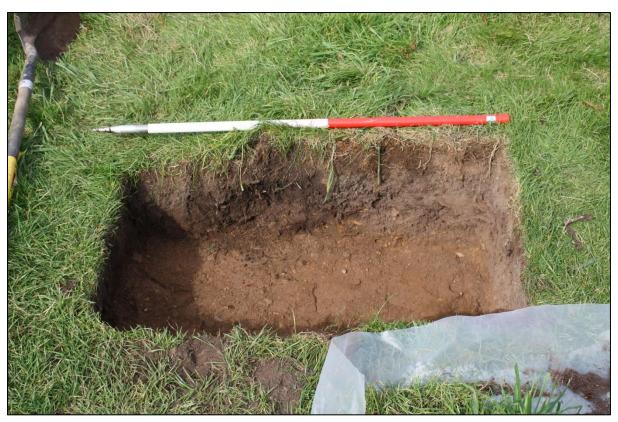
Figure 10: Trench for new panel, I after excavation, facing NW

This was located at SH21064 81794, adjacent to the stile and gate onto the road. A Im x 0.6m hole, aligned NE-SW, was hand dug for the insertion of a steel box frame to hold the feet of the panel, which were then set into concrete contained within the box. As the hole was dug into a slope, it was 0.2m deep at the south-western end, but almost 0.4m deep at the upslope, north-eastern end. All material was excavated onto a plastic sheet to minimise impact on the grass. The excavation revealed an orange-brown subsoil with iron staining (03), overlain by up to 0.2m of greyish-brown sandy-silt (02). The uppermost deposit comprised a rooty, peaty brown topsoil (01) with bracken roots. There were no artefacts recovered. After installation of the panel, the turf was then relaid over the excavated area.

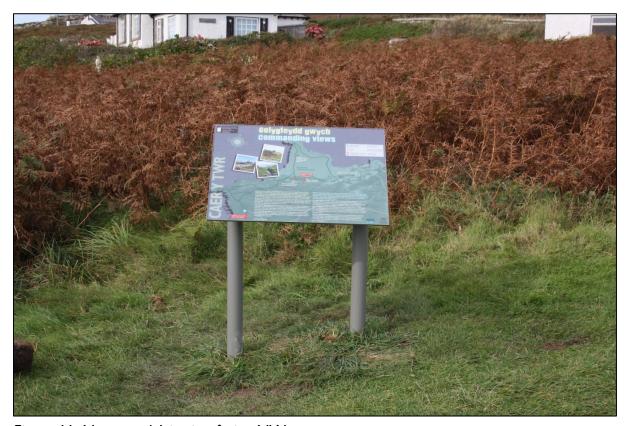
Figure 11: New panel 1 in situ, facing NW

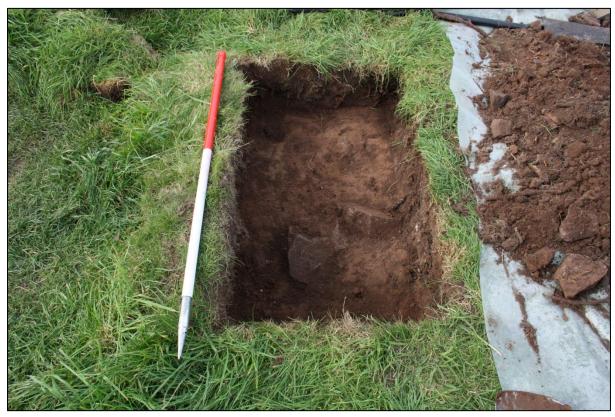
Figure 12: Trench for panel 2, part-excavated, facing NW

This was located at SH21123 81953. A $Im \times 0.6m \times 0.2m$ deep hole, aligned NW – SE, was hand dug for the insertion of a steel box frame to hold the feet of the panel, which were then set into concrete contained within the box. All material was excavated onto a plastic sheet to minimise impact on the grass. The excavation revealed a firm, orange-brown claysilt (04). It is possible that this reflects an old ground surface, related to the earlier excavations at the site, and/or to the adjacent hut circle itself. Towards the south-eastern end of the trench were two angular/sub-angular stones up to 0.25m diameter, embedded in the base of the trench. Two areas of disturbance in the SE and SW corners represented the holes for the earlier panel. The basal deposit was overlain by a 0.10-0.12m thick relatively loose, grey-brown sandy-silt (03) with frequent angular stone (c.40%), and bracken roots. This was interpreted as probable back-filling from earlier excavations of the adjacent hut circle. A leached podzol layer and associated lower iron deposit overlay this (02) with a rooty layer above (01). There were no artefacts recovered. After installation of the panel, the turf was then relaid over the excavated area.

No deposits of archaeological significance were disturbed by the installation of the new interpretation panels. It is possible that the deposit (04) revealed in the base of the trench for Panel 2 reflects an old ground surface, related to the earlier excavations at the site, and/or to the adjacent hut circle itself. Certainty of this interpretation would only be confirmed by further investigation.

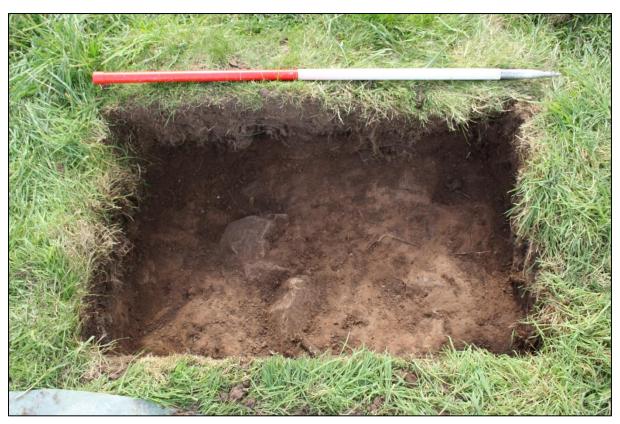
Figure 13: Trench for panel 2, part-excavated, facing SW

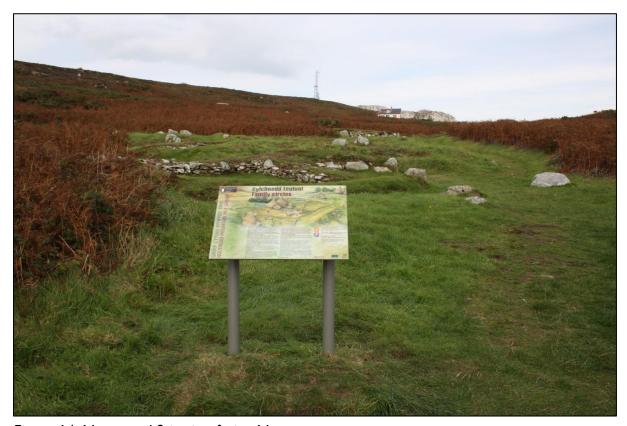
Figure 14: New panel 2 in situ, facing N

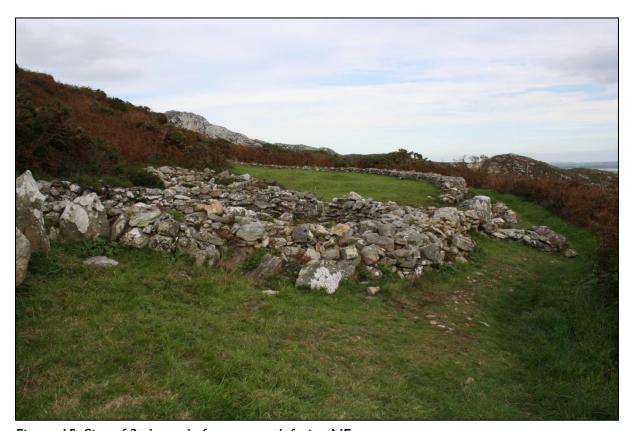
Figure 15: Site of 3rd panel after removal, facing NE

(Removal of earlier panel only). The legs of the earlier panel were cut through at ground level using an angle grinder, and sharp edges flattened. No ground disturbance took place. This was located at SH21327 82122.
