**The Cottage, Sant
Ffraed House**

**Heritage Impact
Statement and Historic
Building Record
Planning Ref.
DM/2023/00951**

Prepared by:
**The Environmental Dimension
Partnership Ltd**

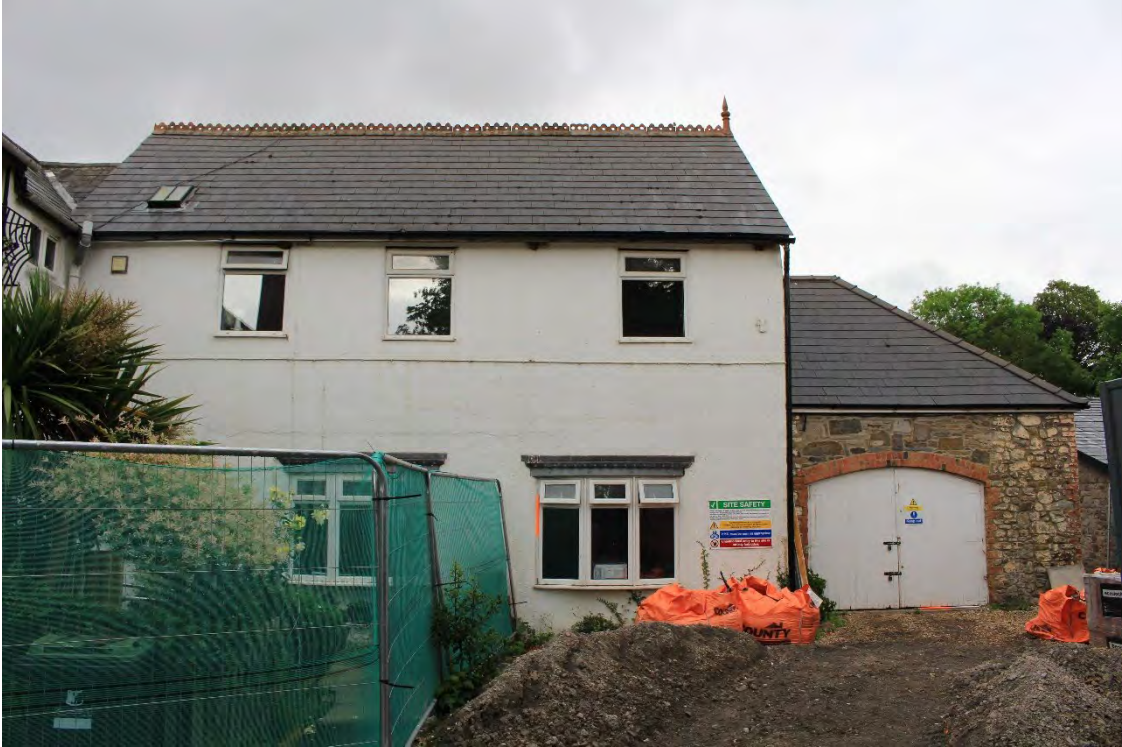
Image EDP A1.1: View of the western elevation of the 'Cottage', looking east. Showing the two-storey section and 'coach house' section to right.

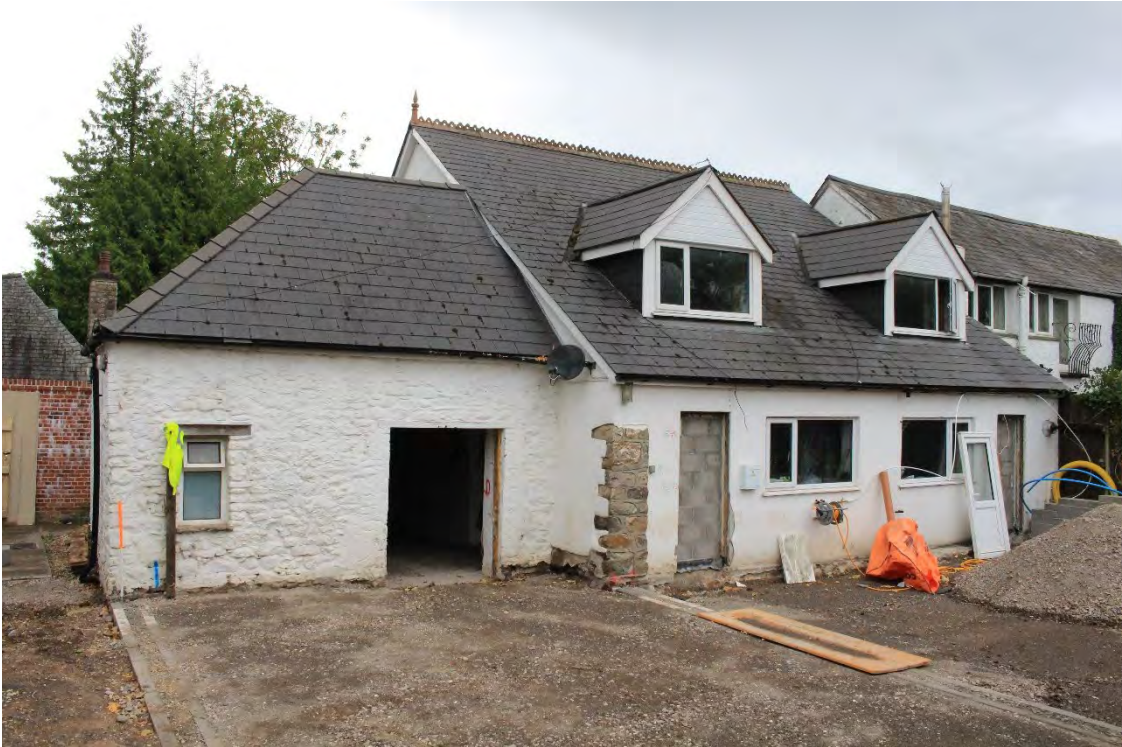
Image EDP A1.2: View of the eastern elevation of the 'Cottage', showing the main section to right and 'coach house' section to left. The majority of the fabric on the main section, shown here, is later 20th century in date.

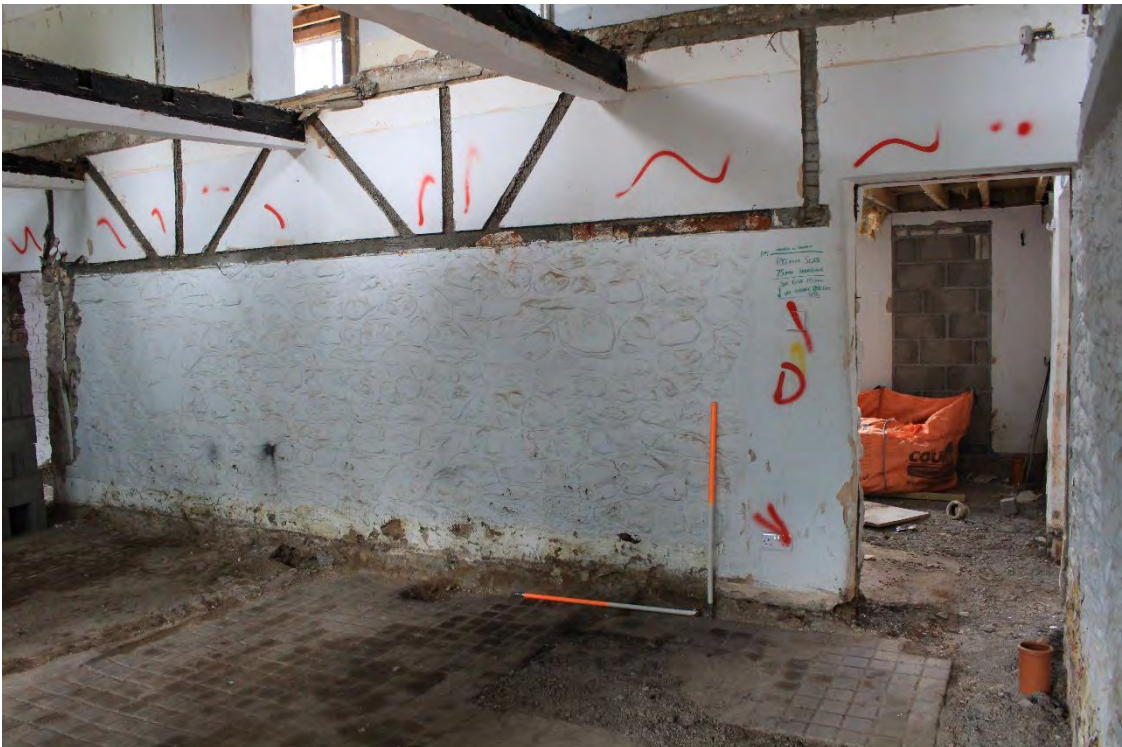
Image EDP A1.3: View of the stone spine wall dividing G1 and G2, with brick on the upper part of the wall.

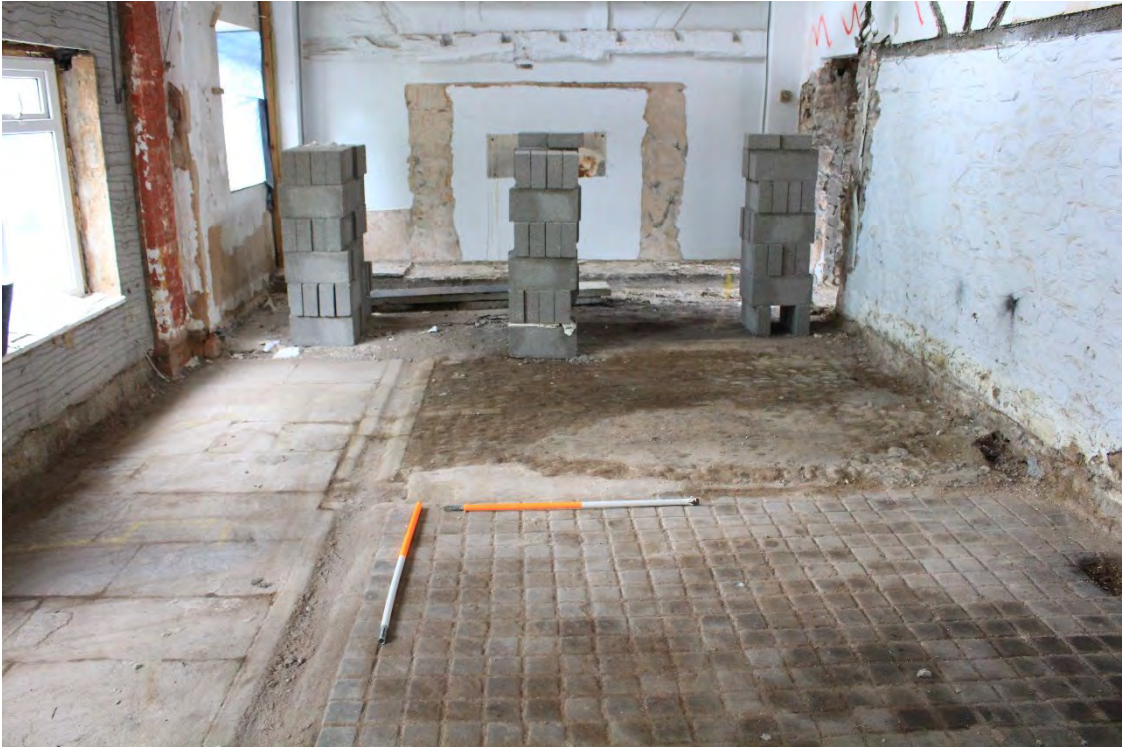
- 4.24 The westernmost room (G1) has the floor exposed, with concrete and concrete plinth at the northern end, flagstones and drain noted along the western side and a small patch of cobbles to the east (**Images EDP A1.4-6**). The remainder is of 20th century stable bricks. The internal walls are exposed, along with the floor joists for the upper floor and these joists are all of square section sawn timber of 19th/20th century date with square joist notches (**Image EDP A1.7**).

Image EDP A1.4: General view of room G1 looking north, showing the flooring.

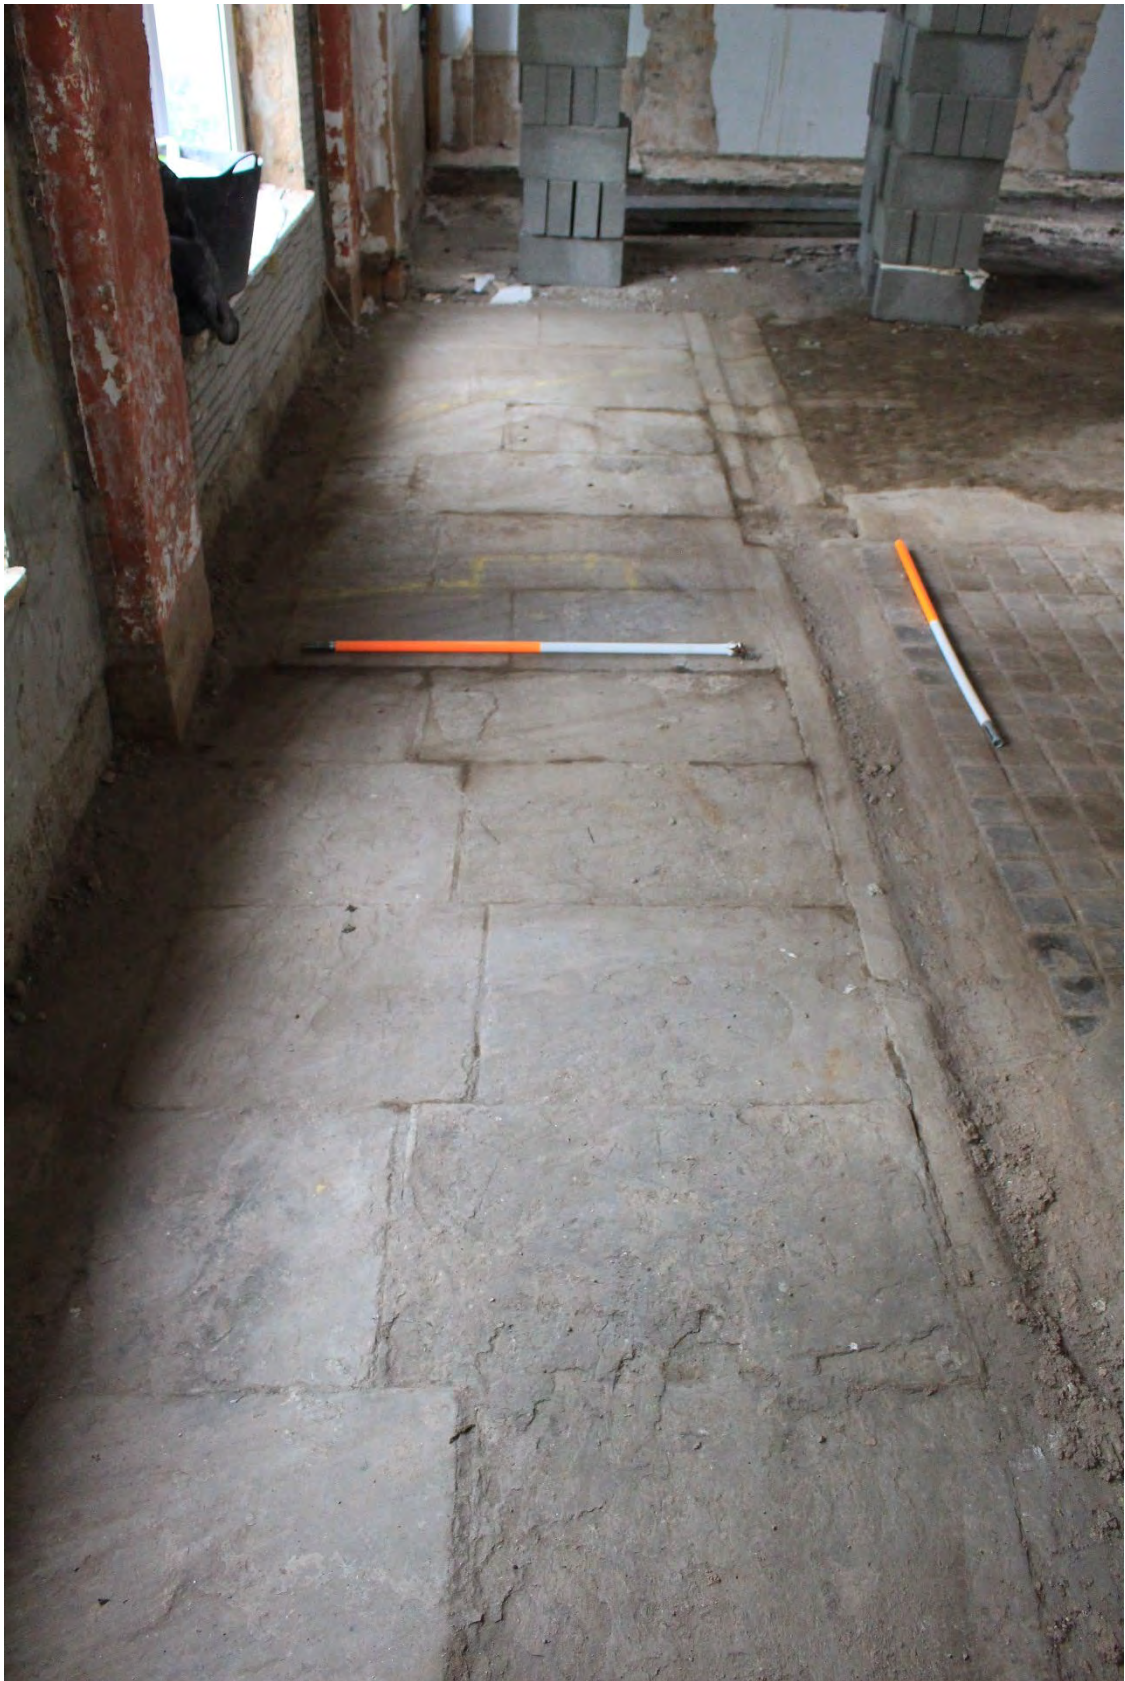
Image EDP A1.5: Detail of the flagstone section of the floor in G1, looking north.

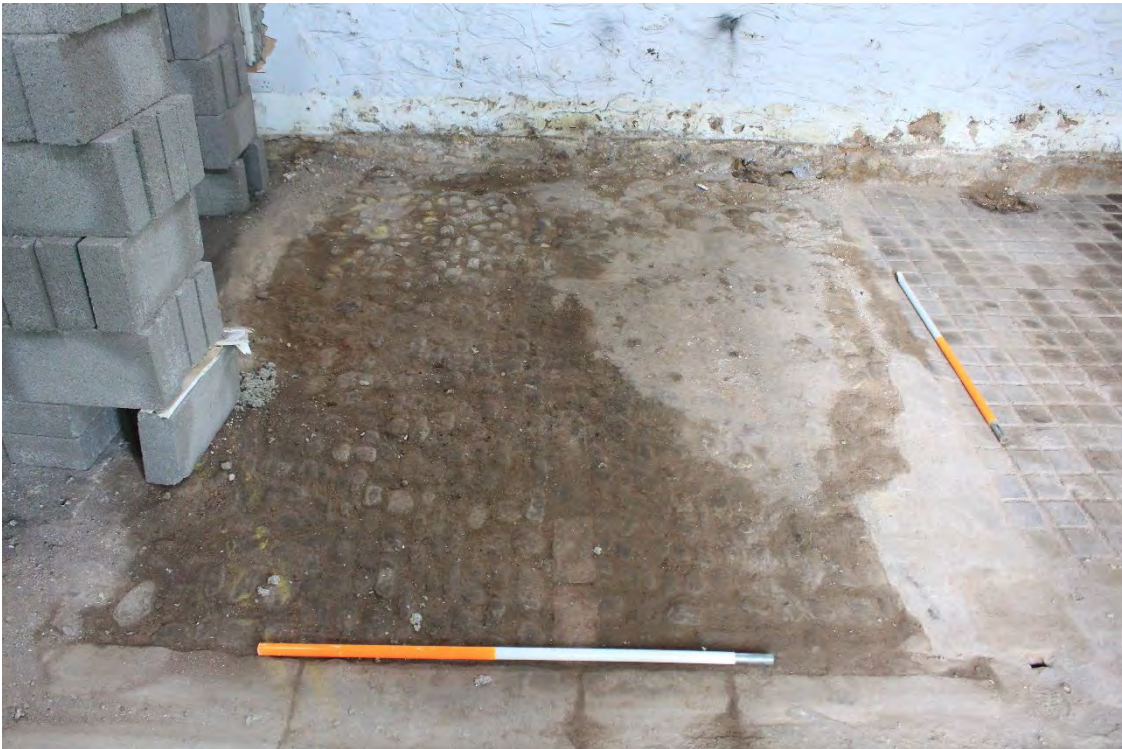
Image EDP A1.6: Detail of the cobble section in G1, looking east.

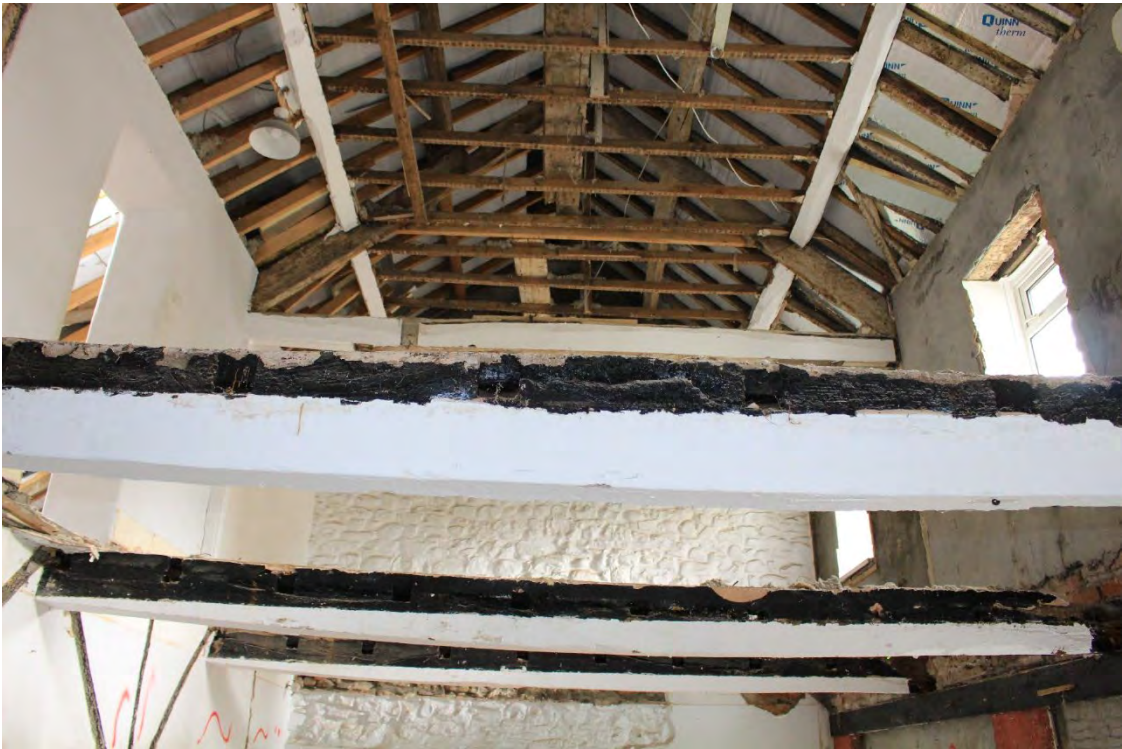
Image EDP A1.7: View of the 19th century timber joists of the upper floor in G1, looking south.

- 5.6 In terms of interventions to the fabric, the main floor joists in G1 are to be replaced due to ongoing issues with decay, but in an case these are square-section regular sawn timbers of evident later 19th century date, which possess no significance.

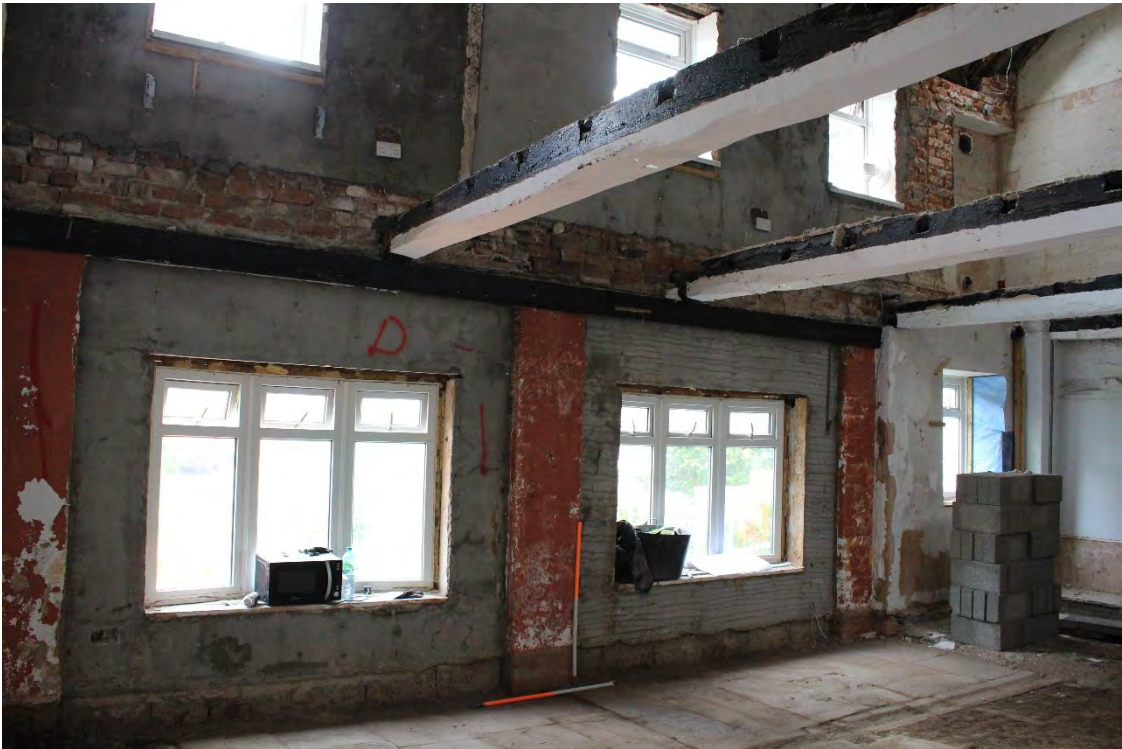
Image EDP A1.8: View of the western wall of G1, showing the blockwork infill of the former openings with windows. The floor joists of the upper floor can also be seen.

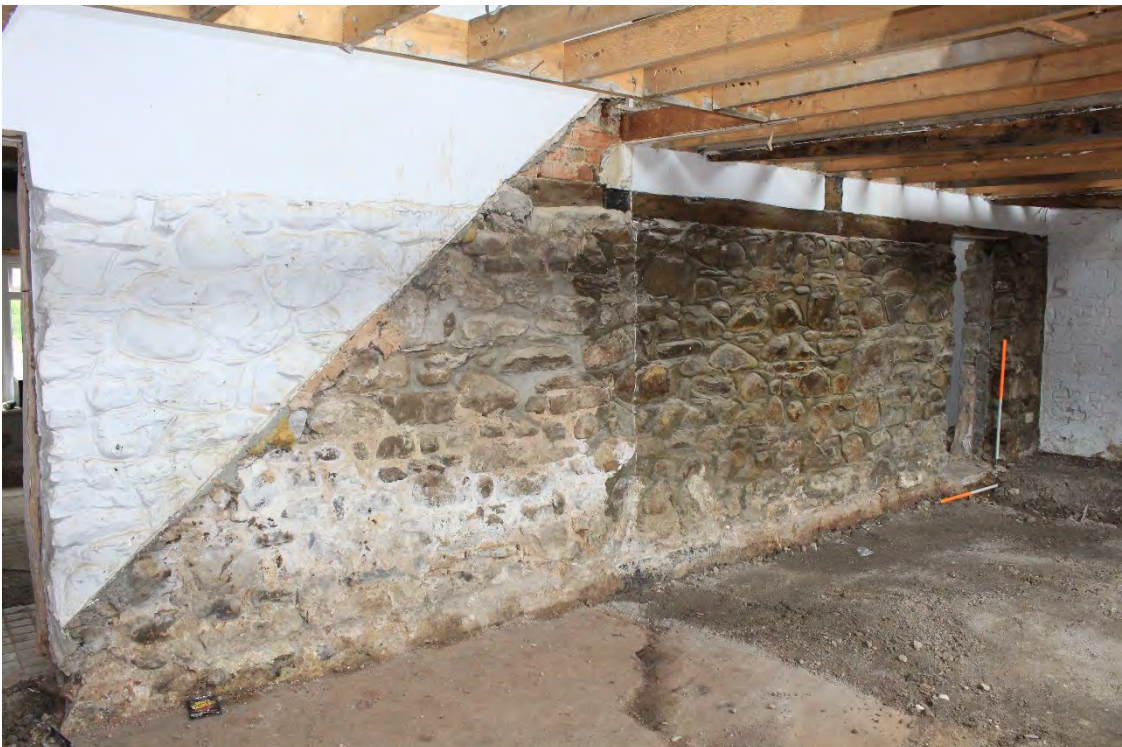
Image EDP A1.9: View of the eastern face of the main spine wall, showing stone below and timber frame above.

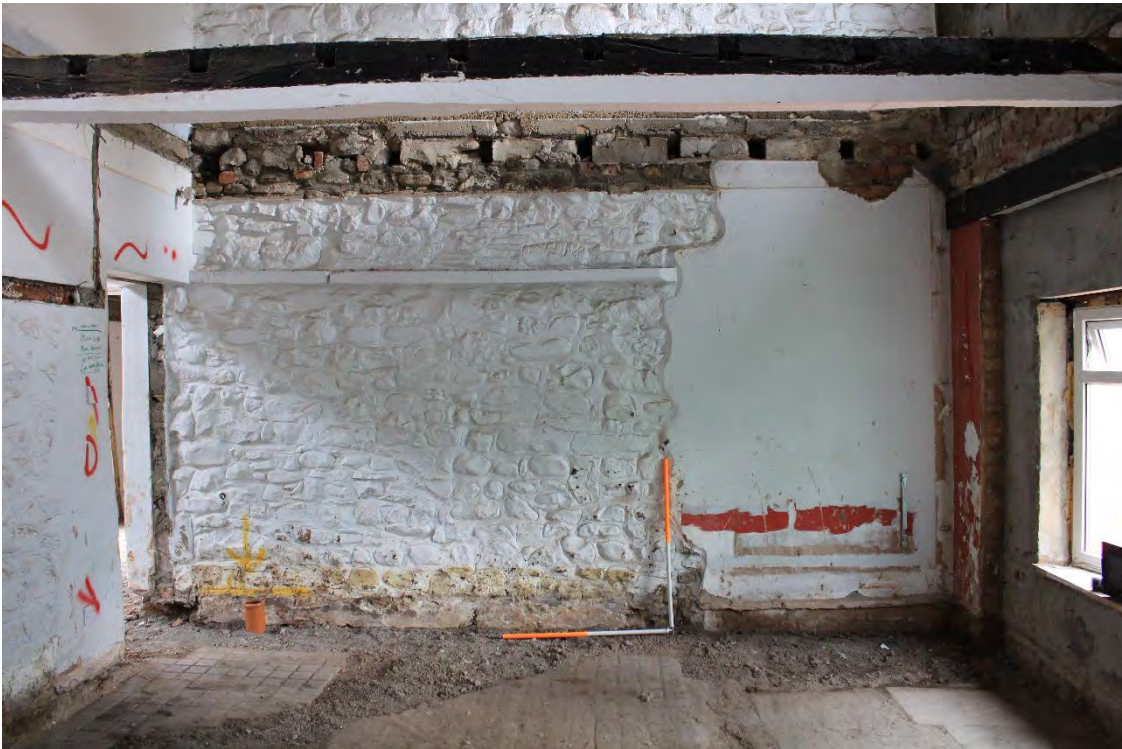
Image EDP A1.10: View of the lower part of the southern gable in G1, looking south. Showing the inserted joist holes to take the later floor.

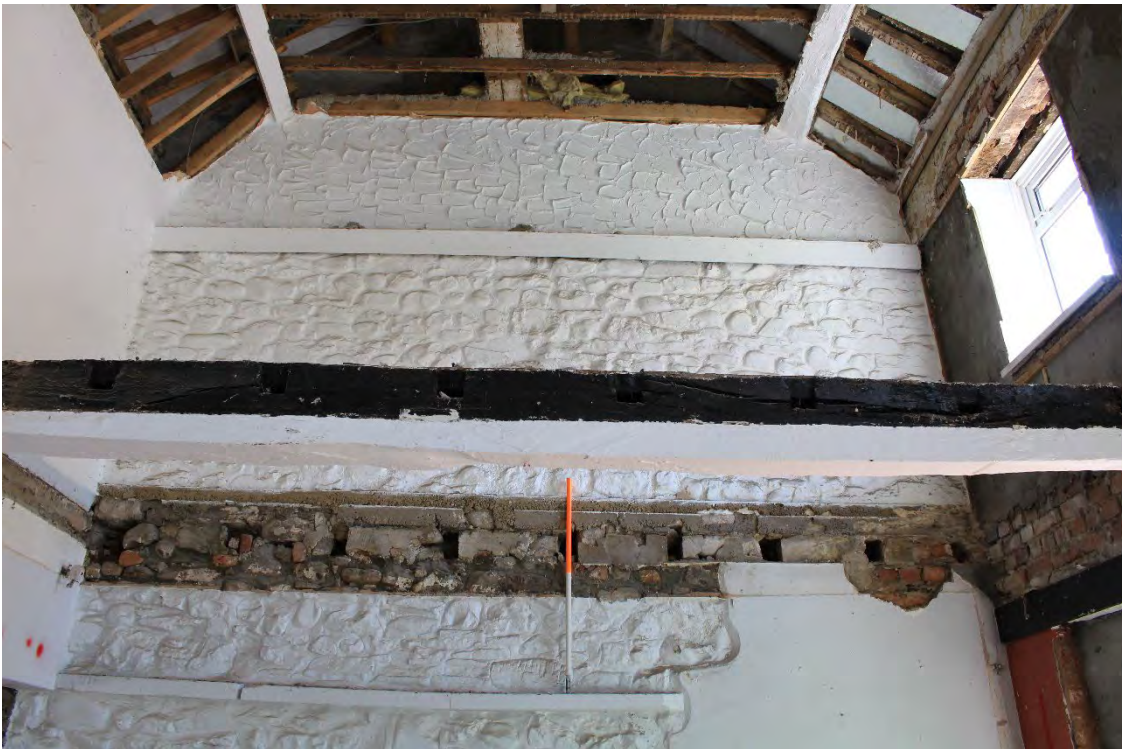
Image EDP A1.11: View of the Upper part of the southern gable in G1, showing the rendered upper portion most likely hiding brickwork, looking south.

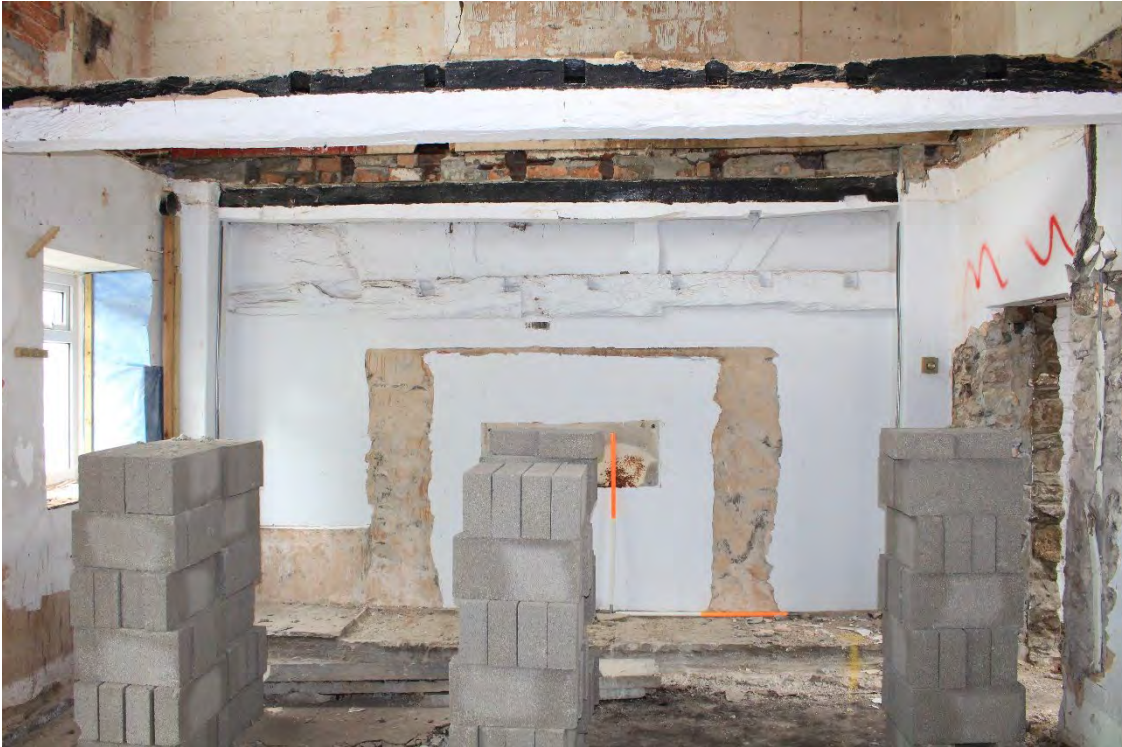
Image EDP A1.12: View of the northern gable, looking north and showing the earlier, lower timber beam and the later raised floor above.

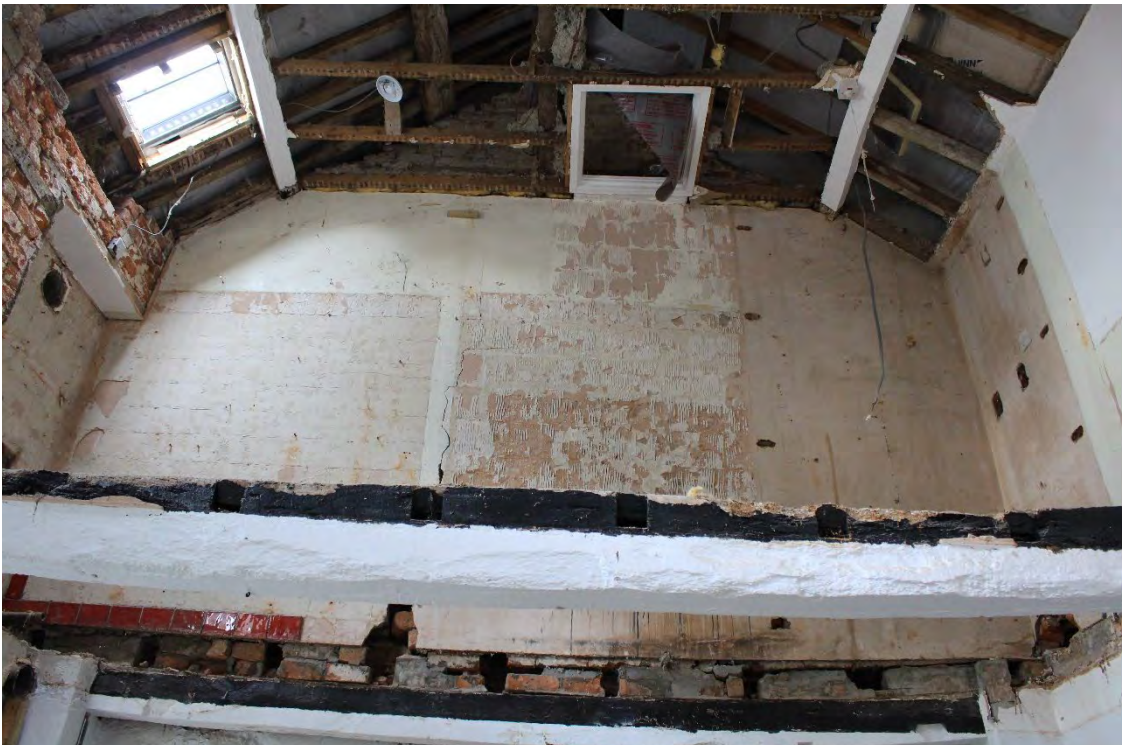
Image EDP A1.13: Upper part of the northern gable, which is rendered brickwork, looking north.

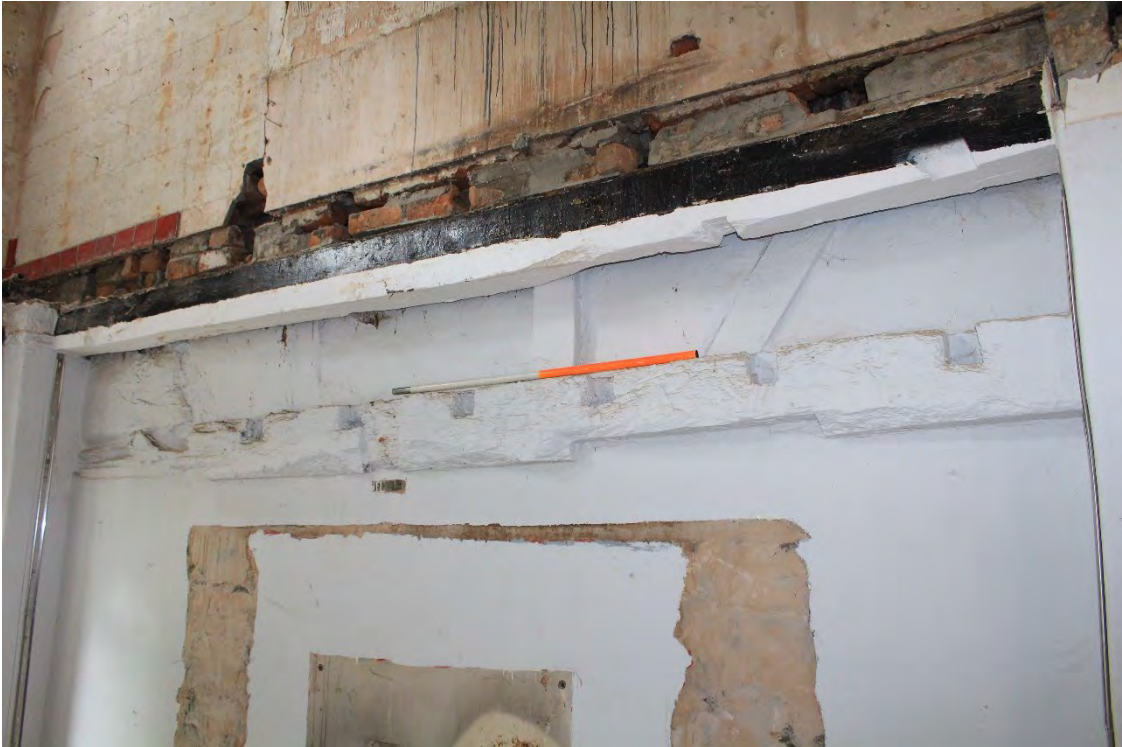
Image EDP A1.14: Detail of the timber beam looking north-west and showing the cutout recess indicating a door into the northern building. Also showing the later beam above, where the floor has clearly been raised.

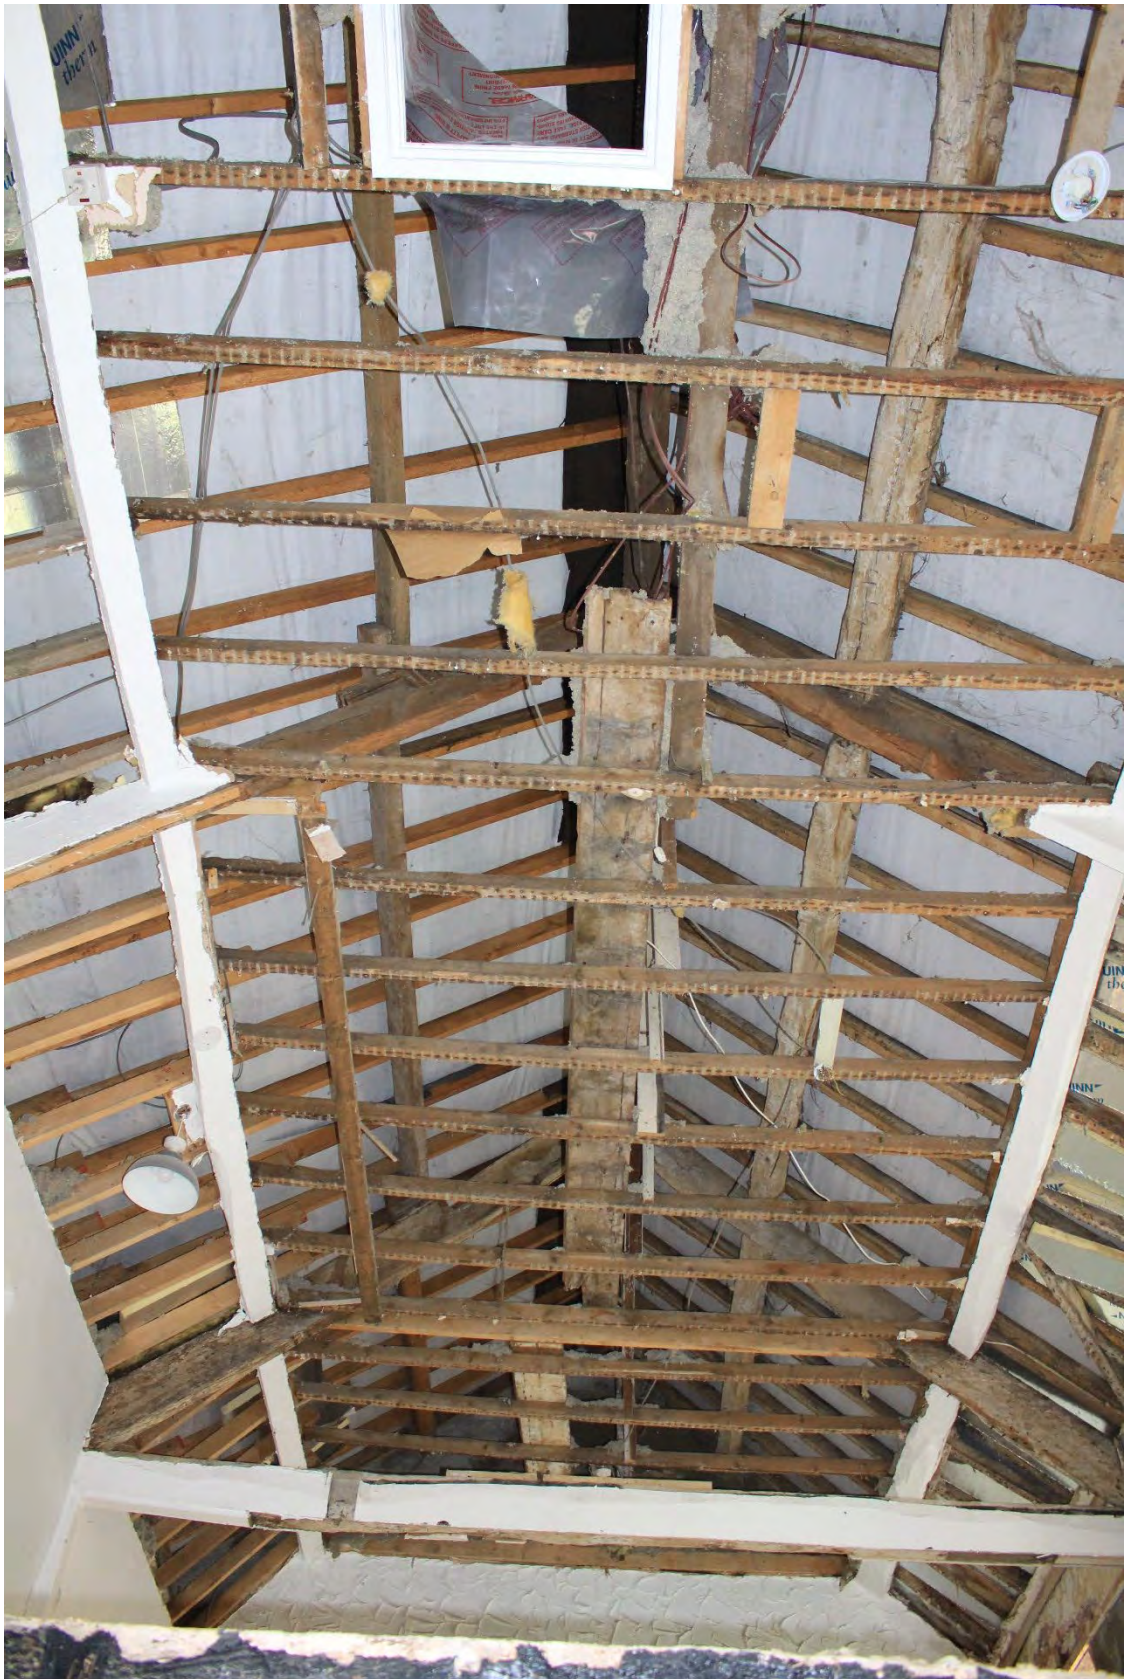
- 4.29 The internal floor structure above room G1 has been removed, thereby providing views upwards to the underside of the roof structure. This is a simple collar truss construction with the main collars having been cut at some point in the past. Whilst the trusses appear to be of 19th century date, all the rafters on the eastern pitch are 20th century replacements and show that there has been wholesale rebuilding (**Image EDP A1.15**).

Image EDP A1.15: View of the roof structure of the main section, looking south. The east (left-hand) pitch has been completely replaced in the 20th century.

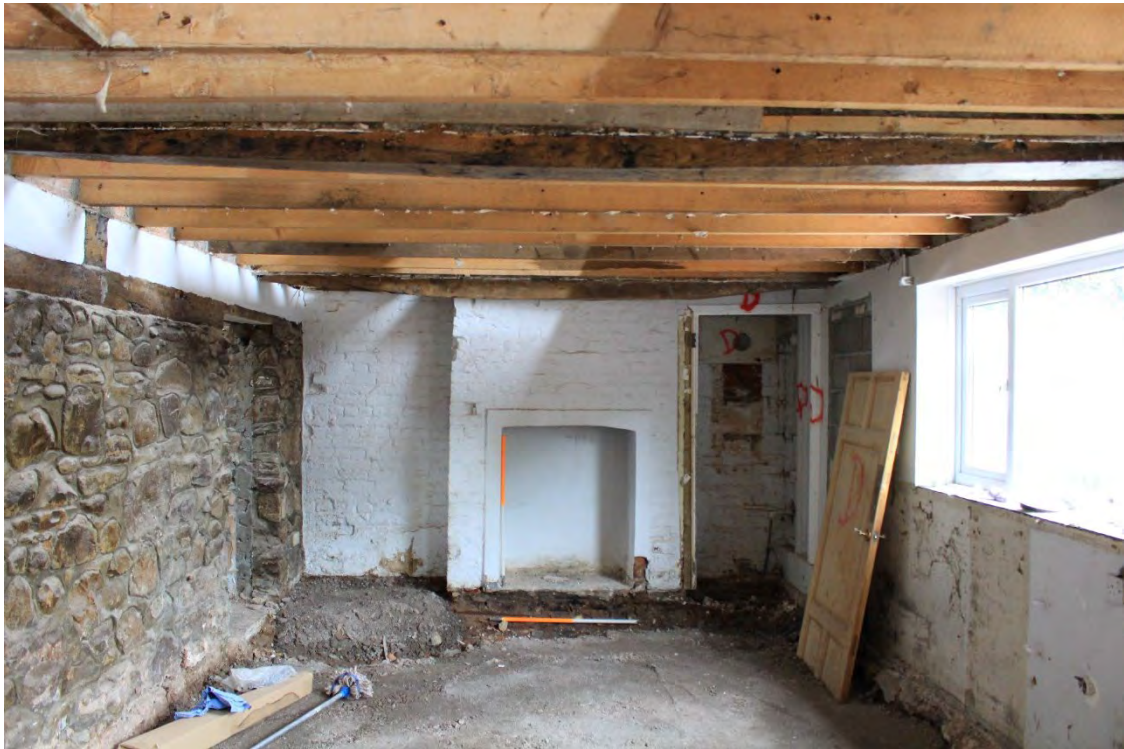
Image EDP A1.16: General view of room G2 looking north, showing the stone spine wall with timber frame on top to the left and brick fireplace on the northern wall. The right-hand wall is rendered blockwork.

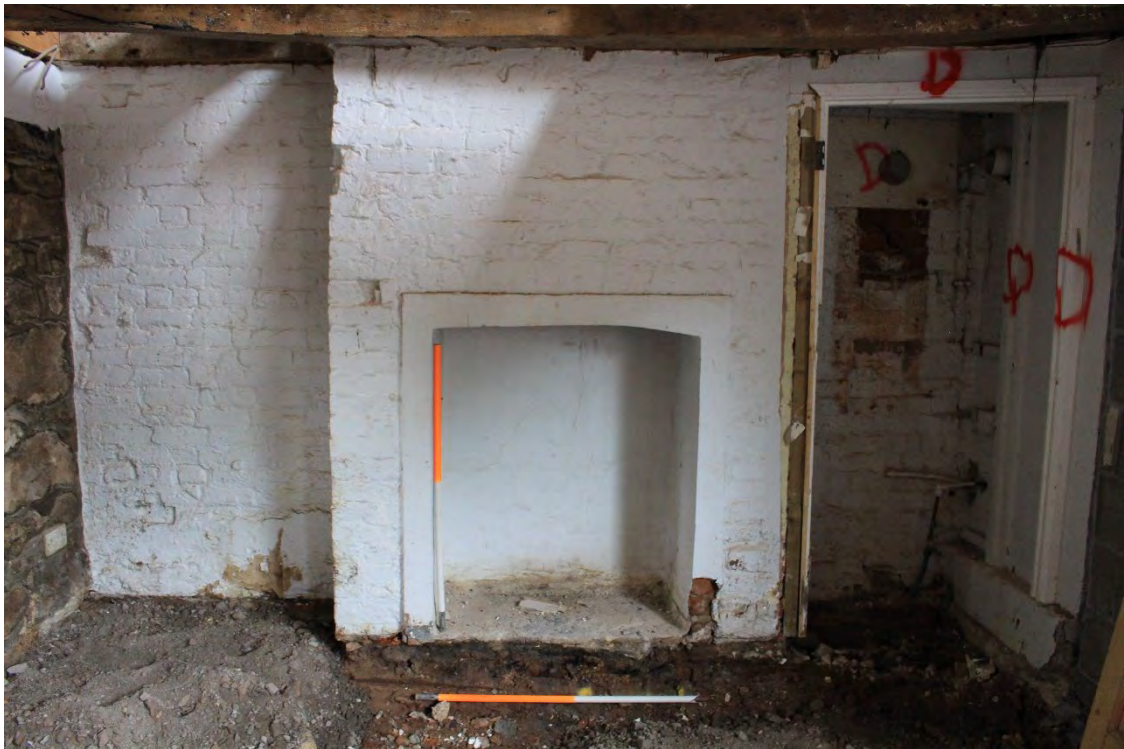
Image EDP A1.17: View of the fireplace and adjacent cupboard in the northern elevation of G2, looking north.

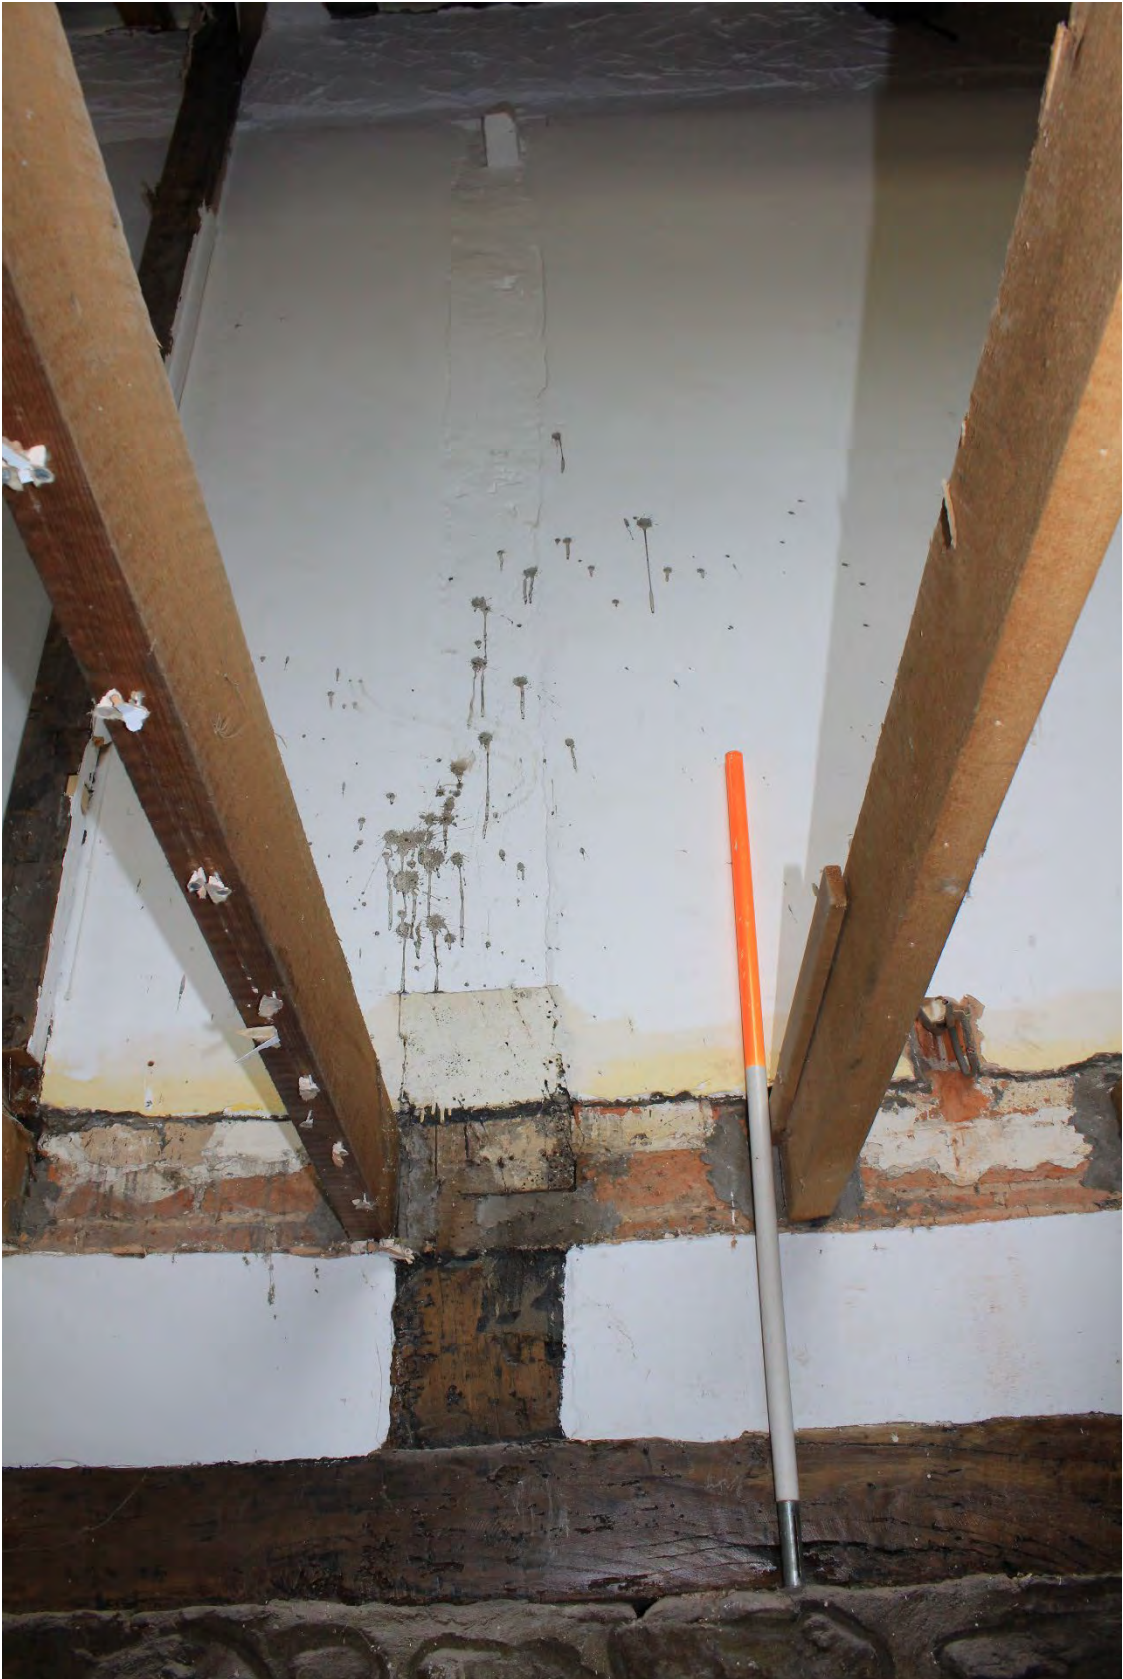
Image EDP A1.18: View of the exposed 19th century timber upright in the upper part of the central spine wall looking west, showing the cut off timber truss.

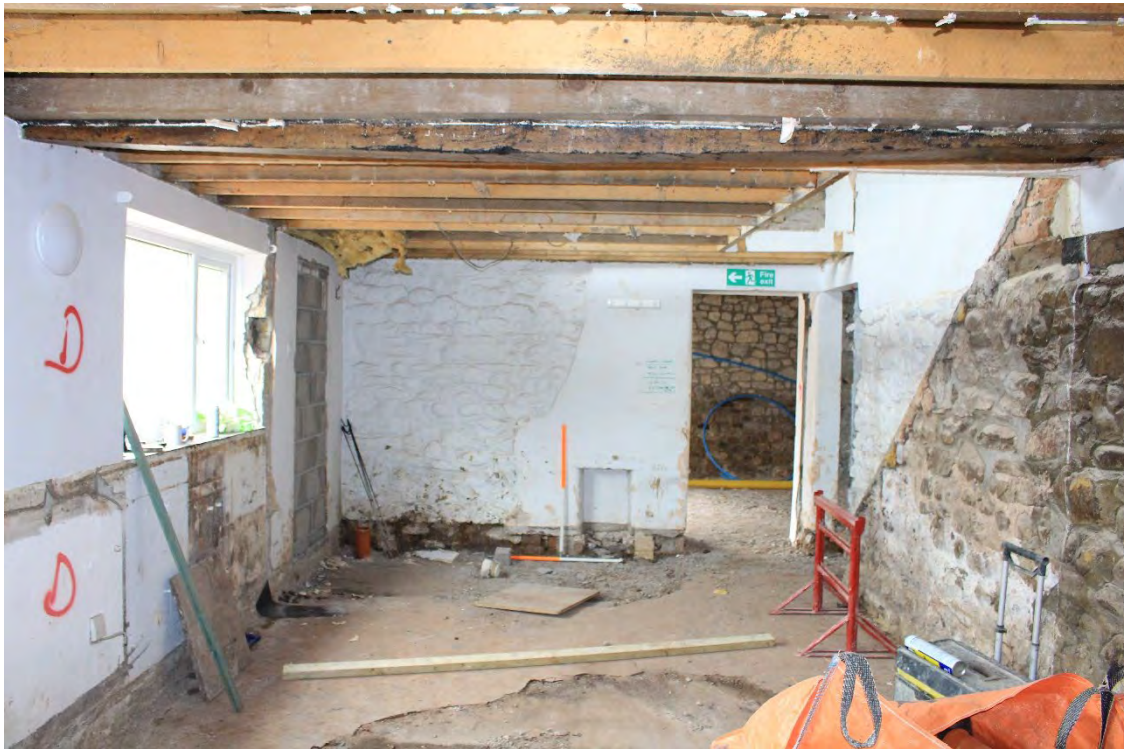
Image EDP A1.19: General view of Room G2 looking south, showing the lower part of the gable and door into the 'coach house' section G3.

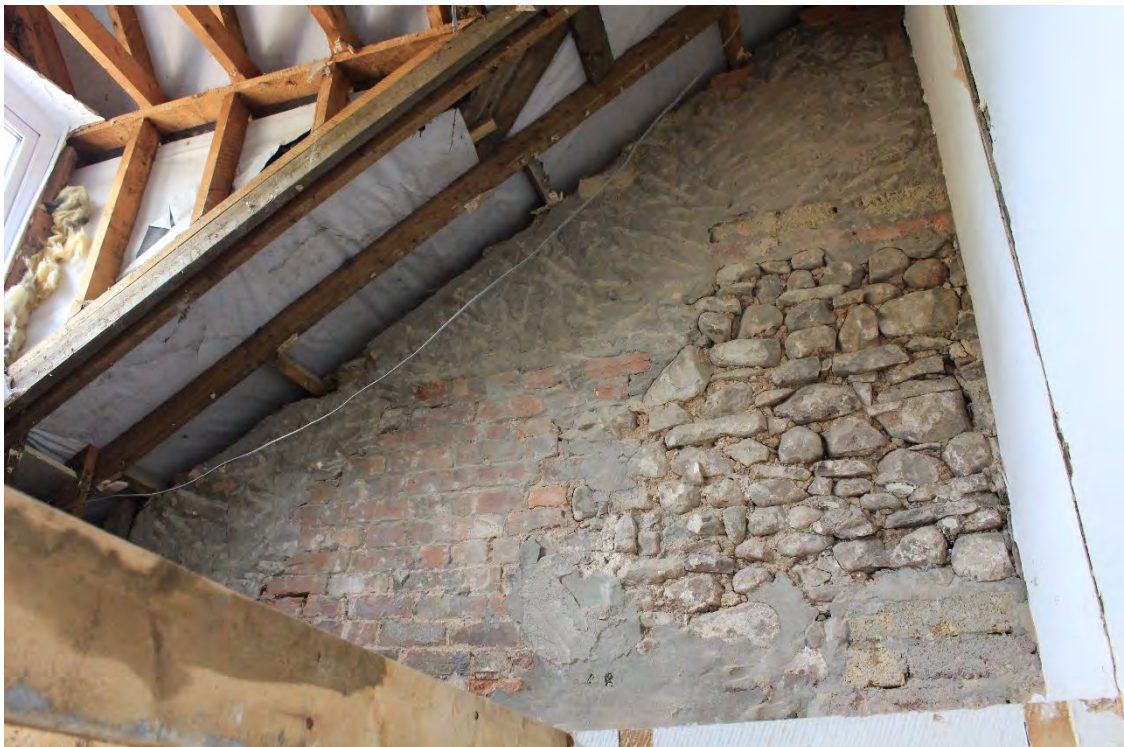
Image EDP A1.20: Upper part of the gable end in G2, looking south, showing brickwork rebuilding/extension here. Also showing the 20th century roof.

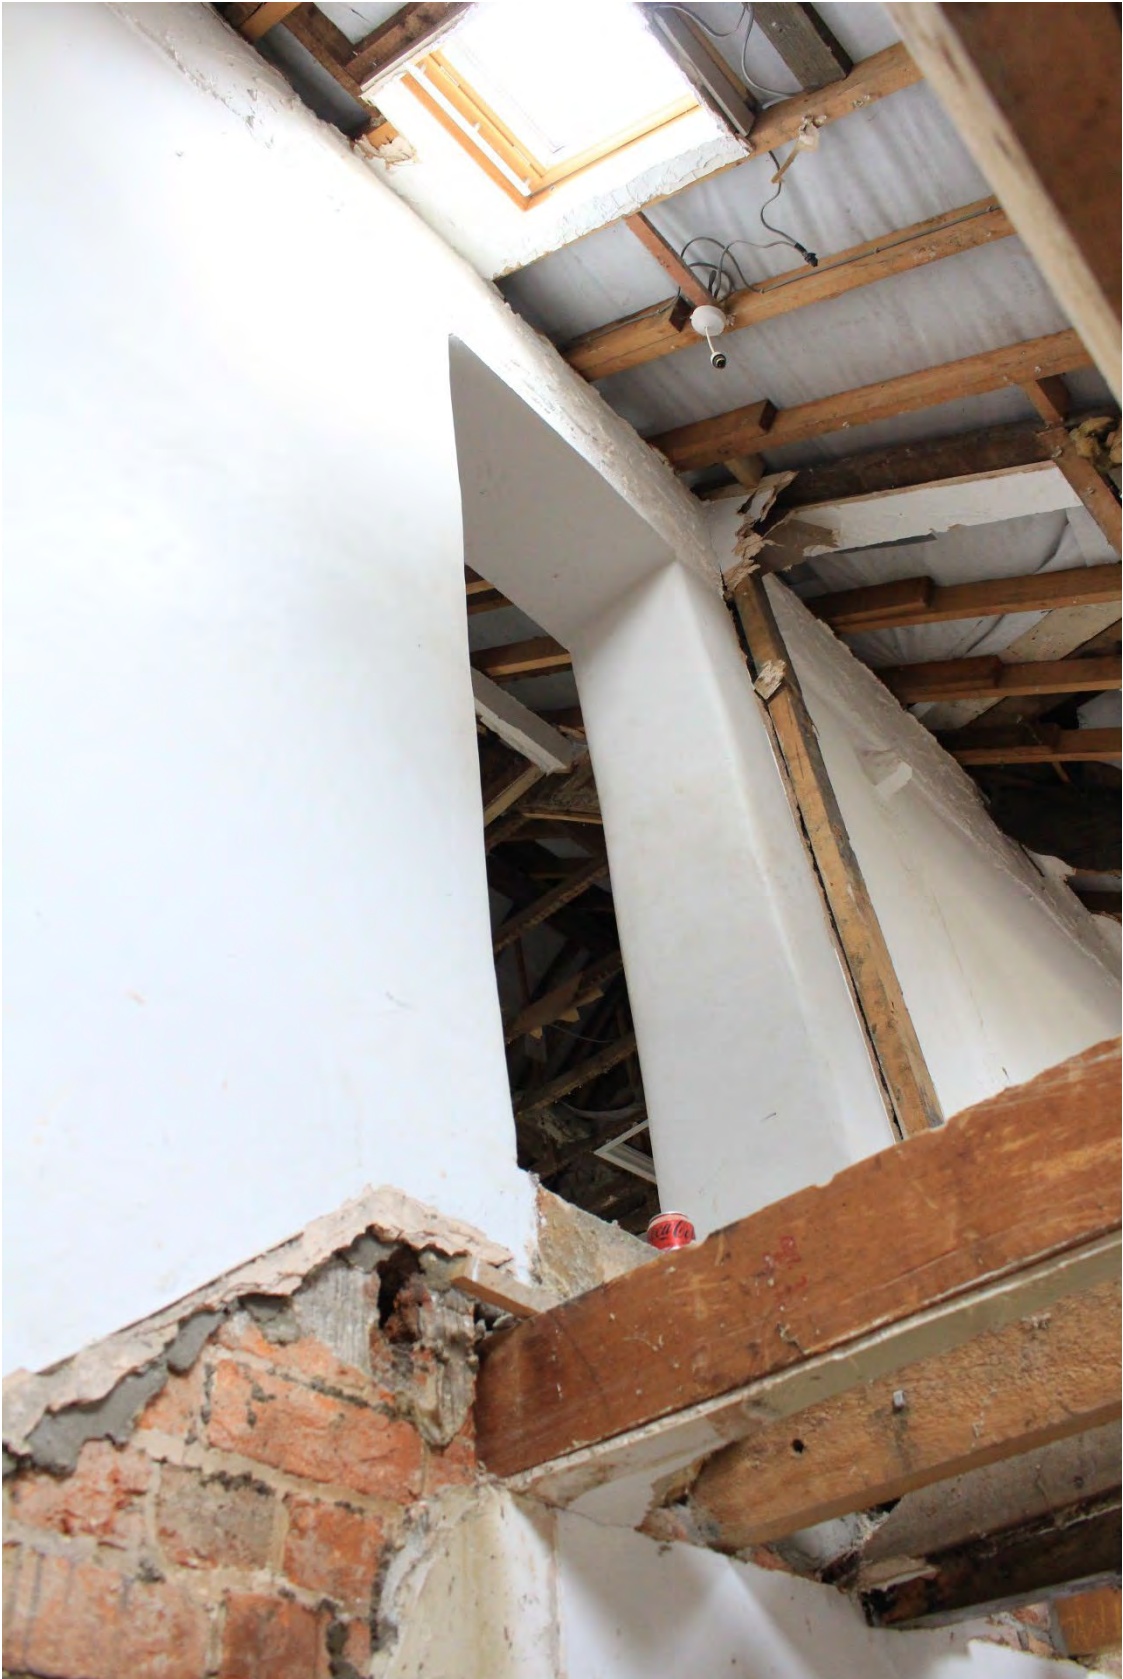
Image EDP A1.21: View of the door in the spine wall between the two upper rooms looking north-west. Also showing detail of the brickwork of the upper half of the spine wall.
