**The Cottage, Sant
Ffraed House**

**Heritage Impact
Statement and Historic
Building Record
Planning Ref.
DM/2023/00951**

Prepared by:
**The Environmental Dimension
Partnership Ltd**

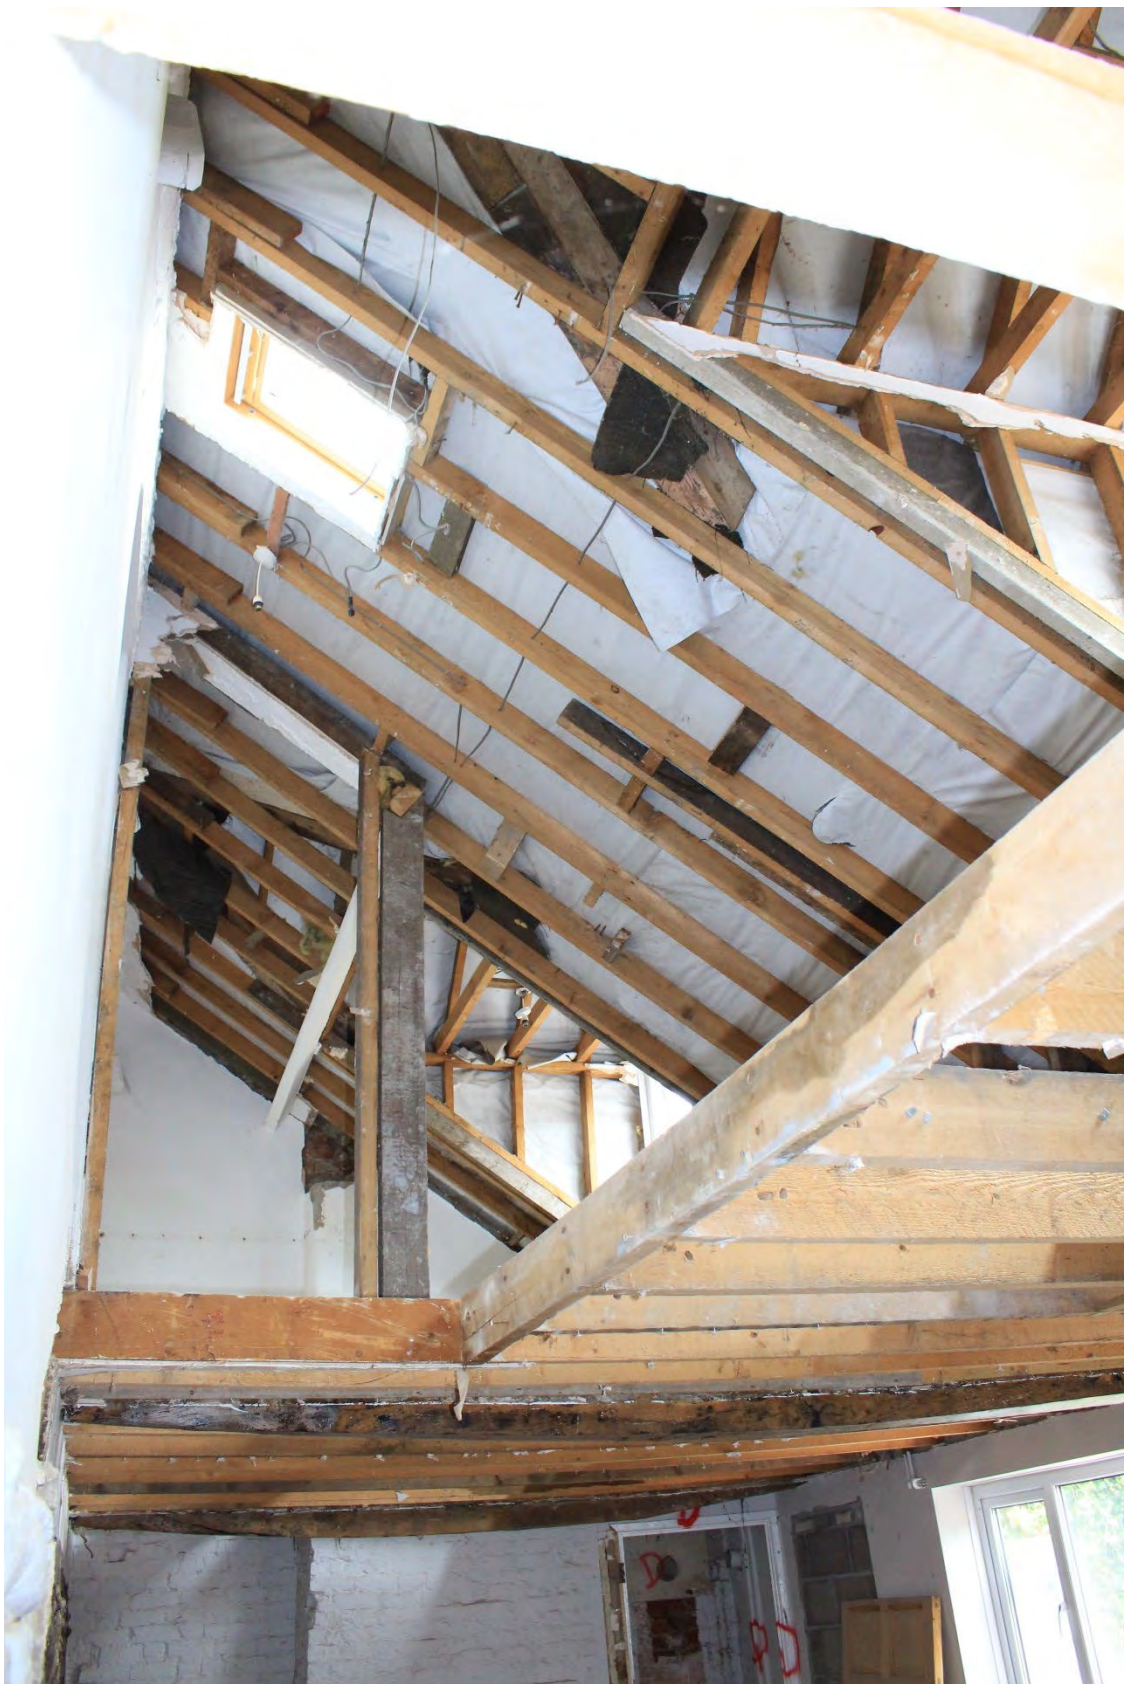
Image EDP A1.22: View into the upper floor above G2 looking north, showing the completely 20th century floor and roof structure.

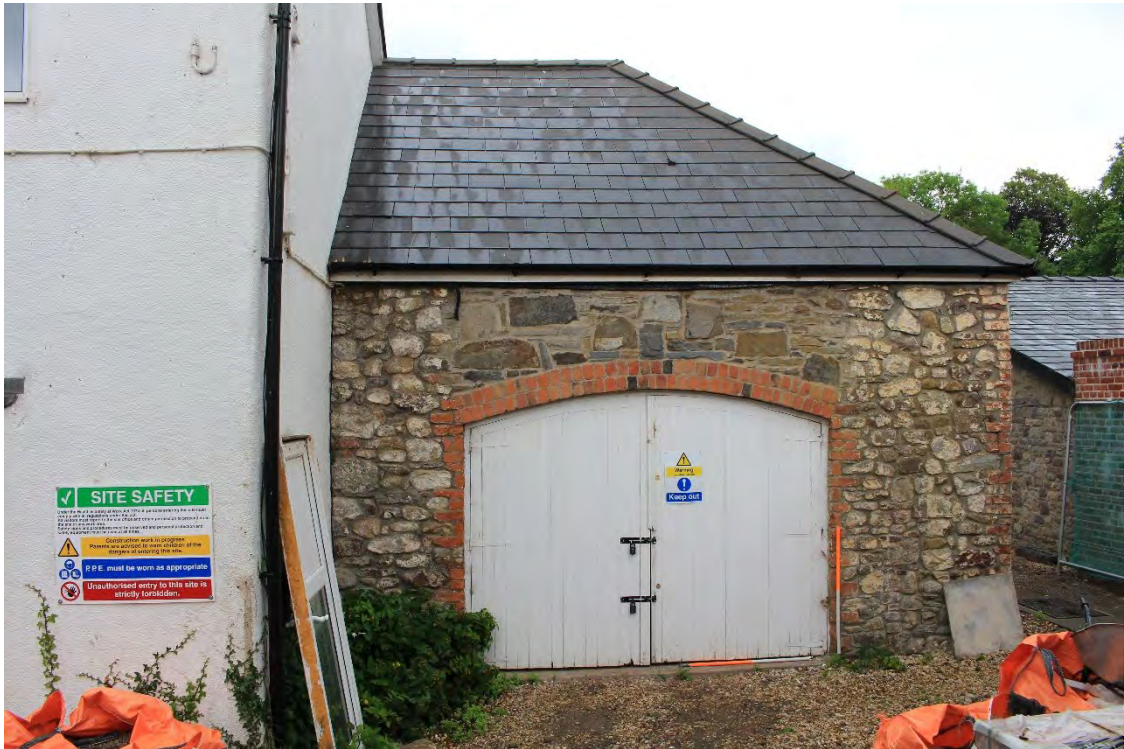
Image EDP A1.23: View of the western elevation of the 'coach house' section looking east, showing the clearly infilled section of opening above the brick arch.

- 5.18 In terms of other exterior alterations, the 'coach house' opening on the main elevation would be opened out to its former extent, with the later brick segmental arch and infill above being removed and replaced with an oak beam. The brick jambs will remain. The new door here, in common with the windows, would be powder coated aluminium double-glazed units. Considering that the current windows are PVC and the doors are modern, this element is not considered to alter the significance of the building. In fact, there would be a slight enhancement by restoring the 'coach house' opening to its former extent and reinstating this historic feature of the building.

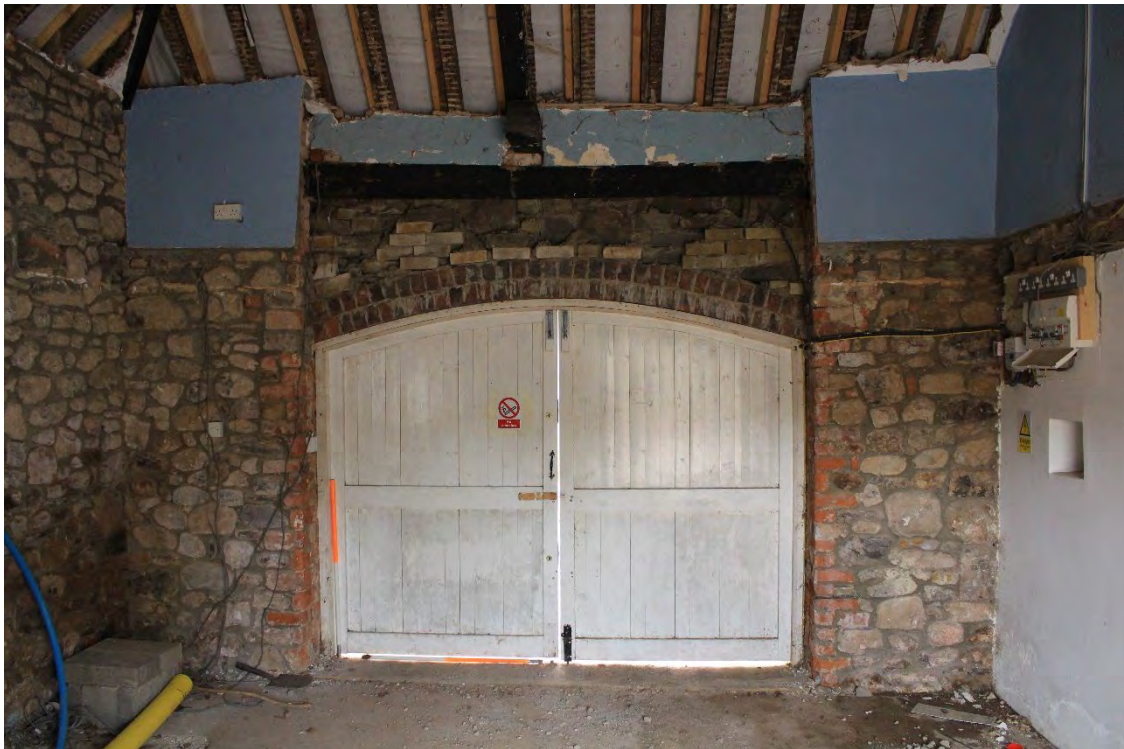
Image EDP A1.24: View of the interior of G3 (coach house) showing the inside of the former opening and infill above the brick arch.

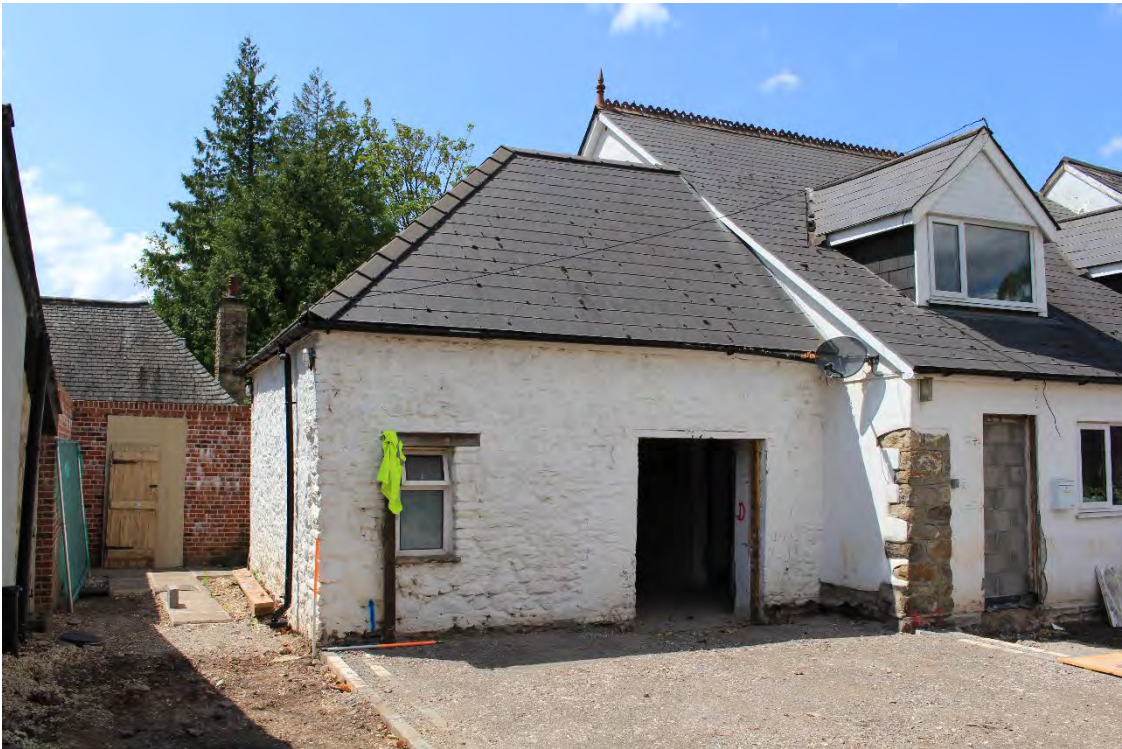
Image EDP A1.25: Eastern and western elevations of the 'coach house' section, looking west, showing the two openings in the eastern wall and the plain southern wall.

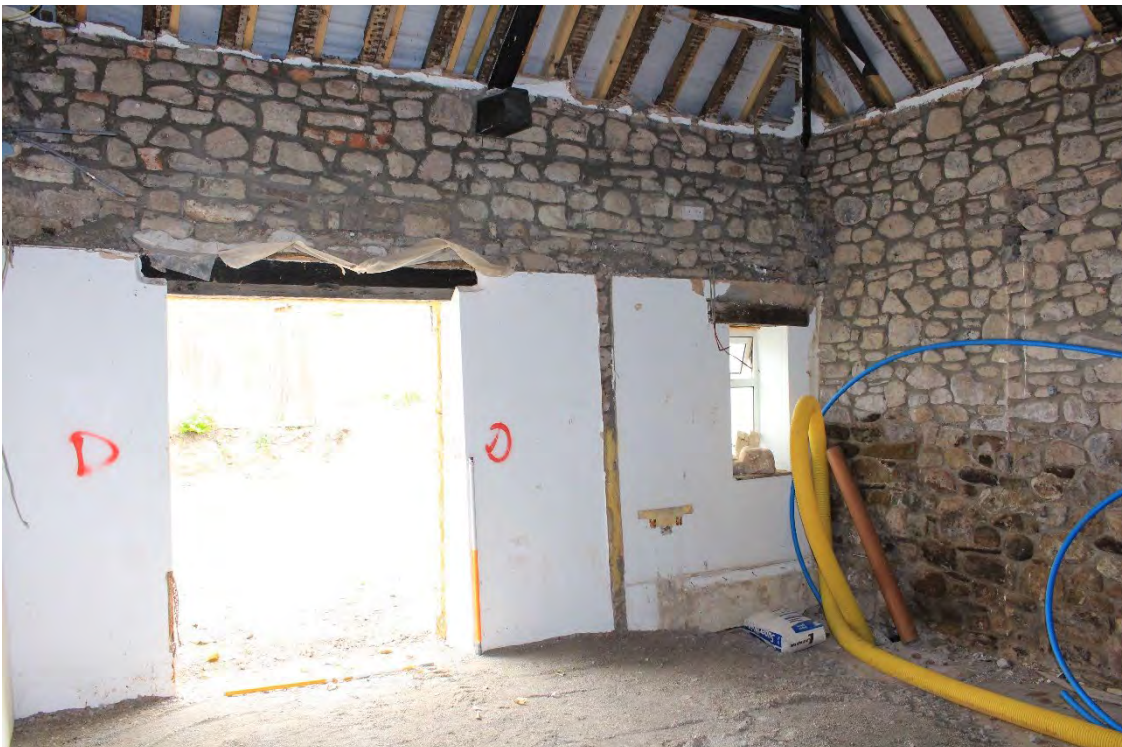
Image EDP A1.26: General view of the Interior of G3 (coach house) section, looking east.

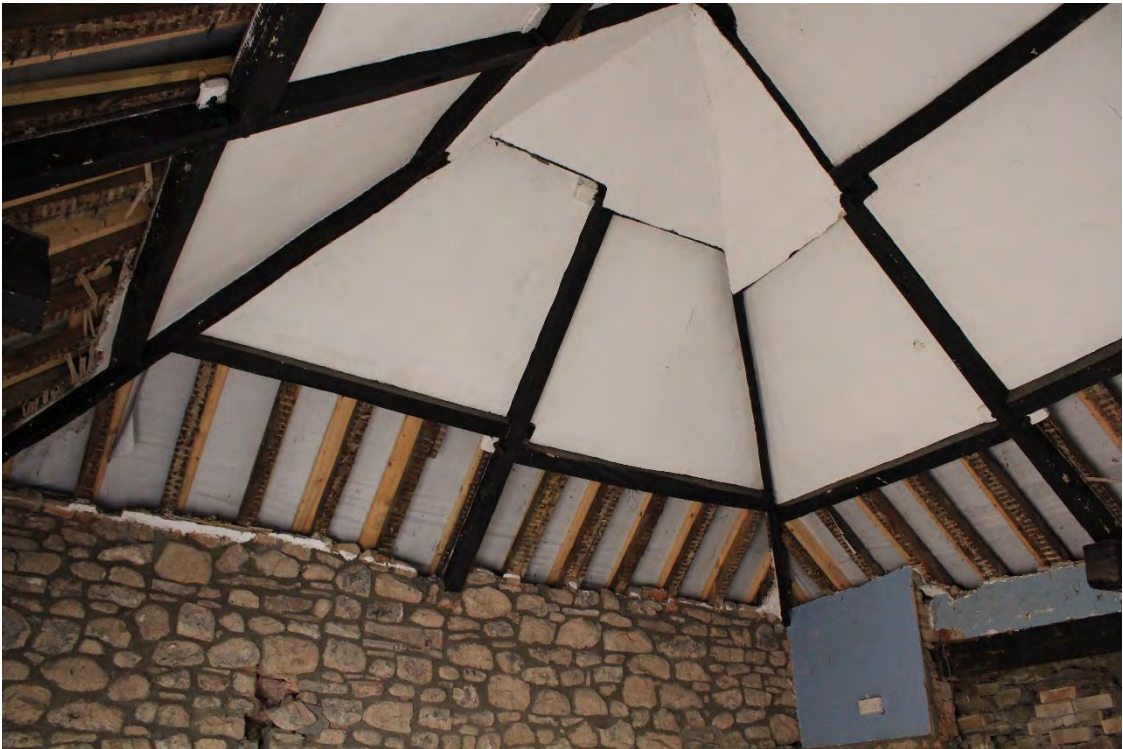
Image EDP A1.27: View of the roof structure within G3 (coach house) looking south.

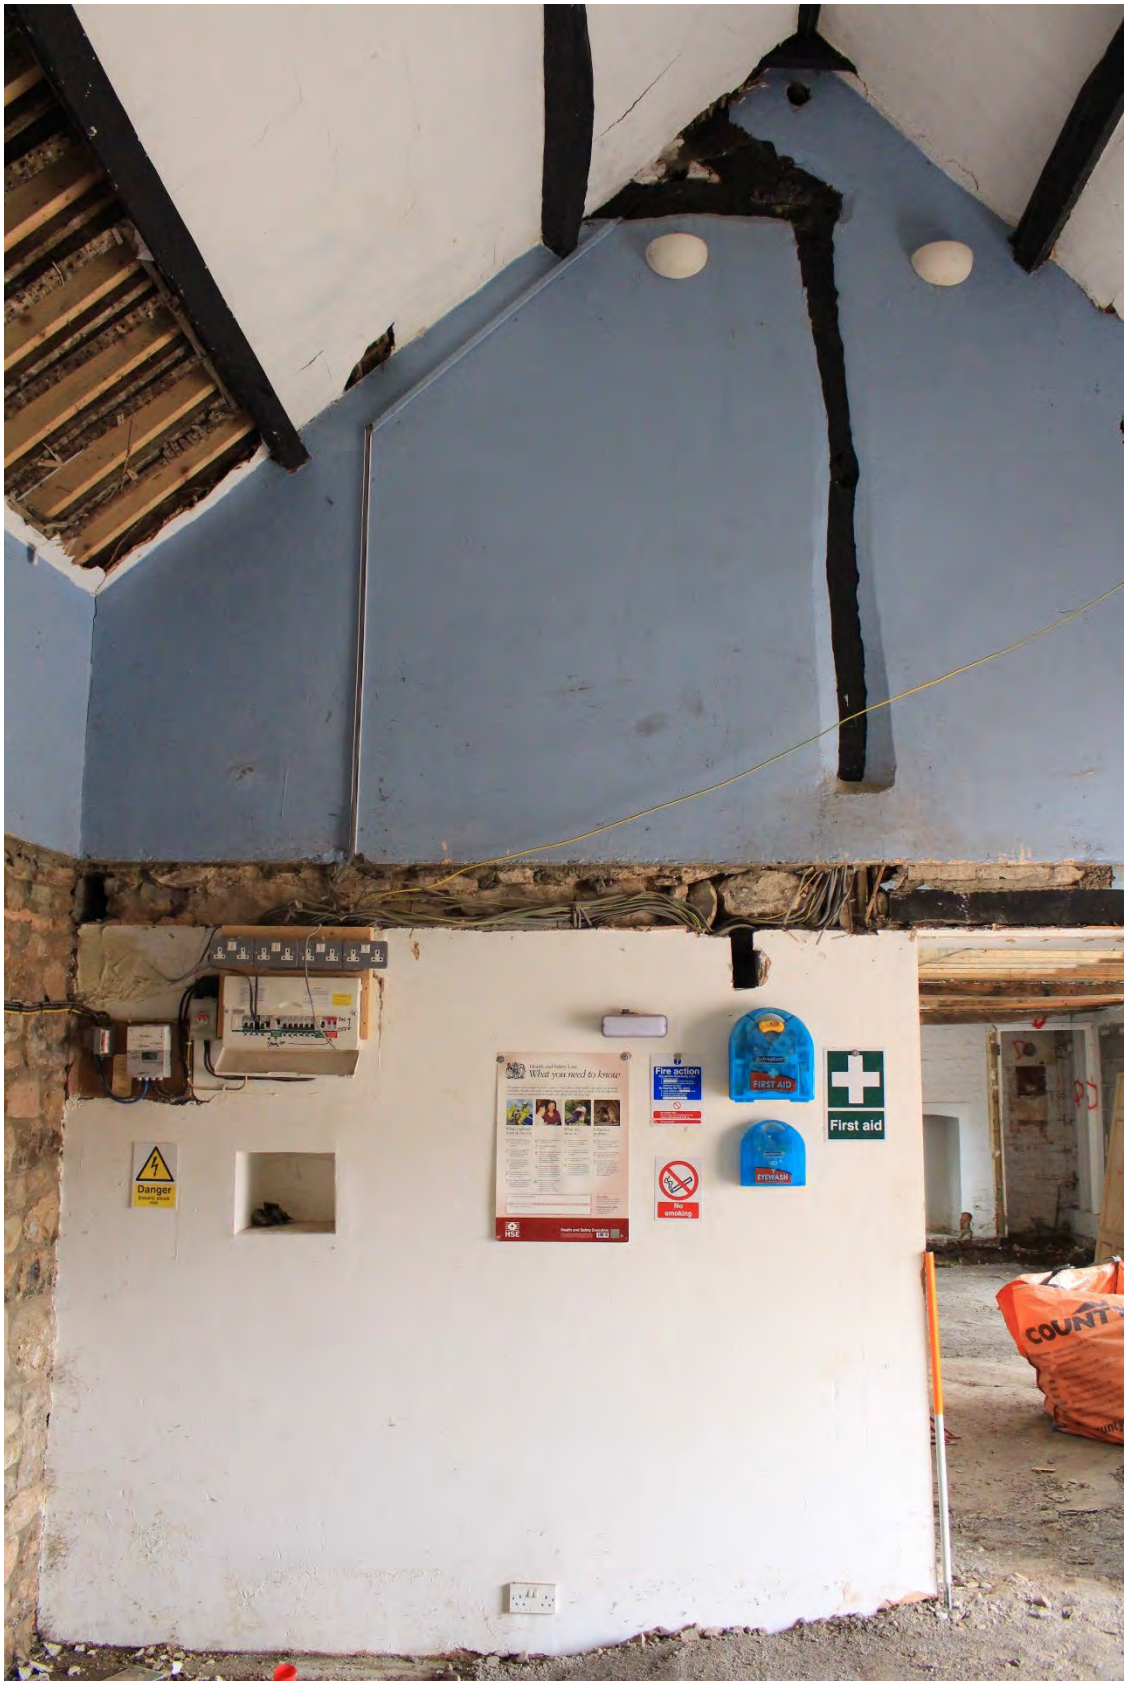
Image EDP A1.28: General view of G3 (coach house) looking north, note the exposed timber frame within the gable end indicating the roof had been raised.

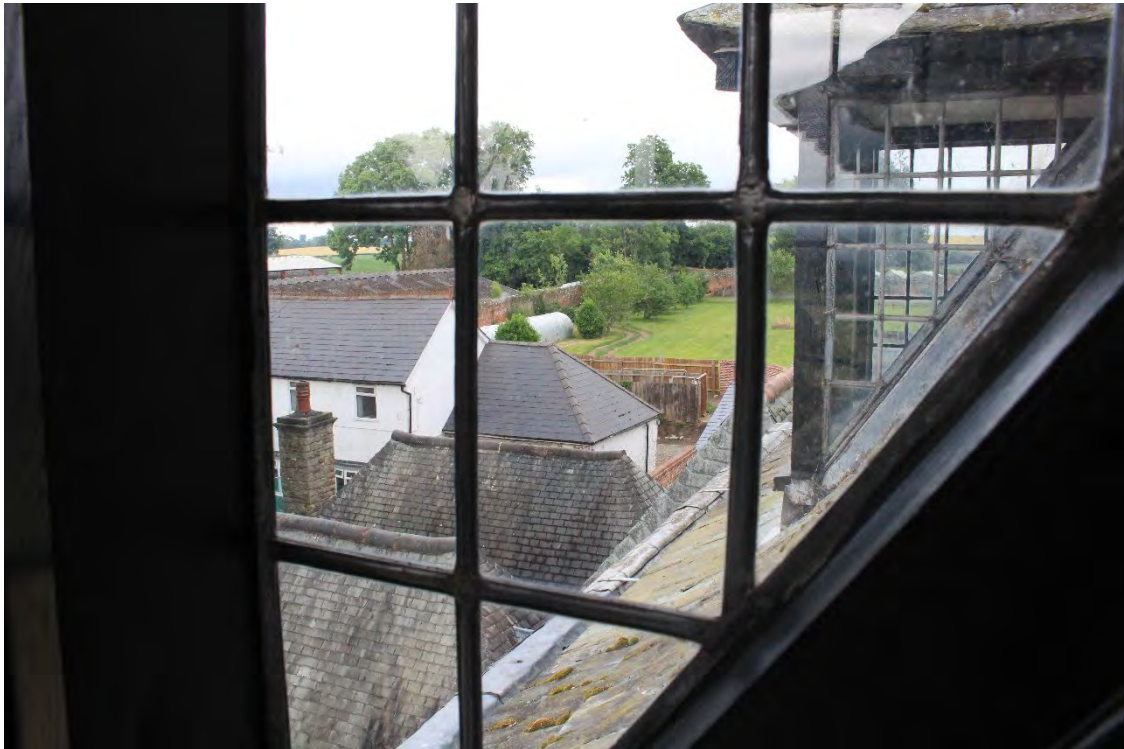
Image EDP A1.29: Typical view towards the site from the attic rooms in the main house, looking north-east (the window within the shot is that of the stairwell, and no view is possible from this window). This shows the view across the functional service areas of the complex and how the extension would not be incongruous.

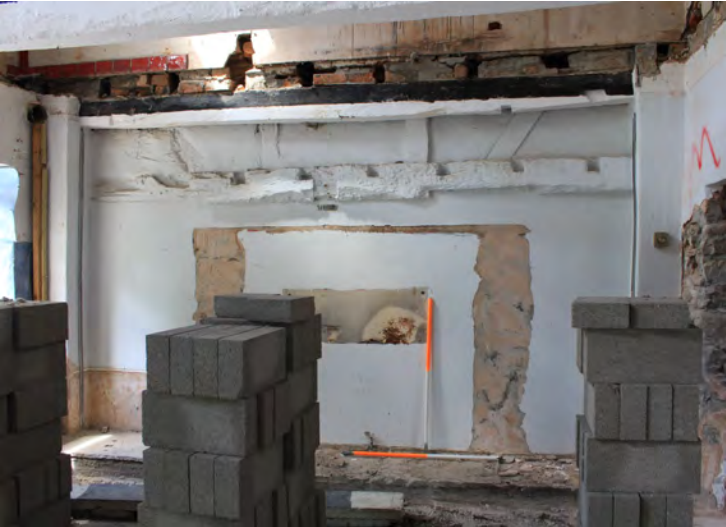
IMG_6575	<p>Only the face of the lower beam could be readily observed but it was seen to be in poor condition and as such there is no evidence for cut/adze marks other than at the extreme eastern end, where possible hand saw marks are visible and likely indicate it was pit/tresle sawn. Probable square section, although depth could not be observed. Very crudely chamfered with adze. Beam ends not observed due to later fabric. Recessed square door head at eastern end with crude/incomplete chamfer. Possible recessed door head at western end, although very crude and disturbed by later features/decay. No evidence for plank and muntin or wattle and daub groove/pegs observed due to it being embedded in fabric. Square floor joist notches to upper half. Later rectangular notch to face.</p> <p>Upper timbers partially obscured but comprised upright and two diagonal raking struts jointed to main beam with unpegged mortise and tenon joints. Section could not be observed due to being embedded in wall. Faces are flat and sawn with very crisp angle, but no cutmarks observed.</p>

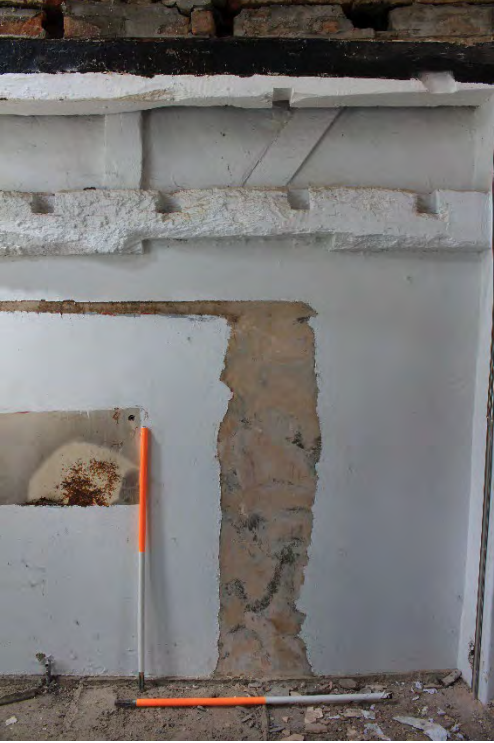
A photograph showing a close-up of a wooden door head and uprights. The door head is a thick, light-colored wooden beam with a crude chamfered edge. The uprights are also made of wood and are joined to the door head with mortise and tenon joints. The surrounding wall is white plaster, and the floor is dirt. An orange-handled tool is visible in the foreground.	IMG_6576	Detail of recessed door head and uprights at eastern end of northern gable. Crude chamfer with adze. Beam end enclosed by later fabric to right. One vertical upright and one raking strut appear more regularly sawn with unpegged mortise and tenon joint.

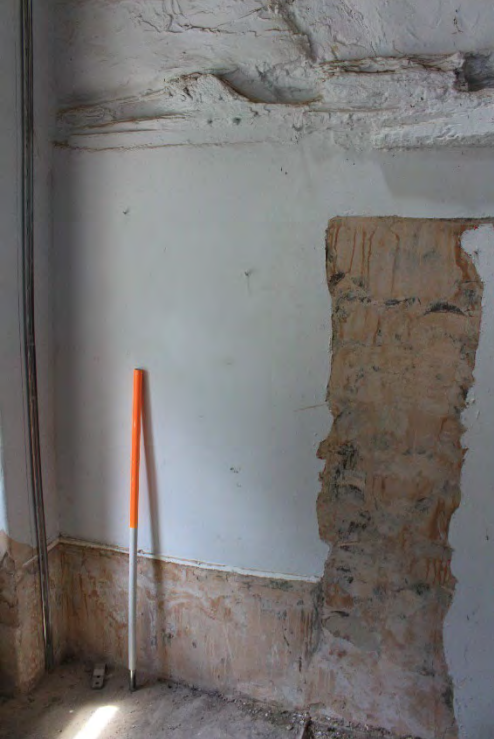
A photograph showing the interior of a northern gable. The wall is white with a horizontal wooden beam near the top. A vertical wooden beam is visible on the right side. A brick wall section is visible on the right. An orange-handled tool is leaning against the wall on the left.	IMG_6584	Detail of possible recessed door head and uprights at western end of northern gable. Much disturbed/decayed. Beam end obscured by later fabric, including a later timber insert of square planed wood visible to lower face to left, most likely for support due to decay.

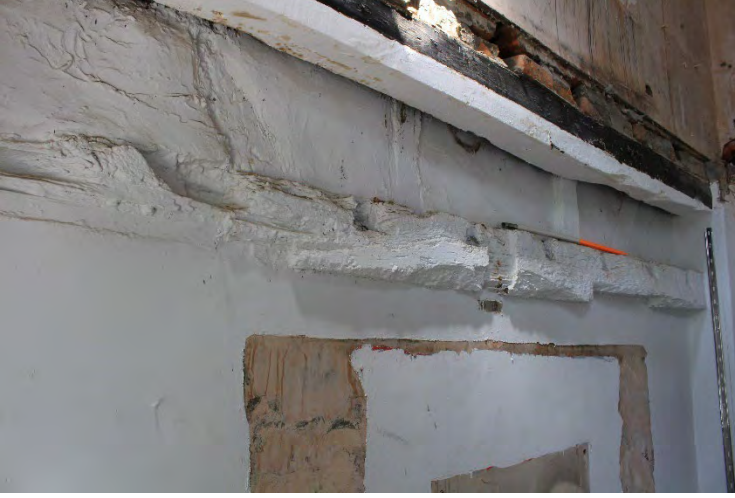
IMG_6578	<p>Detail of beam from western end, showing more clearly the inserted timber support on the underside of the beam at the western end. The left hand raking strut was poorly preserved and obscured making interpretation difficult.</p>
Northern Gable

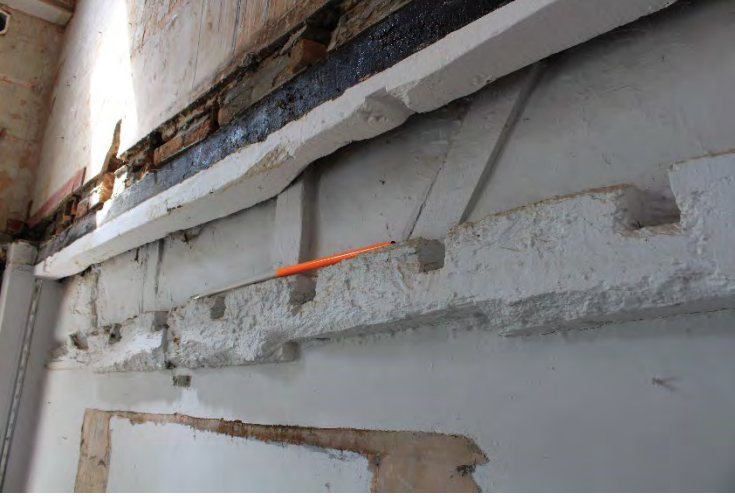
IMG_6577	<p>Detail of beam from the eastern end, showing more clearly the crude adze chamfer on and around the recessed door head. Also showing more clearly the crisp and more regularly sawn uprights, suggesting beam is potentially re-sited.</p> <p>Upper beam is later floor joist, upright rectangular section with regular machine saw marks, some crude axe marks to 'rusticate' the beam.</p>

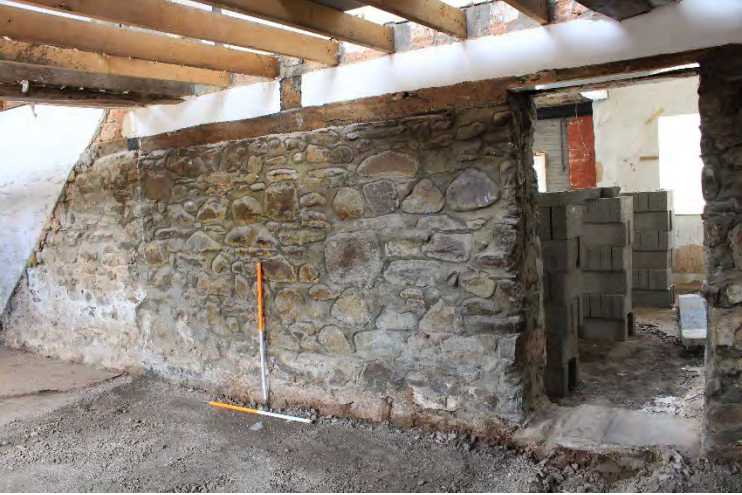
IMG_6539	<p>The timber is completely embedded in the wall so only the eastern face could be seen, other than where a door is cut into the northern end. Square timber cill sitting on top of stone spine wall also partially obscured by plaster and paint.</p> <p>The cill beam is square sectioned. Concentric markings indicate mechanical finishing, indicative of a circular sander. This will have removed any evidence of earlier finishes. No chamfer.</p> <p>Uprights also square sectioned (?) and flush.</p> <p>Unpegged joints, possibly lap but more likely mortise and tenon. No evidence for floor joist recesses or any mortise holes in the face.</p> <p>The lower stonework is random rubble and not coursed, like the rest of the building, suggesting a cosmetic rebuild.</p> <p>The timber cill is at the same level as the beam in the northern wall, however, they are of differing section, details (i.e. lack of chamfers) and finishes.</p> <p>Floor joists above are of 20th century sawn soft wood form.</p>

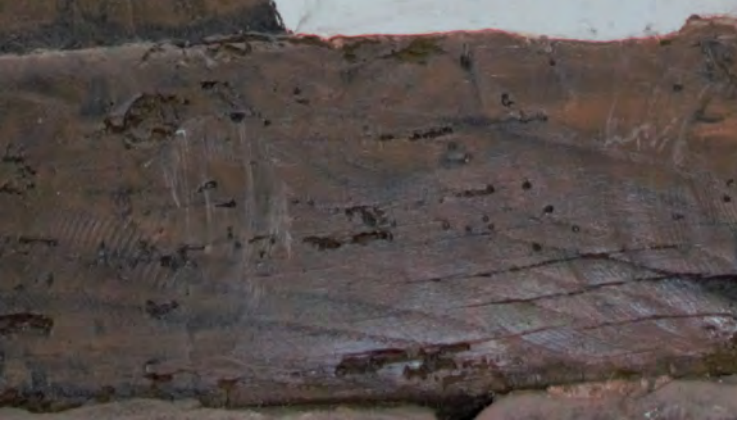
IMG_6537	Regular concentric circular markings on the timber, indicative of mechanical disc sanding.
Central Spine Wall

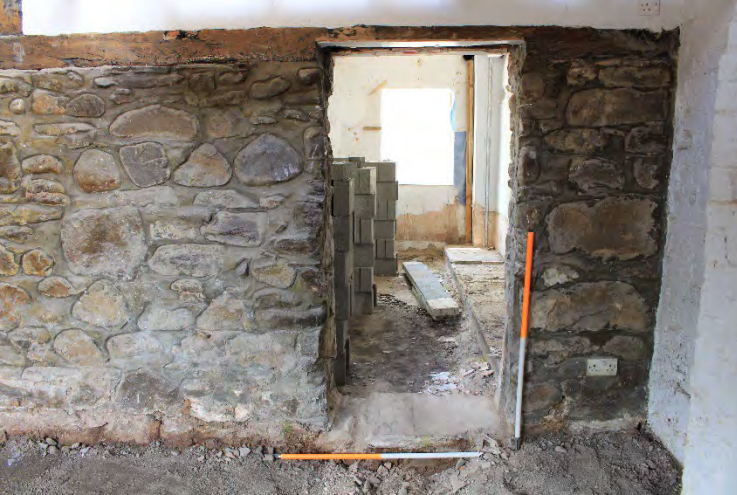
IMG_6532	<p>Square timber frame sitting on top of stone spine wall. Only visible on eastern face, partially obscured by plaster and paint. Uprights also square section(?) and flush. Unpegged joints, possibly lap but more likely mortise and tenon. No chamfer.</p> <p>Recessed door head cut in with no chamfer.</p> <p>Floor joist above are 20th century sawn soft wood.</p>

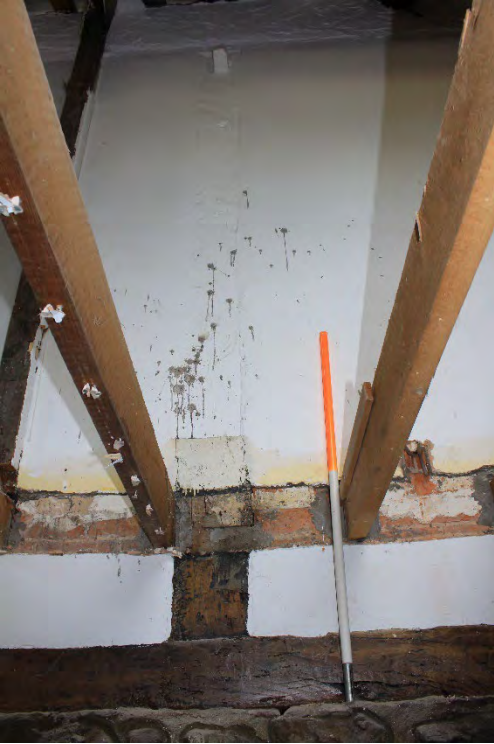
A photograph showing a close-up of a wooden truss joint. Two large, light-colored wooden beams are joined together, with a smaller rectangular section of wood (a truss) visible at the top. The joint is set into a white wall. A vertical metal rod with an orange top is visible in the foreground, likely used for scale or support. The floor below is made of dark, rough stone or brick.	IMG_6537	<p>Detail of upright and joint. Square section(?), sawn and planed, no cut/sawn marks observed. Unpegged joints, possibly lap but more likely mortise and tenon. No chamfer, beam ends not observed due to later fabric. Cut rectangular section truss visible at top of photograph, set into upright but joint (mortise and tenon?) not fully observed due to brick infill.</p> <p>Floor joist are 20th century sawn soft wood.</p>

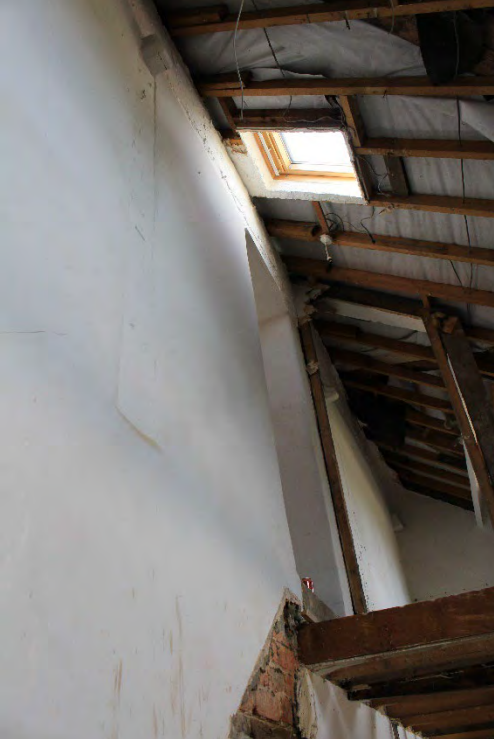
A photograph showing the interior of a building, focusing on the central spine wall. The wall is white and shows signs of wear and tear. Three upright timbers are visible, supporting the roof structure. A modern 20th-century roof is visible on the right side. A small window is visible in the upper part of the image.	IMG_6548	General disposition of the three upright timbers in the central spine wall. Modern 20 th century roof to right.

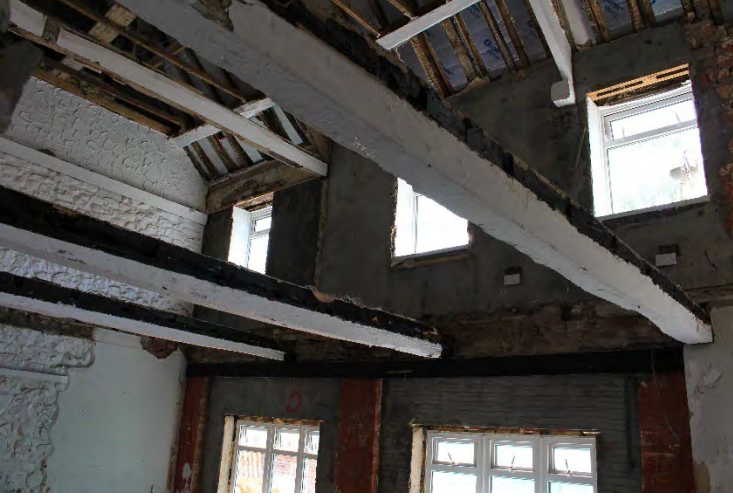
IMG_6569	<p>Four floor joists. Upright rectangular section, with curve to underside to mimic 'sag'. Regular straight saw marks indicating mechanically sawn and with some crude axe marks to lower face to 'rusticate' the beams. Otherwise, no chamfers or stops. Upper with rectangular notches for joists. Beam ends decay on exterior (west) wall.</p>
First floor joists

- 5.6 In terms of interventions to the fabric, the main floor joists in G1 are to be replaced due to ongoing issues with decay, but in an case these are square-section regular sawn timbers of evident later 19th century date, which possess no significance.

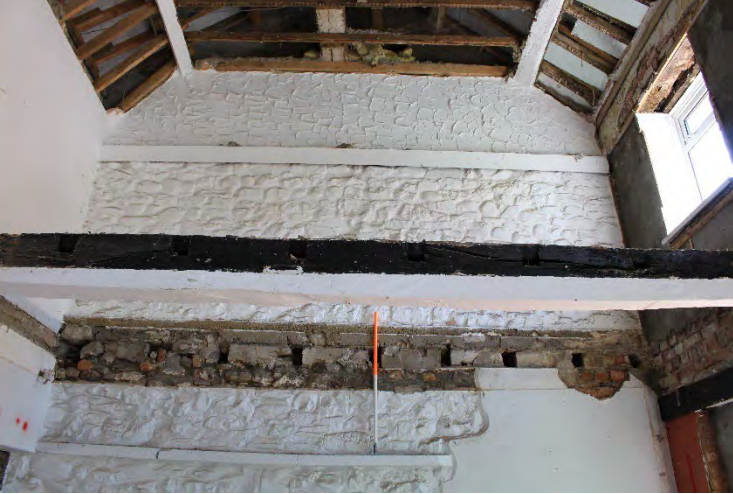
IMG_6555	<p>Four floor joists. Upright rectangular section, with curve to underside to mimic 'sag'. Regular slight curved saw marks indicating mechanically sawn and with some crude axe marks to 'rusticate' the beams. Otherwise, no chamfers or stops. Upper with rectangular upright notches for joists. Beam ends decay on exterior (west) wall.</p>

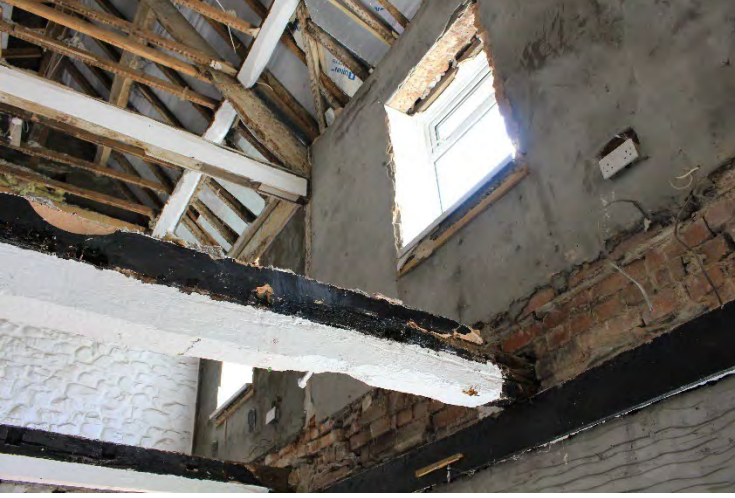
IMG_6552	<p>Four floor joists. Upright rectangular section, with curve to underside to mimic 'sag'. Regular slight curved saw marks indicating mechanically sawn and with some crude axe marks to 'rusticate' the beams. Otherwise, no chamfers or stops. Upper with rectangular notches for joists. Beam ends decayed on exterior (west) wall.</p>
Frist floor joists

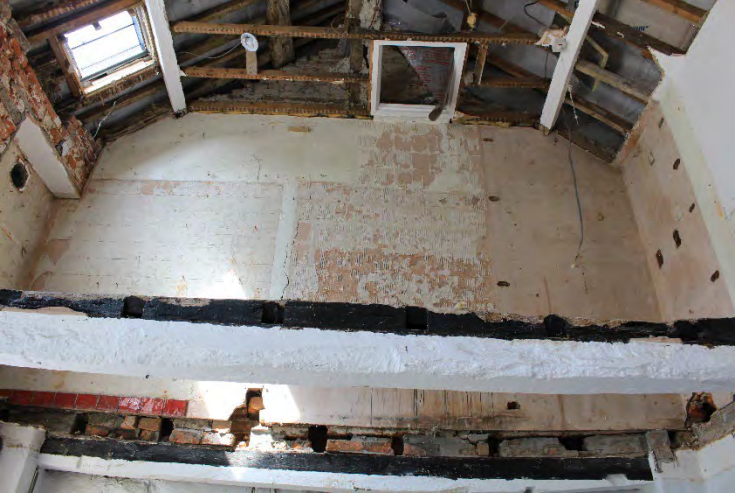
IMG_6552	<p>Four floor joists. Rectangular section, with curve to underside to mimic 'sag'. Regular slight curved saw marks indicating mechanically sawn and with some crude axe marks to 'rusticate' the beams. Otherwise, no chamfers or stops. Upper with rectangular notches for joists. Beam ends decayed on exterior (west) wall.</p>

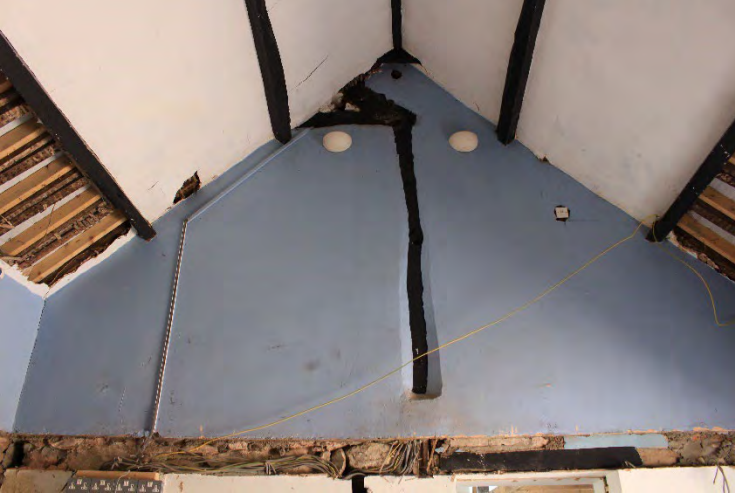
IMG_6516	<p>Single upright and end of truss observed on one side embedded in fabric. Full section not observed due to later covering. Upper joint with truss clasped with iron plate. No cut/adze marks observed due to later overpainting.</p>
Coach house

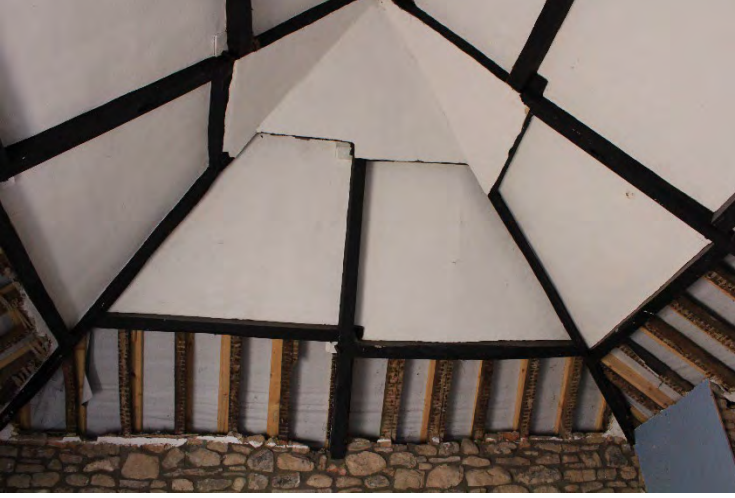
IMG_6381	<p>Hipped roof, regular sawn square section timbers regular saw marks. No chamfering. Purlins staggered butt joints with tusk tenon joint pinned with timber round peg.</p>

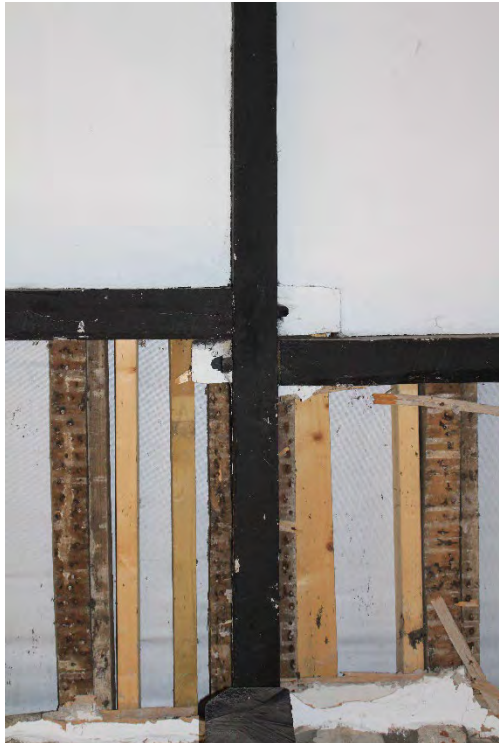
A photograph showing the interior of a wooden structure under construction. A prominent dark vertical post stands in the center. Horizontal beams are visible above and below it. The walls are made of brick and wood framing. The floor is covered with snow.	IMG_6377	Hipped roof, regular sawn square section timbers regular saw marks. No chamfering. Purlins staggered butt joints with tusk tenon joint pinned with timber round peg.
