CPAT Report No. 2967

Bwlch-Du, Nantglyn, Denbighshire

Organisation	Clwyd-Powys Archaeological Trust
Client Name	Dean Turner
CPAT Project No	2725
Project Name	Bwlch-du, Nantglyn
Project Type	Level 3 Historic Building Recording
Project Manager	Tim Malim
Project Supervisor	Chris Matthews
Grid Reference	(SH9872058380).
County/LPA	Denbighshire
Planning Reference	(25/2022/0583/PF)
CPAT Report No	2967

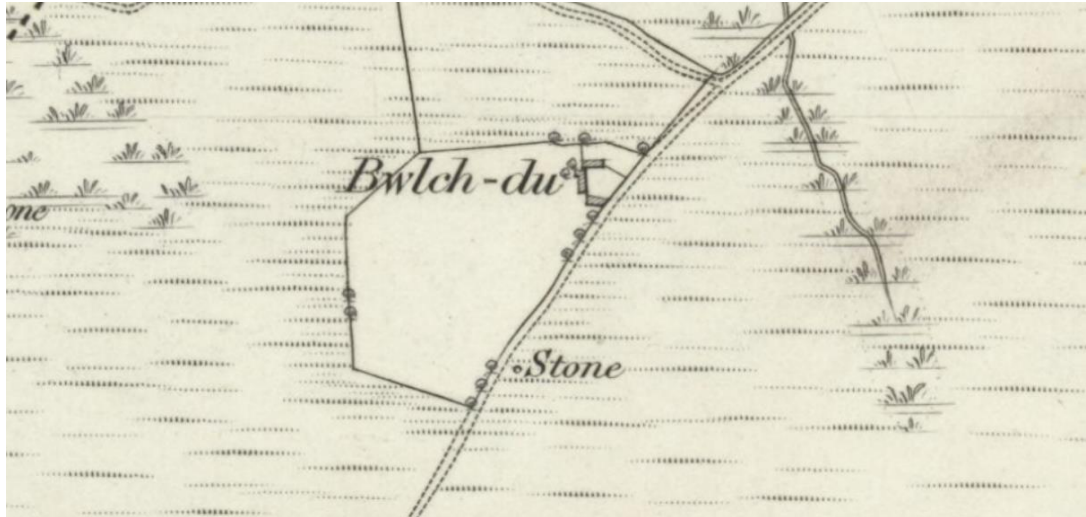
Figure 2: 1875 First Edition Ordnance Survey map depicting Bwlch-du

- 2.3. The earliest depiction of the structure is on the 1874-1875 First Edition Ordnance Survey map, where it continues to be present throughout modern mapping. In 1875, the site is depicted with the main northern east-west aligned range, the north-south aligned western range with a small annexe on the northwest corner (the pigsty), and the southern east-west aligned range (cart shed), all forming a courtyard that adjoins a trackway to the east (Figure 2). The structures appear relatively unchanged between the late 19th century to mid 20th century with the exception of the pigsty which is only depicted in the first edition, however, this may be a reflection of the level of detail in the later maps rather than its absence.

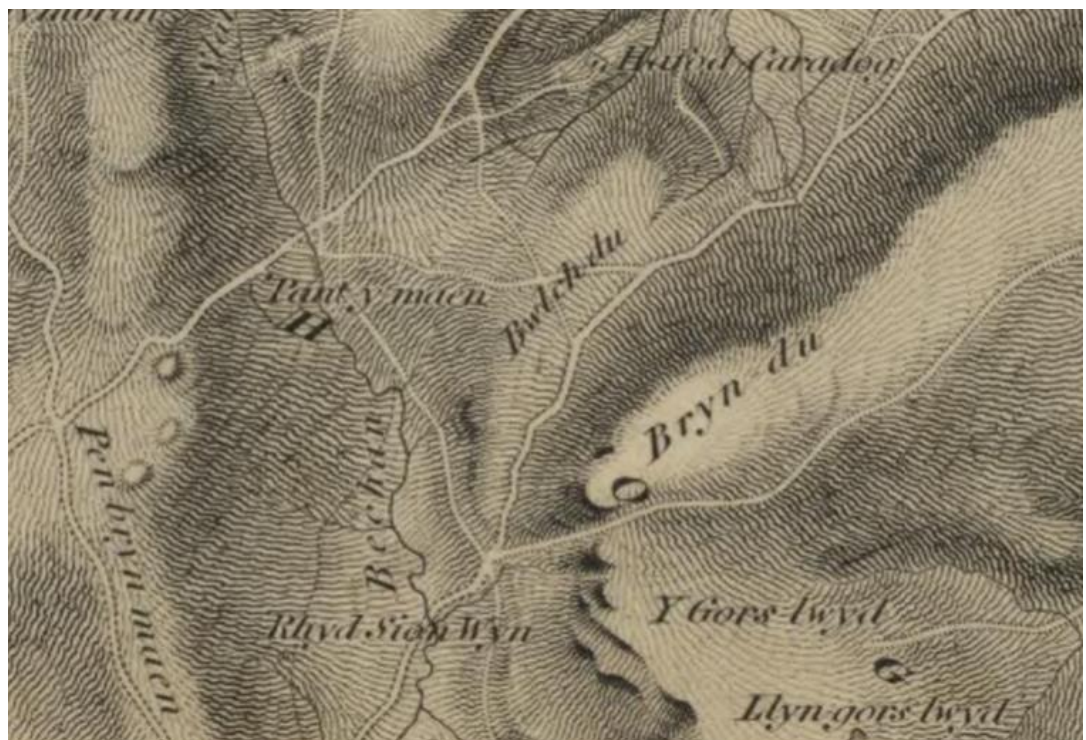
Figure 3: Old Series Ordnance Survey Maps of England and Wales 1839 showing Bwlch-du

- 2.2. The structure is not depicted on the 1839 Old Series Ordnance Survey Maps, however, the placename Bwlch-du (meaning black Saddle or Pass) is depicted at a triangular intersection of roadways (Figure 3). The structure is also not depicted on the 1841 Tithe map for the parish of Llanrhaadr in Cinmerch, with the site forming part of a large open plot, noted as allotments. In 1841, the land was owned by Miss Harriet Myddelton of Ruthin Castle but had previously formed part of the wider Myddelton estate, which on the death of Richard Myddelton of Chirk Castle in 1796, the last surviving male heir of the Myddelton Family, the estate was divided between his sisters (Denbighshire Archives, 1981).

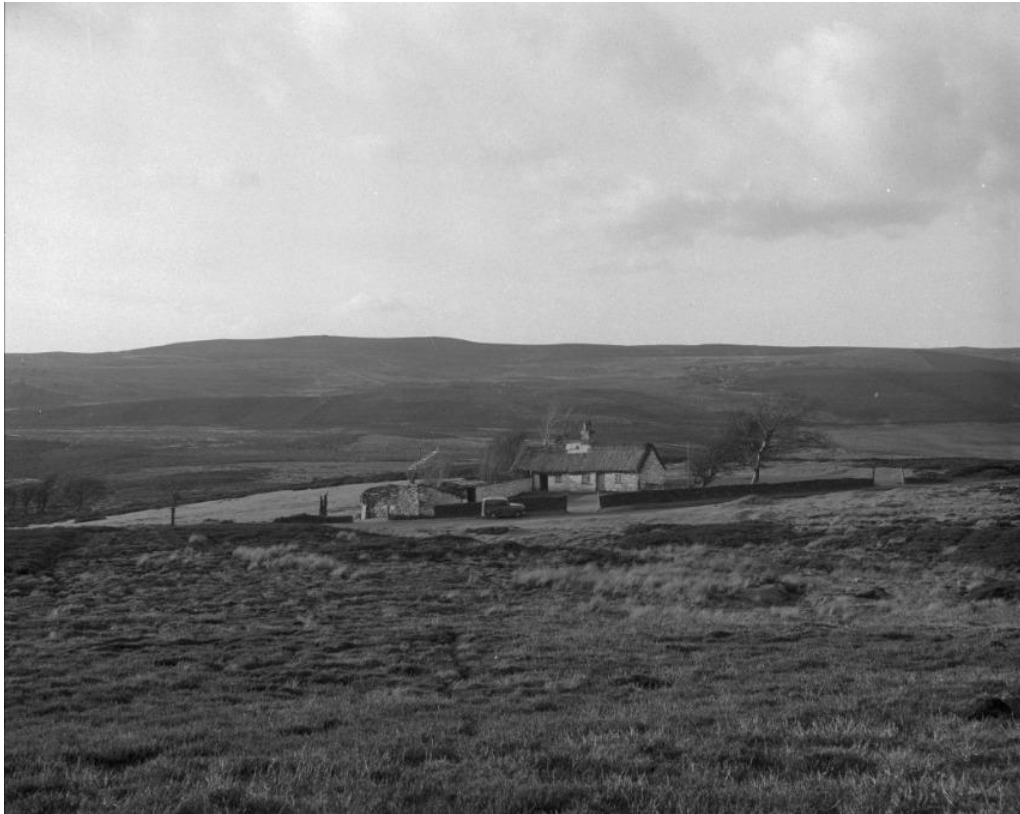
Figure 4: Picture of Bwlch-du dating to the 1920s (provided by the landowner).

- 2.5. A photograph of Bwlch-Du from the 1920s shows the main northern range as an active thatched cottage(s) with a tall chimney stack topped with a king and queen pot (Figure 4). The southern range is shown with a slate roof and adjoins the roadside boundary to the east. The western range is depicted with a shallow-pitched roof, however, there is some indication that it may be out of use by this point, with the southern extent appearing ruinous. By 1971, a

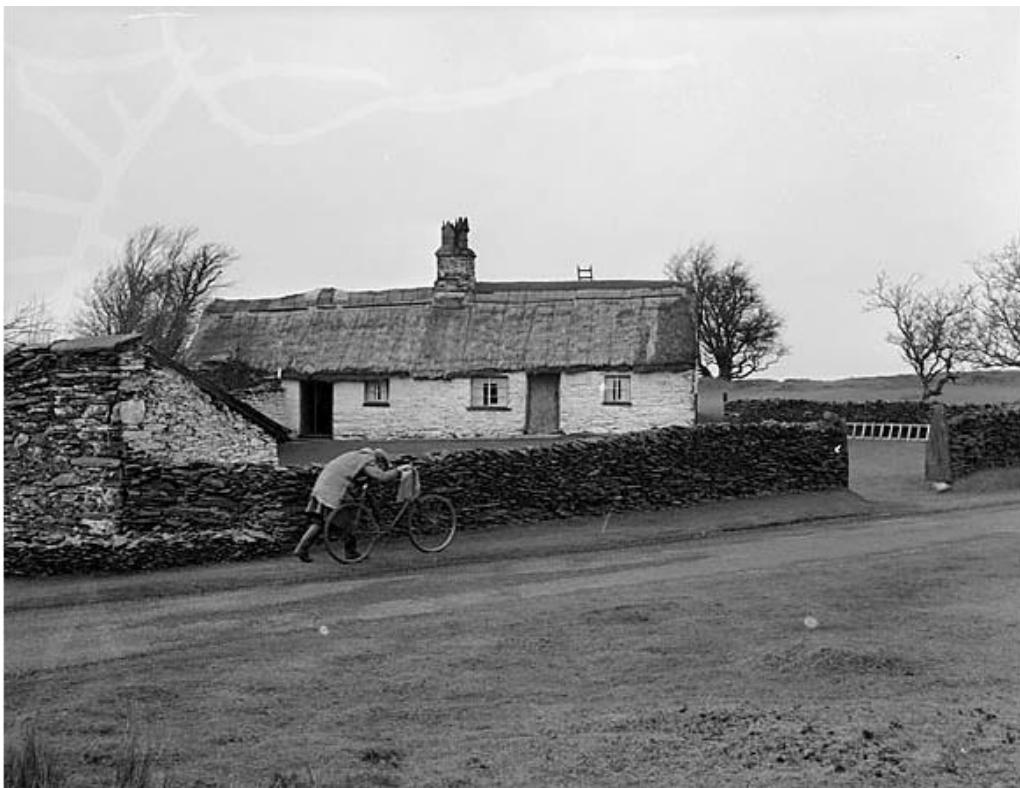
Figure 5: Picture of Bwlch-du dating to 1971 (provided by the landowner).

photo shows the site largely unchanged, however, only the northern and southern ranges are visible.

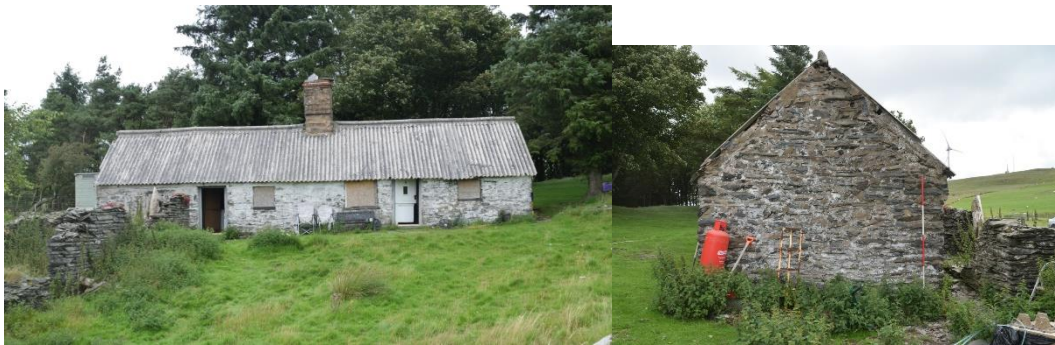
Figure 6: (left) south facing elevation of northern range (CPAT photo 5079_021). (right) west facing gable wall of northern range (CPAT photo 5079_001).

- 3.2. The northern range is comprised of two adjoining cottages, defined in Figure 17 as A and B, each formed by two rooms and separated by a central chimney stack. The combined structure comprises rough rubble slate coursing with a lime mortar bonding and lime rendering on the south facing elevation (Figure 6). The north facing elevation had protruding bedrock forming the lower foundation. This was exposed by a shallow gully running along the rear of the property that is likely to have been formed by the former thatch roof depicted in the 1970s (Figure 5). The upper courses of the west-facing gable appear to have been re-instated with concrete, likely during the re-roofing of the properties.

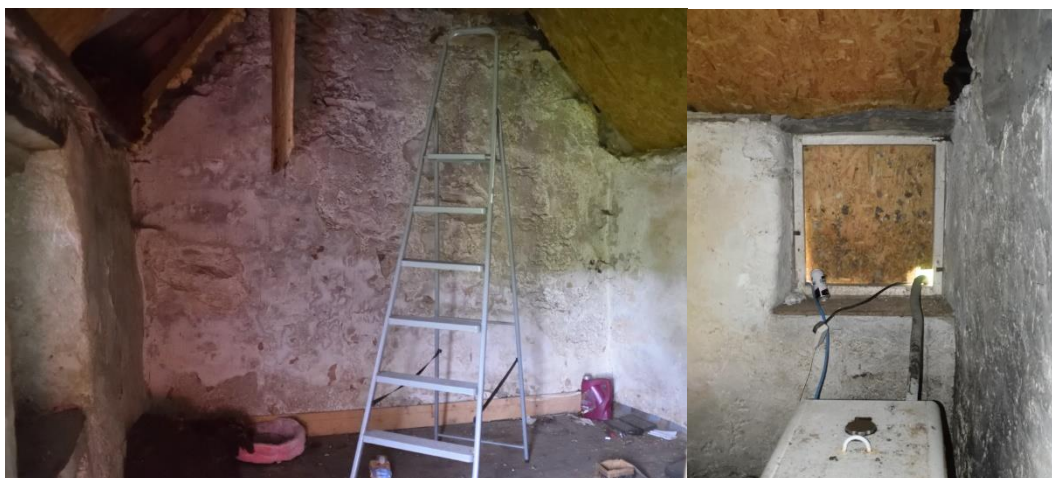
Figure 8: Gable end and rear window of room 1A (CPAT photo 5079-031 and 32).

- 3.7. Room A of cottage 1 forms the western end of the structure which is accessed through a doorway from room B. The room has two windows, one to the front and one to the rear, the latter positioned in line with the dividing wall. The internal walls consist of visible rubble coursing with a thick whitewashed lime render. The ceiling had been clad in modern OSB chip board, limiting the visibility of the roof structure, however, one section had collapsed exposing basic timber purlins below the asbestos roof. The floor consists of a timber board overlaid by modern lino, with a partly installed modern pine skirting board. Evidence of the re-roofing of the cottage is also apparent in the upper coursing of the gable wall, where the masonry and render has been replaced by concrete.

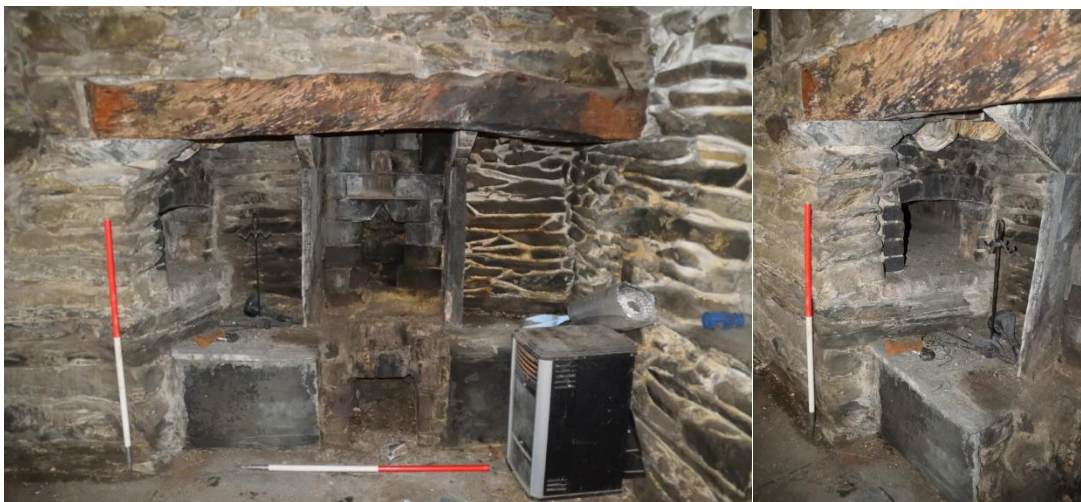
Figure 9: Inglenook style Fireplace (left) and bread oven in room 1B (right) (CPAT photo 5079-023 and 24).

- 3.8. Room B, is the first room accessed from the main entrance into the property. This room has a single window on the front adjacent to the door. The internal walls consist of visible rubble coursing with a thick whitewashed lime render on the south and east facing walls, with remnants of render on the north facing wall. The ceiling had been clad in white painted timber boarding laid horizontally along the length of the structure, forming a half sloped ceiling. The floor consists of weathered slate flagstones, likely to be original (Figure 10). On the west facing wall of the room is a large inglenook style fireplace with a broad timber beam lintel (likely oak) defining a large 2.1 m wide recess (Figure 9). Within the left side of the fireplace is a red brick lined bread oven with a stone slab base that is built into the central dividing wall that separates the two properties. The brick lining is formed by red unfrogged wire-cut bricks measuring 114mm (wide) by 80mm (thick) by 230mm (long), which is consistent with the common dimensions of mid to late 19th century brick. Within the fireplace is what appears to be a later insert defined by two cement rendered pads on either side, between which is a cast iron coal fire with a brick smoke draft designed to draw the smoke into the centre of the stone-built chimney stack, which is shared with the adjacent property. The red bricks forming the insert are unfrogged and wire cut, measuring 114mm (wide) by 68mm (thick) by 235mm (long), which is also consistent with the common dimensions of mid to late 19th century brick. Within the beam of the fireplace were forged iron fittings, likely associated with light fittings such as lanterns or candles or for other fittings relating to the fireplace.

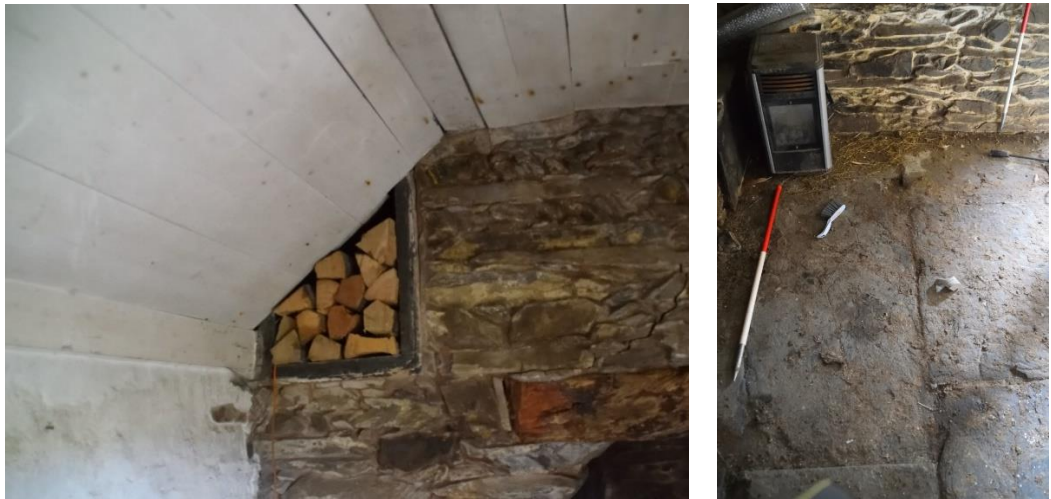
Figure 10: Wood store next to fireplace and stone slab flooring in room 1B (CPAT photo 5079-026 and 29).

- 3.9. To the left of the fireplace is a recess set between the chimney stack and the ceiling that is presently being used as a wood store, which is also likely to reflect its original function (Figure 10).

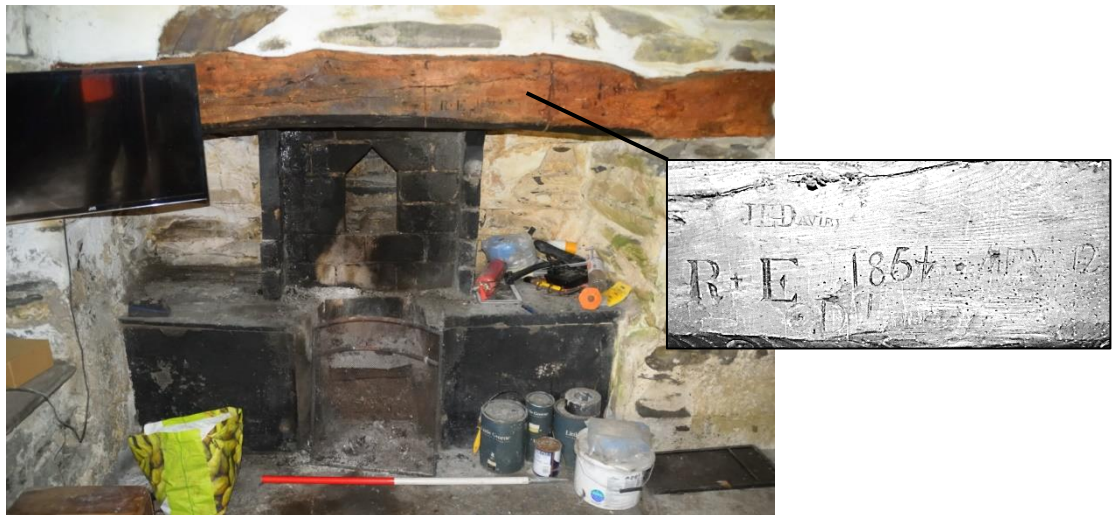
Figure 11: Inglenook style fireplace in Room 2A with lintel engravings (CPAT photo 5079-039 and 46).

- 3.11. Within the fireplace beam are several engravings that date to between the mid-19th century and early 20th century. These include R + E 1854 (with the 4 carved upside down), J E Davies, D I and MEY 12 (possibly 1912). There is no indication that the timber beam has been reused, therefore these engravings are likely to reflect the occupancy of the cottage, providing a pre first edition Ordnance survey map date of 1854. There appears to have been a later attempt

to remove the engravings, likely for presentation, by cutting a section into the beam. Within the beam is a forged square head nail dating to between the 18th and mid-19th century.

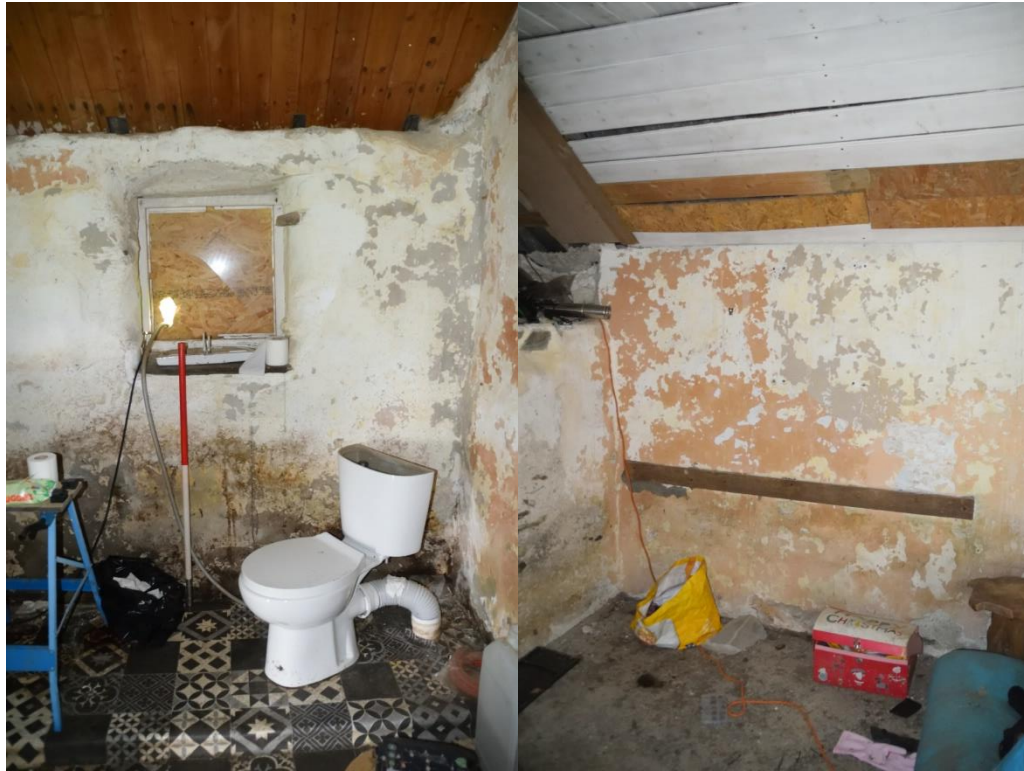
Figure 12: (Left) rear wall and window of room 2B (right) rear plaster rendered wall of room 2A (CPAT photo 5079-053 and 60).

- 3.12. The ceiling within this room has been clad with white painted timber boards laid horizontally along the length of the property, forming a half-sloped ceiling. The floor consists of modern 20th / 21st century poured concrete.

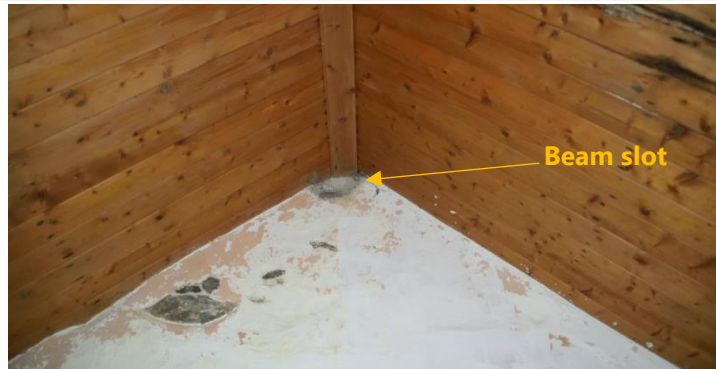
Figure 13: West facing internal gable wall showing beam slot at the apex of the roof. (CPAT Photo 5079-075)

- 3.3. The structure is roofed with corrugated asbestos that is built onto a basic timber frame supported by the internal stone divisions. The timber roofing frame associated with the former thatched roof appears to have been removed, however, there is evidence of infilled timber

slots within room 2B that suggest a large central beam, likely roughhewn based on the circular form of the infill.

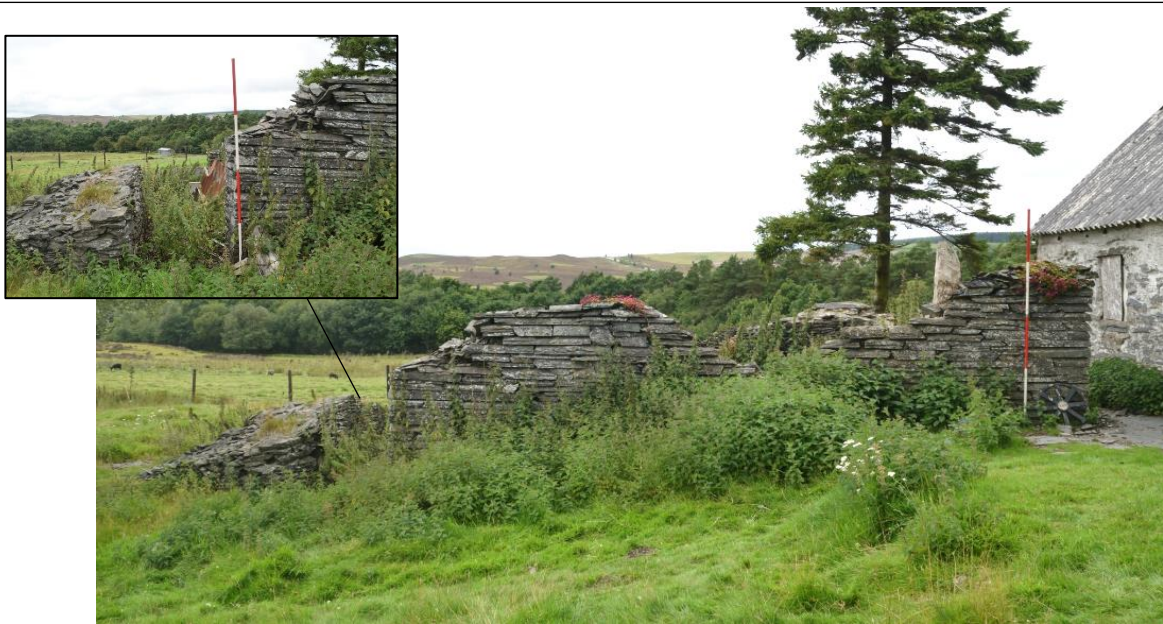
Figure 14: Upstanding walls of the eastern range (CPAT photo 5079-011 and 12).

- 3.15. The most visible element of the western range is the structure referred to as the outbuilding, with walls surviving to a height of 1.5m (Figure 14). The extant remains indicate two doorways, one on the northern side adjacent to the cottage, and another within the eastern wall adjoining the southern gable. At the time of the survey, the interior was largely inaccessible due to overgrowth and debris, however, evidence of a blocked-up door within the western wall is present and is defined by an infill of machine cut slate. The upstanding wall that forms the east facing exterior is also likely to be a later addition, defined by a regular coursing of machine cut slate. The remainder of the walls, which only stand to between 0.5 and 1m high, comprise of lime mortared rubble slate courses comparable to the construction of the cottages.

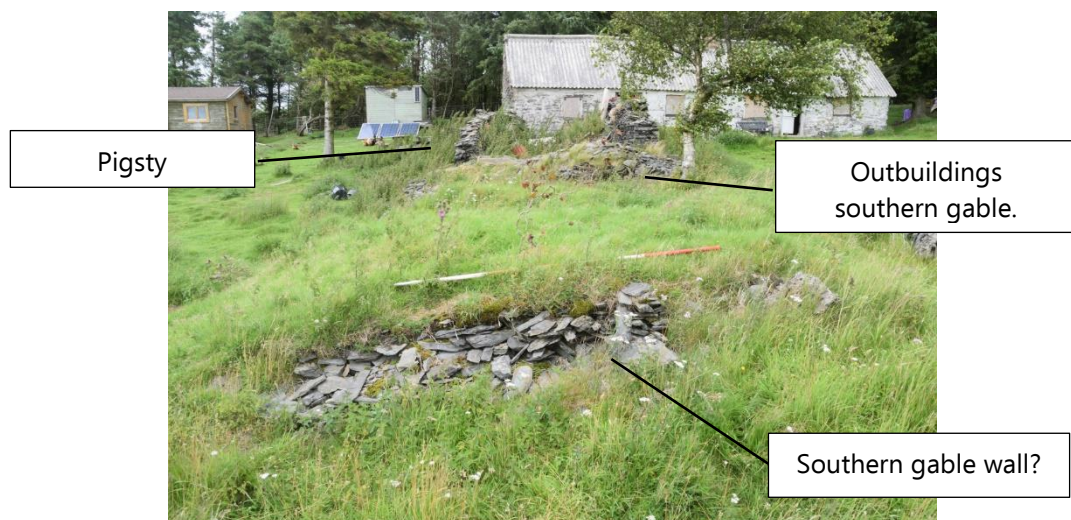
Figure 15: Southern building platform of eastern range (CPAT photo 5079-015).

- 3.17. To the south of the upstanding remains is a rectangular platform extending a further 10m south from the gable wall of the outbuilding and measuring approximately 4.9m wide. A possible associated building footprint is defined on the eastern side and southern end by the remains of a foundation level slate rubble wall (Figure 15). On the southern side of the outbuilding there appears to be a rectangular masonry pad and rubble tip that may represent some form of buttress against the outbuilding wall, or an internal feature for the former structure.

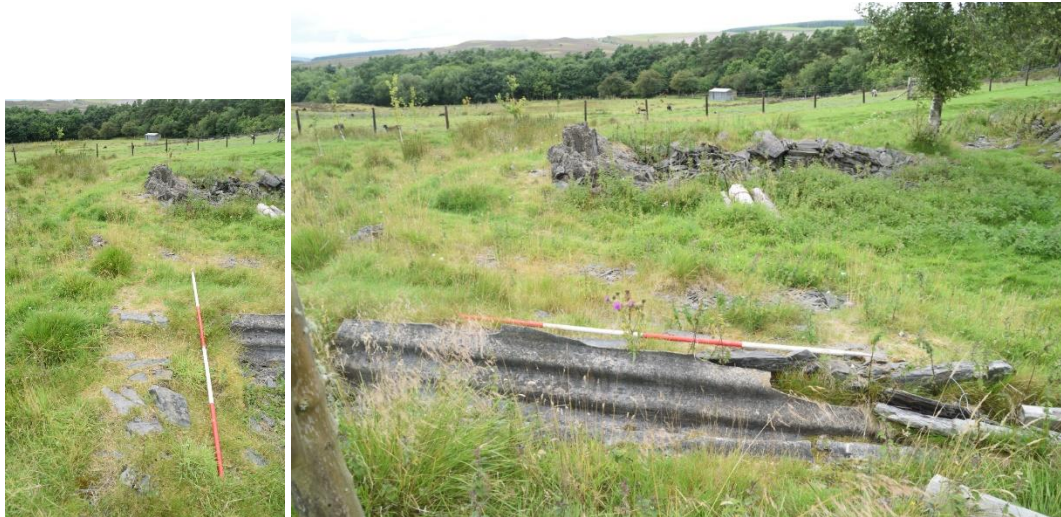
Figure 16: Remains of cart shed roof and wall foundations of the southern range (CPAT photo 5079-019 and 20).

- 3.18. The southern range is now only evident as the remains of foundation level walls and demolition materials including corrugated roofing. Based on the visible foundations, the structure was defined by walls on the east, south and west and open to the north.

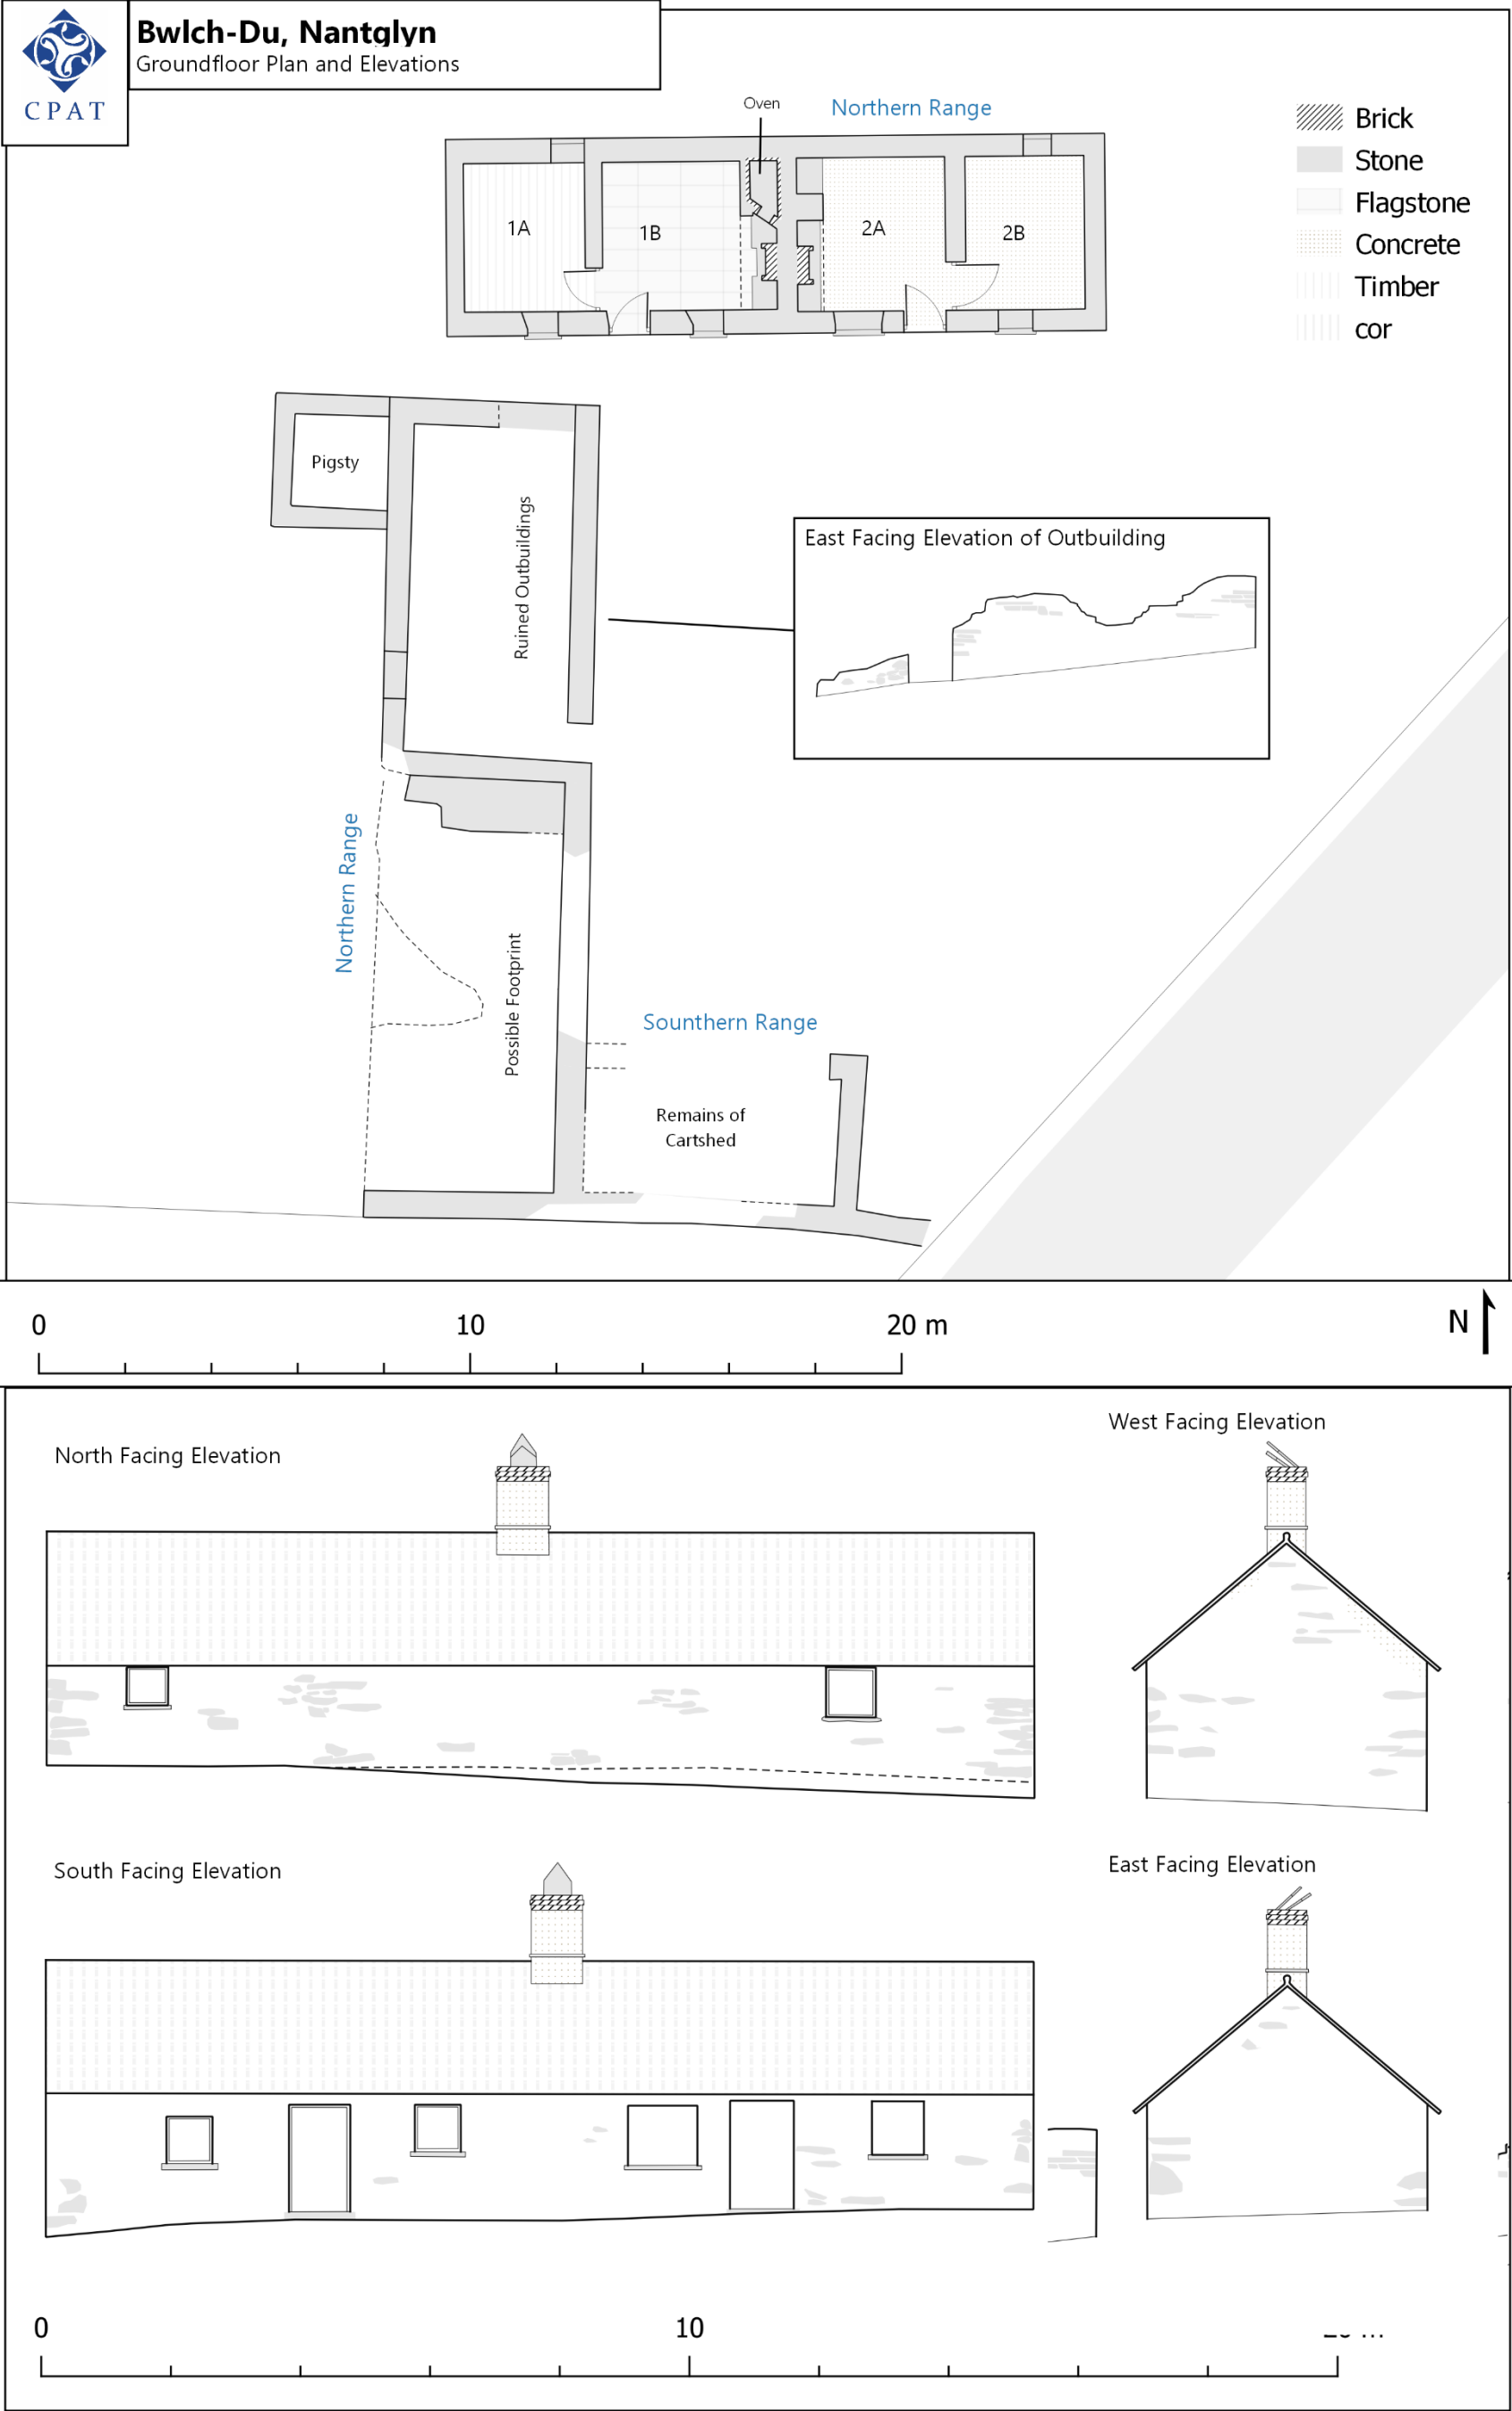
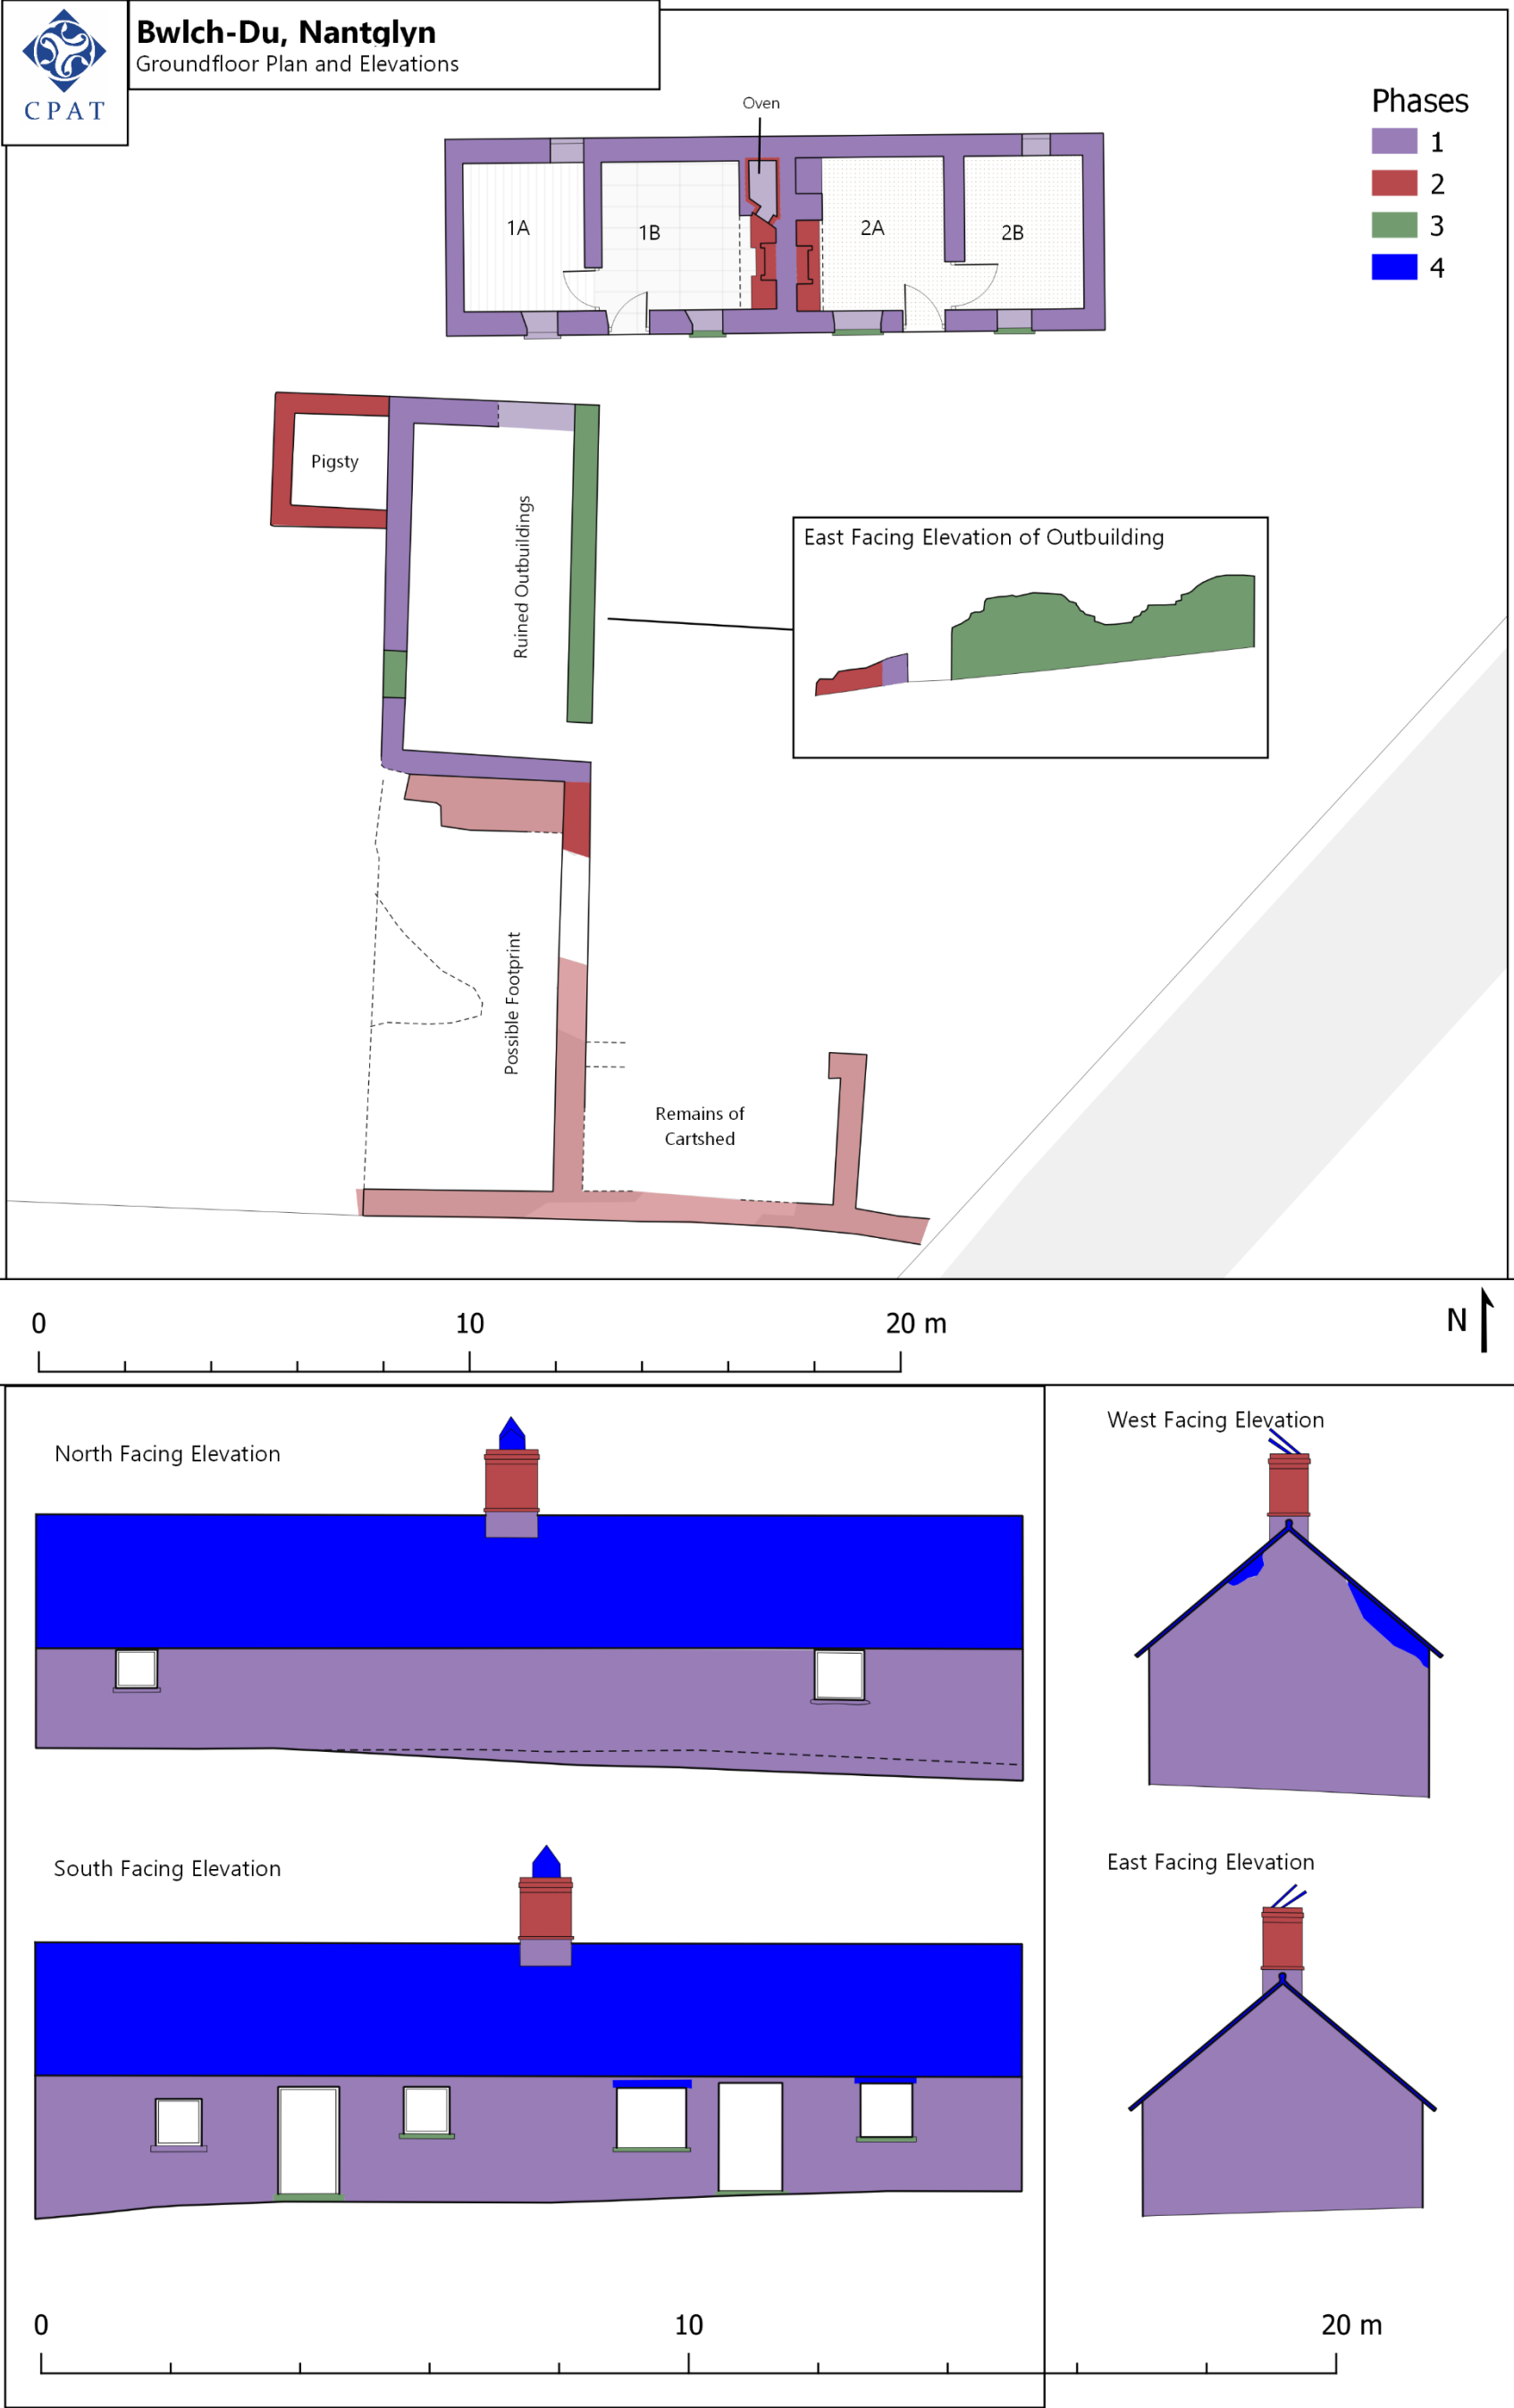
Figure 18: Structural phasing plan

Phase 1 is formed by the rubble slate walls that make up the structure itself. These appear to have been relatively unaltered, with no indication that the internal divisions have been changed.

Phase 2 consists of alterations to the chimney stack and fireplaces with the insertion of a coal burning range and the probable re-lining of the bread oven. Based on the type of brick used, as well as the type of fireplace, this is likely to date to the late 19th century.

Phase 3 consists of possible modifications to the windows with the insertion of new machine cut slate lintels.

Phase 4 consists of 20th and 21st century modifications that include the replacement of the roof with corrugated asbestos and concrete infills within the gable walls.

Phase 1 is formed by the rubble slate walls that make up the western and southern elevations of the northern outbuilding. These appear similar in form to the masonry of the northern range.

Phase 2 consists of the now mostly foundation level remains of the structure abutting the southern gable of the outbuilding and the pigsty abutting the northwest corner of the outbuilding. These structures are shown to be in existence in the 1875 Ordnance Survey map.

Phase 3 consists of the infilling of the doorway within the western elevation of the outbuilding, and the formation of the eastern elevation of the outbuilding, suggesting that it had previously been open. These in-fills are defined by a noticeable different coursing comprised of large machine cut blocks of slate. The 1920s image of the structures shows that this elevation was present and lime rendered with a whitewash.
