CPAT Report No. 2967

Bwlch-Du, Nantglyn, Denbighshire

Organisation	Clwyd-Powys Archaeological Trust
Client Name	Dean Turner
CPAT Project No	2725
Project Name	Bwlch-du, Nantglyn
Project Type	Level 3 Historic Building Recording
Project Manager	Tim Malim
Project Supervisor	Chris Matthews
Grid Reference	(SH9872058380).
County/LPA	Denbighshire
Planning Reference	(25/2022/0583/PF)
CPAT Report No	2967

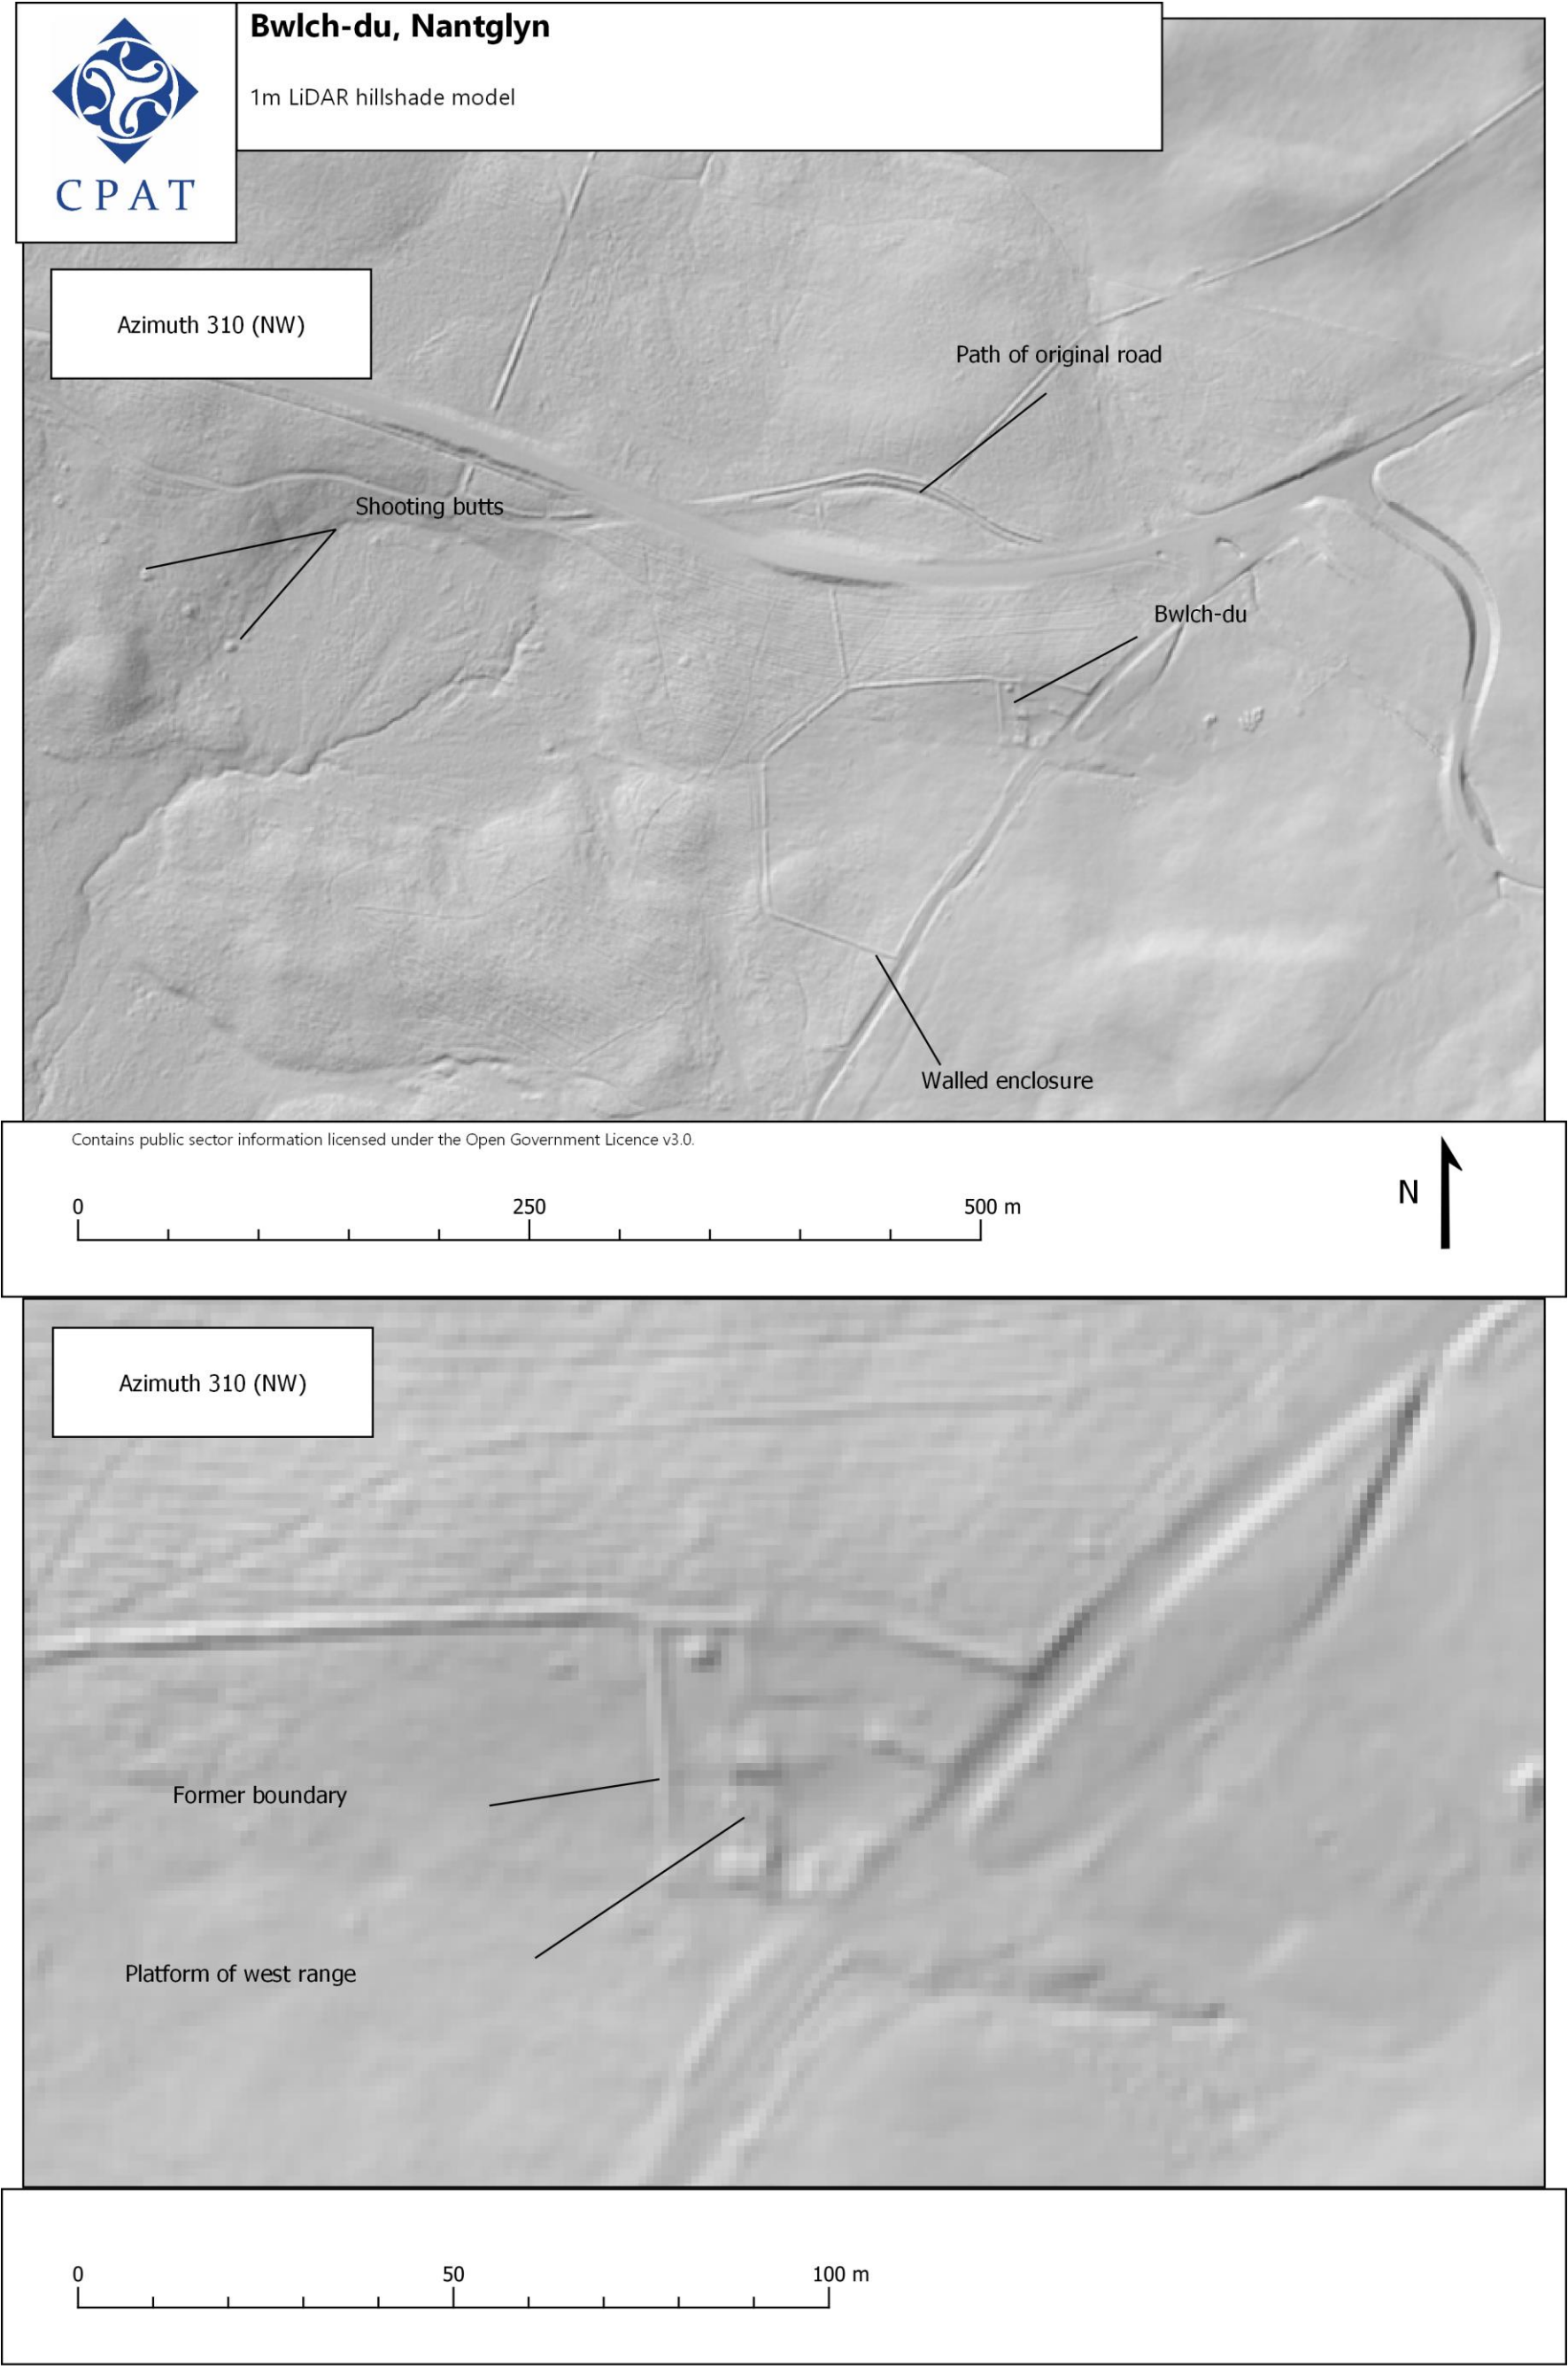
Figure 19: National Environment Agency LiDAR data hillshade modelling.

- 3.19. During the survey, earthworks were noted within the vicinity of the structure and are also visible in the 1m resolution National Environment Agency LiDAR data set (Figure 19). These present as a clear low but steep sided bank that runs parallel with the western range of buildings and links to a broader earthwork that connects to the southern range, forming a courtyard around the structures. This feature is possibly illuded to in the mid-20th century ordnance survey maps as a partially intact former boundary but does not correspond with boundaries present on the earlier mapping.

- 3.20. Another notable feature shown on the LiDAR data (Figure 19) is an alignment of circular mounds 450m to the west of the property which most likely represent shooting butts relating to hunting and sport shooting. This is reflective of the landscapes known use in the later 19th and early 20th centuries as upland hunting grounds.

- 3.21. The LiDAR also shows the remnant of the former trackways to the north that have since been rerouted with the establishment of the B4501.
