CPAT Report No. 1933

Pentre Saeson Foundry, Wrexham

Historic Building Survey

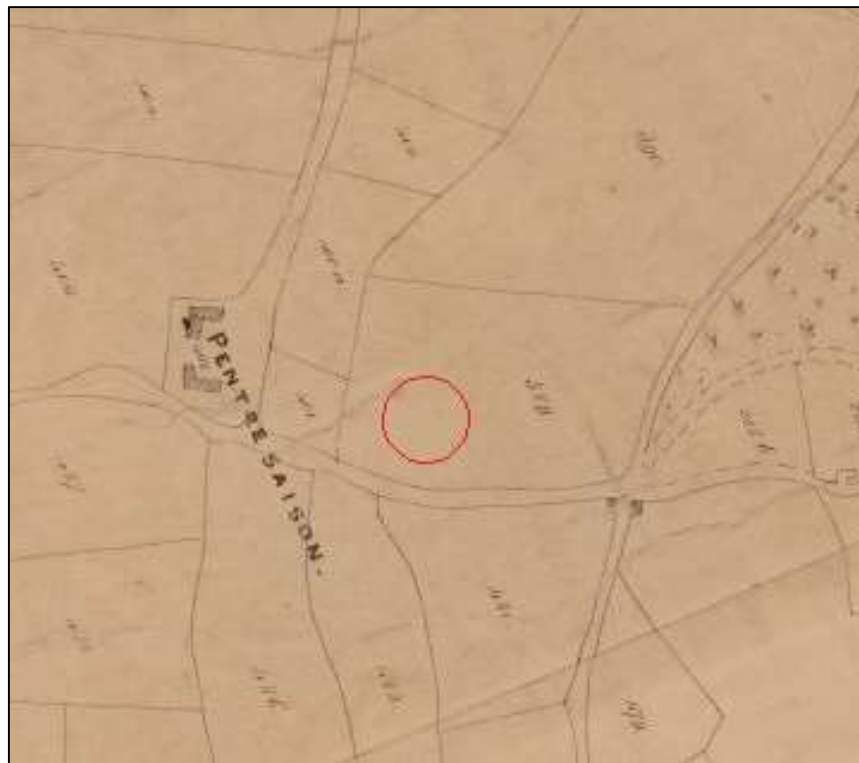
Fig. 2 Extract from the 1839 Tithe Map with the approximate location of the foundry complex circled in red

- 2.3. The origins of the foundry at Pentre Saeson are somewhat unclear. One source records that the foundry site was purchased and founded by John Wilkinson during the 1790s, and that it was in operation during the early 19th century (britishlistedbuildings.co.uk, accessed March 2023). However, the foundry is not recorded by the 1839 Tithe Apportionment, which records the site as Gate Field, owned by Robert Roy and others and occupied by Margaret Hughes (Fig. 2).

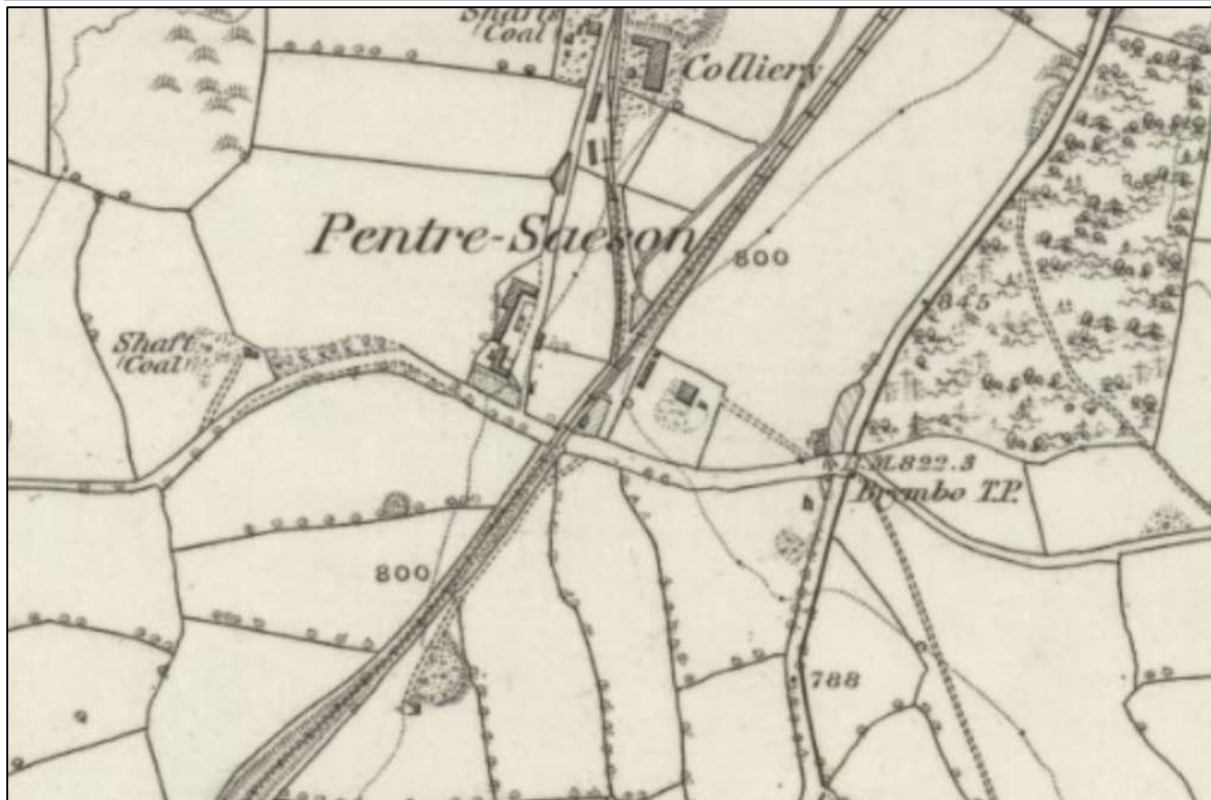
- 2.4. The earliest cartographic source that records the foundry is the 1879 Ordnance Survey Map, which was surveyed in 1873 (Fig. 3). This depicts the main foundry building and another smaller building to the east of it, with the outbuilding to the west, with another detached building to the north of it. The Wrexham and Minera railway line runs immediately to the west of the site and there is a colliery served by a spur line to the north-west.

Fig. 3 Extract from the 6" Ordnance Survey Map of 1879 showing the foundry complex (centre)

- 4.2. Map regression suggests that the outbuilding was built at some point between 1839 and 1873, and is therefore broadly contemporary with the foundry itself.

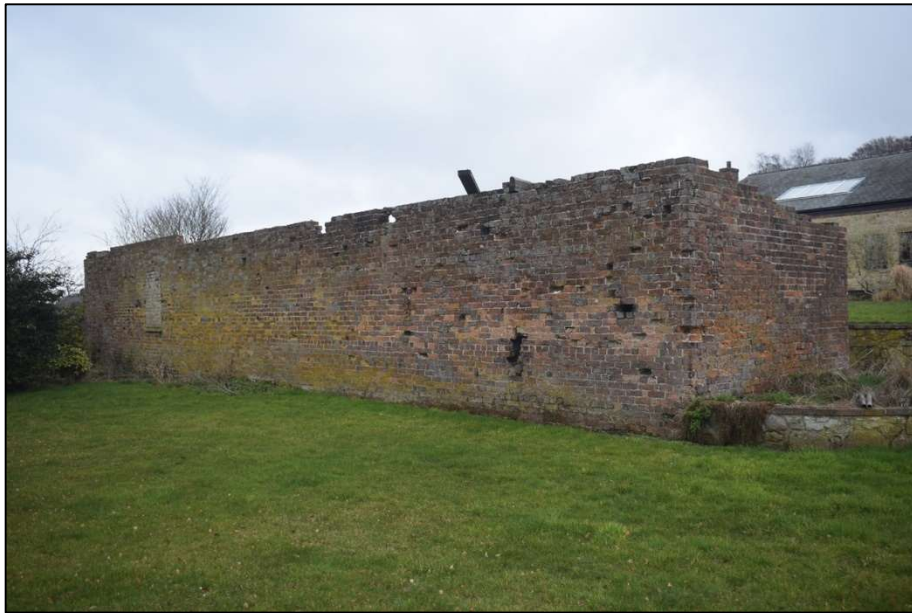
Fig. 4 Outbuilding viewed from the south-west Photo CPAT 5040_003

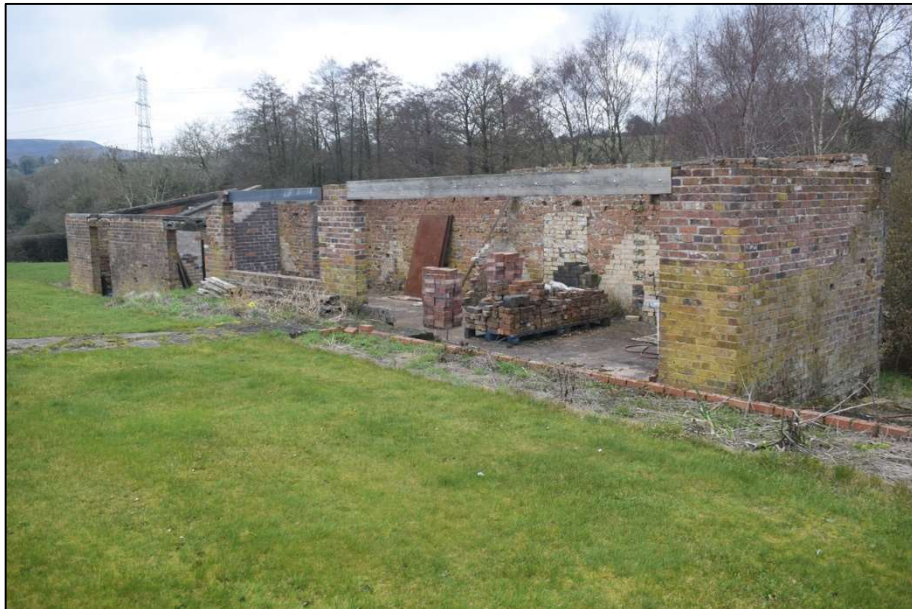
*Fig. 5 Outbuilding viewed from the north-east showing the large later opening in the east elevation
Photo CPAT 5040_006*

- 3.5. The access into the upper level was via a single wide opening, which appeared to be a later alteration. There were the remains of several partition walls running from east-west visible in the fabric of the west elevation, indicating that this area had been subdivided into several small rooms (Fig. 7). There was a chimney stack with a small fireplace at the north end of the west elevation (Fig. 8). There was a single voussoir window in the west elevation which had been infilled with buff coloured fire bricks, which had greenish vitreous residues adhering to them, suggesting they had been subjected to high temperatures. Fire bricks had also been used to repair the internal face of the west elevation and one of the partition walls.

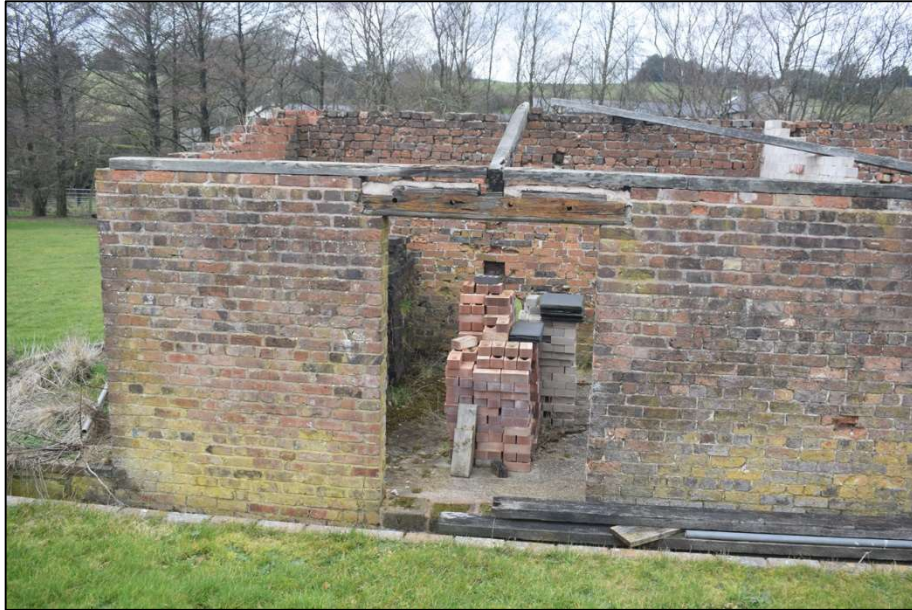
- 3.4. The roof frame was almost completely missing with only a section of wall plate and a single rafter still in situ (Fig. 6). The flooring on both levels of the building was concrete and probably a later alteration. The external doorways into the building were located on the east elevation. The two rooms on the lower level were accessed by two doorways, both with wooden lintels made from railway sleepers. There were a series of internal doorways allowing access through the entire building.

Fig. 6 View west of the southern end of the building showing the remnant roof structure Photo CPAT 5040_010

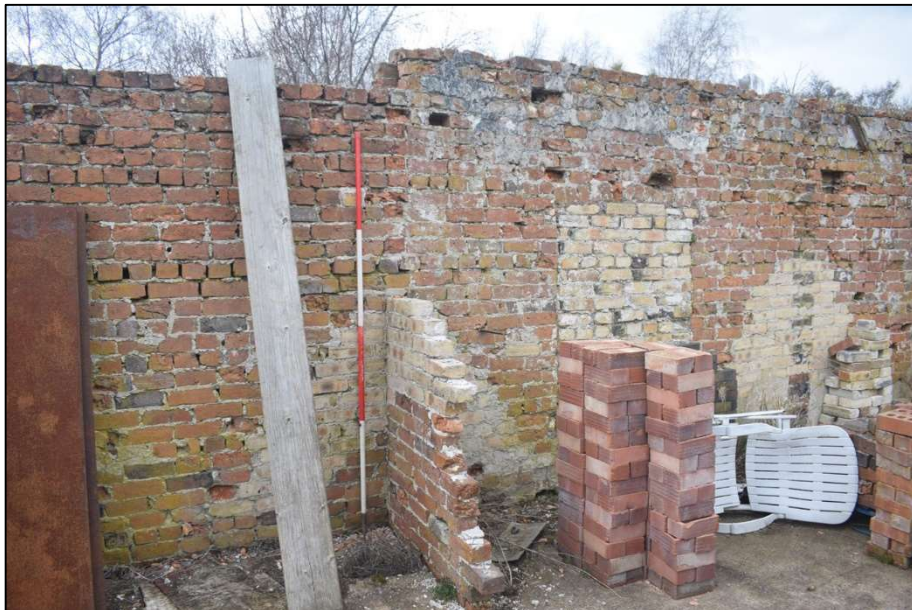
Fig. 7 Internal partition within the northern section of the building Photo CPAT 5040_024

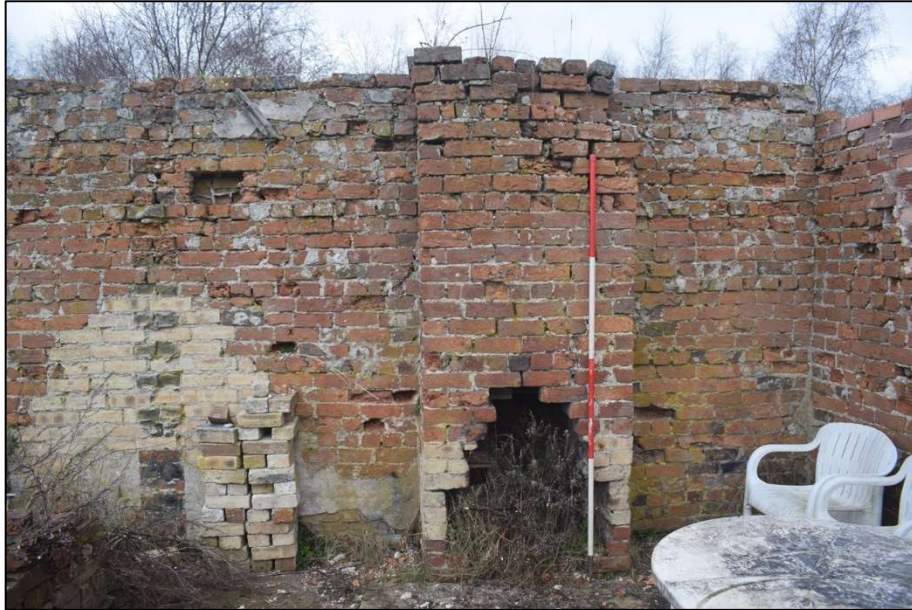
Fig. 8 Chimney stack at northern extent of the building Photo CPAT 5040_028

- 4.4. The northern end of the building may have been a workers communal room or bait shed, as suggested by the presence of a fireplace. There was a second room adjacent to this lit by a window in the west elevation, which may have been an office or working area. Internal subdivisions to the east of this suggest the presence of two small rooms to the south of this, but it is unclear what these were used for.
