CPAT Report No. 1875

Van Mine, Llanidloes, Powys

Historic Environment Desk-based Assessment

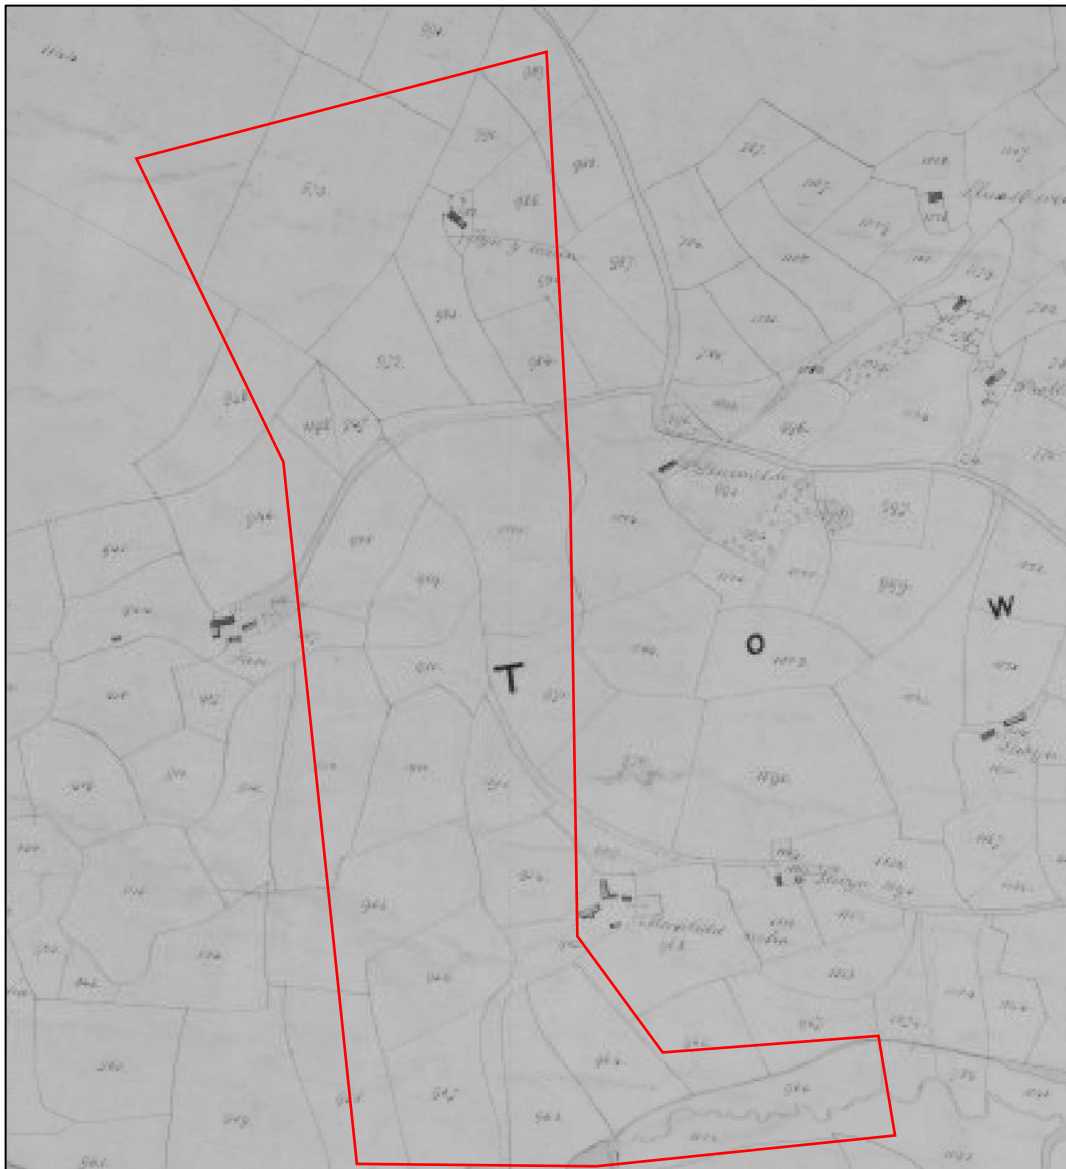
Fig. 2: 1846 Tithe map, approximate extent of assessment area outlined in red

- 2.10. The earliest readily available map of the Development Area is the Ordnance Surveyors drawing (No 321) of 1822, but this only shows the farm of Ty'n y Waen within the assessment area and has not been reproduced. Likewise a copy of the 1828 Arwystli Enclosure map that was made in 1874 for the Plas Machynlleth estate – the owners of the mine site at the time. The tithe map (Fig. 2) did not show any evidence of buildings predating the mine within the assessment area and a search of the tithe field names in the associated apportionment was similarly unproductive. No field names which might identify potential archaeological sites were found in this search.

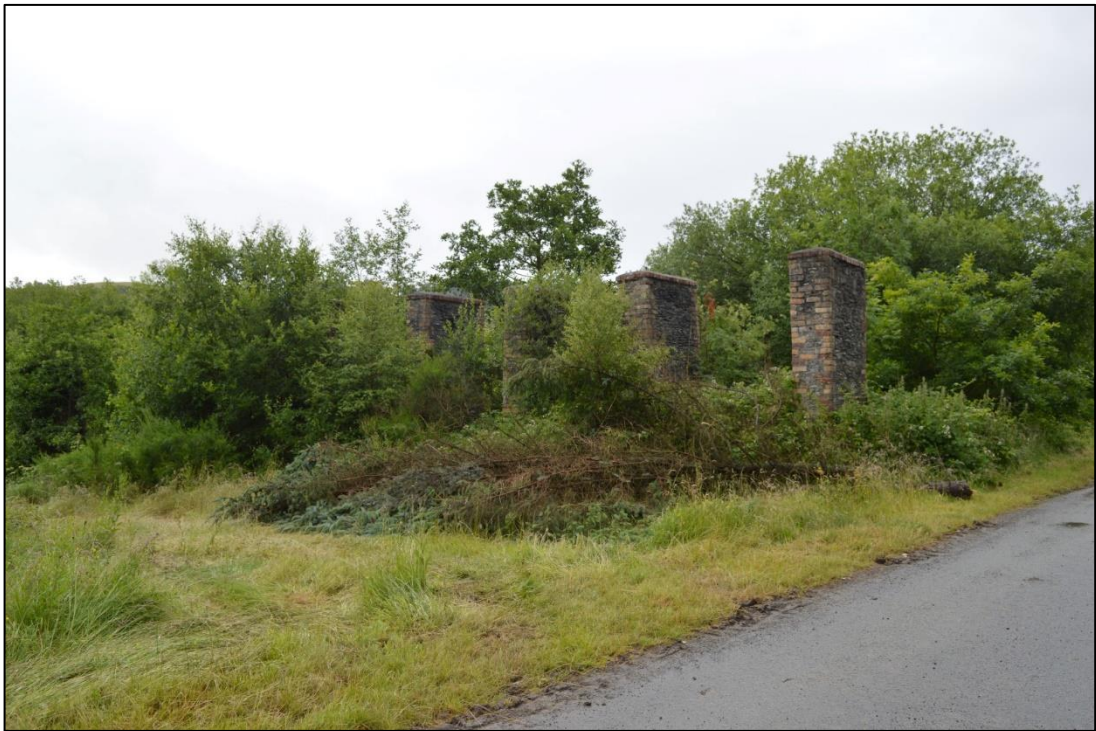
Fig. 8: The piers (PRN 214949) that once carried a tramway across the mine site, from the north. CPAT 4999-0001

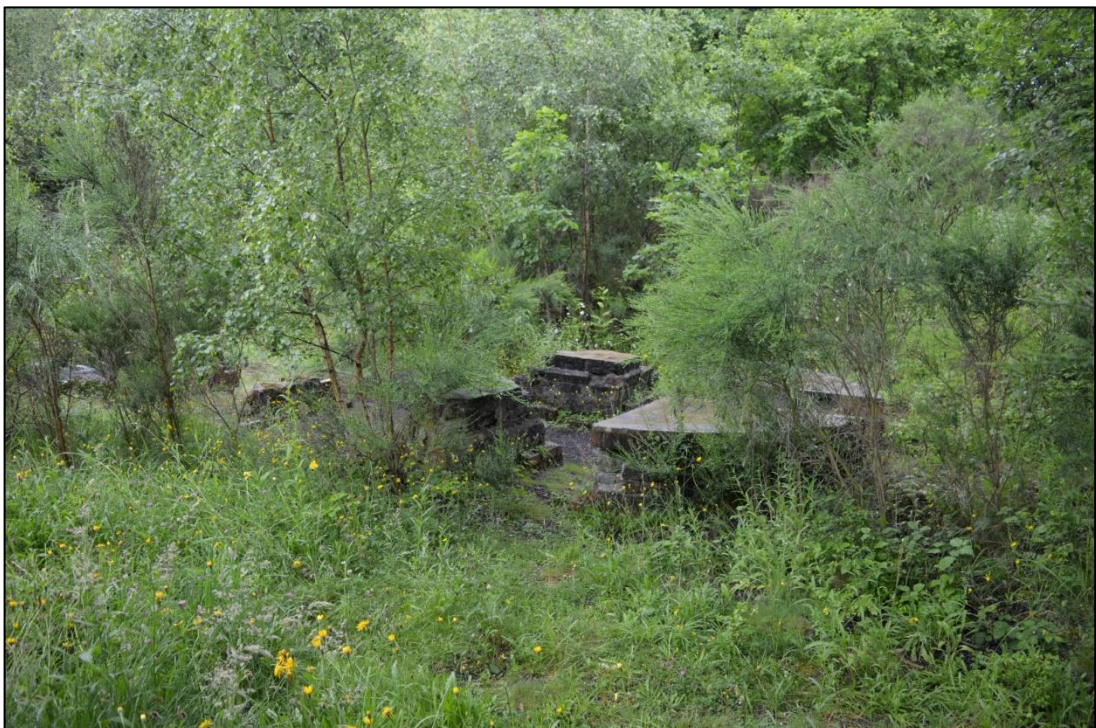
Fig. 9: Machinery foundations (PRN 214950) on the lower dressing floor, from the north. CPAT 4999-0011

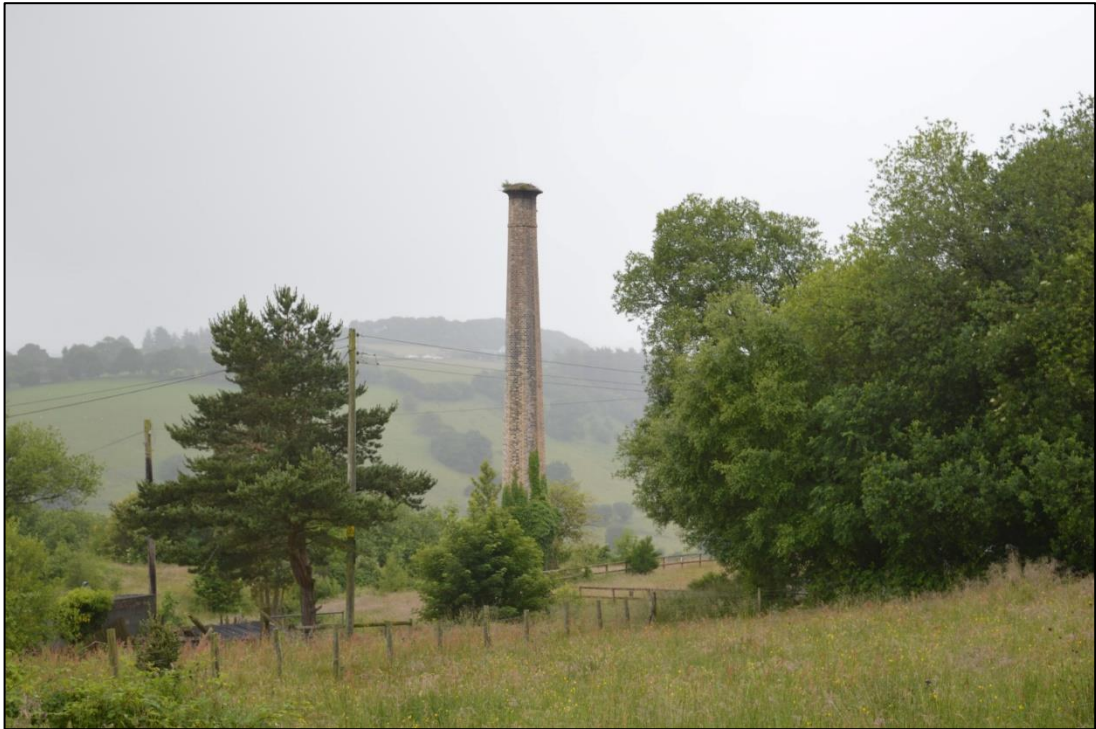
Fig. 10: One of the Grade II Listed chimneys at Seaham's Shaft (this is PRN 42523), from the north-north-east. CPAT 4999-0003

- 3.5. A total of 63 heritage assets (as listed above) have been recorded within the assessment area, though one of these (PRN 5936) is a general record for the mine itself. Two (PRNs 42523 and 42524), each a brick chimney (see Fig. 10) that once served a boiler house at Seaham's Shaft, are designated as listed buildings at Grade II; all other assets are undesignated. Each asset is depicted as point data on Fig. 6; their extents (except PRN 5936) are depicted on Fig. 7.

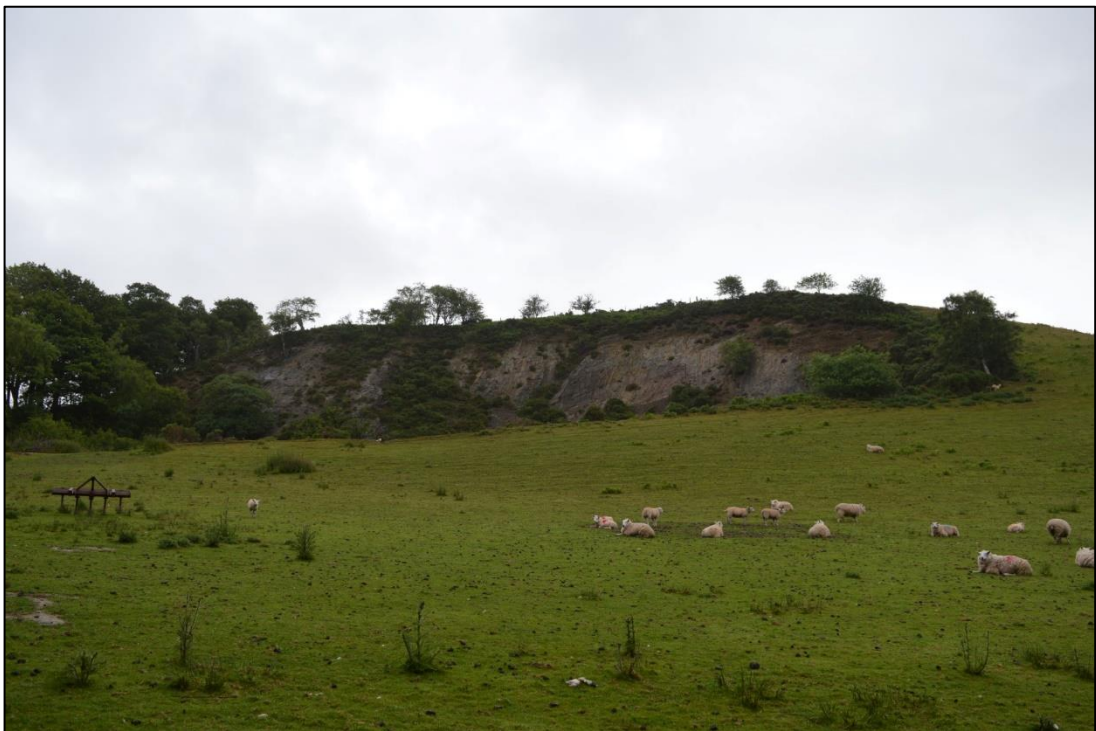
Fig. 11: The Mine quarry (PRN 22057), used to provide stone for the backfilling of worked out sections of the mineral vein, from the west. CPAT 4999-0002

- 2.7. The profitability of the mine continued to increase and in 1876 it produced its highest yield, comprising 6850 tons of lead ore and over 2000 tons of zinc, though by the 1890s it had become less desirable owing to the drop in the price of lead on the market and thereafter passed through the hands of a number of companies. When the mine finally closed in 1921 it had produced nearly 97000 tons of lead ore and over 28000 tons of zinc. The remarkable width of the mineral vein led to a method of working more akin to that found in coal mines, whereby as soon as a section of vein was worked out, it was packed with waste material and stone dug from the nearby quarry (Fig. 11) to preserve the stability of the ground and allow adjoining sections to be worked safely.
