**CPAT Report No. 1832**

# **Lower Bryntalch, Abermule, Powys**

Historic Building Survey

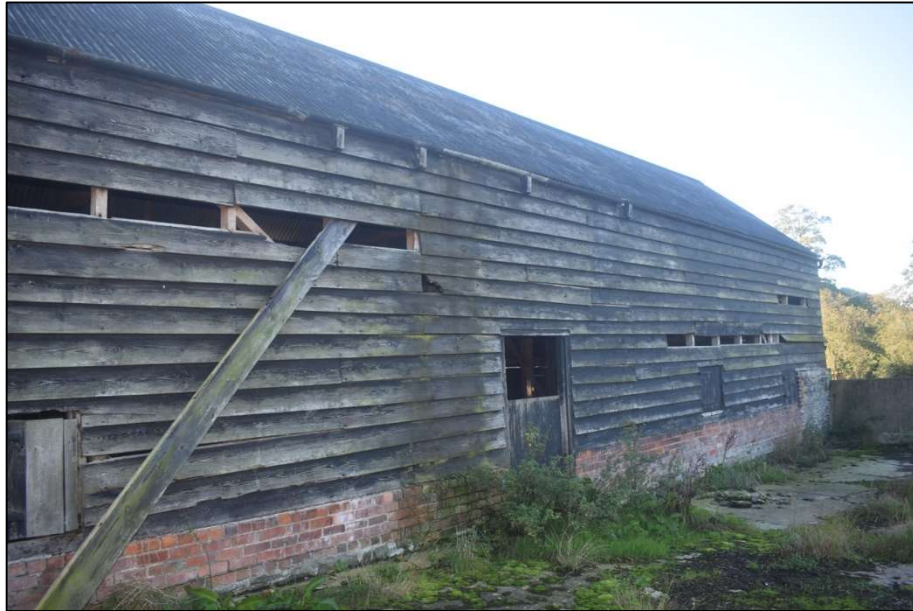
- 3.2. The barn measured approximately 28m by 6m and was essentially a five bay design with the south-western most bay occupied by two boxes, probably for keeping calves. The other four bays formed an open cowshed on the lower floor with an access corridor running along the south-east elevation. A cross corridor also ran through the central bay. The upper floor comprised a hayloft accessed from the south-east side by four high level doorways (Figure 4).

*Fig. 3 North-west elevation of the barn Photo CPAT 4956-002*

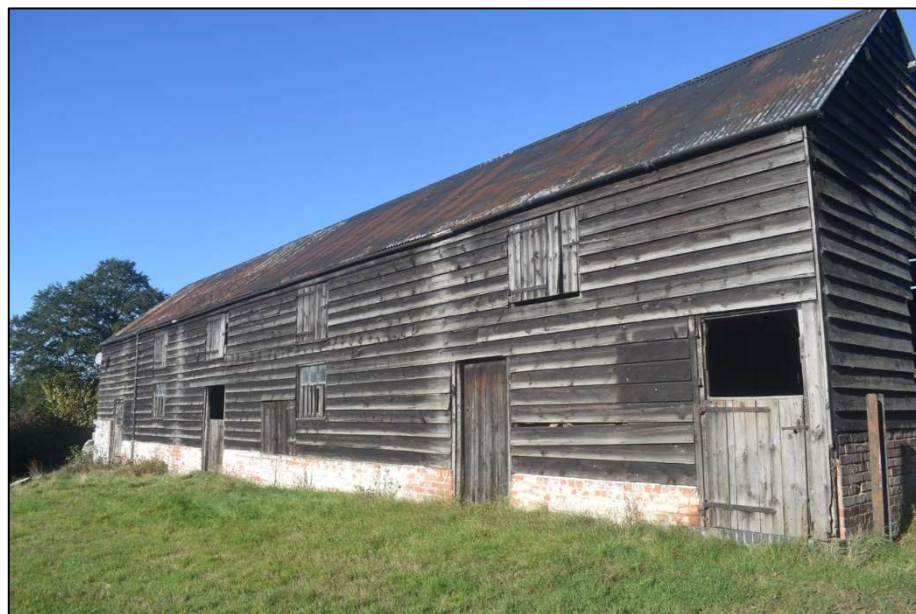
*Fig. 4 South-east elevation*

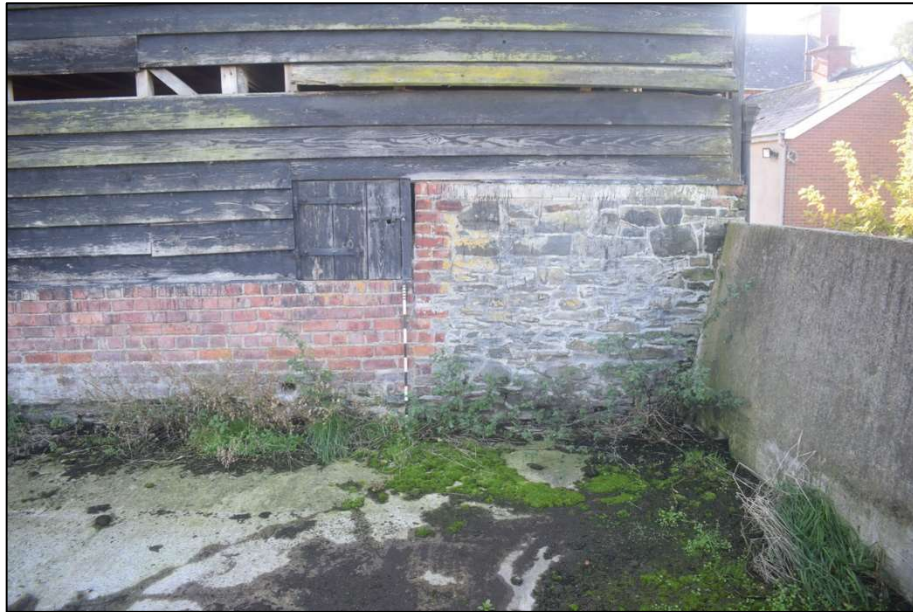
- 3.3. The barn was constructed in machine cut timber on a lime mortared brick plinth built in a running bond with a header course every three courses. The frame at the south-west end of the building was constructed upon a raised wall, constructed from random uncoursed grey sandstone approximately 1.8m in height (Figure 5).

*Fig. 5 Stonework on the south-west extent of the building Photo CPAT 4956-004*

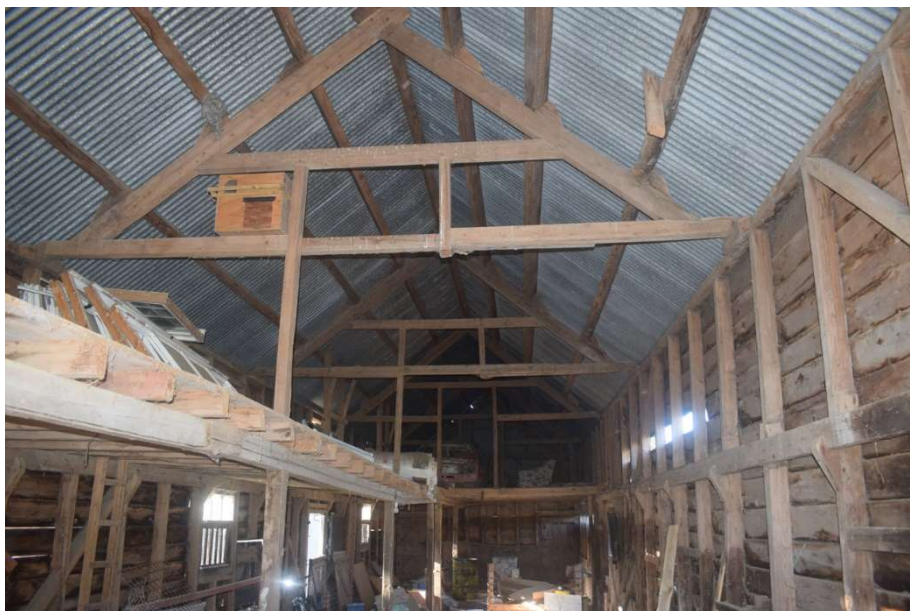
- 3.4. The roof frame comprised a simple collared truss supporting three purlins and a ridge beam located in the recess between the top of the principal rafters. The roof frame appeared to be fairly modern in date and lacked any rafters or battens. The roof was sheathed in tin sheeting. The wall frames comprised a simple box frame construction, with cross bracing in some of the frames. The horizontal wall beams were mounted on timber supports (Figure 6). Part of the north-east wall and the hayloft floor had been removed to allow access for loader tractors and telehandlers.

*Fig. 6 View from the north-east of the interior of the barn Photo CPAT 4956-014*

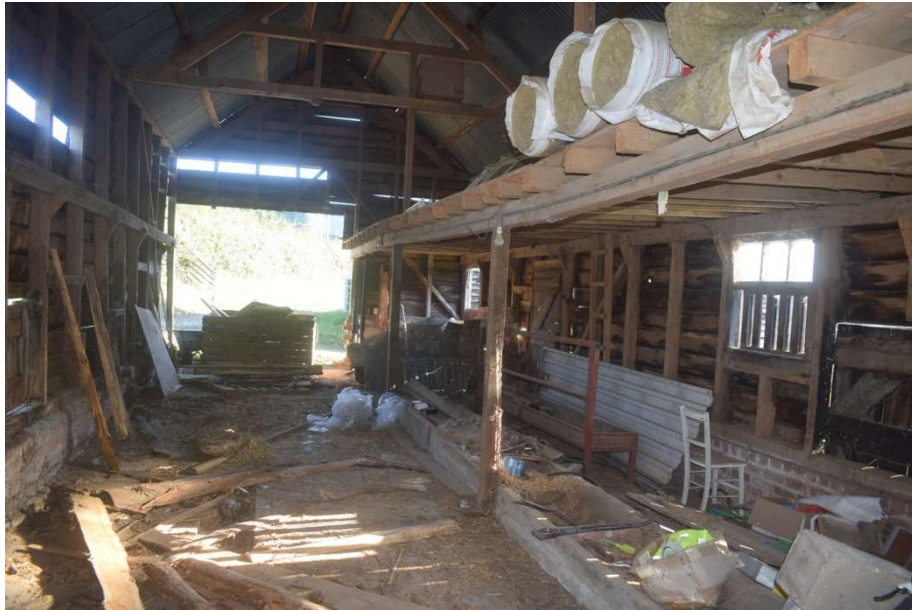
*Fig. 7 General view of the barn interior Photo CPAT 4956-026*

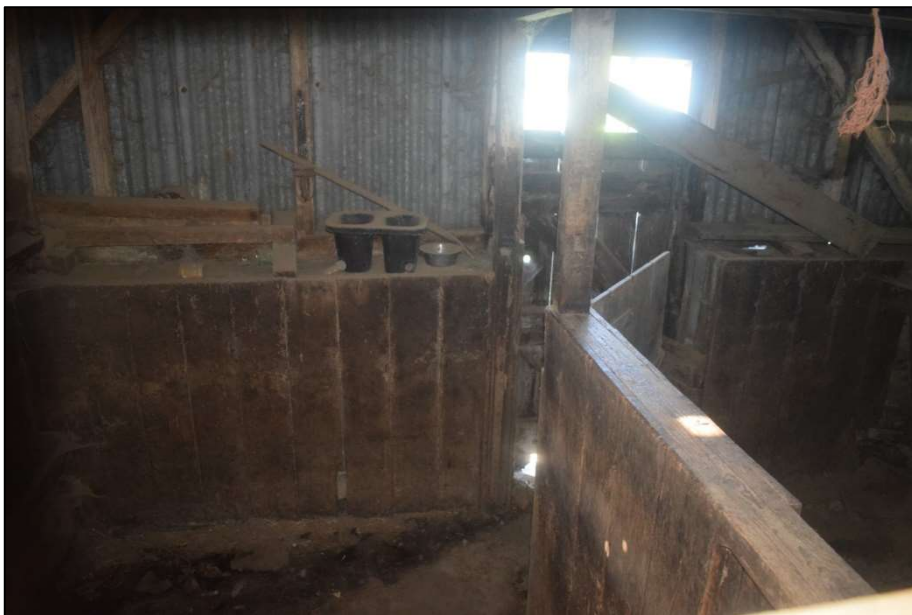
*Fig. 8 Internal view of the boxes at the south-west end of the barn Photo CPAT 4956-024*

- 3.5. The structure of the extant barn is believed to date from the 1930s, when it was rebuilt following a fire. The timber framing seems quite modern in appearance, with little age related fading or deterioration. Interestingly the design appears to be very similar to the earlier form of the barn, as suggested by the shape of the building recorded on late 19<sup>th</sup> century mapping and also the design of the adjacent range on the north-eastern side of the farmyard (Figure 9).
- 3.6. The boxes at the south-west end of the building are rather too small to be loose boxes and were probably used as a calf shed (Figure 8).

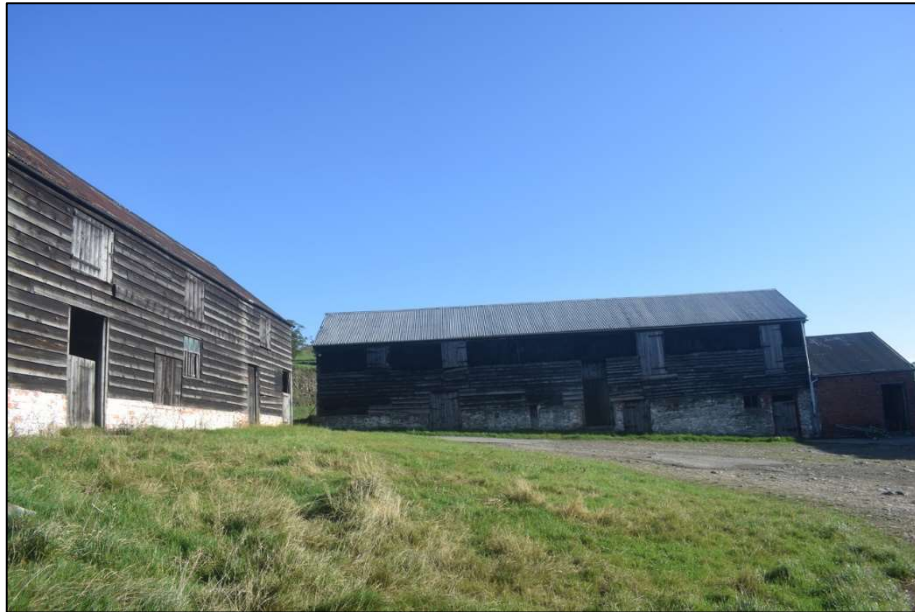
*Fig. 9 Barn constructed in a similar style to the north-east of the cowshed (left of shot) Photo CPAT 4956-012*
