BANGOR STREET, CAERNARFON

Brîff Gwylio Archaeolegol / Archaeological Watching brief

Rhif y Prosiect / Project Number: G2766

Rhif yr adroddiad / Report Number: 1720

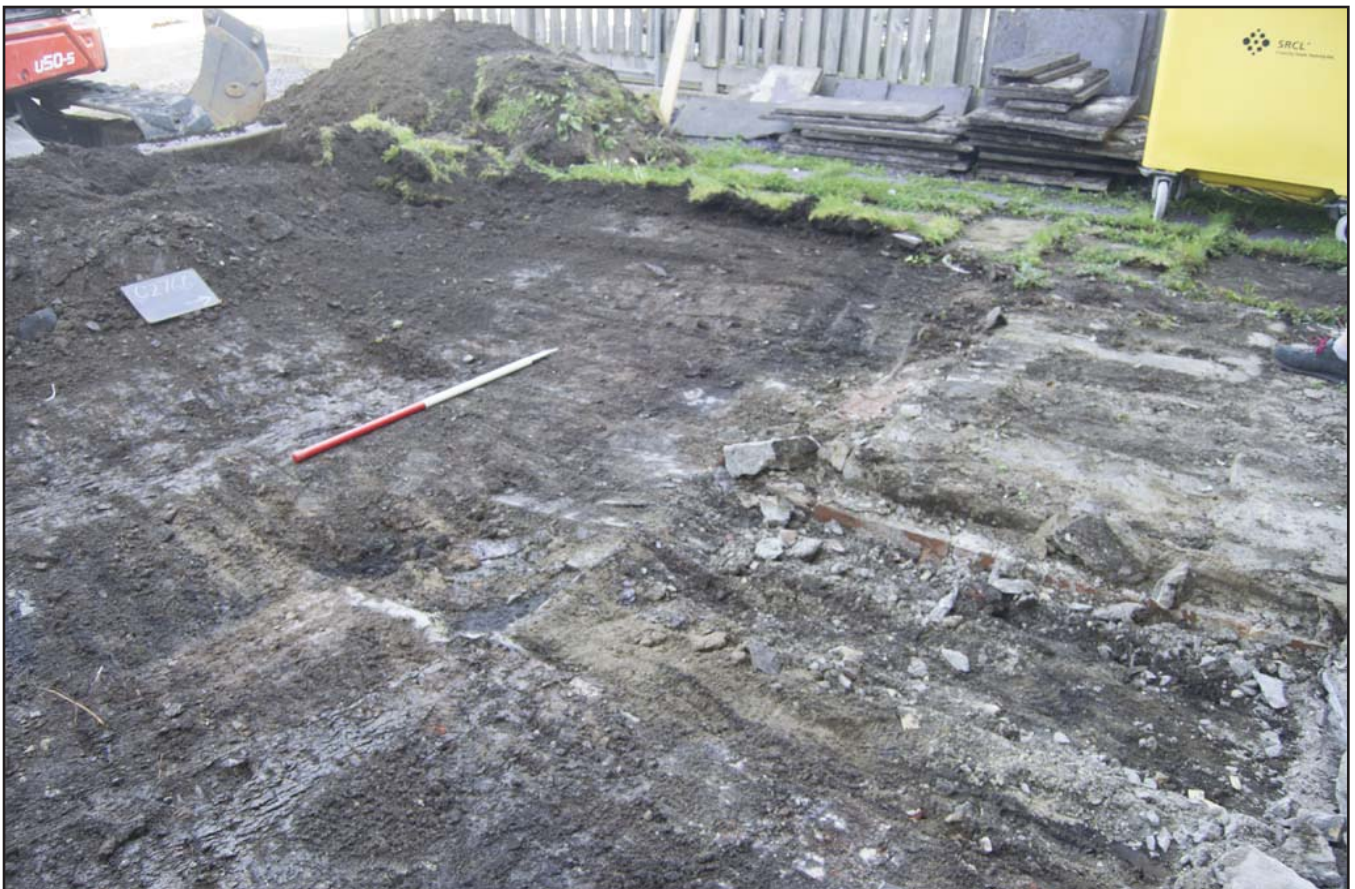
Plate 4: Stripped area with concrete pad and bricks in the NE of extension area (mid-excavation); scale 1x1m; view from SE (archive reference: G2766_004).

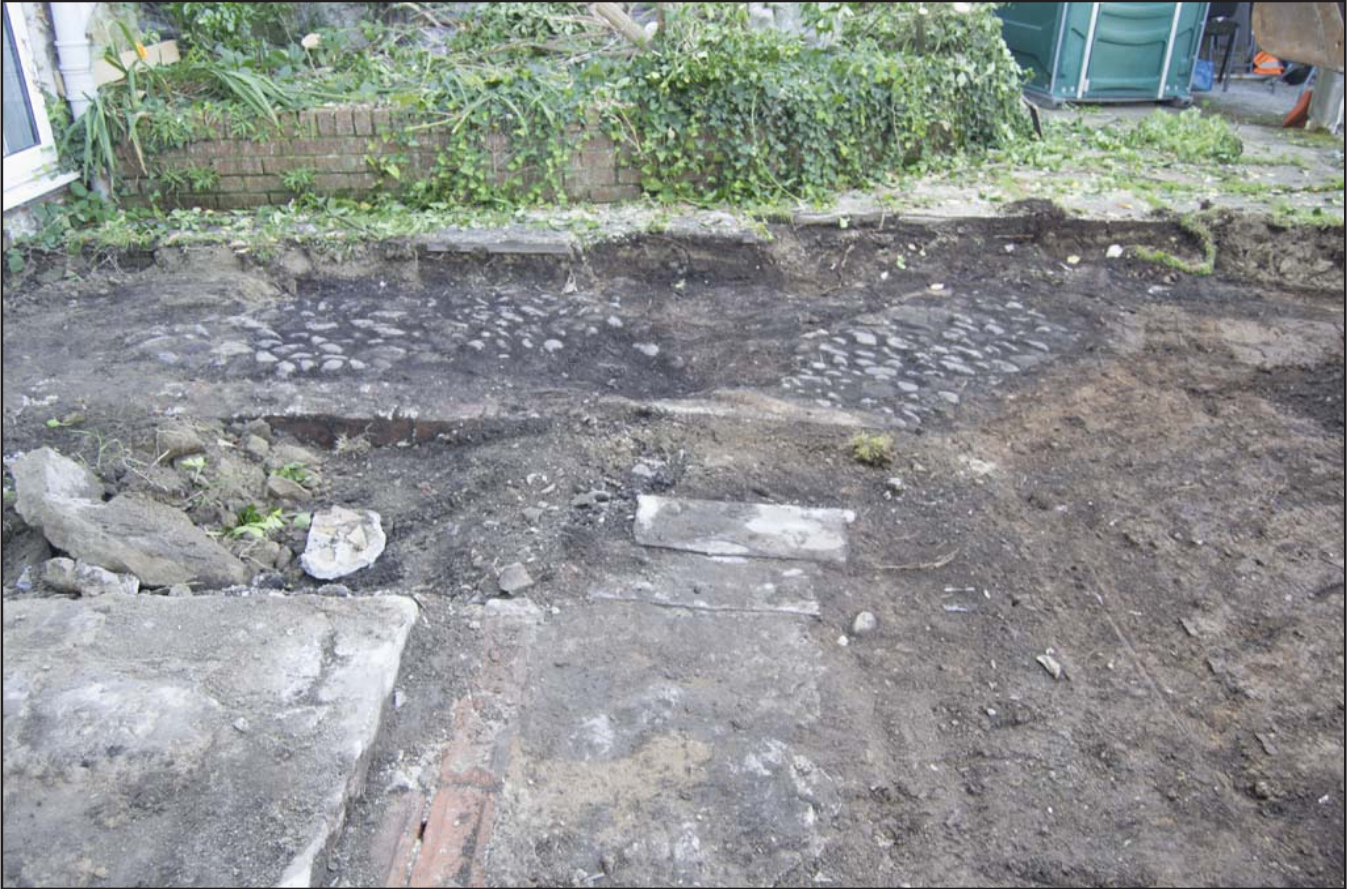
Plate 7: View of cobbled path; scale not used (archive reference: G2766_010).

The removal of the cobbled surface and modern raised garden bed (cf. Plate 7) exposed a compacted soil surface ((104); cf. Plates 29 and 30). A 0.50m wide and 0.40m deep drainage trench for the extension was cut through this deposit (cf. Plates 31 and 32); this exposed an east-west aligned 0.45m wide cut for a former wall or drainage feature, which was heavily truncated, with the only the base of the cut visible. The cut was filled by the compacted soil surface ((104); cf. Plates 33 to 36). This feature was also identified when a foundation cut was inserted across the northern end of the extension area (cf. Plate 37).

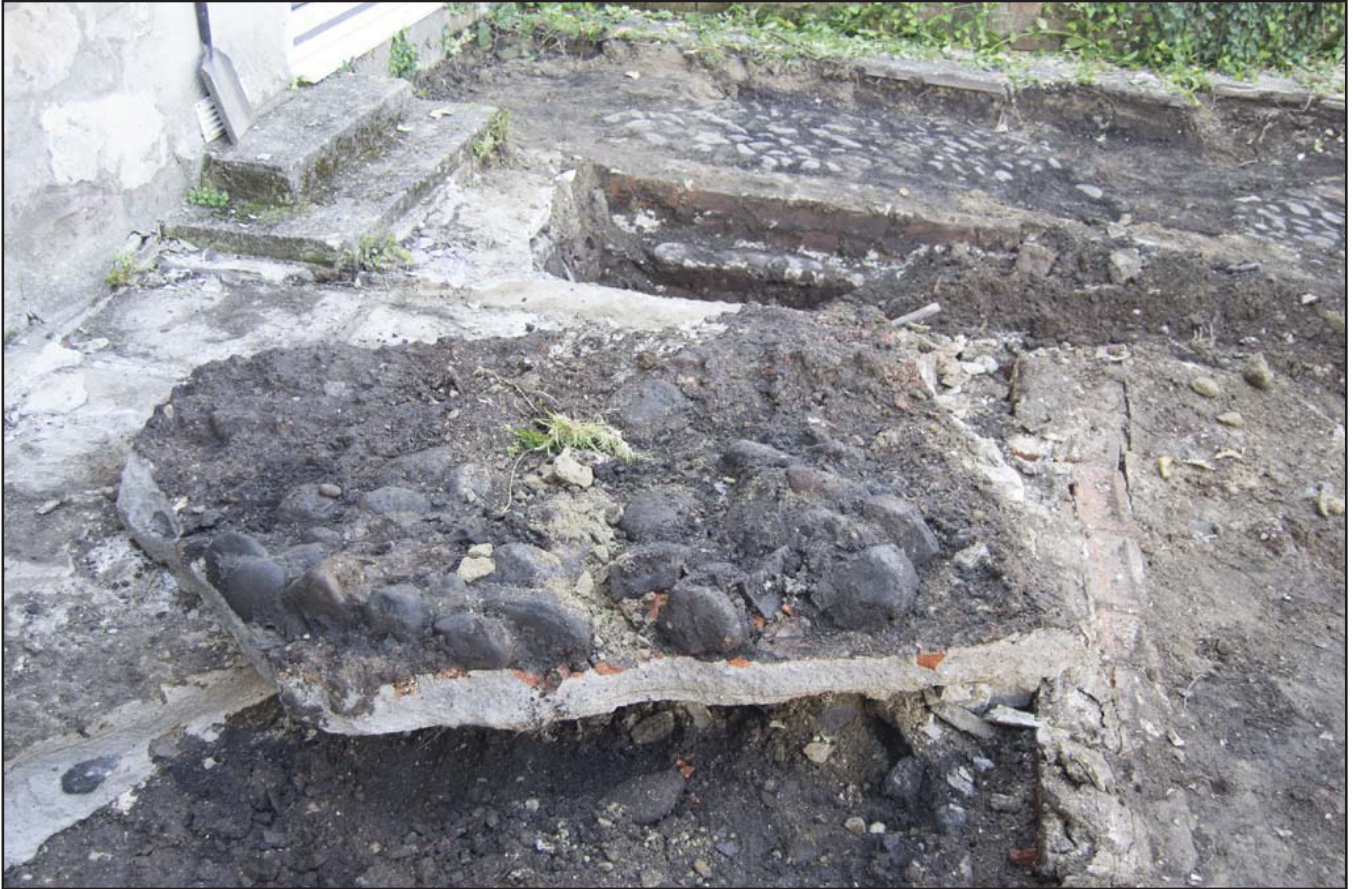
Plate 9: Shot of yard cobbles attached to the underside of removed concrete pad; scale not used; view from N/A (archive reference: G2766_012).

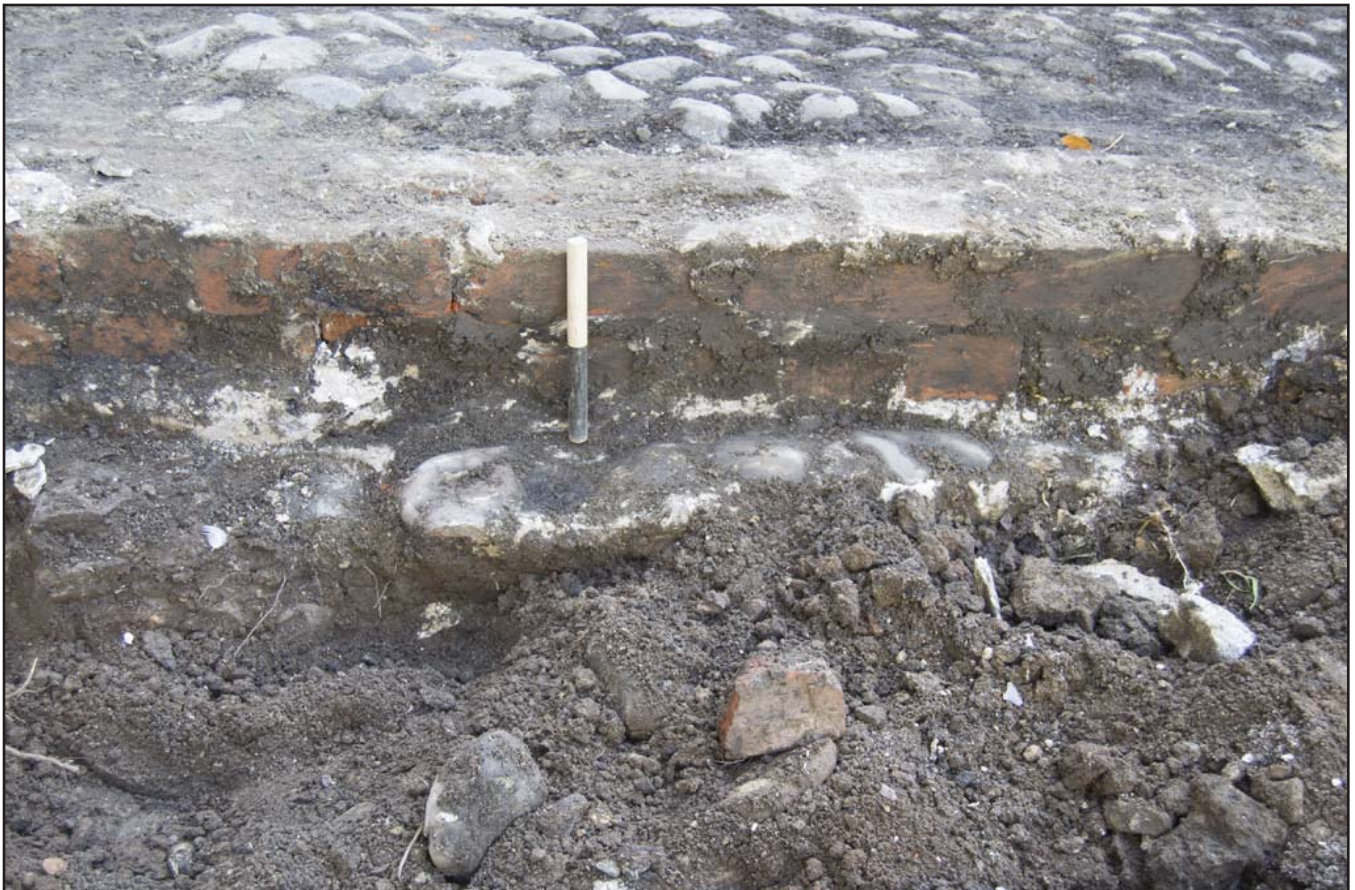
Plate 10: Cobbles below brick edge around concrete pad; scale 1x0.3m; view from N (archive reference: G2766_014).

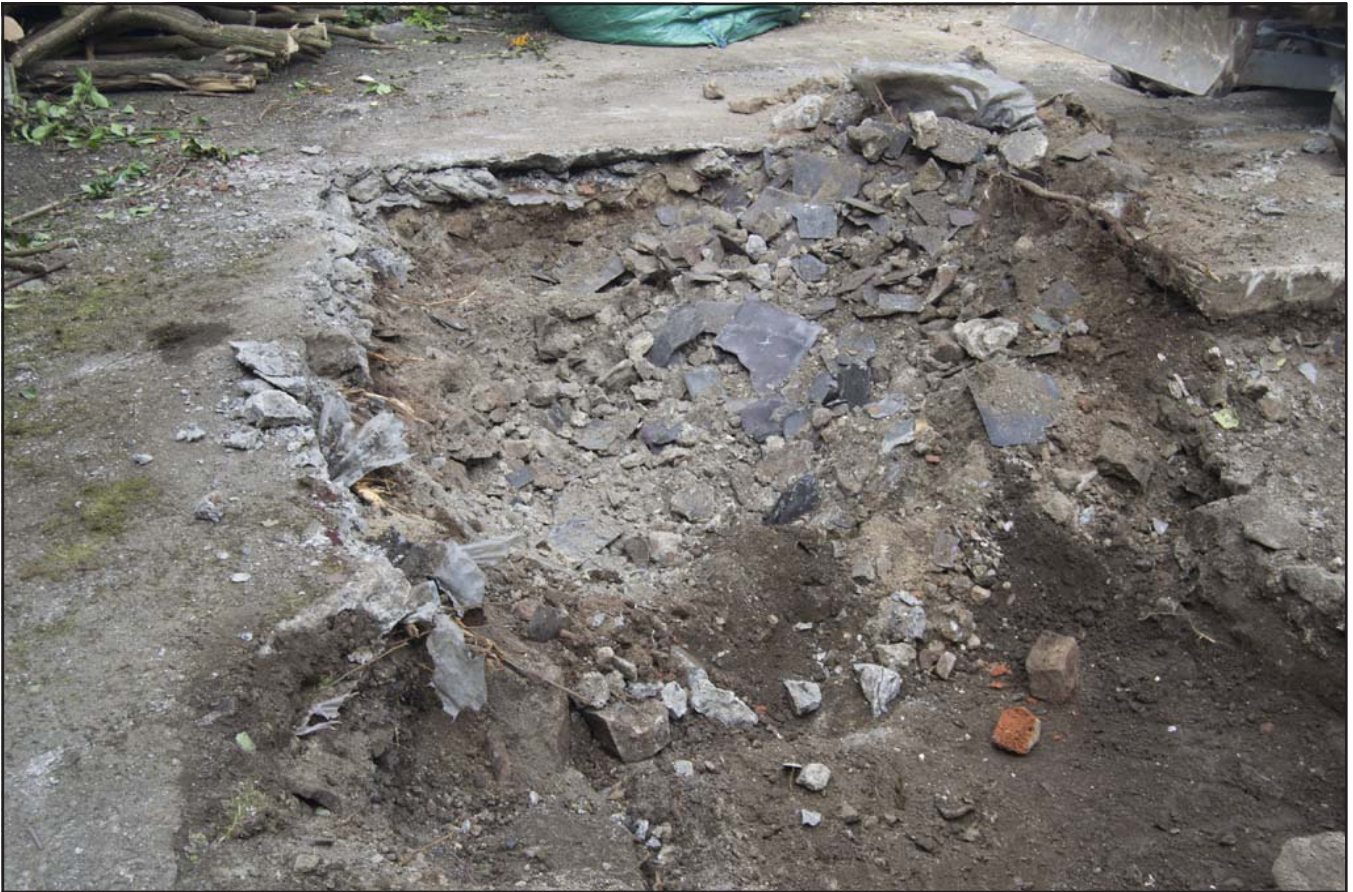
Plate 11: Working shot - view of demolition debris at west end of extension area; scale not used; view from E (archive reference: G2766_017).

Beneath the concrete area at the western end of the site was a deposit of stone, brick and mortar fragments ((123); cf. Plates 11, 12 and 16), interpreted as demolition material associated with the former outbuildings. This deposit partly sealed foundation level structural remains that included internal divisions and exterior walls for the outbuildings. The exterior wall {106} was orientated north to south and ran across the extension footprint for a length of 5.0m; it was in a degraded condition, measured 0.40m in width x 0.20m in depth, and was constructed from irregular sized and shaped stone with lime mortar (cf. Plates 17 to 20). The truncated patch of brick flooring (105), butted the west facing edge of the wall, suggesting they were associated, whilst a patch of degraded floor surface (111) was attached to the interior of the wall at southern end (cf. Plates 16 and 17). Possible internal partitions were also visible, including an east-west aligned wall {107} that butted {106}; this wall measured 0.80 in length, 0.40m in width and 0.20m in depth and was built from irregular sized and shaped stone with limestone mortar. Further subdivisions and phases were also visible, including a brick and stone wall ({121}; cf. Plate 22) aligned northeast-southwest that butted {107} and a north-south aligned wall {108=112} to the west of {106} (Plates 20, 22, 24 and 26), with an associated foundation cut [117]. Located between walls {106} and {108} was a truncated cobbled area

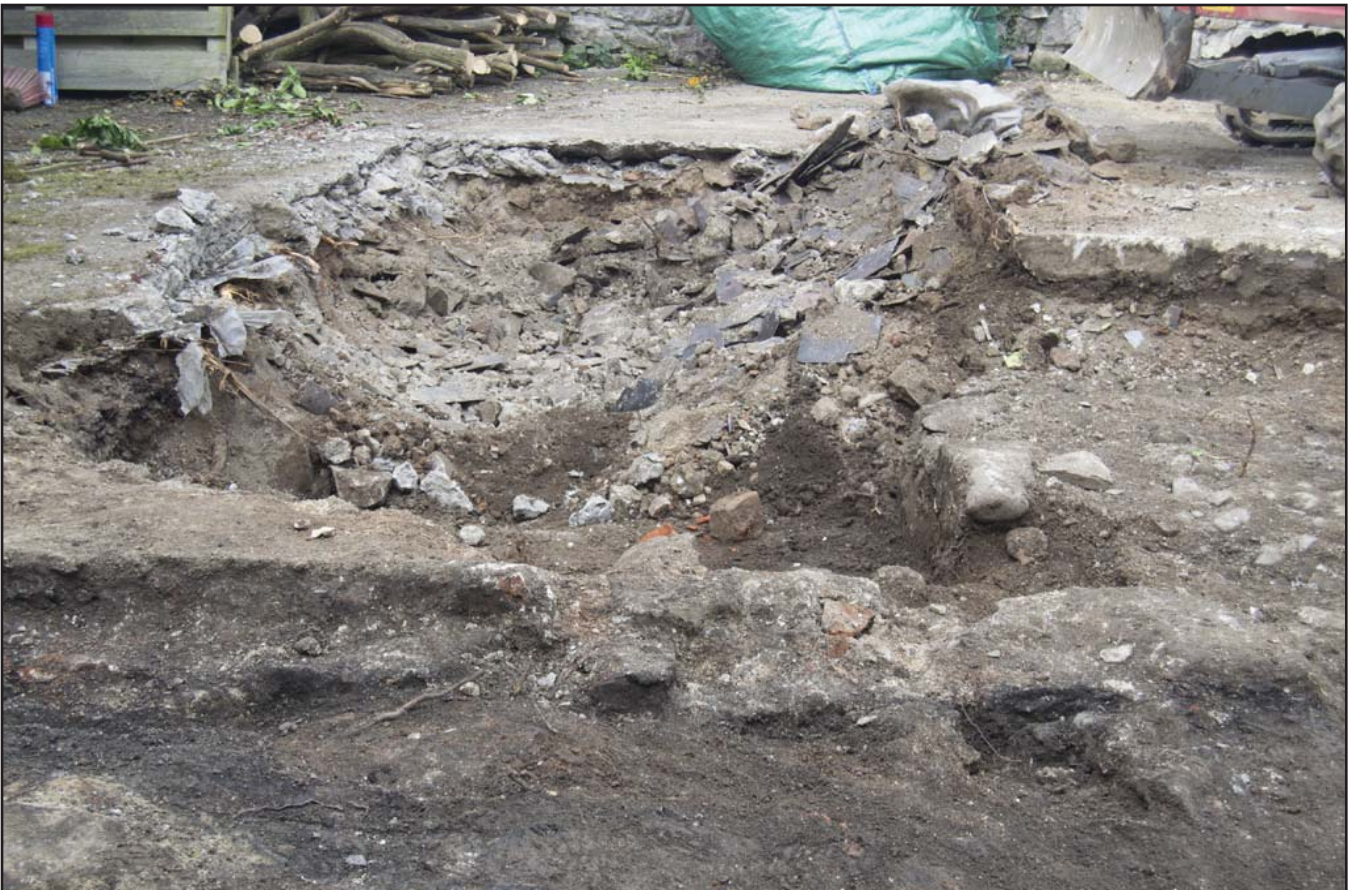
Plate 12: Working shot of removal of demolition debris to west end of extension area; scale not used; view from NE (archive reference: G2766_018).

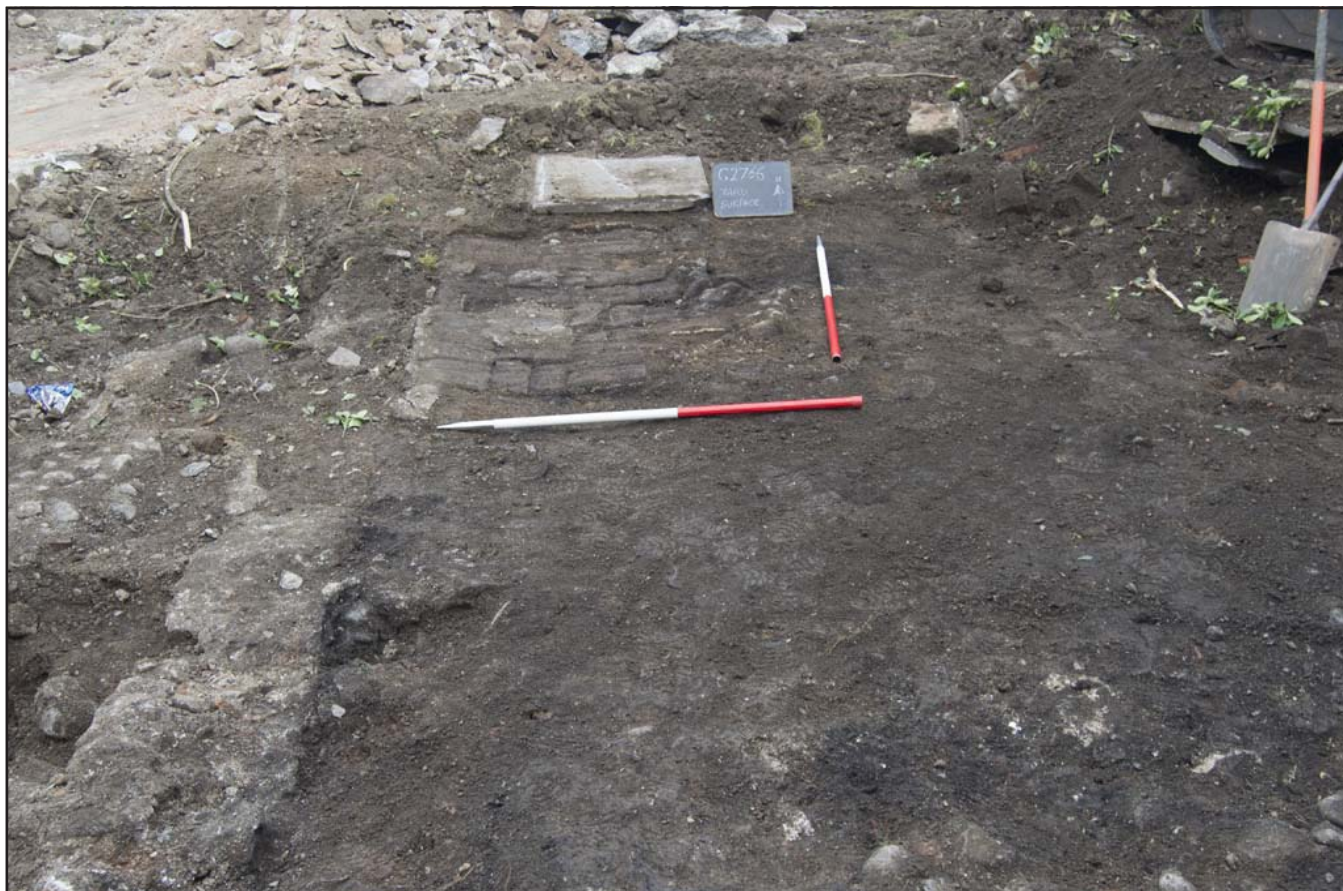
Plate 13: View of slate manhole cover and brick yard surface and wall aligned N/S; scale 2x1 m; view from S (archive reference: G2766_019).

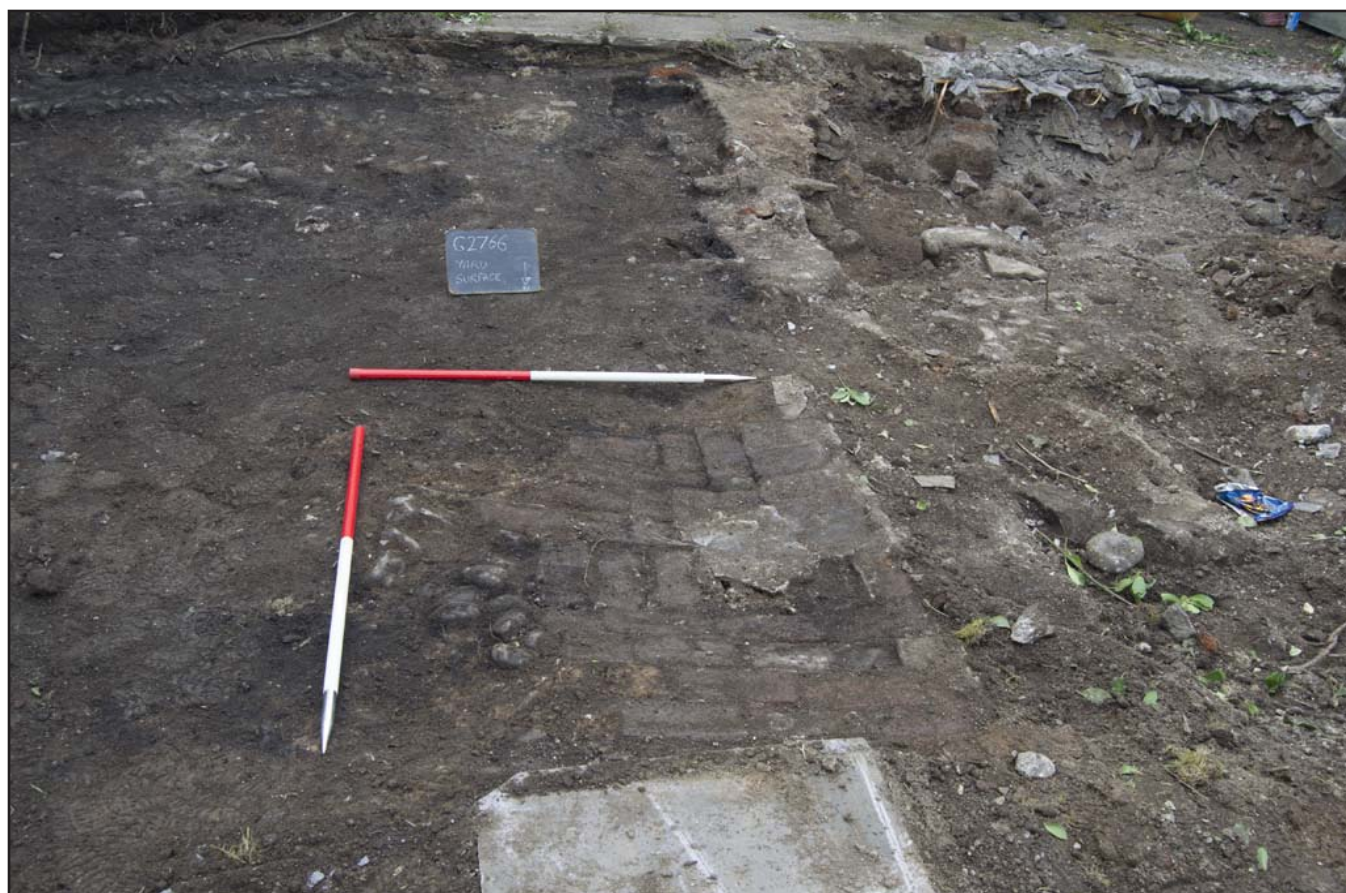
Plate 14: View of slate manhole cover and brick yard surface and wall aligned N/S; scale 2x1 m; view from N (archive reference: G2766_020).

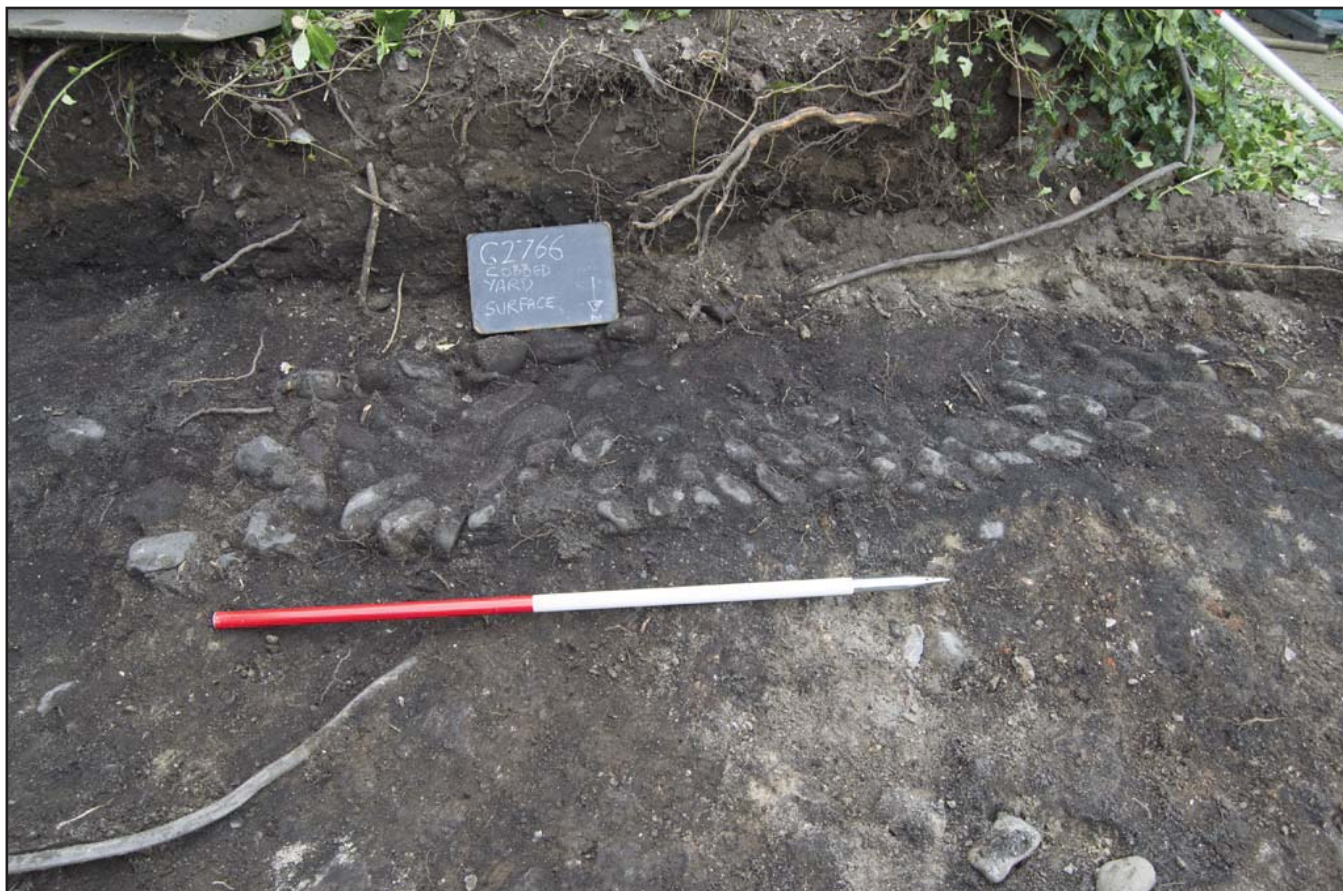
Plate 15: View of cobbled path at southern end of extension area after brick wall of raised flower bed was removed; scale 1x1m; view from N (archive reference: G2766_021).

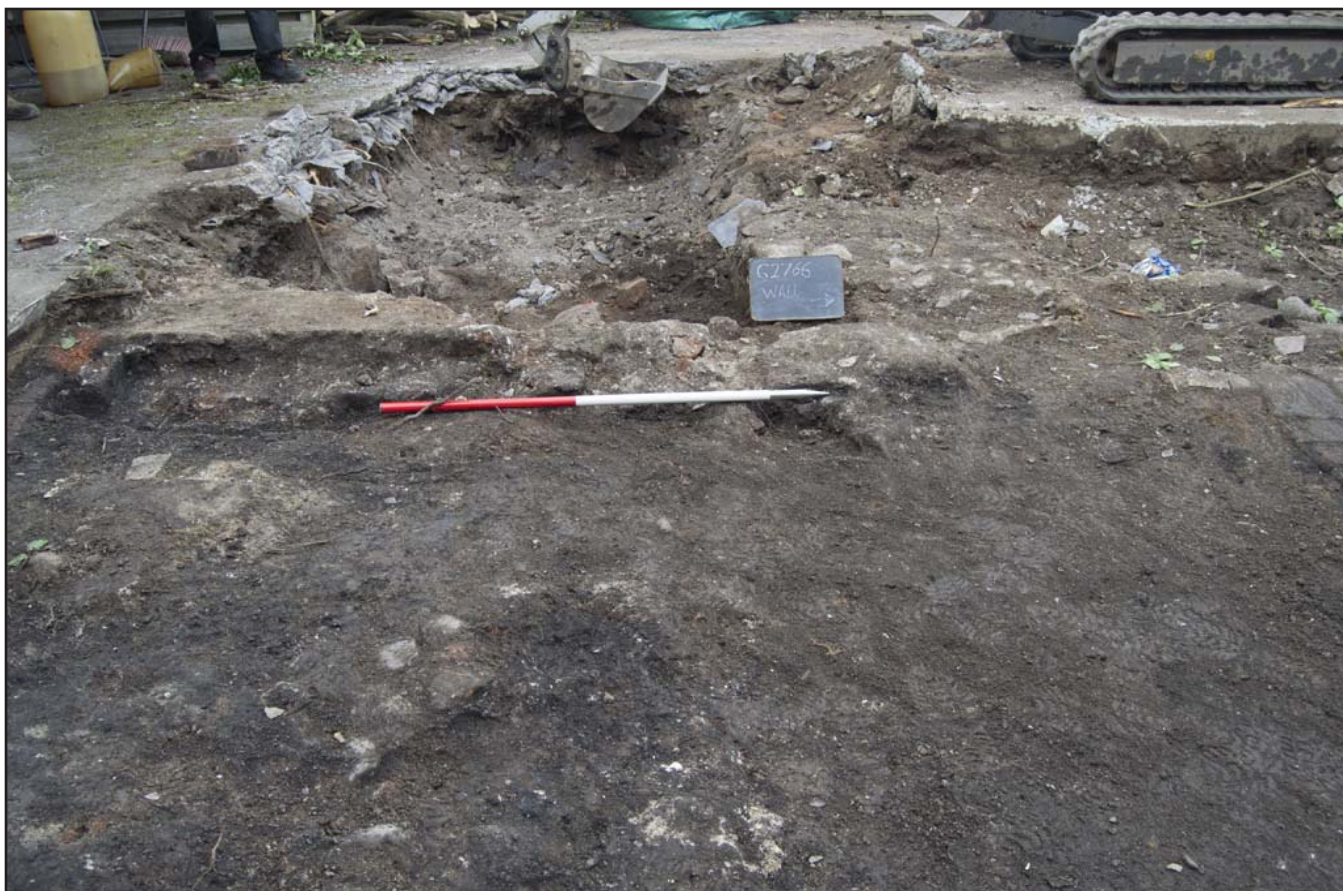
Plate 16: View of yard and 19th century wall; scale 1x1m; view from S (archive reference: G2766_022).

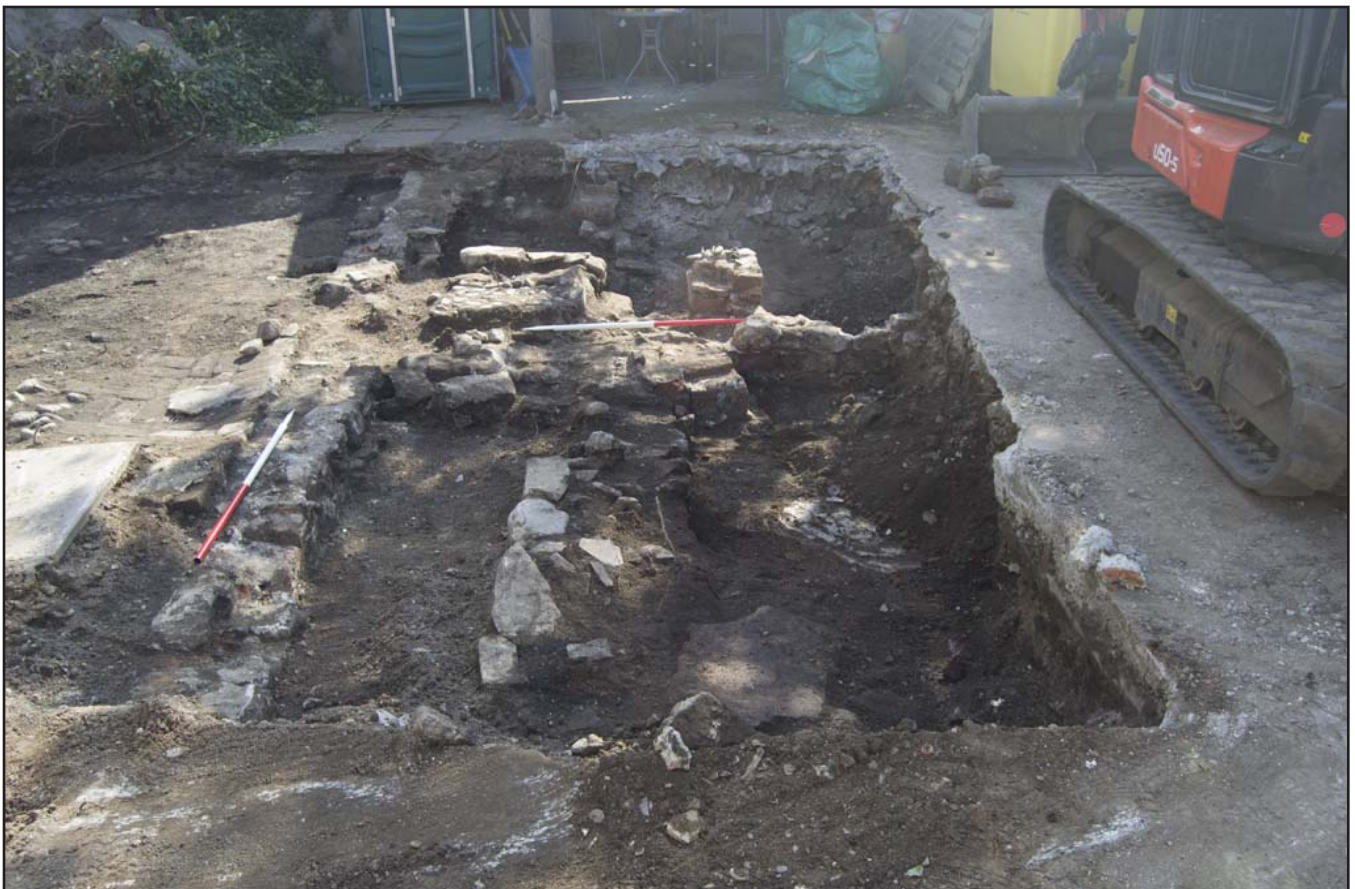
Plate 18: Post-ex shot of base of buildings and yard area; scale 2x1m; view from N (archive reference: G2766_028).

During the watching brief, foundation footings for two conjoined 19th century outbuildings were partly exposed at the western end of the property boundary. This included a north-south aligned brick and stone wall that formed the eastern end of the outbuildings, along with an east west aligned partition wall, possible internal divisions and drainage. Part of the area was filled with demolition debris which contained 19th century pottery sherds, broken bricks, broken slates, and oyster shells. Further interpretation was limited due to the truncated nature of the structures, but they were clearly those visible on historic mapping and would have been part of the former undertaking business, with the outbuildings themselves being the mortuary (Oattes, 2024).

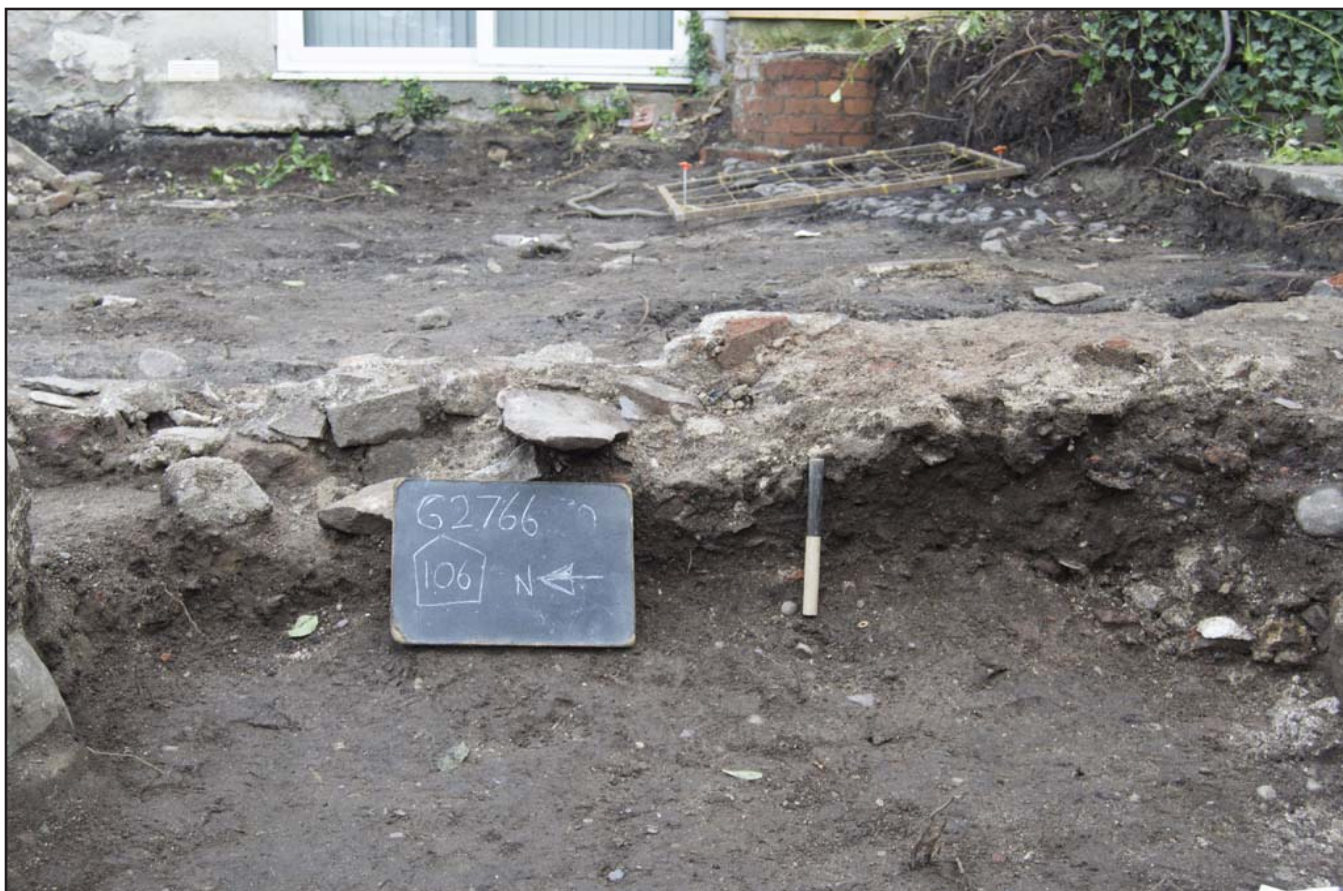
Plate 20: West facing elevation of 108 at the northern end; scale 1x0.3m; view from W
(archive reference: G2766_038).

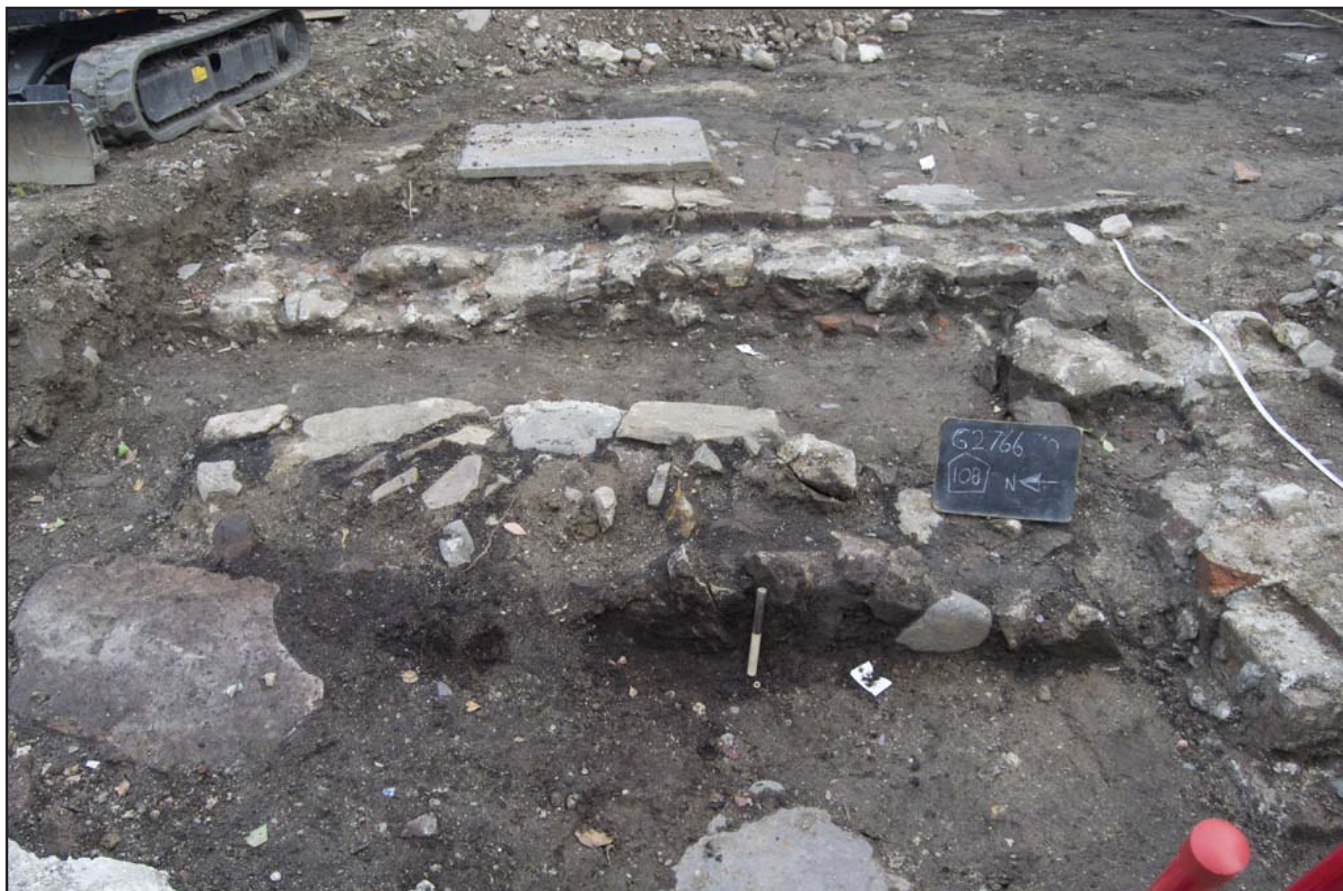
Plate 21: West facing elevation of wall 108; scale 1x0.3m; view from W (archive reference: G2766_040).

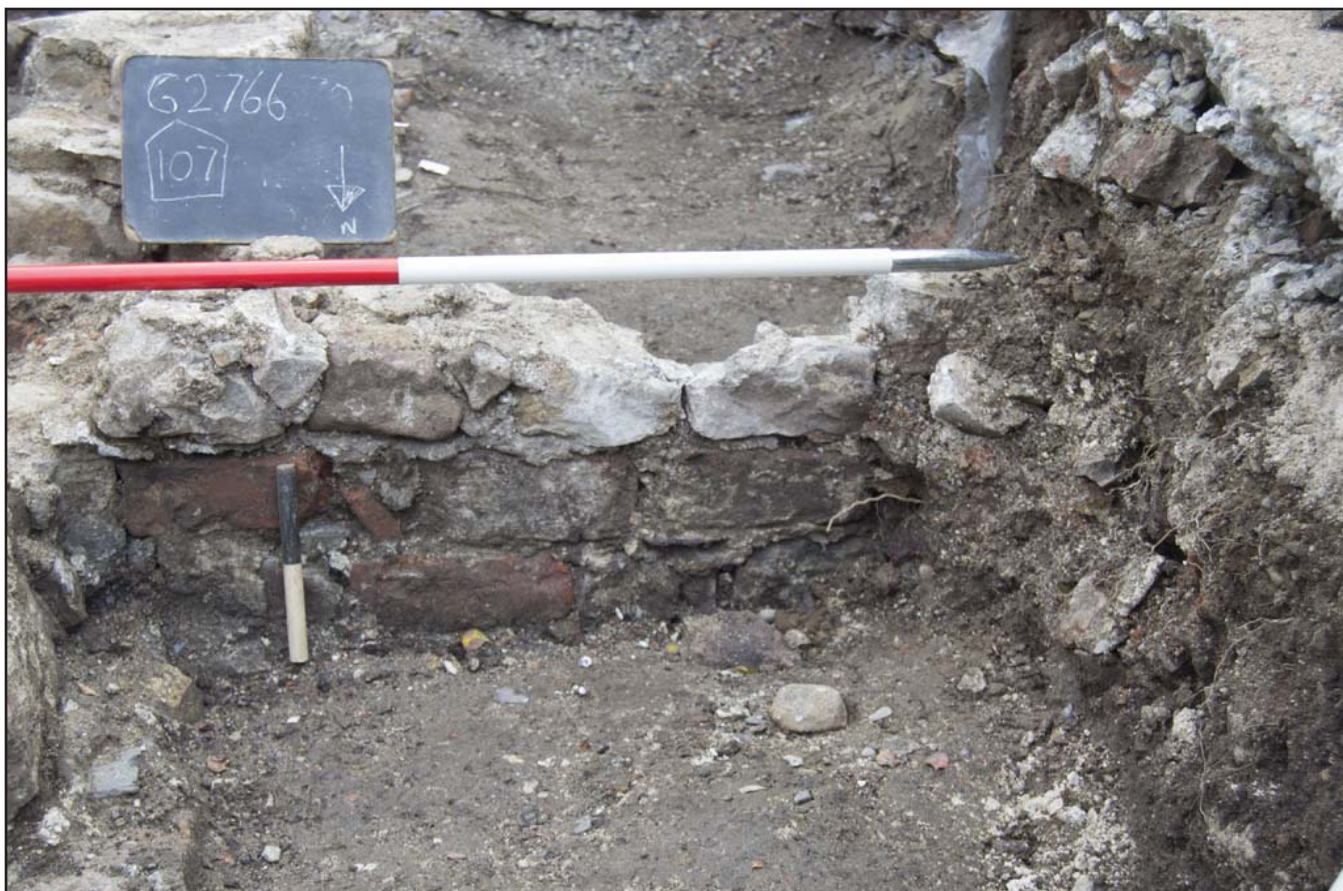
Plate 22: South facing elevation of wall 121 with 107 in the background; scale 1x0.3 & 1x1m; view from N (archive reference: G2766_041).

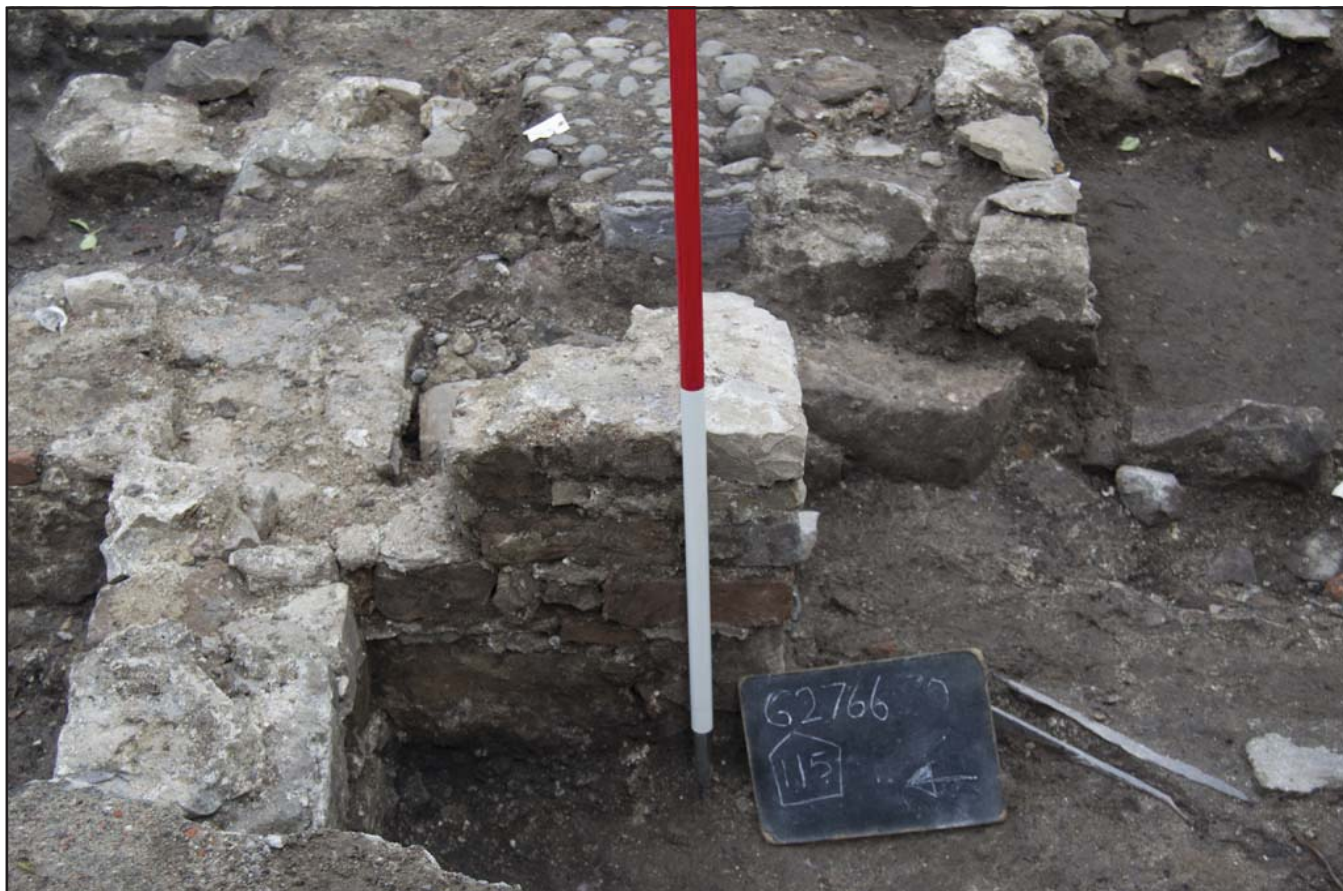
Plate 23: South facing elevation of wall 114/115; scale 1x0.3 1x1m; view from W (archive reference: G2766_042).

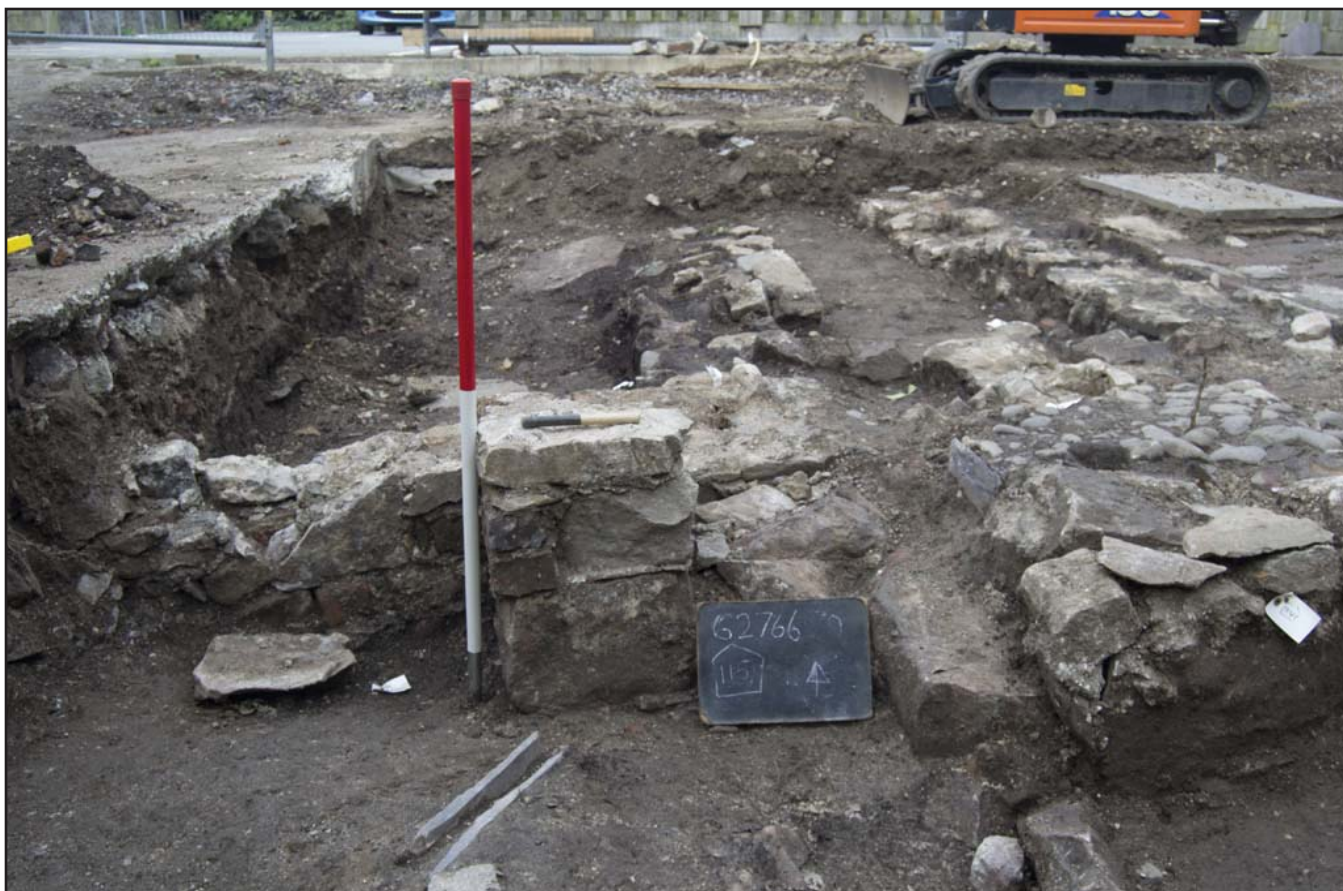
Plate 24: East facing elevation of wall 114/115 with 121 in the background; scale 1x0.3 & 1x1m; view from S (archive reference: G2766_043).

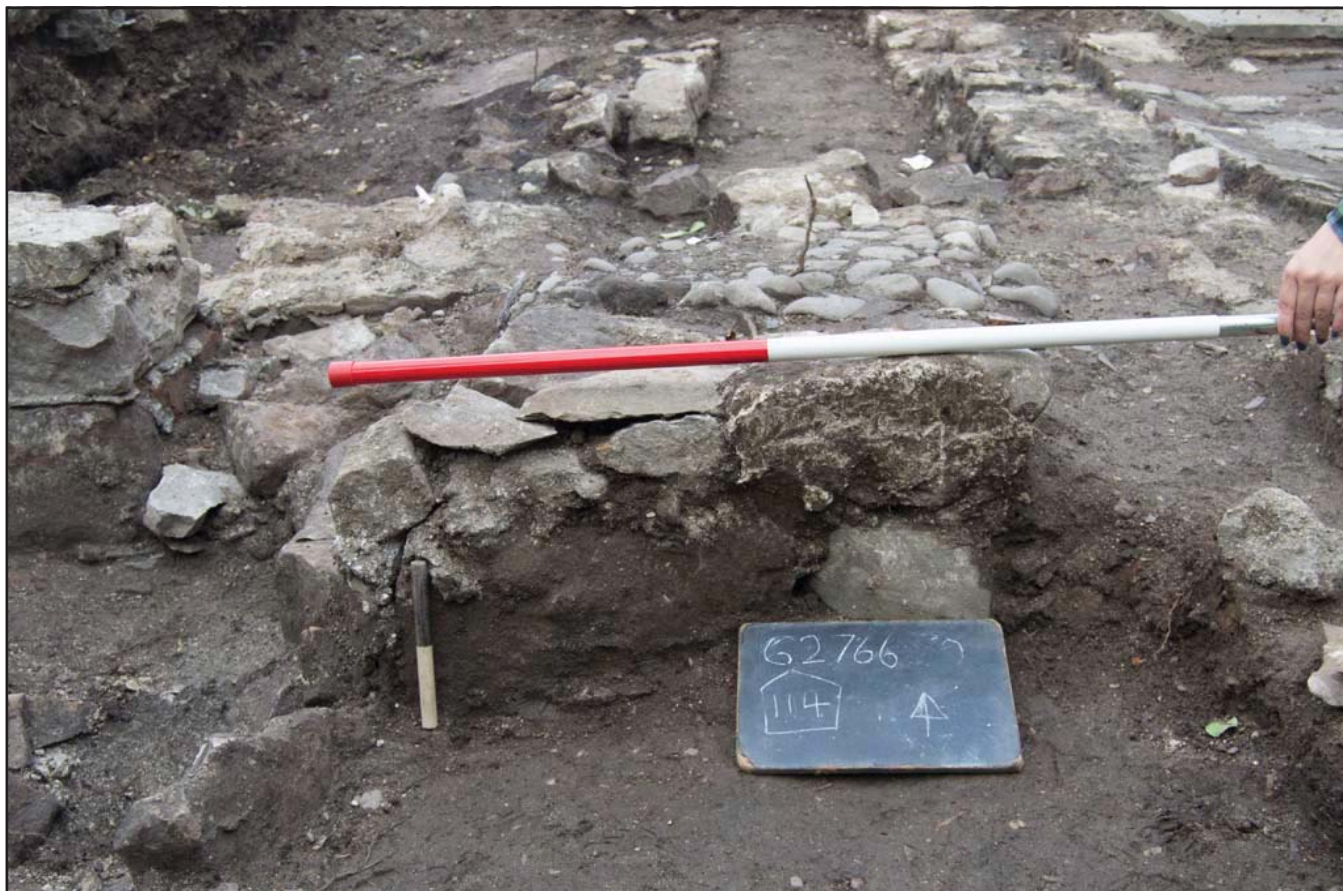
Plate 25: South facing elevation of wall 114/115; scale 1x0.3 1x1m; view from S (archive reference: G2766_044).

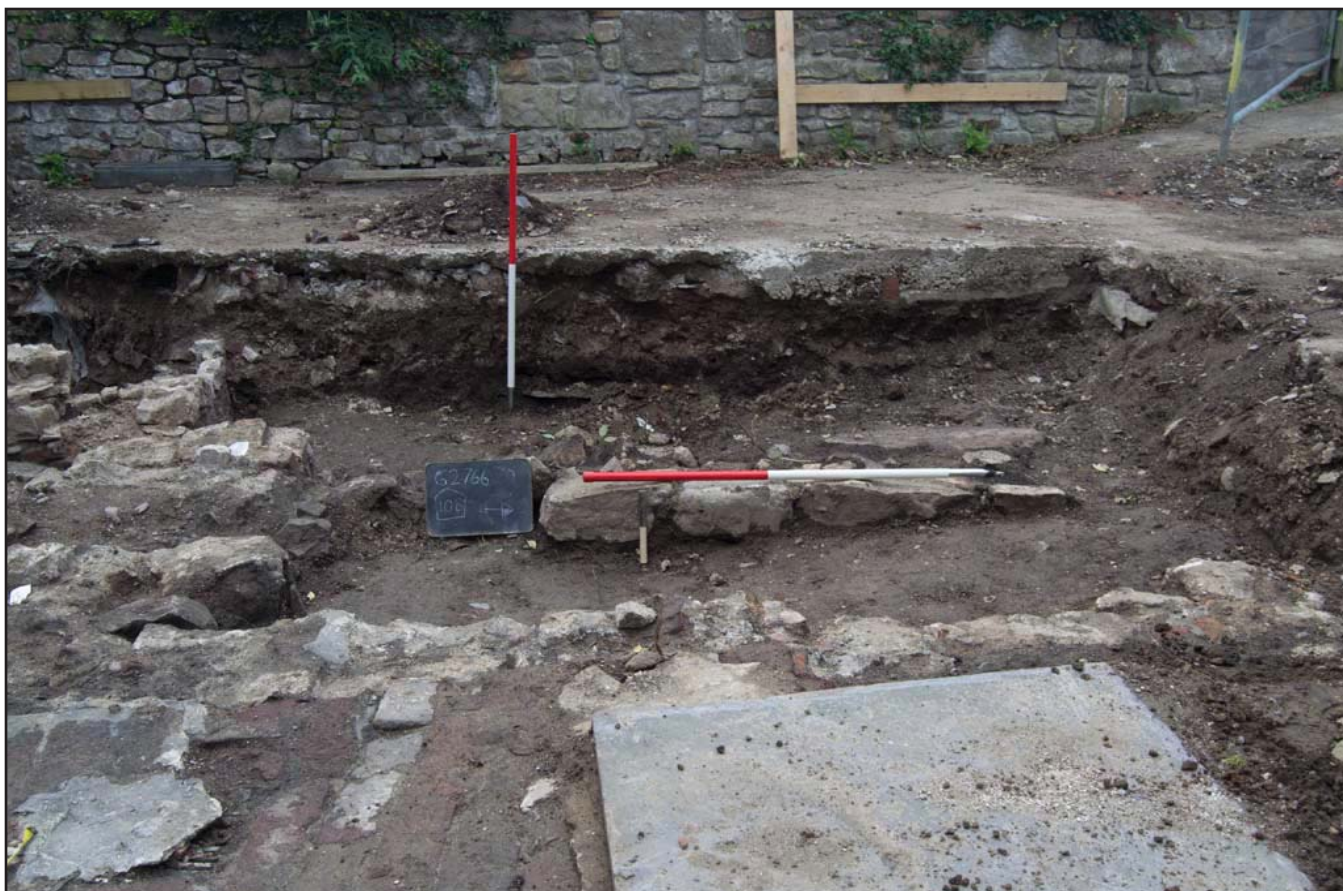
Plate 26: East facing elevation of wall 108 - northern end of wall with 106 in the background; scale 1x0.3m 2x1m; view from E (archive reference: G2766_045).
