BANGOR STREET, CAERNARFON

Brîff Gwylio Archaeolegol / Archaeological Watching brief

Rhif y Prosiect / Project Number: G2766

Rhif yr adroddiad / Report Number: 1720

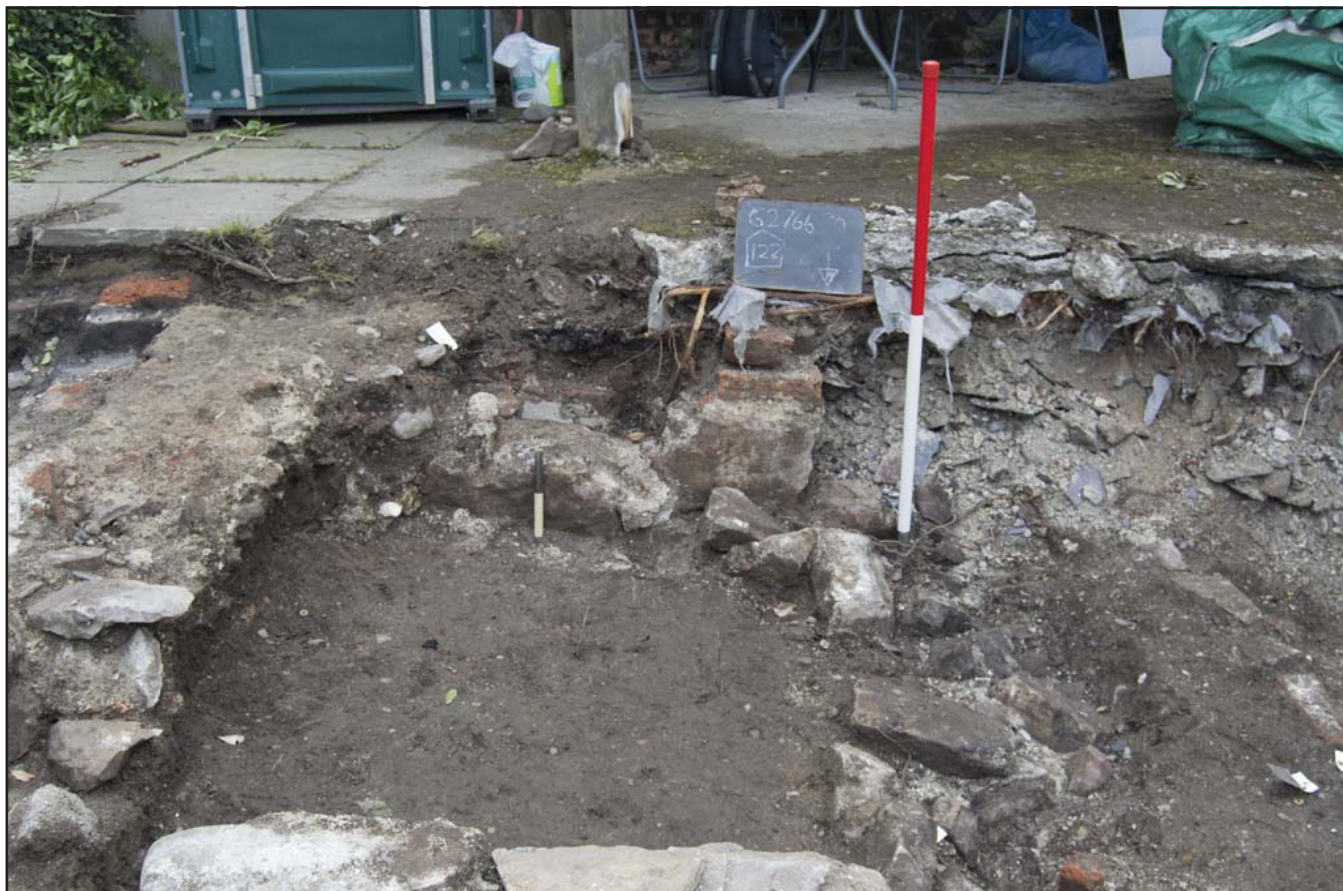
Plate 27: North facing view of wall 122; scale 1x0.3 1x1m; view from N (archive reference: G2766_047).

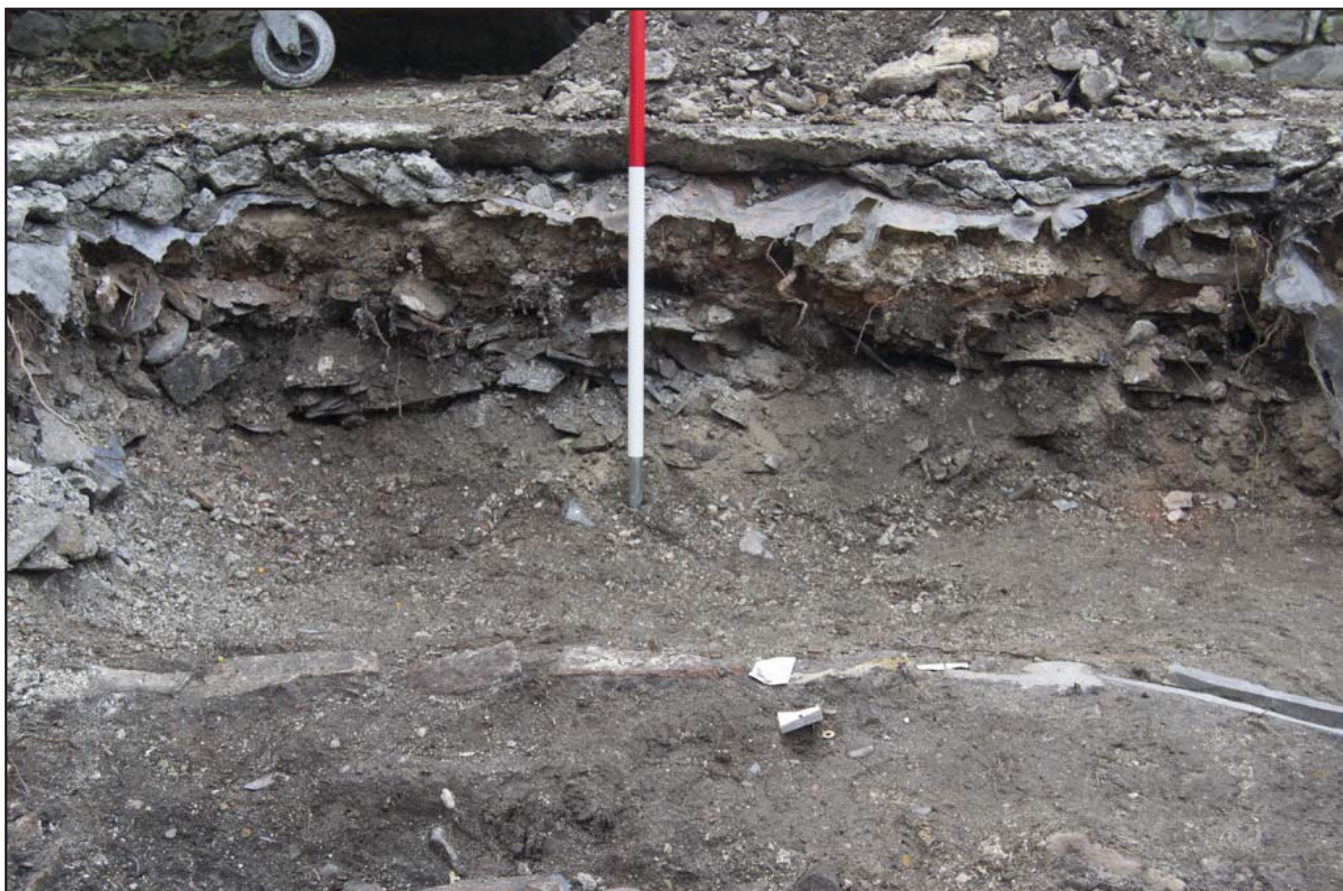
Plate 28: East facing section at the limit of the excavation showing concrete, plastic and demolition material; scale 1x1m; view from E (archive reference: G2766_048).

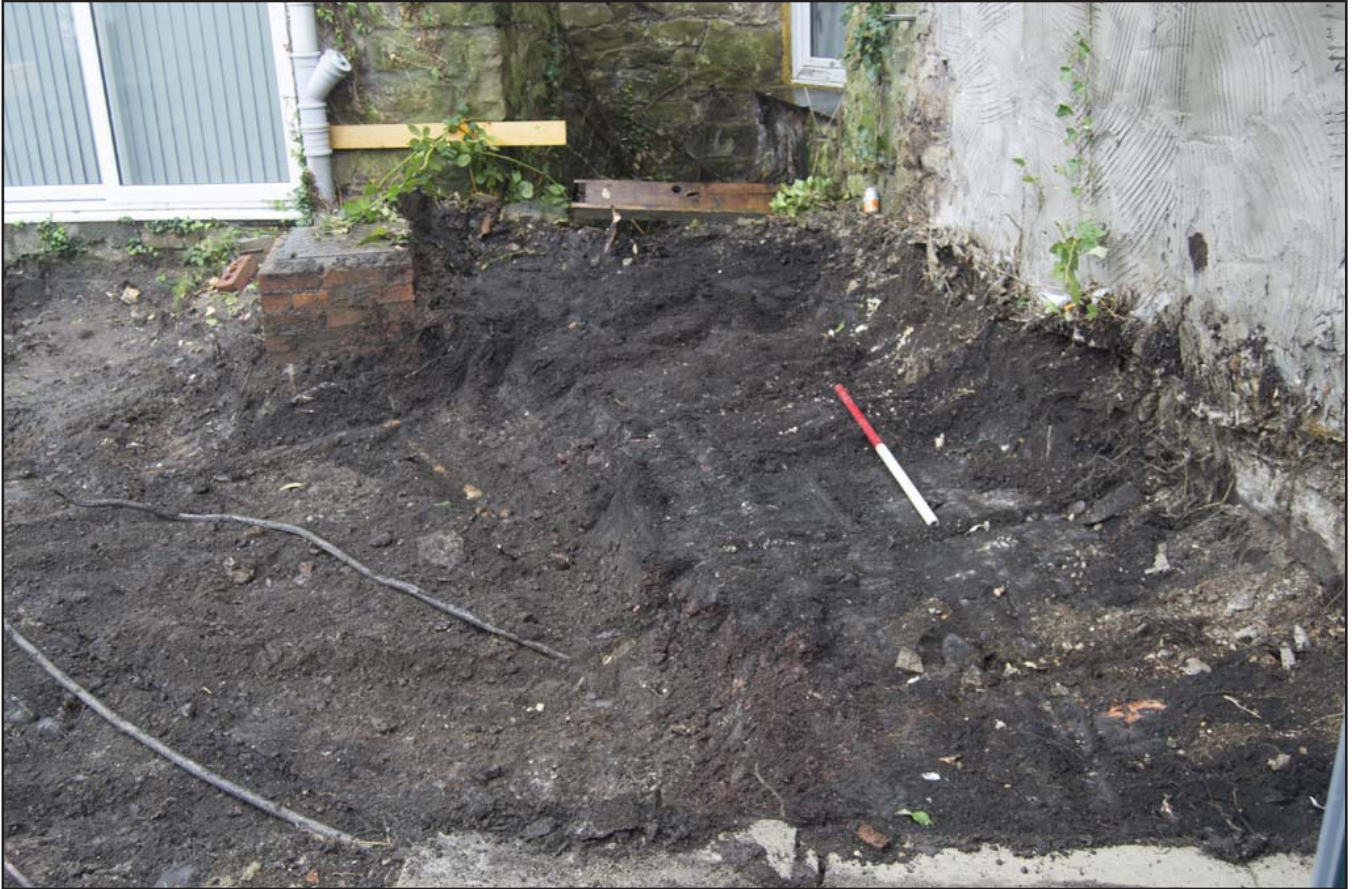
Plate 29: Southern boundary wall after raised flower bed was removed; scale 1x1m; view from W (archive reference: G2766_050).

The removal of the cobbled surface and modern raised garden bed (cf. Plate 7) exposed a compacted soil surface ((104); cf. Plates 29 and 30). A 0.50m wide and 0.40m deep drainage trench for the extension was cut through this deposit (cf. Plates 31 and 32); this exposed an east-west aligned 0.45m wide cut for a former wall or drainage feature, which was heavily truncated, with the only the base of the cut visible. The cut was filled by the compacted soil surface ((104); cf. Plates 33 to 36). This feature was also identified when a foundation cut was inserted across the northern end of the extension area (cf. Plate 37).

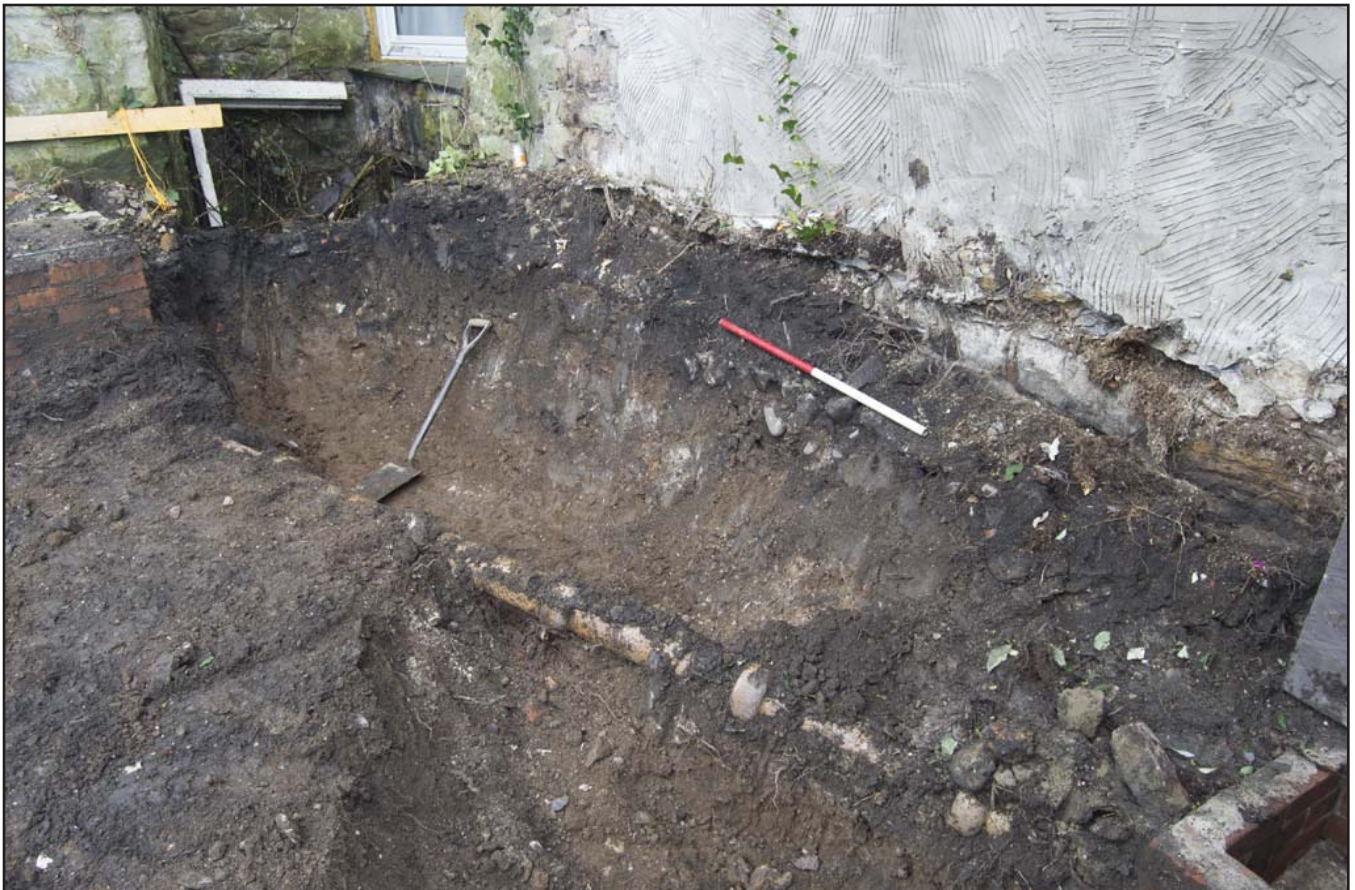
Plate 30: View of southern drainage ditch showing remnant cobbles of yard surface; scale 1x1m; view from NW (archive reference: G2766_056).

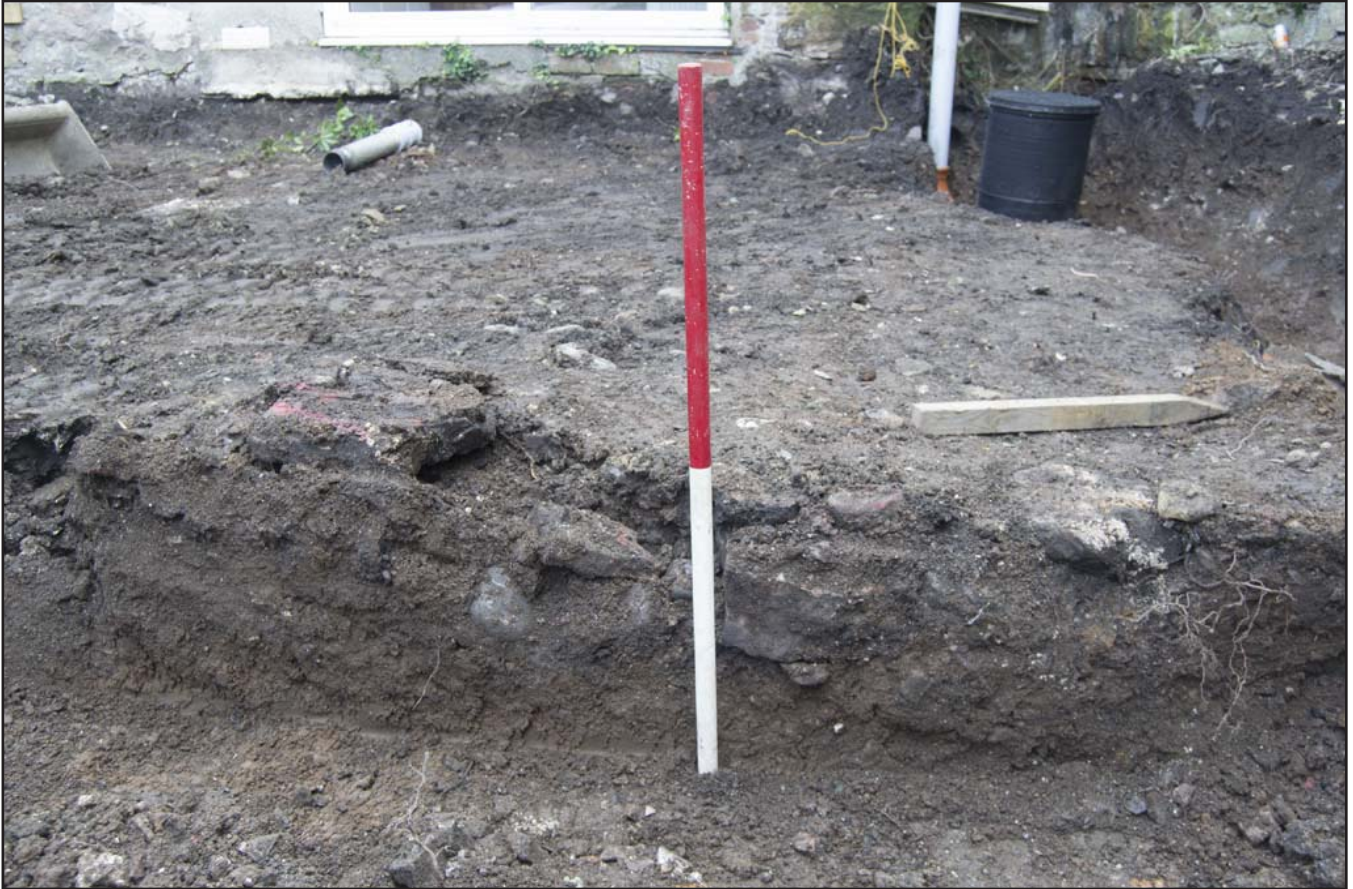
Plate 31: West facing section of drainage trench showing stones and cobbles of yard surface; scale 1x1m; view from W (archive reference: G2766_061).

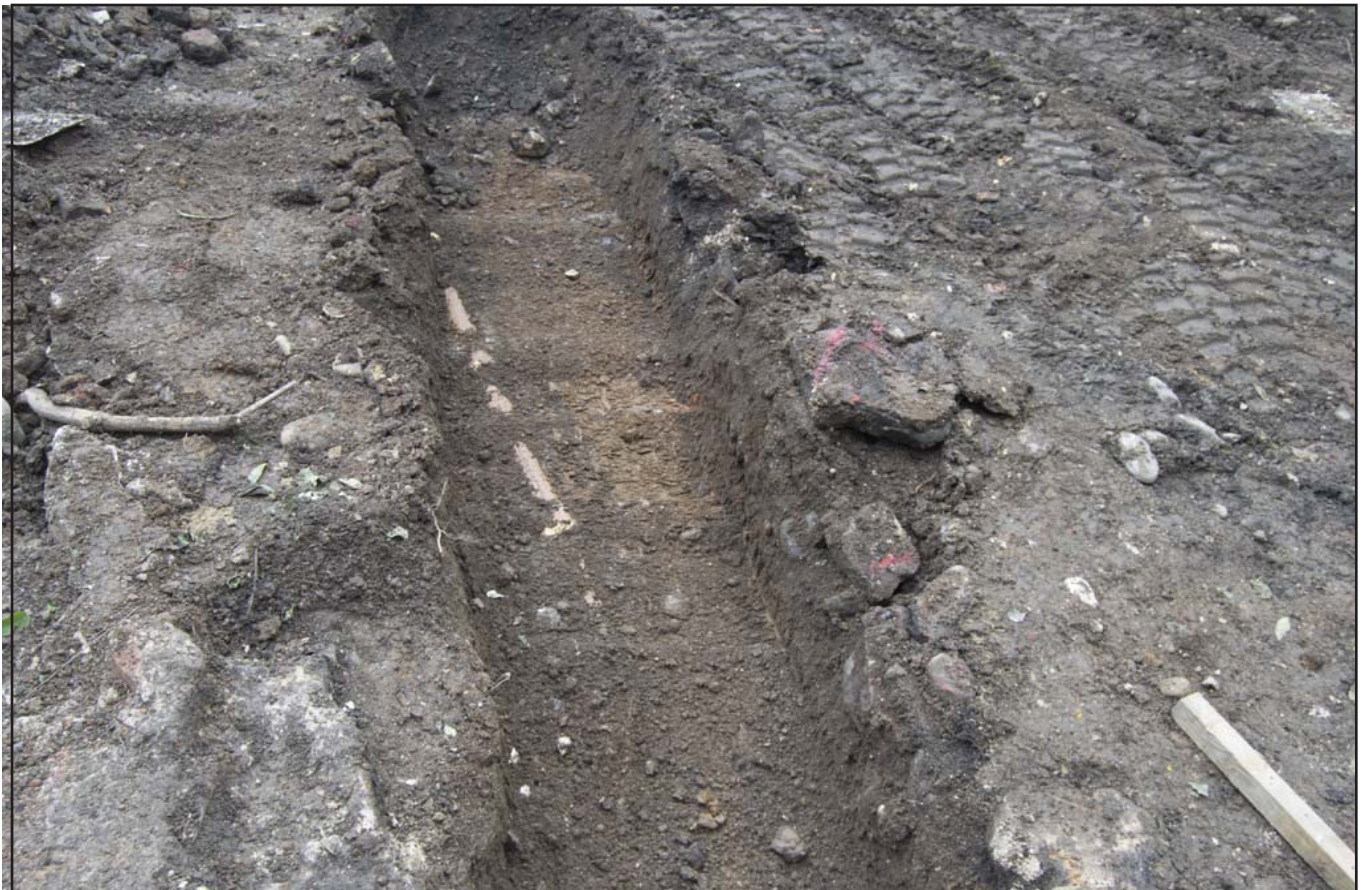
Plate 32: Length of central drainage trench showing modern waste pipe; scale not used; view from S (archive reference: G2766_063).

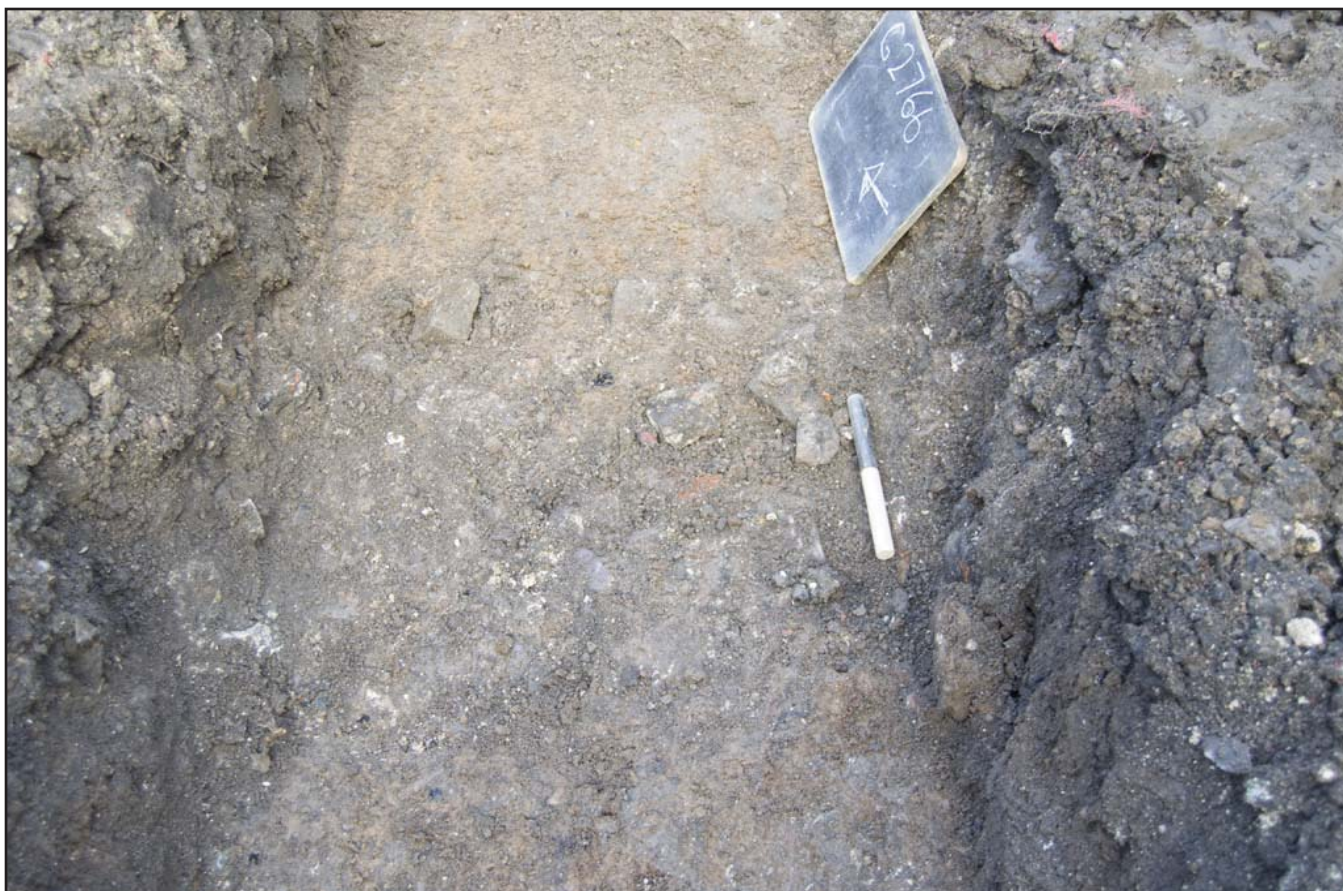
Plate 34: Remains of wall 125 in the base of central drainage trench; scale 1x 0.3m; view from S (archive reference: G2766_065).

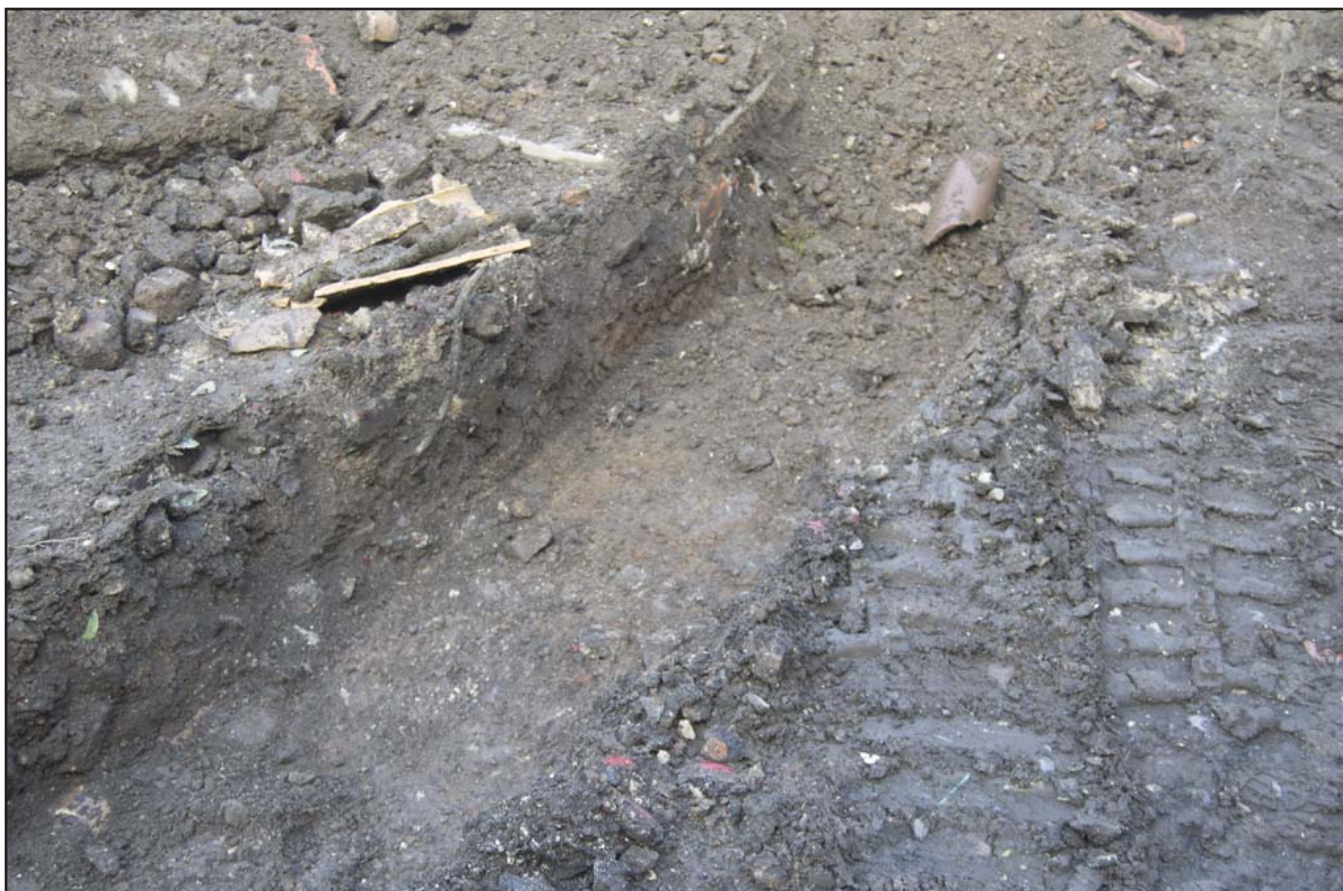
Plate 36: Remains of wall 125 in central drainage trench; scale not used; view from SE (archive reference: G2766_070).

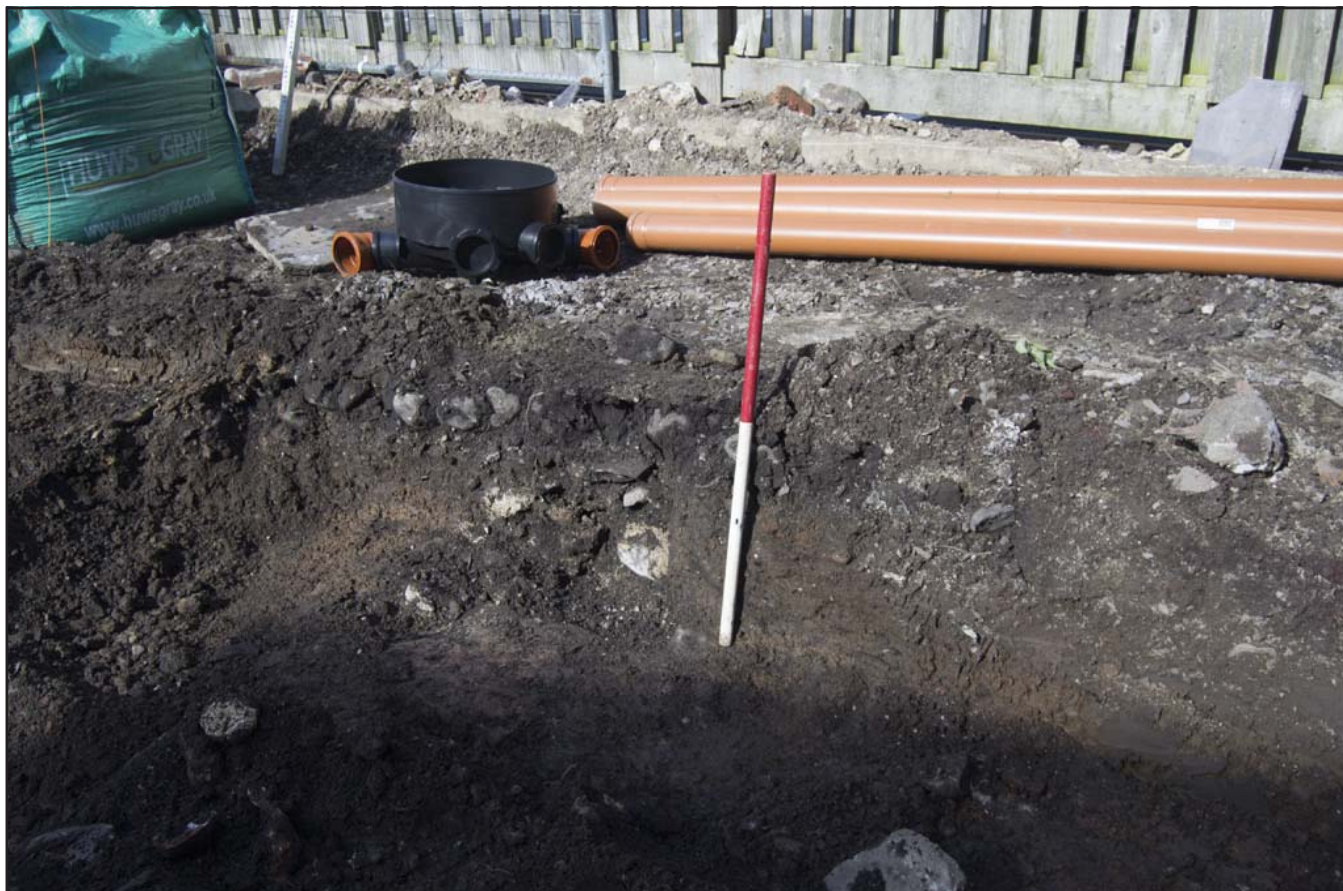
Plate 37: Remains of wall 125 in central drainage trench; scale 1x1m; view from SSE (archive reference: G2766_074).

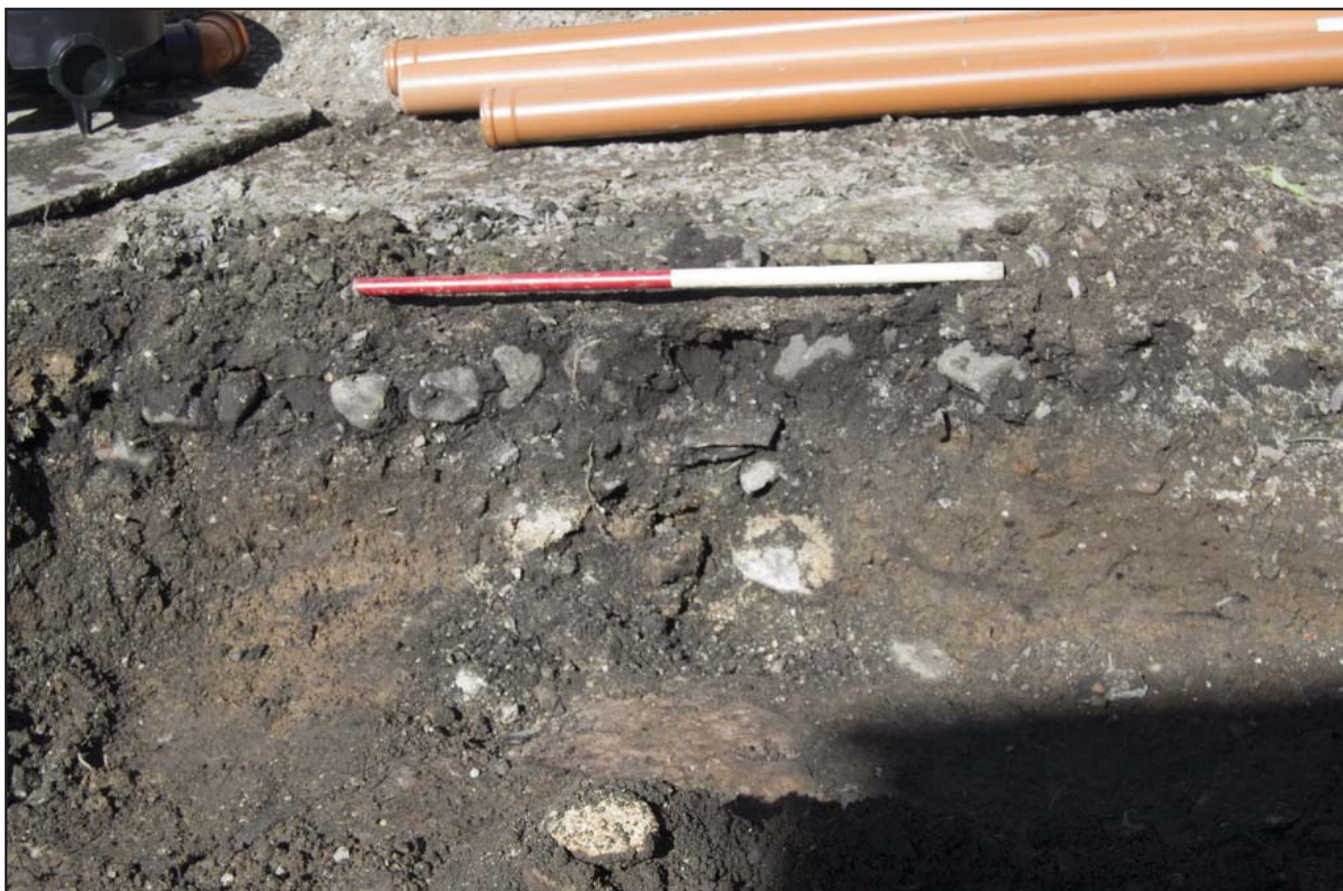
Plate 38: Remains of wall 125 in central drainage trench; scale 1x1m; view from S (archive reference: G2766_075).

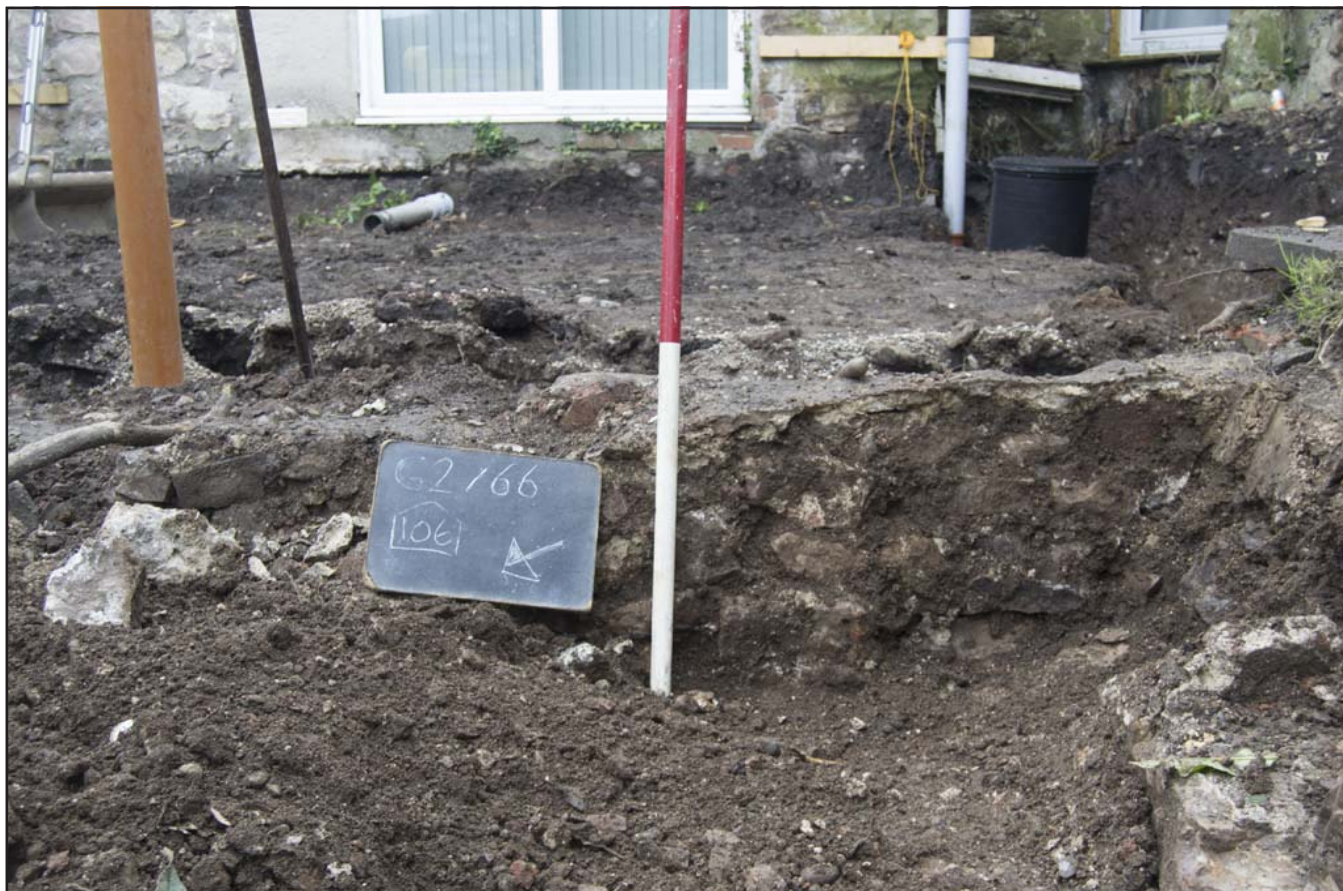
Plate 39: NW elevation of wall 106 in southern footings; scale 1x1m; view from NW (archive reference: G2766_077).

Wall {106} was partly removed to accommodate the southern foundation cut for the extension area; this exposed a depth of 0.48m and further characterised the wall, showing the use of stone and brick fragments in its construction (cf. Plates 39 to 41). The remainder of the southern foundation cut exposed garden soil (cf. Plates 42 and 43), whilst the remainder of the northern foundation cut exposed a more compacted soil and a modern drainage cut.

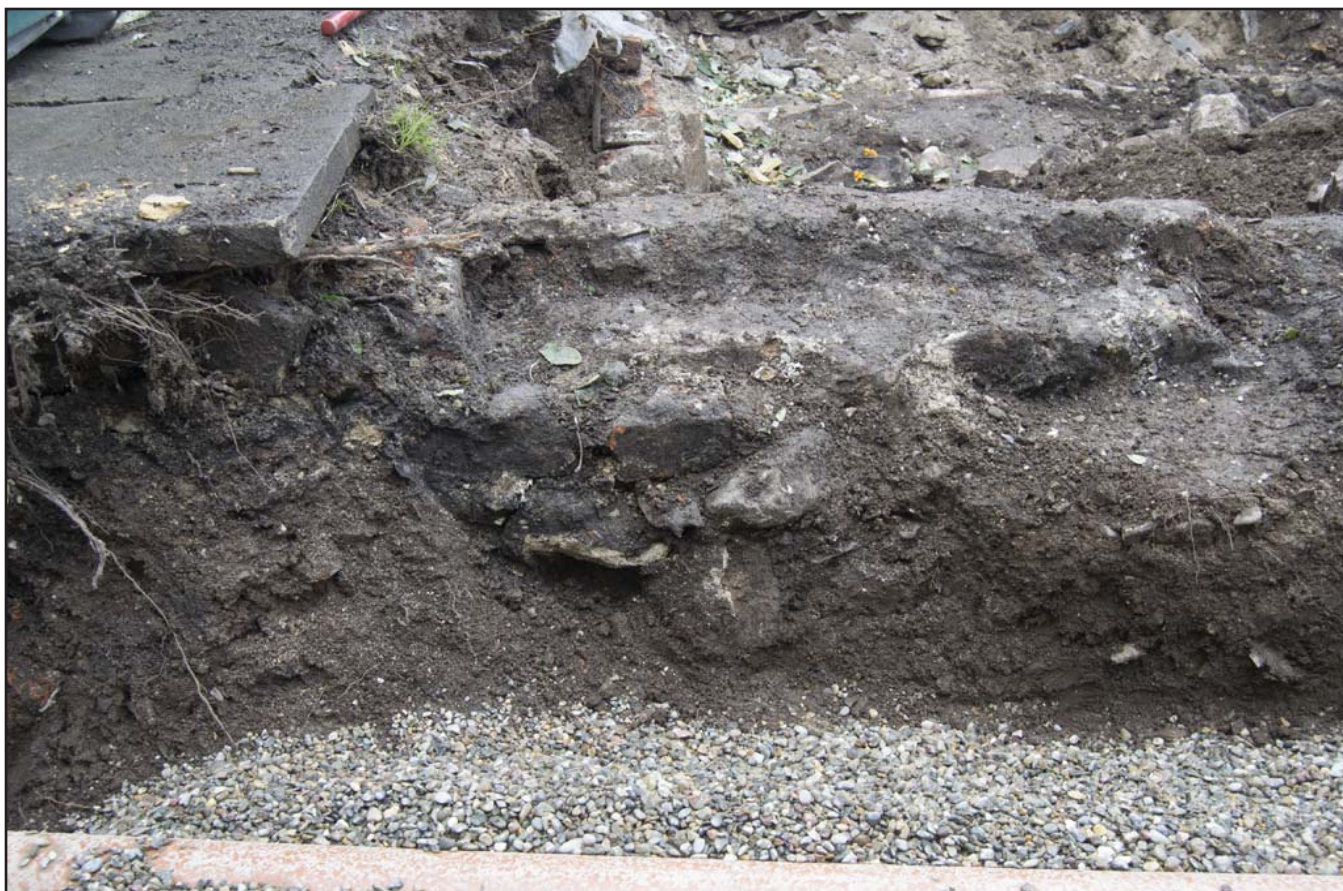
Plate 40: East facing elevation of 106; scale not used; view from E (archive reference: G2766_079).

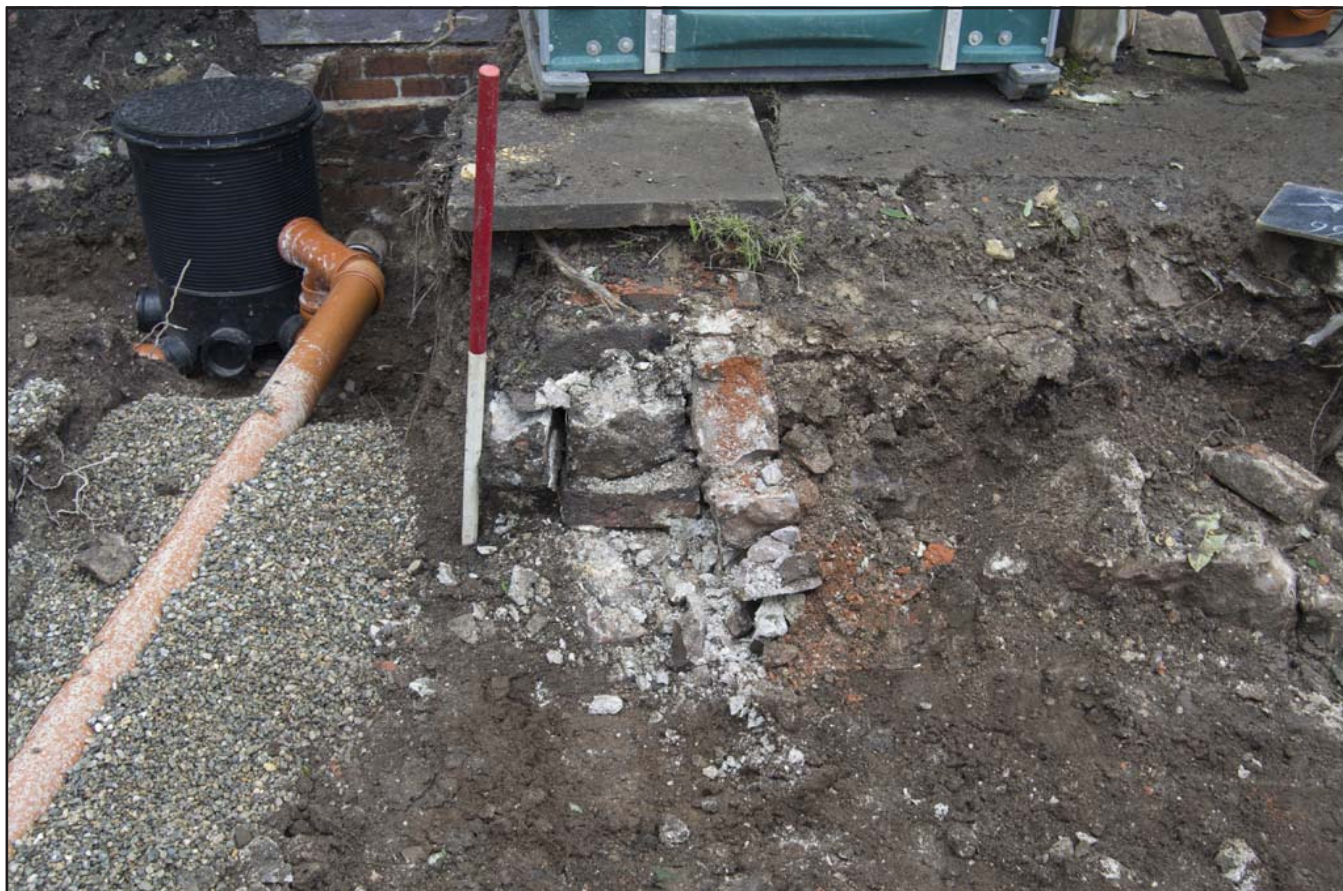
Plate 41: North facing elevation of 106 partially removed; scale 1x1m; view from N (archive reference: G2766_084).

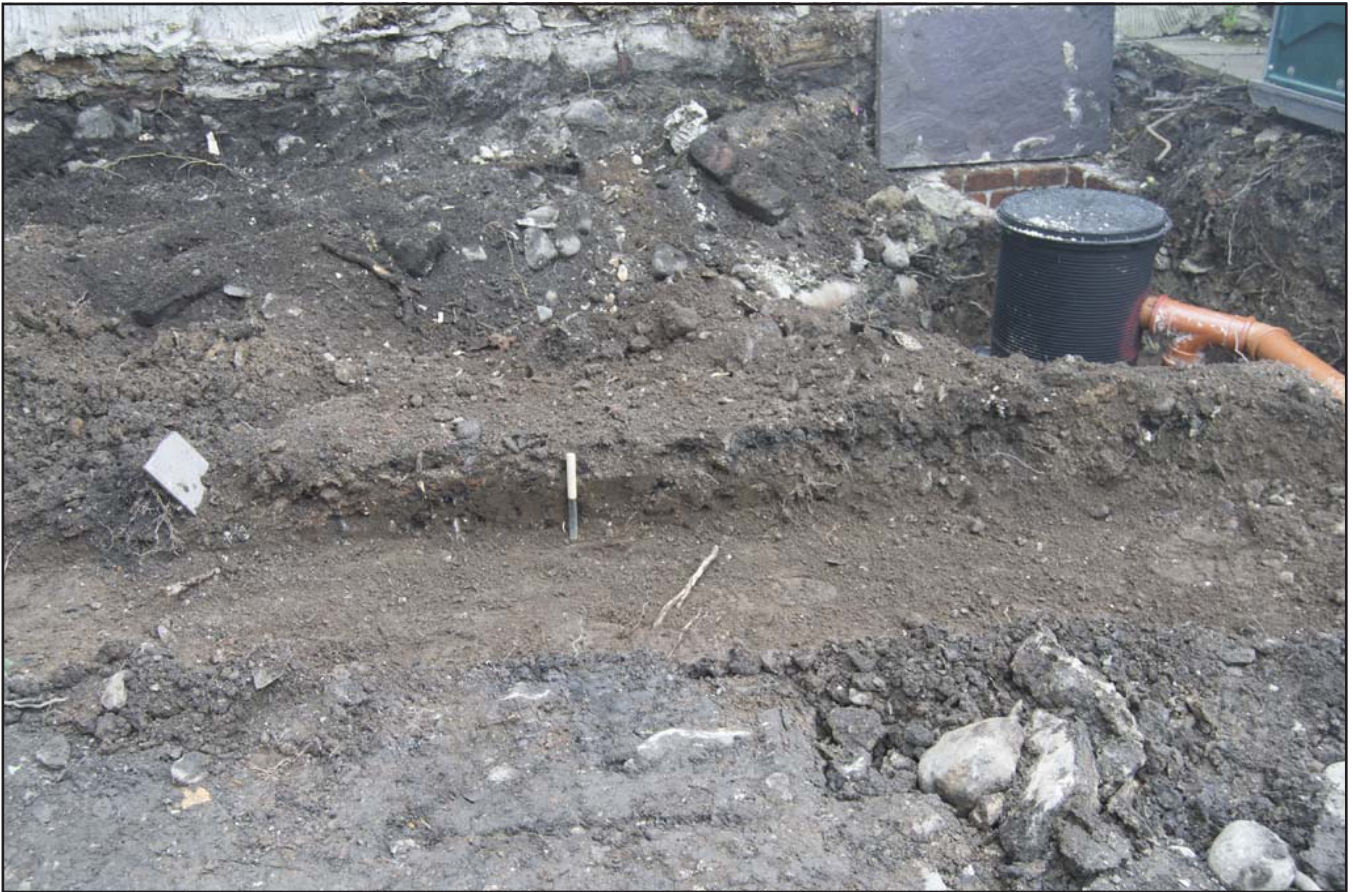
Plate 43: Layers of former yard surface in southern foundation trench; scale 1x 0.3m; view from N (archive reference: G2766_088).

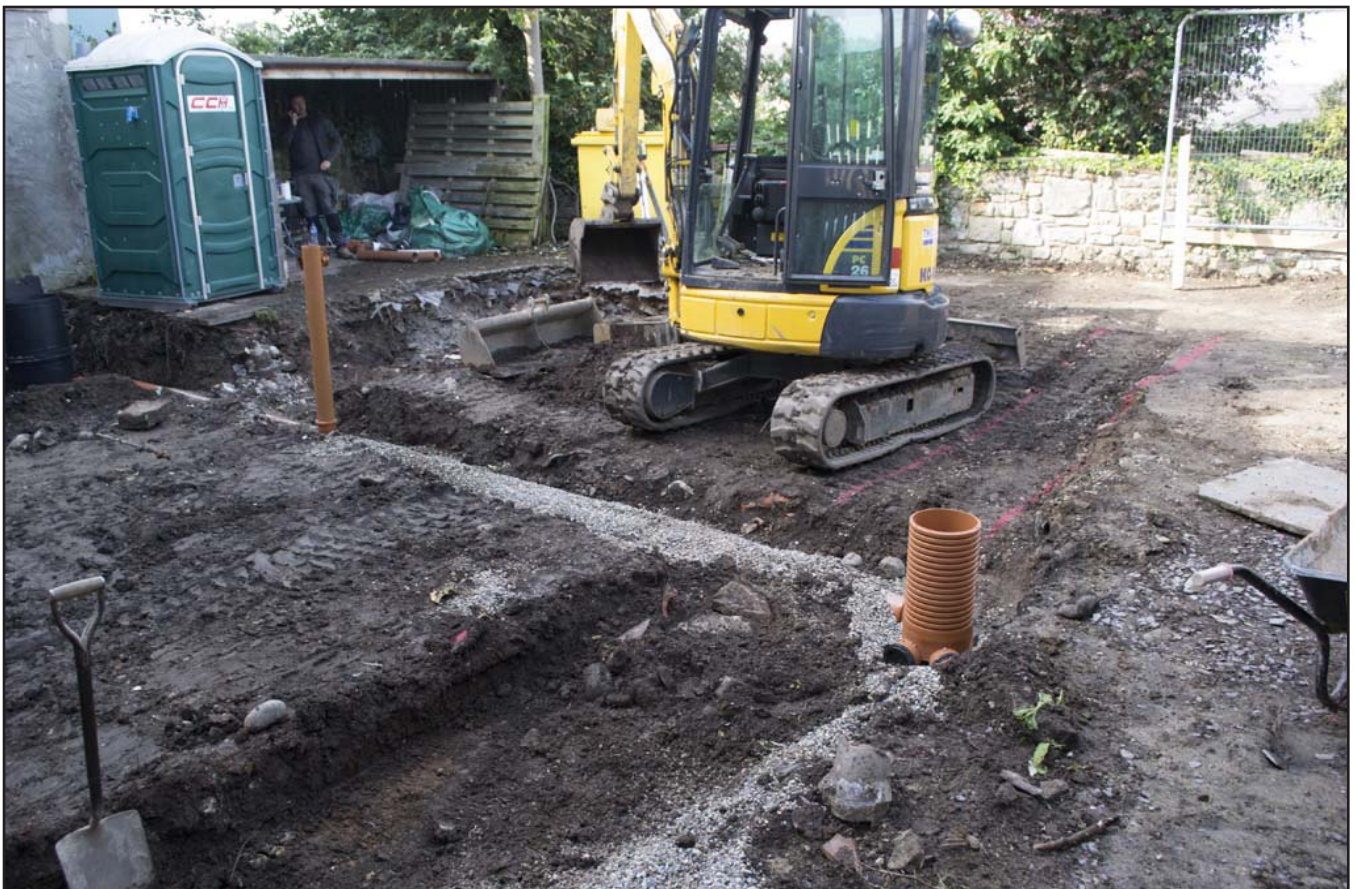
Plate 44: View from northeast of foundation trench (northern end) showing in-situ irregular shaped stones; not structural; scale not used; view from NE (archive reference: G2766_093).

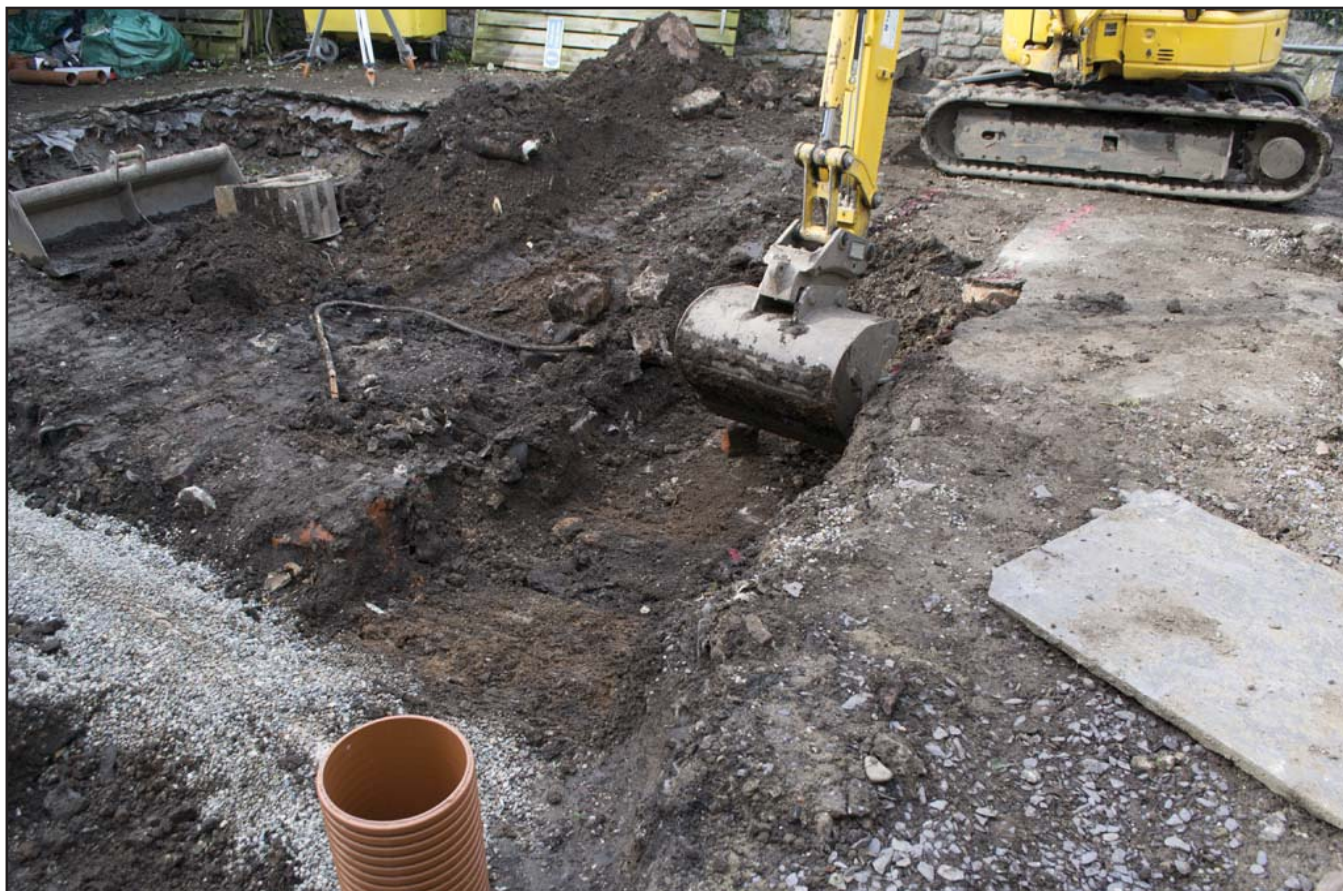
Plate 45: View from northeast of foundation trench (northern end) detailing modern drainage cut; scale not used; view from SE (archive reference: G2766_096).
