The Boathouse, Church Lane Llanfoist, Monmouthshire

Level 2 Building Survey and Archaeological Watching Brief

Report No. 1769

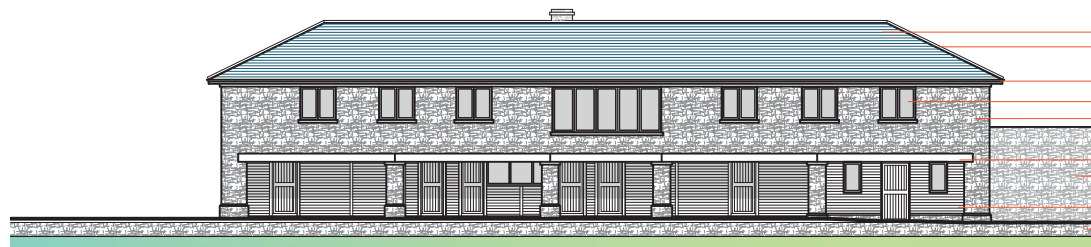
Figure 2. Existing ground floor plan and front elevation

GROUND FLOOR PLAN AS EXISTING (SCALE 1:50 @ A1)

FRONT ELEVATION AS EXISTING (SCALE 1:50 @ A1)

- SLATE ROOF COVERING
- LEAD ROLLS TO HIPPS & RIDGES
- BLACK UPVC RAINWATER GOODS
- STAINED TIMBER CASEMENT WINDOWS
- NATURAL STONEWORK WALLS
- TIMBER LINTELS
- STONEWORK RETAINING WALL
- STAINED TIMBER HORIZONTAL BOARDING
- STONEWORK WALL BOUNDING CANAL

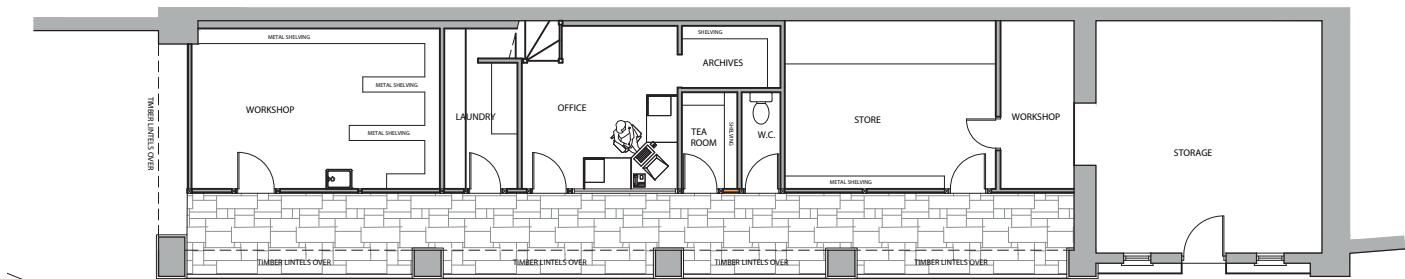
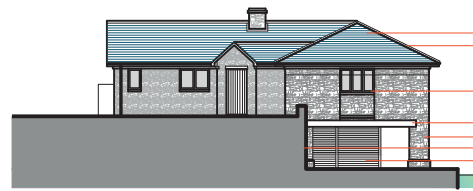
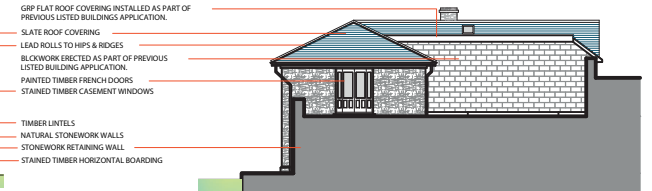
Figure 3. Existing basement plan and rear and side elevations

BASEMENT PLAN AS EXISTING (SCALE 1:50 @ A1)

SIDE ELEVATION AS EXISTING (SCALE 1:50 @ A1)

REAR ELEVATION AS EXISTING (SCALE 1:50 @ A1)

- GRP FLAT ROOF COVERING INSTALLED AS PART OF PREVIOUS LISTED BUILDINGS APPLICATION.
- SLATE ROOF COVERING
- LEAD ROLLS TO HIPS & RIDGES
- BLOCKWORK ERECTED AS PART OF PREVIOUS LISTED BUILDINGS APPLICATION.
- PAINTED TIMBER FRENCH DOORS
- STAINED TIMBER CASSEMENT WINDOWS
- TIMBER LINTELS
- NATURAL STONEWORK WALLS
- STONEWORK RETAINING WALL
- STAINED TIMBER HORIZONTAL BOARDING

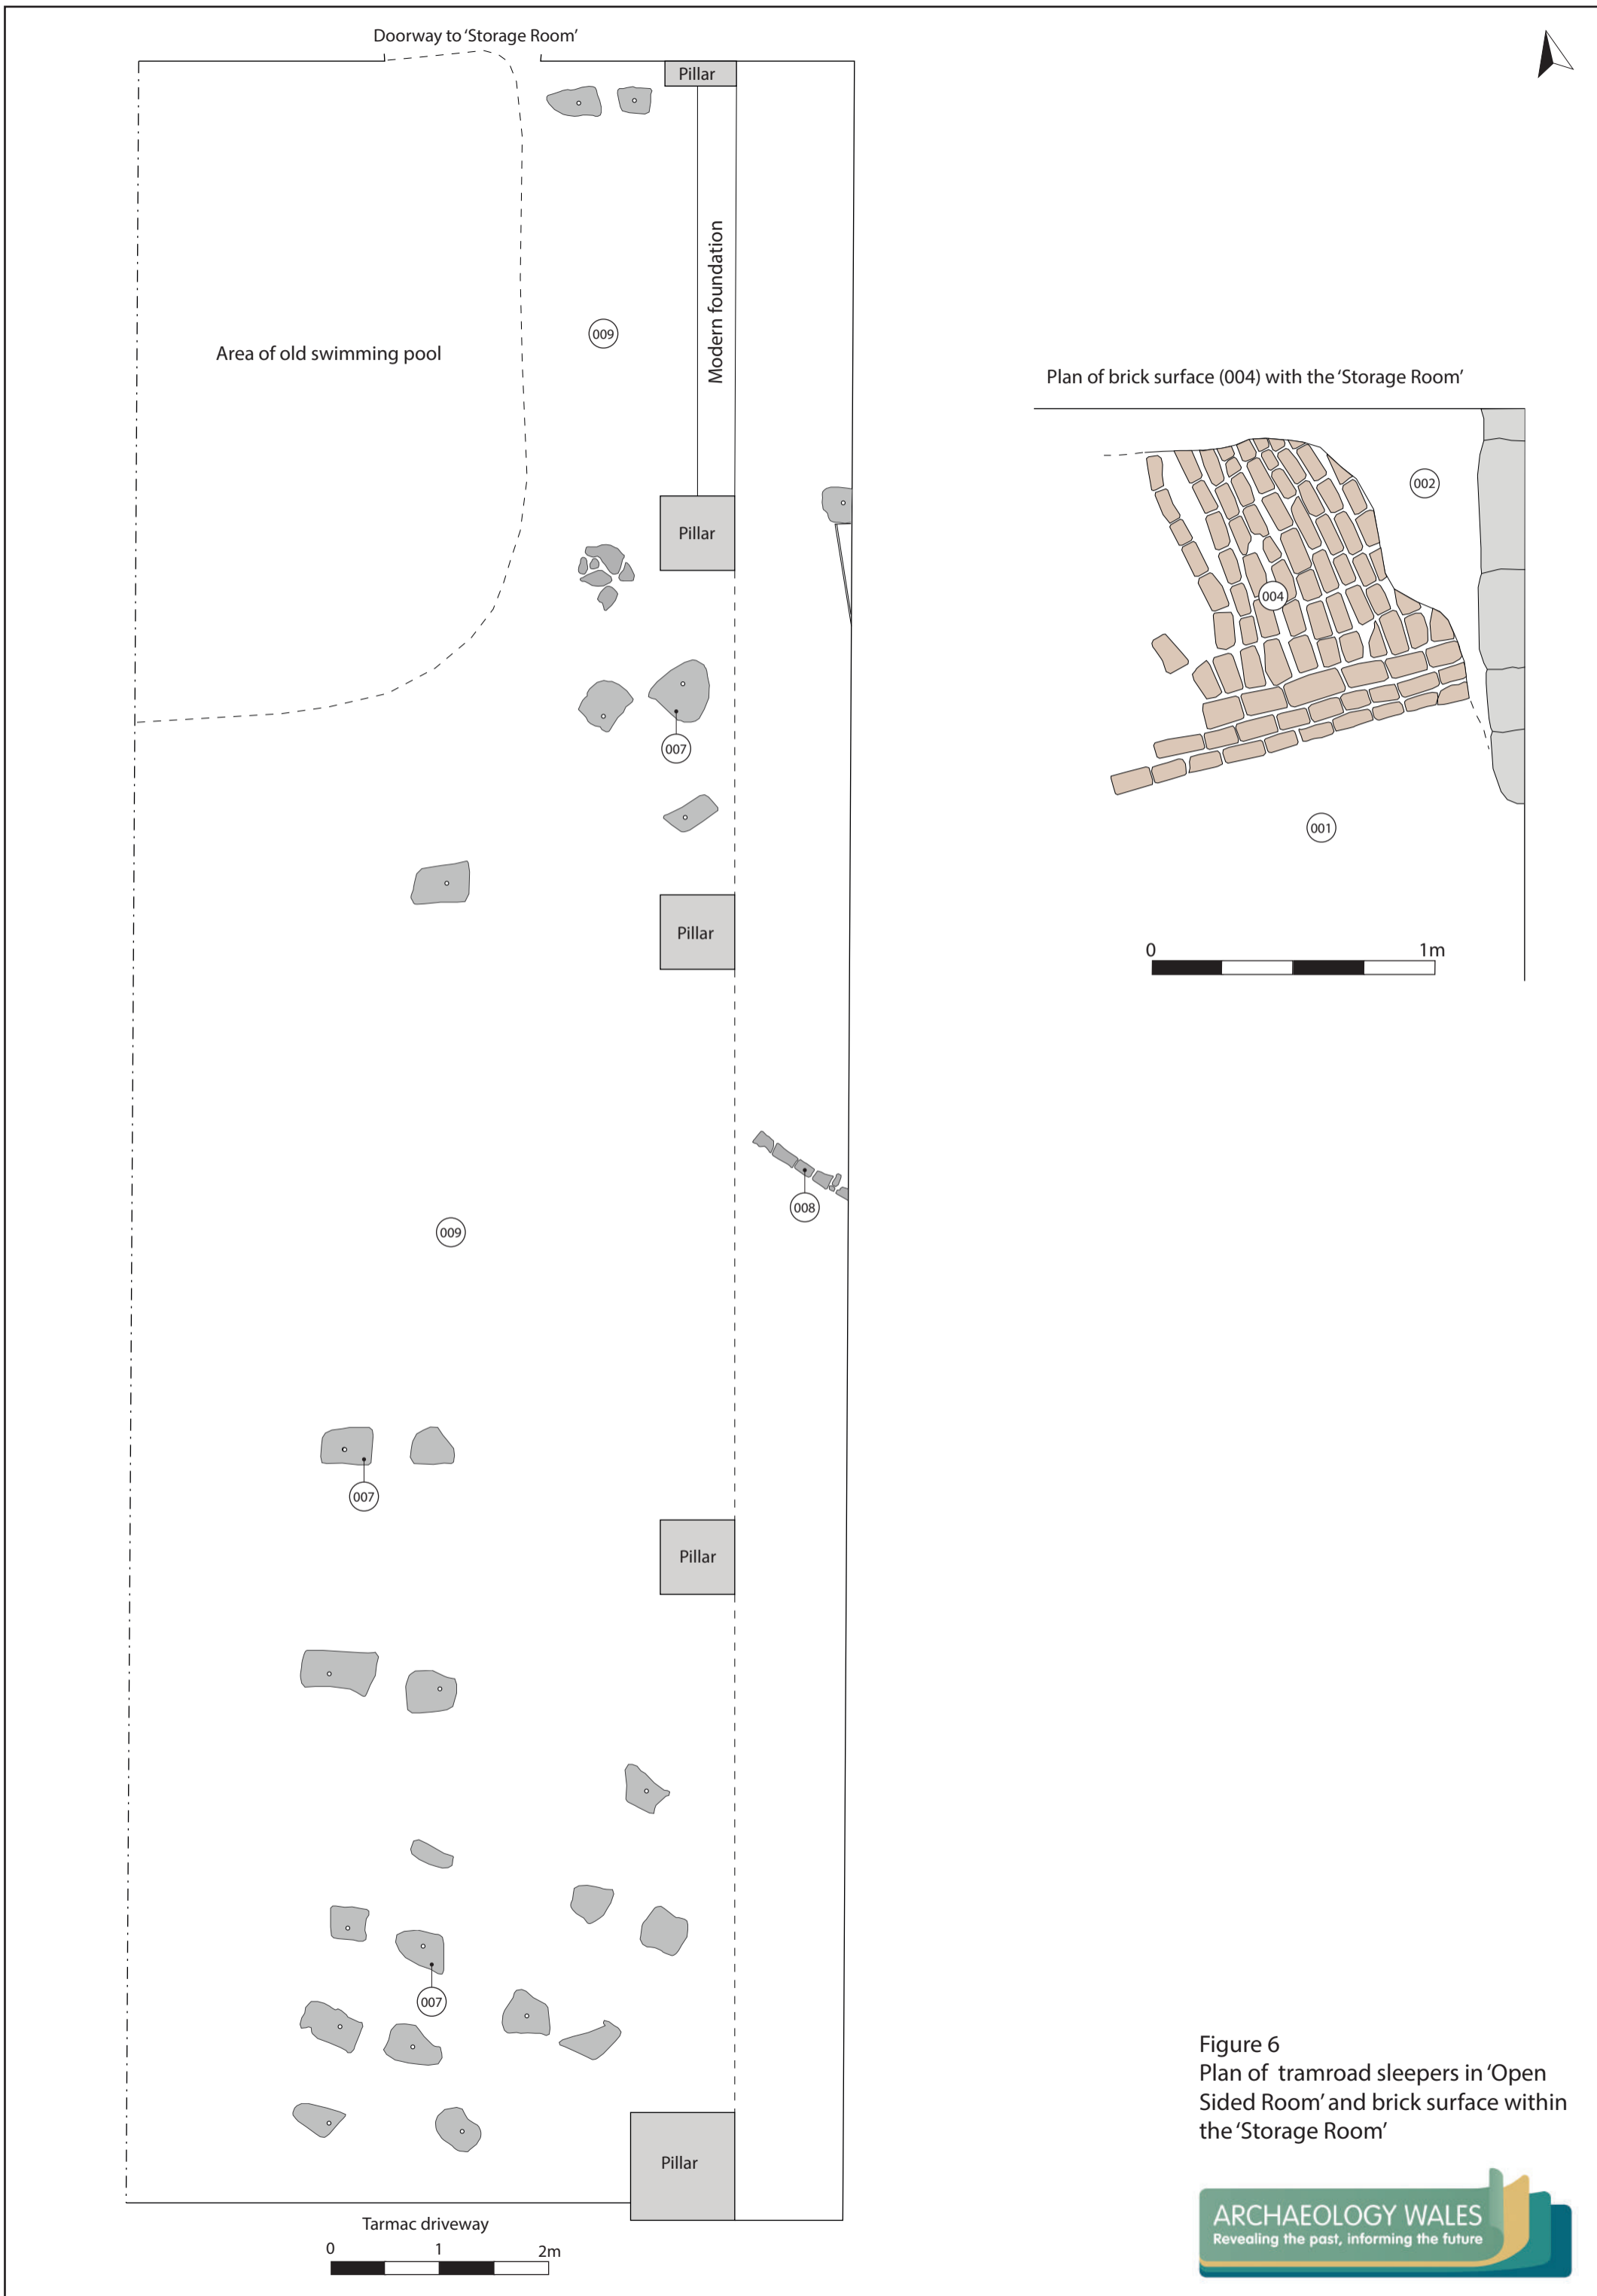
Figure 6
 Plan of tramroad sleepers in 'Open Sided Room' and brick surface within the 'Storage Room'

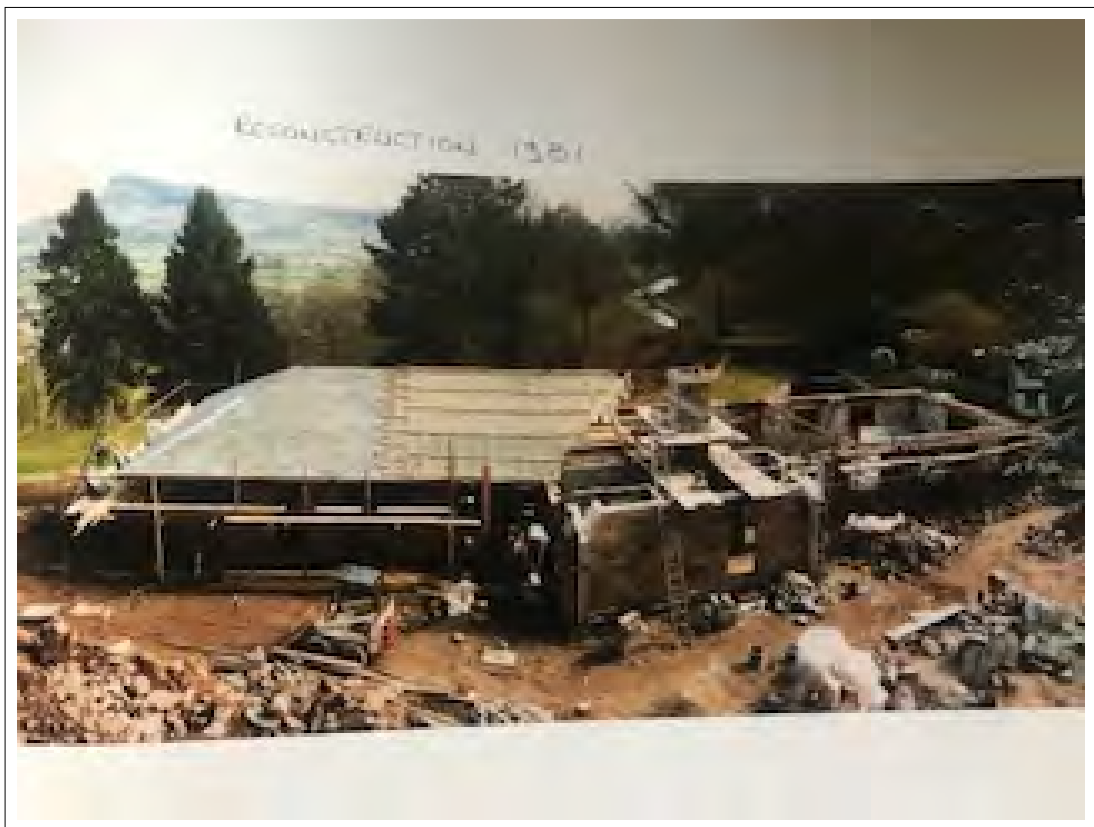
Photographs of the renovation work show that the roof was completely removed and replaced with a hipped slate roof in the same style (Plate 5). It is possible to see that originally the hillside came much closer to the rear of the building (Plate 6), but that this was cut back during the renovation work and construction of the extension. During this period a swimming pool was constructed in the ground floor (Plate 7).

Plate 5. Photographs received from the current owner prior to and during renovations in the 1980s

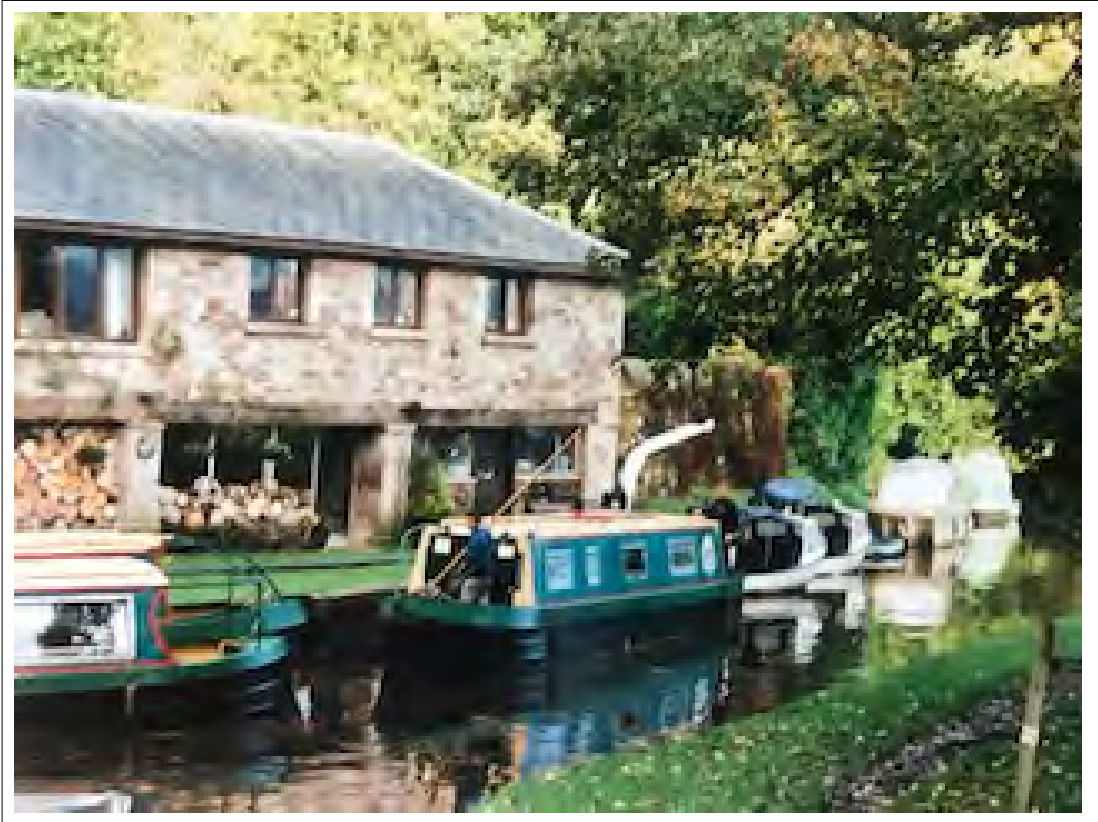
The first floor of the building continued as residential use under the current owners from the early 2000s. The ground floor was adapted to offices, working areas and storage for Beacon Park Boats (Plate 8), with partition walls enclosing the Open Sided Room (Plate 9).

Plate 9. Photographs received from the current owner of the storage area in early 2000s

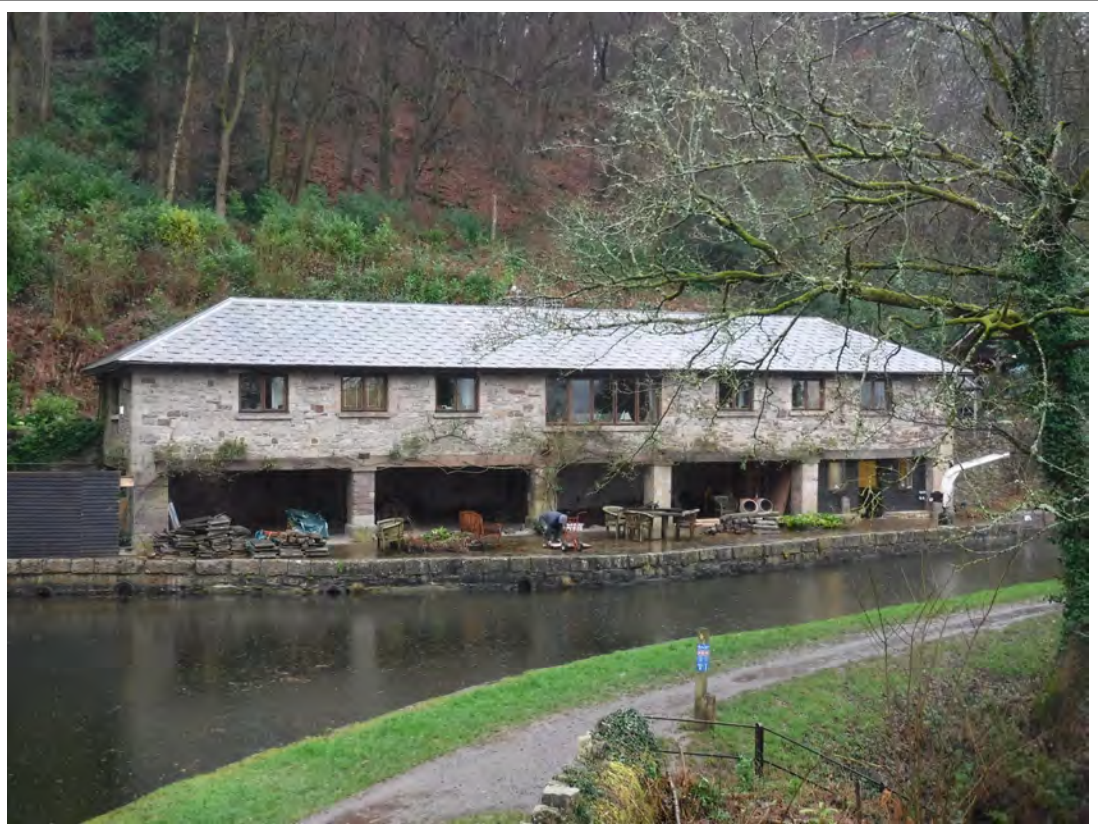
The Boathouse building is a rectangular stone-built two-storey building with a hipped slate roof, orientated north – south (Plate 10). The ground floor is built into the hillside to the west, with the east side open to the canal.

Plate 10. East-facing elevation of The Boathouse, looking west

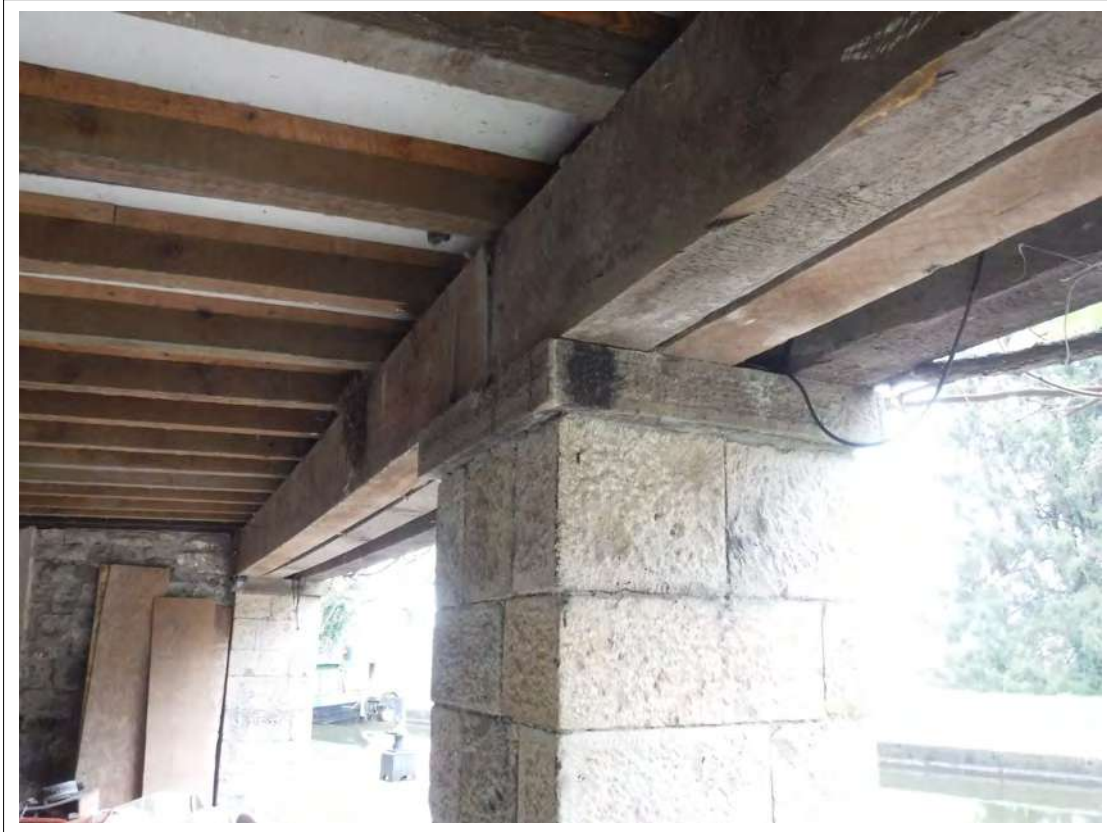
Plate 15. Detail of the top of a pillar showing modern mortar, looking north-east

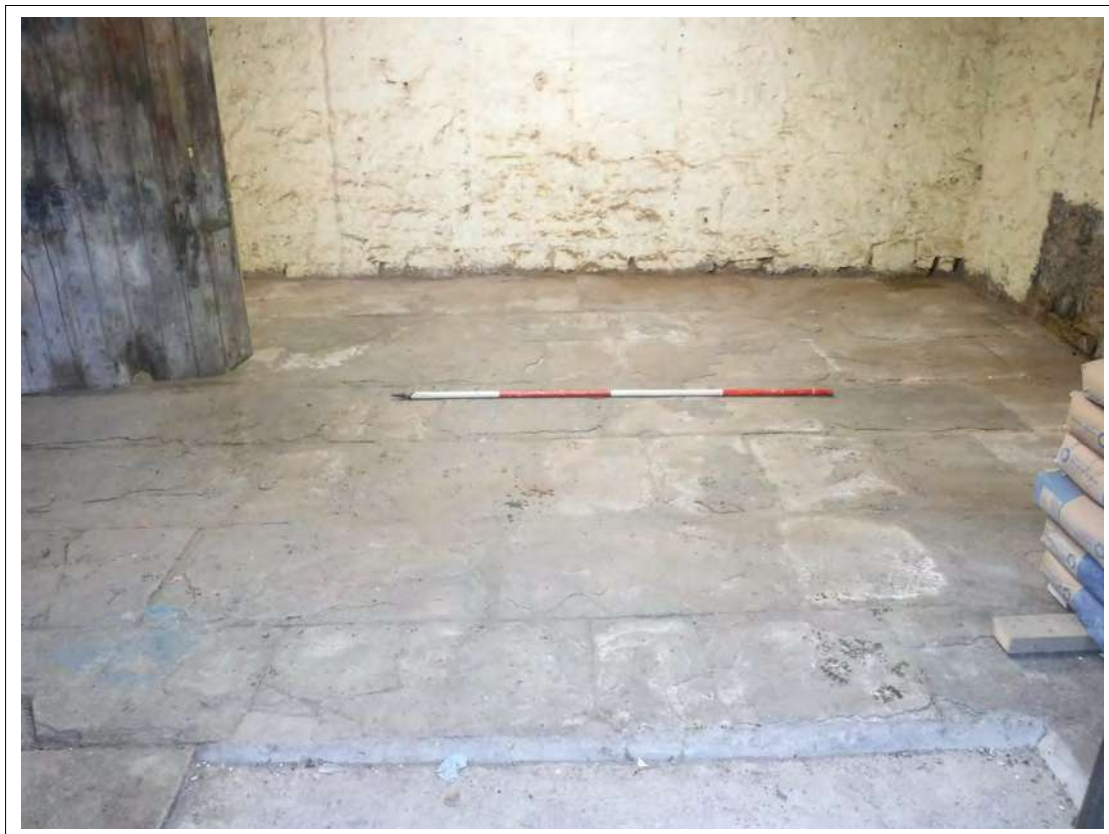
The floor is of large stone slabs laid in a regular linear arrangement (Plates 28 and 29). The slabs vary in size, averaging 0.5m by 0.9m. They have no bonding material. The stones are generally in good condition, although some are badly cracked. In places the remains of a form of pitch coating can be observed. A 2m by 2m area to the external door to the east has been concreted.

Plate 28. Flagstone floor of Storage Room, looking west. Scale 2m

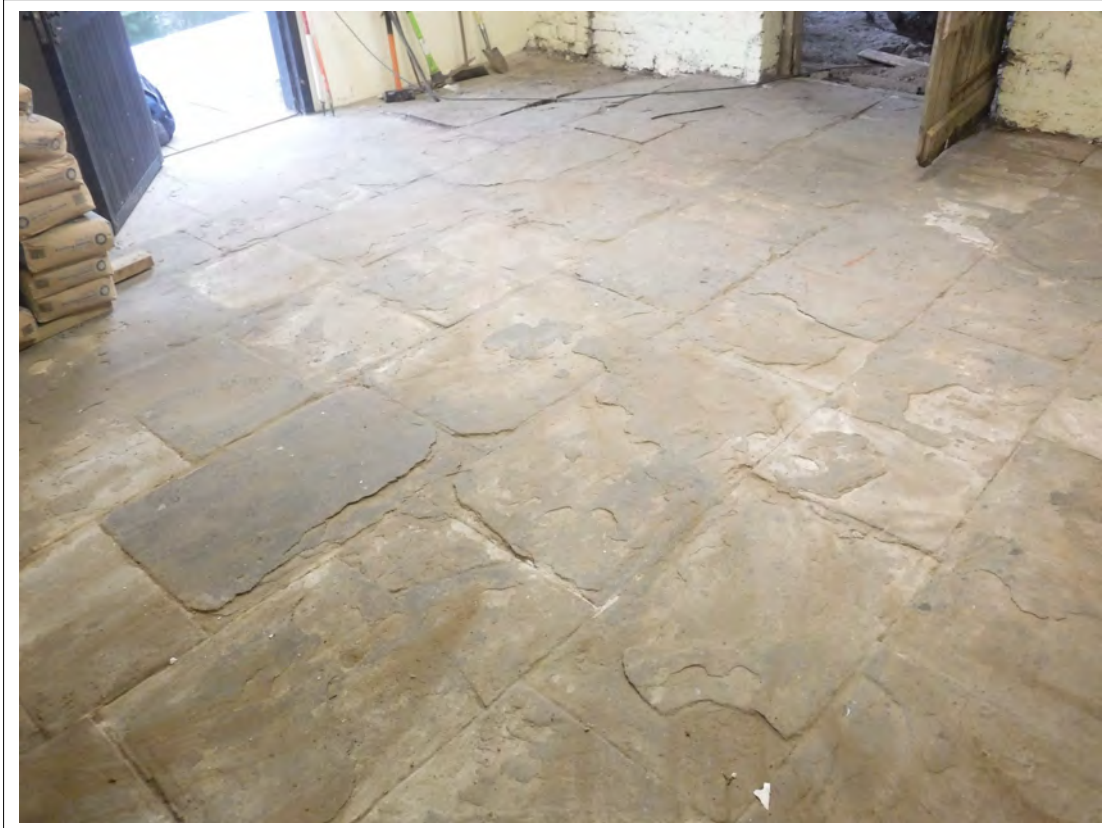
Plate 29. Flagstone floor of Storage Room, looking south-east

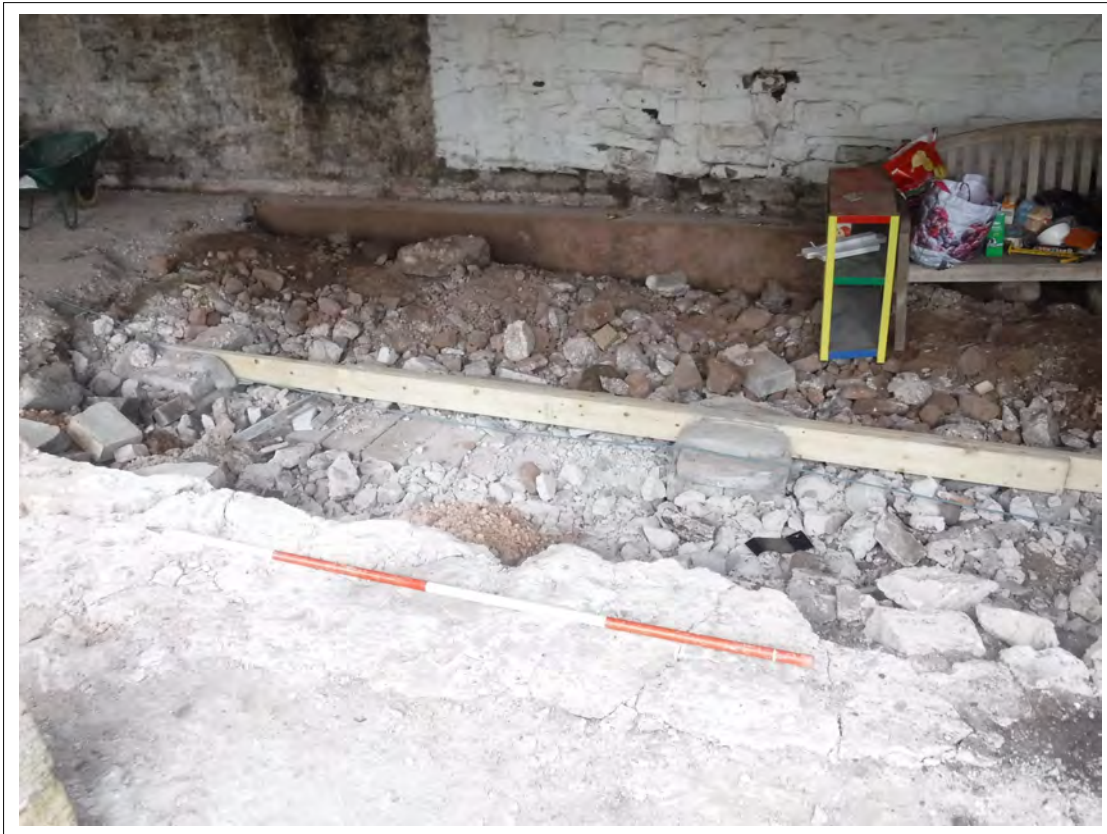
The floor consists of dirt and rubble. To the south there are several large stones which do not appear to be part of a laid floor. In the northern area is a large hole that is partially rubble filled with broken concrete around (Plate 35). This is the remains of a swimming pool which was constructed in the 1980s.

Plate 35. Remains of swimming pool, looking south-west. Scale 2m

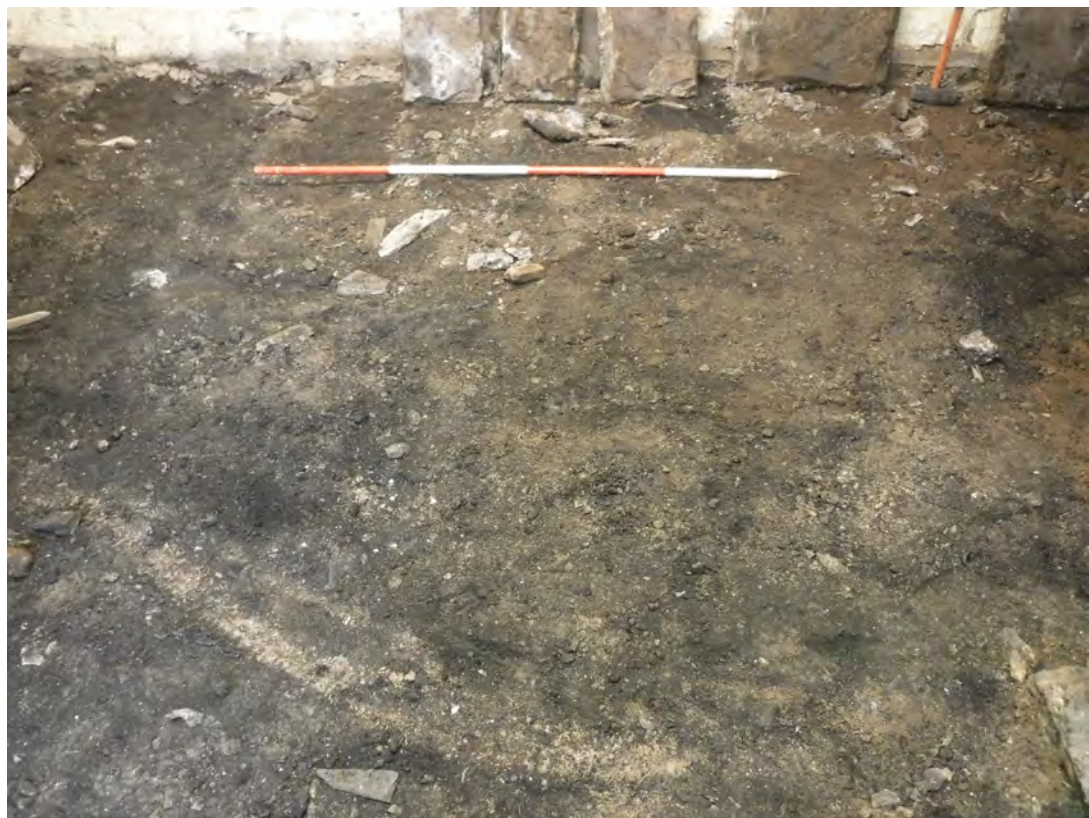
Overlying context (002) was a loose dark greyish black sooty deposit (001). This deposit was encountered throughout the entire area. It varied in thickness, averaging 0.1m (Plate 46). Within this deposit metal objects and CBM were recovered, along with a clay tobacco pipe with the bowl fully intact. This deposit was clearly a levelling deposit for the Warehouse floor.

Plate 46. Deposit (001) in the Storage Room. Scale 2m

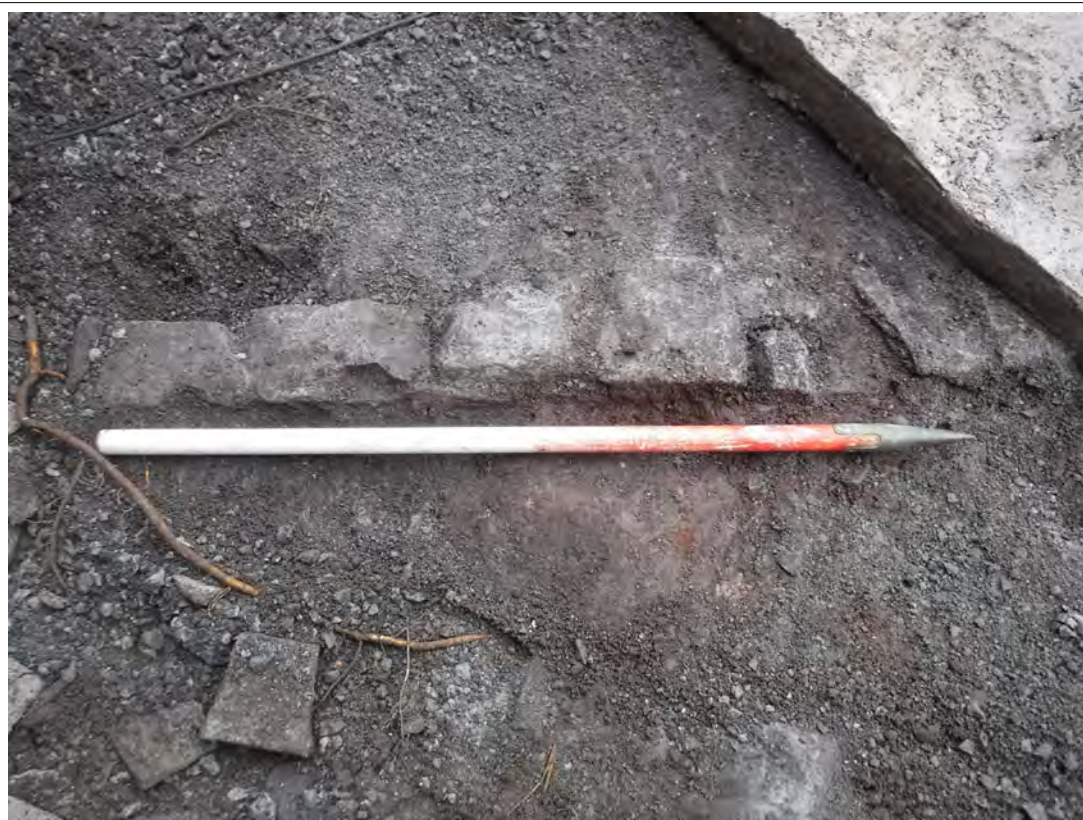
Plate 47. Wall (008) to the east of the Open Sided Room, looking north. Scale 1m

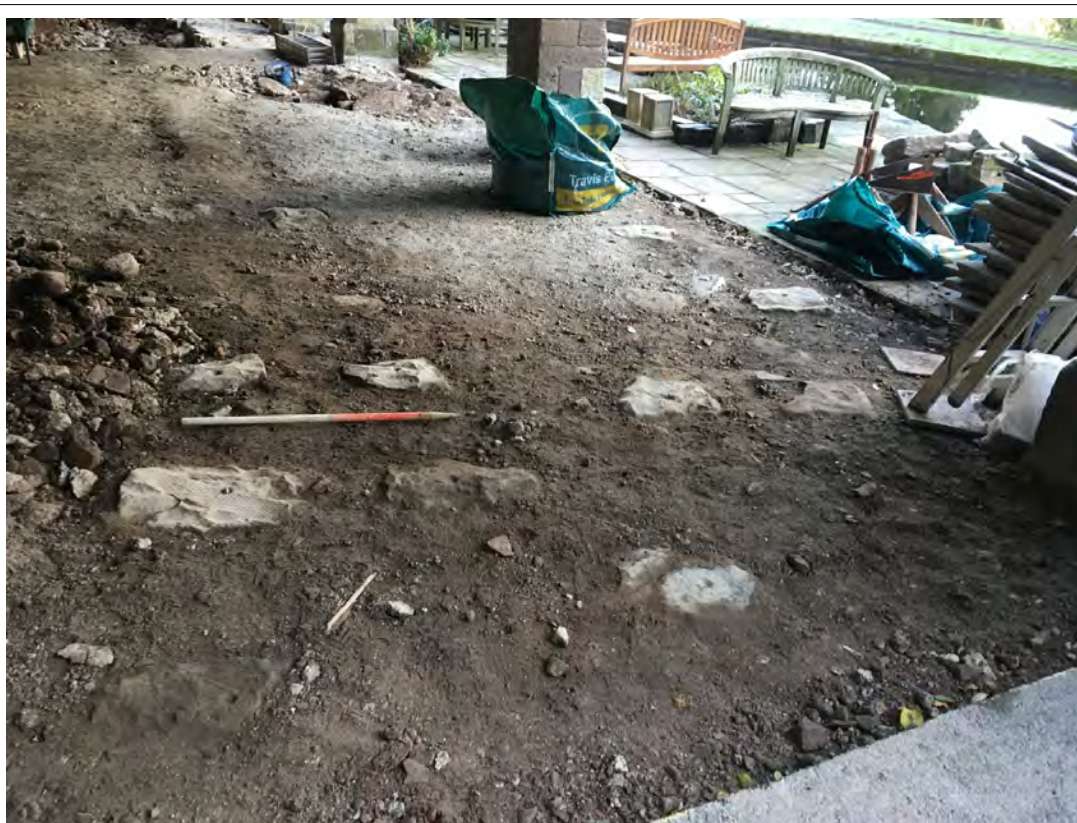
Plate 48. Alignments of sleeper stones in the Open Sided Room, looking north. Scale 1m
