Trinity Chapel, Pencoed

Level 3 Building Survey

Report No . 1970

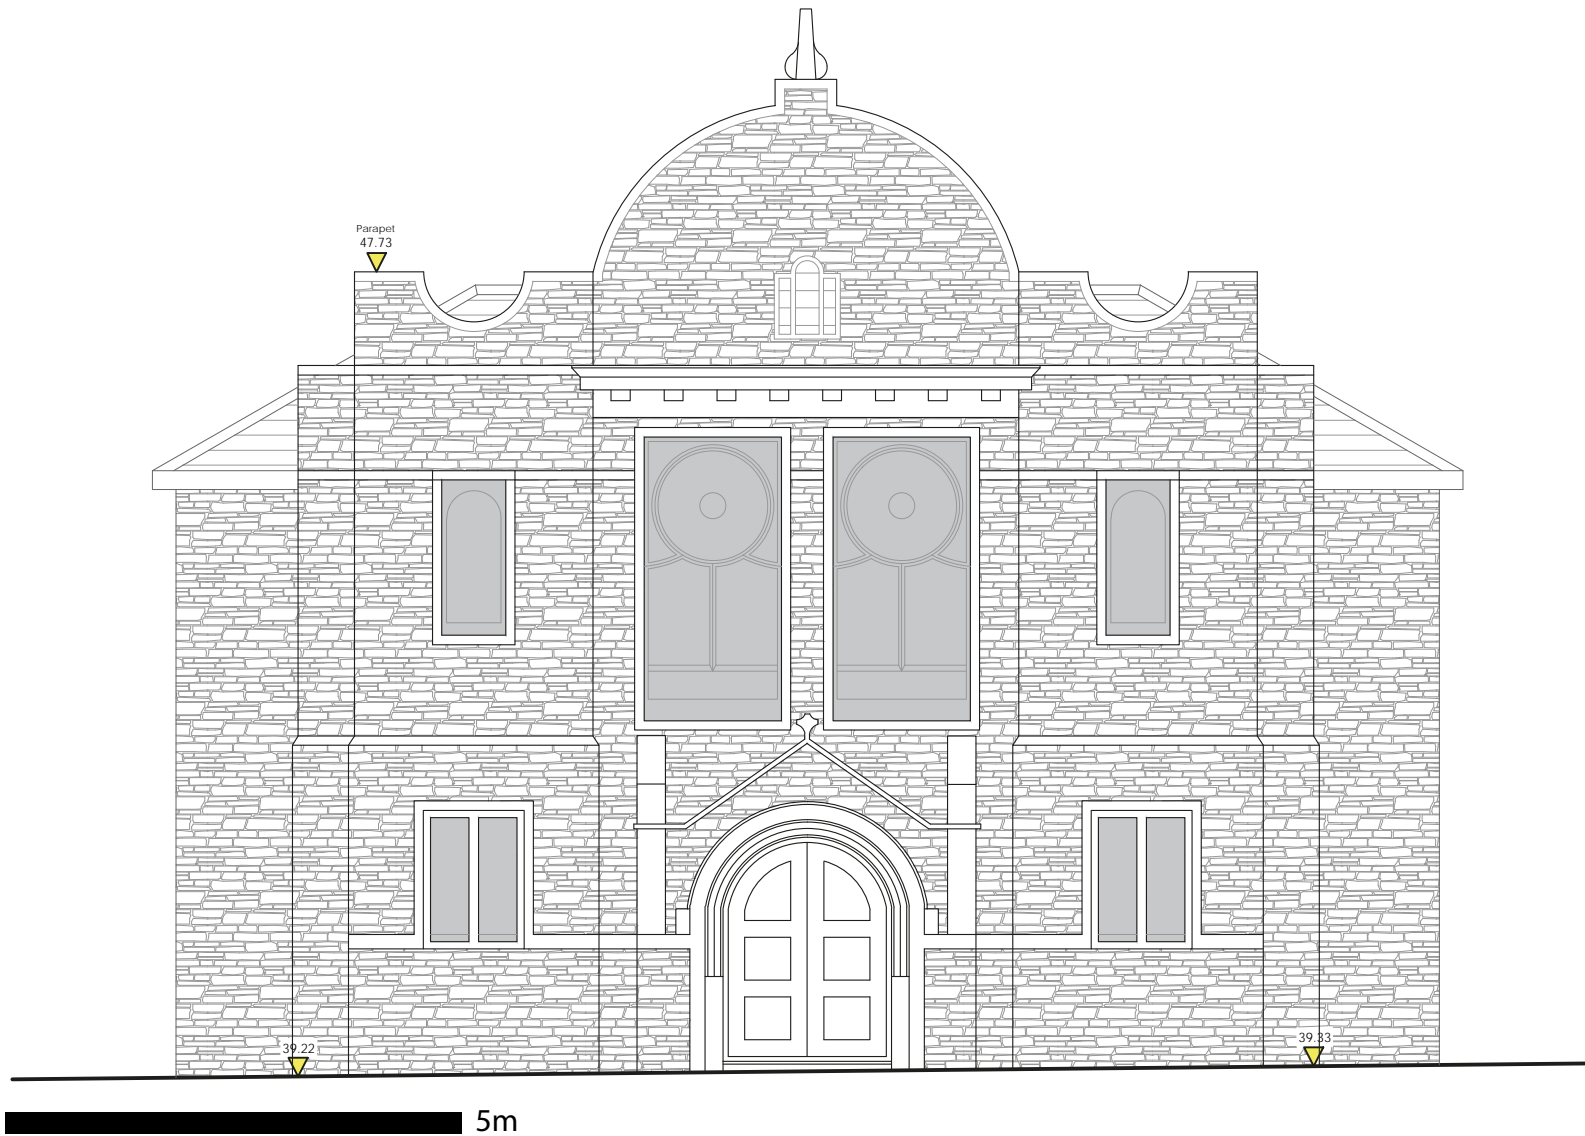
Figure 4. Trinity Chapel facade.

- 5.3. The front façade is a two storey, three bay gable end (Plate 1). The outer bays are slightly projecting and are topped with concave semi-circular parapets. The central bay has a semi-circular parapet with decorative cement finial.

- 5.8. There is a bevelled string course to the outer bays at first floor height, and two thin smooth finished ashlar string courses to the upper part of the elevation. There are rough tooled ashlar quoins to each end of the façade exterior.

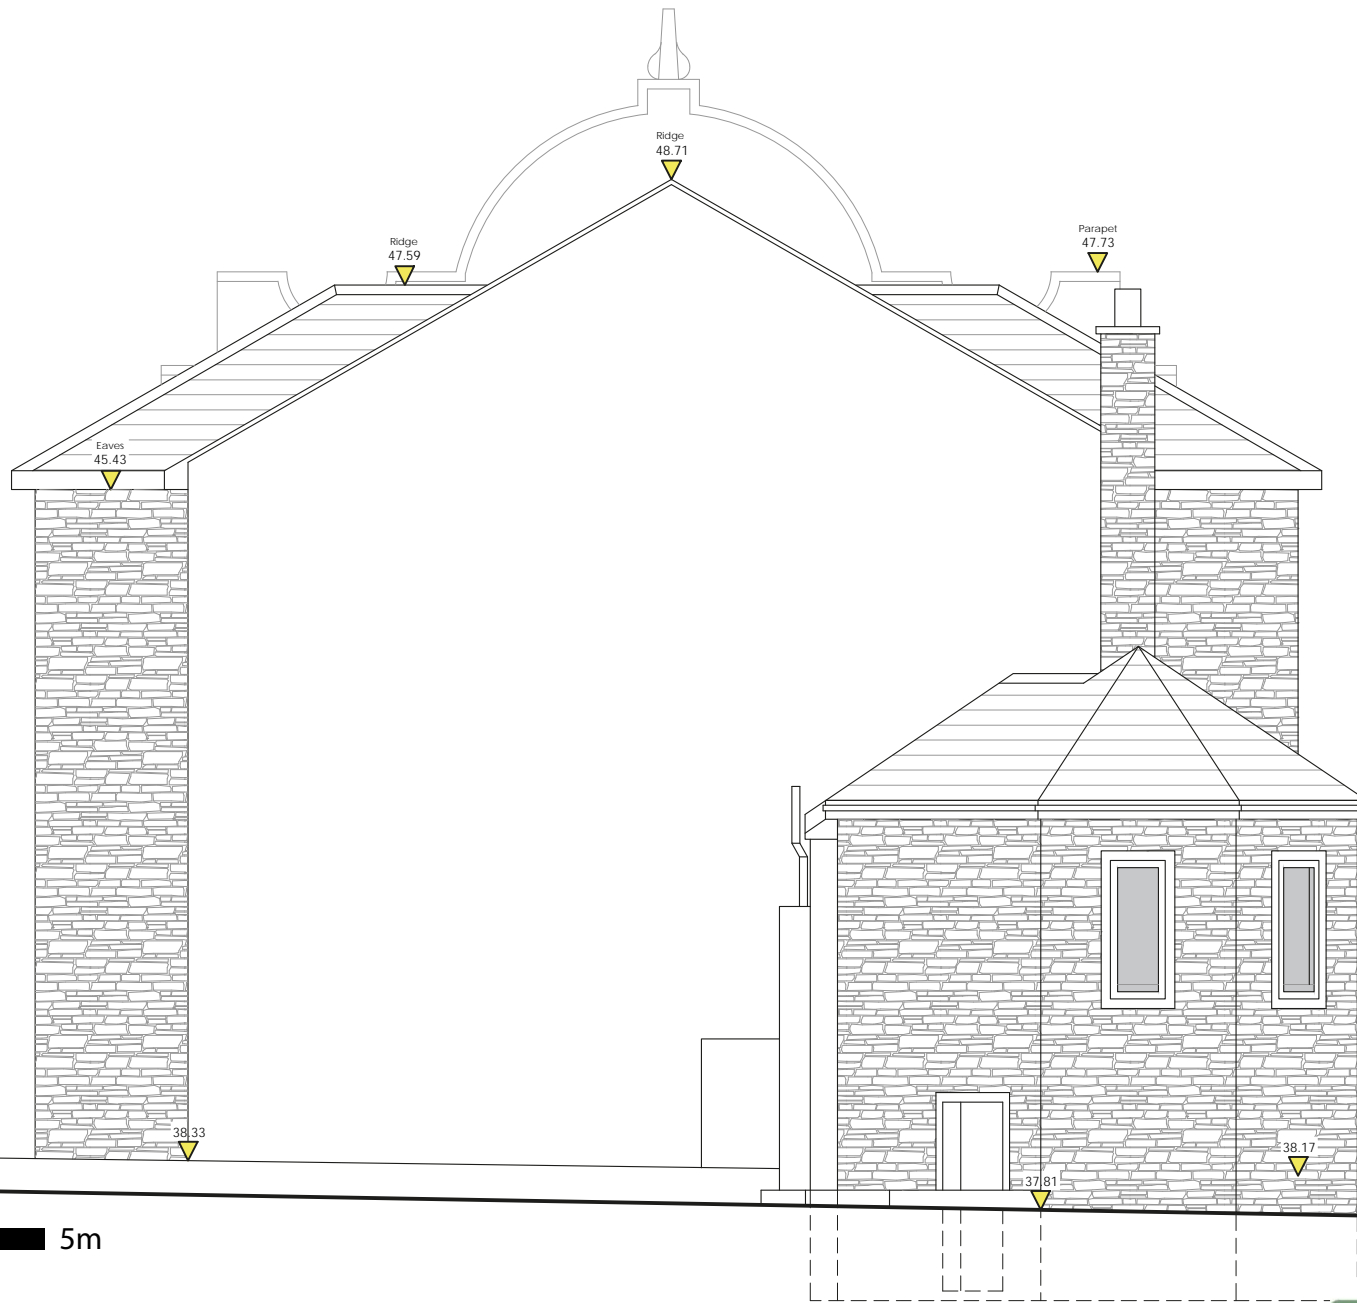
Figure 5. SE facing elevation.

- 5.16. The SE-facing elevation of the gable end is 10m wide, with an additional 1.5m to each side being the sides of the projecting cross-gables (Fig. 5; Plates 20 and 21). The projecting element to the rear is 3m wide and includes the S- and E-facing elevations.

- 5.17. This gable end is rendered with smooth finished cement render. The sides of the cross-hips are of the same rough finished stone blocks as the building's side elevations. To the NE of the gable end, in front of the hip side, is a chimney stack, in rough tooled ashlar like the front of the building, although with cement render to the interior (Plate 22). It has two red ceramic chimney pots.

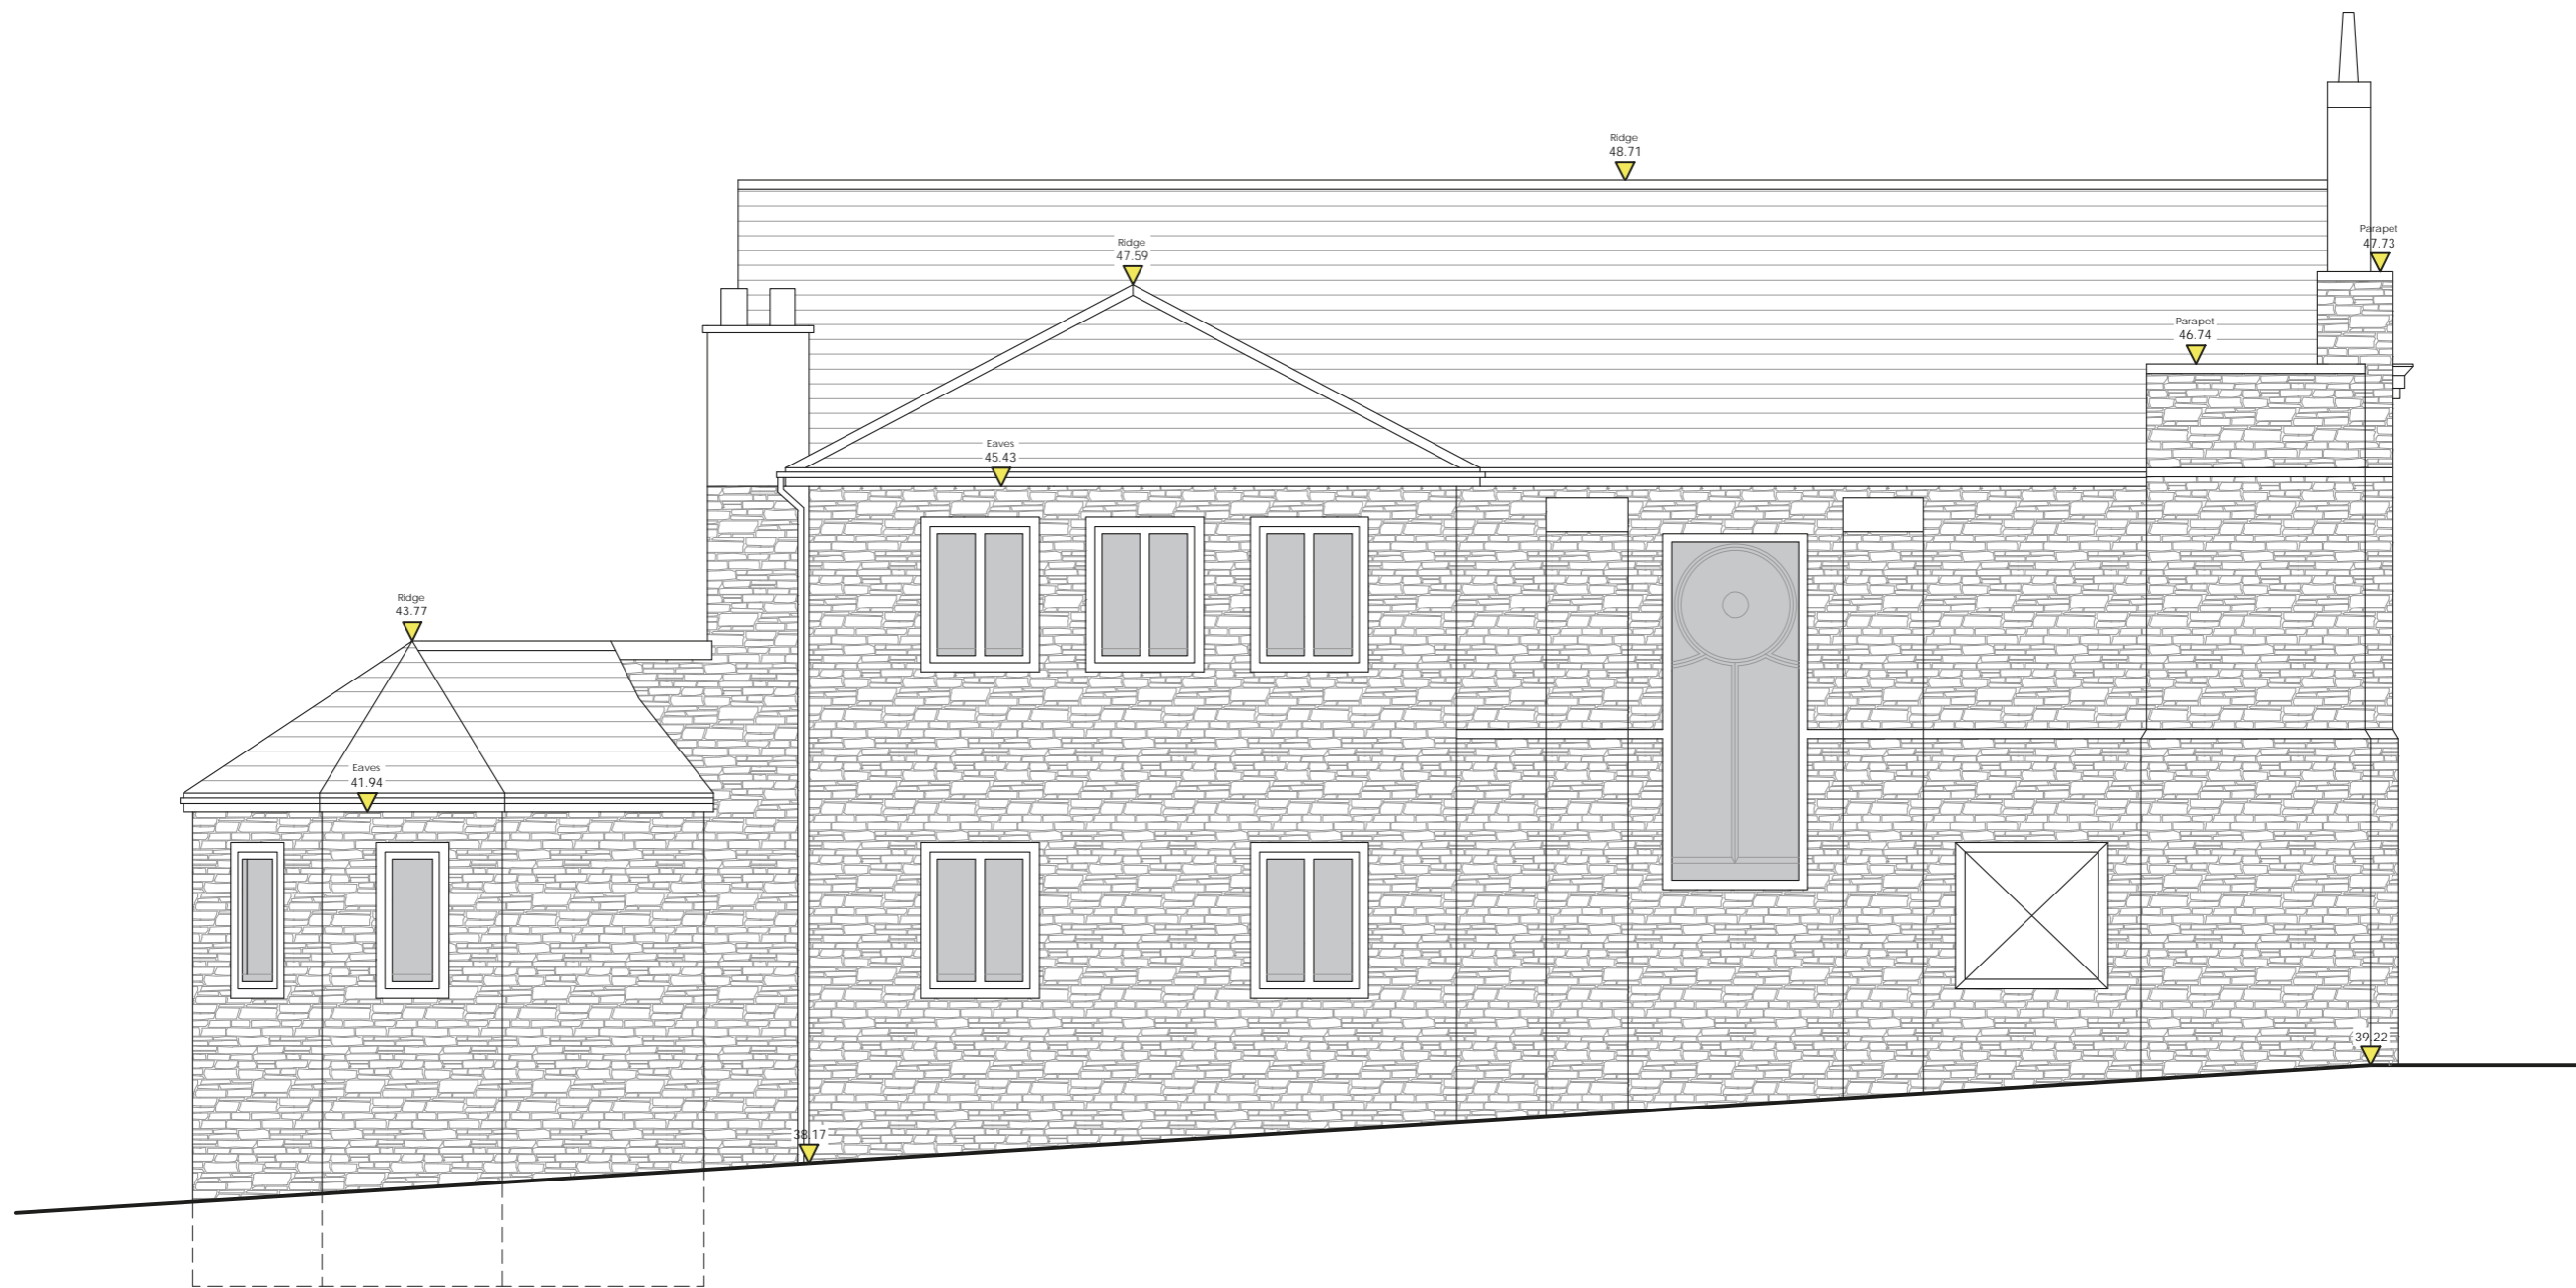
Figure 7. NE facing elevation.

- 5.20. This elevation consists of the long side of the main building, the projecting cross-hip end, and the NE- and N-elevations of the rear projecting element.

- 5.21. The long side of the main building and the end of the projecting transept are almost an exact mirror of the SW facing elevation, including window size and location, with the exception that the stonework is rough tooled ashlar like the front elevation (Plates 29, 30, 31 and 32).

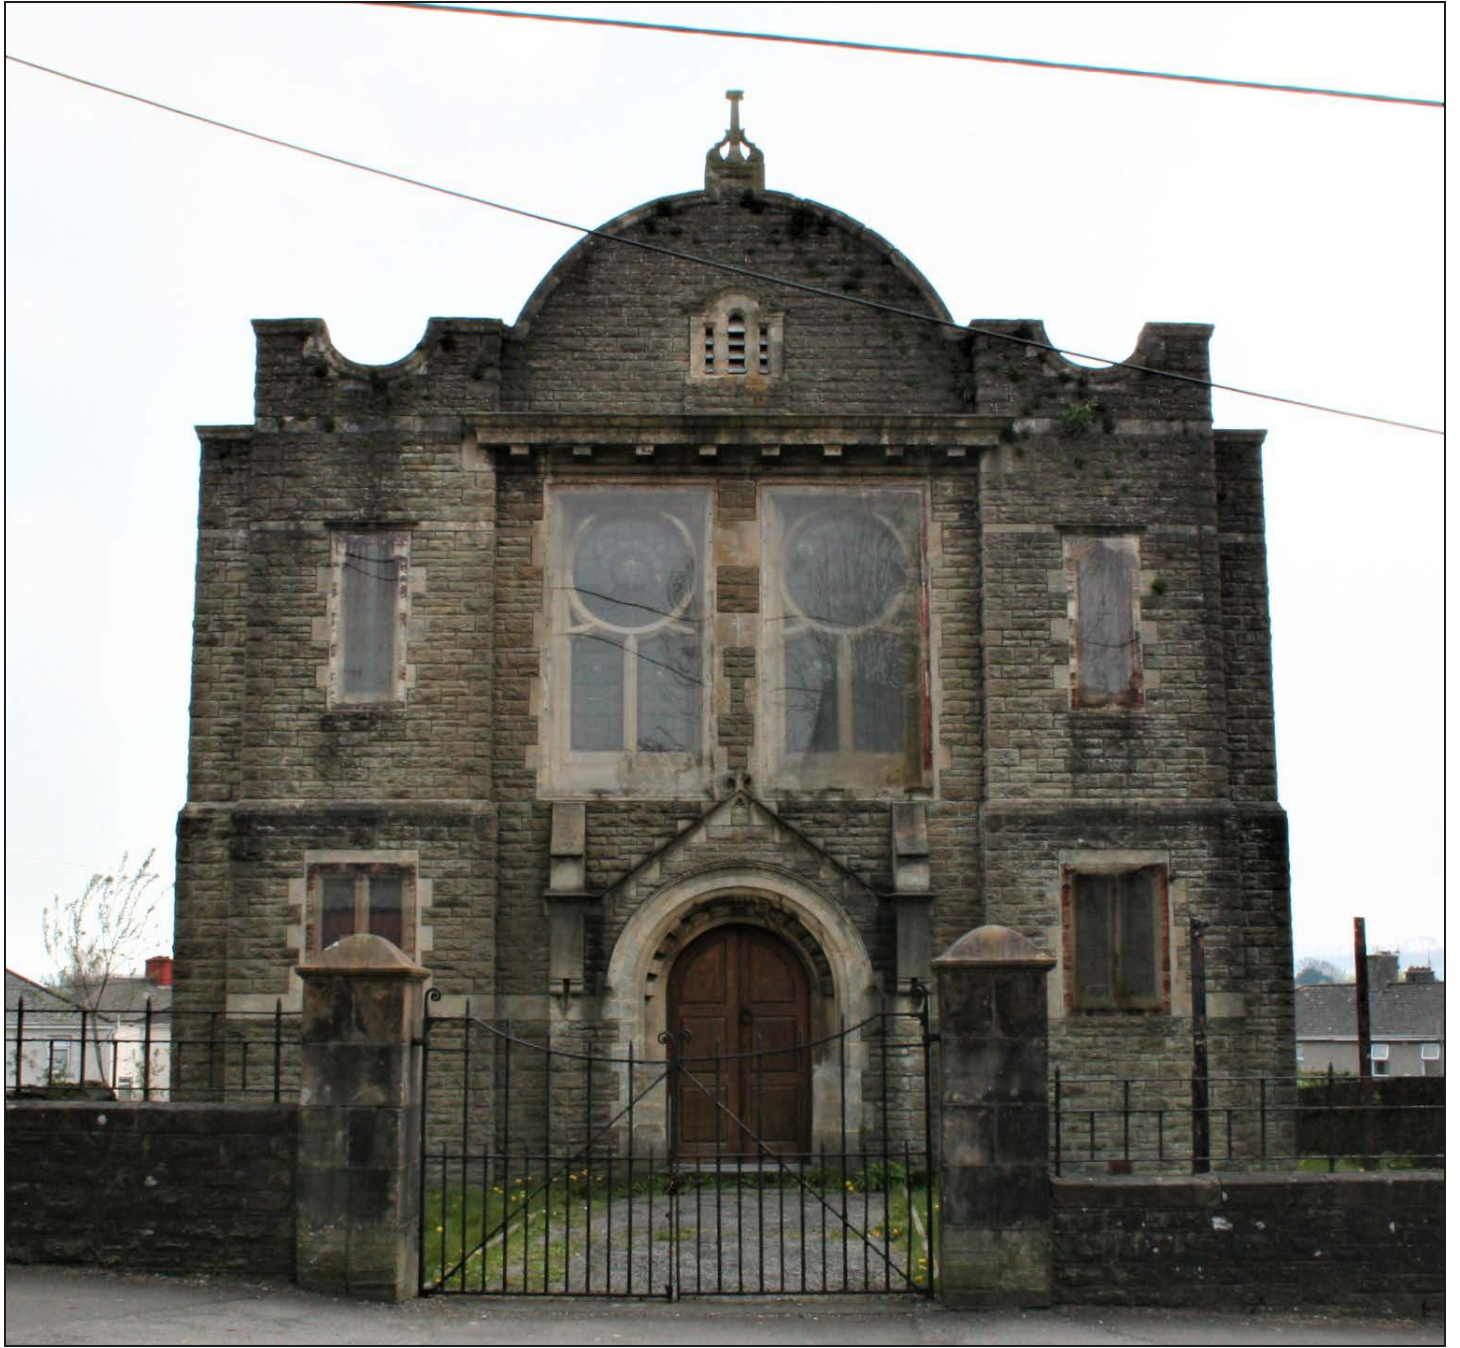
Plate 1. Trinity Chapel facade.

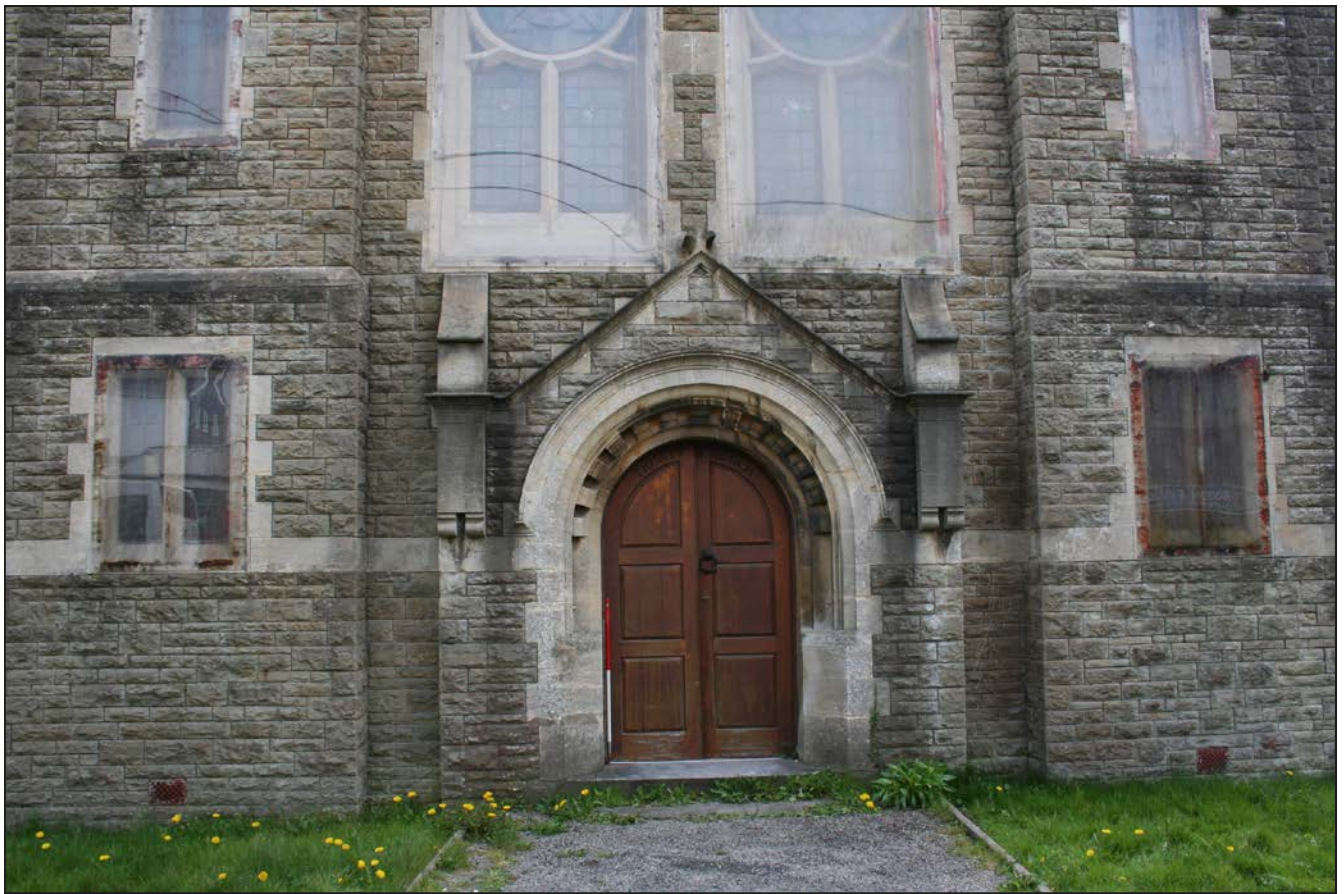
- 5.4. The main entrance to the chapel is to the centre of the façade. The aedicule projects slightly from the façade (Plate 2). The door is a solid wood, round topped double door with three fielded panels to each side. It has a wrought iron circular handle (Plate 3) and the name “TRINITY CHURCH” is painted at the top (Plate 4). The door surround is a round arch in smooth finished limestone ashlar blocks. There are quoins to the sides and a hood mould above. There is denticulated decoration to the interior of the arch (Plate 5). The outer part of the aedicule is in the same randomly coursed rough tooled ashlar blocks as the main building. There is a smooth ashlar band course at the height of the base of the arch. This continues across the entire front elevation. The aedicule has a triangular pediment with a trefoil finial and moulded piers to either side (Plate 6).

Plate 2. Main entrance to the chapel, looking SE

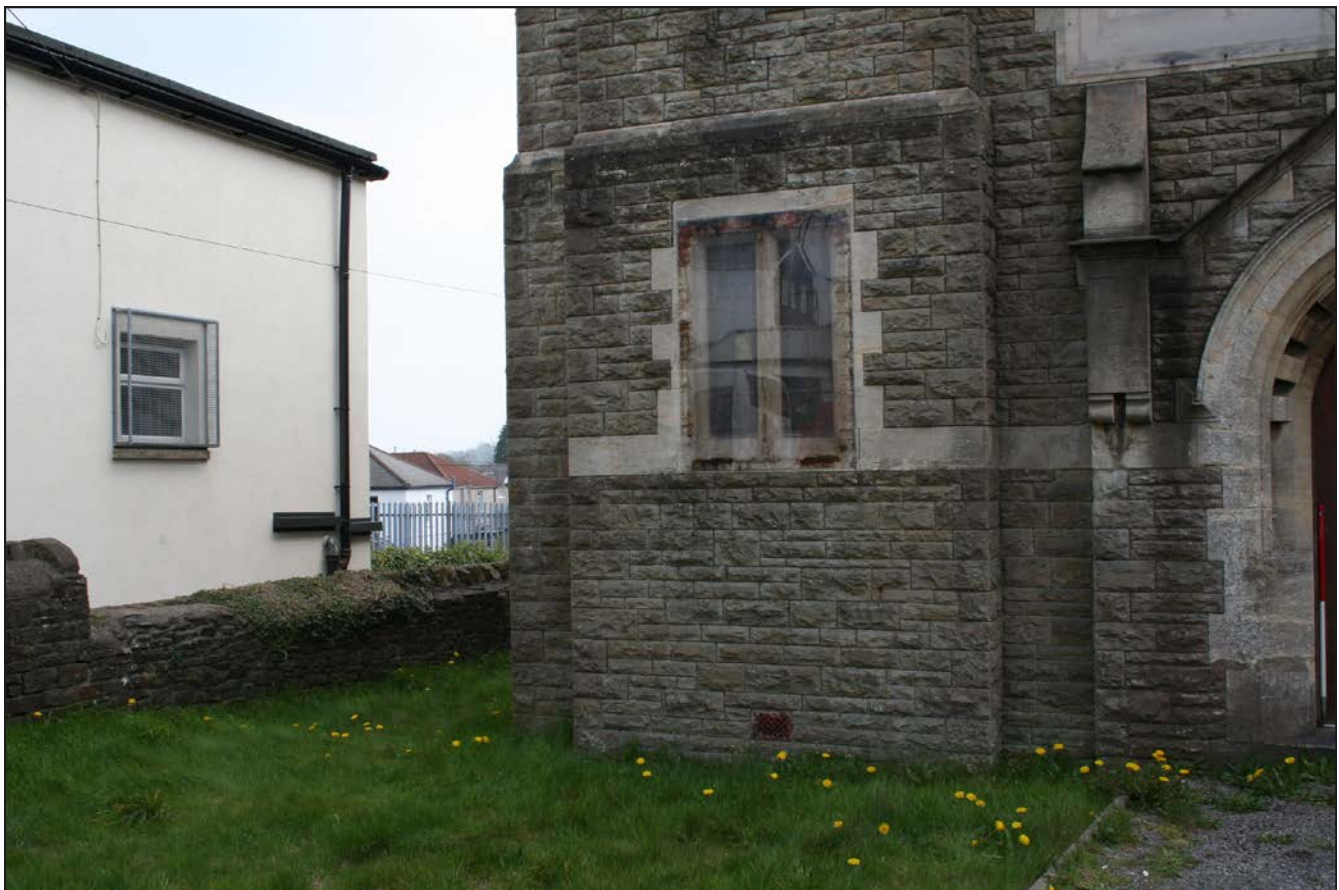
- 5.5. There are two windows to the ground floor, one to each other bay (Plates 7 and 8). They are two-light mullion stained-glass windows in chamfered stone frames with smooth finished ashlar quoins. The base of the windows is at the height of the lower band course.

Plate 7. Ground floor window to left-hand side of main entrance, front elevation, looking SE

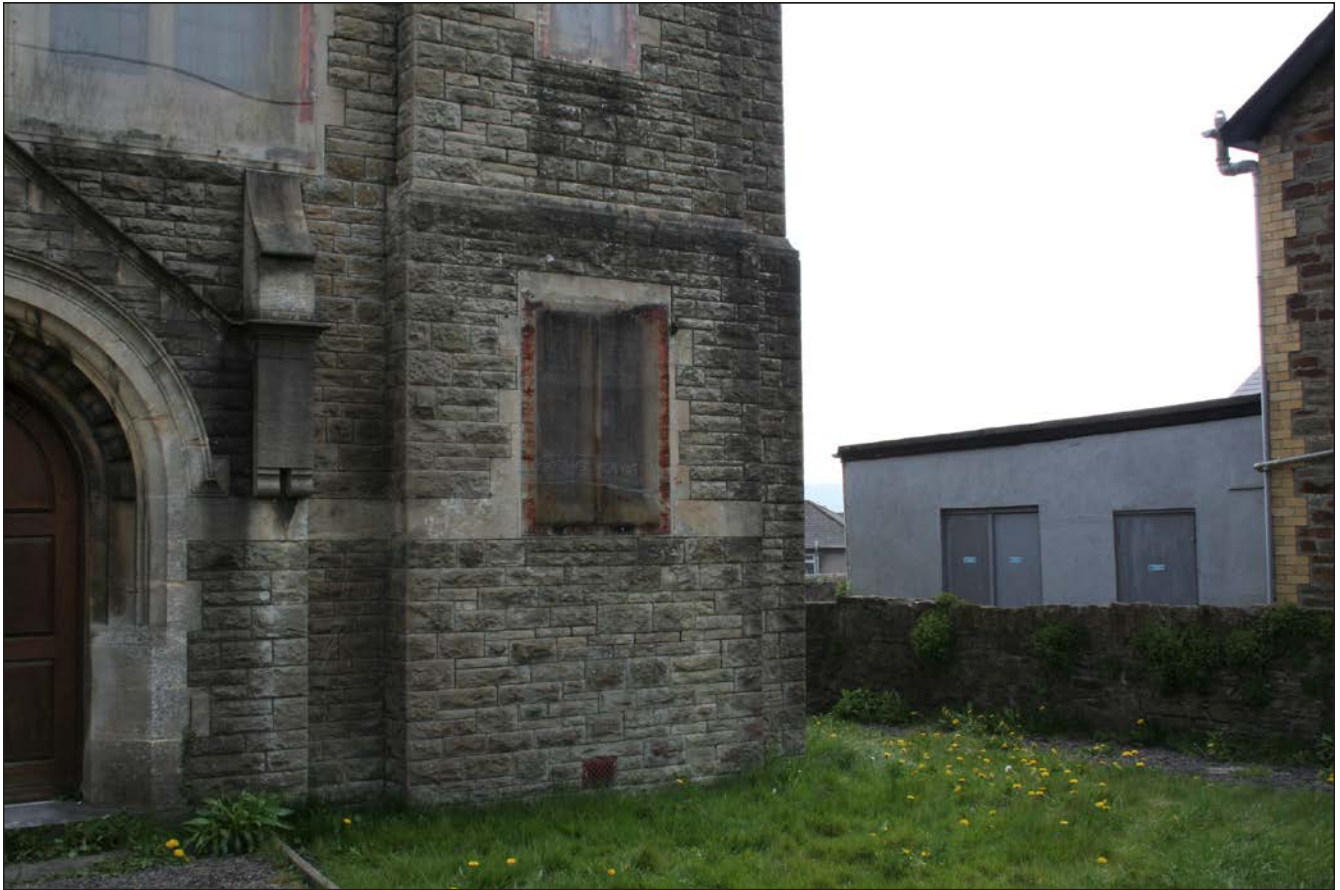
Plate 8. Ground floor window to right-hand side of main entrance, front elevation, looking SE

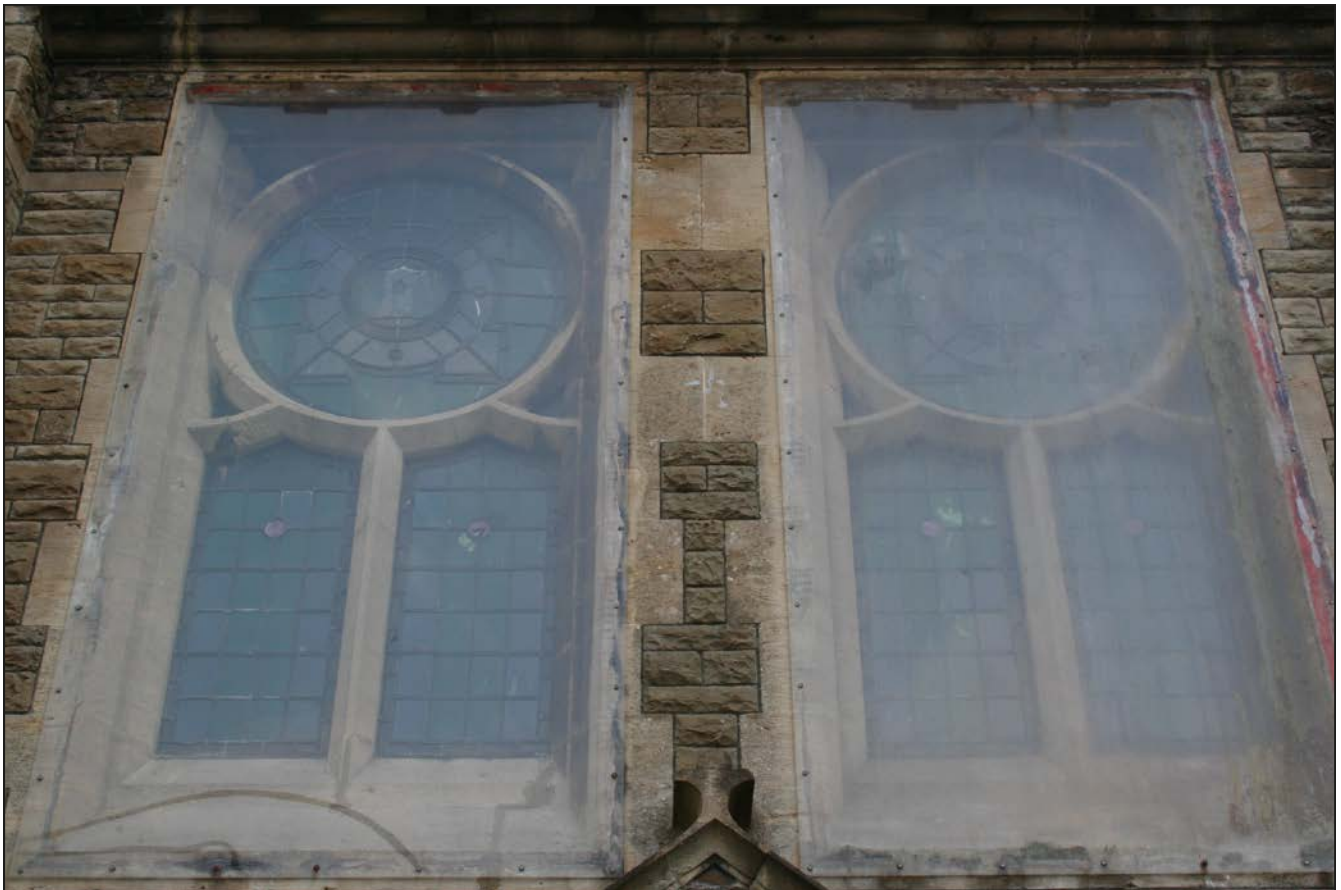
- 5.6. There are four first floor height windows, two larger windows to the central bay and smaller ones to each outer bay. The central windows have a circular light to the top and two mullion lights to the bottom (Plate 9) while the outer windows are single lights with round arch tops (Plate 10). All the lights are stained-glass, and the window surrounds are stone with smooth finished ashlar quoins.

Plate 9. Upper central windows to front elevation, looking SE

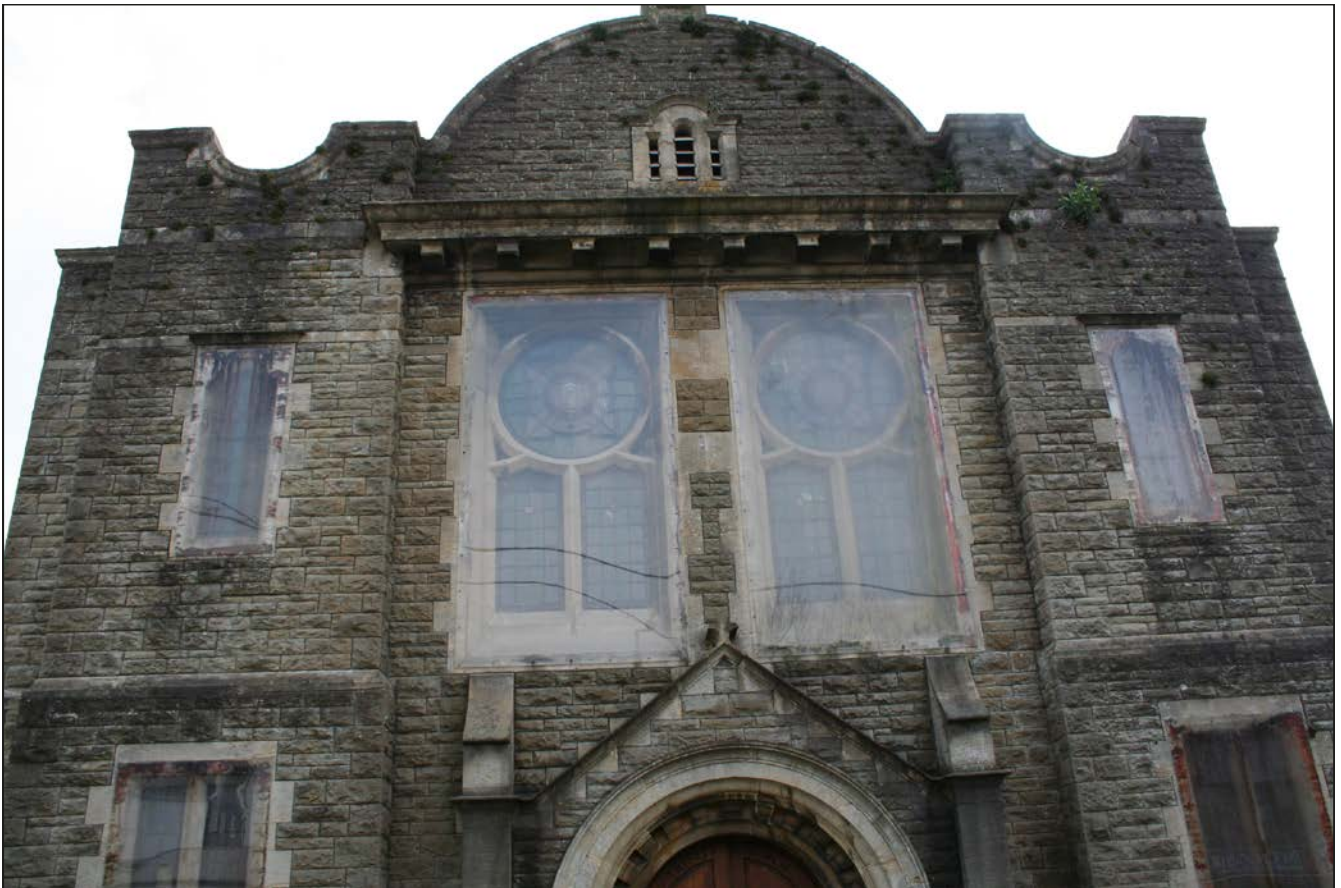
- 5.7. Above the upper windows of the central bay is a projecting moulded cornice with dentils to the underside (Plate 11). There is a vent to the centre of the central semi-circular pediment which is stone framed with three openings and an arched cornice above.

Plate 11. Front elevation, first floor level, looking SE

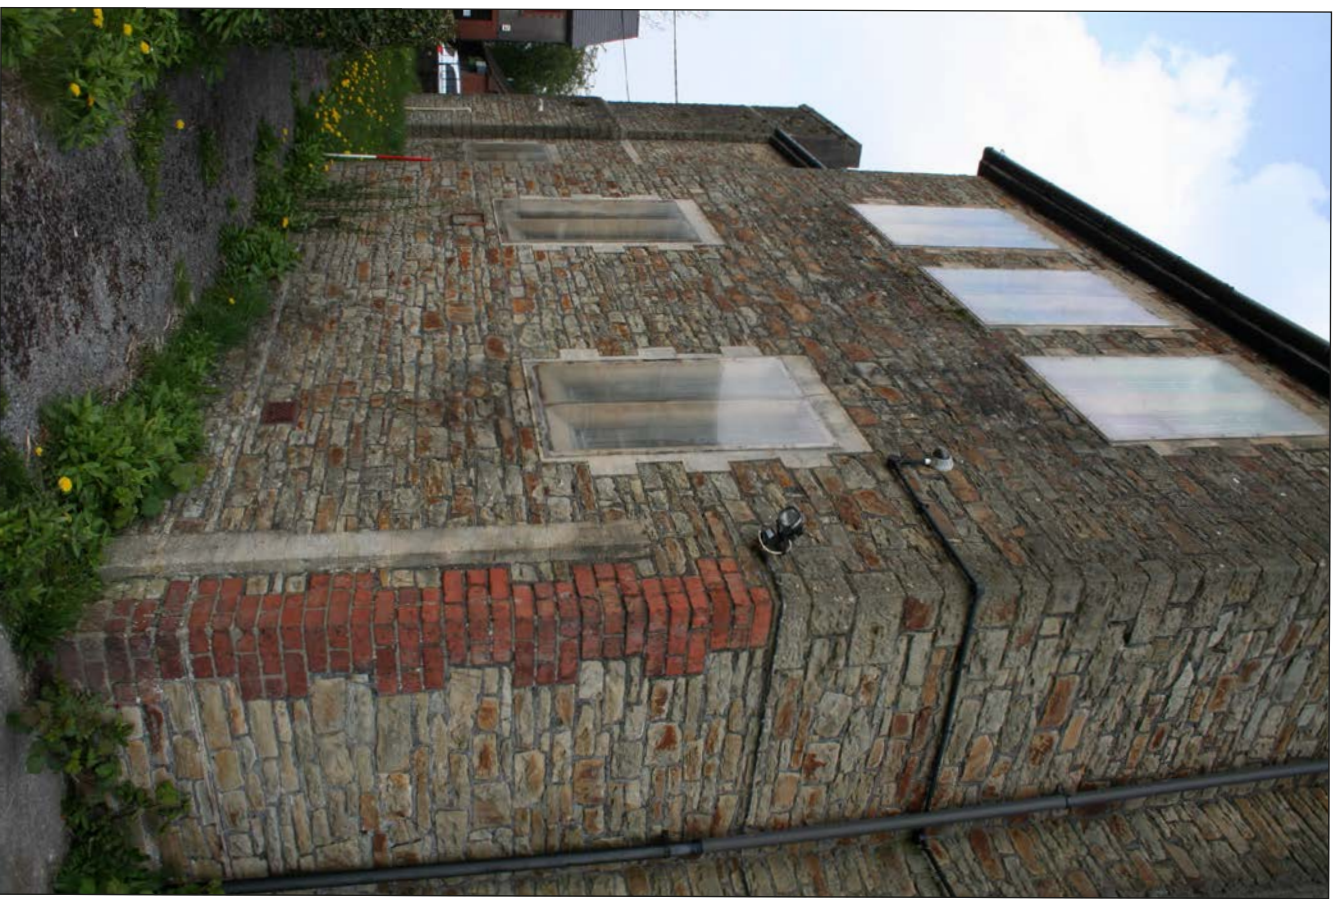
- 5.13. There are five windows to the cross-hip end, two to the ground floor and three above (Plate 17). They are all the same size and style, being two-light stained-glass mullion windows with round arch tops in a chamfered stone frame with smooth finished ashlar quoins.

Plate 17. SW hip end of transept, looking N

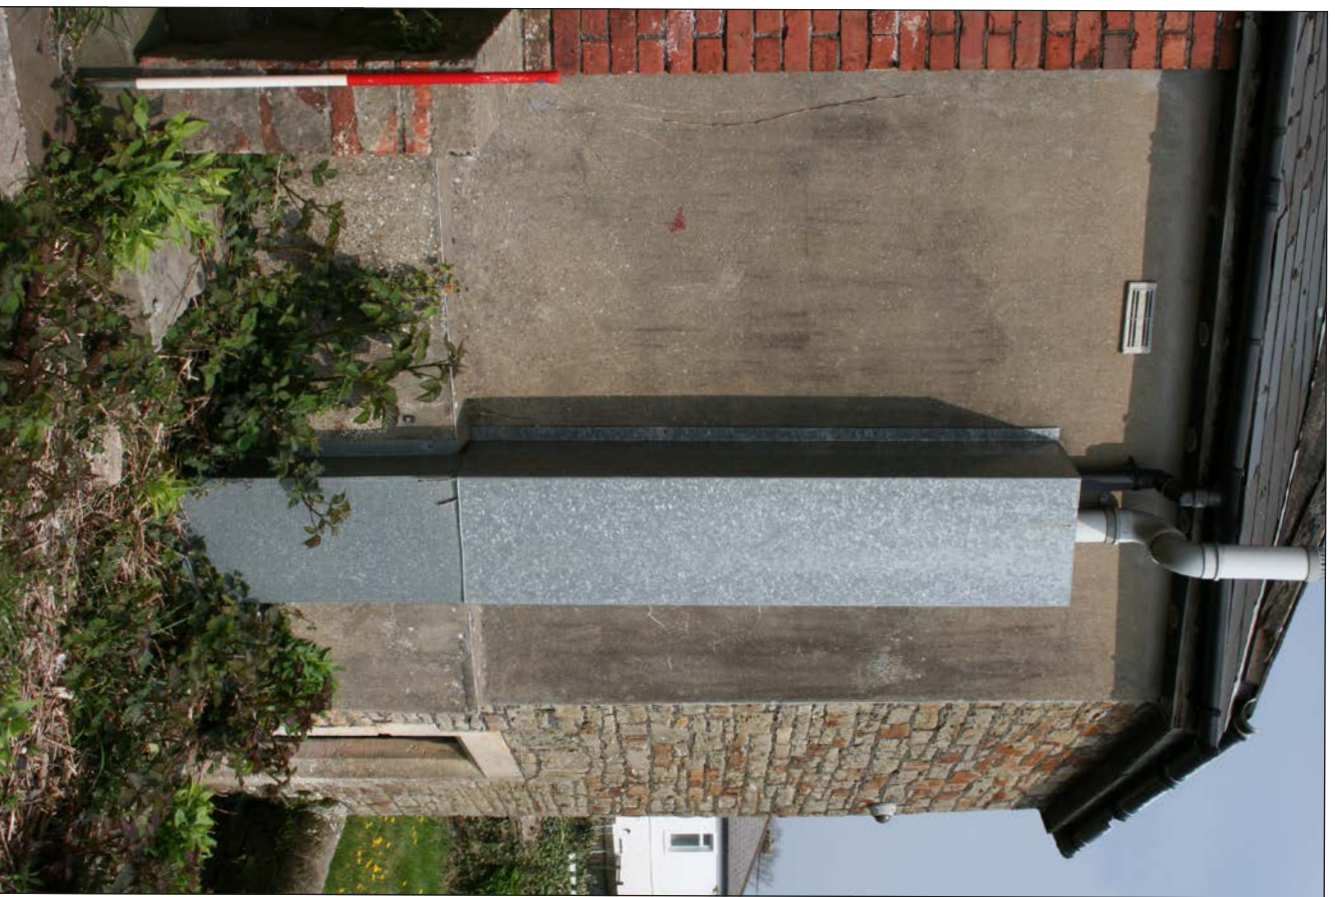
- 5.14. To the top of the elevation there are wooden soffits and fascias to the roof eaves and plastic guttering.
- 5.15. The SW facing elevation of the rear projecting element is single storey with slate gable roof. There is a door to the NW end accessed by five cement steps with a low brick wall (Plate 18). The door is black painted metal in a red brick surround. The SE end of the elevation is smooth rendered cement. It has a modern galvanised steel casing for the boiler outlet pipe attached (Plate 19).

Plate 19. SW-facing elevation of rear projecting element, looking NE

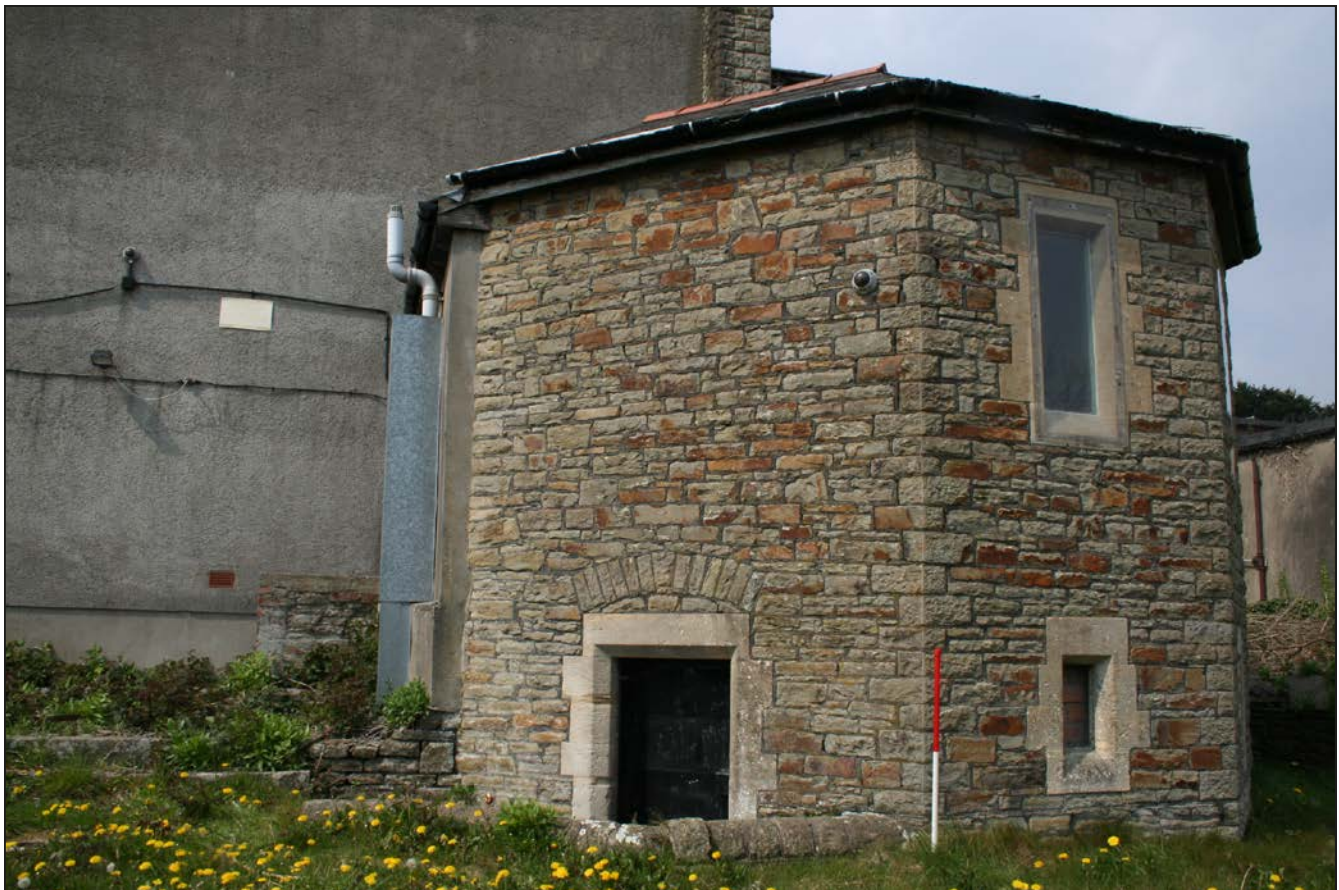
- 5.18. The rear of the projecting element is of rough finished stone blocks (Plate 23). The door to the basement is located on the S-facing elevation, accessed by a flight of stone steps with a stone retaining wall with round capstones (Plate 24). The door is black-painted metal in a metal frame (Plate 25). It has a limestone

Plate 23. Rear elevations of the rear projecting element, looking N

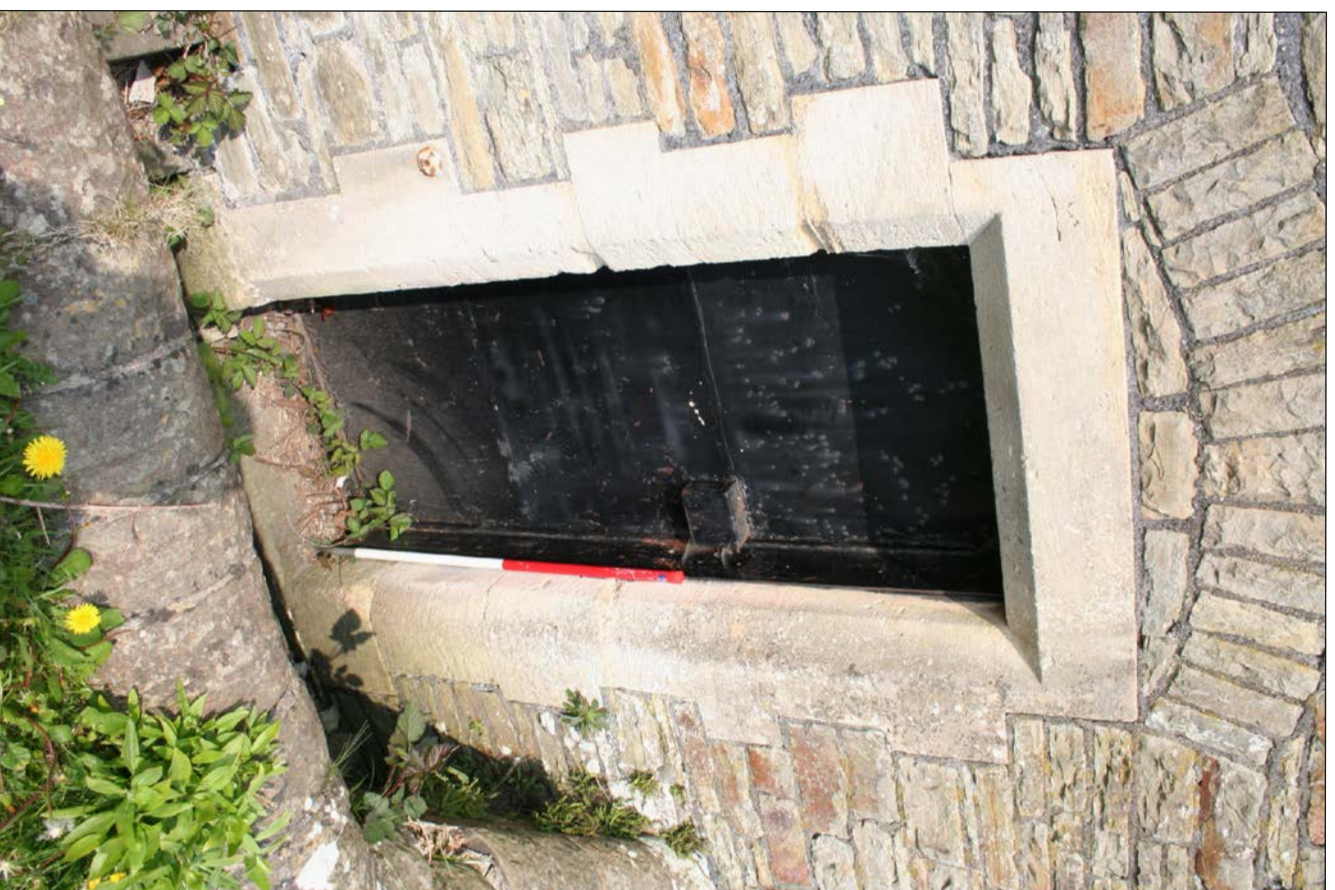
Plate 25. Door to basement of rear projecting element, looking N

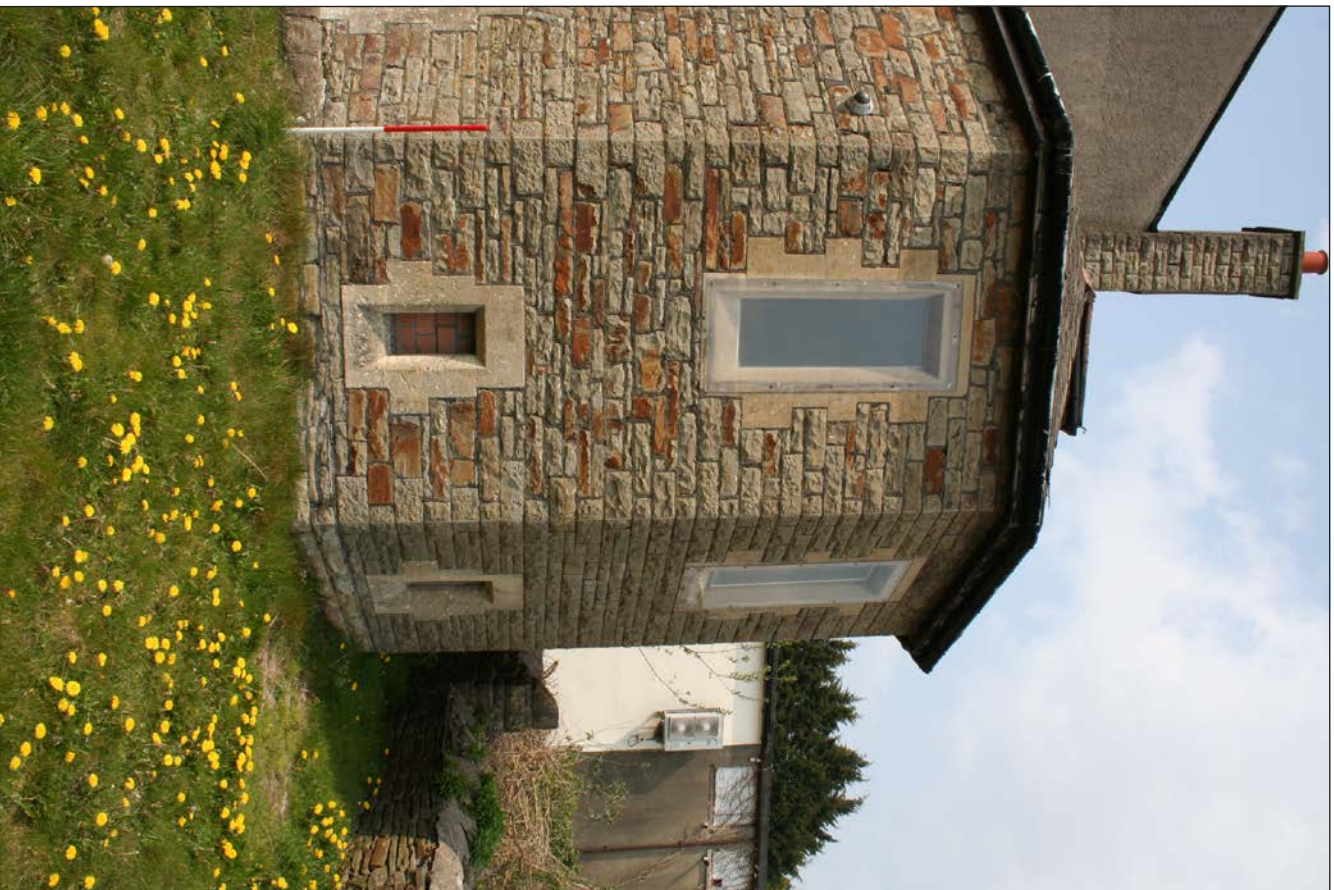
- 5.19. There is a small rectangular window to the basement and larger one to the ground floor on both the SE- and E-facing elevations (Plate 26). Those to the basement have been filled with brick on the interior (Plate 27). Those to the ground floor are single-lights with reinforced glass (Plate 28). They all have smooth finished ashlar quoin surrounds.

Plate 26. Rear elevations of the rear projecting element, looking N
