Trinity Chapel, Pencoed

Level 3 Building Survey

Report No . 1970

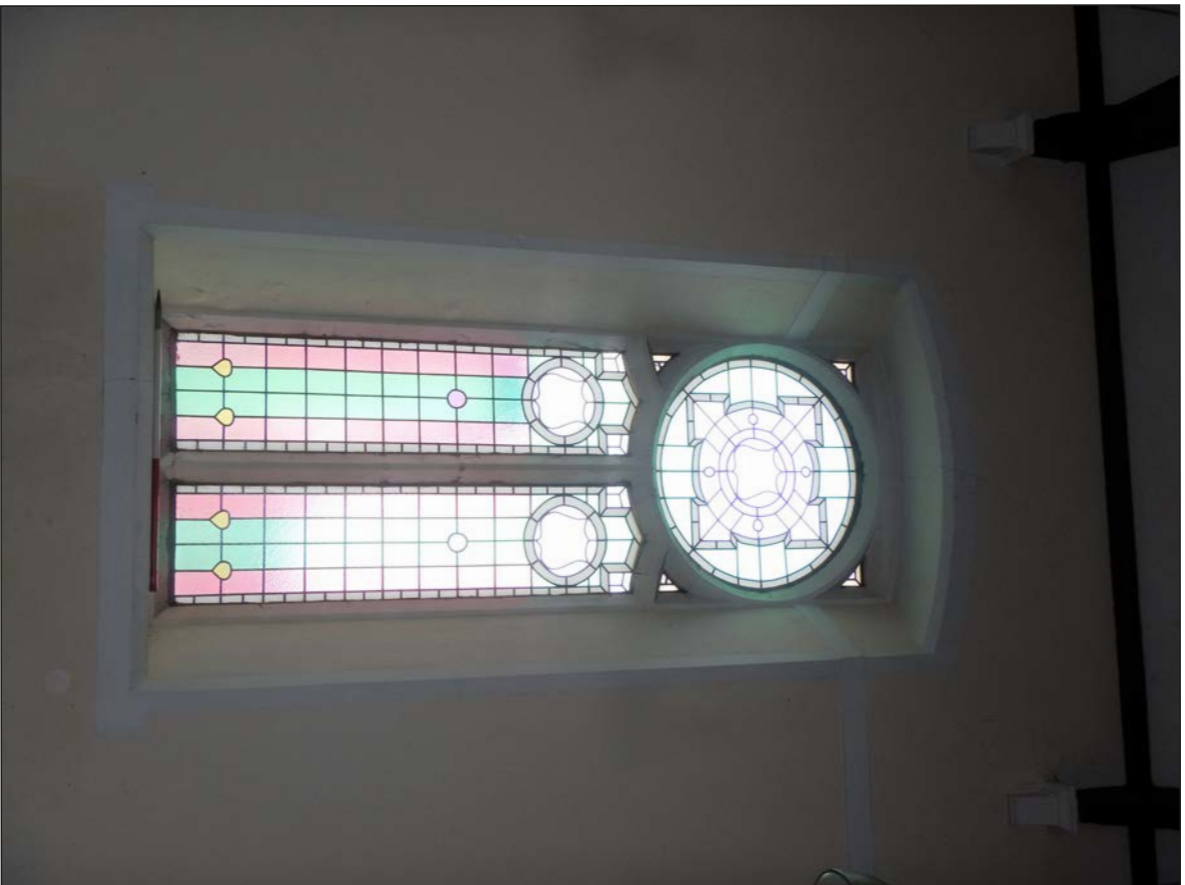
5.33. The left-hand wall (NE) has two windows to the main body of the nave (Plate 44) and five in the transept to the rear. The north-westernmost window is a three-light mullion window which sits immediately above the dado rail (Plate 45). The lights are stained glass with heart-shaped patterns, and they are in a white-painted stone frame. The window measures 1.54m wide and 1.15m high and is deeply recessed. The reveals are painted plaster and the wooden sill is in the same wood as the dado. The second window to the SE is 2.8m high and 1.3m wide. It is the same style as the large windows to the front wall, with a round light to the top and two mullion lights to the bottom, all stained-glass (Plate 46). The frame is white-painted stone. It is recessed, with a low segmented arch to the top of the recess and painted plaster to the canted reveals. The front edge of the reveal has a white painted surround and there is a white painted band near the top of the window that continues across the wall to the SE where it joins a section of moulded cornice supporting a neo-classical pilaster and frieze to the top of the opening to the transept (Plate 47).

Plate 46. Detail of window to NE wall of nave, looking NE
