Graigwen, Llangybi

Heritage Impact Assessment

Report No . 1913

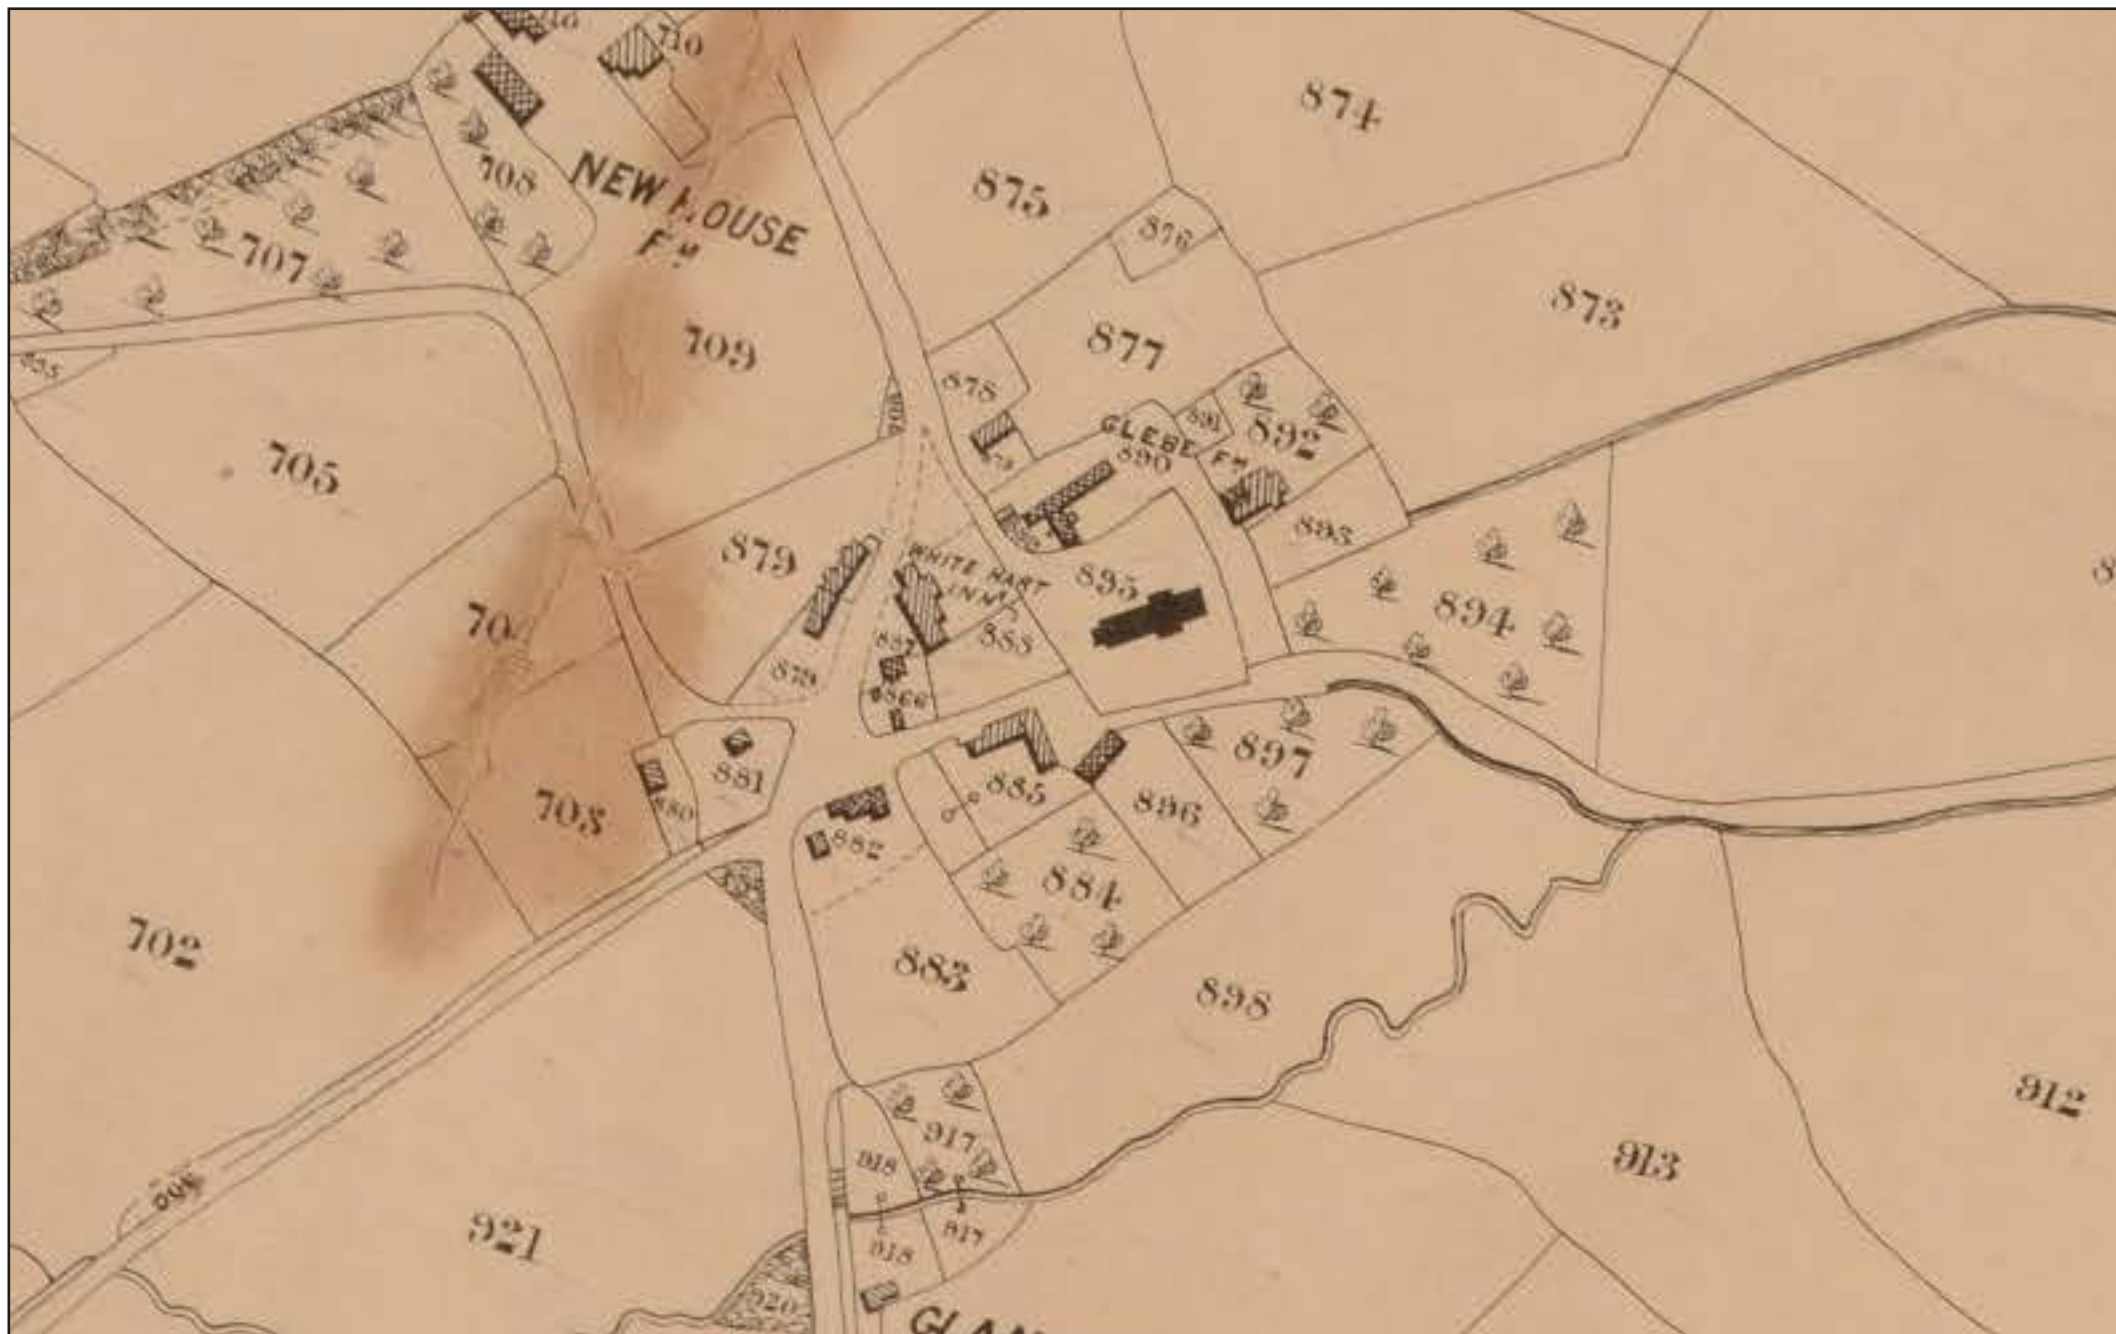
Figure 6. Plan of the parish of Llangibby in the County of Monmouth 1841.

The Tithe map of the Parish of Llangibby 1841 (Figure 6) documents the village core around St Cybi's Church (LB 2669; PRN 00352), with the main axes of movement and

communication already defined with Ton Road, Park Road and Usk Road. The church - located in plot 895 - and its surroundings – 890 to 893 including yards orchards and gardens – are property of Reverent William Charles Addams. Aside from this area, the village at this point has sparse settlement located to the immediate west of the church.

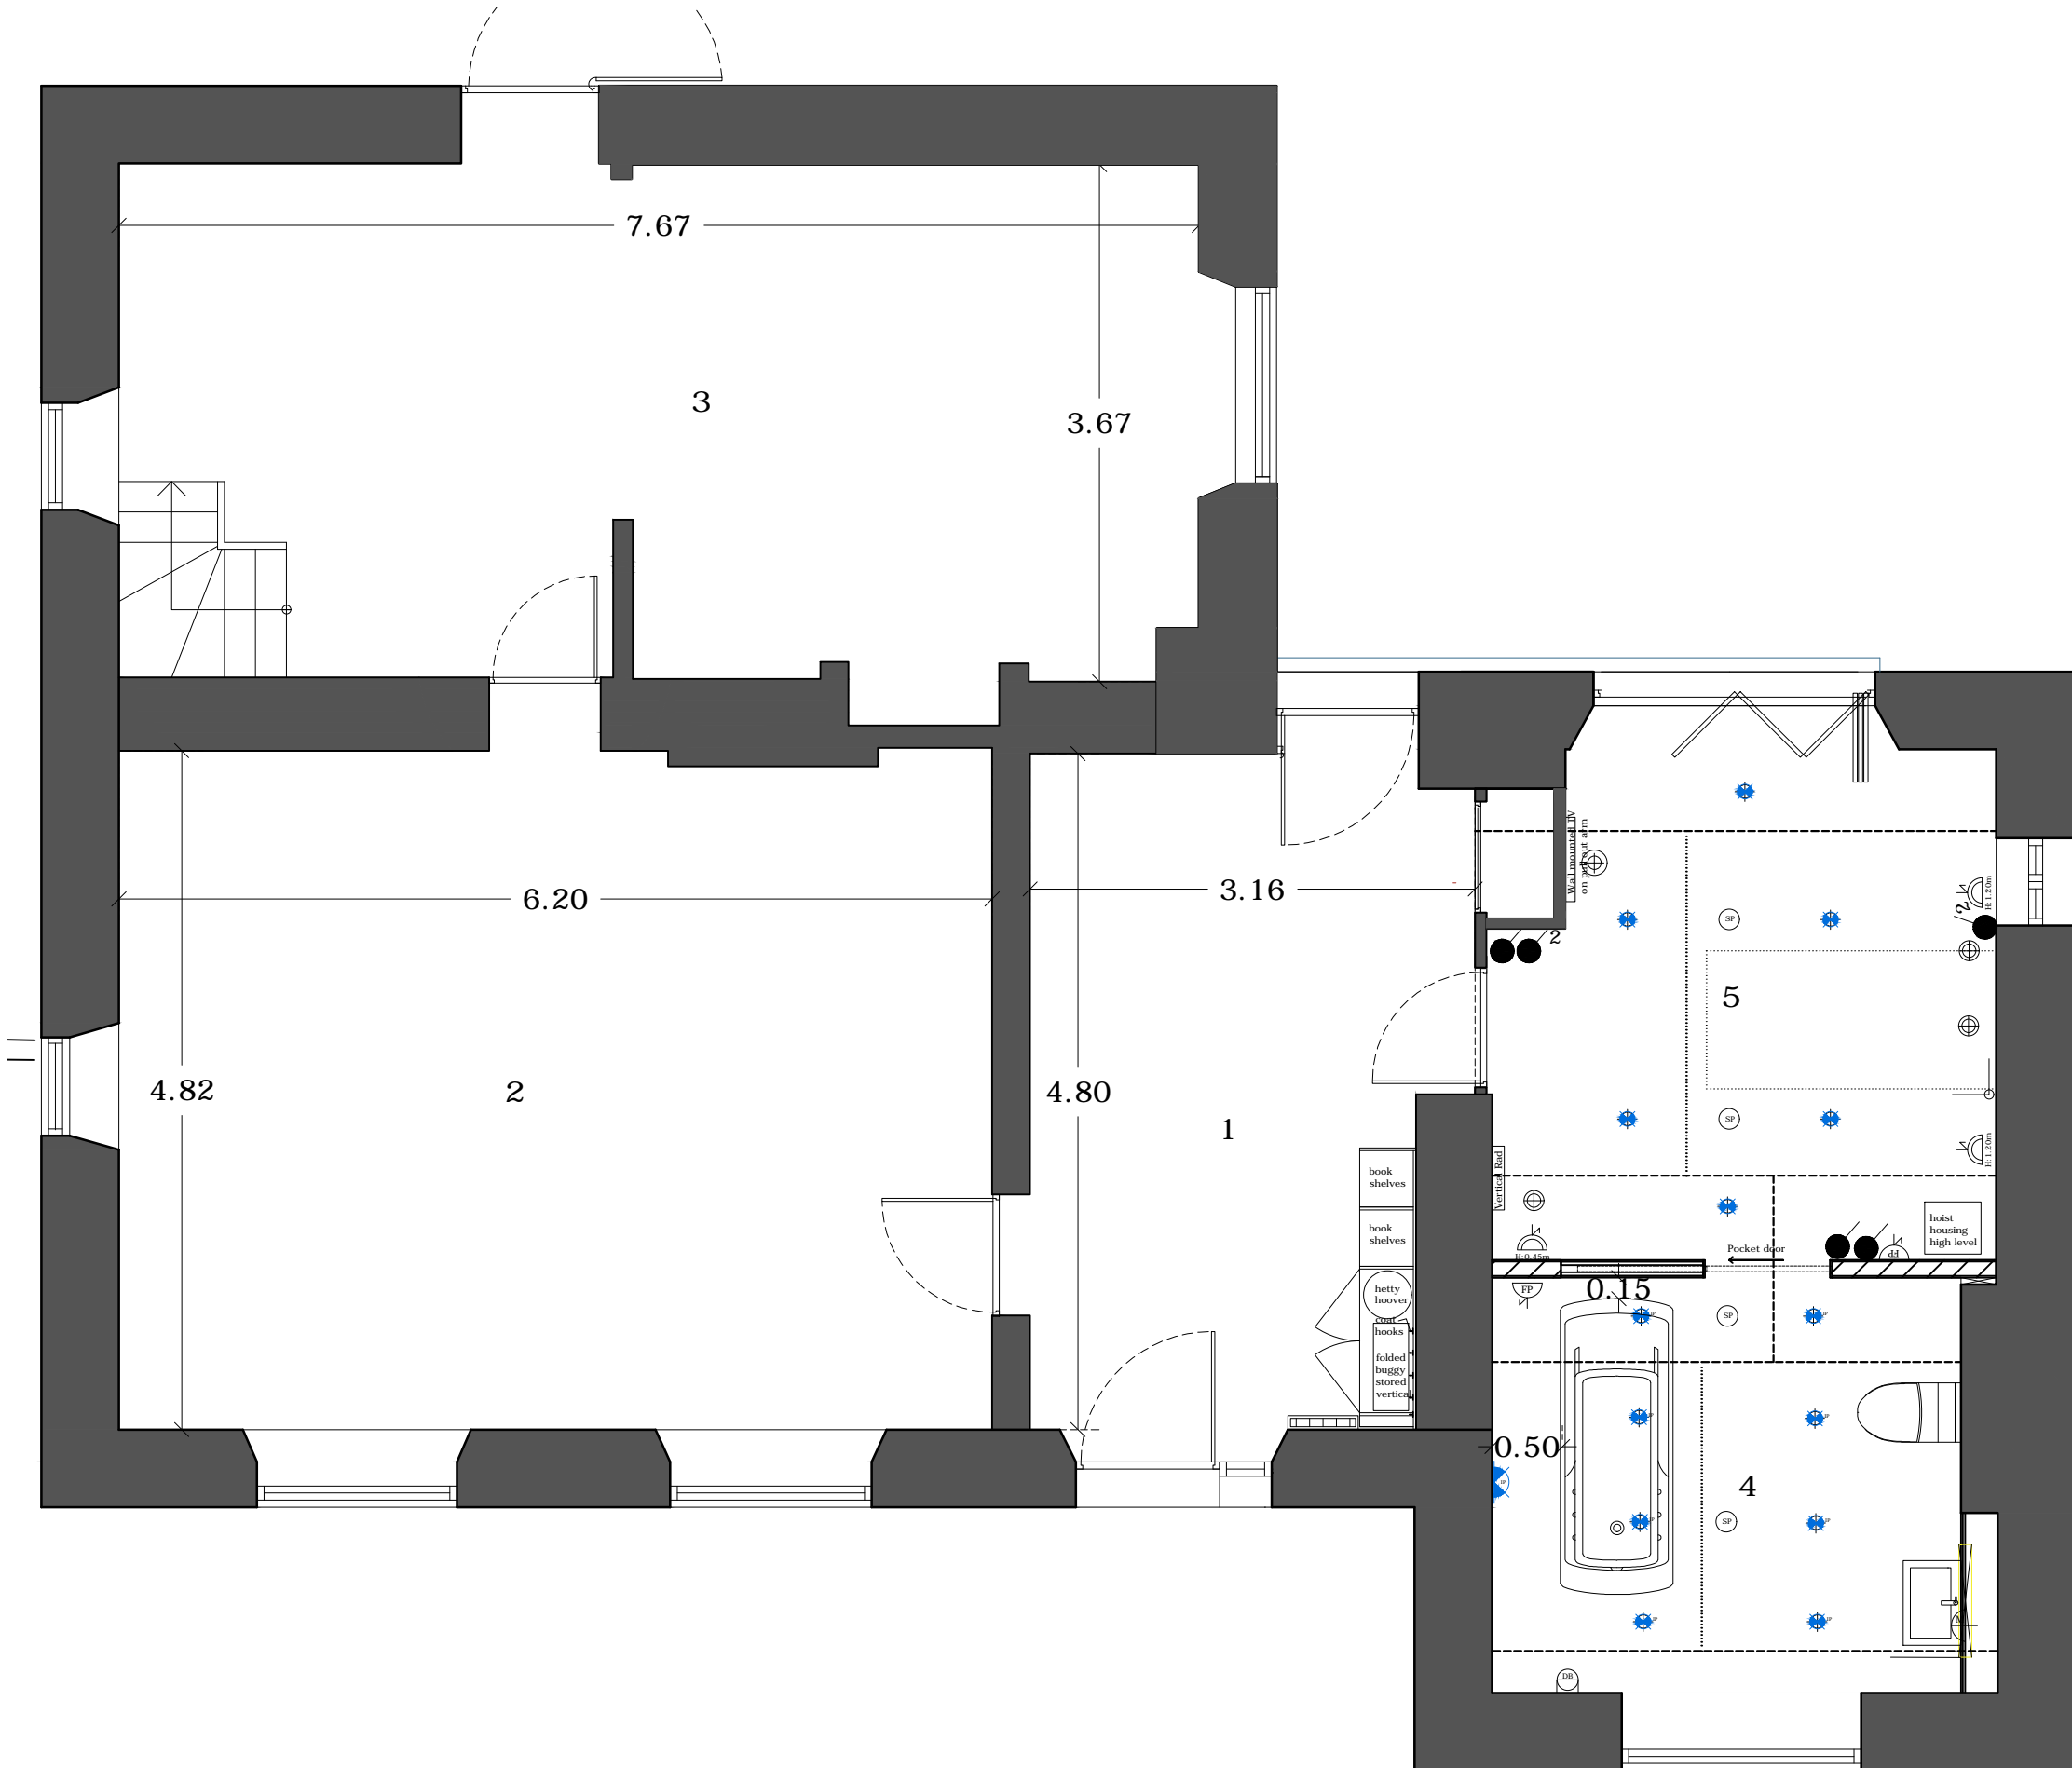
1 2 5m
**Proposed Room Plan
 ELECTRICAL PLAN**

NOTE ALL CEILING FITTINGS TO BE SLIMLINE DUE TO HOIST SYSTEM.

Finally, the proposed design requires the installation of a H-frame hoist in the bedroom and bathroom areas. Various options have been considered; however, it is noted that the current ceiling is in poor condition and therefore unsuitable for the installation of the hoist. Current designs foresee the removal of the ceiling and posterior reinstallation. This change is considered of outmost importance and should be supported at consent in so far as it is carried out with minimal disruption.

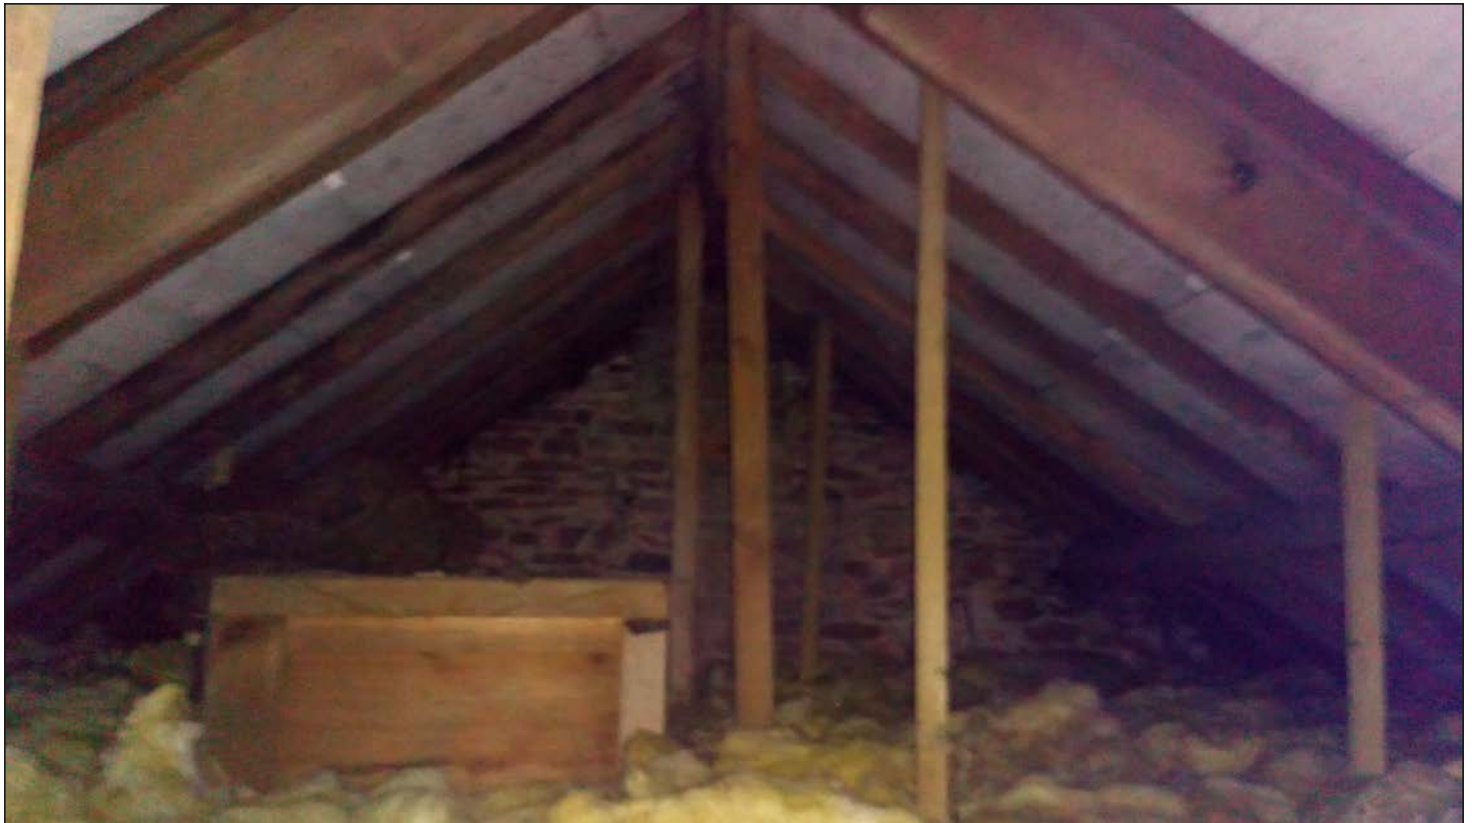
Plate 16. Remnants of original masonry.

As already noted, it is in this area where the original masonry is visible.

Physical evidence regarding its original design is still available in the very fabric of the building, however, the latter is masked by the characteristic white render wrapping the structure today. The original fabric can be observed in the attic interior composed of local rubble stone.
