Pengloddfa, Llangernyw Conwy

Level 2: Archaeological Building Recording

Report No. 1714

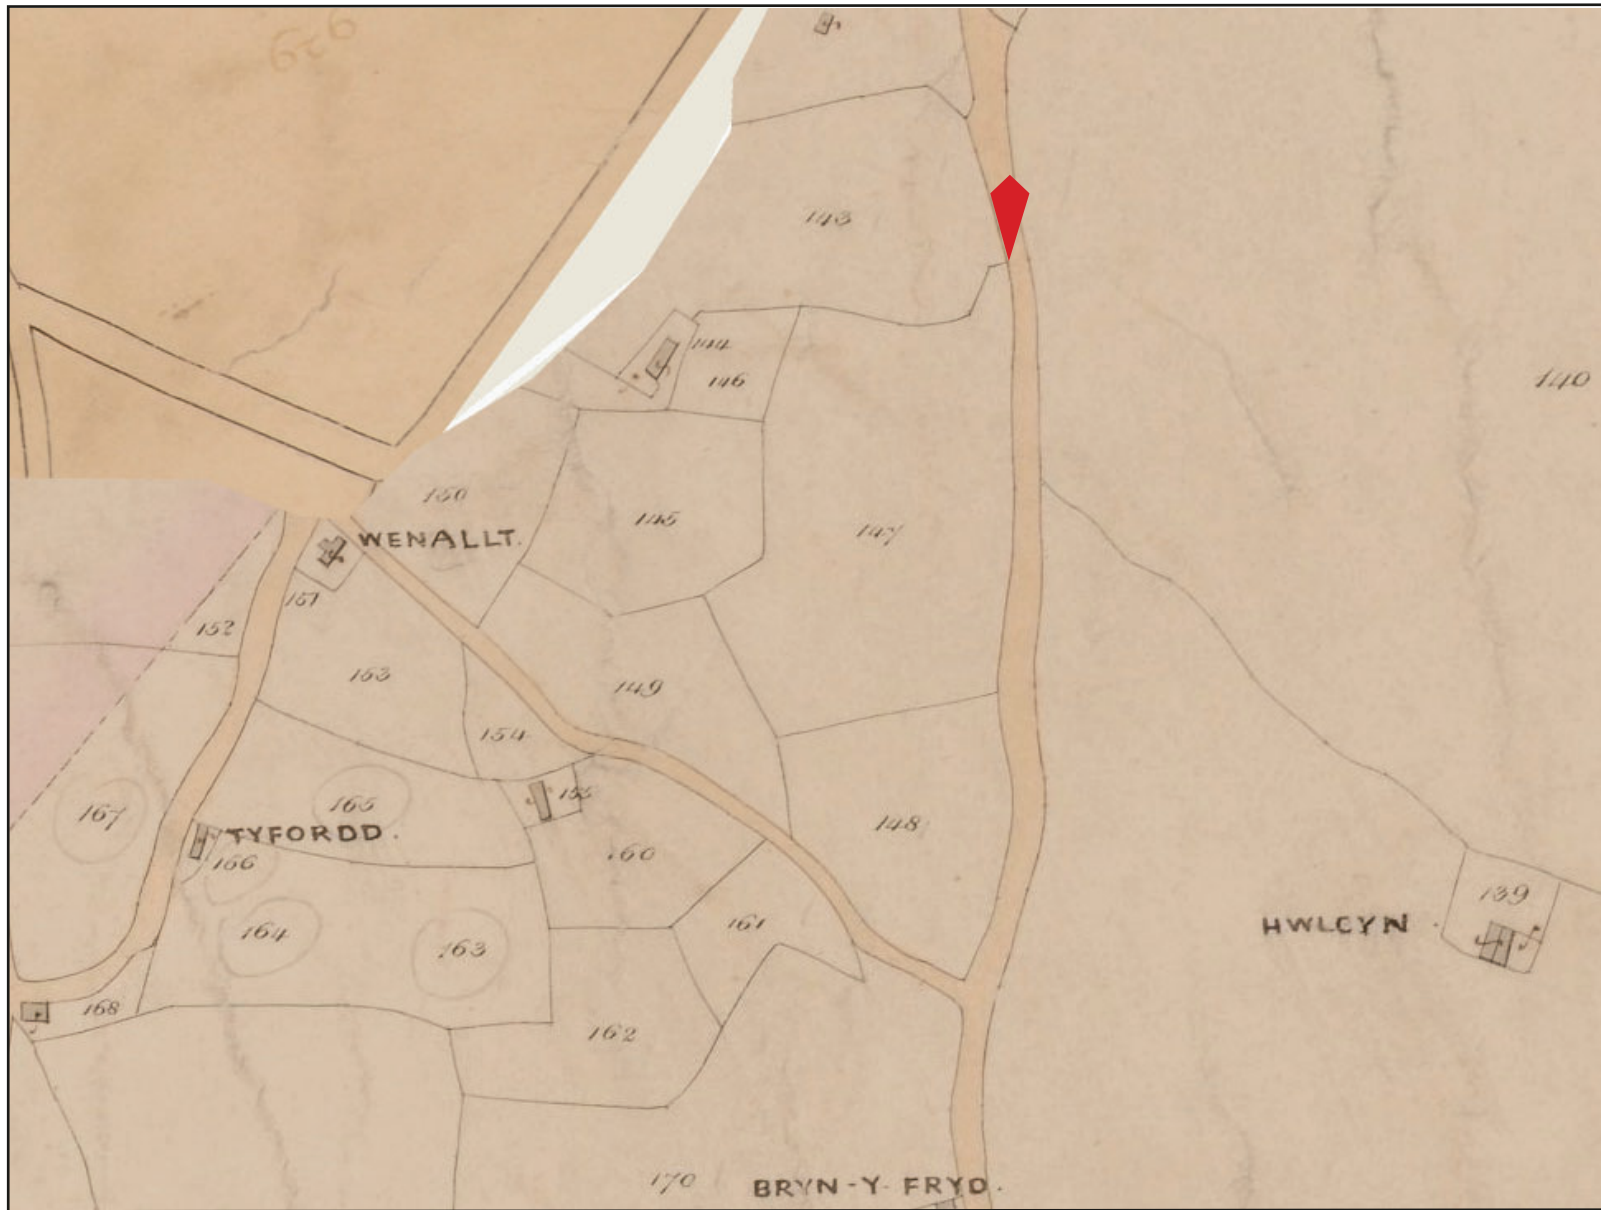
Figure 3. Tithe map, Plan of the parish of Llangerniew in the County of Denbigh, 1840, 1:4,752

The Pengloddfa farmhouse building is not present on the Tithe map. The field in which it is situated, 143, is listed as being pasture, occupied by Robert Roberts and owned by Jane Hughes. Roberts also occupied the pasture fields to the south and presumably the farmhouse labelled as Tyn y bryn in field 144, at the location of the modern farmhouse Bryn Hedydd. The field immediately to the north of 143, 142, is listed as arable, with Robert Jones as the owner/occupier. A rectangular building is depicted in the field, possibly a farmhouse.

The two roads which form the eastern and western boundaries of field 143 are already established at this point. Together with a north-west to south-east orientated road to the south they form a small triangle of land containing the fields and buildings detailed above. These fields have irregular shapes characteristic of a prehistoric landscape.

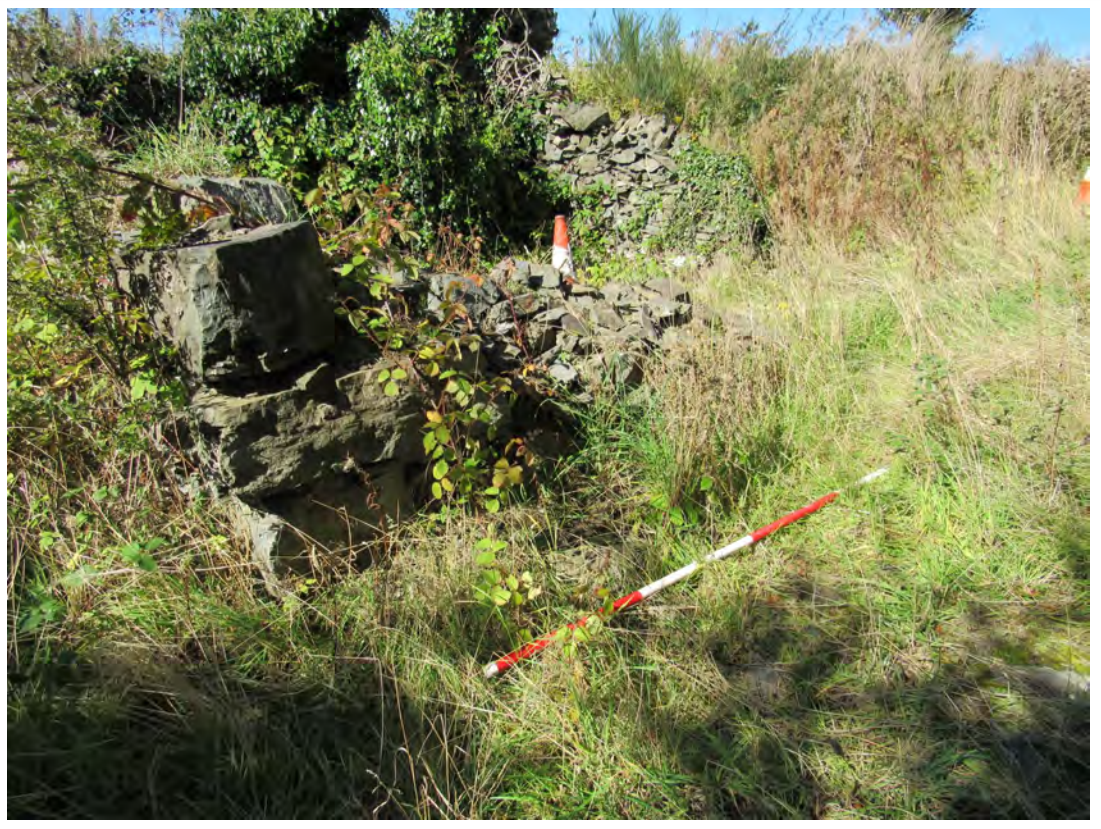
Plate 5. Quoinstones of SE corner of house ruins. View NW. 2m scale.

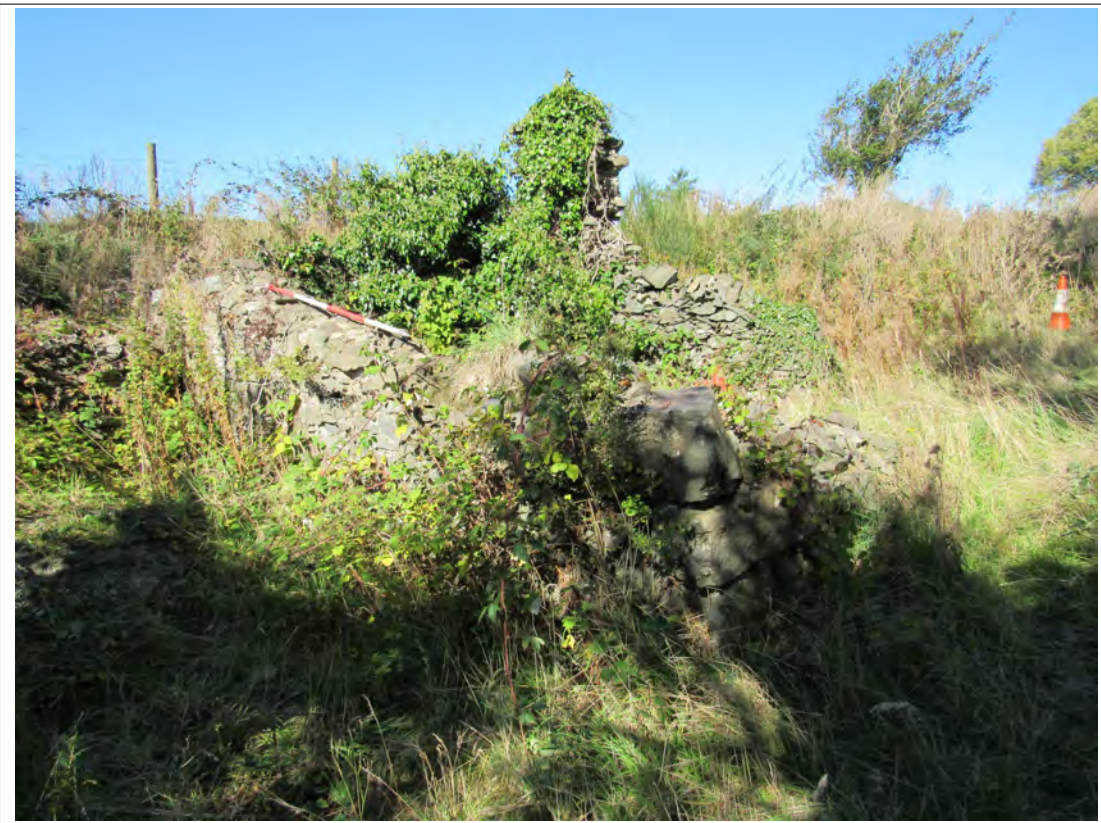
Plate 6. Southern wall of house ruins. View NW. 2m scale.

The south elevation of the house was built from irregularly coursed mudstone, with no characteristic features remaining. The wall survived to 1.4m in height. 3m to the south, the southern dry stone boundary wall had a scar of a wall running towards the southern house elevation, although no evidence of this return was visible on the southern elevation of the house.

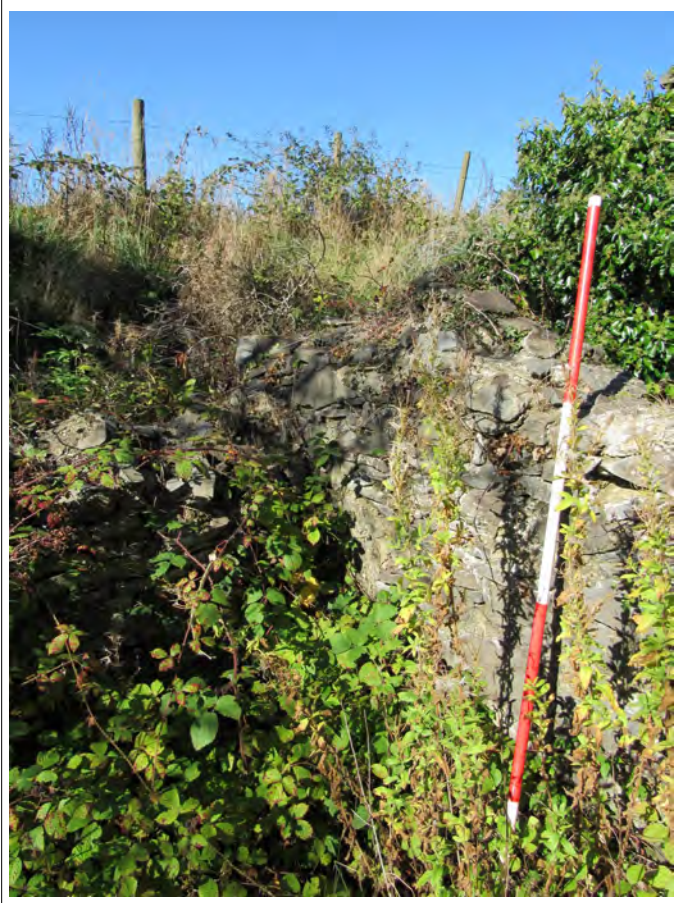
Plate 7. Join of southern wall of house ruins and western boundary wall. View NW. 2m scale.

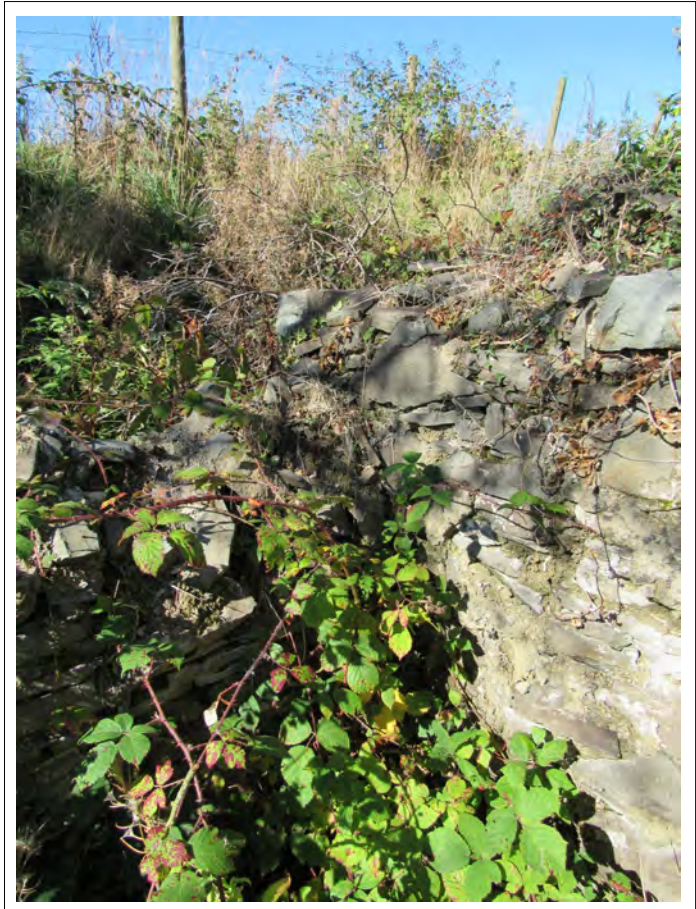
Plate 8. Join of southern wall of house ruins and western boundary wall, detail. View NW.

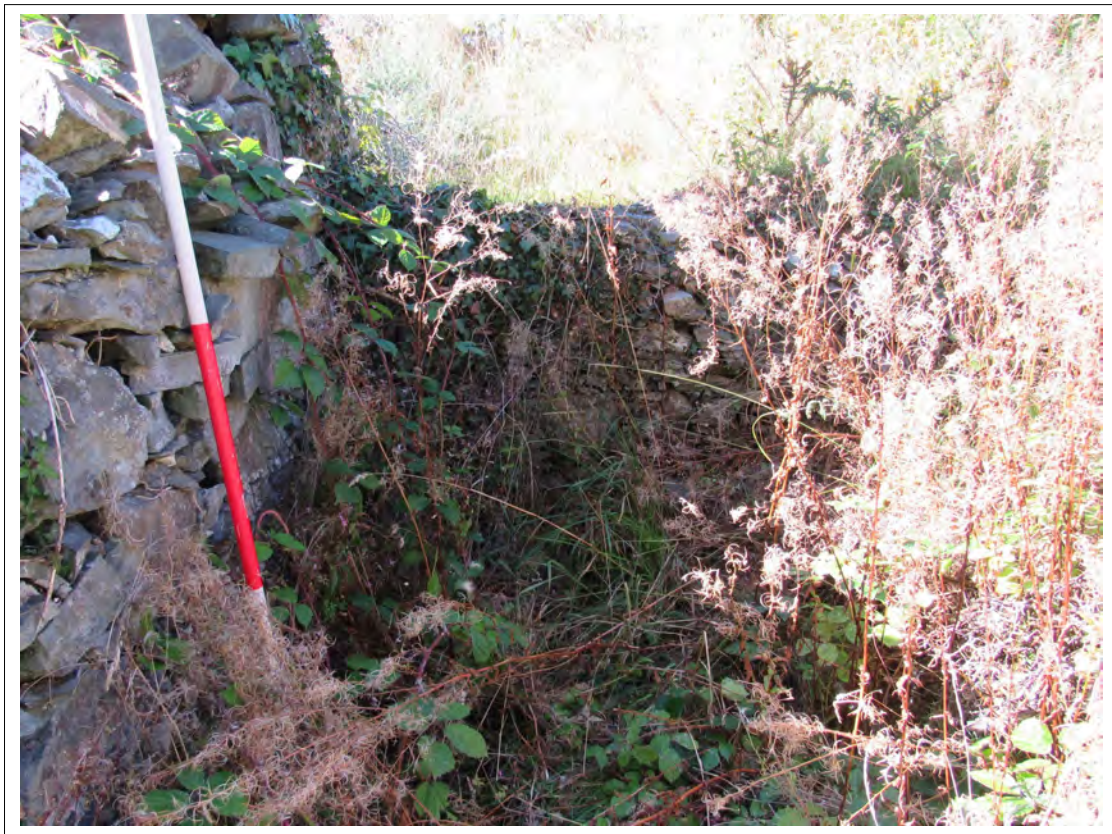
Plate 9. Join of northern wall of house ruins and western boundary wall. View W.
2m scale.

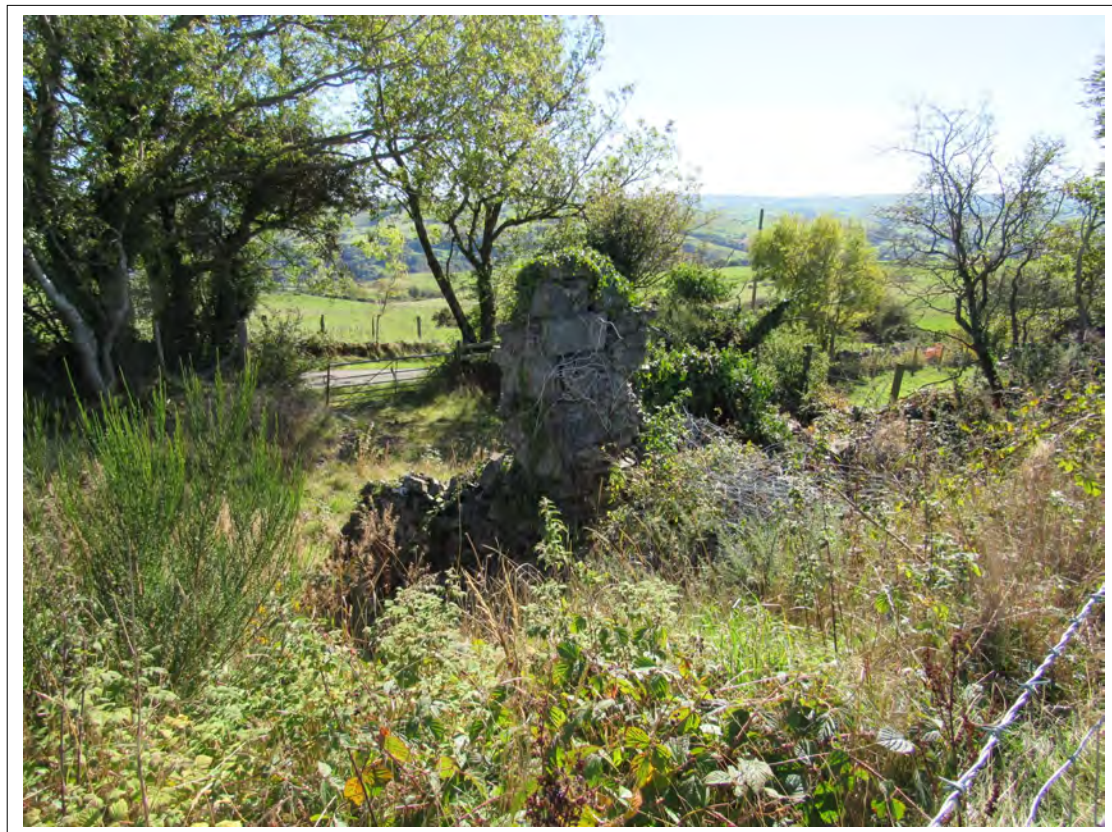
Plate 10. House ruins, quoinstones of NW corner. View SE.

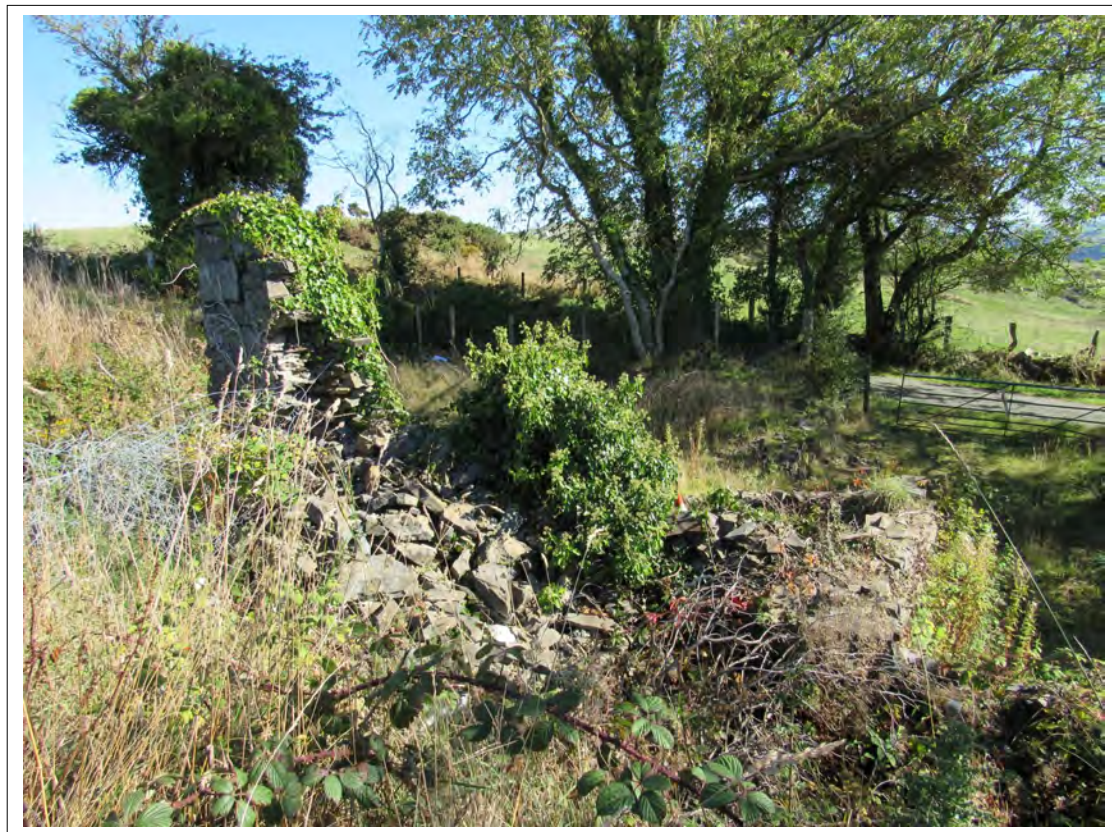
Plate 12. House ruins, western wall. View E

The west facing elevation of the house could be viewed from the adjacent field at the top of the bank. The rubble collapsed western wall was visible, with the NW corner of the house built from substantial hewn quionstones, surviving to a height of 3.5m from the ground level at the base of the bank.

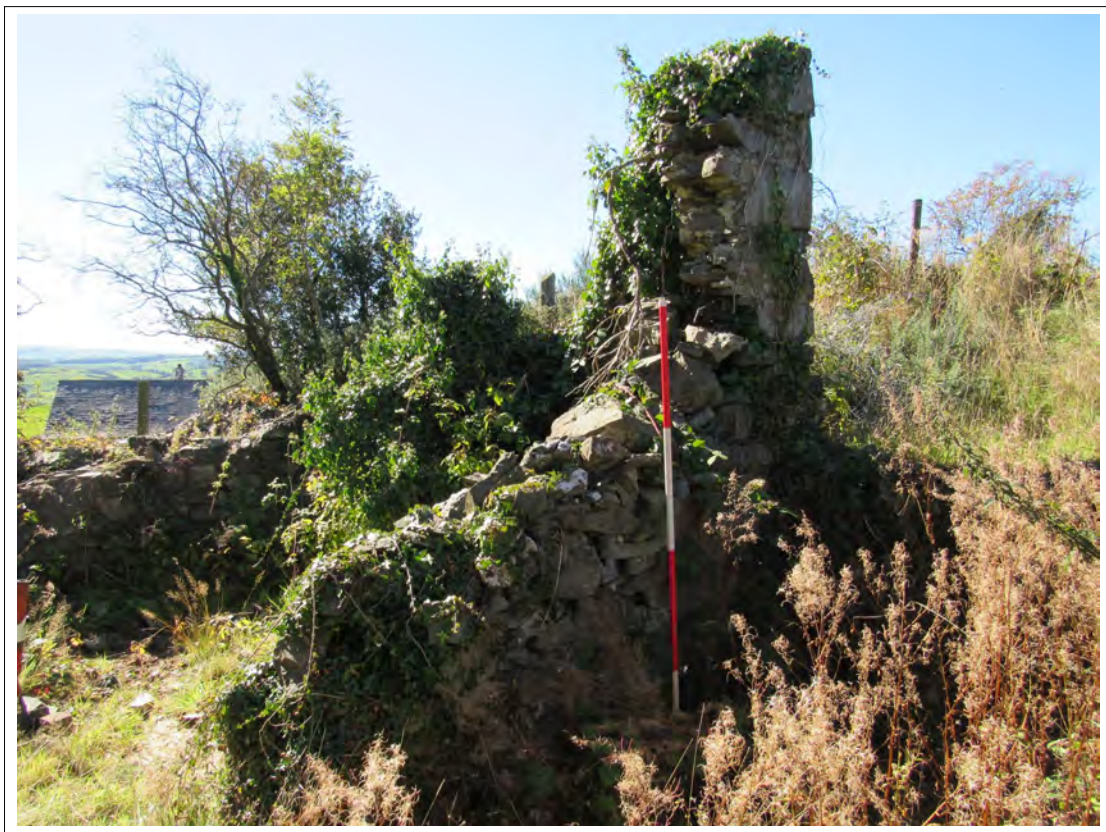
Plate 17. House ruins, north wall. View S. 2m scale

The remains of the northern rubble wall of the house appear to have been robbed and removed, with the NE corner of the building completely missing. The western dry stone boundary wall continued for 2m to the north of the house, before becoming obscured by vegetation where the bank of the hill rose up to the north.

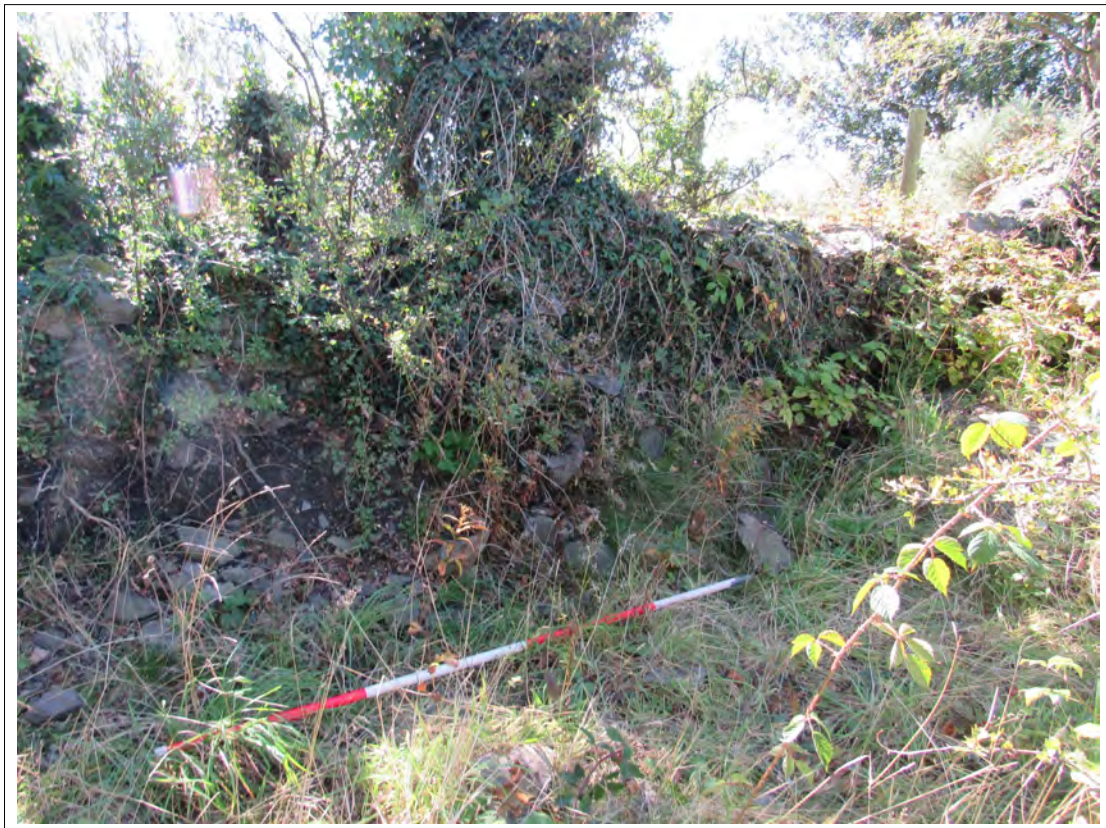
Plate 21. Southern dry stone boundary wall with scar of a wall return. View SW. 2m scale.

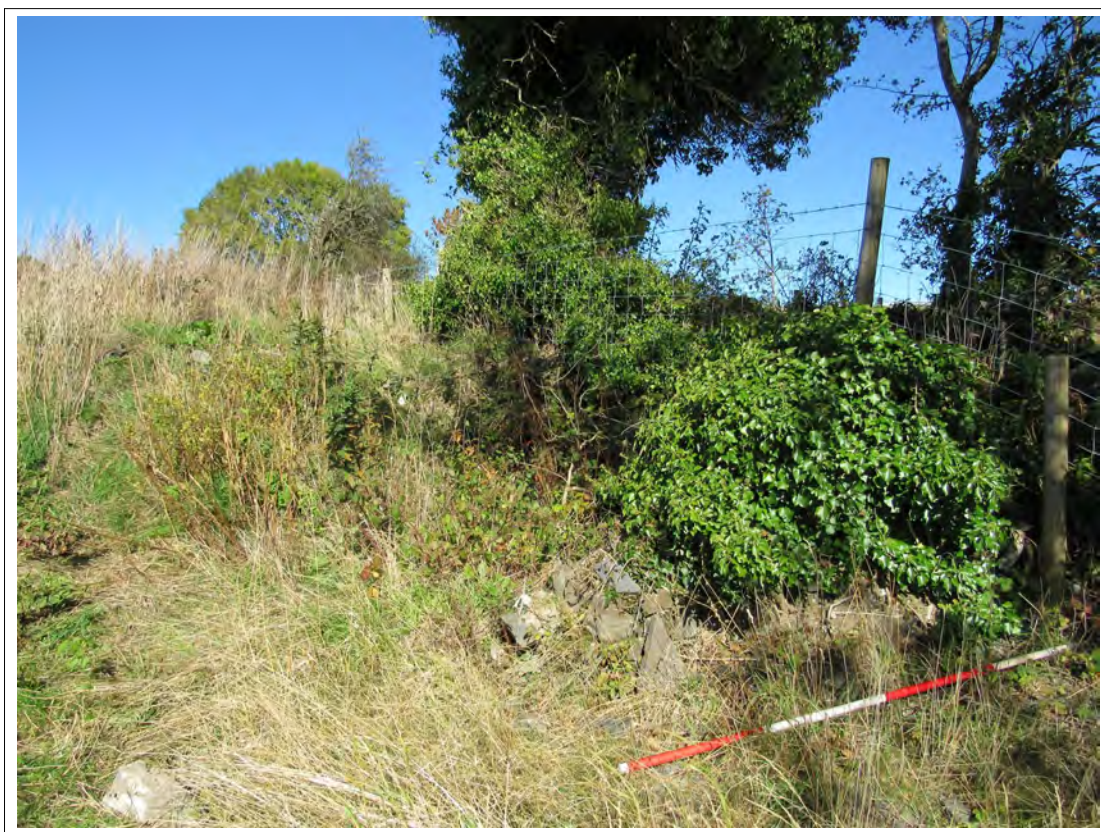
Plate 23. Northern wall protruding westwards from eastern boundary dry stone wall. View N. 2m scale.

To the north-east of the house ruins, running westwards from the dry stone wall of the eastern plot boundary, the remains of a segment of rubble stone wall was on an east to west line, measuring 2.5m in length, 0.7m in height and 0.45m in width.
