Historic Building Recording

Rhiw Chapel

Client:	Mike Catherall	
Author(s):	Blair Poole & Rachael Matthews	
HER Event No:	PRN 218145	
Planning Application:	15/2023/0320	
Document Ref:	24-1014-HBR-v1.2	
Date:	26 March 2024	
NGR:	318637,356494

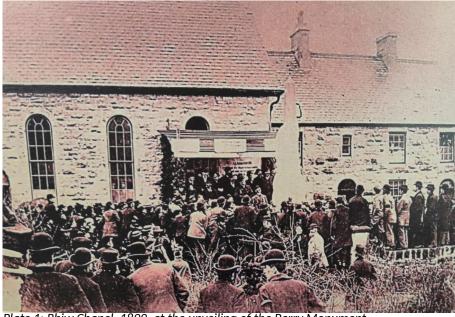
Plate 1: Rhiw Chapel, 1899, at the unveiling of the Parry Monument

- 3.18 Mr Catherall , the client, supplied a photograph of the erection of the monument, held by a neighbour. This is dated to the 6th April 1899 and records Lloyd George as being in attendance (Plate 1). The image is of low resolution, however, the materials and fenestration is clearly visible. The image depicts a free standing podium in front of the chapel for dignitaries, and the congregation gathering around for the unveiling of the monument.

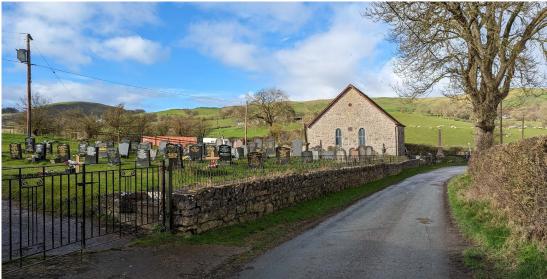
Plate 2: The setting of the chapel, looking west

6.1 A site visit was undertaken on 23rd February 2024 by Blair Poole and Rachael Matthews of DAS on behalf of Mike Catherall. The chapel is sited in a rural environment to the north of the village of Llanarmon yn Iâl, to the south of Ffordd Rhiw (Plate 2).

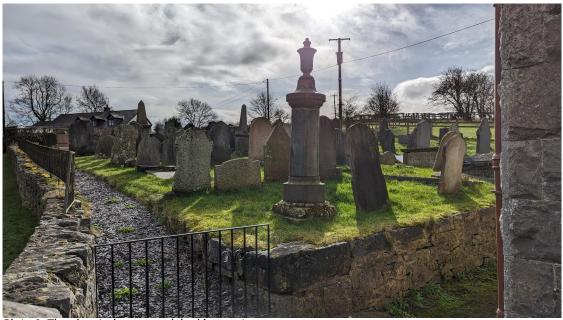
Plate 3: The elevated graveyard, looking east

6.2 The elevated graveyard to the east of the chapel has been separated from the site boundary and is not directly impacted by the development (Plate 3).

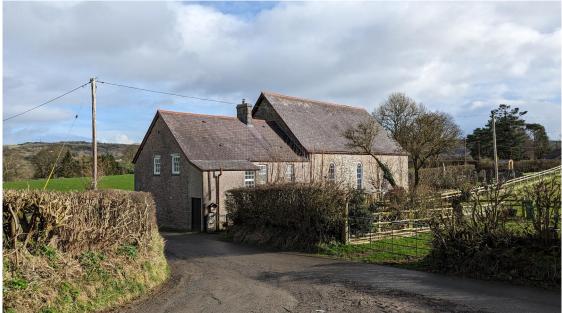
Plate 4: The chapel, looking north

6.3 The land to the rear of the chapel slopes up towards agricultural fields, which afford substantial views of the surrounding area (Plate 4).

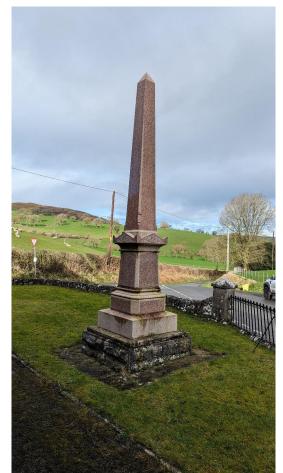
Plate 5: The Parry Monument, looking northwest

6.5 This is a stone obelisk dating from 1899 (Plate 1) as a memorial to John Parry, noted above (Plate 5). The monument is in good condition and has a clear inscription on the north face of the pedestal (Plate 6).

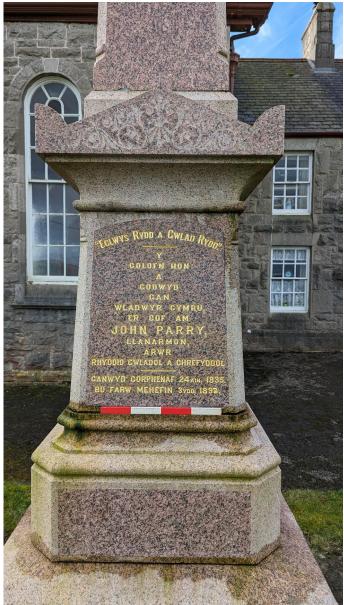
Plate 6: The Parry Monument, Inscription 6.6 The transcription reads:

"ECLWYS RYDD A GWLAD RYDD" Υ **G**GOLOFN HON А GODWYD Gan WLADWYR CYMRU ER COF AM JOHN PARRY

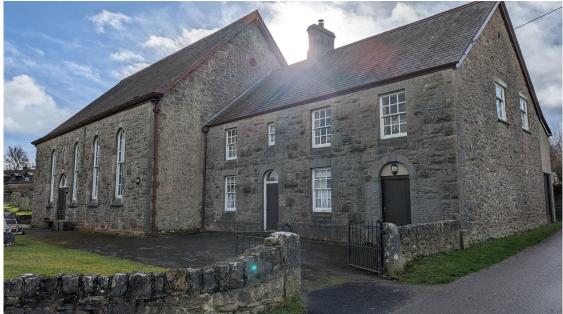
Plate 7: The west elevation and Ty Capel, looking southeast

6.9.1 The western elevation is mainly obscured by Ty Capel with metal balance beams, rack and pinion paddle mechanisms and metal handrails on top (Plate 7).

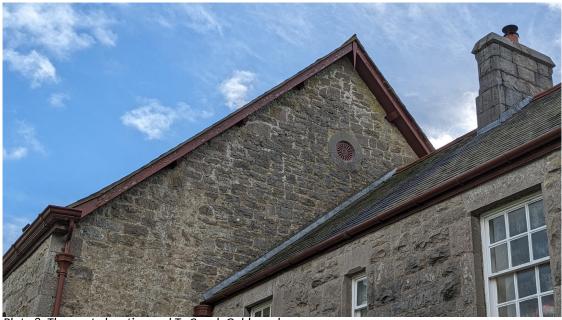
Plate 8: The west elevation and Ty Capel, Gable end

- 6.9.2 The elevation is of randomly coursed grey roughly hewn stone, thought to have been locally sourced, with dressed stone quoins at the northern edge. Chamfered dressed stone form a plinth at the base of the structure.
- 6.9.3 Rough concrete render has been applied to the face of the wall in front of the junction with Ty Capel from the plinth to the eaves. This obscures much of the face and slightly overlies the quoins, showing this to be a later repair.
- 6.9.4 At the northern edge a red painted metal drainpipe leads from the guttering to a drain. A metal ogee drain hopper, cornice-profiled cast-iron, is located just below the gutter. This is undecorated in style, however, a further ogee hopper can be seen on the frontage of Ty Capel, at the junction with the chapel, which has

rosette decoration on its front panel, suggesting differing dates for these hoppers (Plate 8).

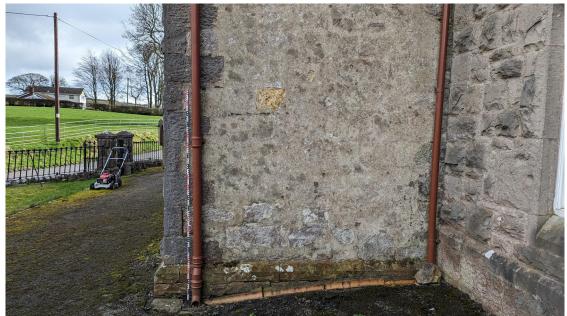
Plate 9: The west elevation showing render and plinth

6.9.5 Located centrally to the elevation, towards the top of the gable, is a metal wheel spoke vent with stone surround of Limestone ashlar, chamfered, flush surrounds (Plate 8). The junction of the two structures showed that Ty Capel butted the chapel and was a later addition (Plate 9).

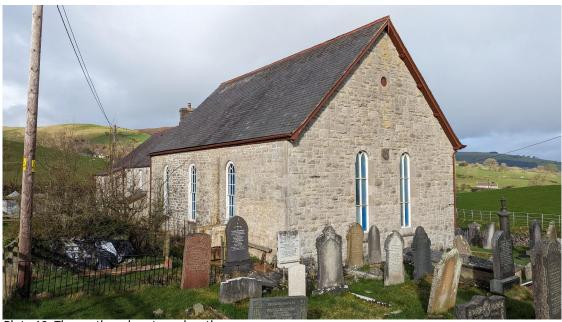
Plate 10: The south and eastern elevations

6.9.6 The Southern elevation was partially obscured by a small garden area and had a slightly elevated, 0.4m, ground level compared to the north elevation (Plate 10).

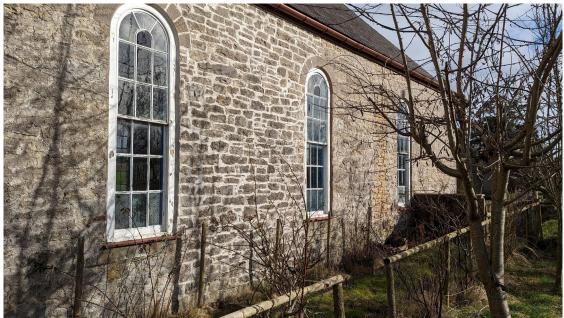
Plate 11: The south elevation fenestraion

6.9.7 This elevation was of roughly hewn, random coursed, stone, with the junction of Ty Capel being marked by pebble dash render on the domestic structure. Repair work and repointing could be seen at multiple places across the southern elevation, with the southwestern end forming the most intact area of historic fabric. Stone ashlar quoins were present at the southeastern edge.

6.9.8 A series of three full height windows were located, equally spaced, across the face of the structure (Plate 11). These windows were 19 pane, wood farmed,

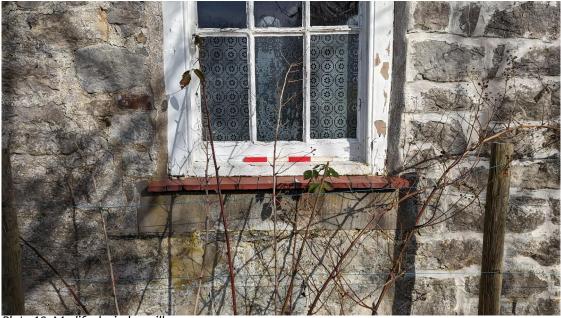
Plate 12: Modified window cills

arched sash windows, with ashlar stone arched voussoir lintels. The cills were formed of sloping red tiles over stone inset cills on the western and central windows (Plate 12), with later brick repair on the eastern window. Much of the wooden framework appeared to be later repair, with some 19th century moulding still in place. There also appears to have been multiple panes replaced in each window.

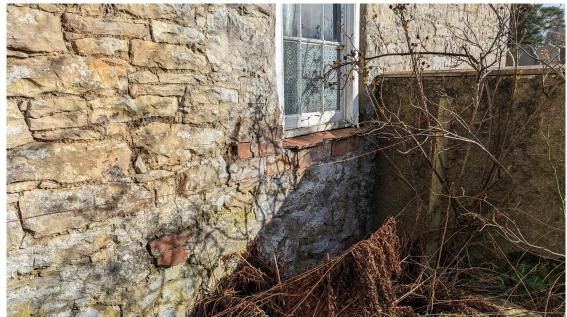
Plate 13: Rough nature of repairs to the southern elevation

6.9.9 The rough approach to the repair work on the southern elevation suggests that this was often away from public view, and it wasn't considered important enough to warrant the cost of matching materials or decoration (Plate 13).

- 8.9.2 Within the standing building the survey revealed repair work on the window woodwork, and cills on southern elevation, as well as repointing and stone repair on the southern elevation. Render had also been added to the western elevation. Externally ghosting on the southern elevation also revealed that a later toilet block, visible on the early OS maps, had been added, and subsequently removed.

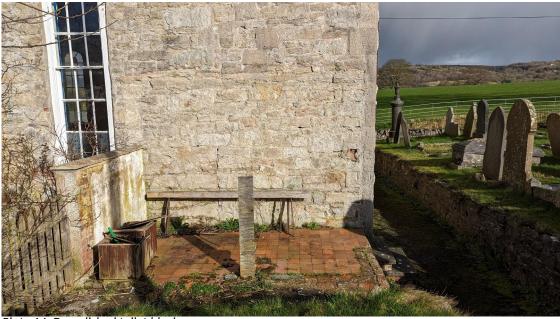
Plate 14: Demolished toilet block

6.9.10 At the eastern end of the southern elevation a tiled platform was present, with scarring on the southern wall. This platform had a series of three concrete

capped, brick formed, steps, and the foundation course of an external wall to the east and south. The standing garden dividing wall, 20 courses high, is thought to form part of this structure (Plate 14).

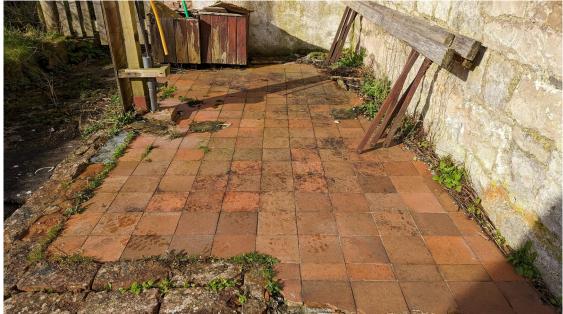
Plate 15: Demolished toilet block floor

6.9.11 An external toilet block is known to have been located at this point, and it is thought that this is the ghosting of that structure, seen on the 1910 OS map. Blocked drains and water inlets support this (Plate 15).

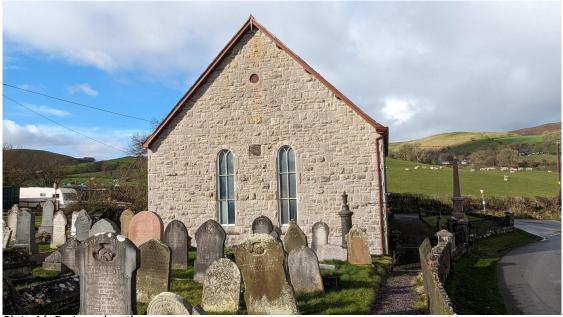
Plate 16: Eastern elevation

6.9.12 The eastern elevation overlooks the graveyard and was constructed of roughly hewn stone in a random coursed bond, with decorative stones quoins at the north and south corners (Plate 16).

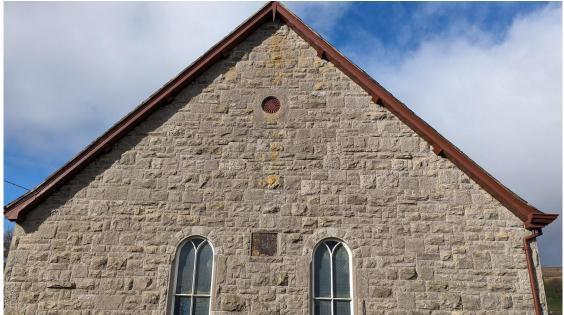
Plate 17: Eastern elevation detail

6.9.13 The wooden eaves, above the gable, had a decorative pendant finial, and located centrally, in the upper gable area, was a metal wheel spoke styled vent, with grey stone ashlar voussoir surround (Plate 17).

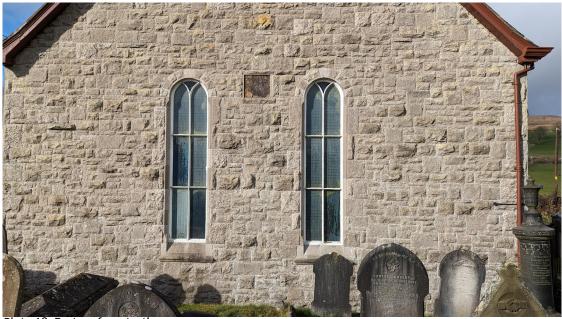
6.9.14 Two windows, equally spaced, occupy this elevation. These windows have decorative stone quoin edging, arched stone lintels, and chamfered stone cills, with fluting along their base (Plate 18). These are seven pane sash windows in a wooden frame appear to be replacements, not matching those seen on the north or south elevations, or in the historic image of the site (Plate 1).

6.9.15 A stone inscription plaque is located between the two arched windows
 (Plate 18), which is a re used piece of fabric from the original 18th century building. It's material is slightly different to the rest of the standing building, of a yellow soft stone. This suggests the earlier structure may have been of a different material.

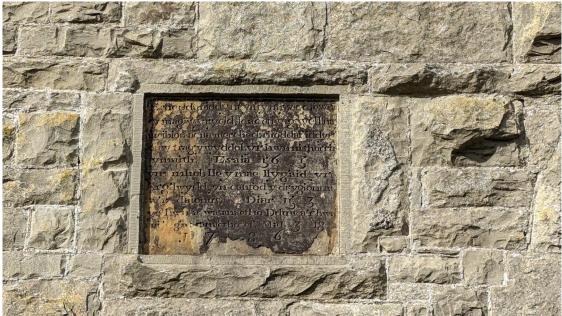
Plate 19: Eastern inscription stone

6.9.16 The stone is worn in areas and uses an older Welsh version of biblical translations, and is thought to read: *Ie heddaf iddynt ynry nayae ofewn y mag* wyrydd *Ie ac enw gwell na meibion ac na merched*; rhoddaf iddynt enw tragywyddol yr hwn ni thorrir ymaith. Esaia 56 5. Yn mhoblleymae llygaid yr Arglwydd yn canfod y drygionus yr daionus. Diar 15 3. Yr hwna wasanaetho Dduwa'r hwn n^{***}g^{***}naetho ef Mal 3 18. 1786.

- 6.9.17 These represent three biblical quotes, Isiah 56, 5, Proverbs 15, 3, and Malachi 3, 18. As with the south and western elevations, a stone plinth runs along the base of the wall. At the northern corner a metal drain is located, which runs directly from the gutter, with no additional hopper in place.
- 6.9.18 The northern elevation is the main facade of the structure and takes a prominent position at the road junction (Plate 20).

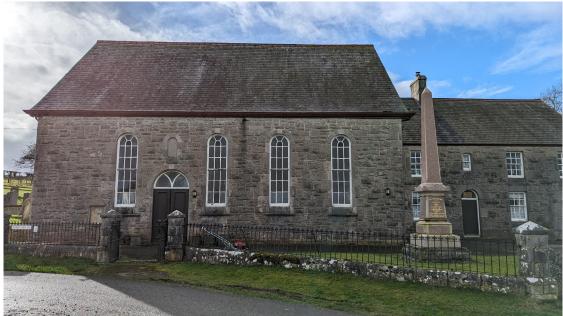
Plate 21: Northern elevation

6.9.19 This elevation is of random coursed stone, with quoins present at the east and west corners (Plate 21). The structure sits on a chamfered stone plinth, above which three evenly spaced small metal vents are noted (Plate 22).

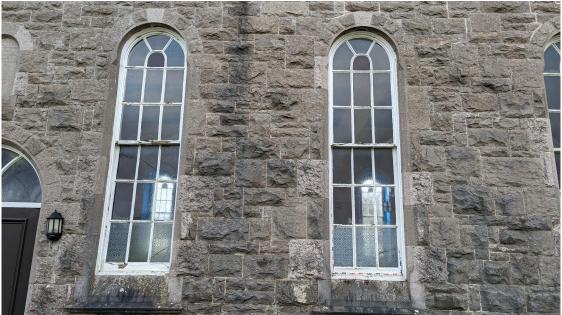
Plate 23: Northern elevation window orm

6.9.20 The northern elevation contains four full height windows which have decorative stone quoin edging, arched stone lintels, and chamfered stone cills, with fluting along their base (Plate 23). The wooden frames show multiple phases of repair, suggesting some 19th century fabric remains, interspersed with modern soft wood repairs. The westernmost window has a full wooden frame, however, the other three have stone frames above the cills, which the sash window closes onto.

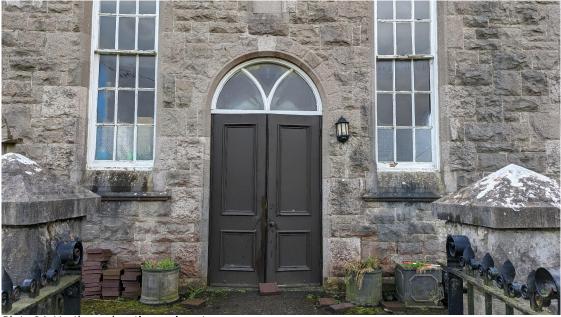
Plate 24: Northern elevation main entrance

6.9.21 The double door entrance to the chapel is located towards the eastern end, sited between windows 1 and 2 (Plate 24). The doorway is flanked by large stone quoins, with and arched ashlar stone lintel above the three pane door light, set int a

wooden frame (Plate 24). The stone threshold is tied into the stone plinth surrounding the structure.

6.9.22 The doorframe and doors appear to be original 19th century fitting, with cast metal door handle typical of post 1840 style.

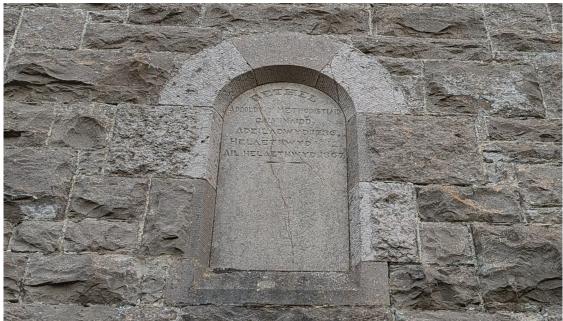
Plate 25: Northern elevation inscription

6.9.23 Above the entrance was a grey stone inscription from the erection of the standing structure. This reads "Bethel. Addoldy Y Methodistiaid. Calvinaidd. Adeilwdwyd 1786. Helaethwyd 1812. Ail Helaethywd 1867". This has been translated as "Bethel Methodist Place of Worship. Calvinist. Built 1786. Enlarged 1812. Second Extension 1867". This translation suggests elements of the first chapel may have been incorporated into the existing structure. It became apparent during

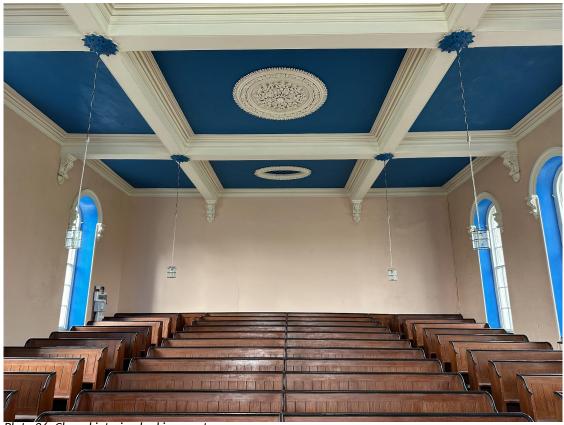
Plate 26: Chapel interior, looking west

- 6.10.2 The walls were of light pink plaster with no decoration on the south, west and north walls (Plate 26). The ceiling was divided into deep blue painted panels by painted white false beams, with decorative cornice work in the insets. Along the central panels were a series of circular ceiling roses housing vents. The east and west roses had decorative white surrounds of floral design, with metal inset vents. The central roses were much more decorative in style with a grape and vine outer, and acanthus leaf inner.

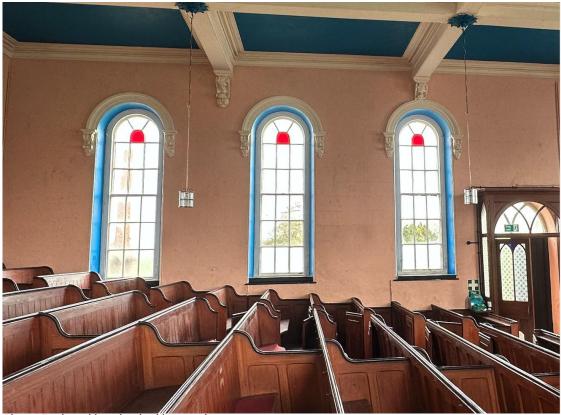
Plate 27: Chapel interior, looking north

6.10.4 The windows were deep set, with painted blue surrounds, of wooden frame and moulded arched hoods, sat on decorative plaster corbels and dark painted wood cills (Plate 27).

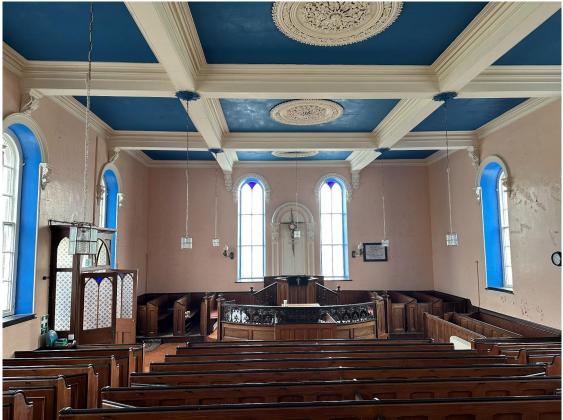
Plate 28: Chapel interior, looking east

- 6.10.7 The entrance vestibule was a shallow wooden frame porch, with a window style that matches those seen on the eastern wall, with decorative cross design frosted glass, and blue glass inset above a wood frame arched upper (Plate 28).

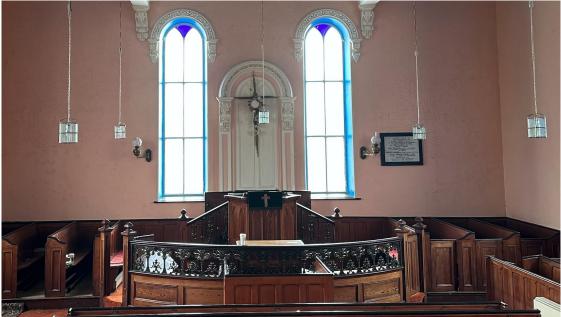
Plate 29: Chapel interior, looking towards lectern

6.10.8 The eastern area contained a raised wooden dais pulpit and lectern, sited in front of a recessed decorative wood and plaster panel (Plate 29). The materials used for this dais and lectern were reasonably modern, with veneer panelling and cast metal railings, which may even represent a 20th century modification.

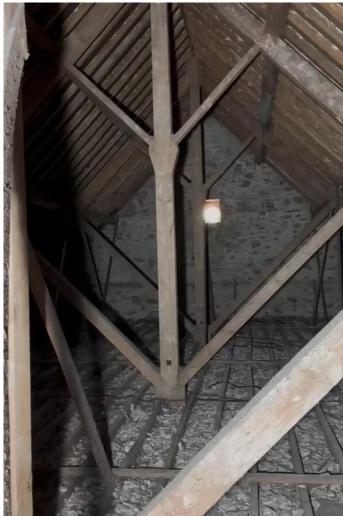
Plate 30: Roof posts and trusses

6.11.1 Access to the roof space allowed for a view of the construction material and form (Plate 30). This view revealed a king post construction with double principal rafter struts, with worked shoulder joints.

6.11.2 The roof was replaced in the 20th century, however, the main roof structure appears to be 19th century in date, suggesting only the batons and covering was replaced.

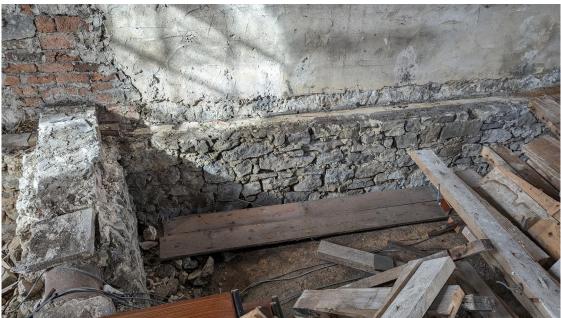
Plate 31: Foundation wall on western wall of chapel, with heating pipework in amalgam

6.12.1 Some soft stripping works have been carried out at the site, which have revealed evidence of the construction material, including the rough stone foundations of the western wall (Plate 31) and the underfloor pipework for the heating system for the chapel.

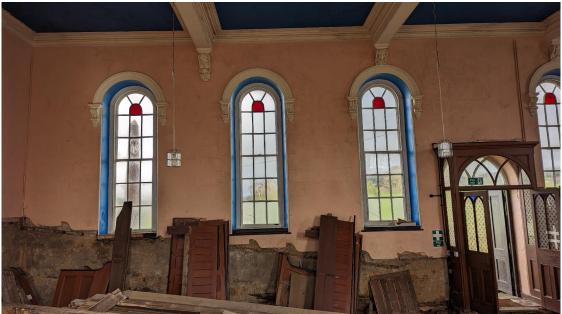
Plate 32: Removed pews and panelling

6.12.2 The strip revealed an original stone construction with later brick repair work that had been plastered over. Th wall plaster also respected the run of panelling along the walls (Plate 32).

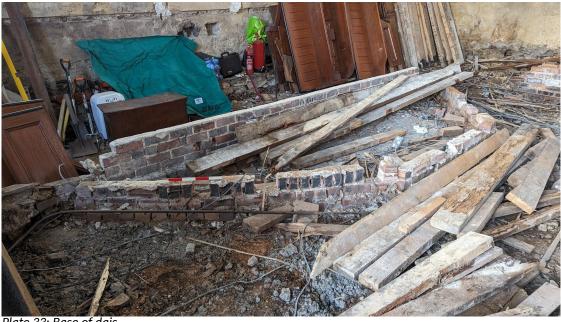
Plate 33: Base of dais

6.12.3 The brickwork around the raised dais was of frogged brickwork from Llay Hall, Wrexham. Llay Hall operated between 1877 and 1949, with this stye of brick dating from the early 20th century.

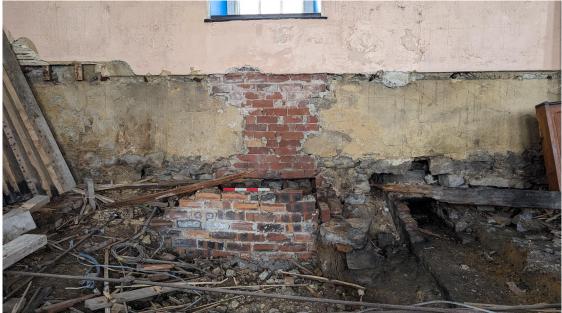
Plate 34: 20th century repair and 19th century heating culvert

6.12.4 On the southern wall, towards the eastern end of the chapel, a later phase of 20th century brick repair could be seen (Plate 34). This marked the position of the external toilet block and appears to relate to the insertion of drains. To the west of this a defunct heating culvert was present, which led to the large bore ceramic heating pipe seen in Plate 32.

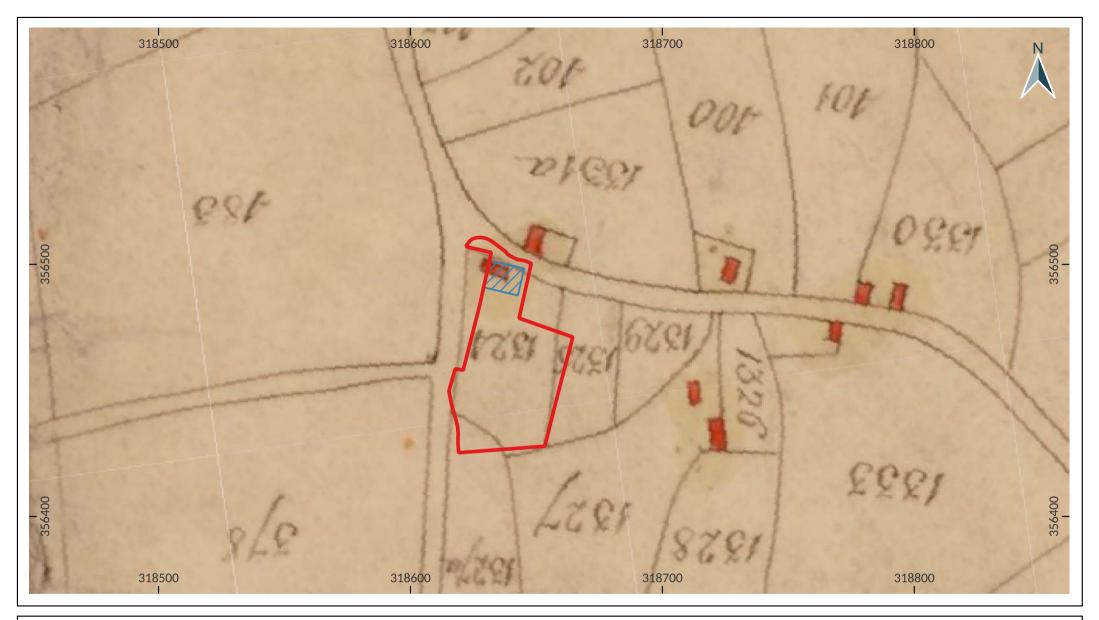
Figure 4: 1872-74 OS Map - Flintshire XVI

- 3.15 The 1872 Ordnance Survey (OS) 25" for Flintshire (Sheet XVI) shows the site within its modern day footprint as Methodist Chapel (Figure 4). The chapel building, with a benchmark of 244m AOD, no longer visible. By the 1872 OS map Ty Capel, the domestic structure to the west of the chapel can be seen. This places construction of Ty Capel between 1867 and 1872. On site recording does confirm these structures are not contemporary, and Ty Capel is a later construction phase. The rapid development of the re building of the chapel, and within five years the addition of the additional buildings, suggest the Welsh revival may have been fervent in this area. The graveyard is recorded to the east with several buildings to the east along Ffordd Rhiw. The building opposite has gone, but the outline of the plot is visible on the map; limekilns are noted close-by to the north, northeast and west of the site.
