## **Nebo Independent Chapel, Bryn Road, Glyncoed**

Building Recording (Level 3)

Report No. 1762

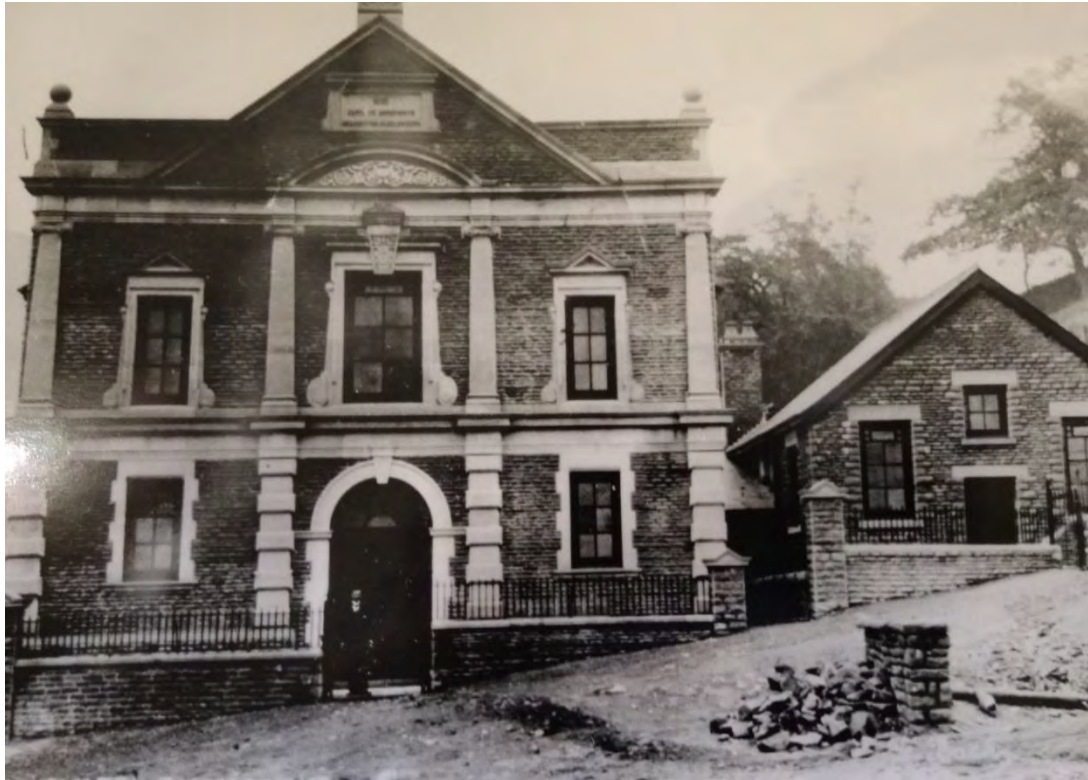
Photo 1: Undated photos, but showing the original frontage of Nebo Chapel

An early, undated, photograph found in the regional archive shows the original façade of the chapel (Photo 1). It was a three bay, two storey elevation with a segmental pediment in Classical style. It appears to have had carved stone decorative elements. The storeys are marked by string courses and the bays by pilasters. To the ground floor the pilasters are banded, while to the first floor they appear to be Doric although the detail is hard to make out. **The ground floor window surrounds are quoins and the first floor's are decorative with small pediments to the side windows and a keystone above the central window.** There is a decorative arched pediment and a date stone to the centre of the gable. The photograph also depicts the small building to the south-east of the chapel, which also appears on the historic mapping (see below).

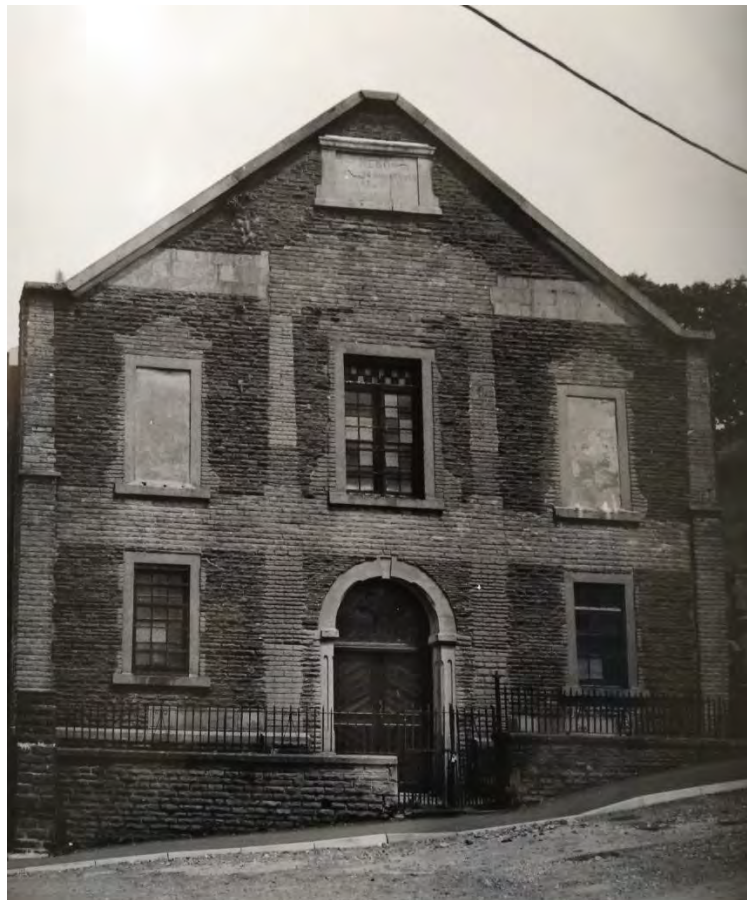
Photo 2: Also undated, but believed to be later 20<sup>th</sup> century in date. Note the removal of the decorative elements and the roof parapet and central chimney, and blocking of upper windows.

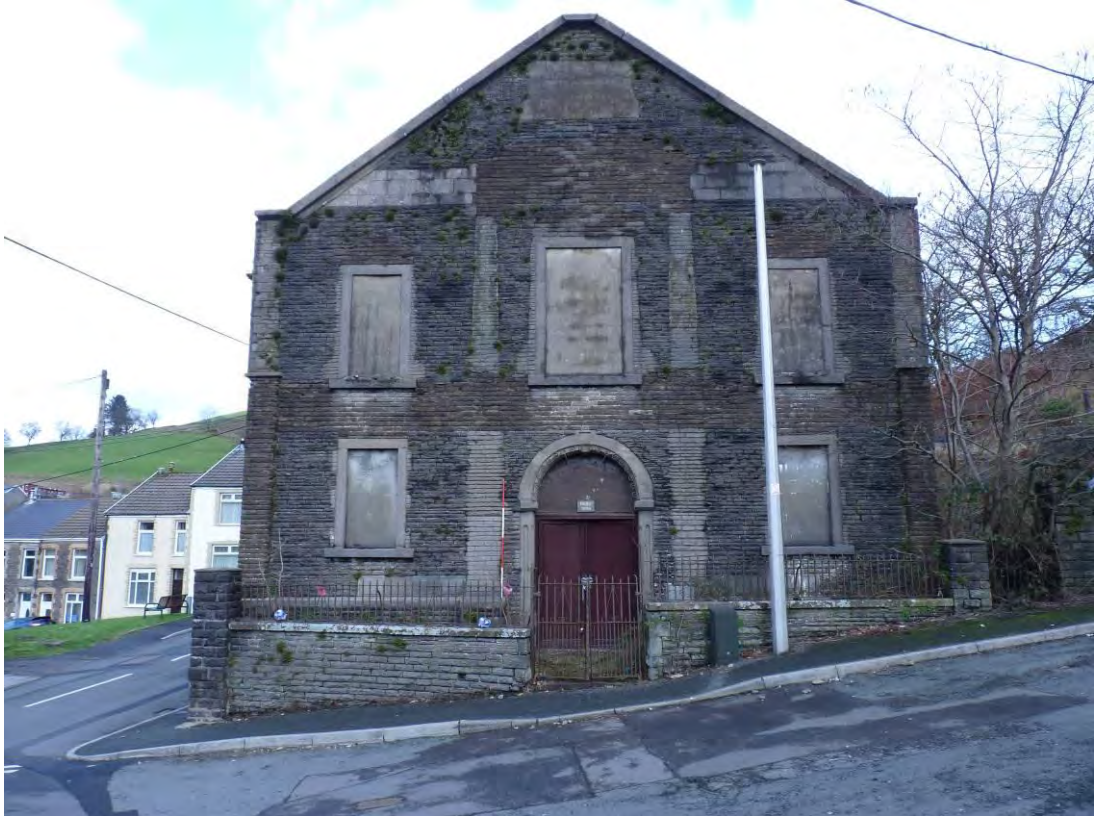
The front elevation is a gabled end, three bay, two storey façade (Photo 3), 11.5m tall to the apex, 8m tall to the side (12m wide). The lower storey has two windows either side of the central entrance, while the upper storey has three windows, with a larger one to the centre.

The front elevation is principally constructed of rough finished coursed stone. The blocks vary slightly in size, averaging 0.08m high by 0.36m long. It shows evidence of significant alterations to the original façade. There are scars on the façade where the original Classical style pilasters, string courses and other decorative elements (as visible in Photo 3) were located. Where earlier decorative stonework has been removed it has been replaced by concrete render to mimic the appearance of the surrounding stonework. This includes around the window surrounds, where there were originally quoins.

Photo 3: Current frontage to Nebo Chapel. Note the blocking of all windows openings, the removal of the date plaque, and replacement of the front door. View northeast, 2m scale.

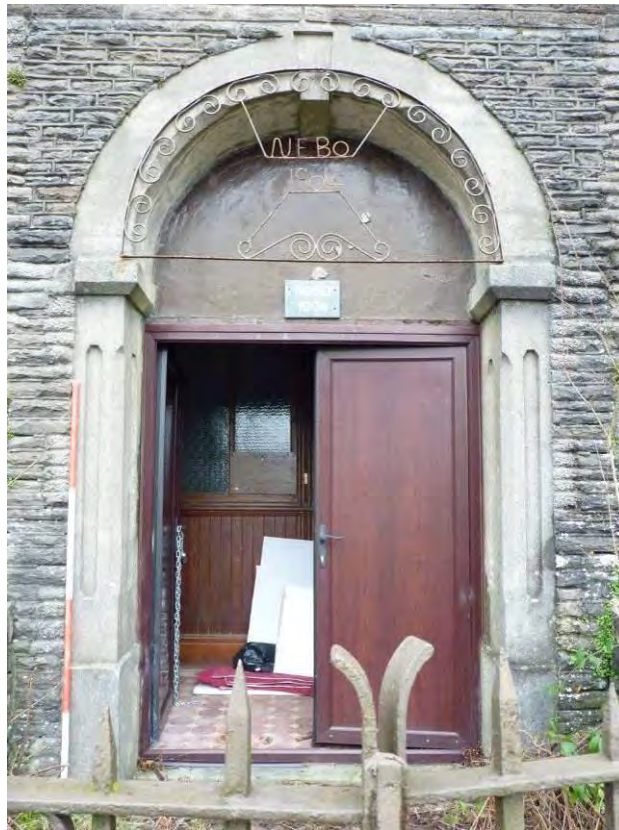
The windows have been blocked with concrete and have a plain concrete surround with slightly raised sills. The entrance is recessed with a concrete moulded architrave in a mock-Classical style. It has fluted pilasters to the sides and an arched pediment with a recessed keystone. Above the doorway **is decorative ironwork including 'Nebo 1904'** (Photo 4). The door itself is modern wood effect uPVC.

Photo 4: Entrance door to Nebo Chapel. View northeast, 2m scale.

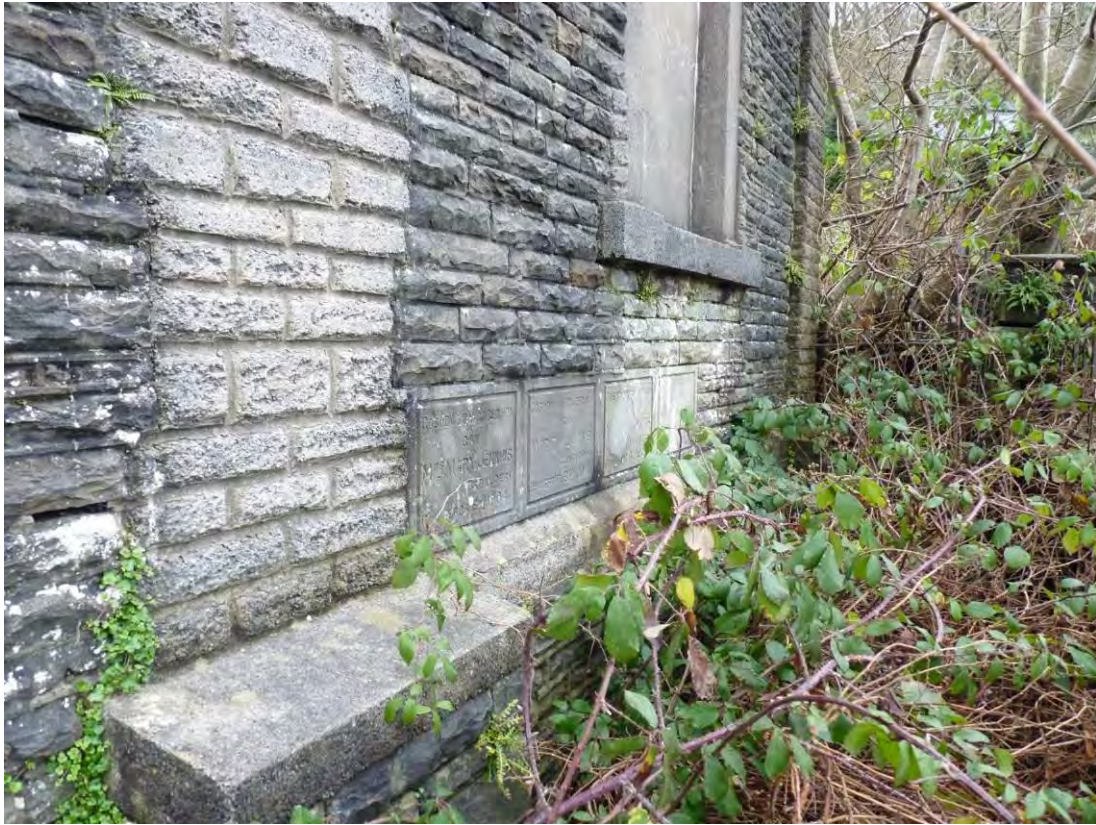
To either side of the entrance are foundation stones laid by members of the chapel, four to the right-hand side (Photo 5) and three to the left (Photo 6). The stones are inscribed with the name of the individual, where they are from, and the date:

Photo 5: Foundation plaques on front wall (also showing undergrowth in front). View east.

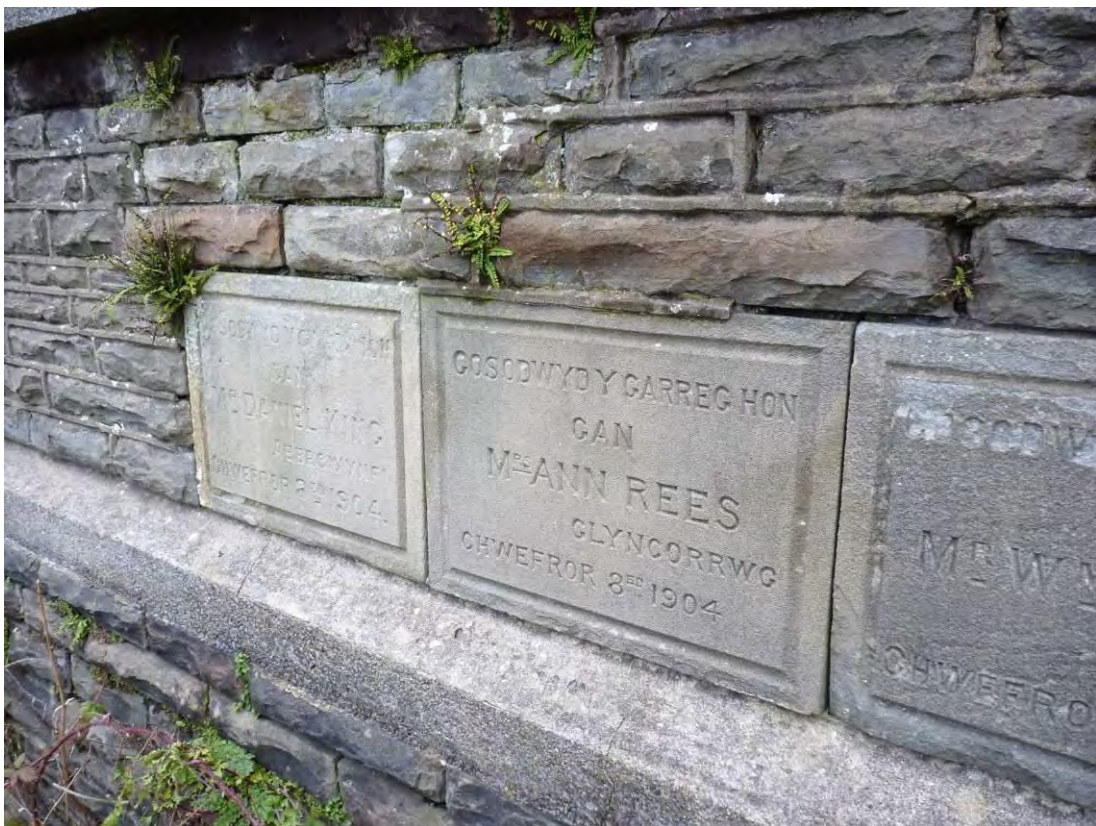
Photo 6: Foundation plaques on front wall. View north.

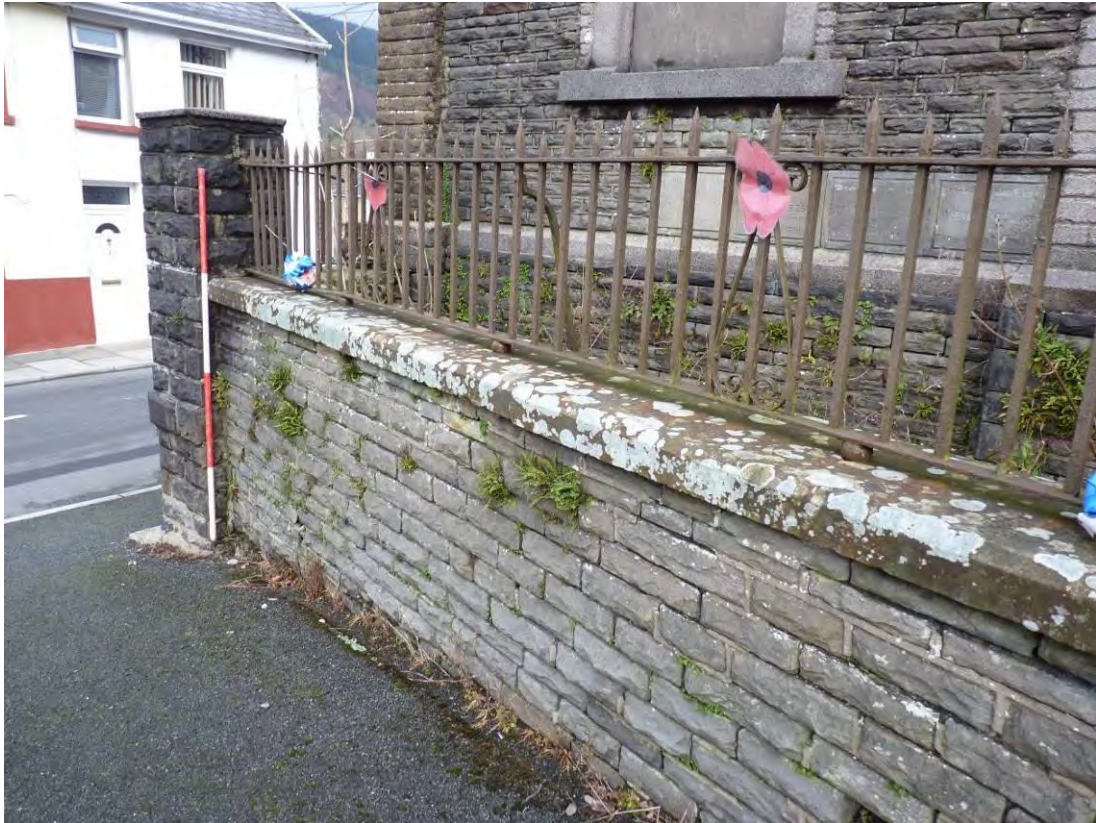
There is an enclosed frontage across the whole of the front elevation (Photo 7), extending 2.8m out from the front wall. It is enclosed by a low rough finished coursed stone wall topped with cast iron railings and a cast iron gate and two pillars to either end with a plain cap stone. The area is currently overgrown but the flooring was coloured patterned red concrete with a black star in a circle (Photo 8).

Photo 7: Enclosure wall around front of the chapel. View north, 2m scale.

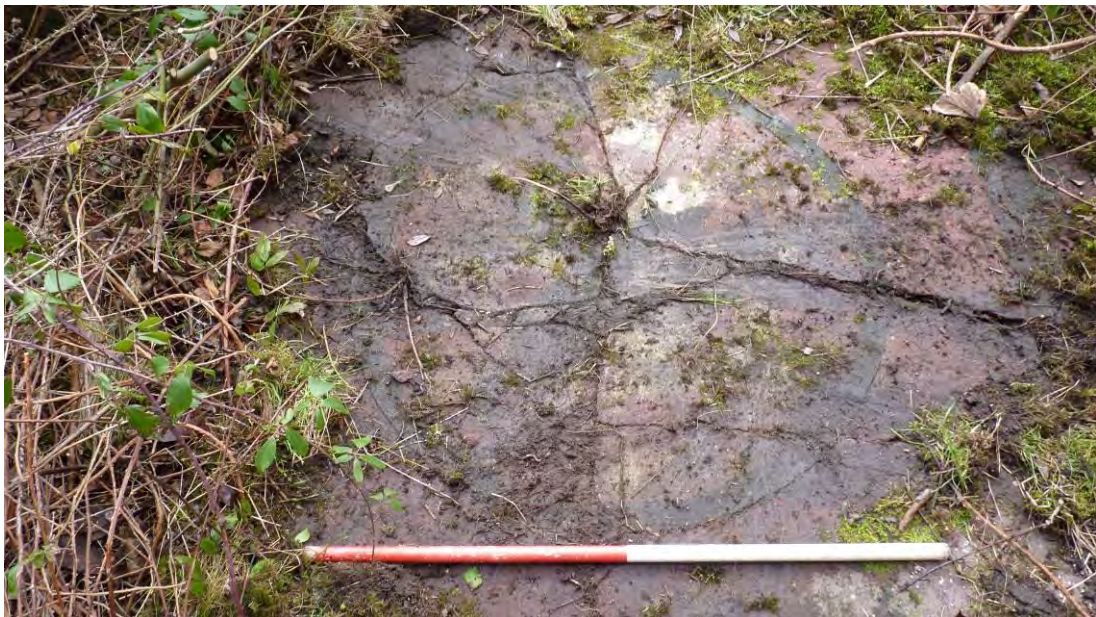
Photo 8: Coloured concrete flooring in front of chapel, showing a black star in circle. View southwest, 1m scale.

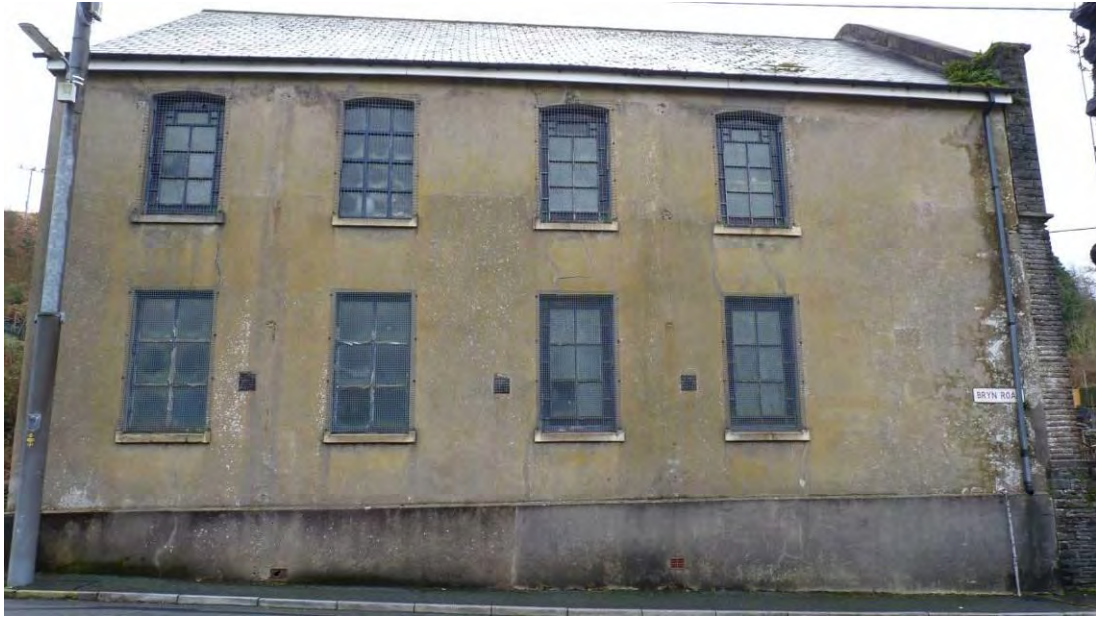
The north-west elevation, which is on Bryn Road, is two storeys high with four bays (Photo 9). It is plain rendered with no decoration.

The windows are flush to the wall with protruding stone sills and lintels. They are wooden framed six pane rectangular windows to the ground floor, and six pane with decorative surrounds and swept arches to the upper floor. The second from the left window to the upper floor is eight pane and probably a later replacement.

Photo 9: North-west elevation on Bryn Road. View southeast.

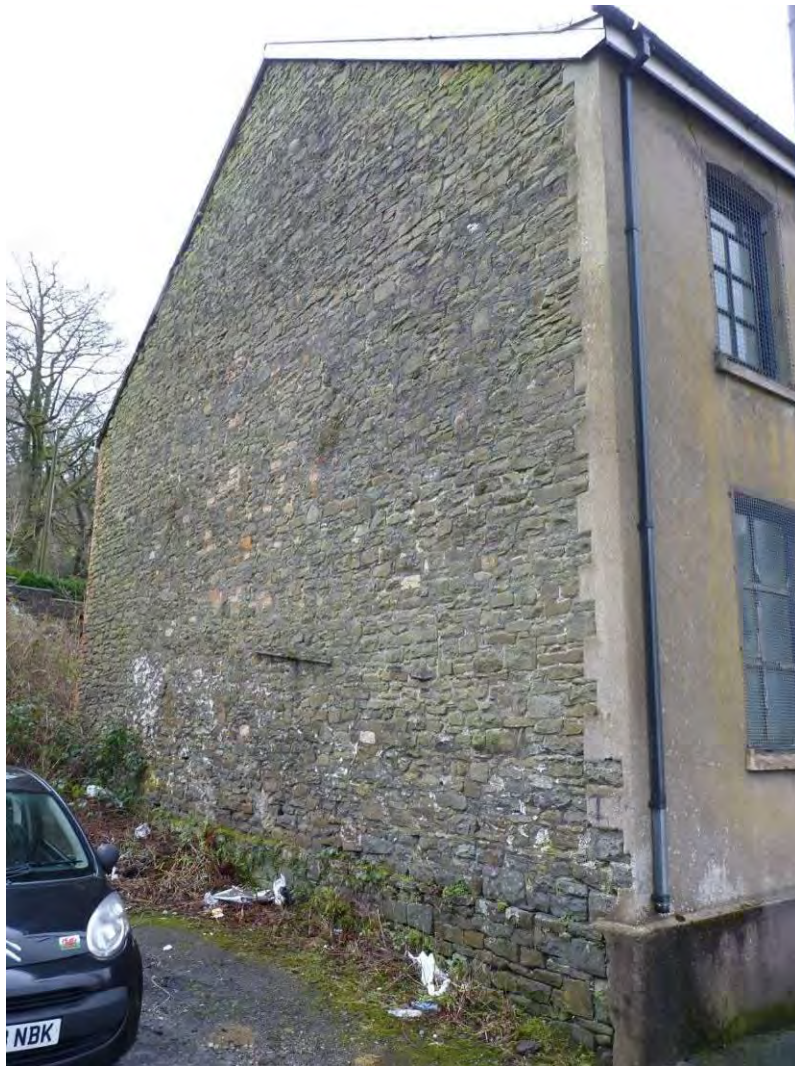
Photo 10: North-east gable elevation. View south.

The north-east elevation is a single gabled end with no windows or other features. It is constructed of random uncoursed stone of varying sizes (Photo 10).

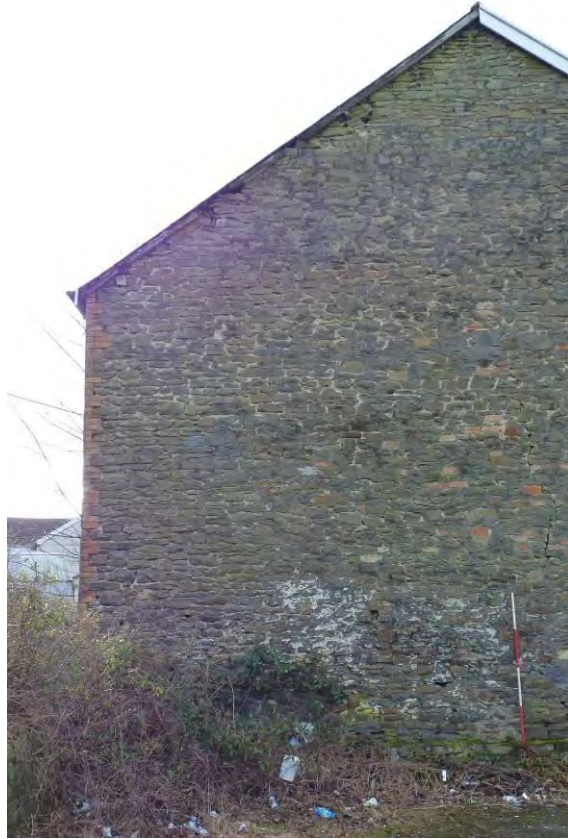
Photo 11: North-east gable elevation. View southwest, 2m scale.

To the right-hand side the render used on the north-west elevation wraps round and end in a quoin style. To the left-hand side a quoin design is created in red brick (Photo 11).

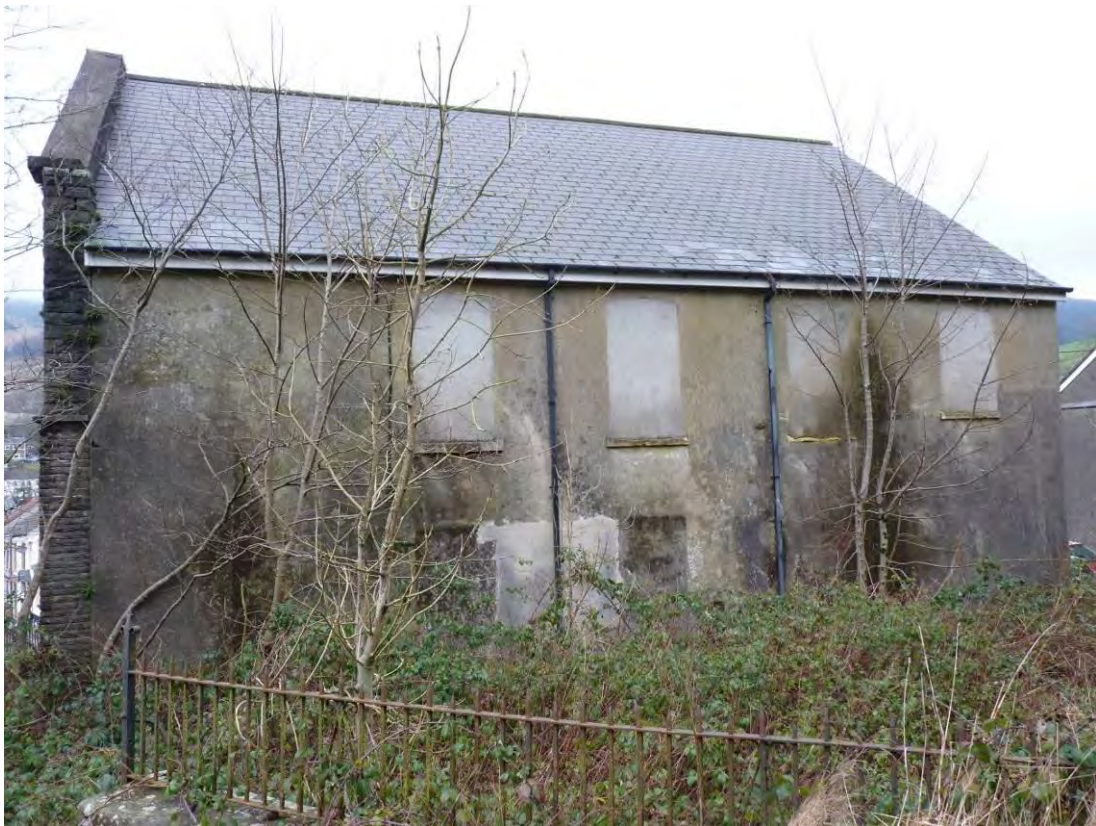
The ground floor also shows evidence of some modification, although the original features are less easily identified. There are two darker patches in the render which correspond to the blocked windows encountered in the interior of the chapel (see below). There is no evidence of the blocked doorway observed in the chapel interior towards the rear of the building, indicating that this was blocked before the elevation was rendered.

Photo 12: South-east elevation, with blocked openings. Those to the ground floor appear to have been blocked prior to rendering. View northwest.

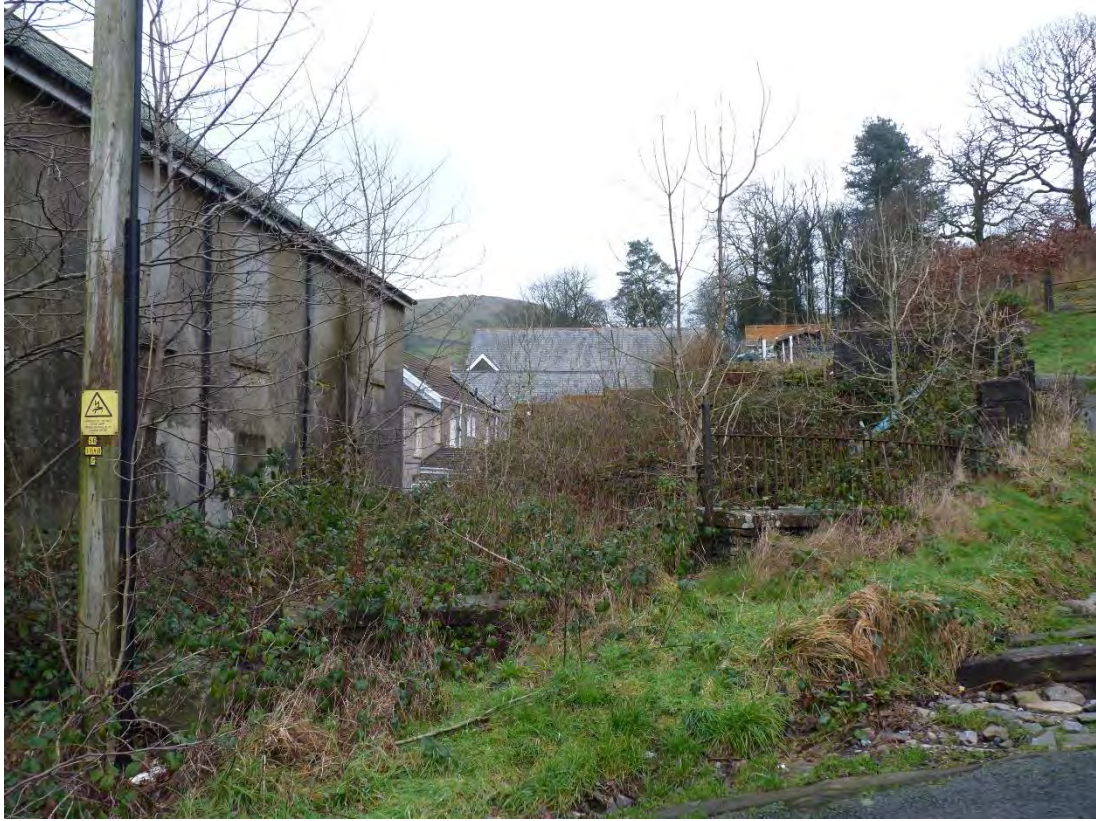
To the exterior of the elevation is an enclosed area surrounded by a stone wall with cast iron fencing (Photo 13). This area is now overgrown, and is the location of the former neighbouring building observed during the map regression.

Photo 13: Overgrown area to the southeast of the chapel, former site of building seen in Photo 1.  
View northeast.

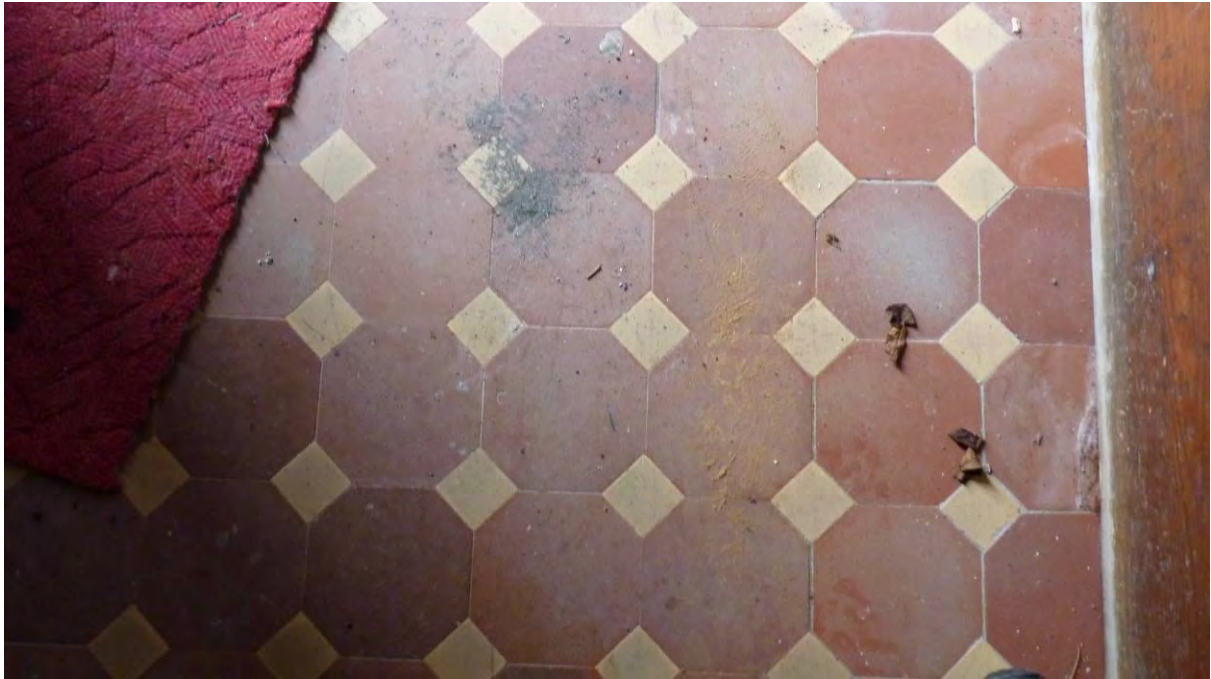
The floor is tiled with original floor tiles, with red octagonal tiles and mustard yellow diamond dot tiles (Photo 15).

Photo 15: Floor of the vestibule.

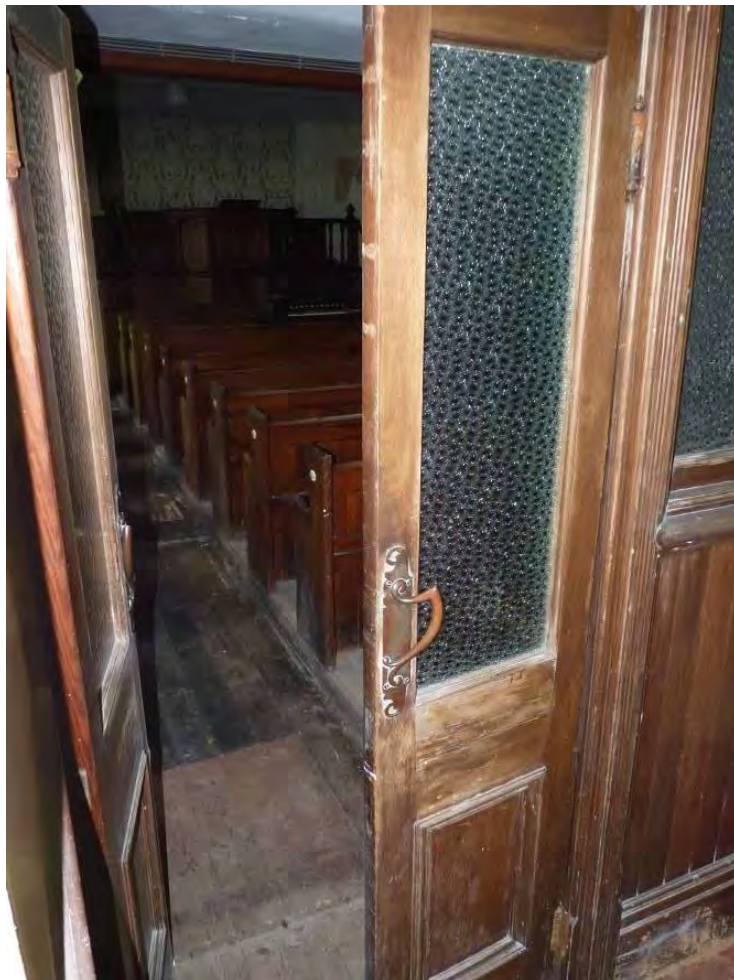
The south-western (exterior) wall is rendered in concrete to give the appearance of large coursed ashlar blocks. The north-eastern wall, to the chapel interior, is a wood and glass screen, consisting of vertical wooden boards to the bottom half and patterned glass panes above. There are eight large panes separated by mullions, each with two small square transom panes of yellow glass above. Two wooden doors in the same style at either end of the screen led into the chapel. They were narrow double doors, 2.12m high and 0.98m wide, with brass handles and single patterned glass panes to the upper part (Photo 16). Each has two light windows above.

Photo 16: Doorway (one of two) giving access from the vestibule to the main chapel. View northeast.

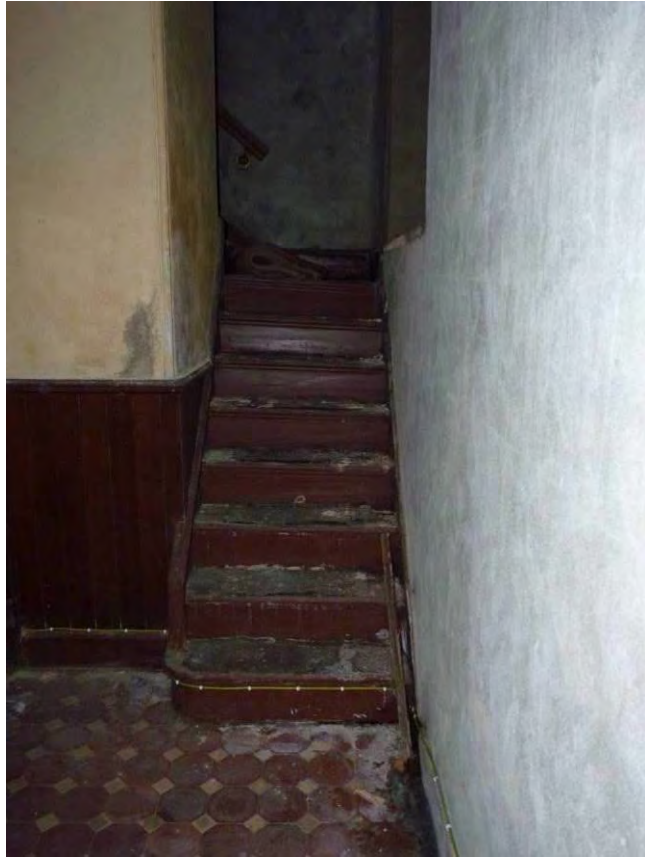
To either side of the room are staircases leading up to the gallery/upper level (Photos 17 and 18), those to the right (southeast) inaccessible due to dry-rot.

Photo 17: Staircase to the first floor on the southeast end of the vestibule, inaccessible due to rot.

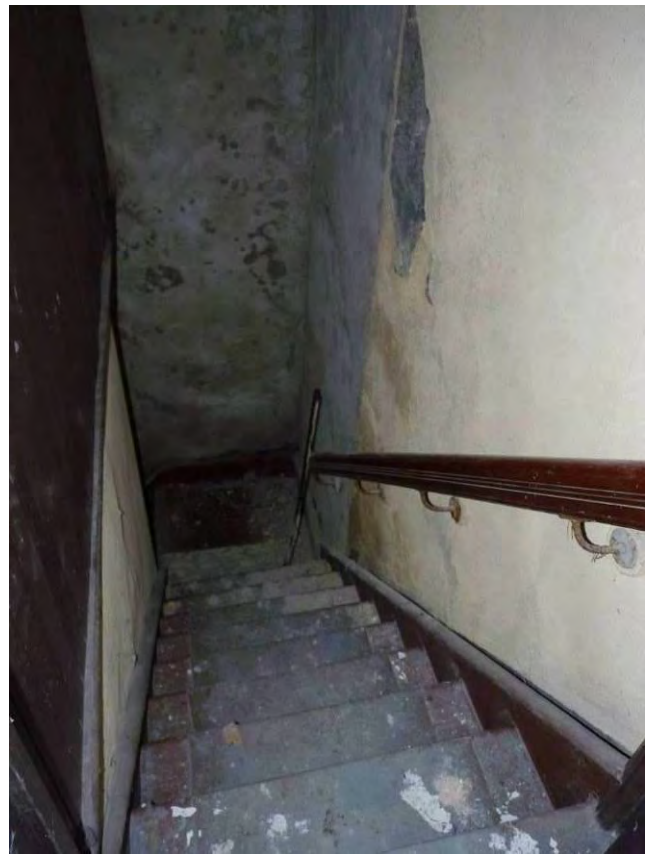
Photo 18: View down the staircase on the northwest side. View southwest.

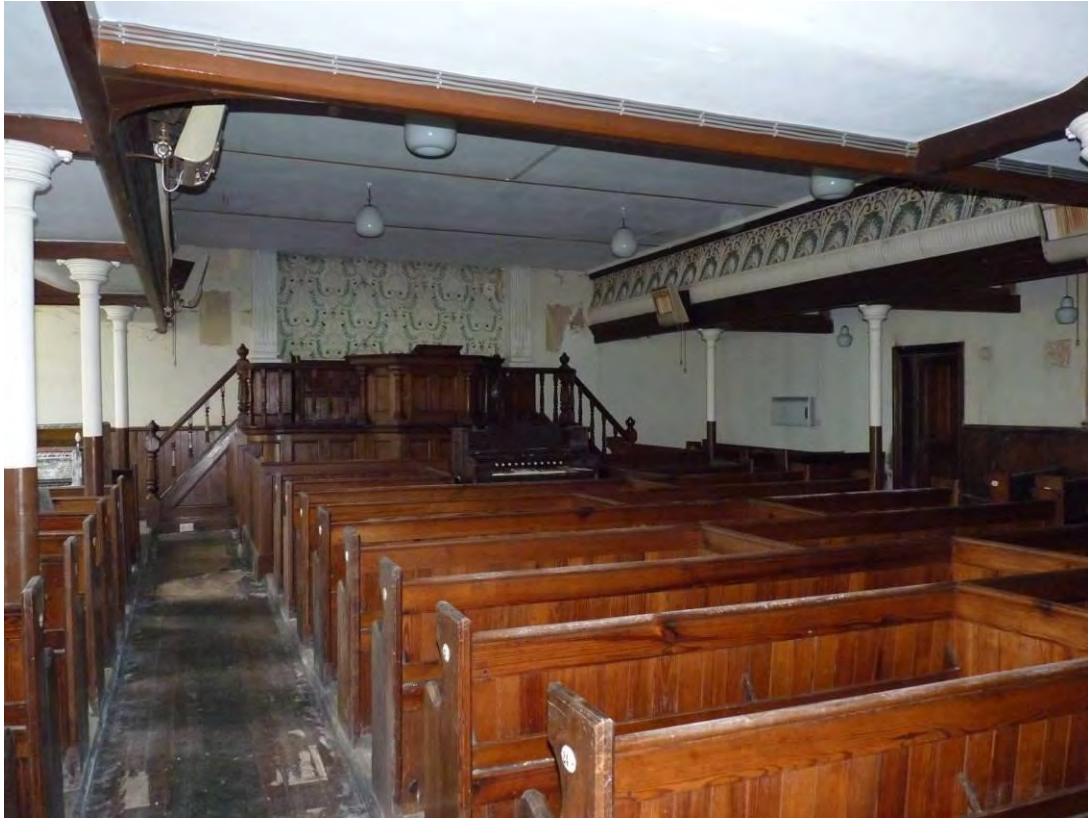
Chapel: The main chapel is a rectangular room 12.34m long by 10.74m wide. There are pews to the centre and down both sides, with two aisles running all the way to the pulpit against the rear wall (Photos 19 and 20).

Photo 19: View across the main chapel area towards the pulpit. View northeast.

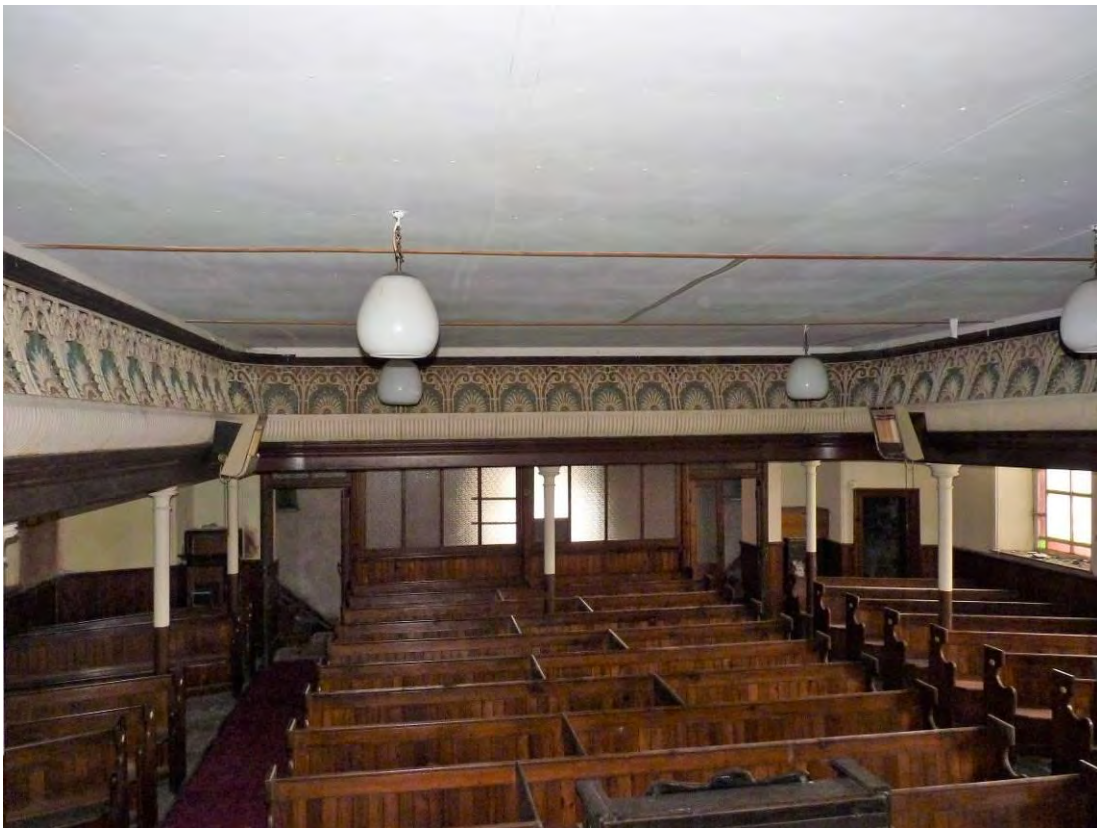
Photo 20: View from the pulpit back across the main chapel area, also note the inserted ceiling) across the gallery railings. View southwest.

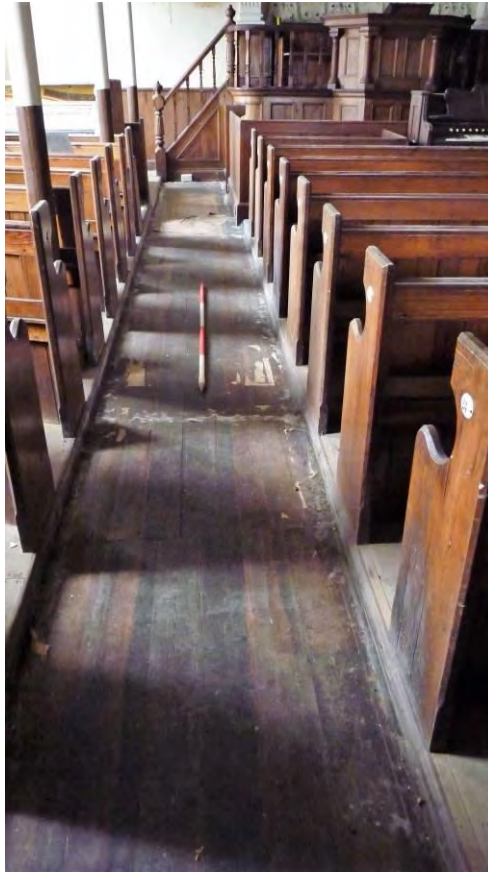
The floor consists of wooden floorboards, which in places have become subject to dry-rot. The south-east aisle retains a red carpet, while the other is now bare (Photo 21). The areas of the pews are slightly raised above the aisle, the central area 0.15m higher and the sides 0.08m higher. There are 10 pews in the central area, which are parallel to the rear wall. The pews are of wood with carved bench ends, with a spacing of 0.8m. There are alternating off-centre partitions in each pew (Photo 22). Those pews on the sides are placed at a slight angle to the side walls, so that they face the pulpit. They are spaced at 1m between each pew. There are nine pews along the left-hand (north-western) side (Photo 23). Only six remain on the right-hand side, but it is possible to see the scars on the wall where the missing three would have originally been (Photo 24).

Photo 21: Flooring (wooden floorboards) within the chapel area. View northeast, 2m scale.

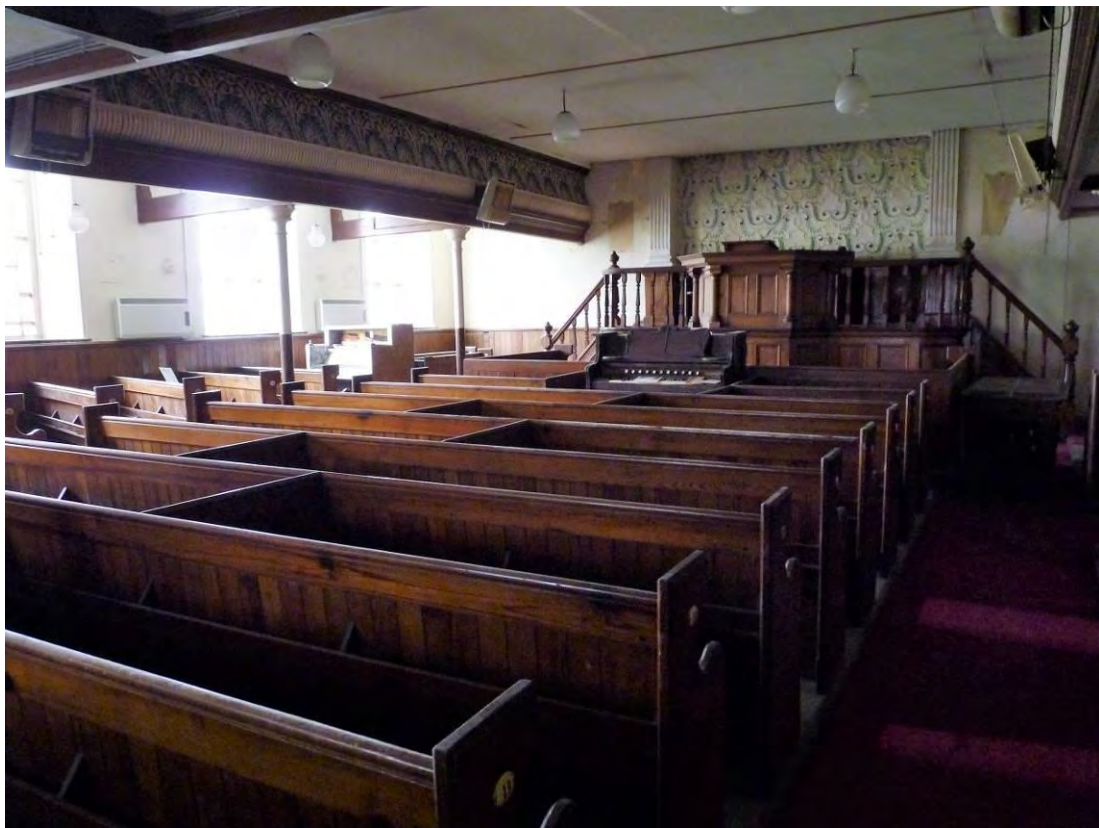
Photo 22: The central pew area, showing off-centre partitions. View north.

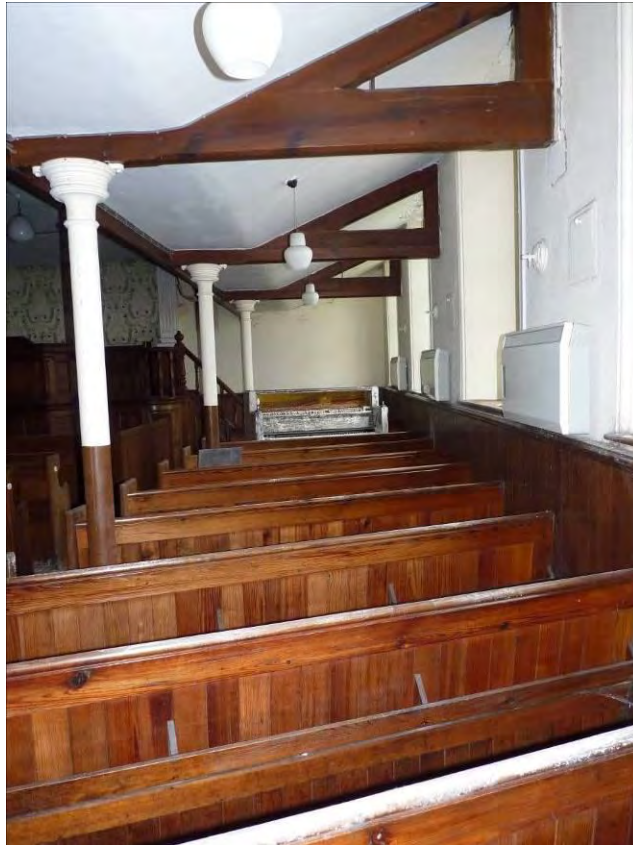
Photo 23: Pews along the northwest wall, also note the pillars and buttresses holding the gallery above. View southwest.

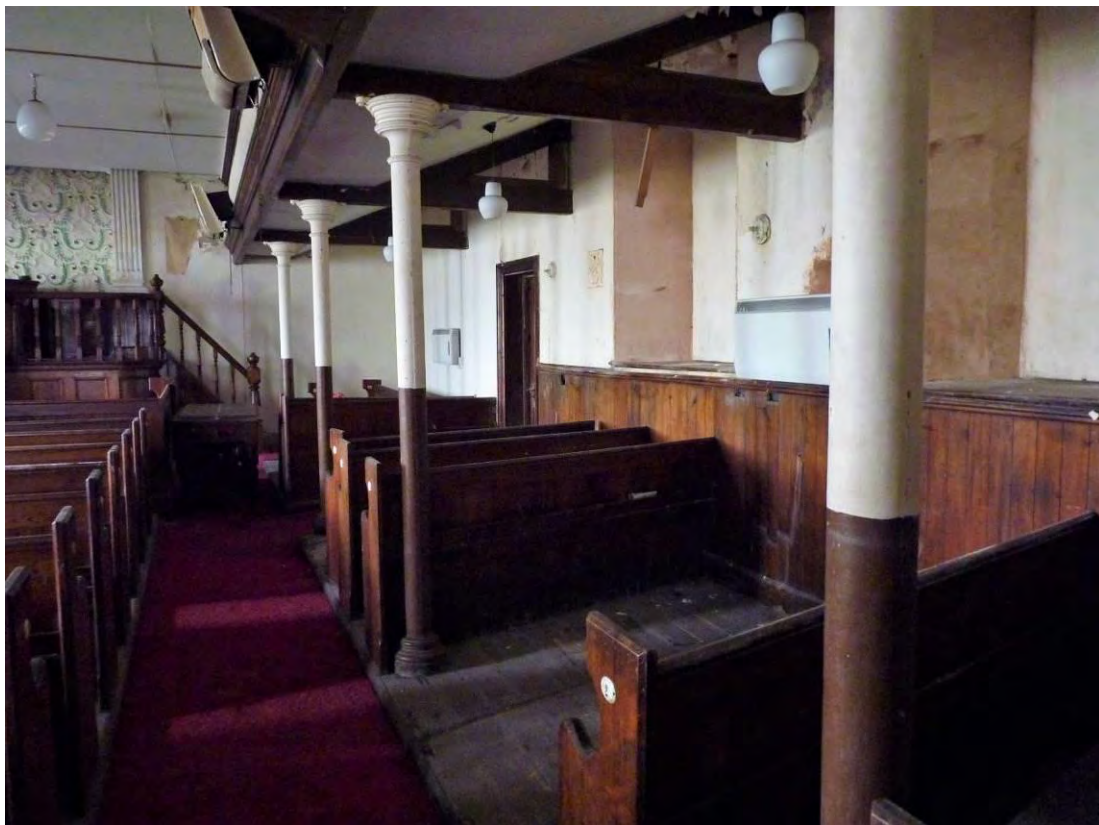
Photo 24: Pews along the southeast wall, partly removed. View northeast.

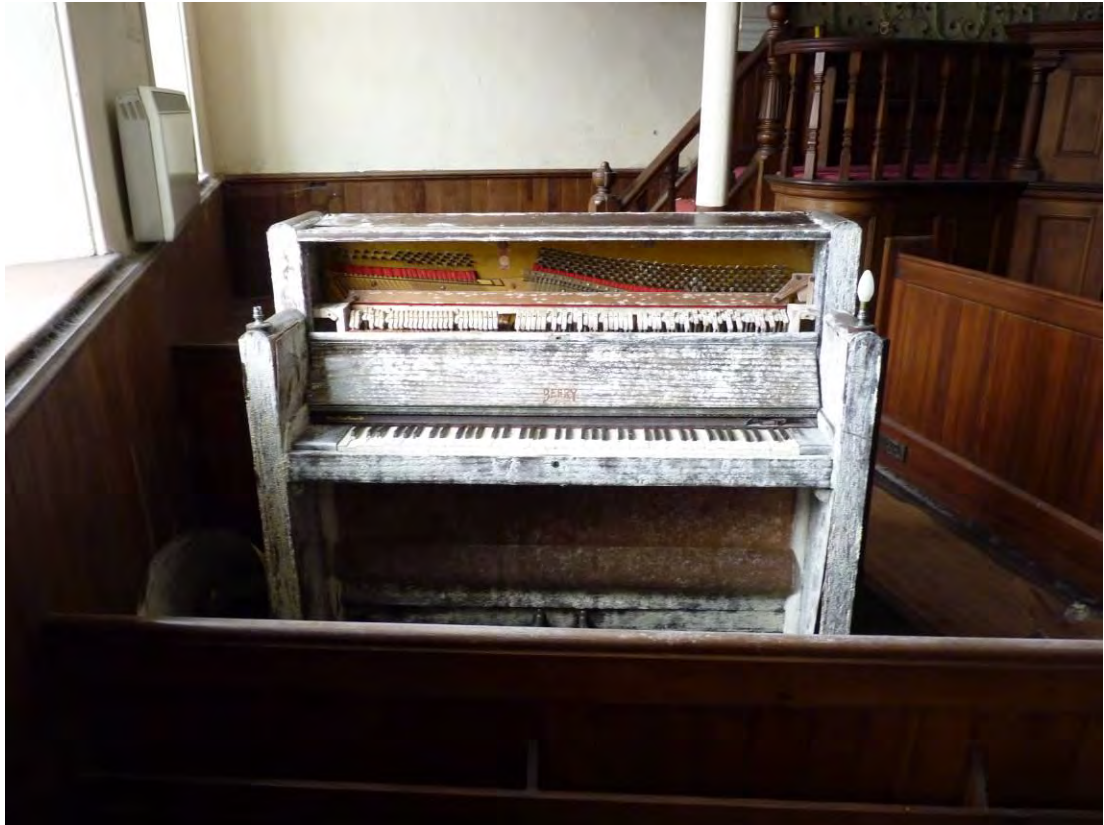
To the rear (northeast) of the building along either side of the pulpit are the pews of the choir. These were perpendicular to the rear wall, and had three rows. In front of the left-hand side choir pews is a piano in poor condition (Photo 25). To the front of the pulpit is the chancel, which is a rectangular space bounded by a single row of pews (Photo 26). An organ is located in front of the chancel (Photo 27).

Photo 25: Piano along the northwest wall.

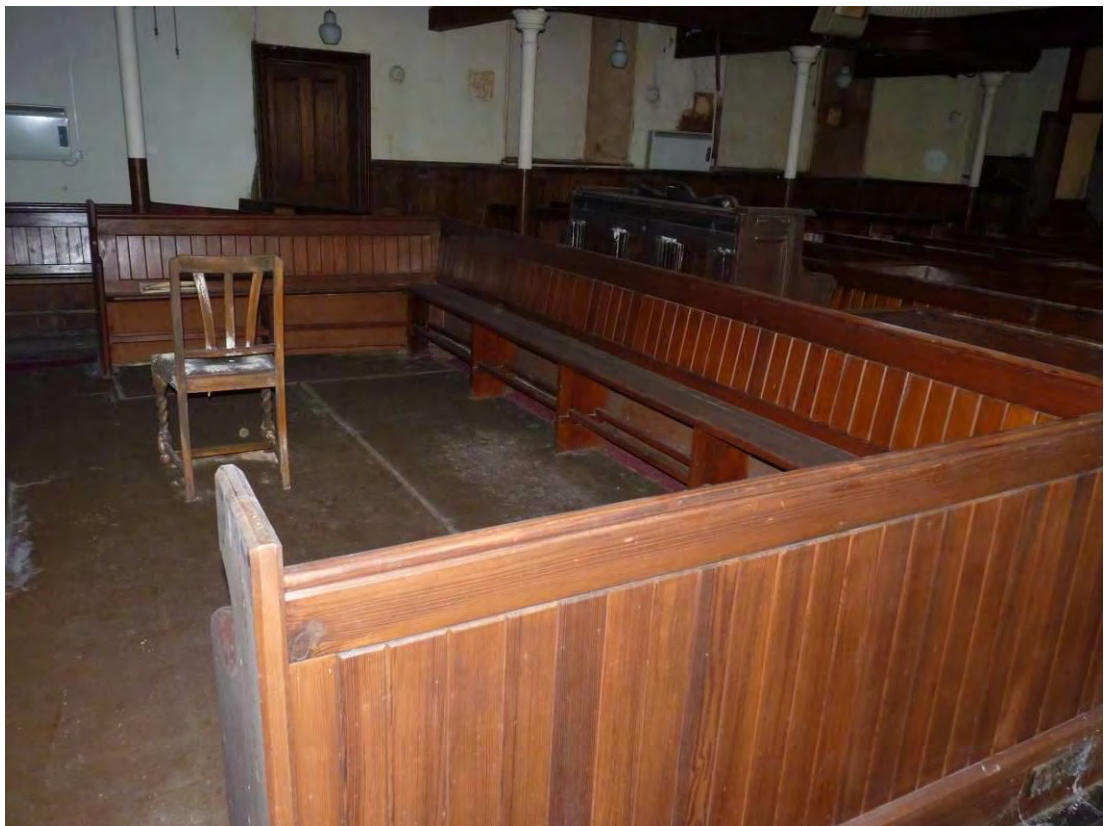
Photo 26: Chancel area in front of the pulpit. View south.

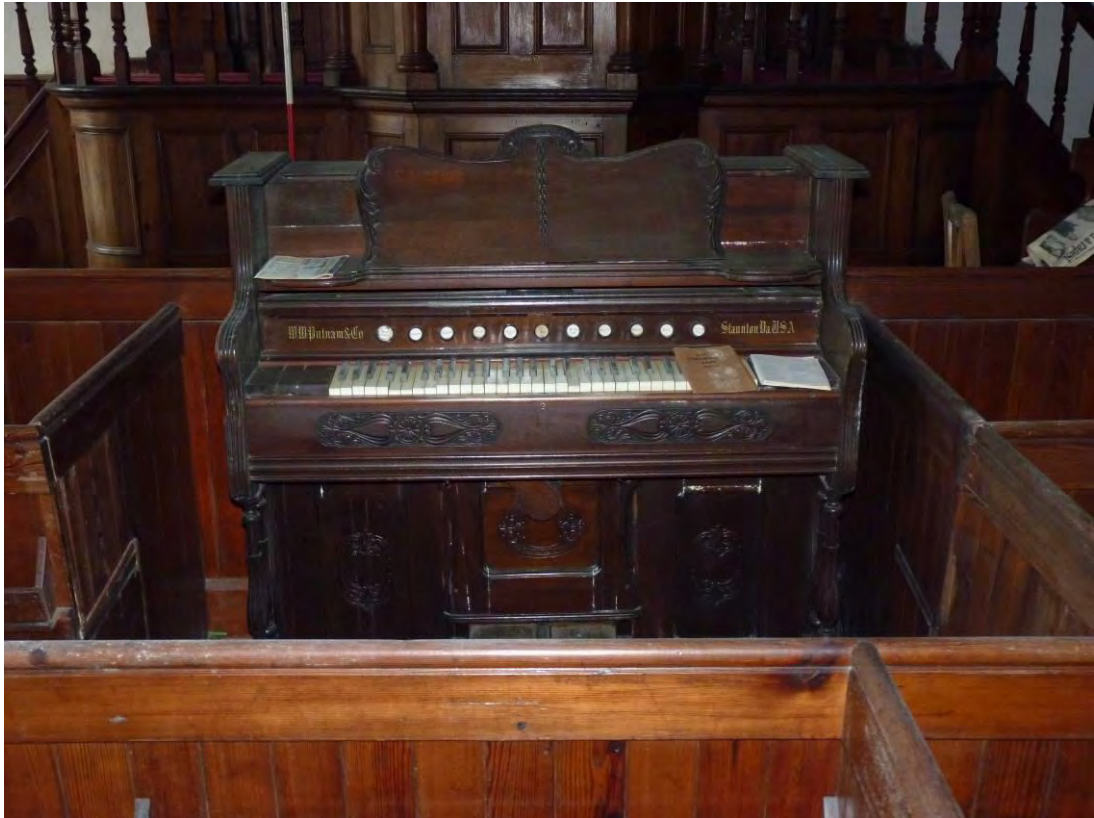
Photo 27: Organ, placed centrally behind the chancel area. View northeast.
