## **Nebo Independent Chapel, Bryn Road, Glyncoed**

Building Recording (Level 3)

Report No. 1762

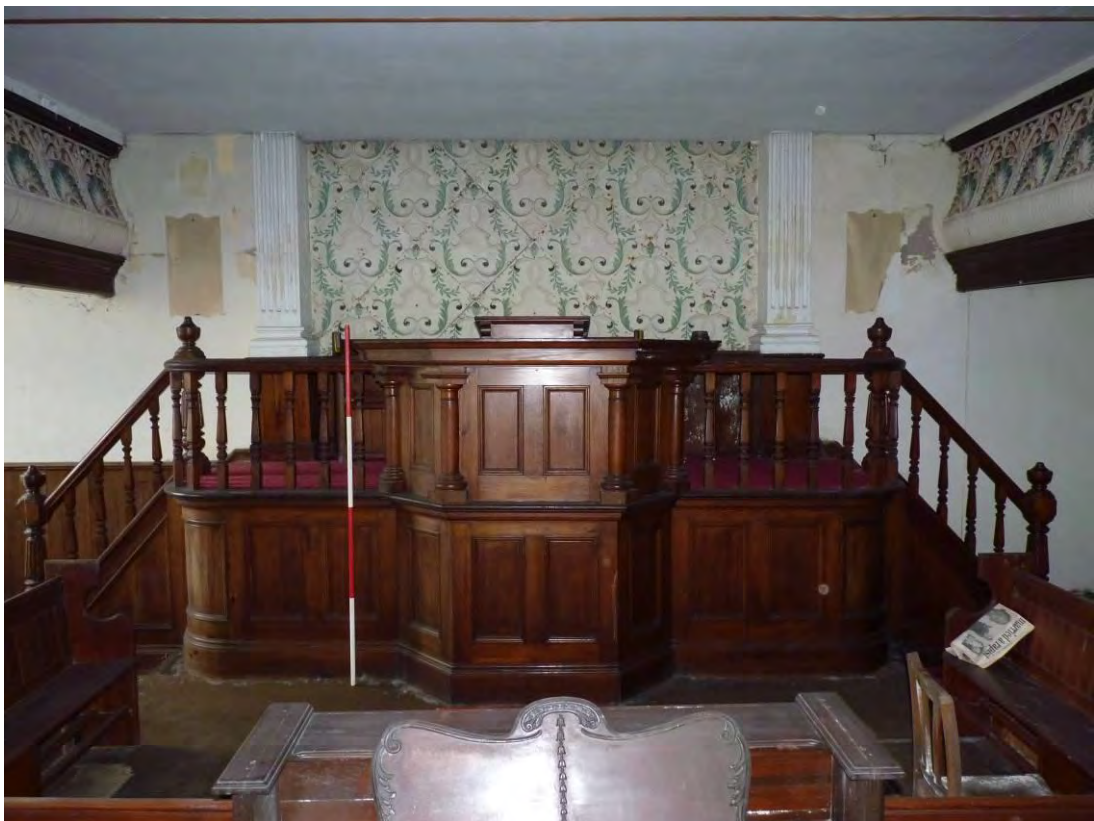
The pulpit is reached by steps up from the aisles on either side. It is of wood panels with wooden balustrades (Photo 28 & 30). The stairs and pulpit are carpeted with red carpet (Photo 31). There is a pew along the rear wall (Photo 32) and a small cupboard to the right-hand side (Photo 33).

Photo 28: The pulpit. View northeast, 2m scale.

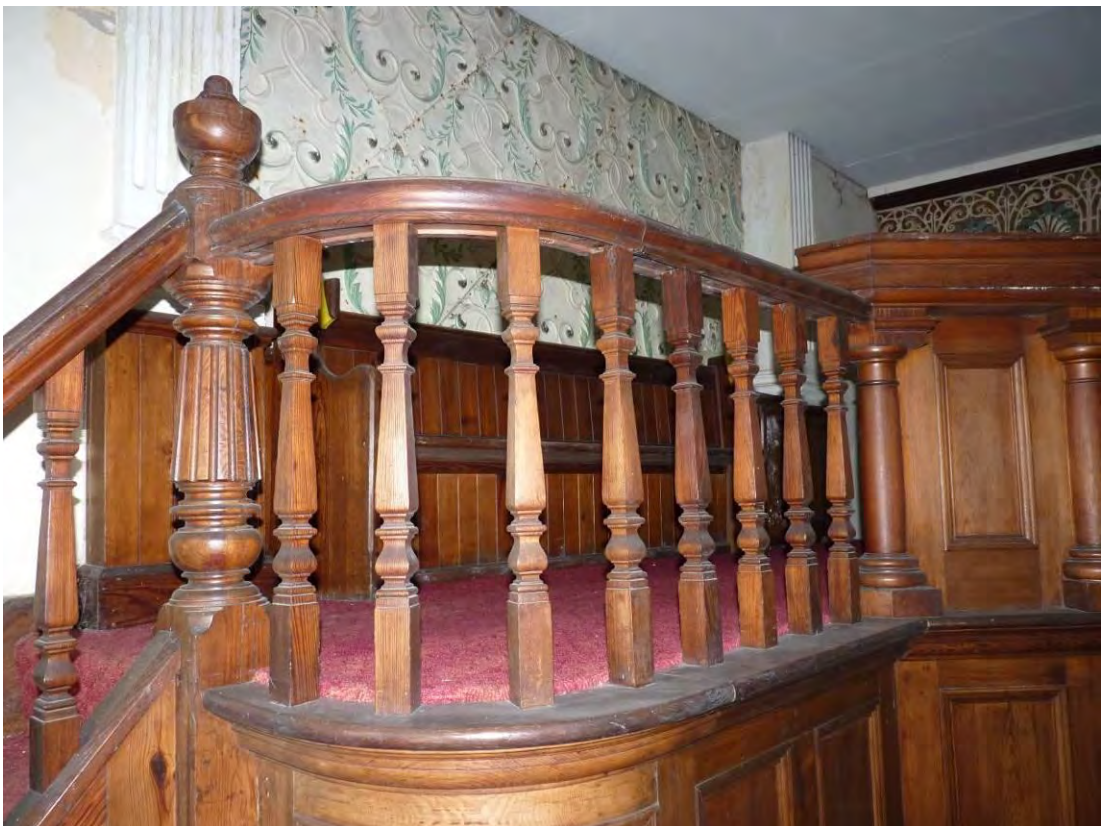
Photo 30: Wooden balustrades to the pulpit. View east.

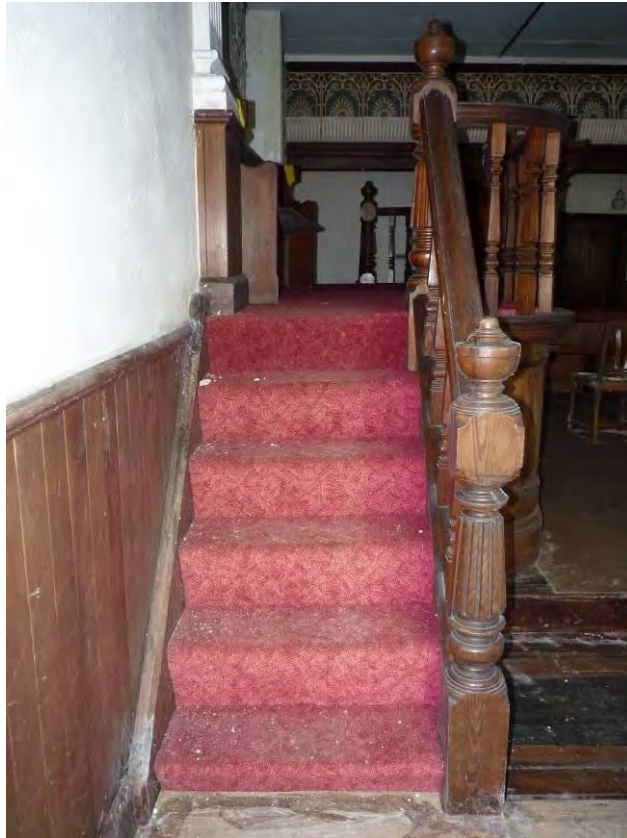
Photo 31: Stairs to the pulpit. View southeast.

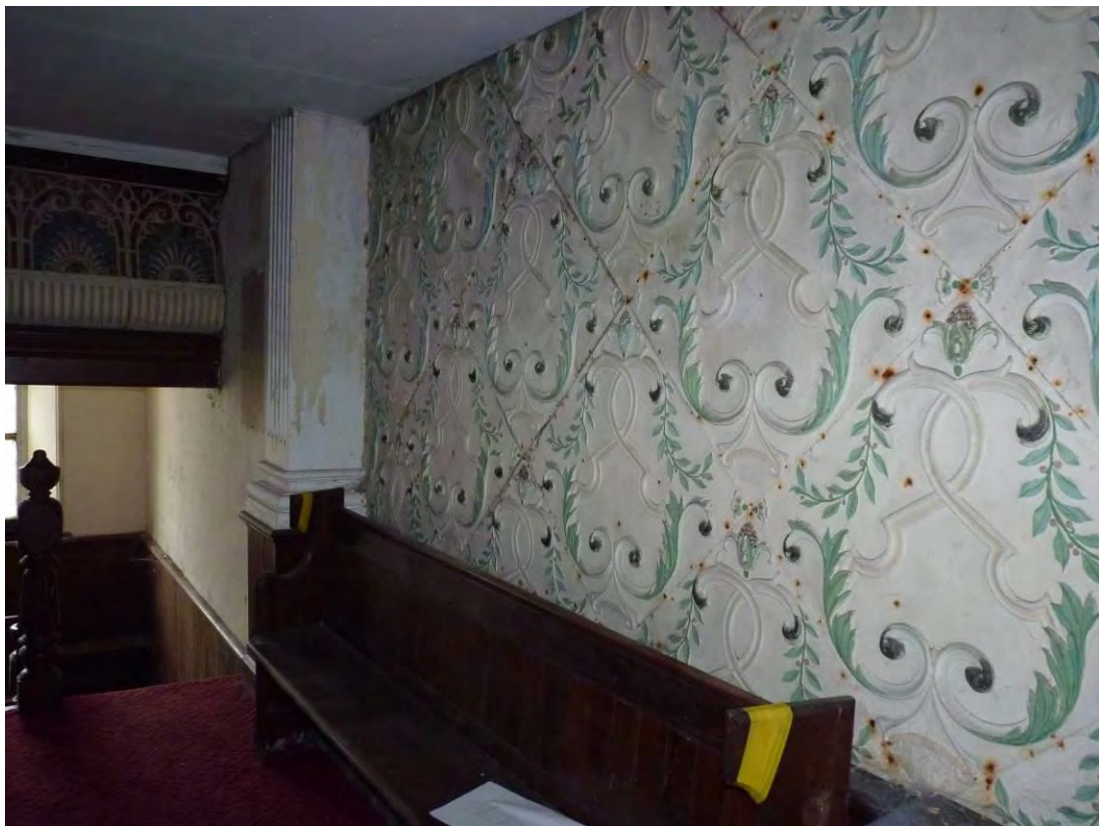
Photo 32: Pew along the rear wall of the pulpit. Also note the recessed wall with decorative paper tiles. View north.

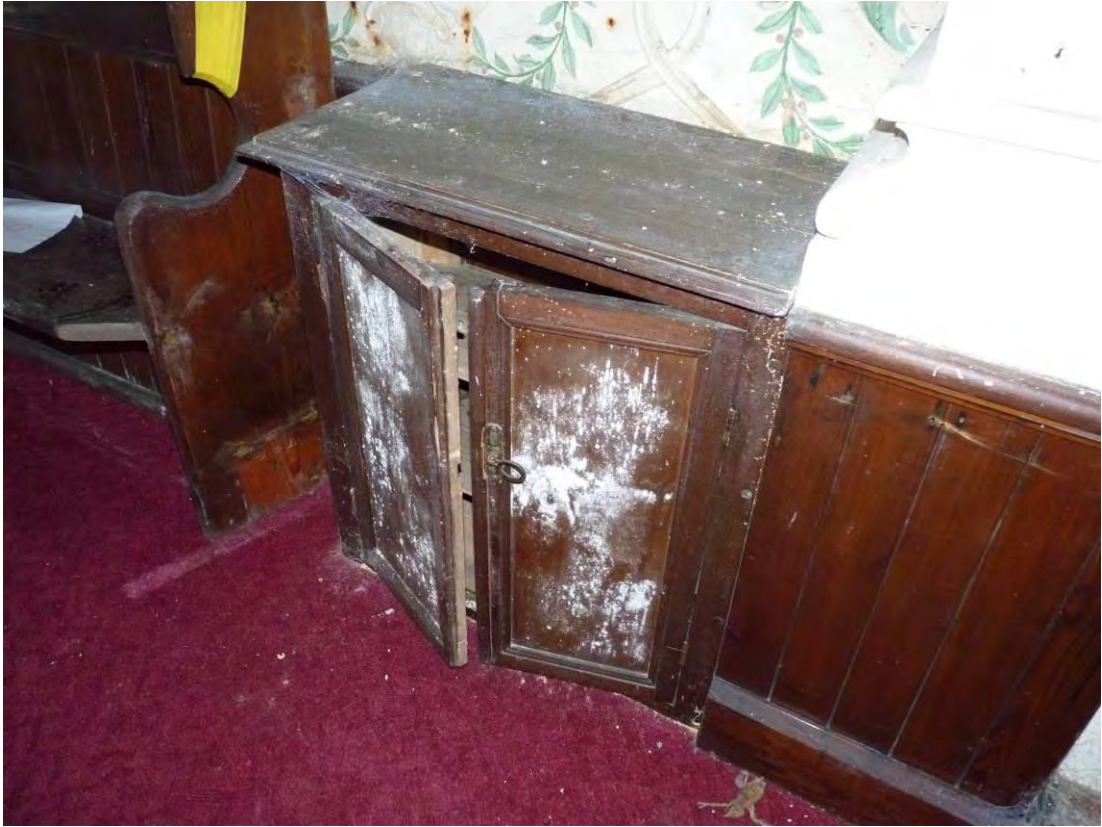
Photo 33: Small cupboard at the rear of the pulpit.

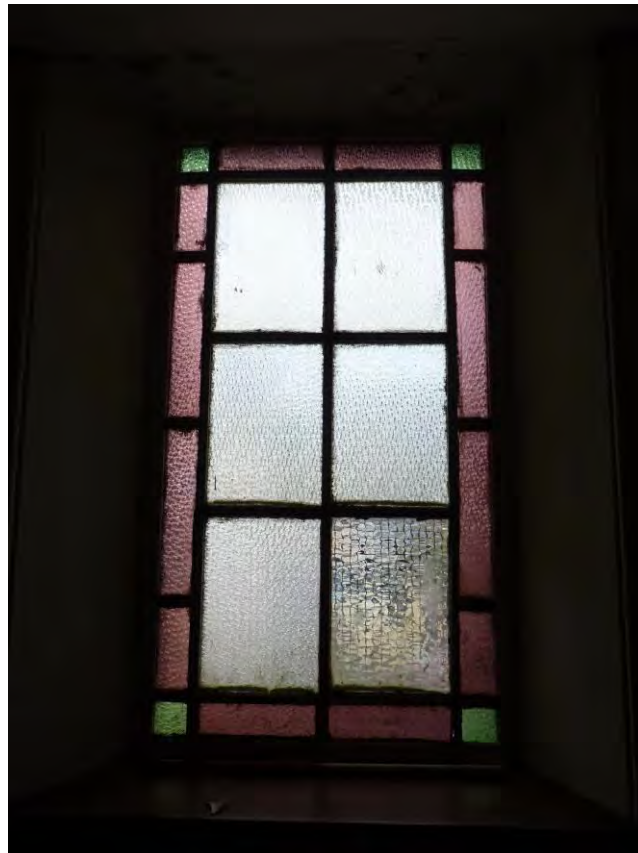
The left-hand wall has four wooden framed windows recessed into the wall. The south-western two windows consisted of six panes of clear glass with coloured glass surrounds and are probably original (Photo 36). The north-eastern two consist of six panes of clear glass, some of them patterned, and are probably later replacements (Photo 37).

Photo 36: Possible original ground floor windows within the chapel, in the northwest wall. View northwest, 1m scale (along base).

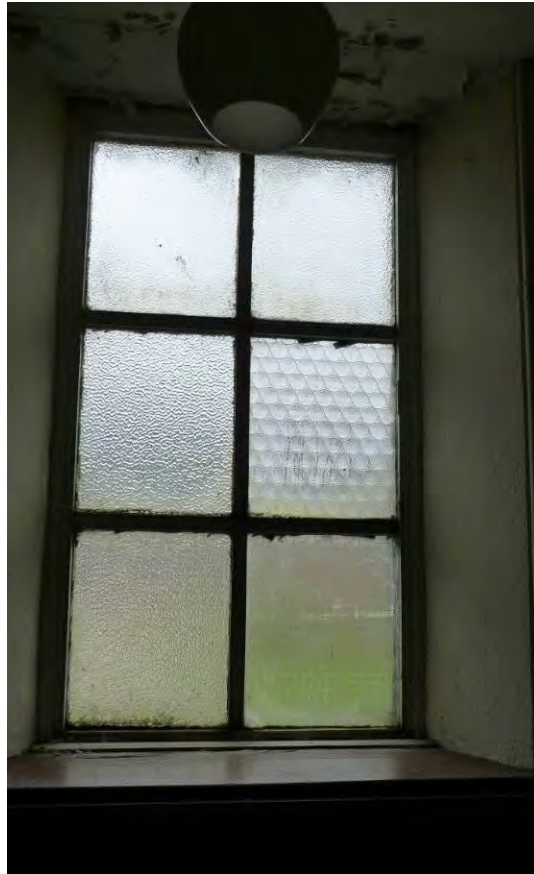
Photo 37: Possible later replacement ground floor windows within the chapel, in the northwest wall.  
View northwest.

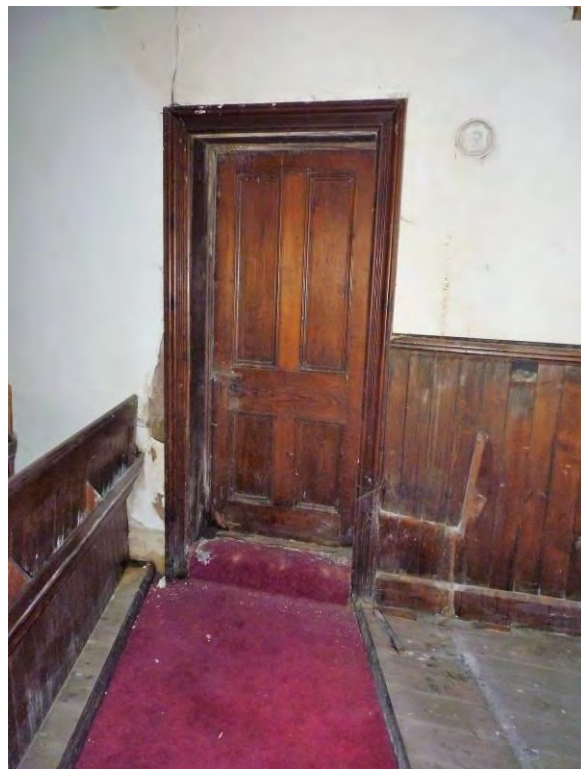
Photo 38: Blocked doorway in the southeast wall, originally leading to the adjacent building.

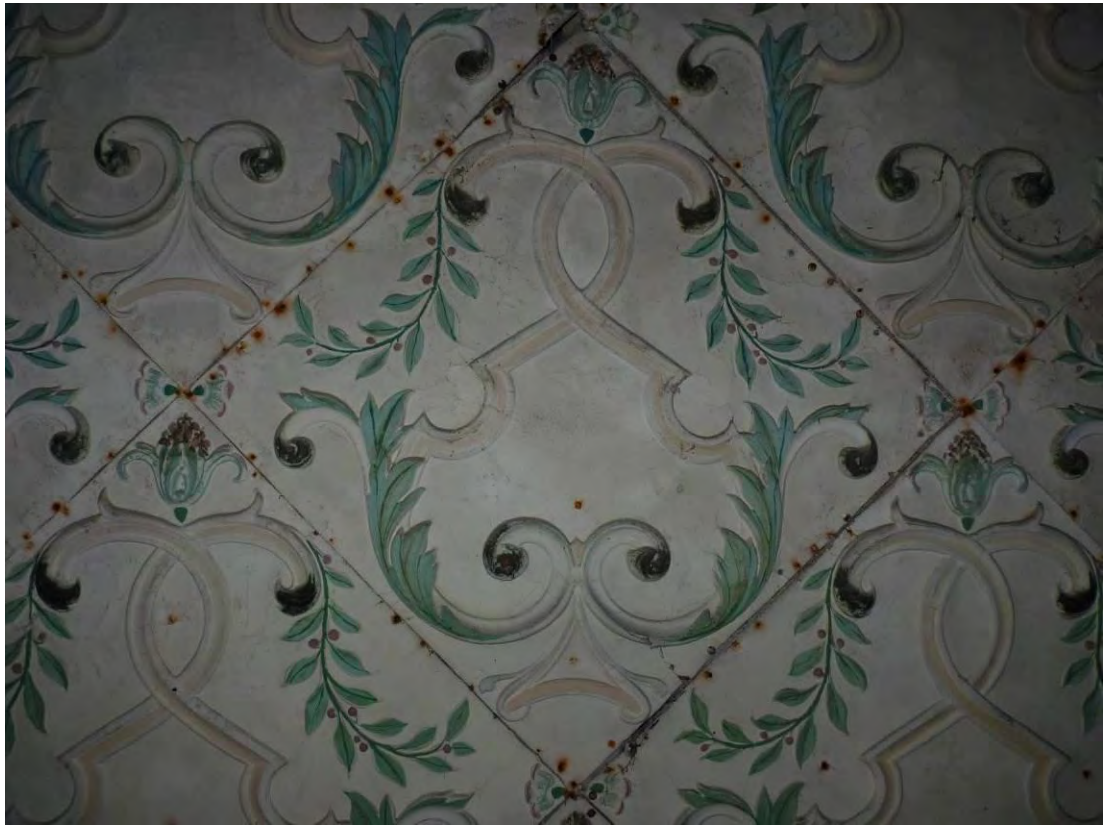
Photo 39: Detail of the decoration in the recessed wall behind the pulpit.

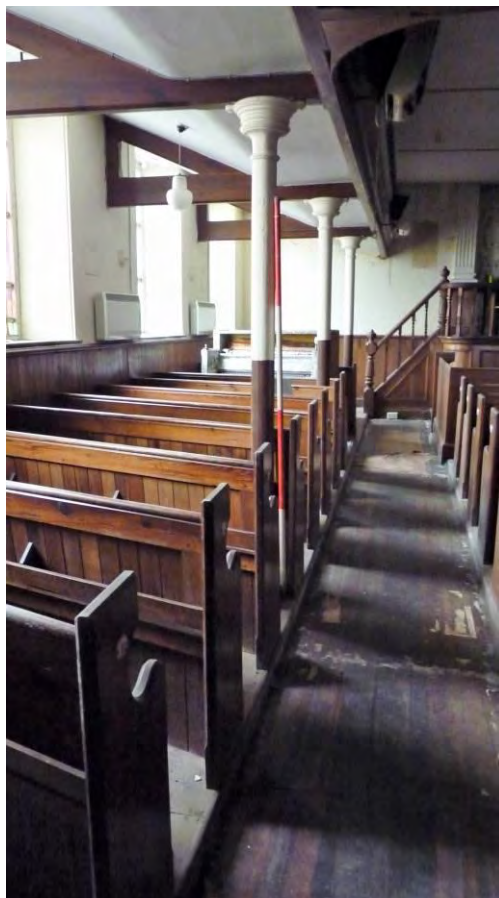
The chapel ceiling consists of two parts. The outer, which runs around the front and sides but not the rear wall is original, and is the base of the galleries above. These are supported by wooden buttresses and cast iron columns – four down either side and one to the rear of the chapel (Photos 40 & 41). The pillars are in the Doric style, and painted brown to the lower and white to the upper halves. The central part of the ceiling, which covers the rest of the space, is a modern suspended ceiling constructed from plasterboard. This ceiling sits above the wrought iron decorated screen of the balcony, which has carved wood beams to the bottom, with fluted plasterwork and then decorated ironwork above (Photos 42 & 43). It has been boarded with MDF board behind. Modern (*circa* 1980s) electric heaters have been installed along the balcony, and four modern light fittings are suspended from the modern ceiling.

Photo 40: Buttresses and columns holding the gallery above. View northeast, 2m scale.

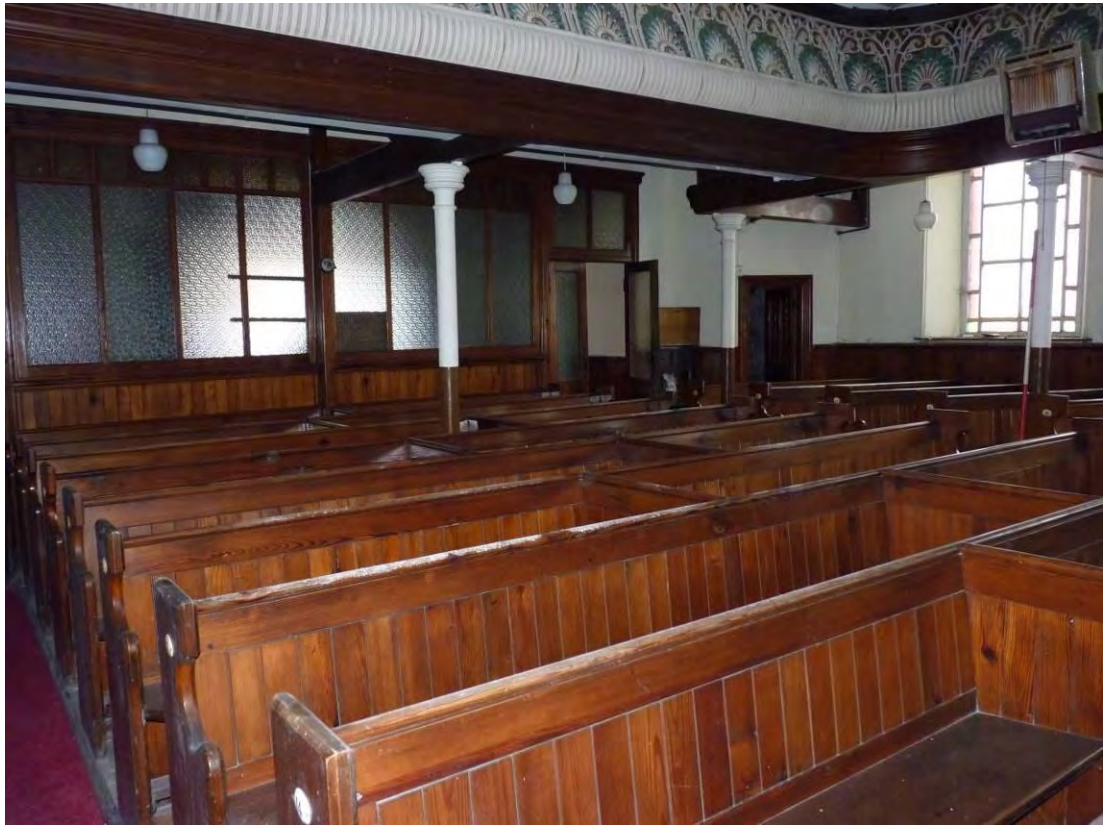
Photo 41: Buttresses and columns holding the gallery above, at the southwest end of the chapel. View west, 2m scale.

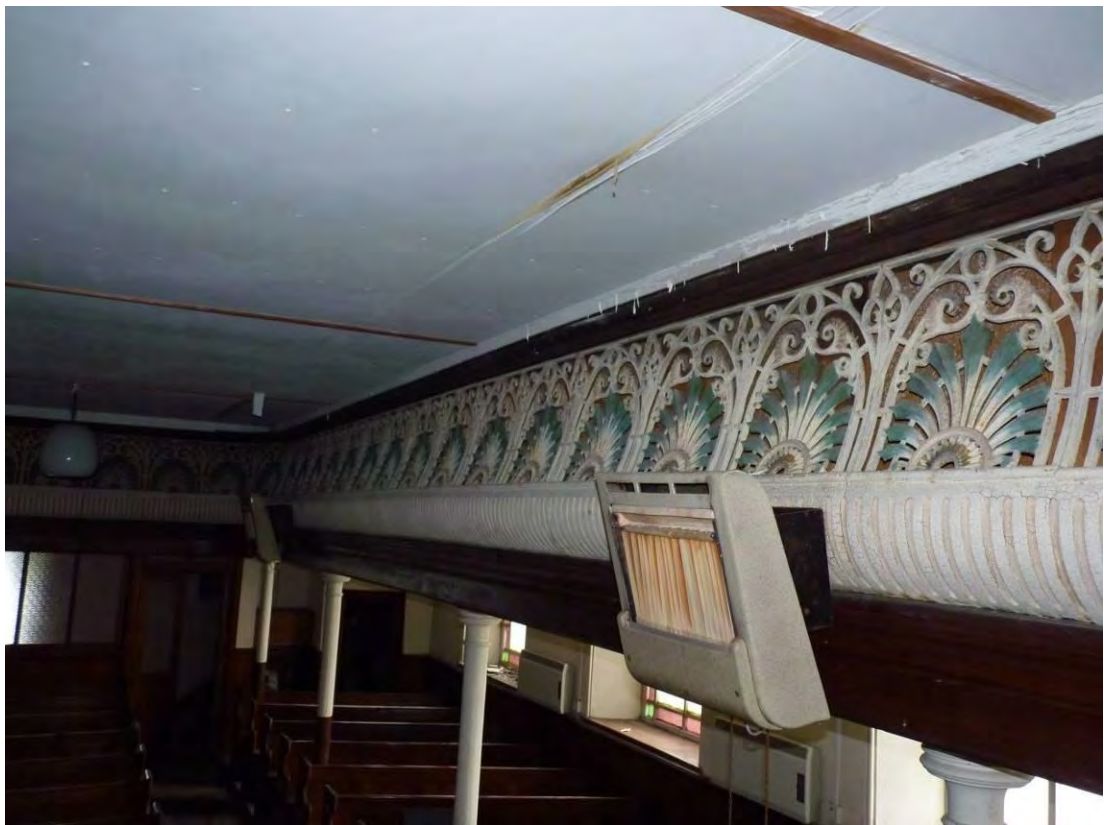
Photo 42: Decorated screen to the gallery. View west.

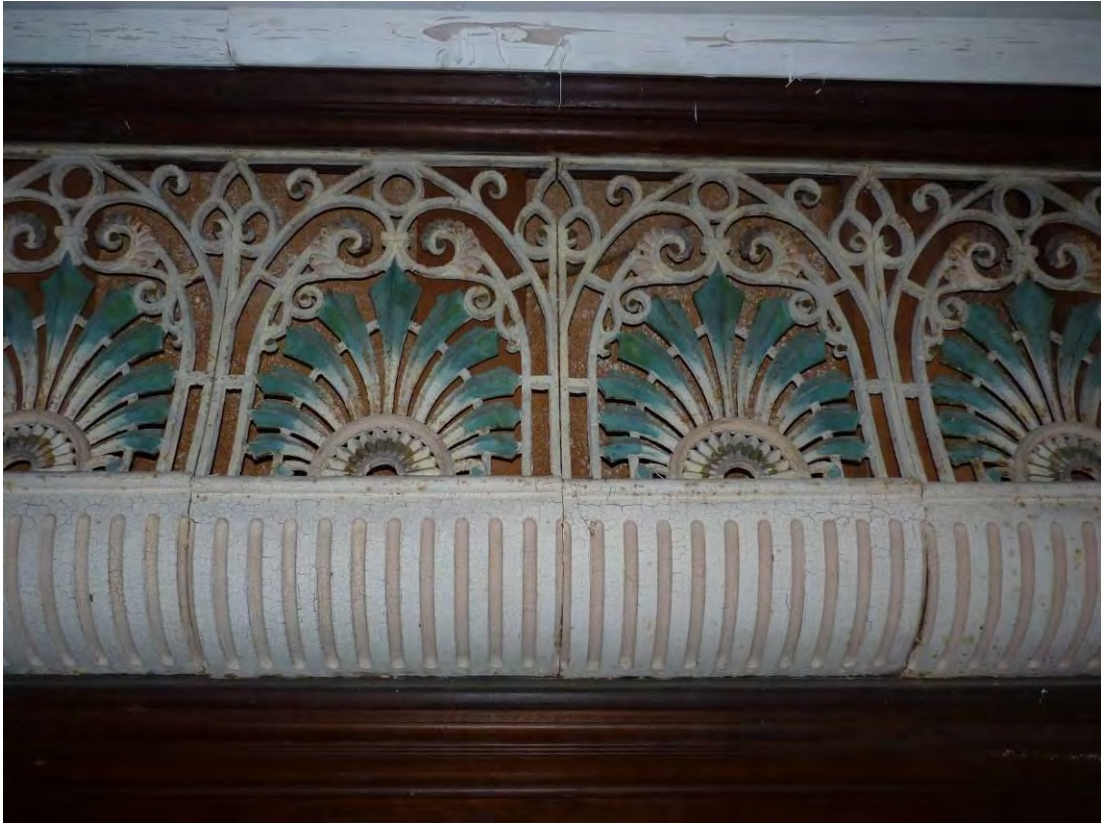
Photo 43: As above, in detail.

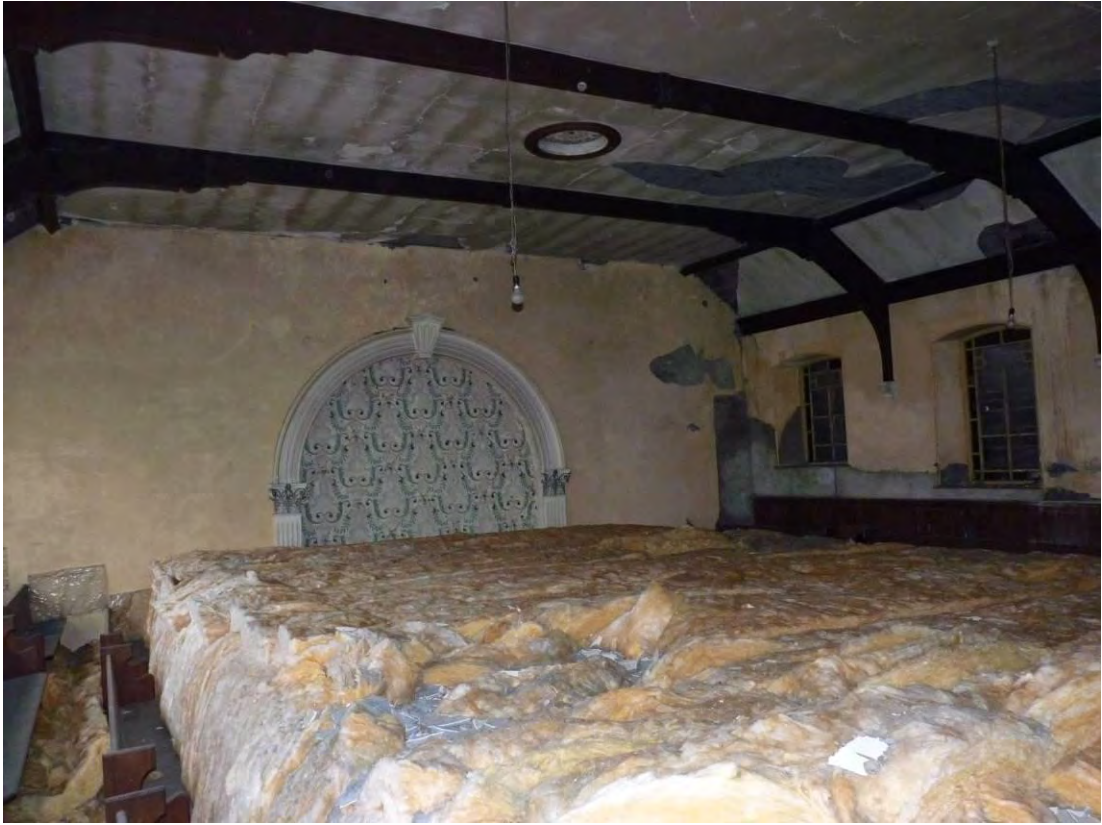
Photo 45: View from the top of the 1<sup>st</sup> floor access stairs, showing the insulation-covered inserted ceiling. View east.

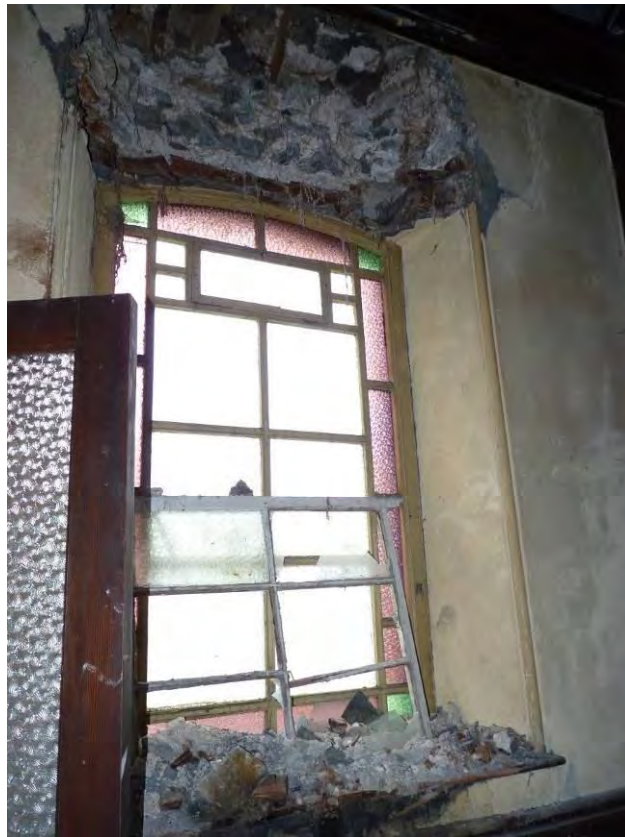
The walls are painted plaster in a poor state of repair. On the north-west wall part of the wall above the left-hand window has collapsed, revealing the rubble stone construction and lime mortar with coal inclusions (Photo 48). On the front wall large areas of plaster have fallen, behind which is a brick wall (Photo 49). The bricks are red brick with mortar, in a stretcher bond. They show clear signs of damp with mould growing in places.

Photo 48: 1<sup>st</sup> floor window in northwest wall, with collapsed lintel. View north.

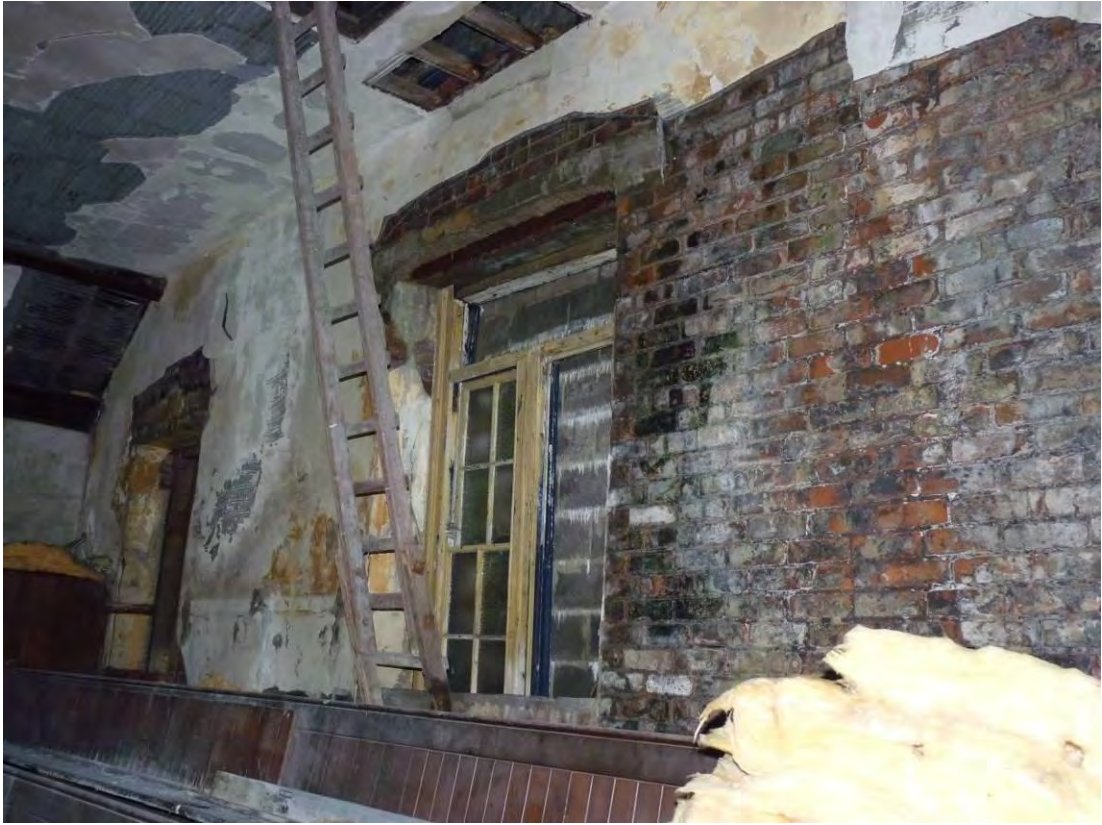
Photo 49: Inner face of the southwest gable wall, showing brick lining, blocked windows, and roof access. View south.

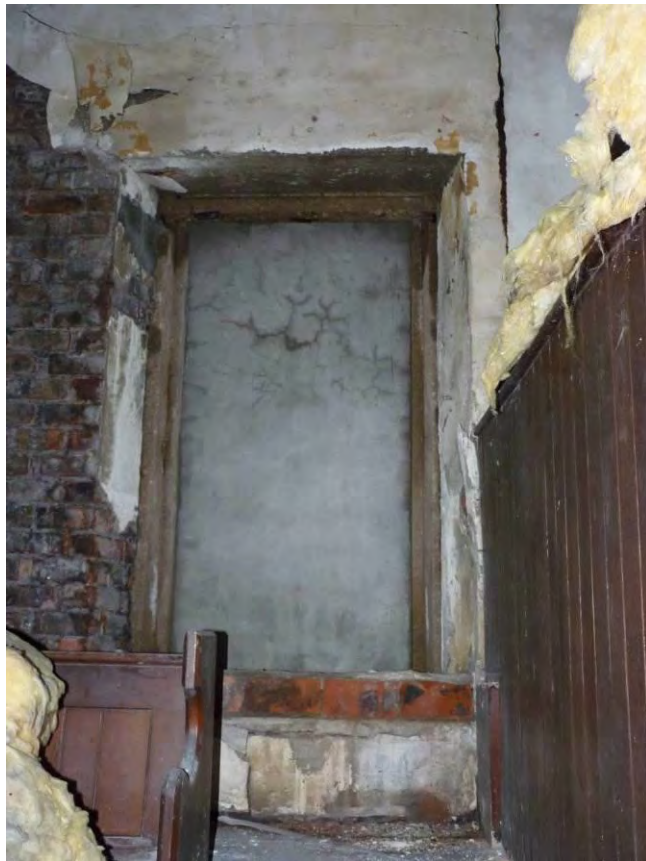
The front wall has three large recessed window openings that have been blocked up with breeze blocks and concrete, most likely in the 1980s. The original wooden window frames are still in place in the central window, although in poor repair. It is mullion and transom, with sash windows to either side of the mullion, although only the left-hand side panel panes are extant. This has eight panes with clear patterned glass. The window is recessed, and has plain stone lintels and sills. The side windows do not retain the window frames, although a simple wooden frame is still in place (Photo 50). The side windows have no lintel and have a red brick sill.

Photo 50: Blocked window opening on the 1<sup>st</sup> floor, southwest gable wall. View southwest.

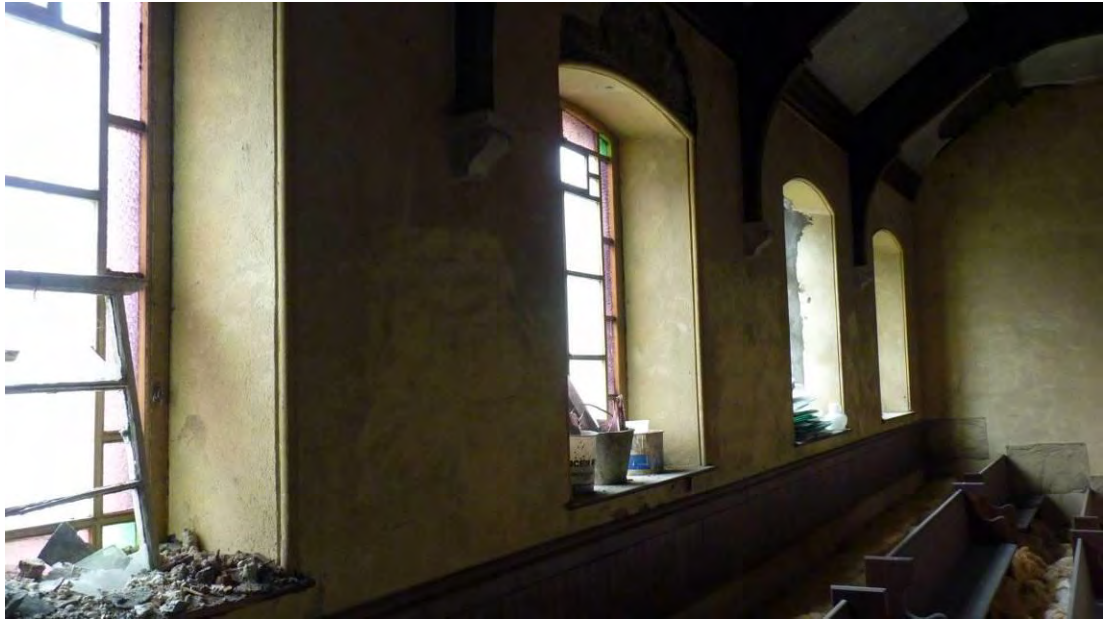
The long walls both have four windows. They are all in the same style, recessed with a single band plaster detail to the edge of the opening (Photo 51). They are swept head with flat wooden sills. The windows have a central six light section of clear glass with a transom above and coloured border of red textured glass with green corner pieces. On the south-west wall the far left-hand window has been partially blocked at the bottom, shortening the height of the window.

Photo 51: 1<sup>st</sup> floor windows along the northwest wall. View north.

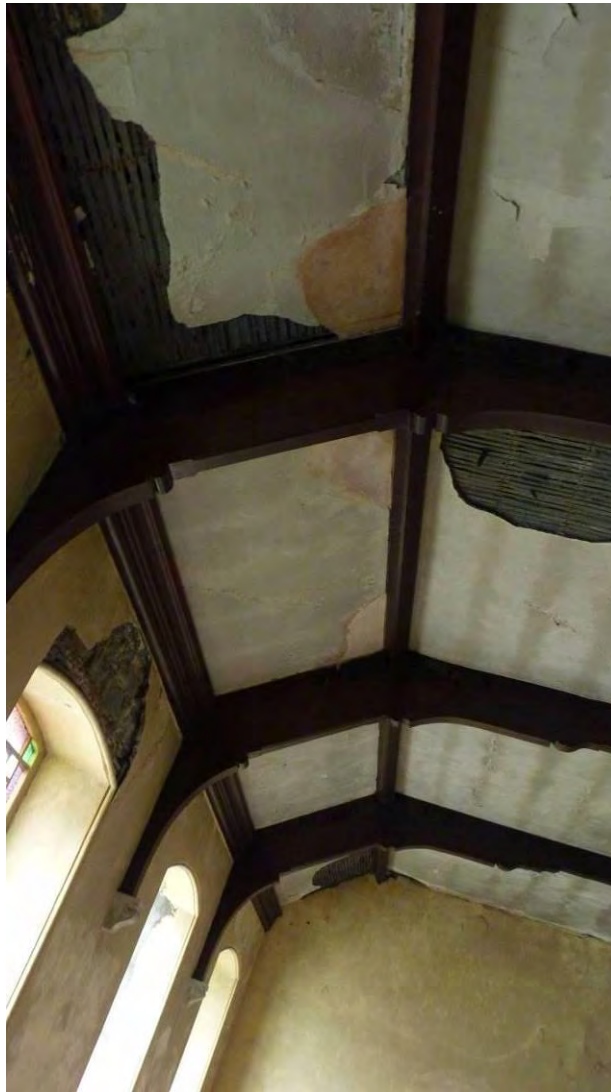
The roof is four bay, chamfered (Photos 52 & 53), with carved detail decoration on the ceiling joists. The ceiling is painted lath and plaster in poor state of repair. In places the plaster has collapsed, revealing the laths behind. To the centre of the ceiling is a decorative medallion in a stylised floral motif. Two light bulbs hang from the central bay on long wires with no fittings.

Photo 52: Ceiling detail, showing the ceiling joists against the northwest wall.

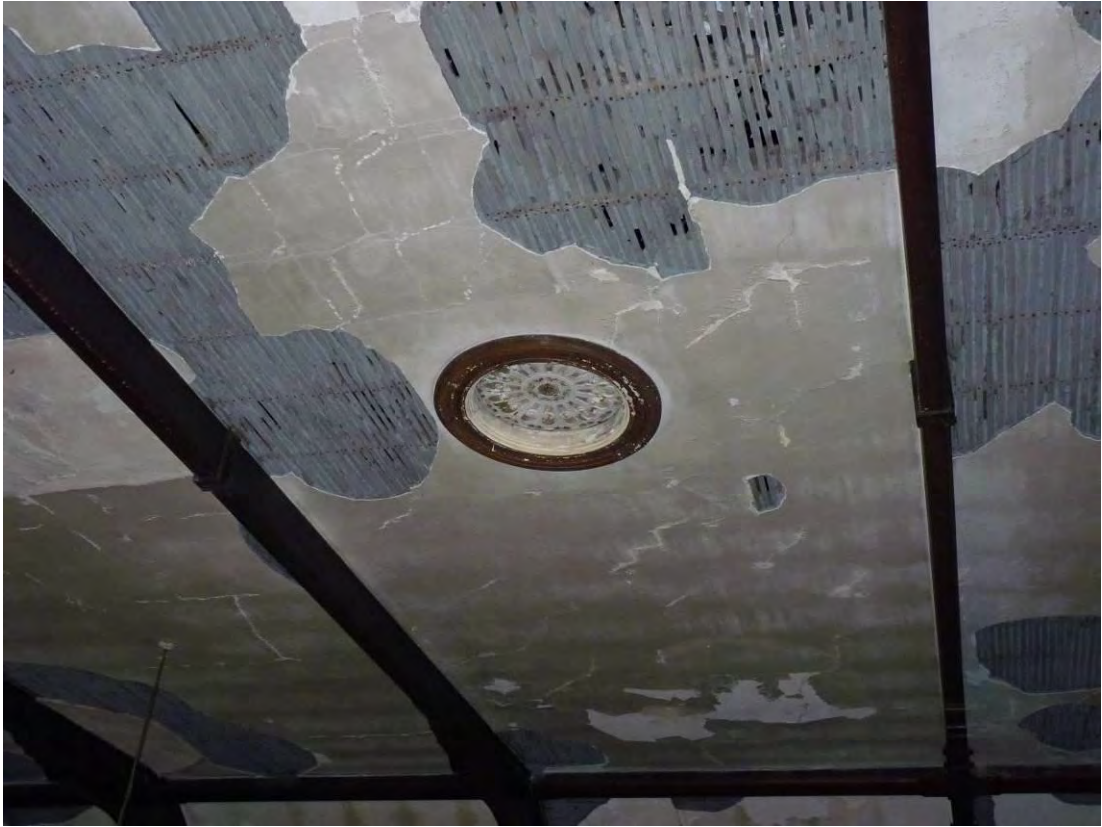
Photo 53: Ceiling detail, showing the lathe and plasterwork and the central decorative medallion.
