On behalf of Purcell ®

Issue 01
April 2024
TE Cardiff 7 Ltd

HOWELL'S: LEVEL 4 HISTORIC BUILDING RECORD, FORMER HOWELLS DEPARTMENT STORE, CARDIFF

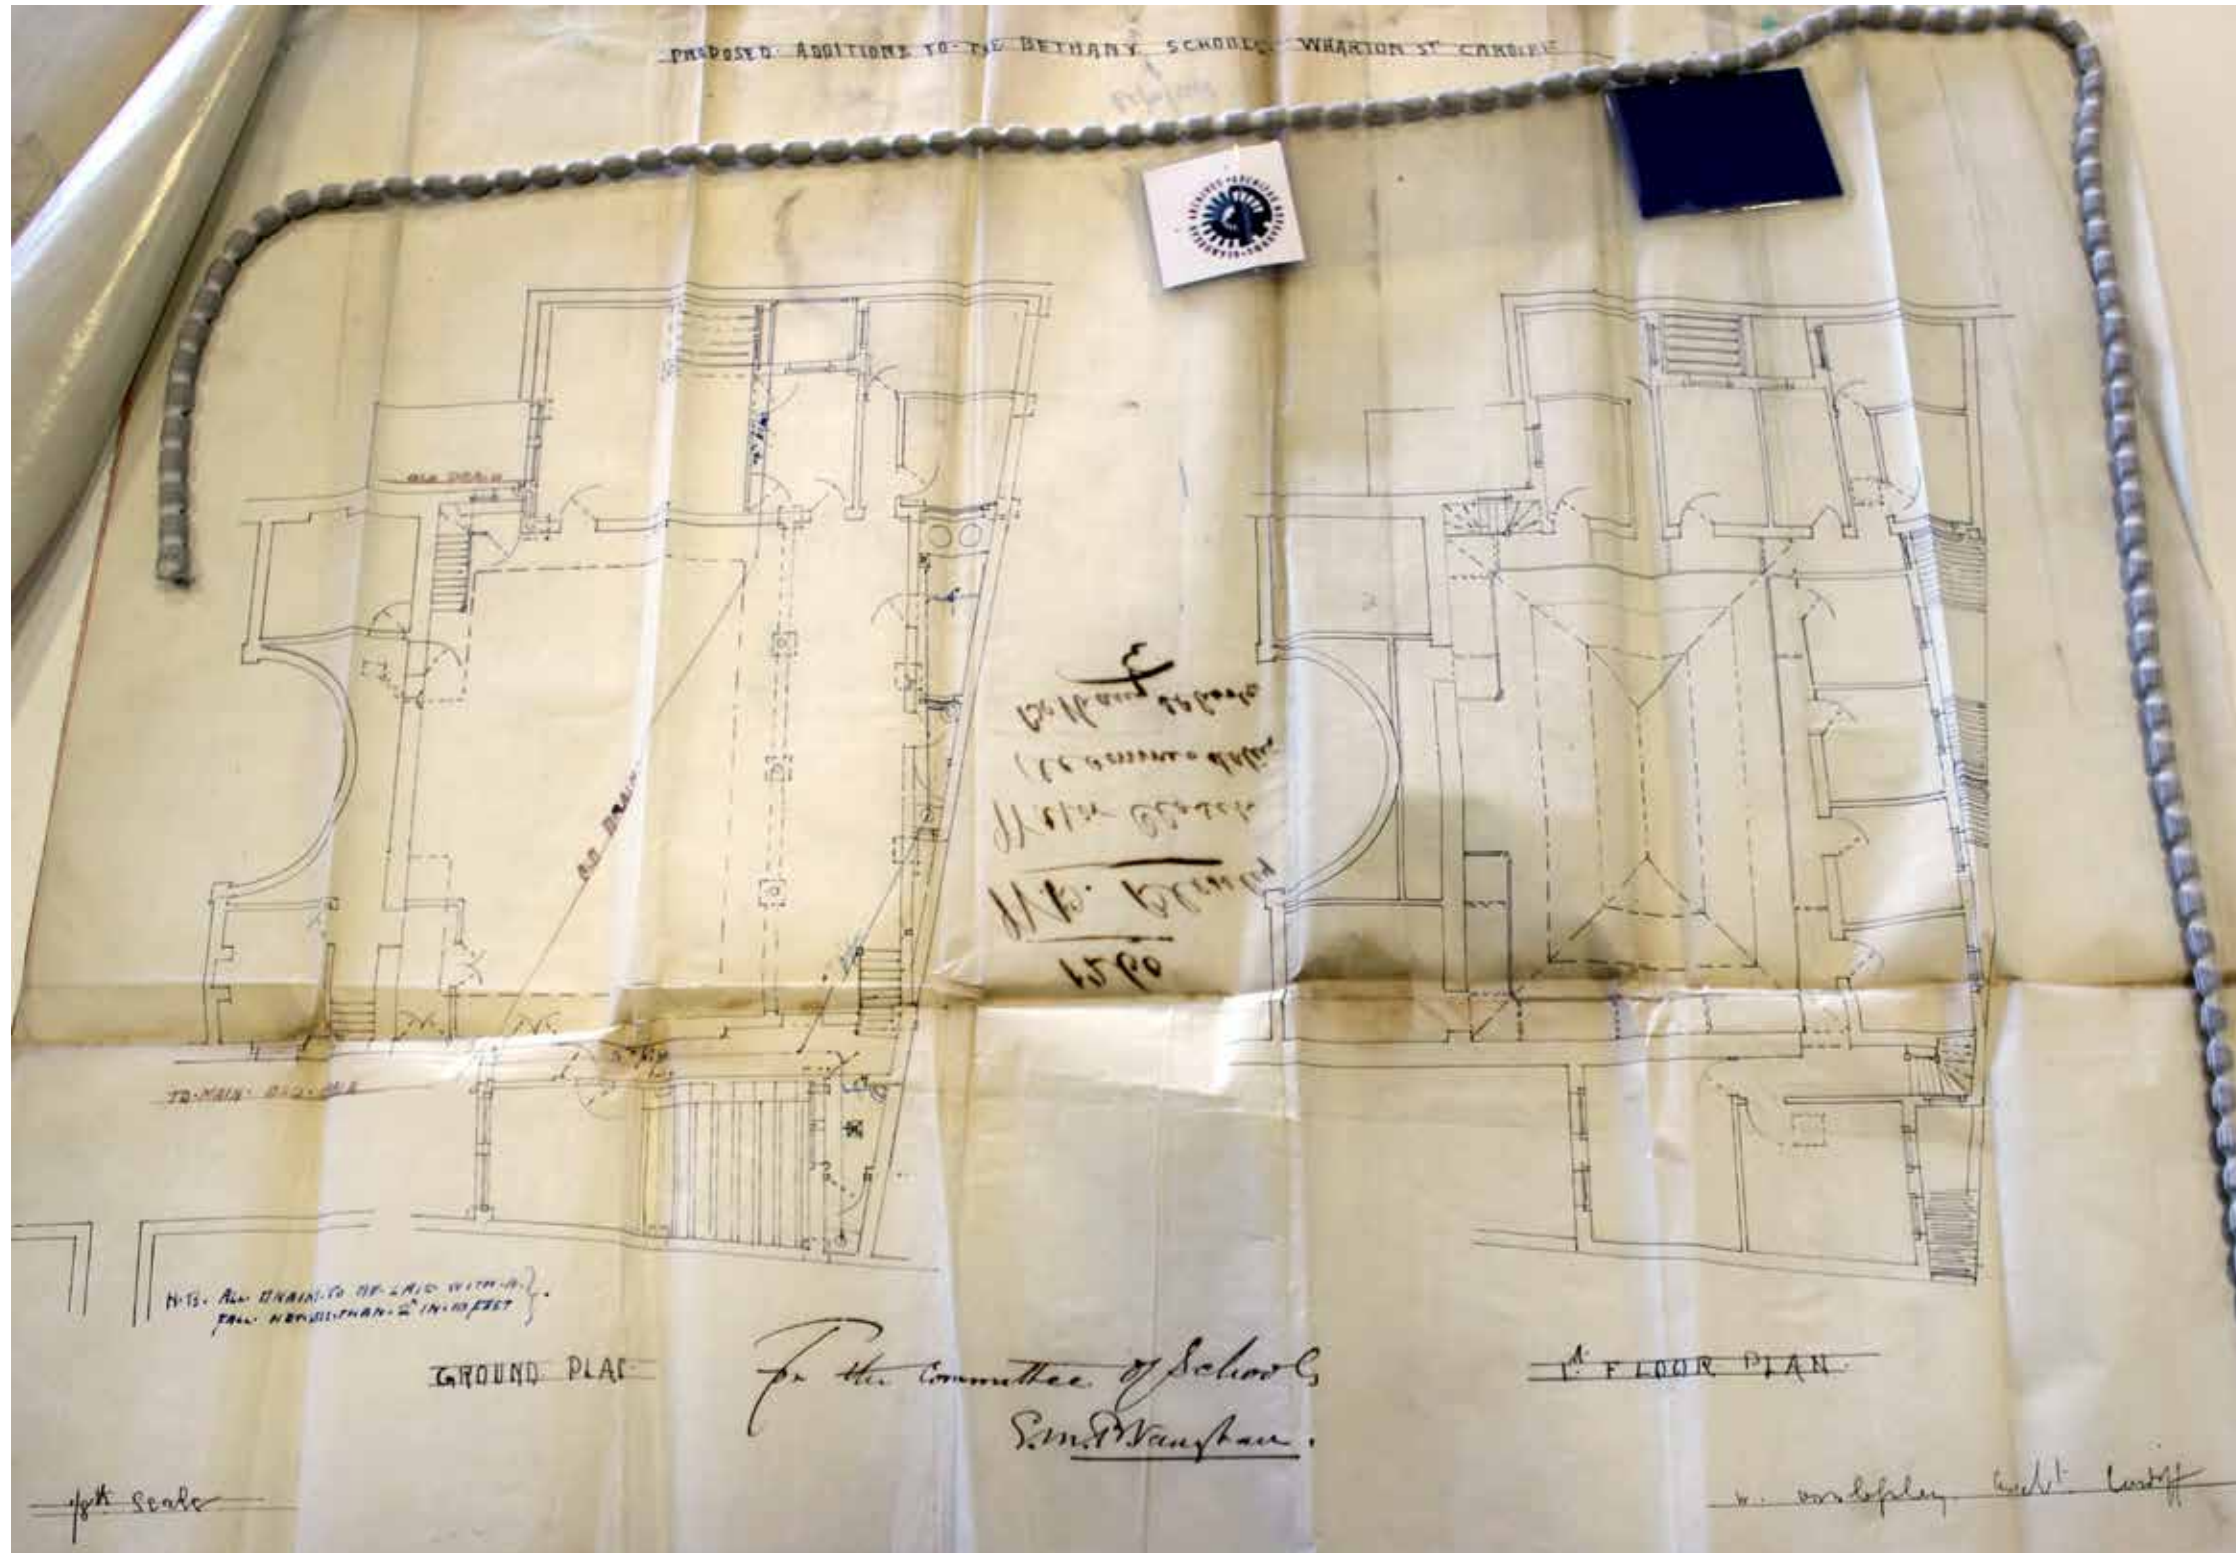
Plan of the ground and first floors of the Bethany Sunday School by W.D. Blessley 1878. (Glamorgan Archives) (**permission pending**)

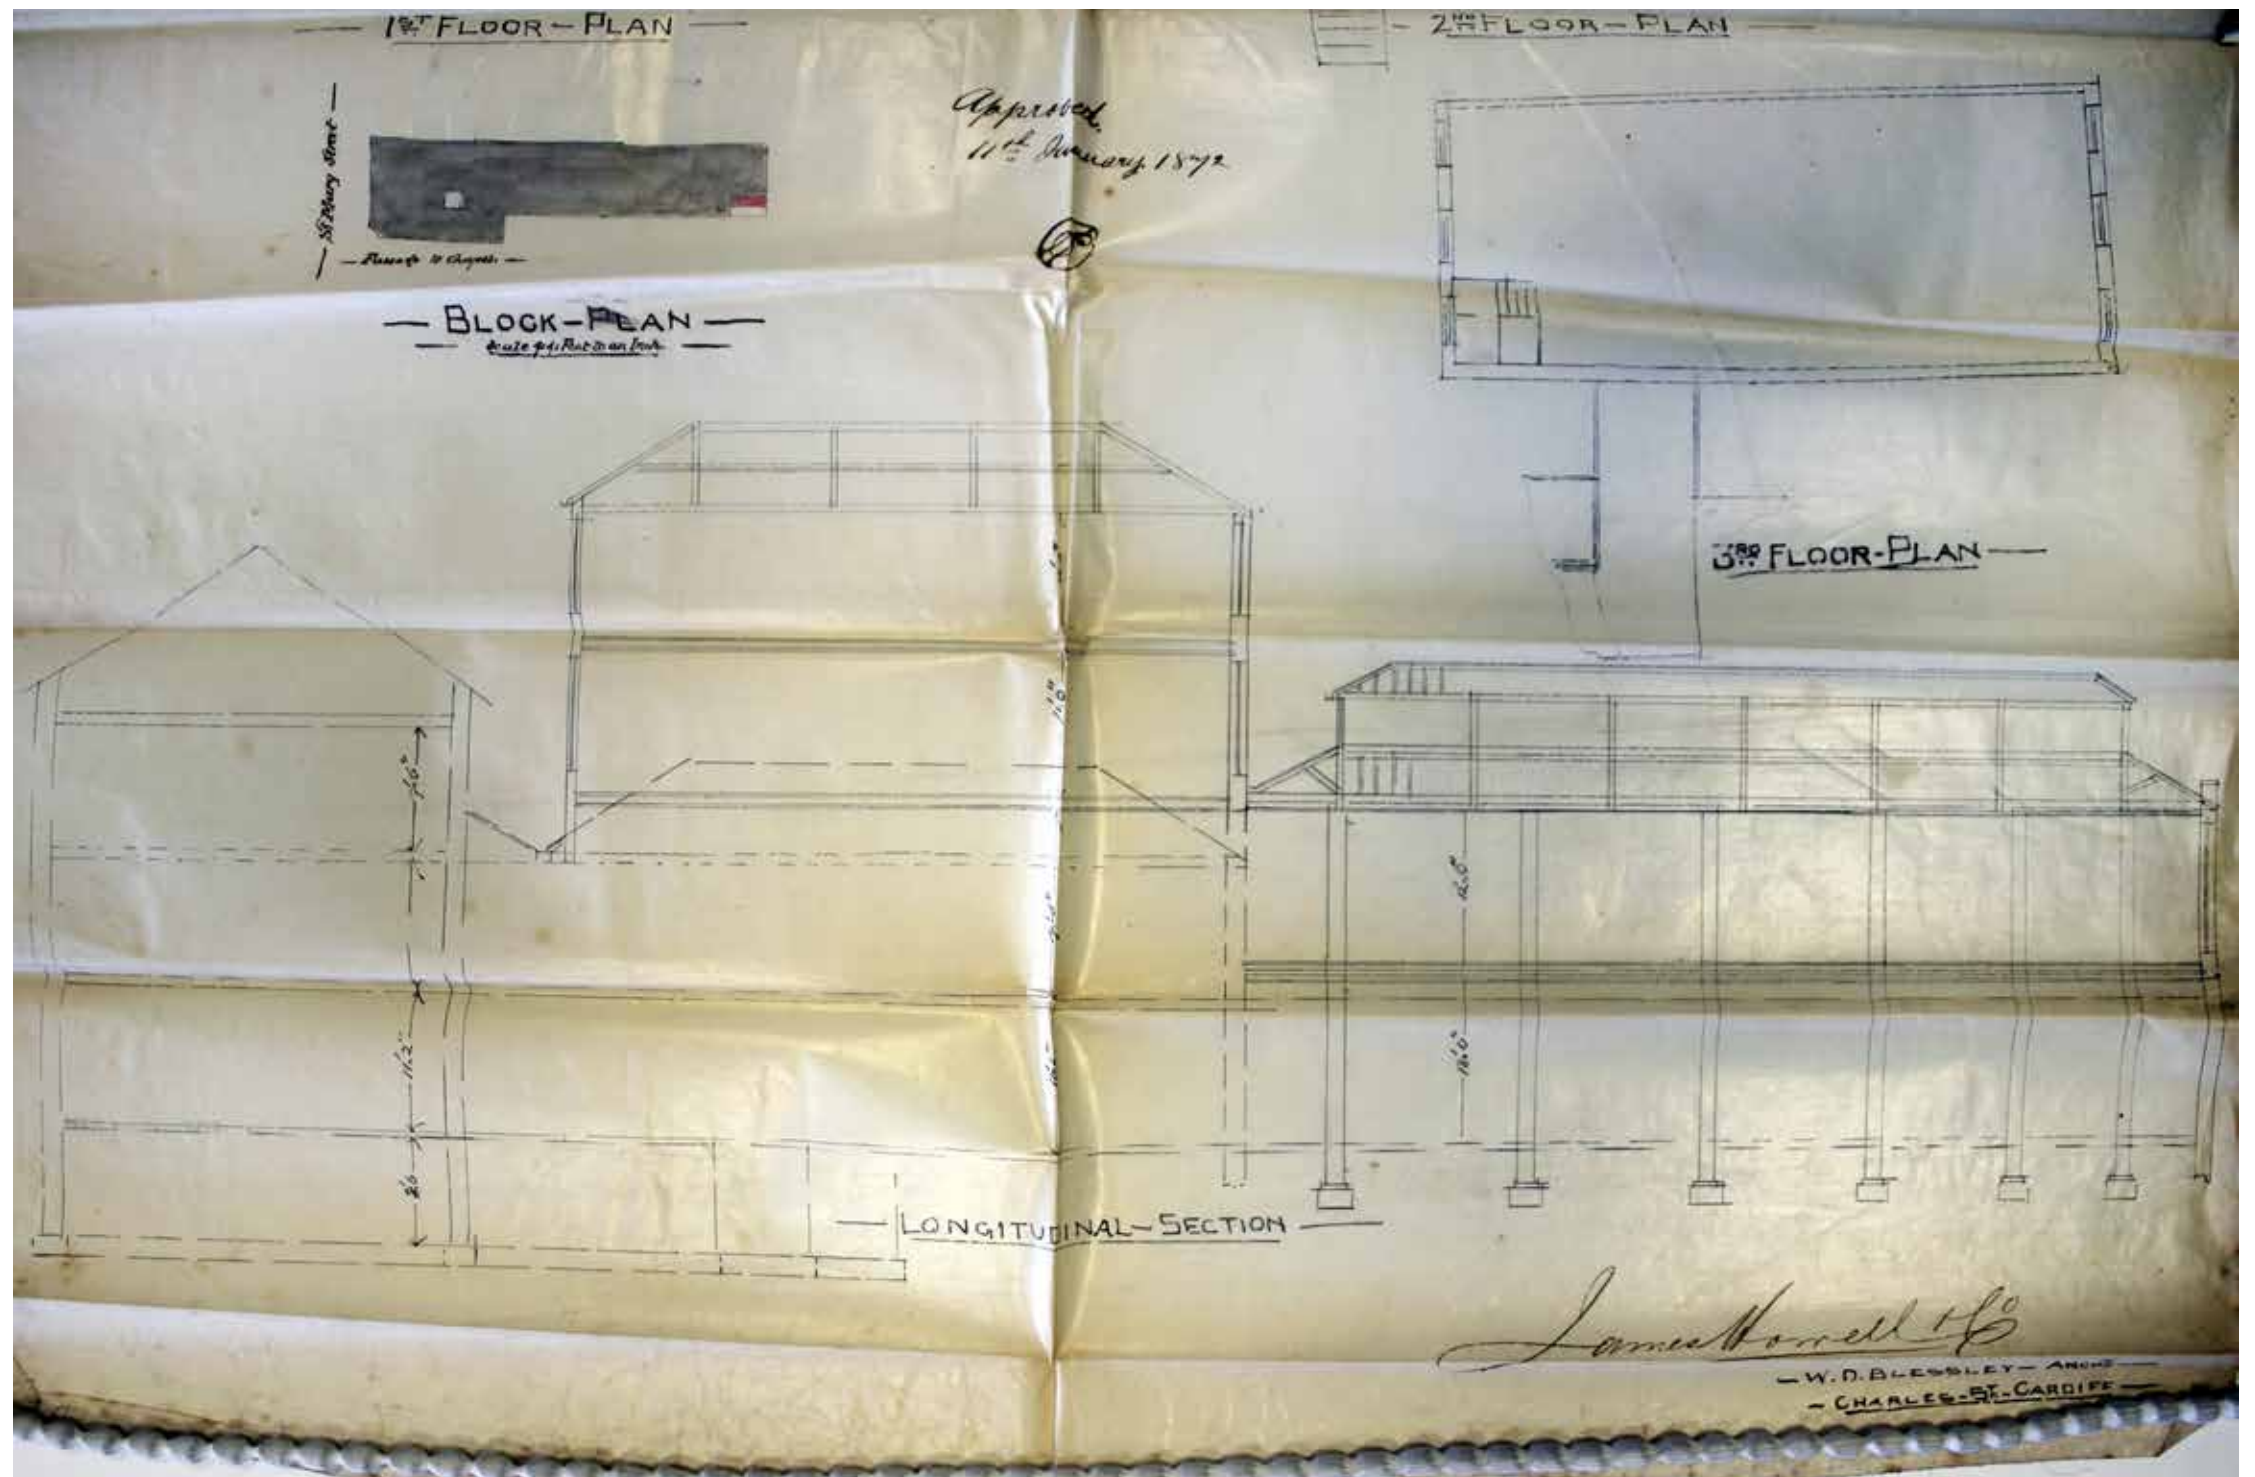
Section of the first phase of the St Mary's building by W.D. Blessley, 1872 (Glamorgan Archives) (**permission pending**)

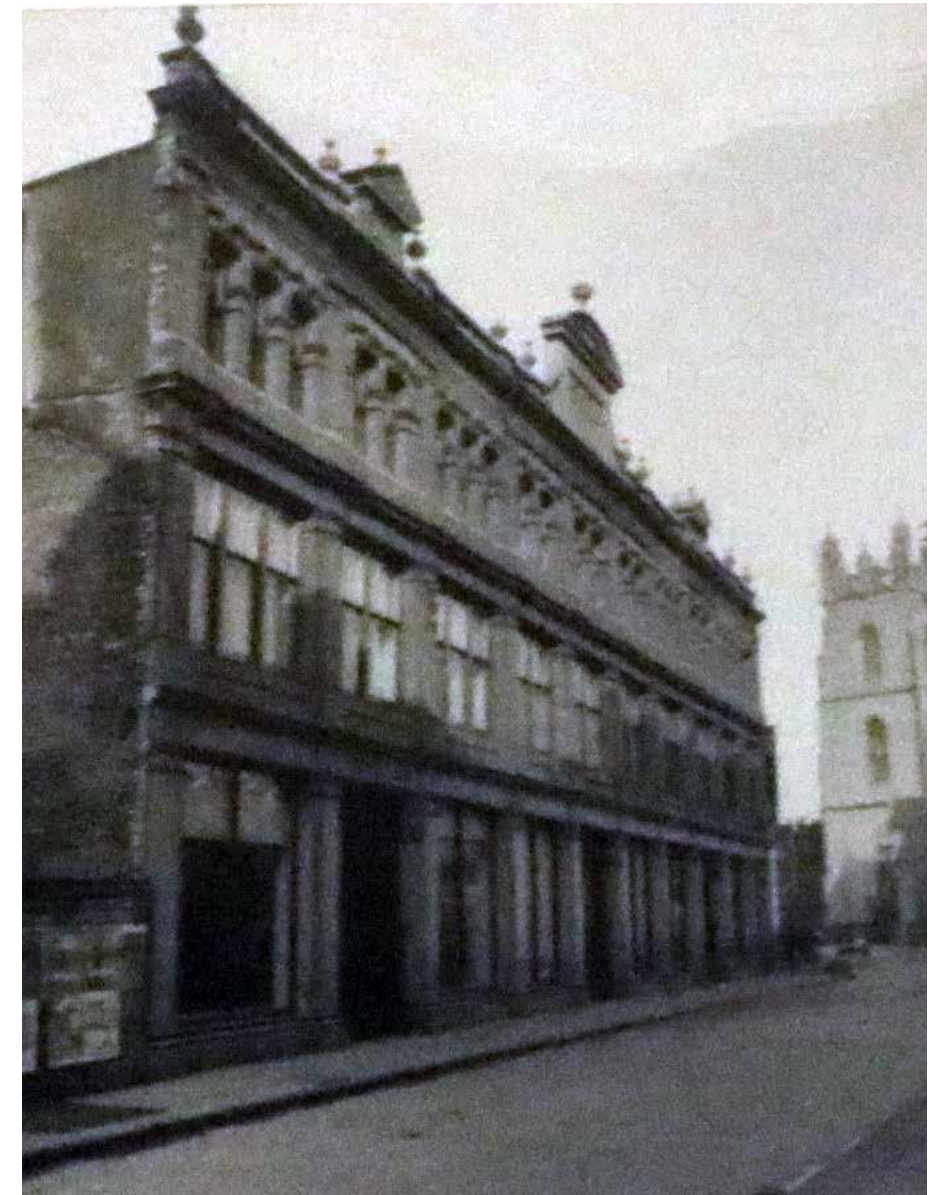
Trinity Street buildings pictured in the late 19th century or early 20th century - note the now missing urns to the parapet and the taller ground floor windows (House of Fraser Archive) (**permission pending**)

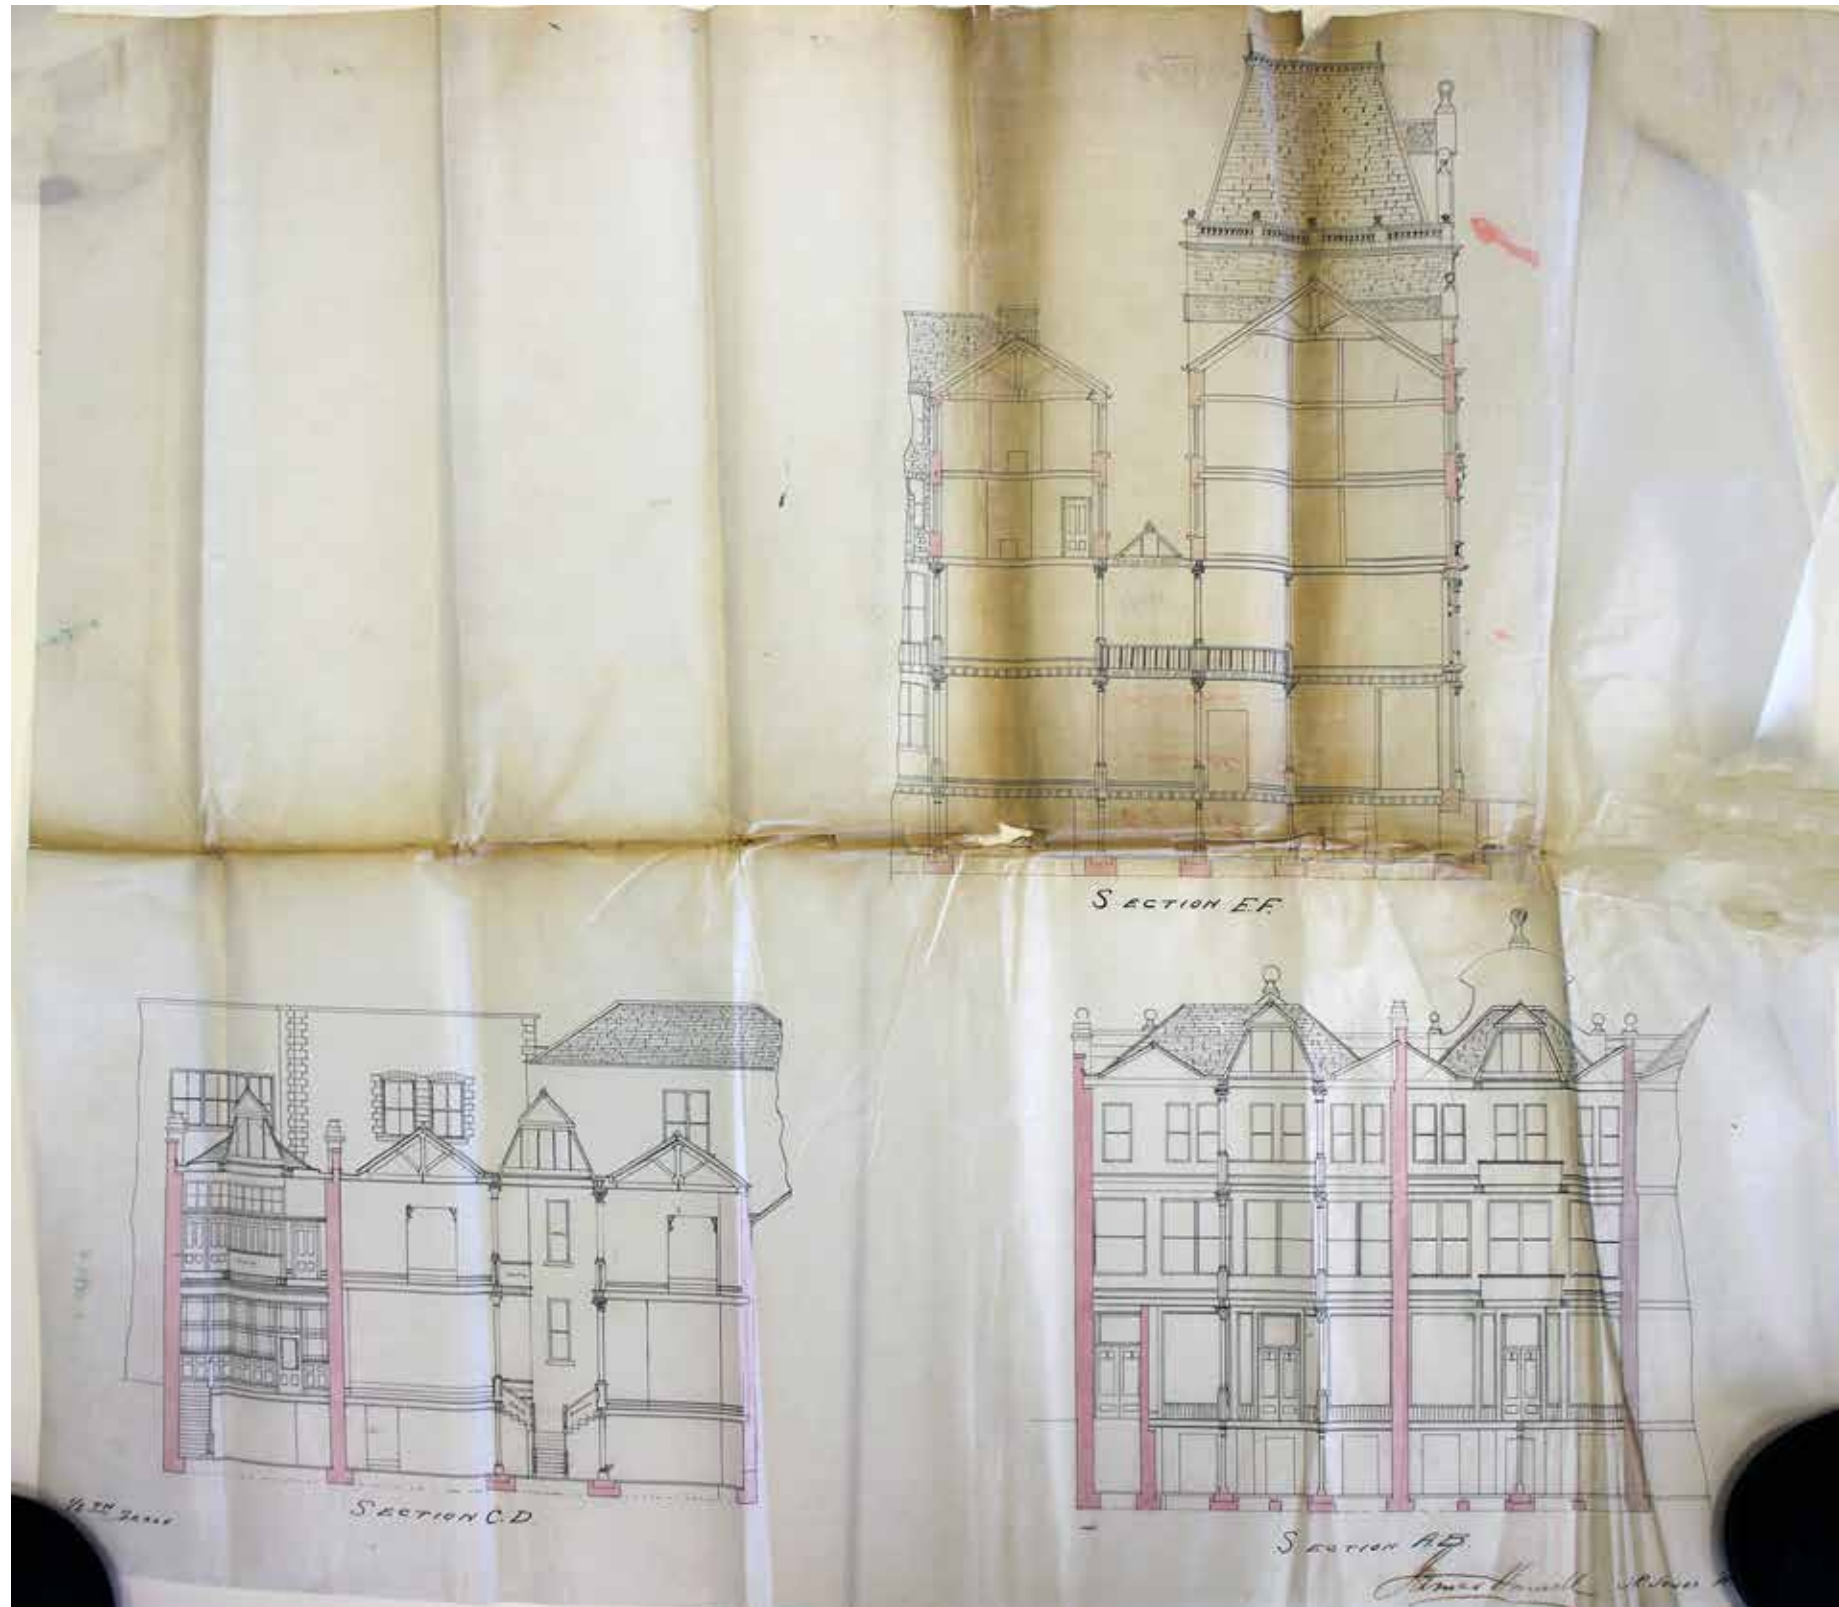
Sections through the Trinity and St Mary Street buildings produced by J.P. Jones in 1888 showing the Trinity and St Mary Street buildings. Jones's 1888 additions are tinted in pink. Section E-F cuts through the northern part of the 4/5 storey St Mary Street building. Section C-D shows the the eastern portion of the St Mary Street shop floor, Section A-B shows the inner face of the Trinity Street façade. (Glamorgan Archives)

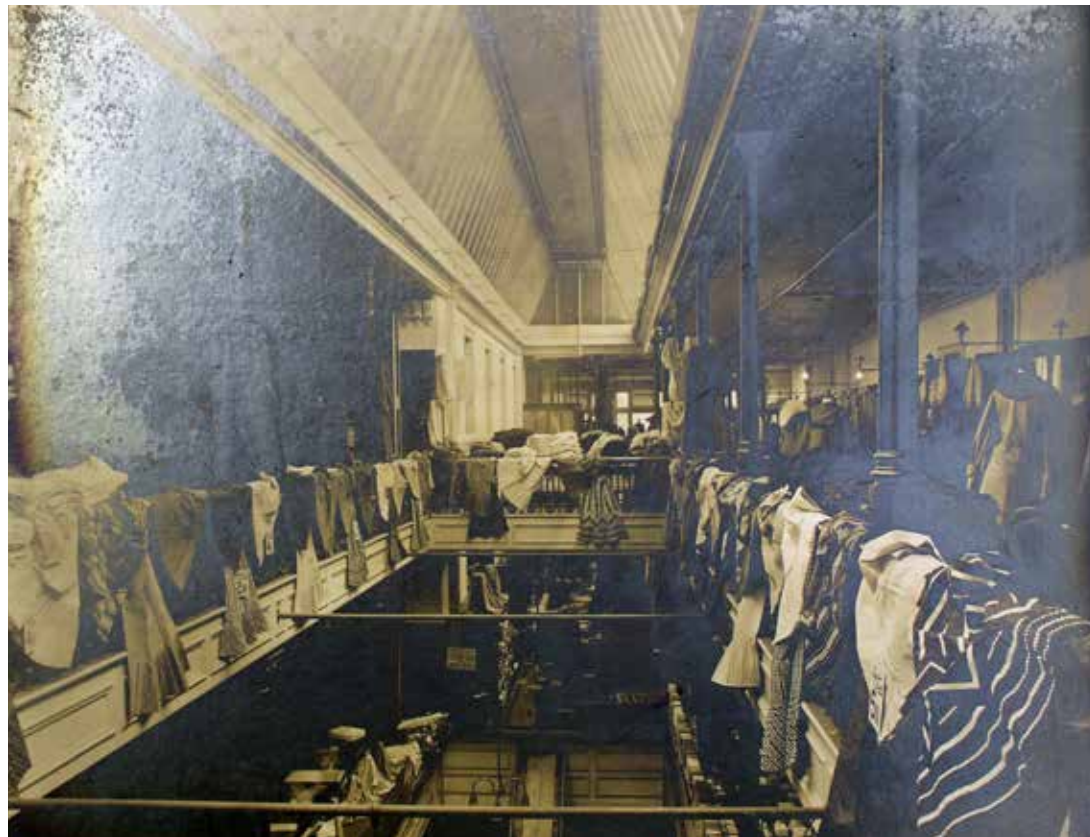
Interior of the St Mary Street shop floor in 1912, showing the long glazed lantern where the 1870s and 1880s phases met. (Glamorgan Archives) (**permission pending**)

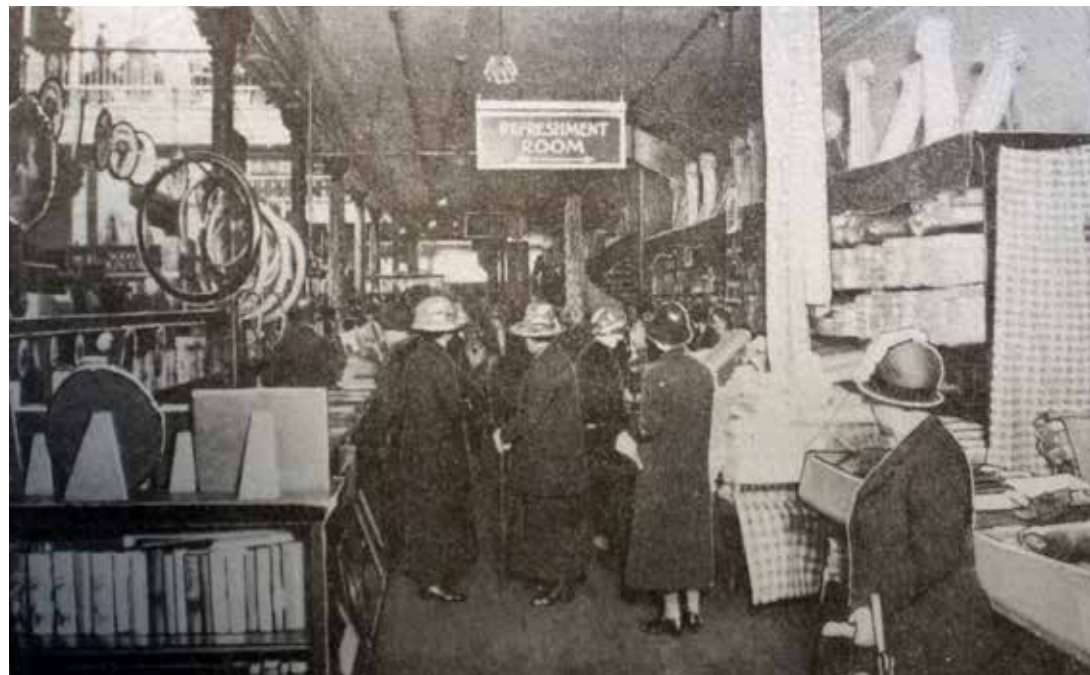
Interior of the St. Mary Street shop floor in the 1920s, showing this part of the shop before the rooflights, now overclad but likely still extant, were covered over (Glamorgan Archives). (**permission pending**)

Photographs of the interior of the shop from the 1910s and 1920s show that there were lightwells throughout the shop, with long lateral rooflights (the form of which remains visible at roof level, with corrugated metal sheeting likely concealing them) bringing daylight into the deep plan of the shop. These galleries were covered over in the twentieth century to increase the area of shop floor. Within the northern extensions to both the St Mary Street and Trinity Street shop floors Jones used columns made by Archibald D. Dawnay.

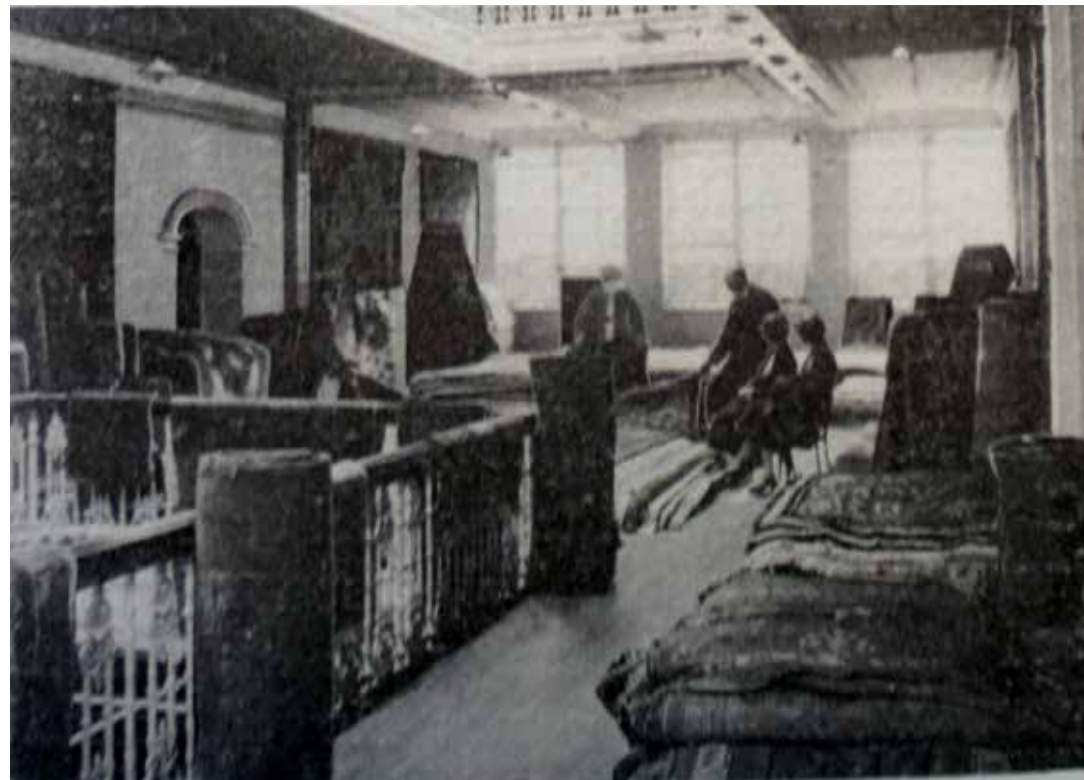
Interior of the Trinity Street shop floor in the 1920s showing the lightwell - the balustrading shown in this photo matches that extant to the upper floor of the former Bethany Sunday School (Glamorgan Archives) (**permission pending**)

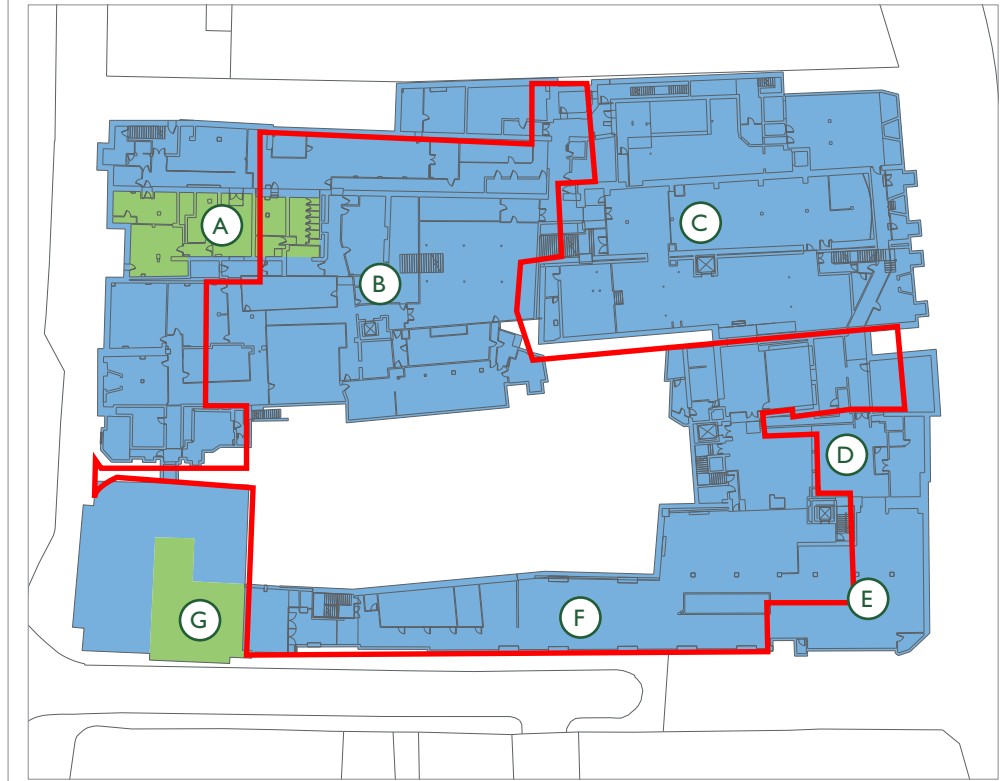
BASEMENT: CEILINGS SIGNIFICANCE PLAN

- A Stone flags still exposed
- B Floor level rises - potentially a culvert beneath
- C Timber stairs with twisted balusters
- D Stone flags still exposed
- E Concrete floor/screed dominates
- F Marginally less grand 1930s terrazzo and mosaic stair than that to the Percy Thomas Corner Building
- G Colourful linoleum tile throughout this section of the basement
- H Modern orange tile
- I 1930s stair with modern surfaces to the treads and risers
- J 1930s stair from the basement to the third floor. Terrazzo with inlaid mosaic strips to the tread
- K Parquet flooring in poor condition to areas of former shop floor

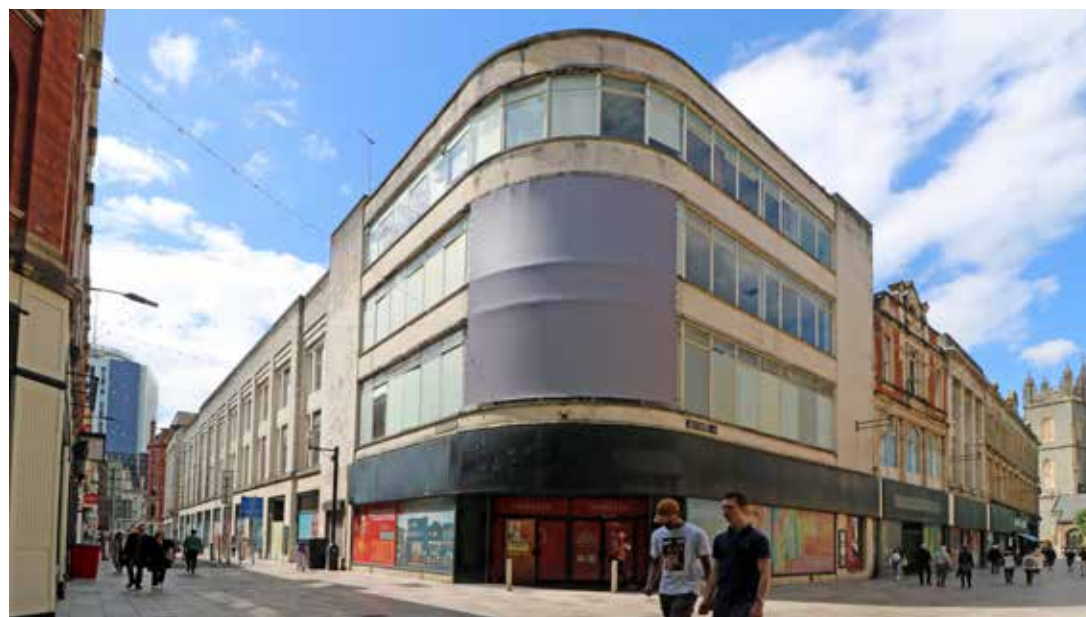
View of Howells and elevations B and C, looking west. IMG_8317.

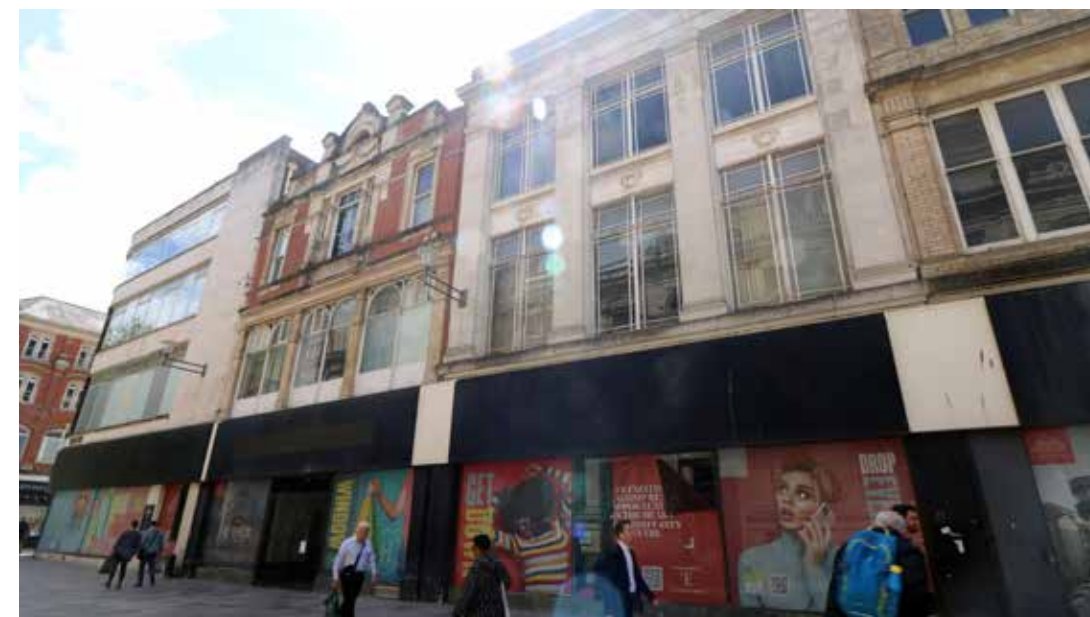
View of external elevation C, Trinity Street, IMG_8313.

The Interwar Trinity Street building exterior is three storey, three bay wide Inter-War neo-classical building. There are three fixed pane shop windows to the ground floor with original vertical pivot windows above. The division of the façade into the three distinct bays arises thanks to Percy Thomas's use of giant order Doric pilasters. The building is clad in Portland Stone, with metal spandrel panels dividing the first and second floor windows.

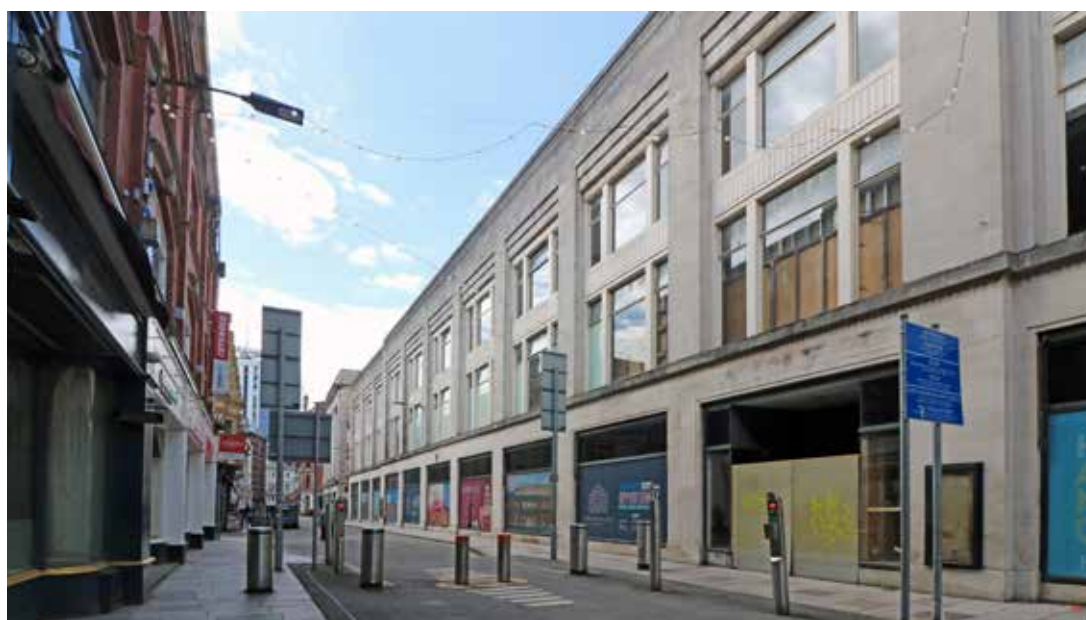
View along Wharton Street (Elevation B). IMG_8320

The Wharton Street building provides a long, three-storey frontage to the street. The massing of the building is broken up by the projection of the seven central bays beyond the slightly recessed bays to the east and west – one to the former and three to the latter. The yellow-stock brick side elevation to the western end is visible from the street, with the Portland Stone to the principal elevation continued onto the side returns as quoins and a cornice. The rear elevation of the building is largely obscured and is covered with render and white glazed brick.

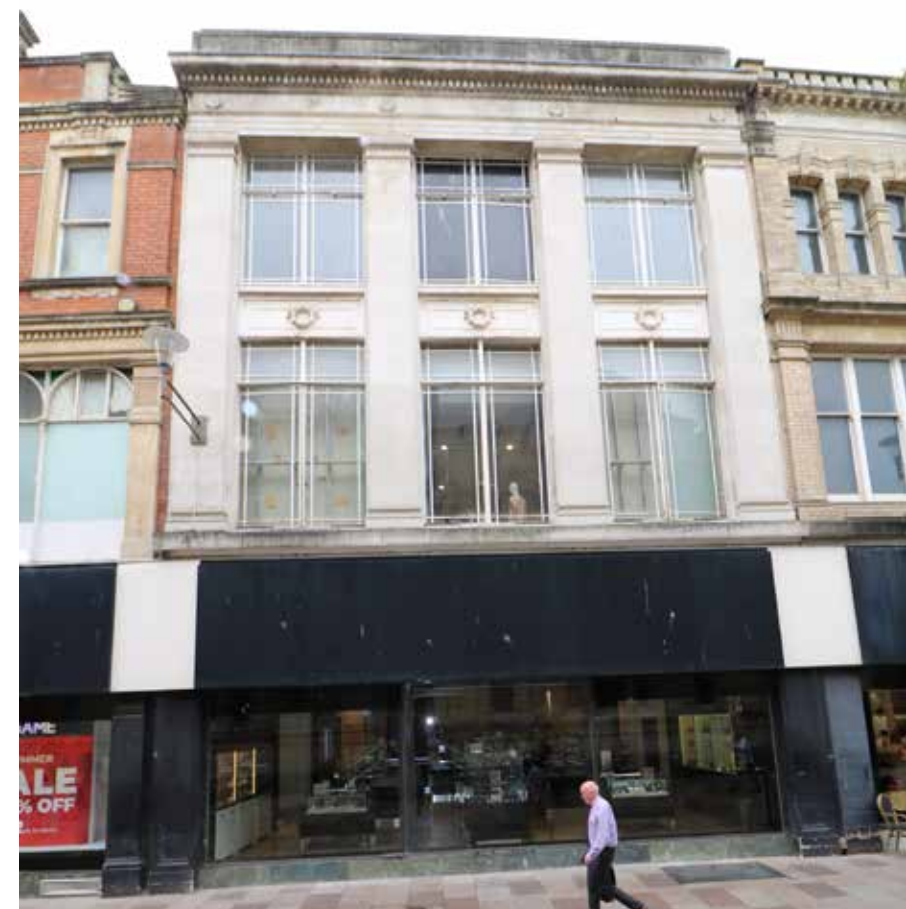
Photo of the Gas and Plumbing building facade, taken in 2022, IMG_0493

The principal elevation of the Gas and Plumbing Warehouse on Trinity Street has a 20th century shop front to ground floor, with large areas of plate glass and marble stall risers. The entrance to the shop is located in the centre of the façade and is recessed. Ashlar pilasters at first floor level separate the building into three bays, with paired windows with thin timber glazing bars infilling the bays. The bottom lights are rectangular, with arched transom lights above. A plain frieze is set beneath a dentilled cornice. The third floor is red brick with ashlar stone dressings to the windows and gable end. Stone panels are carved with '12', '13' (the street address) and 'Established 1840'. It is designed in a Northern European or Dutch classical language to the upper floors, and is built of red brick with Bath stone dressings. There is a pediment to the apex of the gable roof.

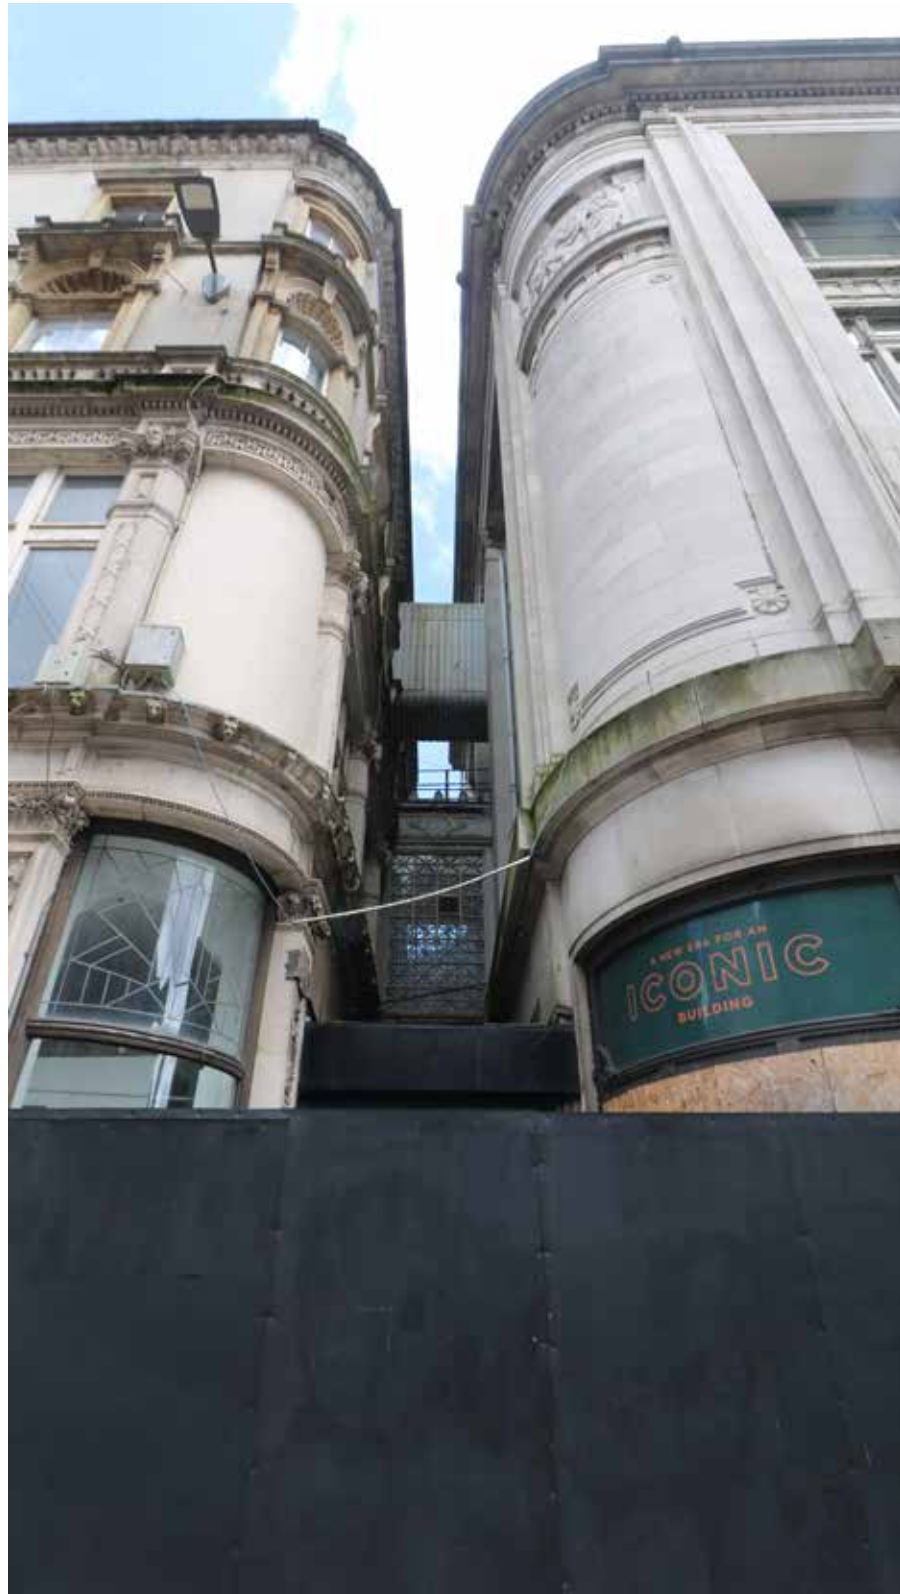
View of external elevation A, St Mary's Street. IMG_8332.

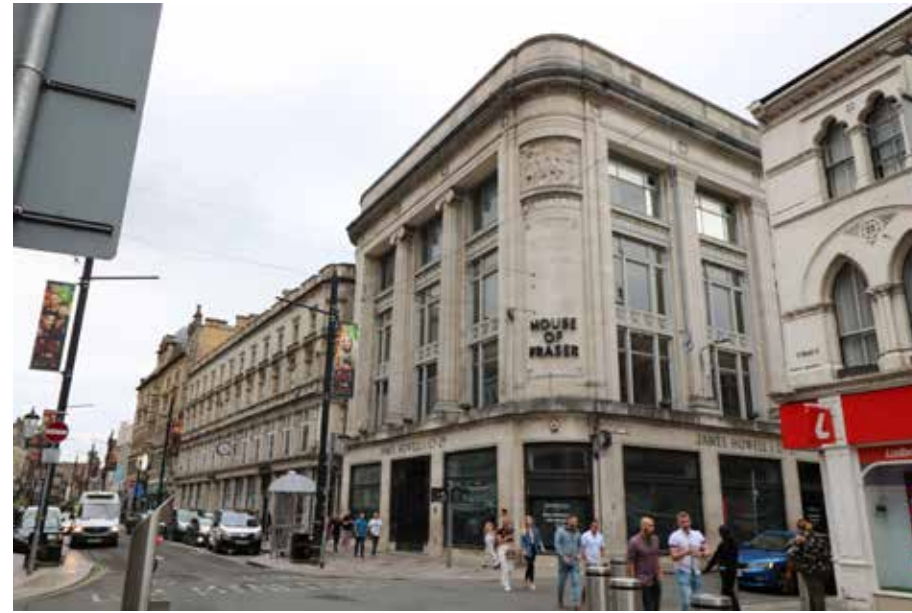
Photo of the Percy Thomas Corner Building on St Mary's Street, 2022. IMG_0660

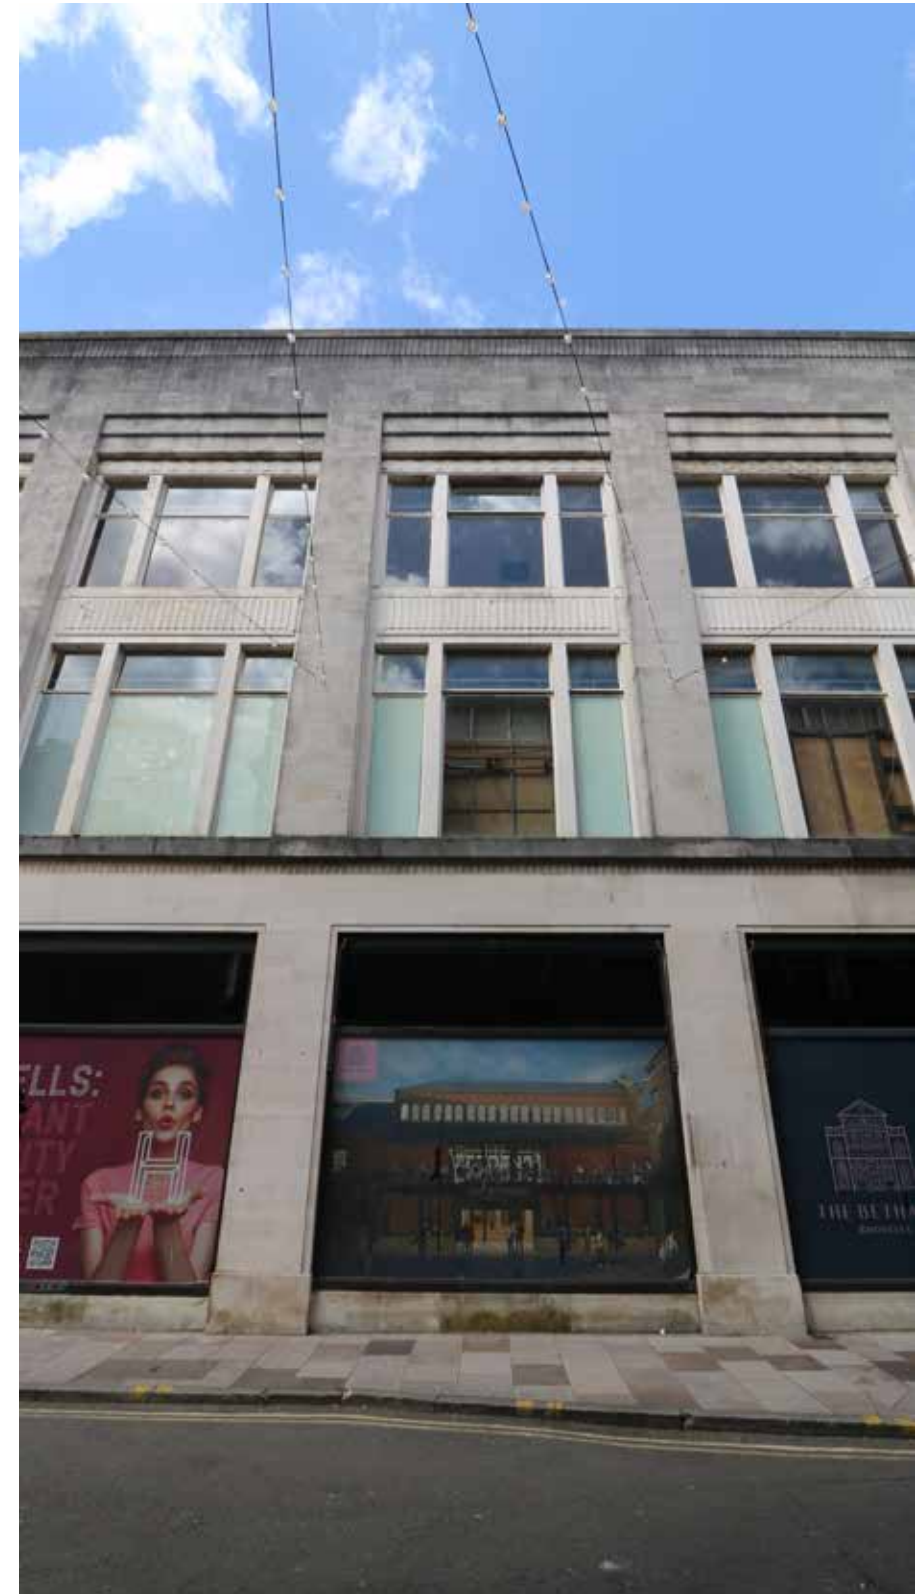
View of external elevation B, Wharton Street. IMG_8324.

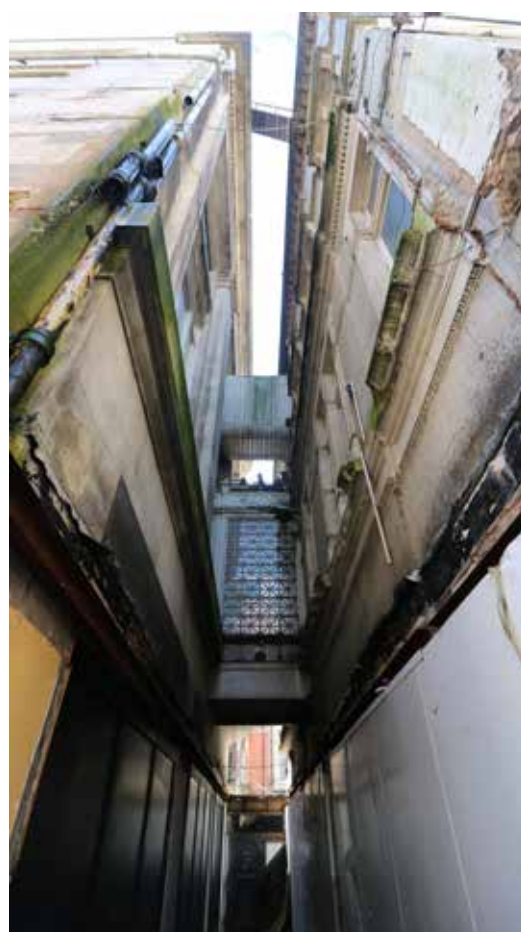
View of the alley leading west from Wharton Street Courtyard to St Mary Street. IMG_8295.

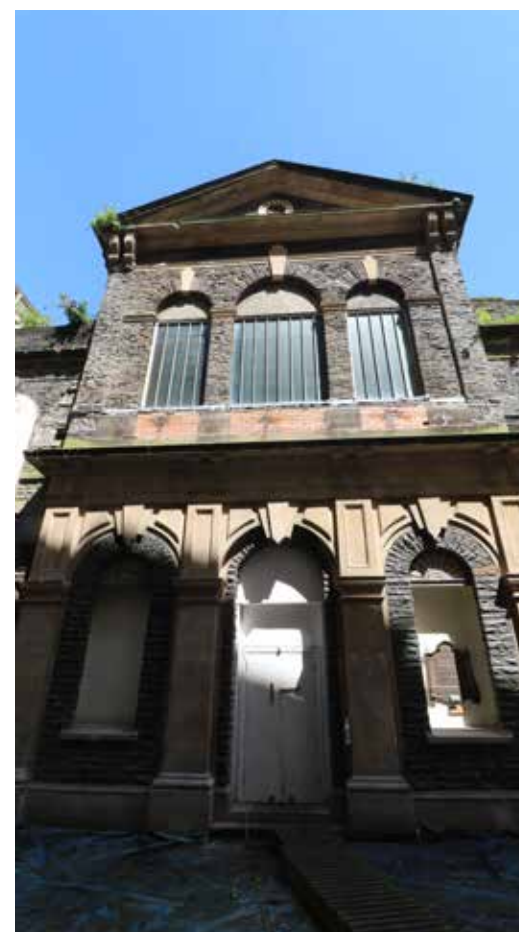
View of the west elevation of Bethany Baptist Chapel, the eastern elevation of the Wharton Street Courtyard. IMG_8297.
