On behalf of Purcell ®

Issue 01
April 2024
TE Cardiff 7 Ltd

HOWELL'S: LEVEL 4 HISTORIC BUILDING RECORD, FORMER HOWELLS DEPARTMENT STORE, CARDIFF

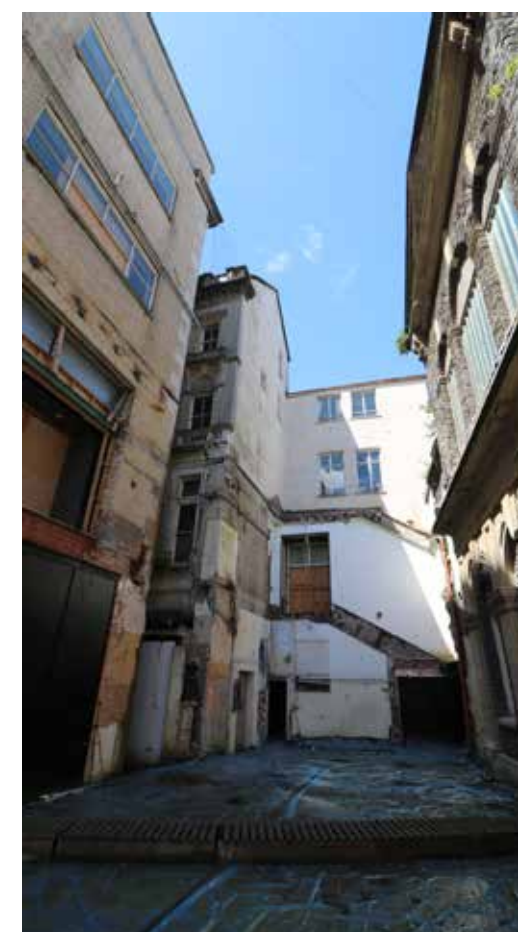
View of the south elevation of the St Mary Street Building, the northern elevation (and northeast and north western corners) of the Wharton Street Courtyard. IMG_8300.

Courtyard, is four storeys, the upper three in yellow brick with bands of stone continuing the line of a fourth storey Wharton Street evaluation string cornice. There are large metal casement windows set at second, third and fourth floors, with double entrance doors with surrounding glazing set near to the southern edge of the building at ground, first and second floor level, indicative of a corridor since demolished. These materials and line of corridor is mirrored in the west elevation of the Wharton Street building opposite (IMG_8301).

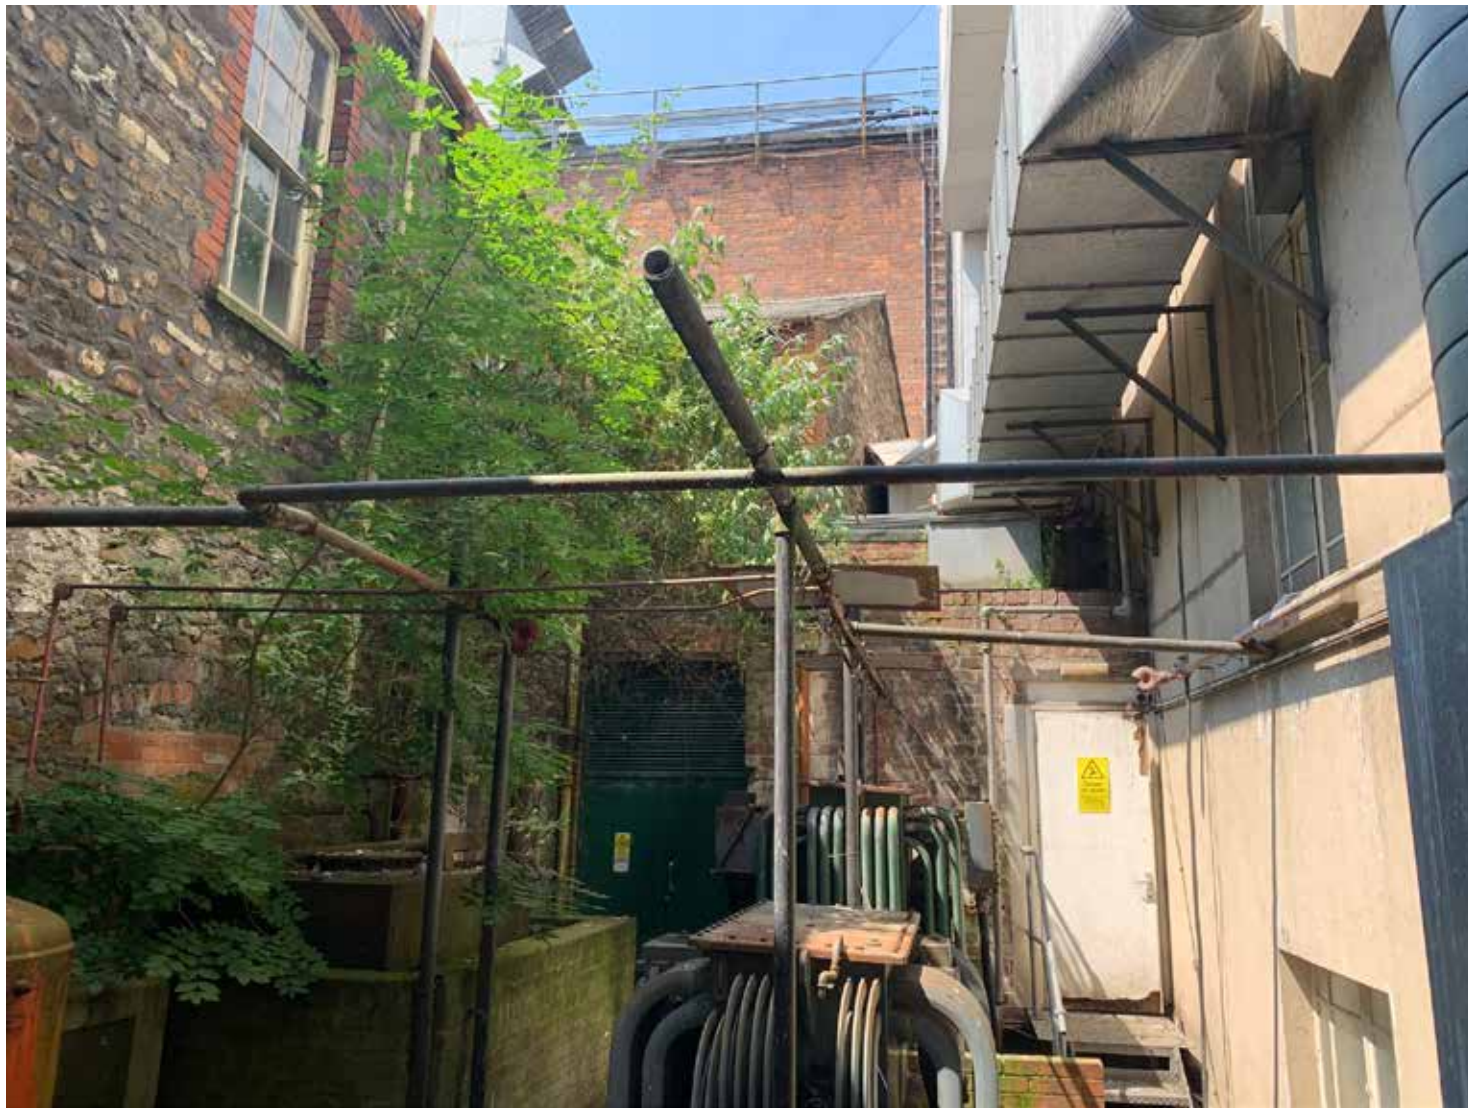
There is one lightwell to the east of the Sunday school, at the centre of the site (1.21). This provides a view of the eastern elevation of the Sunday school, as well as a narrow section of the west elevation of the Gas and Plumbing warehouse, the north elevation of the Wharton Street building, and a glimpse of the south wall of the Main Trinity Street shop. The east elevation of the Sunday School is characterized by rubblestone walling, 6-over-6 pane sash windows set in brick surrounds, with a shallow brick arch to head of each window (IMG_3582). The gabled roof of the north wing of the Sunday School is visible to the north, in rubblestone and brick. The courtyard is occupied by plant machinery (IMG_3579).

View of Sunday School lightwell, 1.21. IMG_3579.

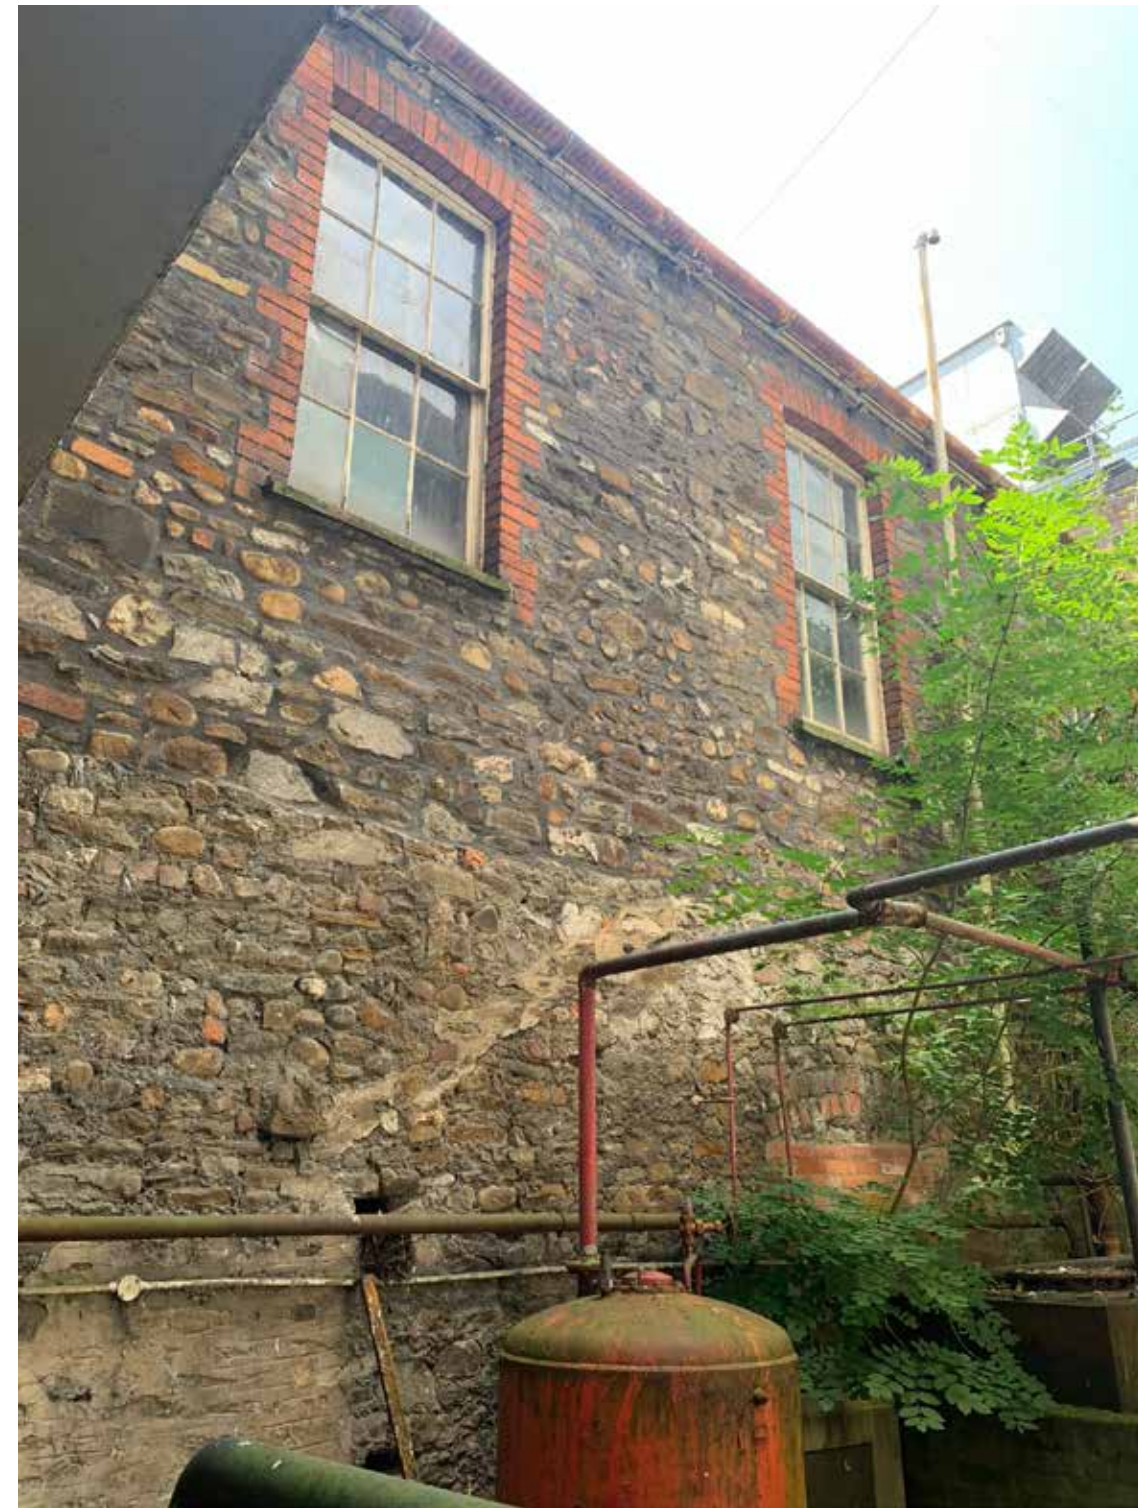
View of the east elevation of the Sunday School, the west side of the Sunday School Lightwell. IMG_3582.

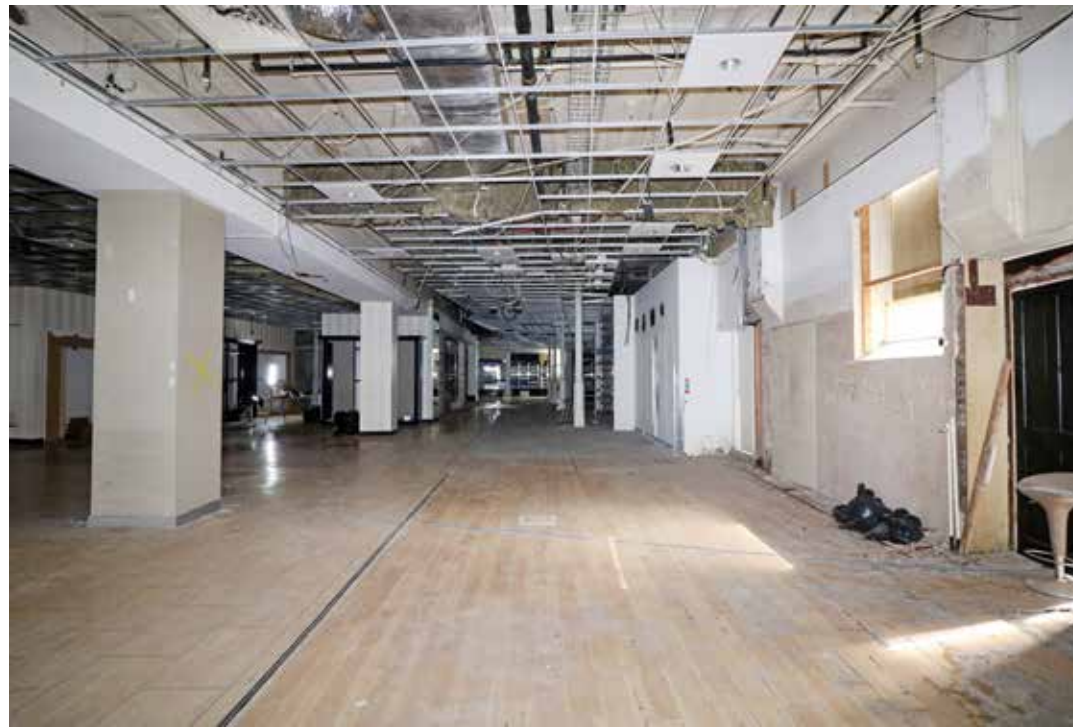
View of room 0/05, in character area IA. IMG_8075.

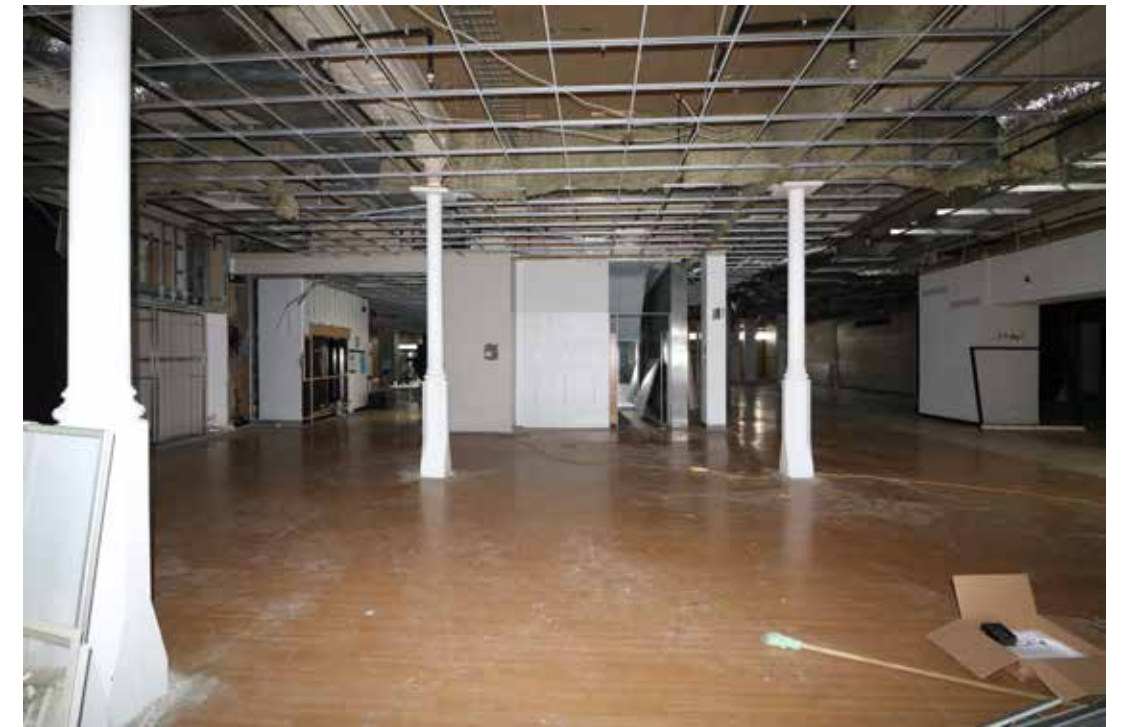
View of room 0/04, in character area IA. IMG_8062.

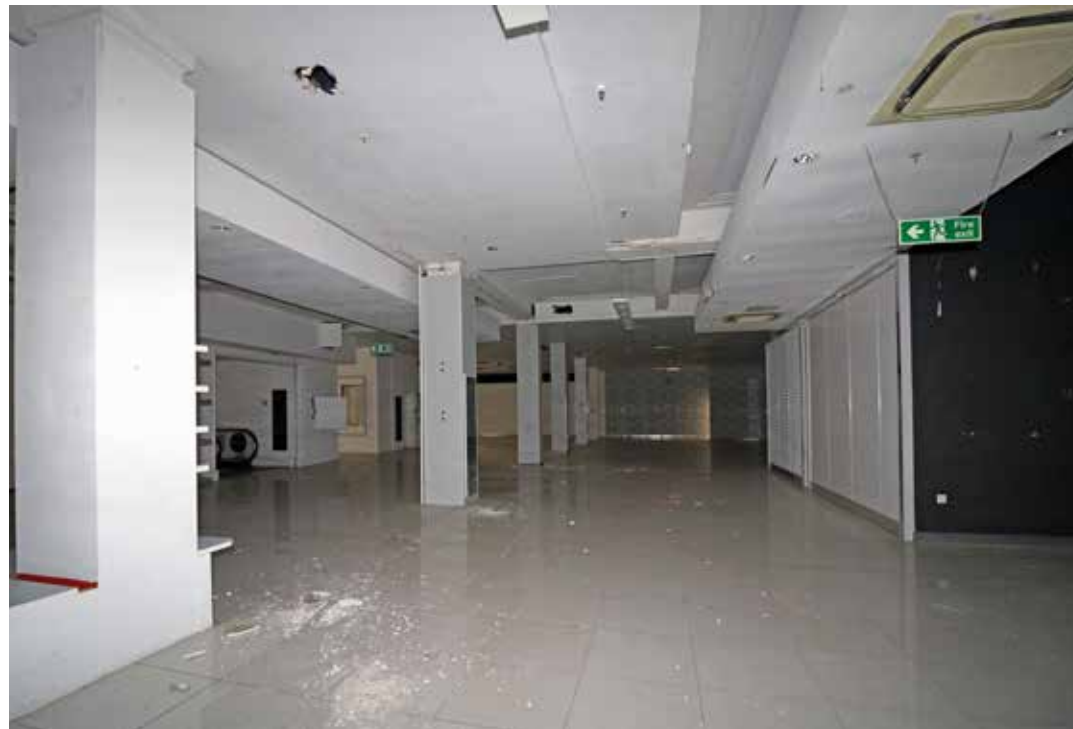
View of room 1/04, in character area IA. IMG_7702.

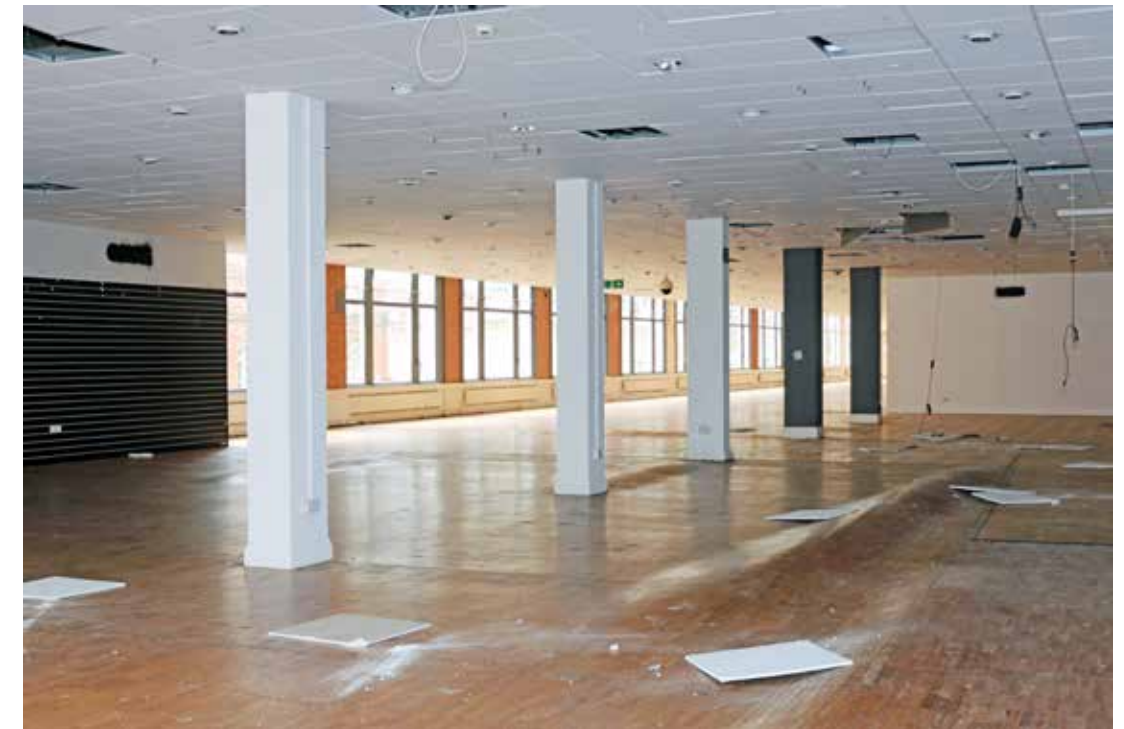
View of room 2/04, in character area IB. IMG_7547.

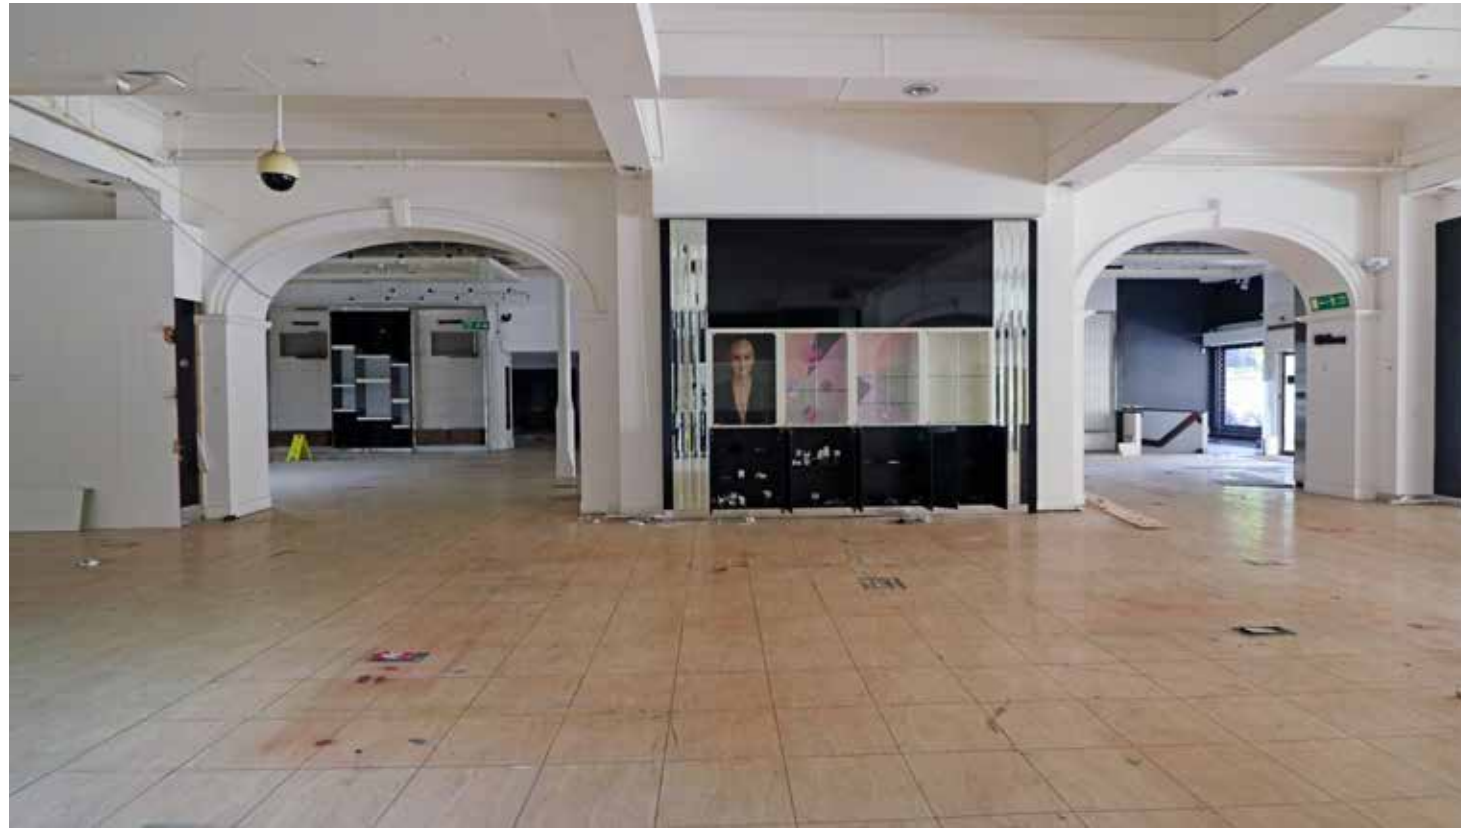
View of room 0/24. IMG_8272.

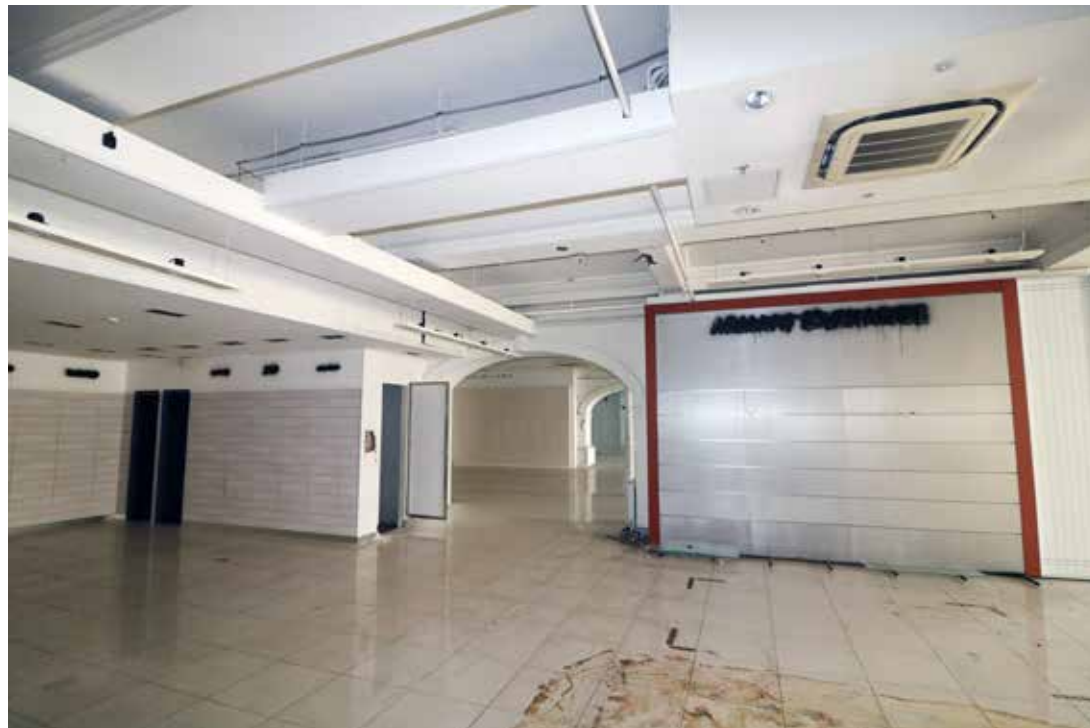
View of room 1/06. IMG_7730.

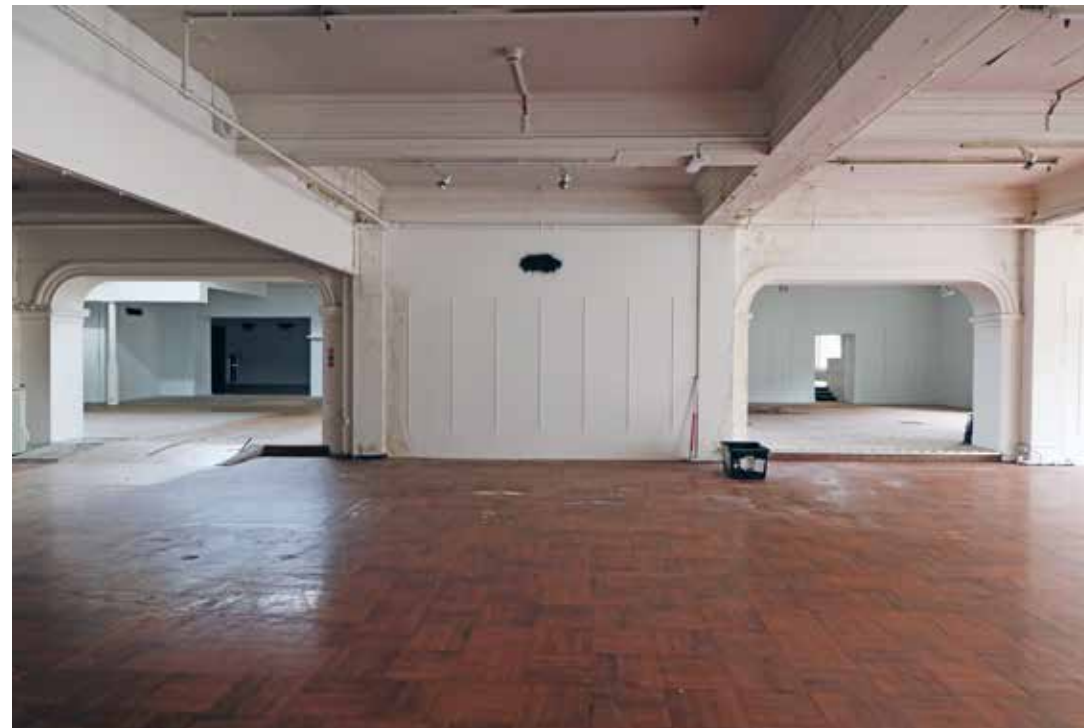
View of room 2/01. IMG_7525.

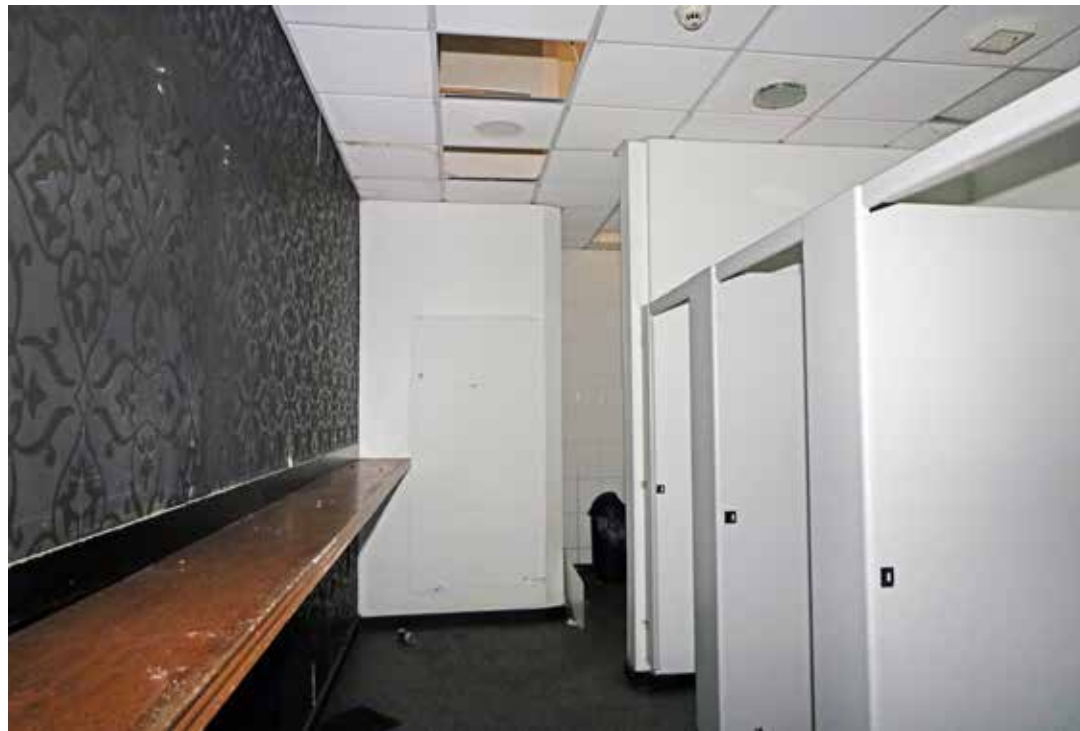
Modern toilet fit out, 1/07. IMG_7740.

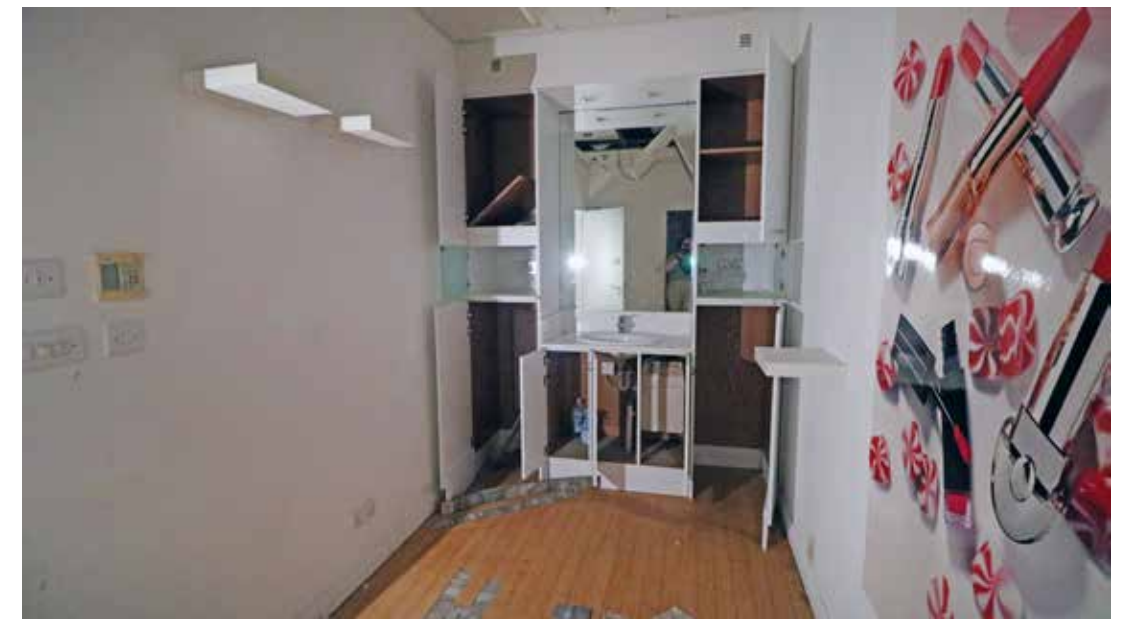
View of room 0/25a on the ground floor. IMG_8288.

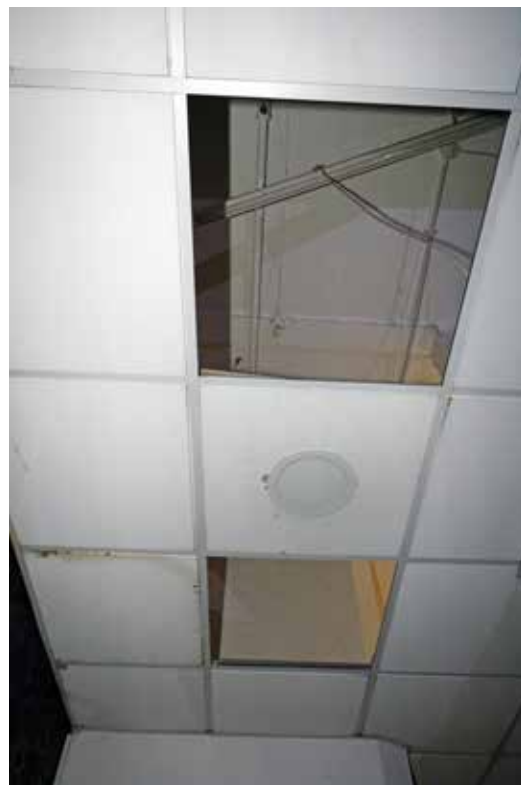
Twentieth century suspended ceilings obscure historic ceilings above as illustrated with IMG_7741, to house services and lighting. The rooms at the rear of the Trinity Street building had windows overlooking a central lightwell courtyard, and these windows are blocked by the modern plasterboard finishes.

Original ceiling and modern plasterboard, 1/07. IMG_7741.

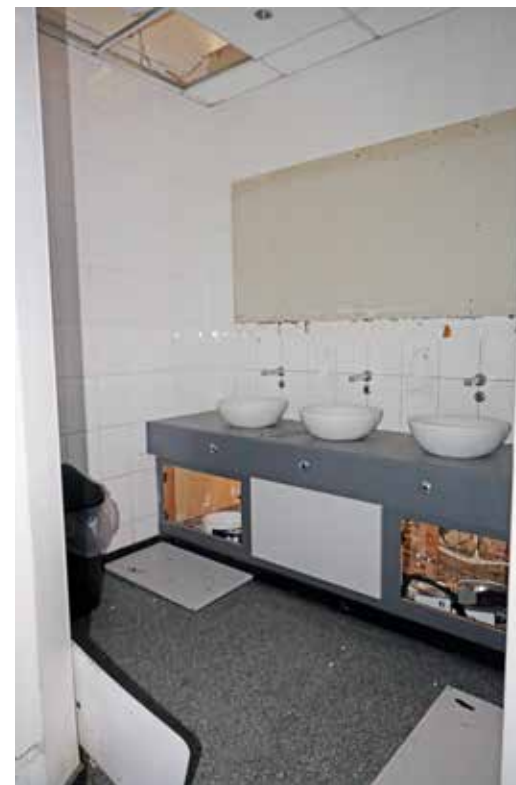
Modern toilet fit out, 1/07. IMG_7742.

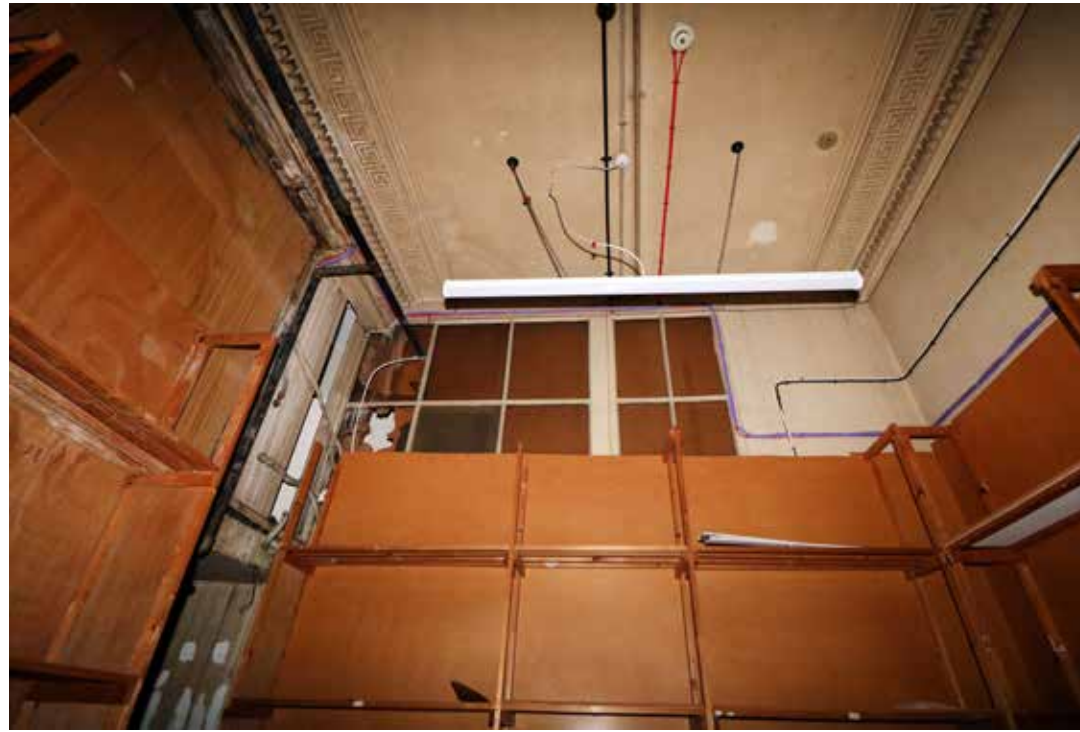
Type A is a ground floor double height storeroom (0/02) adjacent to the main shopfloor with high level partition windows on the southeast wall. The walls are lined with timber shelving units and the room has a carpet tile floor. The ceiling has the remains of historic cornicing; however, the room has been subdivided with two separate entrances to each half.

Room 0/02, a double height stockroom with historic cornicing. IMG_8025

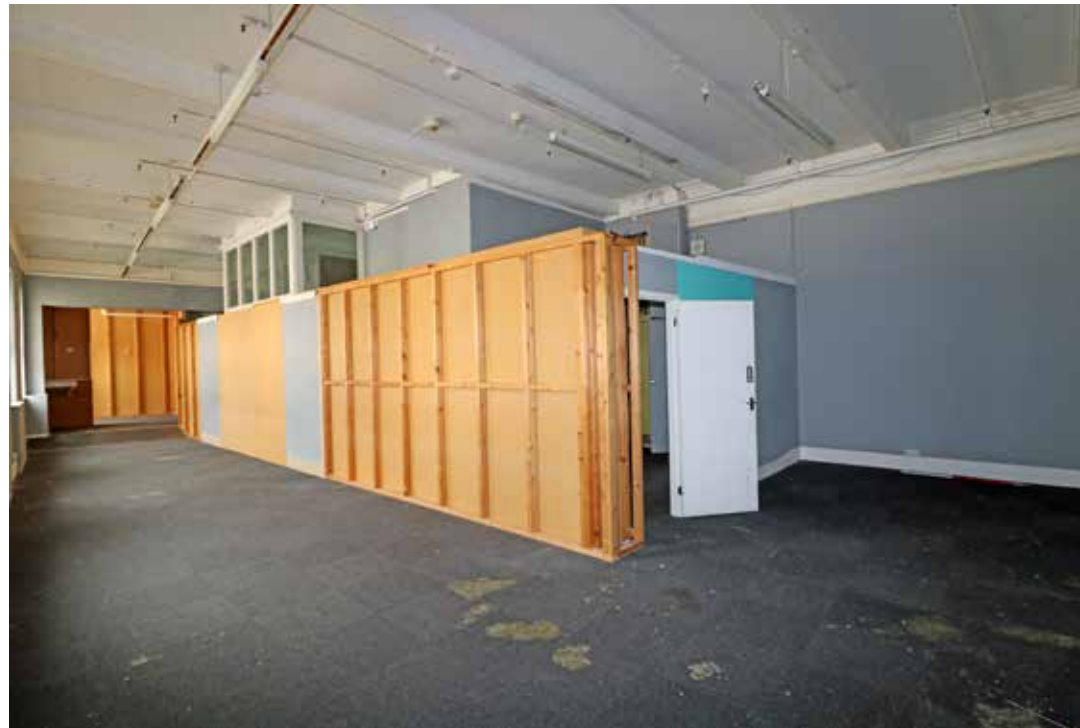
Two second floor former stockrooms (2/14 and 2/15) feature heavily moulded cornice and timber ceiling joists visible to the ceiling, and tall timber skirting. The top of the central 20th century staircase of the St Mary Street building is in the centre of room 2/14. The central space has been subdivided with modern plasterboard walls that leave the cornicing and ceiling intact. The northwest wall is lined with timber or metal casement windows. Room 2/15 has a moulded cornice and timber ceiling joists with timber and metal casement windows to the south east and north east walls. The space is open and the walls lined with tall skirting. The doors all have moulded architraves and there is a large blocked opening to the south west wall with a moulded architrave and low panelled risers.

Room 2/14 on the second floor. IMG_7608.

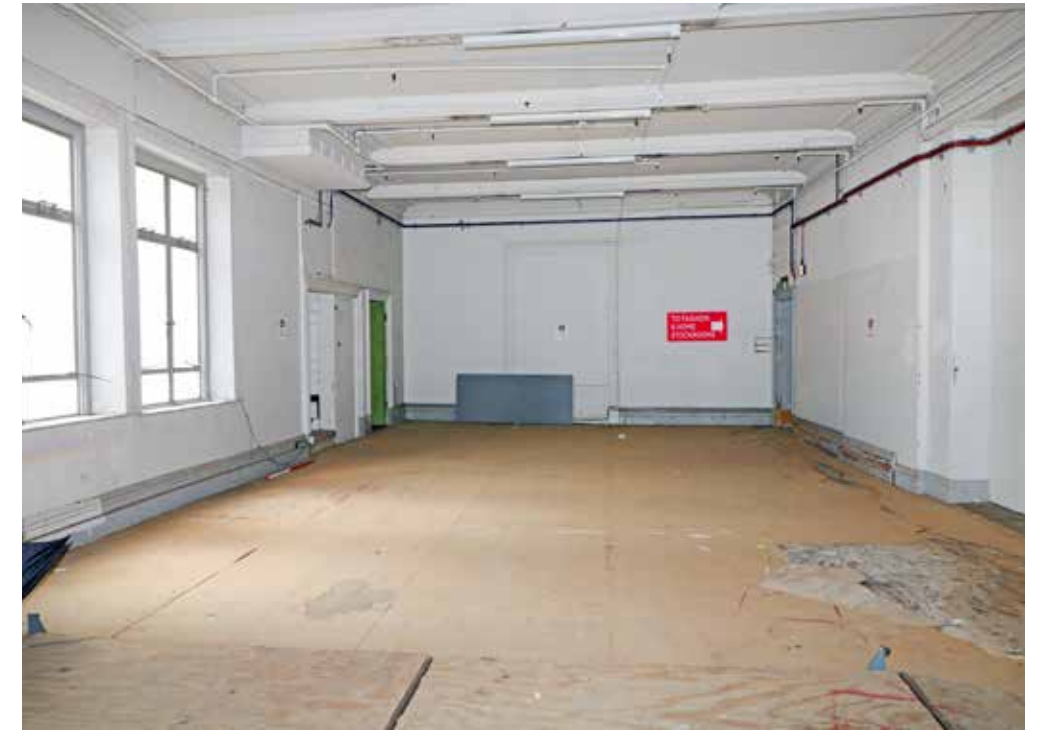
Room 2/15 on the second floor looking south west. IMG_7617

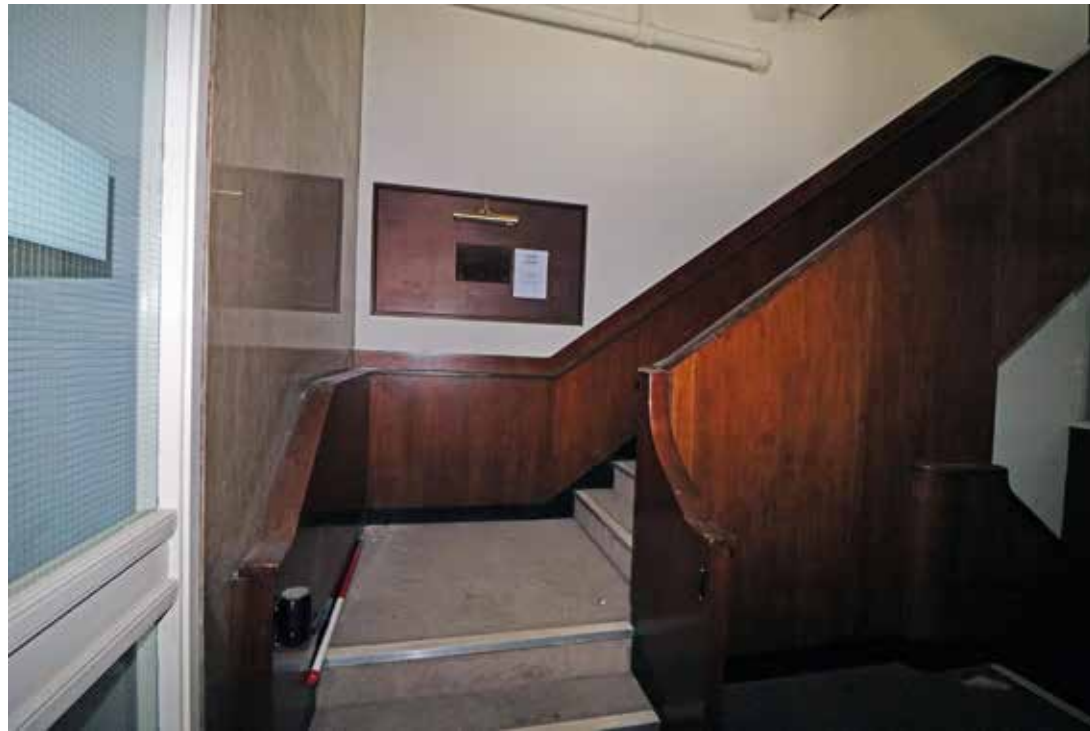
2/13 staircase at second floor. IMG_7602

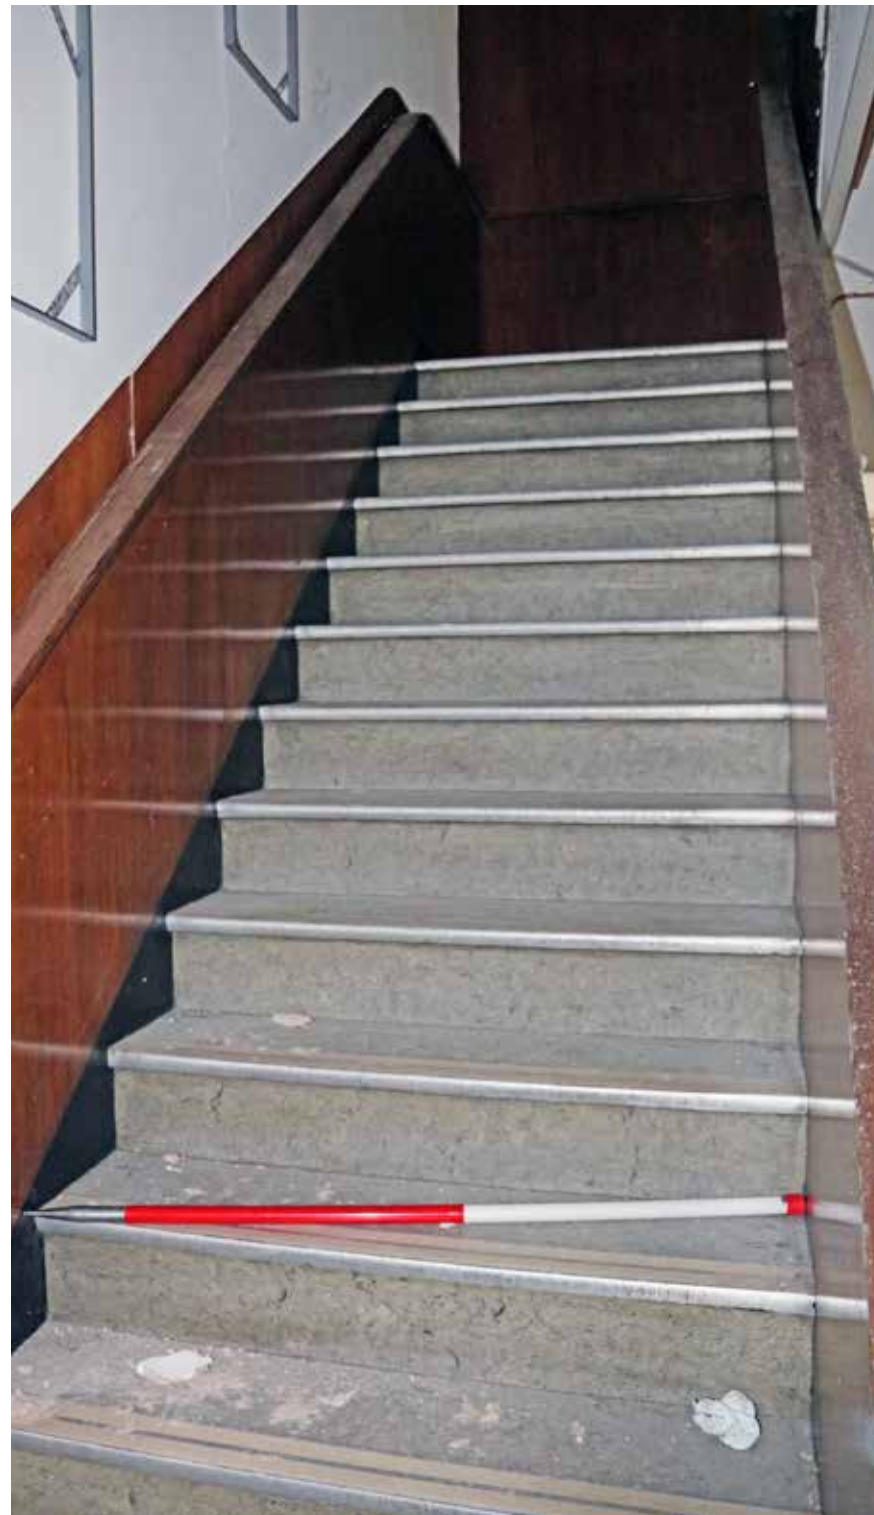
1/01 staircase at first floor level. IMG_7650

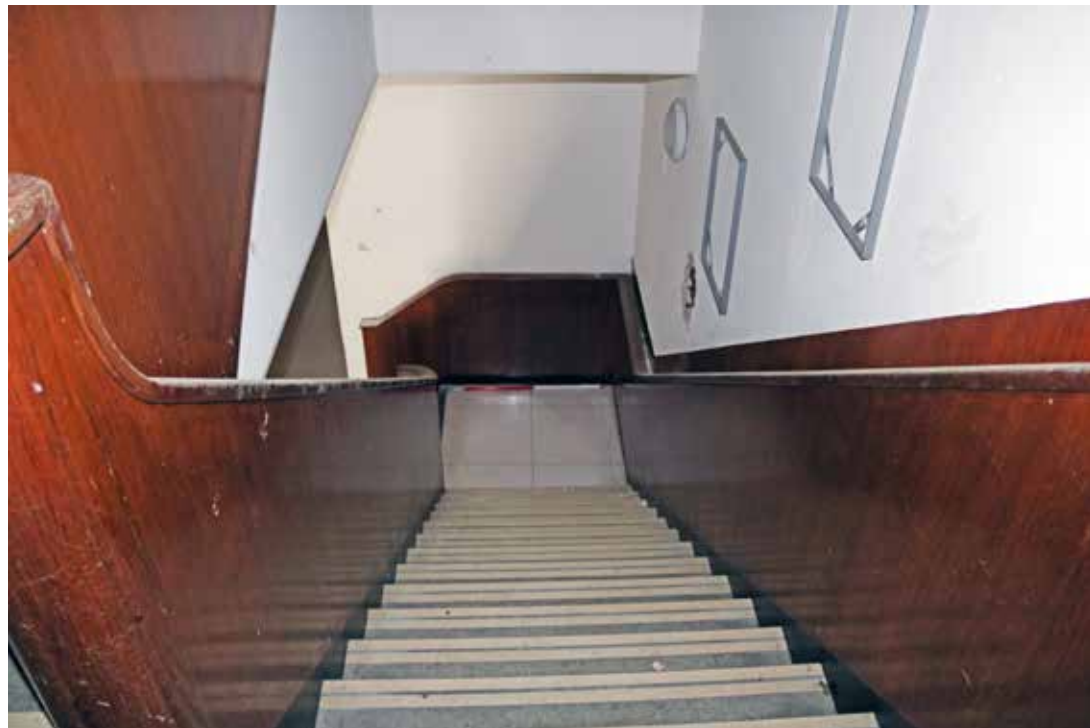
1/01 staircase at first floor level. IMG_7649

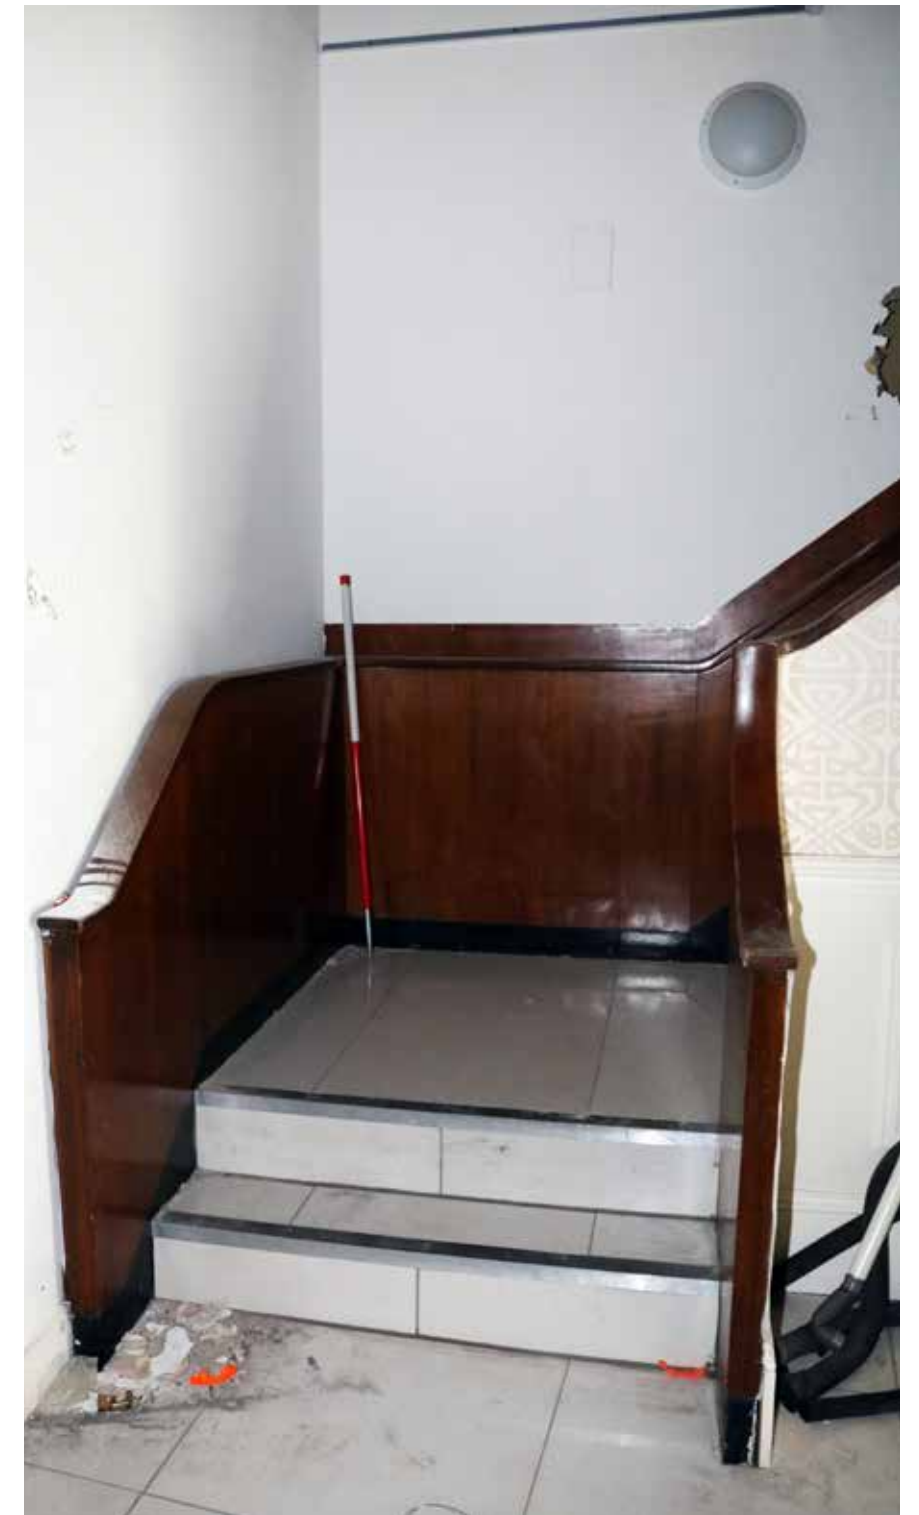
1/01 staircase at first floor level. IMG_7651

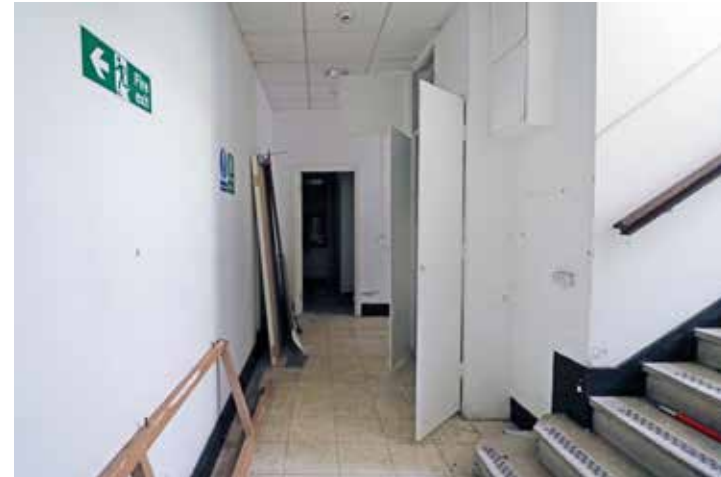
Character Area 4B. (0/25, 1/27, 2/06) This public access stair-core is located to the rear of the Gas and Plumbing Warehouse, and rises from basement to the second floor: within the rear of the Gas and Plumbing Warehouse. Terrazzo stair risers, tread and high wall string, with a band of decorative tiling at the top of the wall string. There are metal and rubber handrails mounted to the plastered walls. External windows are metal, casement, embedded within the eastern wall, overlooking a large lightwell. Marble wall string and cast-iron heating goods are included on the ground to basement stair. A single staircase, 2/05, 3/15, which appears to be a back of house stair, near to this stairwell rises from second to third floor, in the same style, with a single wall of distorted glass.

0/25 staircase and landing at ground floor level. IMG_8280

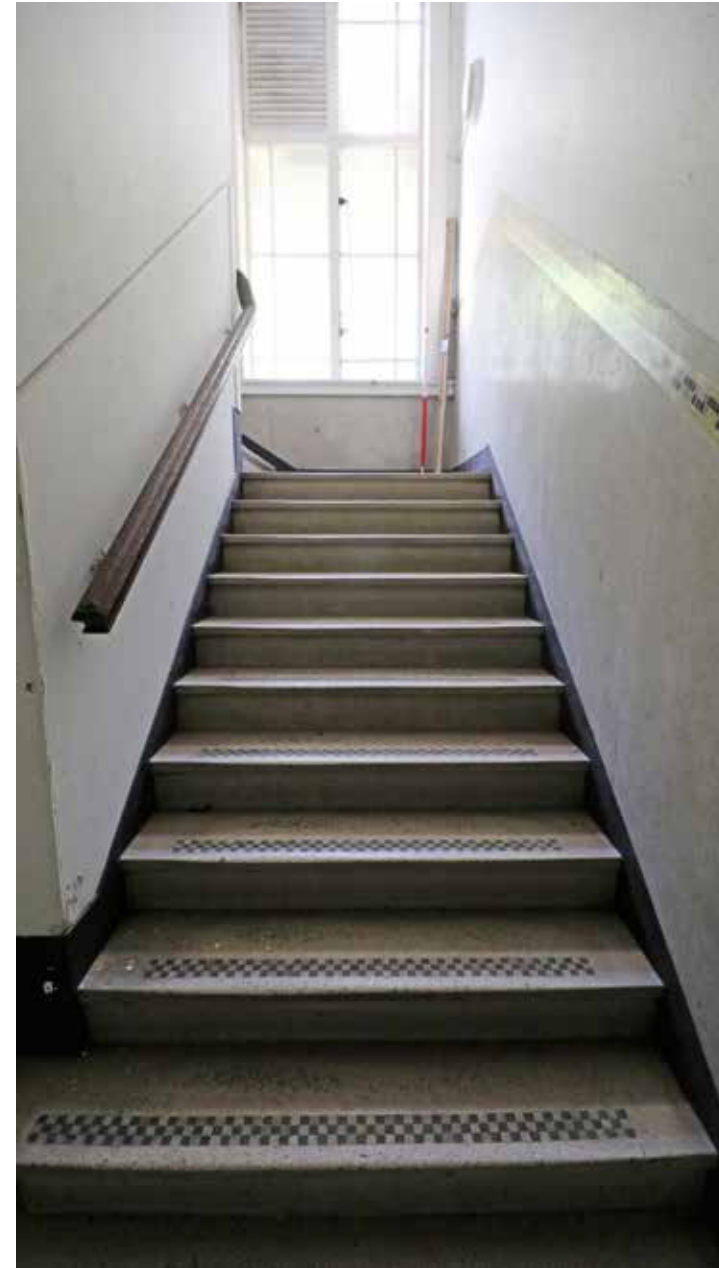
0/25 staircase and landing at ground floor level. IMG_8282

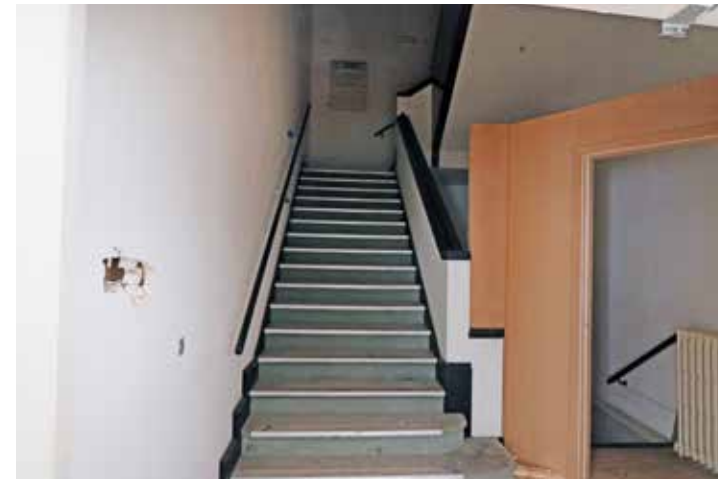
Character Area 4C. (0/22), 1(0/22), 2(0/22) Staircase within the southern corner of the Wharton Street building from ground to second floor, a public stairwell. Carpeted with metal nosing, black timber wall string with plaster and black timber topped balustrade. White plastered walls.

0/22 staircase at ground floor level. IMG_8238

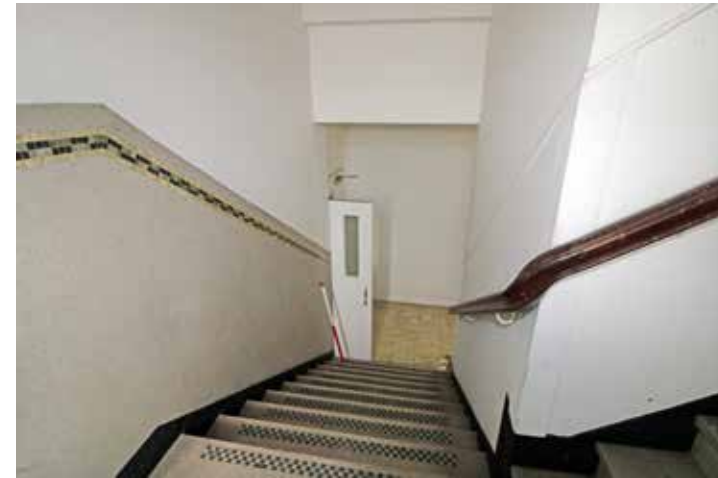
1/27 staircase between first and second floors. IMG_7847

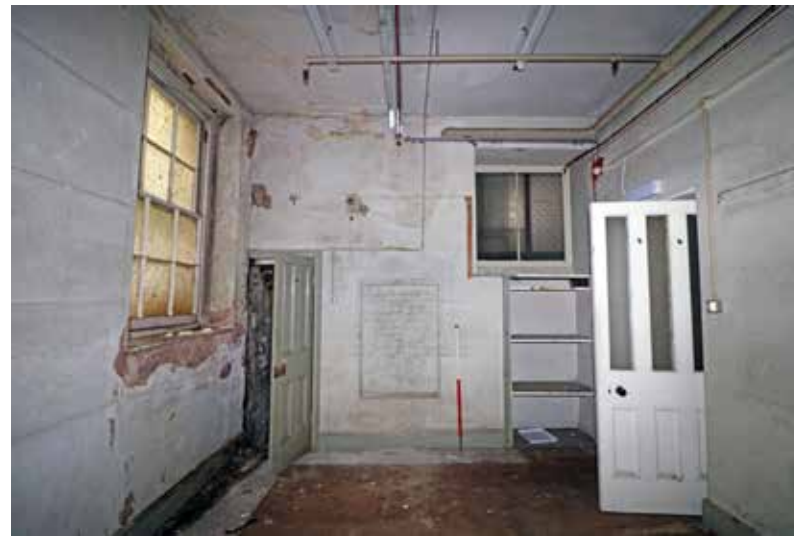
(0.13, 0.14, 0.15, 0.16, 0.18) A series of small service rooms set behind the Aspe on the GF southeast are historic in character; largely undressed stone with wood casement windows, with the occasional metal replacement, cupboards and memorial stone tablets embedded within the walls. These stone tablets indicate the space was in use for religious worship and memorial in the 1820s, and suggests these spaces once formed publicly accessible, if ancillary spaces to the main chapel.

Southeast view of room 0/16. IMG_8172.

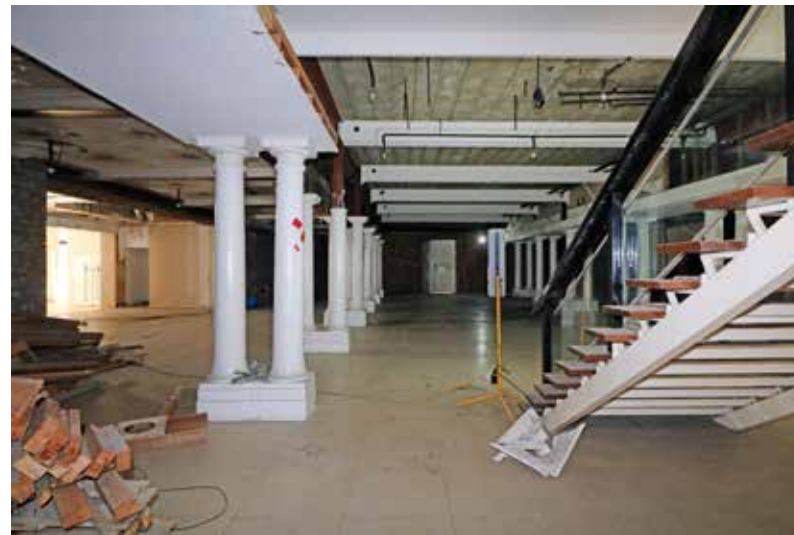
South-west view of the chapel, 0/20, including plywood columns, historic arcade plaster roof and modern steel and concrete roof. IMG_8208
