On behalf of Purcell ®

Issue 01
April 2024
TE Cardiff 7 Ltd

HOWELL'S: LEVEL 4 HISTORIC BUILDING RECORD, FORMER HOWELLS DEPARTMENT STORE, CARDIFF

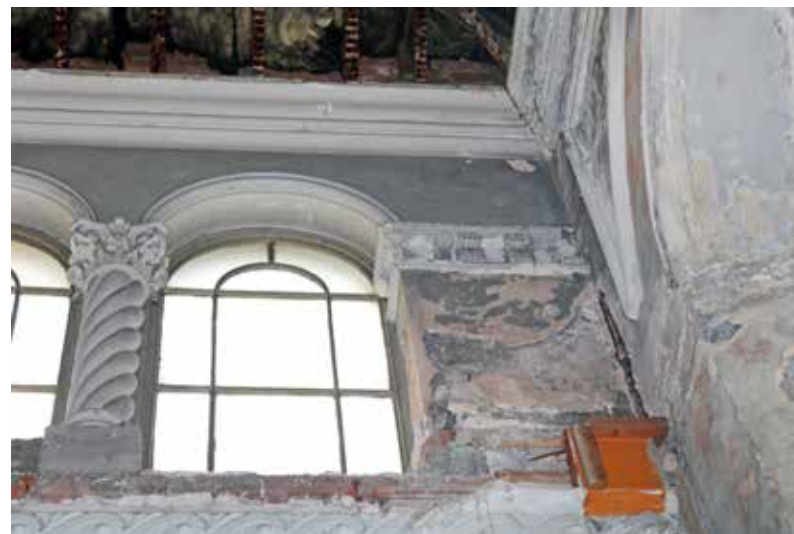
Detail of windows and steel support at clerestory level, 1/02. IMG_7684

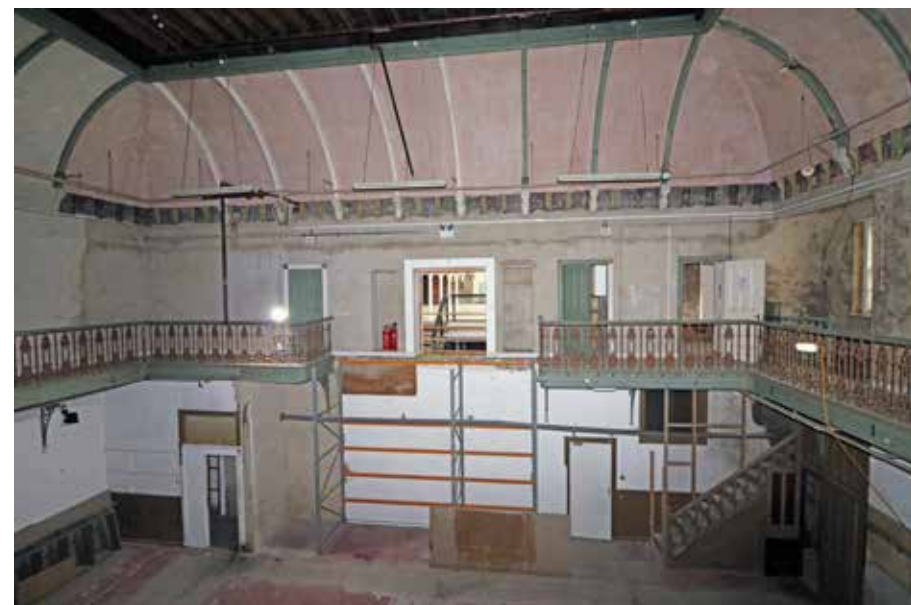
View towards the Chapel, from 1/10 to 1/02. IMG_7808.

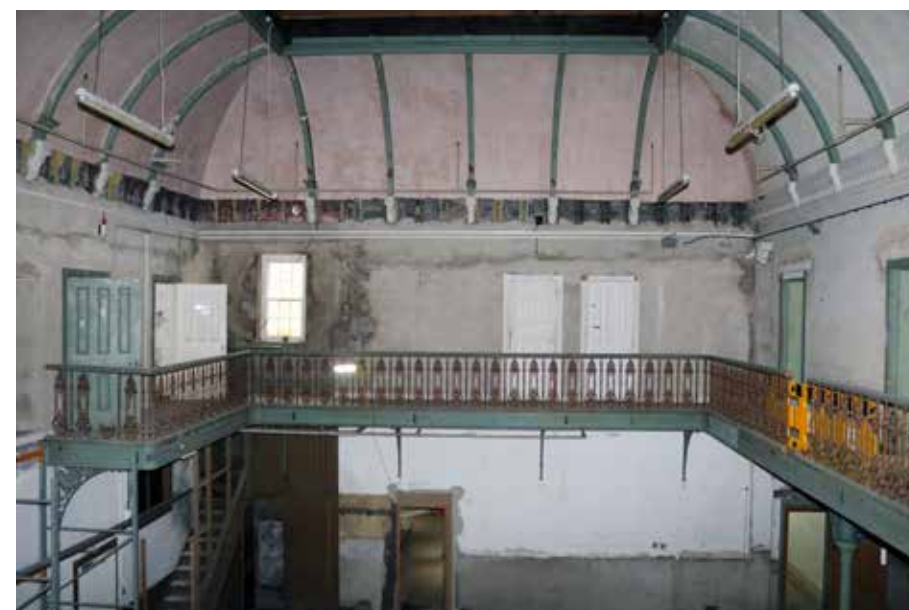
View of the hall, 0/06, from 1F balcony. IMG_7815.

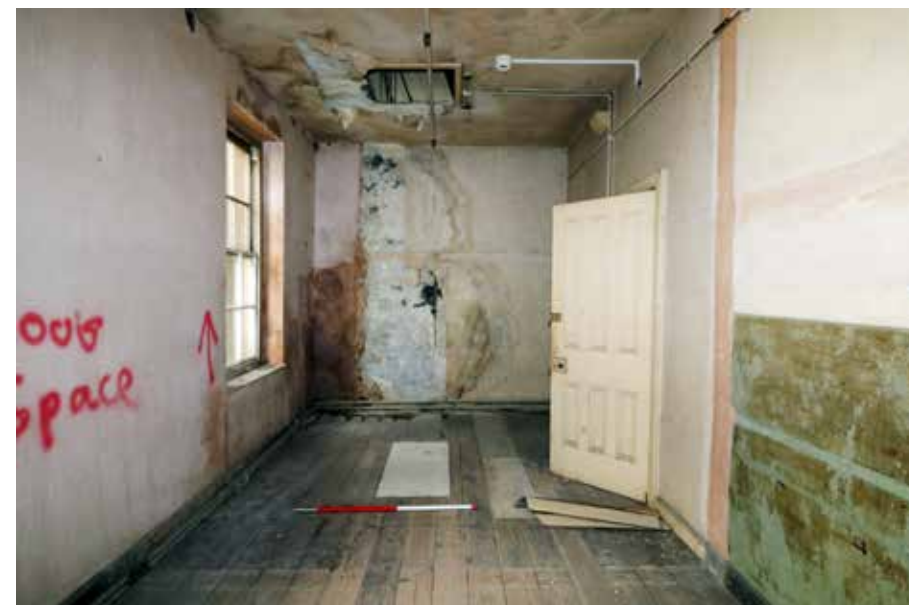
View of room 1/24. IMG_7820.

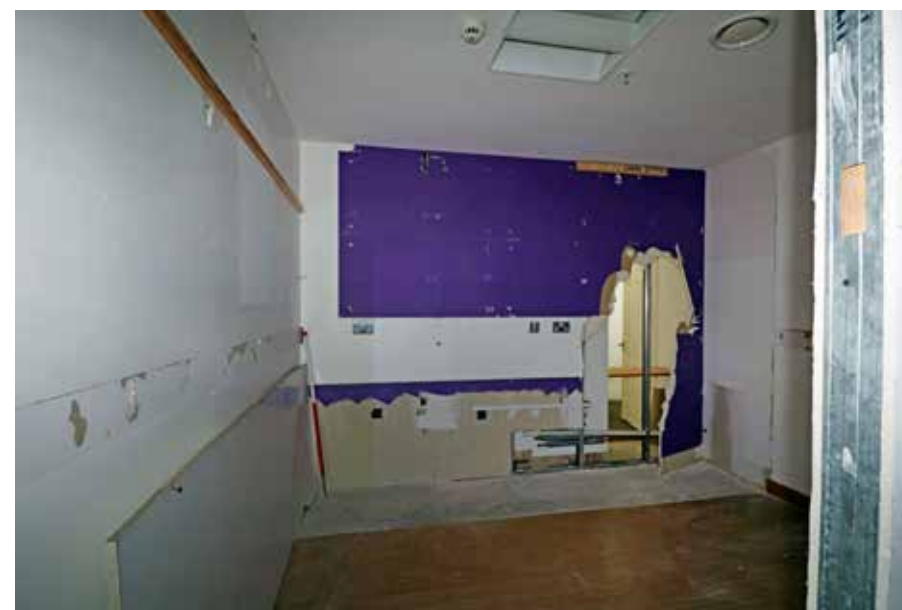
View of room 1/12. IMG_7762.

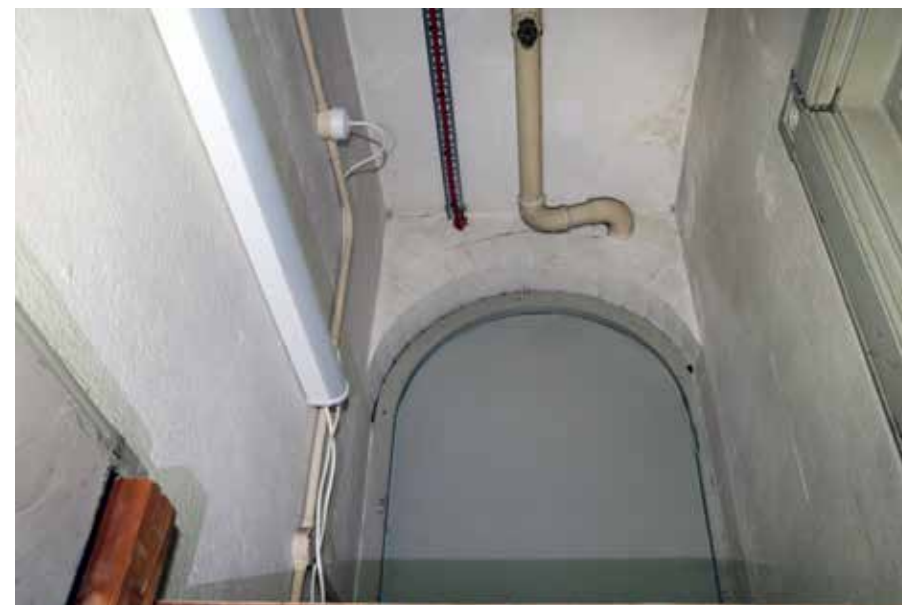
Detail of door arch in room 0/08. IMG_8127.

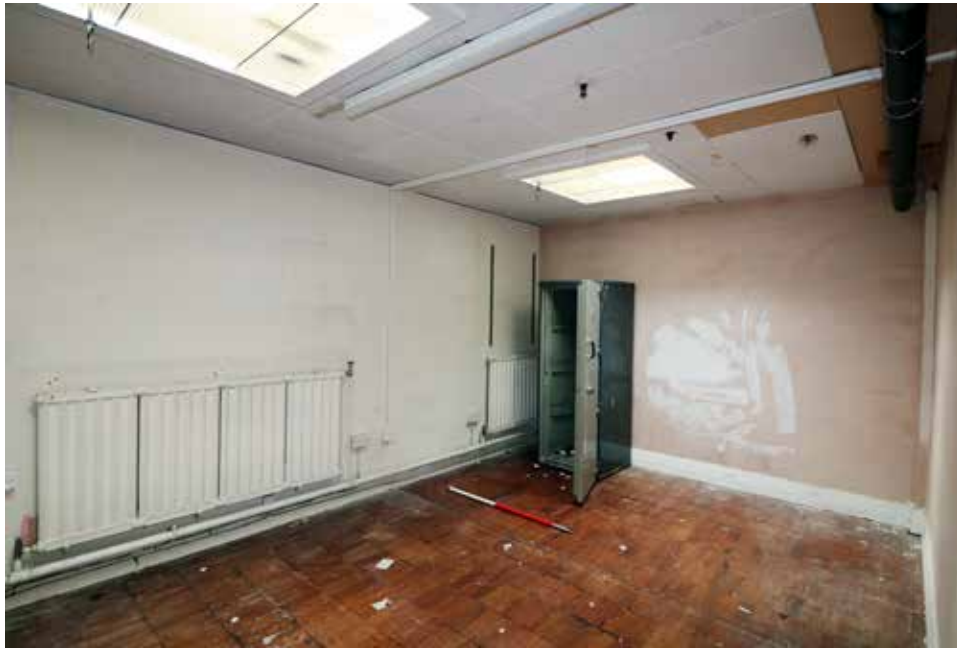
View of room 3/2, from type 7A. IMG_7462.

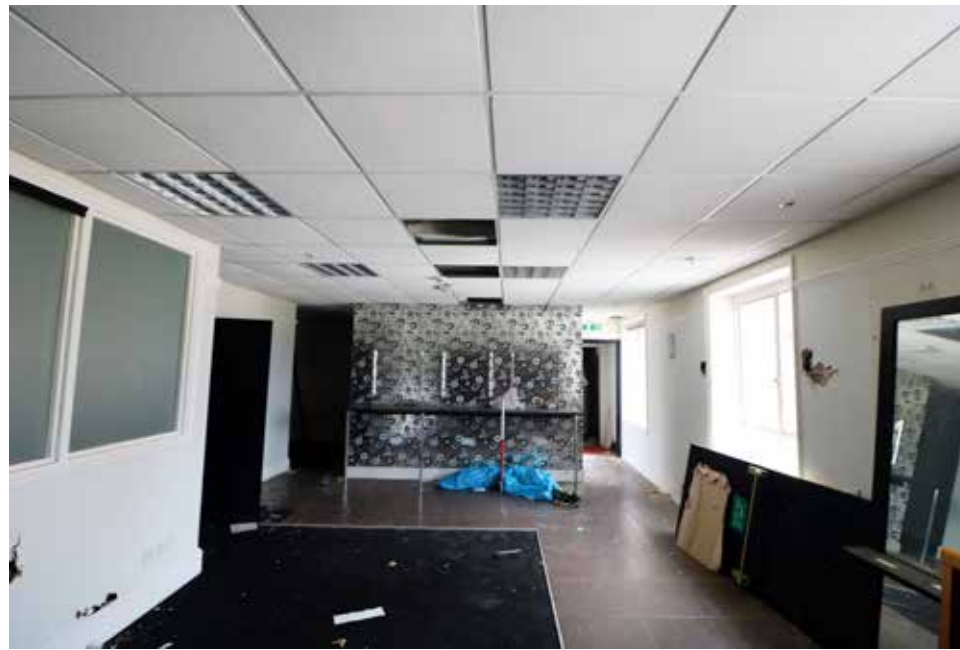
View of room 3/28, from type 7B. IMG_7488.

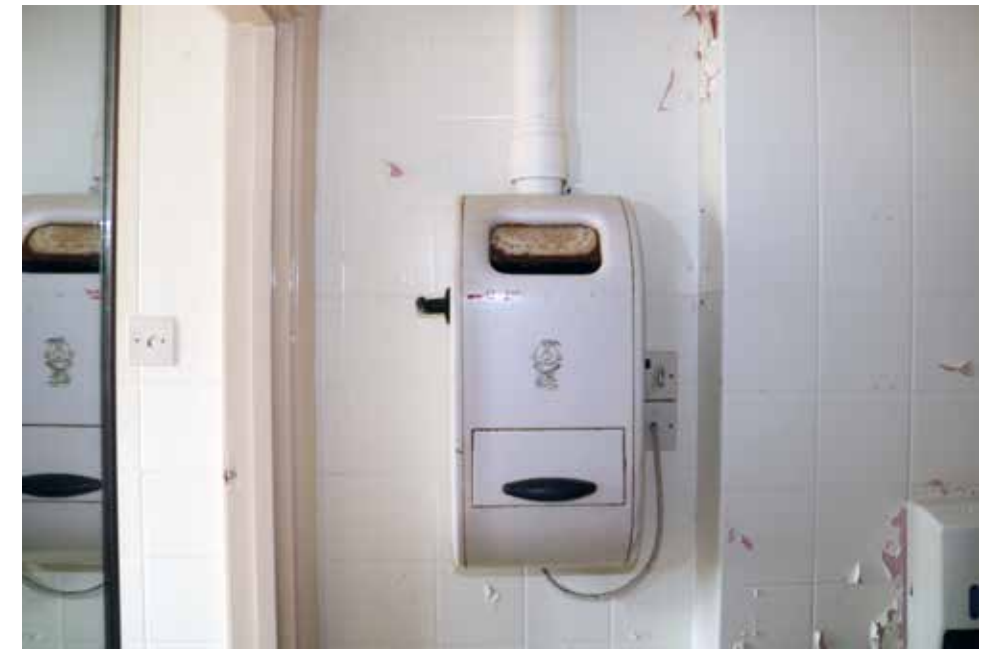
Detail of incinerator in room 3/16, from type 7C. IMG_7440.

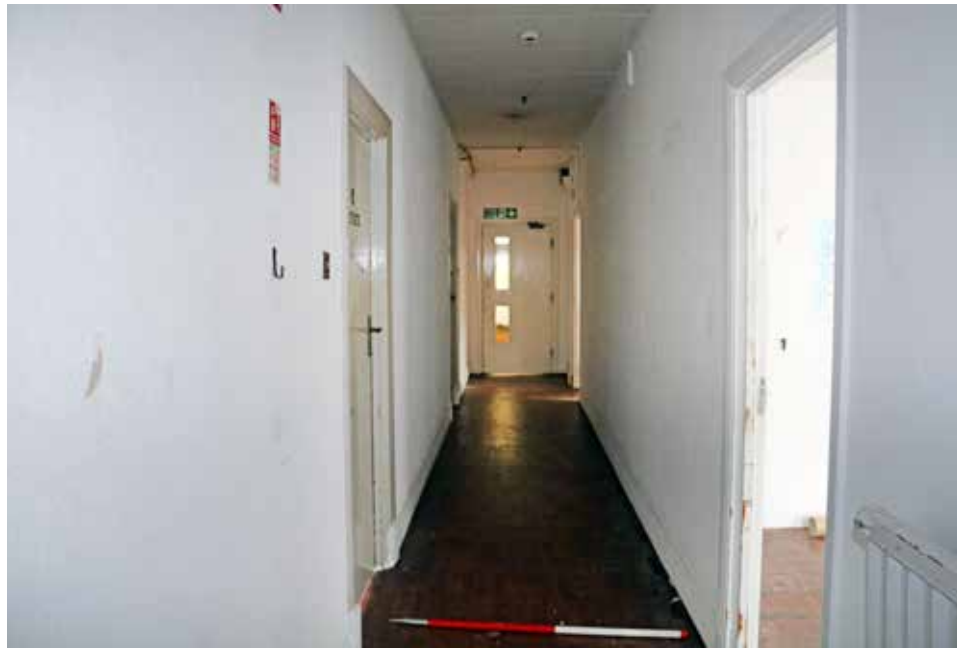
View of corridor, room 3/22, from type 7D. IMG_7467.

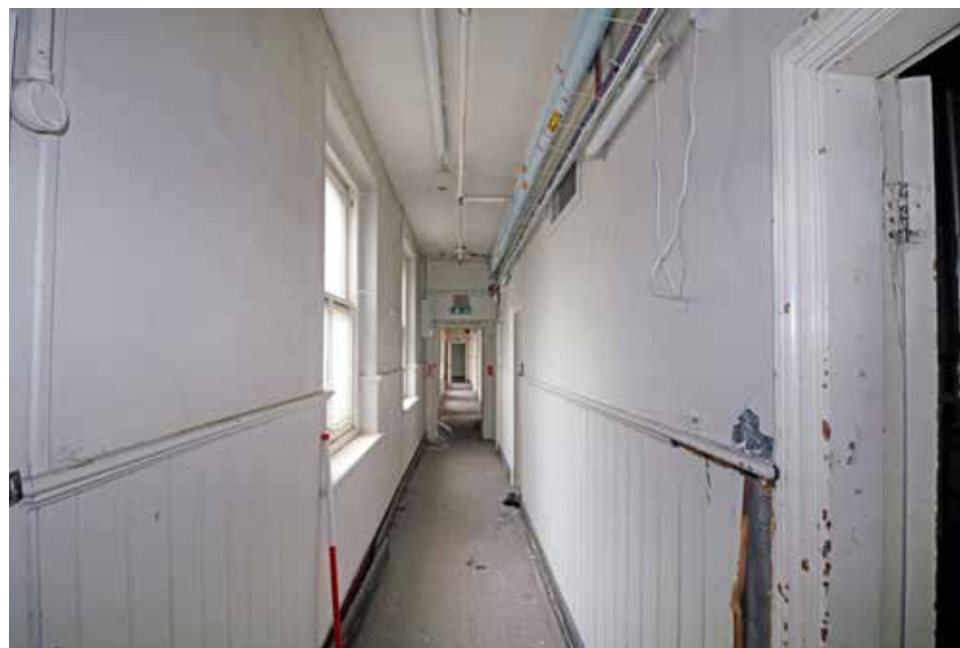
There are two spaces of this type, both within the St Mary Building South area, shown on the plan as 3.32, 3.37. These corridors are characterized by white painted, tongue and groove board wainscoting, which appears contemporary to the late 19th century building. Windows that line the western wall are timber frame hung casement. Walls above the wainscot are white plaster with a plaster ceiling, and carpeted floor.

View of corridor, 3/32, from type 7E. IMG_7503.

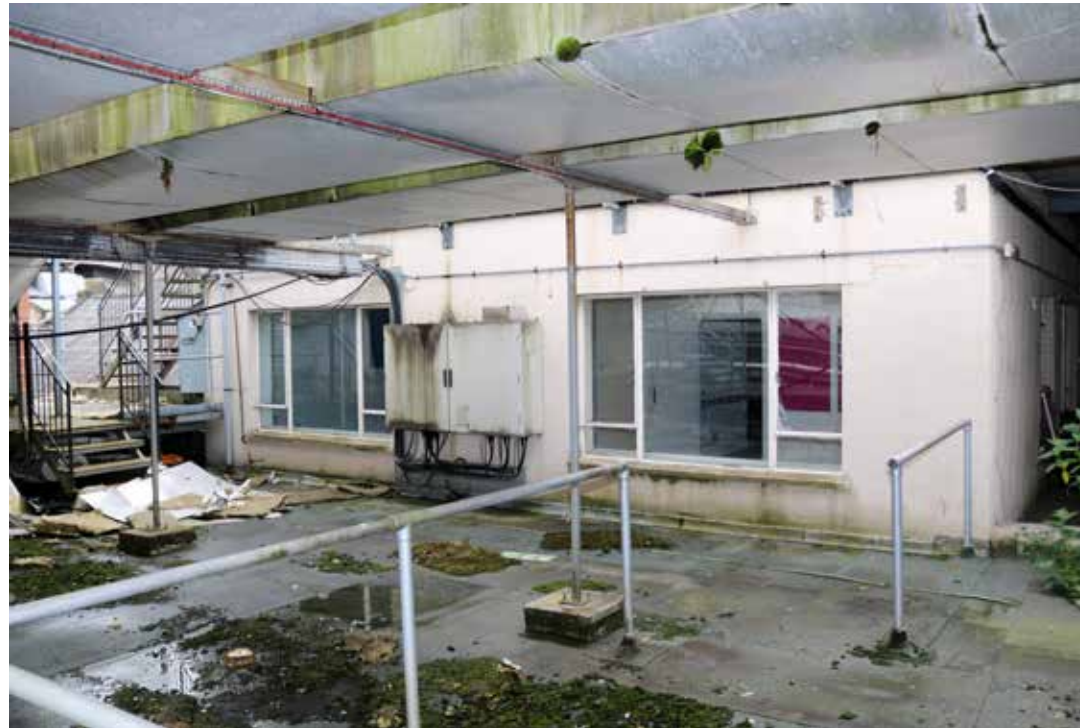
View of roof, 3/18. IMG_7445

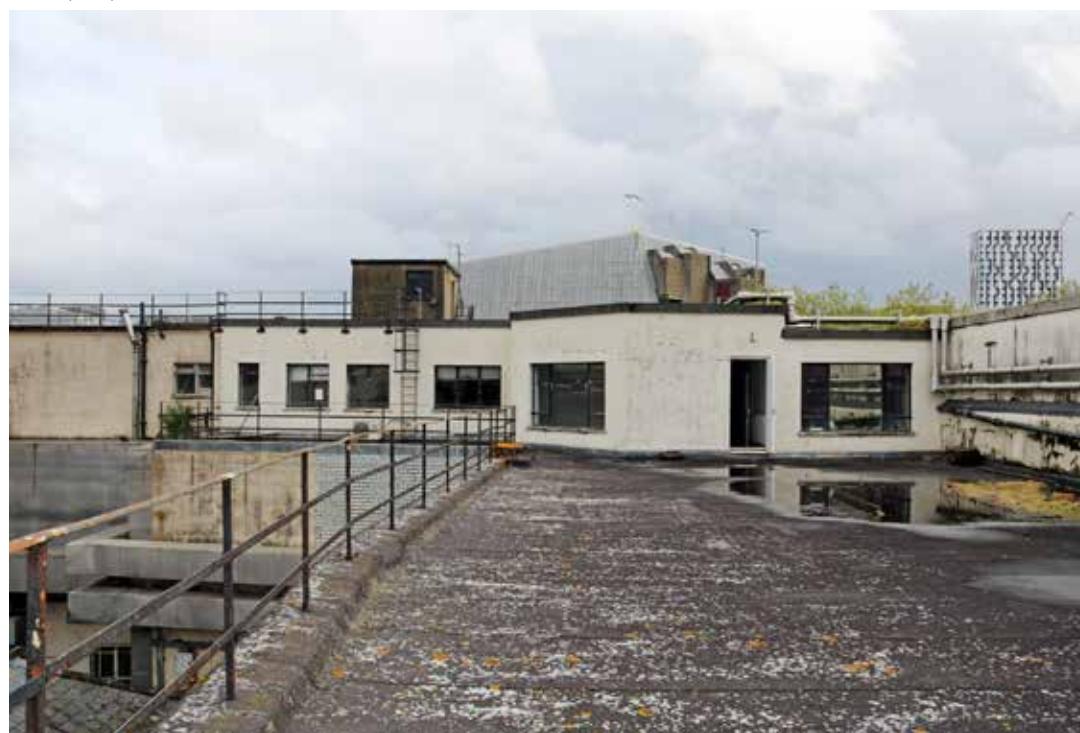
Character Area 8B Roof. (3/26) This area is a large, rectangular space that constitutes the flat roof of the Wharton Street building. A tall wall lines the roof edge to the south, and a metal railing to the south, offering wide views across the various building roofs that comprise the Howells department store. It is surfaced in roofing felt, accessed via a door within the western side of the 1960s Corner Building.

View of roof, 3/26. IMG_7479

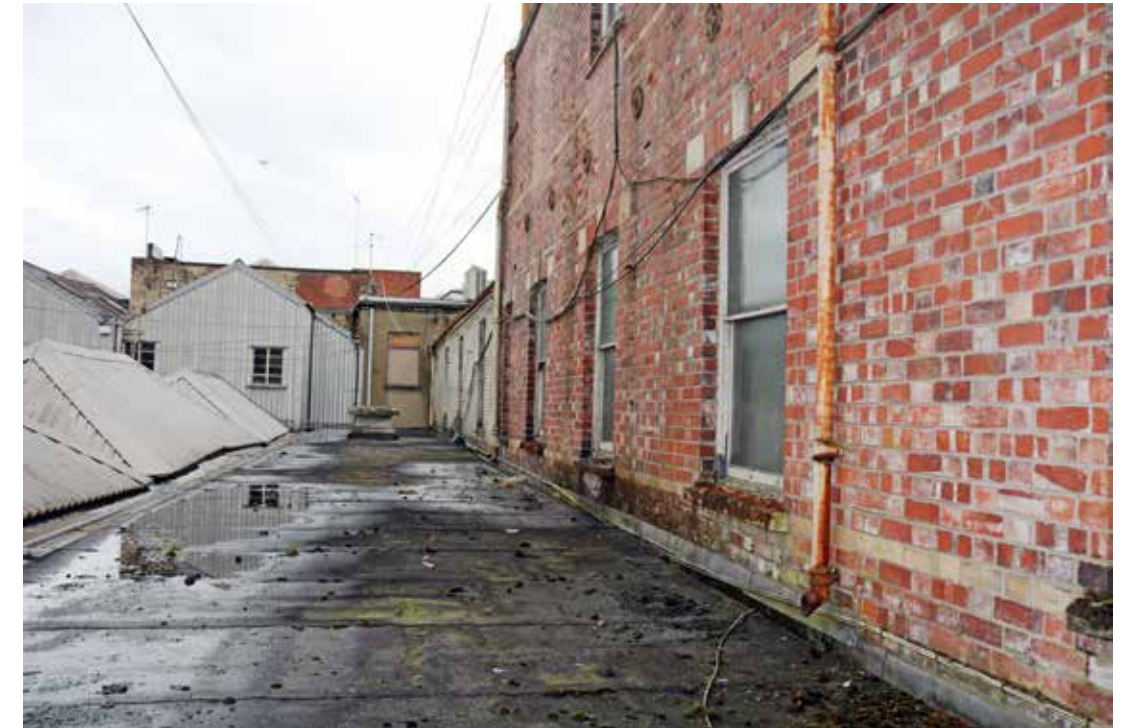
View of the northern wall of St Mary Street building, 2/10. IMG_7642.

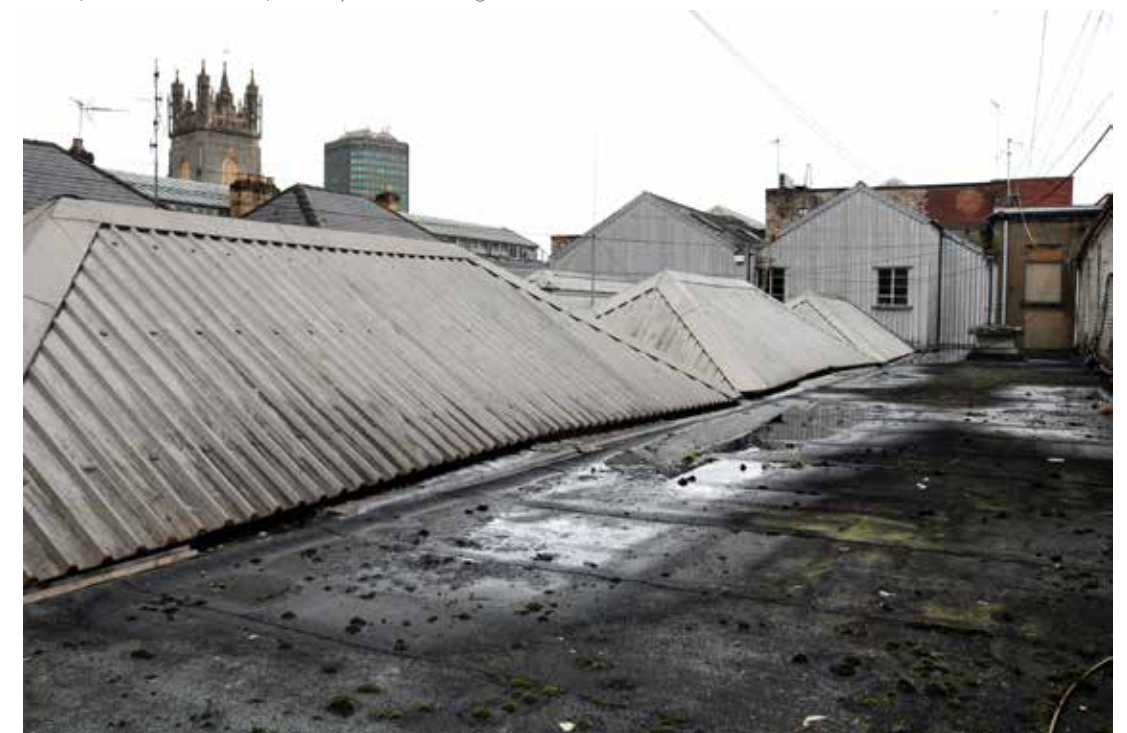
View of St Mary building roof, 2/10. IMG_7641.

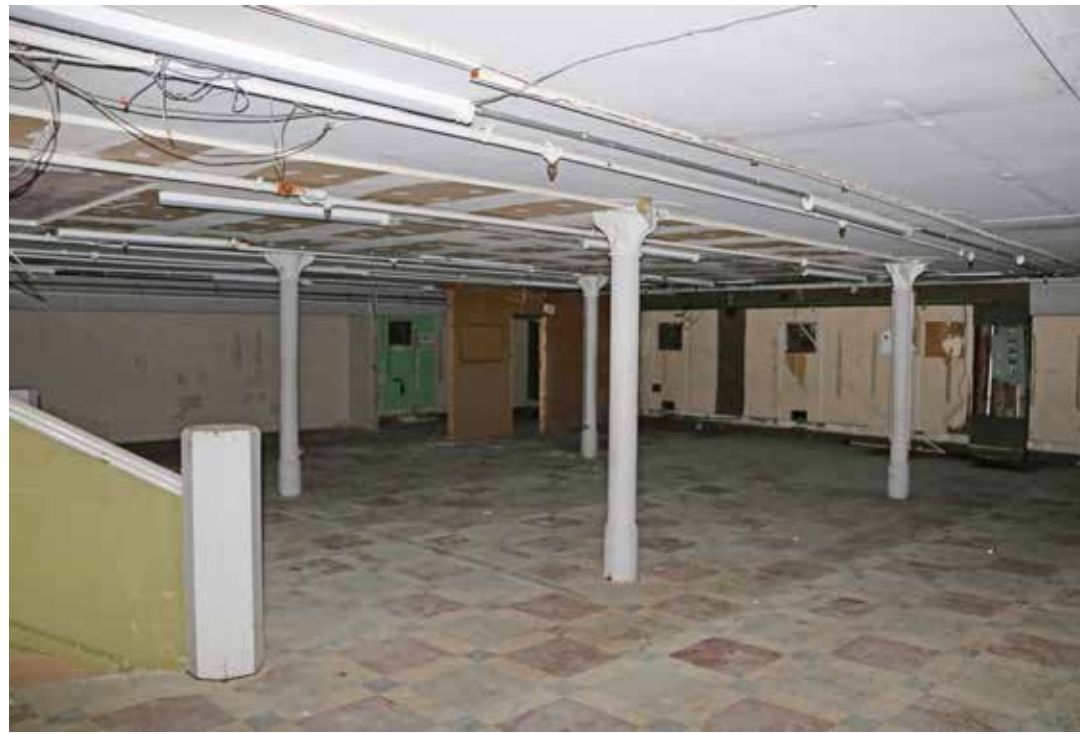
View of former shop floor, B/12

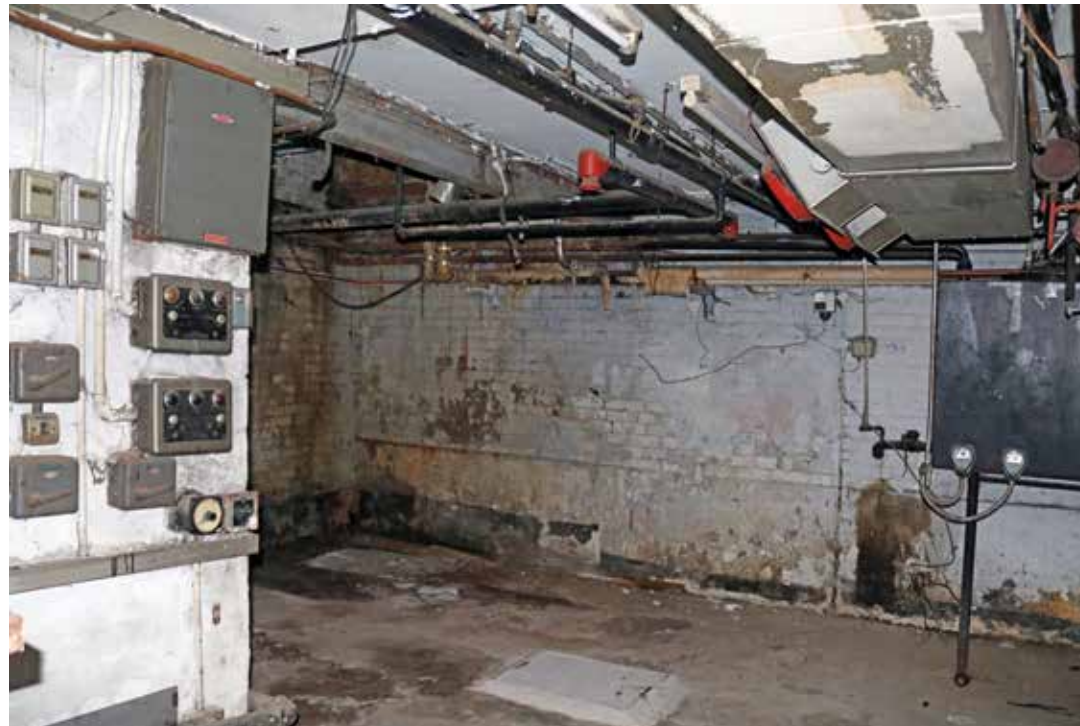
View of side room and Midland Electrical Manufacturing switches, B/02

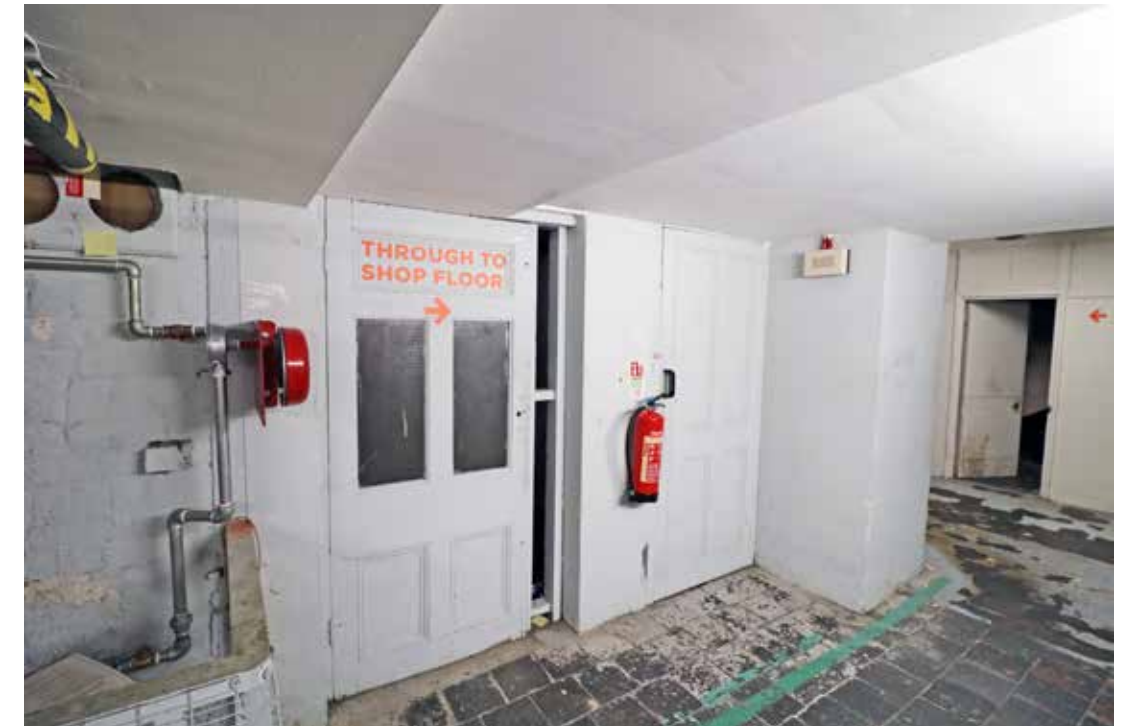
Character Area 9C. (B/1, B/3, B/7, B/11, B/15) The corridor spaces across the basement are all relatively narrow and utilitarian in character, with some surviving historic features. The flooring treatment is varied, with colourful linoleum and well-worn checkerboard tiles to B/11, and historic stone pavers to B/01 and B/03. Whilst the other corridors appear to be in their original configuration or similar, B/03 is a modern formation, with a blockwork wall forming the north-west side of the corridor. Original, panelled doors survive off a number of the hallways, with a particularly high density in B/01. The most interesting doors within the basement are the two riveted, metal fire doors in B/01; one is a slender, hinged door, and the other is a large sliding door. A pair of hinged, metal fire doors were installed in B/15 c. 1930 and were manufactured by the Manchester-based firm of Mather and Platt.

View of corridor, B/01

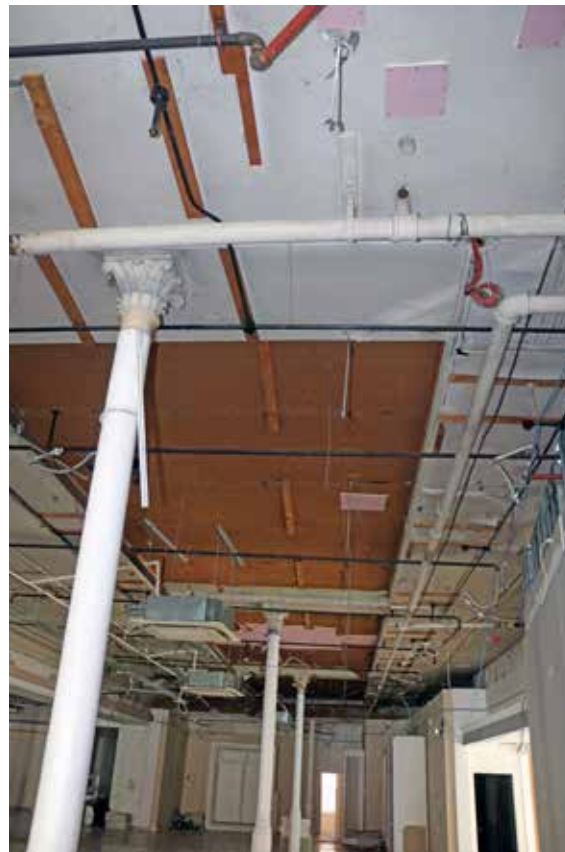
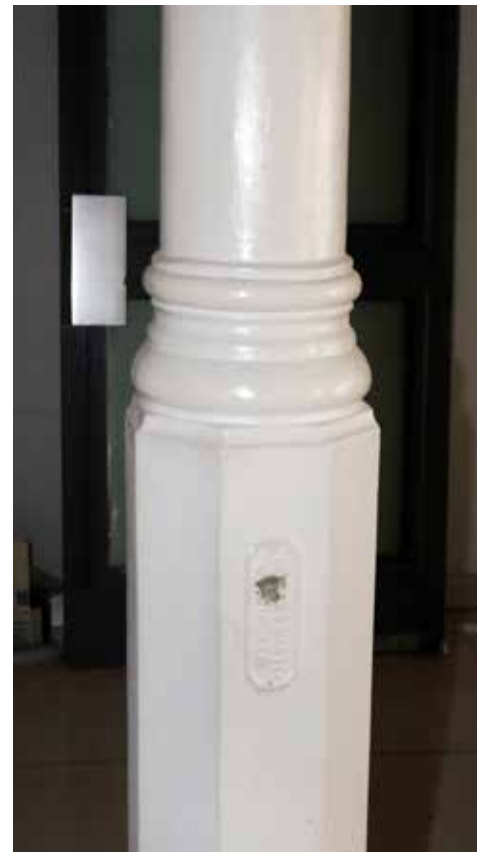
The 1878 columns are of moderate heritage significance for their finely detailed capitals and represent an important facet of the shops original decorative scheme. Furthermore, their placement serves to demonstrate the historic plan form of the space.

In general, the capitals to the columns were obscured by a modern suspended ceiling until it was removed in recent strip out. Plasterboard has been built around the top of some columns to integrate them into the ceiling structure. The columns below the suspended ceiling have been painted white, whereas the capitals above have been painted an off-white or cream colour.

Detail of the four 1878 columns adjacent to the Chapel on the first floor. (IMG_7930.JPG (left), IMG_7934.JPG (right)).

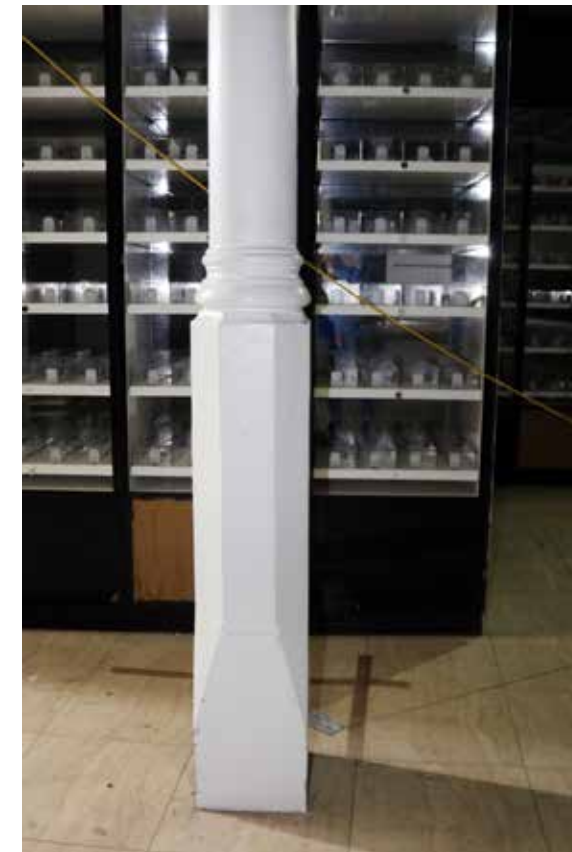
Detail of the column base on the ground floor. (IMG_8084, 1878 column)

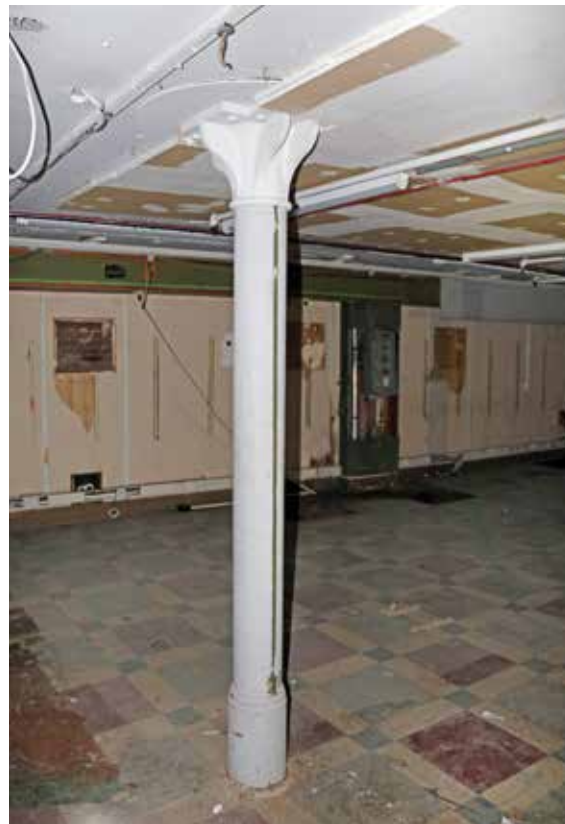
Columns produced by Archibald D. Dawnay of London in c.1889 are evidenced on the basement floor. These columns are of a simple design with low-profile moulding to the base of the columns, bearing the foundry plate of Archibald D. Dawnay. There is no decorative treatment to capitals which suggests that this area was perhaps designed initially to not be an area of shop floor and had a distinct 'back of house' character in comparison to the public decorative features. All the columns are within the open plan space to the eastern end of the St Mary Street basement.

Simple 1889 column to the basement level. One of six within the basement. (b(124).JPG)

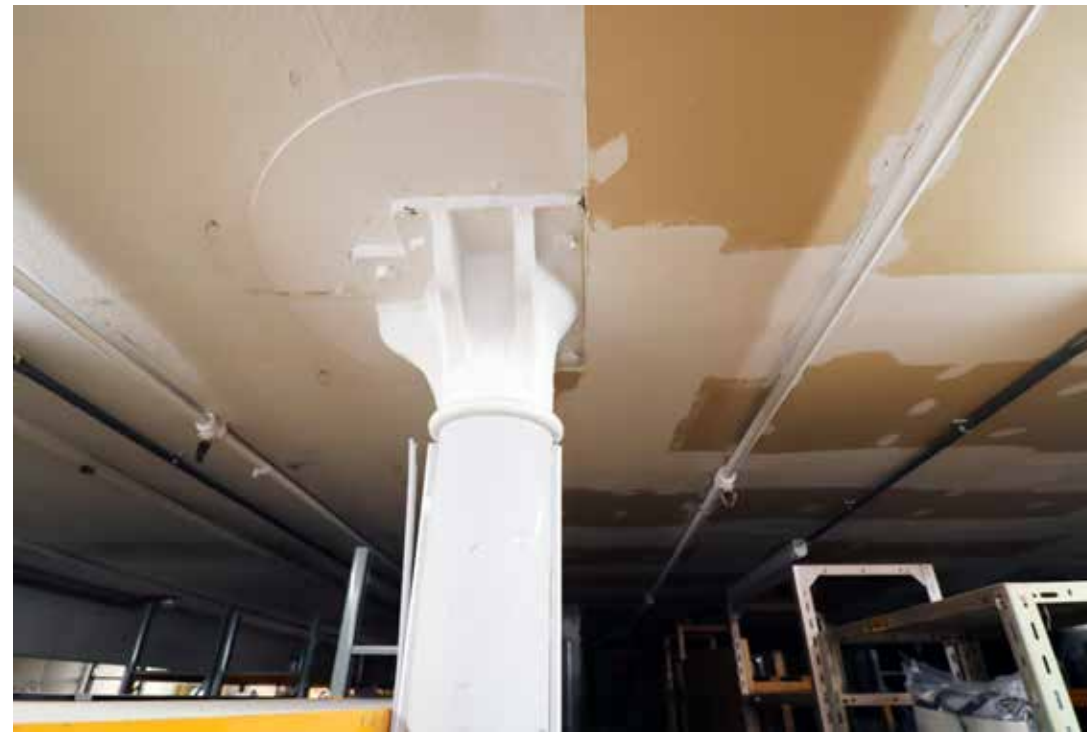
Detail of the capital to the basement column. (b(125).JPG)

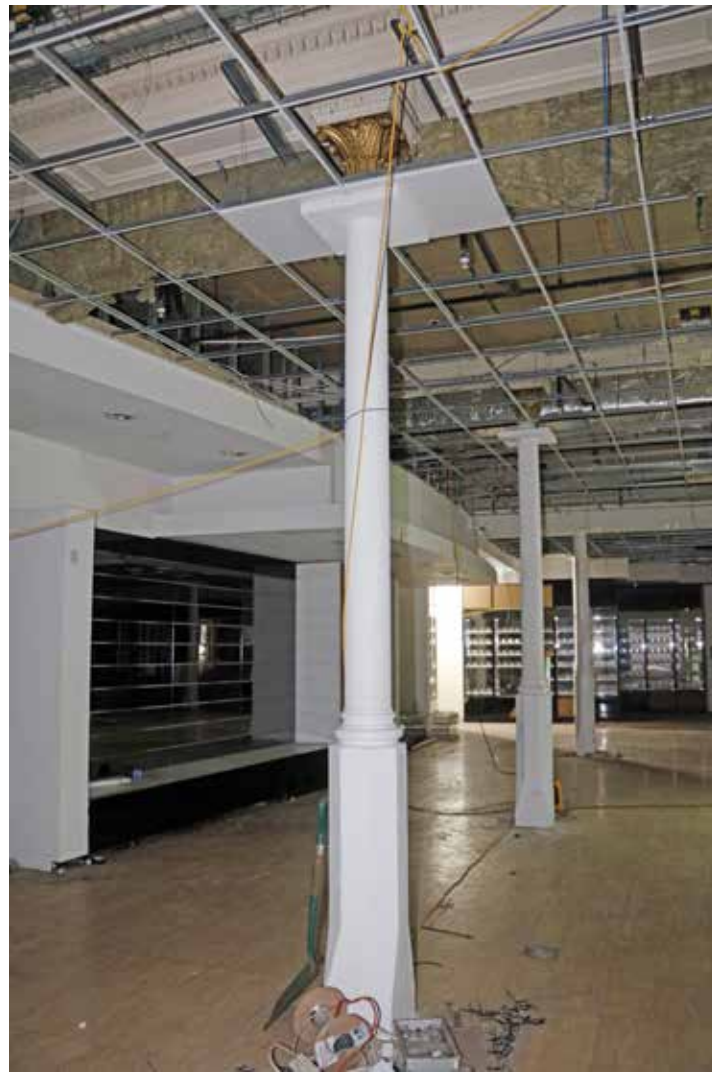
The columns survive throughout the shop floor, extending from the St Mary Street front to the rear of the building. Again, these columns are of moderate heritage significance for their finely detailed capitals and representation of important facet of the shops original decorative scheme, in addition to an indication of the historic plan form of the space.

1889 columns on the east side of the ground floor shop floor, with their Corinthian capitals painted gold above the modern suspended ceiling. IMG_8050

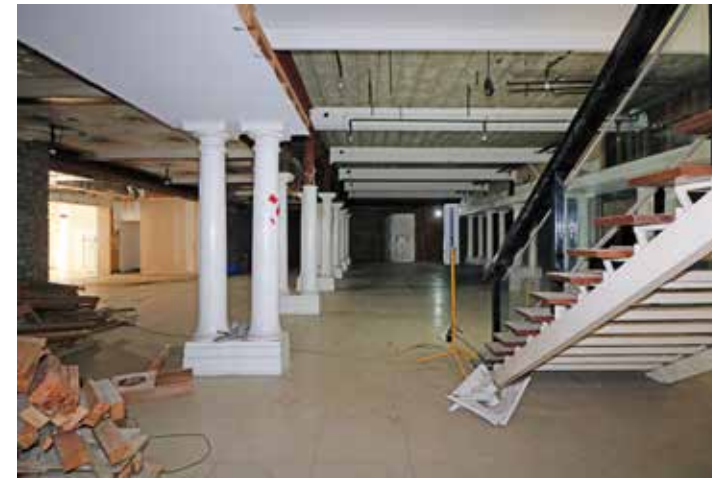
7.4 1840s GALLERY COLUMNS (CHAPEL) – GF, FF
The ground floor columns of the Chapel are modern replacements, likely installed when the nave was subdivided by an inserted concrete first floor to provide additional shopfloor space for the department store. The columns are in pairs, simply designed with a small floral motif to their tops and white in colour. Historic photographs of the interior of the Chapel (page 11 of the HIA) show that originally the ground floor columns more closely resembled the existing surviving columns of the first floor.

The rows of paired columns on the ground floor of the Chapel. IMG_8208.

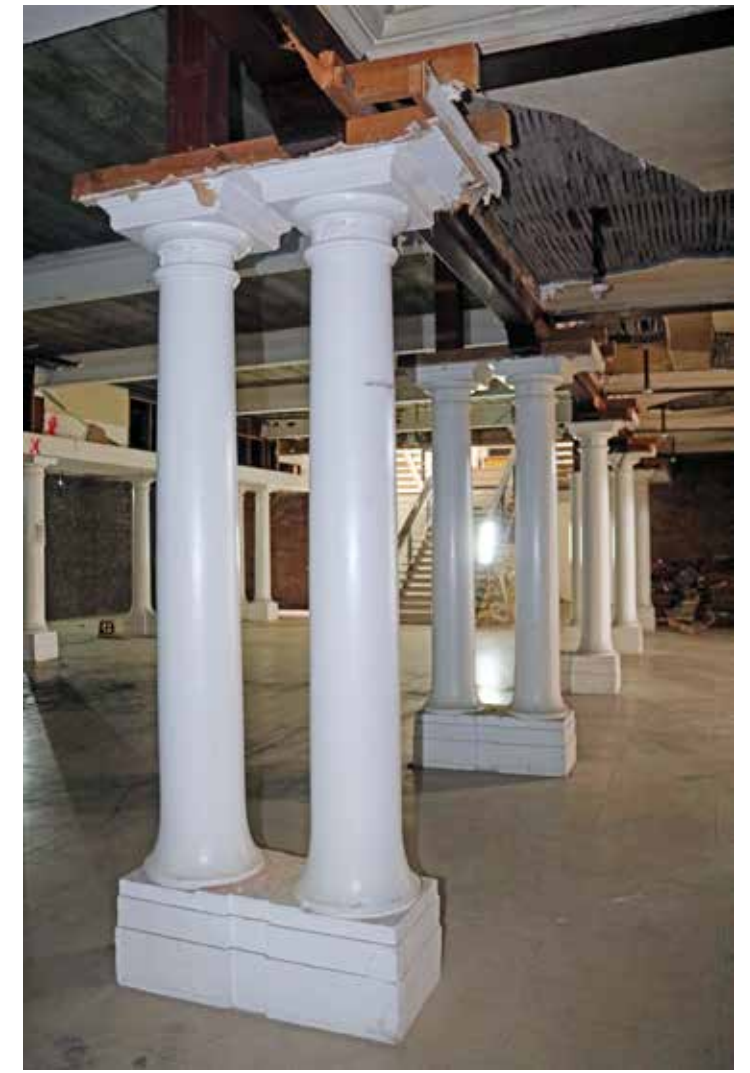
Detail of the ground floor columns; they are of a simple design and stood upon block pedestals. IMG_8217.

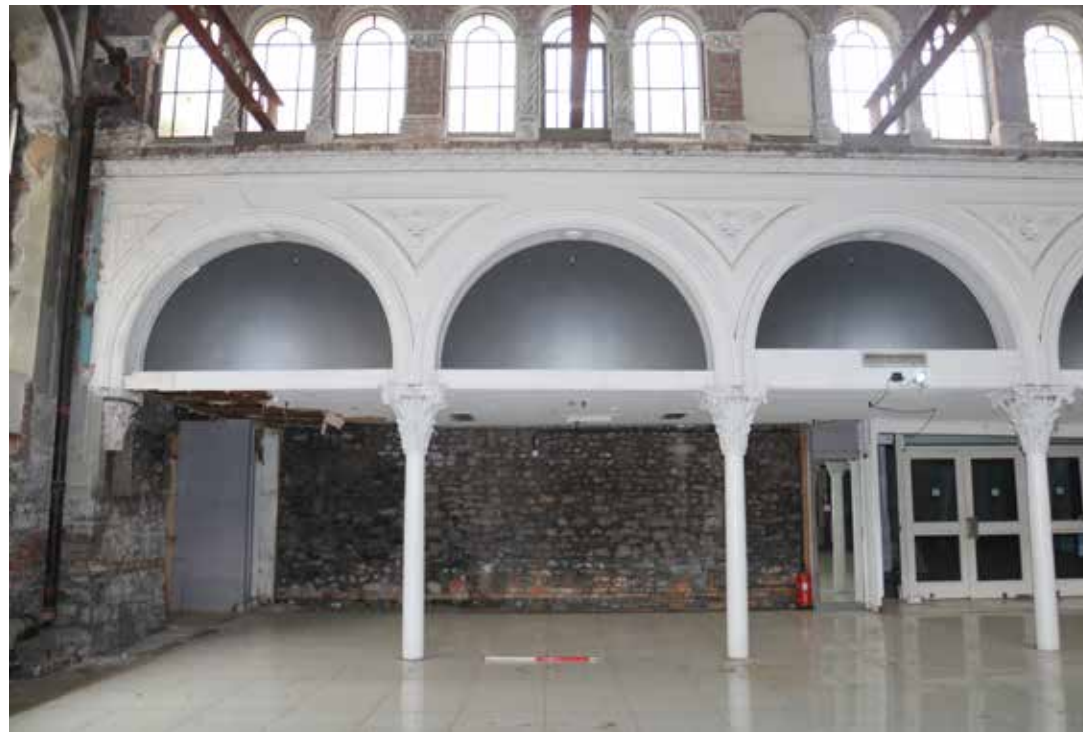
The first floor columns within the chapel are the original to the 1840s Chapel gallery. The columns have simple shafts with highly decorated Corinthian capitals, which support the arches of the side arcades. These archways were once open but have since been partially ceiled to house servicing and lighting. The side aisles originally were galleried seating to house the large congregation, but these were removed when the nave was subdivided. Above the arcade is a clerestory with moulded stone columns in a twisted design.

Side aisle of the Chapel on the first floor, where the original galleried seating once was. The intersecting ceilings through the archways are a later addition. IMG_7661.

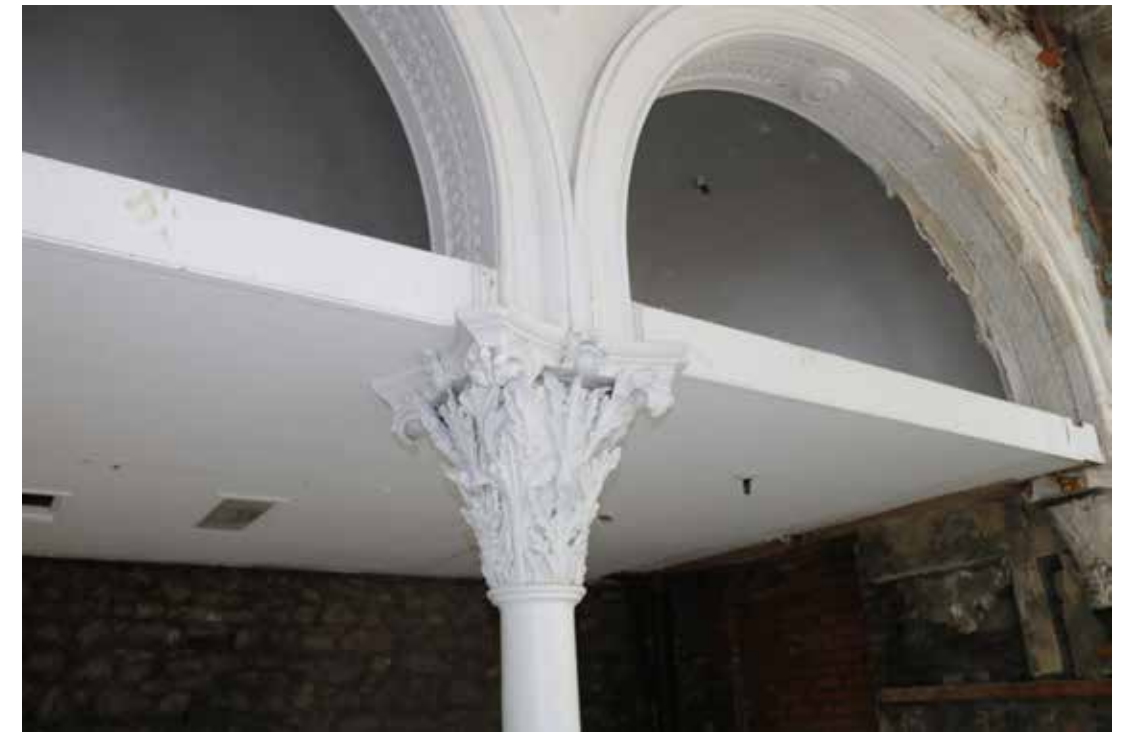
Detail of the Corinthian capitals of the Chapel columns. IMG_7663.

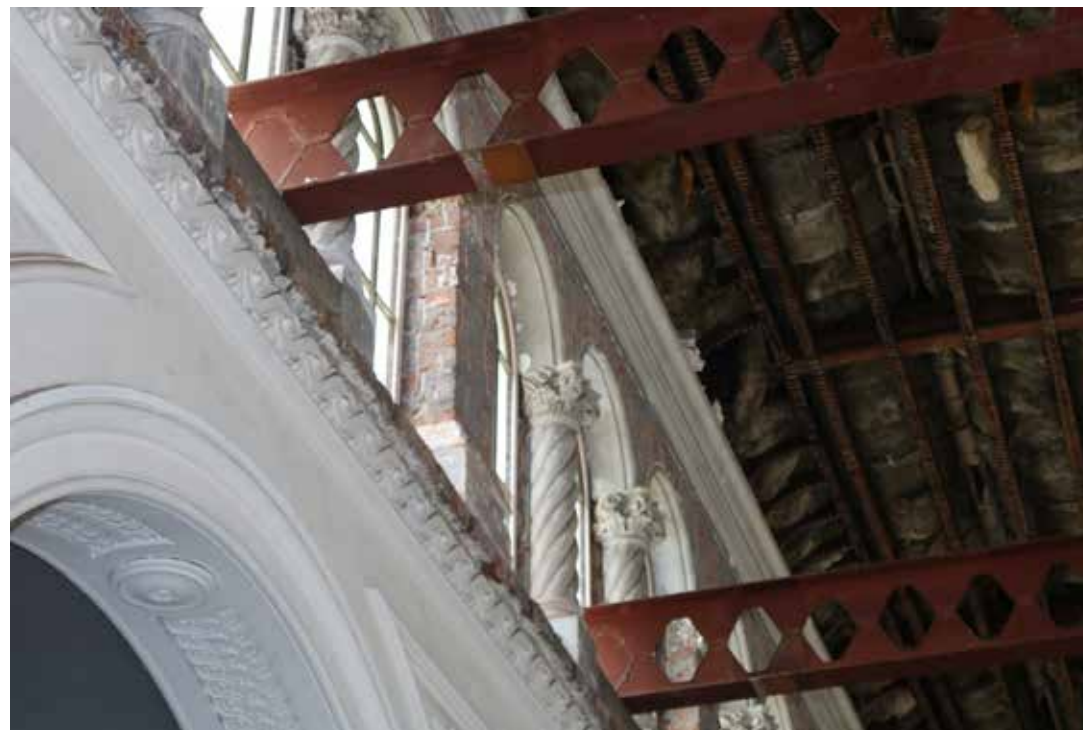
Detail of the clerestory with moulded masonry columns. IMG_7282.

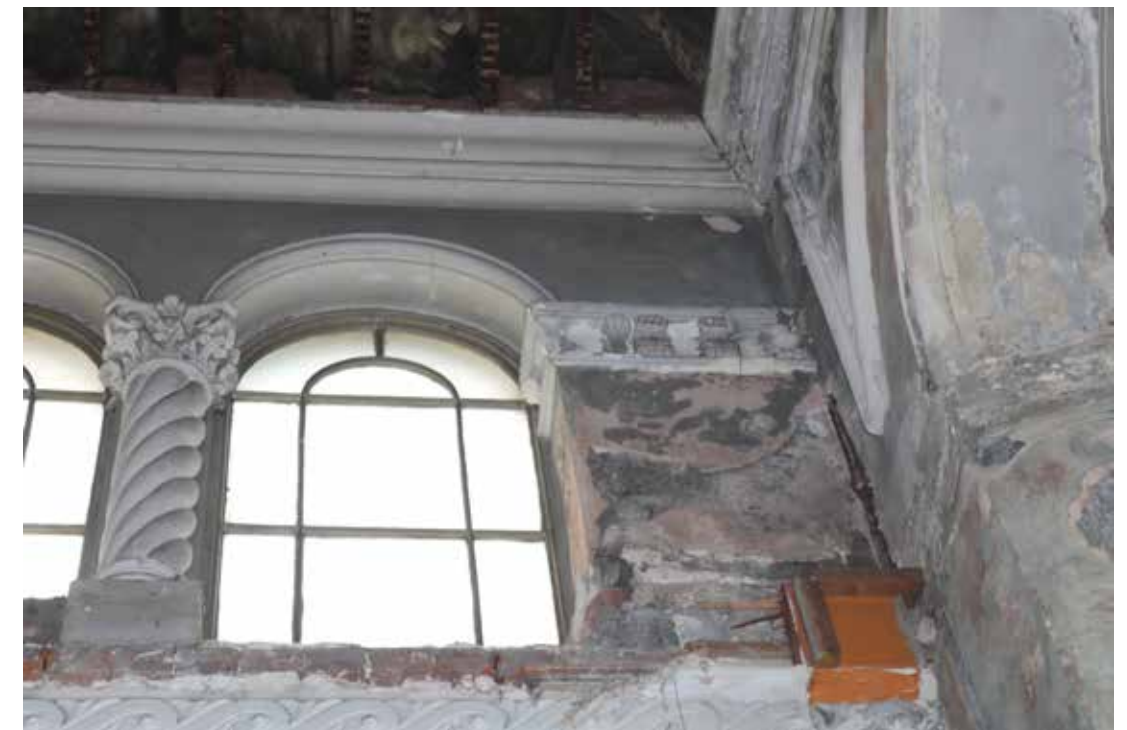
Detail of the clerestory with moulded masonry columns. IMG_7684.

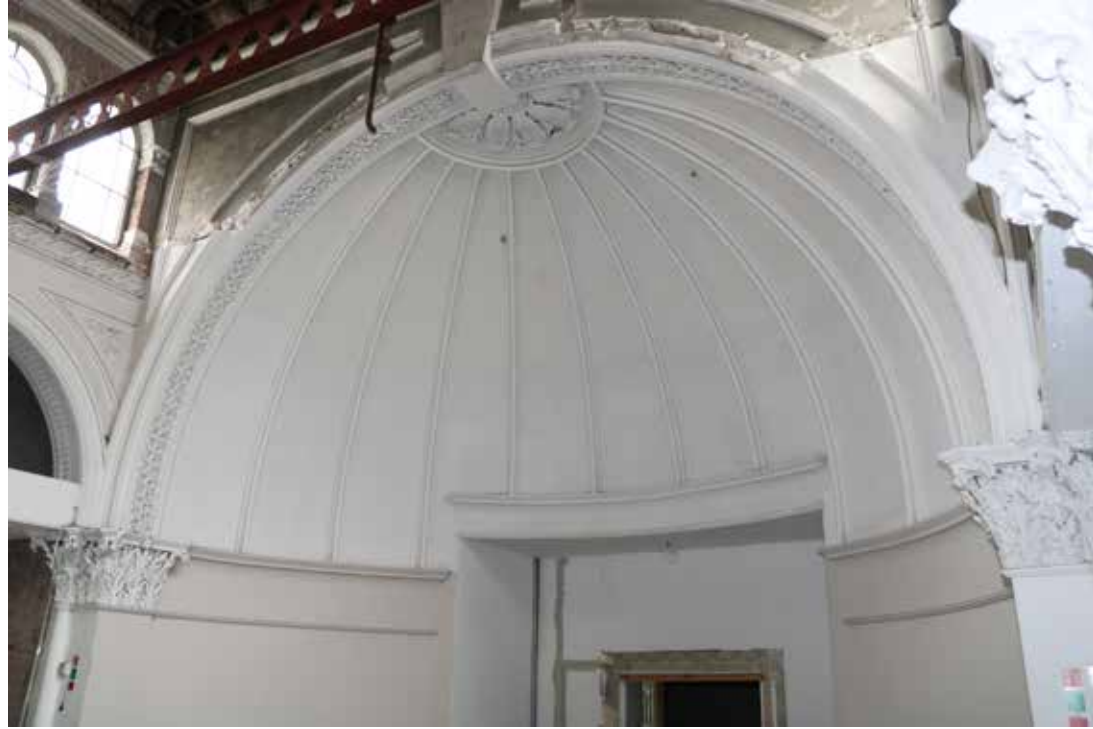
The original plasterwork to the arches of the side aisles on the first floor of the Chapel survive, in addition to the ribbed dome ceiling of the north east end, which previously housed the organ. The decorative motifs of the domed ceiling match the leaf design of the Corinthian capital columns, with the addition of floral motifs between the arches of the aisles.

Decorative plasterwork of the domed ceiling on the north east end of the Chapel. IMG_7668.

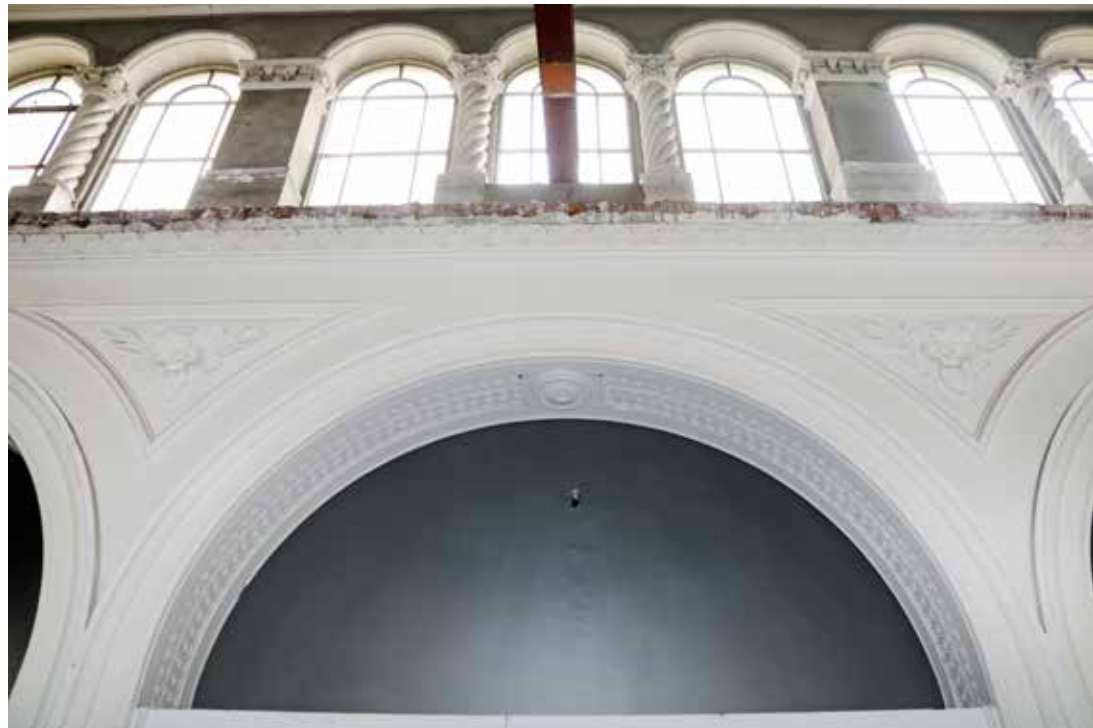
Detail of the original plasterwork side aisle arches. IMG_7664.
