On behalf of Purcell ®

Issue 01
April 2024
TE Cardiff 7 Ltd

HOWELL'S: LEVEL 4 HISTORIC BUILDING RECORD, FORMER HOWELLS DEPARTMENT STORE, CARDIFF

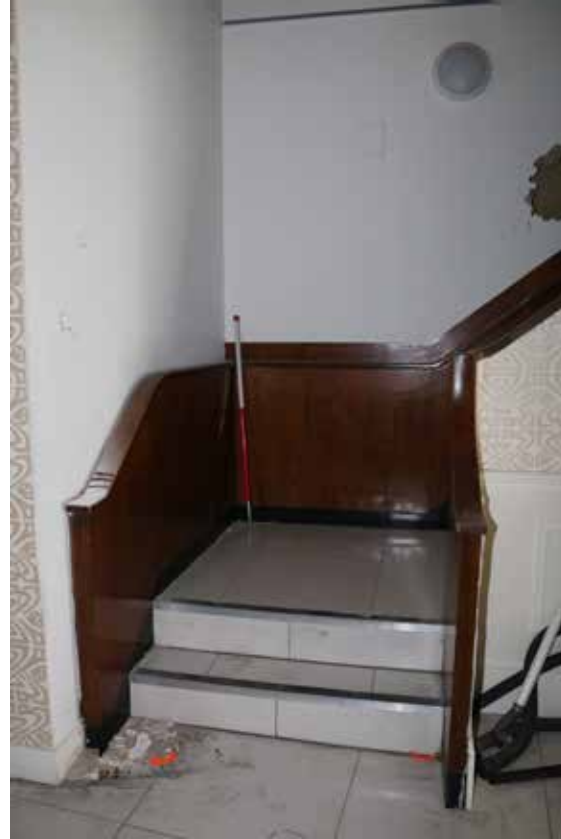
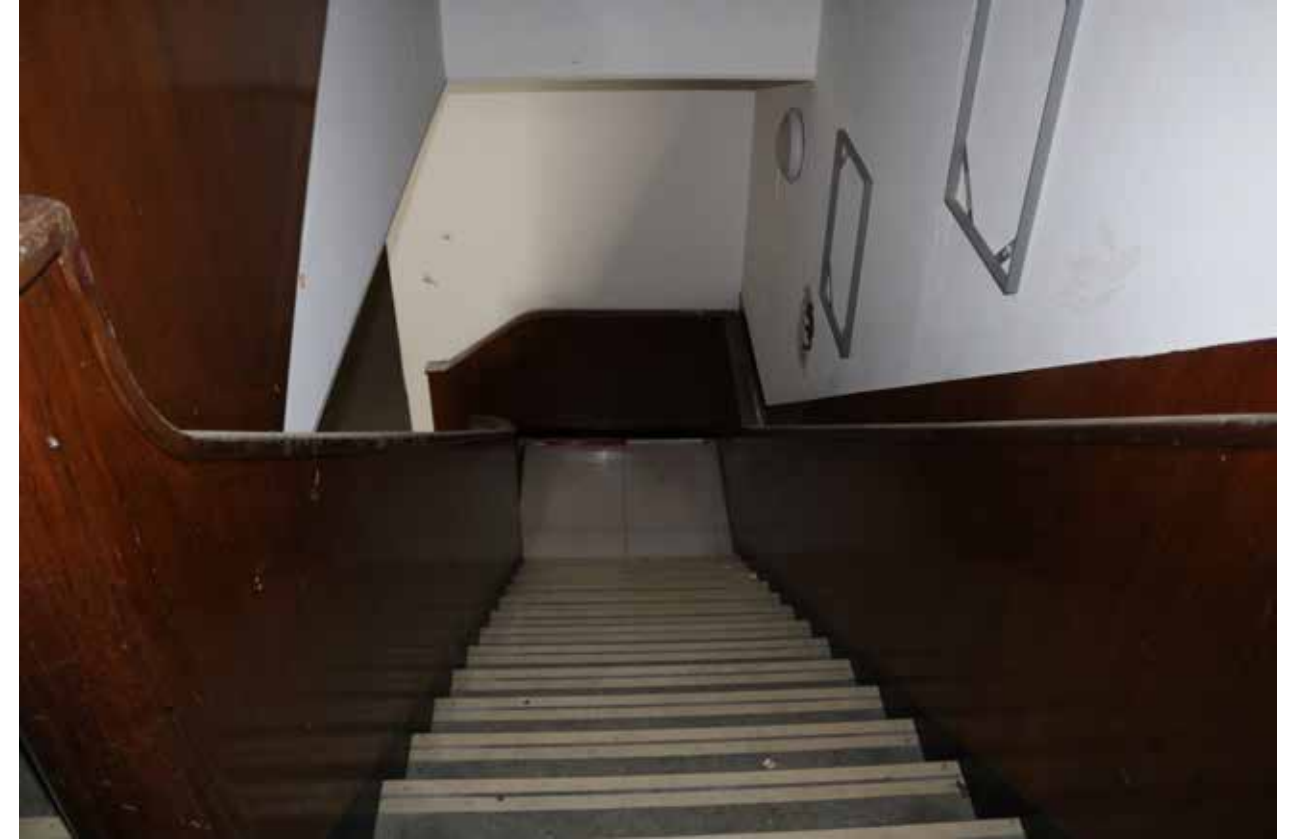
A mid-century staircase has been inserted in the centre of the shopfloor to the St Mary Street building. The staircase has carpeted treads and dark timber veneer balustrades. The solid timber handrail ramps up from the landing and is lightly curved on the bottom two steps down to the shopfloor. It is of a simple design but strongly characteristic of the period it was constructed in.

The central mid-twentieth century staircase. Left: IMG_7651, right: IMG_7649.

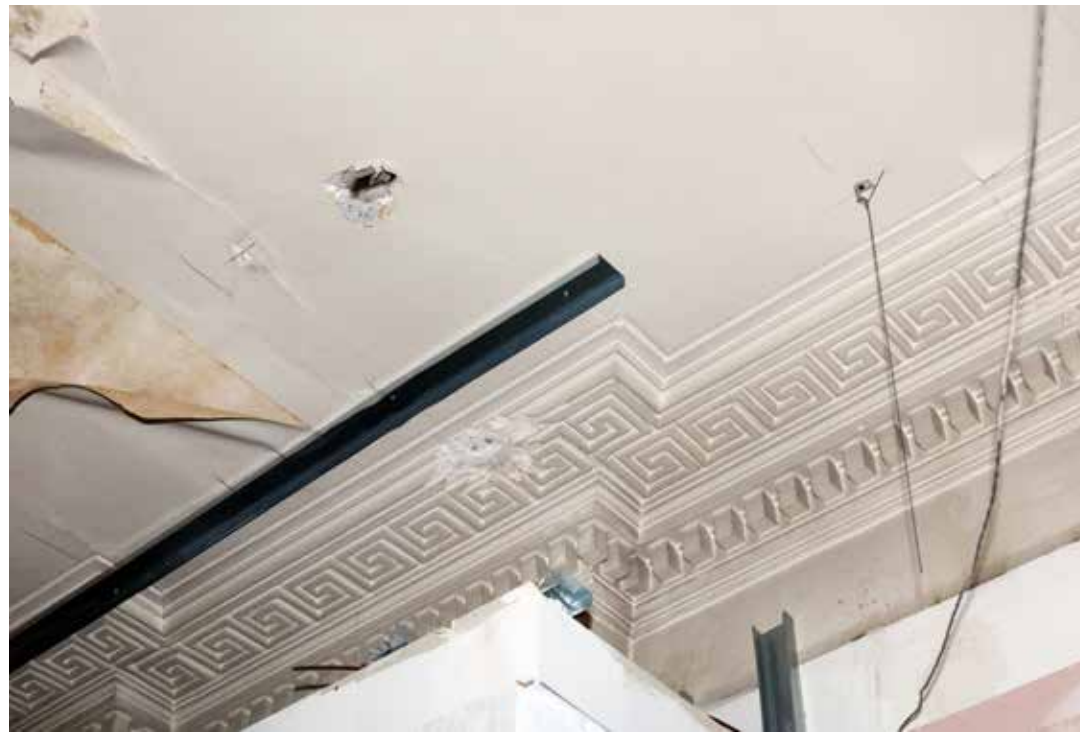
Timber boxing with bolection moulding panels along the underside conceals the structural frame of the St Mary Street building throughout. This boxing is original, from c.1878, in the south sides of the shopfloor and a later phase dating from c.1889 in the north side of shopfloor, on both the ground and first floors. Similarly to the plaster cornicing, the timber boxing survives throughout the shop floor, extending from the St Mary Street front to the rear of the building. The feature makes the structure of the building legible internally, however it was previously long hidden by a modern suspended ceiling. The boxing frames the prism shaped lightwells on the first floor, which have historically been blocked. Ceiling roses have been installed periodically between the lightwells on this floor also.

A section of the meander and dentil plaster cornice on the ground floor. IMG_7933.

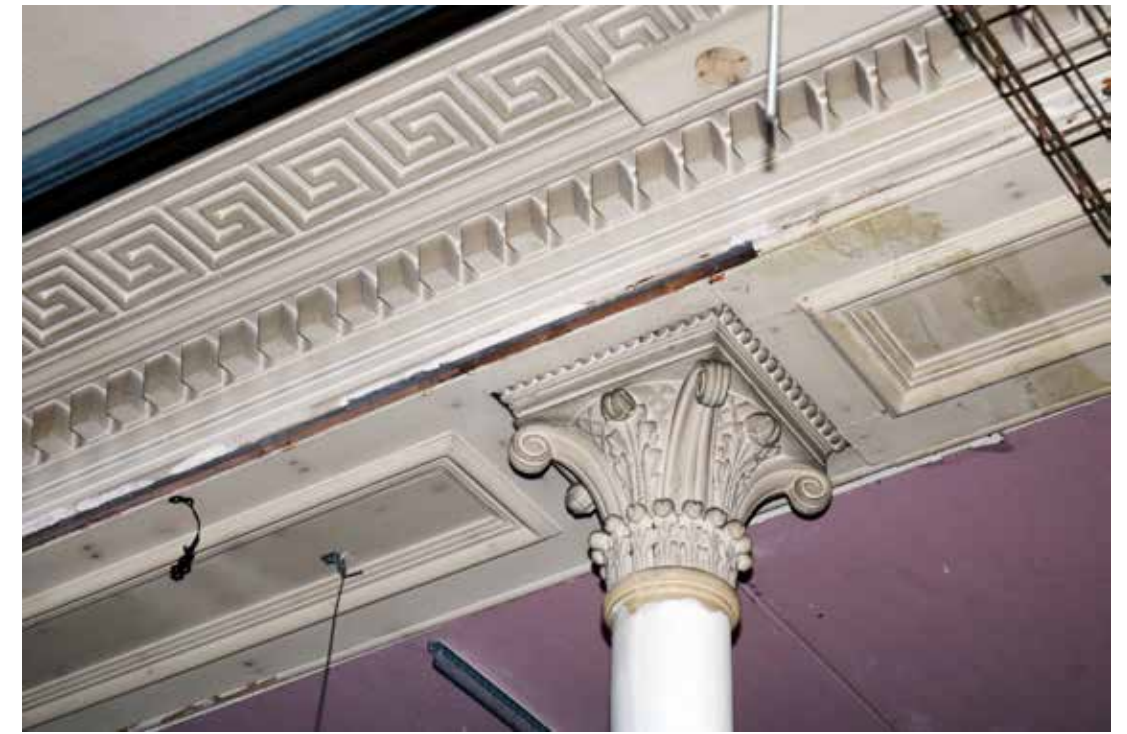
Section of meander and dentil plaster cornice with bolection moulded panel timber boxing, with the Corinthian capital of one of the cast iron columns on the first floor. IMG_7972.

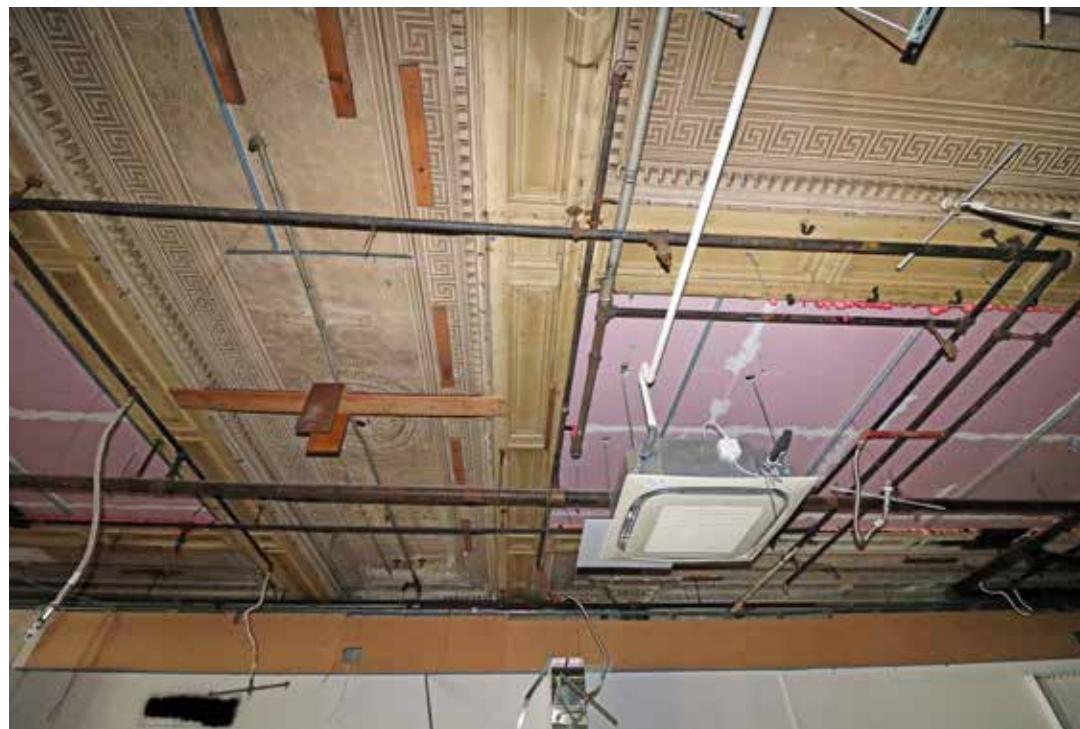
The meander and dentil plaster cornice on the first floor, with the bolection moulded timber boxing framing the historically blocked prism lightwells on the first floor. Also visible is a plaster ceiling rose and the anaglypta wallpaper. IMG_7958.

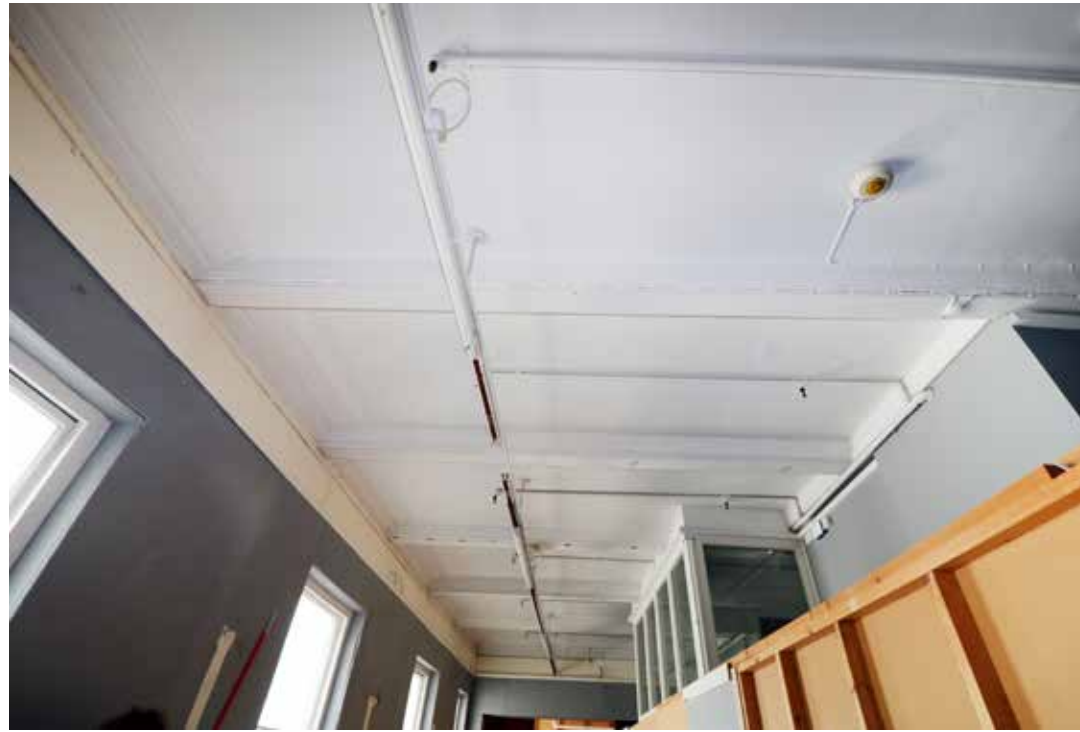
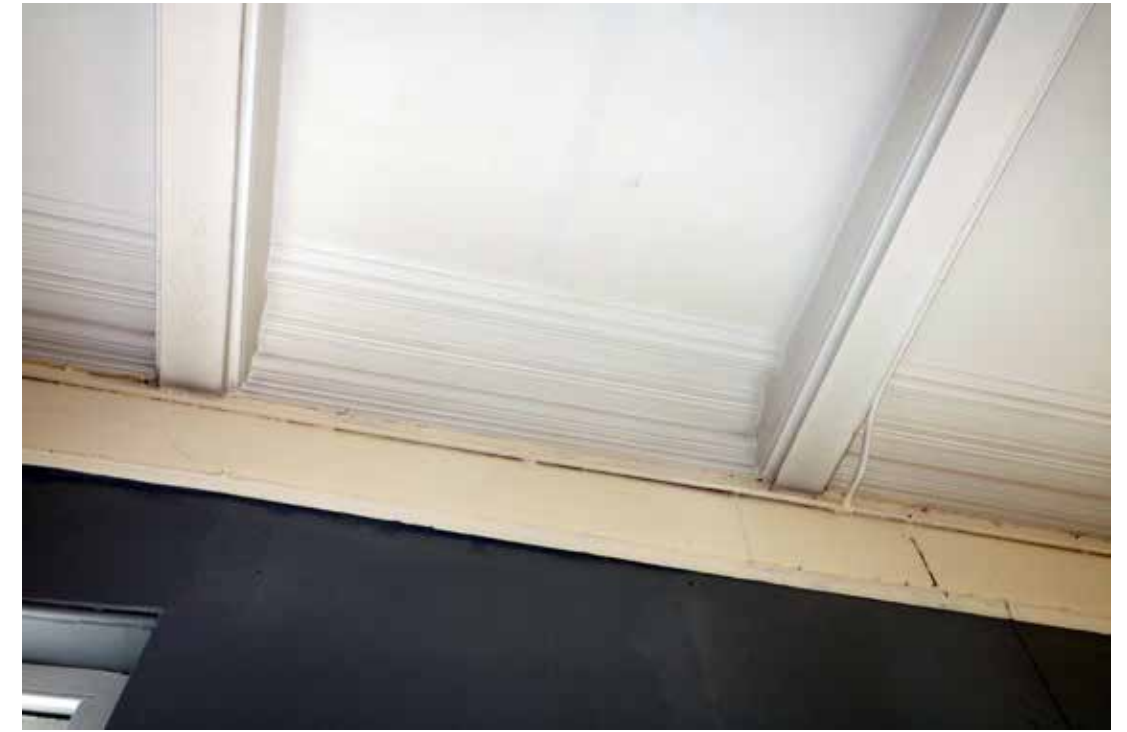
The cornice on the second floor is an original feature of the building, dating from c.1878. It is heavily moulded, with a fillet profile to the wall surface extending across to the ceiling.

This type of cornice is visible to the central room to the north rear range (2/15) and south rear range (2/16) on the second floor. There is a degree of architectural interest from the design of the cornice, with its profusion of parallel convex mouldings of varying sizes and the depth of projection onto the ceiling.

Ceiling of room 2/15 with c.1878 cornice. Left: IMG_7609, right: IMG_7610.

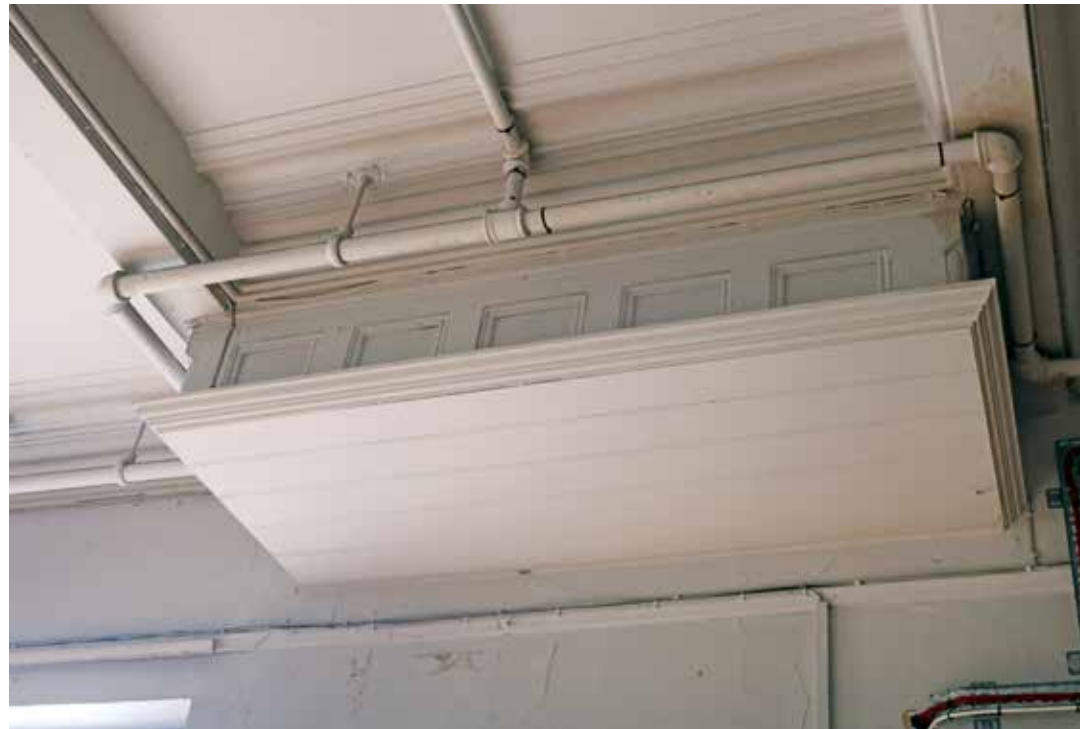
Ceiling of room 2/16 with c.1878 cornice and moulded timber panel boxing and historic service piping. IMG_7625.

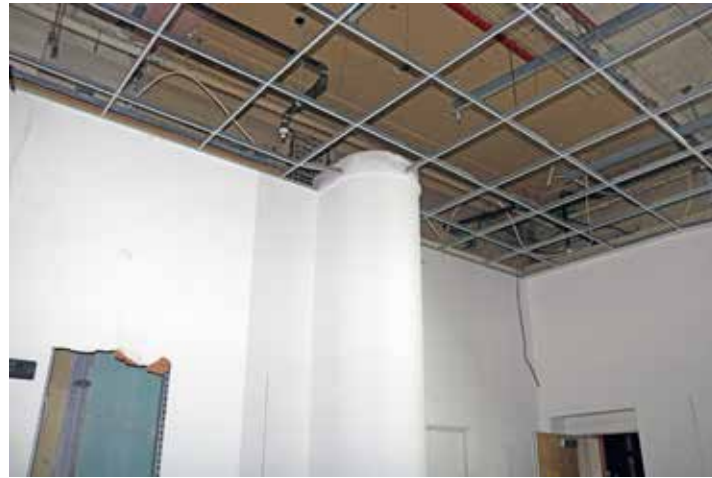
The north corner of 0/04 on the ground floor, which may historically have been partitioned off from the main shop floor. IMG_8049.

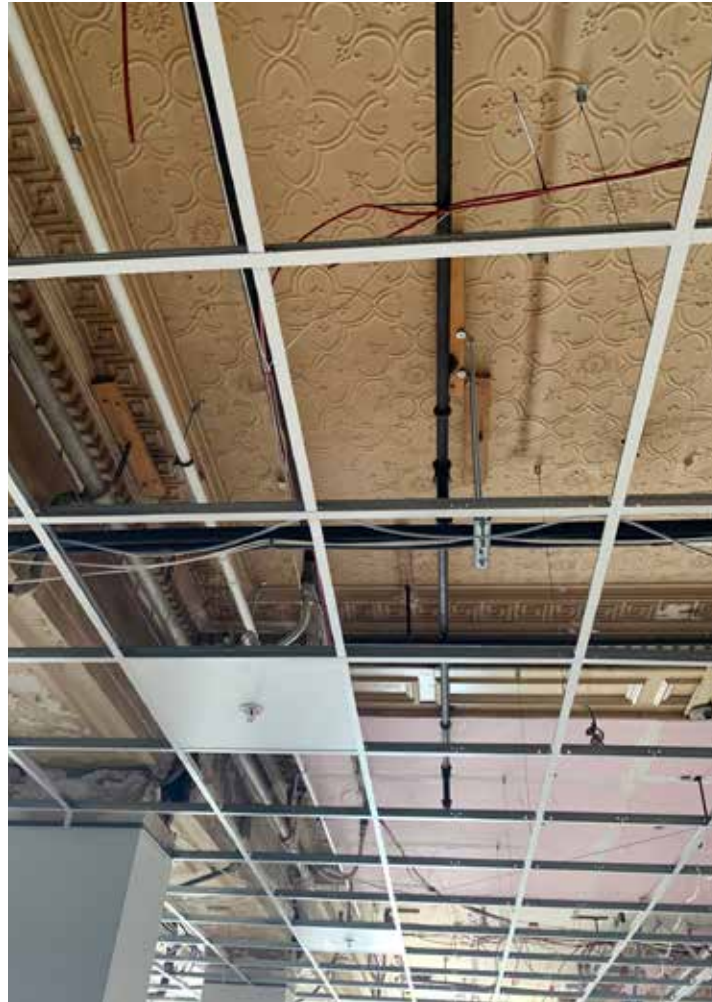
Types B and C are both located in room 1/31. Type B is a repeating pattern of diamond and star motifs with central floral and fleur de lis accents. It closely resembles plaster mouldings and is only present in the south western section of room 1/31/

Anaglypta type B.

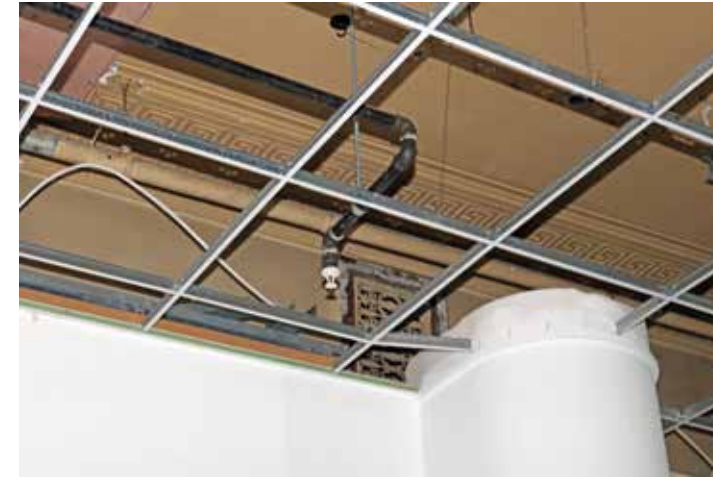
Detail of the type A anaglypta. IMG_8048.

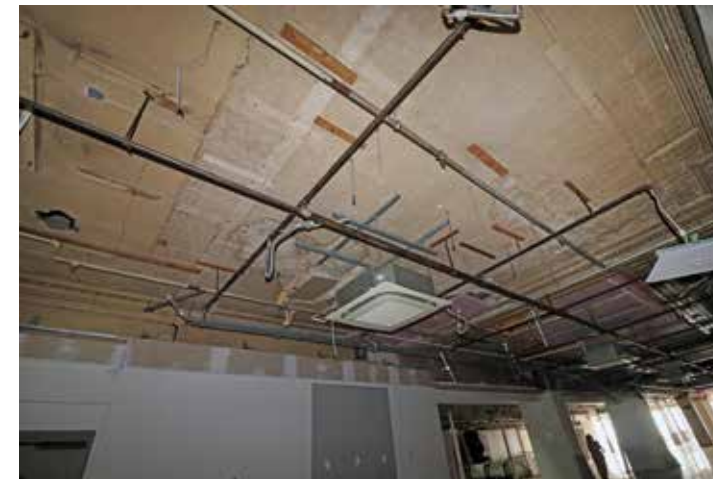
Type C is an interlocking geometric pattern, with leaf accents to create sun shaped focal points. Sections of this anaglypta type have been removed, interrupted by modern servicing and damaged by patches of water ingress. Type C has been more widely used but is still only evident in room 1/31.

Anaglypta type C. IMG_7969.

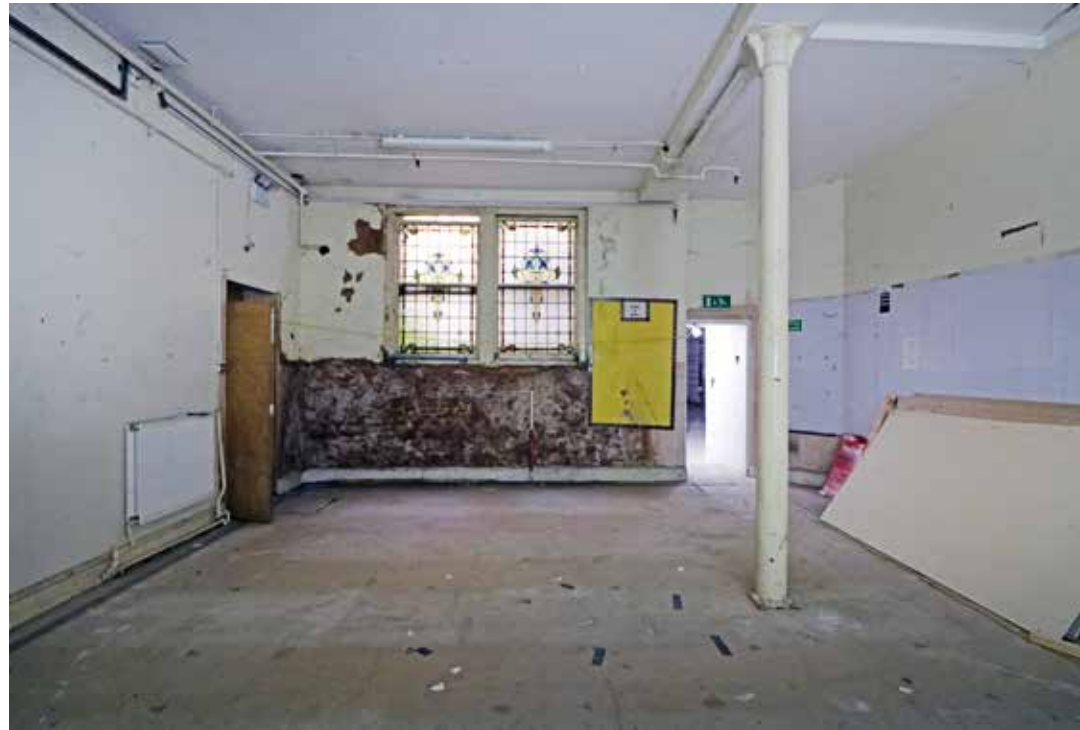
A pair of stained glass timber sash windows have been installed in the ground floor west elevation wall of room 0/07 of the Sunday School north wing.

The stained glass windows are art nouveaux in style and the late Victorian decorative treatment suggests the windows date to c.1900. The central motif is of three four-petalled blue flowers surrounded by a thin stained glass border, ornamented by plant tendrils to each corner.

West elevation wall of room 0/07 on the ground floor of the Sunday School, with the art nouveau windows in context. IMG_8105.

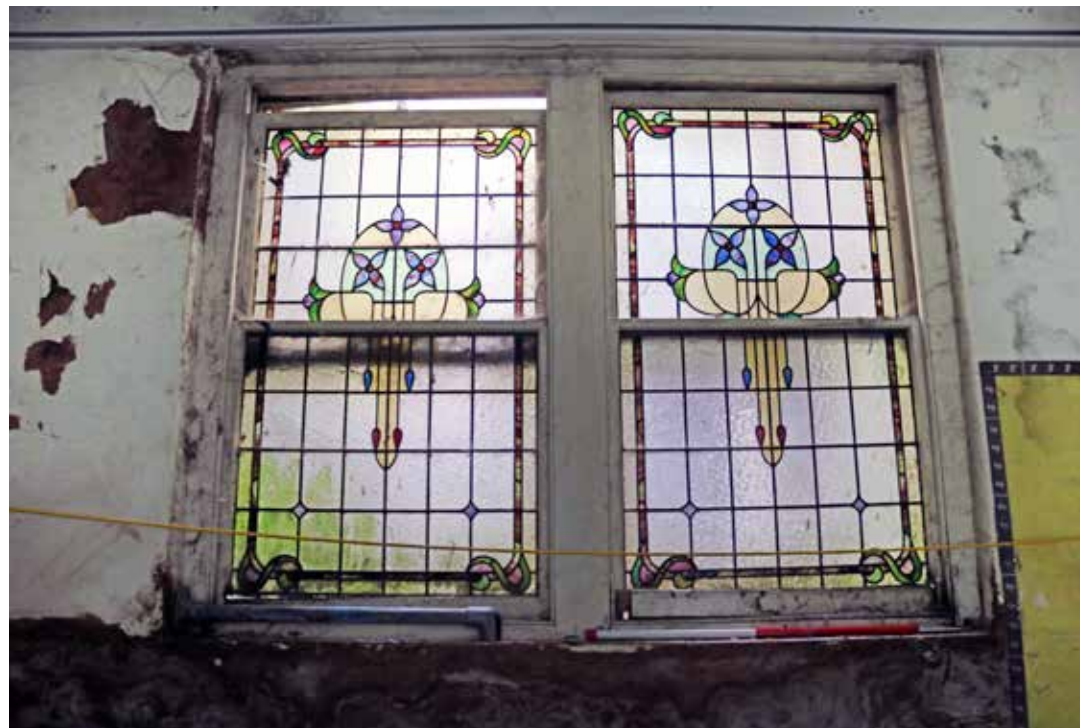
The central floral motif is relatively simple but has been enhanced with a variety of coloured glass, some of which is variegated. The art nouveau style contrasts to the earlier phase of the Sunday School complex and is an indication of the historic development of the site.

Detail of the stained glass design. IMG_8110.

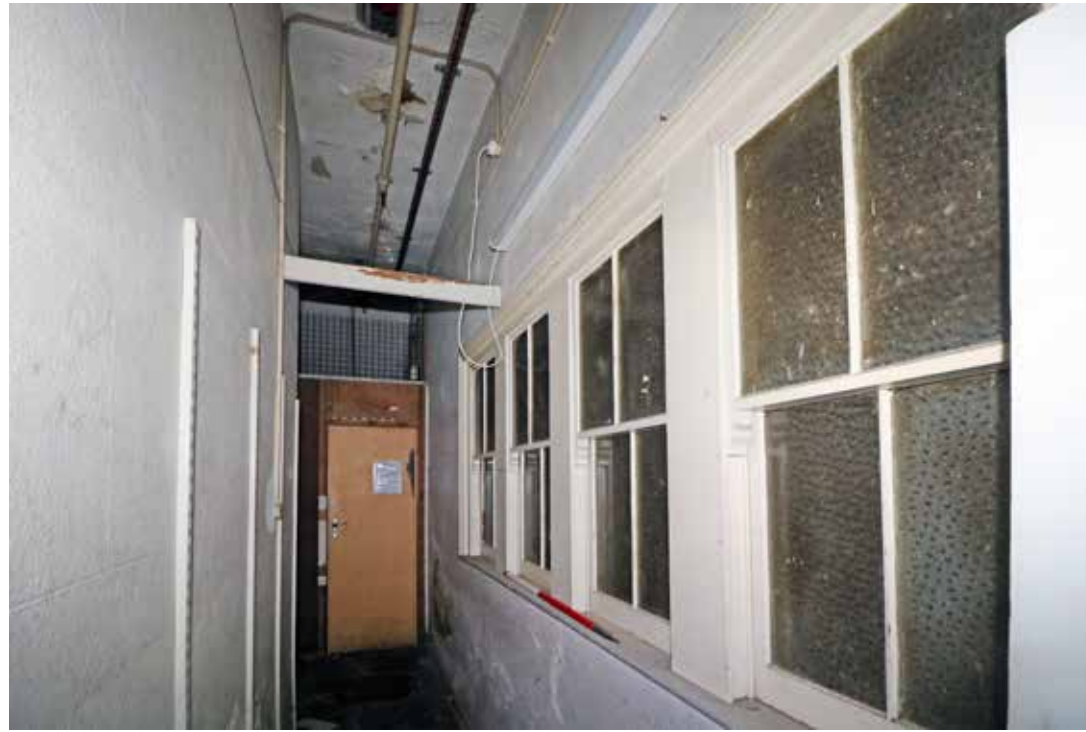
A simple set of four horned timber 2/2 sash windows, set into the north west wall separating the south wing classroom (0/12) from the entrance hall (0/08). These windows are not visible on the 1878 plan of the Sunday School, however they appear to be of late 19th century in origin.

Timber sash windows as seen from 0/08 entrance hall corridor. IMG_8124.

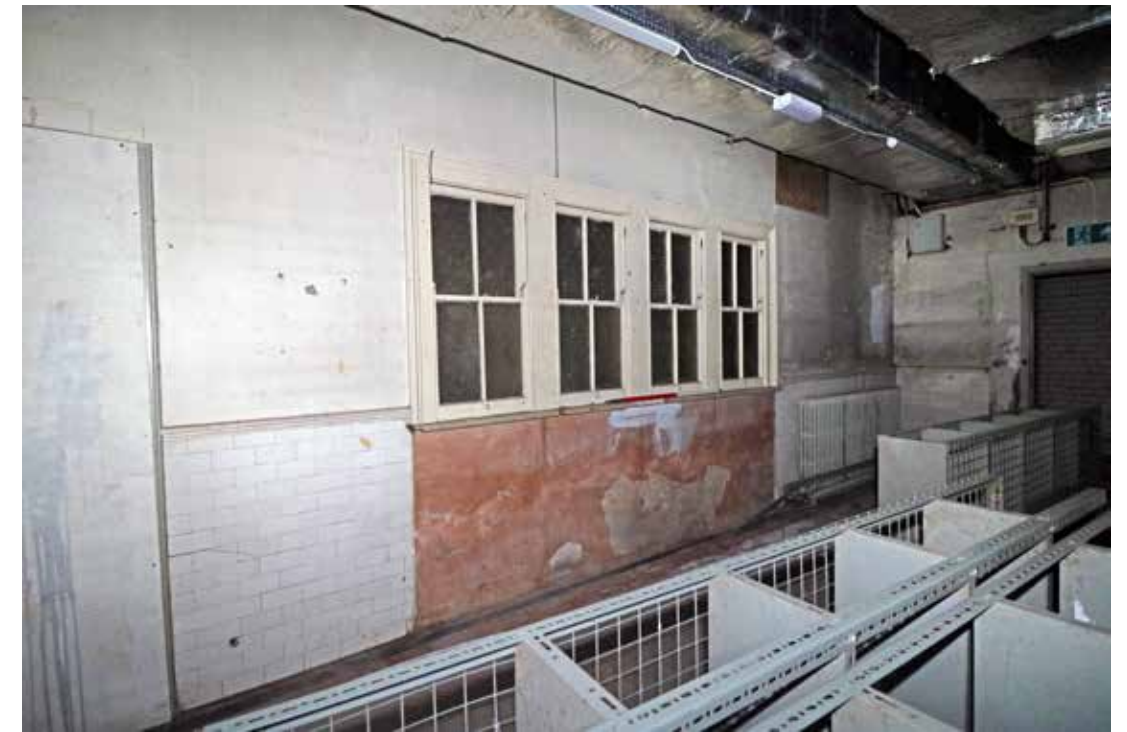
Scarring to the north west wall of 0/12 below these four windows would suggest that this opening was previously a wider doorway opening into the south wing classroom. The white oblong tiling on the walls has been interrupted and the wall beneath the windows has a rendered plaster finish.

Elevation of the north west wall from 0/12, showing the windows with infilled wall beneath. IMG_8145.

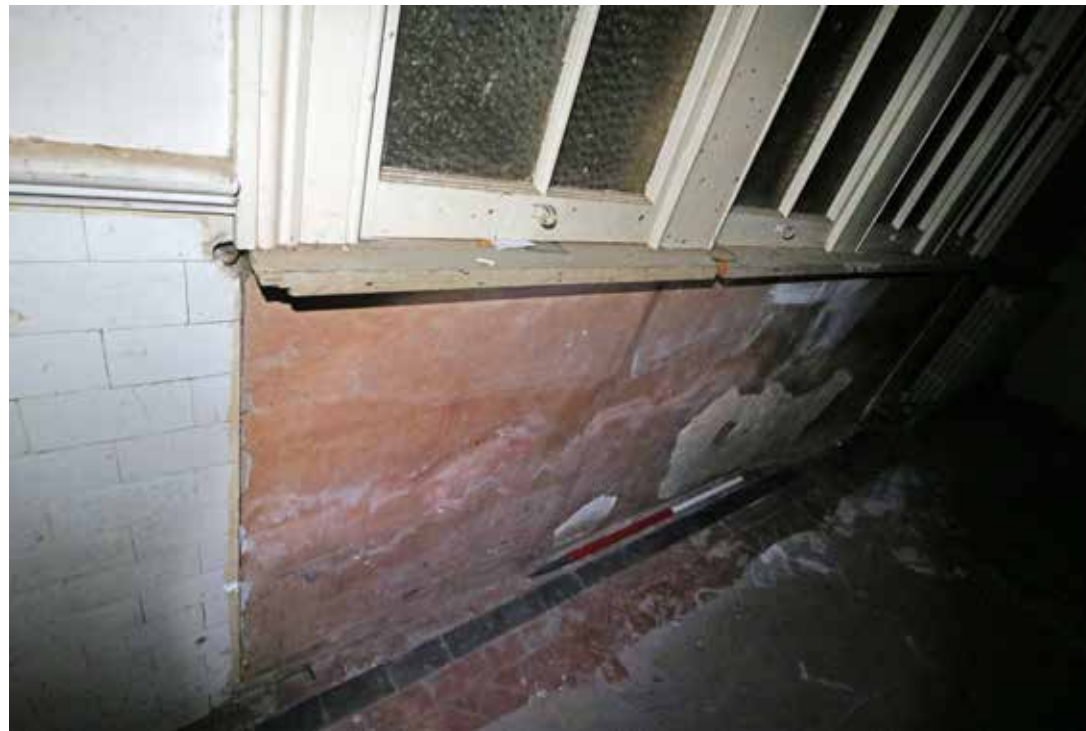
Detail of the join between the tiled finish of the north west wall and the rendered plaster finish beneath the four timber windows. IMG_8149.

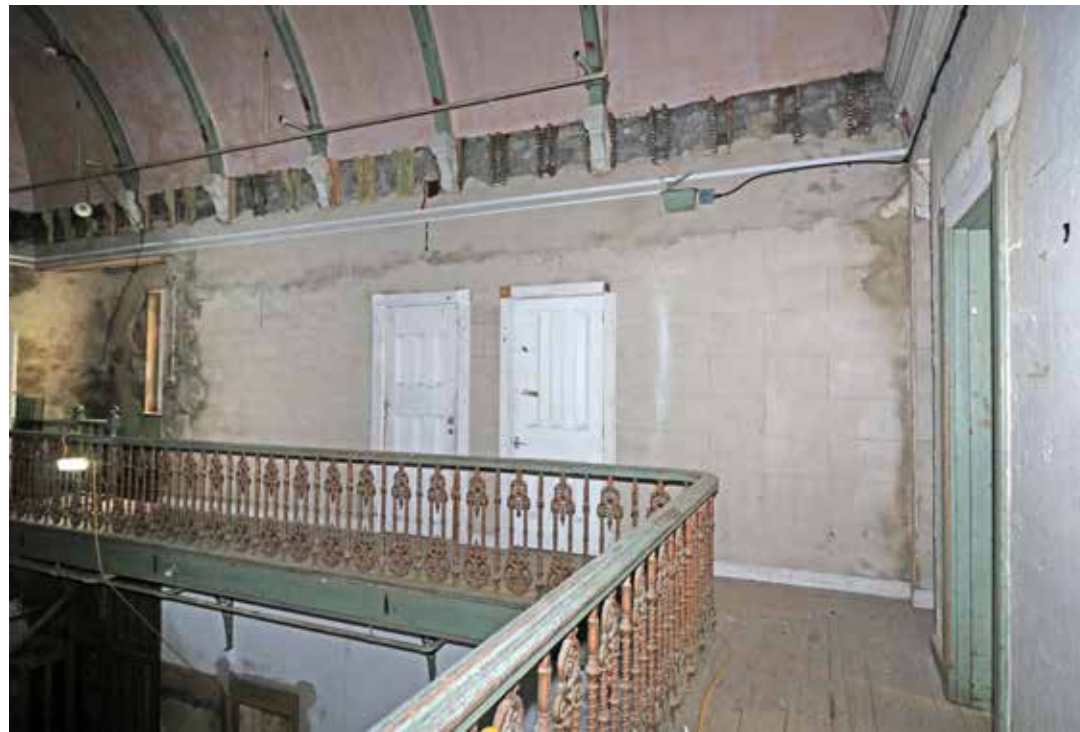
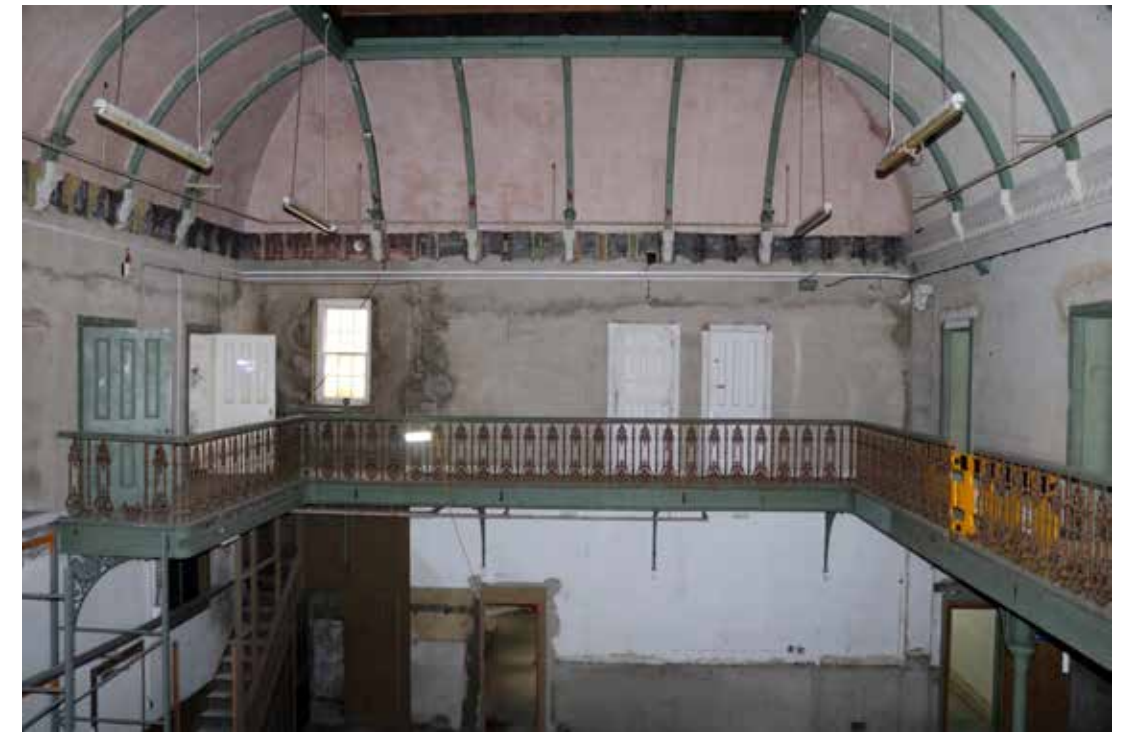
The doorways are of a simple yet characterful treatment, evident in the doors' somewhat distinctive six-panel design. The south west door (to room I/19) comprises of three shorter panels set above three longer panels; the north east door (to room I/17) comprises of three longer panels set above three shorter panels. The panels are all narrow and highly moulded and the doors themselves are set in moulded door surrounds, with circular bosses located to the top corners of the surrounds.

The two 6 panelled doors in the north west wall as seen from the first floor balcony of the Sunday School. Left: IMG_7807, right: IMG_7815.

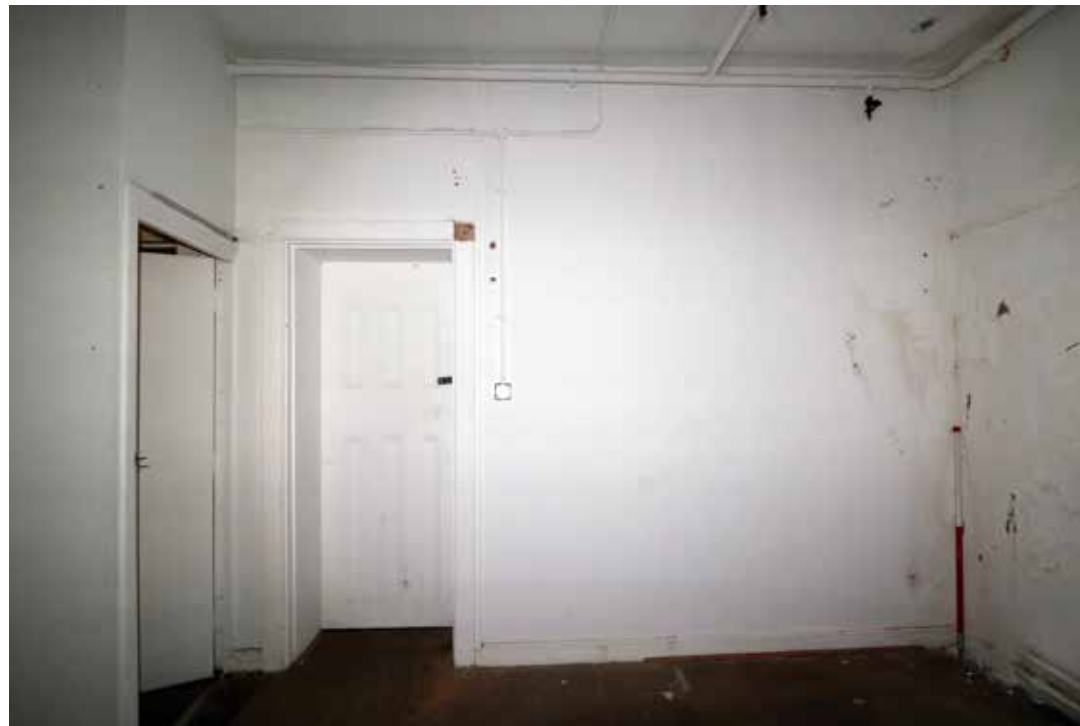
The rear of the south west door as seen from room I/19. IMG_7789.

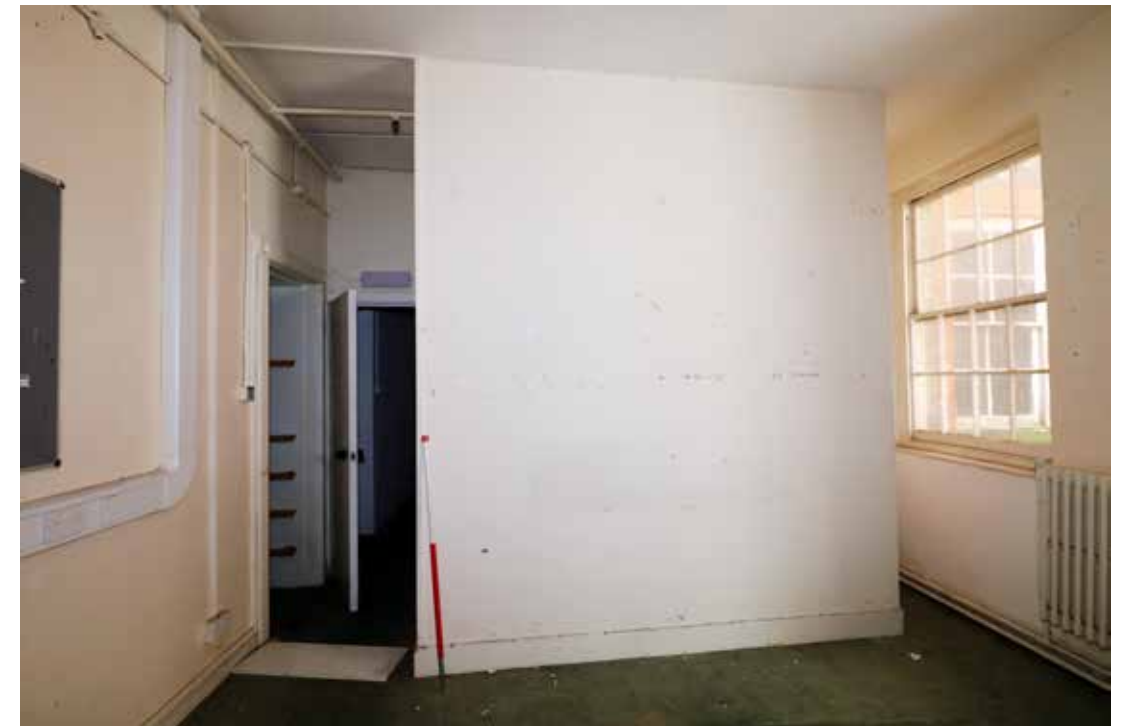
Both doors have deep reveals into the classrooms behind; the north east door into room I/17 has been blocked and timber shelving added to the reveals behind.

Room I/17 showing that the space behind the north east historic door has had timber shelving installed. IMG_7785.

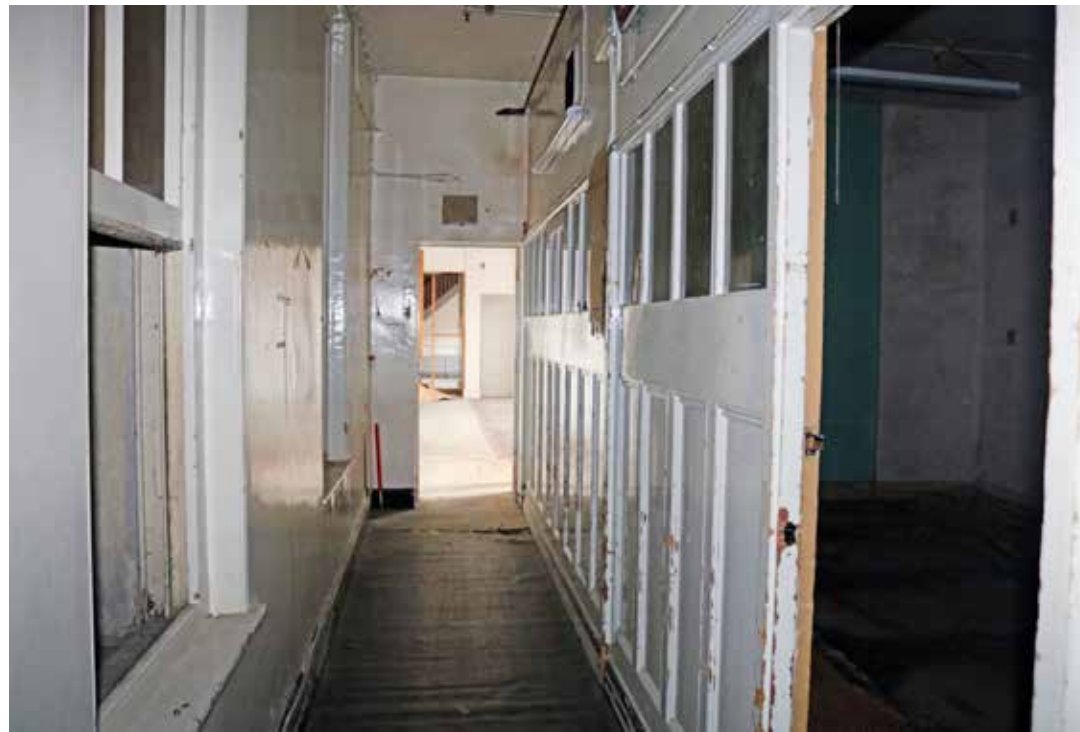
The partition is of a simple design and construction technique. Its heritage significance has been eroded by the blocking of the adjacent lightwell to the east, undermining the legibility of its original purpose. Despite this, it is a characterful addition to the space and illustrates the historic development and function of the wider building.

The timber partition wall as seen from the corridor, looking north west, with the blocked lightwell to the east. IMG_7634.

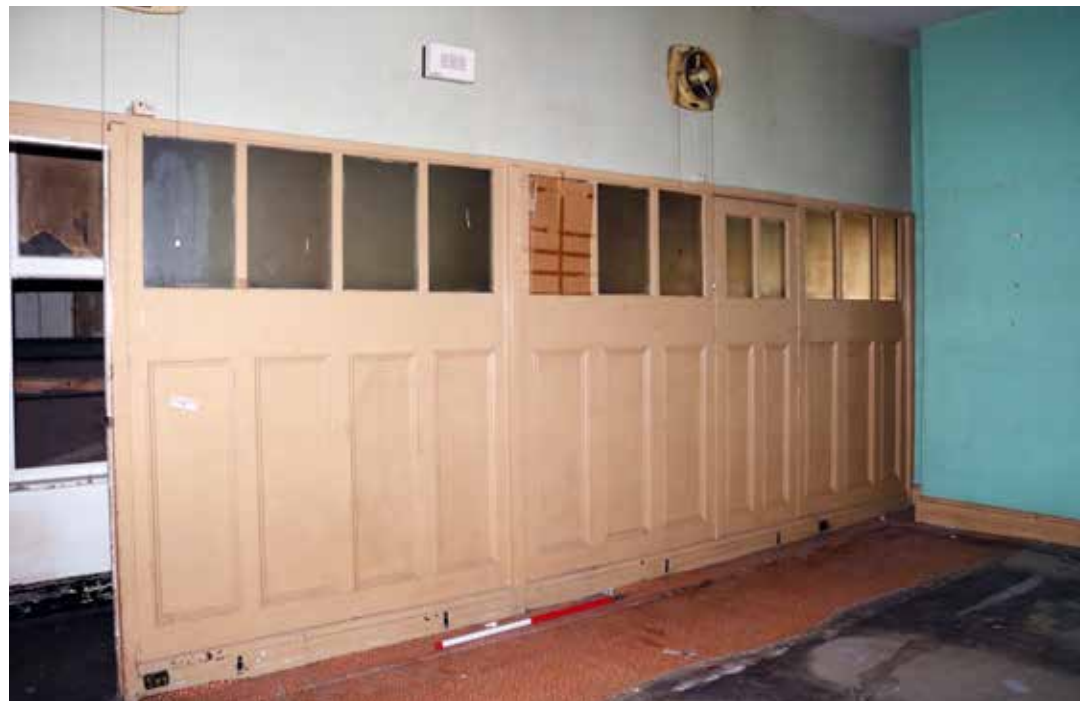
The partition has broad and tall panels that are recessed into the lower level of the partition, with fixed glazed lights above. Doorways have been inserted into the partition on the south and north ends.

The rear side of the timber partition as seen from room 2/17. The inserted doorways can be seen in the first and fourth bays. IMG_7638.

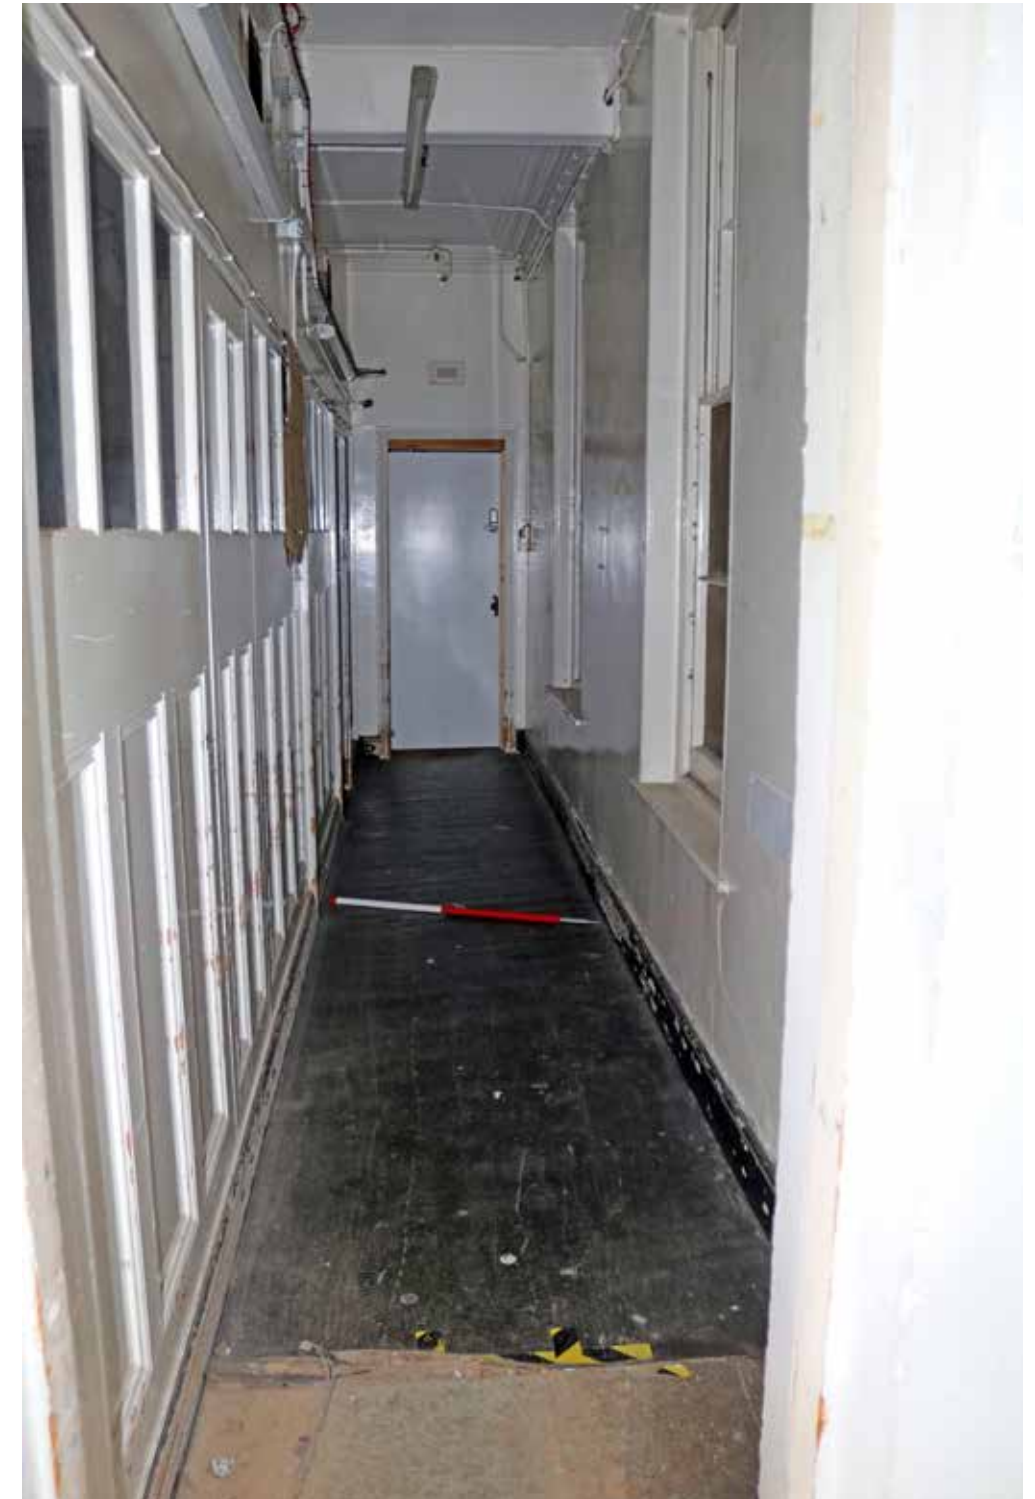
The timber partition within the corridor space, looking south east. IMG_7640.

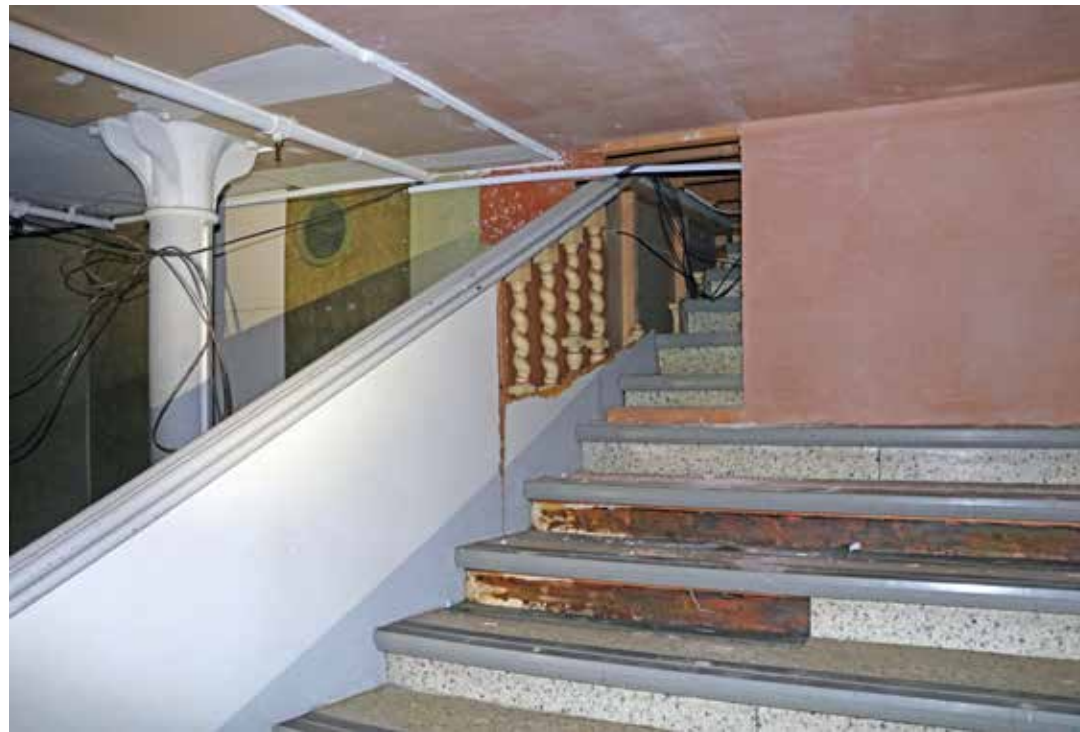
The top of the staircase was cut off when B/12 ceased to be used as part of the shop floor in the latter half of the twentieth century. This resulted in the curtailing of a series of balusters and the handrails, as well as the loss of newel posts from the top of the staircase.

View of the staircase looking south-west, showing the solid boards obscuring much of the balustrading. (b(122)).

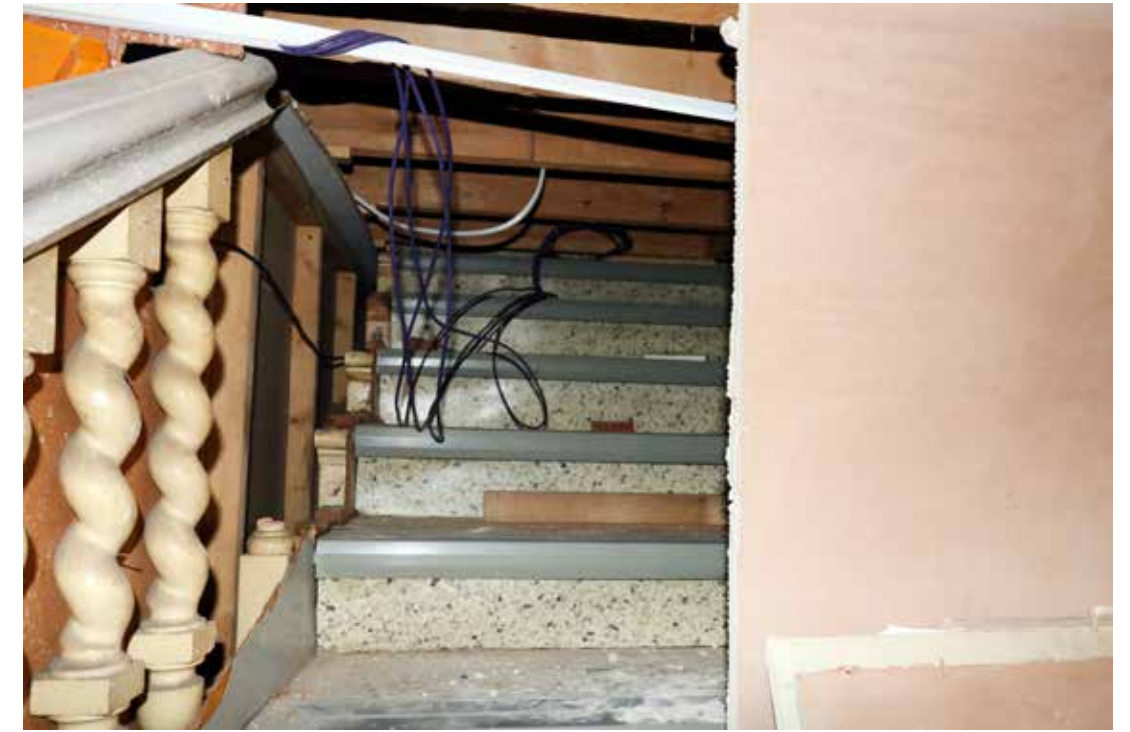
Detail of the historic balusters looking south-west, showing where balusters were cut off to accommodate the new floor above, looking south-west. IMG_0941.

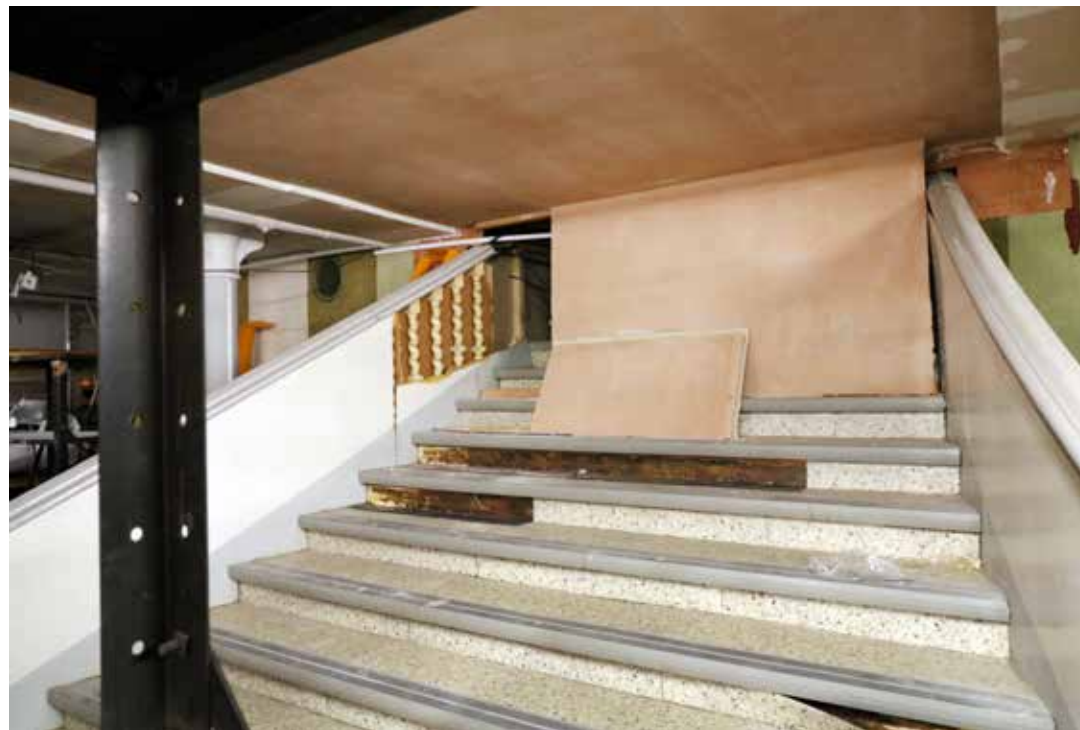
The timber treads and risers are covered by vinyl and the underside of the staircase appears to have been replastered.

View showing where the vinyl has detached from the timber risers, looking south-west. IMG_0938.
