On behalf of Purcell ®

Issue 01
April 2024
TE Cardiff 7 Ltd

HOWELL'S: LEVEL 4 HISTORIC BUILDING RECORD, FORMER HOWELLS DEPARTMENT STORE, CARDIFF

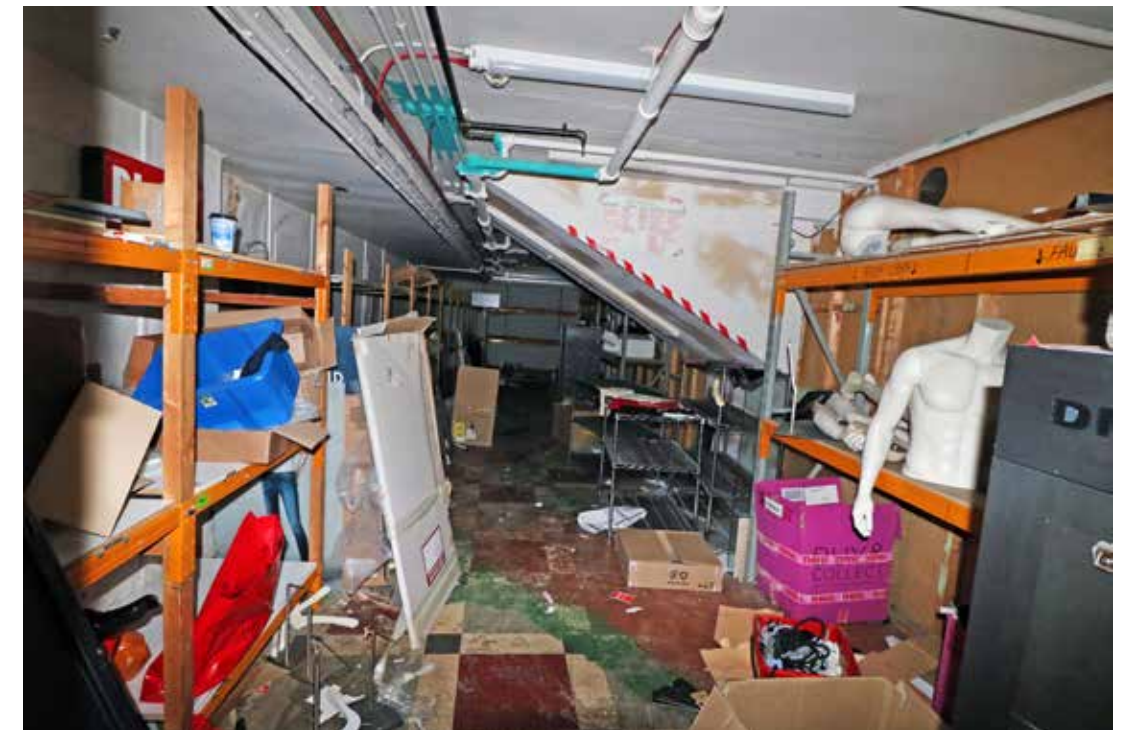
The timber treads and risers are covered by vinyl and the underside of the staircase appears to have been replastered.

Modern plasterboard to the soffit and stringer of the staircase visible in B/10, looking north-west. (b(28)).

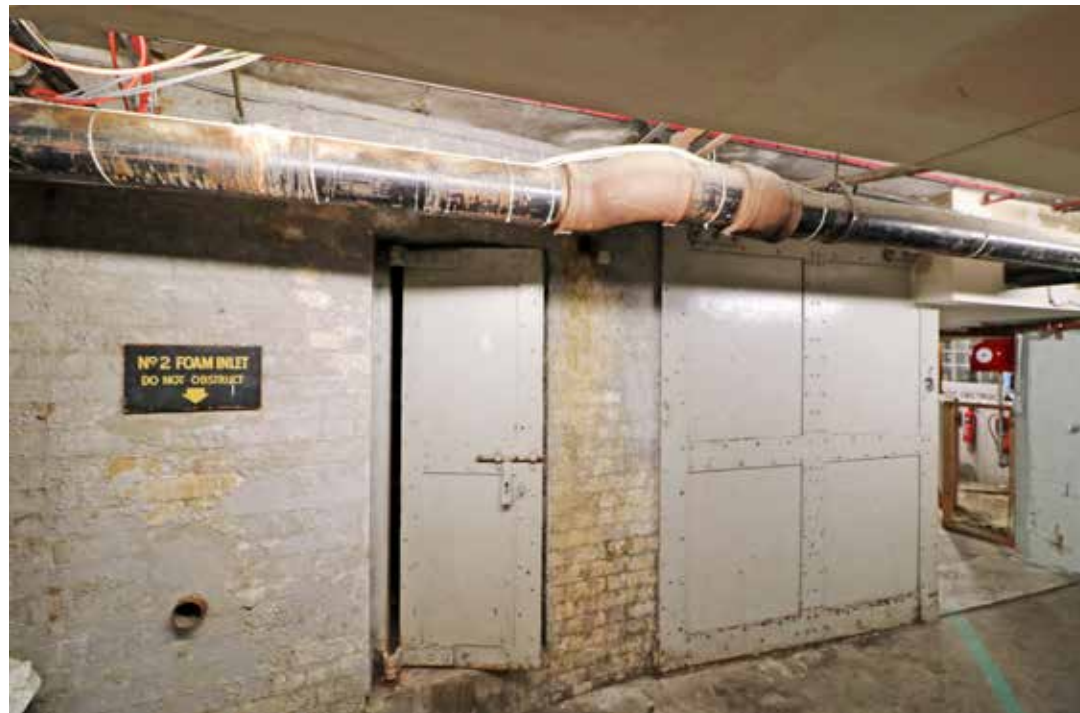
The larger door to the south-west is top hung from a rail, with two castors bolted into the door, allowing it to be slid from side to side with relative ease, despite its substantial mass. However, the door can no longer be moved as modern services run through the opening and modern plasterboard boxing infills the top portion of the opening and part of the door.

There is a slight lip to the threshold of the sliding door, but there does not appear to be any groove for the bottom rail of the door to run within. The door is split into four panels, with riveting to the reinforced rails and stiles.

View of the two fire doors looking south (b(5)).

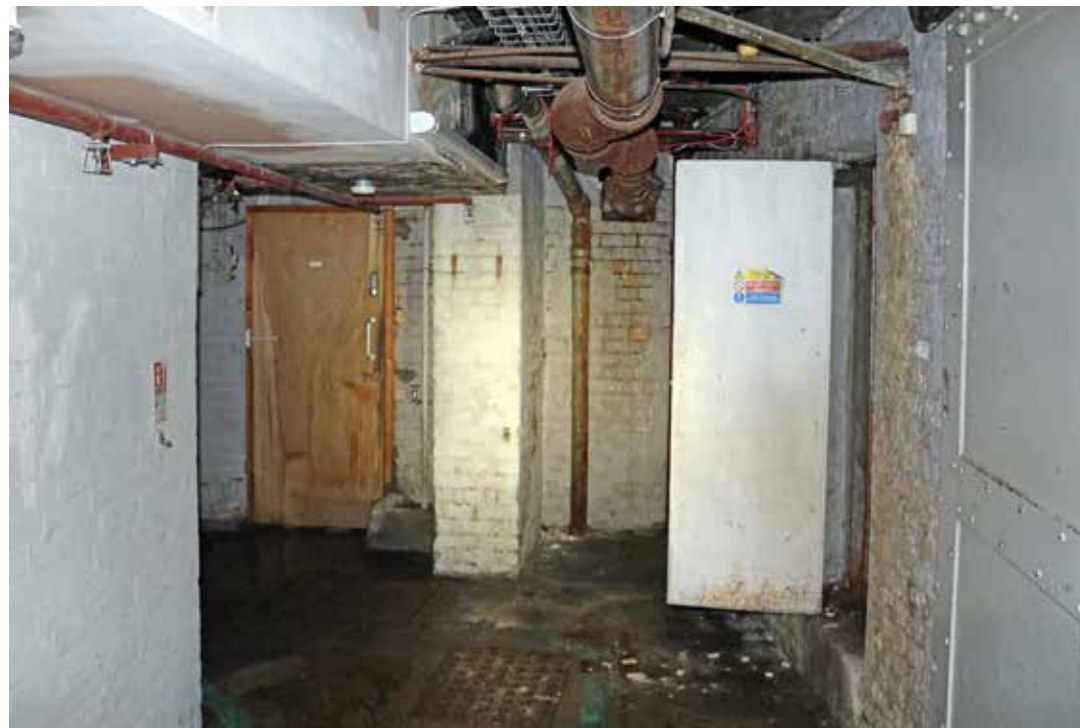
View of the north-west fire door showing the asbestos lining, looking north-east (b(77)).

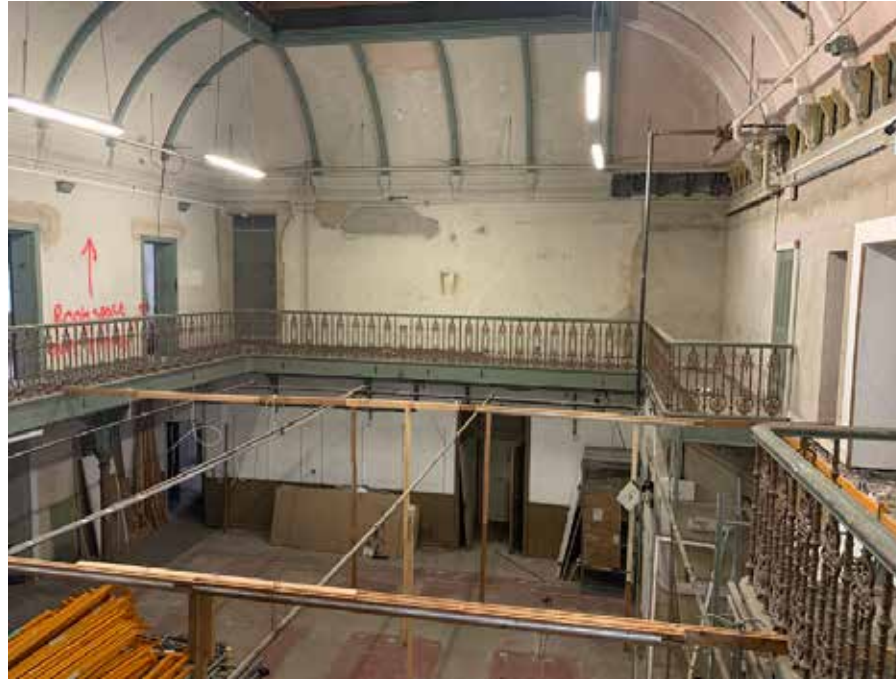
Sunday School interior

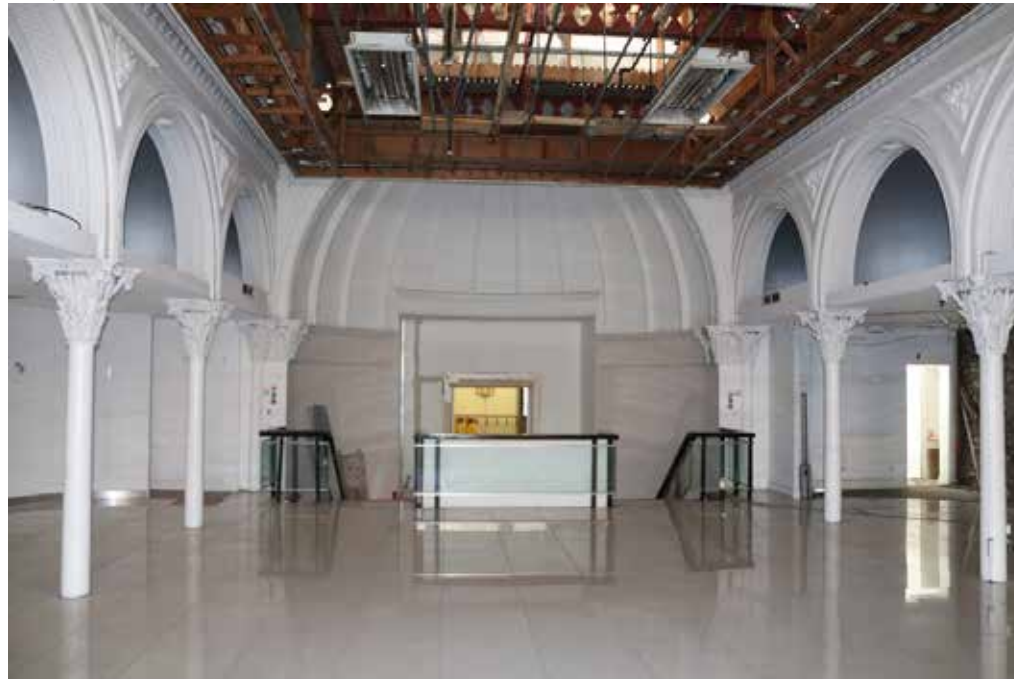
Bethany Baptist Chapel interior

The historic form of the 1865 chapel survives in its basilican plan, with narrow aisles flanking the central aisles, with an eastern Apse. The chapel was divided into various spaces during redevelopment works in the 1960s, during which time a concrete floor was added between ground and first, dividing the single volume space into two shop floors. Large portions of the walls to the north and south were also removed, replaced by long range of double doors to link the space to shop floors on either side. The large organ loft was retained, with a modern stair inserted into the empty apsidal space. Its remodelling in the 1960s to become part of the Howells department store. The empty organ loft within the east of the chapel survives, with modern stairs in the apsidal space.

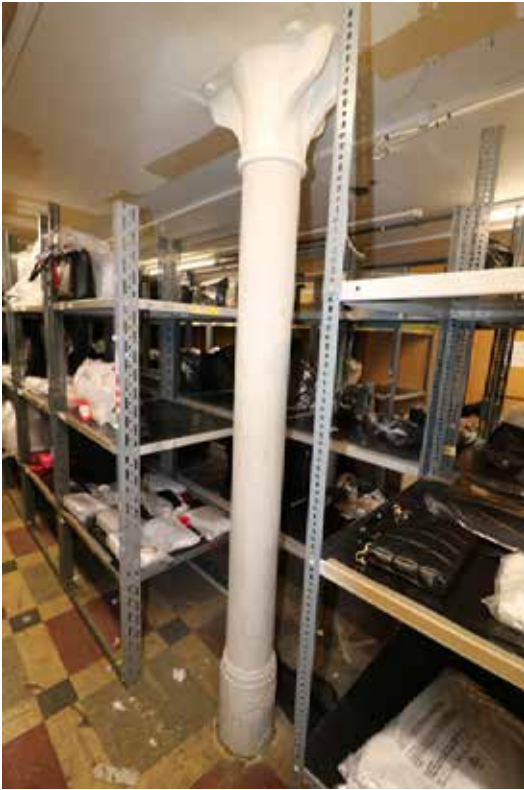
FEATURE NAME	PHASE OF FEATURE	FEATURE DESCRIPTION	LOCATION	SIGNIFICANCE	FEATURE PHOTOGRAPH
BASEMENT					
Cast iron columns	Archibald D. Dawney columns dating to c. 1889	Simple, low profile moulding to the base of the columns, bearing the foundry plate of Archibald D. Dawney. No decorative treatment to capitals.	Open plan space to the eastern end of the St Mary Street basement.	Low heritage significance. Lack the decorative treatment to the capitals evident to the upper floors, suggesting this area was perhaps designed initially to not be an area of shop floor.

Columns produced by Archibald D. Dawnay of London in c.1889 are evidenced on the basement floor. These columns are of a simple design with low-profile moulding to the base of the columns, bearing the foundry plate of Archibald D. Dawnay. There is no decorative treatment to capitals which suggests that this area was perhaps designed initially to not be an area of shop floor and had a distinct 'back of house' character in comparison to the public decorative features. All the columns are within the open plan space to the eastern end of the St Mary Street basement.

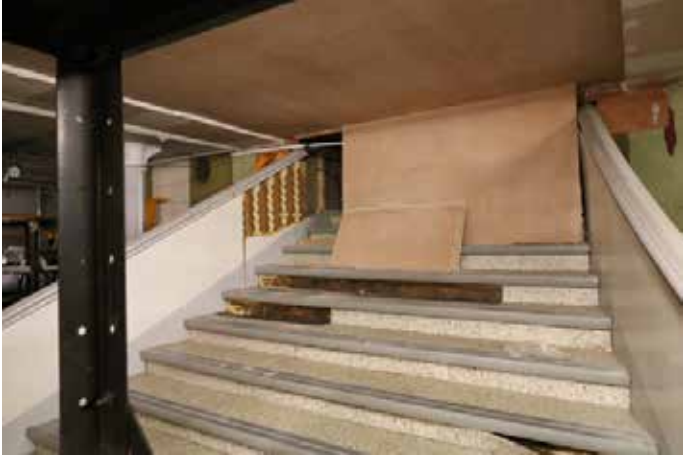
FEATURE NAME	PHASE OF FEATURE	FEATURE DESCRIPTION	LOCATION	SIGNIFICANCE	FEATURE PHOTOGRAPH
Staircase up to ground floor	Late 19th C or early 20th C	Section of twisted balusters visible within former timber boxing	Open plan space to the eastern end of the St Mary Street basement.	Low heritage significance. Modern treads and risers and simple decorative treatment to the balustrade. Later floor blocks access to the ground floor above and areas of the timber balustrade have been cut away.

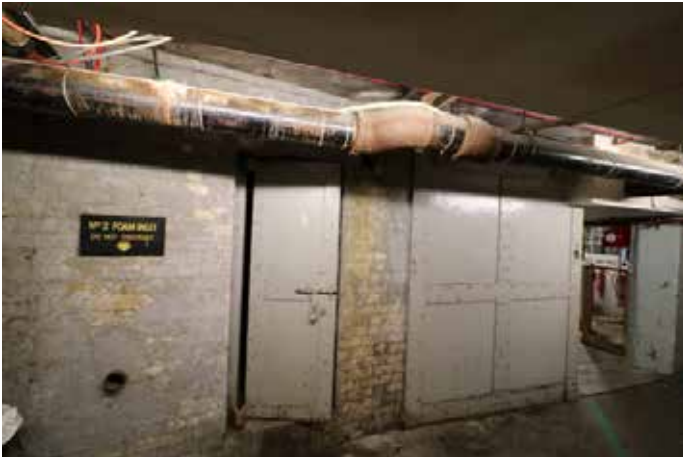
Metal fire doors	Late 19th C or early 20th C	Two thin, riveted metal doors. Broad sliding door and narrow, hinged door. Seemingly installed to create fire compartmentation	North corner of the St Mary Street basement.	Low heritage significance. Utilitarian features which serve to demonstrate the back-of-house nature of this basement area.

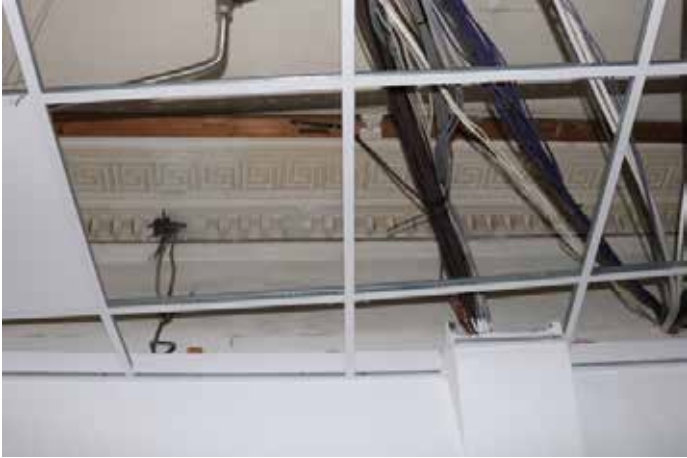
FEATURE NAME	PHASE OF FEATURE	FEATURE DESCRIPTION	LOCATION	SIGNIFICANCE	FEATURE PHOTOGRAPH
GROUND FLOOR					
Meander and dentil cornice	Original – c. 1878 to south of shop, c. 1889 to north of shop	Repetitive plasterwork cornice, with dentil blocks to the angle between the wall/timber boxing and the ceiling. A narrow band of Greek key/meander motif runs parallel to the dentils, along the ceiling.	Survives throughout the shop floor, extending from the St Mary Street front to the rear of the building.	Low to moderate heritage significance. Long obscured by suspended ceilings and accumulated services. Simple decorative motif, easy to produce in large quantities, as is evident at Howell's. Appears to have been appended to a scratch coat, which was run over timber laths to the ceiling.

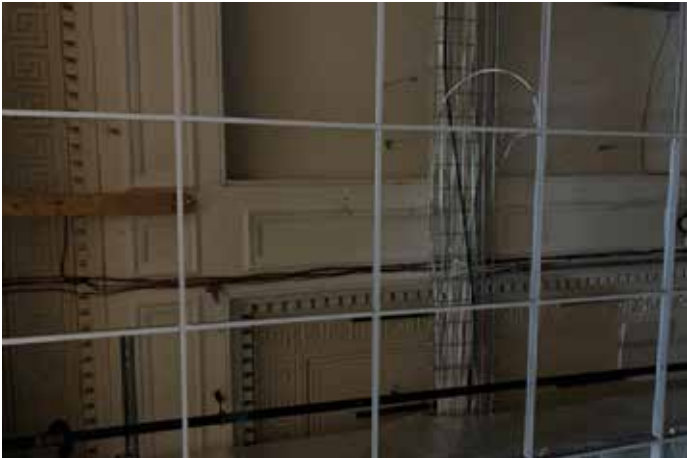
Timber boxing	Original – c. 1878 to south of shop, c. 1889 to north of shop	Timber boxing concealing the structural frame of the St Mary Street building. Bolection moulding forms panels along the underside of the boxing.	Survives throughout the shop floor, extending from the St Mary Street front to the rear of the building.	Low heritage significance. Makes the structure of the building legible internally but has been long-hidden by suspended ceilings and is only ornamented by simple moulded panels.

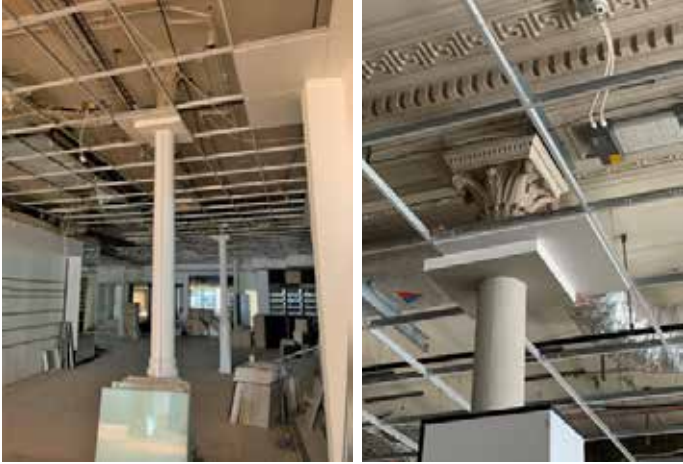
FEATURE NAME	PHASE OF FEATURE	FEATURE DESCRIPTION	LOCATION	SIGNIFICANCE	FEATURE PHOTOGRAPH
Cast iron columns	Original – c. 1878 to south of shop, c. 1889 to north of shop	The pedestal to the columns is square at the base with heavy chamfers shifting it to form an octagon beneath the shaft. They have ornate Corinthian capitals. Most of the columns date to c. 1889 and were made by Archibald D. Dawnay of London, with those adjacent to the chapel produced by Goddard and Massey of Nottingham.	The columns survive throughout the shop floor, extending from the St Mary Street front to the rear of the building.	Moderate heritage significance. The columns have finely detailed capitals and represent an important facet of the shops original decorative scheme. Furthermore, their placement serves to demonstrate the historic plan form of the space.

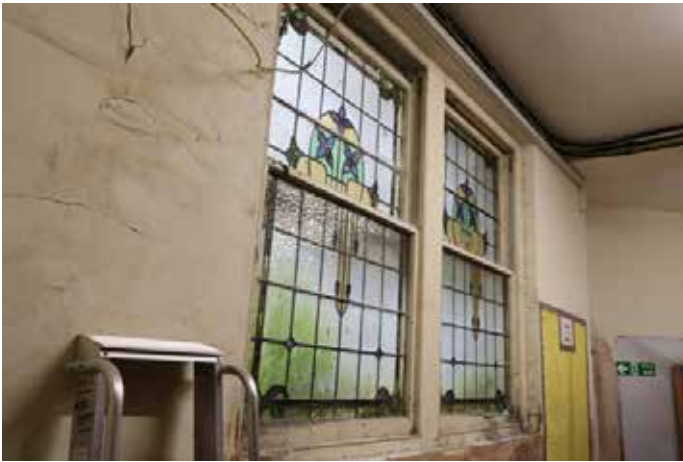
Paired stained glass windows	Art Nouveaux/late Victorian decorative treatment suggests the windows date to c. 1900.	Central motif of three four-petalled blue flowers surrounded by a thin stained glass border, ornamented by plant tendrils to each corner.	West elevation of the Sunday School north wing	Moderate heritage significance. Relatively simple floral motif with a variety of colours used, laying an important part in imbuing the former classroom with a sense of its former use in connection.

A pair of stained glass timber sash windows have been installed in the ground floor west elevation wall of room 0/07 of the Sunday School north wing.

The stained glass windows are art nouveaux in style and the late Victorian decorative treatment suggests the windows date to c.1900. The central motif is of three four-petalled blue flowers surrounded by a thin stained glass border, ornamented by plant tendrils to each corner.

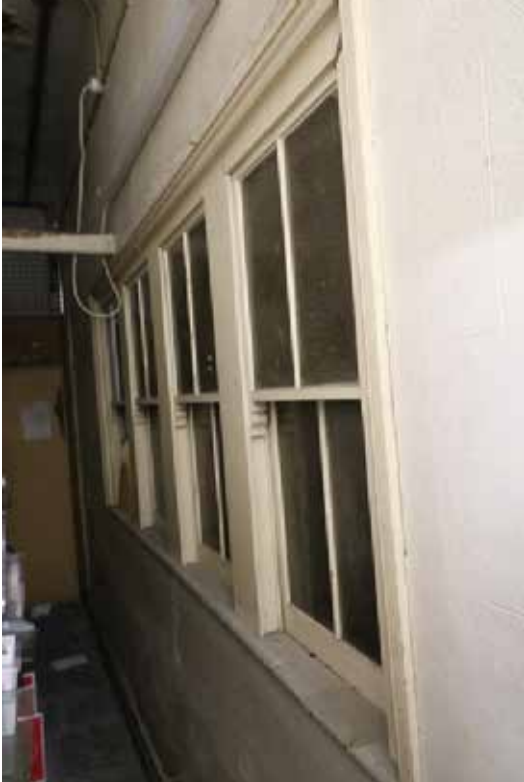
FEATURE NAME	PHASE OF FEATURE	FEATURE DESCRIPTION	LOCATION	SIGNIFICANCE	FEATURE PHOTOGRAPH
Four sash windows	Although they aren't shown on the 1878 plan of the Sunday School, they appear to be of late 19th C date.	Simple set of horned timber sash windows, set into the wall separating the south wing classroom from the entrance hall.	South wing of the Sunday School, separating the former entrance hall and classroom.	Low heritage significance. Simple set of four horned sash windows which remains as an idiosyncratic survival, given the main Sunday School entrance hallway has been blocked for the past 60 years.

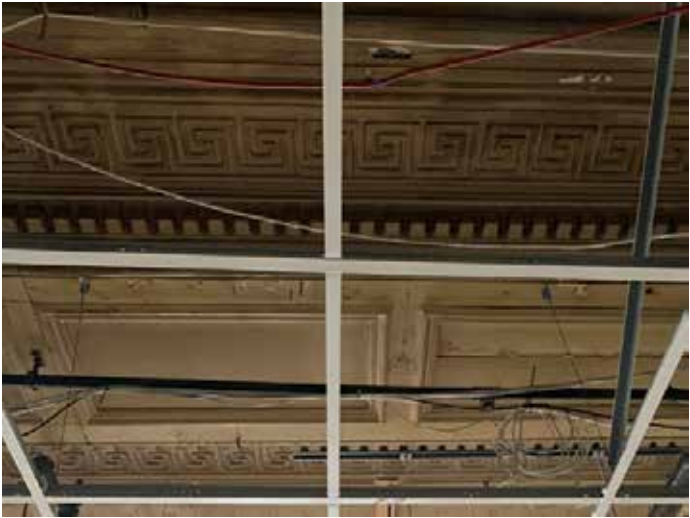
FEATURE NAME	PHASE OF FEATURE	FEATURE DESCRIPTION	LOCATION	SIGNIFICANCE	FEATURE PHOTOGRAPH
FIRST FLOOR					
Meander and dentil cornice	Original – c. 1878 to south of shop, c. 1889 to north of shop.	Repetitive plasterwork cornice, with dentil blocks to the angle between the wall/timber boxing and the ceiling. A narrow band of Greek key/meander motif runs parallel to the dentils, along the ceiling.	Survives throughout the shop floor; extending from the St Mary Street front to the rear of the building.	Low heritage significance. Long obscured by suspended ceilings and accumulated services. Simple decorative motif, easy to produce in large quantities, as is evident at Howell's. Appears to have been appended to a scratch coat, which was run over timber laths to the ceiling.

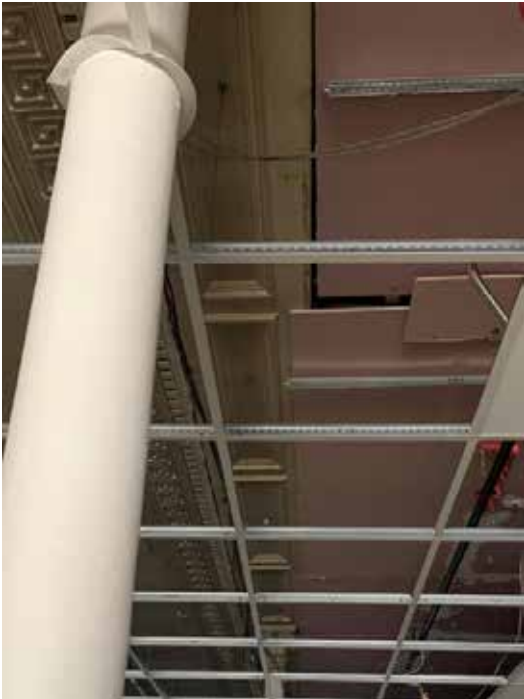
FEATURE NAME	PHASE OF FEATURE	FEATURE DESCRIPTION	LOCATION	SIGNIFICANCE	FEATURE PHOTOGRAPH
Timber boxing	Original – c. 1878 to south of shop, c. 1889 to north of shop	Timber boxing concealing the structural frame of the St Mary Street building. Bolection moulding forms panels along the underside of the boxing.	Survives throughout the shop floor, extending from the St Mary Street front to the rear of the building.	Low heritage significance. Makes the structure of the building legible internally but has been long-hidden by suspended ceilings and is only ornamented by simple moulded panels.

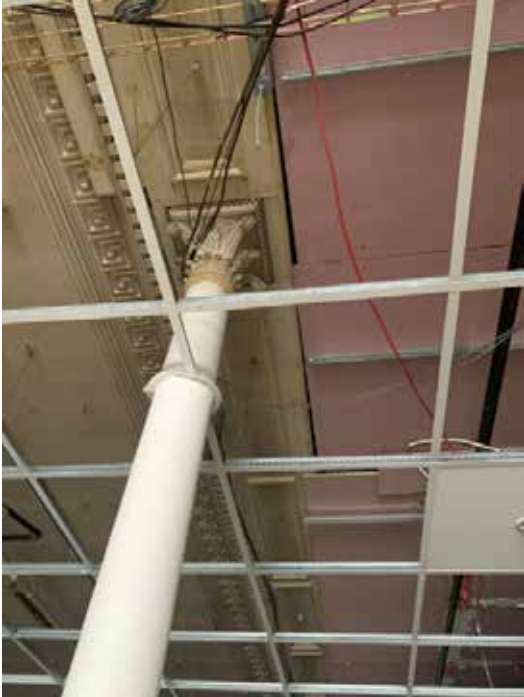
FEATURE NAME	PHASE OF FEATURE	FEATURE DESCRIPTION	LOCATION	SIGNIFICANCE	FEATURE PHOTOGRAPH
Cast iron columns	Original – c. 1878 to south of shop, c. 1889 to north of shop	The pedestal to the columns is square at the base with heavy chamfers shifting it to form an octagon beneath the shaft. They have ornate Corinthian capitals. Most of the columns date to c. 1889 and were made by Archibald D. Dawnay of London, with those adjacent to the chapel produced by Goddard and Massey of Nottingham.	The columns survive throughout the shop floor, extending from the St Mary Street front to the rear of the building.	Low to moderate heritage significance. The columns have finely detailed capitals and represent an important facet of the shops original decorative scheme. Furthermore, their placement serves to demonstrate the historic plan form of the space.

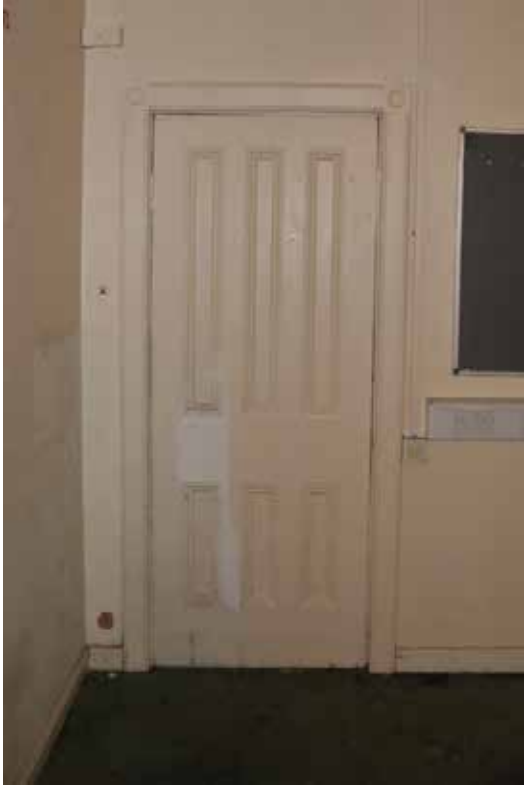
FEATURE NAME	PHASE OF FEATURE	FEATURE DESCRIPTION	LOCATION	SIGNIFICANCE	FEATURE PHOTOGRAPH
Two six-panelled doors	Likely original and installed when the Sunday School was completed in 1879.	The door is comprise of three longer panels set above three shorter panels. The panels are all narrow and highly moulded. They are set in moulded door surrounds, with circular bosses located to the top corners of the surrounds.	Upper level doorways connecting classrooms in the north wing with the central hall of the Sunday School	Low heritage significance. Simple yet characterful treatment, evident in the doors' somewhat distinctive six-panel design.

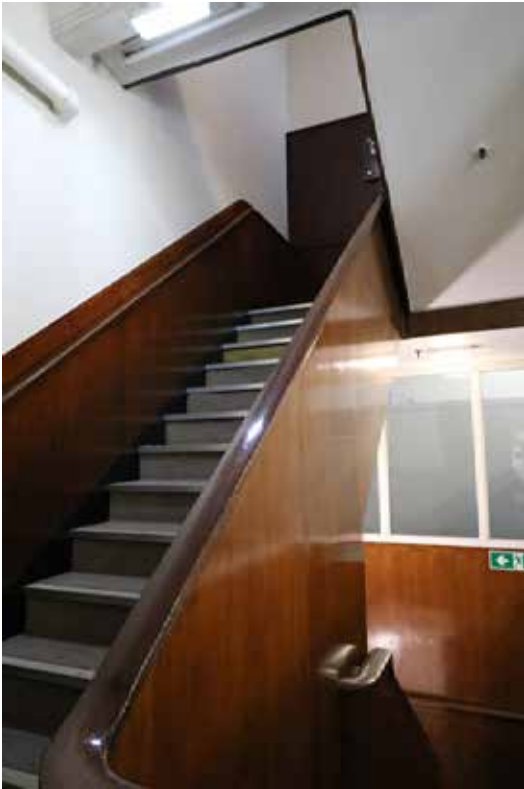
FEATURE NAME	PHASE OF FEATURE	FEATURE DESCRIPTION	LOCATION	SIGNIFICANCE	FEATURE PHOTOGRAPH
SECOND FLOOR					
Staircase	Mid 20th C	The staircase has carpeted treads and timber veneer balustrades. The solid timber handrail ramps up from the landing.	Located to the centre of the northern rear range of the St Mary Street building	Low heritage significance. Simple mid 20th C design and finish to the staircase.

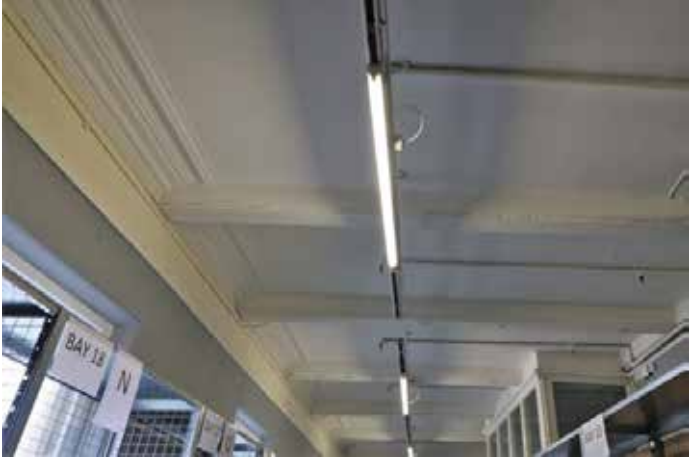
FEATURE NAME	PHASE OF FEATURE	FEATURE DESCRIPTION	LOCATION	SIGNIFICANCE	FEATURE PHOTOGRAPH
Cornice	Original, c. 1878	Heavily moulded cornice, with a fillet profile to the wall surface, extending across to the ceiling.	Visible to the central room to the north rear range and south rear range.	Low heritage significance. Some interest arises from the design of the cornice, with its profusion of parallel convex mouldings of varying sizes.

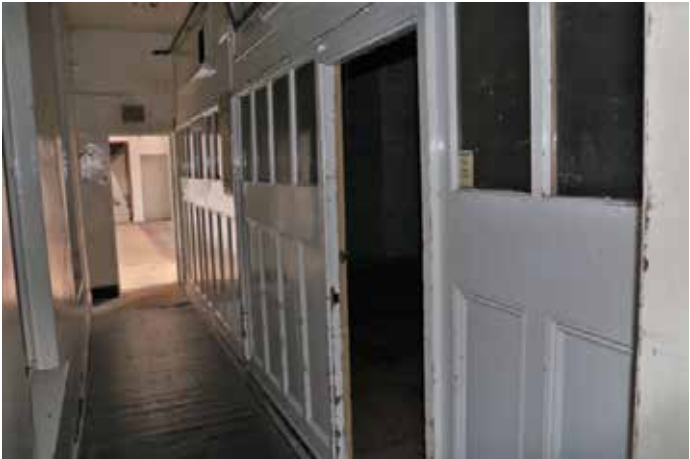
Glazed partition	Late 19th C or early 20th C	Lightweight timber partition, dividing the hallway from an unlit side room. Broad and tall panels are recessed into the lower level of the partition, with fixed glazed lights above.	Located to the east of the second floor lightwell wall. It separates a corridor from a room to western end of north rear range of the St Mary Street building.	Low heritage significance. The partition is simply designed and constructed. Its heritage significance has been eroded by the blocking of the adjacent lightwell, undermining the legibility of its original purpose.
